The Former Black Bull Hotel, Killearn: Archaeological Mitigation

Data Structure Report

on behalf of Killearn Developments Ltd.

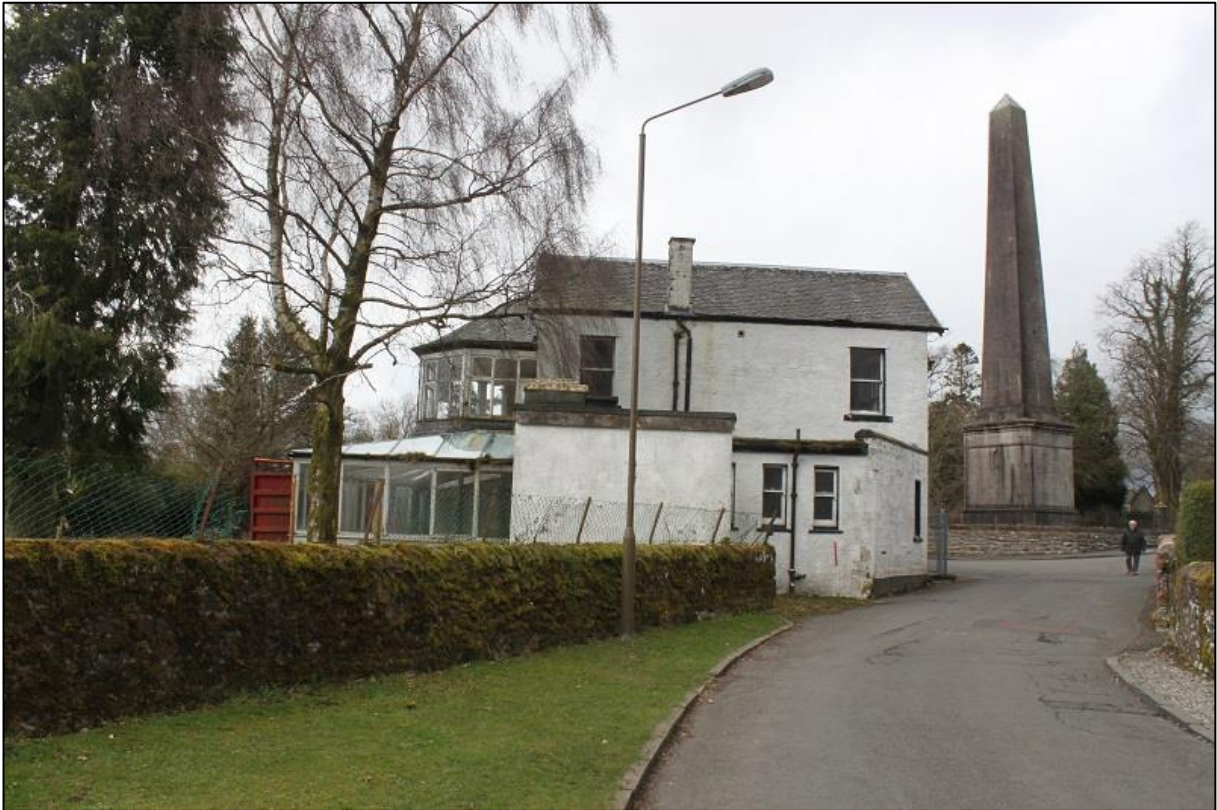
Figure 17a: SE Elevation, Showing Late 19th century Wing With Later Additions to Rear

62. The final area which saw extensive changes during the late 20th century (Phase 6) was the SE end of the SW elevation (Figure 17a). The extension took the form of a conservatory (Rooms di, dii and e) at ground floor level, polygonal on plan, with glazed panes around the external walls. The size of this room was further increased through the removal of the earlier late 19th century wall (which had formed the rear wall of the property), with brick and steel piers added to support the weight of the first floor and roof above. Another opening in the NE end of the NW wall allowed access to the neighbouring food preparation area to the NW, indicating that this large open area had functioned as a restaurant during the latest phase of use at the hotel.

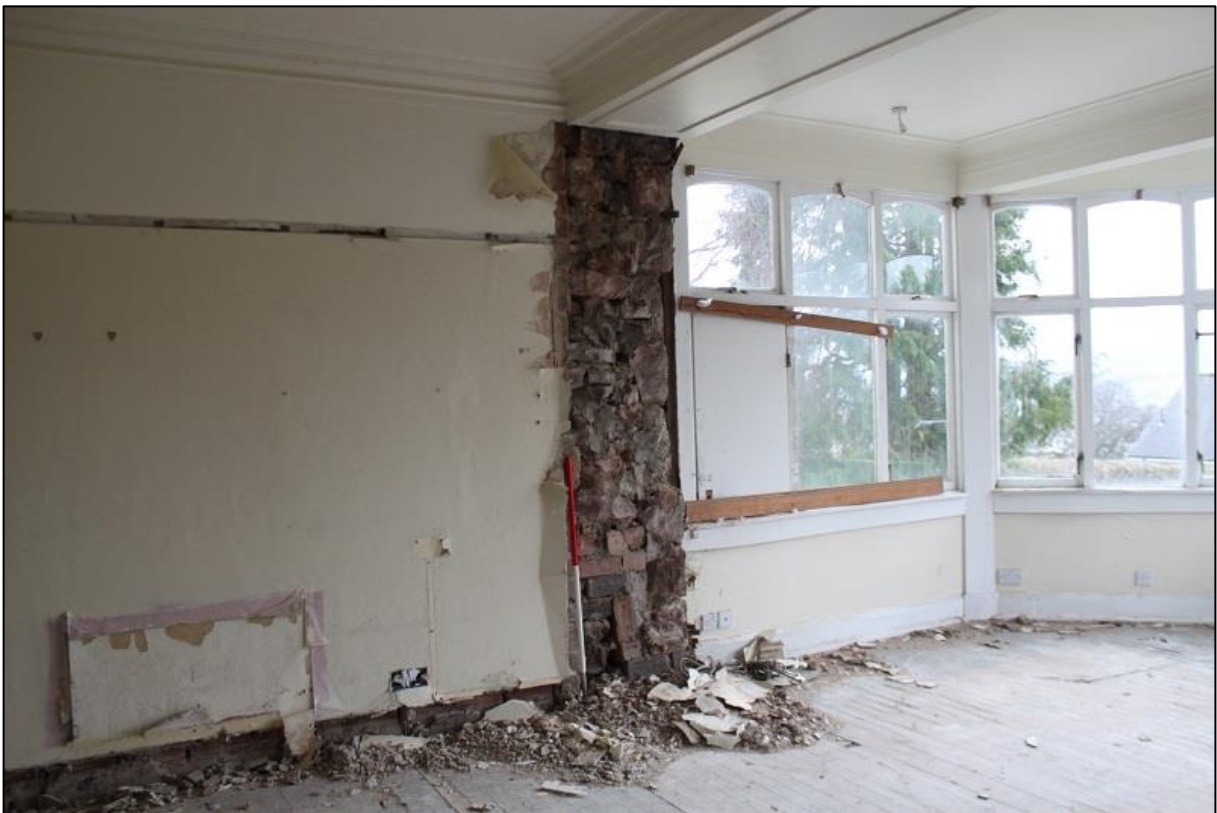
Figure 17a: Interior Room 1d, Showing Later Extension Abutting Late 19th Century Fabric

63. The style of this conservatory was echoed at first floor level in an extension to the Phase 3 Room 1d. Here the rear wall had been removed and the room extended outwards to the SW (Figure 17b), through the creation of a large bay window. This created an apsidal extension that makes extensive use of glazed panes to create a light, airy space. The removal of wall finishes revealed the extent of the surviving earlier fabric and evidence for the entire removal of the SW external wall.

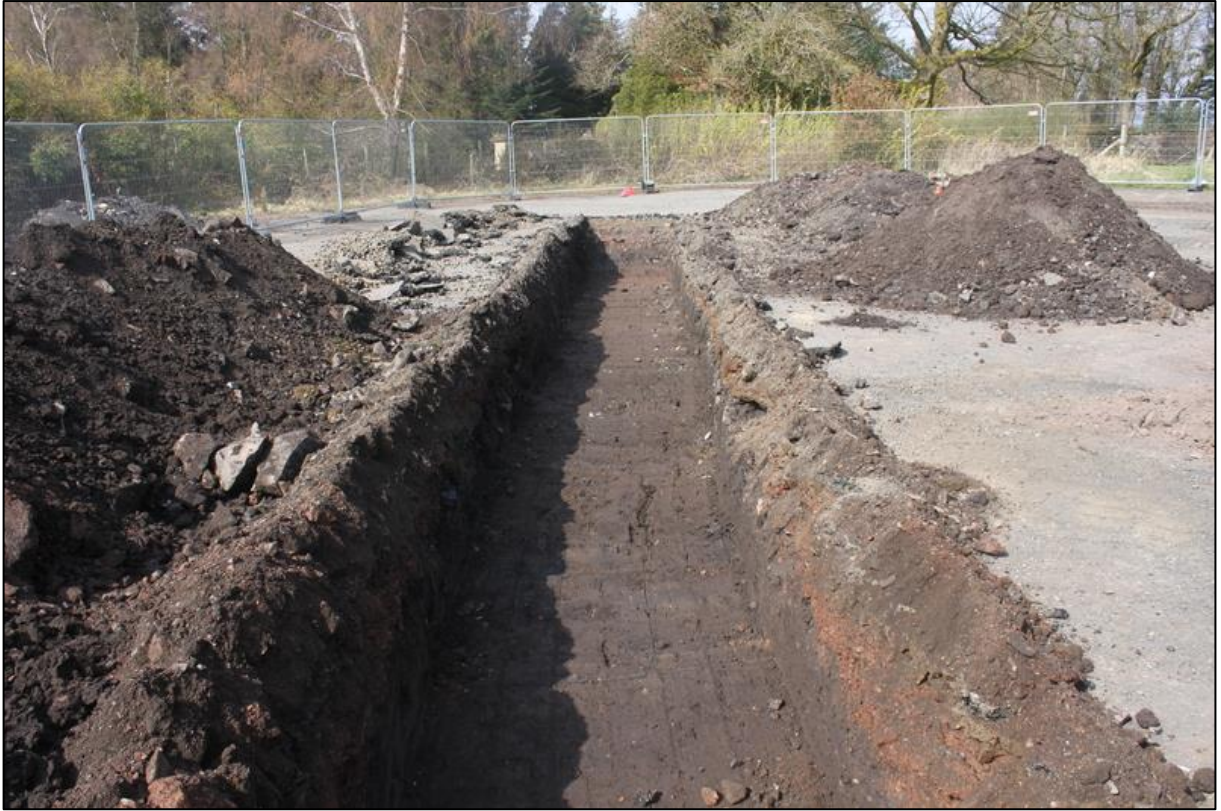
Figure 19a: Post-excitation shot of Trench 2 from the southeast.

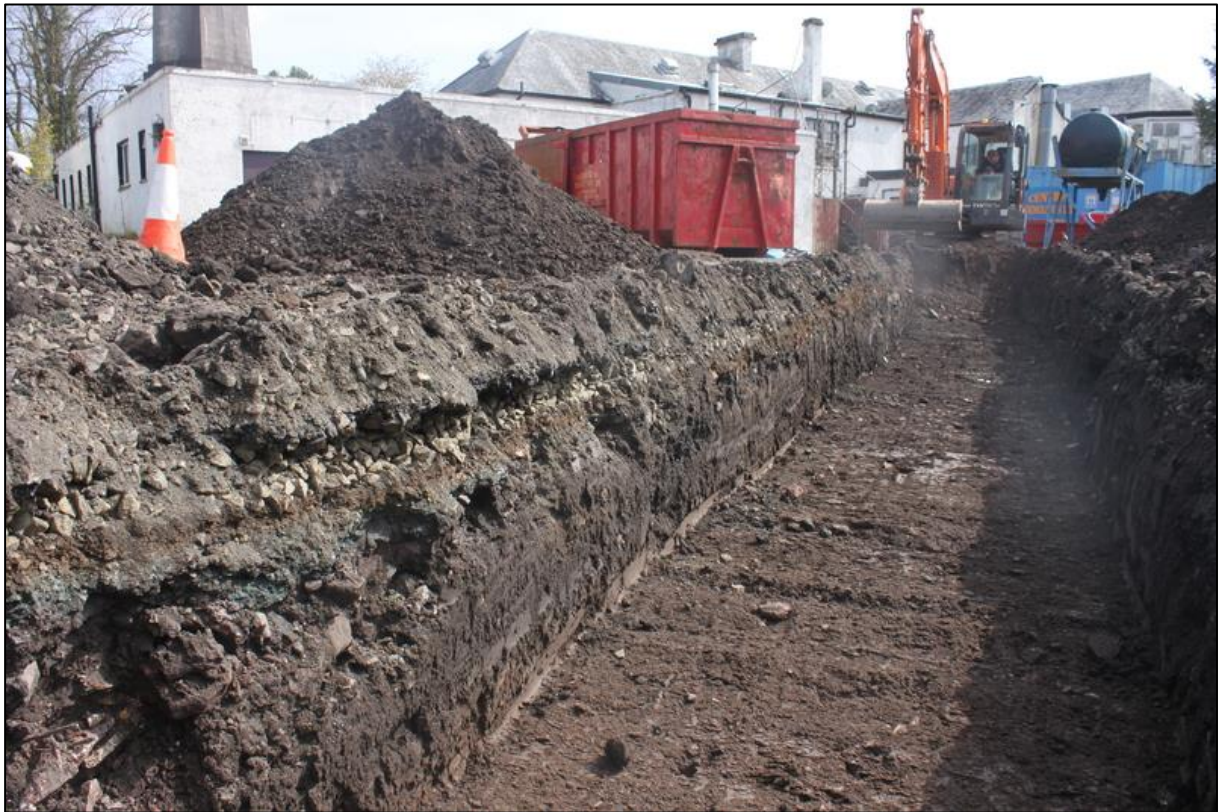
Figure 19b: Post-excitation shot of Trench 3 from the northwest.

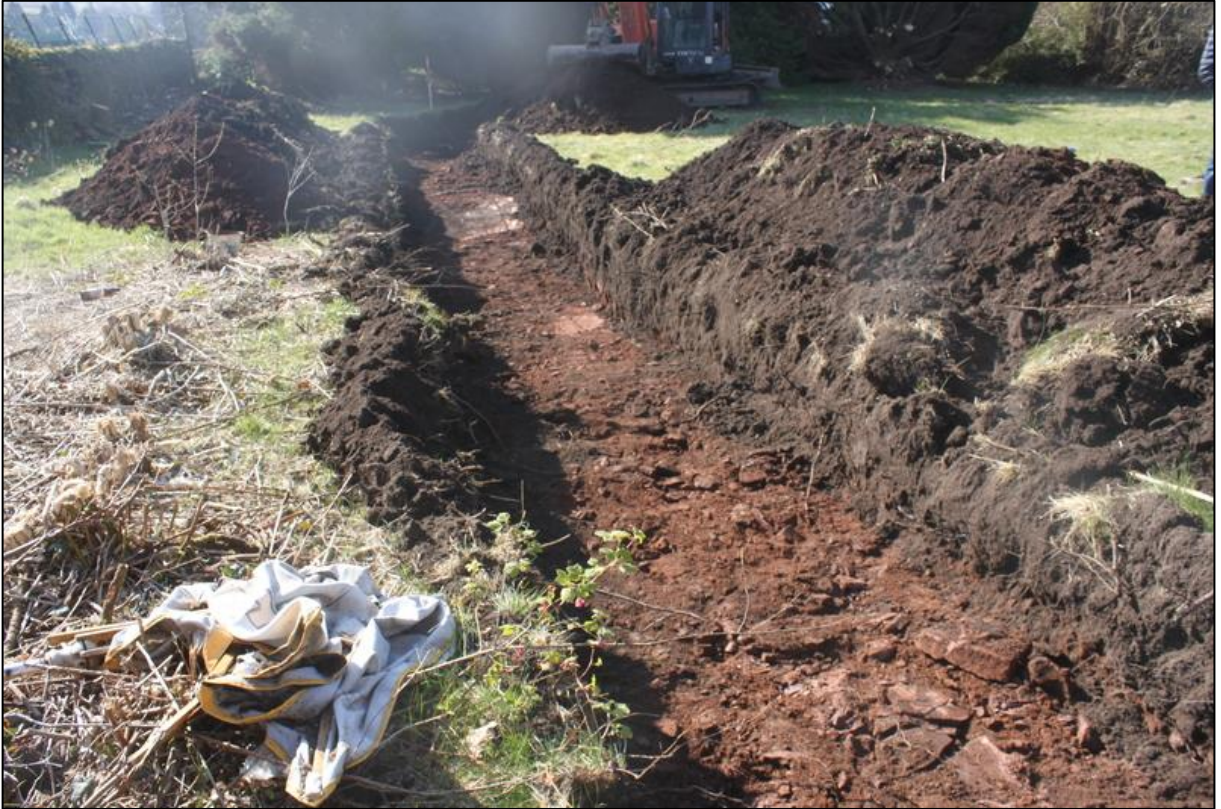
Figure 20a: Post-excavation shot of Trench 5 from the southeast.

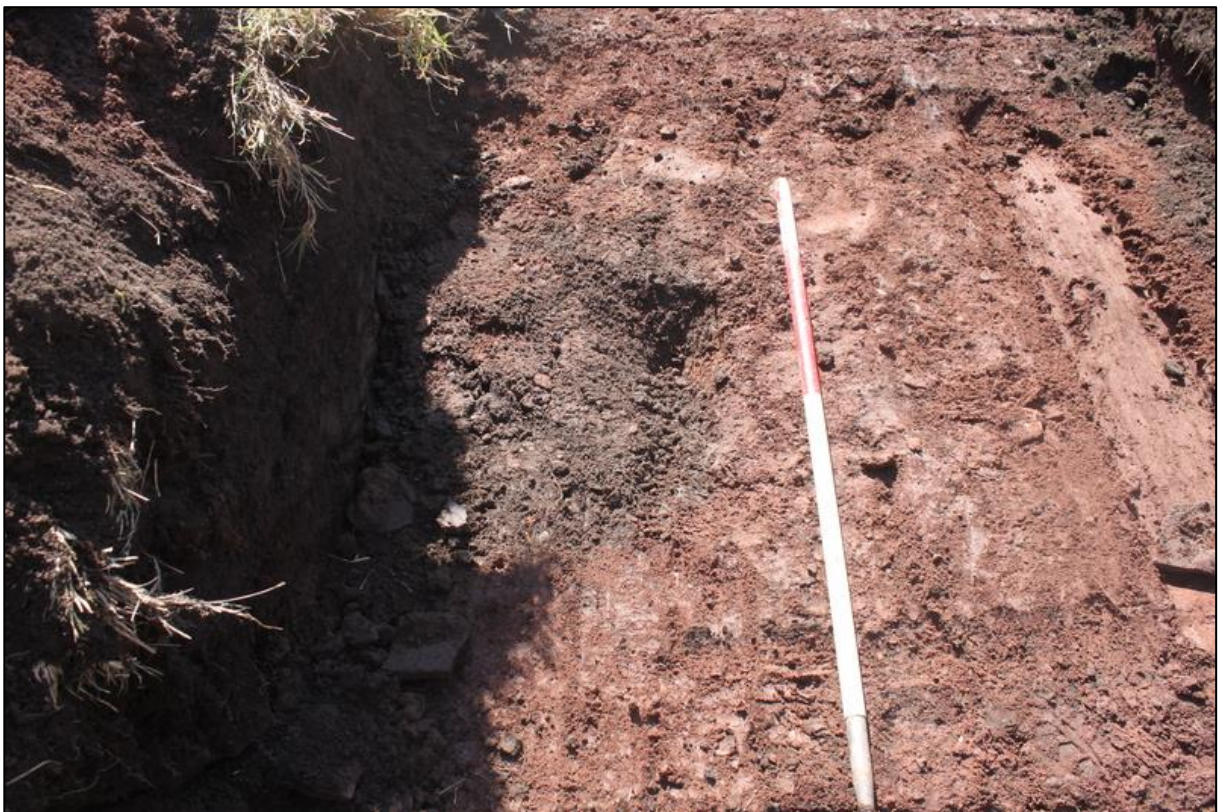
Figure 20b: (005) in Trench 6, photo from the northeast.

87. No significant archaeological deposits or material were located as part of the evaluation works.
88. A large amount of made ground (007) was found in the car park trenches (T1-3) underlying tarmac (008). This deposit contained a large amount of metal, ceramic and glass. These items all appeared to date to the 19th or 20th century. This is likely to represent material from a previous phase of works on the hotel that was repurposed for the construction of the car park.
89. No significant archaeological features were identified in the garden portion of the evaluation area (T4-6). It consisted of a thin layer of garden soil over bedrock. The only feature identified was (005). The material found within (005) was all modern in date, and is likely to have related to modern garden works.
