**Barquhey Farm, Coylton:
Archaeological Mitigation**

Data Structure Report

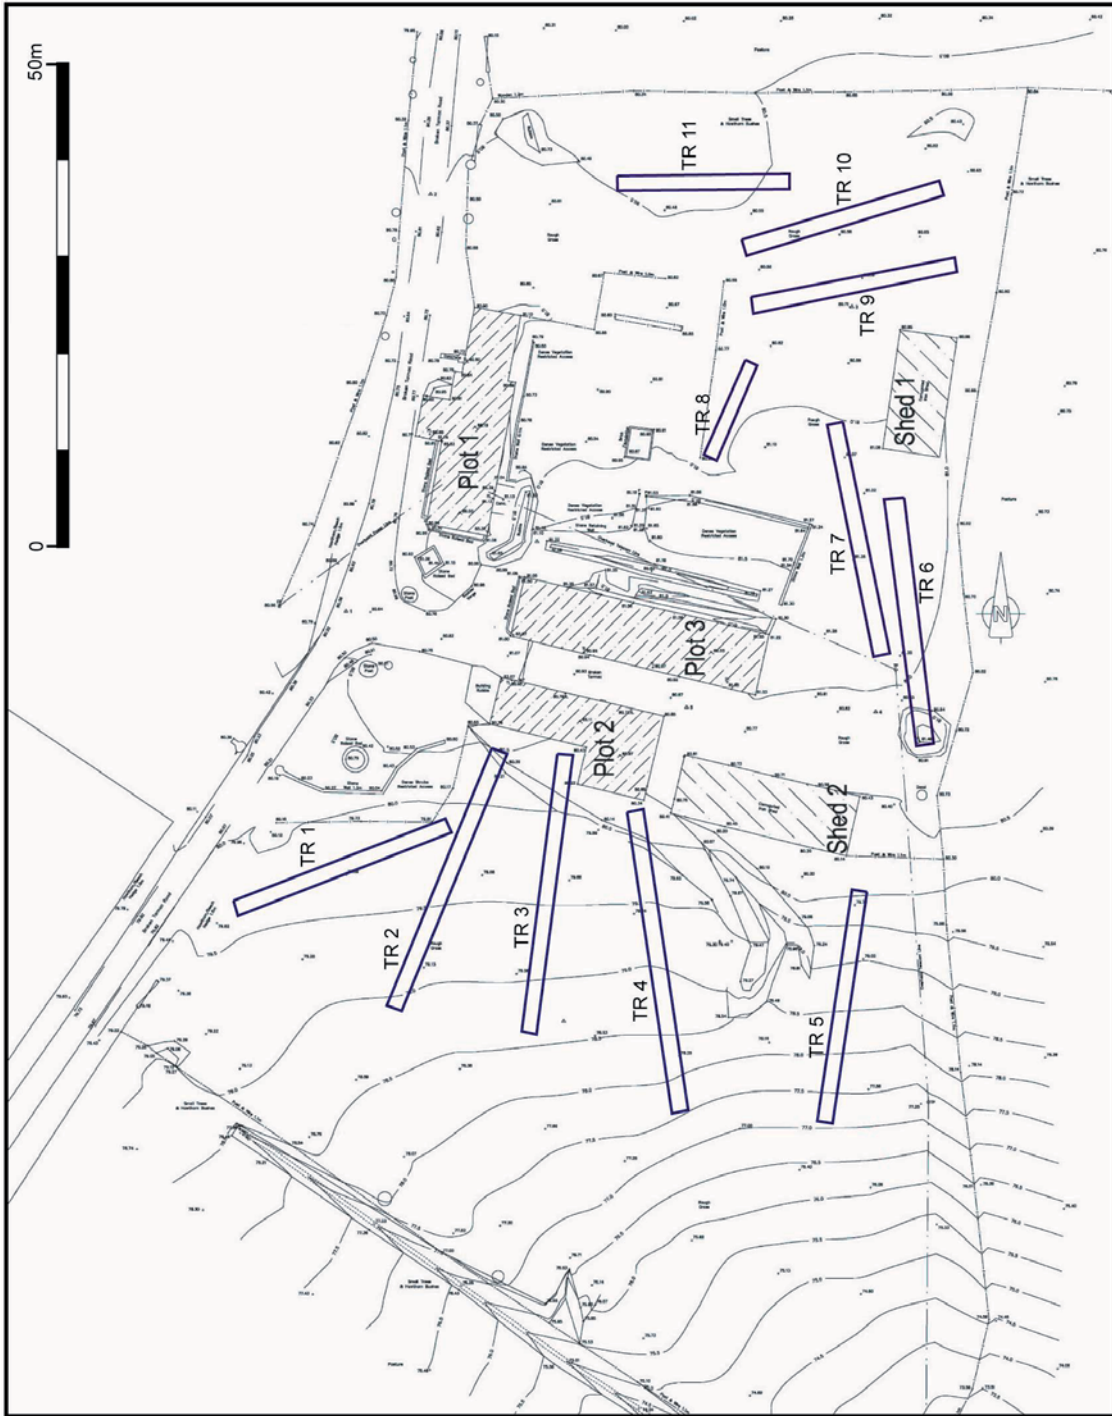
Figure 4: Trench Plan (evaluation trenches as machined in blue)

14. Within the development area there are five extant structures, consisting of a main dwelling, three barns and a shed. All are depicted on Figure 4:

23. The archaeological monitoring involved all the ground breaking works in relation to the Farmhouse (Plot 1, Figure 4). These ground breaking works consisted of the excavation of the underpinning trench around the exterior of the building [100], the reduction of the ground within the interior of the building and the excavation of the foundation trenches for the new extension to the rear of the building.
24. During the monitoring, an area of red gravel and blaze (002) was observed to the east side of building [100] it measured 3m wide and 150mm deep and ran the length of the building. It also overlay the subsoil (003) which consisted of very compact pale mottled orange/grey clay. Also to the east of the building, towards its northern end was a line of

25. A total of eleven trenches were opened across the development area (see Figure 4 for locations). Full descriptions of each are contained in the appendices at the end of this report. Included below is a synthesis of the findings and interpretation.
26. The trenches all showed a common stratigraphic sequence with compact dark brown sandy silty clay topsoil (007) with frequent fine rootlets and moderate small stone inclusions which overlay a very compact mixed orange/grey clay subsoil (008) with frequent small stones and frequent manganese flecks. The topsoil varied in depth from 100-800mm, though was typically about 300mm in depth.

All measurement distances quoted along the trench measure based on the quoted orientation of the trench. See Figure 4 for trench locations.
