Mockham Down Farm, Brayford

Heritage Impact Assessment

1.1 Project Background

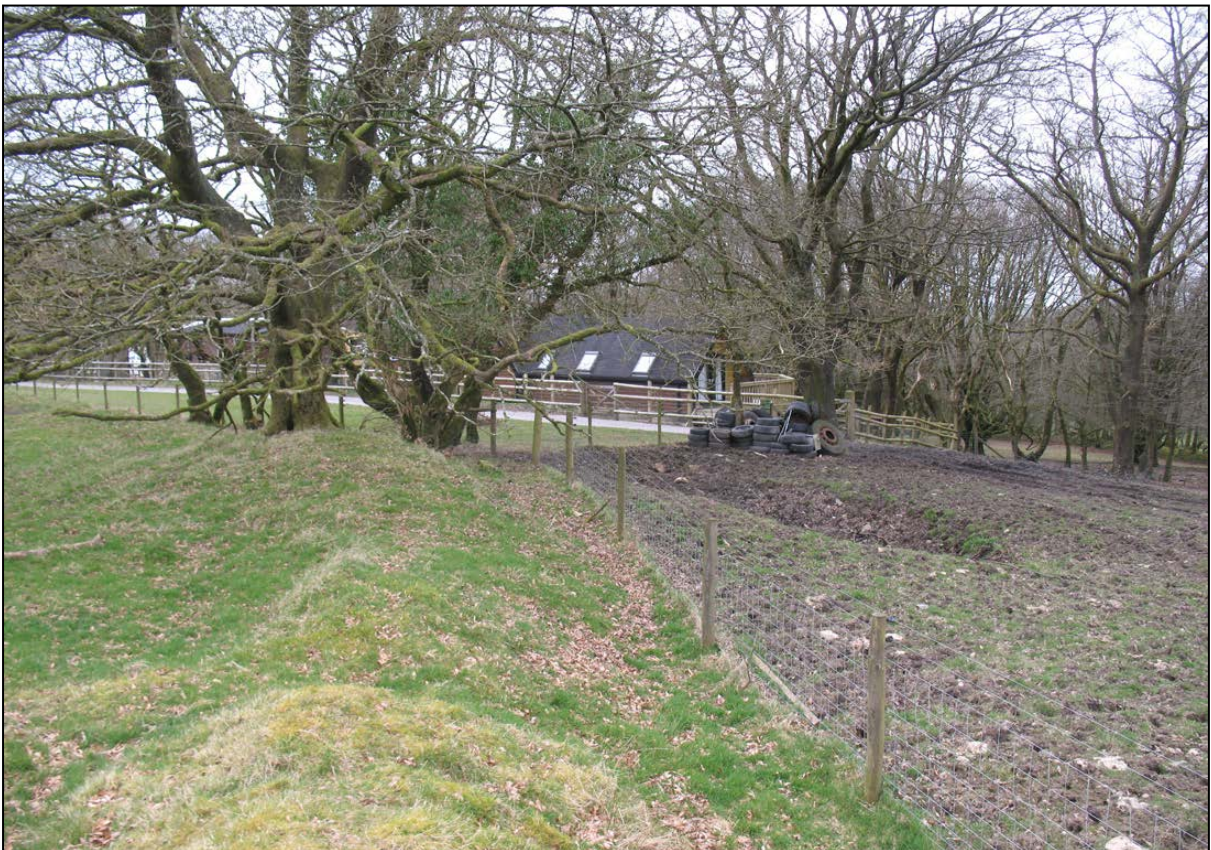
Figure 10: View along the northern bank of the enclosure towards Lodge #1, from the east.

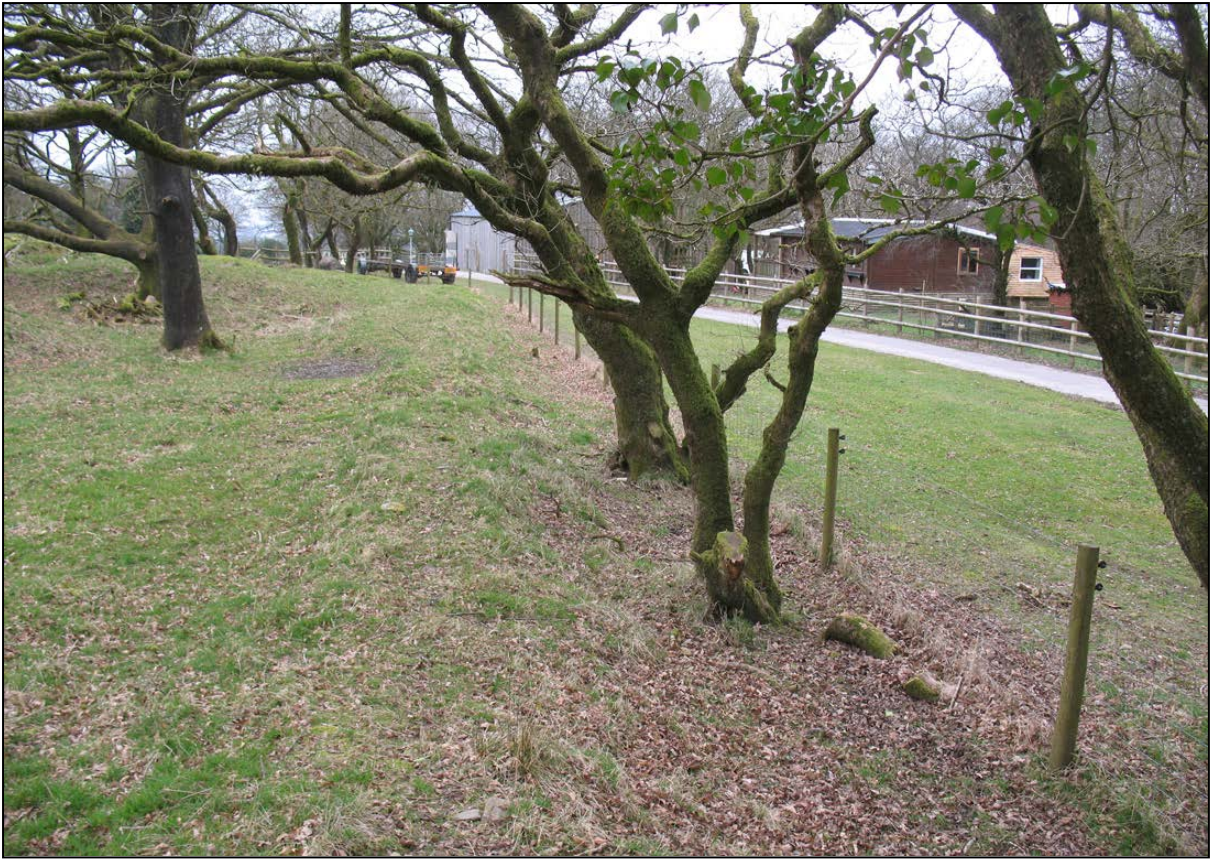
Figure 11: View along the northern bank of the enclosure from the east-north-east; the Old Lodge and Barn are visible.

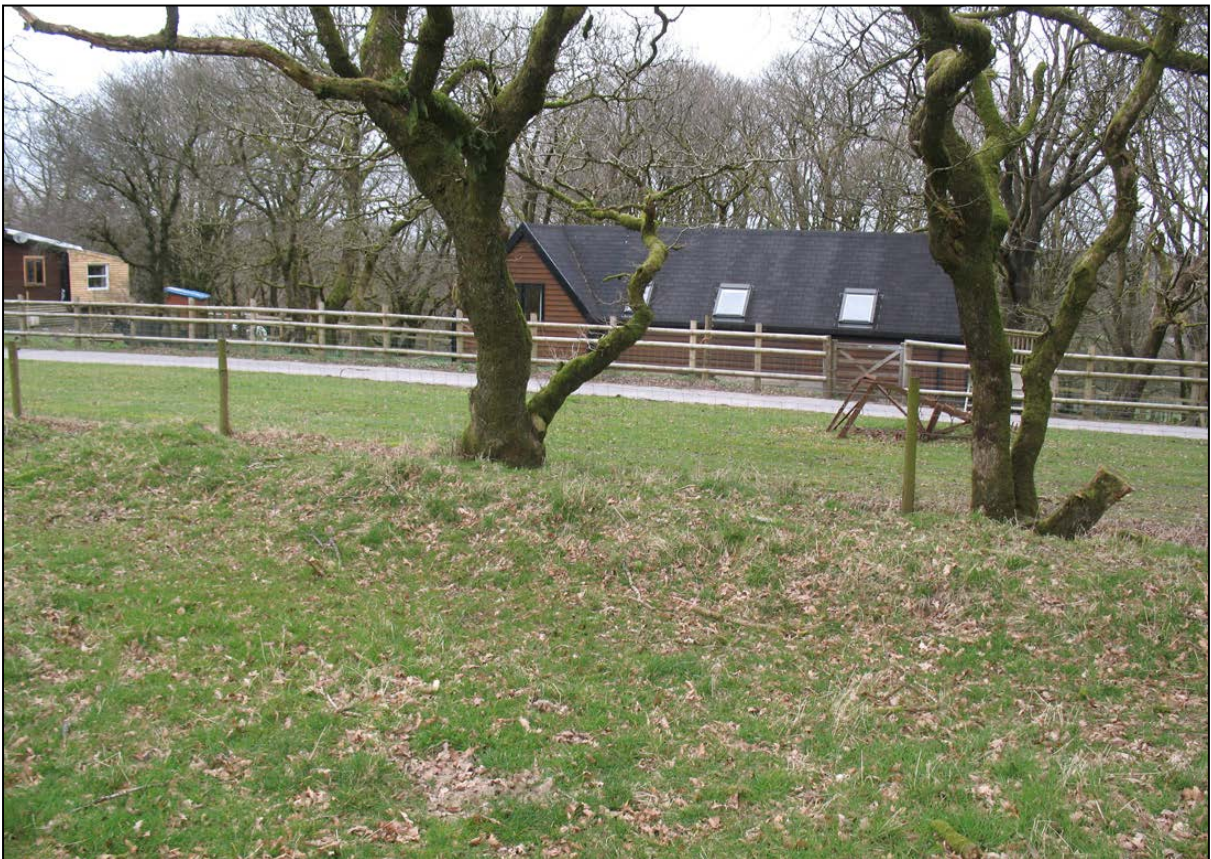
Figure 12: Lodge #1 viewed from the south; the two trees in the foreground stand on the enclosure bank.

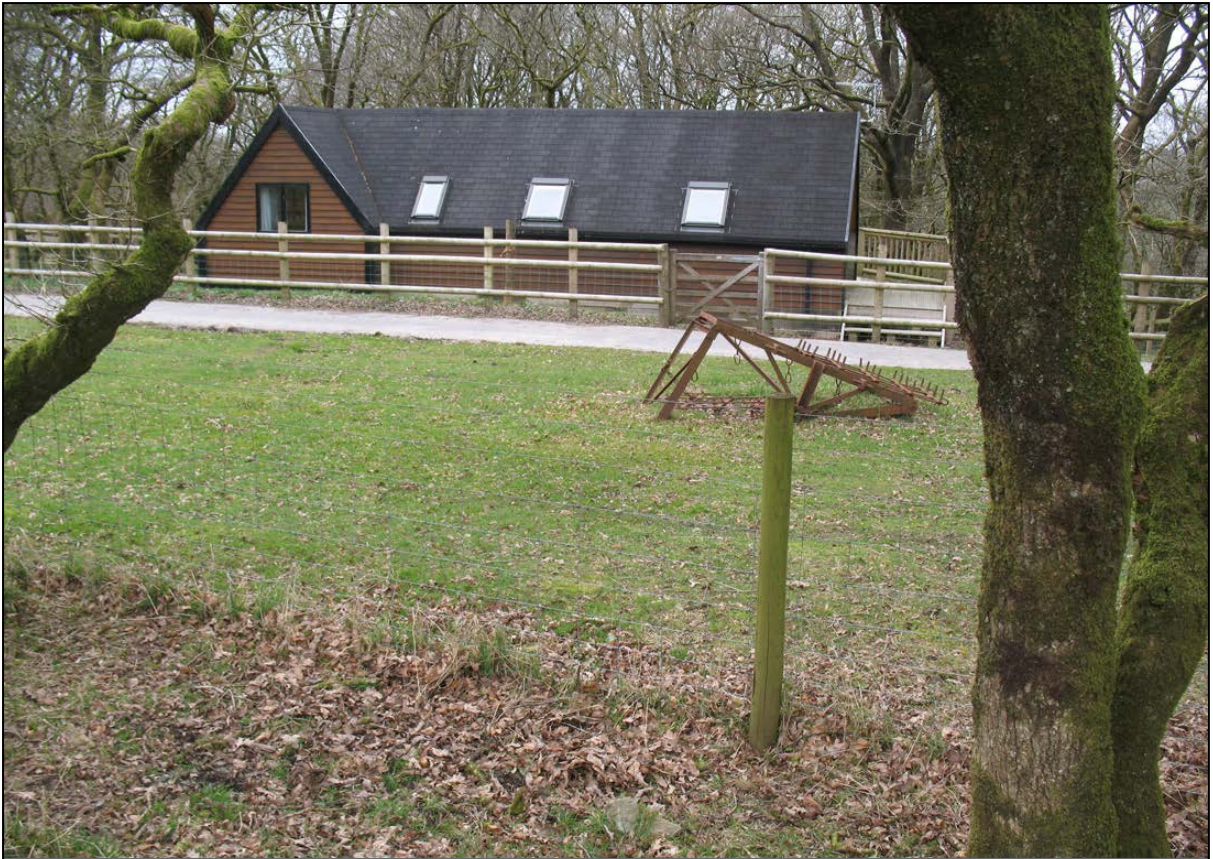
Figure 13: As above, detail of Lodge #1, from the south.

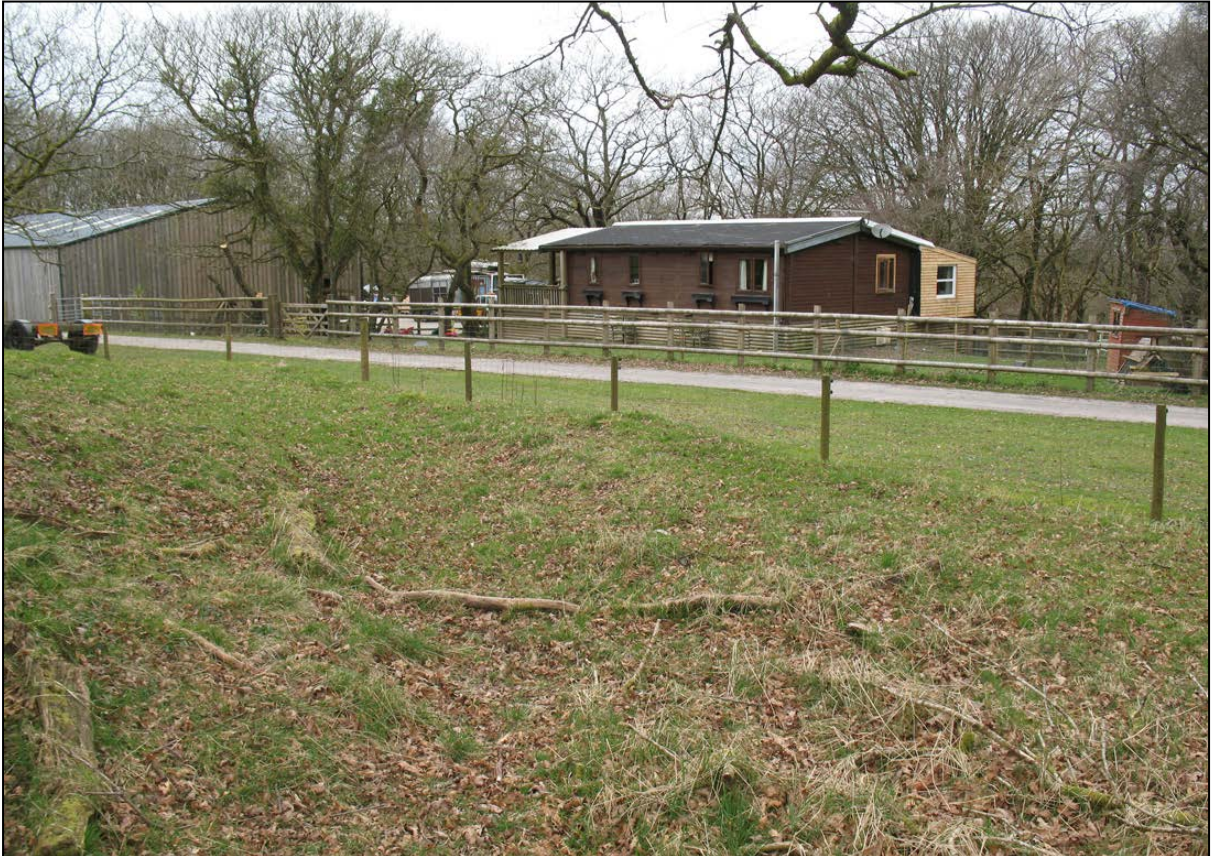
Figure 14: The Old Lodge, viewed from the interior of the enclosure, from the east.

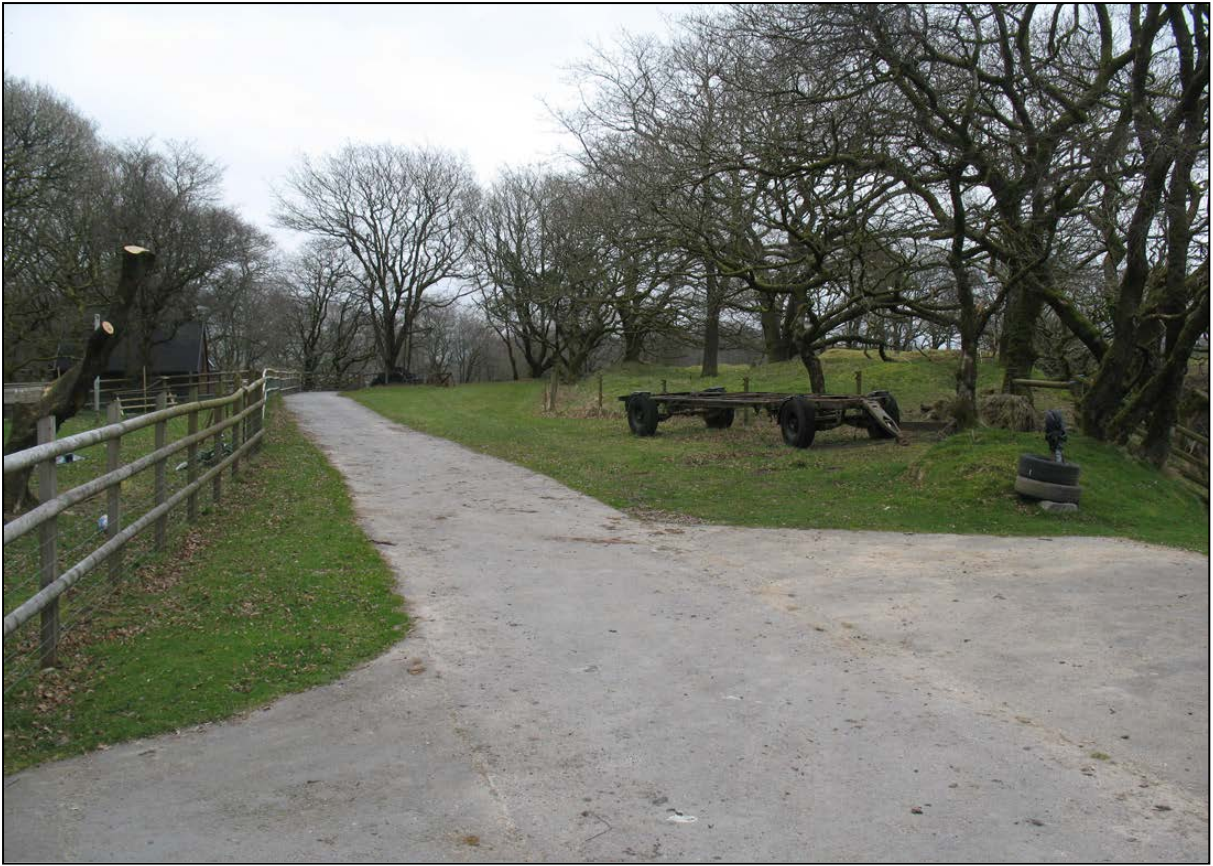
Figure 15: View of the north-western side of the enclosure, showing the tarmac access road, from the west.

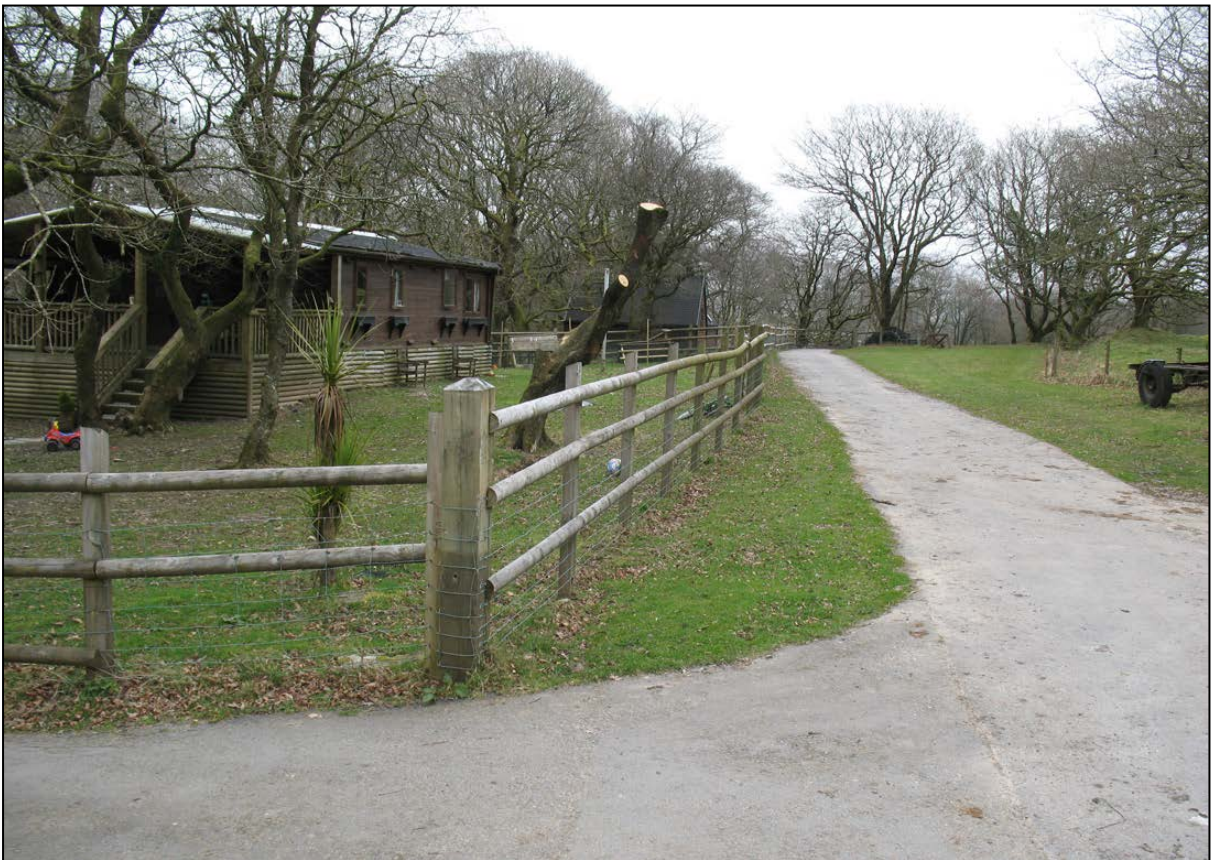
Figure 16: The north-western side of the enclosure, showing the tarmac access road, and the Old Lodge, from the west.

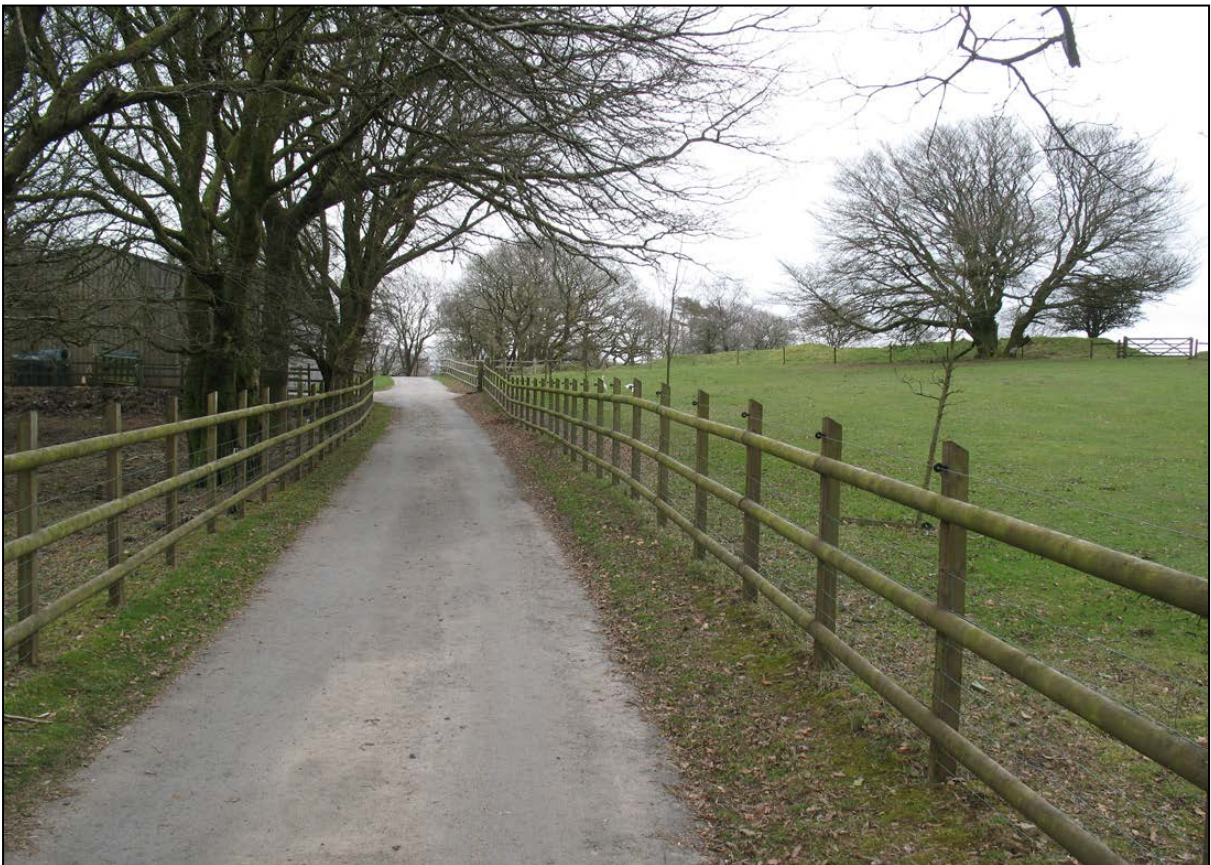
Figure 18: View up the drive to the Barn and lodges, with the earthworks of the enclosure visible on the right, from the west. Lodges #2 and #3 would be located in the woodland to the left of the photograph.

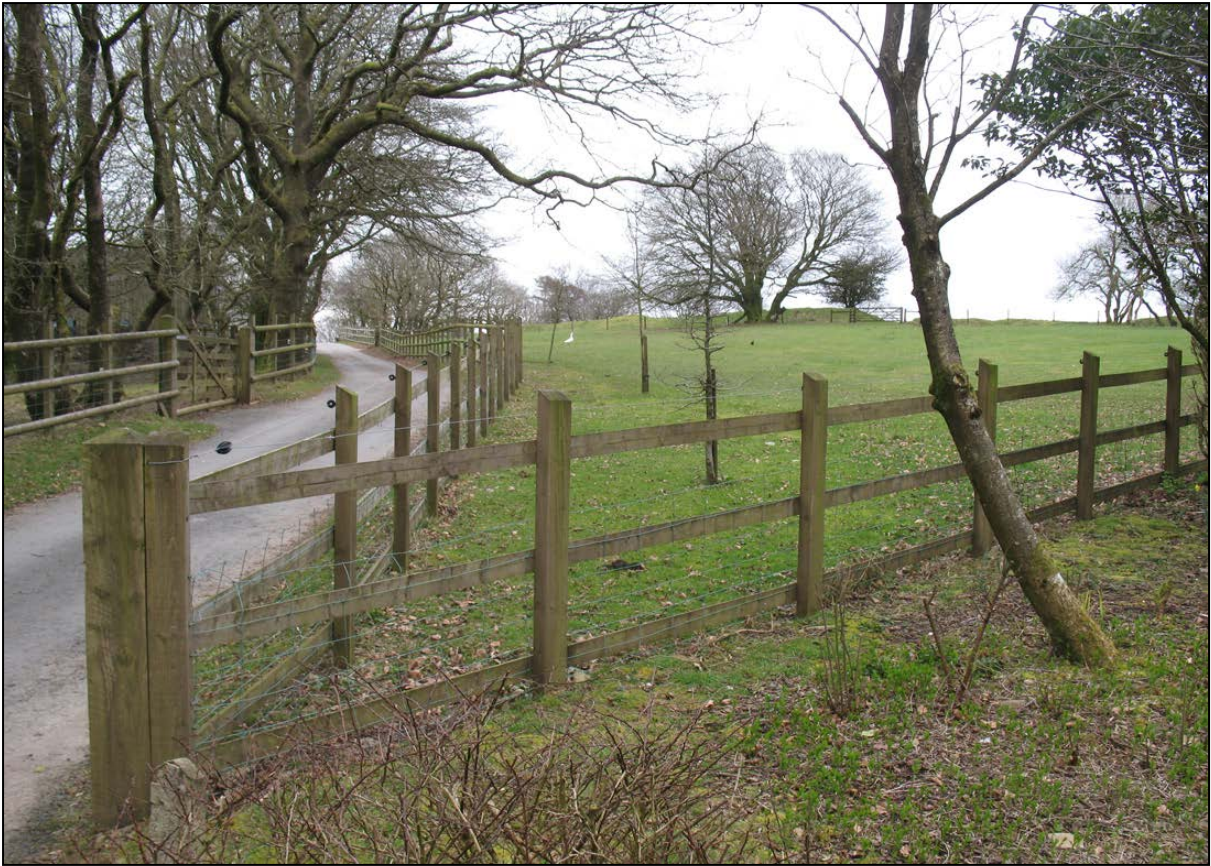
Figure 19: View along the tarmac drive, from the west. The Barn is located behind the trees to the left; the earthworks of the enclosure are on the skyline to the right. Access to Lodges #2 and #3 would be through the gateway on the left.

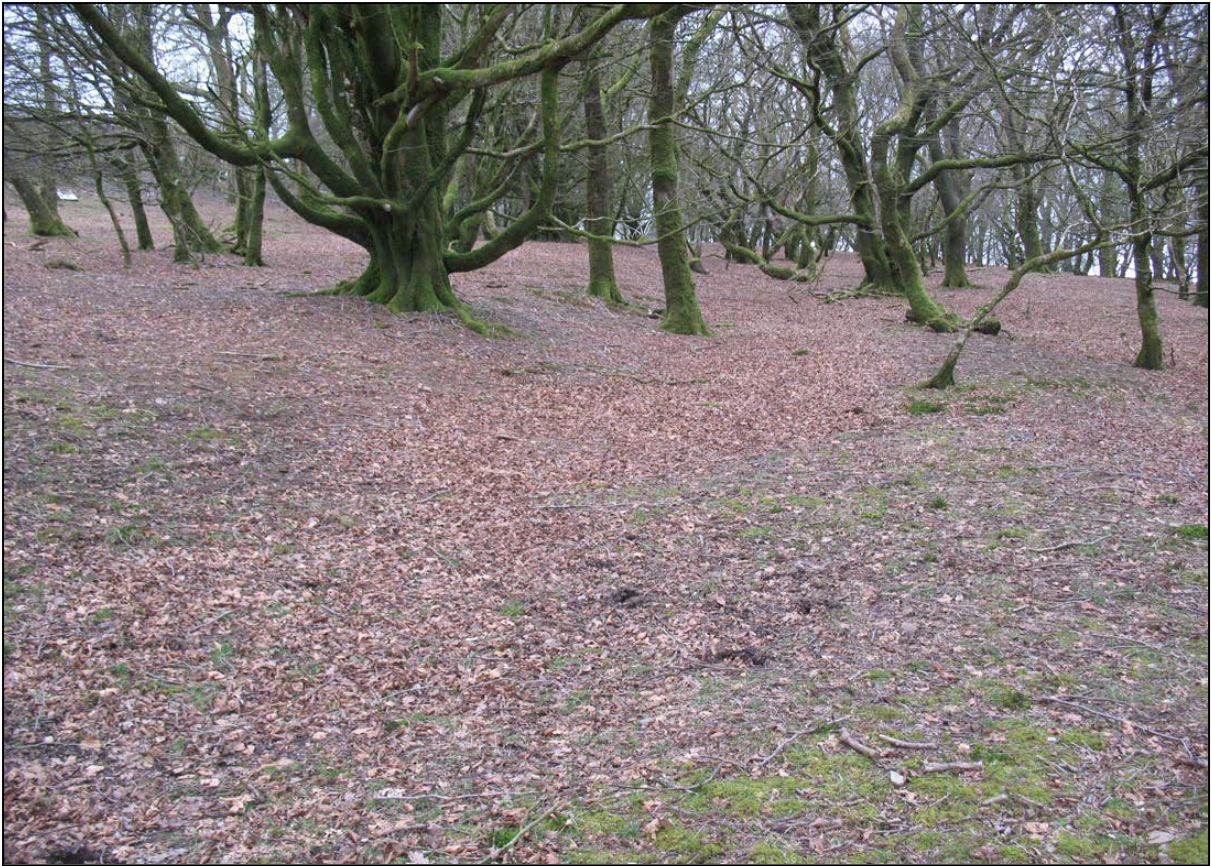
Figure 23: View along the eastern holloway, viewed from the north.

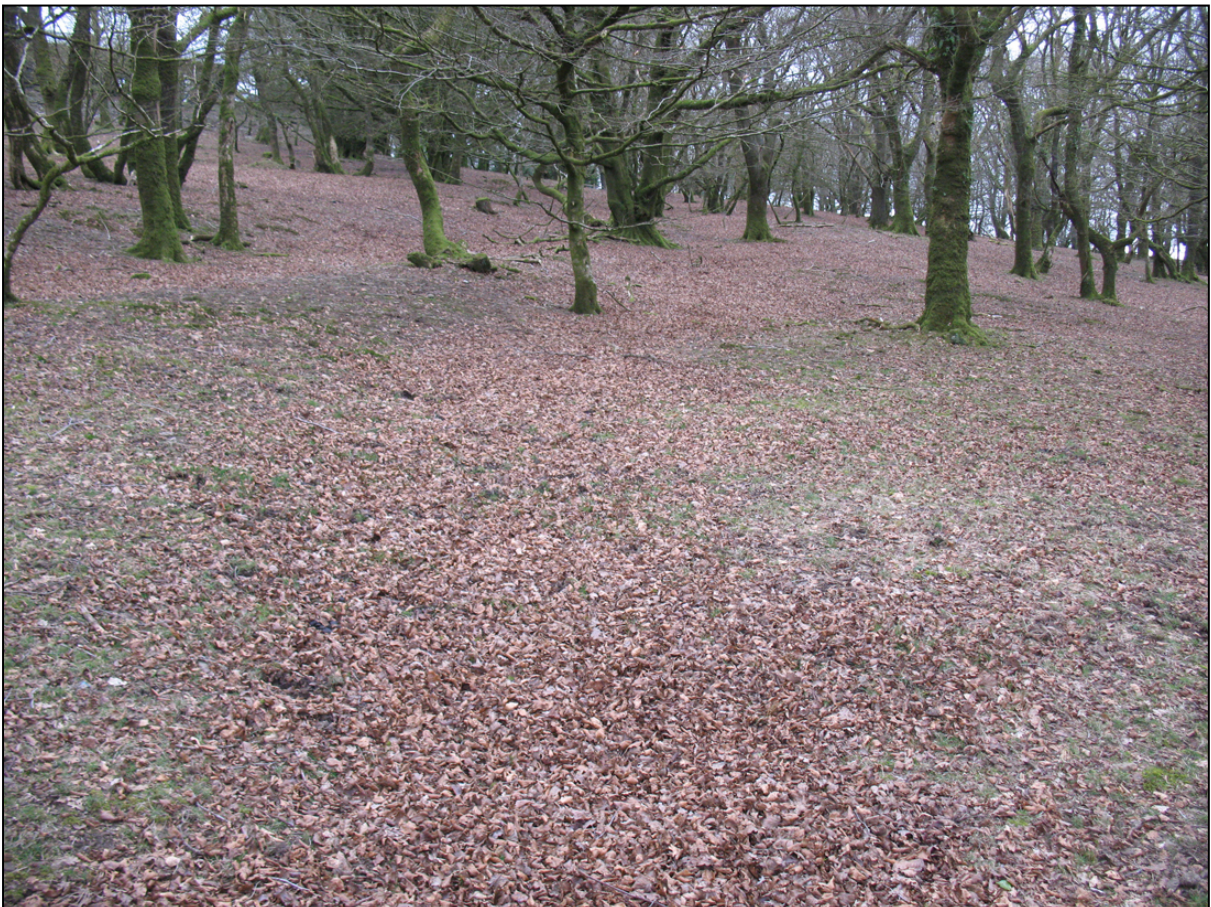
Figure 24: View along the western holloway, viewed from the north.

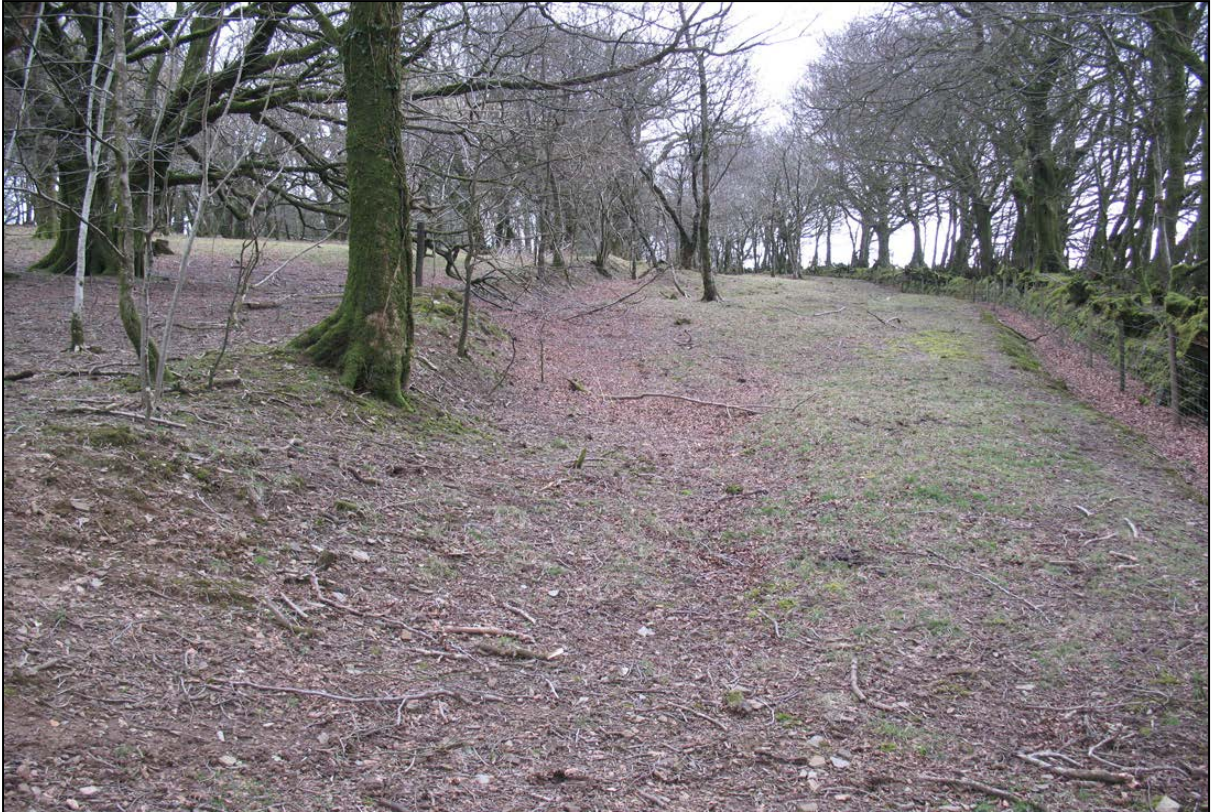
Figure 25: View along the intake from roadside waste, with the relict field bank to the left and the current hedgebank to the right; viewed from the north.

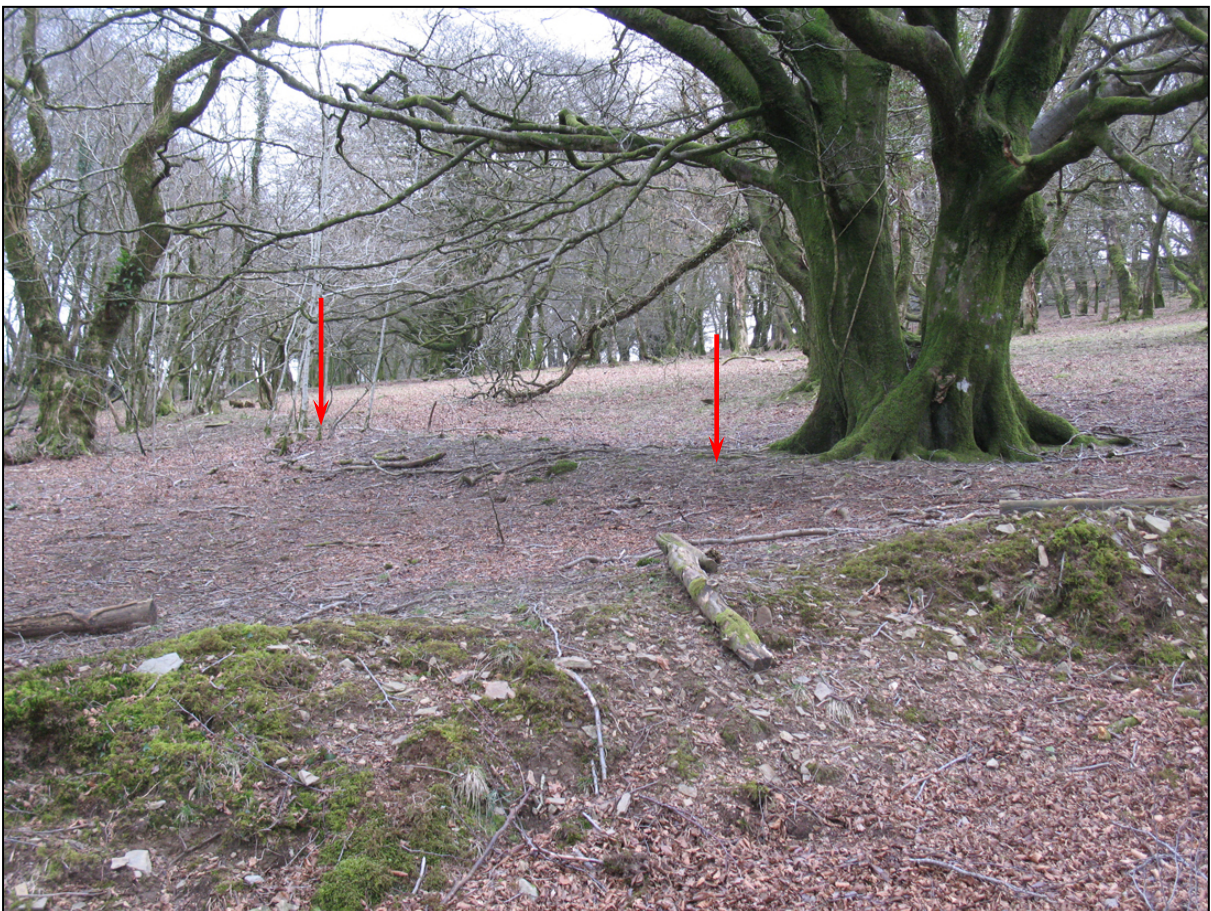
Figure 26: View of the relict hedgebank running west-south-west to east-north-east across the north-west corner of the woodland, with the former roadside bank in the foreground; viewed from the west.
