THE BARNs PENBRO FARM BREAGE CORNWALL

Desk-Based Assessment & Historic Building Recording

South West Archaeology Ltd. report no. 180322

By B. Morris, E. Wapshott & N. Boyd
Report Version: FINAL
22nd March 2018

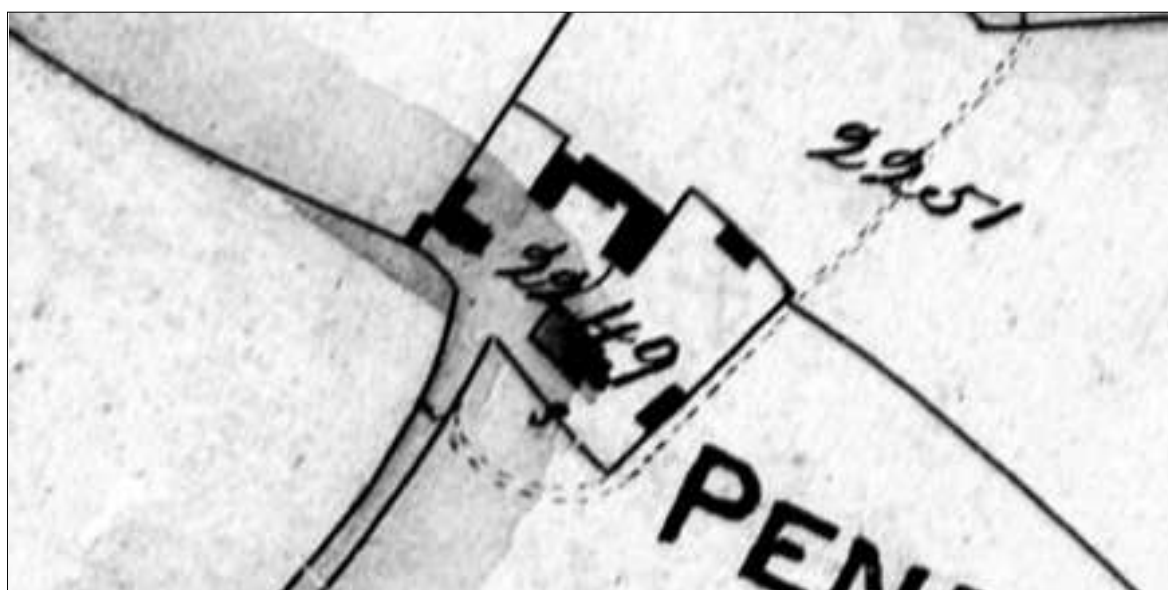
FIGURE 3: EXTRACT FROM THE BREAGE TITHE MAP, SHOWING THE HOUSE AND BUILDINGS AT PENBRO (CRO).

The first detailed map available to this study is the 1839 Breage tithe map (Figures 2-3). Penbro was a reasonably substantial farm of 110a, but this included *Little Penbro* and *Trenance* that may have originated as separate tenements. As noted, the land was owned by the Duke of Leeds, and leased to the Rogers family, with James Hendy as tenant. In terms of the extant farm buildings, B1 and B2 are present, at the centre of a scatter of other smaller buildings.

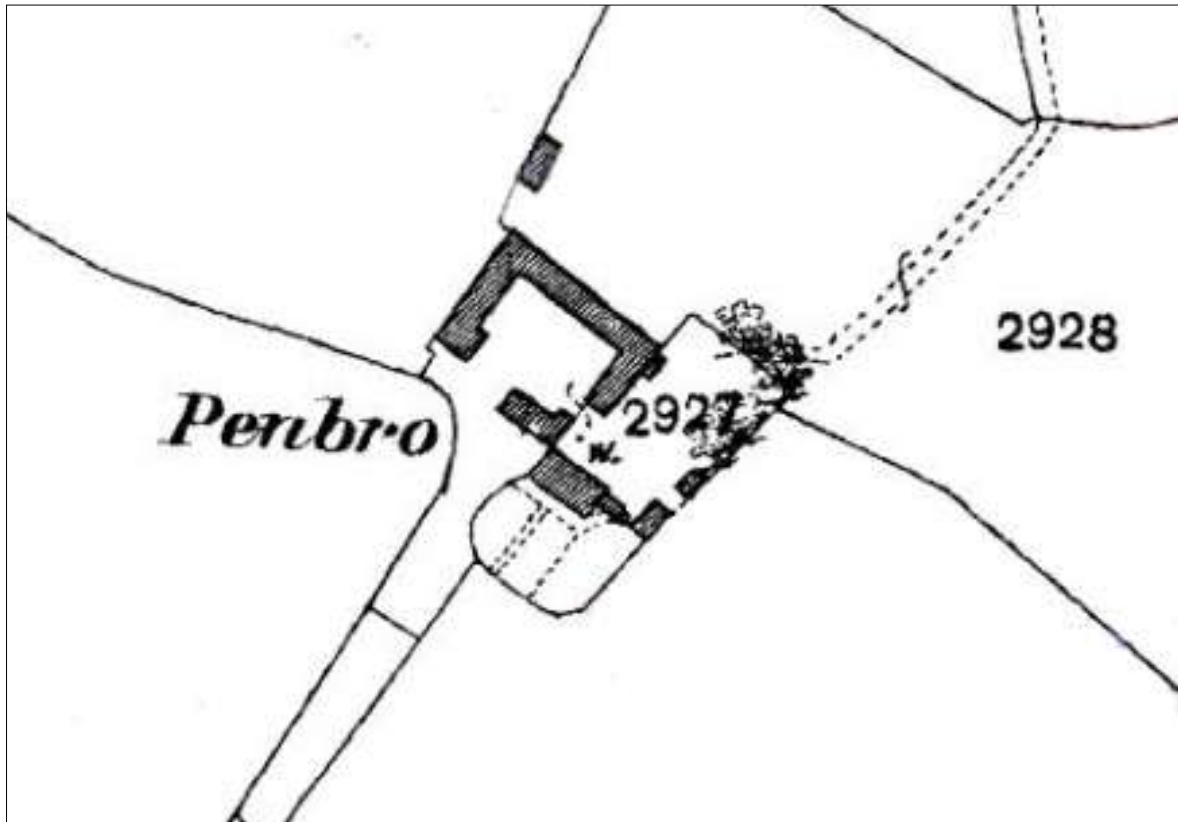
FIGURE 4: EXTRACT FROM THE FIRST EDITION OS 25 INCH MAP (1878).

The 1st edition OS map of 1878 (Figure 4) betrays a dramatic change: the scattered farm buildings of 1839 had been replaced by a range of buildings (B3, B4 and a third structure, demolished after

1973) laid out around a central yard. Based on proximity, the north-east wall of B3 may incorporate part of one of the earlier structures. The depiction of paths in the small enclosure south of B1 would suggest this was a garden, and thus by extension B1 was the farmhouse.

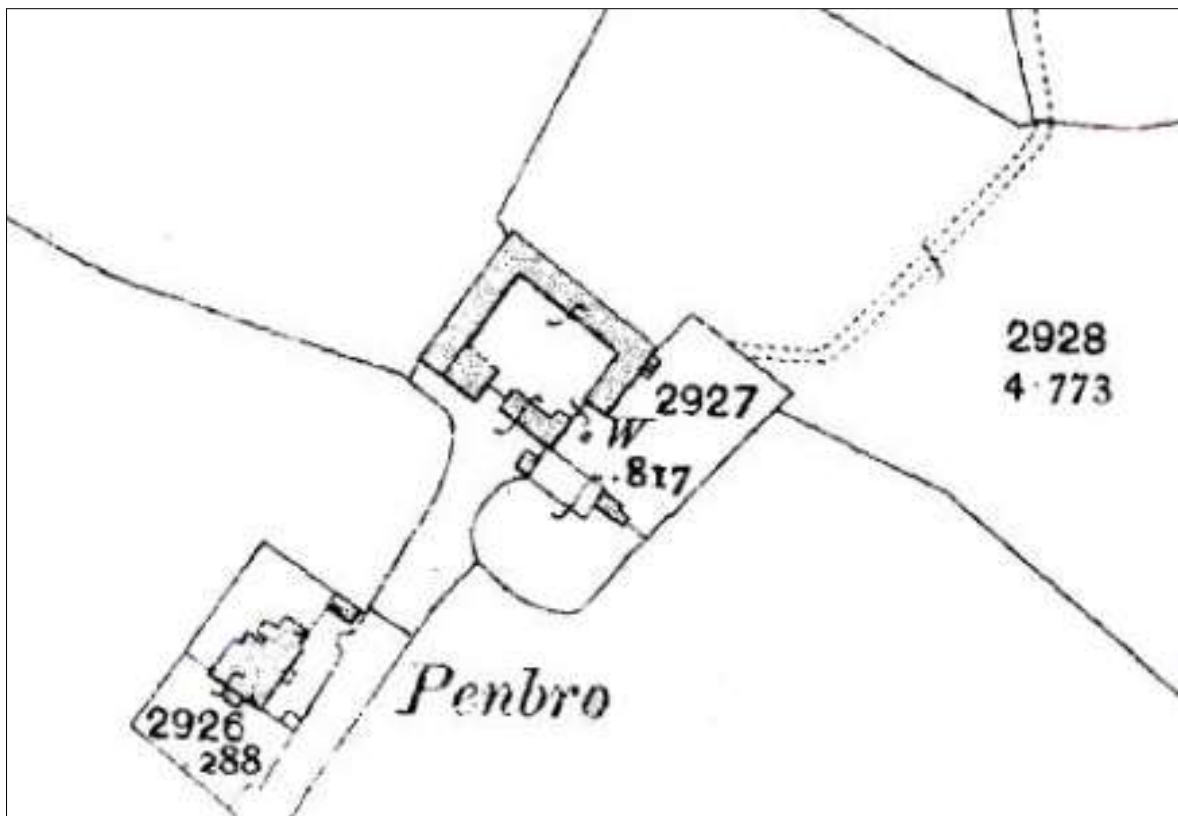
FIGURE 5: EXTRACT FROM THE OS 2ND EDITION 25 INCH MAP (1908).

B4 is also shown on the 1908 OS map (Figure 5) to have been extended to the south-west, with the construction of B5. B1 is shown as roofless, and a new farmhouse is shown to the south-west. This might indicate B1 had been gutted by some catastrophic event, or perhaps stripped during the construction of the new farmhouse. Records relating to the roof at the *dwelling house at Penbro* would indicate that it is the roof of the *old* farmhouse that was being repaired in c.1876; however, the plan does not correspond precisely with B1 [CRO: RH/1/2919; RH/7/10/2/1].

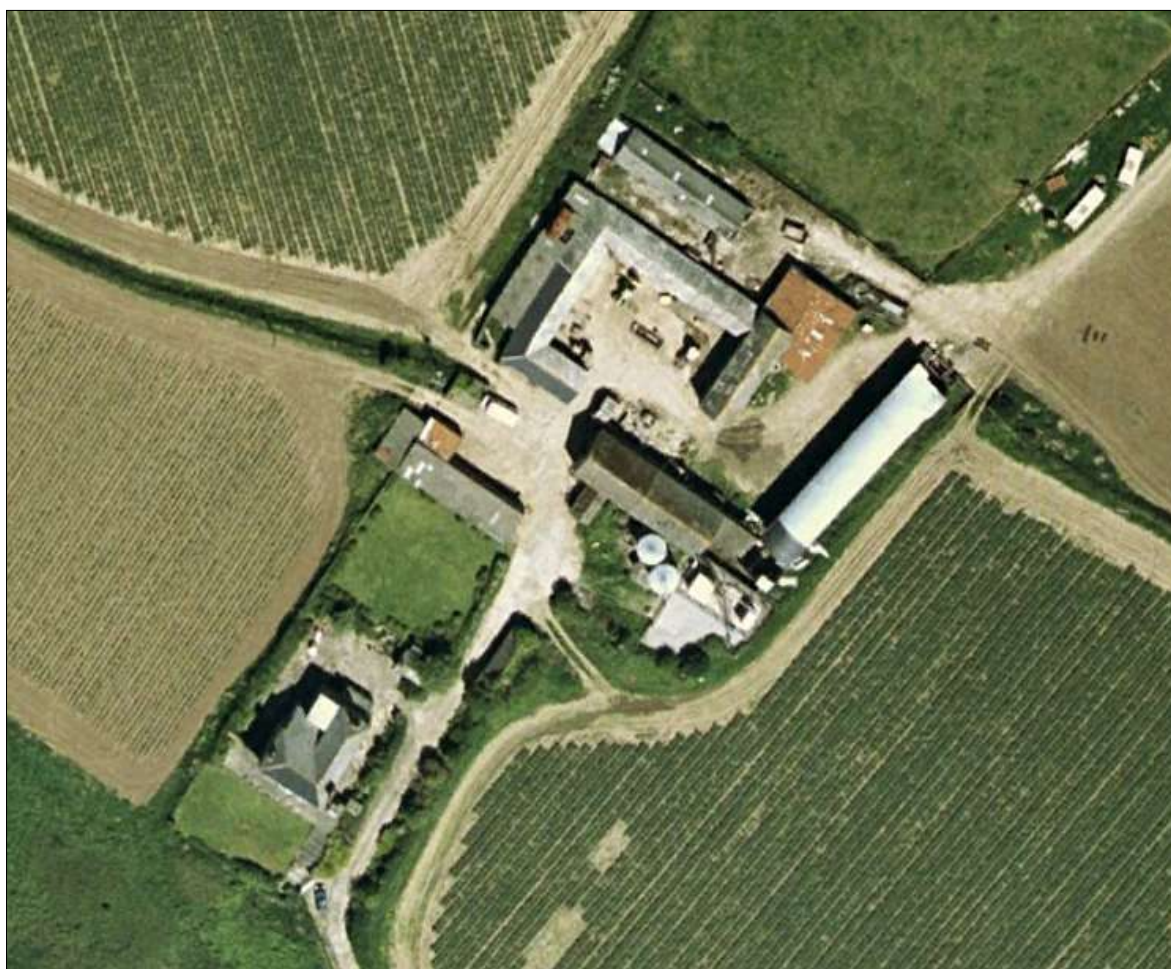
FIGURE 6: 2001 AERIAL PHOTOGRAPH OF PENBRO (© 2018 INFOTERRA LTD. & BLUESKY).

By 1973 (not illustrated), a series of new farm buildings had been constructed, wrapping around many of the older structures, and B1 had been re-roofed. Most of these buildings appear to have been constructed by 1963, and are likely to be steel portal-framed structures (see Figure 6). All of these modern buildings were removed prior to recording, but the 20th century use of the historic buildings must be seen in the context of contemporary structures.

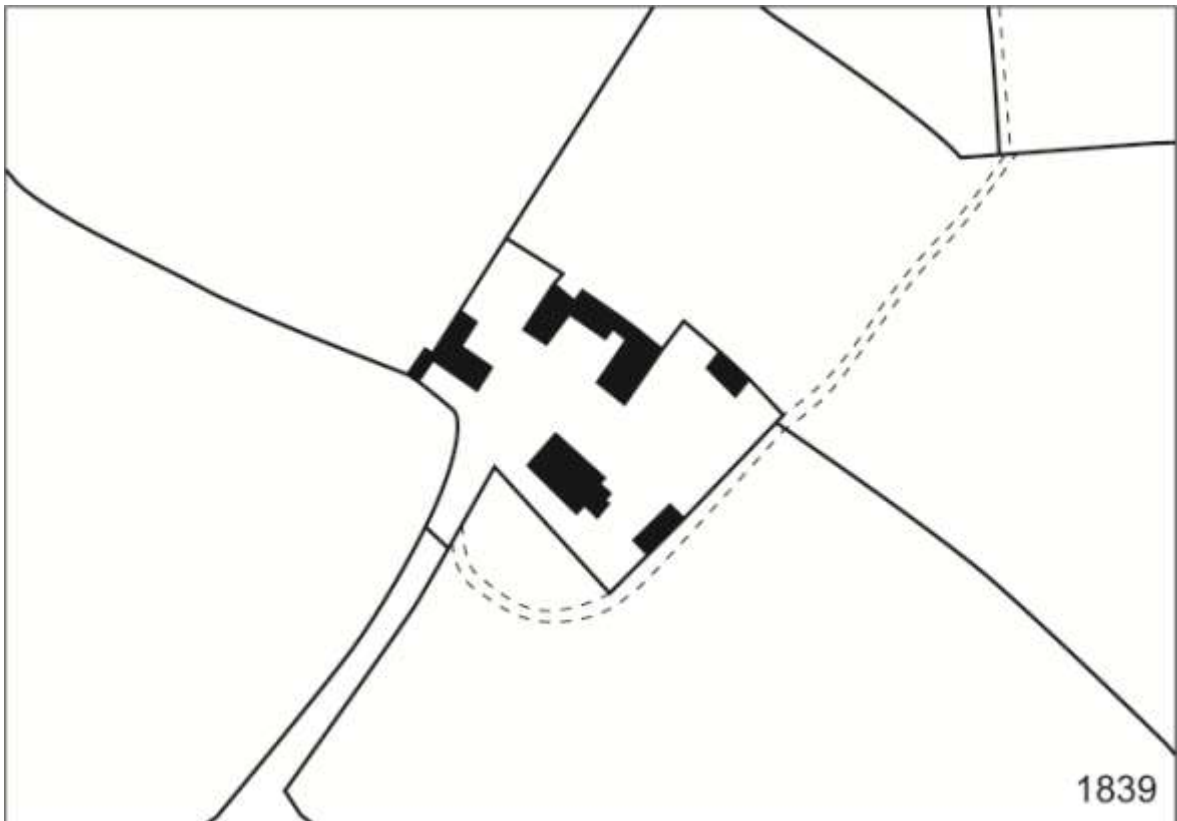
FIGURE 7: THE BUILDINGS AS SHOWN ON THE BREAGE TITHE MAP OF 1839.

The evolution of the farmstead in the later 19th century is relatively complex. The following series of maps (Figures 7-10) shows each stage in relation to the last, with the caveat that some maps are more accurate than others.

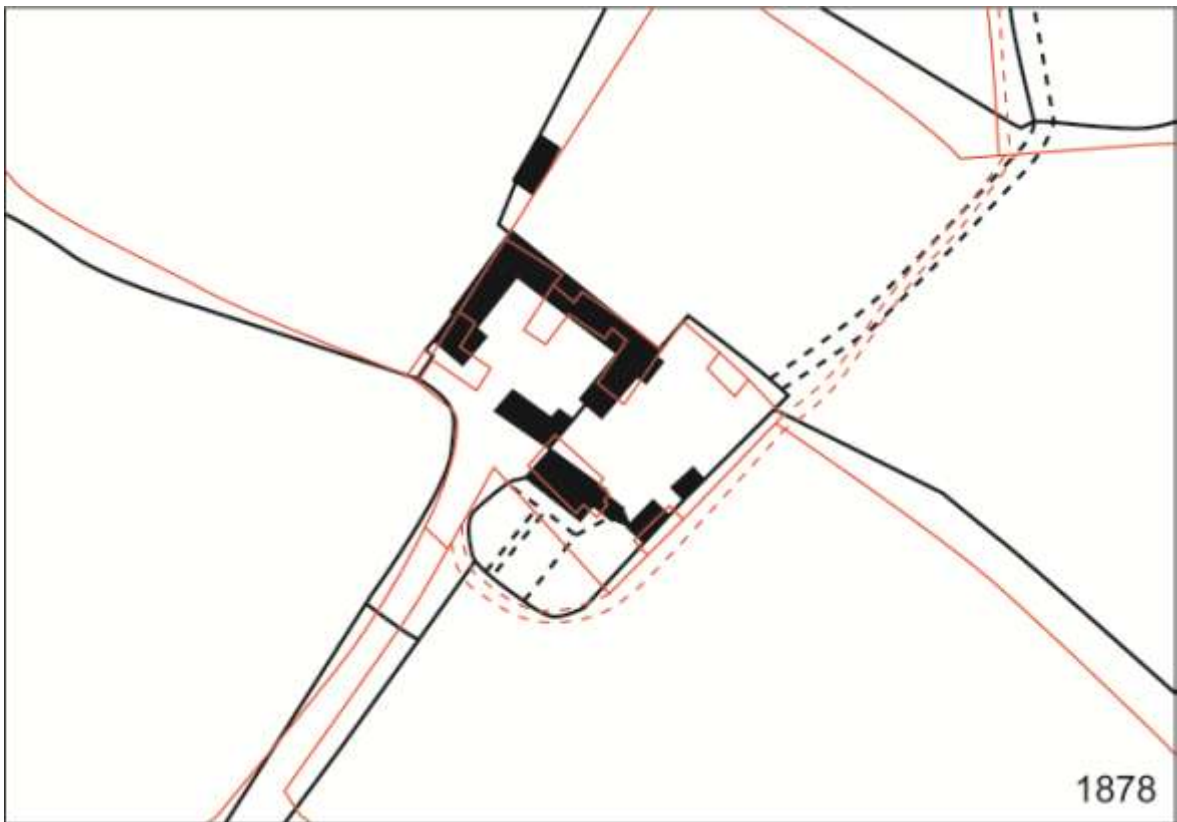
FIGURE 8: THE BUILDINGS SHOWN ON THE 1878 1:25INCH OS MAP, WITH THOSE OF THE TITHE MAP OVERLAID IN RED.

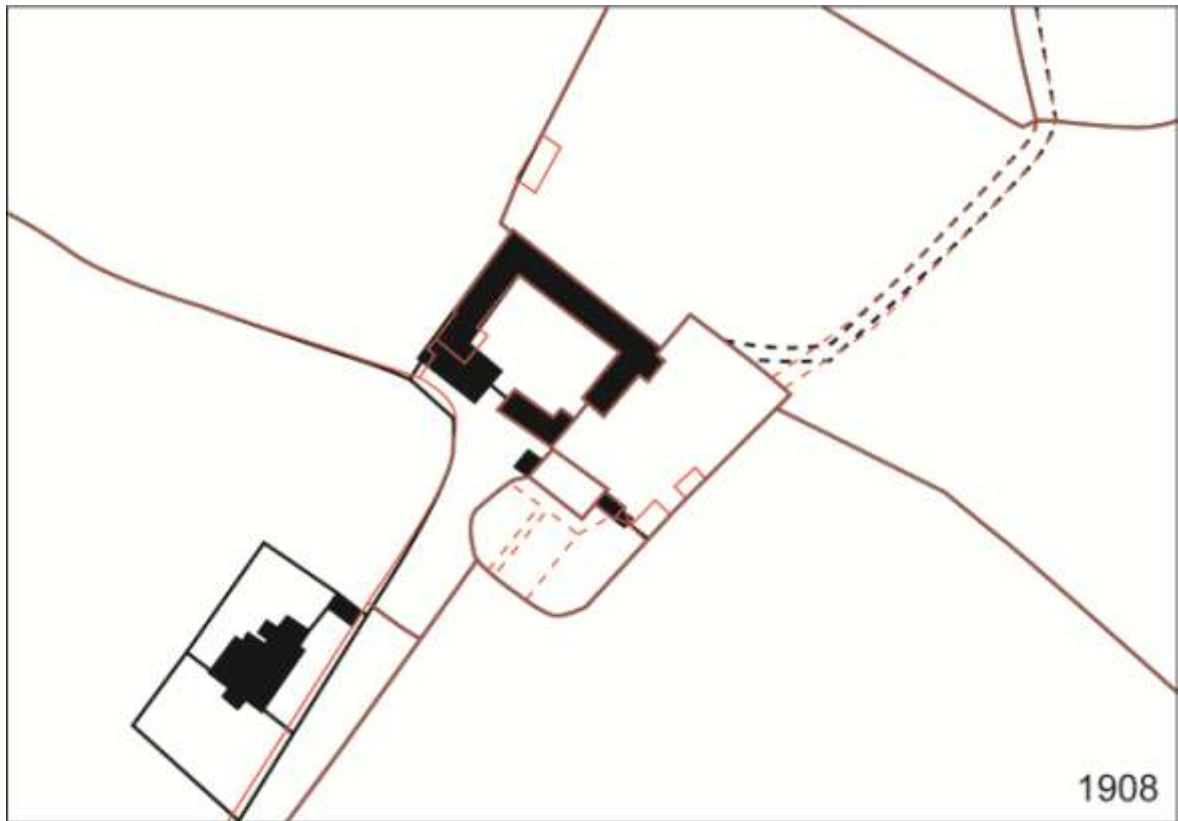
FIGURE 9: THE BUILDINGS AS SHOWN ON THE 1908 OS 1:25 INCH MAP, WITH THOSE OF 1878 OVERLAID IN RED.

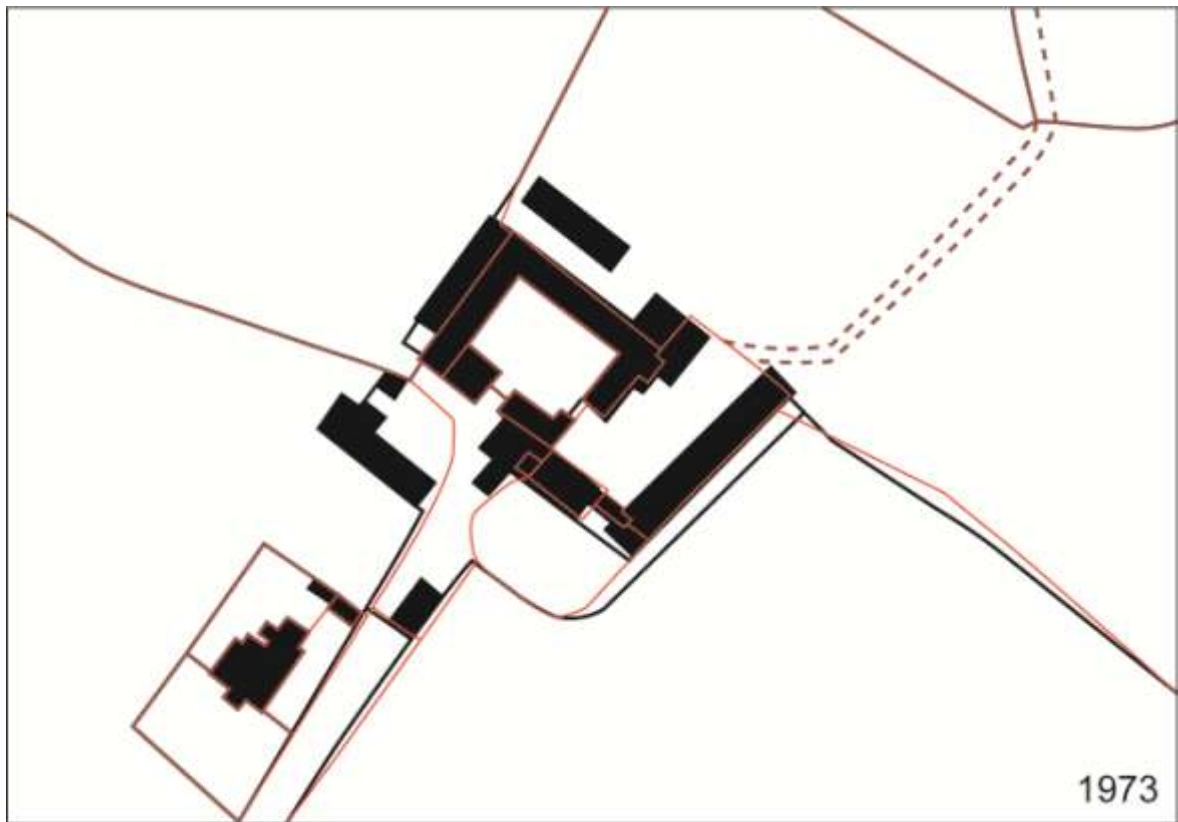
FIGURE 10: THE BUILDINGS AS SHOWN ON THE 1973 OS 1:2500 MAP, WITH THOSE OF 1908 OVERLAID IN RED.

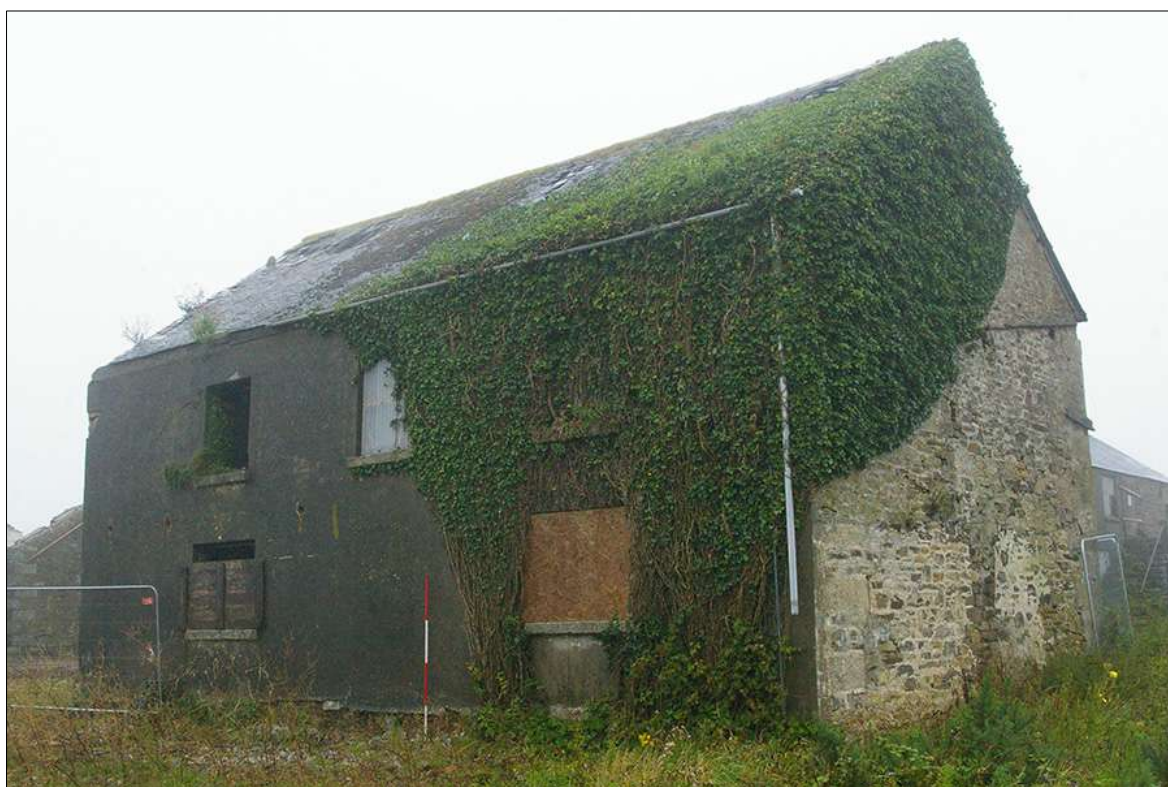
FIGURE 12: B1, SOUTH-WEST ELEVATION; VIEWED FROM THE SOUTH (SCALE 2M).

This building, probably the pre-1876 farmhouse, was comprehensively modified for agricultural use in the early 20th century. Most of the internal features are mid 20th century in date, and point to feed storage and preparation, with a secondary or successive use as animal housing.

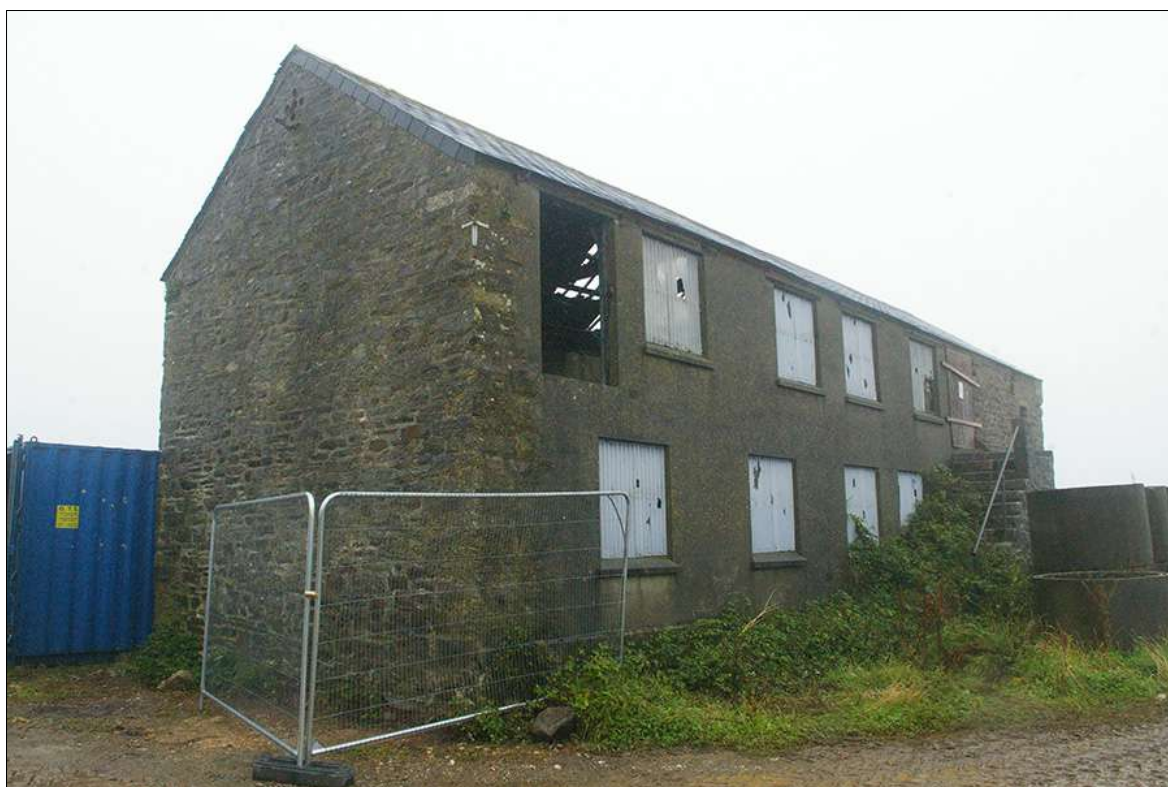
FIGURE 13: B2, SOUTH-WEST AND SOUTH-EAST ELEVATIONS; VIEWED FROM THE SOUTH.

This building, perhaps with domestic antecedents, was comprehensively modified for agricultural use in the 20th century. The earliest elements may be pre 1800 in date, but most of the build is later 19th century, and probably indicates use as a chall barn. All of the internal features are mid 20th century in date, and point to feed storage at first-floor level, with storage or dairying below.

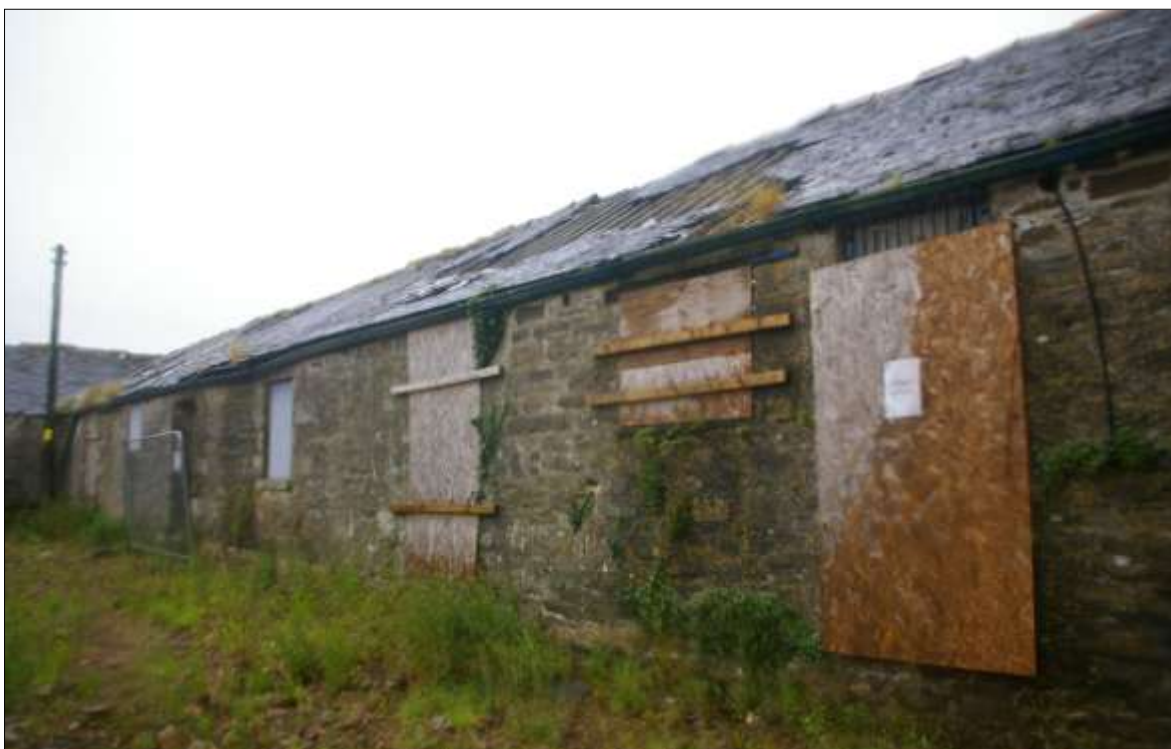
FIGURE 14: B3, THE SOUTH-WEST ELEVATION; VIEWED FROM THE SOUTH-SOUTH-EAST.

Given the difference in build between the north-east and south-west elevations, it is possible this building originated as open-fronted cart shed or animal housing, built in the third quarter of the 19th century, presumably reusing stone from the 1839 buildings. The structure was heavily-modified in the mid 20th century as a milking parlour. All of the internal features are mid 20th century or later in date.

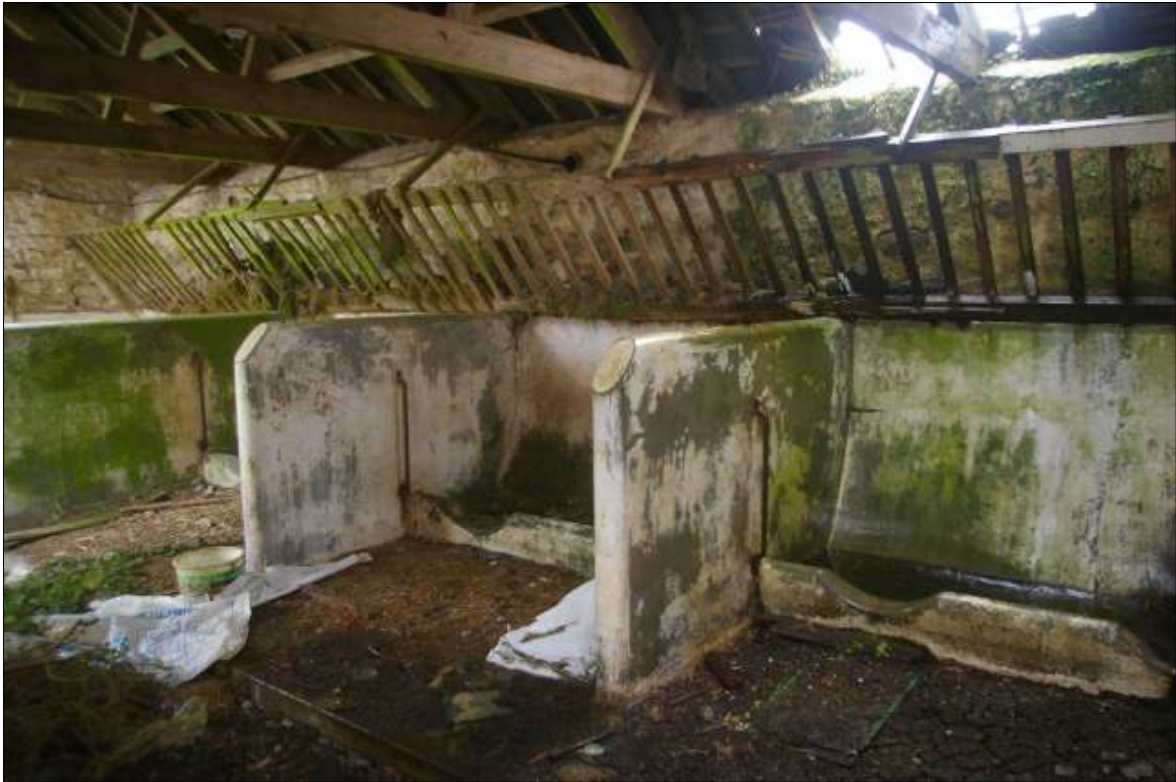
FIGURE 15: B4, SOUTHERN ROOM, THE CONCRETE STALLS AND TIMBER HAYRACKS; VIEWED FROM THE NORTH-EAST.

This building was built in the third quarter of the 19th century, presumably reusing stone from the 1839 buildings. The structure was heavily-modified in the mid 20th century as a dairy and additional milking parlour/cattle housing. All of the internal features are mid 20th century or later in date.

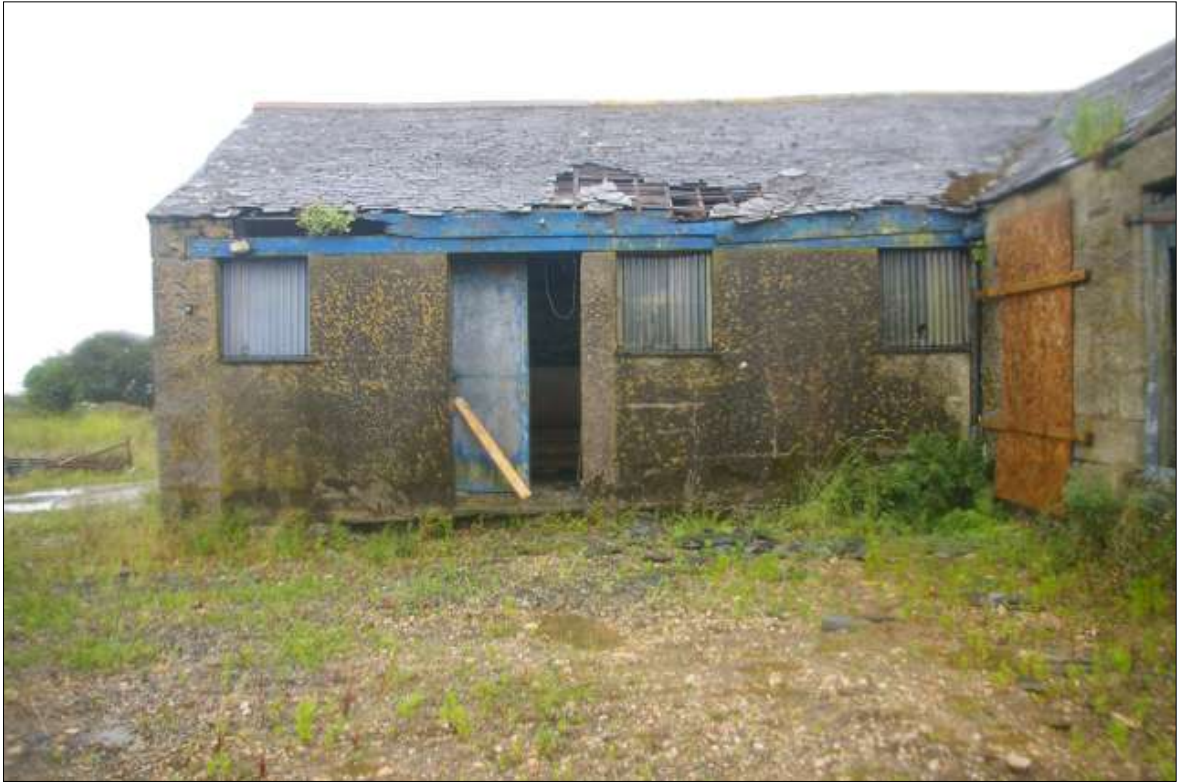
FIGURE 16: B5, NORTH-EAST ELEVATION, WITH CENTRAL GRANITE PILLAR AND OPENINGS INFILLED IN CONCRETE BLOCK; VIEWED FROM THE NORTH-EAST.

B5.1 was built with B4; the rest of the building was constructed after 1878, but before 1908. The structure was heavily-modified in the mid 20th century for storage and as an additional milking parlour/cattle housing. All of the internal features are mid 20th century or later in date.

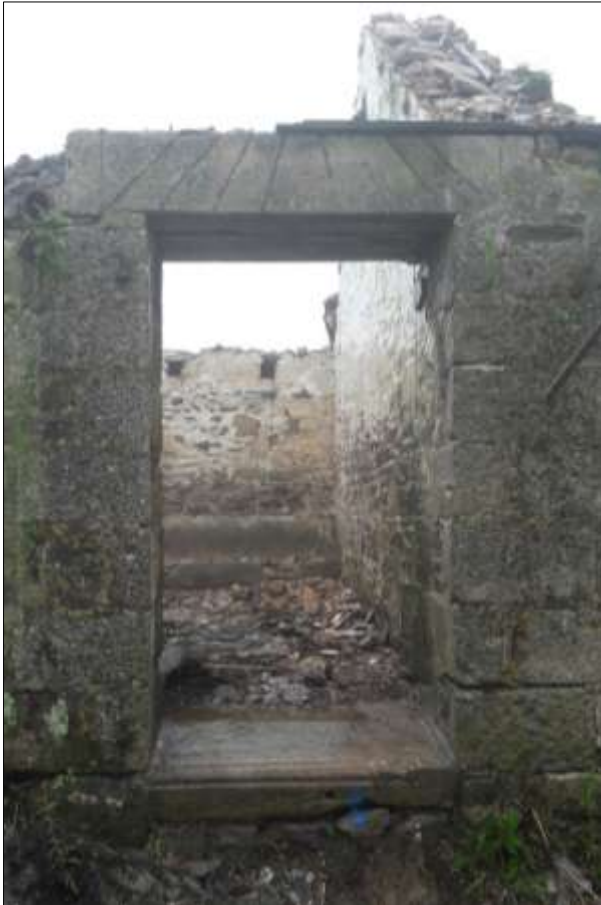
FIGURE 17: B5.2 (D21), NORTH-EAST ELEVATION, SHOWING THE REUSED GRANITE LINTEL (INCISED LINES TO MIMIC VOUSSOIRS, INSERTED UPSIDE-DOWN) AND REUSED MOULDED GRANITE FIREPLACE LINTEL; VIEWED FROM THE EAST.

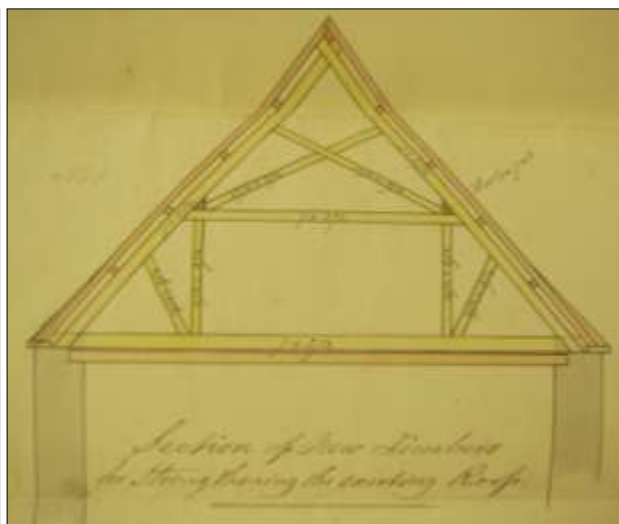
RIGHT: FIGURE 19: PROFILE OF THE PROPOSED ROOF STRUCTURE IN THE FARMHOUSE IN 1876 (CRO: RH/1/2919).

The roof trusses in all the barns were built to the same essential design: pine A-frame trusses with queen struts, with nailed joints and some use of spikes. The trusses are half-lapped at the ridge with a diamond-set ridge pole. The only exception to this is two trusses in B2, which have mortice-and-tenon joints at the ridge, and are bolted. None of the trusses bear much resemblance to the 1876 and earlier trusses intended for the *dwelling house at Penbro*. The pitch of the roofs is quite shallow, with two purlins to each pitch. Rafters and split battens survive except where noted, in varying states of repair, with slates directly attached to the back of the battens. Most sections of historic roof feature white lime plaster torching between the battens and slates, for insulation, weather proofing and vermin control.

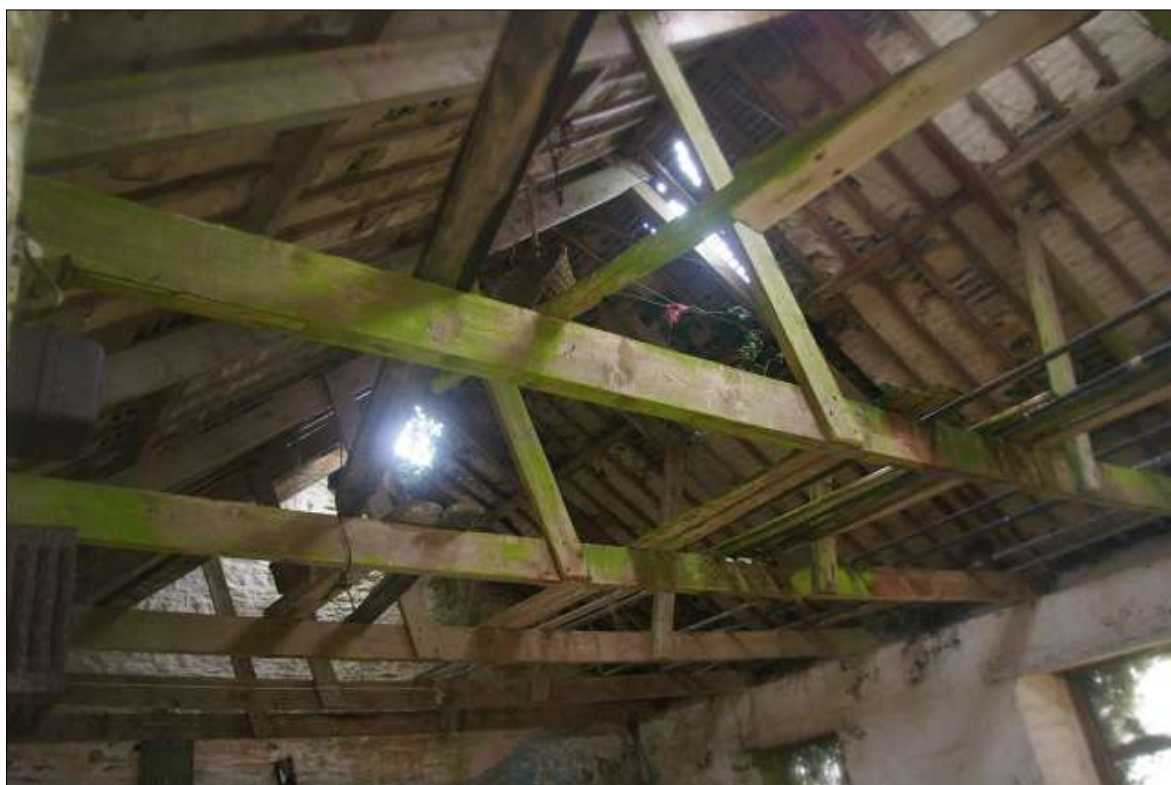
FIGURE 20: B1 ROOF STRUCTURE; VIEWED FROM THE NORTH-NORTH-WEST.

The character of the roofs would indicate the whole complex was re-roofed from the later 19th century, contemporary with the construction of B3-B5. This need not have occurred in a single operation, as B5 was constructed some time after B3 and B4, but the builders clearly adopted a similar template.

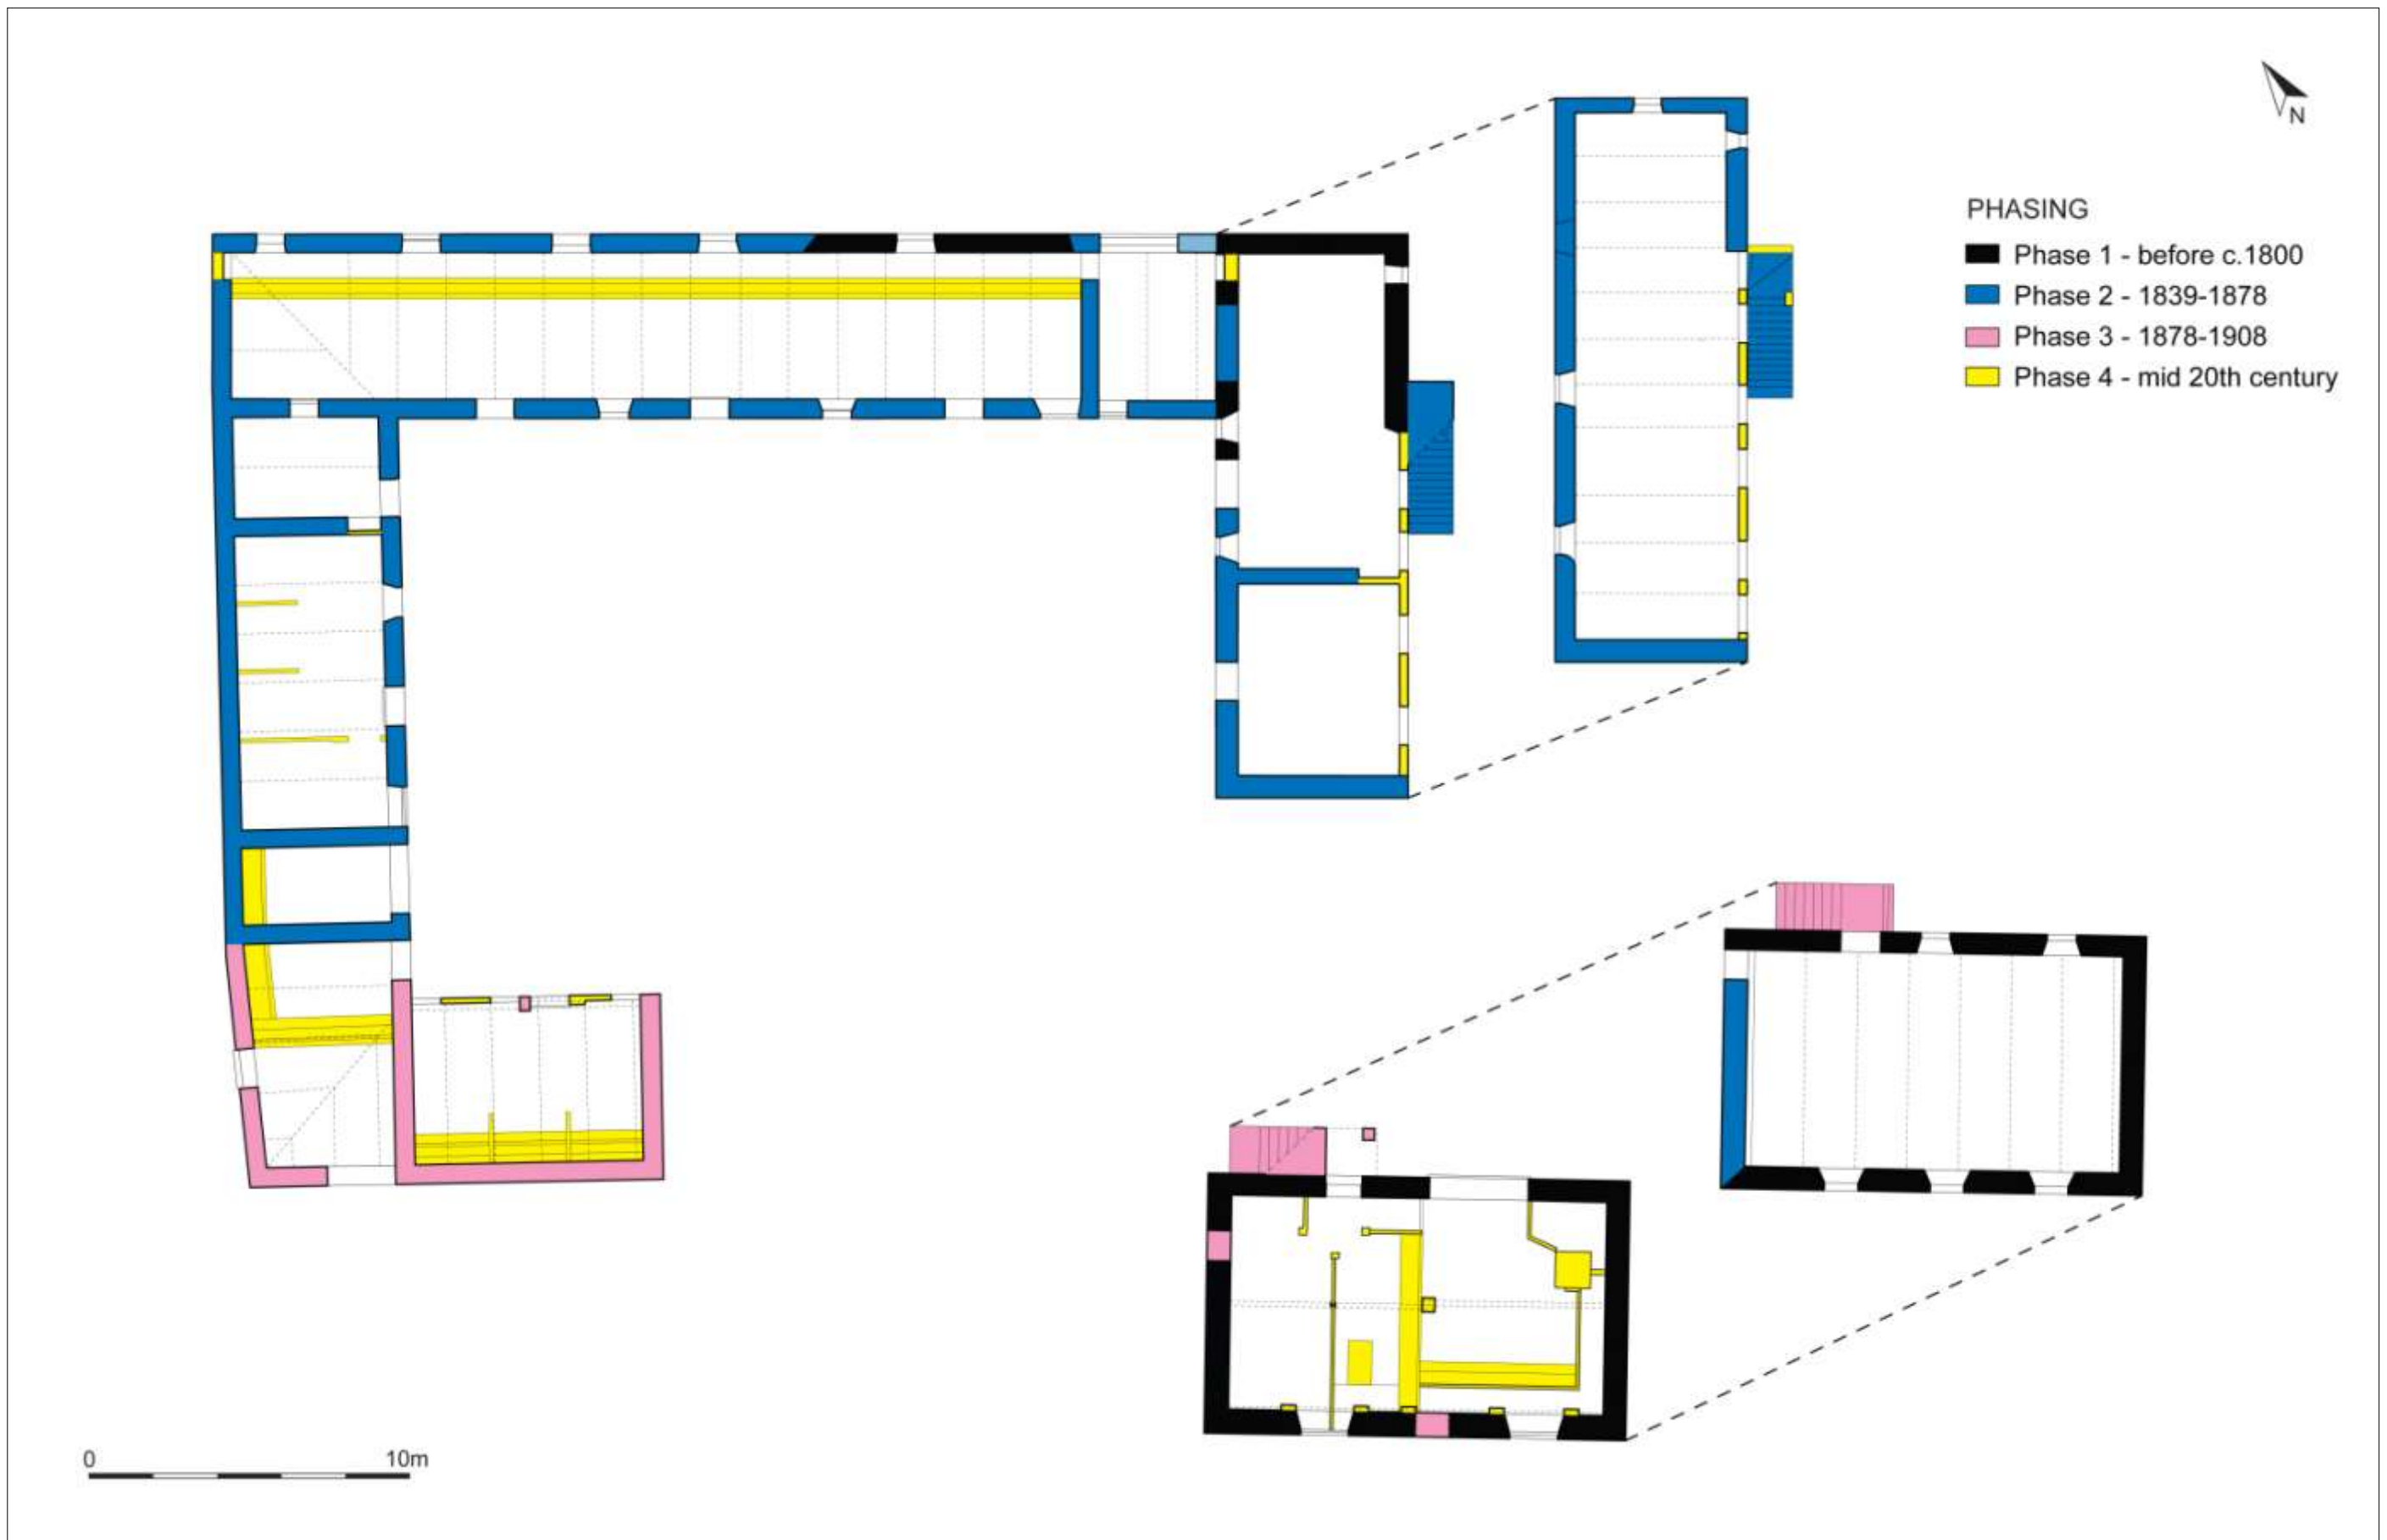
FIGURE 22: PHASE PLAN OF THE BUILDINGS. DRAWING BASED ON SUPPLIED PLANS.

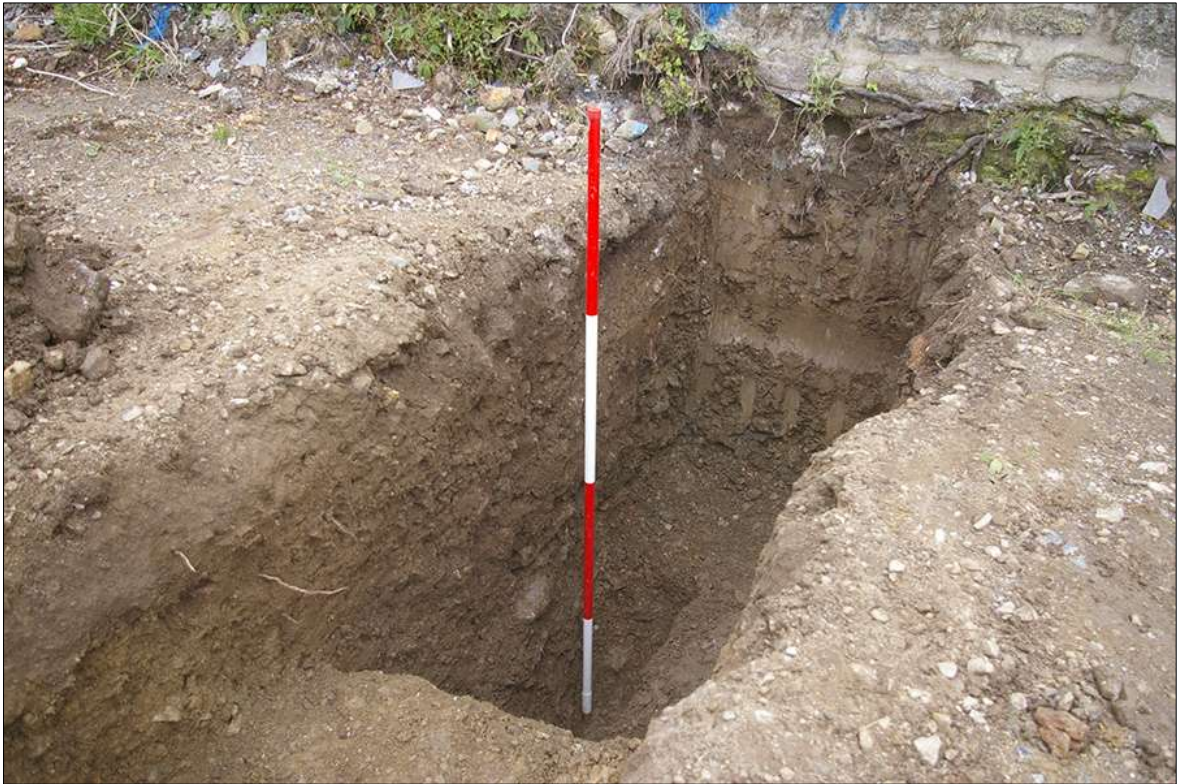
FIGURE 24: DITCH [107]; VIEWED FROM THE SOUTH-SOUTH-WEST (SCALE 2M).

The foundation trench for an extension to B5 c.6×5.50m across was opened against the south-west elevation of B5; the trench was c.0.80m wide and 0.60m deep. A single feature was identified, a ditch [107] c.2.60m wide and 1.44m deep and orientated north-west by south-east. Its fill was overlain by topsoil/yard surface and cut by the south-west elevation of B5. It has steep sloping sides and a flat base and contained five fills (108)(109)(110)(111)(112); fill (109) contained ×4 sherds (16g) of 2nd-3rd century gabbroic but otherwise undiagnostic Romano-British pottery.

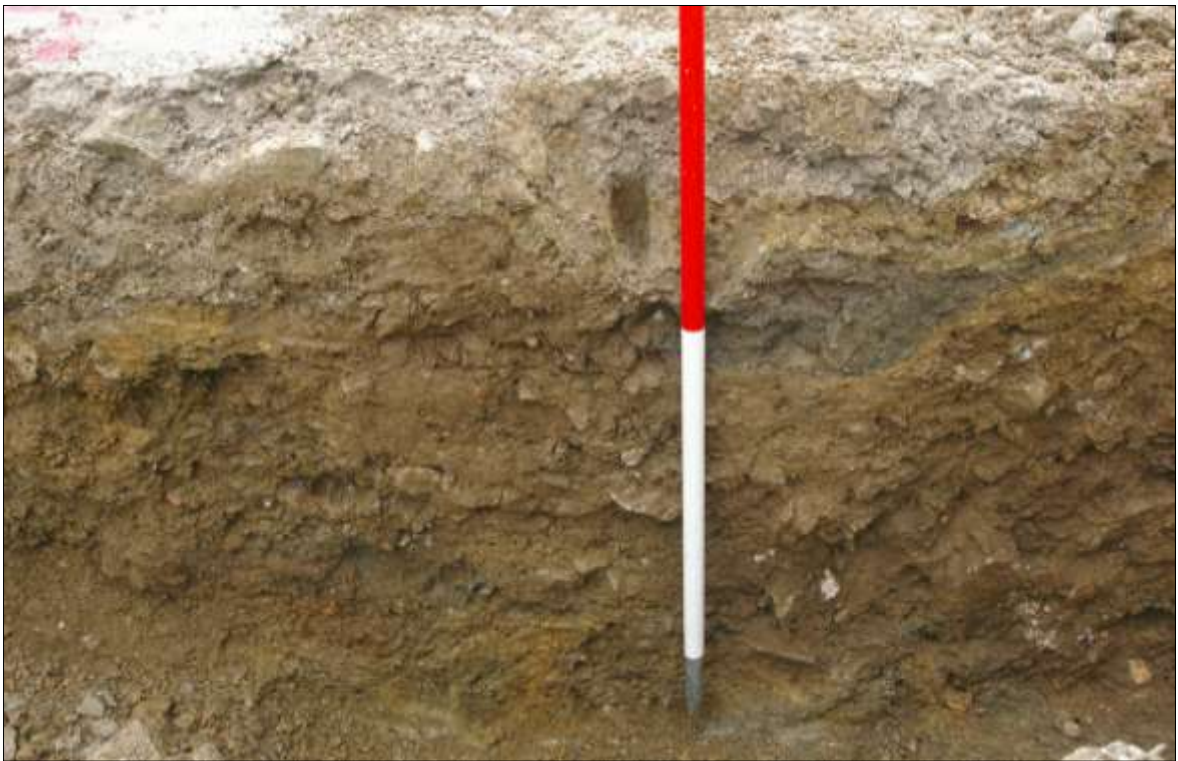
FIGURE 25: SOUTH-FACING SECTION OF DITCH [201], NORTH FOUNDATION TRENCH; VIEWED FROM THE SOUTH (SCALE 1M).

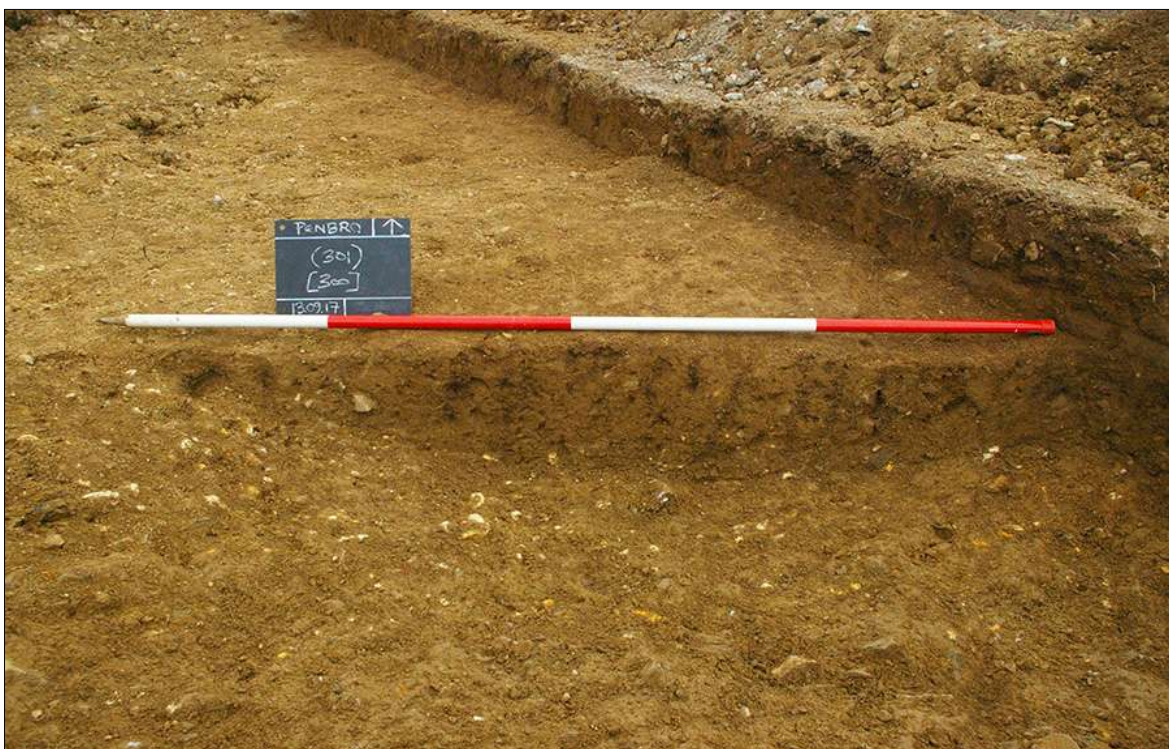
FIGURE 26: FEATURE [300]; VIEWED FROM THE WEST (SCALE 2M).

Two areas c.8×4m and c.16×5m were opened south-east of B1 for the installation of a septic tank and associated soakaways. Just to the west of these trenches, fragments of stone wall were observed and recorded. Walls {302} and {303} were both c.0.60m wide and had been robbed out. Wall {302} was aligned north-west by south-east with an ephemeral return/robbed-out element at its south-eastern end. Wall {303} was aligned perpendicular to wall {302} and ran north-east by south-west. Both walls had an earth-clay bond and were left *in-situ*. Apart from a patch of modern disturbed material (304), and the south-east corner of {302}, no features were observed in the larger trench. A broad but shallow linear ditch was observed and excavated in the smaller trench; ditch [300] was over 8m in length and over 2m wide, with a gentle north slope and a gently-concave base. It contained a single fill (301), a friable mid yellow-brown clay-silt. Feature [300] was not observed in the larger trench, and may have turned to the west.

The broad shallow ditch [300] identified in the septic tank trench may belong to a field boundary running along the eastern side of the farmstead; equally, it is possible it represents the upper fill of an earlier and more substantial feature, possibly even a continuation of ditch [107]. If so, the fill would largely be comprised of redeposited natural material almost indistinguishable from the weathered upper natural.
