THE BARNs PENBRO FARM BREAGE CORNWALL

Desk-Based Assessment & Historic Building Recording

South West Archaeology Ltd. report no. 180322

By B. Morris, E. Wapshott & N. Boyd
Report Version: FINAL
22nd March 2018

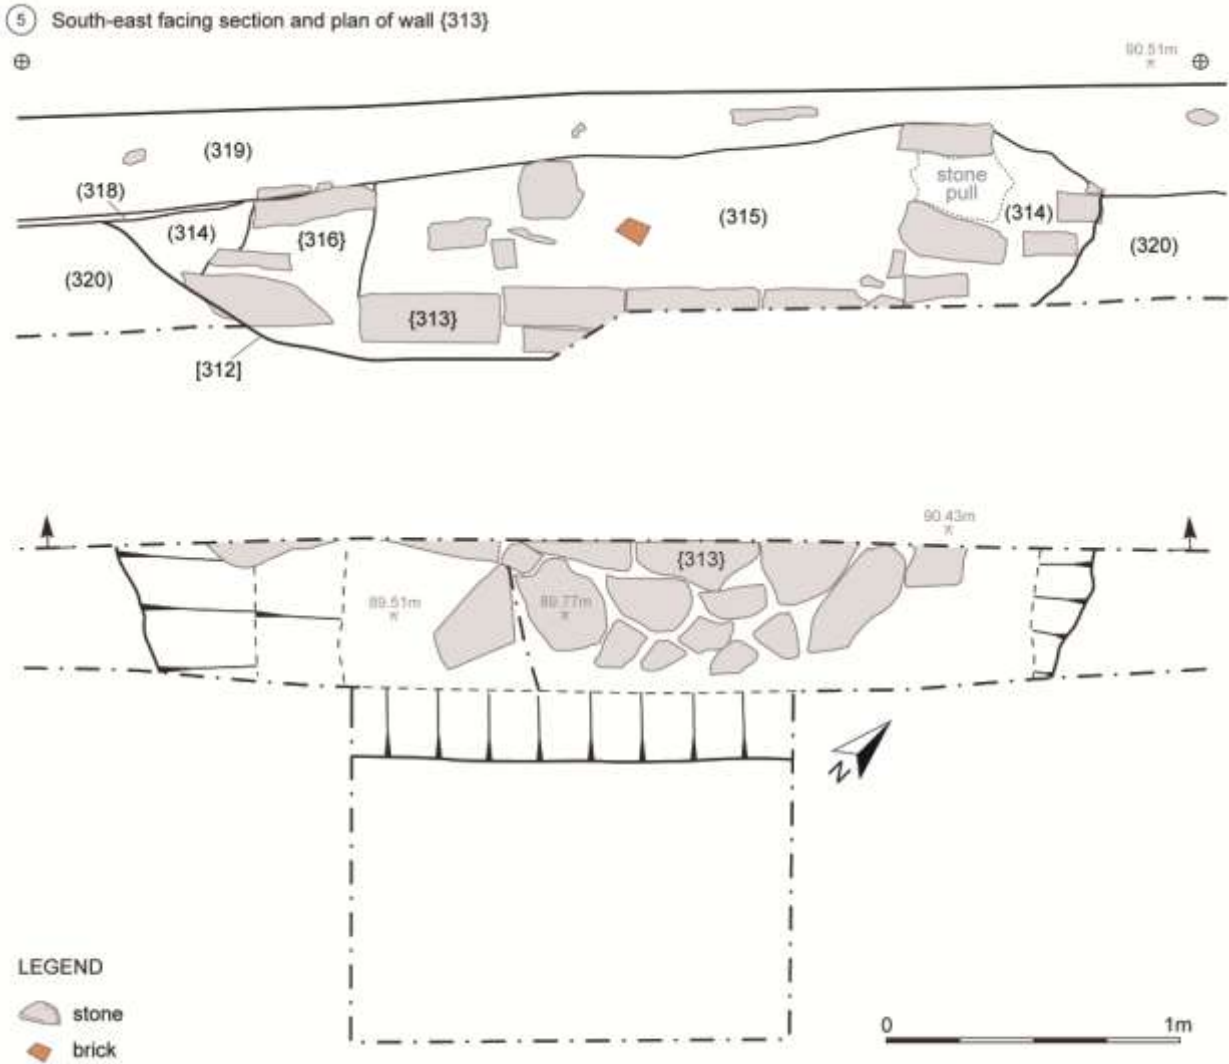
FIGURE 27: PLAN AND SECTION OF WALL {313}.

A water pipe trench, c.36m long by 0.40m wide and 0.75m deep, was excavated around the south-east and south side of B1. It contained a wall {313}; this ran parallel to the trench and the walls of B1. It was c.0.40m wide and was observed to extend for a length c.2.80m, one or two courses deep. It filled construction cut [312], which had steep sides and a flat base. The north-west return of the wall had been robbed out and was barely discernible. The north-west side of

wall {313} was infilled with demolition layer (315). Abutting robbed-out return of wall {313} was layer (318), soft dark brown-grey silt-clay debris c.0.03m thick probably associated with the levelling of the building represented by wall {313}. The trench also exposed modern service pipes and a modern soakaway pit.

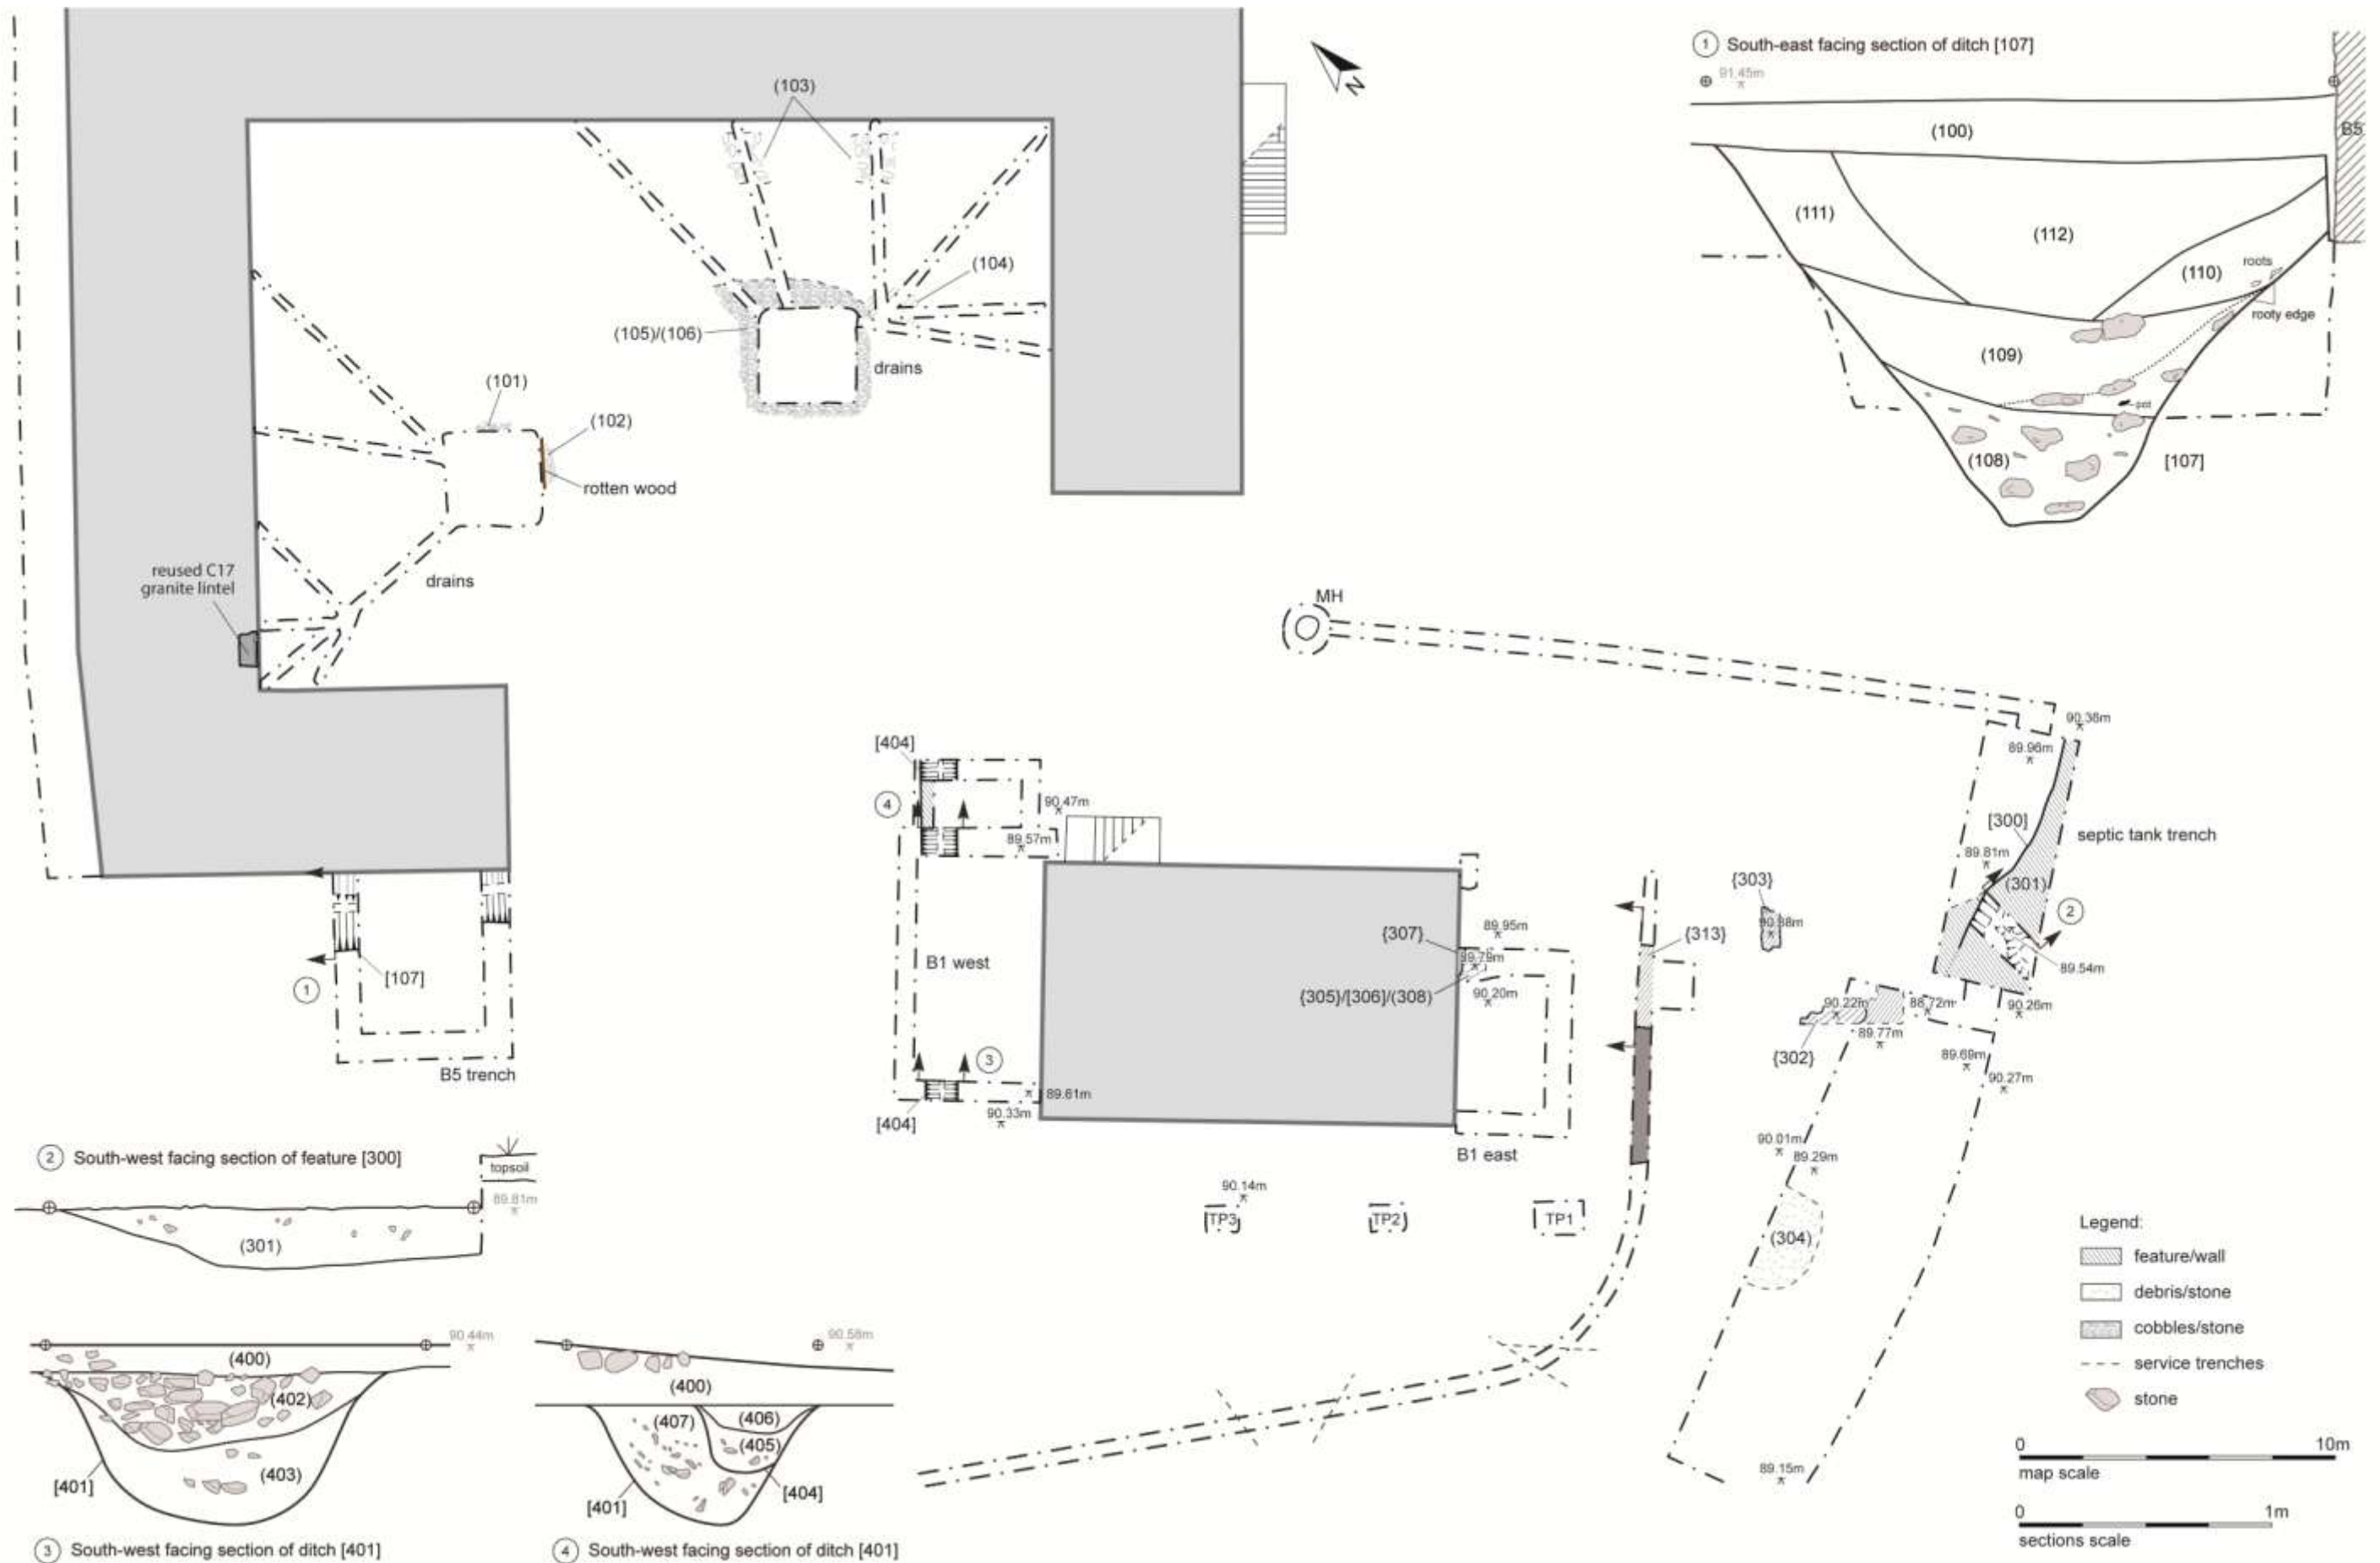
FIGURE 28: SITE PLAN WITH SECTIONS, SHOWING RESULTS OF THE MONITORING AND RECORDING OF EXCAVATIONS.

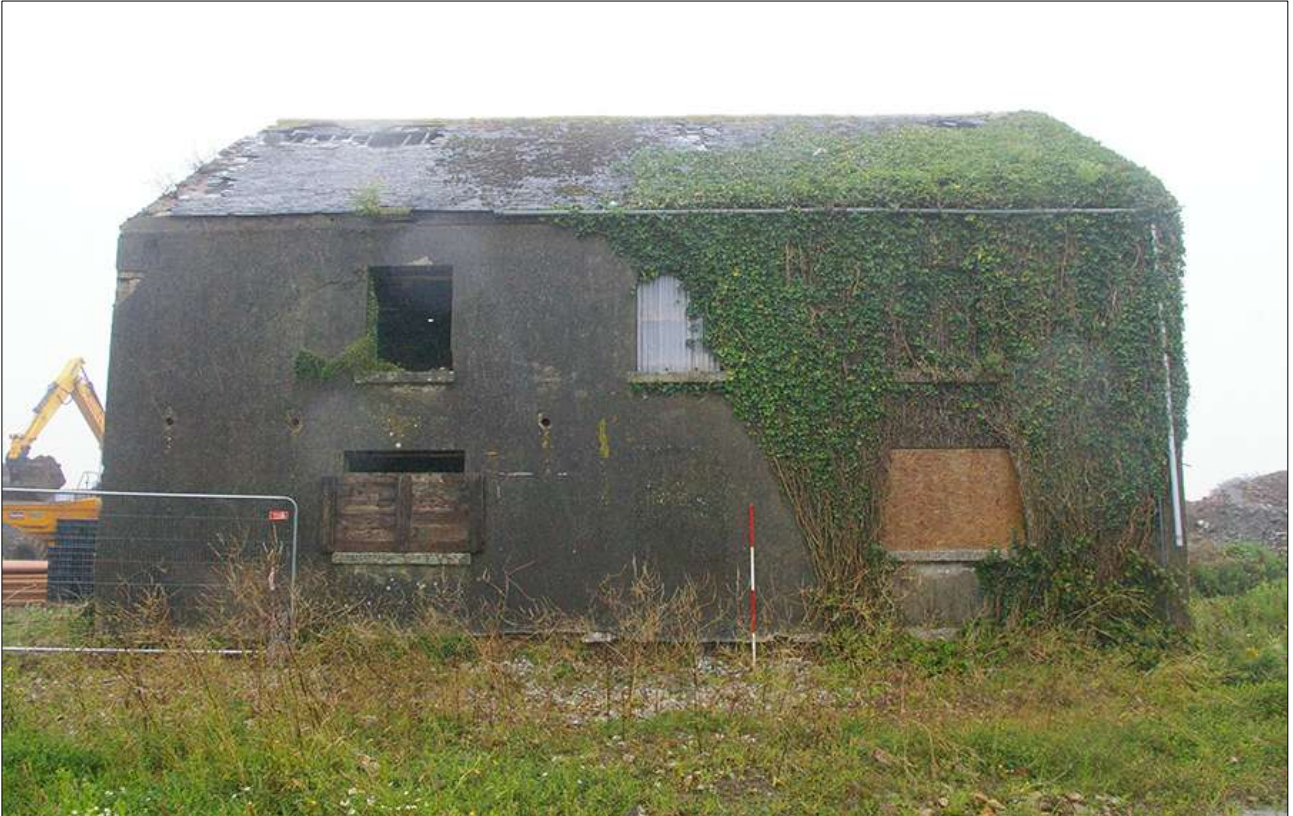
B1, SOUTH-WEST ELEVATION; VIEWED FROM THE SOUTH-WEST (SCALE 2M). BO2 VISIBLE JUST TO THE LEFT OF THE RANGING POLE.

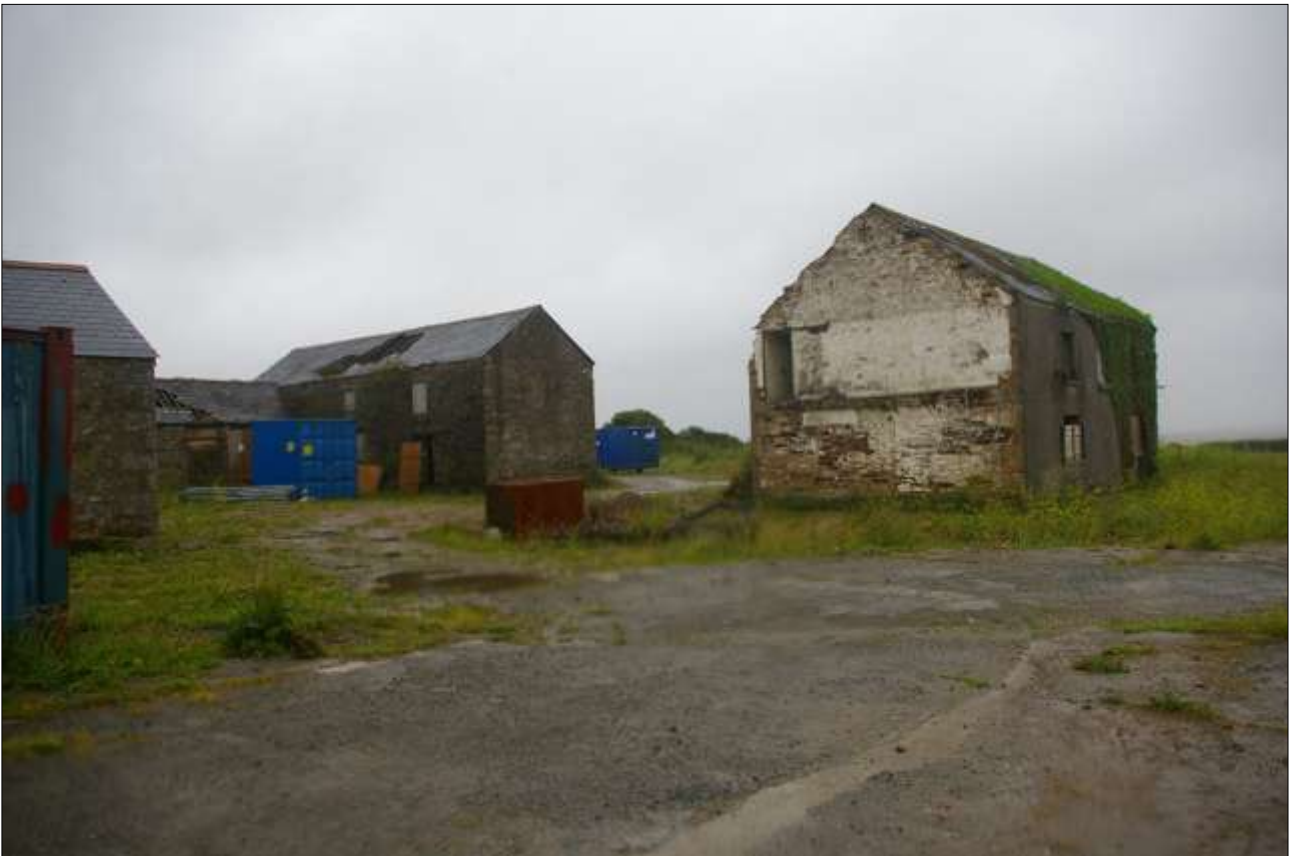
B1 FROM THE WEST, SHOWING ITS RELATIONSHIP WITH THE OTHER BUILDINGS; VIEWED FROM THE WEST.

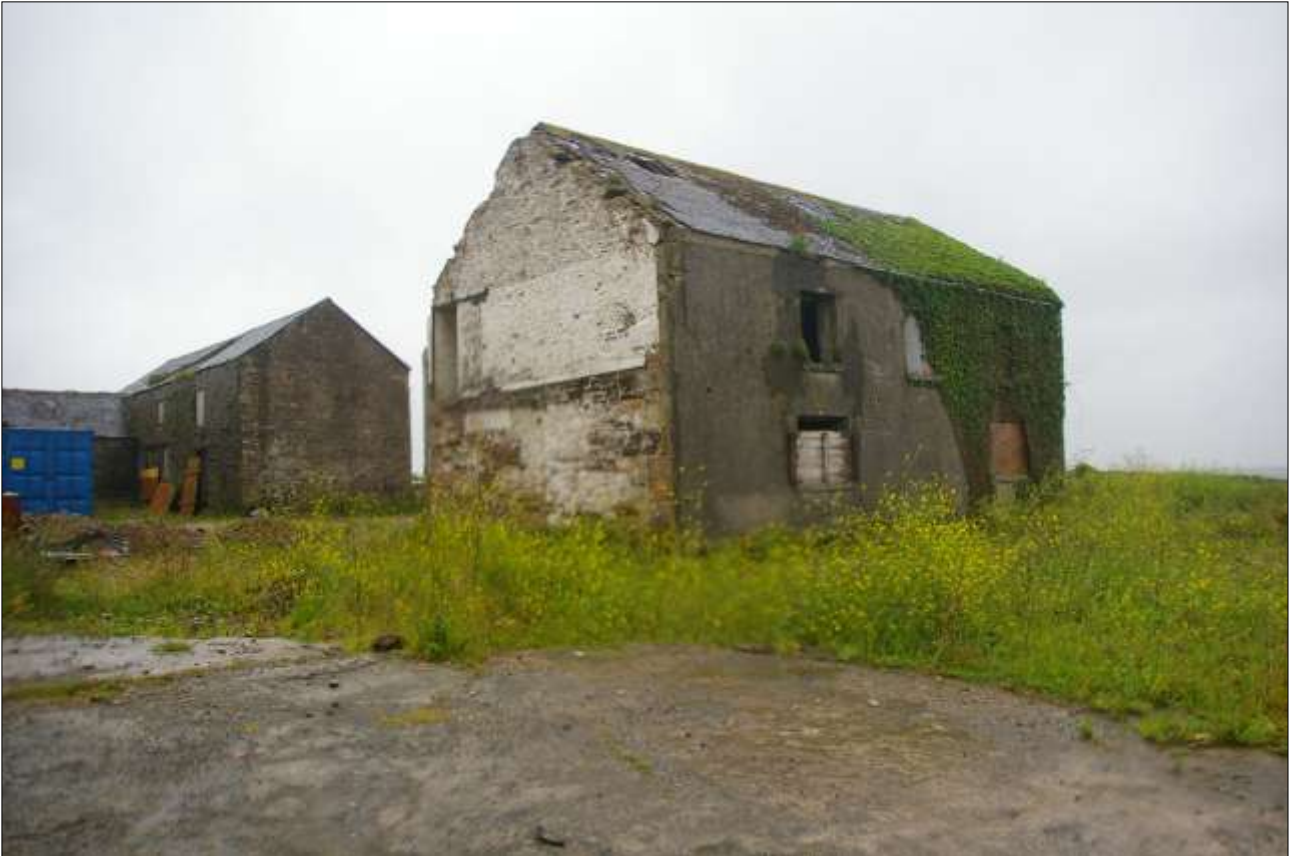
B1, SOUTH-WEST AND NORTH-WEST ELEVATIONS; VIEWED FROM THE WEST-SOUTH-WEST.

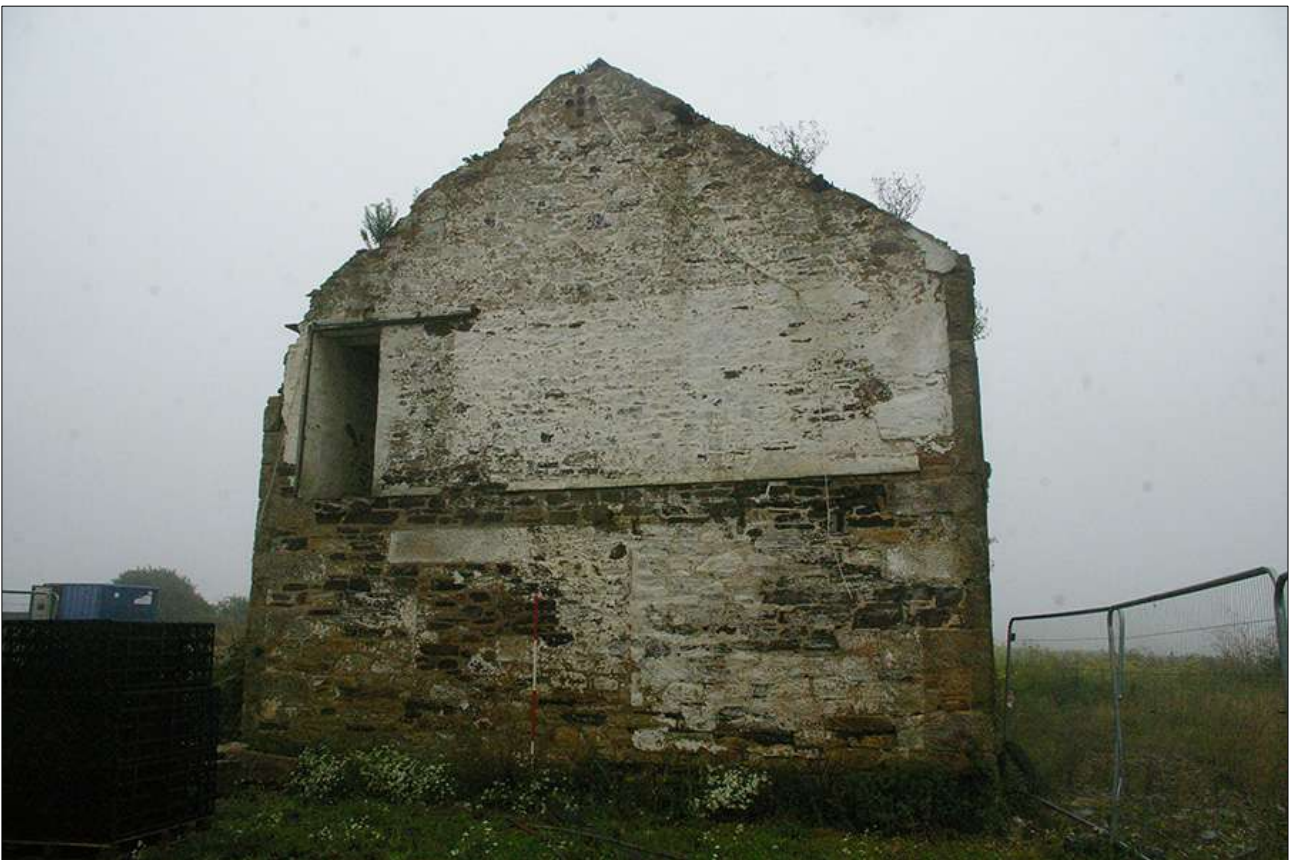
B1, NORTH-WEST ELEVATION; VIEWED FROM THE NORTH-WEST (SCALE 2M).

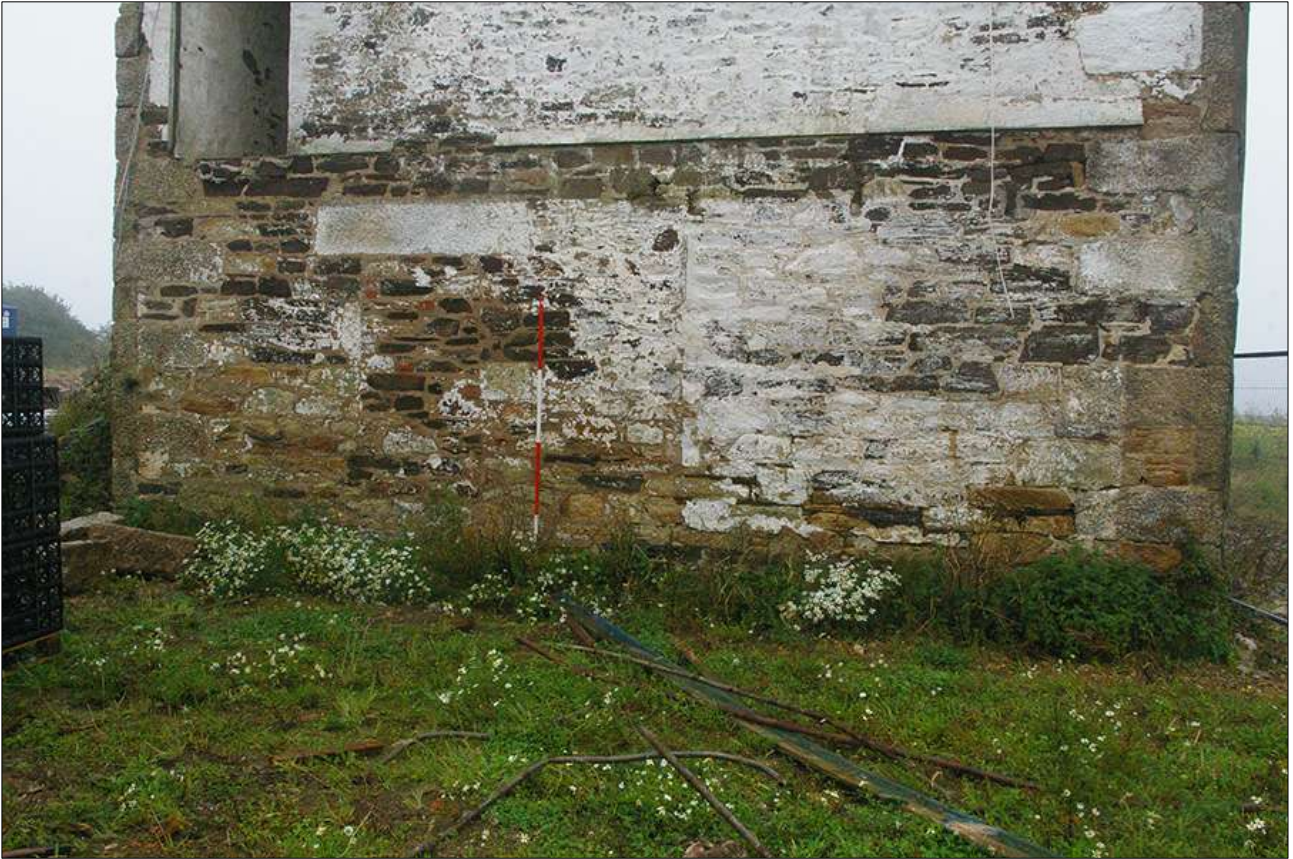
B1, DETAIL OF THE GF NORTH-WEST ELEVATION; VIEWED FROM THE WEST (SCALE 2M). BO3 VISIBLE JUST TO THE LEFT OF THE RANGING POLE.

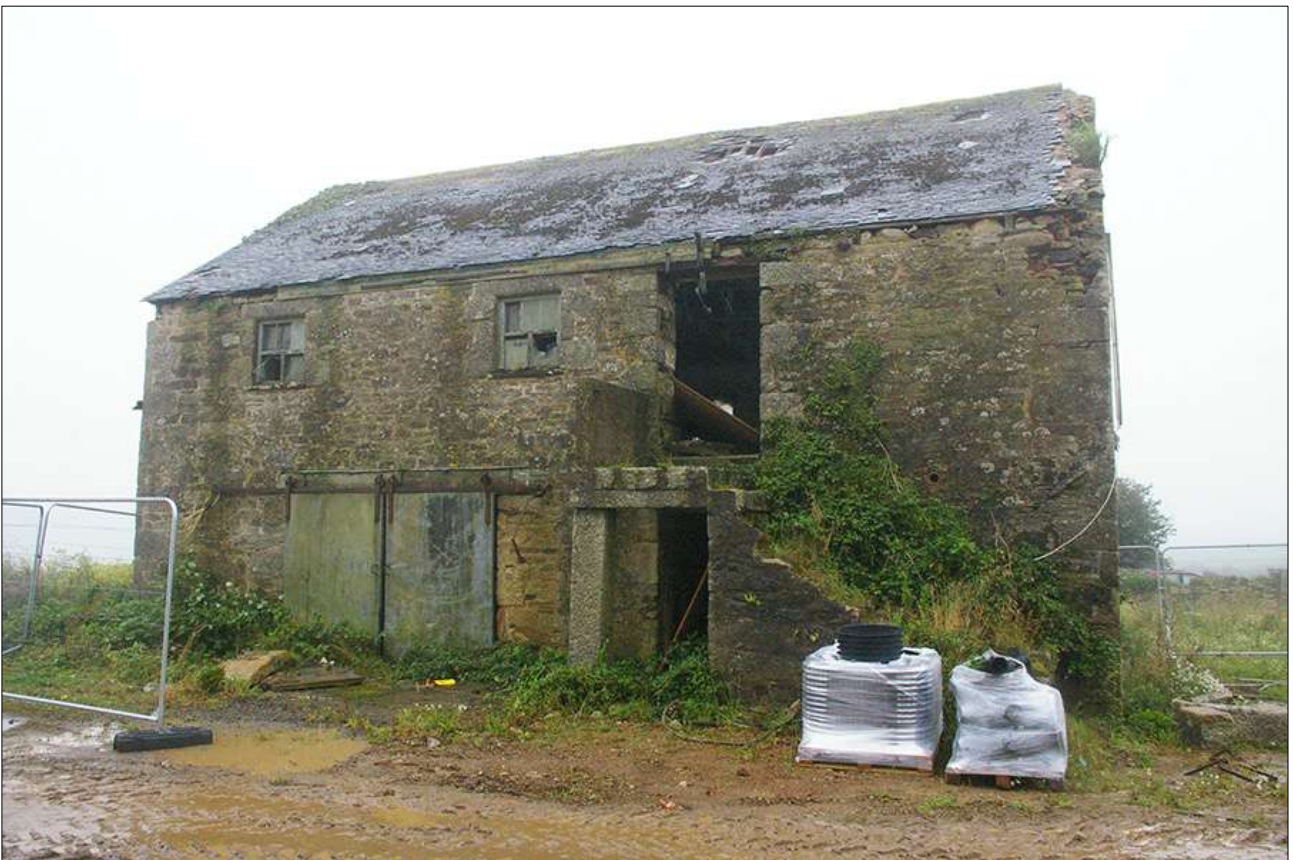
B1, NORTH-EAST ELEVATION; VIEWED FROM THE NORTH.

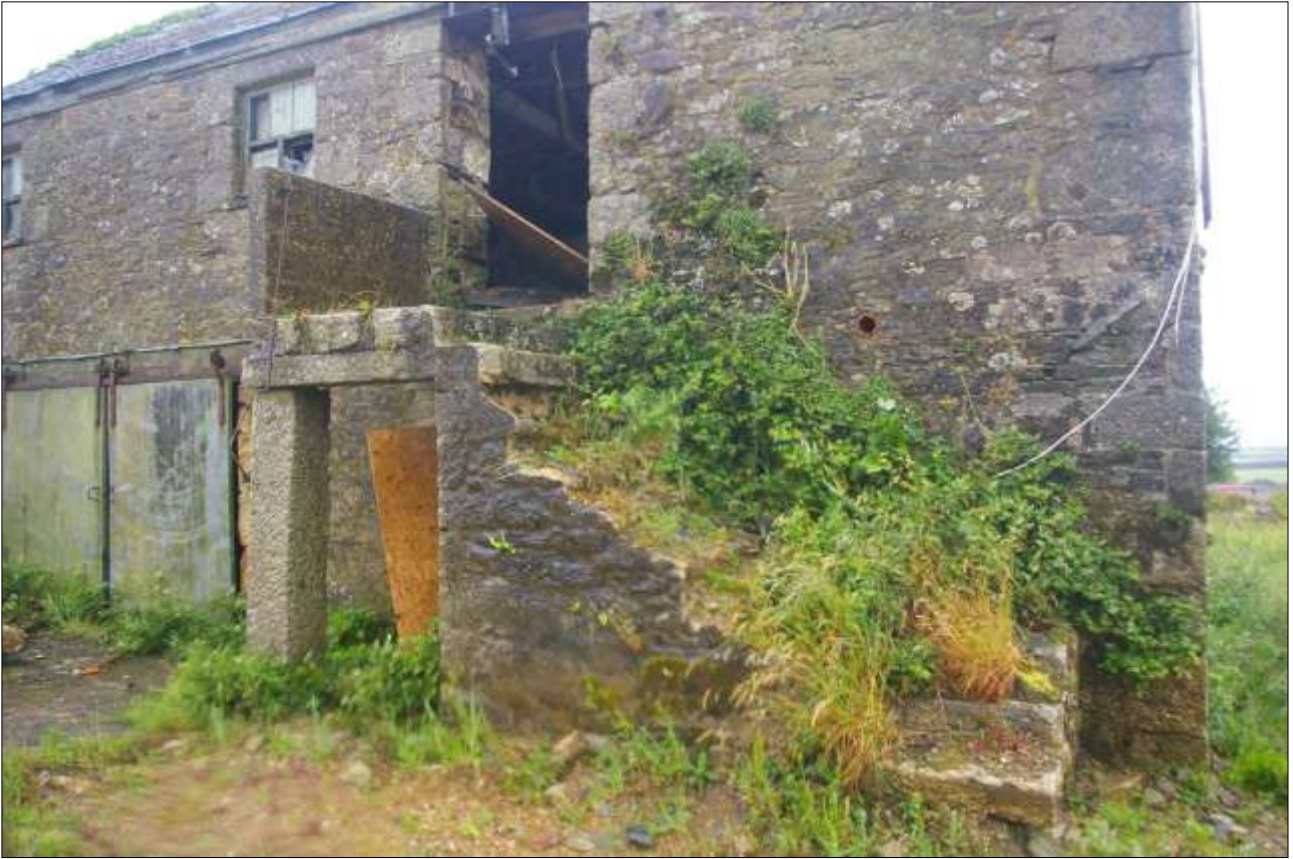
B1, AS ABOVE, DETAIL OF THE STEPS (S1) ADDRESSING THE FORCED FF DOORWAY (D4); VIEWED FROM THE NORTH.

D4	One rebuilt/forced doorway on the first floor, served by a set of external granite and concrete steps. Reveals of reused blocky dressed granite of mixed quality. The stonework appears disturbed and repointed in this area.	
Significant Features:	S1	Exterior stair providing access to the first floor. This is largely of granite, with granite treads (most now lost), with a granite pillar and lintels allowing for access to D2. Later altered with additional cement and concrete block elements. This stair appears to be secondary but details are obscured by its poor condition and ivy.	
Comments:		This elevation is now strongly agricultural in character, but the two small windows appear more domestic in character.	
B1 SOUTH-EAST Elevation		Description	
Fabric Description:		Gable elevation. Stonework as described above, principally Build 2, perhaps with Build 3 at FF level, but partly concealed by ivy. Several different phases of re-pointing/rendering correspond to where

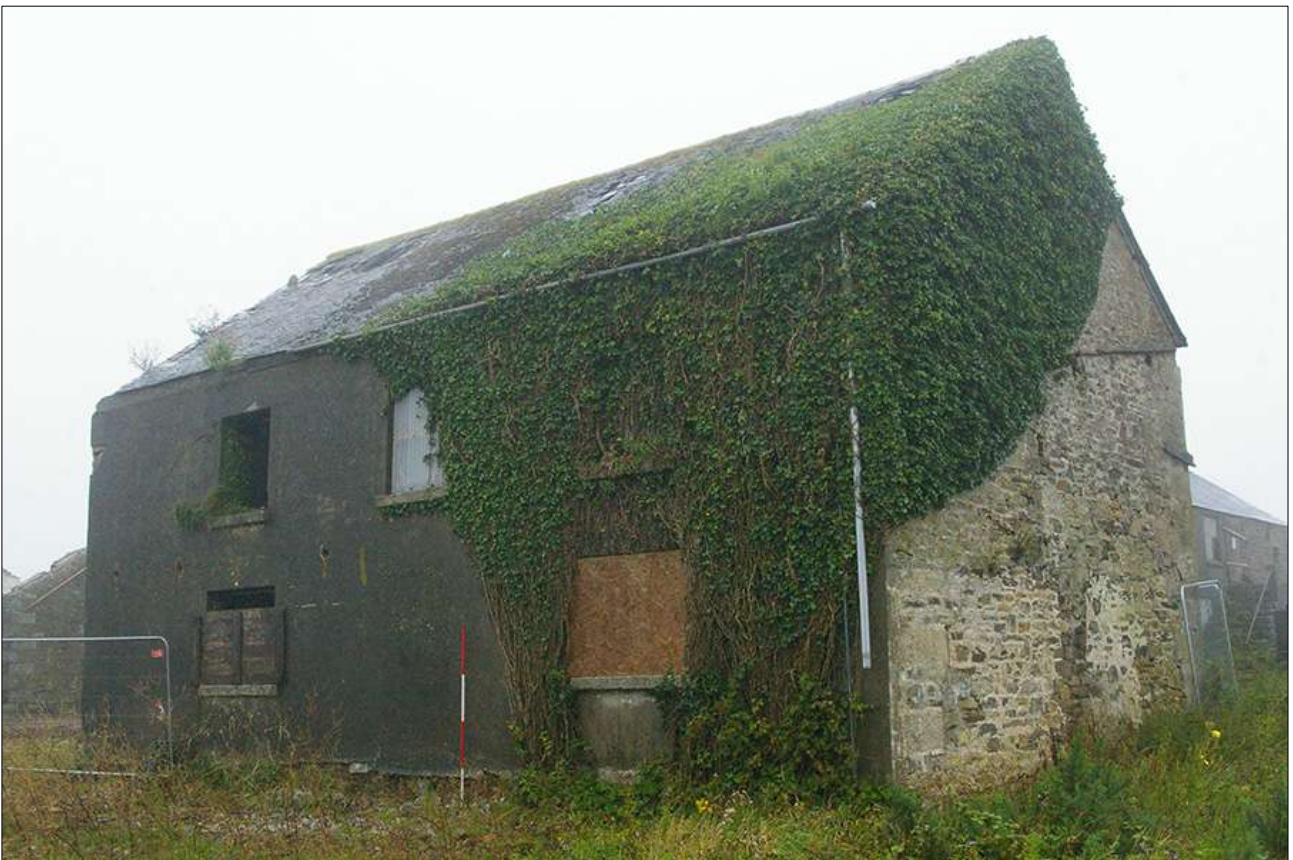
B1, SOUTH-WEST ELEVATION; VIEWED FROM THE SOUTH (SCALE 2M).

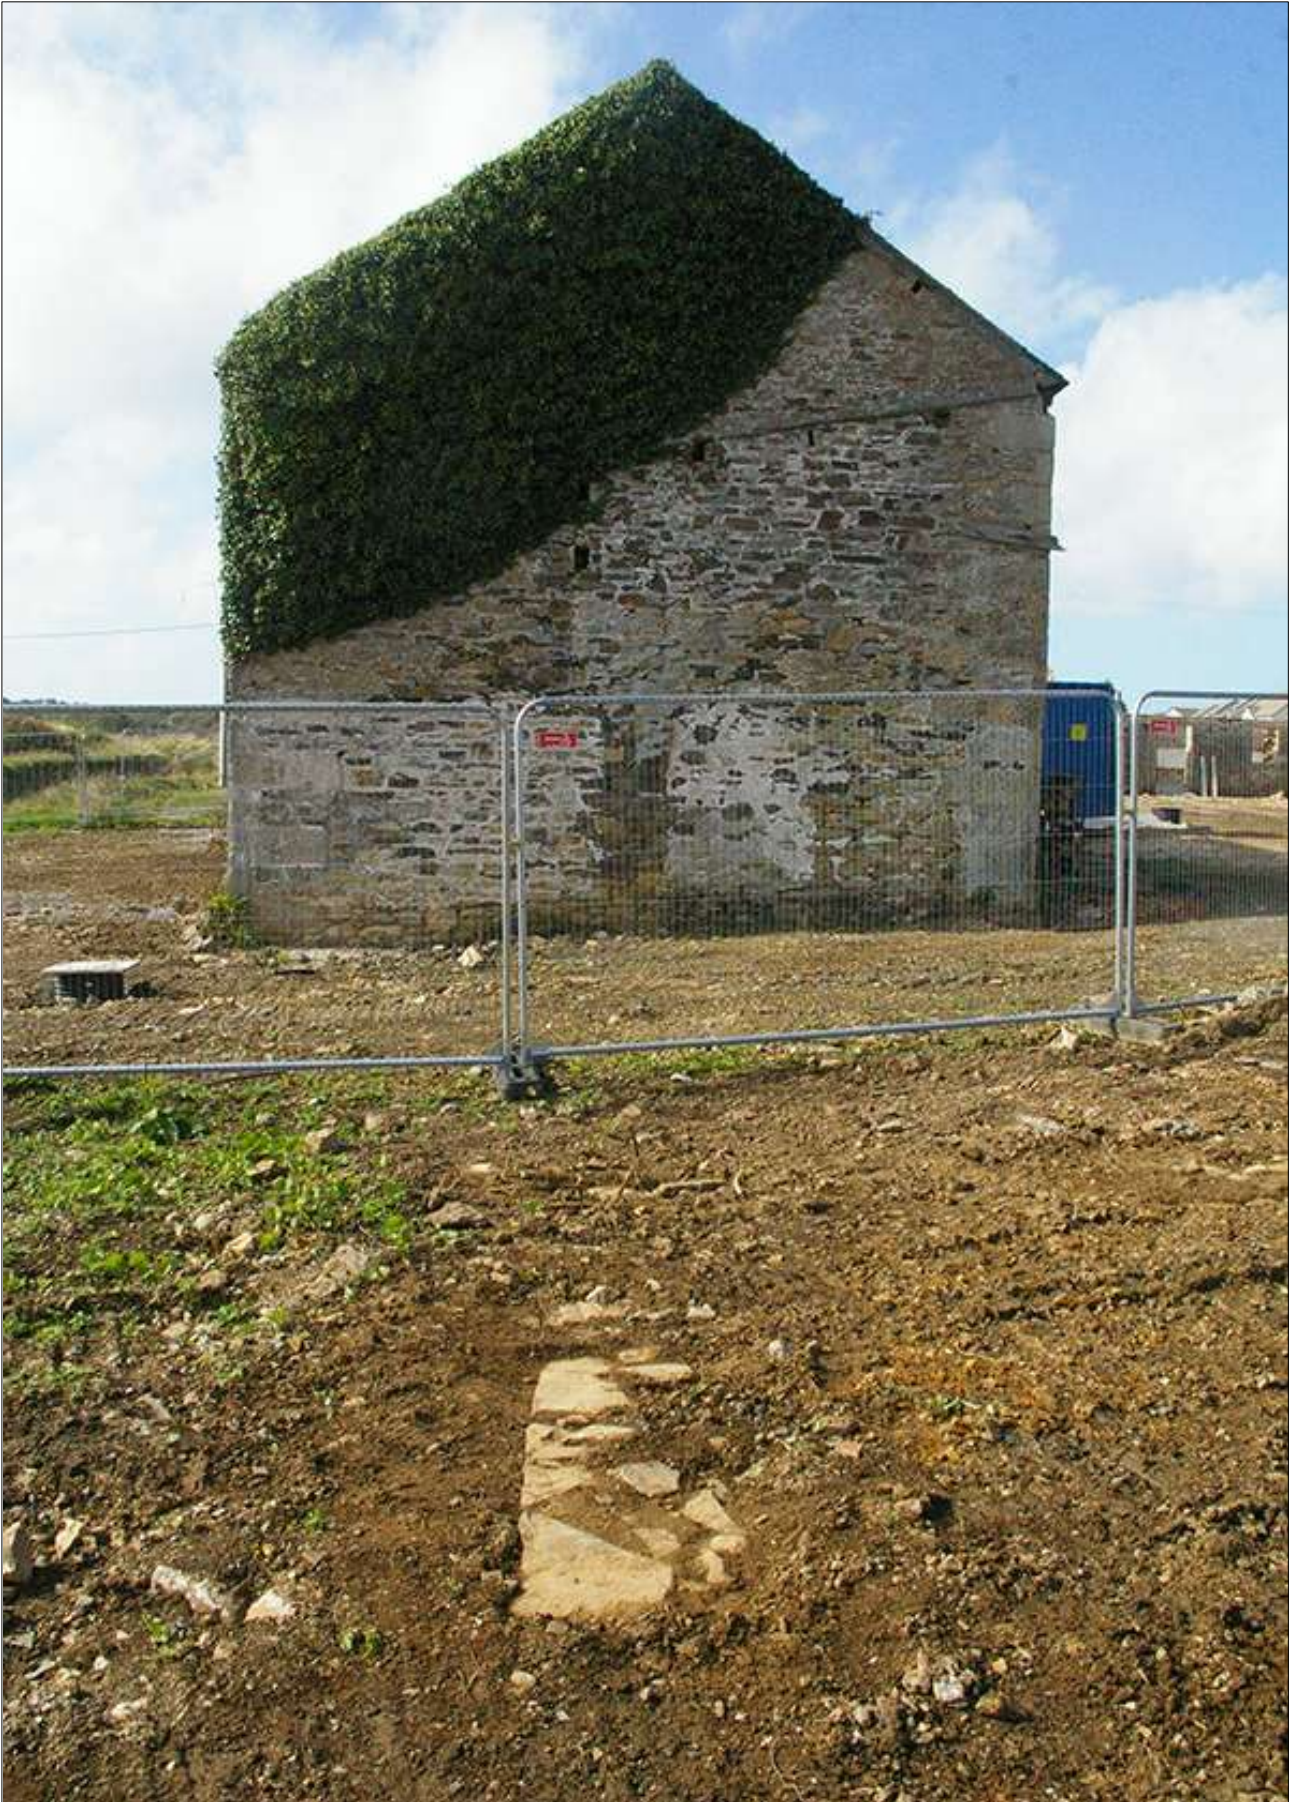
B1, SOUTH-EAST ELEVATION, WALL {302} IN THE FOREGROUND; VIEWED FROM THE SOUTH-EAST.

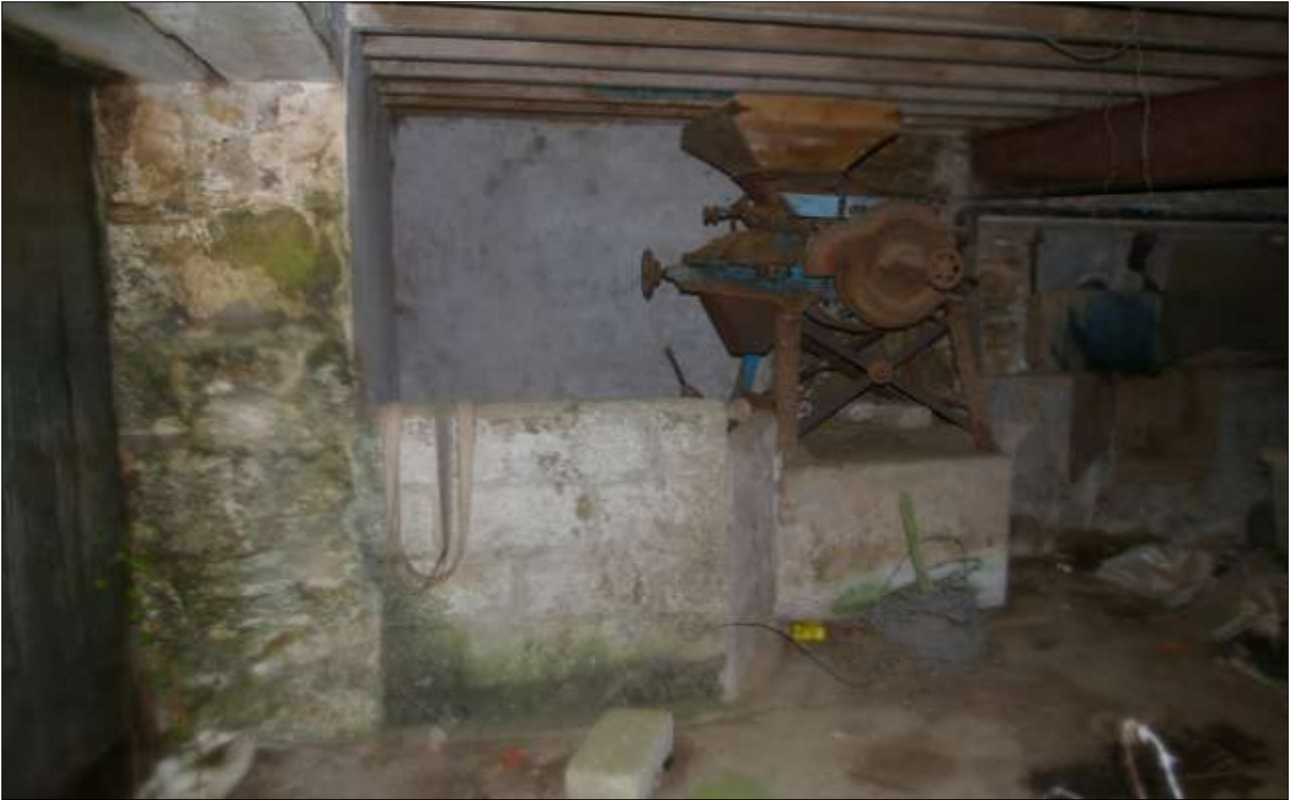
B1.1, EASTERN GF ROOM, SHOWING THE *IN SITU* MACHINERY (S2), AS VIEWED FROM THE DOORWAY (D3) INTO THE WEST ROOM; VIEWED FROM THE NORTH-WEST.

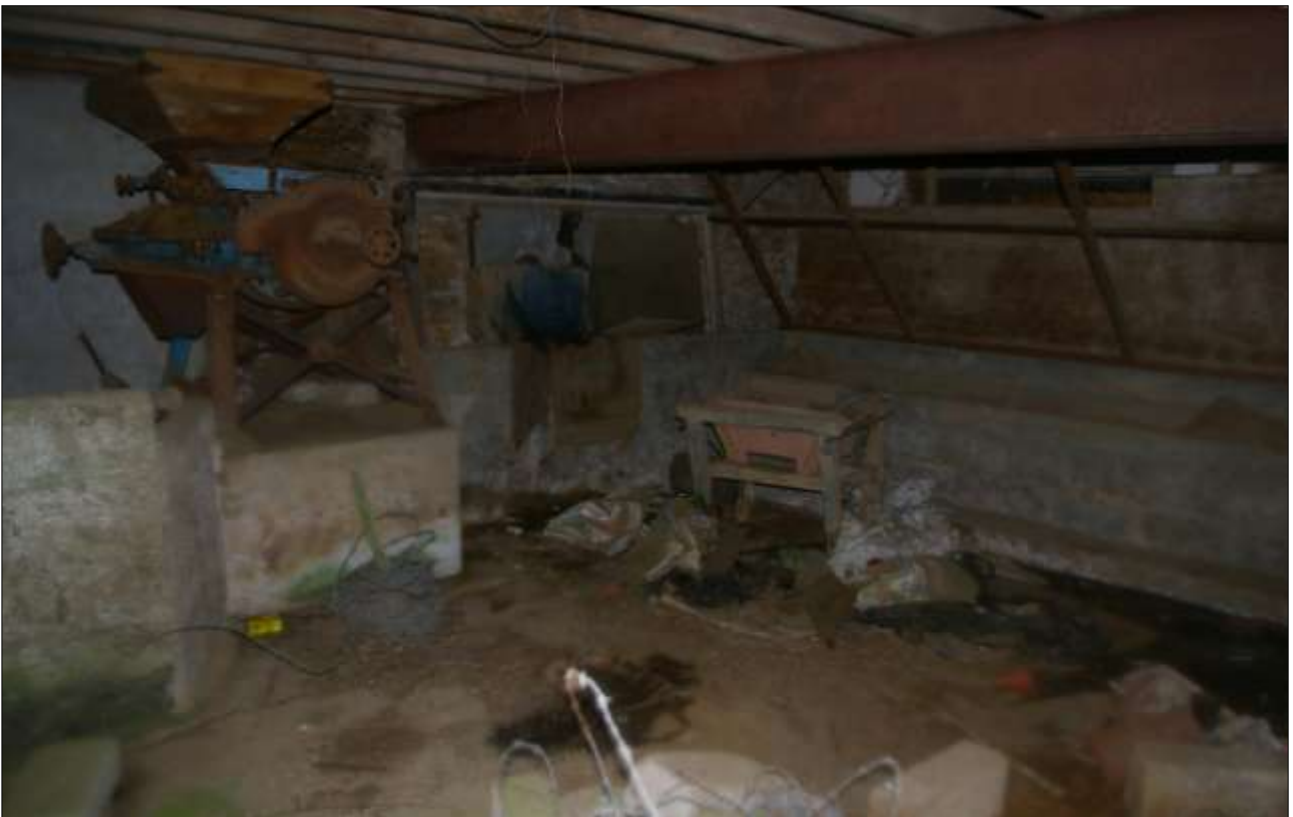
B1.1, EASTERN GF ROOM, SHOWING THE MODERN CONCRETE TROUGHS AND HAYRACK, AS VIEWED FROM THE DOORWAY (D3) INTO THE WESTERN ROOM; VIEWED FROM THE NORTH-WEST.

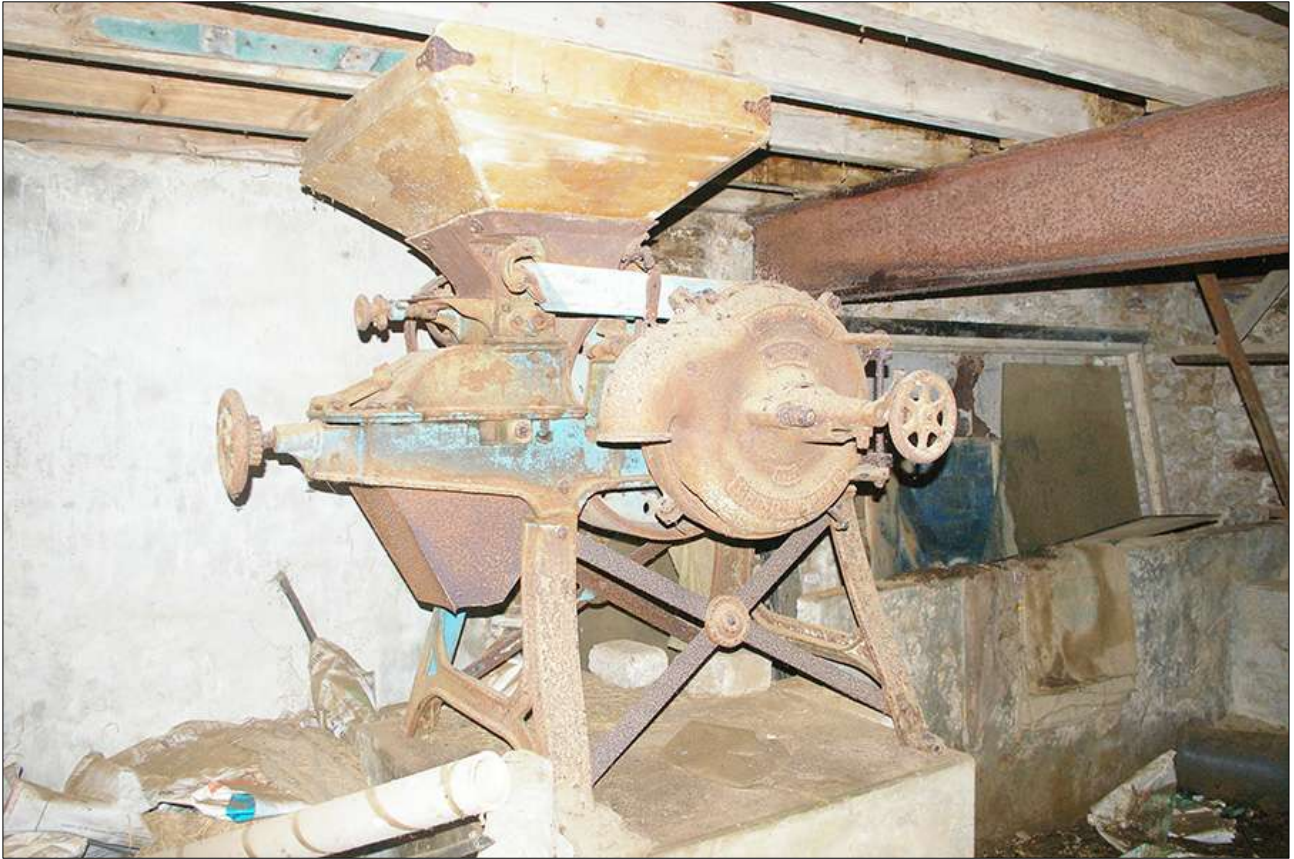
B1.1, WESTERN GF ROOM, *IN-SITU* MILLING MACHINE (S2); VIEWED FROM THE NORTH-WEST.

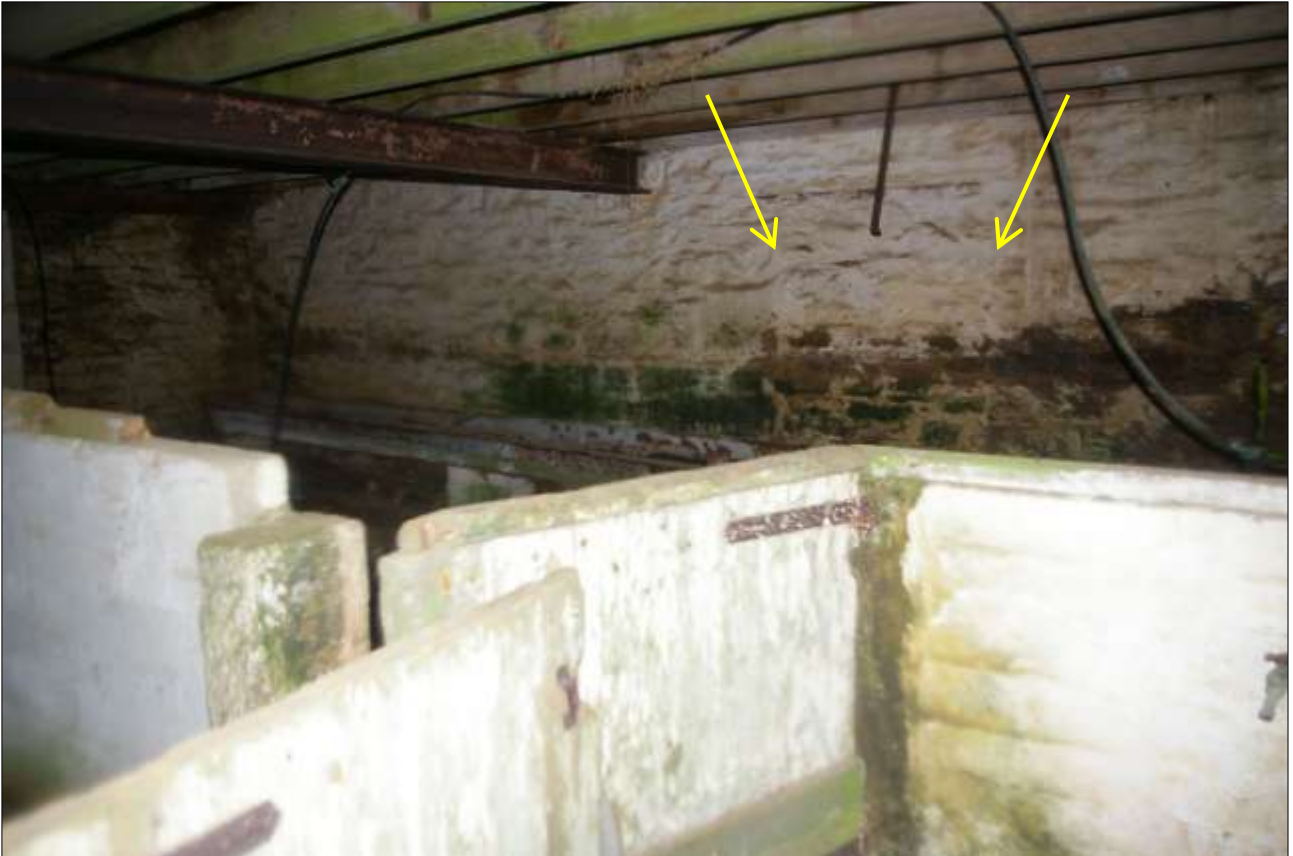
B1.2, WESTERN GF ROOM, SHOWING THE BLOCKED DOORWAY (BO3) (INDICATED); VIEWED FROM THE EAST-NORTH-EAST.

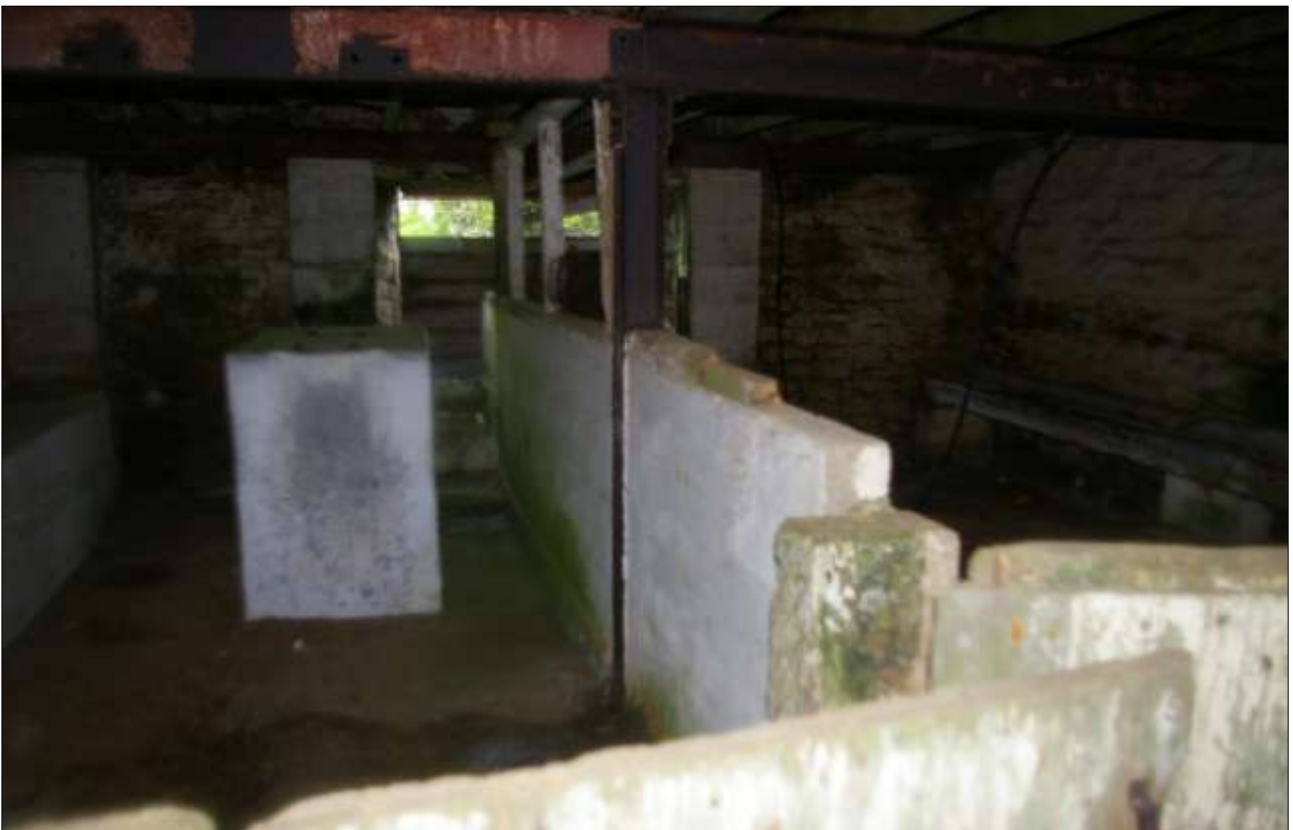
B1.2, WESTERN GF ROOM, SHOWING THE PART-BLOCKED WINDOW, CONCRETE BLOCK PENS AND LARGE CONCRETE PLINTH; VIEWED FROM THE NORTH-EAST.
