THE BARNs PENBRO FARM BREAGE CORNWALL

Desk-Based Assessment & Historic Building Recording

South West Archaeology Ltd. report no. 180322

By B. Morris, E. Wapshott & N. Boyd
Report Version: FINAL
22nd March 2018

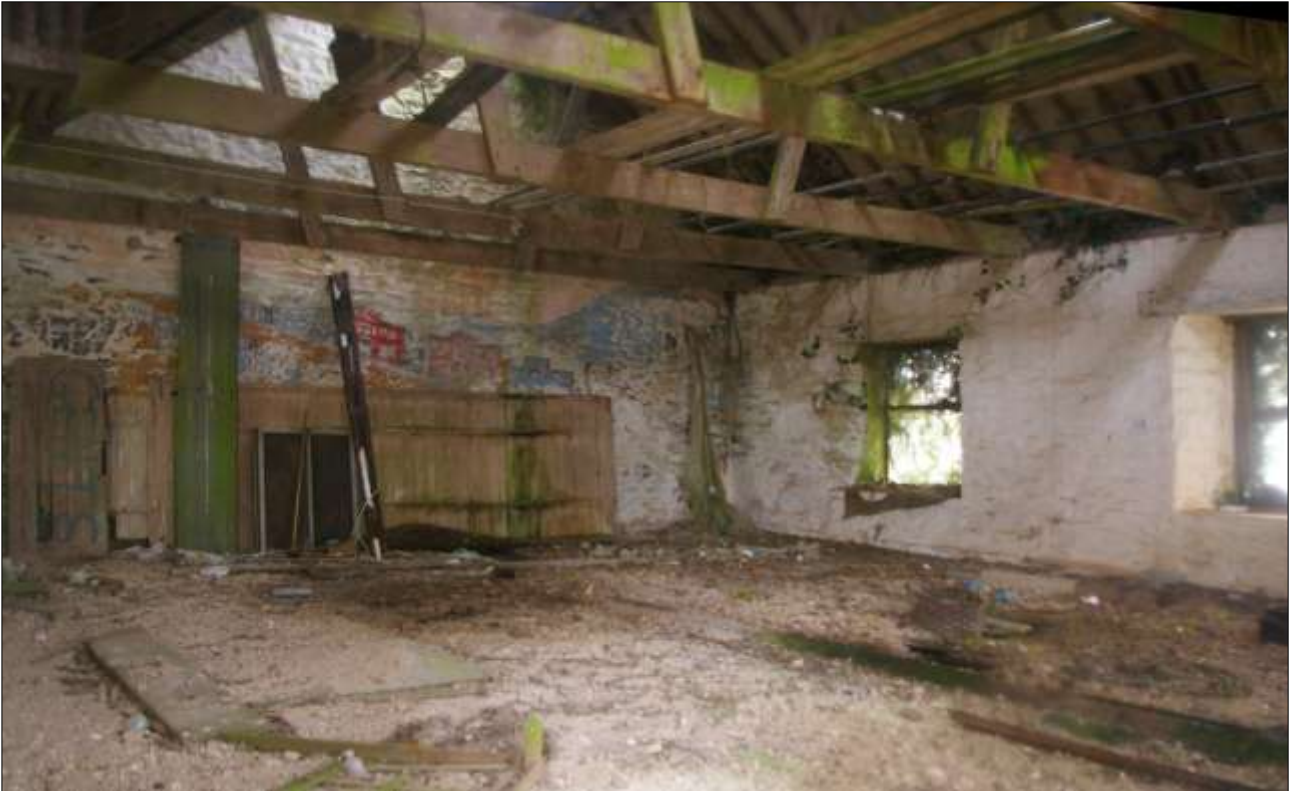
B1.3, FF ROOM, SHOWING THE PAINTED MURAL (S6); VIEWED FROM THE NORTH-NORTH-WEST.

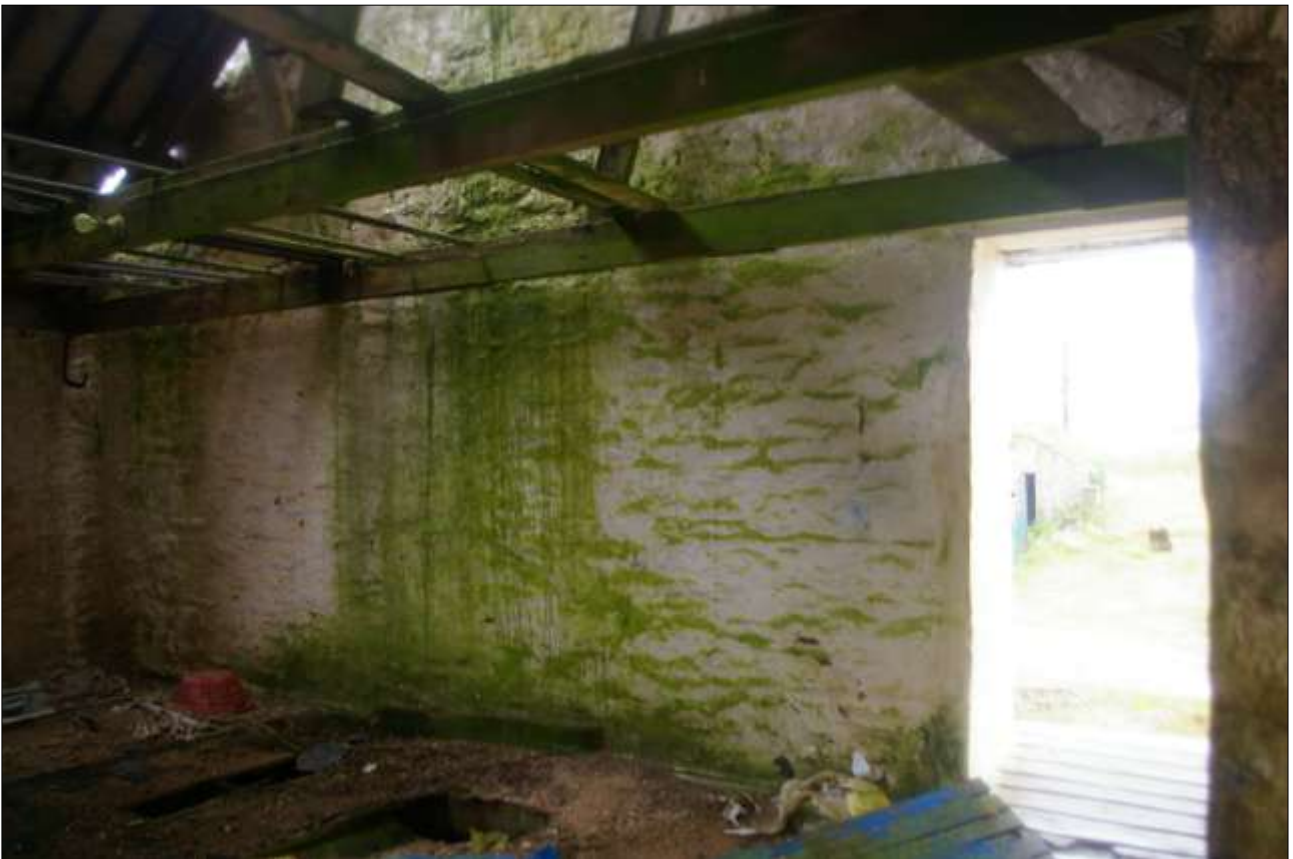
B1.3, FF ROOM, SHOWING THE NORTH-WEST GABLE AND FORCED DOORWAY (D5); VIEWED FROM THE EAST.

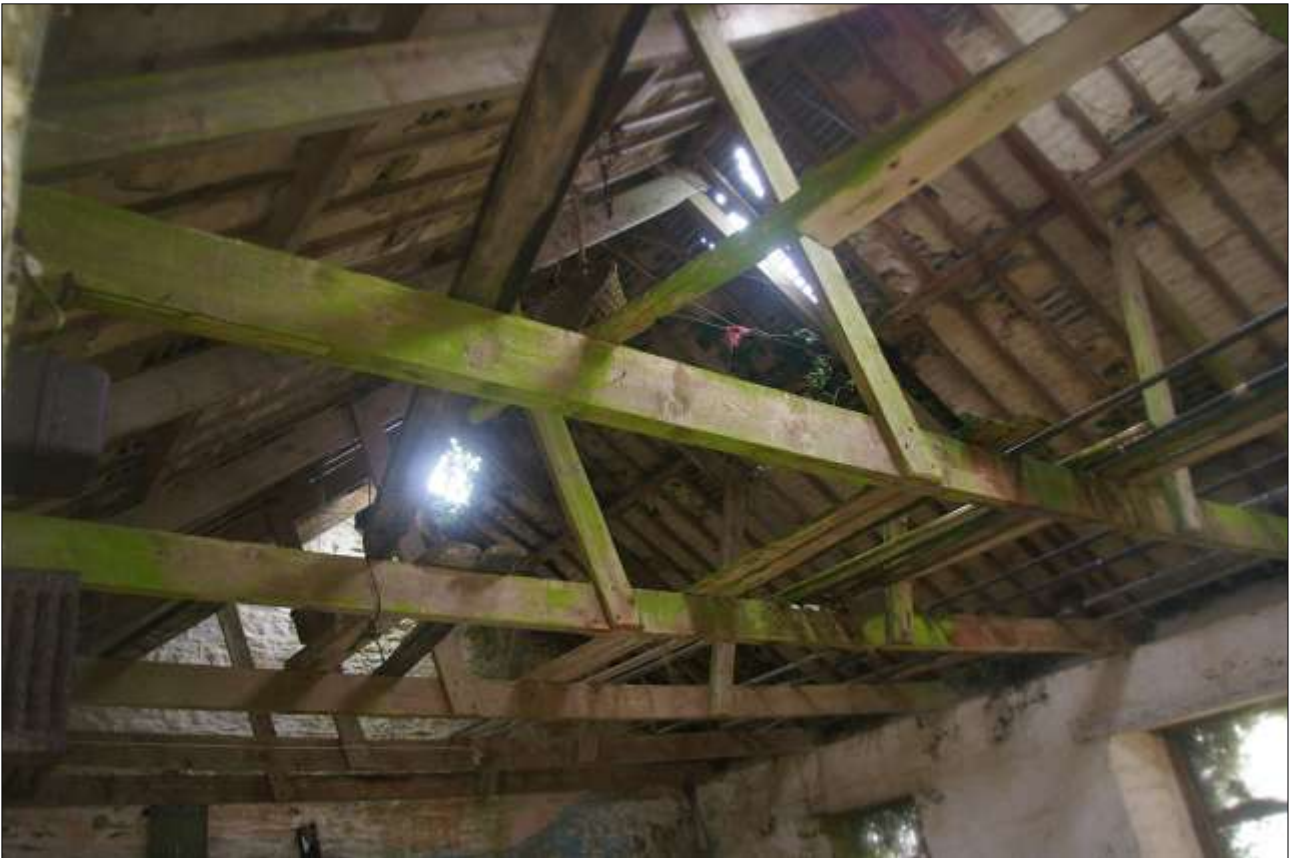
B1.3 ROOF STRUCTURE; VIEWED FROM THE NORTH-NORTH-WEST.

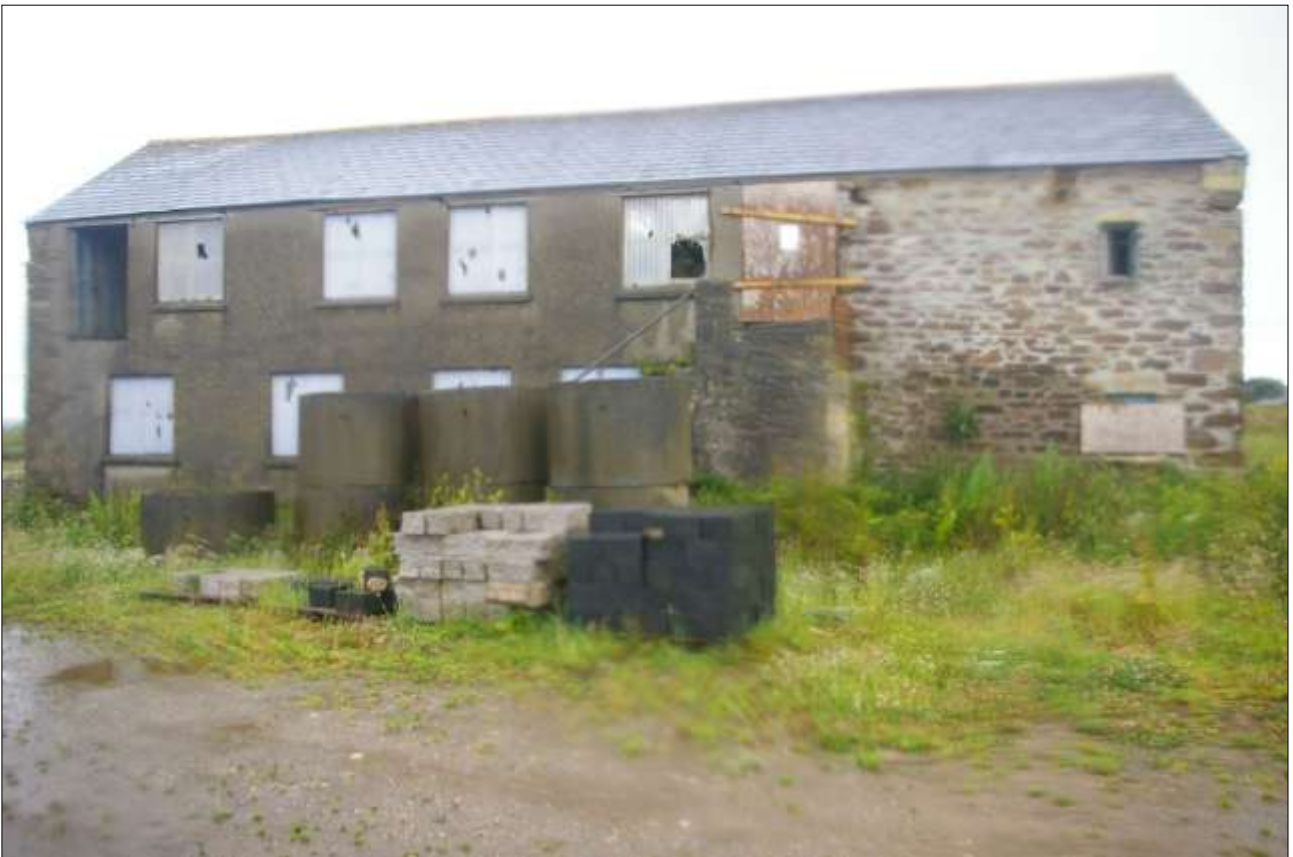
B2, SOUTH-EAST ELEVATION, MOST OF WHICH HAS BEEN REBUILT IN CONCRETE BLOCK; VIEWED FROM THE EAST-SOUTH-EAST.

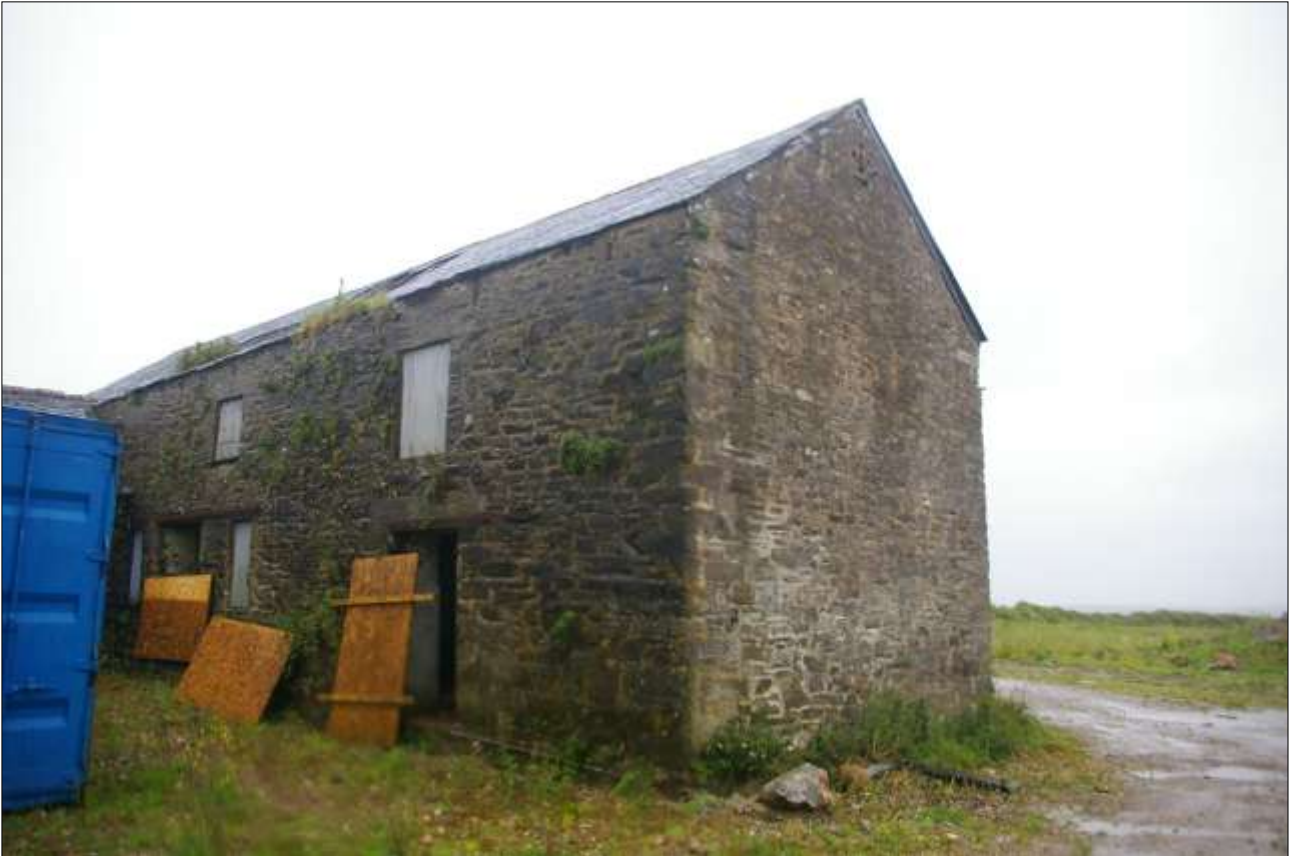
B2, SOUTH-WEST AND NORTH-WEST ELEVATIONS, SHOWING THE ROUGHLY-DRESSED GRANITE LINTELS TO THE TWO SURVIVING ORIGINAL WINDOWS (W20, W21) AND GROUND FLOOR DOOR (D6); VIEWED FROM THE WEST-SOUTH-WEST.

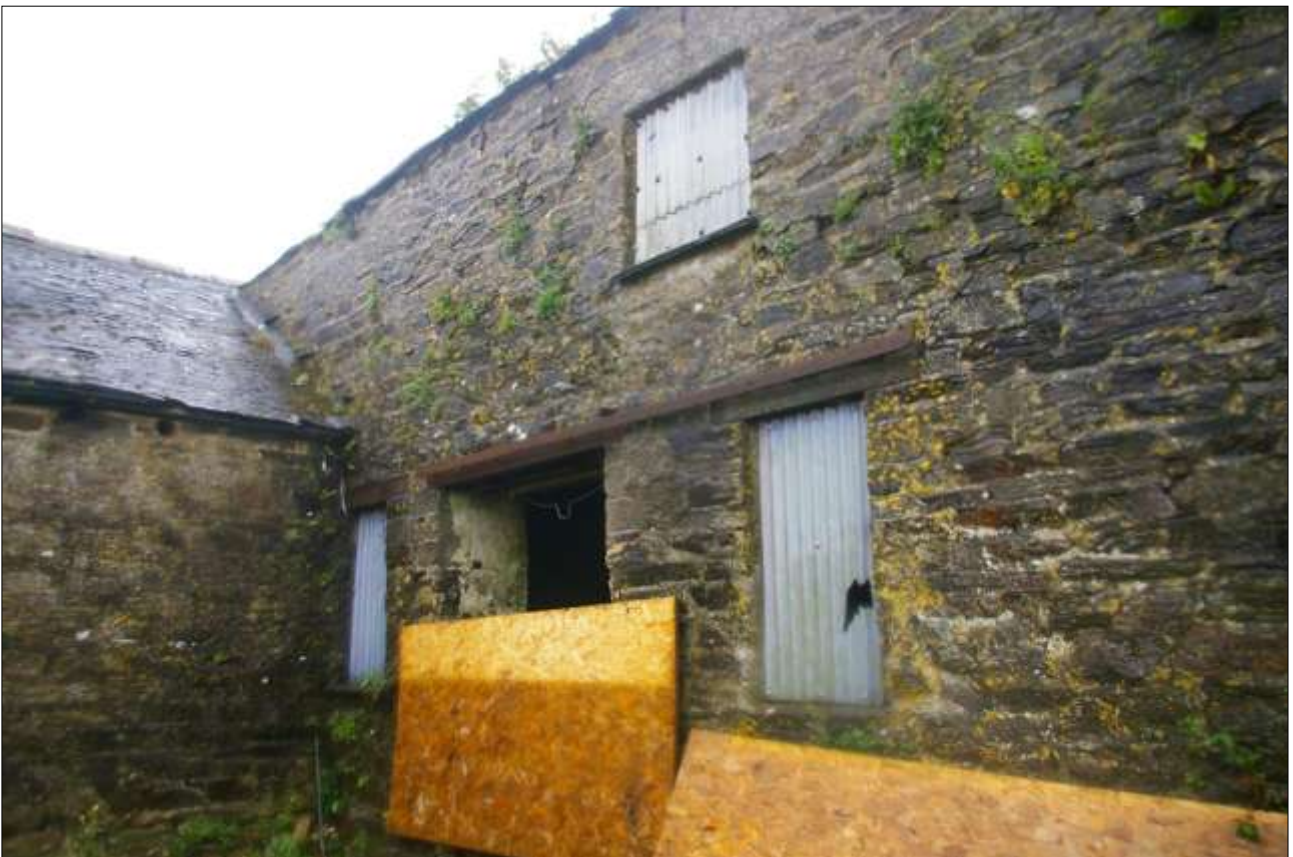
B2, THE NORTH-WEST ELEVATION IN ANGLE BETWEEN B2 AND B3, SHOWING THE FORCED DOORWAY (D7) AND TWO FORCED WINDOWS AT GF LEVEL (W13, W14); VIEWED FROM THE WEST-SOUTH-WEST.

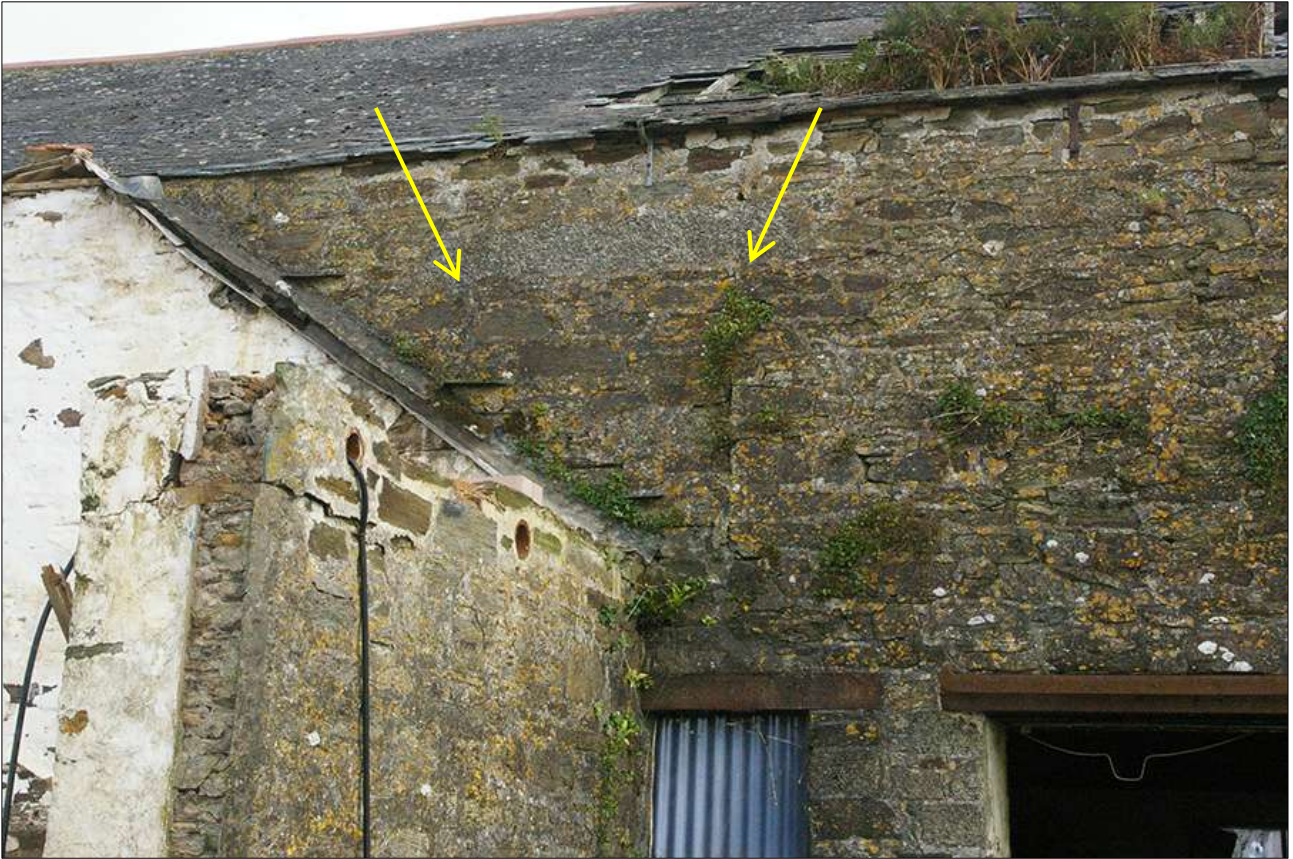
B2, THE NORTH-WEST ELEVATION ABOVE B3, SHOWING THE BLOCKED FF WINDOW (BO7) (INDICATED); VIEWED FROM THE WEST.

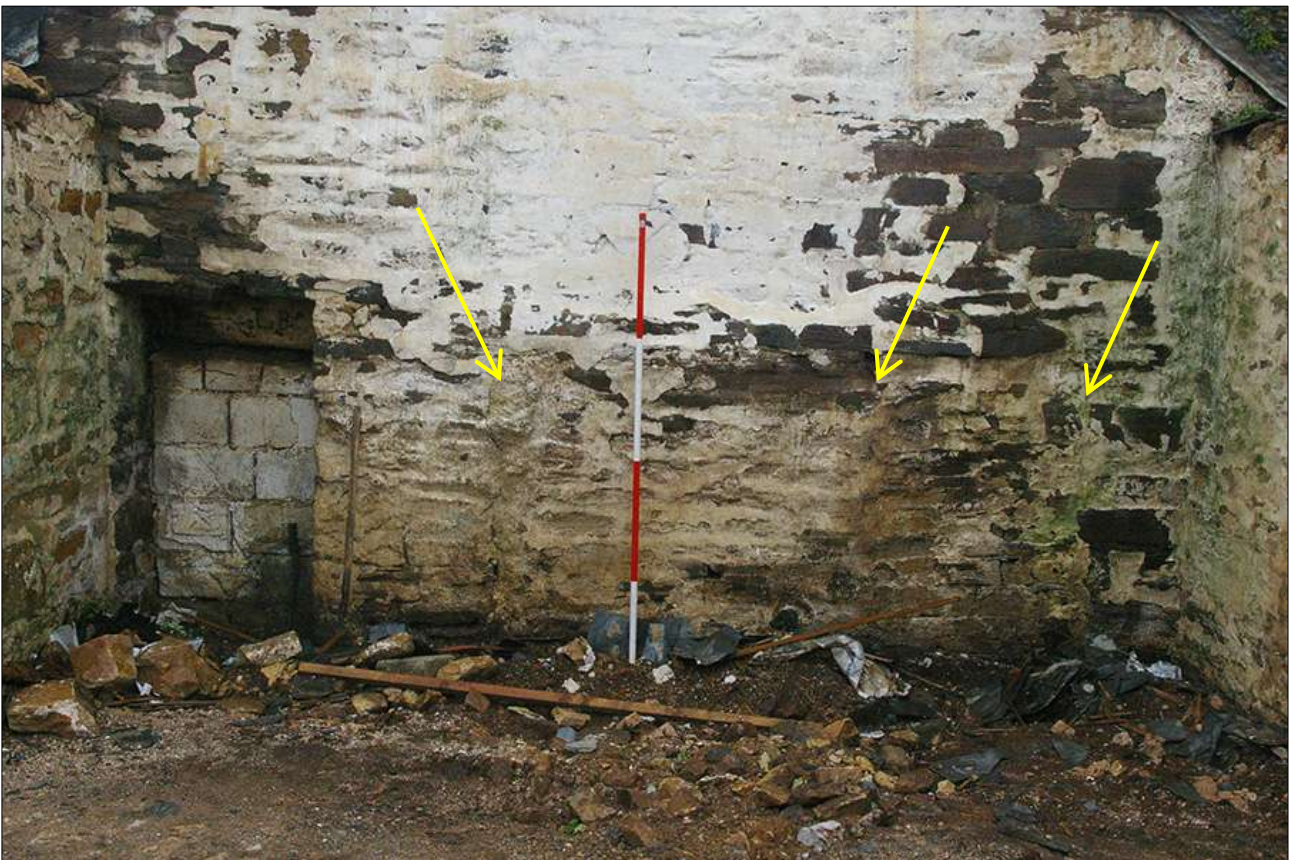
B3, NORTH-WEST ELEVATION, SHOWING THE BLOCKED OPENINGS (BO5, BO6) (INDICATED) AT GF LEVEL; VIEWED FROM THE NORTH-WEST (SCALE 2M).

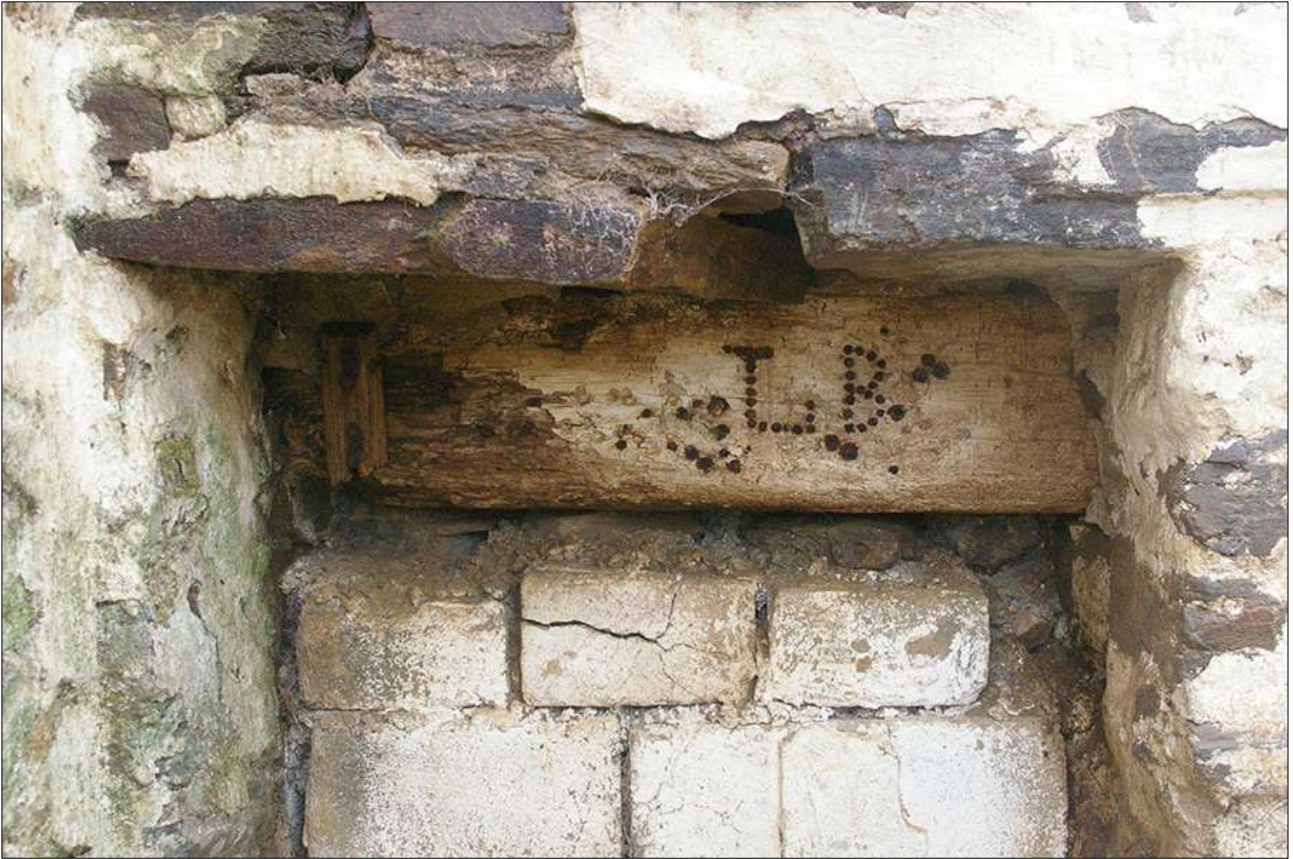
B3, AS ABOVE, DETAIL OF THE LINTEL OF THE BLOCKED DOORWAY (BO6) FROM B2.2 INTO B3.1; VIEWED FROM THE NORTH-WEST.

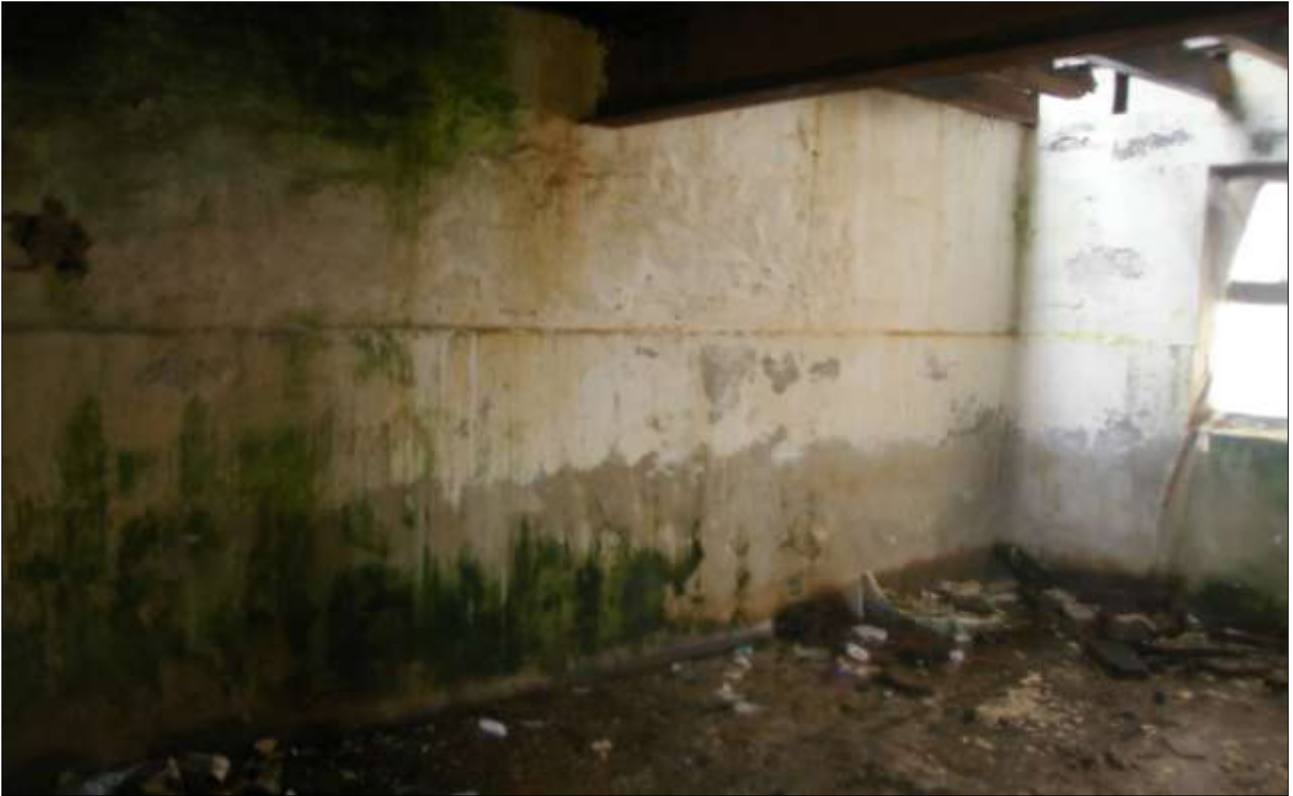
B2.1, SOUTHERN GF ROOM, SHOWING THE INTERNAL DIVIDING WALL; VIEWED FROM THE WEST-SOUTH-WEST.

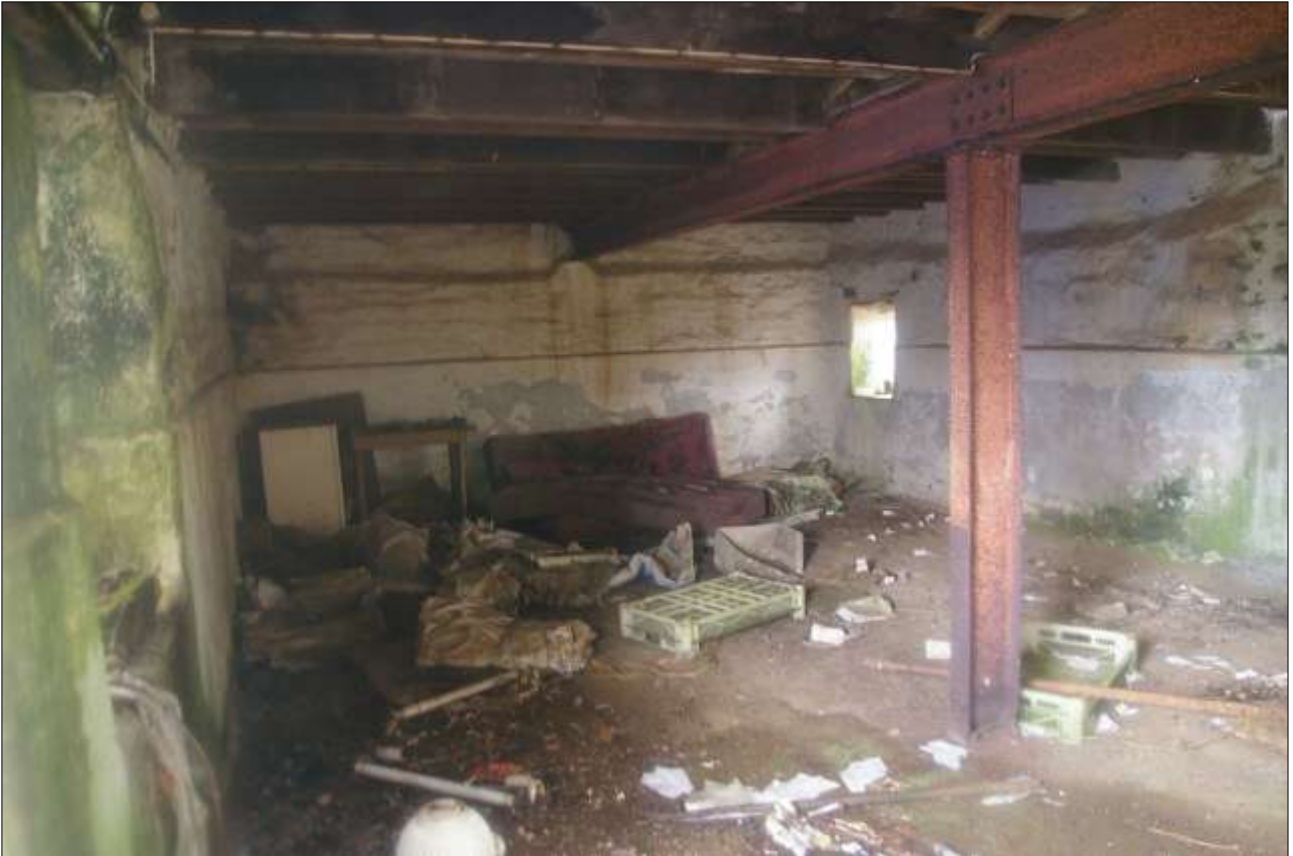
B2.2, NORTHERN GF ROOM, SHOWING THE REMAINS OF HEAVIER WALLS, SLIGHTLY BATTERED TO THE BASE; VIEWED FROM THE SOUTH-WEST.

B2 North Room (B2.2)		
Function:		Unknown function, possibly dairy given the rendered walls.
Walls:		Very heavy stone walls to lower GF, partly rendered to c.1.5m above floor level. At c.2m above floor level the walls narrow by c.0.15m; this is most pronounced to the north-east wall. There is a roughly-shaped projecting block in the north-east wall, seemingly a crude corbel that would once have supported a transverse beam, now replaced with a heavy iron RSJ girder. The walls to the north-east and north-west are battered to their base. The south wall is the partition wall to B2.1; this is thinner and more regular in appearance, rendered to c.1.5m above the floor and heavily whitewashed. It has also been truncated to the north-east, and rebuilt in concrete block.
Floors:		Concrete.
Ceiling:		A heavy iron RSJ girder crosses the centre of the room south-east to north-west, forced into the walls. A second RSJ rises vertically in the middle of the room to provide additional support. The RSJ supports deep narrow timber joists and the 20 th century narrow boarded floor above.

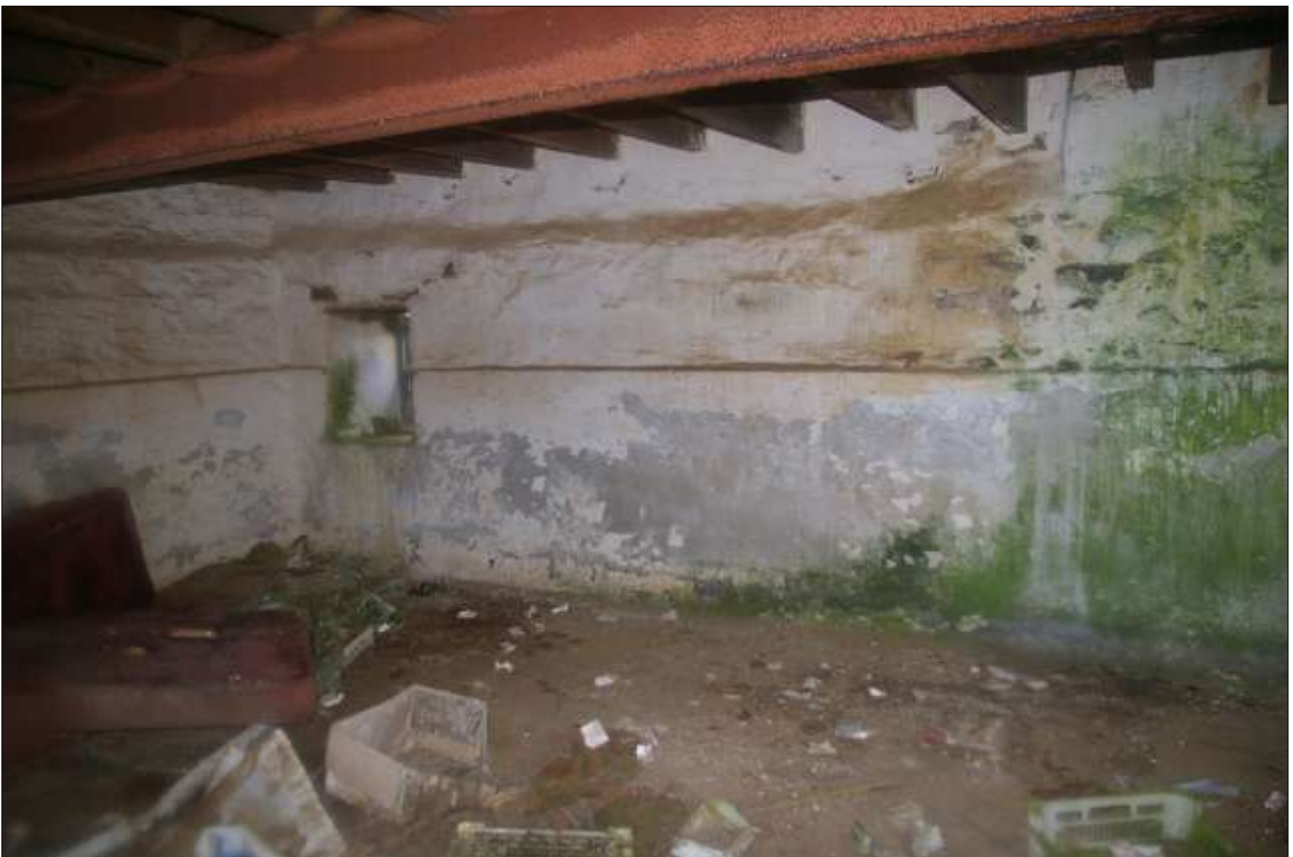
B2.2, NORTHERN GF ROOM, THE NORTH-EAST CORNER OF THE ROOM WITH SMALL FORCED WINDOW (W8); VIEWED FROM THE SOUTH-WEST.

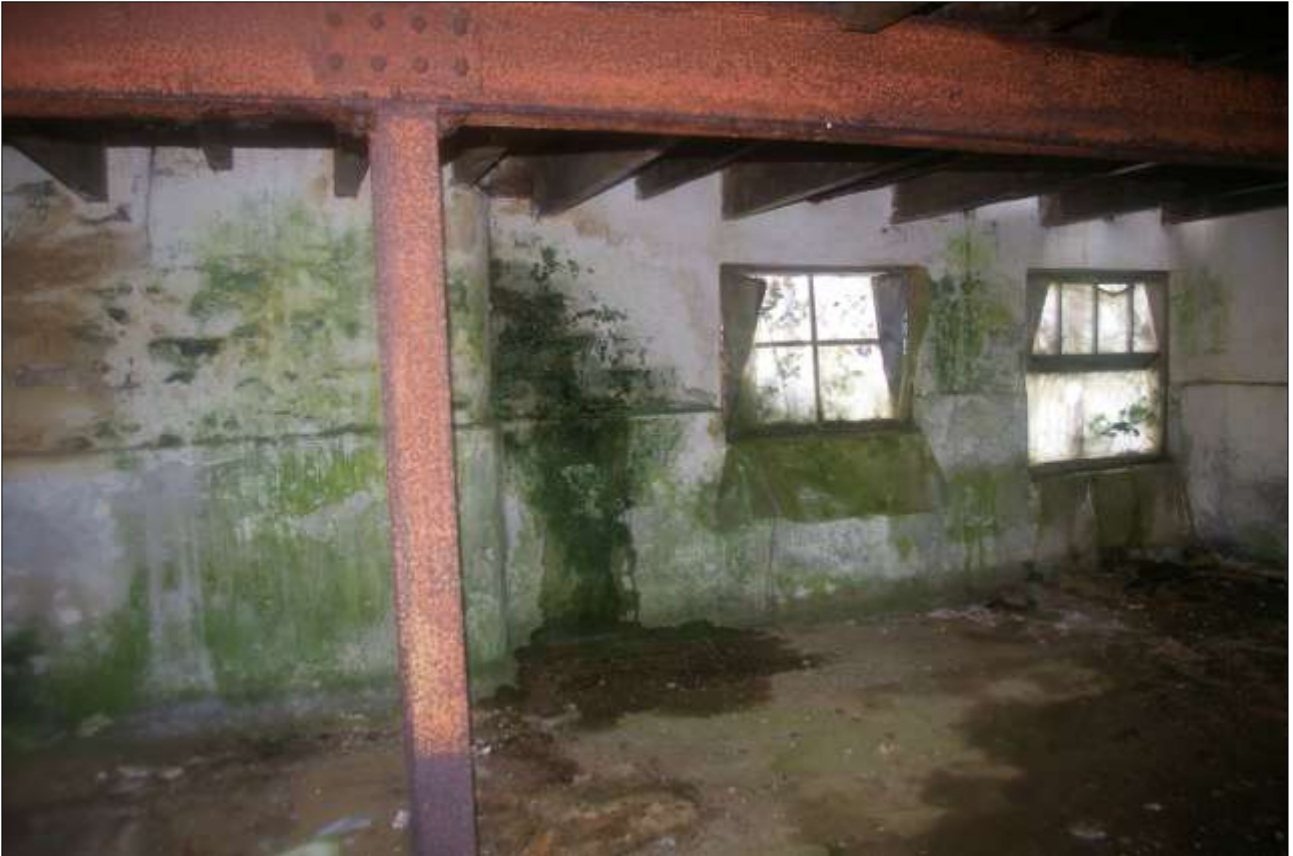
B2.2, NORTHERN GF ROOM, SHOWING THE NARROW CONCRETE BLOCK WALL AND THE TWO METAL HOPPER WINDOWS (W9, W10); VIEWED FROM THE WEST.

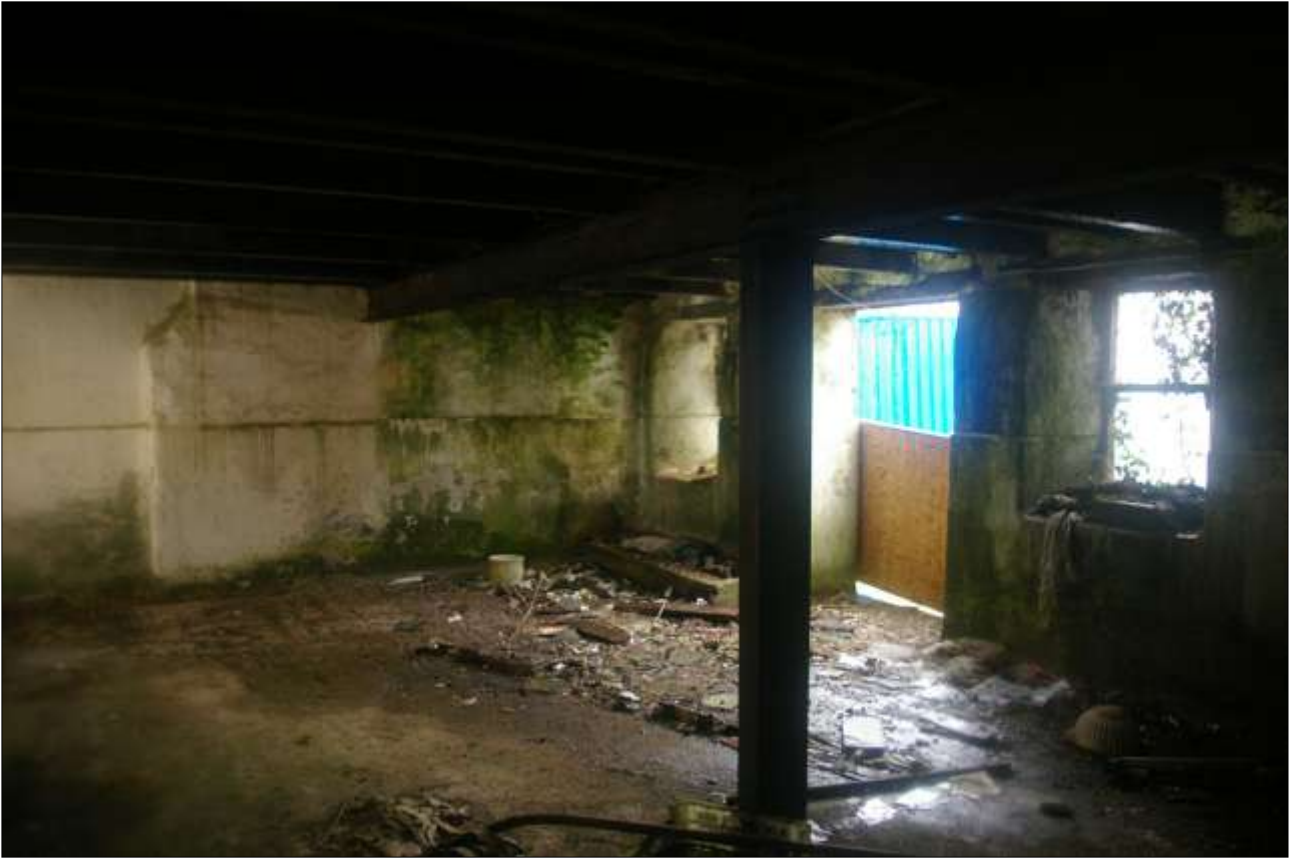
B2.2, NORTHERN GF ROOM, VIEW OF THE SOUTH-WEST CORNER OF THE ROOM, WITH FORCED DOORWAY (D7) AND WINDOWS (W13, W14); VIEWED FROM THE EAST.

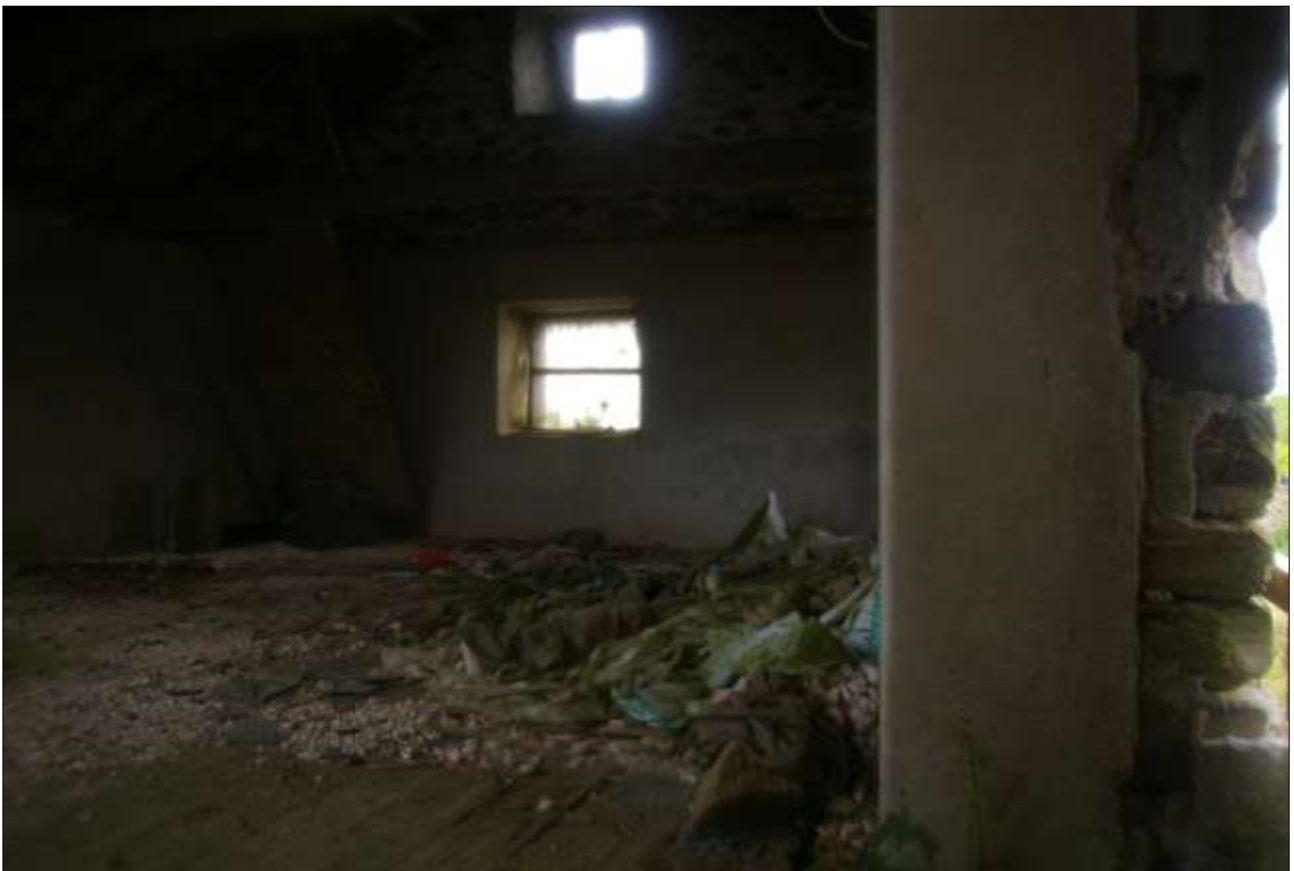
B2.3, FF ROOM, SHOWING THE NORTH GABLE AND INFILLED LOADING DOOR (D8, W22); VIEWED FROM THE SOUTH.

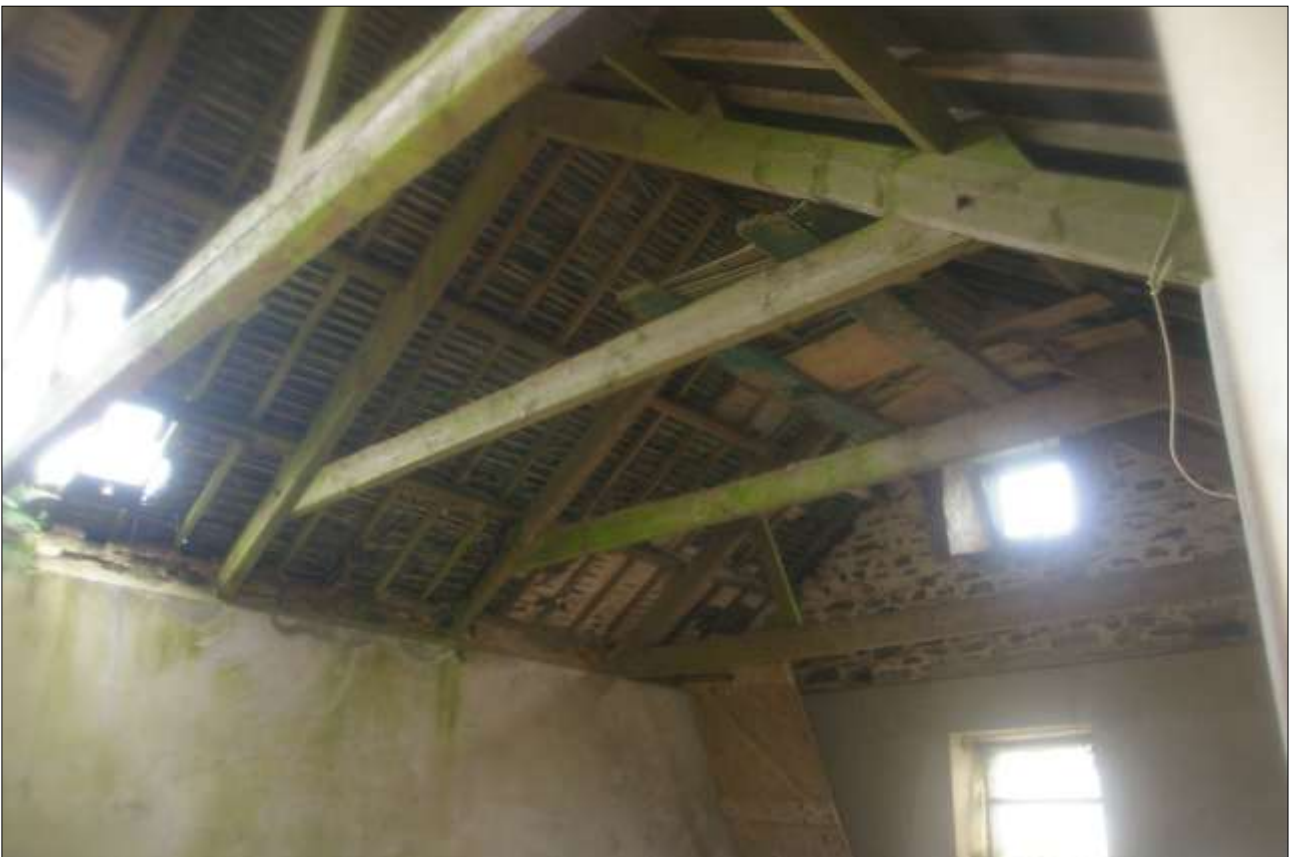
B2.3 ROOF STRUCTURE; VIEWED FROM THE SOUTH.

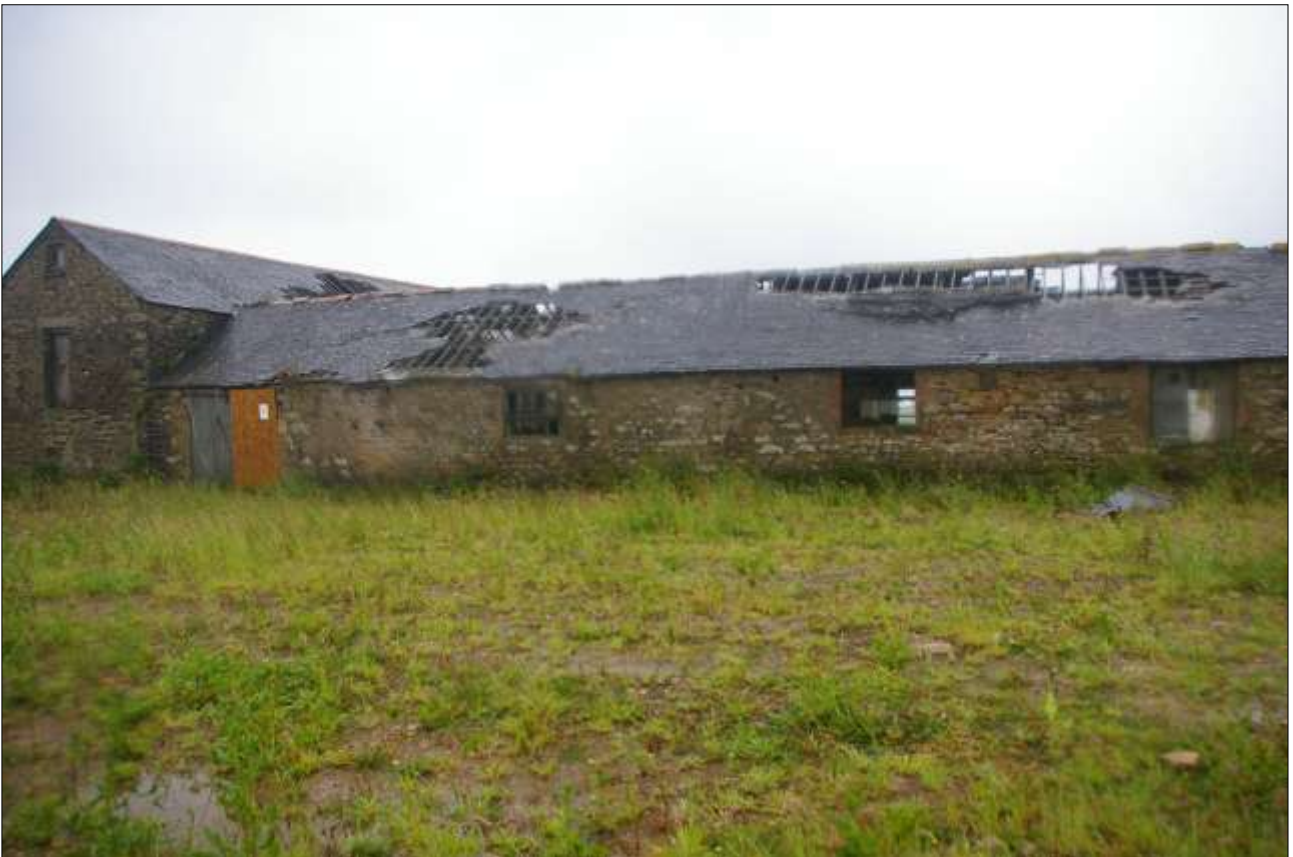
B3, NORTH-EAST ELEVATION, SHOWING THE CHANGE OF BUILD BETWEEN THE FIRST AND SECOND WINDOW FROM THE LEFT; VIEWED FROM THE NORTH-NORTH-EAST.

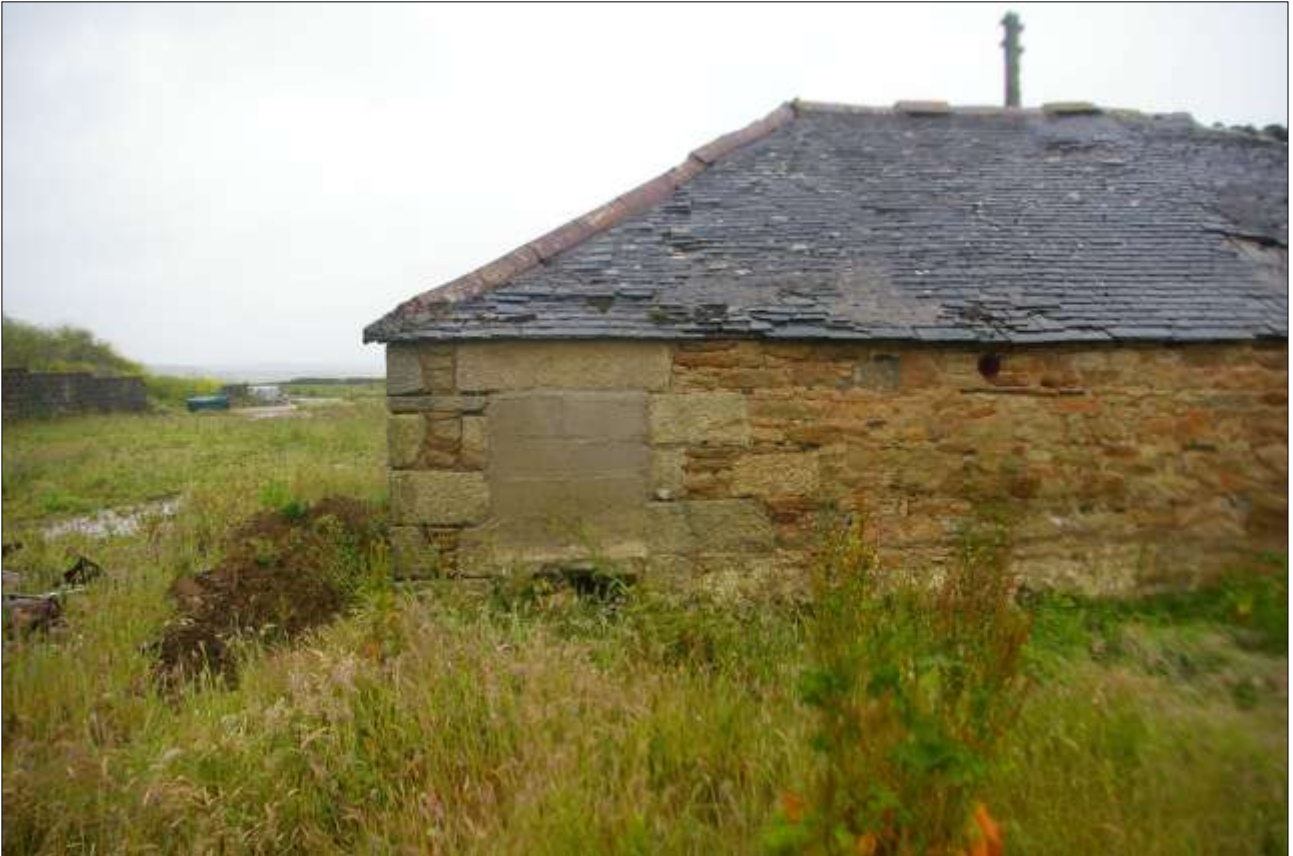
B3, BLOCKED DOORWAY (B08) AT THE NORTH-WEST CORNER, REBUILT TO PROVIDE ACCESS TO FEED CHANNEL; VIEWED FROM THE NORTH-WEST.

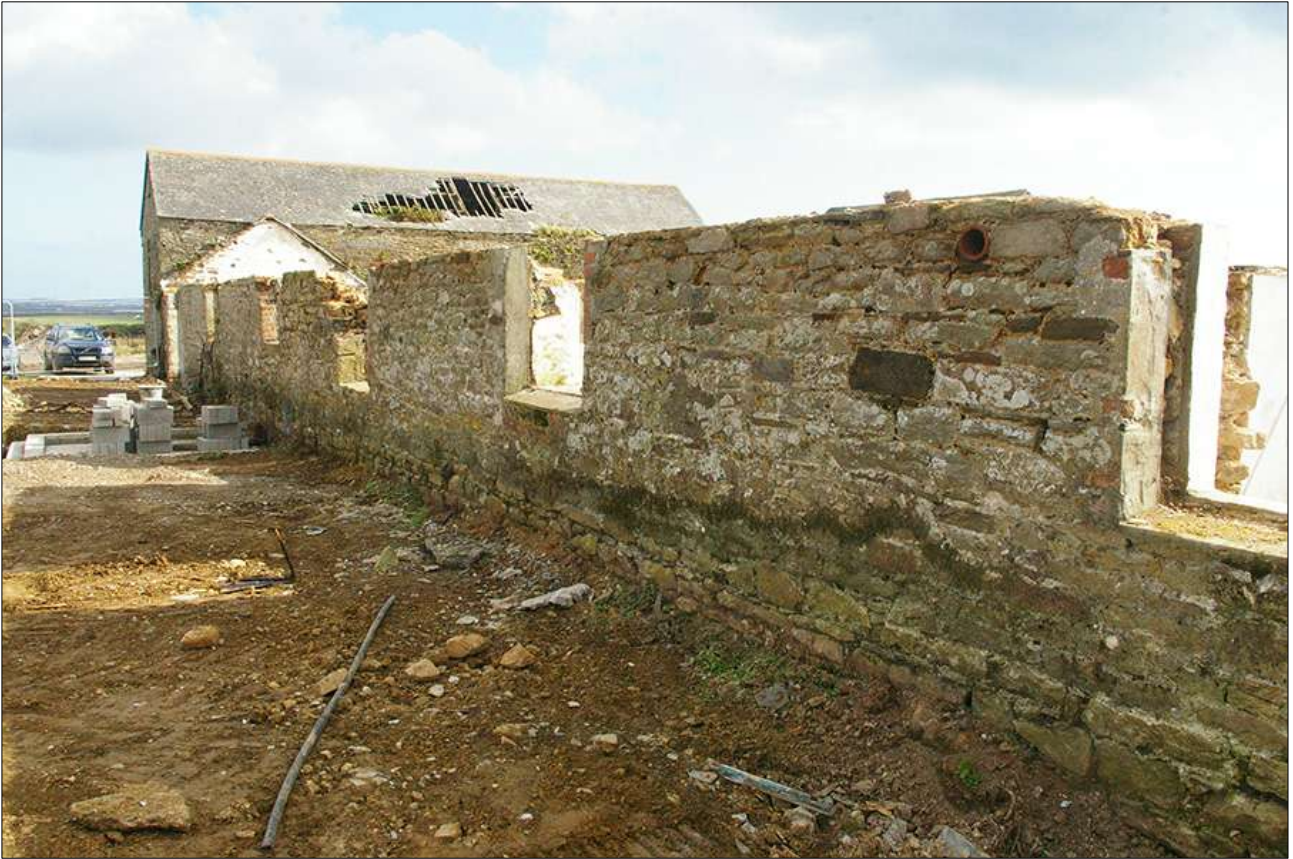
B3, NORTH-EAST ELEVATION; VIEWED FROM THE EAST.

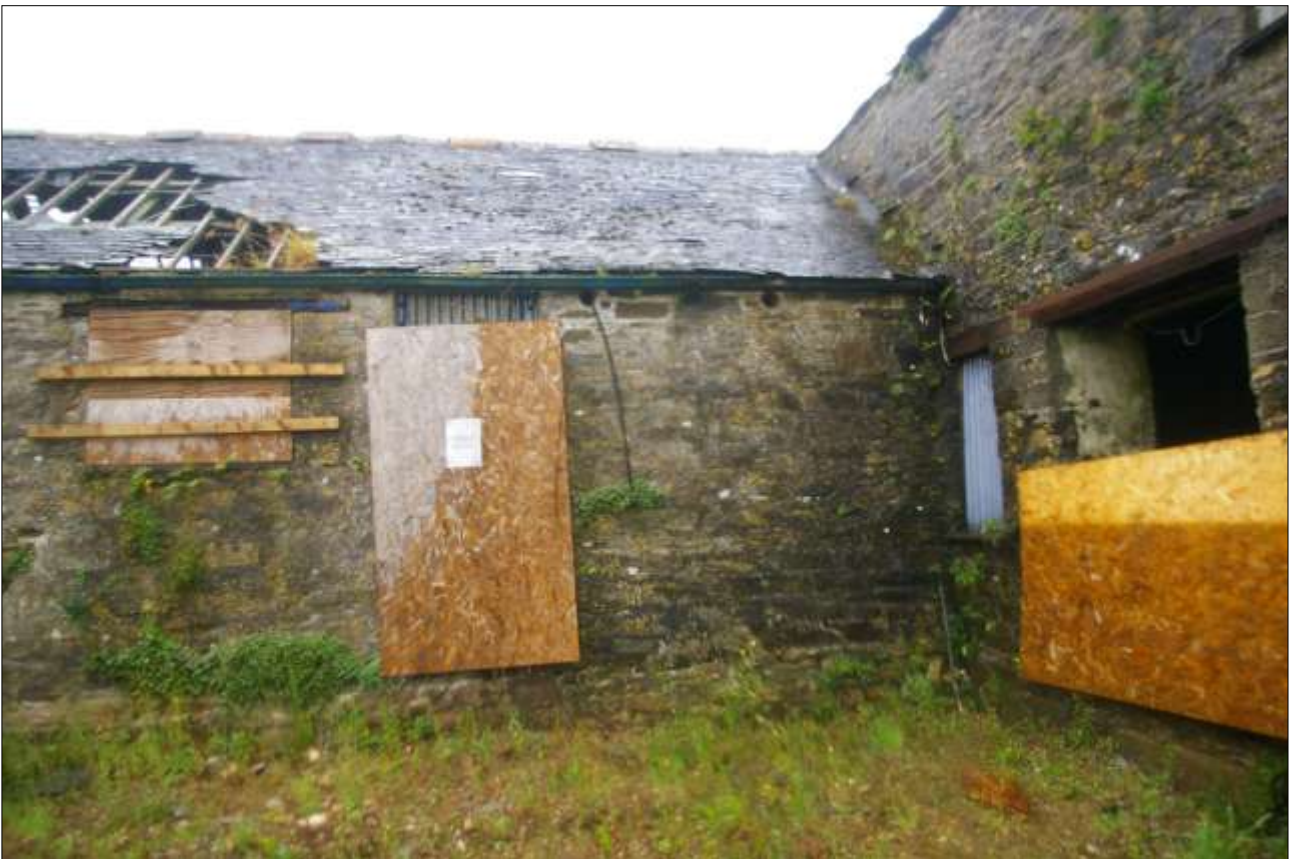
B3, NORTH-EAST ELEVATION; VIEWED FROM THE NORTH.
