THE BARNs PENBRO FARM BREAGE CORNWALL

Desk-Based Assessment & Historic Building Recording

South West Archaeology Ltd. report no. 180322

By B. Morris, E. Wapshott & N. Boyd
Report Version: FINAL
22nd March 2018

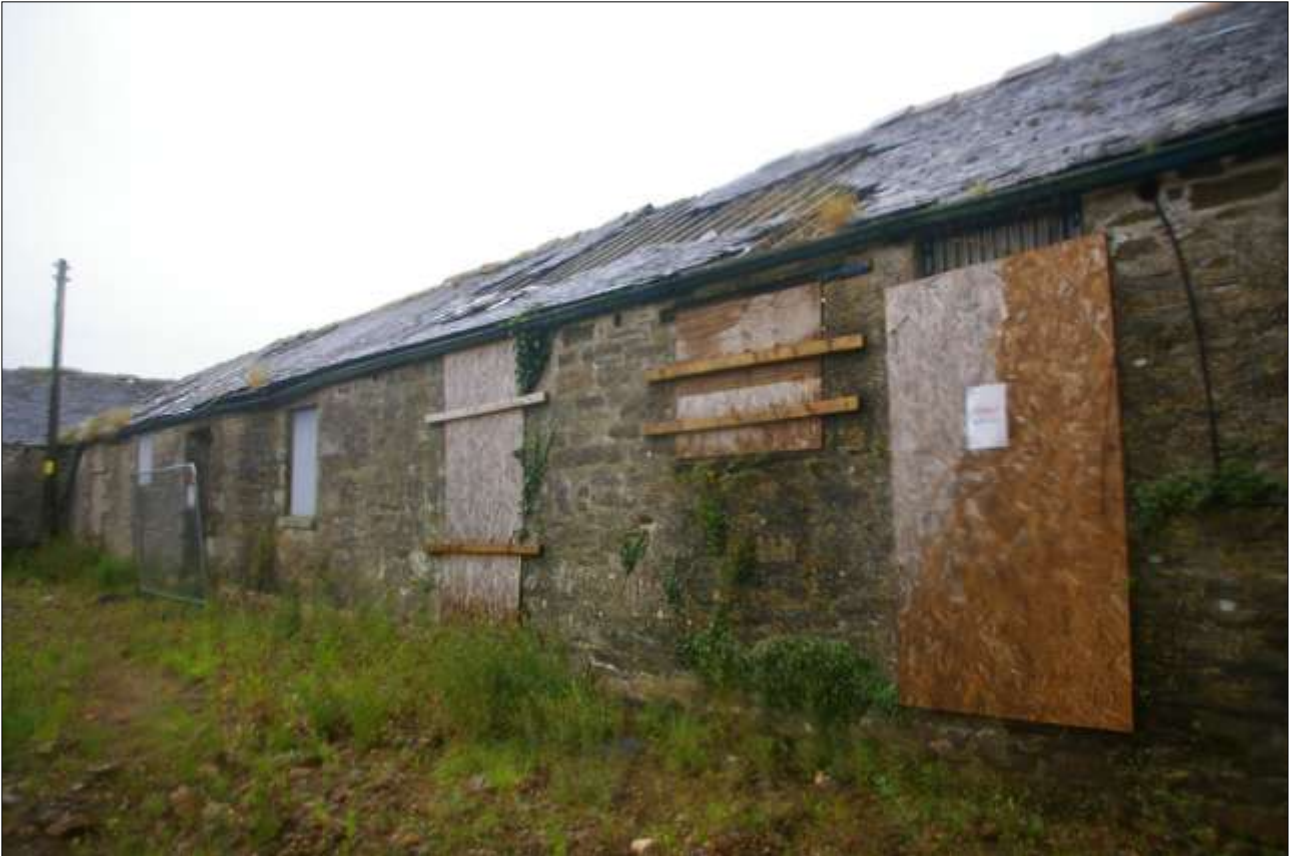
B3, SOUTH-WEST ELEVATION; VIEWED FROM THE SOUTH-WEST.

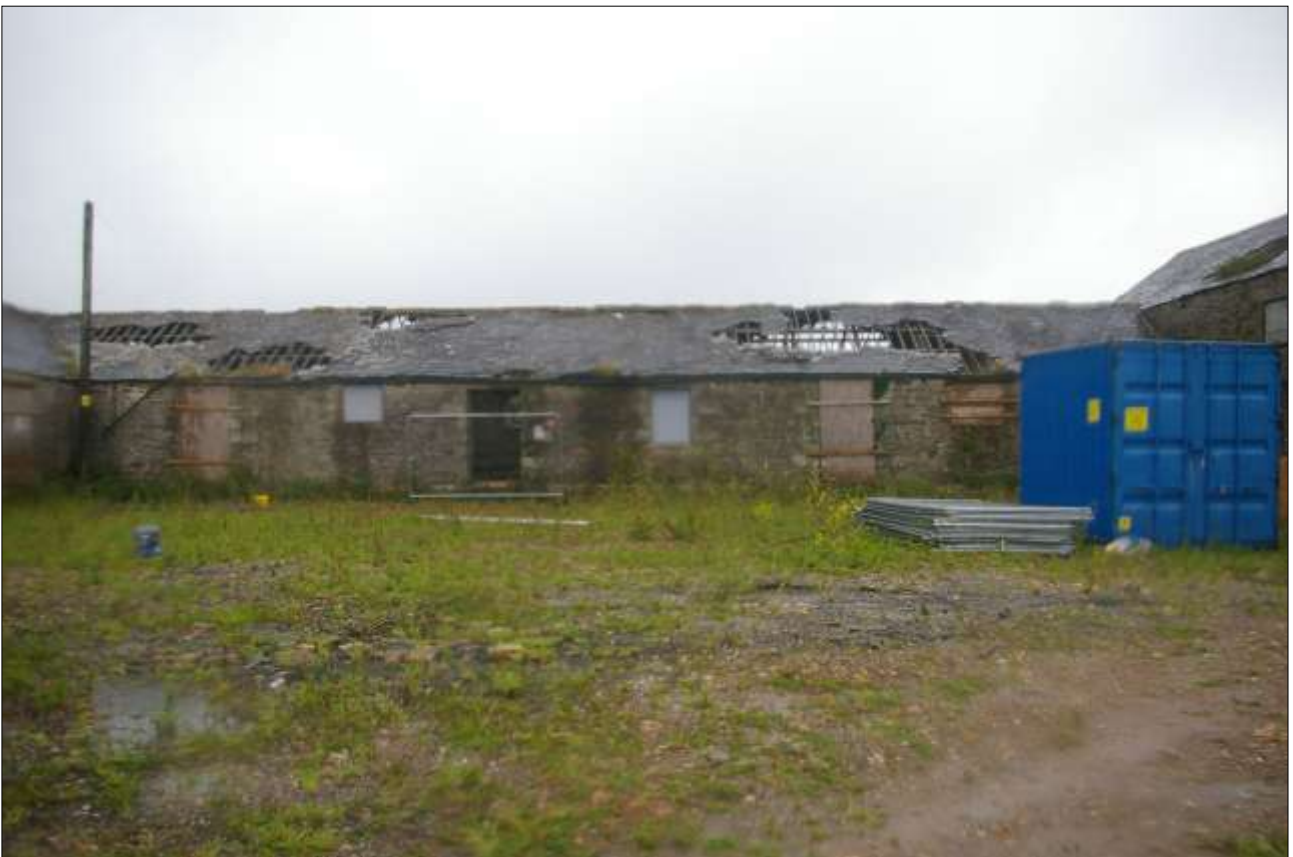
B3, THE SOUTH-WEST ELEVATION; VIEWED FROM THE SOUTH-SOUTH-EAST.

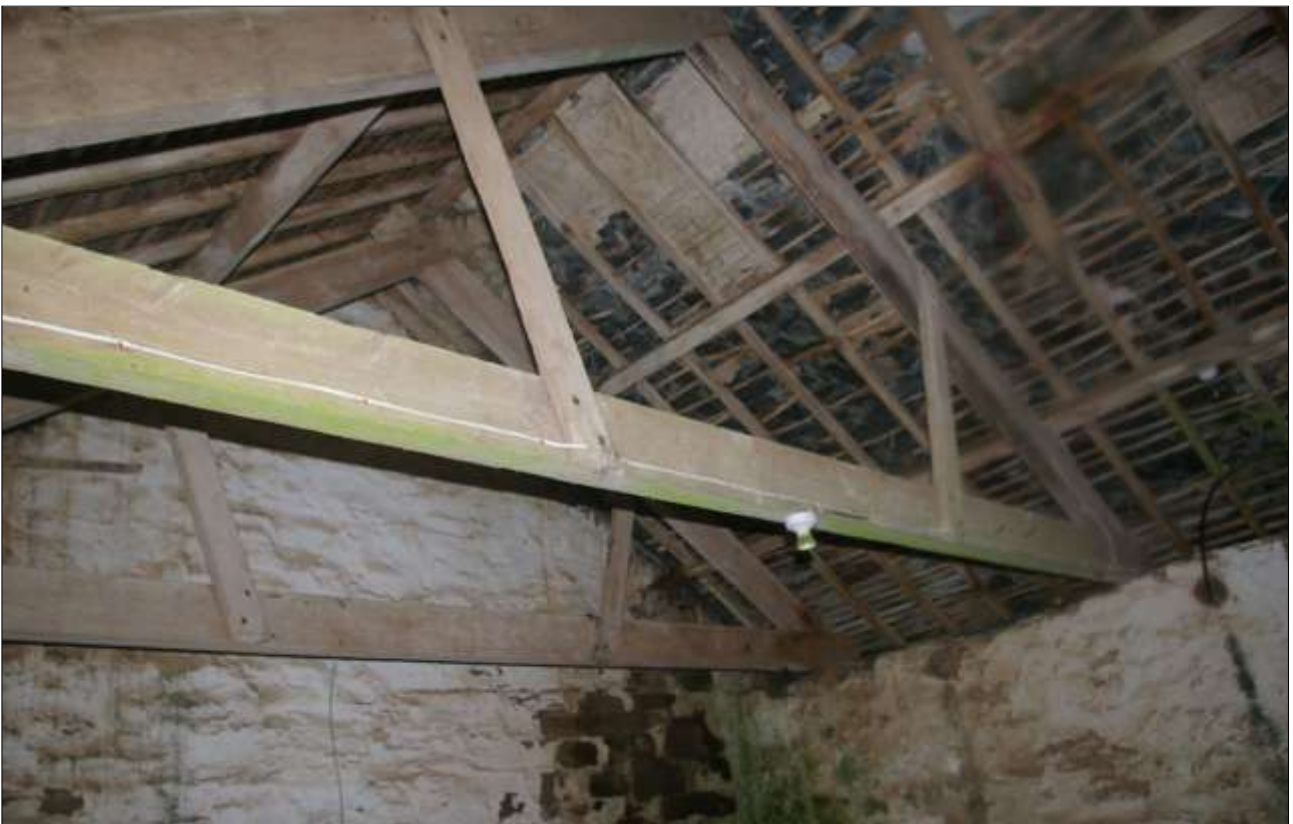
B3.1, EASTERN ROOM AND WALL OF B2; VIEWED FROM THE NORTH.

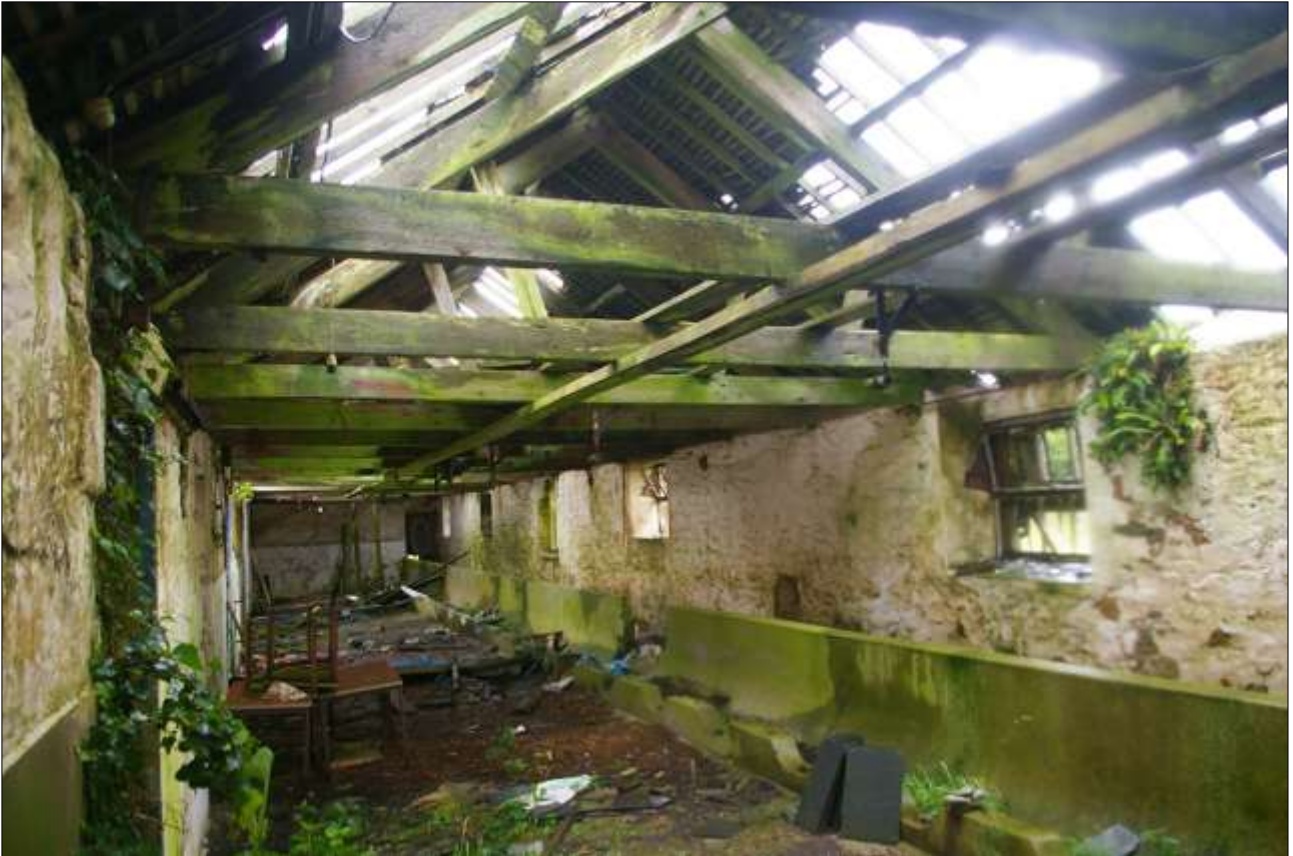
B3.1, EASTERN ROOM, ROOF STRUCTURE; VIEWED FROM THE NORTH.

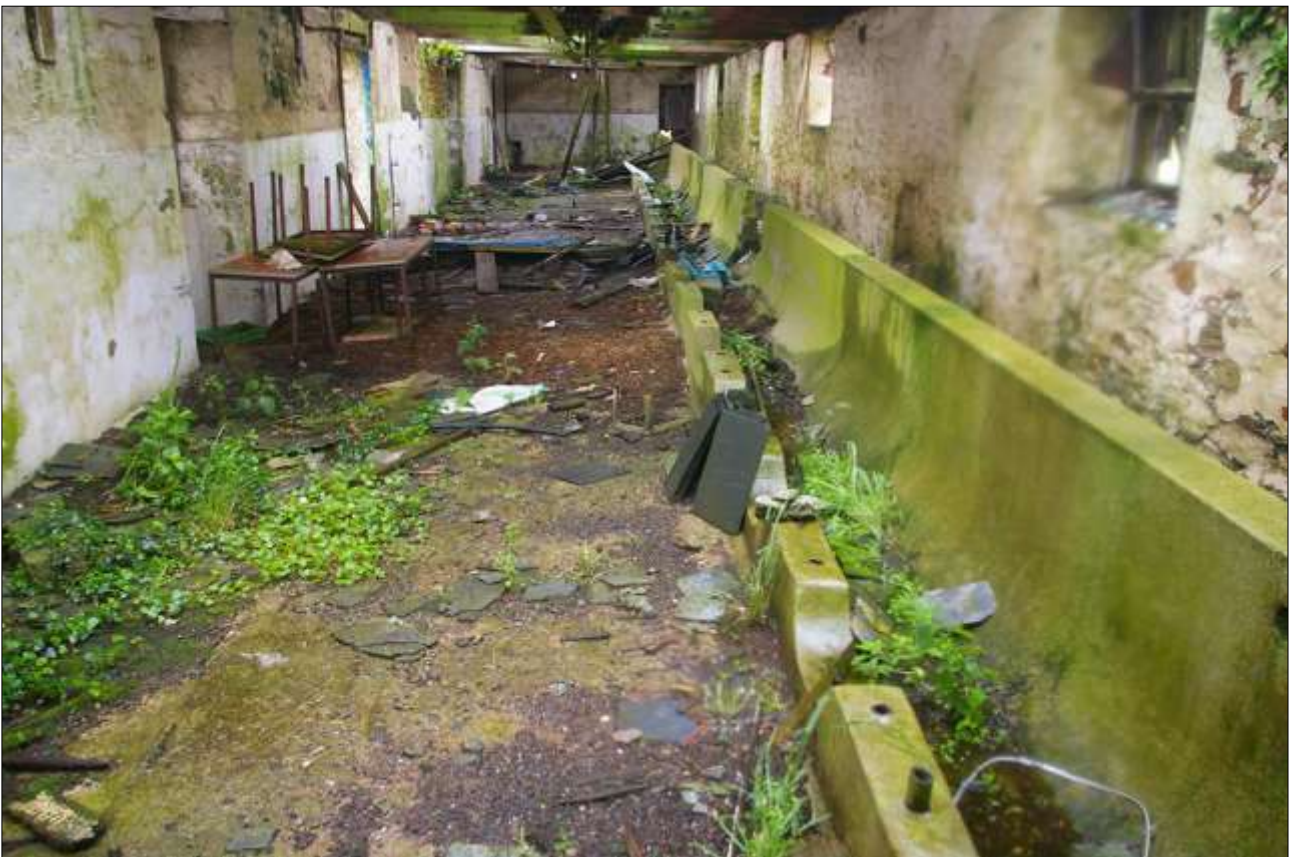
B3.2, WESTERN ROOM, VIEWED FROM THE SOUTH-EAST CORNER.

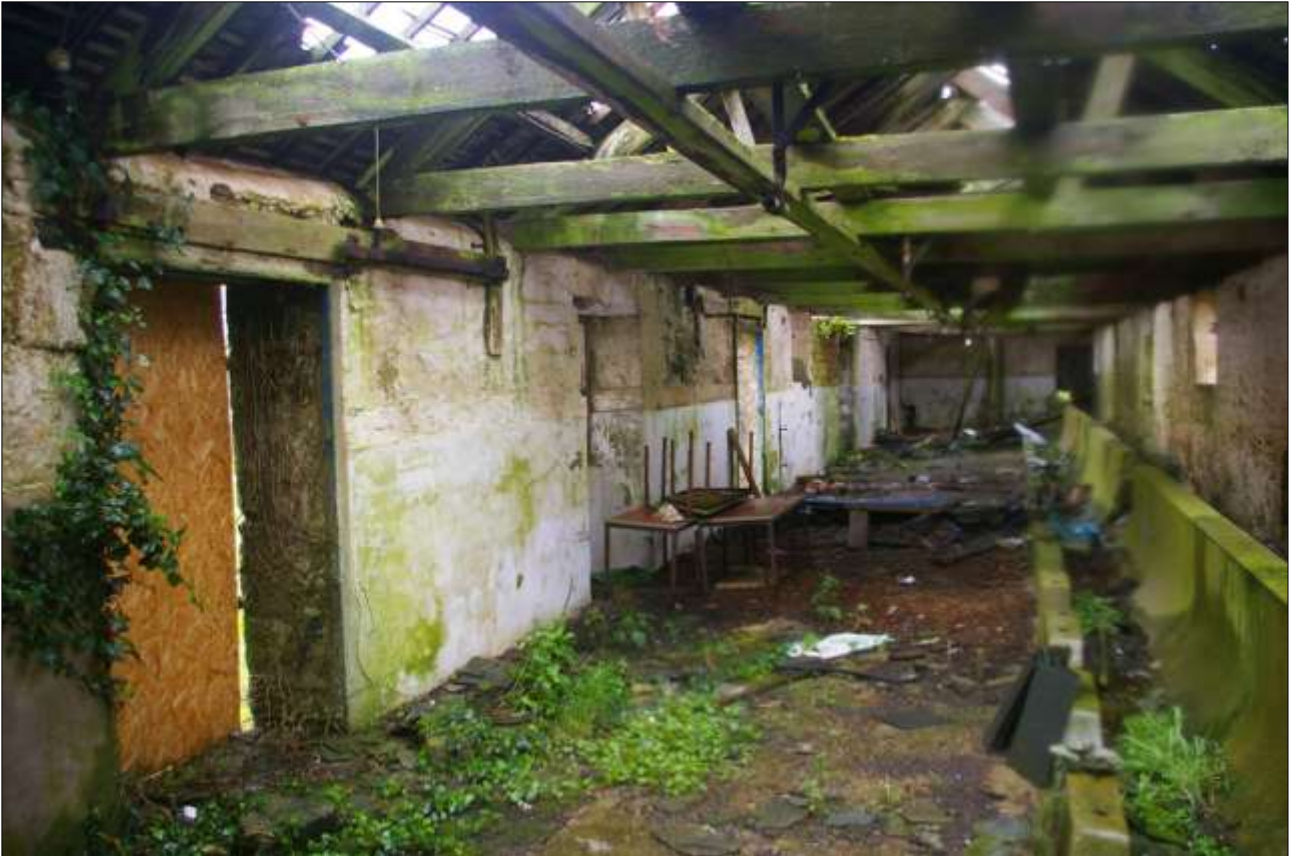
B3.2, WESTERN ROOM, SHOWING THE CONCRETE FLOORS AND CATTLE STALLS; VIEWED FROM THE SOUTH-EAST.

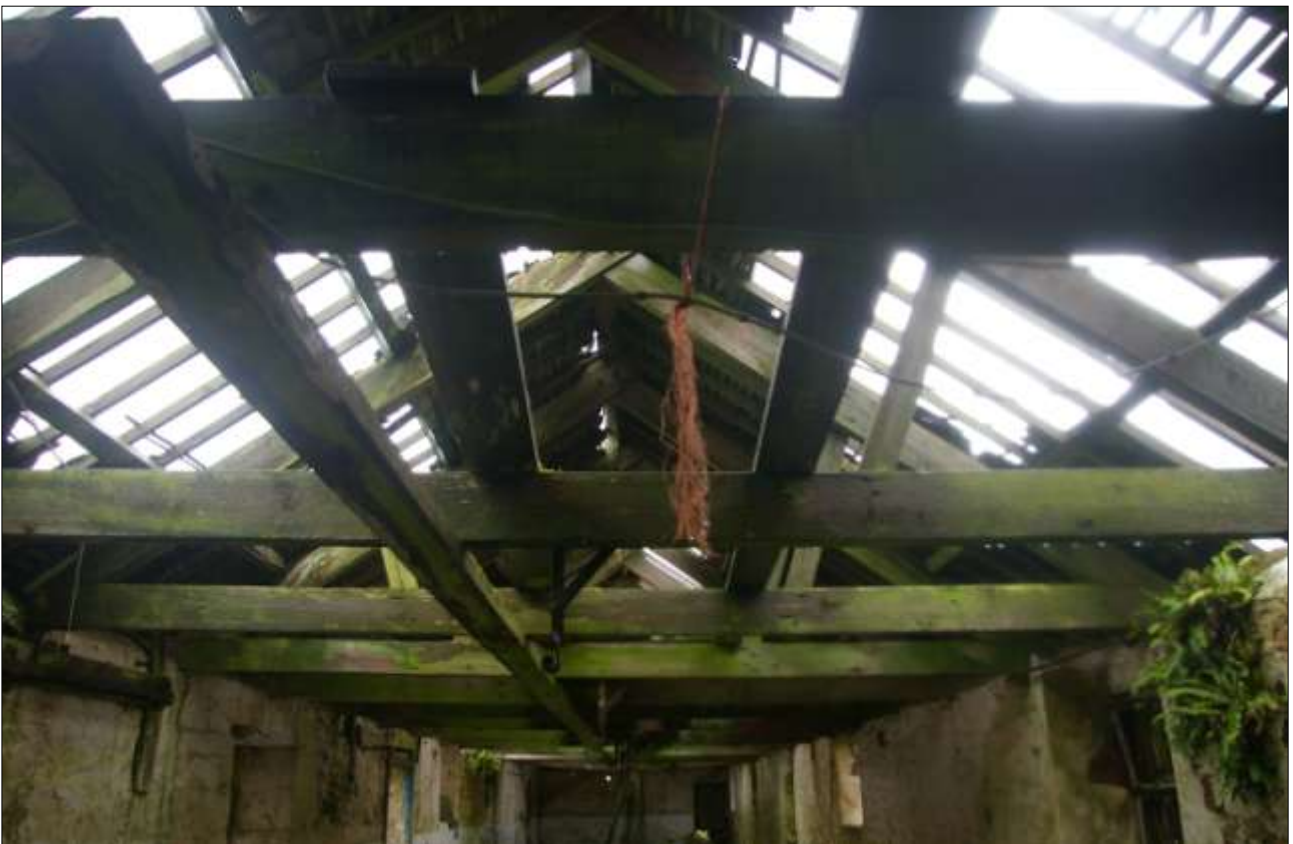
B3.2, WESTERN ROOM, VIEWED FROM THE NORTH-EAST CORNER.

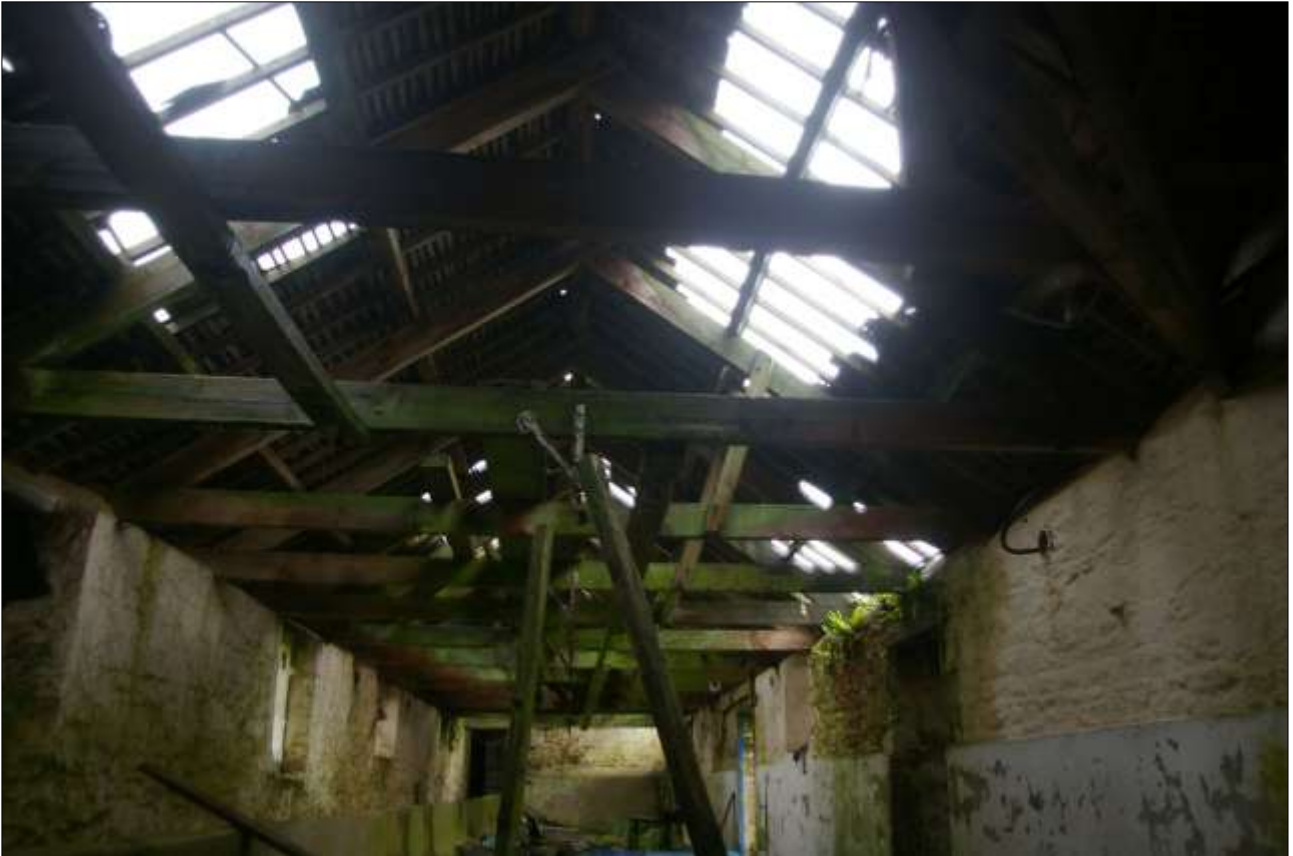
B3.2, ROOF STRUCTURE; VIEWED FROM THE SOUTH-EAST.

Floor:		Concrete, sloping with drain offset to south.
Roof:		Two full A-frames with queen struts. The ridge of the trusses is ½ lapped with a diamond-set ridge pole and the other joints are nailed and spiked. On the north-west and south-west pitches the roof has been replaced, boarded and felted, with fibre-cement slates. The corner is hipped, with heavy bracing to the corner, additional nailed struts etc.
Openings – Doors:	D21	Heavy granite quoins, granite lintel with incised lines to mimic voussoirs (upside-down), 17 th century moulded granite fireplace lintel reused as threshold.
	D22	Forced doorway, with ragged cement patched reveals. Fitted with a narrow timber lintel and an iron rail for a sliding timber door, covered with corrugated sheeting.
	D23	A large double door; heavy dressed block granite lintel, with heavy internal timber lintel and granite block quoins to the reveals. Surface mounted iron rolling door mechanism, galvanised corrugated sheeting over painted sliding timber door.

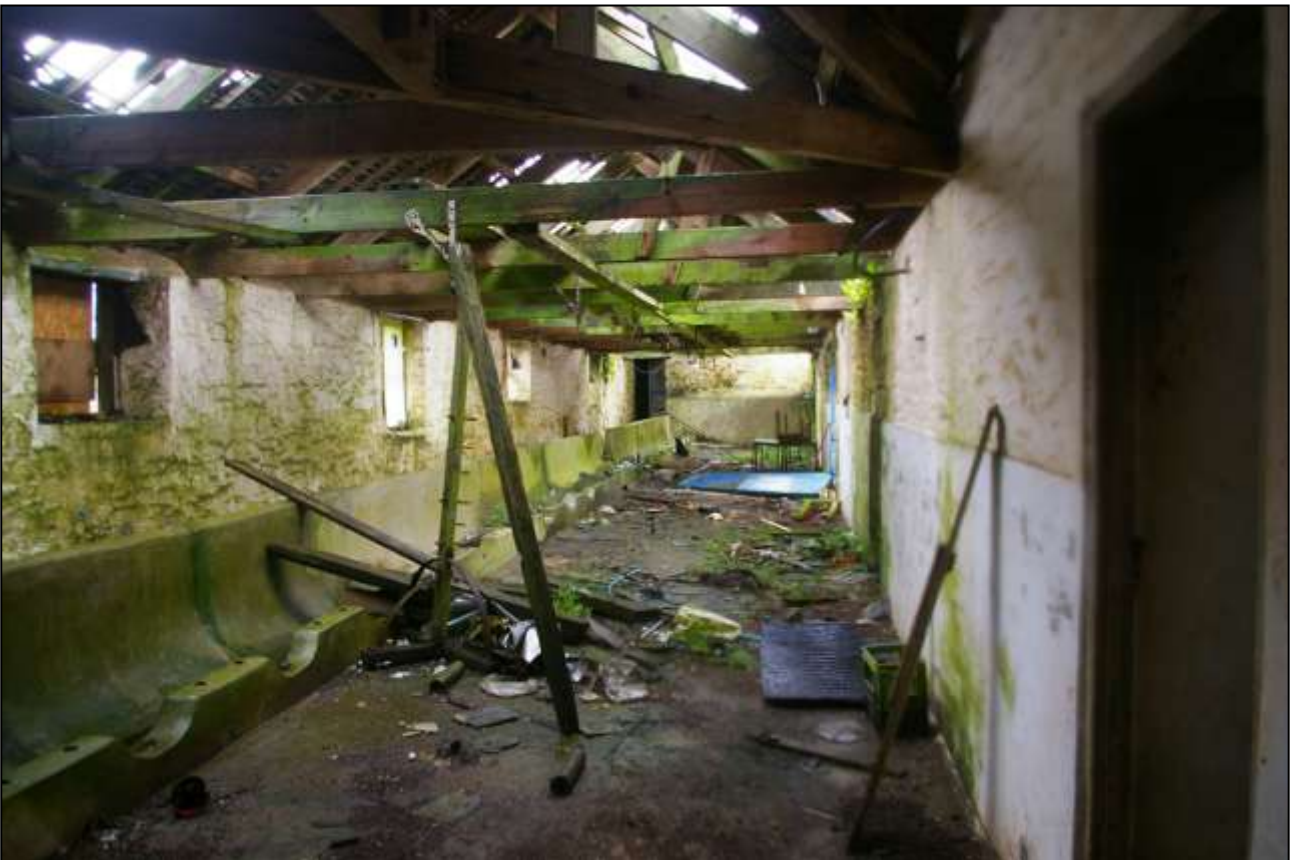
B3.2, ROOF STRUCTURE; VIEWED FROM THE WEST-NORTH-WEST.

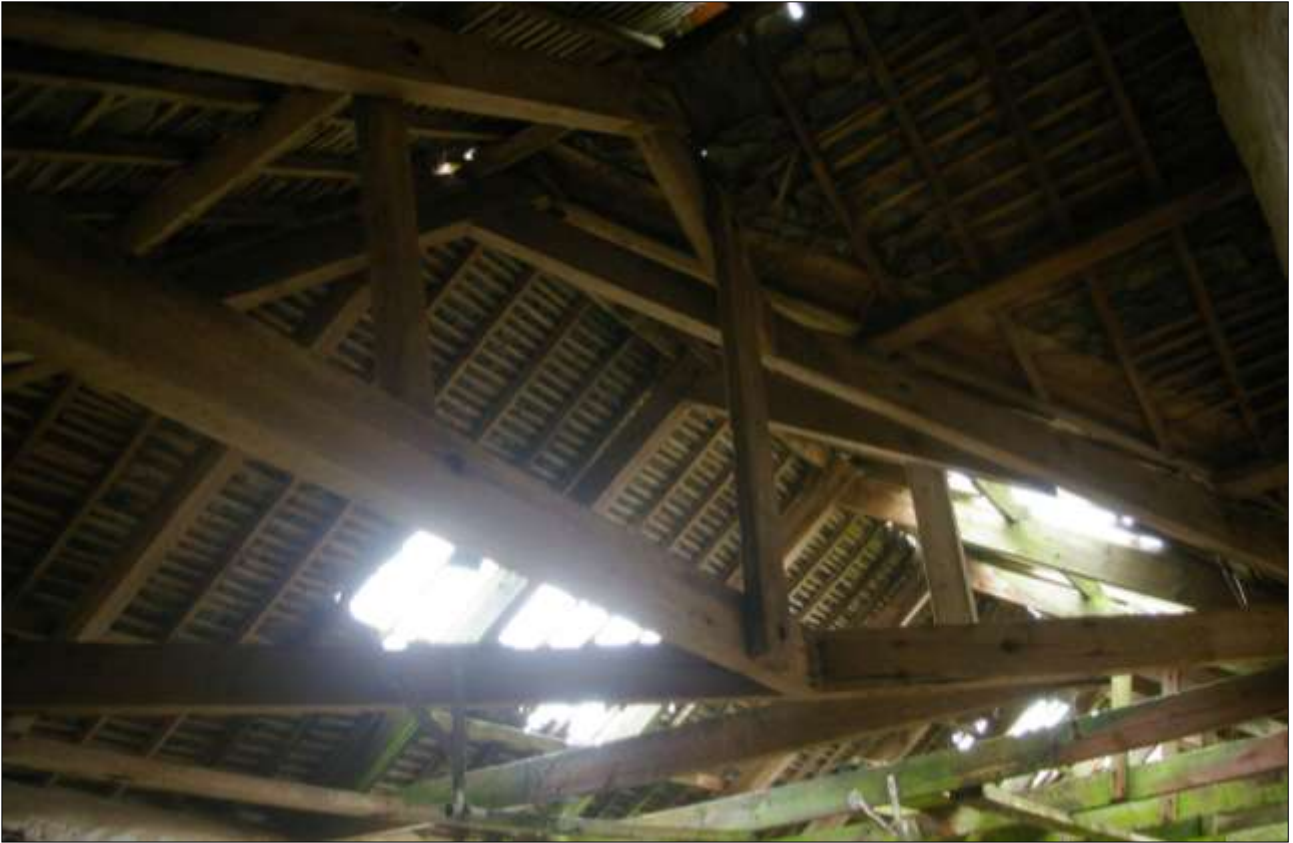
B3.2, WESTERN ROOM; VIEWED FROM SOUTH-WEST CORNER.

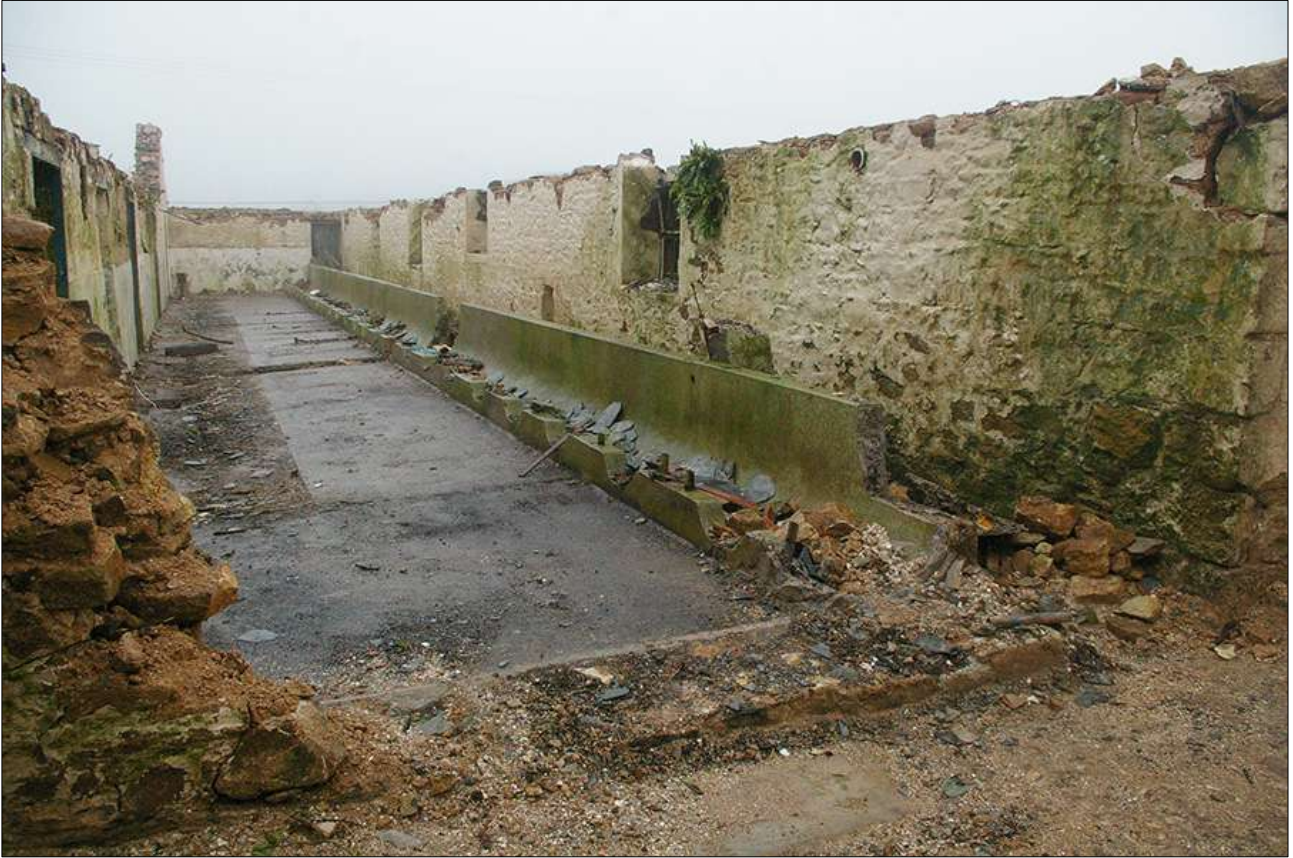
B3.2, DURING WORKS; VIEWED FROM THE SOUTH-EAST.

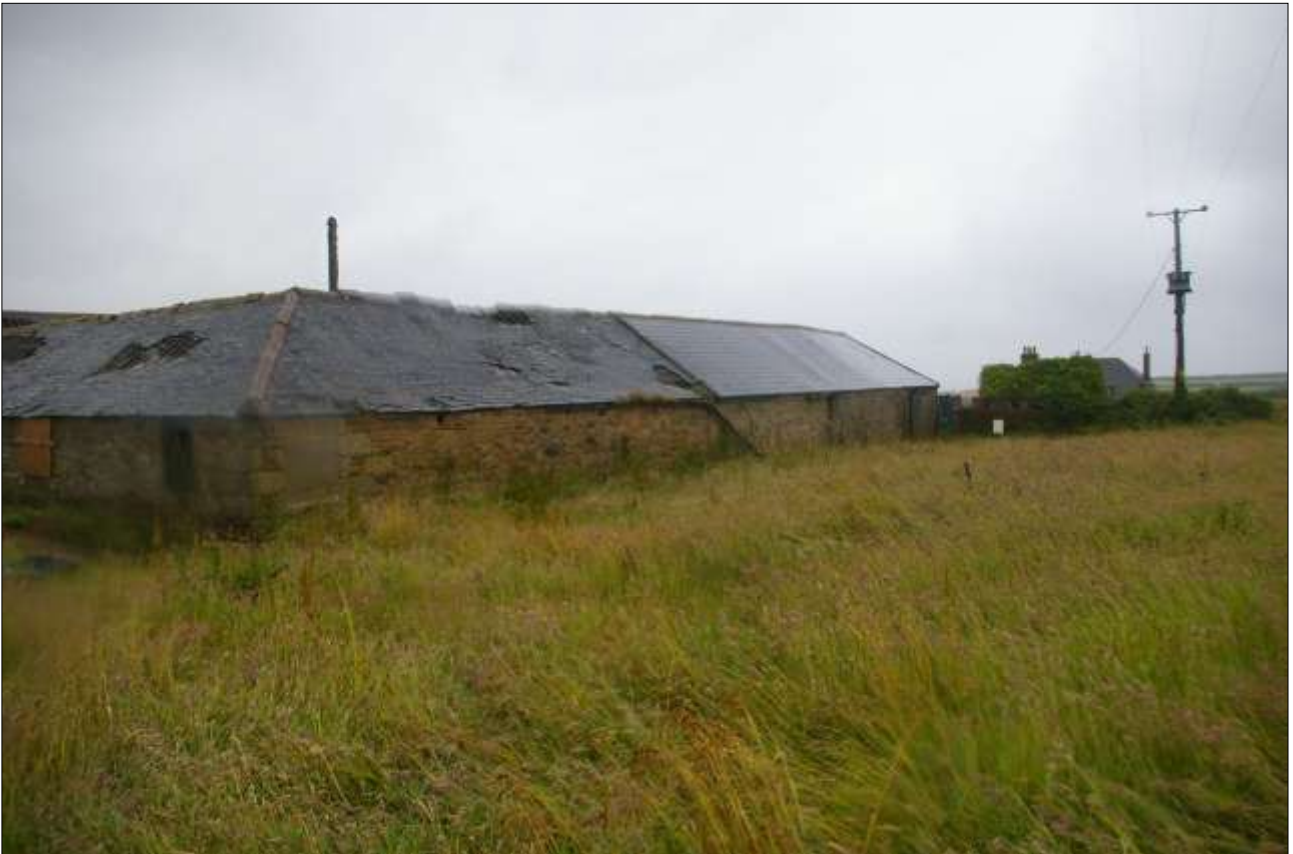
B4, THE NORTH-WEST ELEVATION; VIEWED FROM THE NORTH.

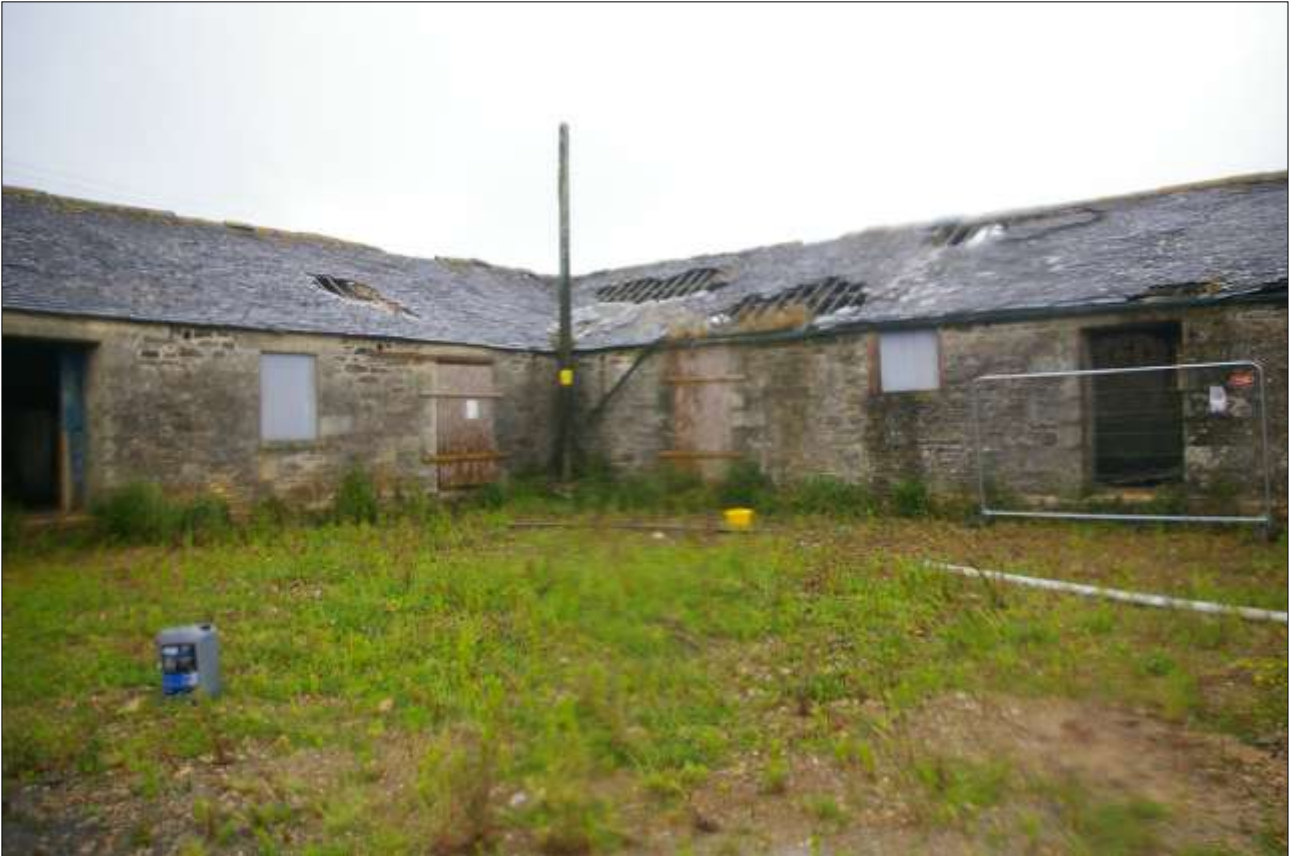
B3 (RIGHT) AND B4 (LEFT), THE ANGLE BETWEEN THE TWO BUILDINGS; VIEWED FROM THE SOUTH.

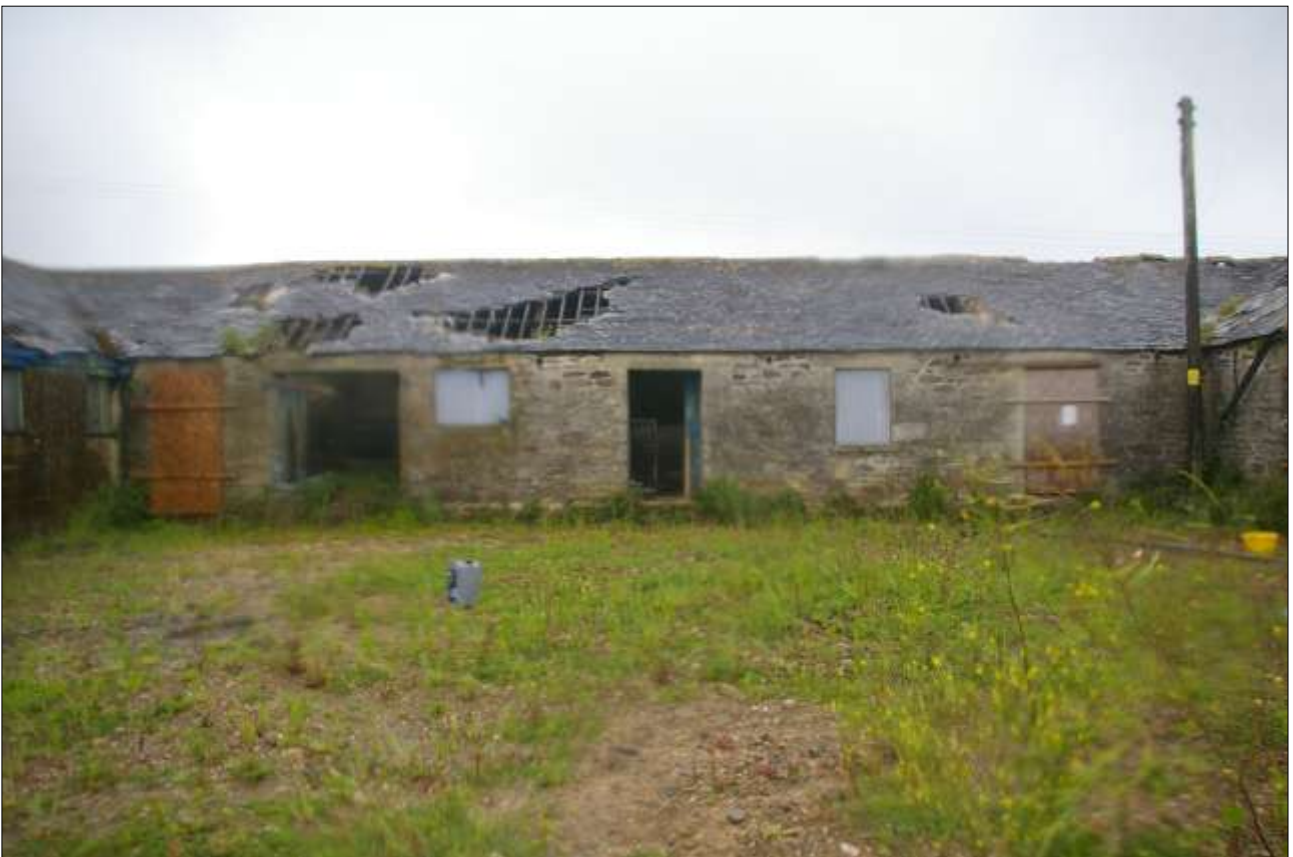
B4 (RIGHT) AND B5 (LEFT); VIEWED FROM THE SOUTH-EAST.

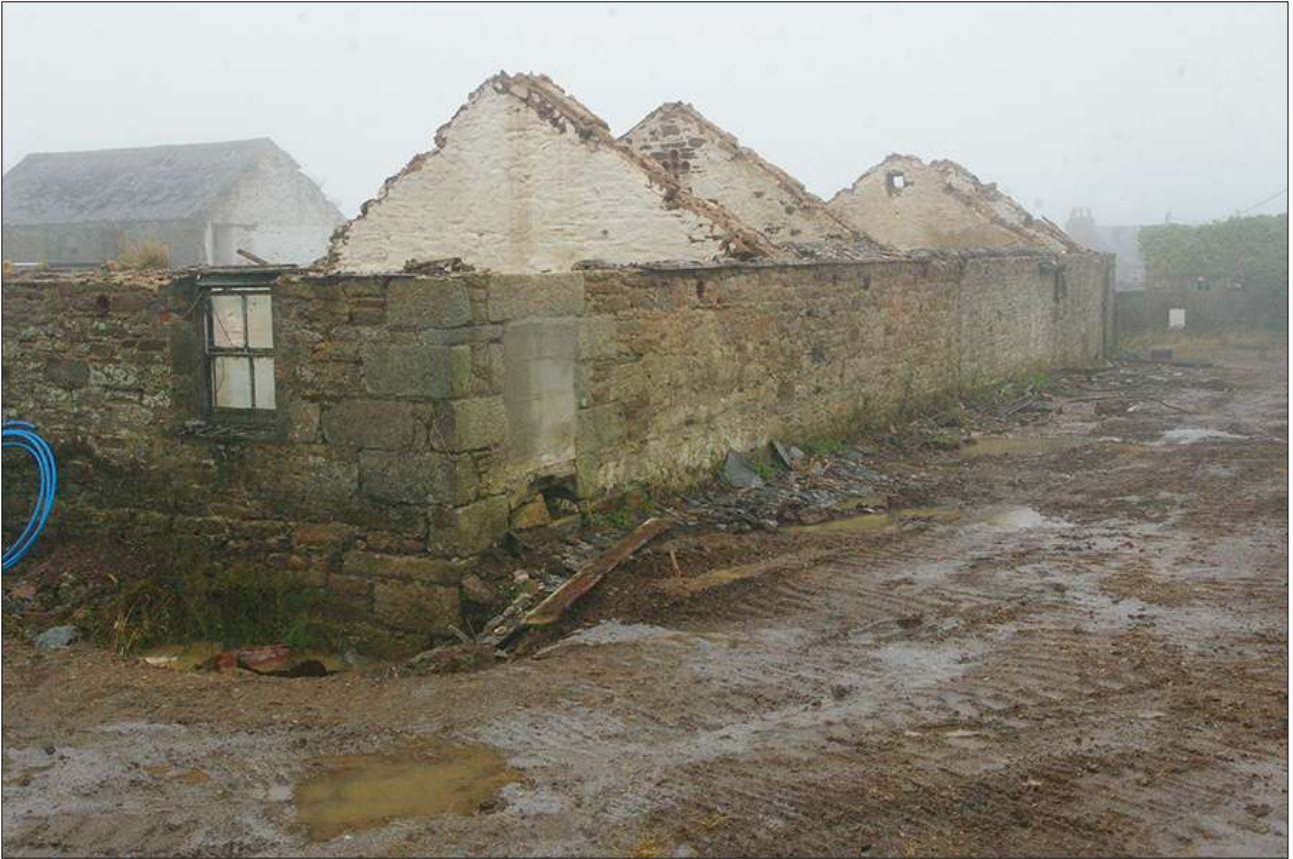
B4, DURING WORKS; VIEWED FROM THE WEST-NORTH-WEST.

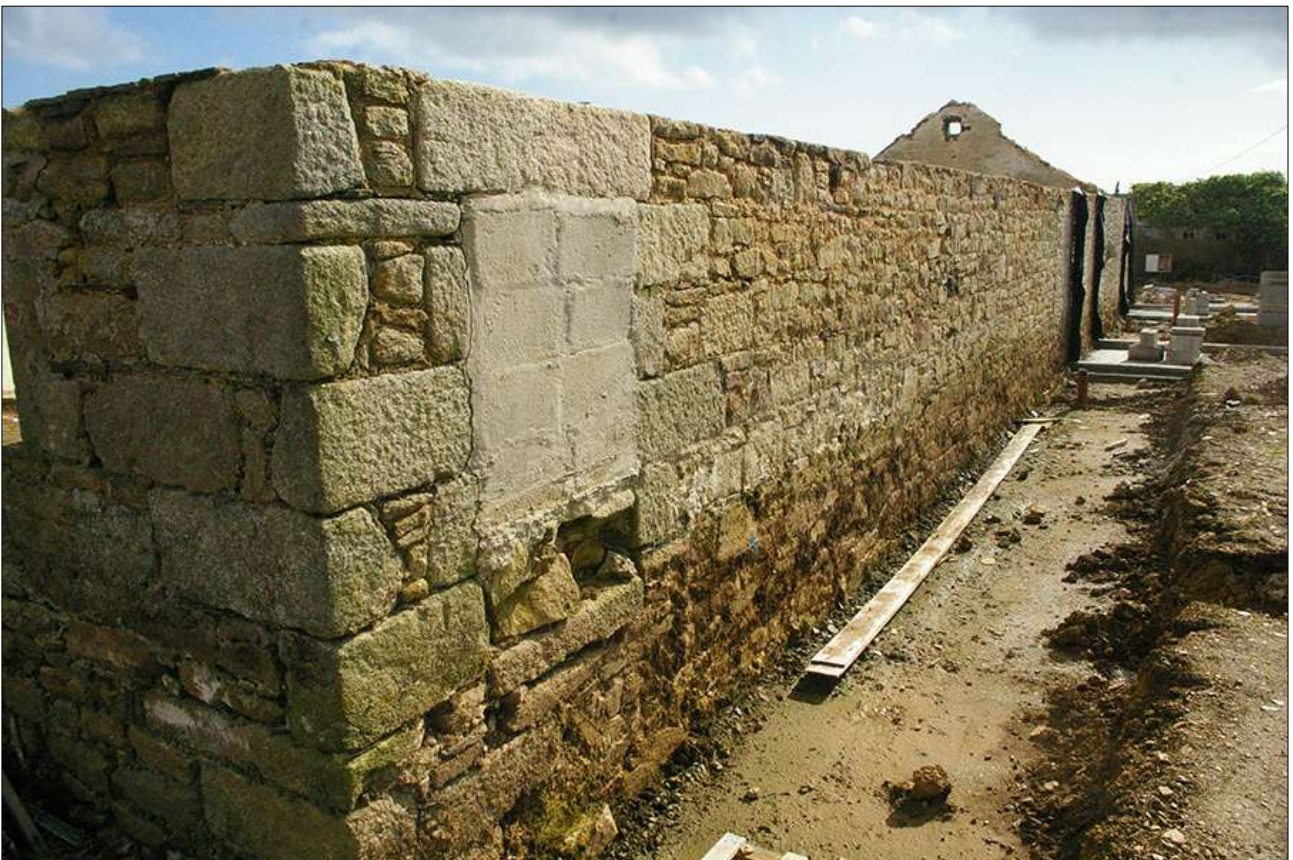
B4, DURING WORKS, SHOWING THE RAISES IN THE STONEMWORK; VIEWED FROM THE WEST-NORTH-WEST.

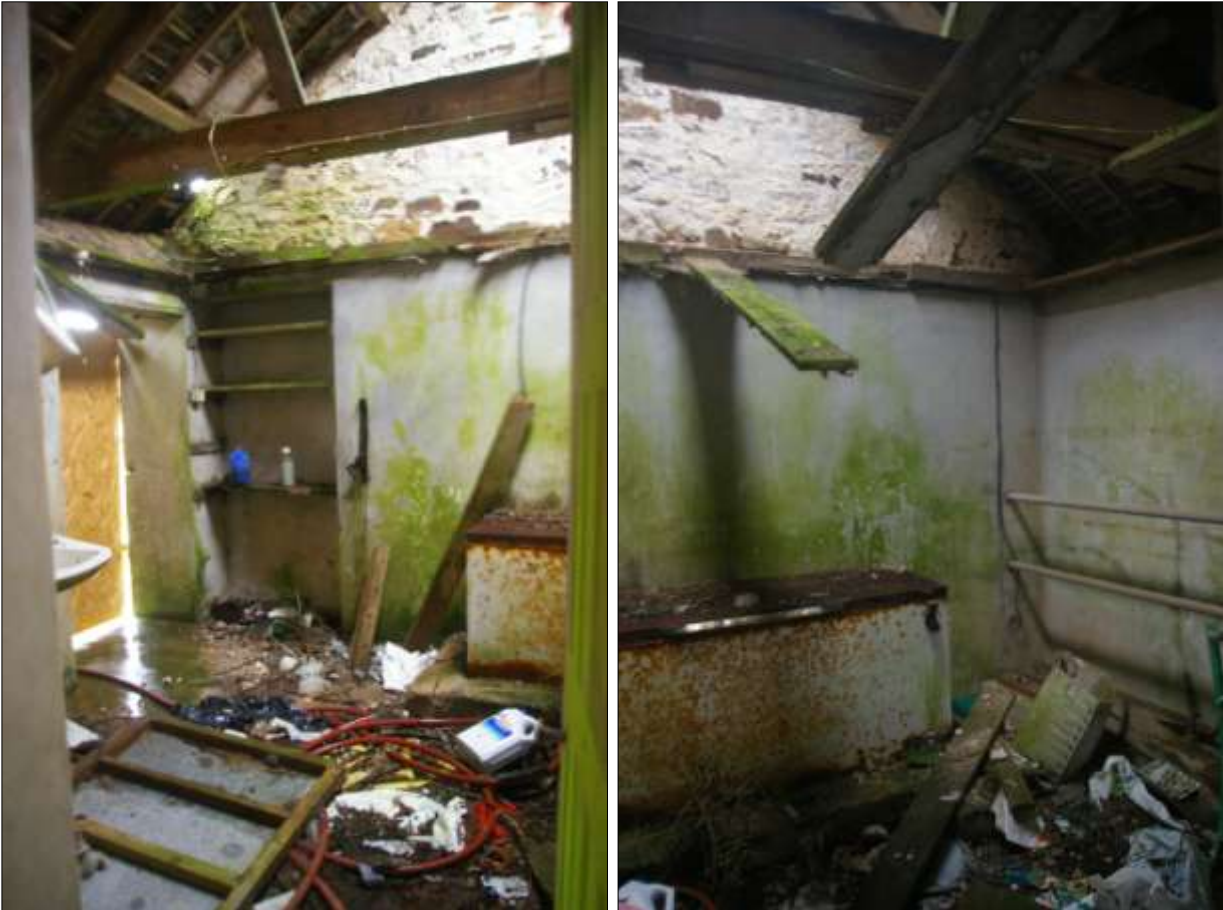
LEFT: B4.1, NORTH ROOM; VIEWED FROM THE NORTH-NORTH-EAST.
RIGHT: B4.1, NORTH ROOM, VIEWED FROM THE NORTH-EAST.

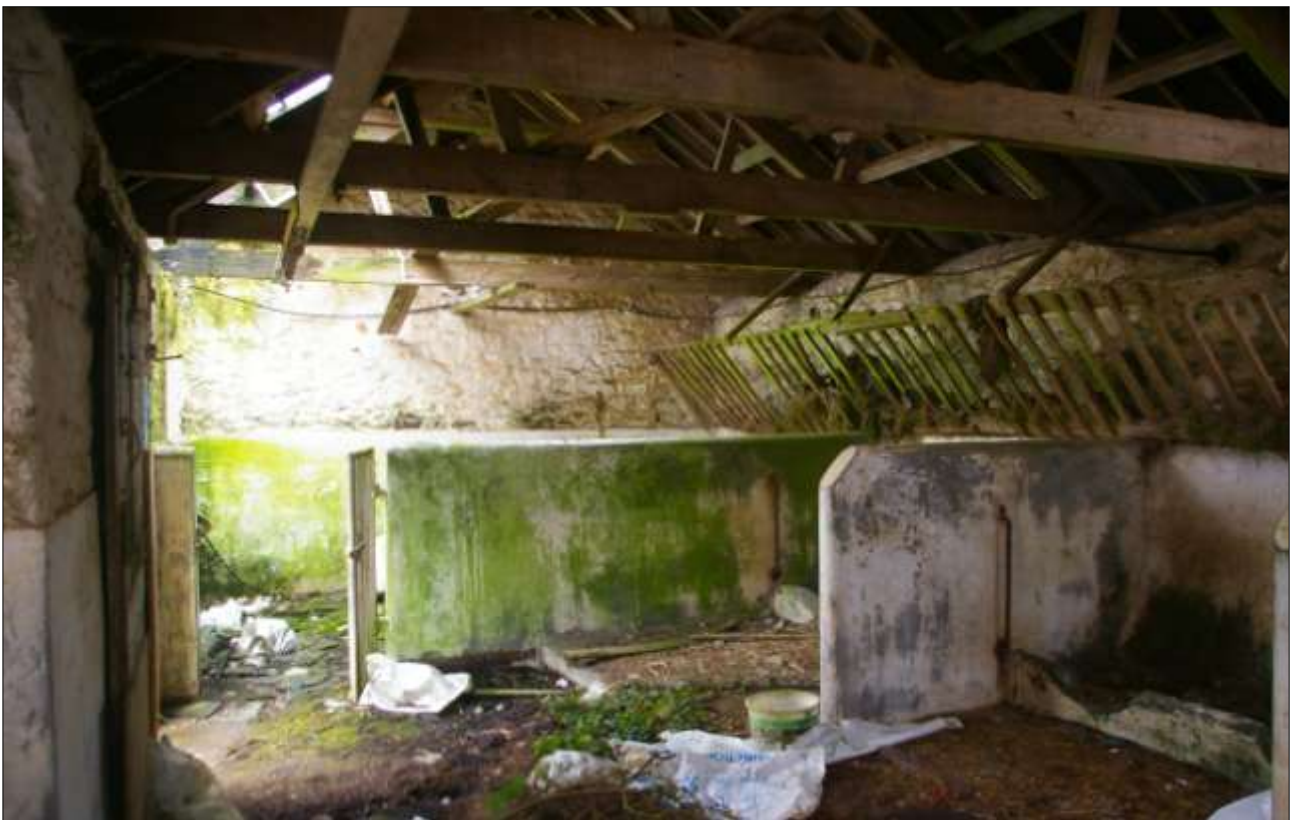
B4.2, SOUTH ROOM, SHOWING THE CALVING PEN WITH GATE; VIEWED FROM THE NORTH-EAST.

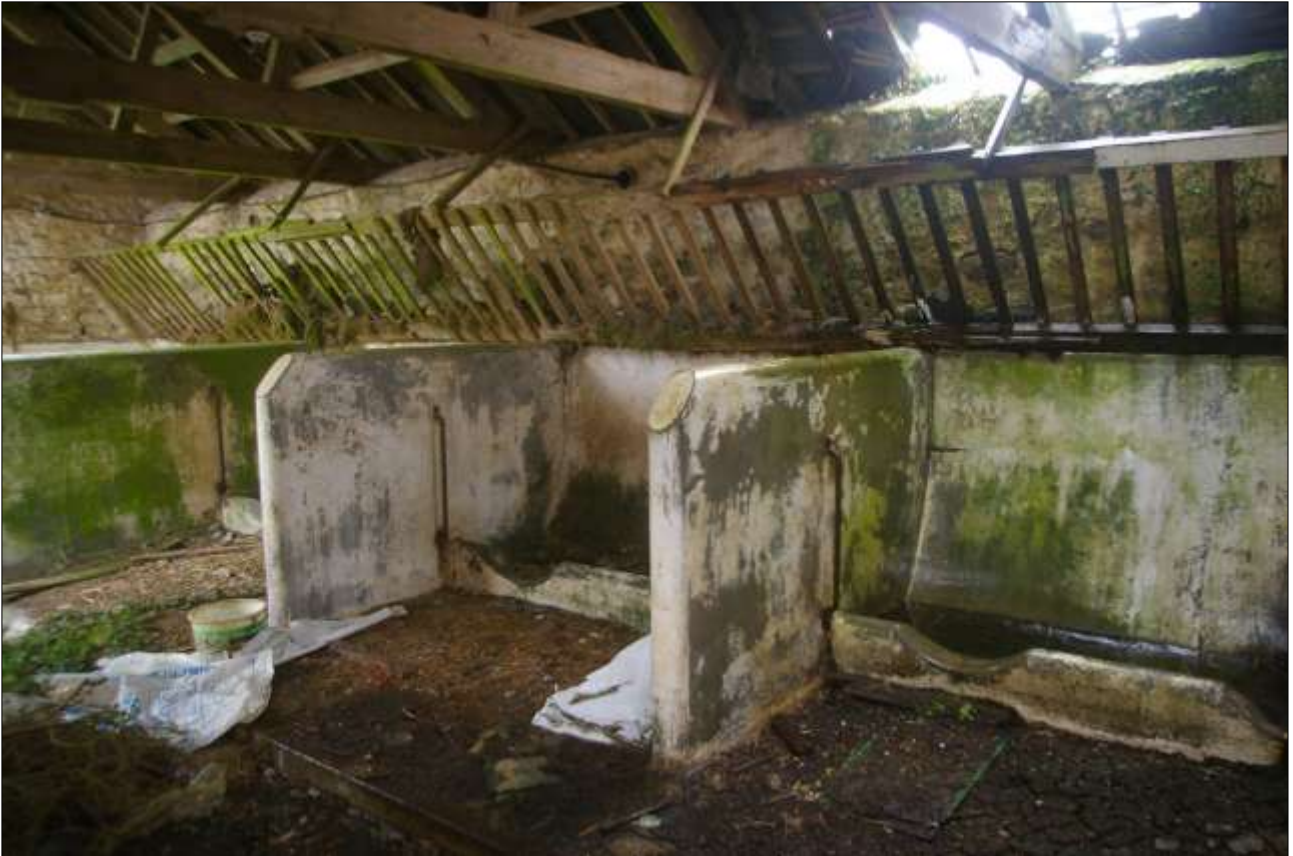
B4.2, SOUTH ROOM, THE CONCRETE STALLS AND TIMBER HAYRACKS; VIEWED FROM THE NORTH-EAST.

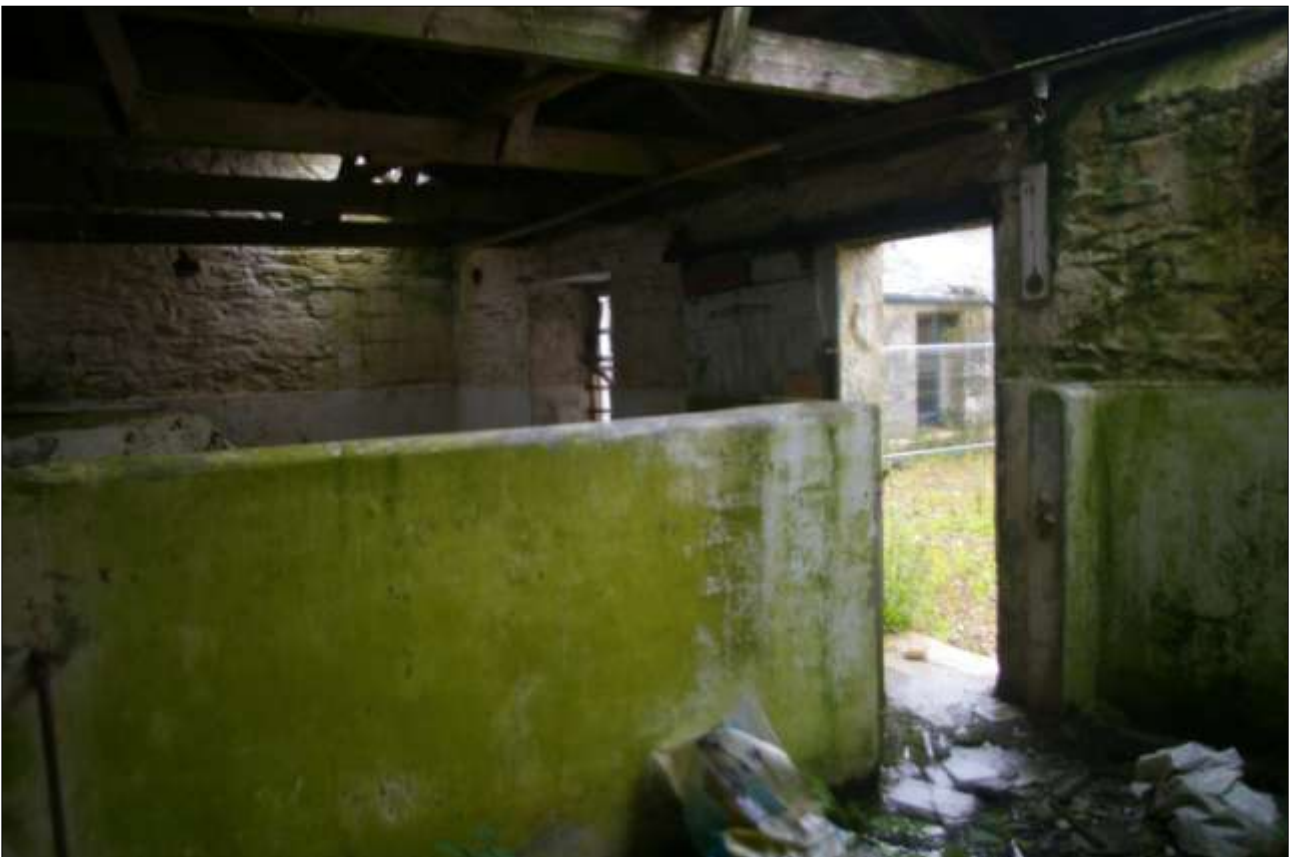
B4.2, SOUTHERN ROOM, SHOWING THE CALVING PEN; VIEWED FROM THE WEST-SOUTH-WEST.
