THE BARNs PENBRO FARM BREAGE CORNWALL

Desk-Based Assessment & Historic Building Recording

South West Archaeology Ltd. report no. 180322

By B. Morris, E. Wapshott & N. Boyd
Report Version: FINAL
22nd March 2018

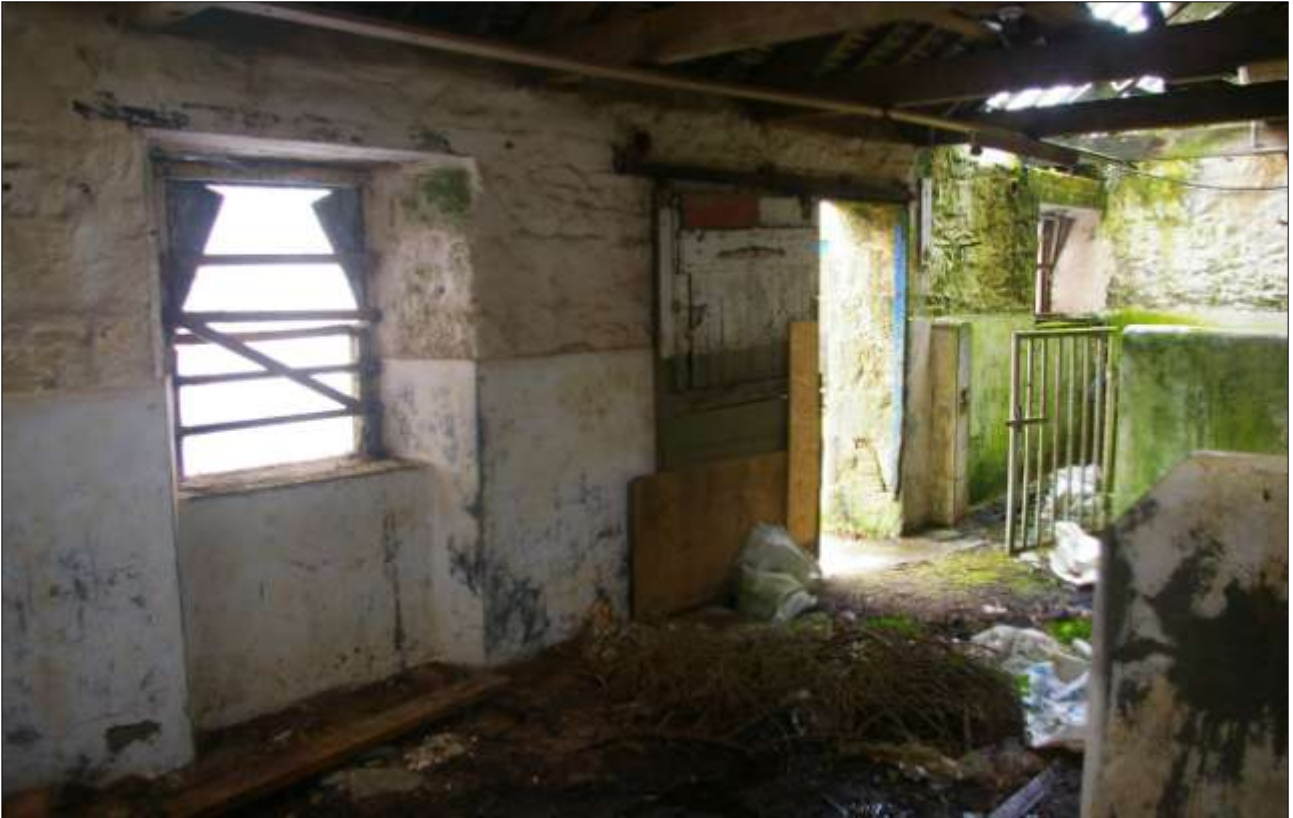
B4, SOUTH ROOM, SOUTH-EAST ELEVATION; VIEWED FROM THE NORTH.

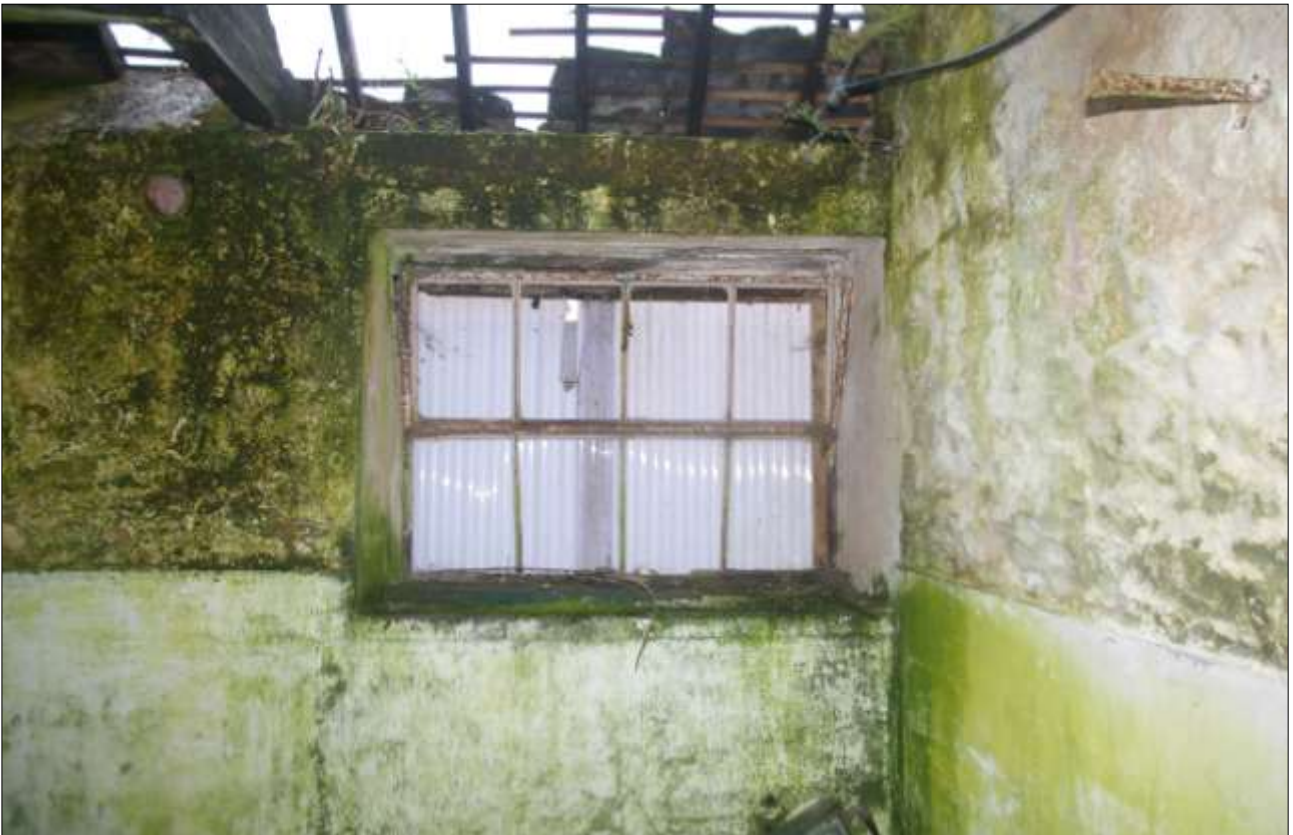
B4.2, SOUTH ROOM, SOUTH-EAST ELEVATION, A METAL HOPPER WINDOW (W32) IN A FORCED OPENING; VIEWED FROM THE WEST-NORTH-WEST.

Floor:		<p>Concrete floor. Drain to east side, step up to the stalls to the west.</p>
Roof Structure:		<p>Five A-frames with queen struts, the ridge of the trusses is ½ lapped with a diamond-set ridge pole and the other joints are nailed and spiked. Rafters and split battens survive with slates directly attached to back of battens. On the west pitch, towards the southern end, the roof has been replaced, boarded and felted, with fibre-cement slates.</p>
Blocked Opening:	BO9	<p>Door to B4.1 blocked in concrete block. Thin timber lintel.</p>
Openings – Doors:	D19	<p>One original central doorway to courtyard, sliding internal timber door.</p>
Openings – Windows:	W31	<p>Window with full-height alcove, slate sill and deep timber lintel. Pegged timber frame, with metal hopper casement inserted, then reinforced with metal horizontal bars.</p>
	W32	<p>Forced window with rendered sides, metal hopper casement.</p>

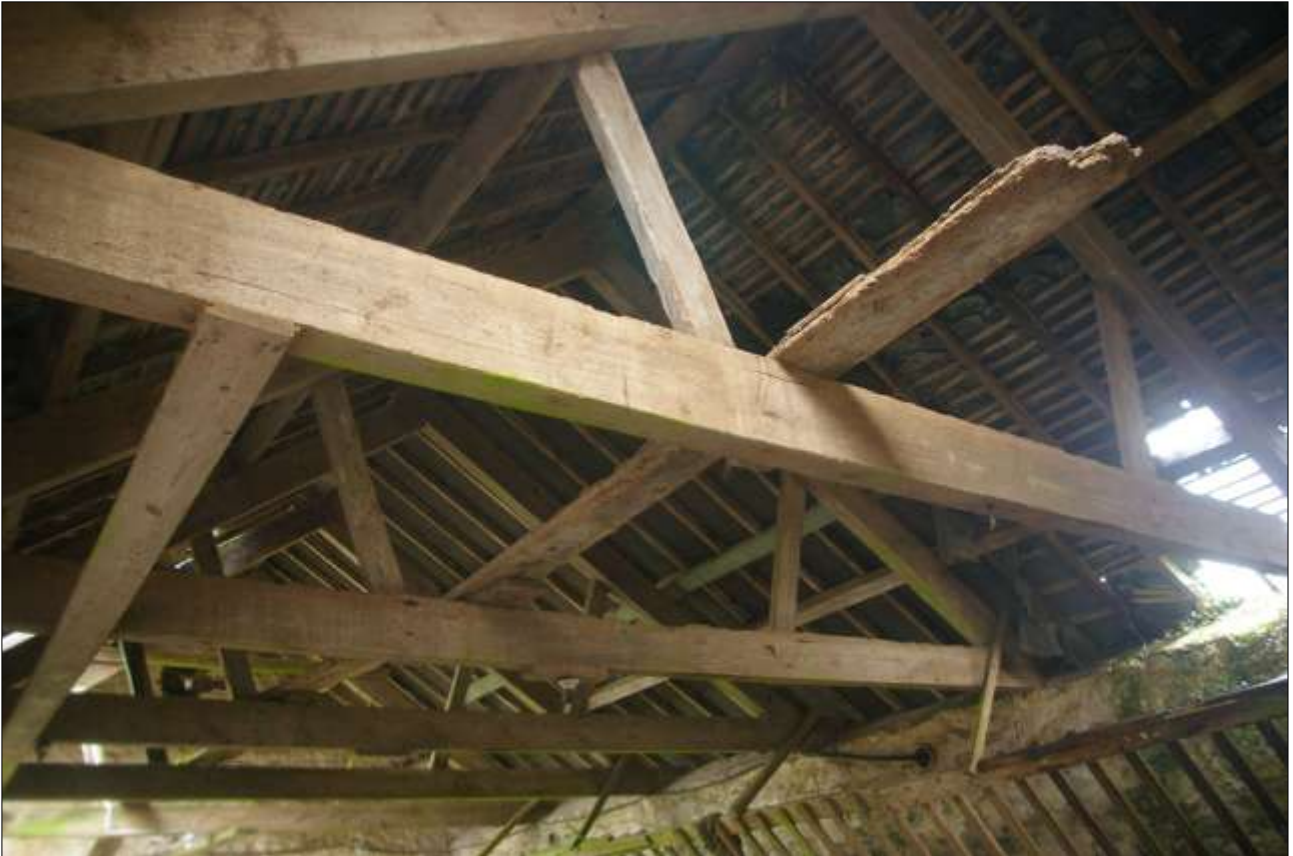
B4.2, SOUTH ROOM, ROOF STRUCTURE; VIEWED FROM THE NORTH-EAST.

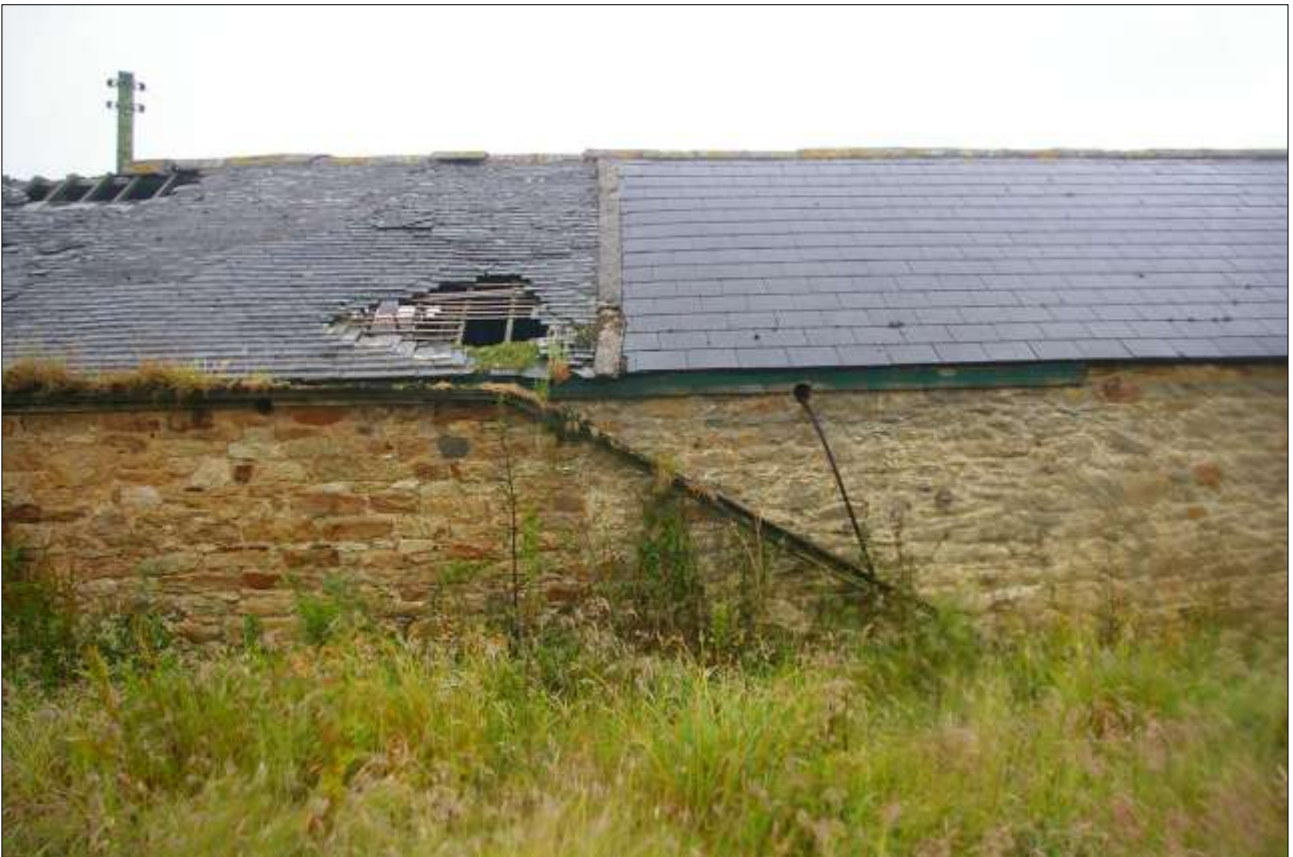
B4 (LEFT) AND B5 (RIGHT), SHOWING THE STONEMWORK; VIEWED FROM THE WEST-NORTH-WEST.

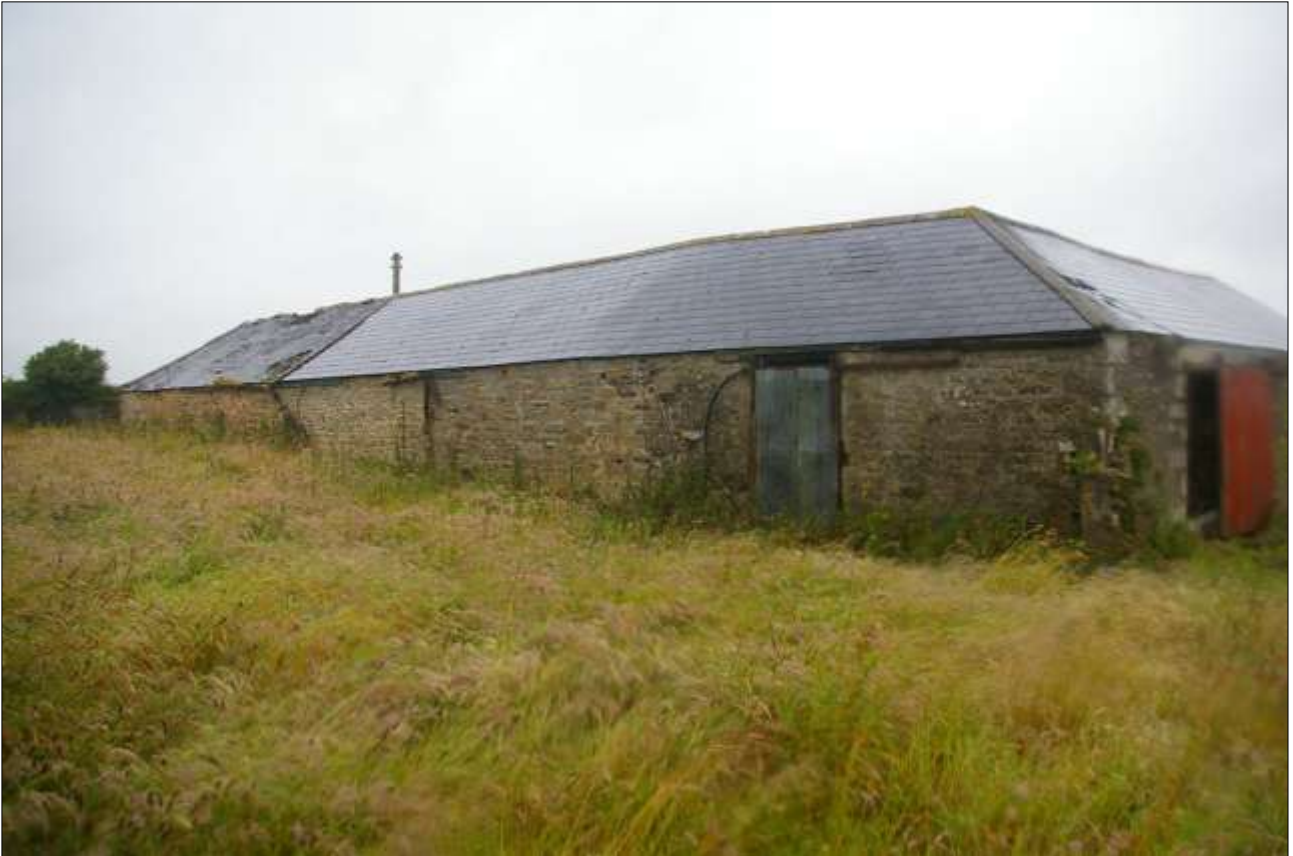
B5, NORTH-WEST ELEVATION; VIEWED FROM THE WEST-SOUTH-WEST.

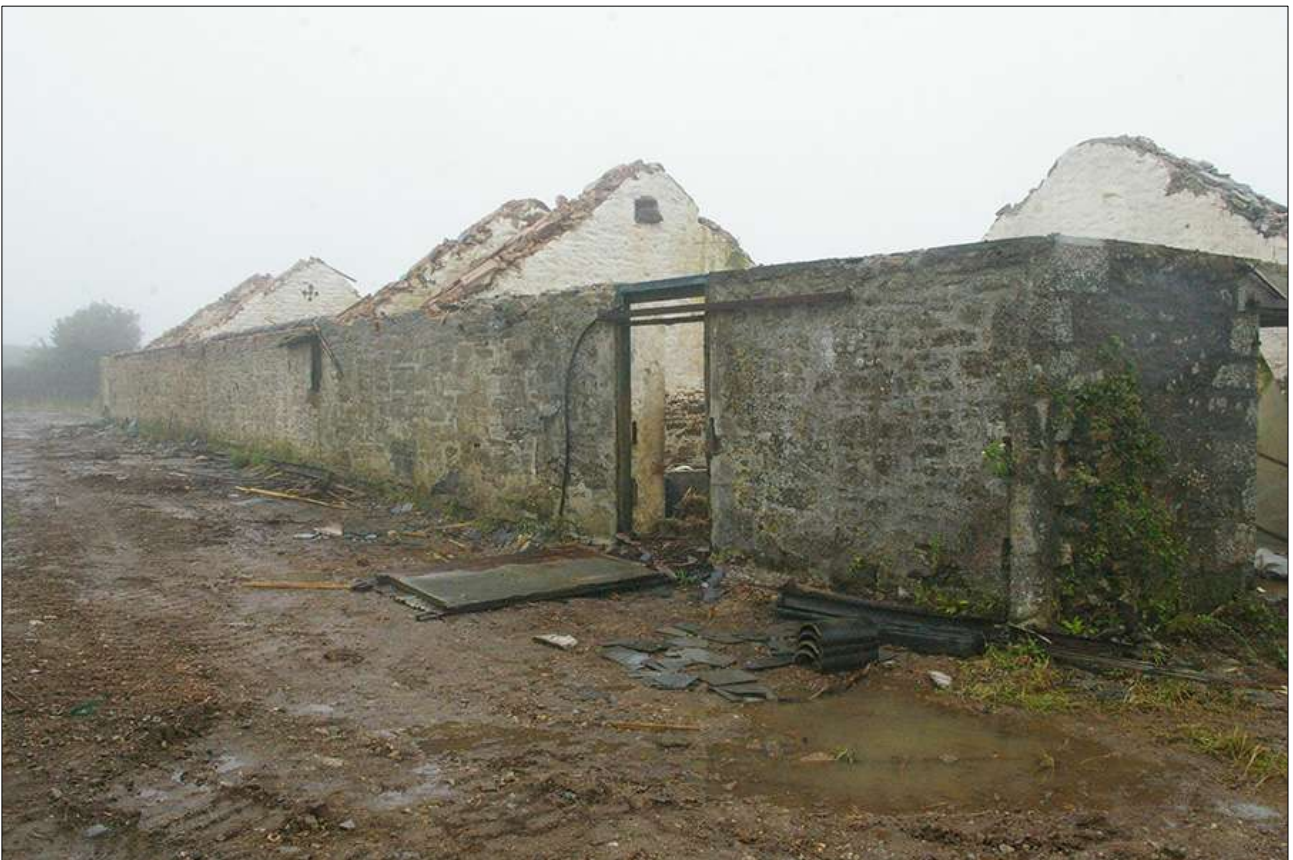
B5, NORTH-WEST ELEVATION, DURING WORKS; VIEWED FROM THE WEST.

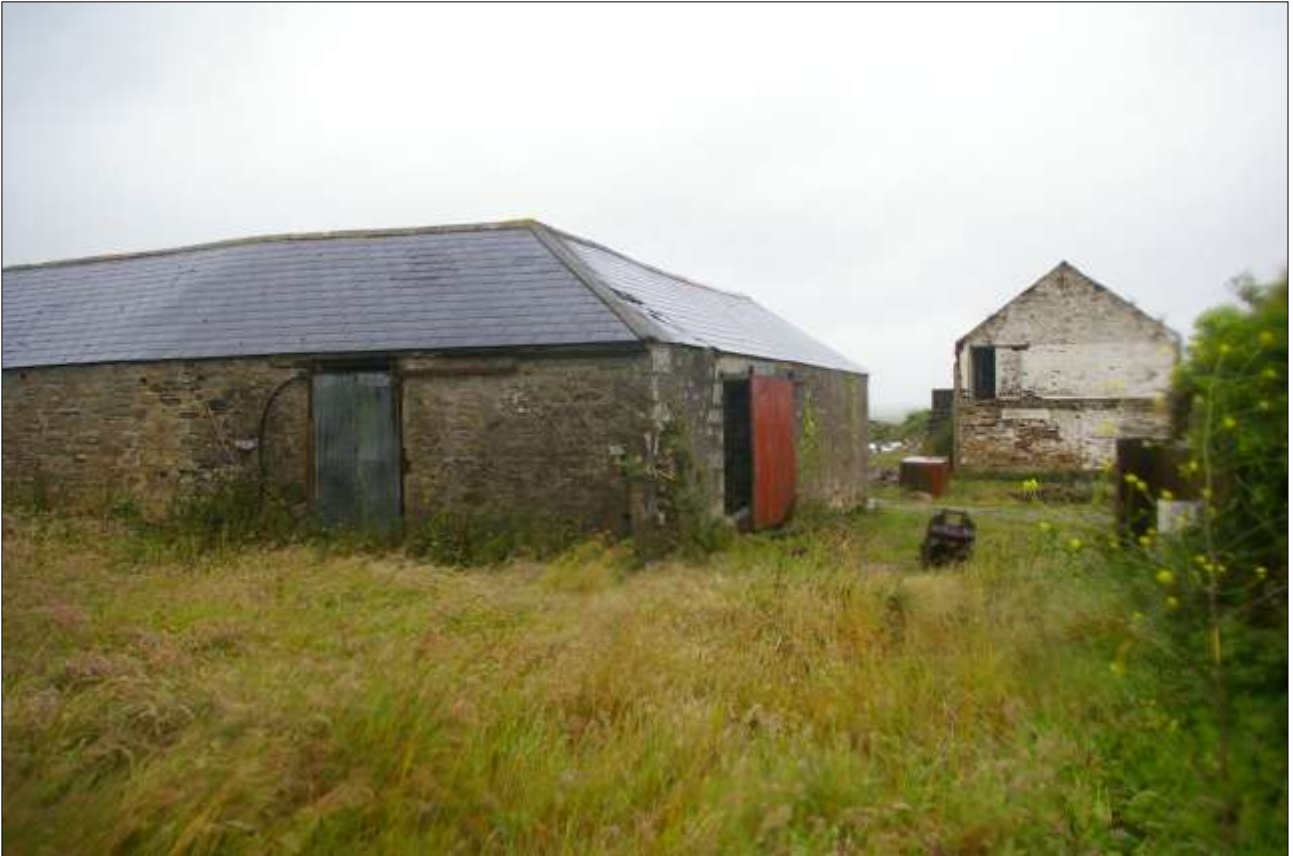
B5; VIEWED FROM THE WEST-SOUTH-WEST.

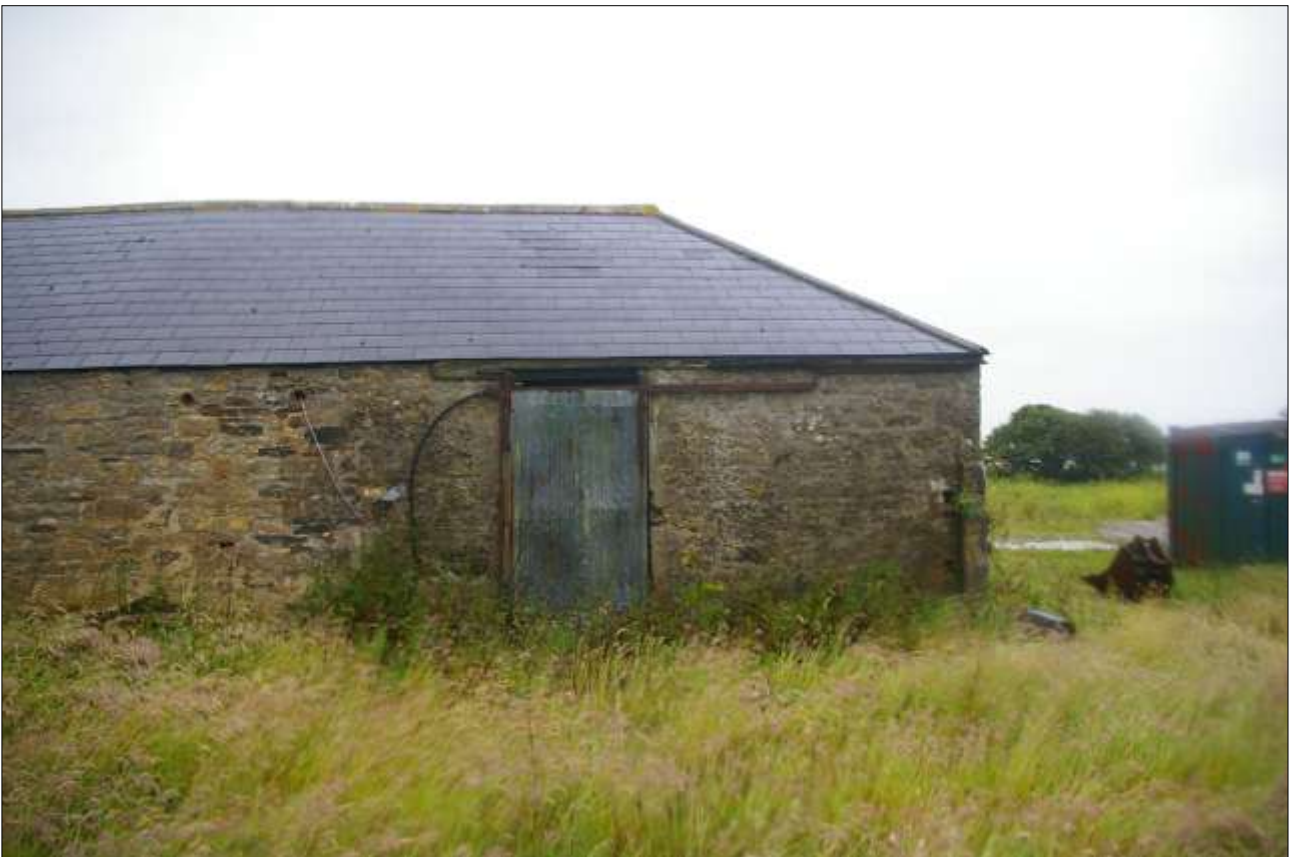
B5, NORTH-WEST ELEVATION, ANGLED SOUTHERN SECTION OF WALLING; VIEWED FROM THE WEST.

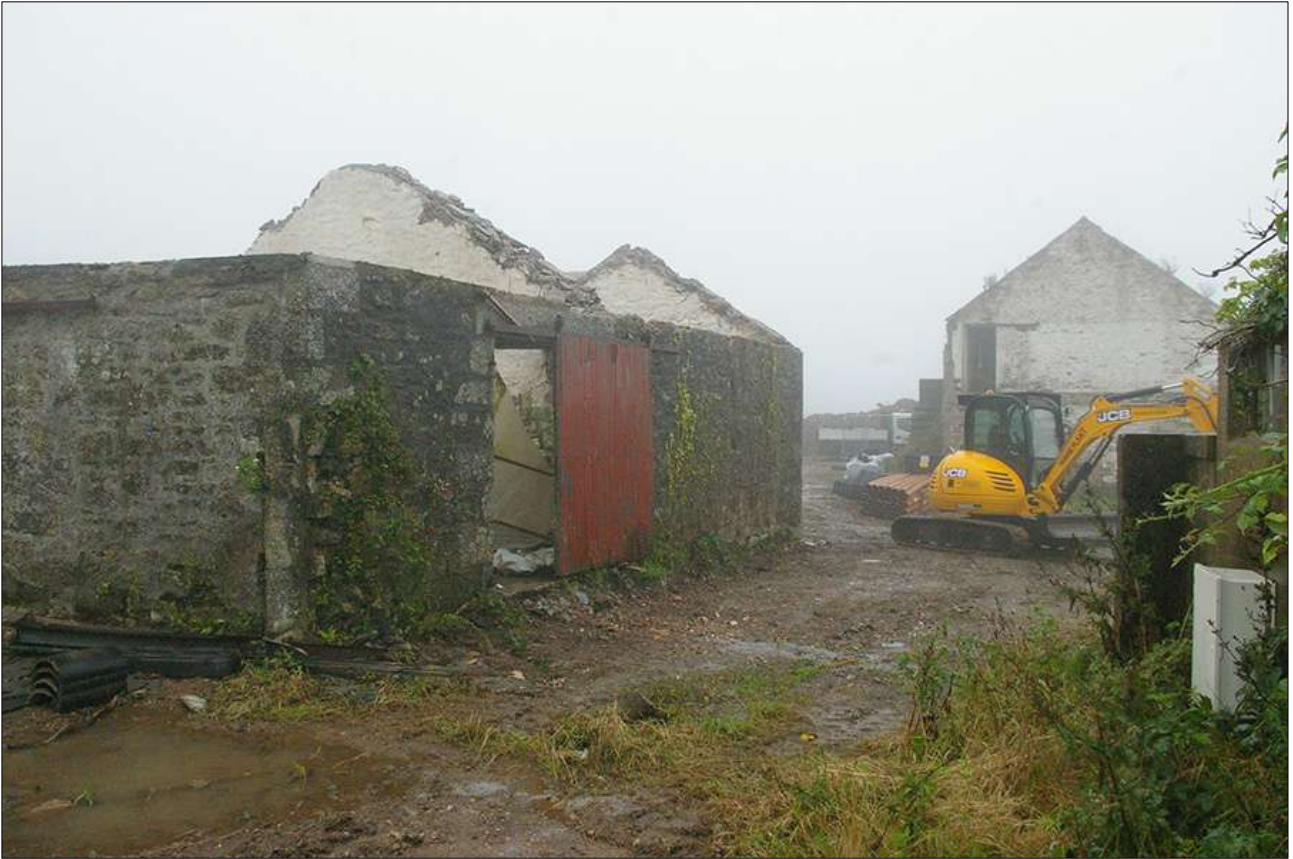
B5, DURING WORKS; VIEWED FROM THE WEST.

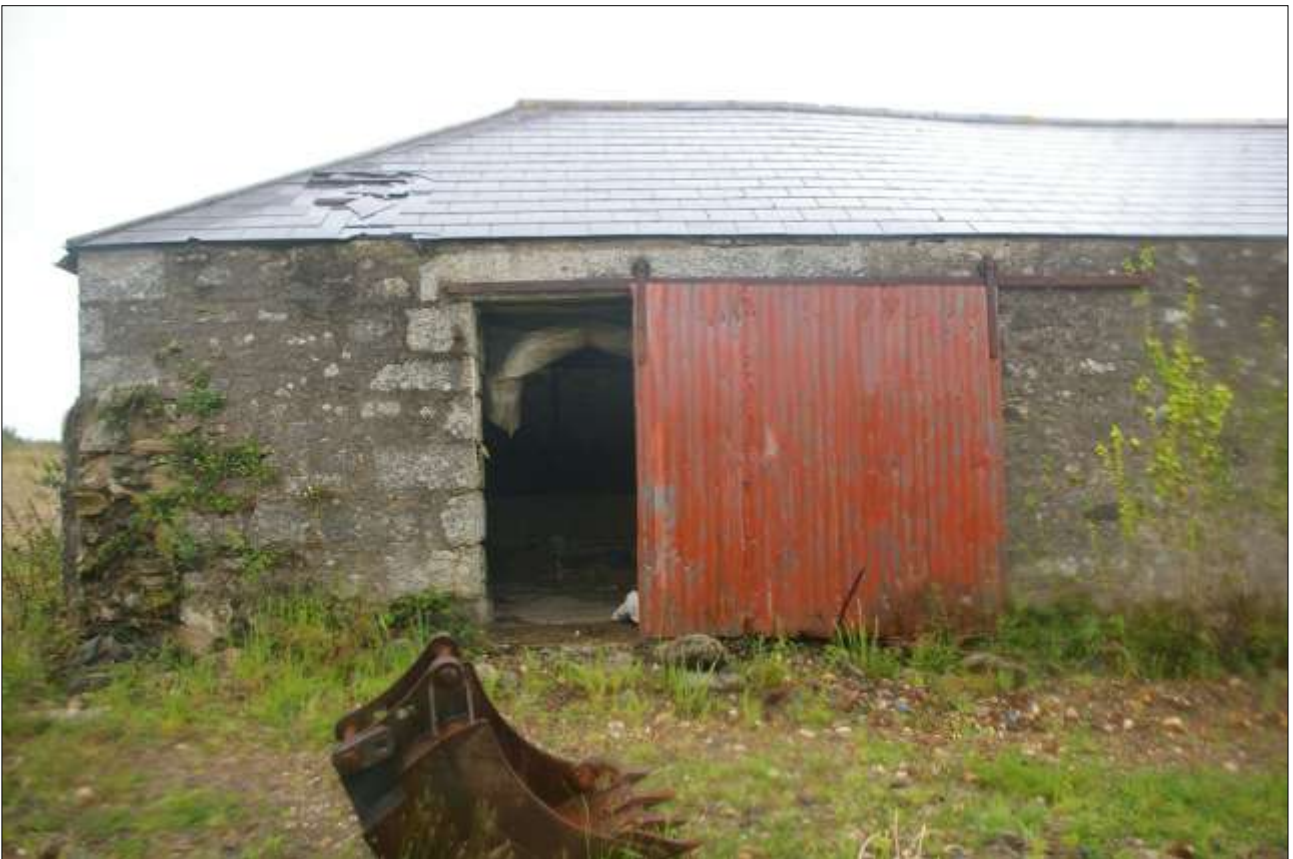
B5, SOUTH-WEST ELEVATION, SHOWING THE WIDE DOORWAY (D23) INTO THE SOUTH-WESTERN ROOM; VIEWED FROM THE SOUTH-WEST.

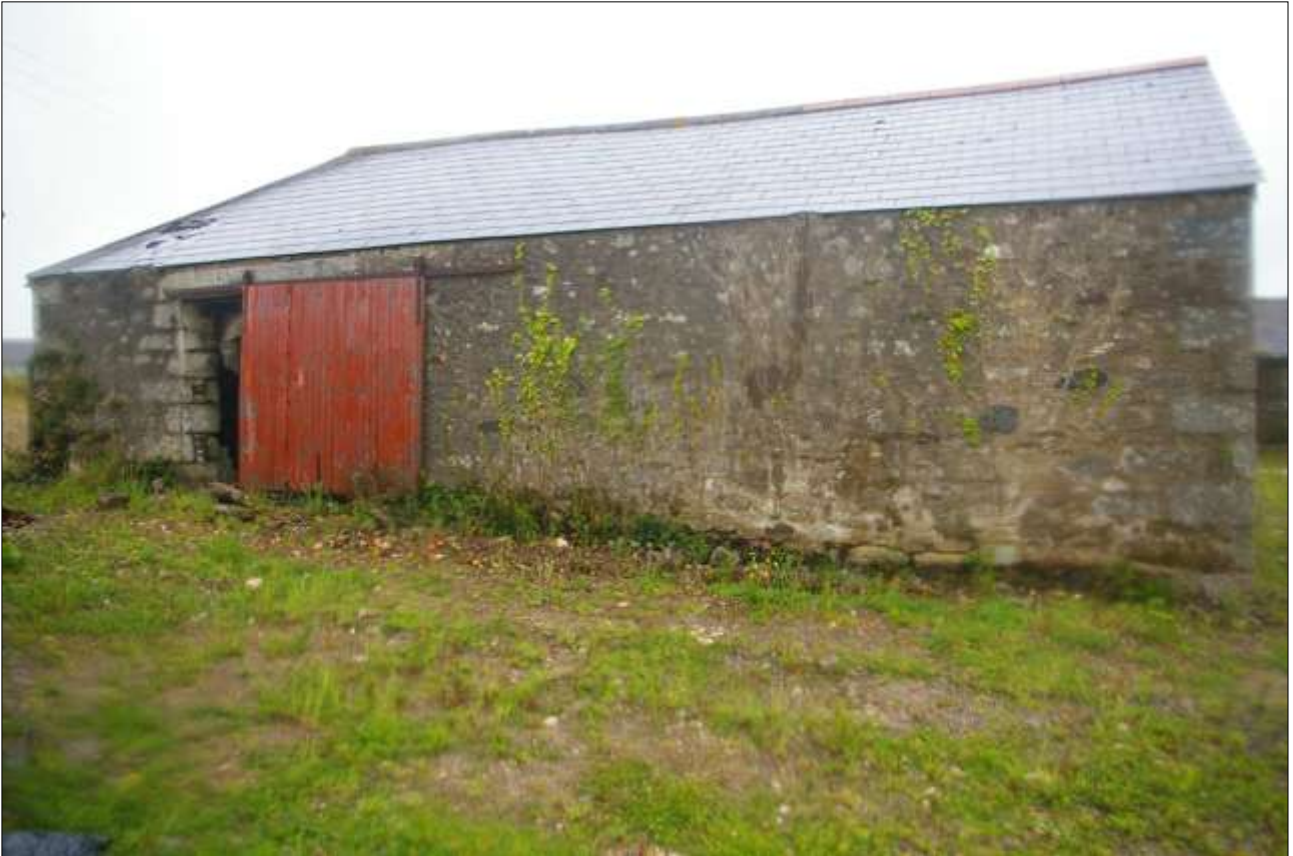
B5, SOUTH-WEST ELEVATION; VIEWED FROM THE SOUTH.

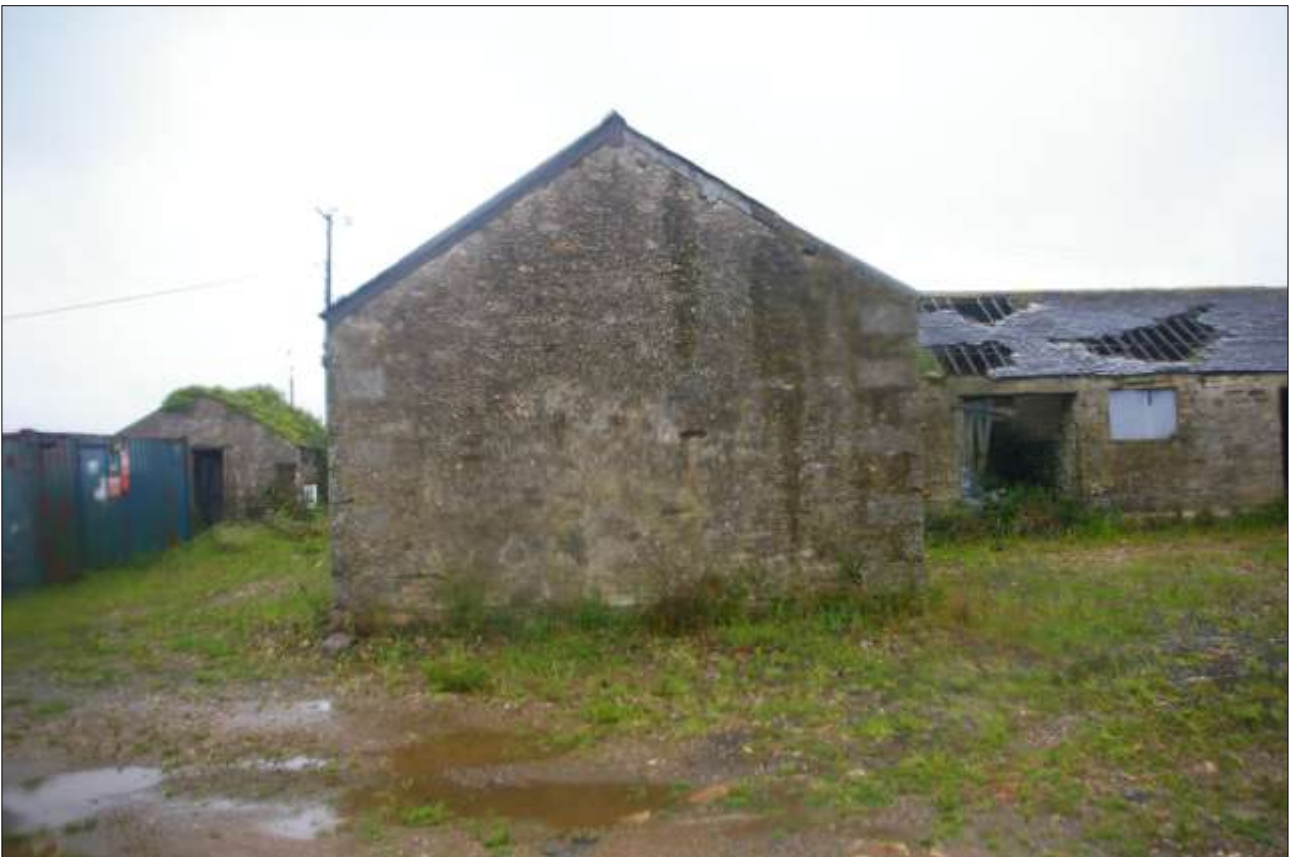
B5, SOUTH-EAST GABLE ELEVATION; VIEWED FROM THE SOUTH-EAST.

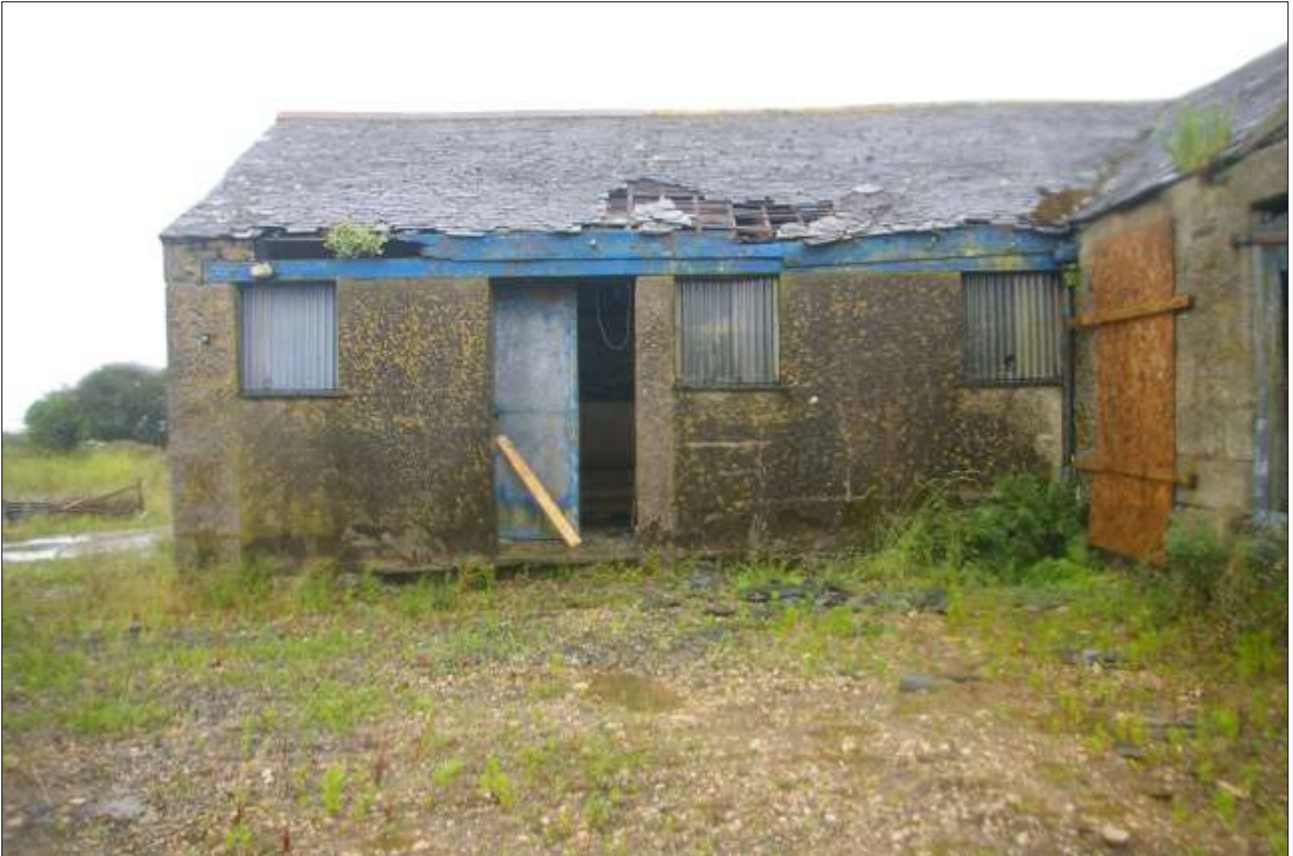
B5, NORTH-EAST ELEVATION, WITH CENTRAL GRANITE PILLAR AND OPENINGS INFILLED IN CONCRETE BLOCK (BO10, BO11); VIEWED FROM THE NORTH-EAST.

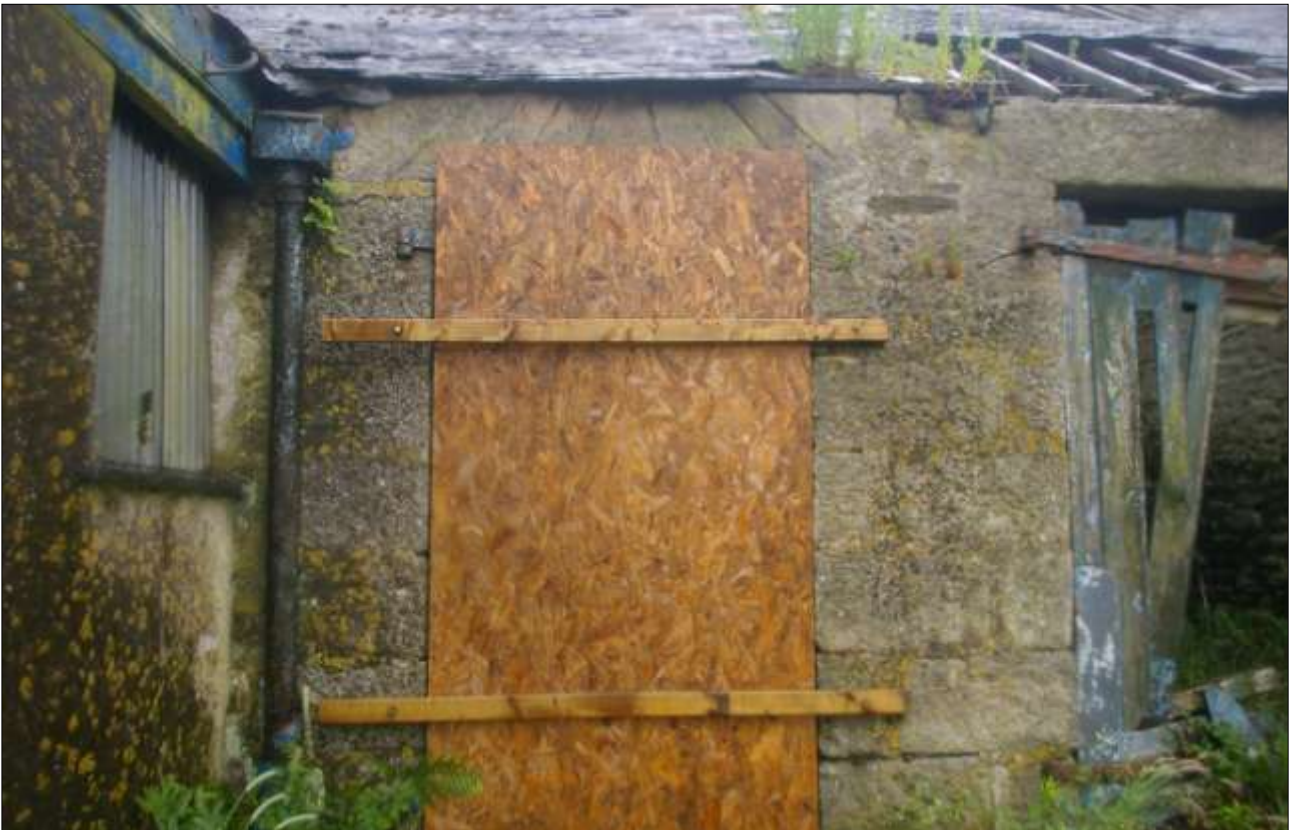
B5, SOUTH-EAST YARD ELEVATION, DOORWAY (D21) INTO THE SOUTH-WEST ROOM WITH INCISED UPSIDE-DOWN LINTEL; VIEWED FROM THE EAST-SOUTH-EAST.

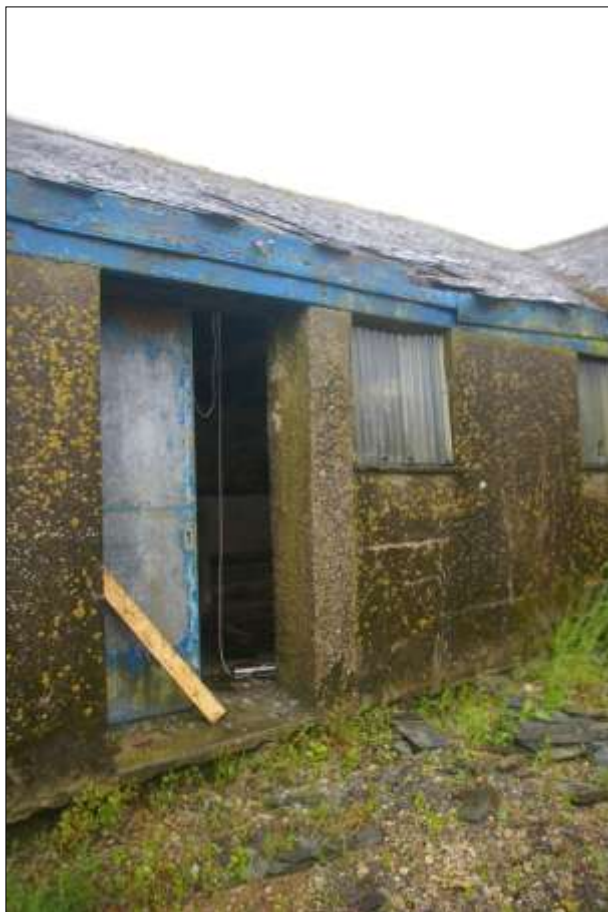
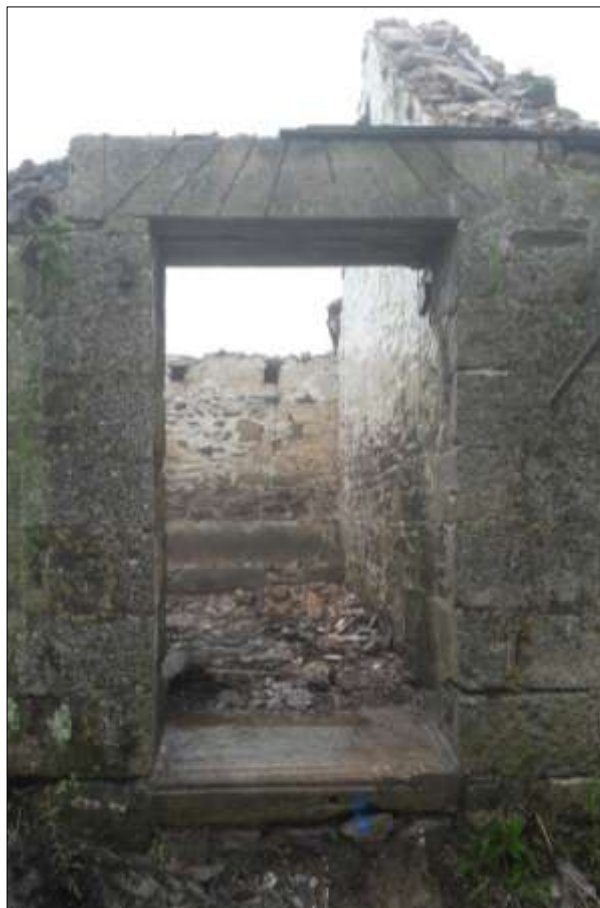
LEFT: B5, NORTH-EAST ELEVATION; VIEWED FROM THE EAST.

RIGHT: B5, DURING WORKS, DOORWAY (D21) INTO THE SOUTH-WEST ROOM FROM THE YARD, SHOWING INCISED LINTEL AND MOULDED GRANITE FIRE-SURROUND REUSED AS A THRESHOLD; VIEWED FROM THE SOUTH-EAST.

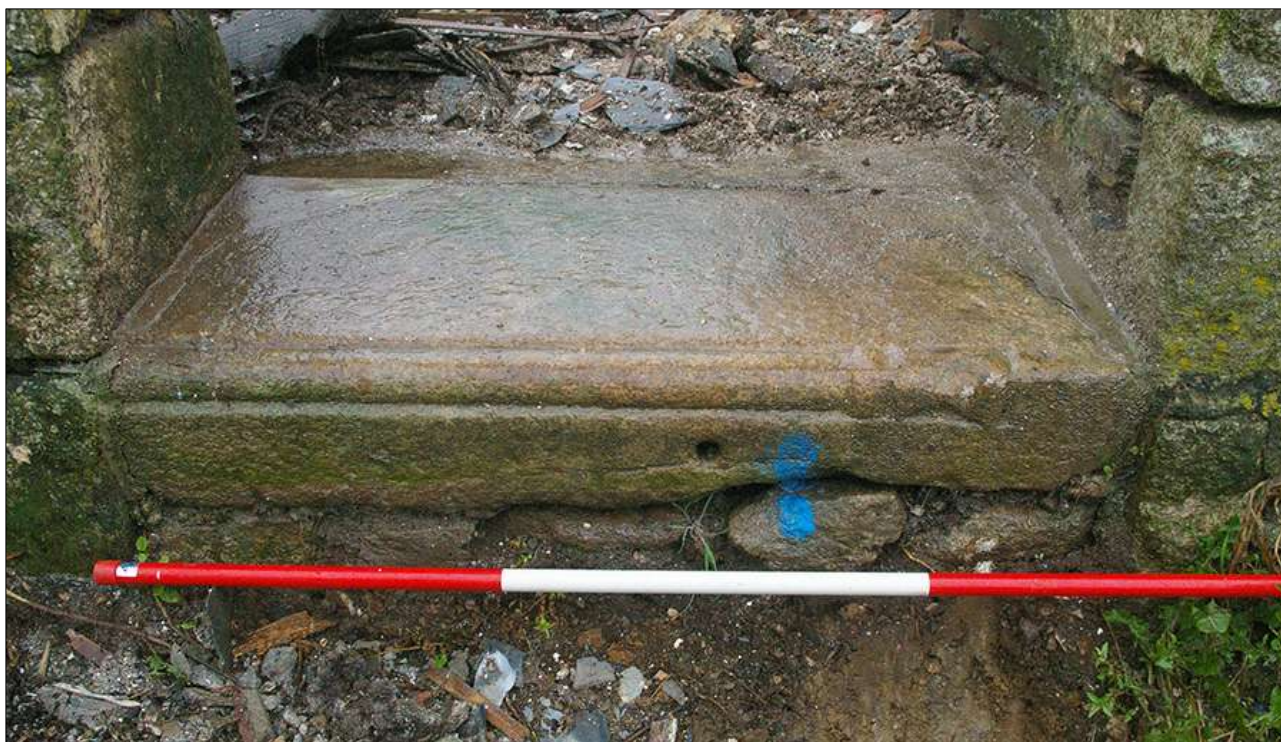
B5, AS ABOVE (RIGHT), DETAIL OF THE MOULDED FIRE SURROUND; VIEWED FROM THE SOUTH-EAST (2M SCALE).

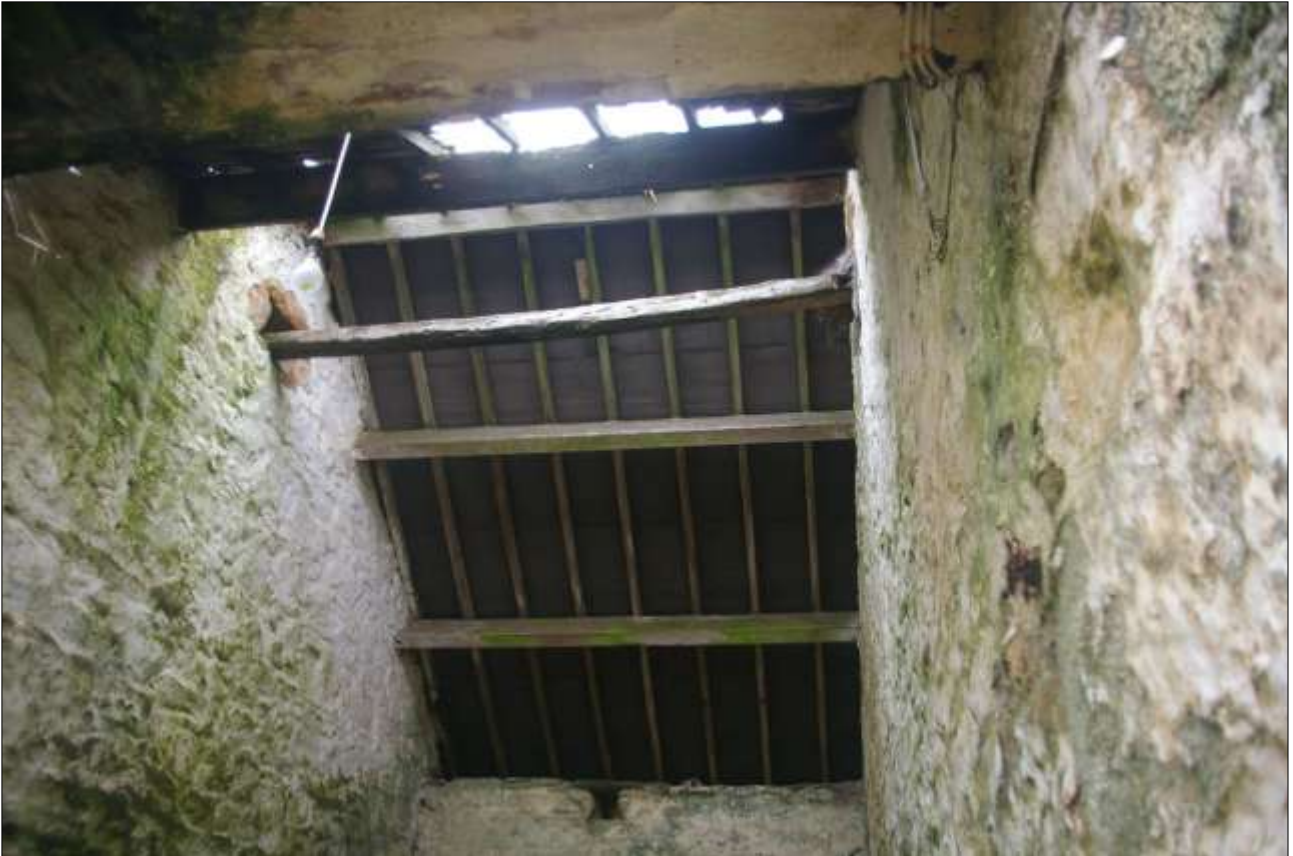
B5.1, NORTH ROOM, ROOF STRUCTURE; FROM THE EAST-NORTH-EAST.

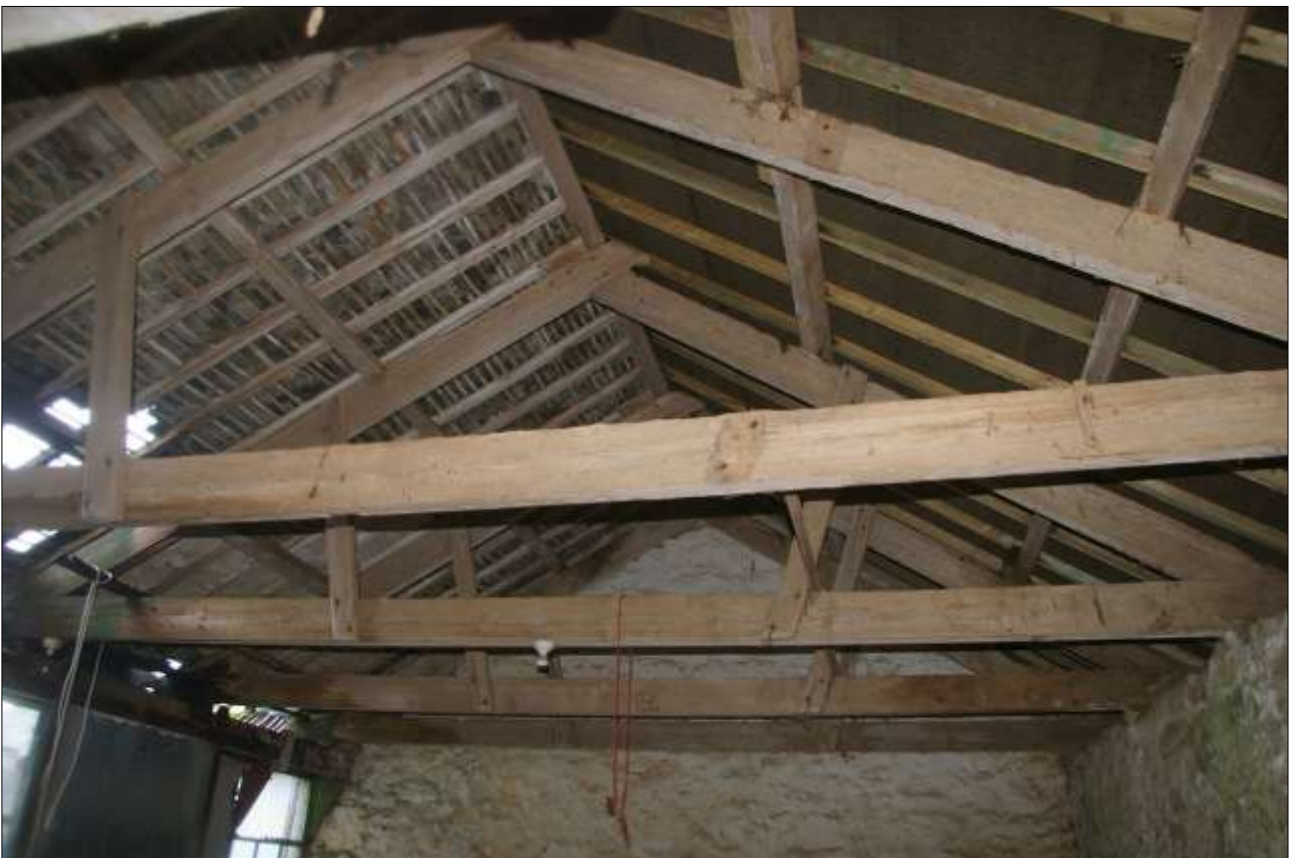
B5.3, EAST ROOM, ROOF STRUCTURE; VIEWED FROM THE WEST-SOUTH-WEST.

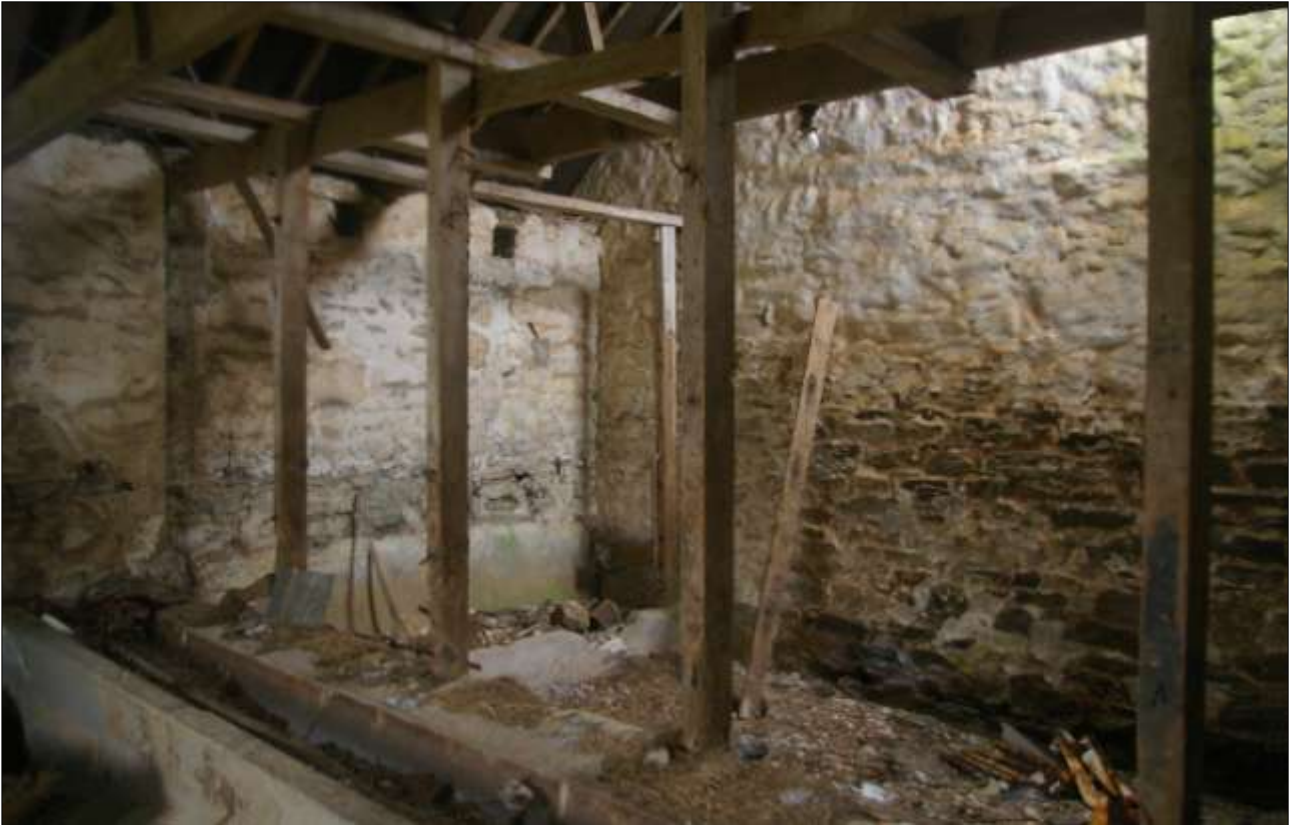
B5.2, SOUTH-WEST ROOM, SHOWING THE FORMER PARTITION; VIEWED FROM THE SOUTH-SOUTH-WEST.

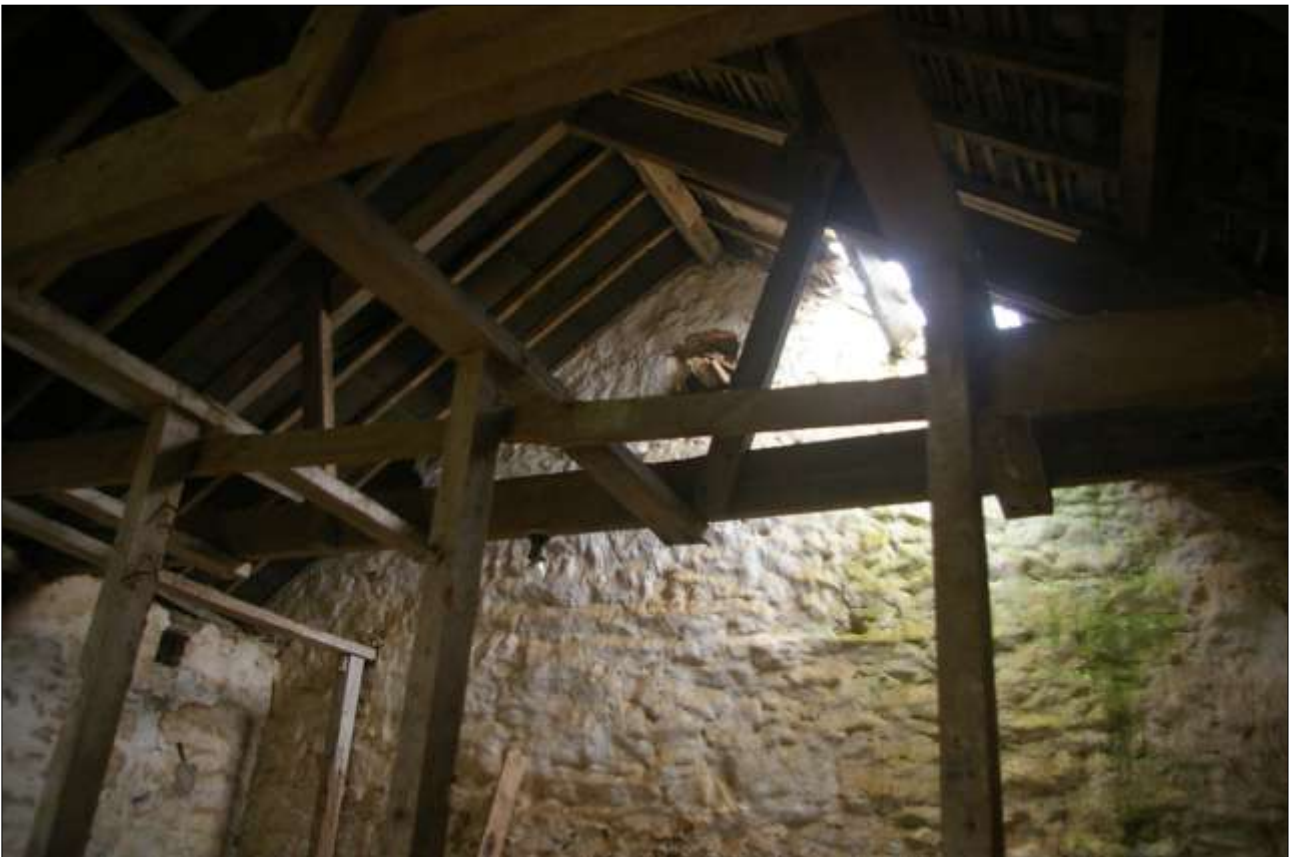
B5.2, SOUTH-WEST ROOM, ROOF STRUCTURE; VIEWED FROM THE SOUTH-SOUTH-WEST.
