THE BARNs PENBRO FARM BREAGE CORNWALL

Desk-Based Assessment & Historic Building Recording

South West Archaeology Ltd. report no. 180322

By B. Morris, E. Wapshott & N. Boyd
Report Version: FINAL
22nd March 2018

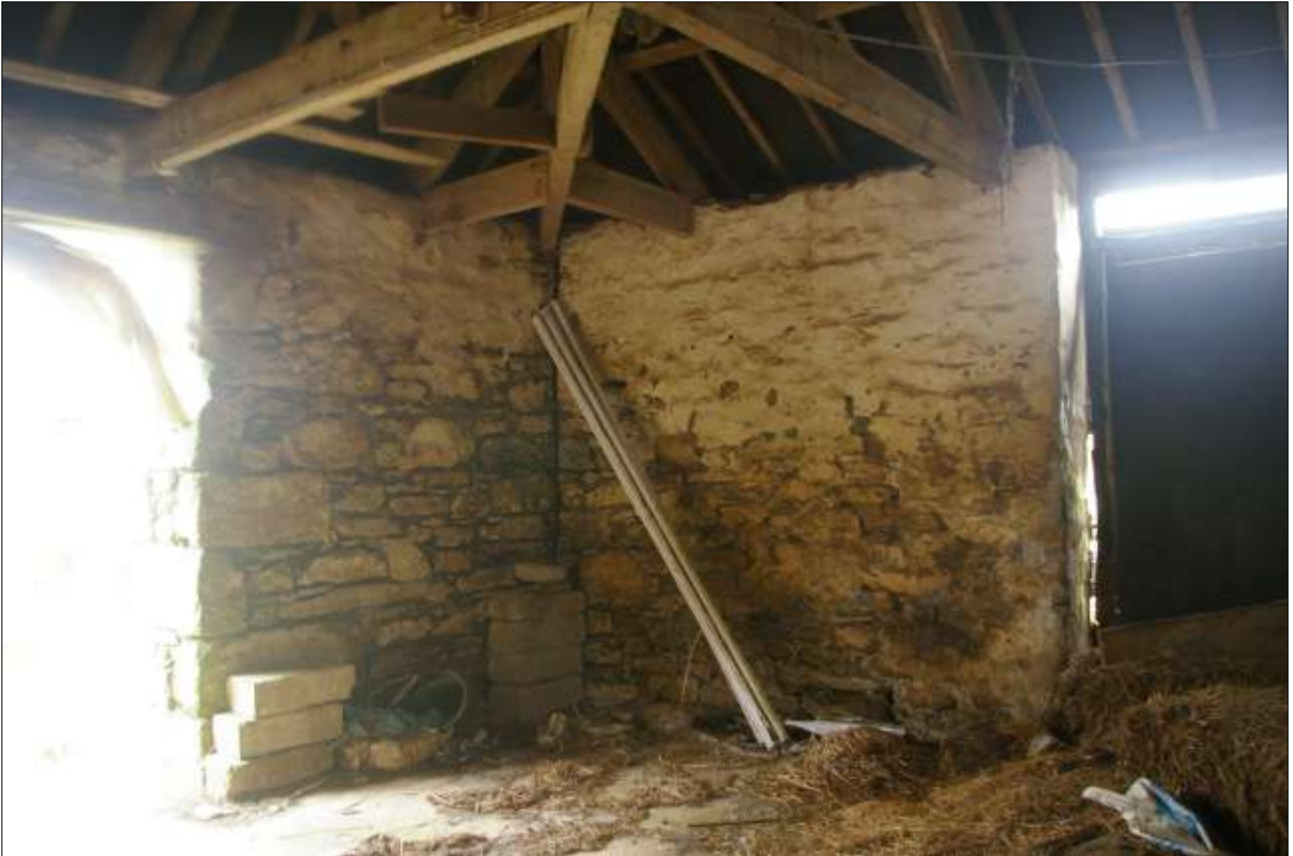
B5.2, SOUTH-WEST ROOM, SHOWING THE SOUTH-WEST ANGLE AND REBUILT SECTION OF WALL; VIEWED FROM THE EAST-NORTH-EAST.

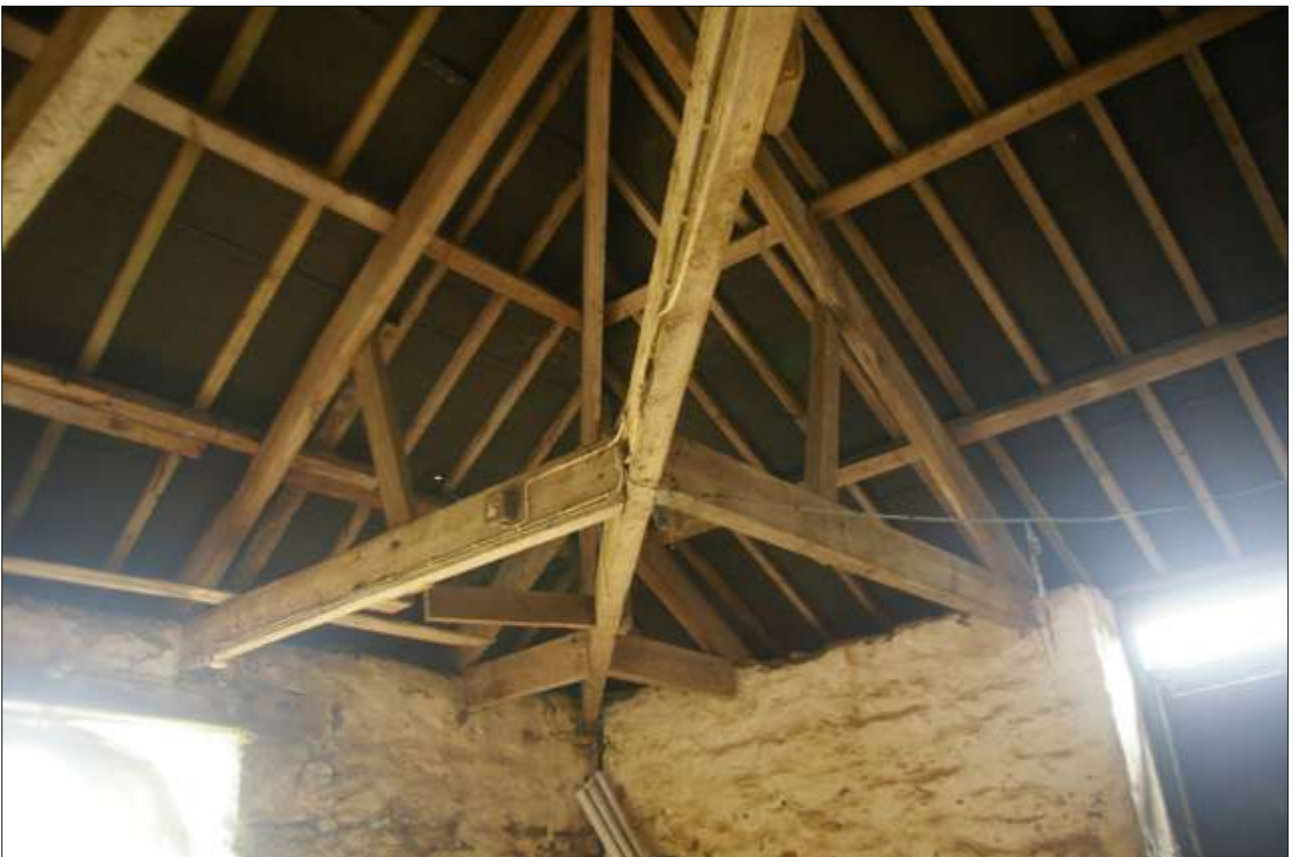
B5.2, SOUTH-WEST ROOM, ROOF STRUCTURE; VIEWED FROM THE EAST-NORTH-EAST.

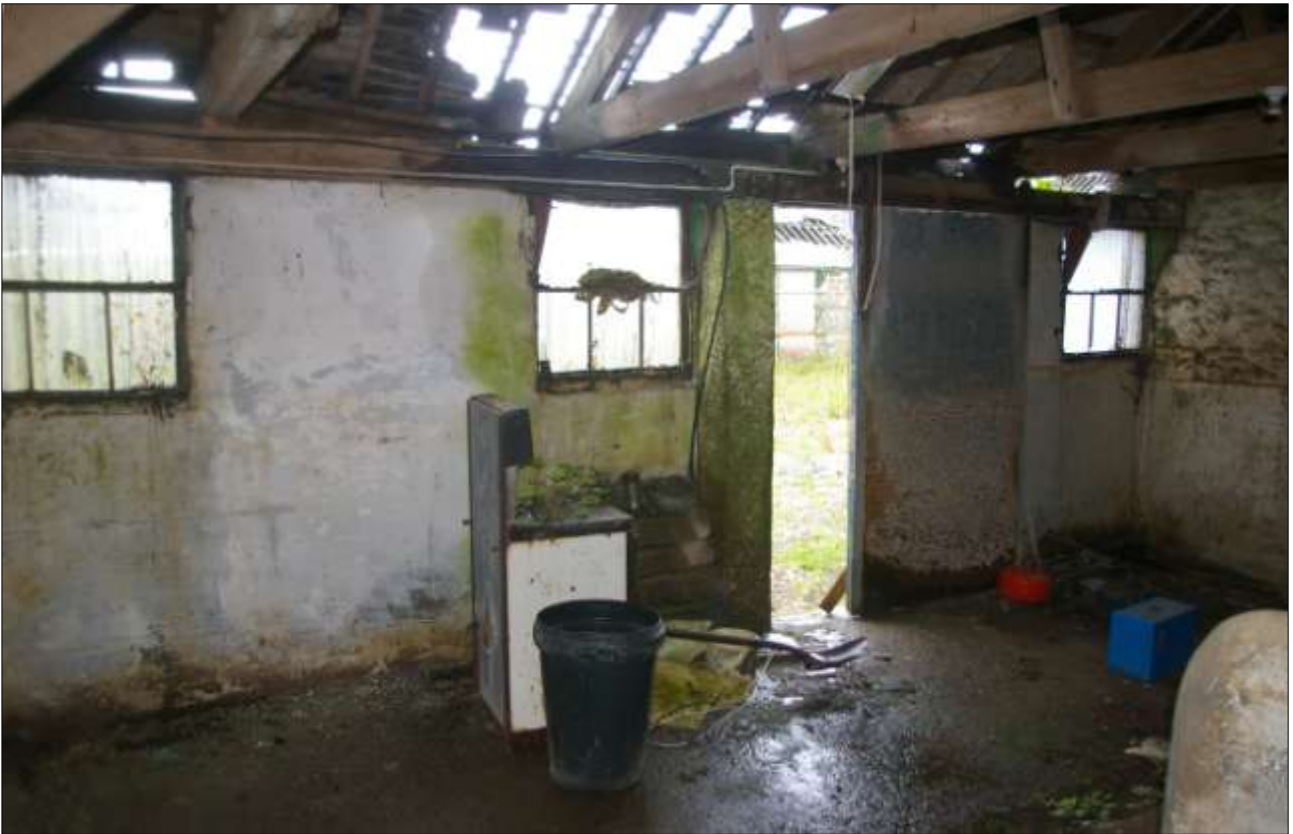
B5.3, EAST ROOM, NORTH-EAST ELEVATION, SHOWING CONCRETE WALLS AND METAL HOPPER WINDOWS (W33, W34, W35; VIEWED FROM THE WEST-SOUTH-WEST).

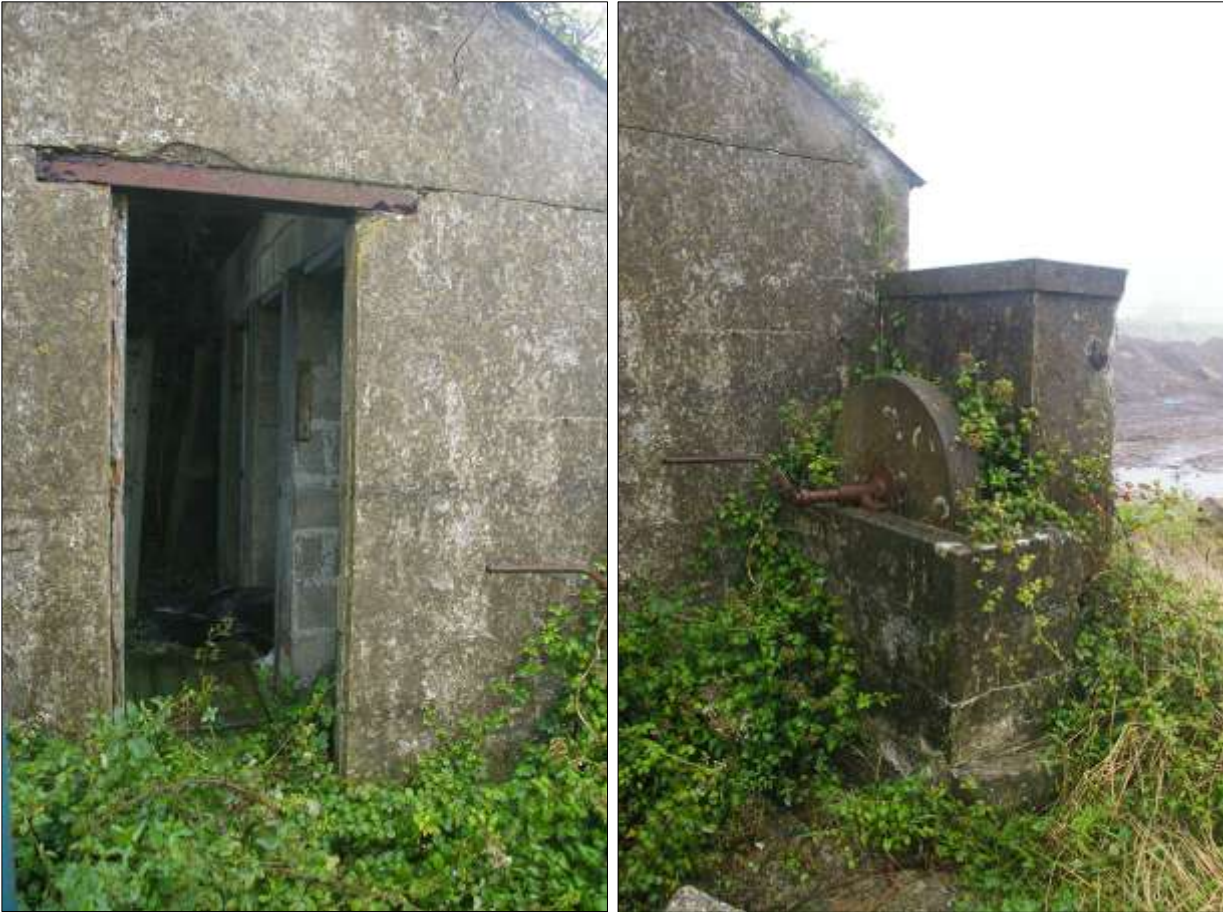
LEFT: B6, SHOWING THE CONCRETE CUBICLES INSIDE THE BUILDING; VIEWED FROM THE EAST-SOUTH-EAST.
RIGHT: B6, GRINDSTONE NEXT TO DOOR; VIEWED FROM THE SOUTH.

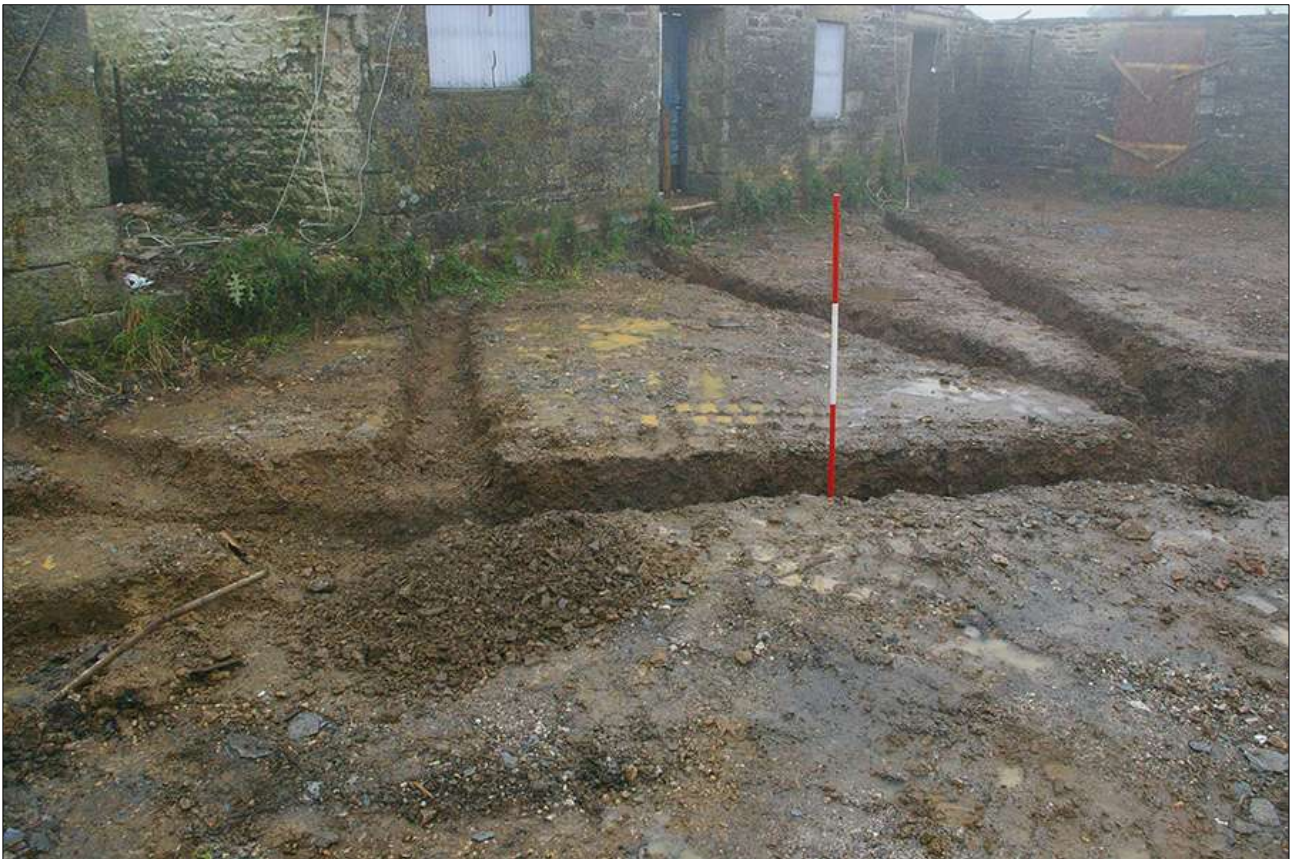
SOAKAWAY NO.1 AND TRENCHES IN THE SOUTH-WEST CORNER OF THE YARD; VIEWED FROM THE SOUTH (SCALE 2M).

(101)	Made ground	Possible remnant yard surface of poorly-sorted sub-angular stones in grey silt loam matrix	Part of (100)	c.0.15m	-
(102)	Made ground	Rotten wooden planks at edge of loose sub-rounded cobbles (80-120mm across), dumped in hollow/pit, caught of edge of pit for soakaway 1.	Overlain by (100)	-	-

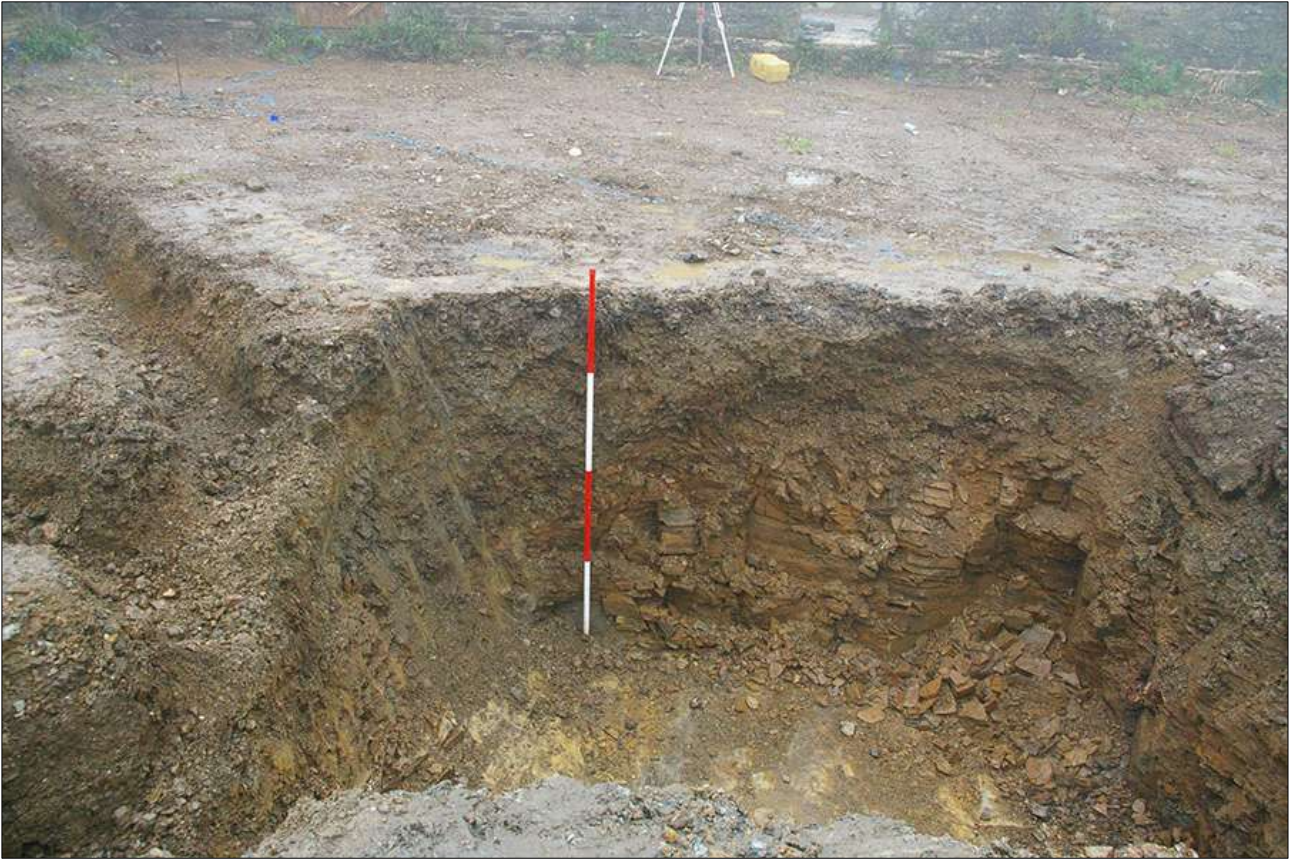
SOAKAWAY NO.1 IN SOUTH-WEST CORNER OF THE YARD; VIEWED FROM THE SOUTH-WEST (SCALE 2M).

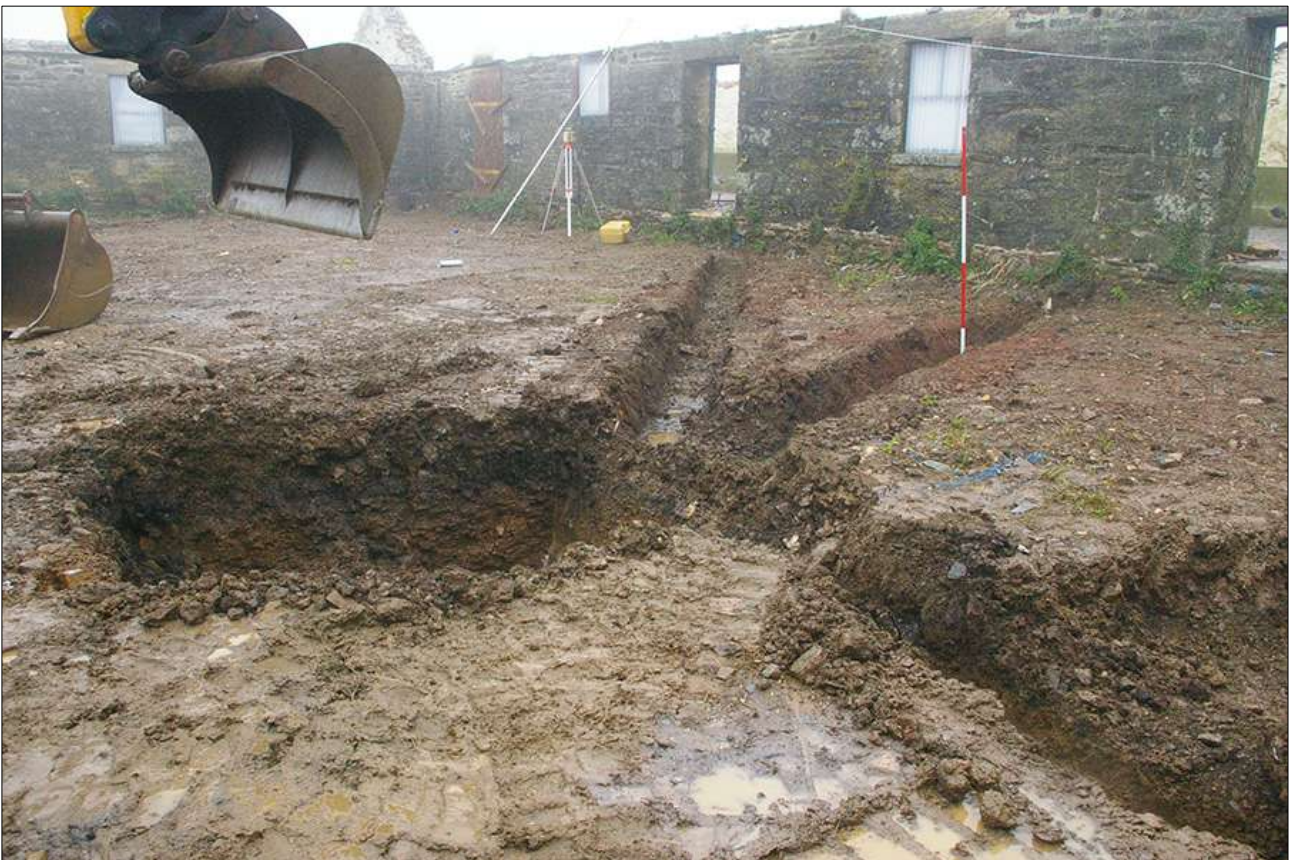
SOAKAWAY NO.2 AND TRENCHES IN THE NORTH-EAST CORNER OF THE YARD; VIEWED FROM THE WEST (SCALE 2M).

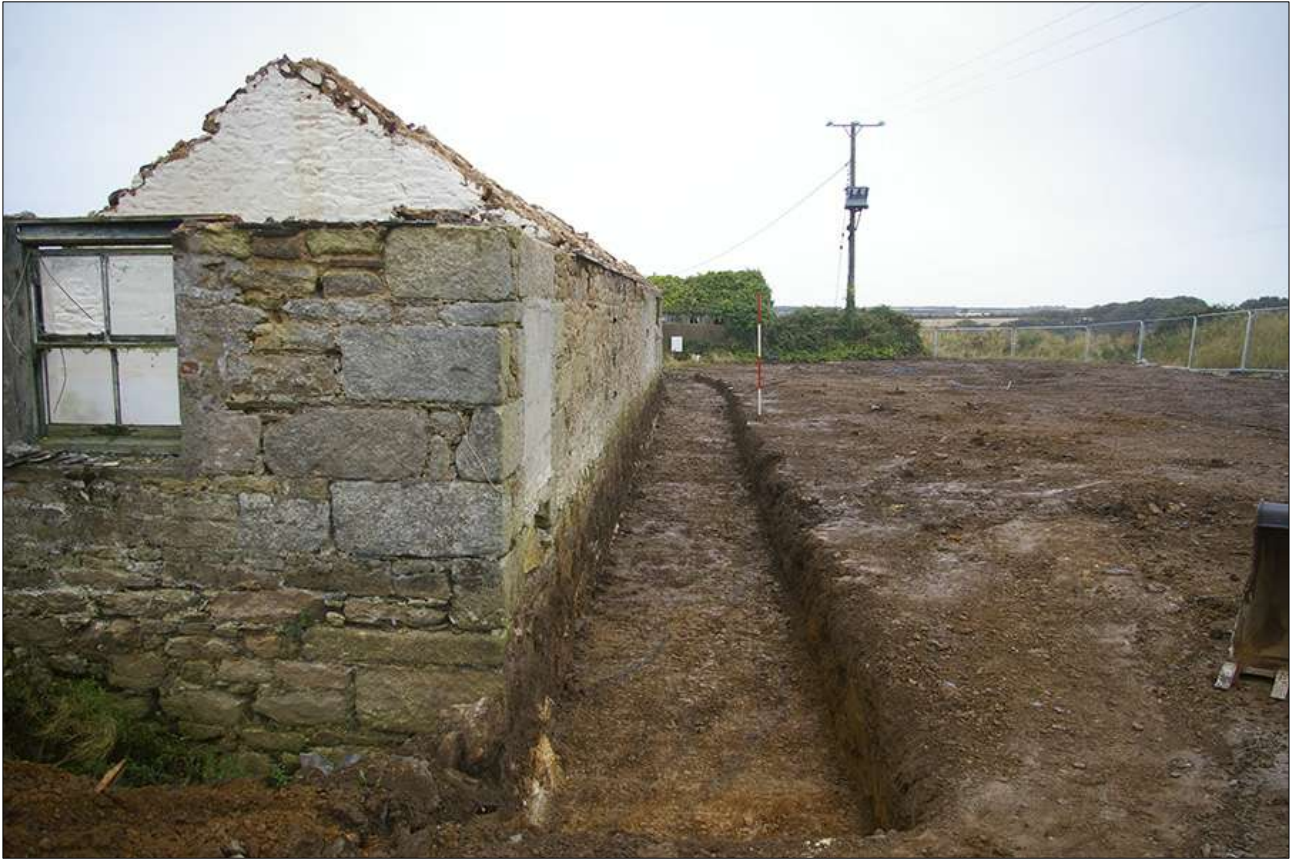
AREA EXCAVATED ALONG THE NORTH-WEST SIDE OF B4 AND B5; VIEWED FROM THE NORTH-EAST (SCALE 2M).

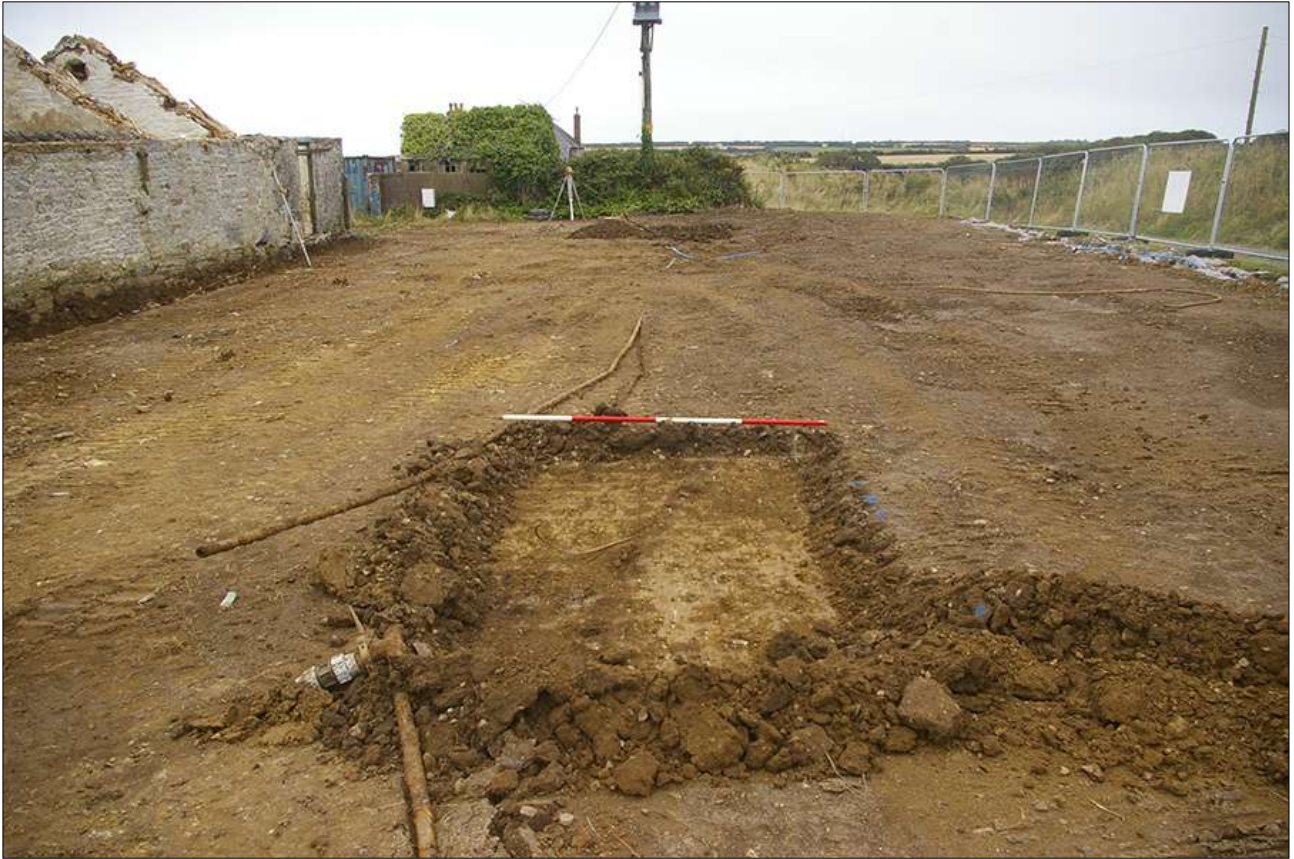
TEST PIT 5 (TYPICAL OF TEST PITS 4-6); VIEWED FROM THE NORTH-EAST (SCALE 2M).

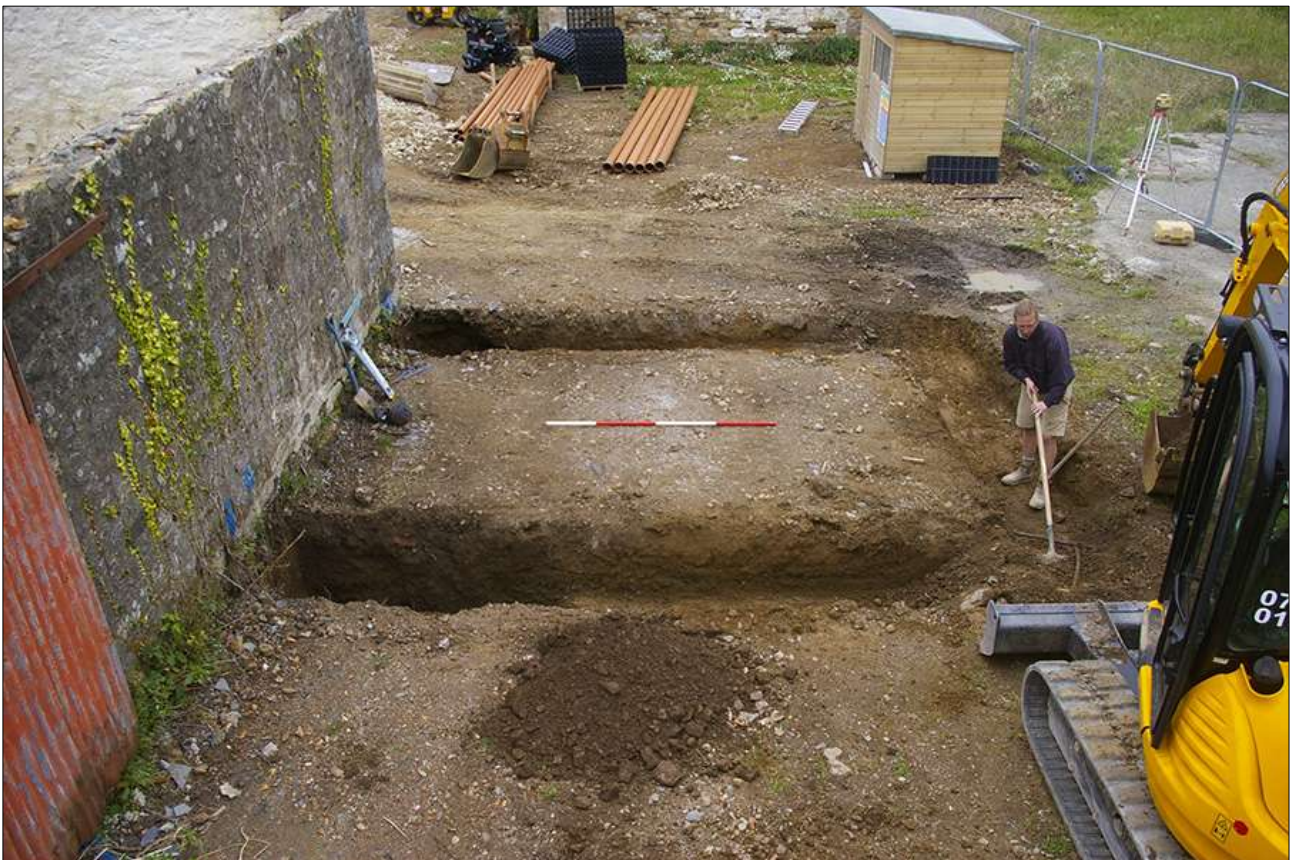
FOUNDATION TRENCH NEXT TO B5, WITH DITCH [107] TO THE LEFT; VIEWED FROM THE NORTH-WEST (SCALE 2M).

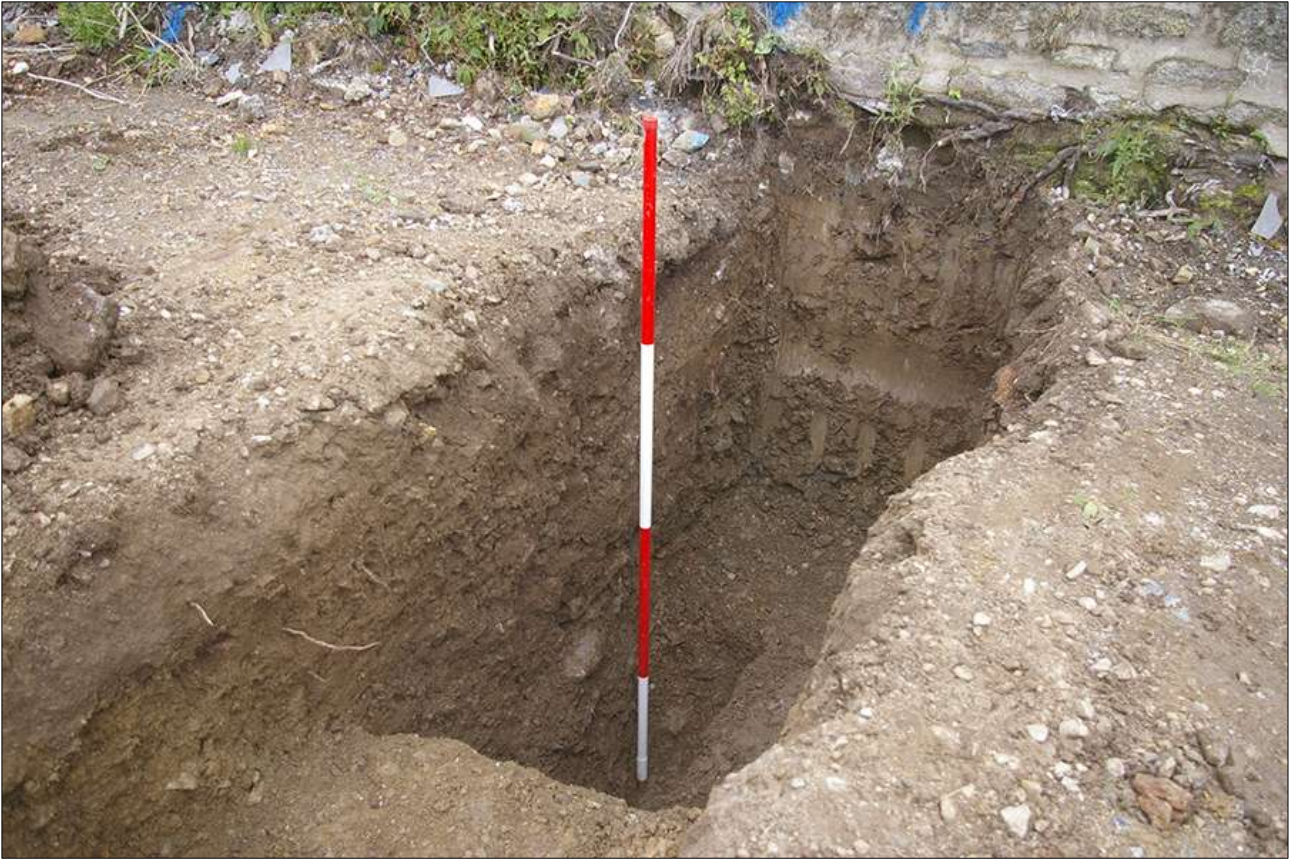
DITCH [107]; VIEWED FROM THE SOUTH-SOUTH-WEST (SCALE 2M).

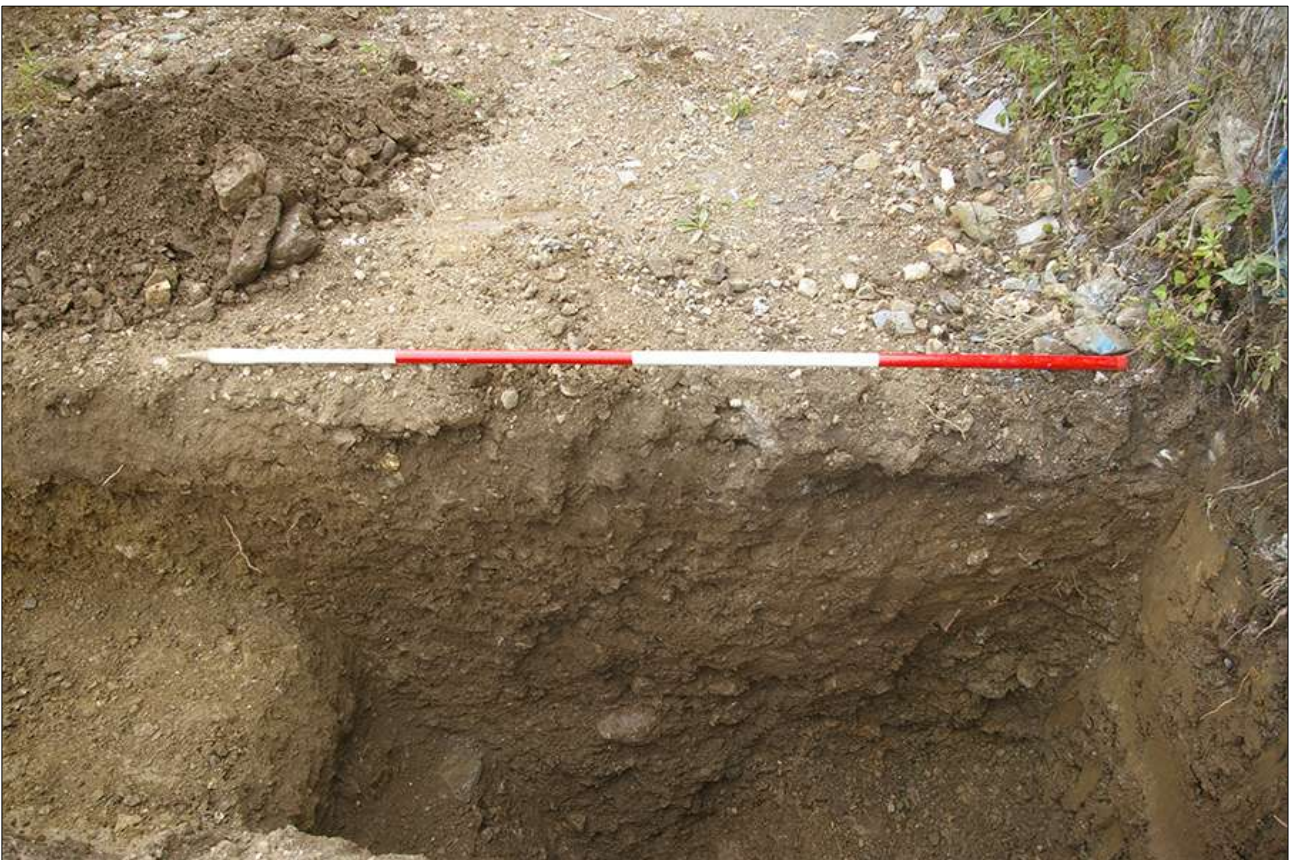
DITCH [107]; VIEWED FROM THE SOUTH-EAST (SCALE 2M).

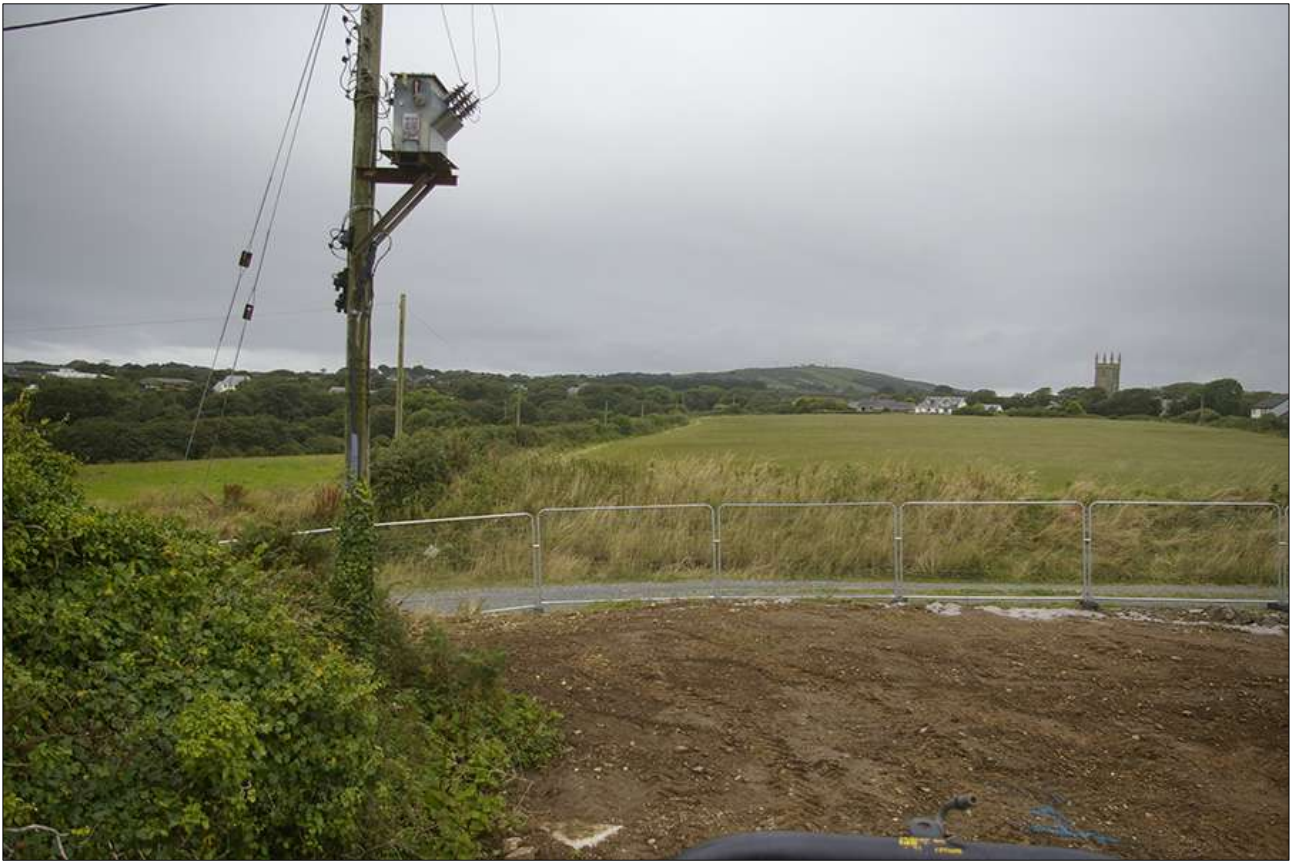
VIEW FROM THE APPROXIMATE LOCATION OF DITCH [107], LOOKING ALONG THE FIELD BOUNDARY TO THE NORTH-WEST.

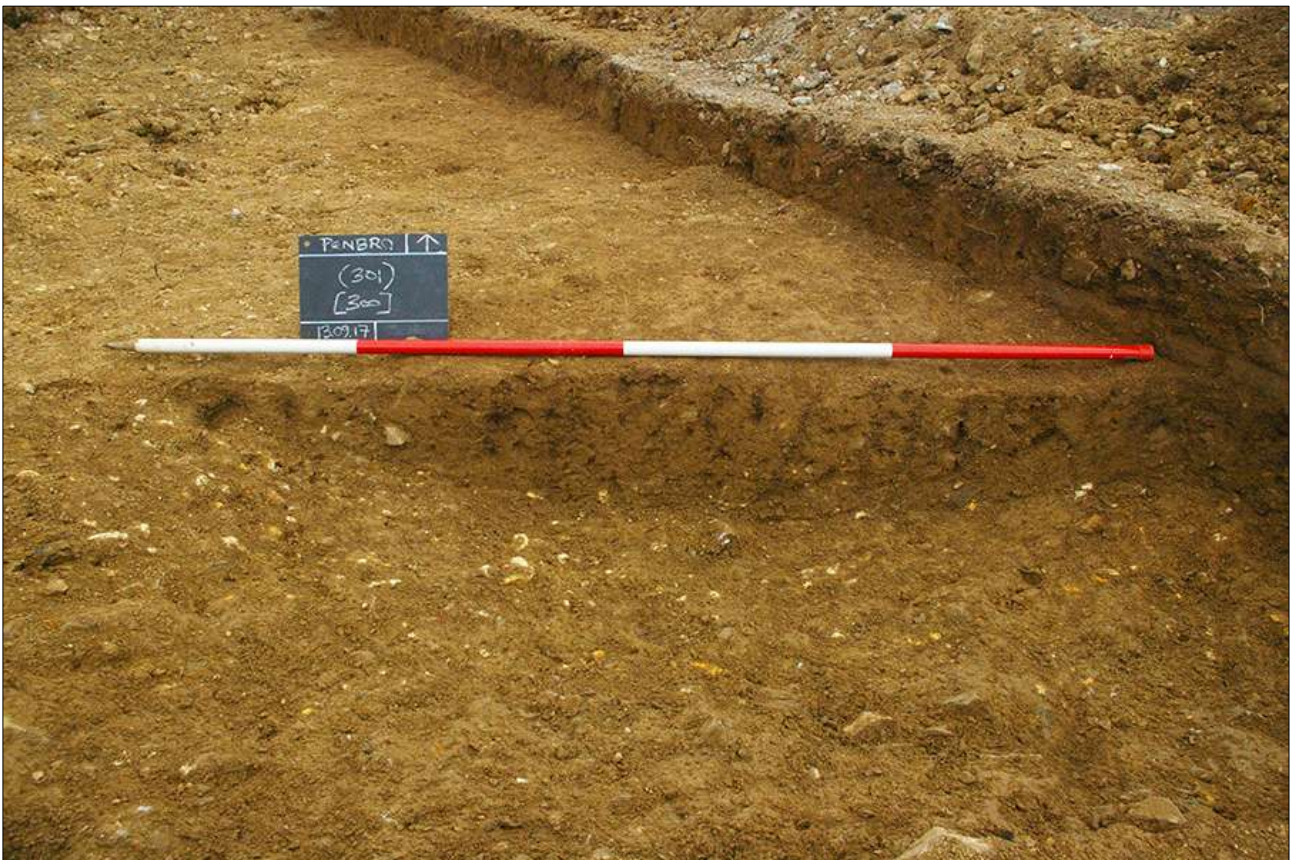
FEATURE [300]; VIEWED FROM THE WEST (SCALE 2M).

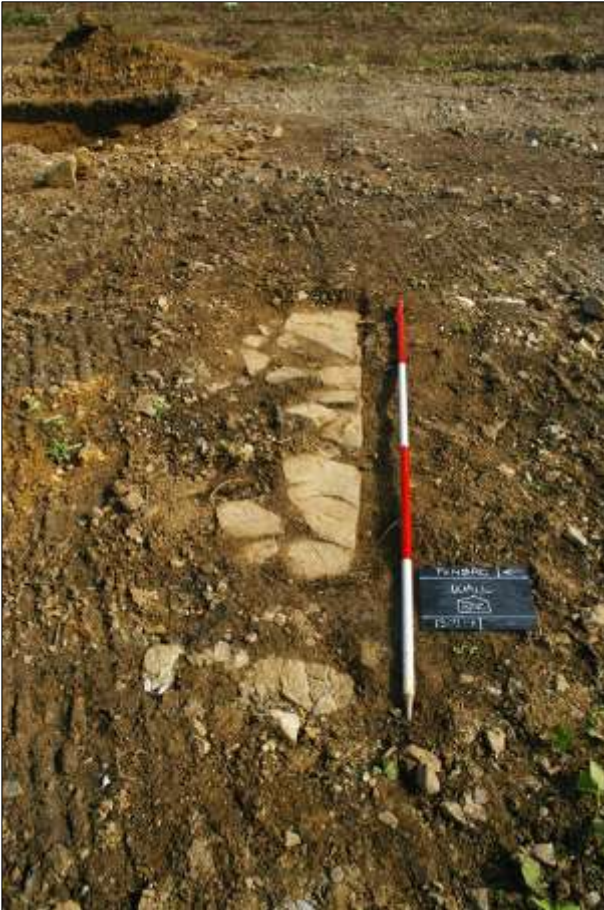
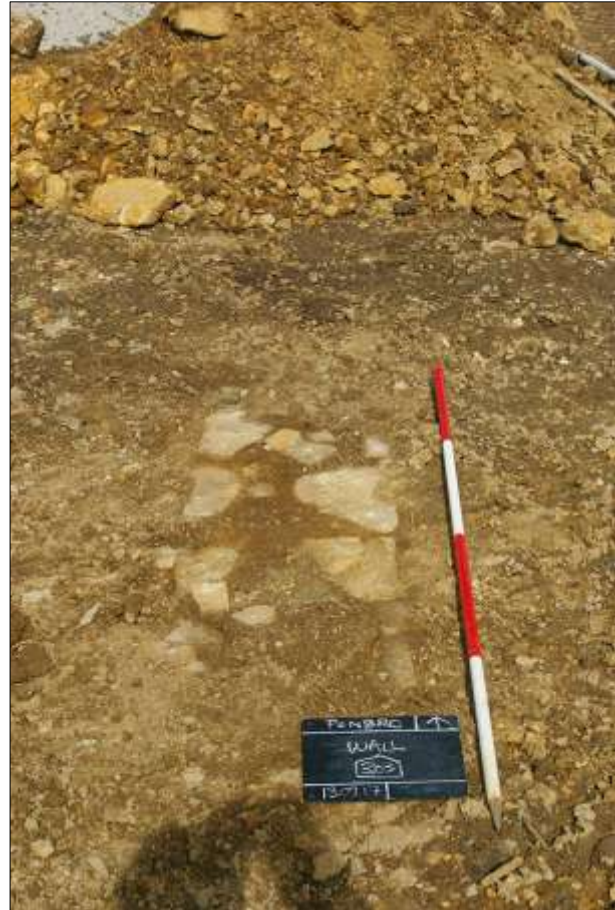
LEFT: WALL {302}; VIEWED FROM THE NORTH-WEST (SCALE 2M).
RIGHT: WALL {303}; VIEWED FROM THE SOUTH-WEST (SCALE 2M).

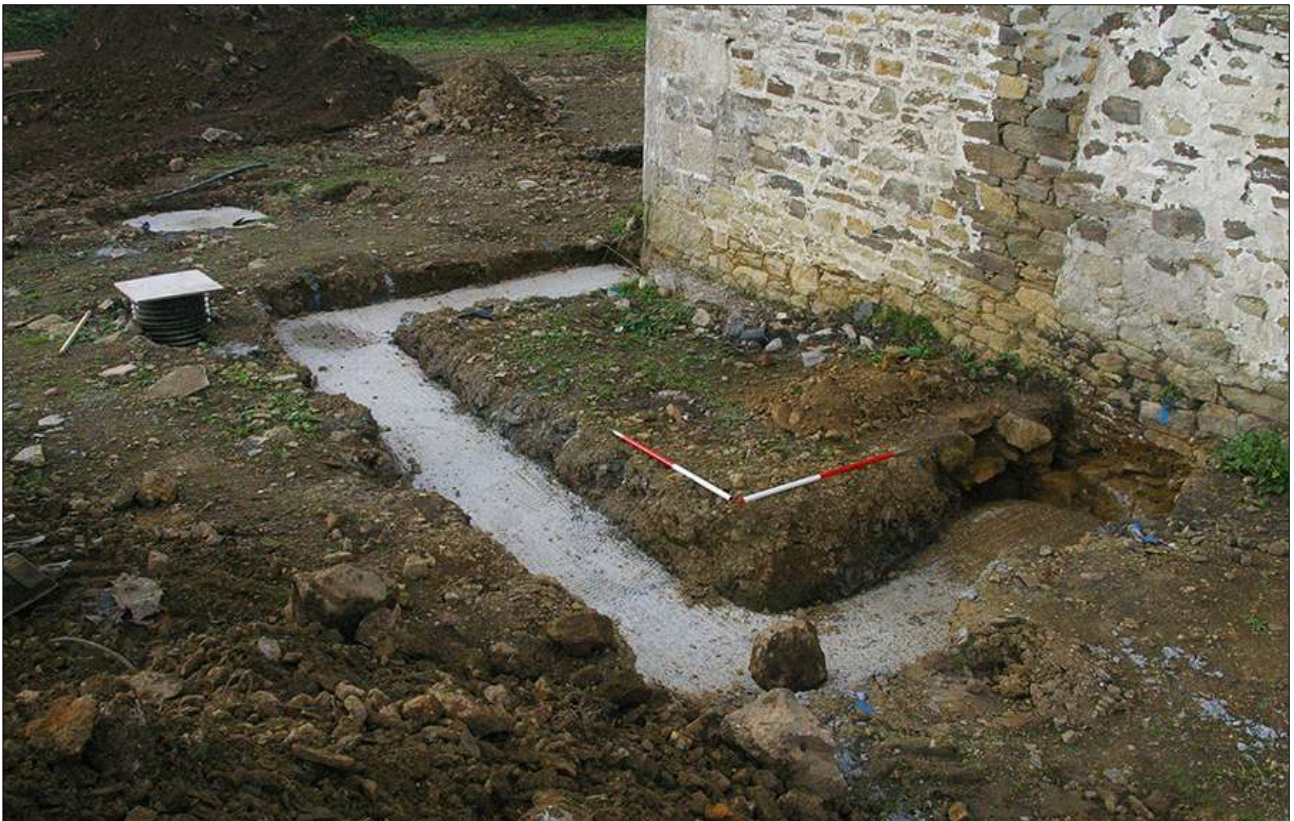
FOUNDATION TRENCH EAST OF B1; VIEWED FROM THE EAST (SCALE 1M).

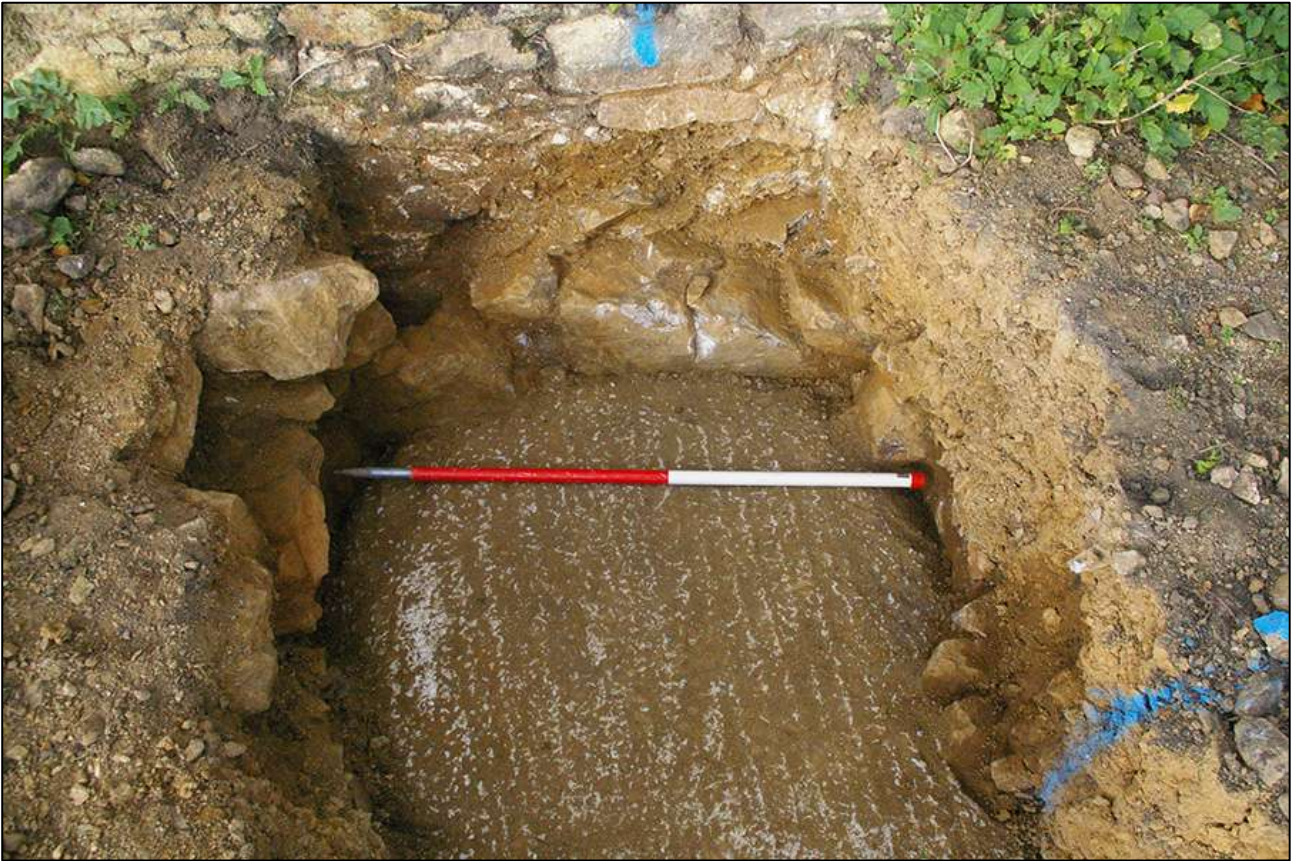
REMNANT WALLS IN THE FOUNDATION TRENCH EAST OF B1, WALLS {305} AND {307}; VIEWED FROM THE SOUTH-EAST (SCALE 1M).

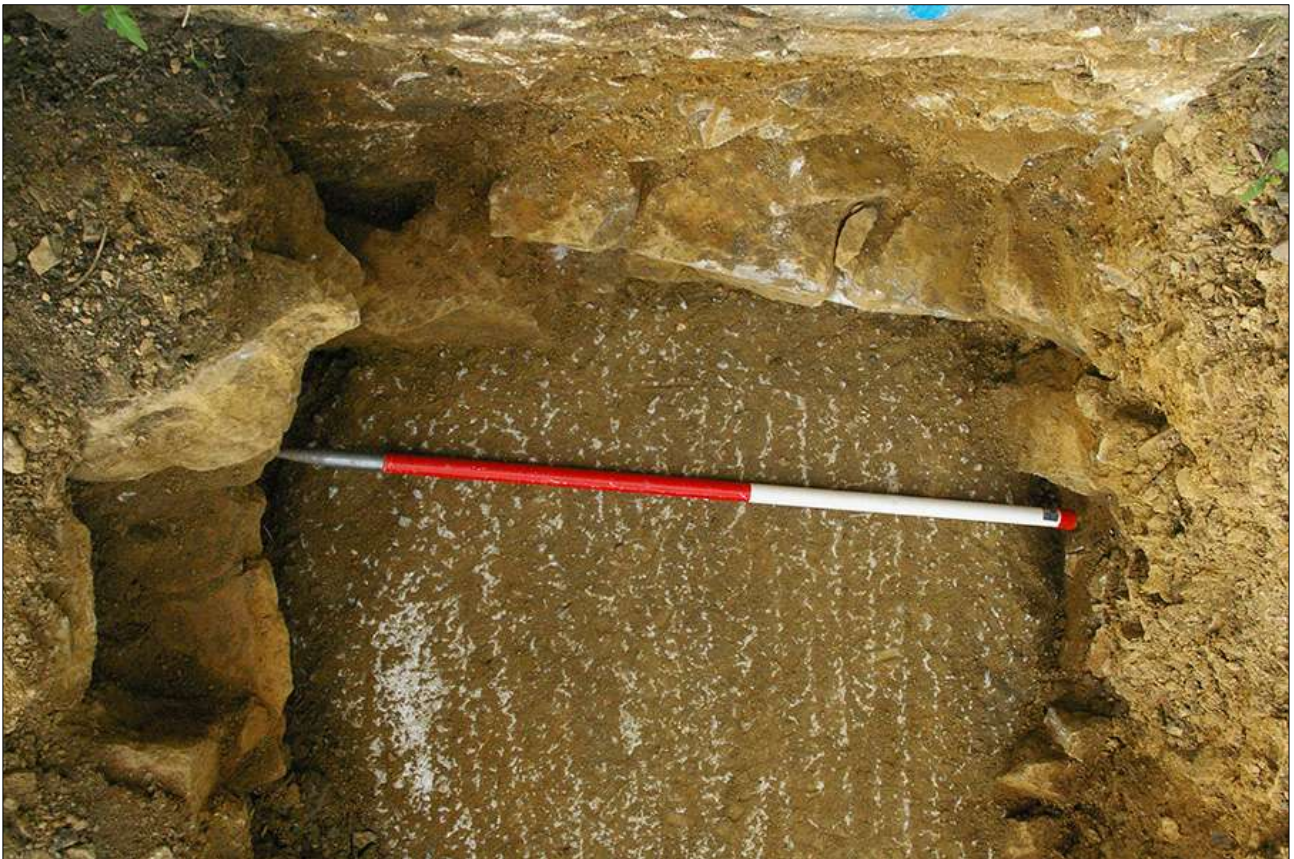
WALLS {305} AND {307}; VIEWED FROM THE ABOVE (SCALE 1M).

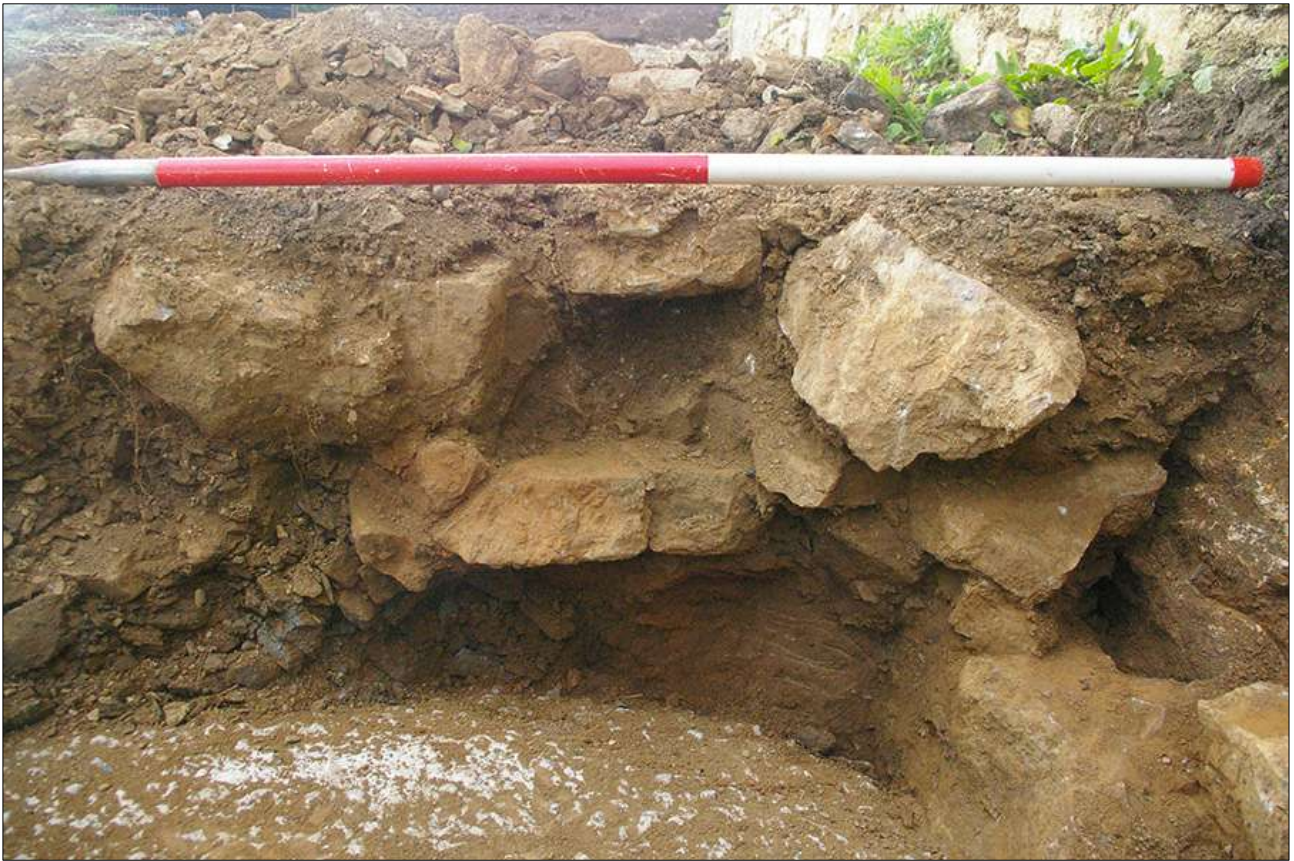
WALL {305}; VIEWED FROM THE NORTH-EAST (SCALE 1M).

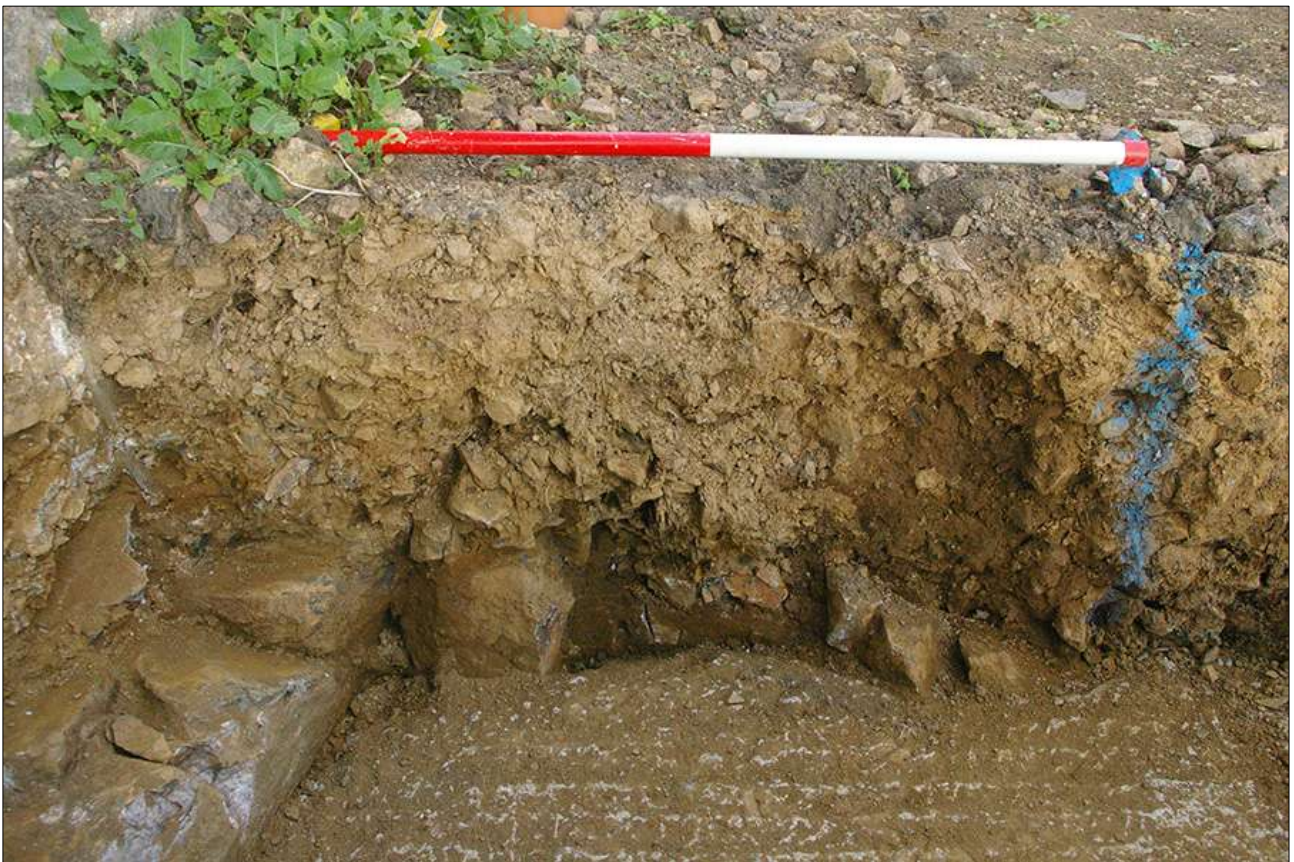
WALL {307} AND FILL (308); VIEWED FROM THE SOUTH-WEST (SCALE 1M).
