THE BARNs PENBRO FARM BREAGE CORNWALL

Desk-Based Assessment & Historic Building Recording

South West Archaeology Ltd. report no. 180322

By B. Morris, E. Wapshott & N. Boyd
Report Version: FINAL
22nd March 2018

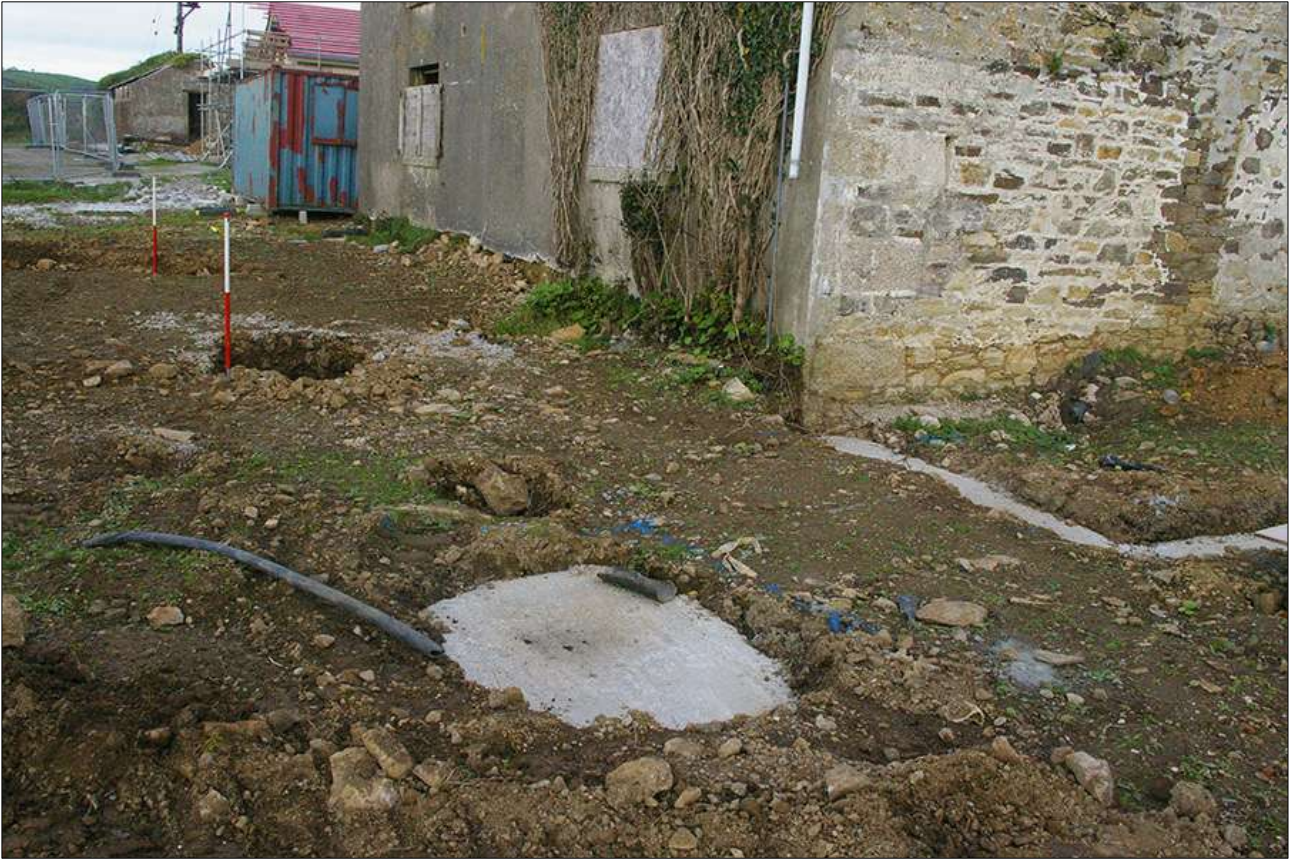
TEST PITS 1, 2 AND 3 SOUTH OF B1; VIEWED FROM THE SOUTH (SCALE 1M).

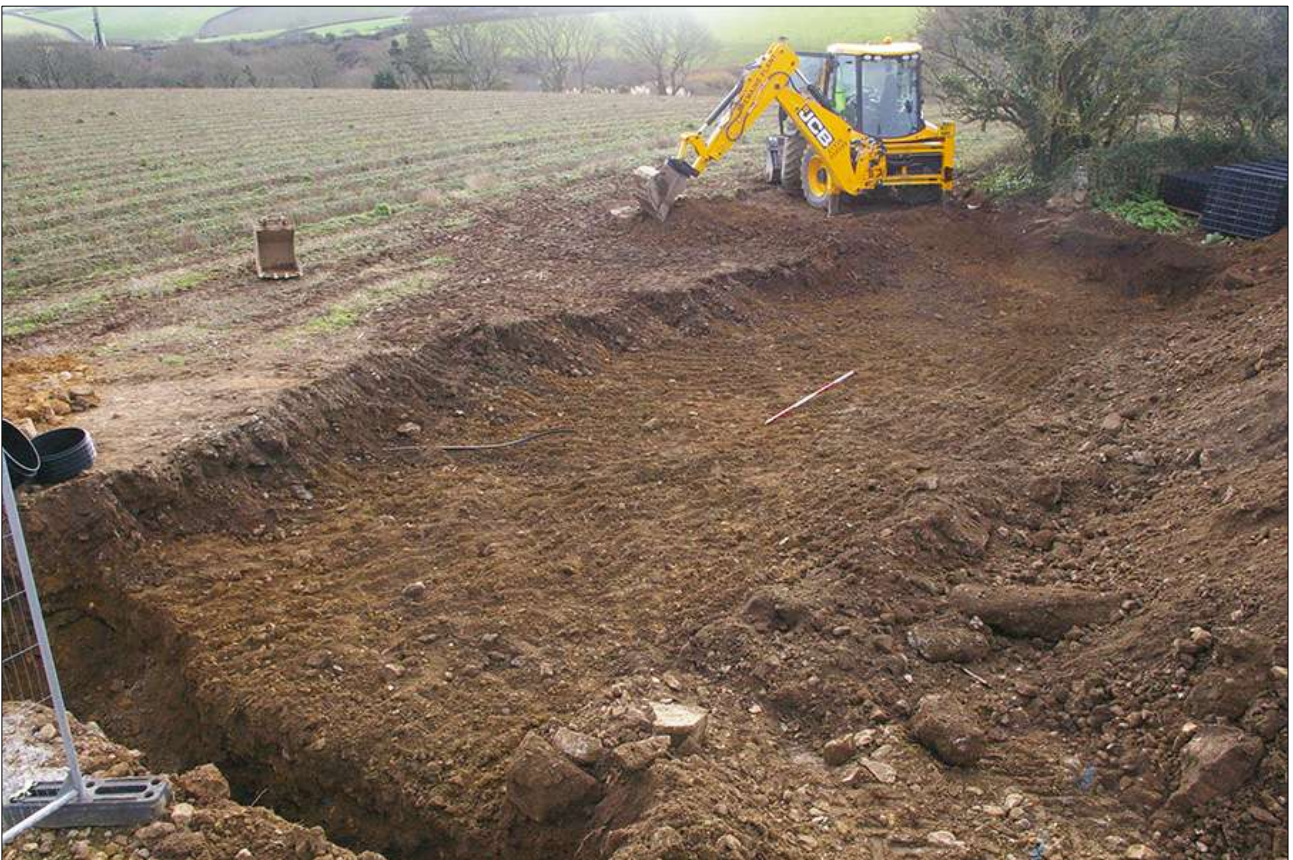
THE LARGE SOAKAWAY TRENCH EAST OF B1, POST-EXCAVATION; VIEWED FROM THE NORTH-NORTH-EAST (SCALE 2M).

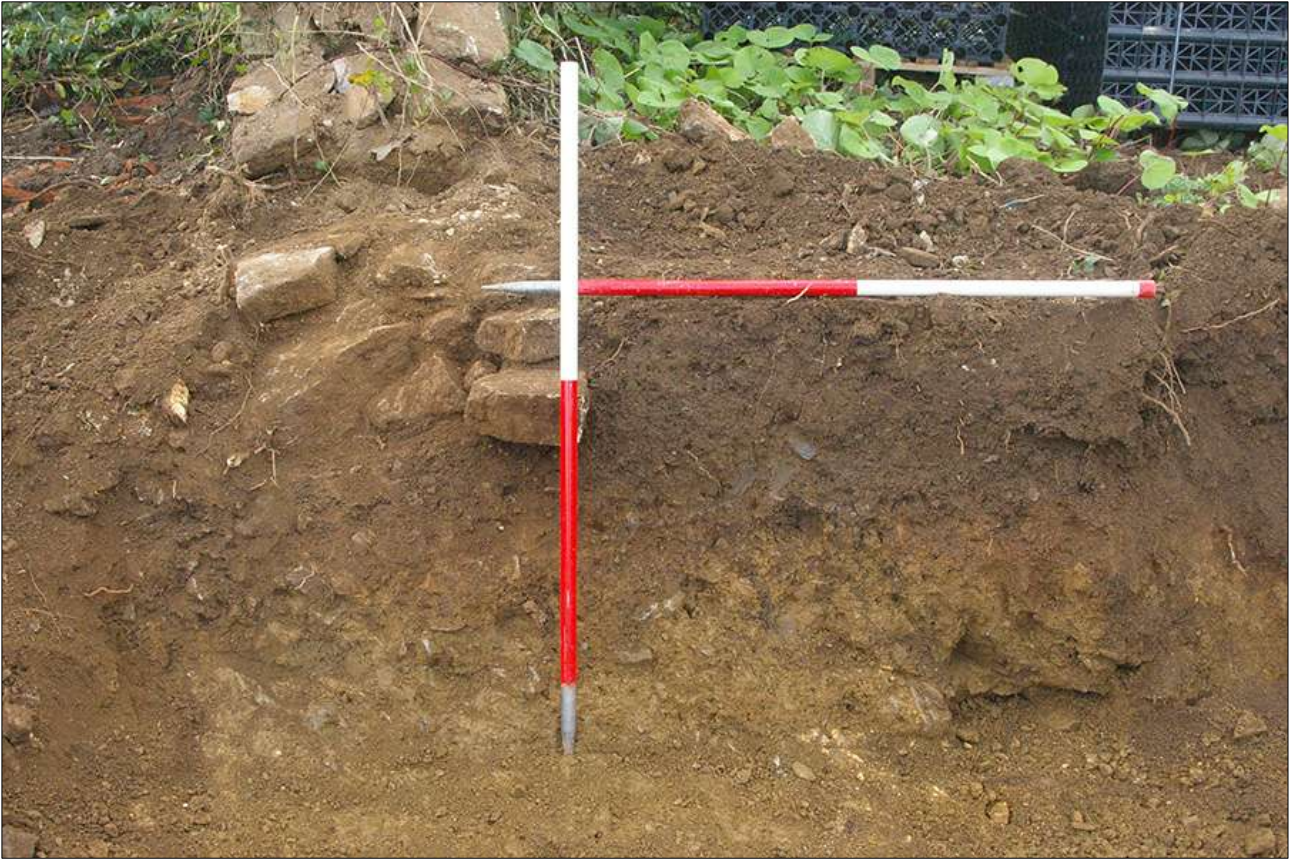
SECTION THROUGH THE EXTANT FIELD WALL AT THE SOUTH END OF THE LARGE SOAKAWAY TRENCH; VIEWED FROM THE NORTH-EAST (SCALE 1M).

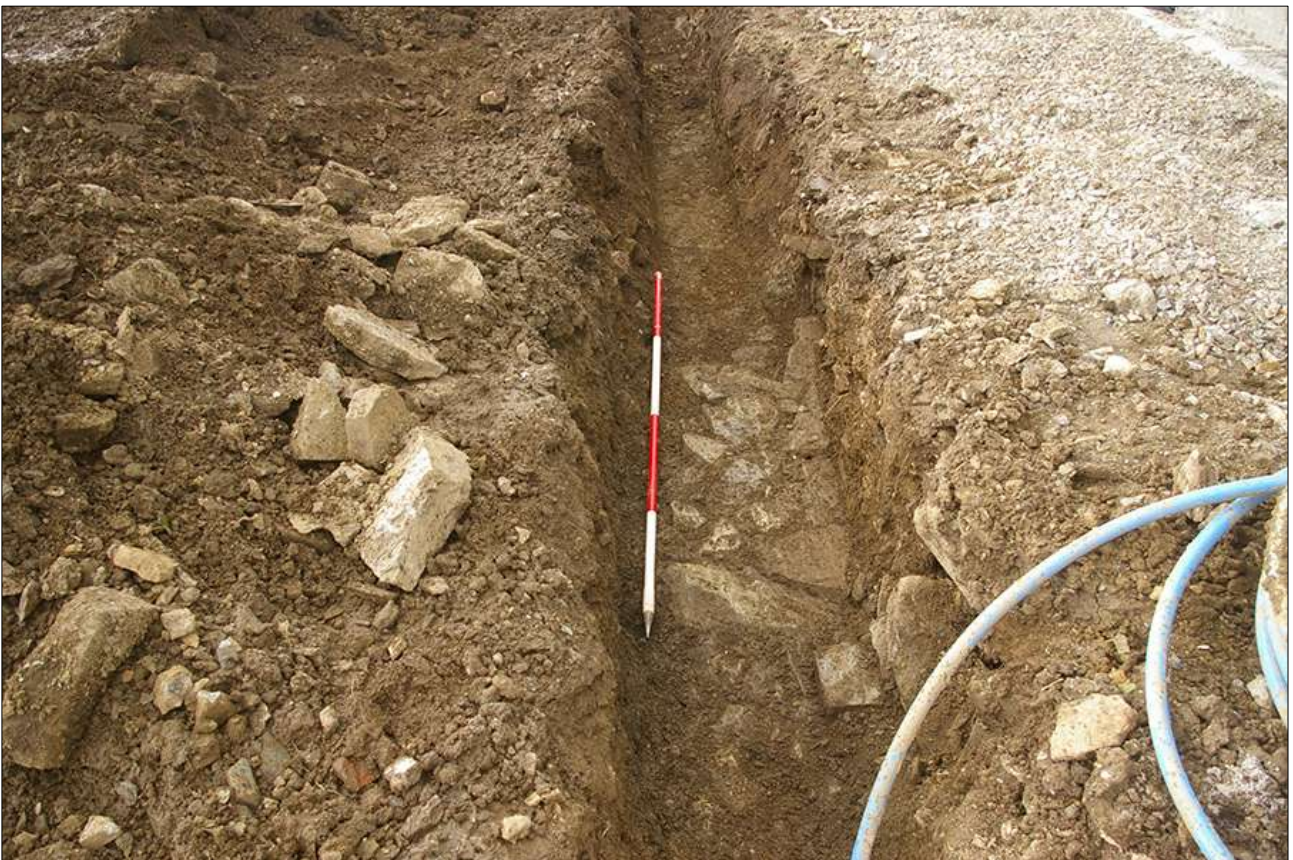
WALL {313}; VIEWED FROM THE NORTH-EAST (SCALE 2M).

(315)	Layer	Demolition layer; mid yellow-brown, soft clay-silt with inclusions of brick, mortar, cement/concrete and slate rubble inclusions and occasional stone from walls that were both removed and partially collapsed inwards.	Overlaid {313}{314}; overlain by (319)	<0.51m	-
{316}	Structure	Wall, probable return heading north-west at the south-west end of Wall {313}, partially demolished/damaged, otherwise the same as {313}.	Fill of [312]; same as {313}; abutted by (314){318}; overlain by (319)	0.36m	-
{317}	void	Possible return of wall {313} at its north-east end, running north-west, but demolished.	Void	void	void

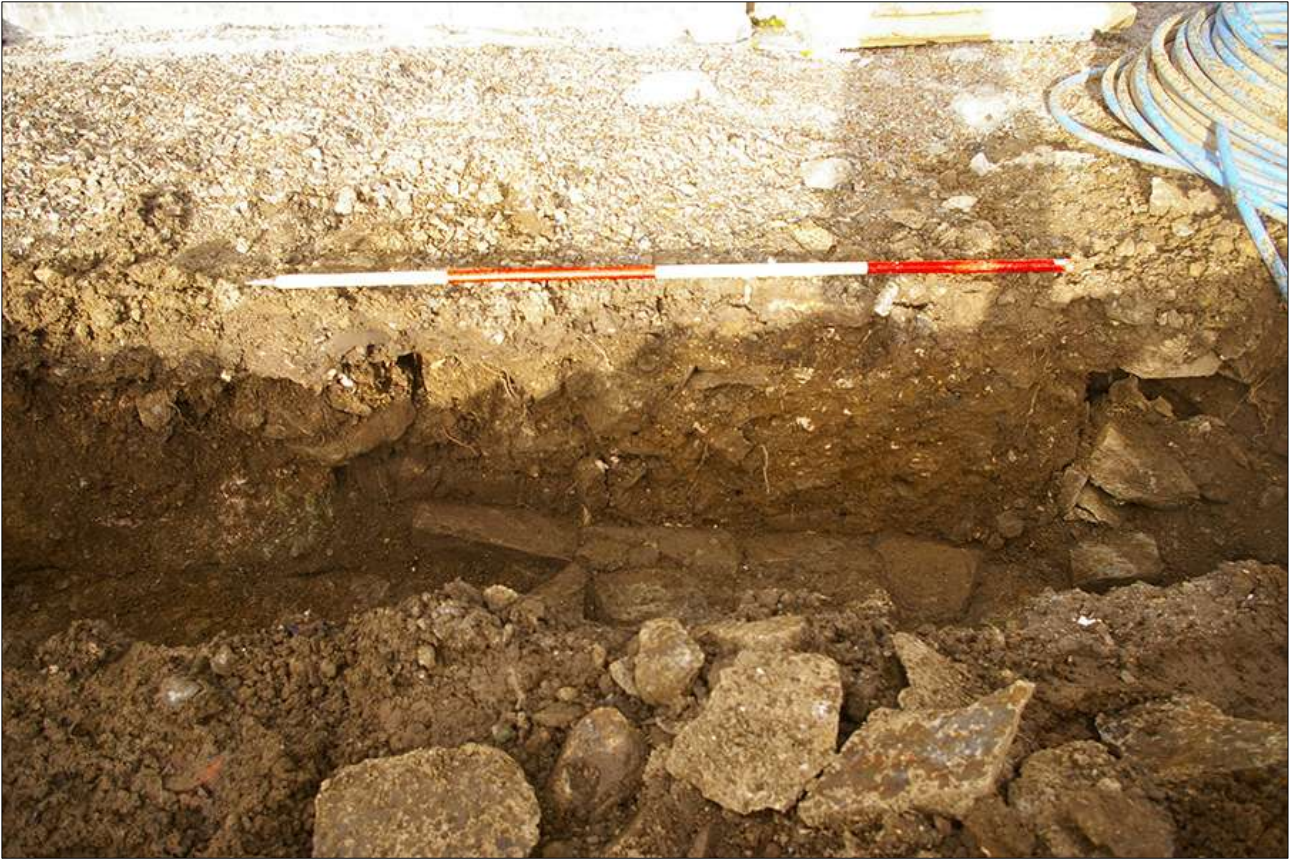
WALL {313}; VIEWED FROM THE SOUTH-EAST (SCALE 2M).

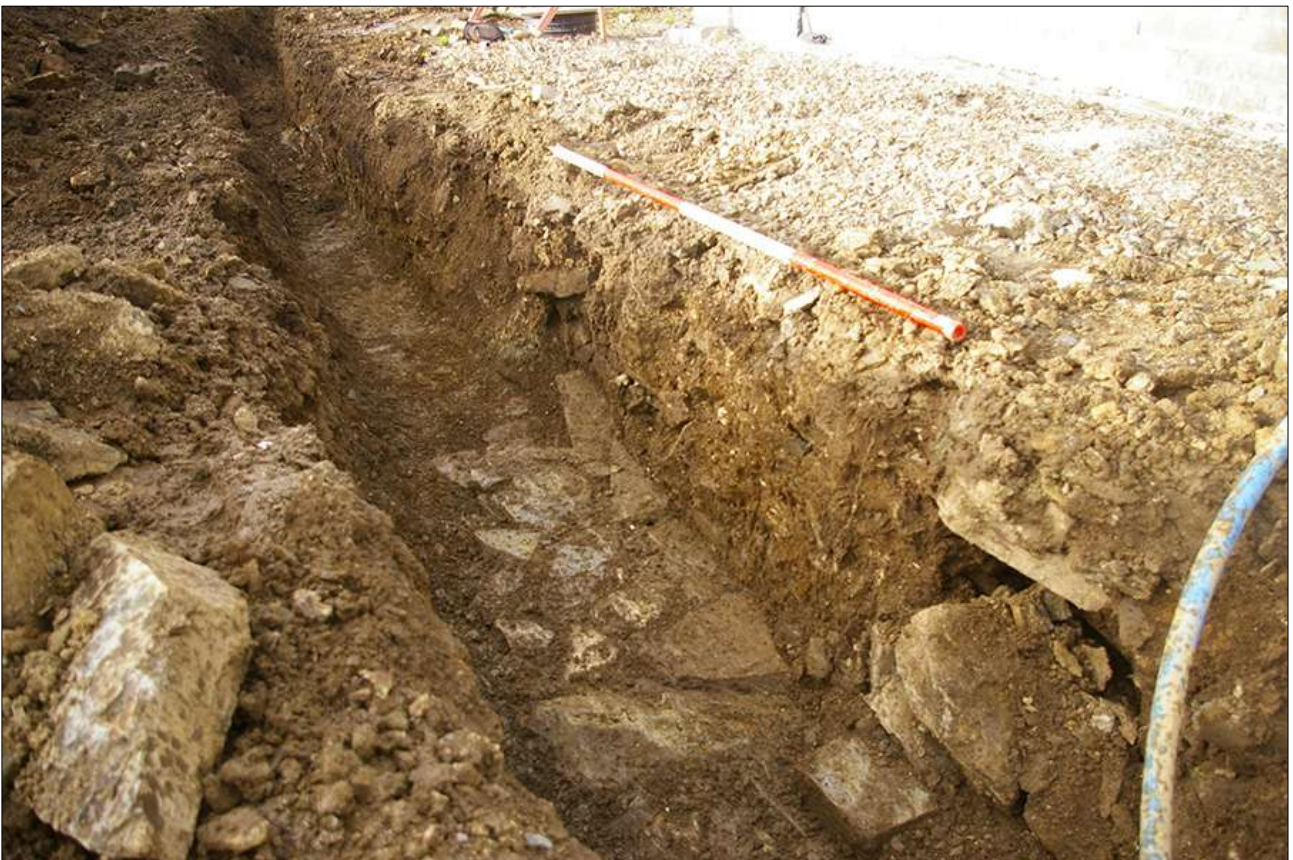
WALL {313}; VIEWED FROM THE EAST (SCALE 2M).

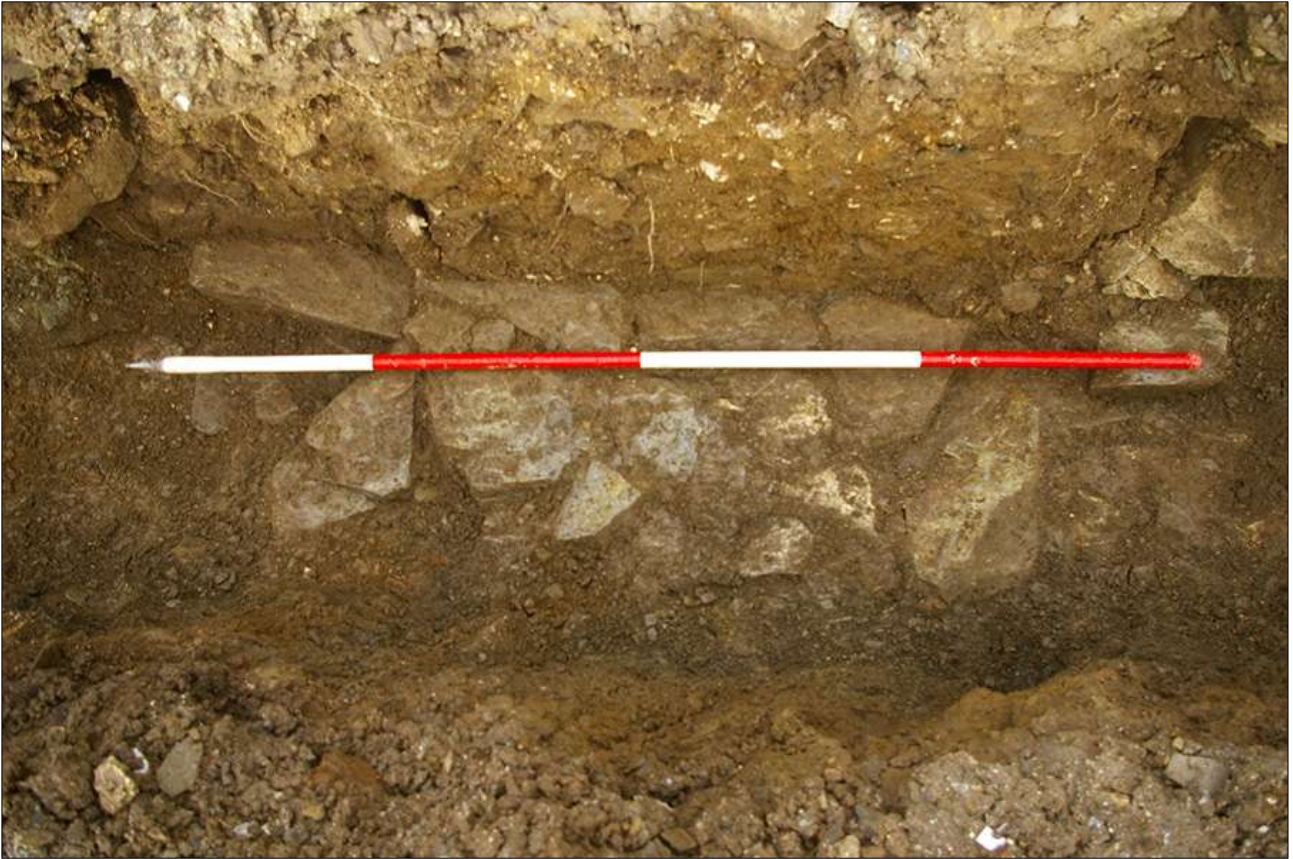
WALL {313}; VIEWED FROM THE SOUTH-EAST/ABOVE (SCALE 2M).

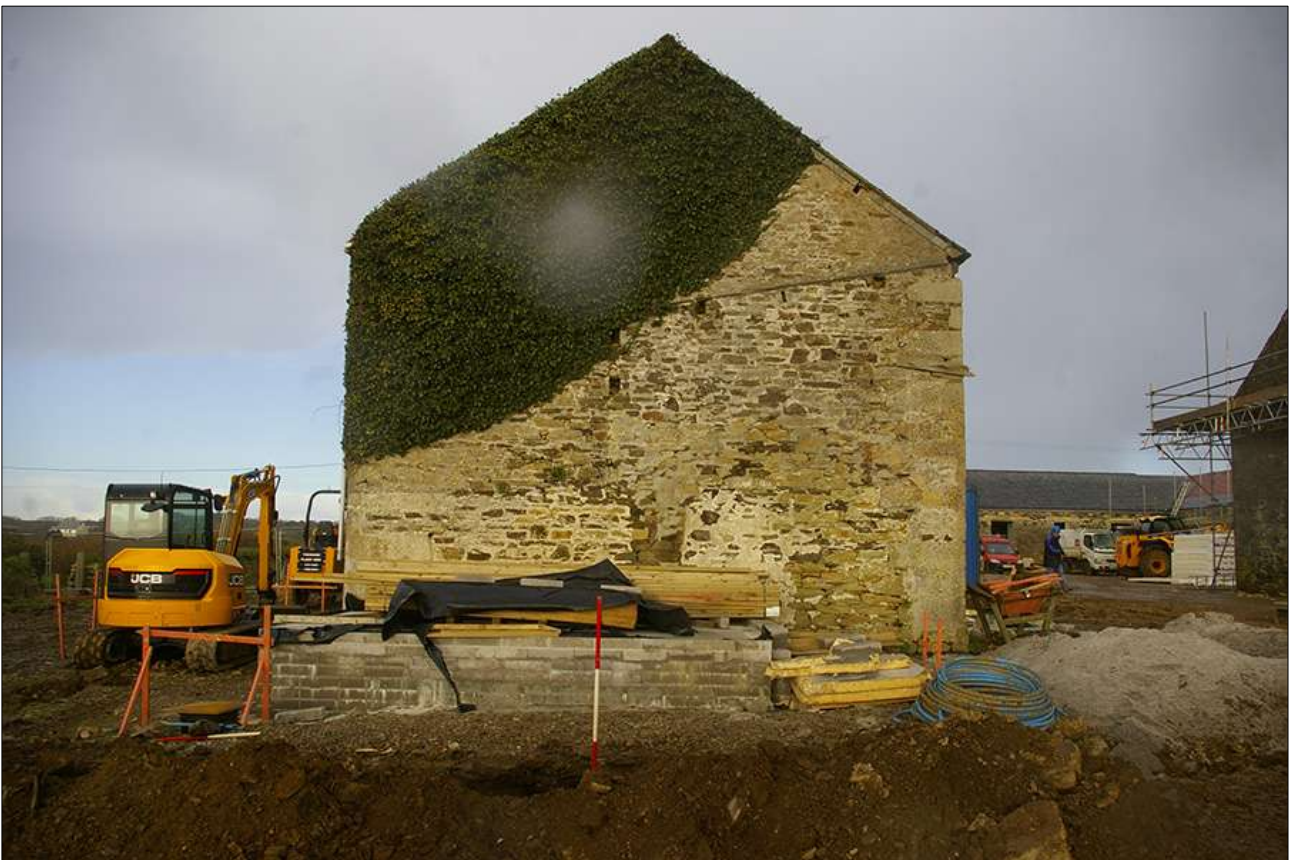
SOUTH-EAST ELEVATION OF B1 IN RELATION TO WATER PIPE TRENCH. THE SOUTH-WEST END OF WALL {313} IS MARKED BY THE RANGING POLE (SCALE 2M).

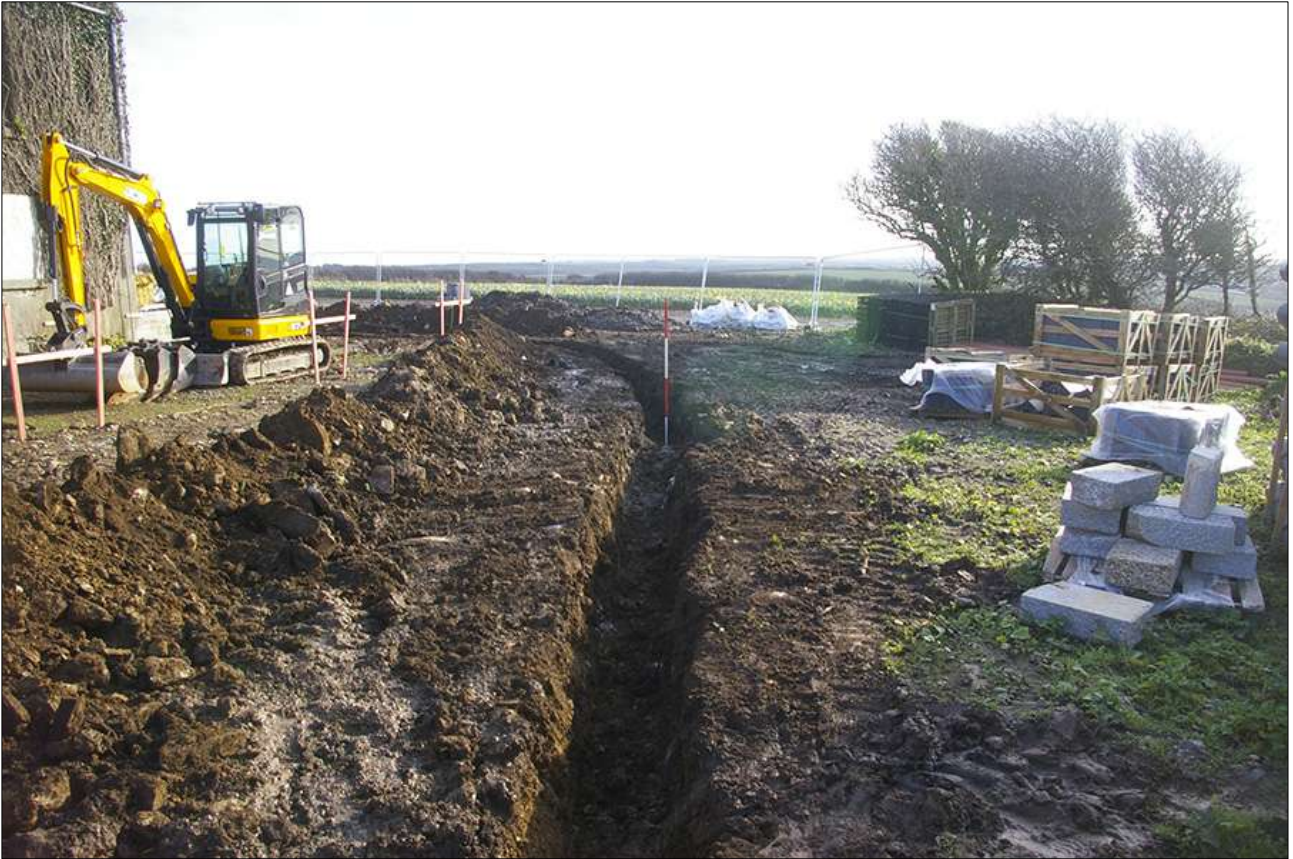
WATER PIPE BESIDE B1; VIEWED FROM THE NORTH-WEST (SCALE 2M).

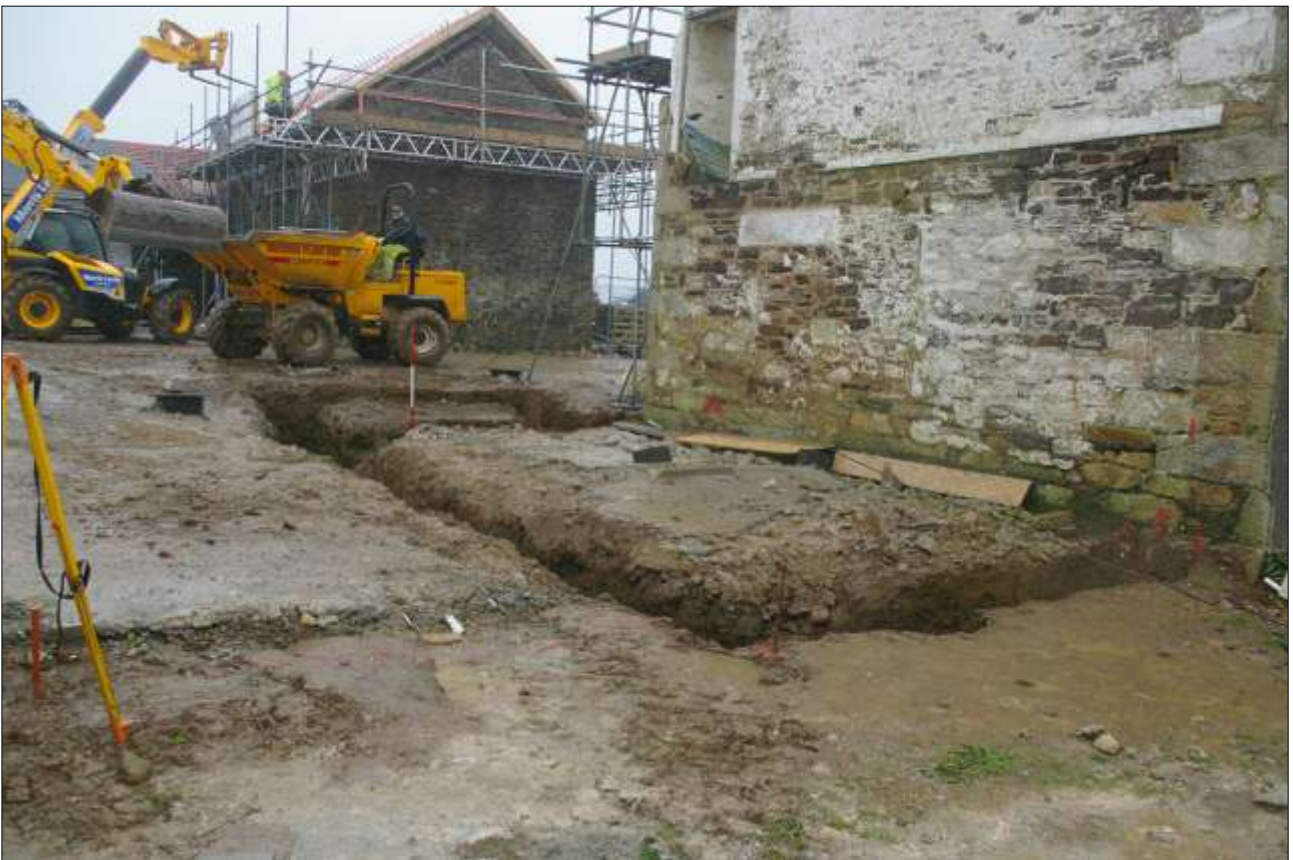
FOUNDATION TRENCH WEST OF B1; VIEWED FROM THE SOUTH-WEST (SCALE 2M).

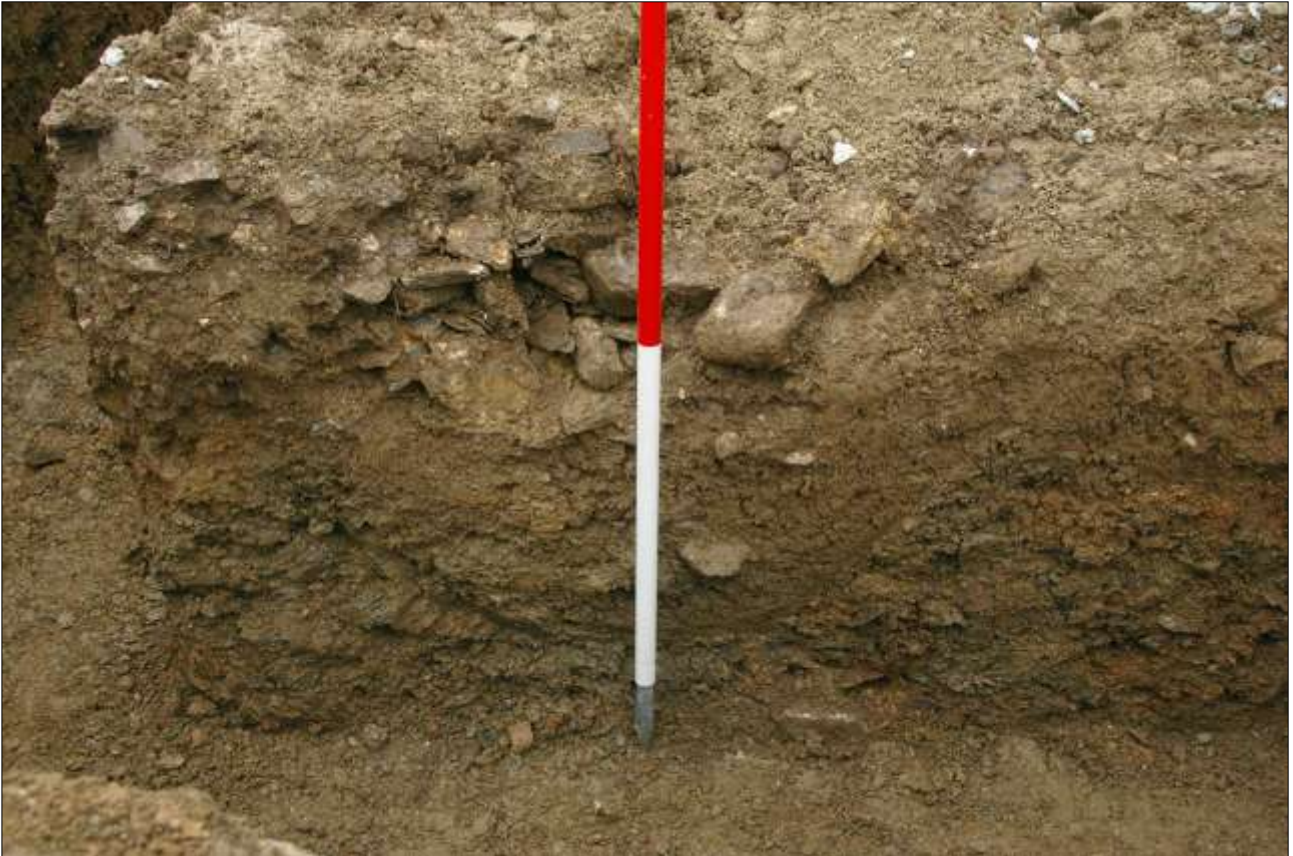
SOUTH-FACING SECTION OF DITCH [201], SOUTH FOUNDATION TRENCH; VIEWED FROM THE SOUTH (SCALE 1M).

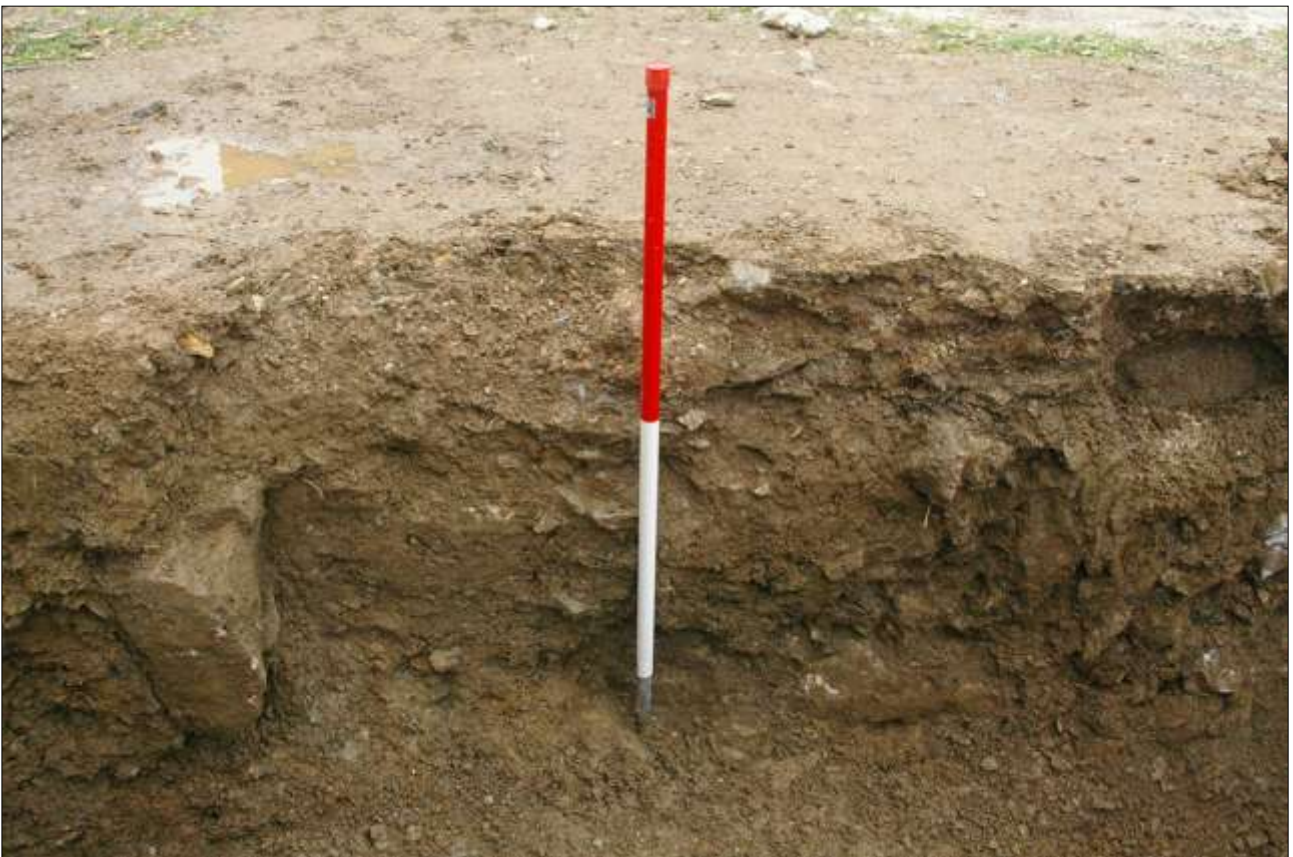
NORTH-FACING SECTION OF DITCH [201], SOUTH FOUNDATION TRENCH; VIEWED FROM THE SOUTH (SCALE 1M)

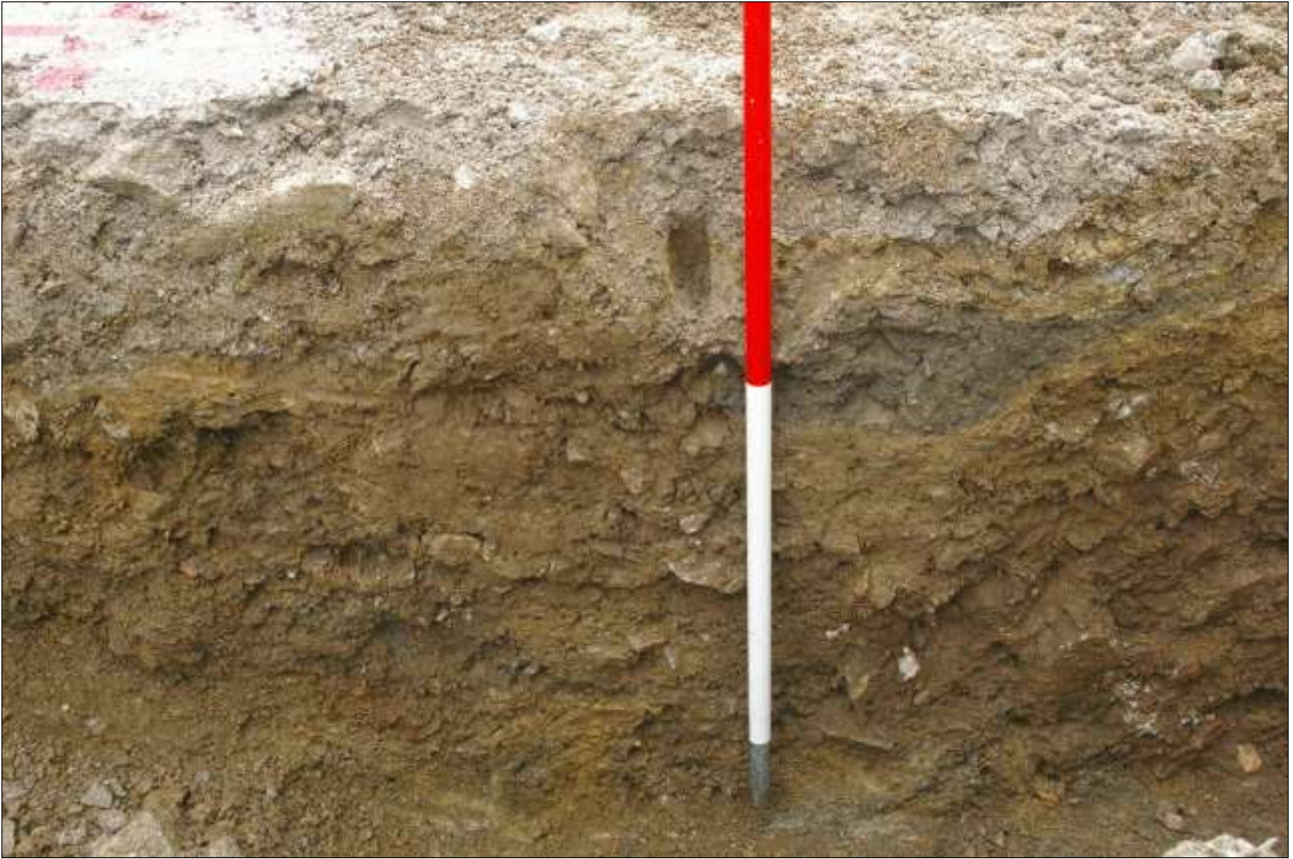
SOUTH-FACING SECTION OF DITCH [201], NORTH FOUNDATION TRENCH; VIEWED FROM THE SOUTH (SCALE 1M).

FIGURE 25: SOUTH-FACING SECTION OF DITCH [201], NORTH FOUNDATION TRENCH; VIEWED FROM THE SOUTH (SCALE 1M).
