79 HEAVITREE ROAD

RESULTS OF AN ARCHAEOLOGICAL EVALUATION AND RAPID BUILDING RECORDING

SOUTH WEST ARCHAEOLOGY LTD. REPORT NO. 181002

79 Heavitree Road, Exeter, Devon Results of an Archaeological Evaluation and Rapid Building Recording

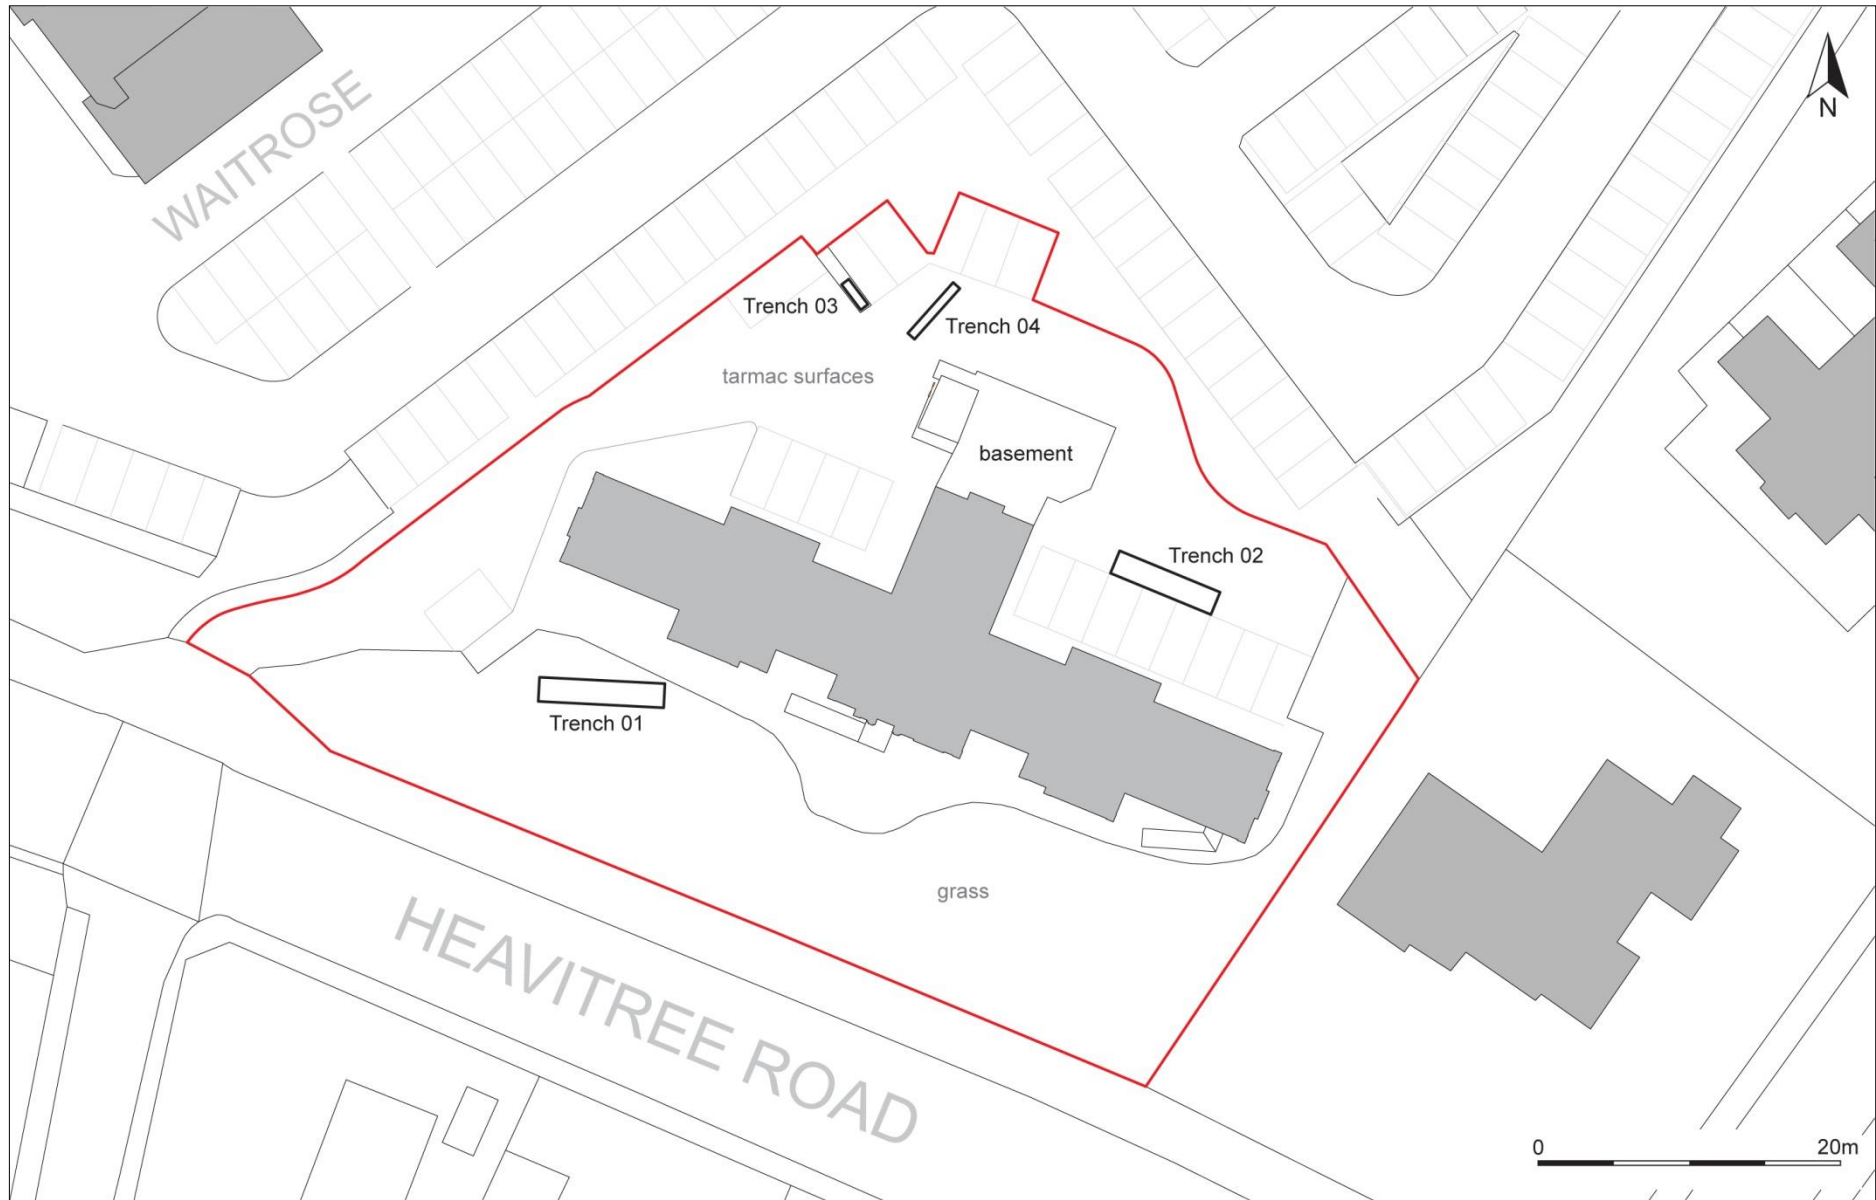
FIGURE 2: SITE PLAN SHOWING LOCATION OF THE TRENCHES (BASED ON SUPPLIED DRAWINGS).

Four trenches totalling c.22m and measuring between 0.60m and 1.60m wide were laid out using hand tapes and opened by tracked mechanical excavator to the depth of weathered natural using a toothless grading bucket. Exposed archaeological deposits were excavated by hand and in accordance with the WSAW and ClfA guidelines. The archaeological evaluation took place between 29th June and 10th October 2017.

The archaeological evaluation was carried out between 29th June and 17th October 2017. Four trenches were excavated around the building by tracked mechanical excavator to the depth of weathered natural using a toothless grading bucket. Each trench was between 0.60m and 1.60m wide, with a total length of c.22m opened. Exposed archaeological deposits were excavated by hand and in accordance with the WSAW and ClfA guidelines. No features of archaeological note were identified. To the rear (north) of the site the stratigraphy consisted of the natural substrate covered by a plastic mesh and overlain by made ground deposited in 2011. To the front (south) of the site a natural sequence of subsoil and topsoil was sealed by a thick layer of natural deposited when the Home was built. What follows is a summary for each trench with finds noted where they occur. See Appendix 3 for detailed context descriptions, Appendix 4 for the full finds concordance and Appendix 5 for the photographic archive.

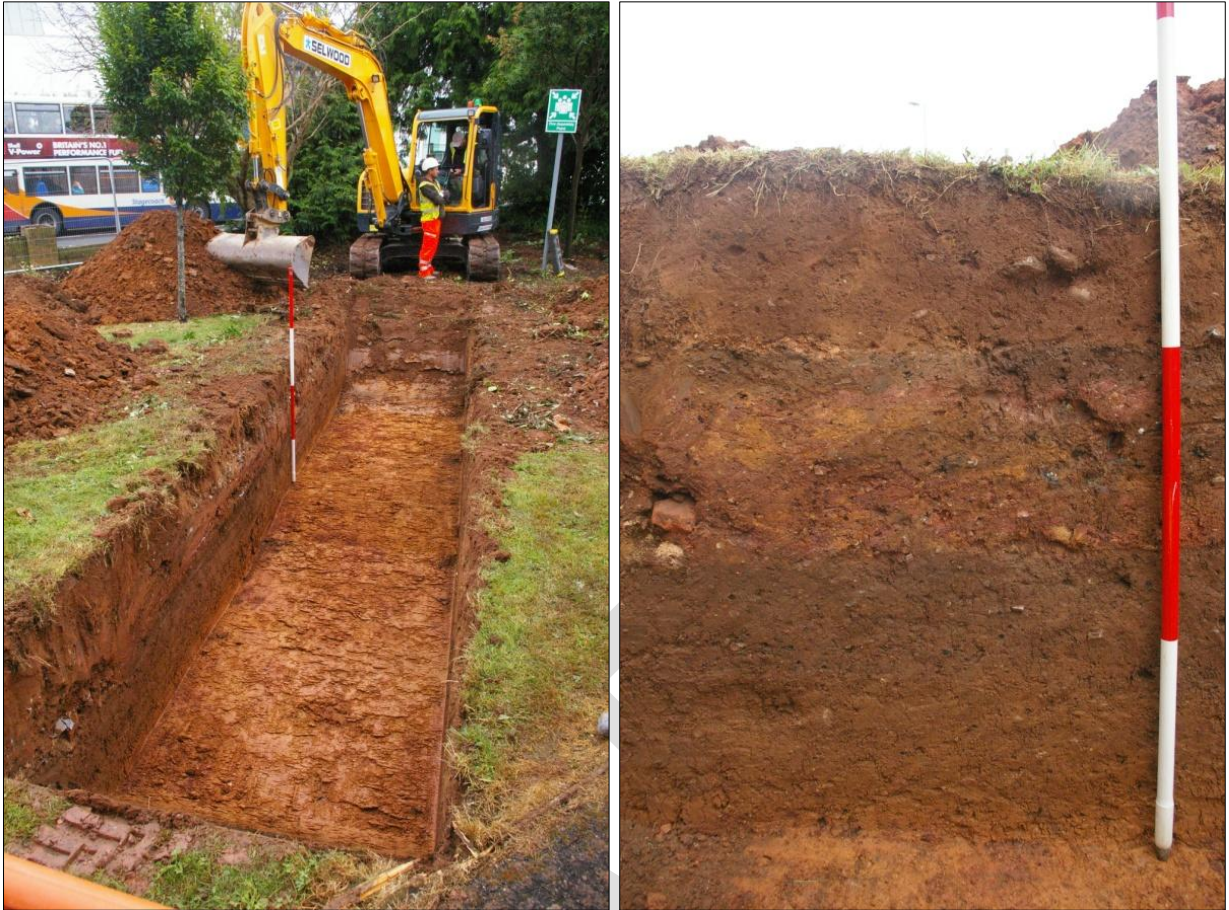
FIGURE 3: (LEFT) TRENCH 01 POST-EXCAVATION; VIEWED FROM THE EAST (2M SCALE).

FIGURE 4: (RIGHT) TRENCH 01, NORTH FACING SAMPLE SECTION; VIEWED FROM THE NORTH (2M SCALE).

Trench 01 was located to the south-west of the existing building and measured 8.30m long and 1.60m wide on an east-to-west alignment. The turf (100) and imported topsoil (101), soft light brown sandy-silt-loams 0.32m thick, overlay a compact heterogeneous deposit of mixed subsoil and topsoil with mortar, brick and slate (102), in a firm mixed brown, pink-red and yellow clay with soil 0.36m thick. This sealed a buried topsoil (103), a firm mid grey-brown silt-loam 0.22m thick; subsoil (104), a soft-to-firm mid yellow-brown silt-loam 0.28m thick; and the natural substrate (Figures 3-4). Finds recovered from this trench included: nine sherds (63g) of post-medieval industrial and South Somerset pottery. No early features or finds were identified.

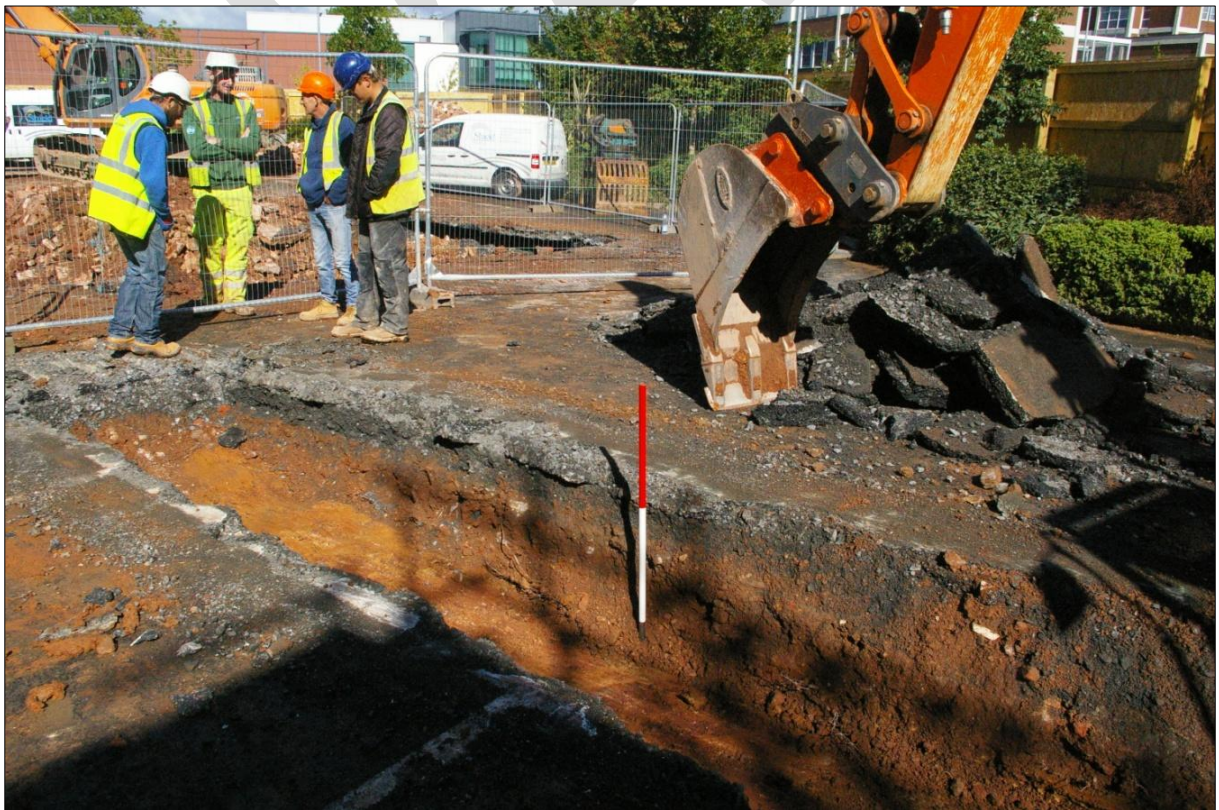
FIGURE 5: TRENCH 02 POST-EXCAVATION; VIEWED FROM THE SOUTH-WEST (1M SCALE).

Trench 02 was located to the north-east of the existing building and measured 7m long and 1.60m wide on a north-west to south-east alignment. A tarmac surface (200) 0.10m thick overlay a layer of made ground (201) of crushed stone aggregate c.0.25m thick. This in turn sealed a layer of made ground (202) of mid grey-red-brown clay and rubble 0.35m thick over a geotextile mesh. This lay directly on the natural substrate (Figure 5). No finds were recovered from this trench.

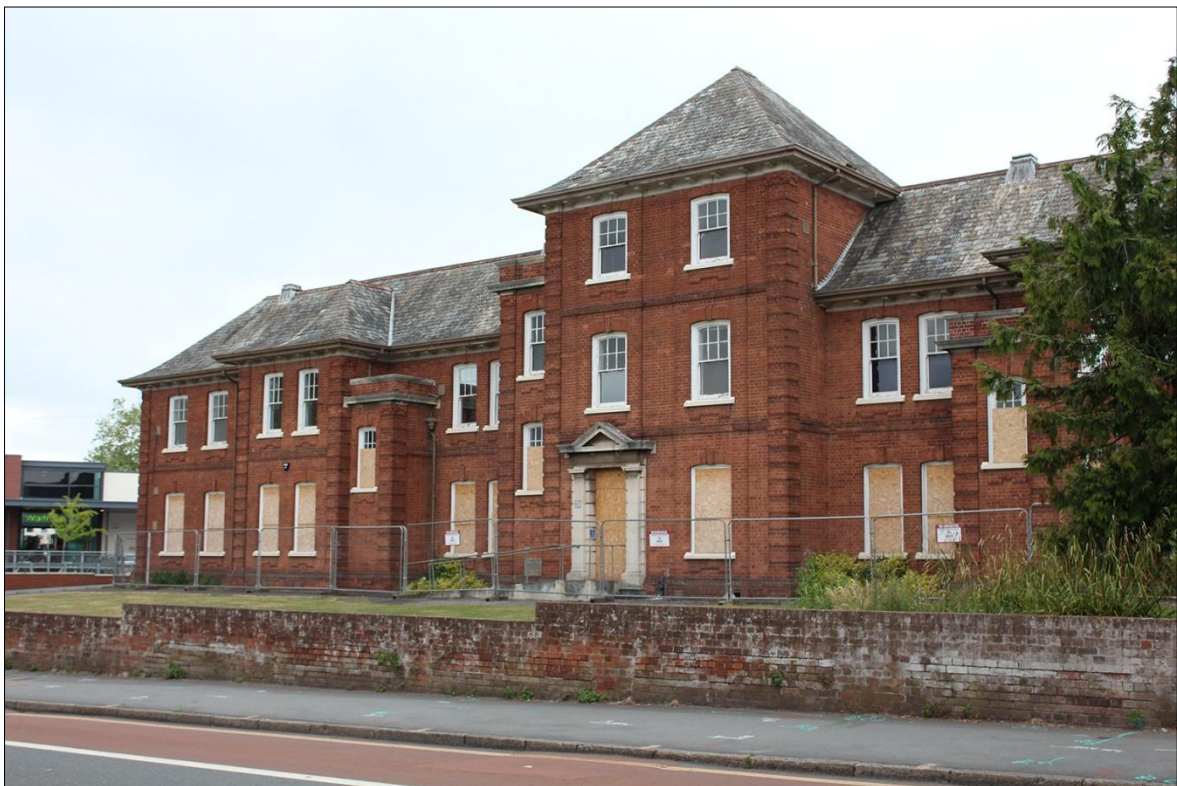
FIGURE 7: THE FRONT (SOUTH-WEST) ELEVATION OF THE BUILDING; VIEWED FROM THE SOUTH.

Number 79 Heavitree Road, a large institutional building of late 'Queen Anne' style, is a purpose-built children's home raised by the Exeter Corporation (as expressed by the inscribed granite foundation stone in the front elevation). It consists of a central projecting block with flanking wings totalling twenty bays in length, and standing two storeys high with additional attic accommodation. It has a broadly symmetrical layout, with shallow intermediate projections from the wings brought forward to both the front and rear, with a stair block on the inner angle of each. There is a central deeply projecting two-bay (to the rear) entrance block with an asymmetric stair to the west side. The building is constructed of a distinctive mix of dark red-orange and red-brown bricks set on a stepped plinth base, with a moulded ogee string course to the first floor.

The front (south-west) façade exhibits carefully-considered classical architectural detailing, with keystone and voussoir-effect brickwork above each window and a flat notched plinth below, and projecting rusticated brick quoins to the corners. The single main entrance is located in the front elevation, comprising a grand stone doorway off-set in the central entrance block. It has a pedimented shallow canopy carried on flat fluted pilasters with a rusticated background. An additional entrance has been forced through the lowering of a window at the eastern end. The windows have stone carved painted sills and wide chunky moulded frames. The windows themselves are nine-over-one pane shallow arched horned sashes to the ground floor, with six-over-one pane shallow arched horned sashes to the first and second floors.

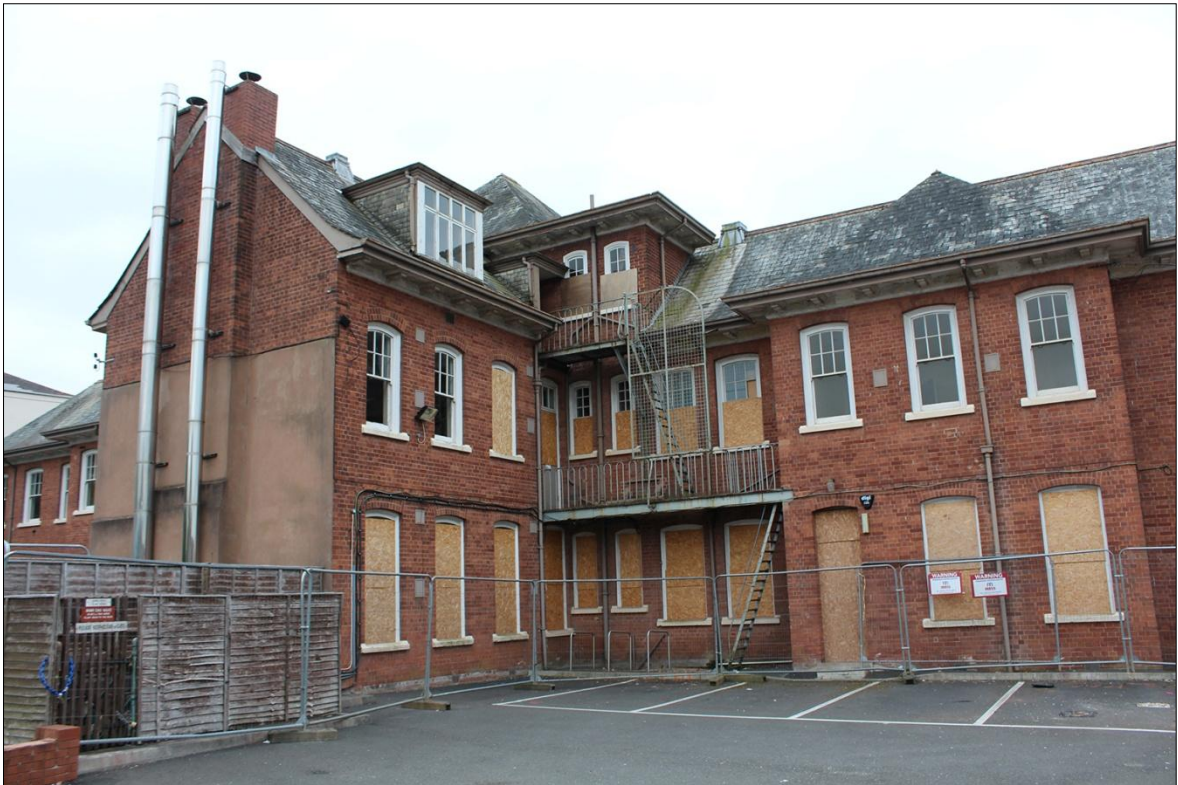
FIGURE 8: THE REAR (NORTH-EAST) ELEVATION OF THE BUILDING; VIEWED FROM THE NORTH.

The rear (north-east) elevation presents a more complex picture. The projecting central rear service wing has clearly been truncated, with cement render repairs contrasting to the brickwork. Historic mapping depicts a long narrow T-shaped projection here, of which the basement survives

(not accessible). As with the front elevation, the rear elevation is defined by shallow intermediate wings brought forward, though each of has a rear doorway with fanlights over. The elevation has the same nine-over-one arched horned sashes to ground floor and six-over-one horned sashes to first floor. However, the surround is simpler, with plain segmental brick arches and lacking the notched plinth below. The central block of the main range rises to a third storey with four-over-one pane horned sash windows; the projecting rear wing has four-light casements in flat-roofed projecting dormers to the second floor. To the rear west side, in the angle between the main range and the rear wing, is a small slate-hung structure that leads to a wrought-iron fire escape stair supported on iron girders.

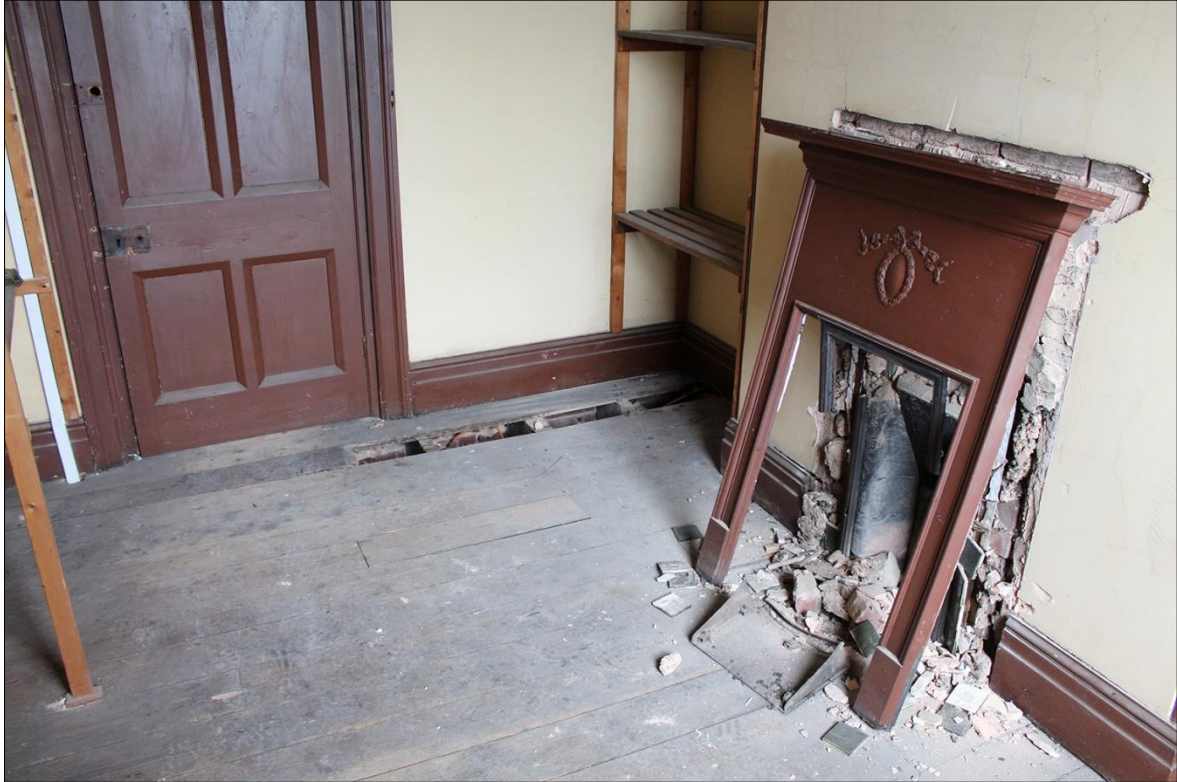
FIGURE 9: THE FINE PERIOD FITTINGS IN ROOM S6; VIEWED FROM THE SOUTH-WEST.

Only the central block was occupied at second floor, accessed from the main stair (S3). A short corridor (S5) leads into two heated private spaces at the front (S6 & S12). Both have fine surviving fireplaces with mock-Georgian surrounds but 'art nouveau' fire grates, reflecting the mix of

architectural referenced within the building. To the east, the larger room (S12) seemingly had its own bathroom (S11) and a door to a storage area in the roof space (S13). To the west and rear side are former toilets (S1 & S2) and a washroom (S9); along with a general store room (S4) and a laundry/linen store (S10). To the rear, in the projecting wing, was a large open heated space with dormers, perhaps a junior staff dormitory (S7). The original decorative colour scheme has survived intact on this level: the walls with rich cream tiles above glazed brown tiles, the moulded dado and picture rails, with brown painted woodwork, original fine panelled doors and moulded surrounds all surviving.

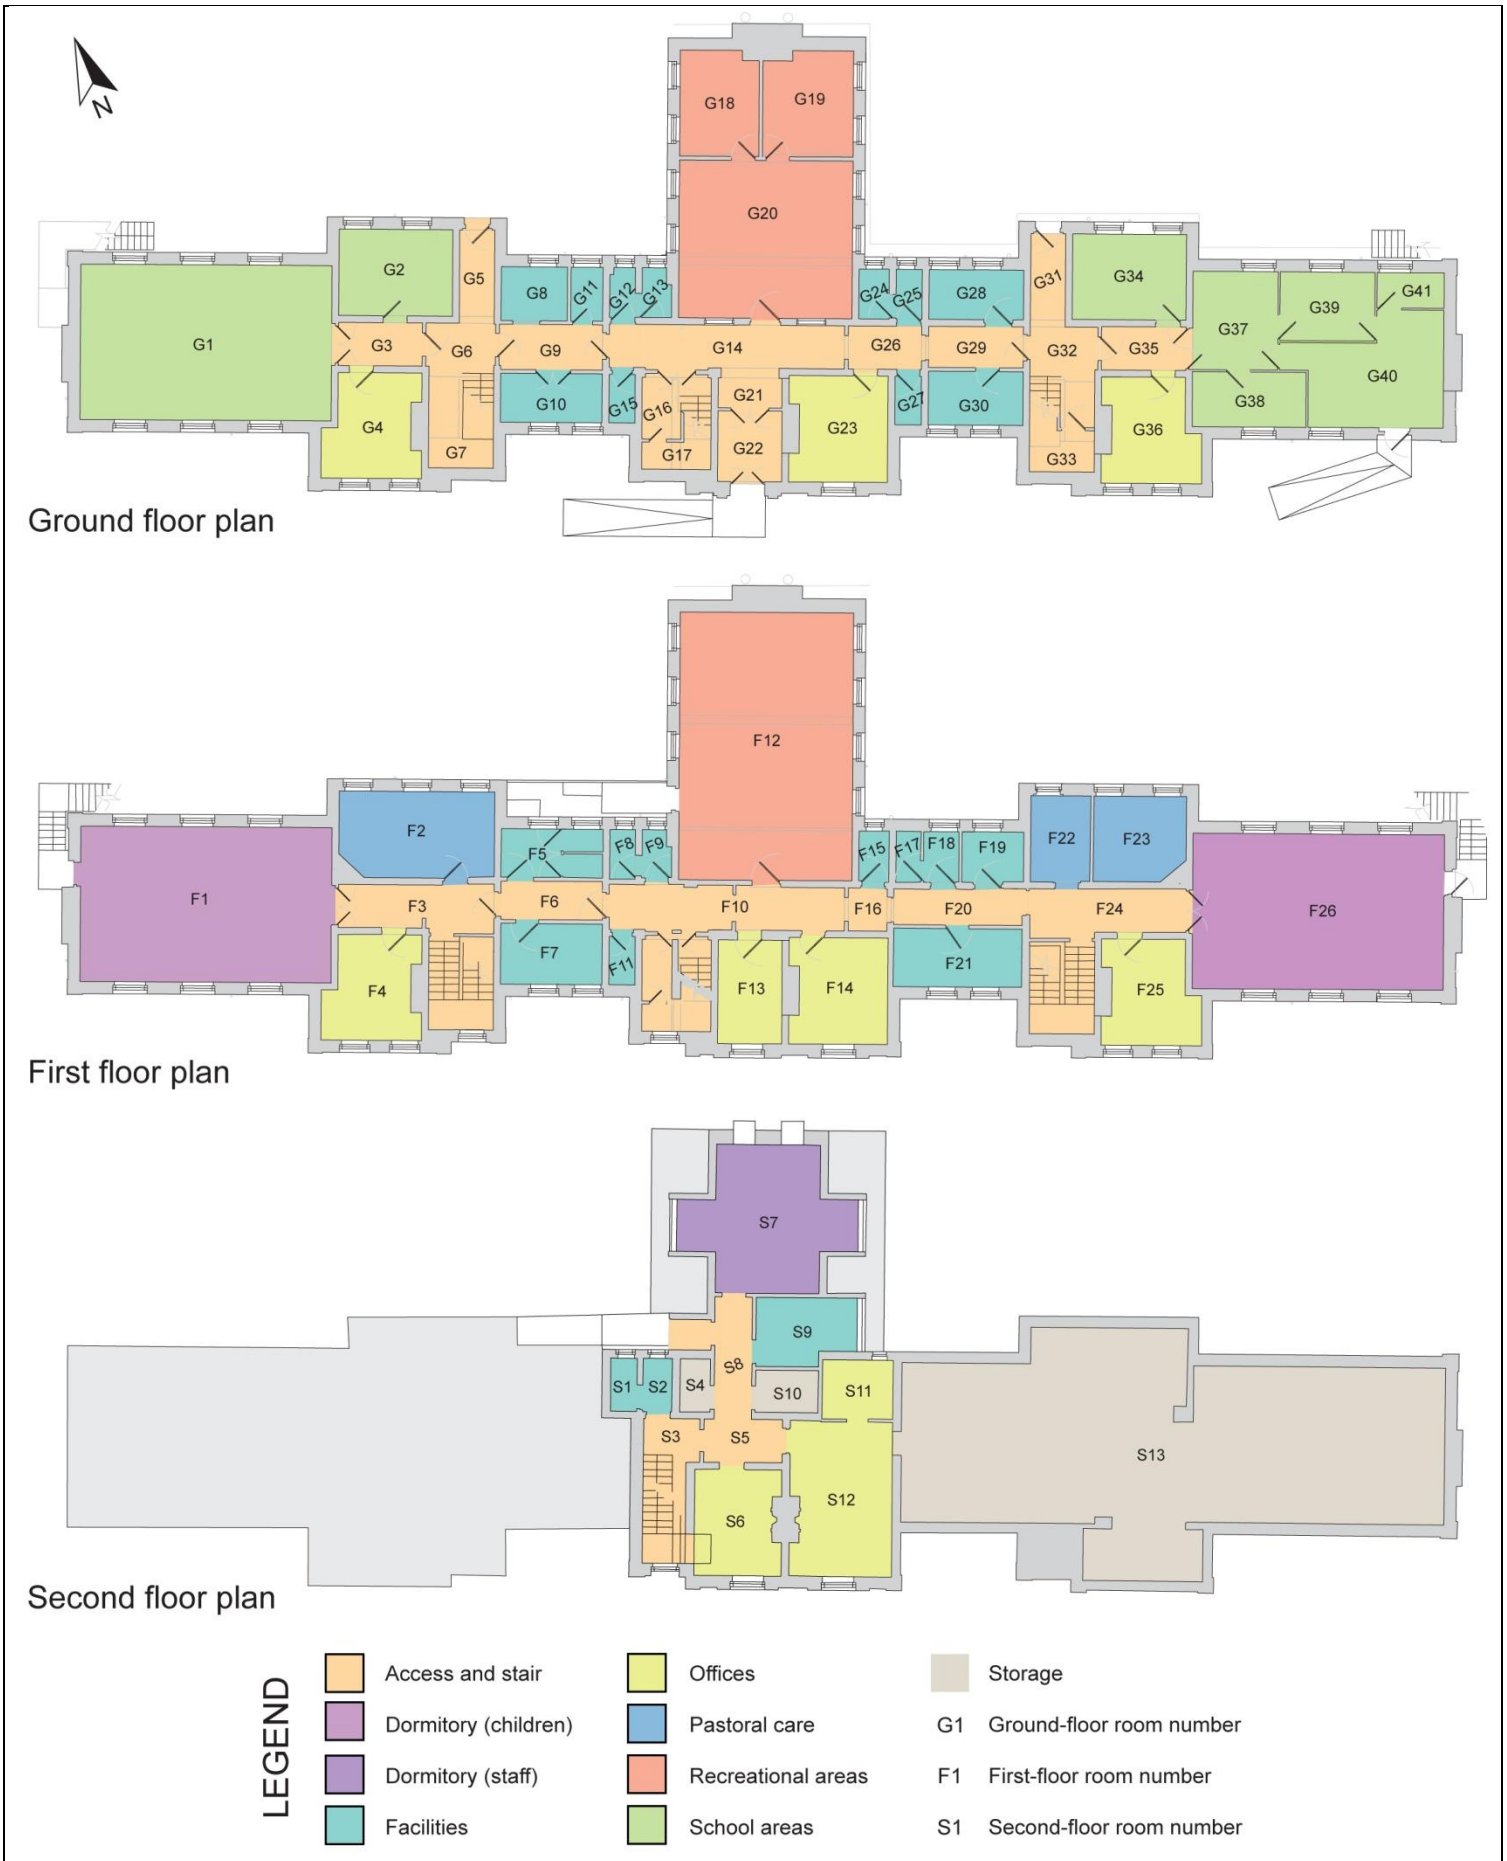
FIGURE 10: BUILDING PLANS SHOWING INTENDED ROOM FUNCTION.

The building has a linear internal plan set on a roughly north-west/south-east alignment arranged to each side of a central spine corridor. The ground and first floors have mirrored layouts to the east and west ends, each with a replicated series of rooms. The second floor is smaller and housed staff accommodation and service rooms.

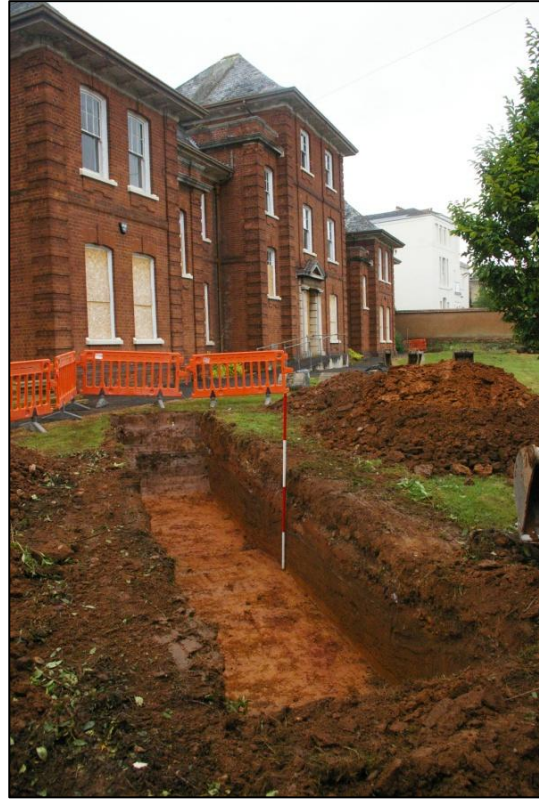
14. RIGHT: TRENCH 01 POST-EXCAVATION; VIEWED FROM THE WEST (2M SCALE).

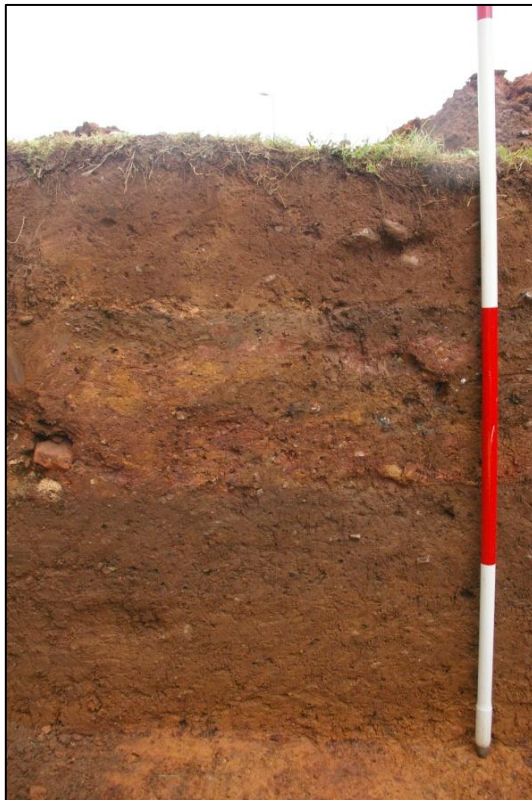
15. LEFT: TRENCH 01 DETAIL OF NORTH FACING REPRESENTATIVE SECTION; VIEWED FROM THE NORTH (PARTIAL 2M SCALE).

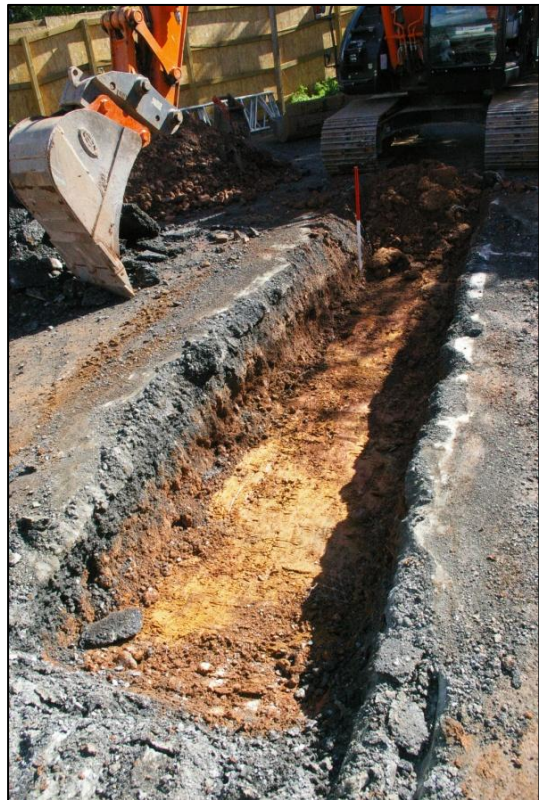
16. RIGHT: TRENCH 02 POST-EXCAVATION; VIEWED FROM THE NORTH-EAST (1M SCALE).

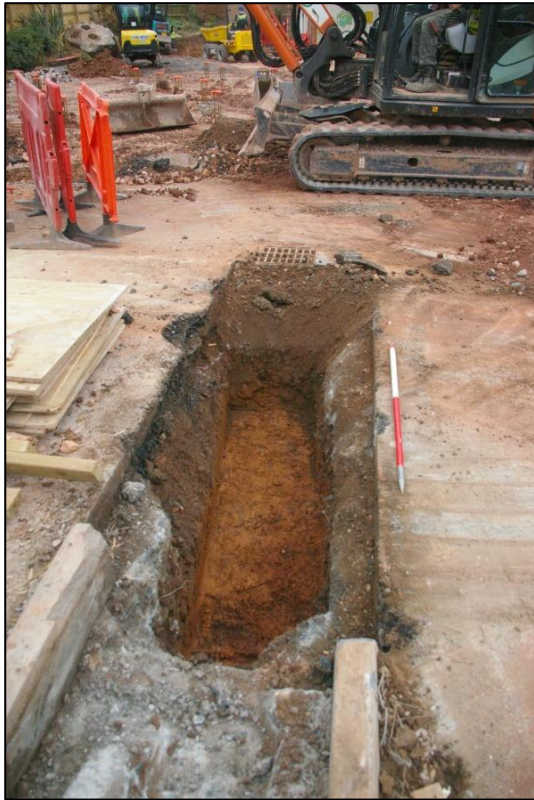
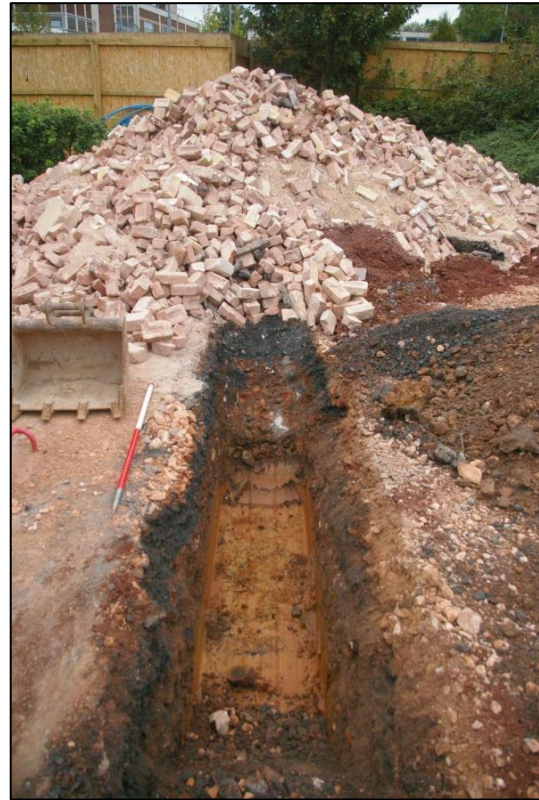
- 17. LEFT: TRENCH 03 POST-EXCAVATION; VIEWED FROM THE NORTH-WEST (1M SCALE).
- 18. RIGHT: TRENCH 04 POST-EXCAVATION; VIEWED FROM THE SOUTH-WEST (1M SCALE).

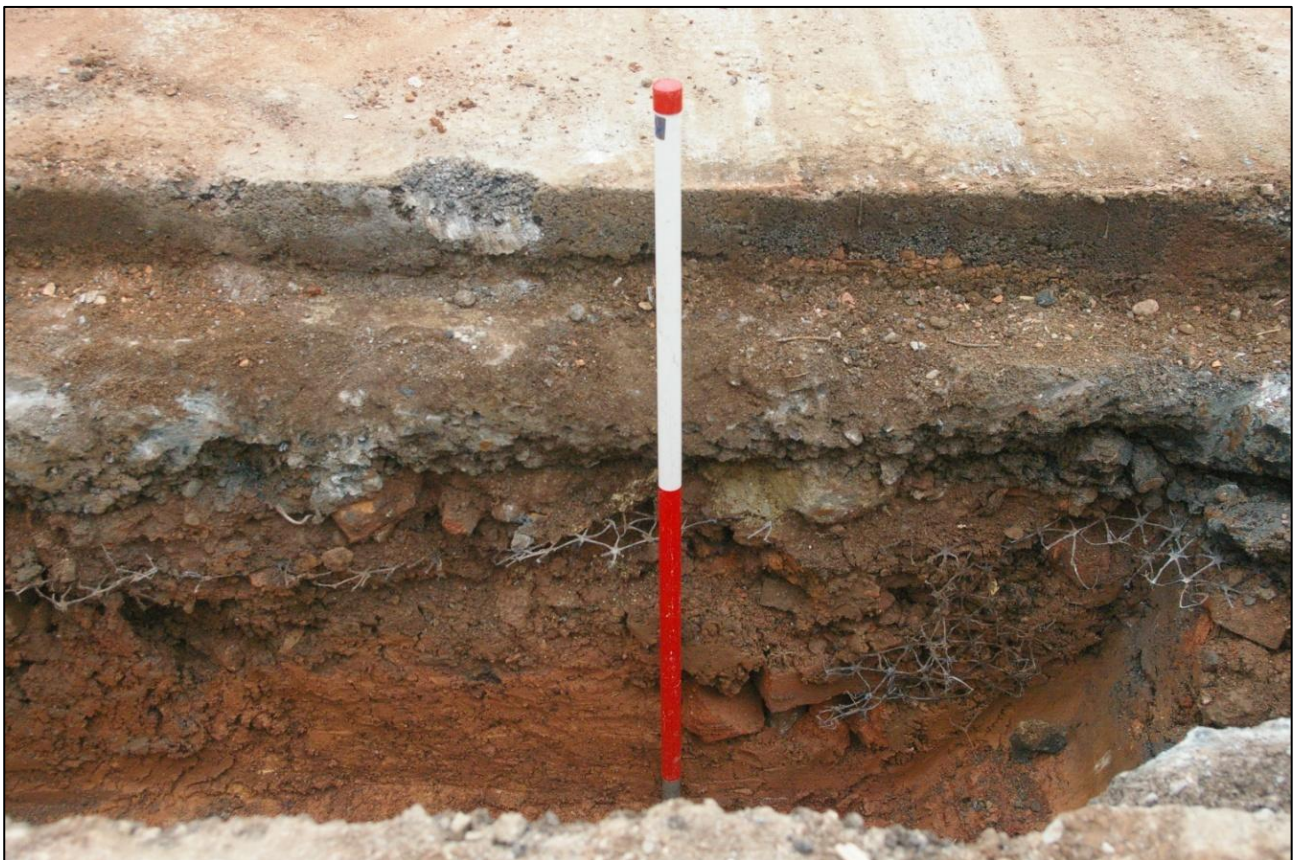
- 19. TRENCH 03 DETAIL OF NORTH-EAST FACING REPRESENTATIVE SECTION; VIEWED FROM THE NORTH-EAST (1M SCALE).

Trench 03 was located towards the north corner of the site and measured 2.10m long and 0.60m wide on a north-west to south-east alignment. A tarmac surface (300) 0.10m thick overlay a concrete surface (301) 0.35m thick. This sealed a layer of made ground (302) of mid grey-red-brown silt-clay and rubble 0.30m thick over a geotextile mesh. This lay directly on the natural substrate. No finds were recovered from this trench.

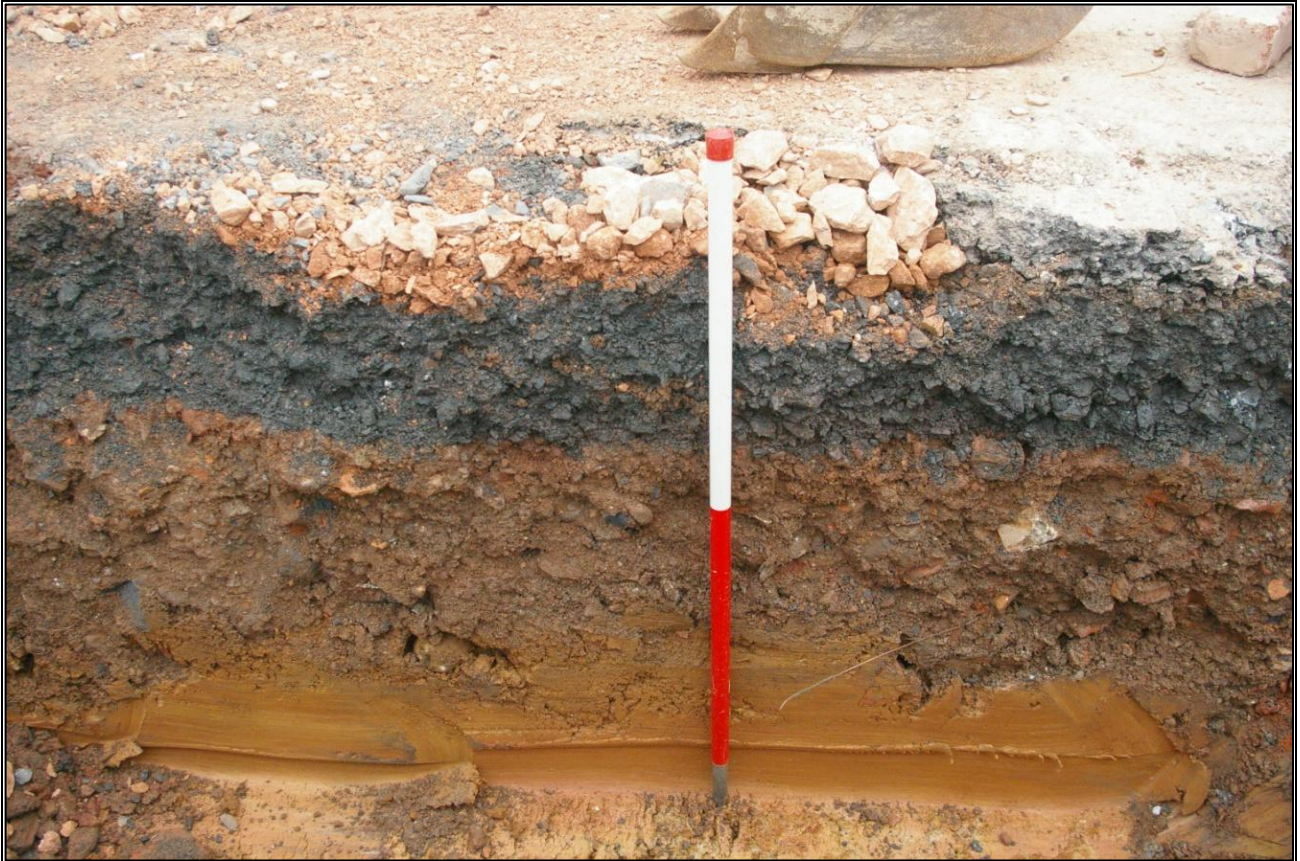
20. TRENCH 04 DETAIL OF SOUTH-EAST FACING REPRESENTATIVE SECTION; VIEWED FROM THE SOUTH-EAST (1M SCALE).

Trench 04 was located towards the north corner of the site and measured 4.50m long and 0.60m wide on a north-east to south-west alignment. A tarmac surface (400) 0.10m thick overlay a concrete surface (401) 0.35m thick. This sealed made ground (401) of mid grey-red-brown silt-clay and rubble 0.45m thick over a geotextile mesh. This directly overlaid the natural substrate. No finds were recovered from this trench.

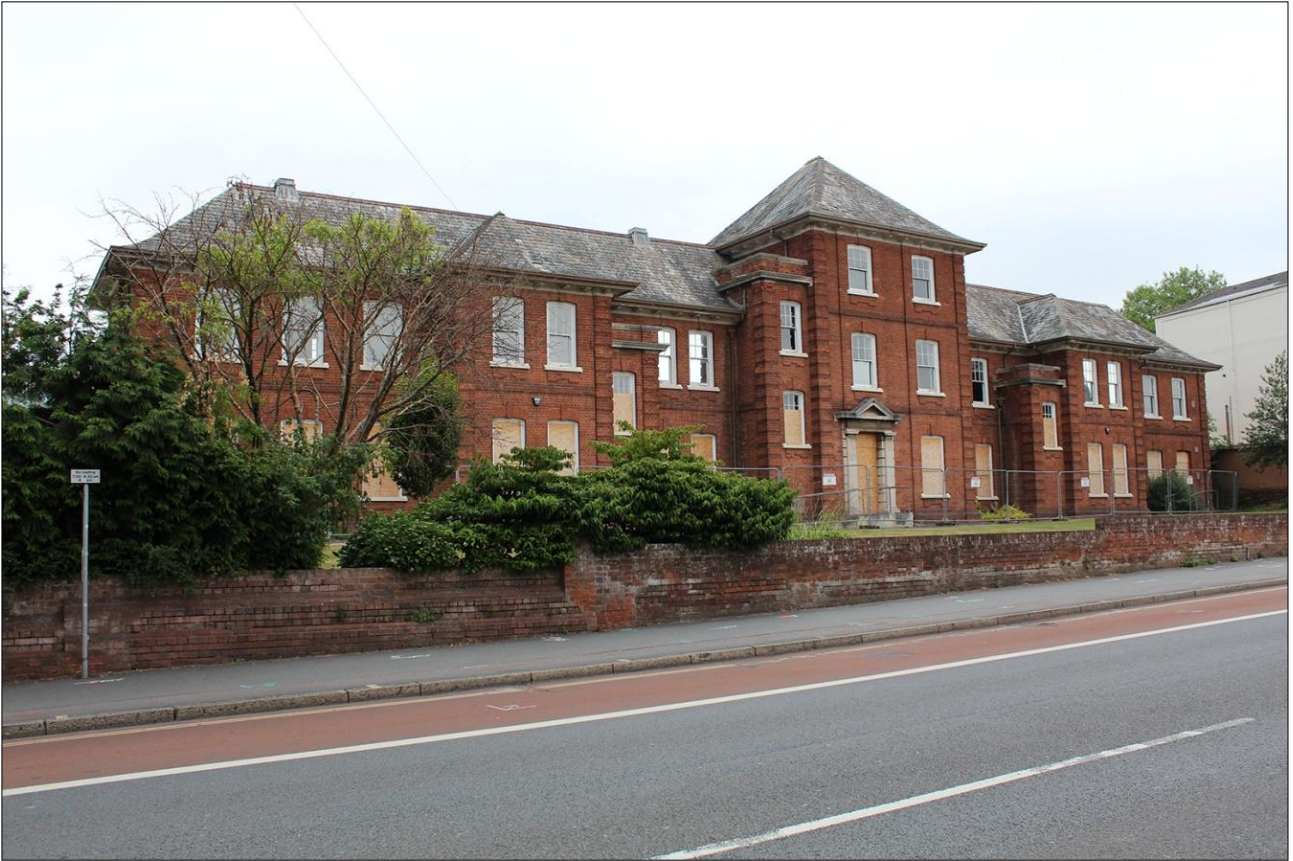
1. FRONT (SOUTH-WEST) EXTERNAL ELEVATION OF BUILDING; VIEWED FROM THE SOUTH-WEST.

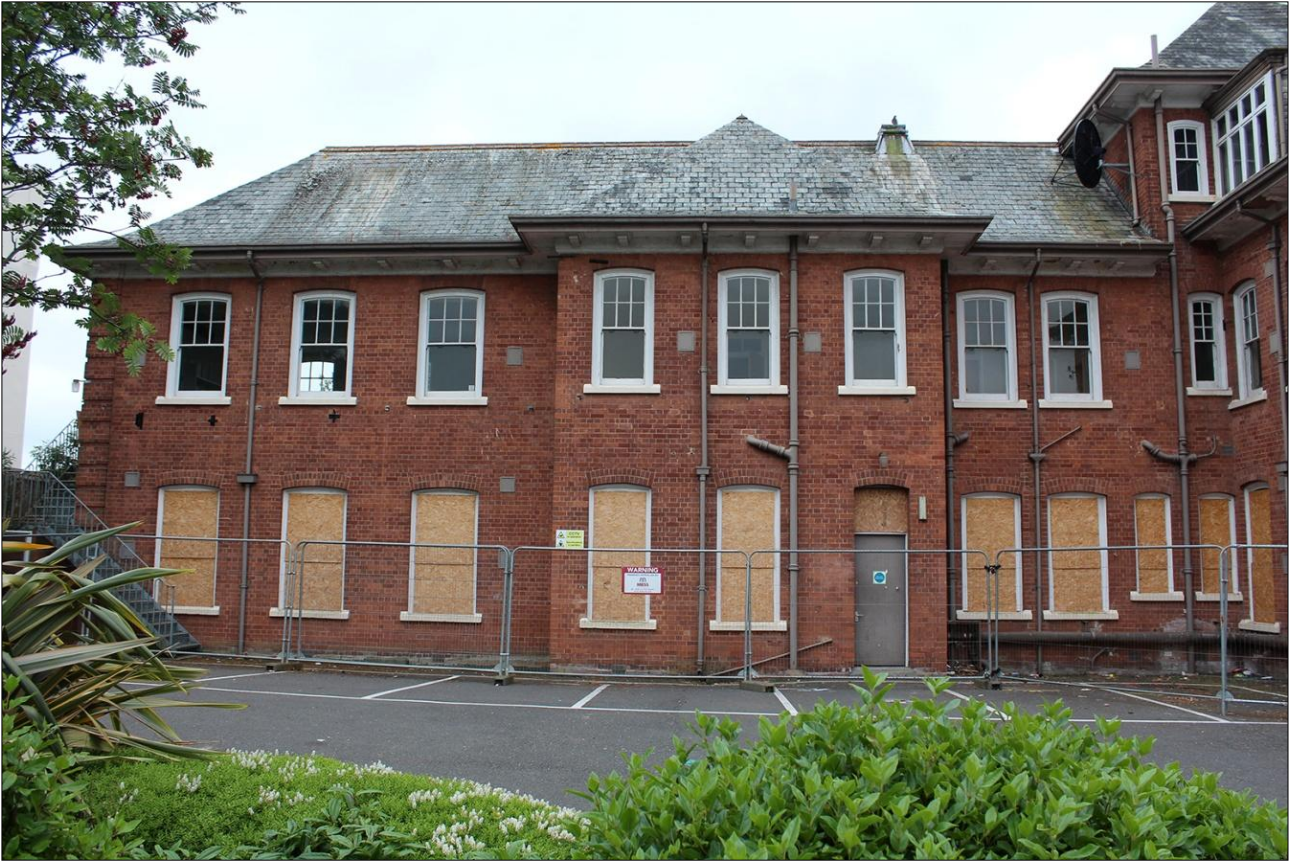
7. REAR (NORTH-EAST) EXTERNAL ELEVATION OF BUILDING, EAST END; VIEWED FROM THE NORTH-EAST.

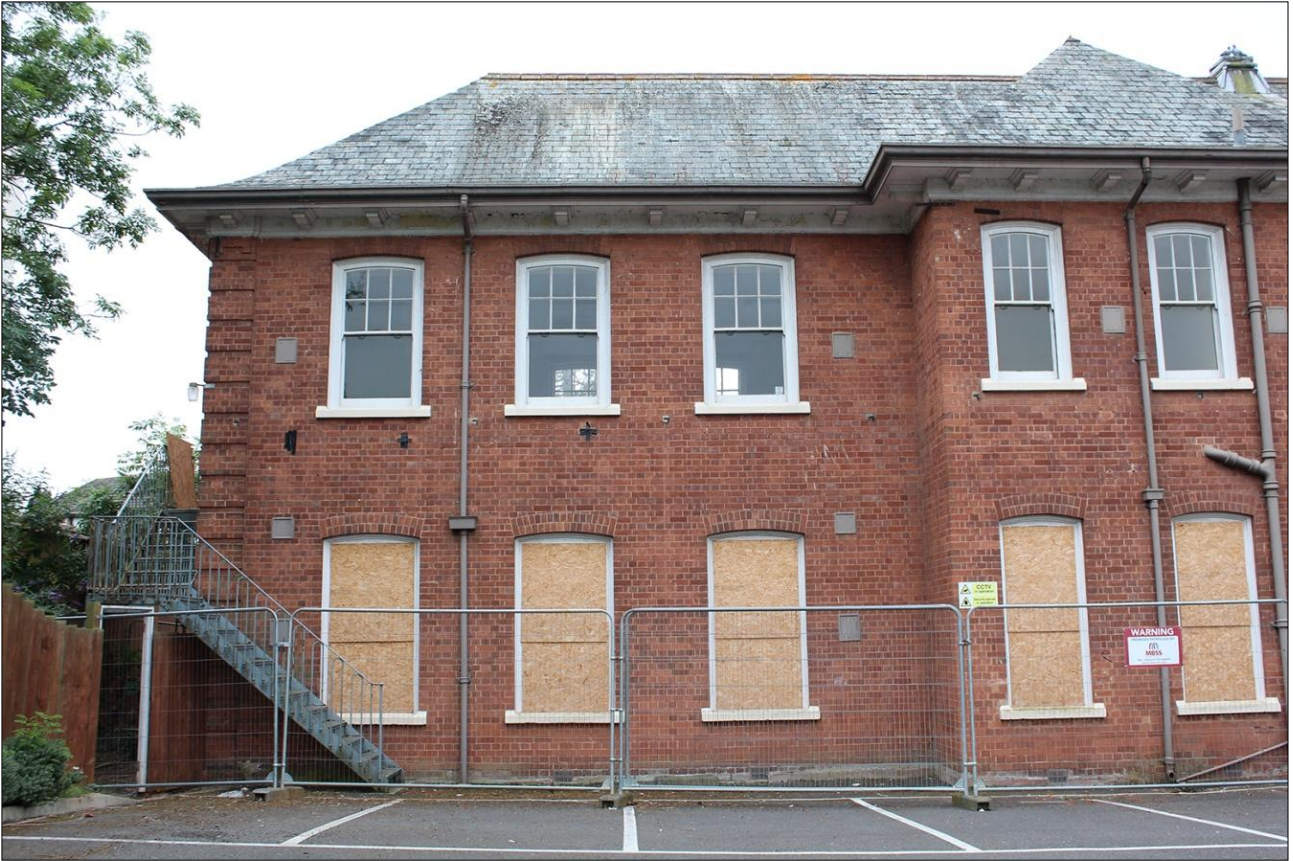
9. REAR (NORTH-EAST) EXTERNAL ELEVATION OF BUILDING, EAST END; VIEWED FROM THE NORTH.

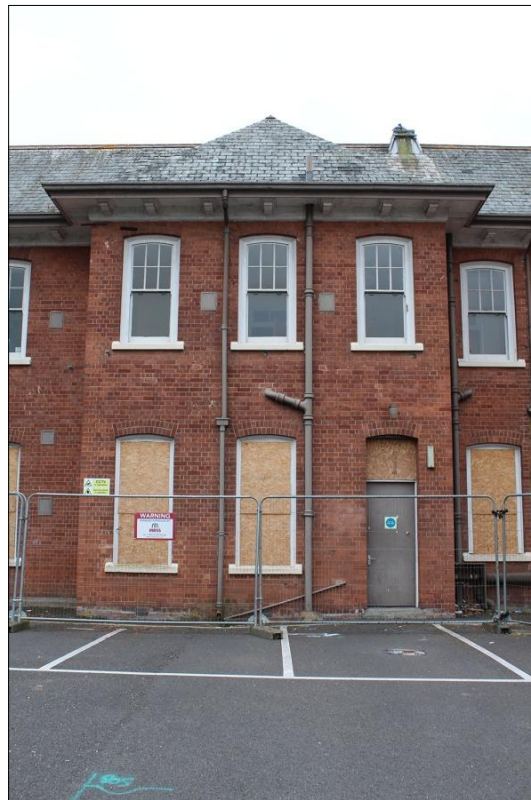
10. REAR (NORTH-EAST) EXTERNAL ELEVATION OF BUILDING, EAST END; VIEWED FROM THE NORTH-EAST.

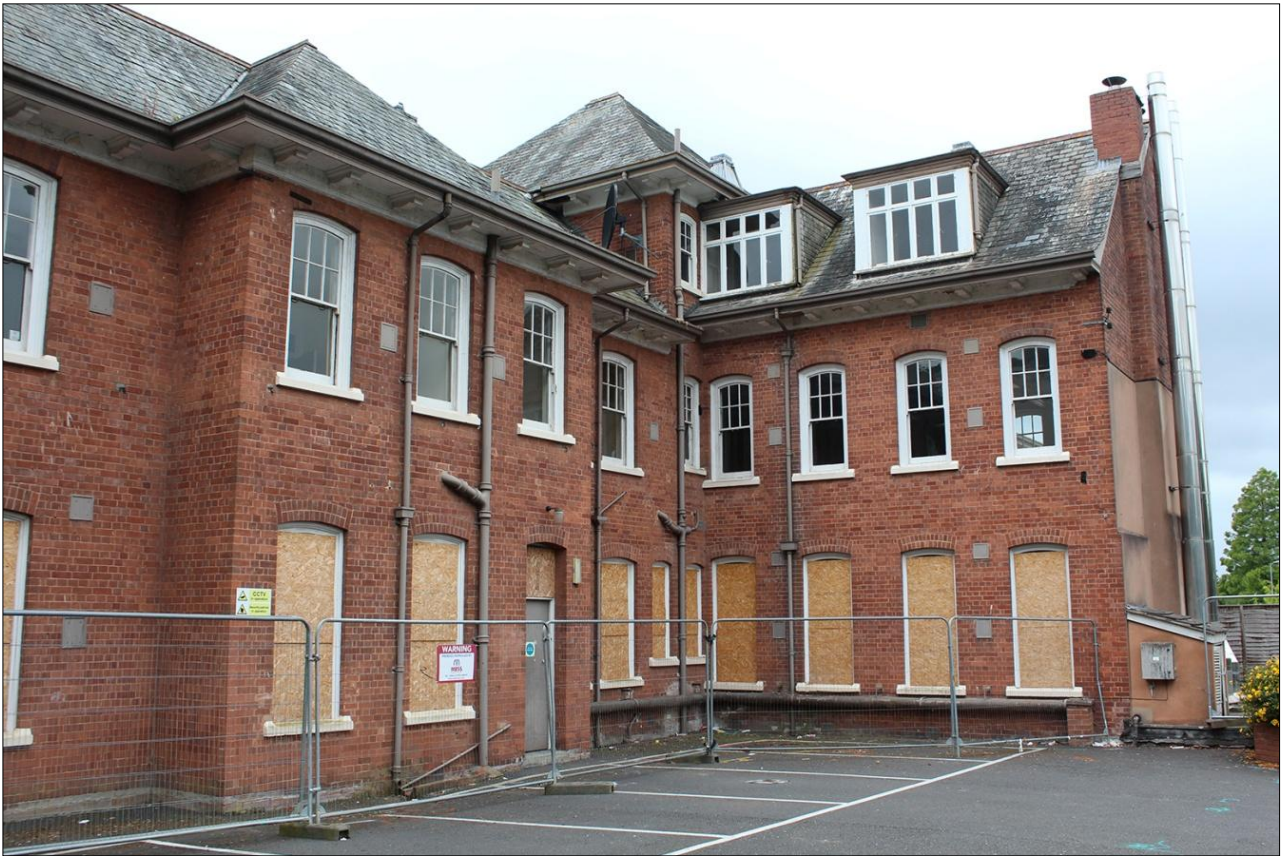
11. REAR (NORTH-EAST) EXTERNAL ELEVATION OF BUILDING; VIEWED FROM THE EAST.

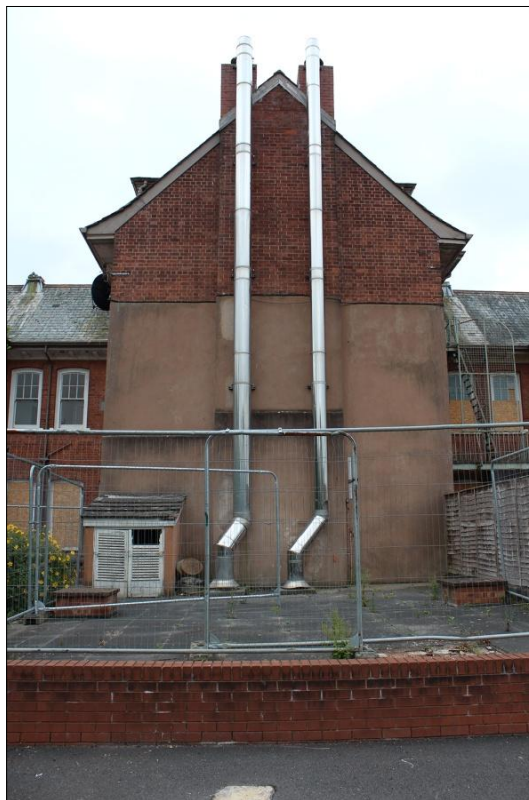
12. REAR (NORTH-EAST) EXTERNAL ELEVATION OF BUILDING, MID; VIEWED FROM THE NORTH-EAST.
