79 HEAVITREE ROAD

RESULTS OF AN ARCHAEOLOGICAL EVALUATION AND RAPID BUILDING RECORDING

SOUTH WEST ARCHAEOLOGY LTD. REPORT NO. 181002

79 Heavitree Road, Exeter, Devon Results of an Archaeological Evaluation and Rapid Building Recording

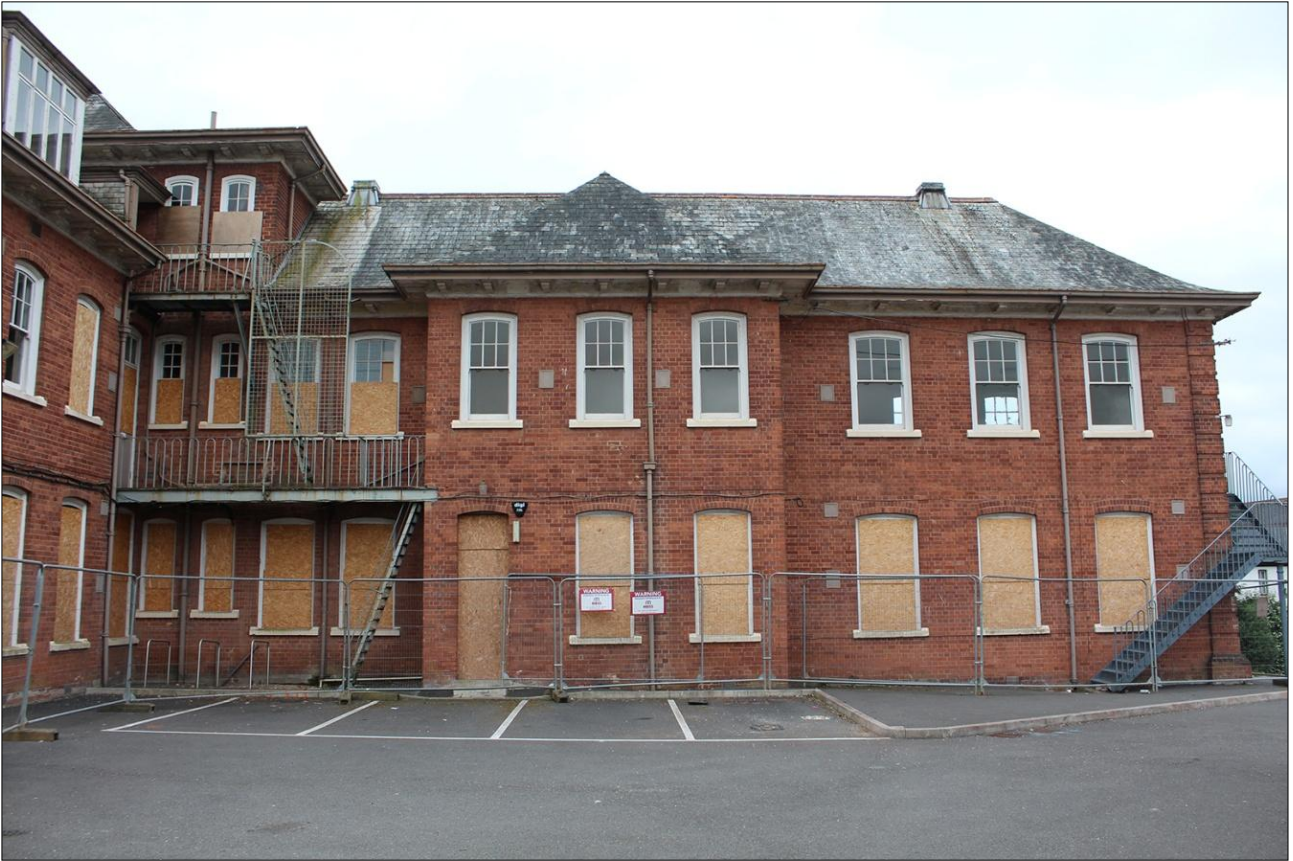
13. REAR (NORTH-EAST) EXTERNAL ELEVATION OF BUILDING, WEST END; VIEWED FROM THE NORTH-EAST.

The rear (north-east) elevation presents a more complex picture. The projecting central rear service wing has clearly been truncated, with cement render repairs contrasting to the brickwork. Historic mapping depicts a long narrow T-shaped projection here, of which the basement survives

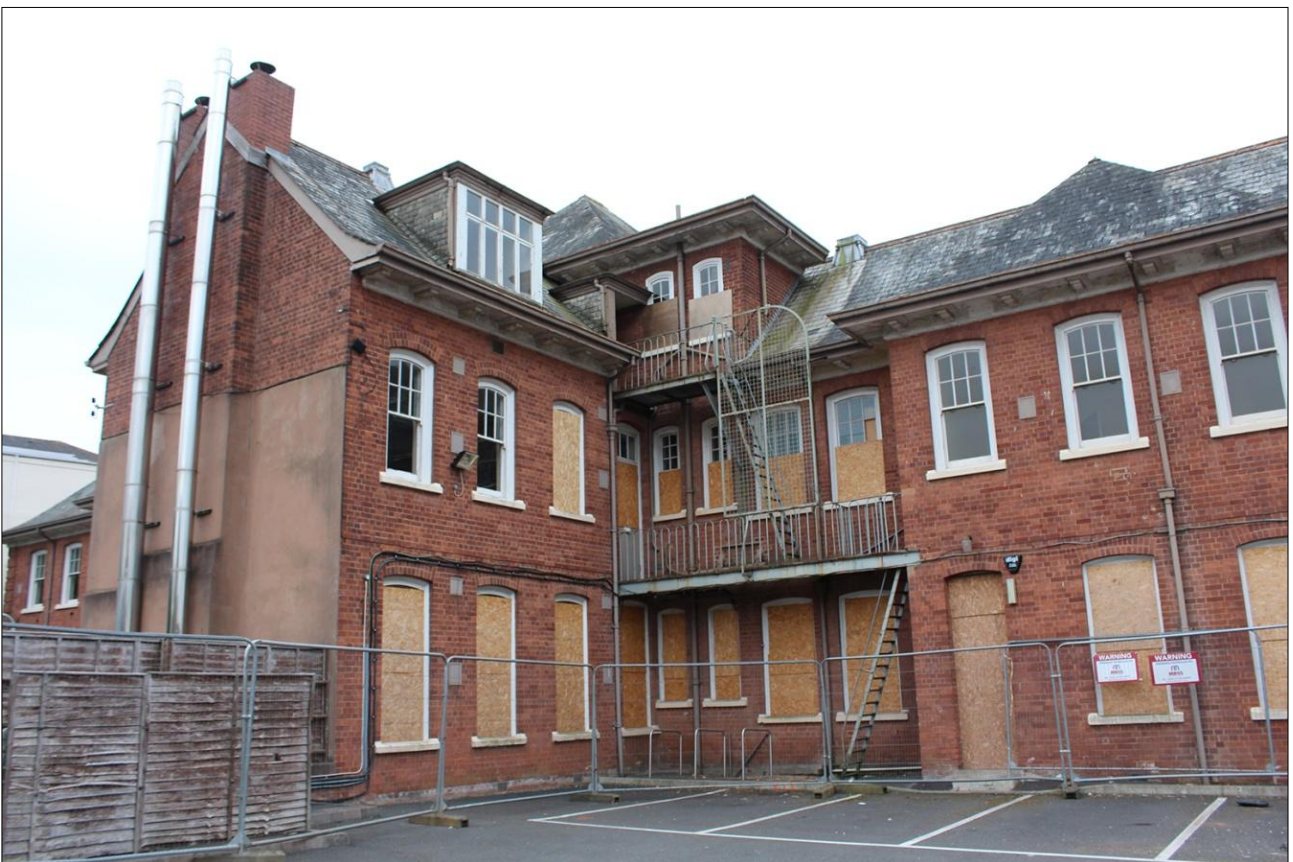
14. REAR (NORTH-EAST) EXTERNAL ELEVATION OF BUILDING, WEST END; VIEWED FROM THE NORTH-WEST.

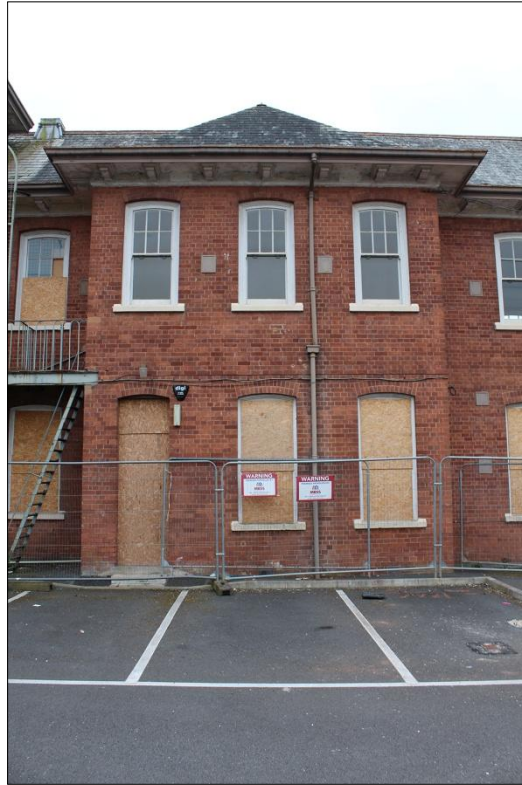
15. REAR (NORTH-EAST) EXTERNAL ELEVATION OF BUILDING, WEST END; VIEWED FROM THE NORTH-EAST.

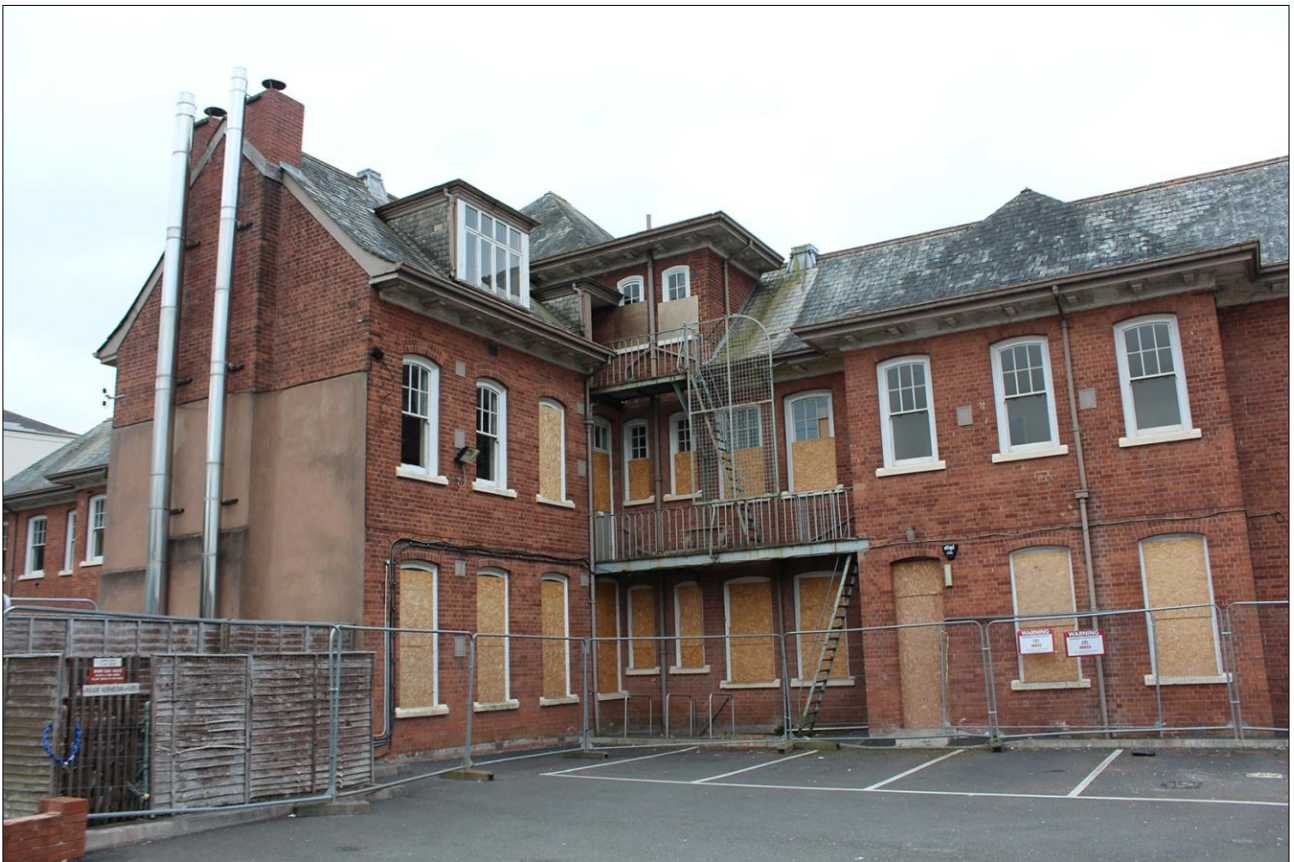
16. REAR (NORTH-EAST) EXTERNAL ELEVATION OF BUILDING, WEST END; VIEWED FROM THE NORTH-WEST.

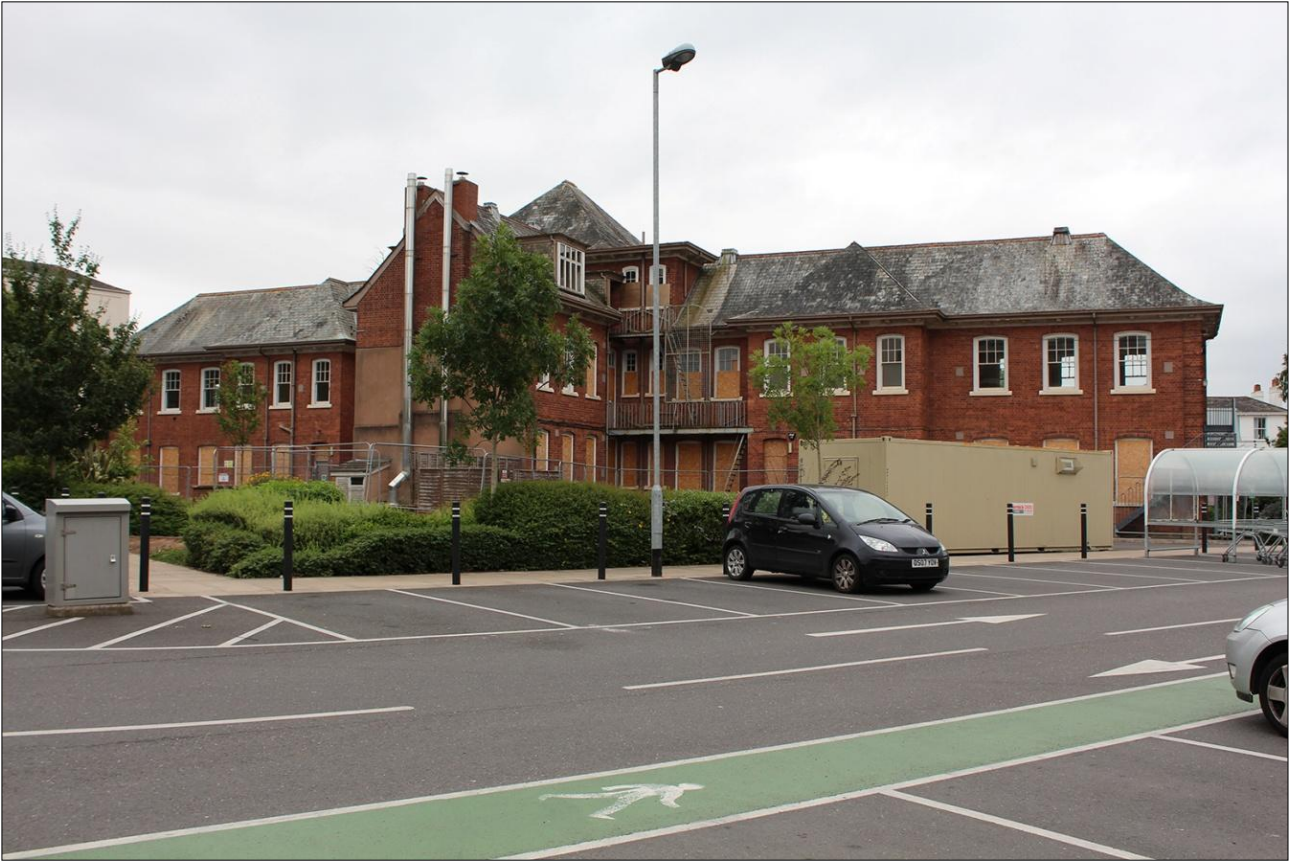
17. REAR (NORTH-EAST) EXTERNAL ELEVATION OF BUILDING; VIEWED FROM THE NORTH-WEST.

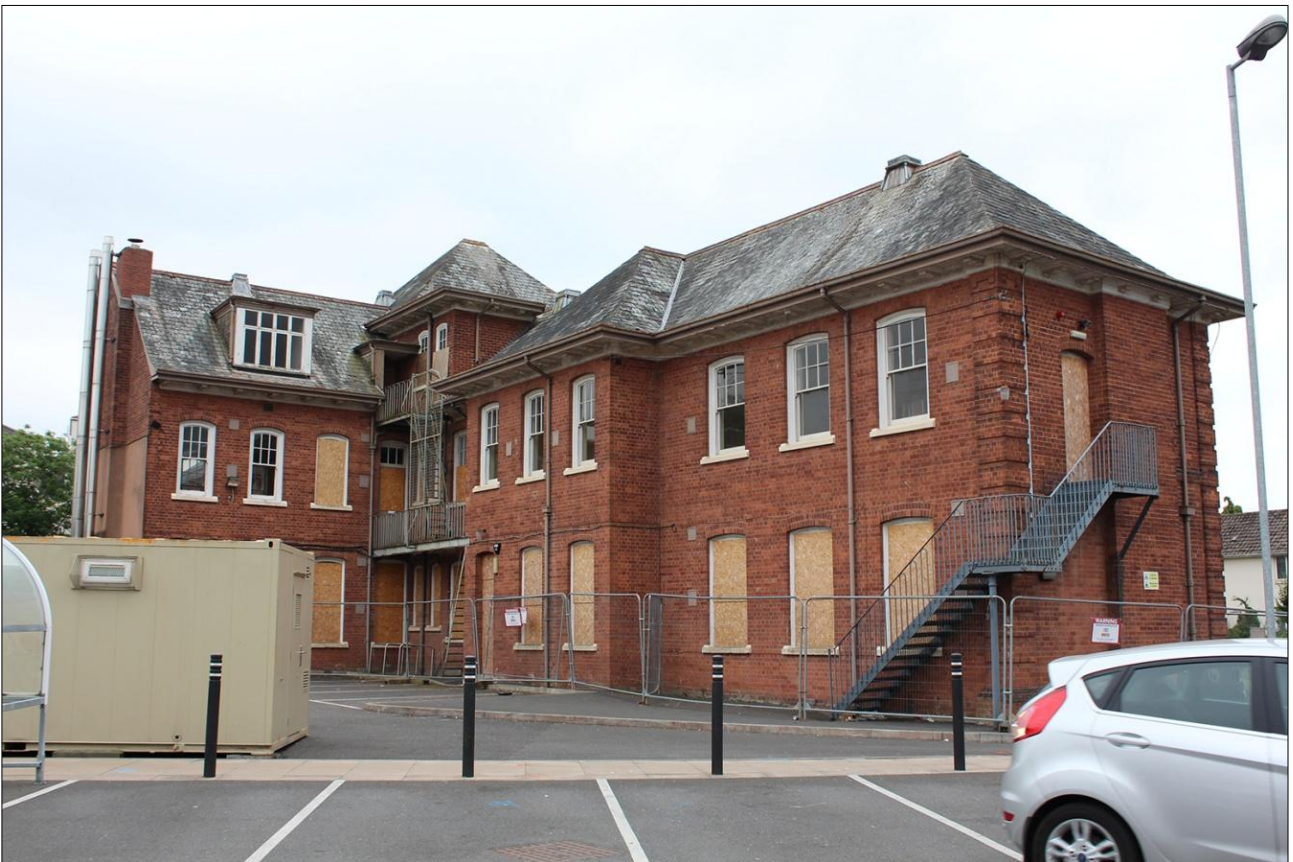
18. REAR (NORTH-EAST) EXTERNAL ELEVATION OF BUILDING, WEST END; VIEWED FROM THE NORTH-WEST.

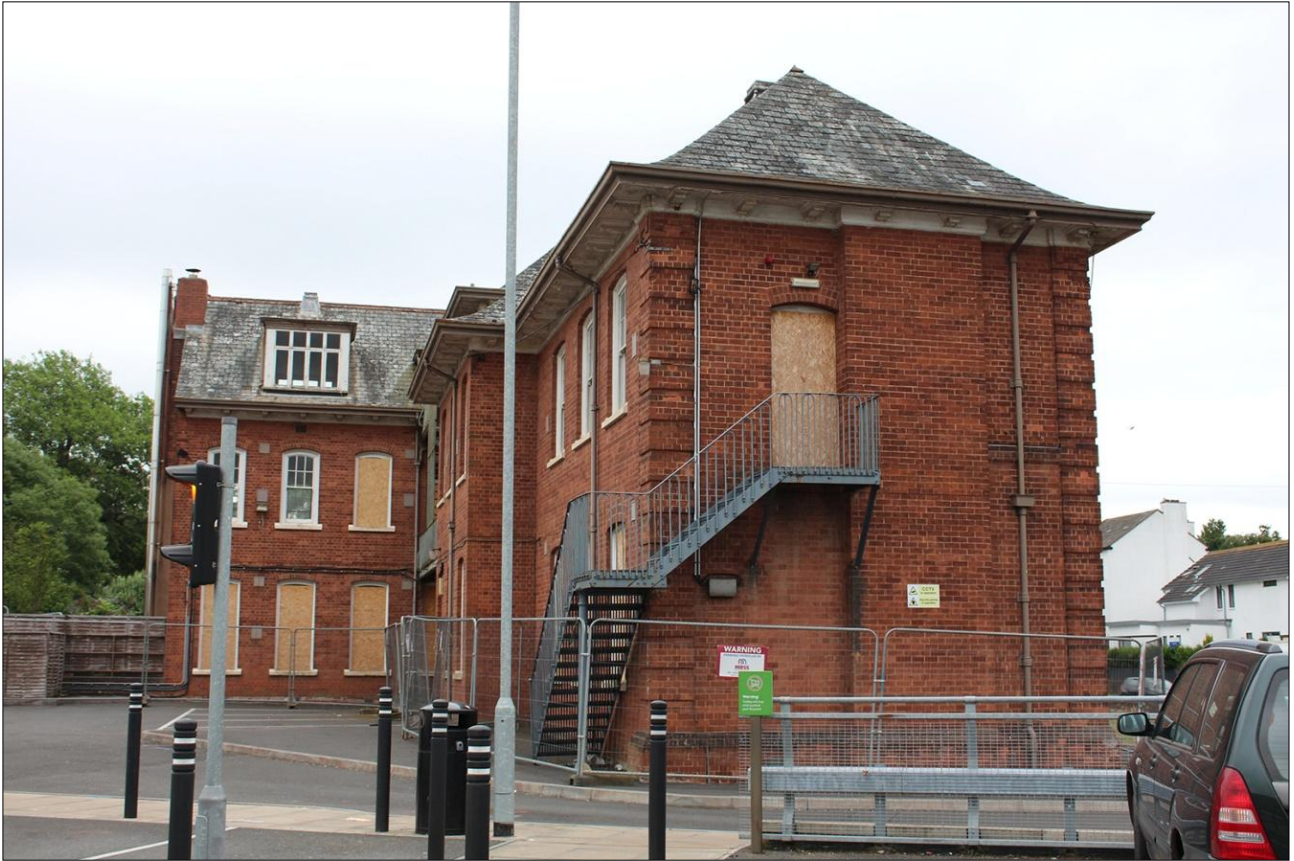
19. REAR (NORTH-EAST) AND NORTH-WEST EXTERNAL ELEVATIONS OF BUILDING; VIEWED FROM THE NORTH-WEST.

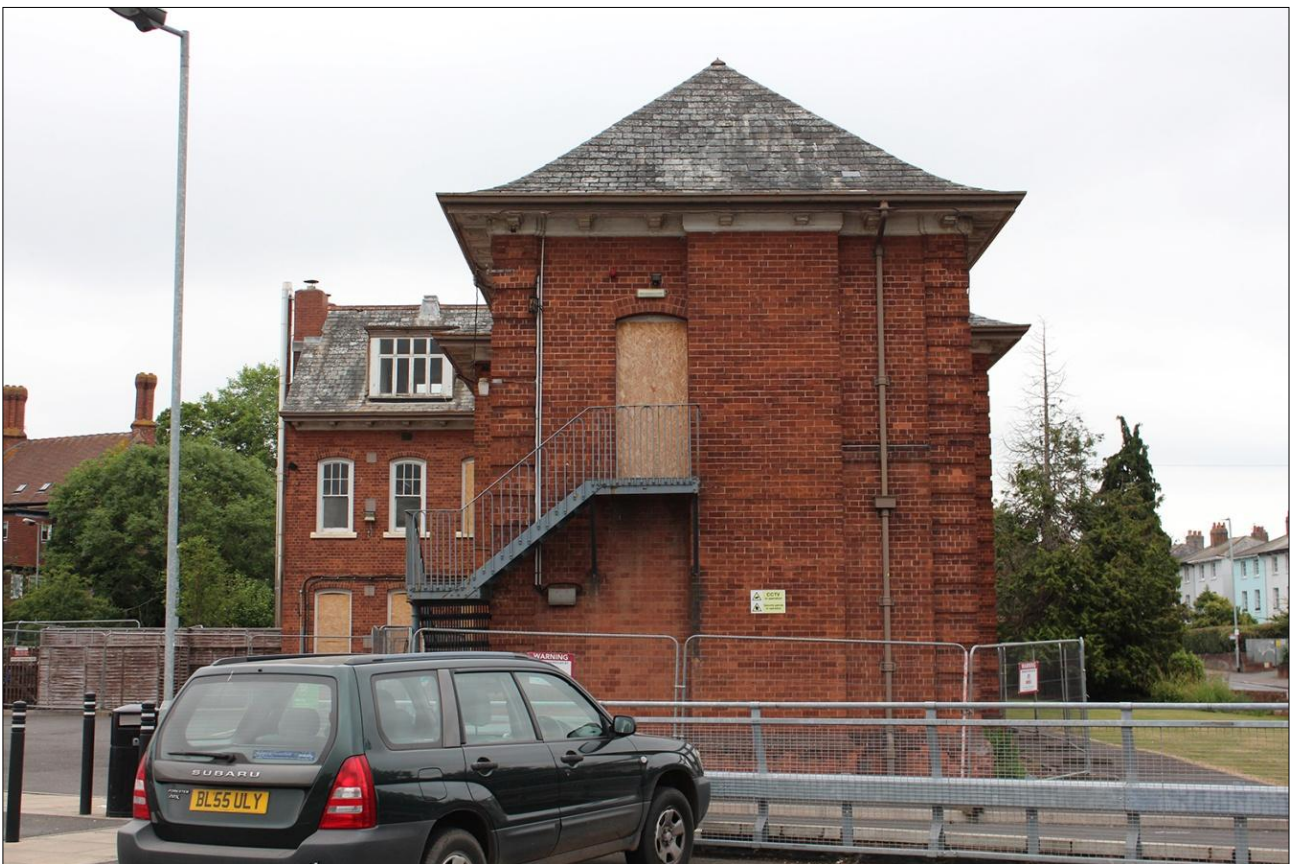
20. NORTH-WEST EXTERNAL ELEVATION OF BUILDING; VIEWED FROM THE NORTH-WEST.

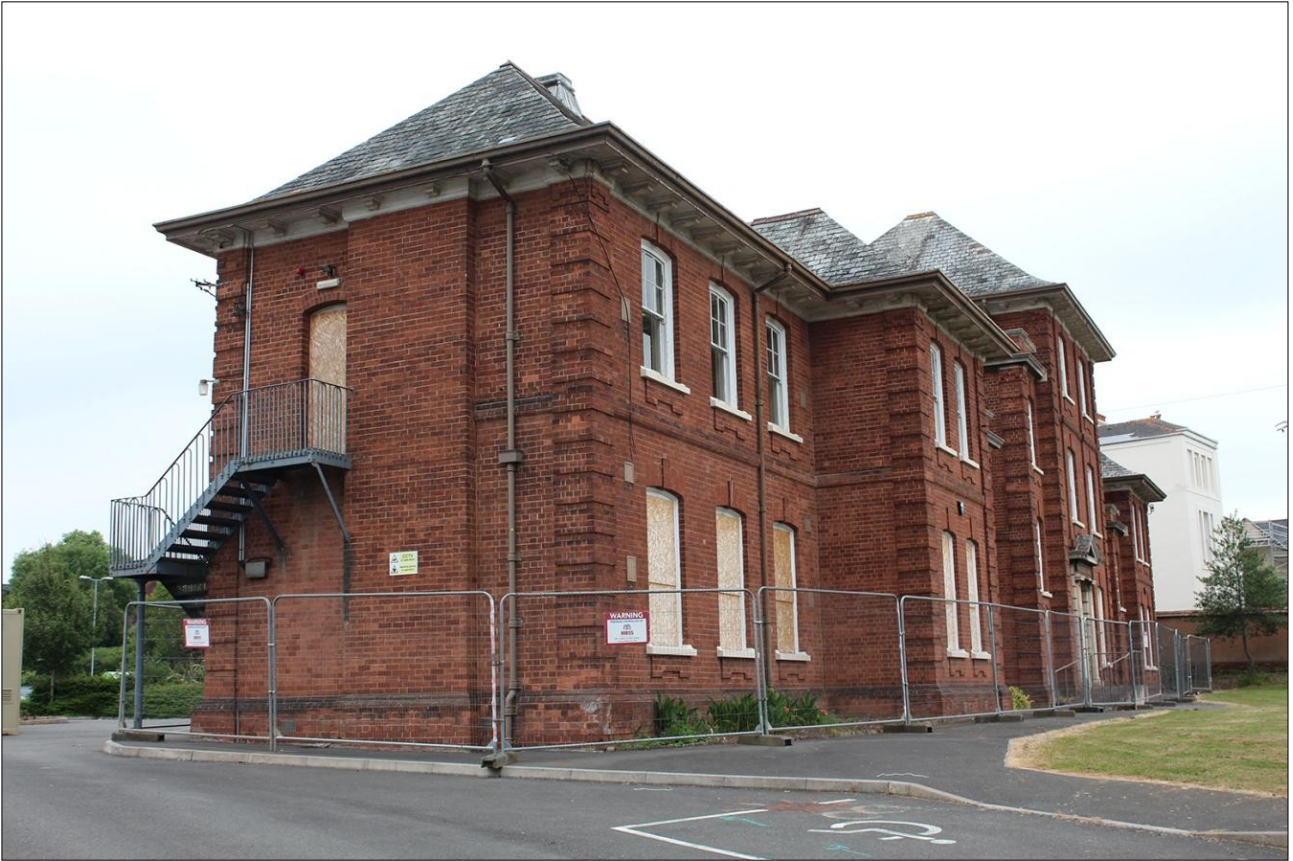
21. NORTH-WEST AND FRONT (SOUTH-EAST) EXTERNAL ELEVATIONS OF BUILDING; VIEWED FROM THE WEST.

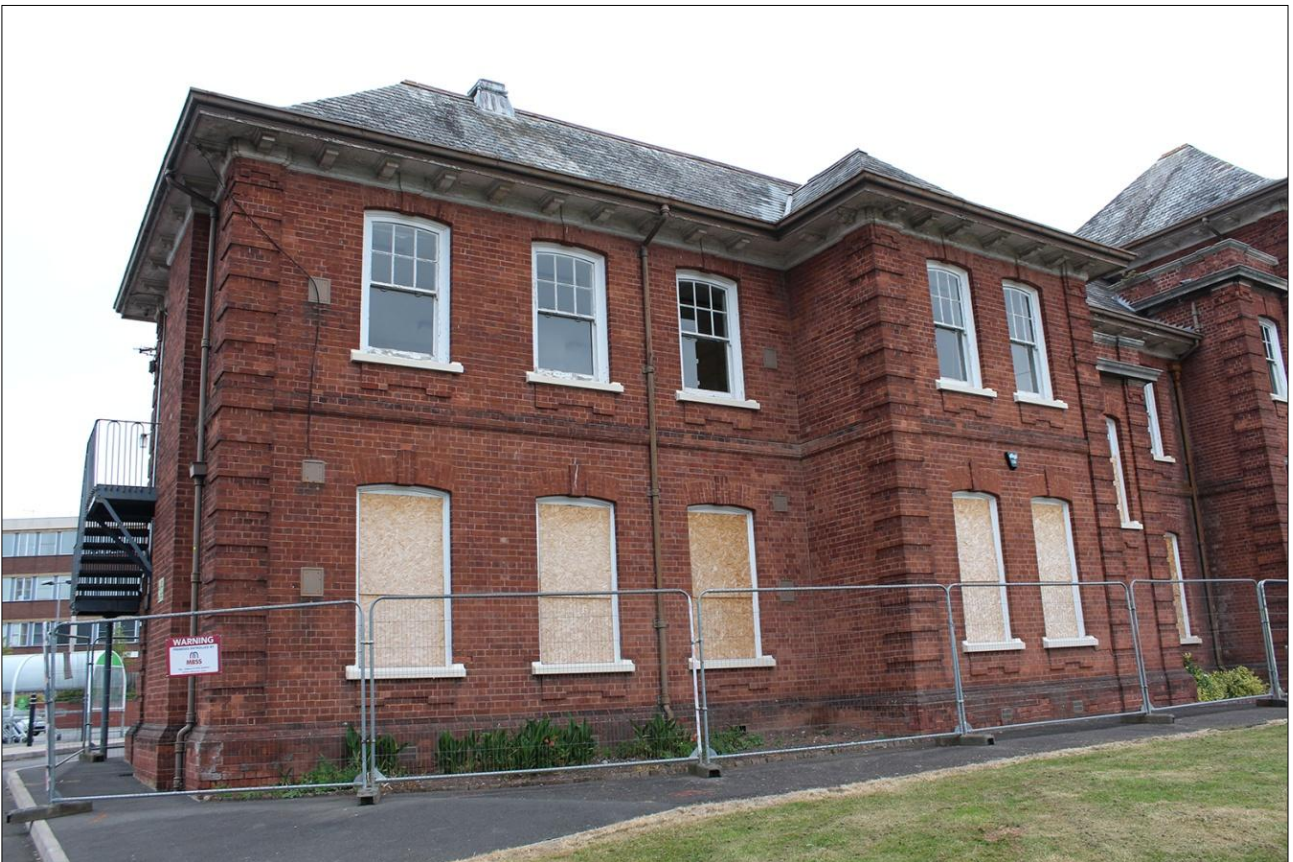
22. FRONT (SOUTH-WEST) EXTERNAL ELEVATION OF BUILDING, WEST END; VIEWED FROM THE SOUTH-WEST.

The front (south-west) façade exhibits carefully-considered classical architectural detailing, with keystone and voussoir-effect brickwork above each window and a flat notched plinth below, and projecting rusticated brick quoins to the corners. The single main entrance is located in the front elevation, comprising a grand stone doorway off-set in the central entrance block. It has a pedimented shallow canopy carried on flat fluted pilasters with a rusticated background. An additional entrance has been forced through the lowering of a window at the eastern end. The windows have stone carved painted sills and wide chunky moulded frames. The windows themselves are nine-over-one pane shallow arched horned sashes to the ground floor, with six-over-one pane shallow arched horned sashes to the first and second floors.

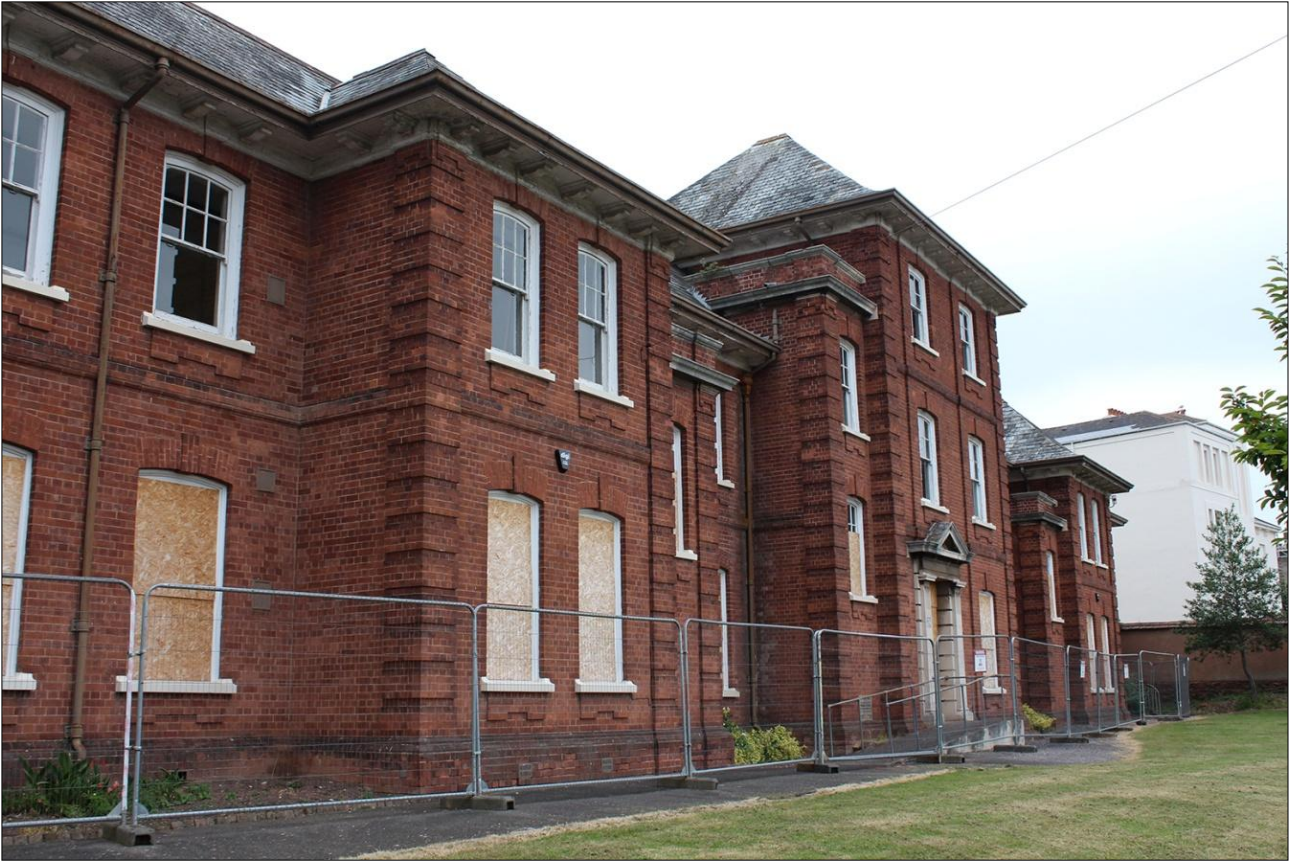
23. FRONT (SOUTH-WEST) EXTERNAL ELEVATION OF BUILDING; VIEWED FROM THE WEST.

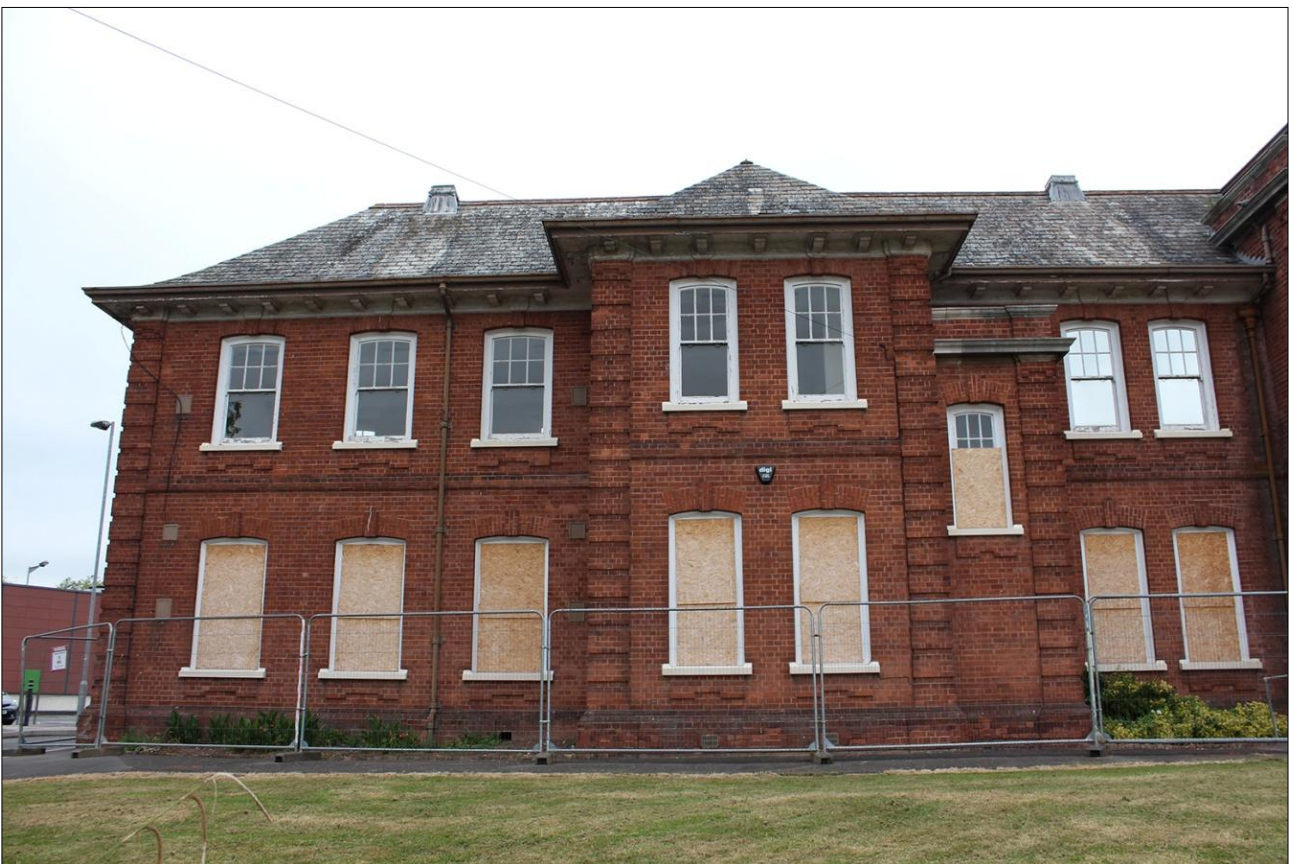
24. FRONT (SOUTH-WEST) EXTERNAL ELEVATION OF BUILDING, WEST END; VIEWED FROM THE SOUTH-WEST.

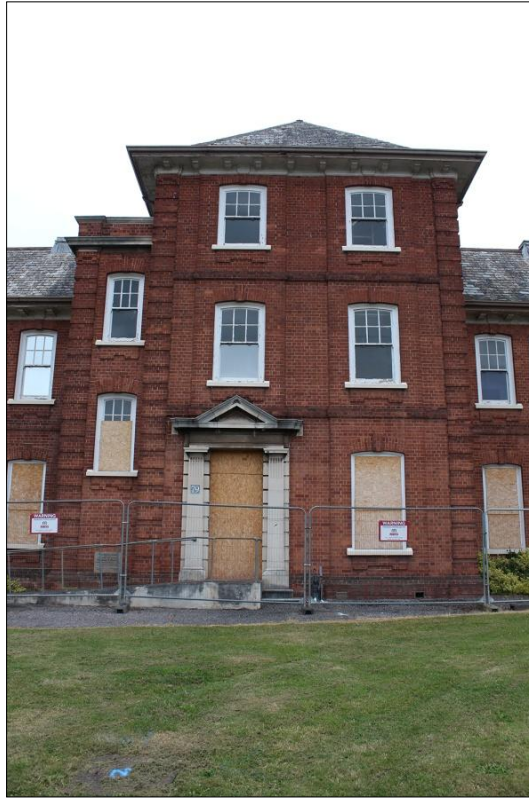
25. FRONT (SOUTH-WEST) EXTERNAL ELEVATION OF BUILDING, MID; VIEWED FROM THE SOUTH-WEST.

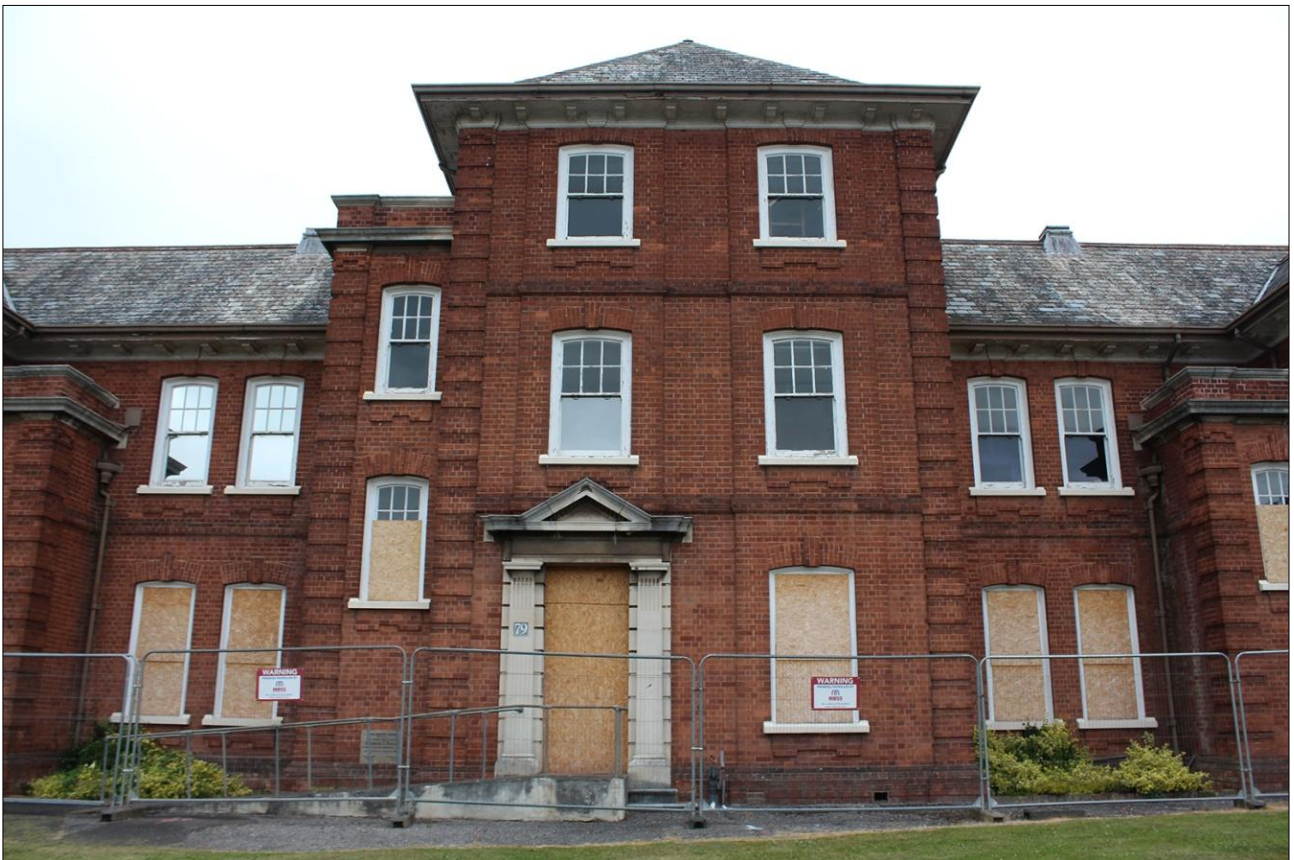
26. FRONT (SOUTH-WEST) EXTERNAL ELEVATION OF BUILDING, MID; VIEWED FROM THE SOUTH-WEST.

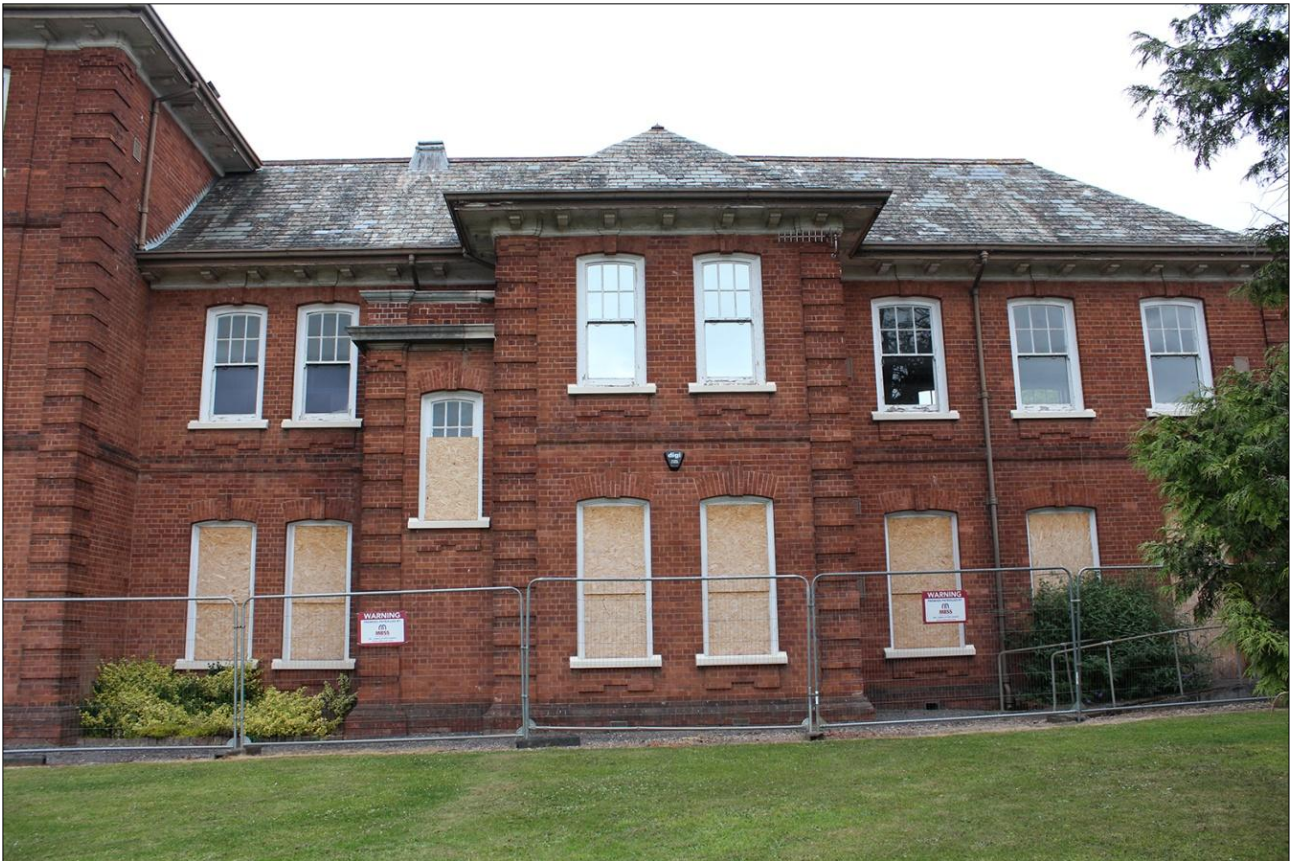
27. FRONT (SOUTH-WEST) EXTERNAL ELEVATION OF BUILDING, EAST END; VIEWED FROM THE SOUTH-WEST.

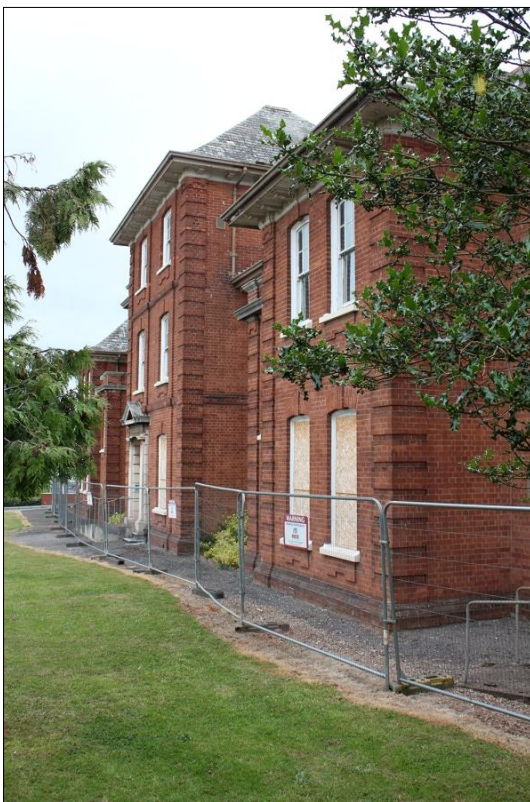
LEFT: 28. FRONT (SOUTH-WEST) EXTERNAL ELEVATION OF BUILDING; VIEWED FROM THE SOUTH-EAST.

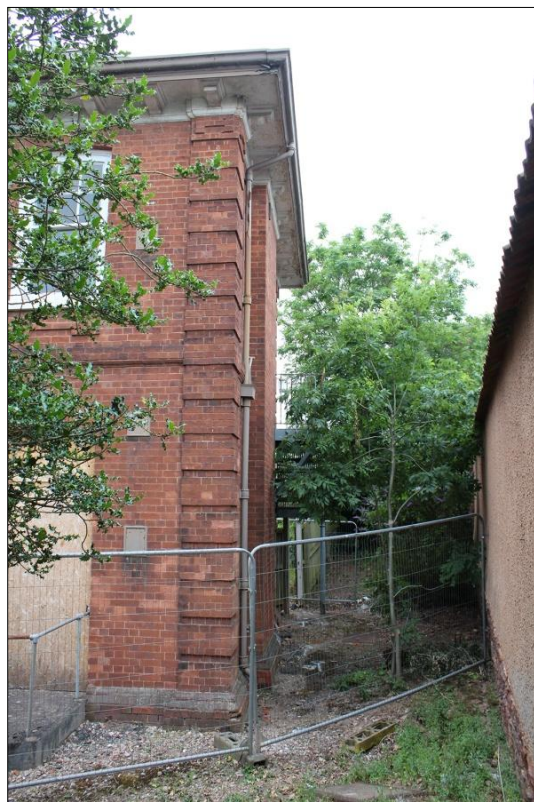
RIGHT: 29. NARROW PASSAGE ALONG SOUTH-EAST SIDE OF BUILDING, BOUNDARY WITH ADJACENT PROPERTY; VIEWED FROM THE SOUTH-WEST.

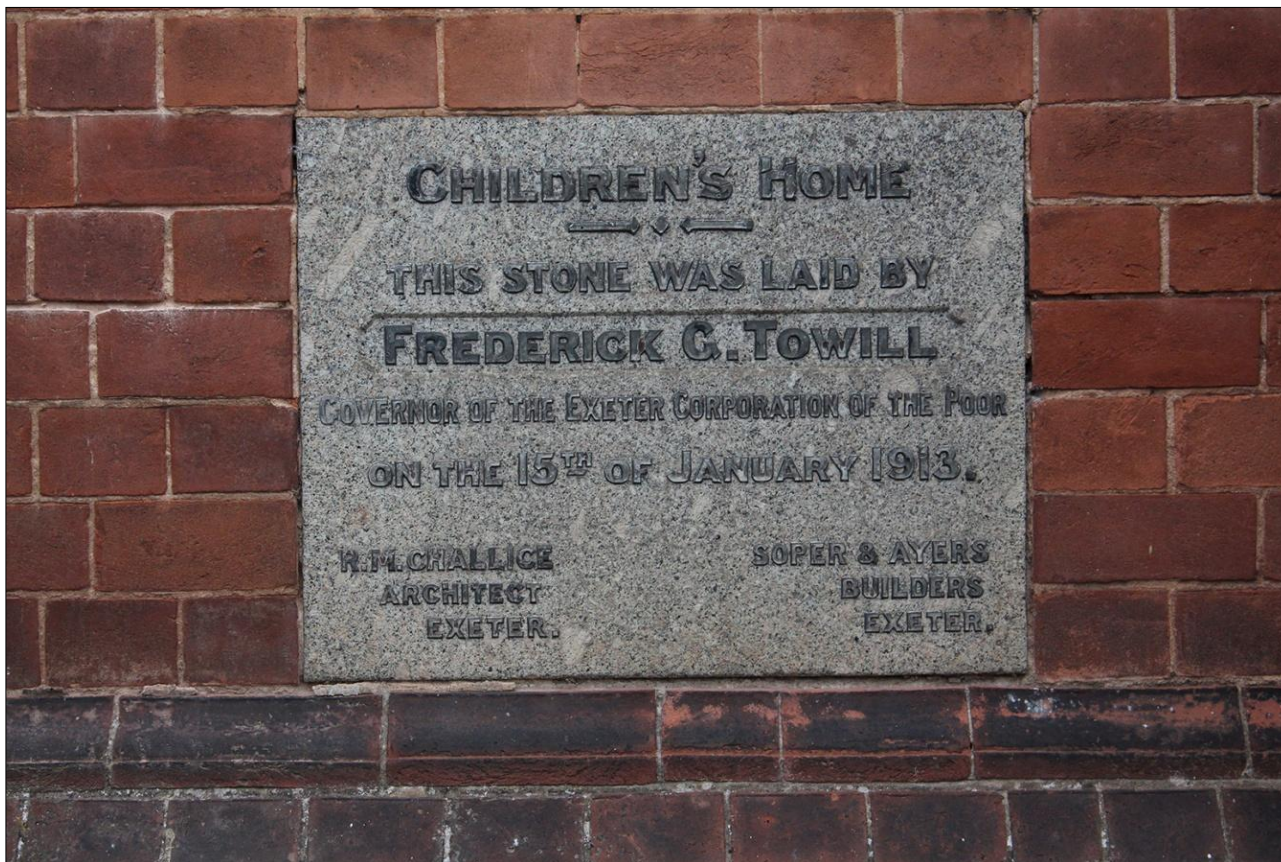
31. DETAIL OF PLAQUE/FOUNDATION STONE IN FRONT (SOUTH-WEST) EXTERNAL ELEVATION OF BUILDING; VIEWED FROM THE SOUTH-WEST.

Number 79 Heavitree Road, a large institutional building of late 'Queen Anne' style, is a purpose-built children's home raised by the Exeter Corporation (as expressed by the inscribed granite foundation stone in the front elevation). It consists of a central projecting block with flanking wings totalling twenty bays in length, and standing two storeys high with additional attic accommodation. It has a broadly symmetrical layout, with shallow intermediate projections from the wings brought forward to both the front and rear, with a stair block on the inner angle of each. There is a central deeply projecting two-bay (to the rear) entrance block with an asymmetric stair to the west side. The building is constructed of a distinctive mix of dark red-orange and red-brown bricks set on a stepped plinth base, with a moulded ogee string course to the first floor.

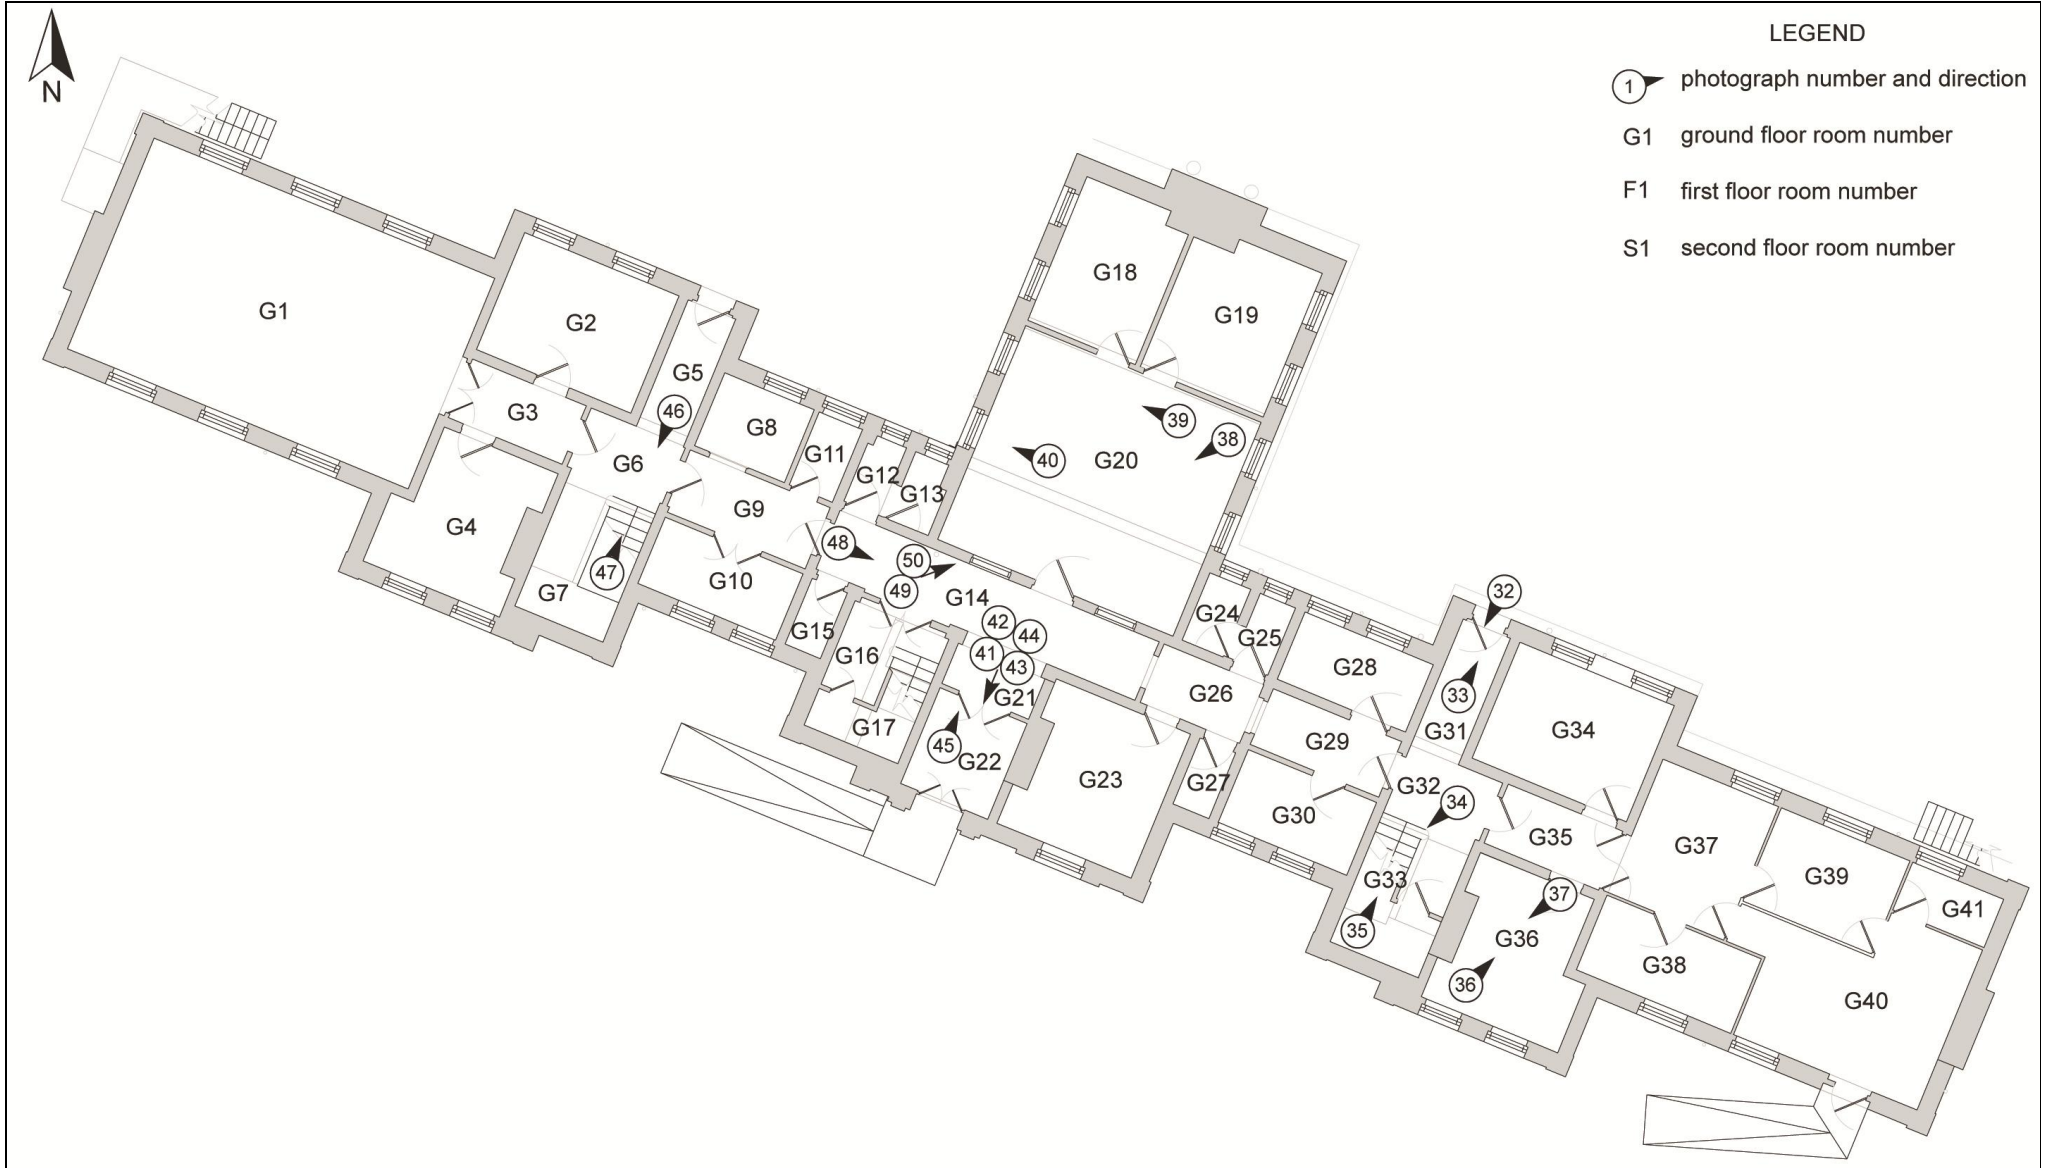
PLAN SHOWING THE LOCATION AND DIRECTION OF PHOTOGRAPHS TAKEN (GROUND FLOOR).

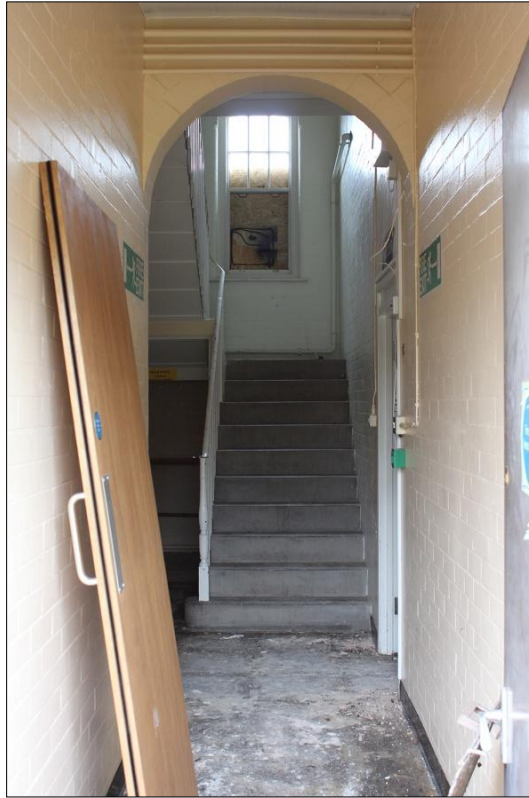
32. VIEW OF REAR ENTRANCE CORRIDOR ROOM 31, EAST WING OF BUILDING; VIEWED FROM THE NORTH-EAST.

Two good original 9-over-1 pane shallow arched sash windows to front wall.	
G31	Hallway leading to rear door to yard/playground area?	Polished cream ceramic 'subway' style narrow tiles, black tiles to skirting. Integral arches to openings between hallway and corridor. Shallow arched four pane hopper sash with brass catch above door to rear. Historic pipework for heating system. Worn slate slab threshold to external doorway.	Space of good surviving historic character.
G32	Lobby, part of spine corridor	Polished cream ceramic 'subway' style narrow tiles, black tiles to skirting.	Altered by numerous fire door partitions which have been inserted into the building.
G33	Stairs to/from dormitory	Fine cast-iron stair banister with flat handrail and stick balusters, coiled curtail step and 'turned effect vase-style' newel post. Concrete steps. Polished cream ceramic 'subway' style narrow tiles, black tiles to skirting. Integral arches to openings between hallway and corridor. Small green tiles to floor, early vinyl or similar?	Space of good surviving historic character.

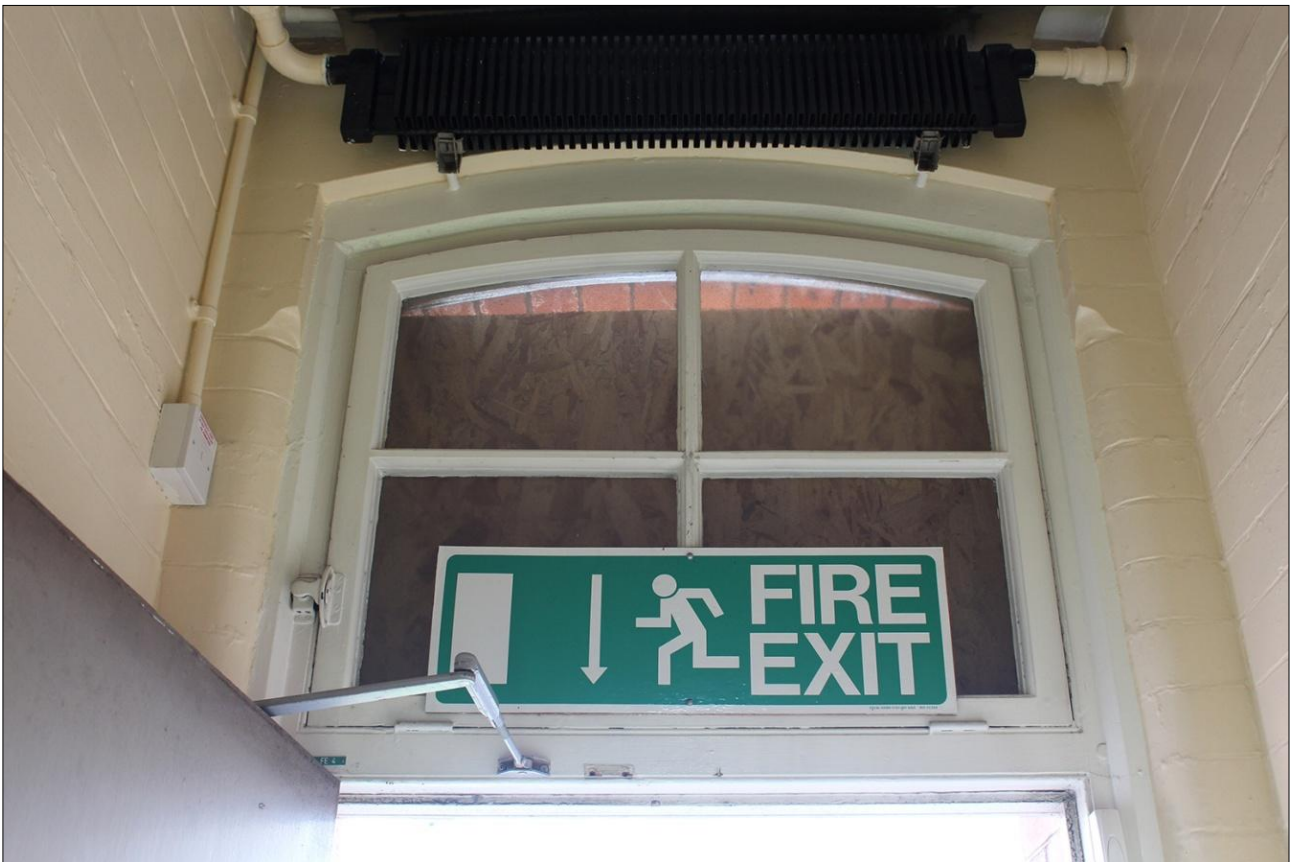
33. DETAIL OF WINDOW OPENING ABOVE REAR DOOR OF ROOM 31, EAST WING OF BUILDING; VIEWED FROM THE SOUTH-WEST.

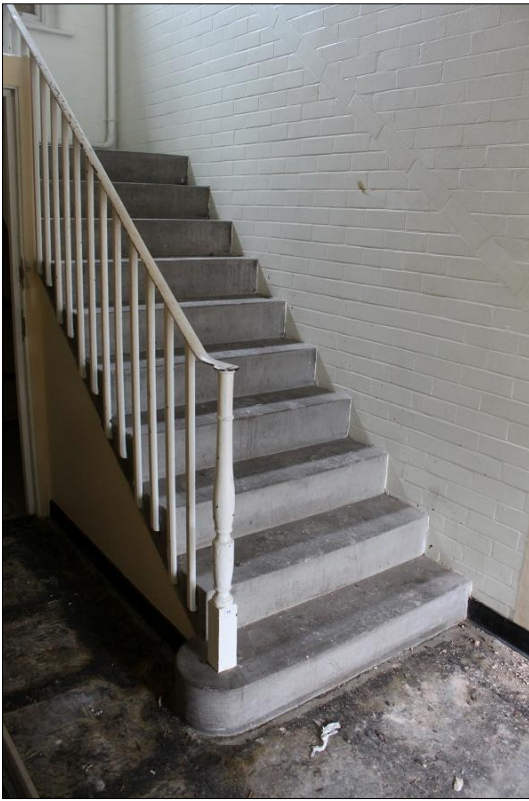
LEFT: 34. DETAIL OF STAIRWELL IN ROOM 32, EAST WING OF BUILDING; VIEWED FROM THE NORTH-EAST.
