79 HEAVITREE ROAD

RESULTS OF AN ARCHAEOLOGICAL EVALUATION AND RAPID BUILDING RECORDING

SOUTH WEST ARCHAEOLOGY LTD. REPORT NO. 181002

79 Heavitree Road, Exeter, Devon Results of an Archaeological Evaluation and Rapid Building Recording

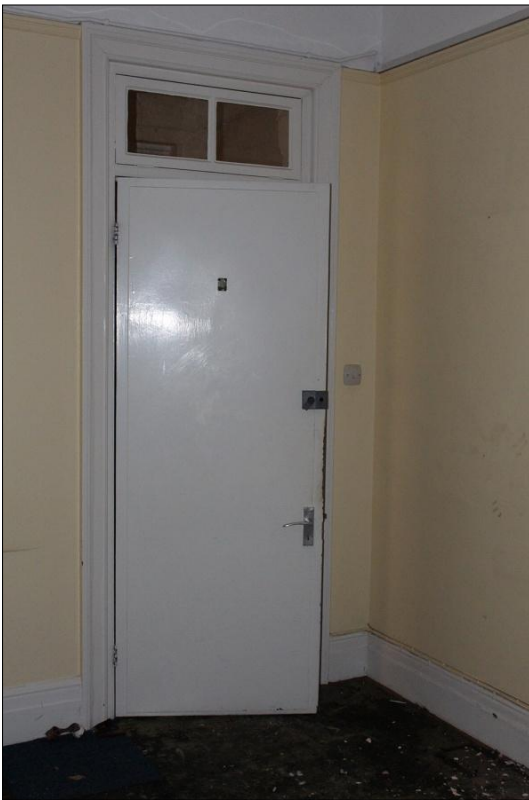
LEFT: 36. DETAIL OF DOOR OPENING IN ROOM 36; VIEWED FROM THE SOUTH-WEST.

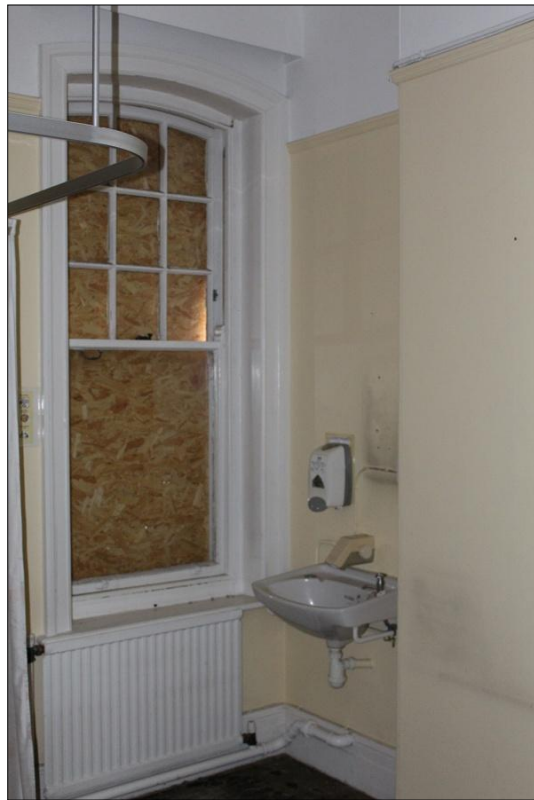
RIGHT: 37. DETAIL OF ROOM 36; VIEWED FROM THE NORTH-EAST.

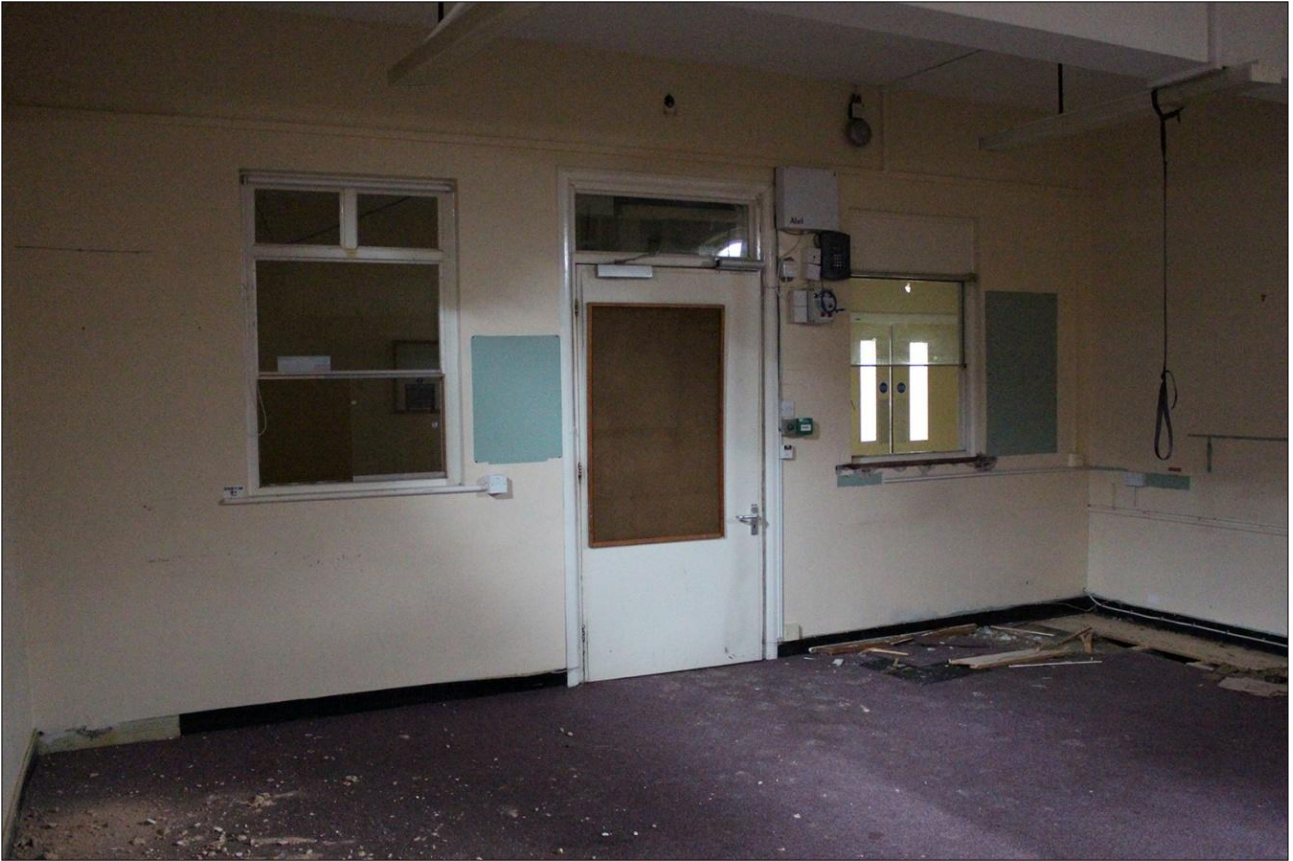
38. VIEW OF ROOM 20, DOOR AND WINDOW OPENINGS IN INTERNAL SOUTH-WEST WALL; VIEWED FROM THE NORTH-EAST.

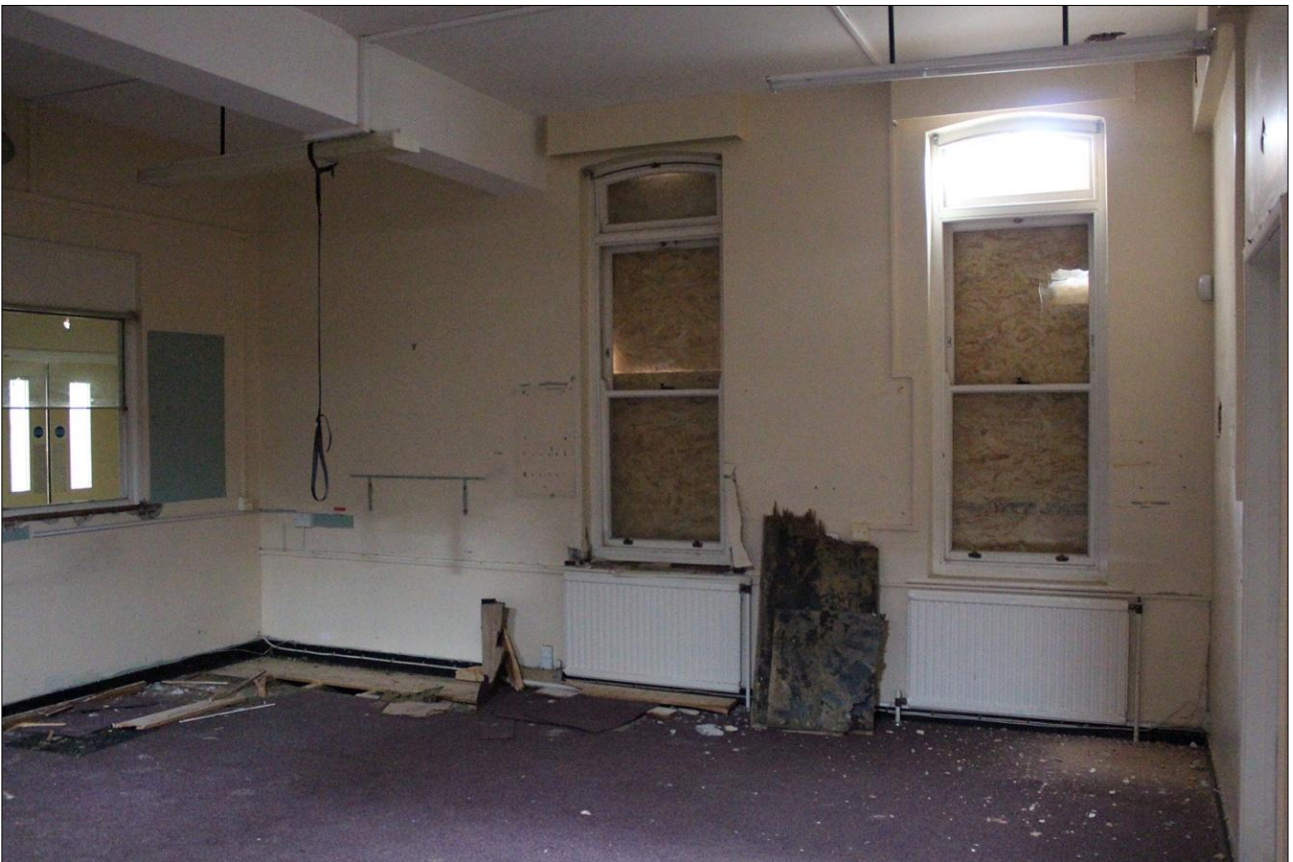
39. VIEW OF ROOM 20, WINDOW OPENINGS IN NORTH-WEST WALL; VIEWED FROM THE EAST.

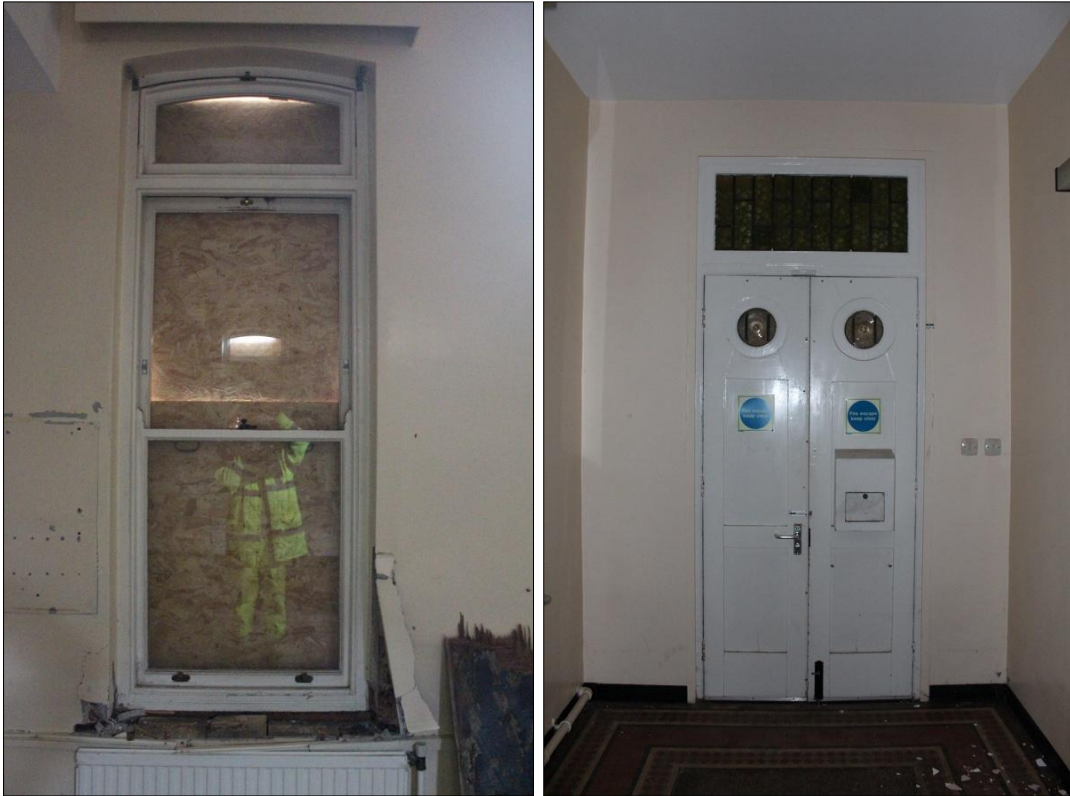
LEFT: 40. DETAIL OF WINDOW OPENING IN NORTH-WEST WALL, ROOM 20; VIEWED FROM THE SOUTH-EAST.
RIGHT: 41. DETAIL OF THE FRONT DOOR, ROOM 22; VIEWED FROM THE NORTH-EAST.

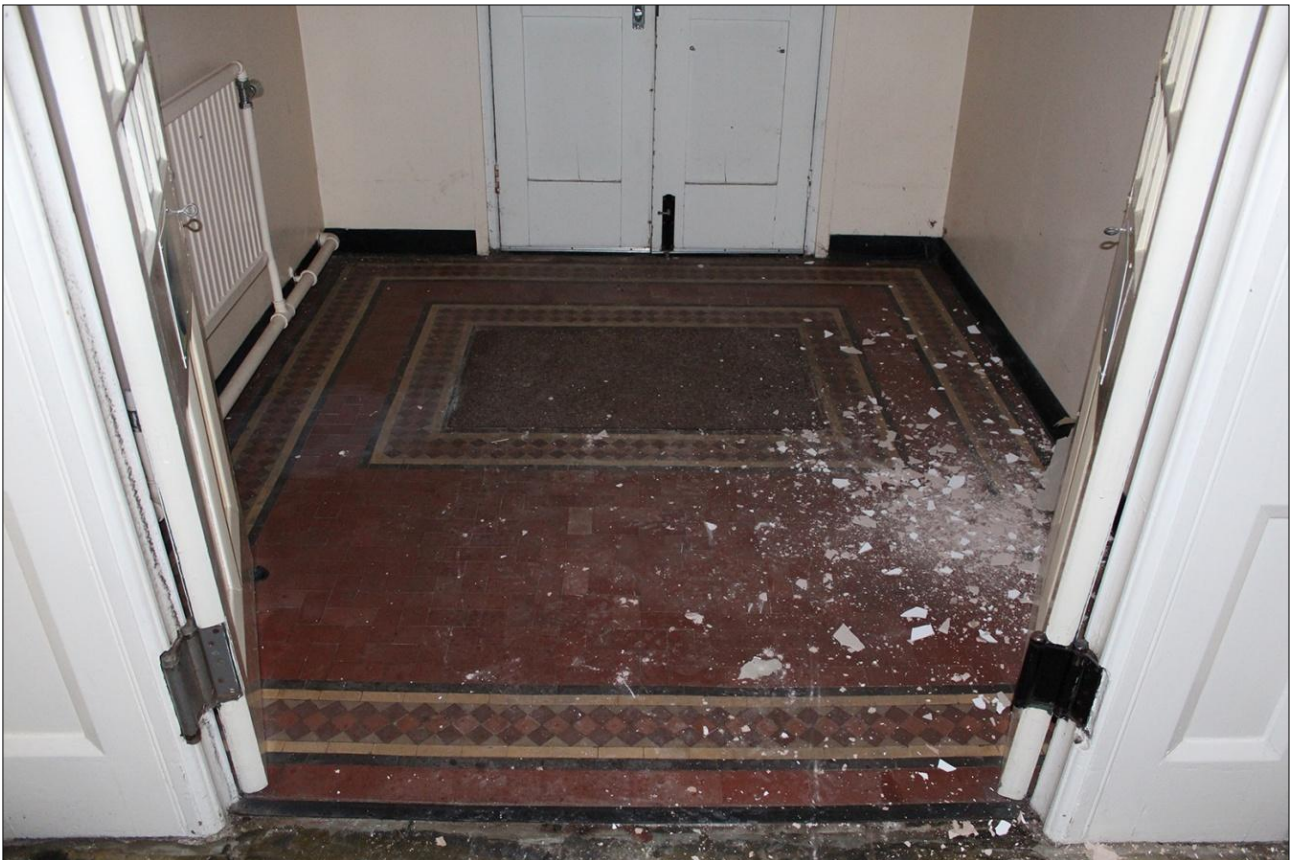
42. DETAIL OF FLOOR IN ROOM 22; VIEWED FROM THE NORTH-EAST.

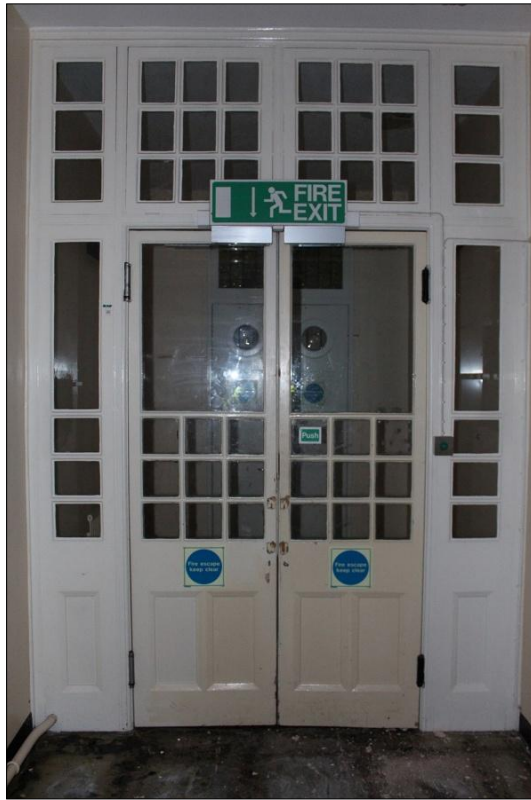
43. DETAIL OF SCREEN BETWEEN ROOM 21 AND ROOM 22; VIEWED FROM THE NORTH-EAST.

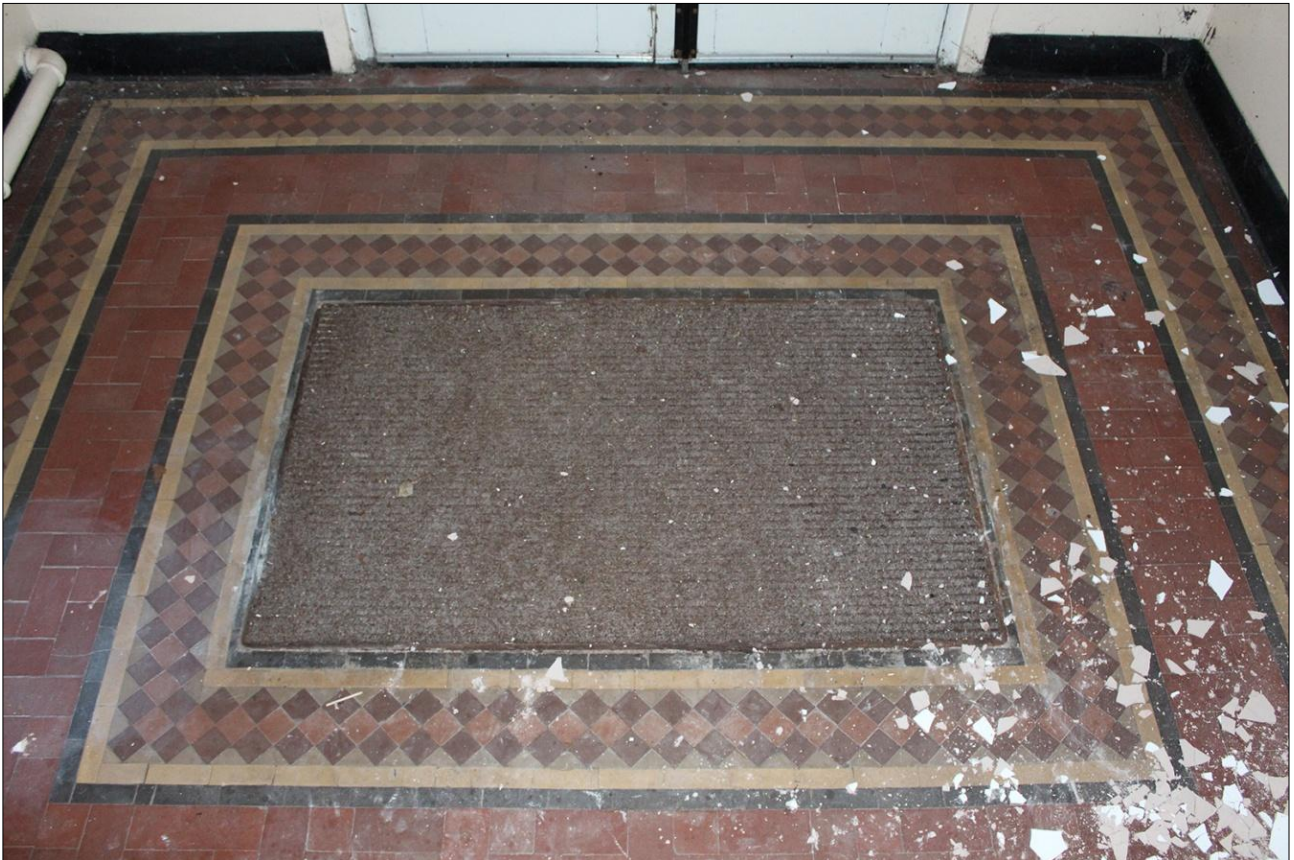
44. DETAIL OF FLOOR SURFACE WITHIN ROOM 22; VIEWED FROM THE NORTH-EAST.

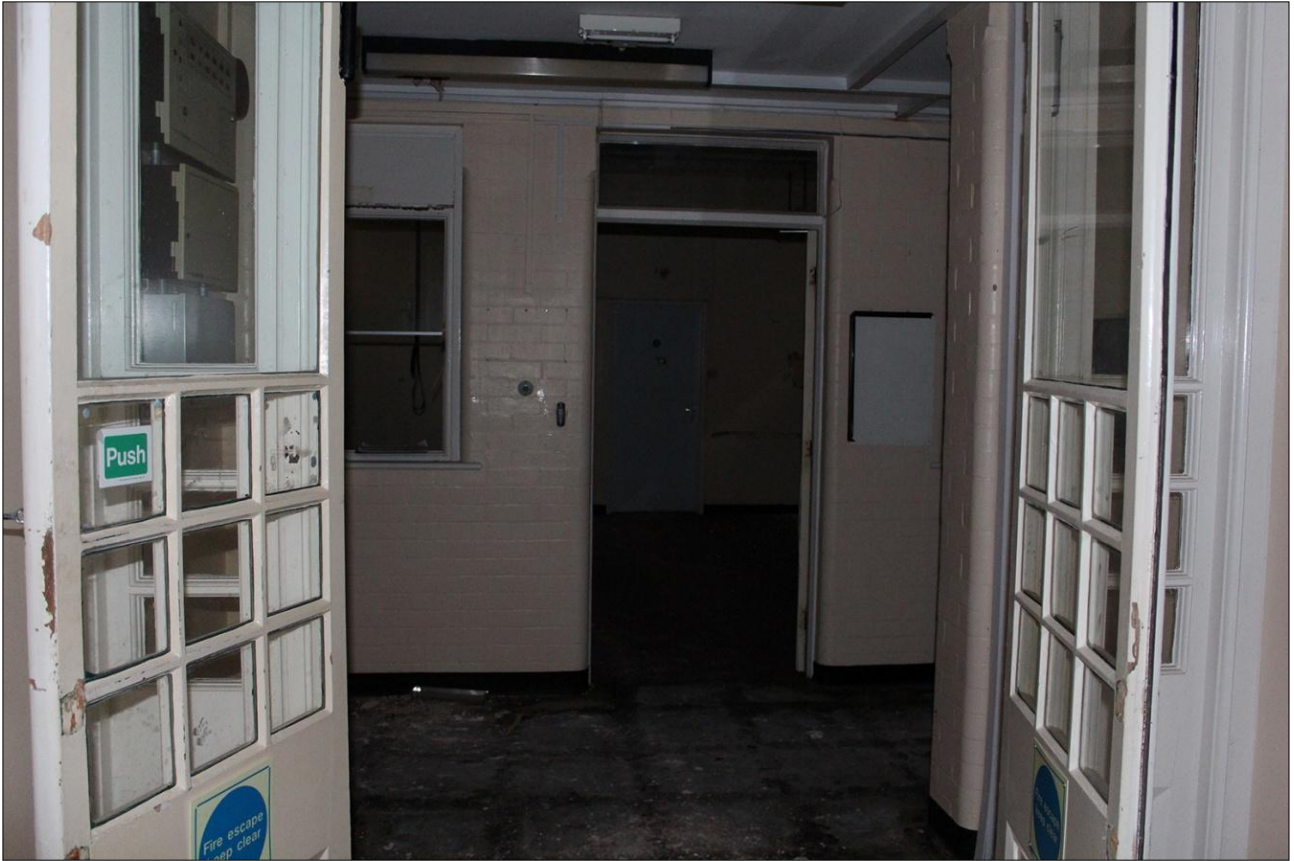
45. VIEW OF ROOM 21; VIEWED FROM THE SOUTH-WEST.

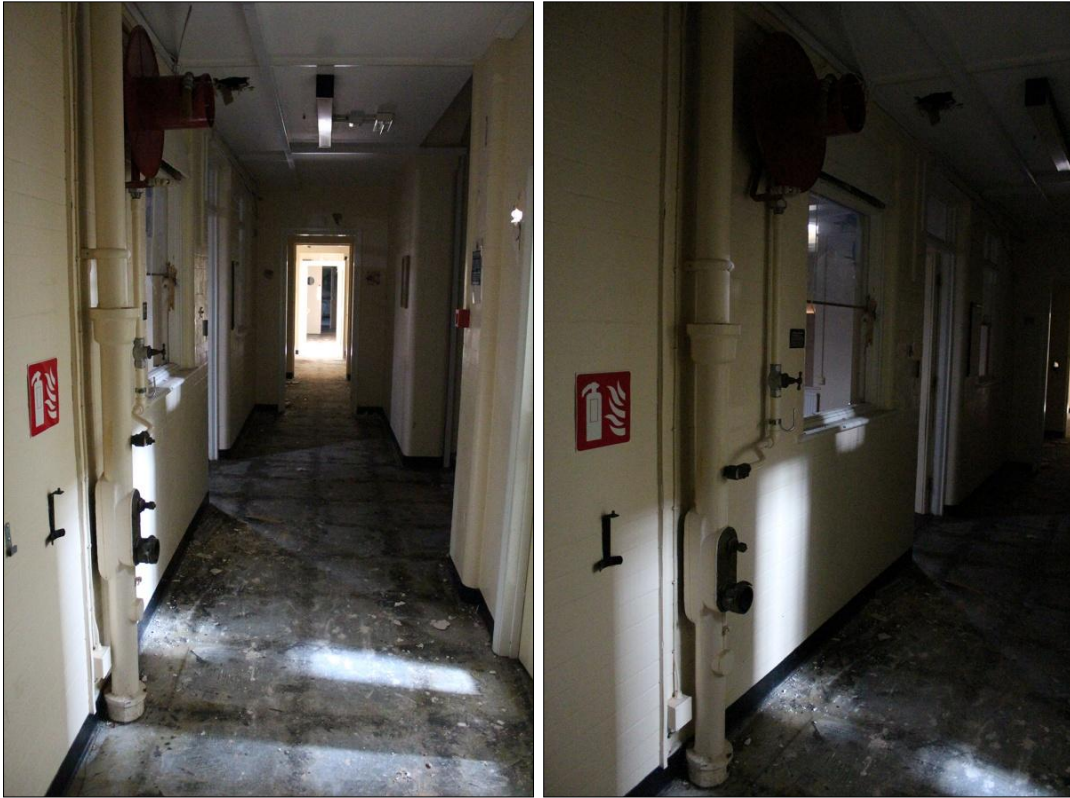
LEFT: 48. VIEW ALONG MAIN CORRIDOR ROOM 14; VIEWED FROM THE NORTH-WEST.

RIGHT: 49. DETAIL OF THE FIRE HYDRANT IN THE MAIN CORRIDOR, ROOM 14; VIEWED FROM THE WEST.

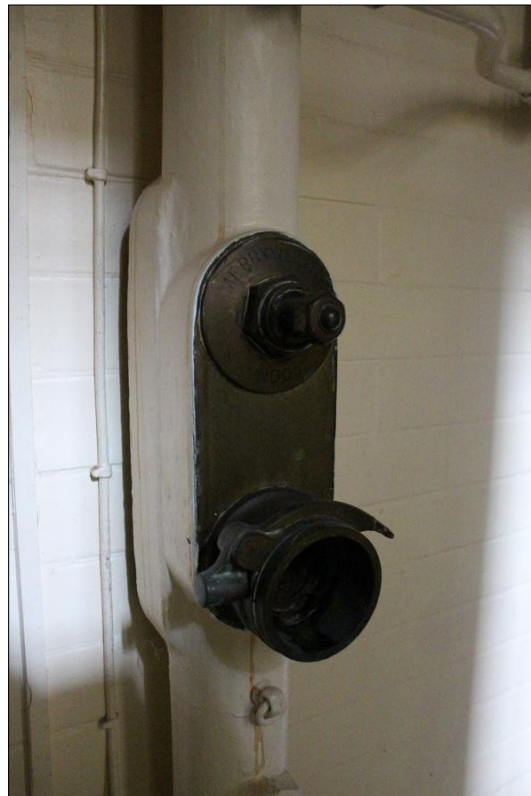
50. DETAIL OF THE FIRE HYDRANT IN THE MAIN CORRIDOR, ROOM 14; VIEWED FROM THE WEST.

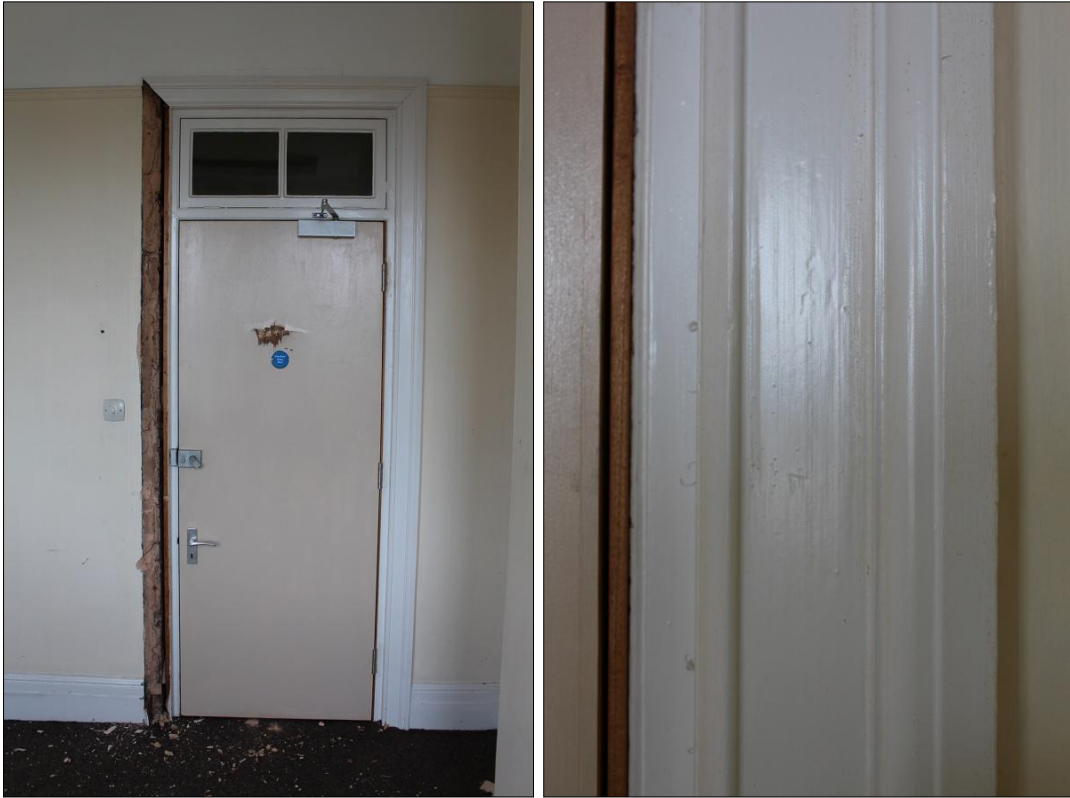
LEFT: 51. DETAIL OF DOOR IN NORTH-EAST WALL, ROOM F4; VIEWED FROM THE SOUTH-WEST.

RIGHT: 52. DETAIL OF THE MOULDINGS ON THE DOOR FRAME, NORTH-EAST WALL, ROOM F4; VIEWED FROM THE SOUTH-WEST.

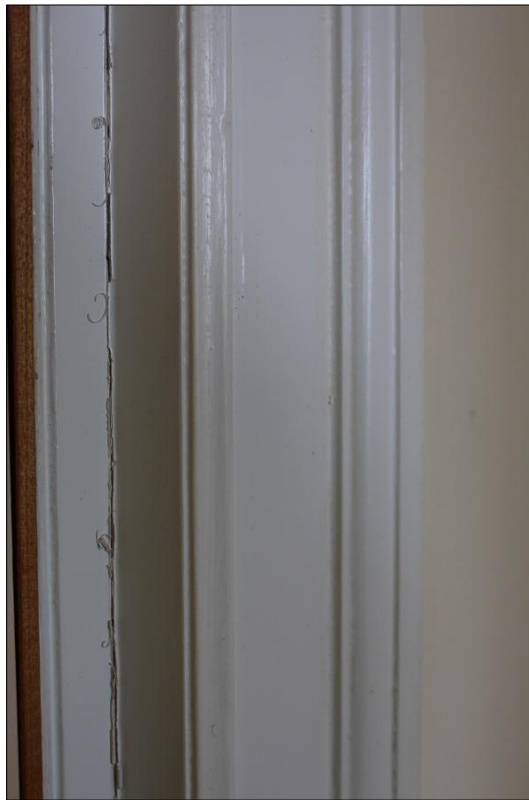
53. DETAIL OF THE MOULDINGS ON THE DOOR FRAME, NORTH-EAST WALL, ROOM F4; VIEWED FROM THE SOUTH-WEST.

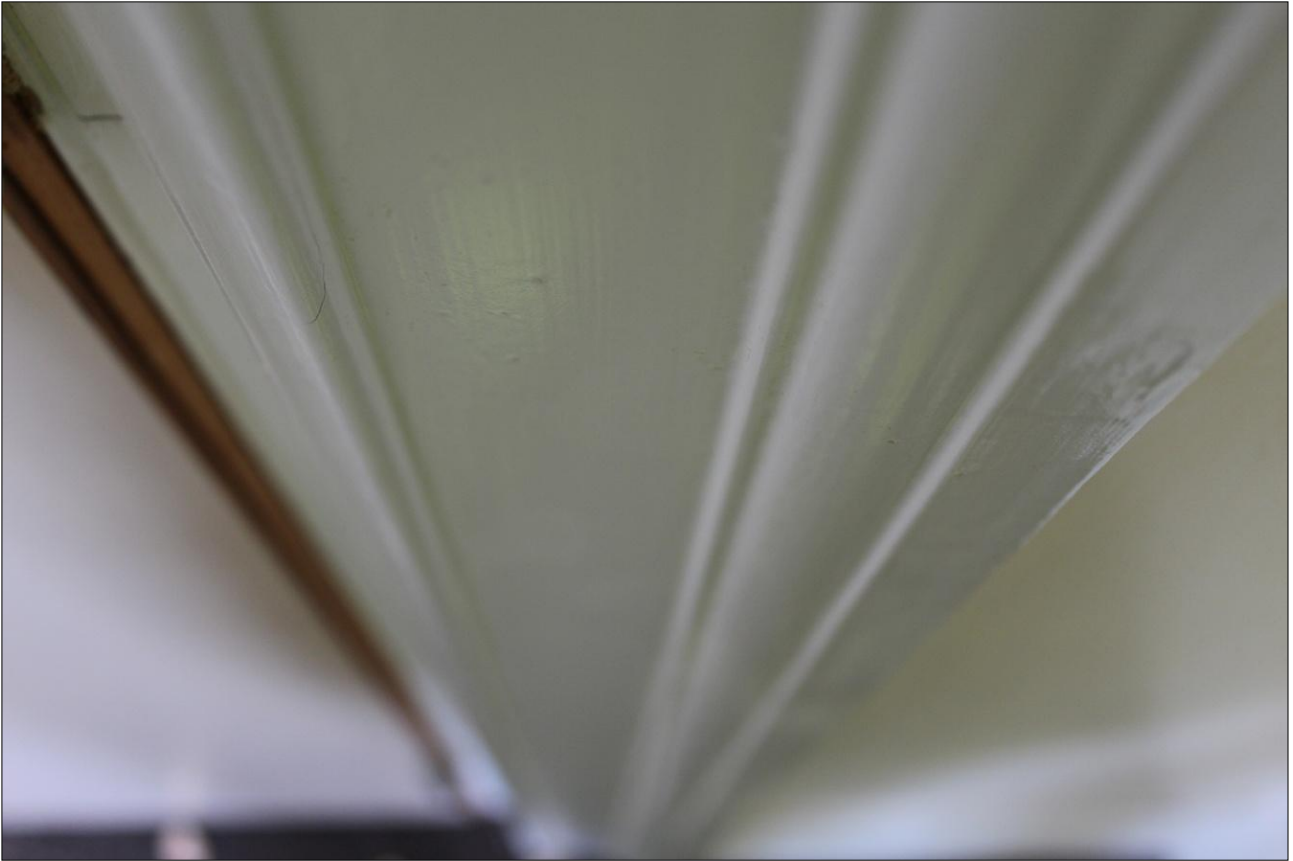
54. DETAIL OF THE MOULDINGS ON THE DOOR FRAME, NORTH-EAST WALL, ROOM F4; VIEWED FROM THE SOUTH-WEST.

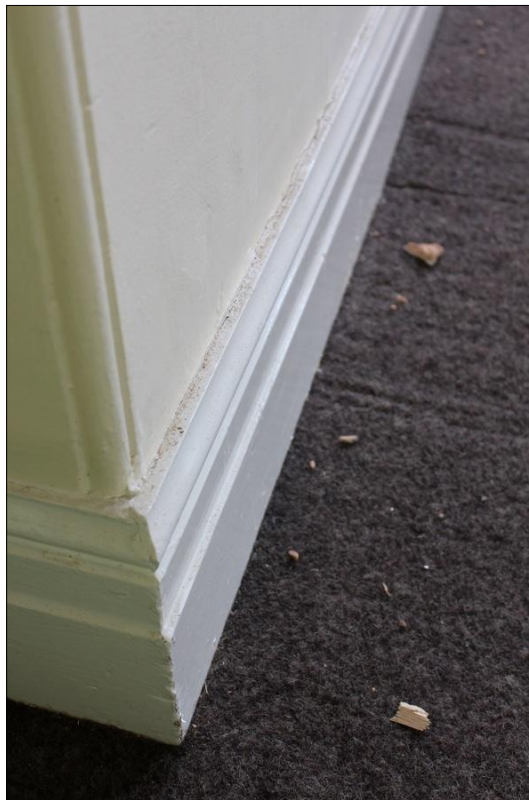
55. DETAIL OF SKIRTING, ROOM F4; VIEWED FROM THE NORTH-EAST.

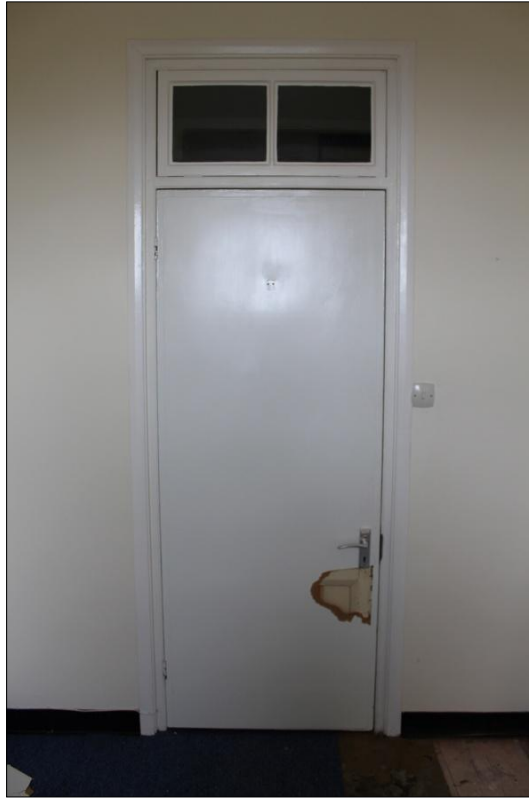
59. VIEW OF THE DOOR IN THE NORTH-EAST WALL OF ROOM F13, SHOWING IT TO BE AN ORIGINAL 1913 PANELLED DOOR; VIEWED FROM THE SOUTH-WEST.

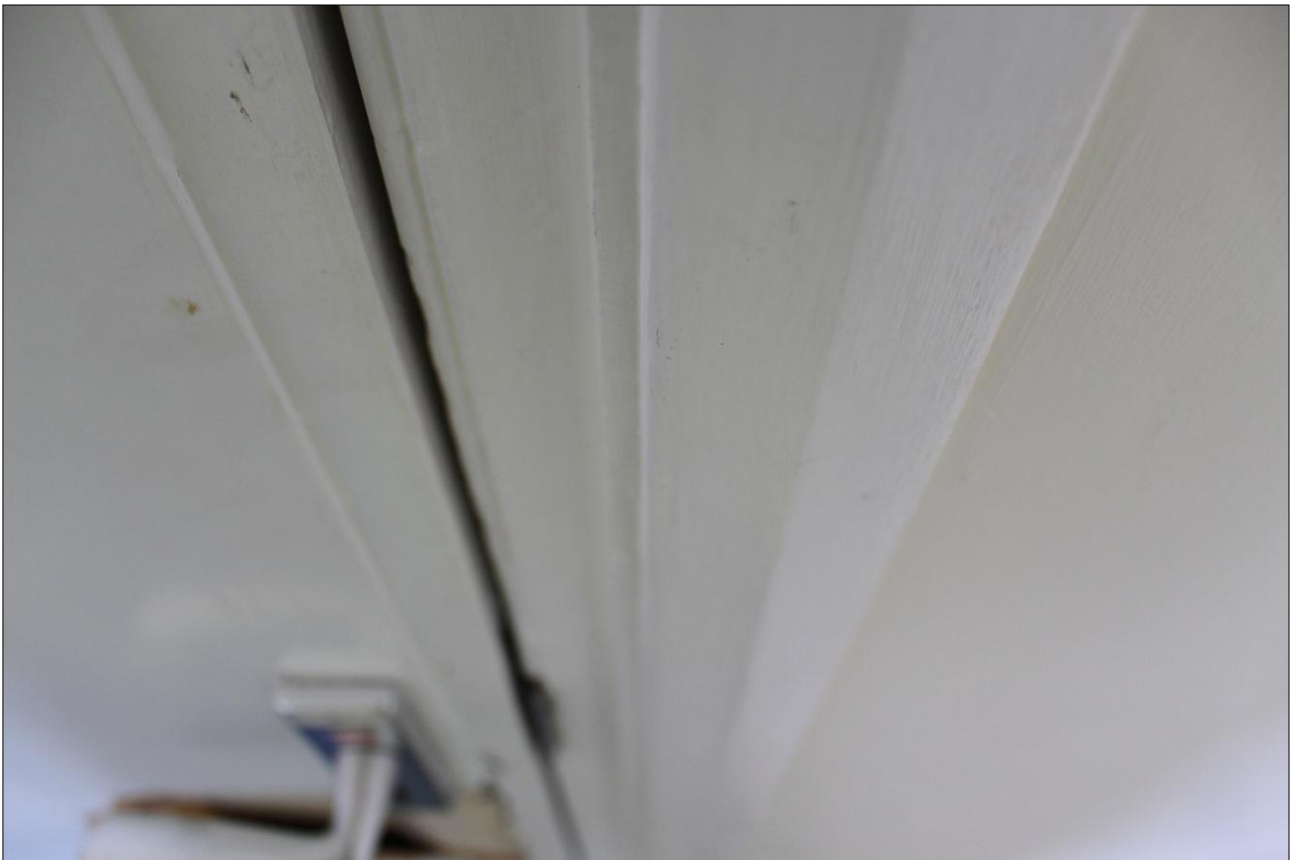
60. DETAIL OF THE MOULDINGS ON THE DOOR FRAME IN THE NORTH-EAST WALL, ROOM F13; VIEWED FROM THE SOUTH-WEST.

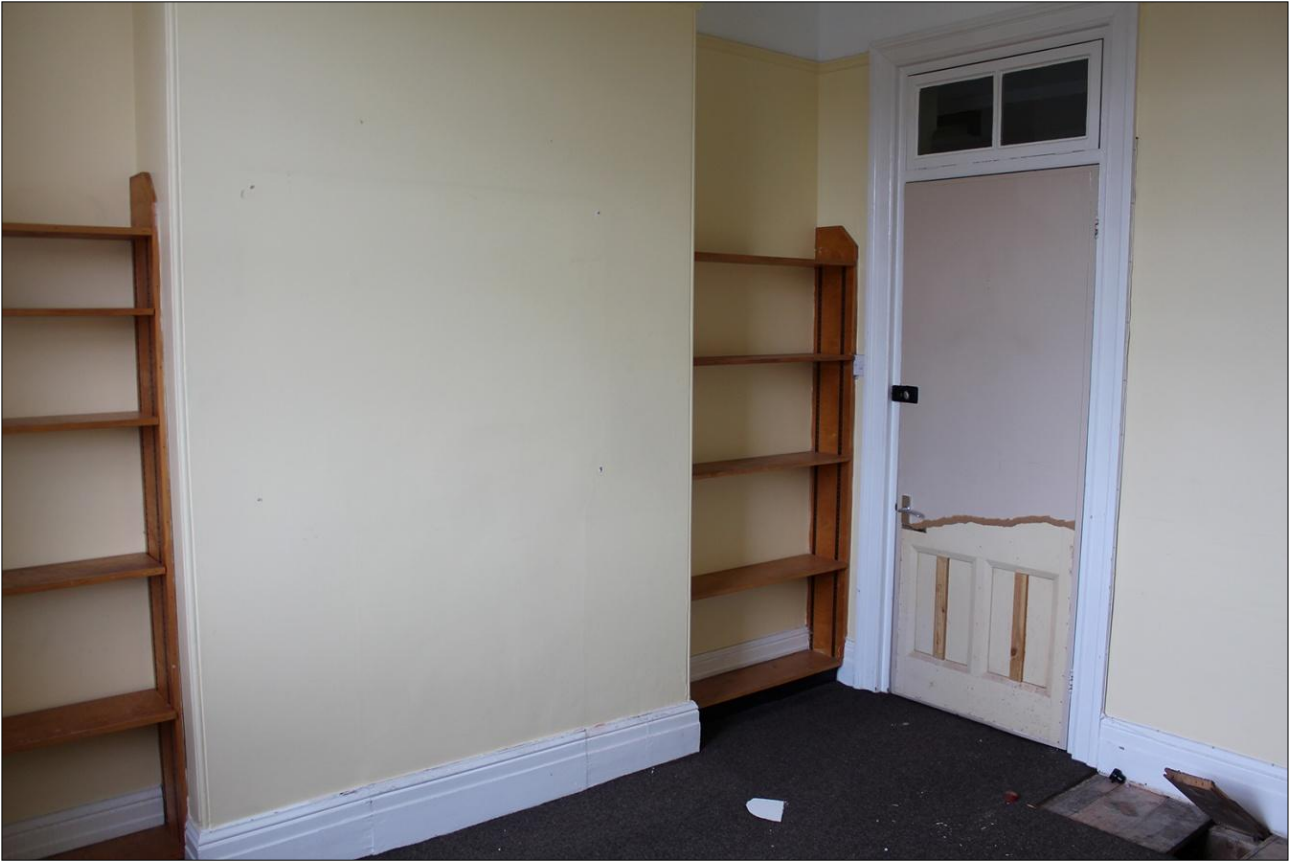
61. VIEW OF ROOM F14 SHOWING THE BLOCKED FIREPLACE IN THE NORTH-WEST WALL; VIEWED FROM THE SOUTH-EAST.

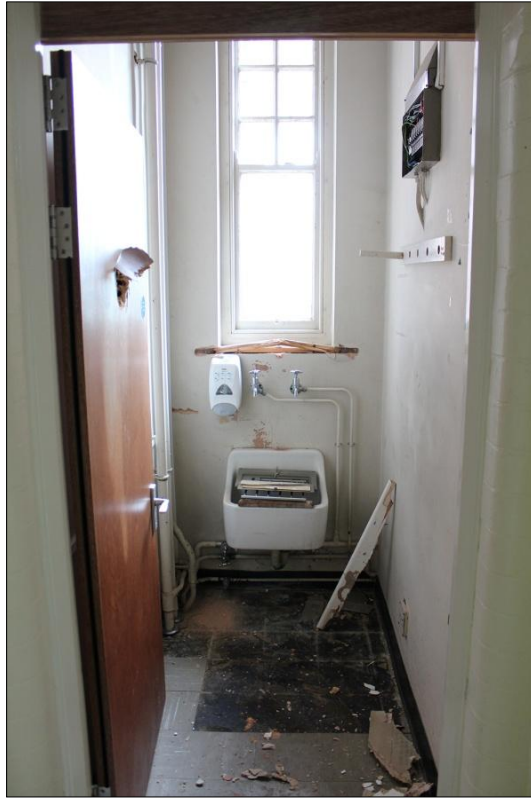
63. DETAIL OF F15 SHOWING INDICATING FORMER FUNCTION AS BATHROOM; VIEWED FROM THE SOUTH-WEST.

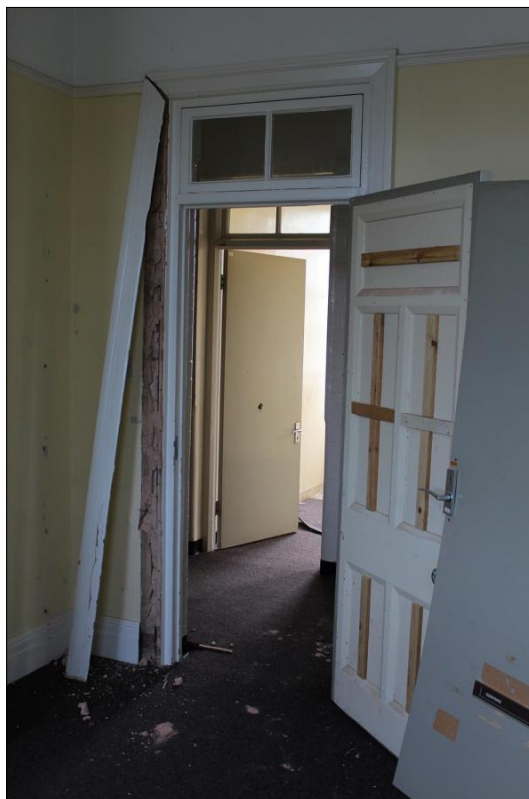
66. VIEW OF THE DOOR IN THE NORTH-EAST WALL OF ROOM F25, DEMONSTRATING IT TO BE A 1913 ORIGINAL; VIEWED FROM THE SOUTH-EAST.

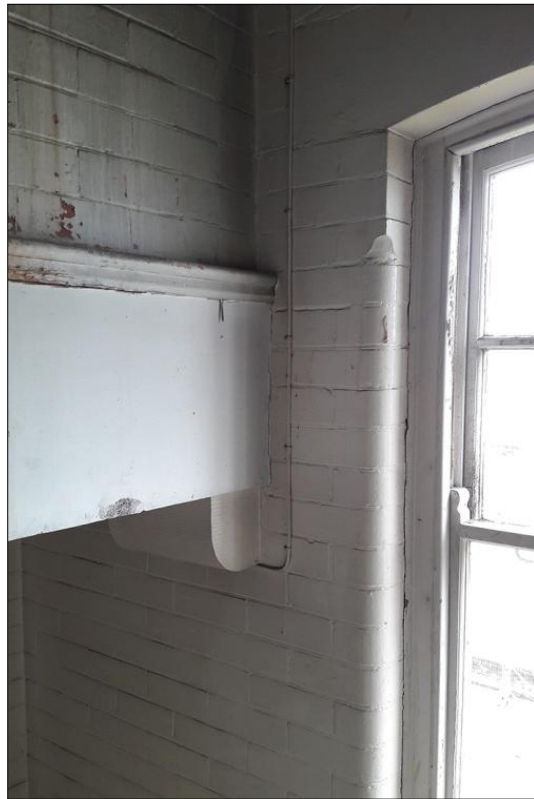
LEFT: 72. DETAIL OF STAIRWELL G7 FROM SECOND FLOOR LANDING; VIEWED FROM THE NORTH-EAST.

RIGHT: 73. DETAIL OF STAIRWELL G7 FROM SECOND FLOOR LANDING, SHOWING THE CORBEL SUPPORTING THE HEAVY BEAM; VIEWED FROM THE NORTH-EAST.

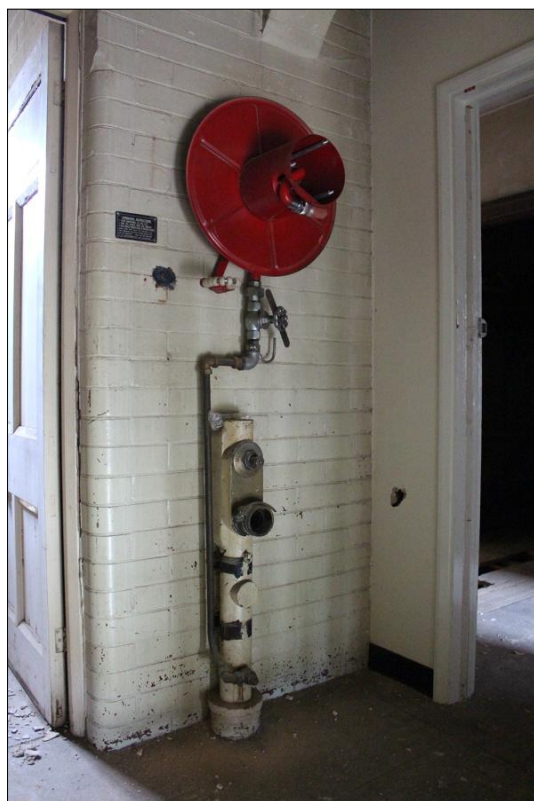
LEFT: 75. THE FIRE HYDRANT IN ROOM S3; VIEWED FROM THE WEST.

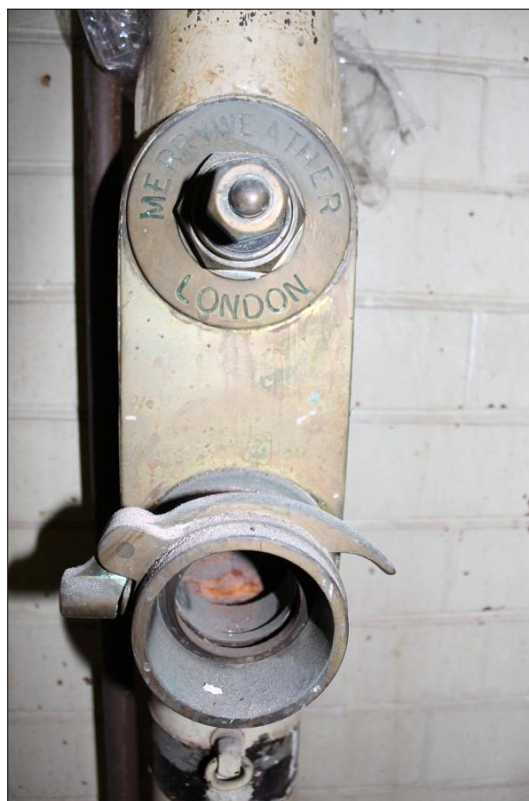
RIGHT: 76. DETAIL OF THE FIRST HYDRANT IN ROOM S3; VIEWED FROM THE WEST.

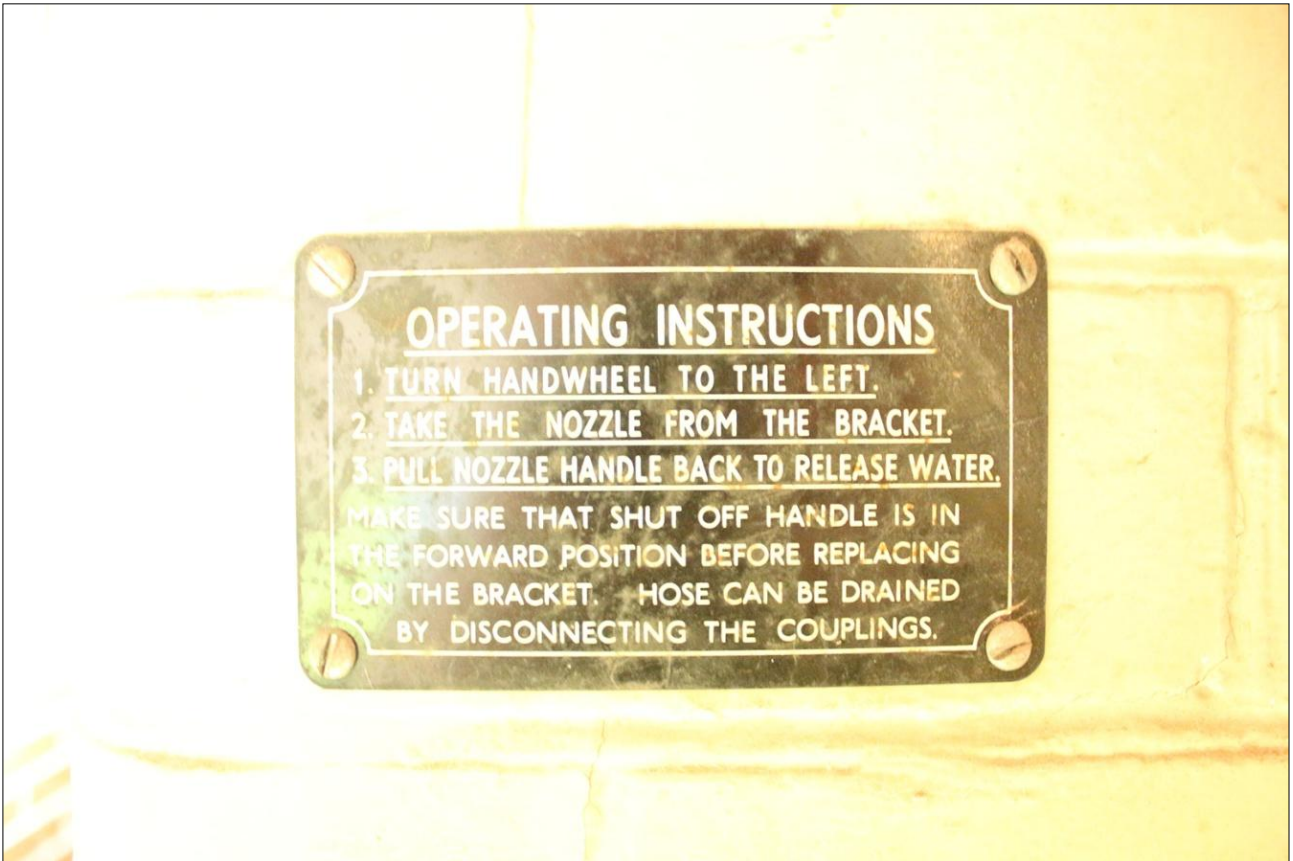
77. OPERATING INSTRUCTIONS FOR THE FIRE HYDRANT IN ROOM S3; VIEWED FROM THE WEST.

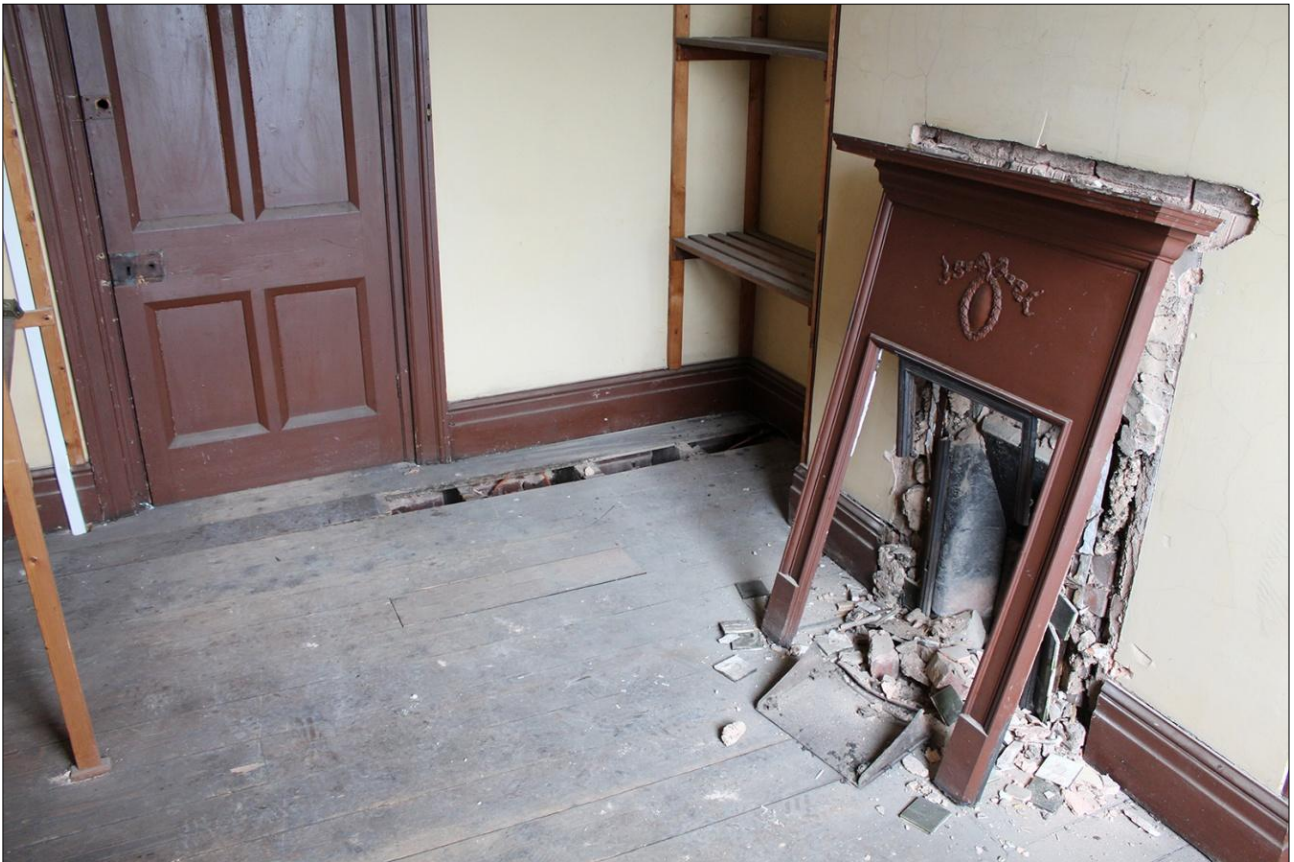
81. DETAIL OF THE FIREPLACE IN THE SOUTH-EAST WALL OF ROOM S6; VIEWED FROM THE SOUTH-WEST. THE FIREPLACE WAS TORN OFF TO CHECK FOR ASBESTOS.

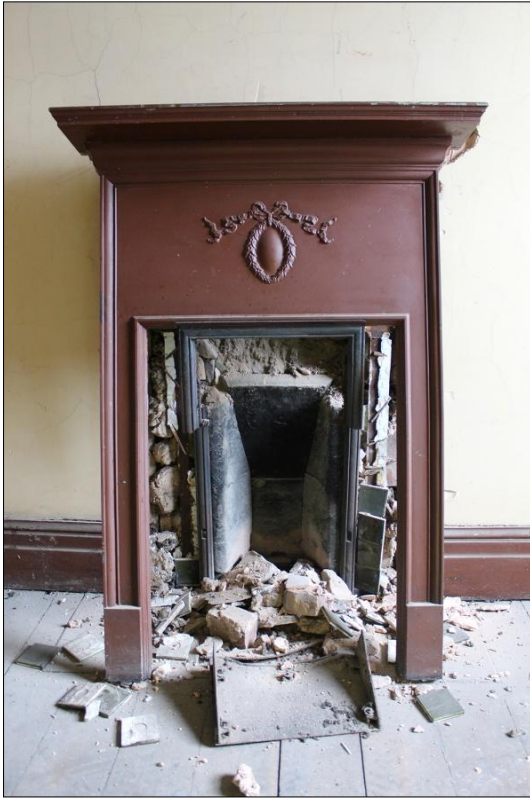
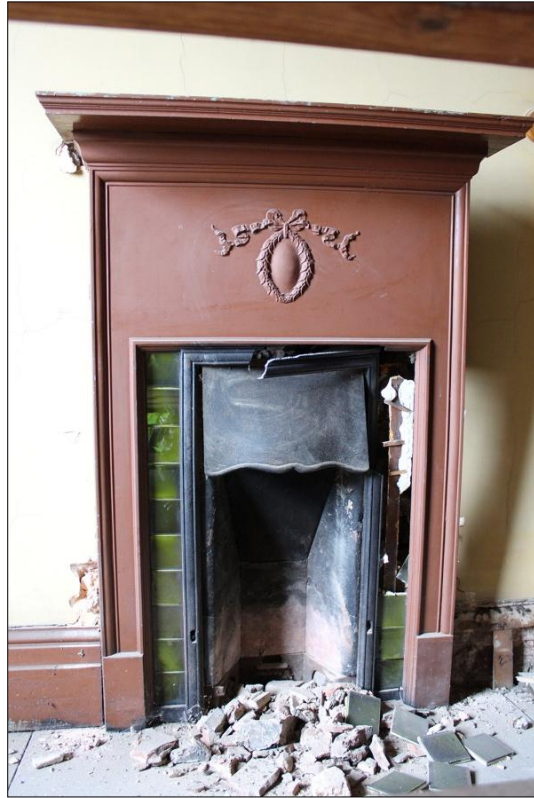
LEFT: 82. DETAIL OF FIREPLACE WITHIN THE SOUTH-EAST WALL OF ROOM S6; VIEWED FROM THE NORTH-WEST.
RIGHT: 83. DETAIL OF FIREPLACE WITHIN THE NORTH-WEST WALL OF ROOM S12; VIEWED FROM THE SOUTH-EAST.

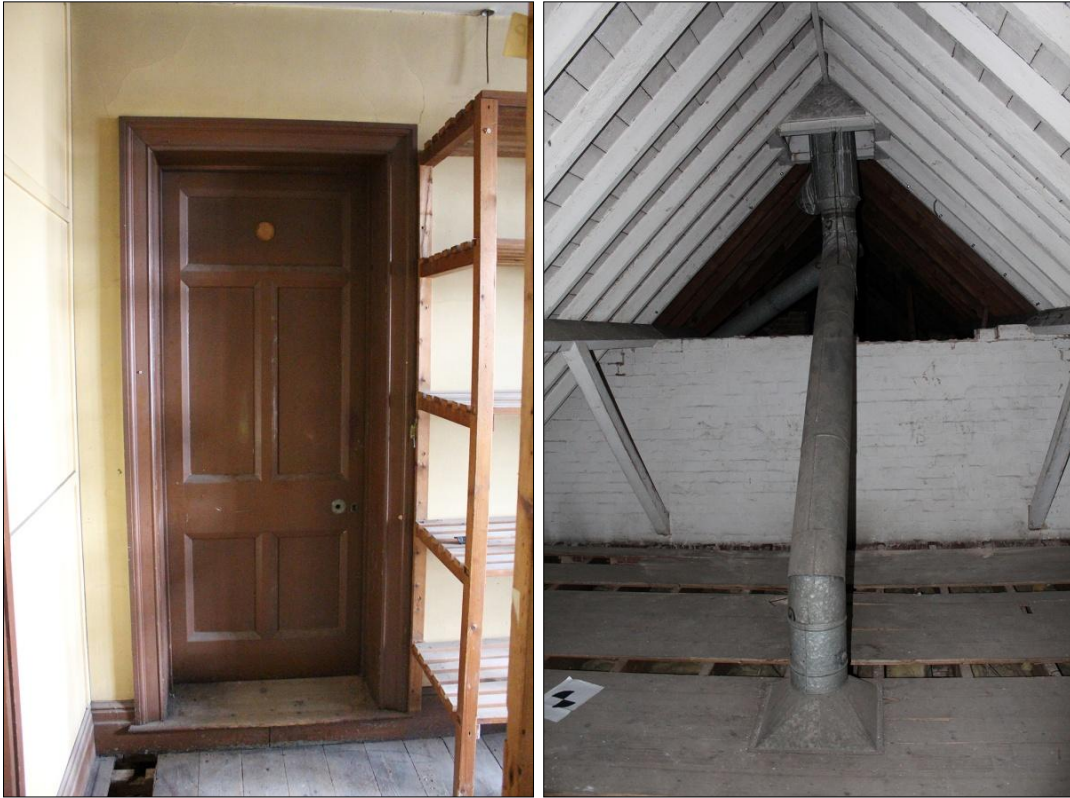
LEFT: 86. DETAIL OF THE DOOR OPENING IN THE SOUTH-EAST WALL OF ROOM S12; VIEWED FROM THE NORTH-WEST.
RIGHT: 87. DETAIL OF THE METAL CHIMNEY FLUE WITHIN ROOM S13; VIEWED FROM THE NORTH-WEST.

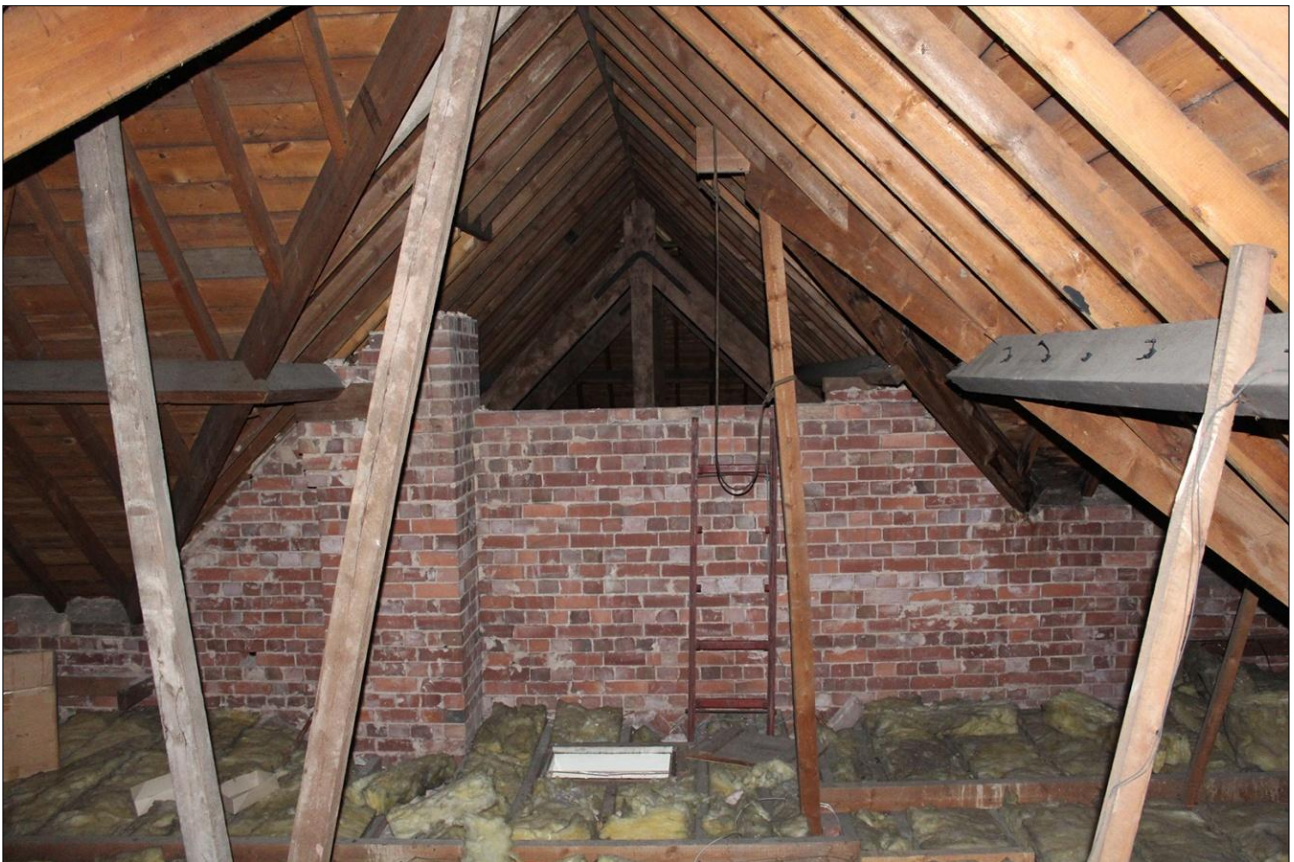
88. DETAIL OF THE ROOF STRUCTURE WITHIN ROOM S13 WITH DIVIDING BRICKWORK; VIEWED FROM THE NORTH-WEST.
