79 HEAVITREE ROAD

RESULTS OF AN ARCHAEOLOGICAL EVALUATION AND RAPID BUILDING RECORDING

SOUTH WEST ARCHAEOLOGY LTD. REPORT NO. 181002

79 Heavitree Road, Exeter, Devon Results of an Archaeological Evaluation and Rapid Building Recording

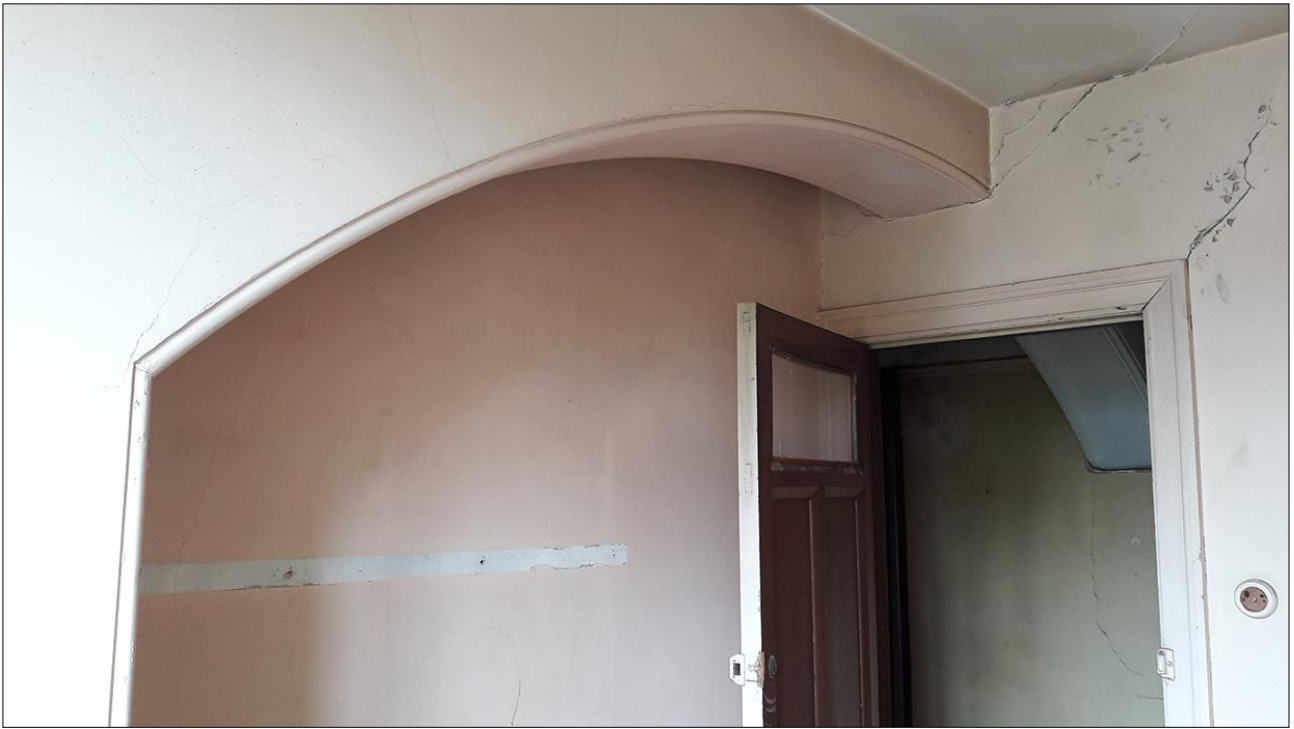
91. DETAIL OF THE DOOR OPENINGS IN THE NORTH-WEST WALL OF CORRIDOR S8; VIEWED FROM THE SOUTH-EAST.

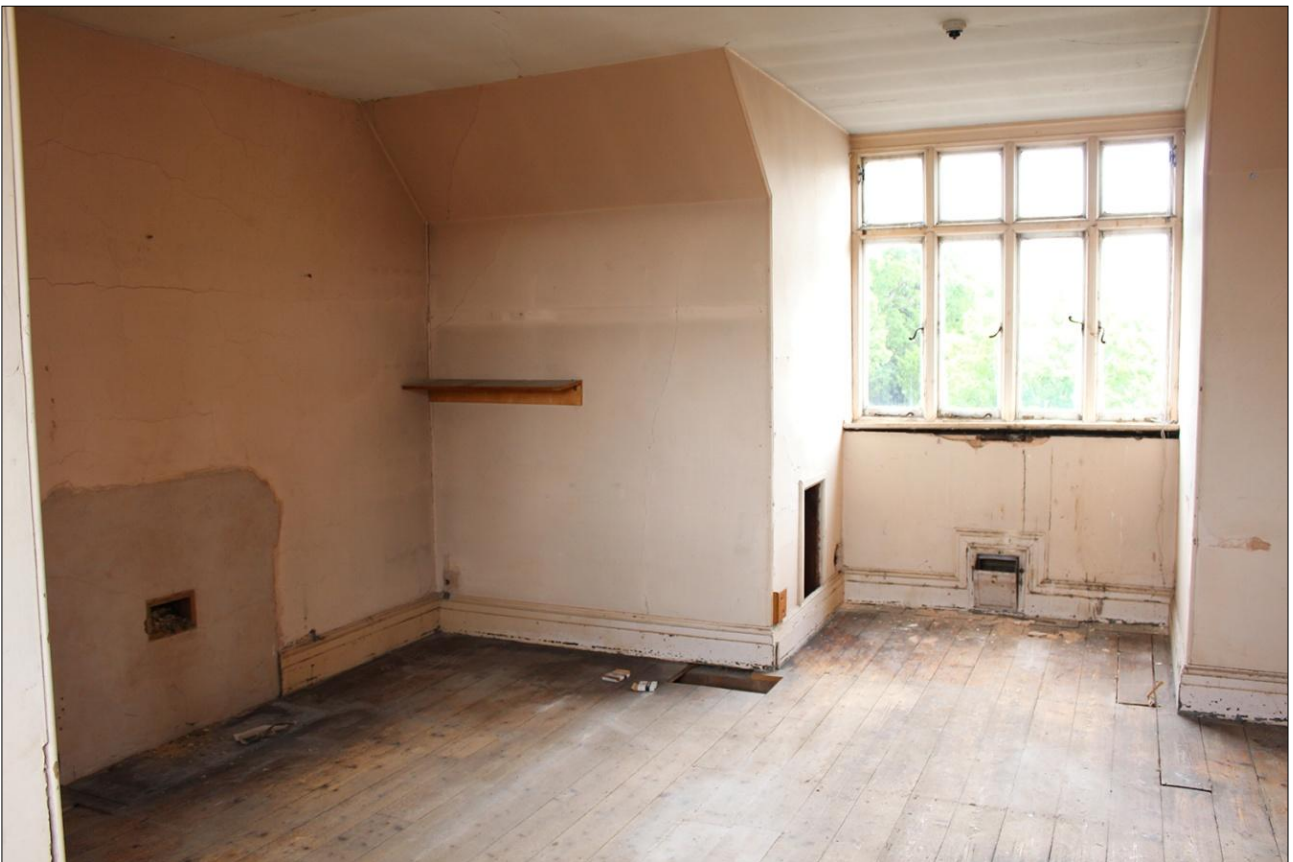
95. VIEW OF ROOM S7; VIEWED FROM THE NORTH-EAST.

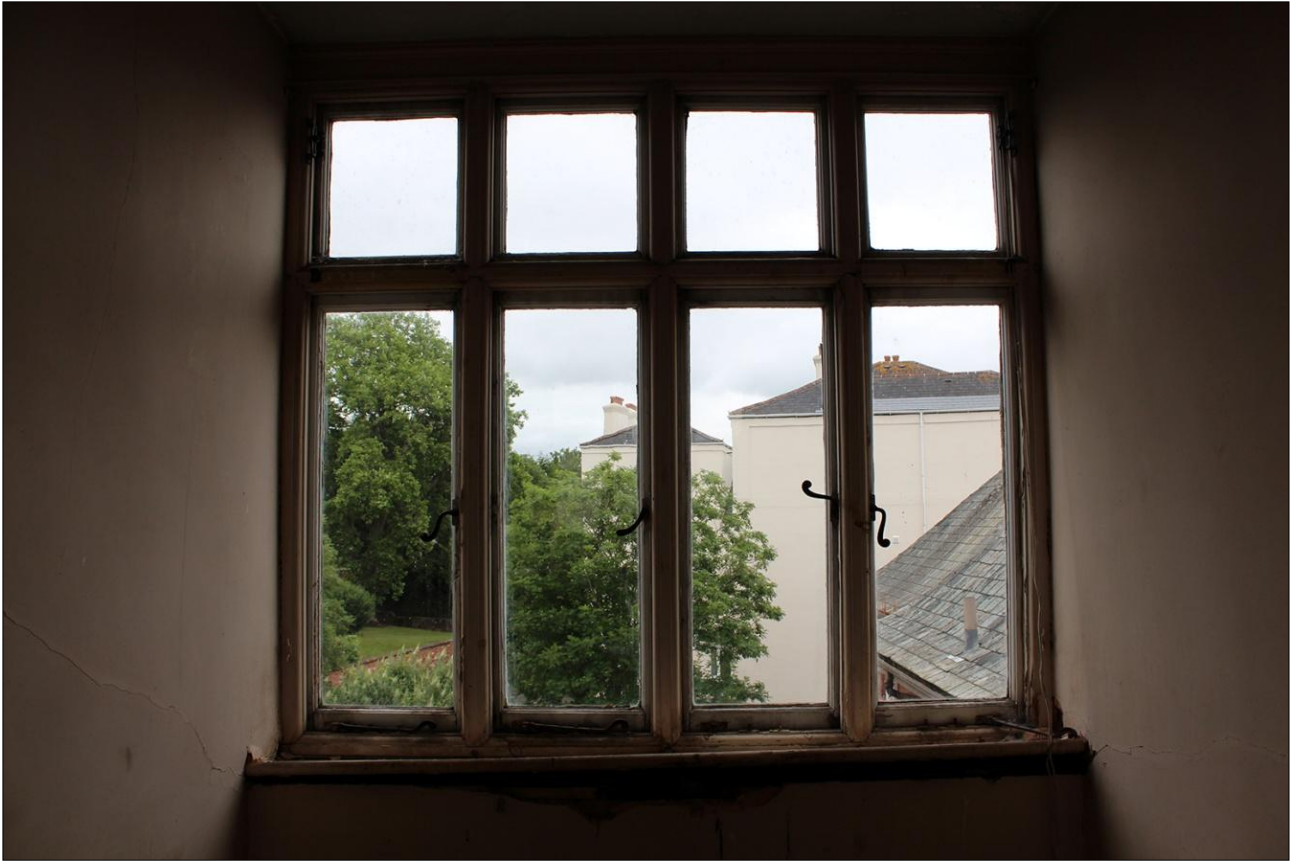
96. VIEW OF ROOM S7; VIEWED FROM THE NORTH-WEST.

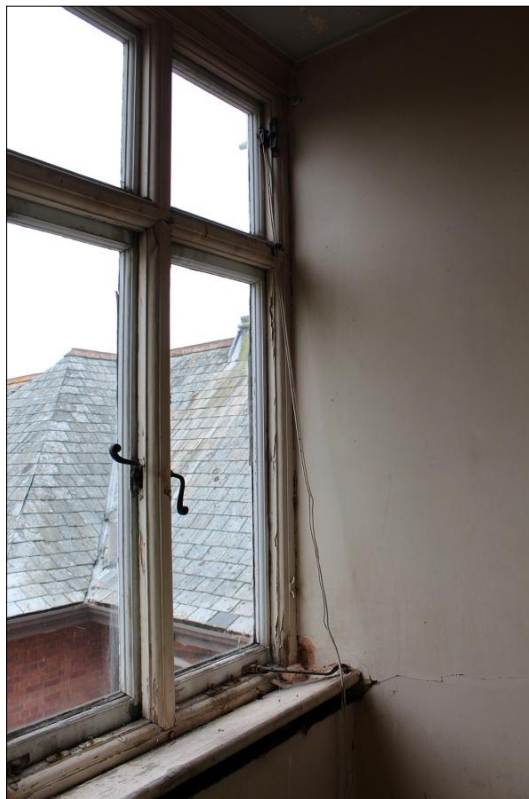
97. DETAIL OF THE WINDOW OPENING IN THE SOUTH-EAST WALL OF ROOM S7; VIEWED FROM THE NORTH-WEST.

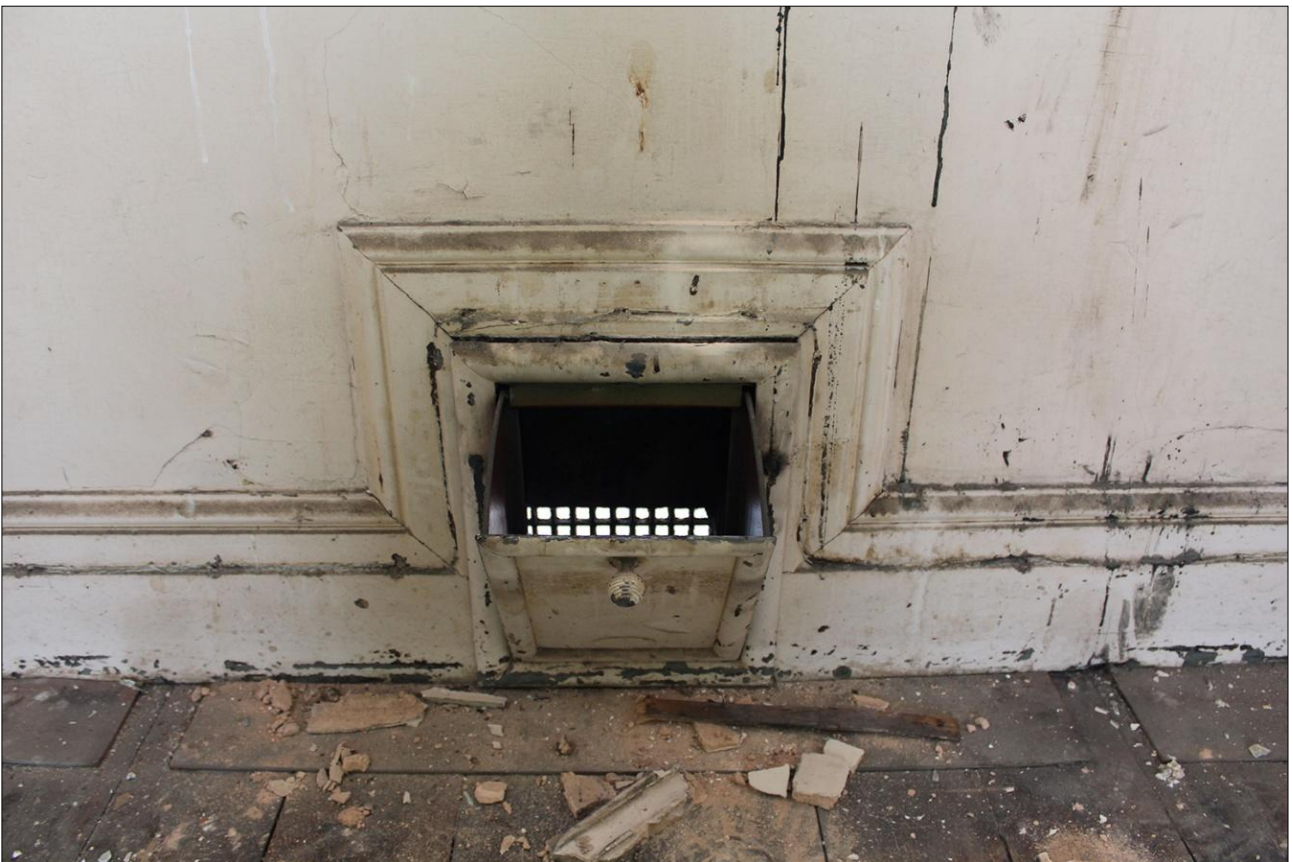
99. DETAIL OF THE VENT OPENING IN THE SOUTH-EAST WALL OF ROOM S7; VIEWED FROM THE NORTH-WEST.

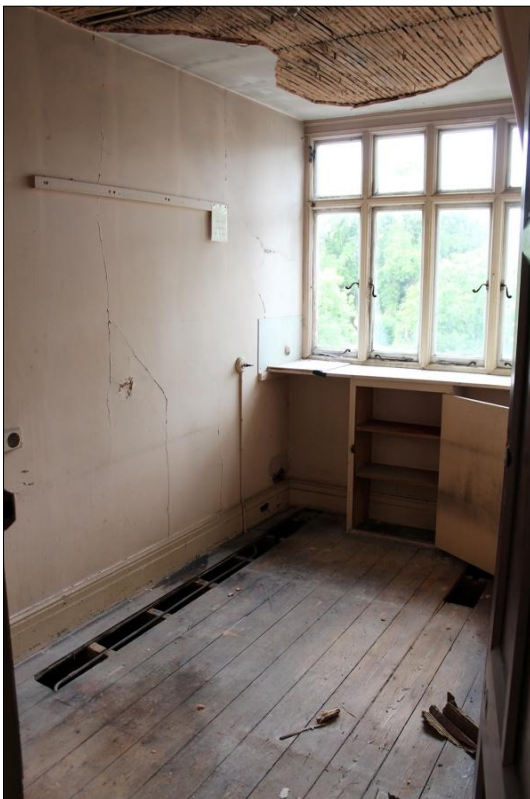
101. DETAIL OF THE FLOORBOARDS IN ROOM S7; VIEWED FROM THE SOUTH-WEST.

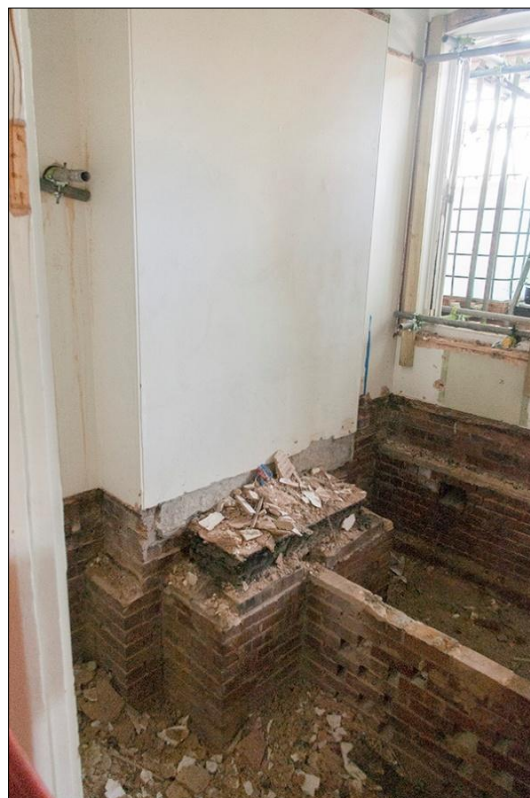
106. ROOM G1, SHOWING THE UNDER-FLOOR CAVITY; VIEWED FROM THE SOUTH-EAST.

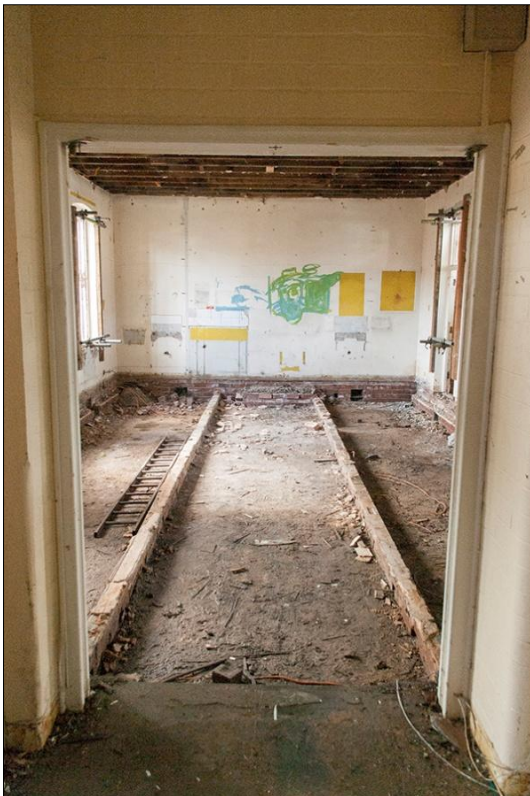
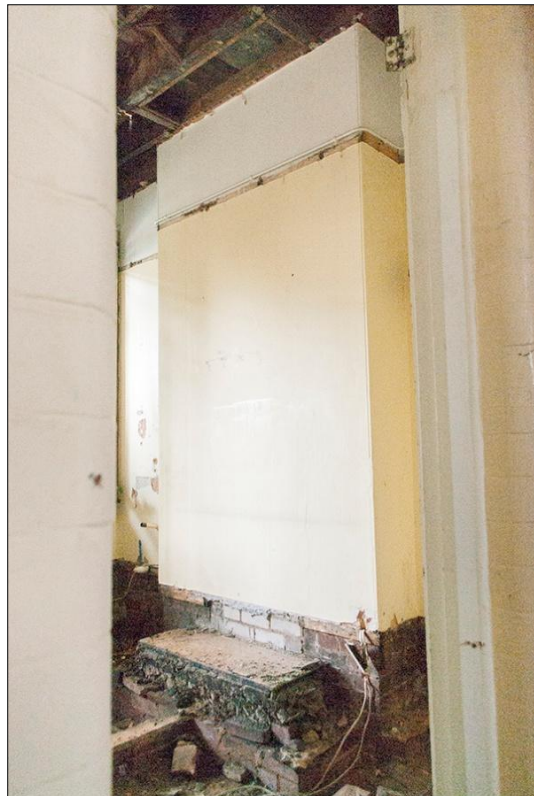
108. THE PARTITION WALL WITH DOOR BETWEEN ROOM G3 AND ROOM G6, SHOWING THE ORIGINAL HEIGHT OF THE OPENING; VIEWED FROM THE NORTH-WEST.

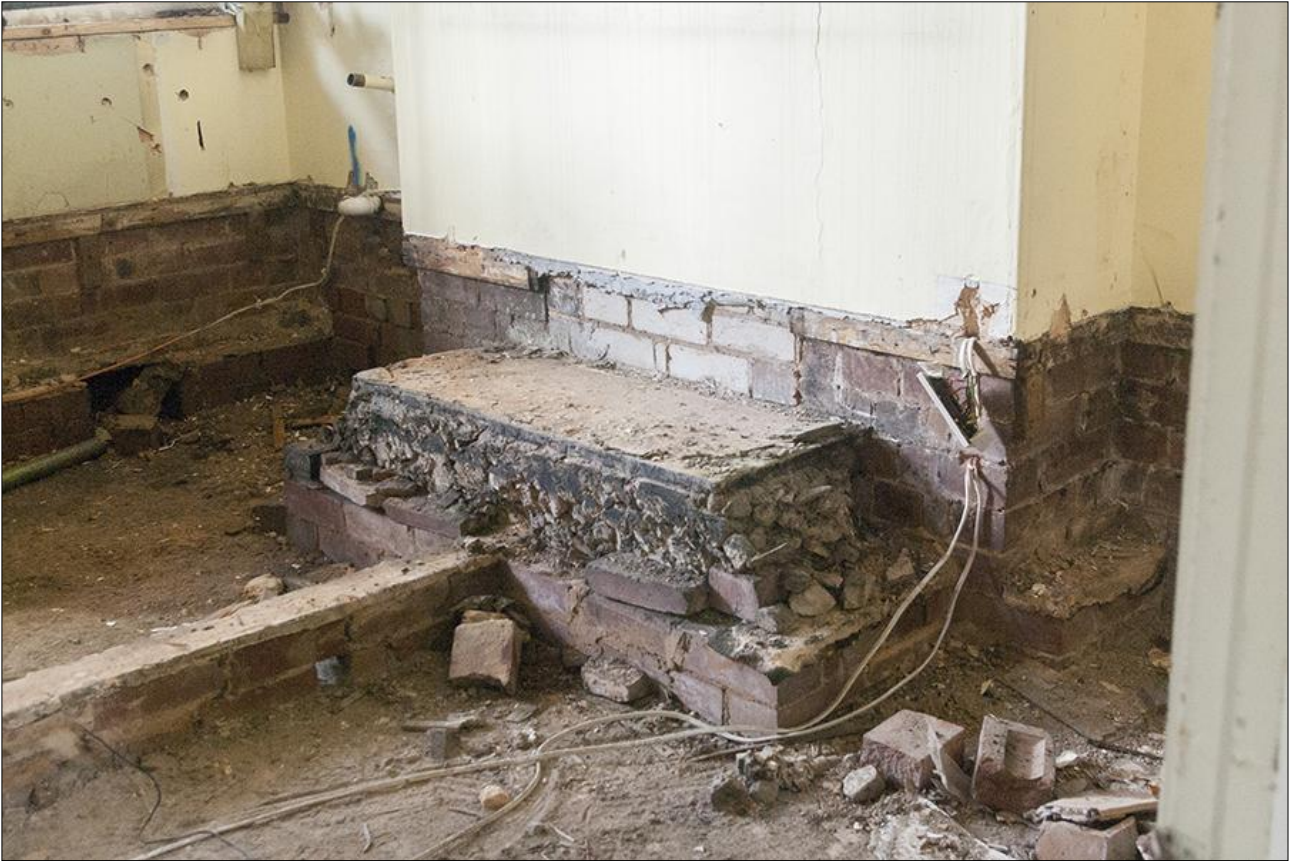
LEFT: 109. ROOM G37-G40, SHOWING THE UNDER-FLOOR CAVITY; VIEWED FROM THE NORTH-WEST.
RIGHT: 110. ROOM 36, SHOWING THE BLOCKED FIREPLACE AND RAISED HEARTH; VIEWED FROM THE NORTH-EAST.

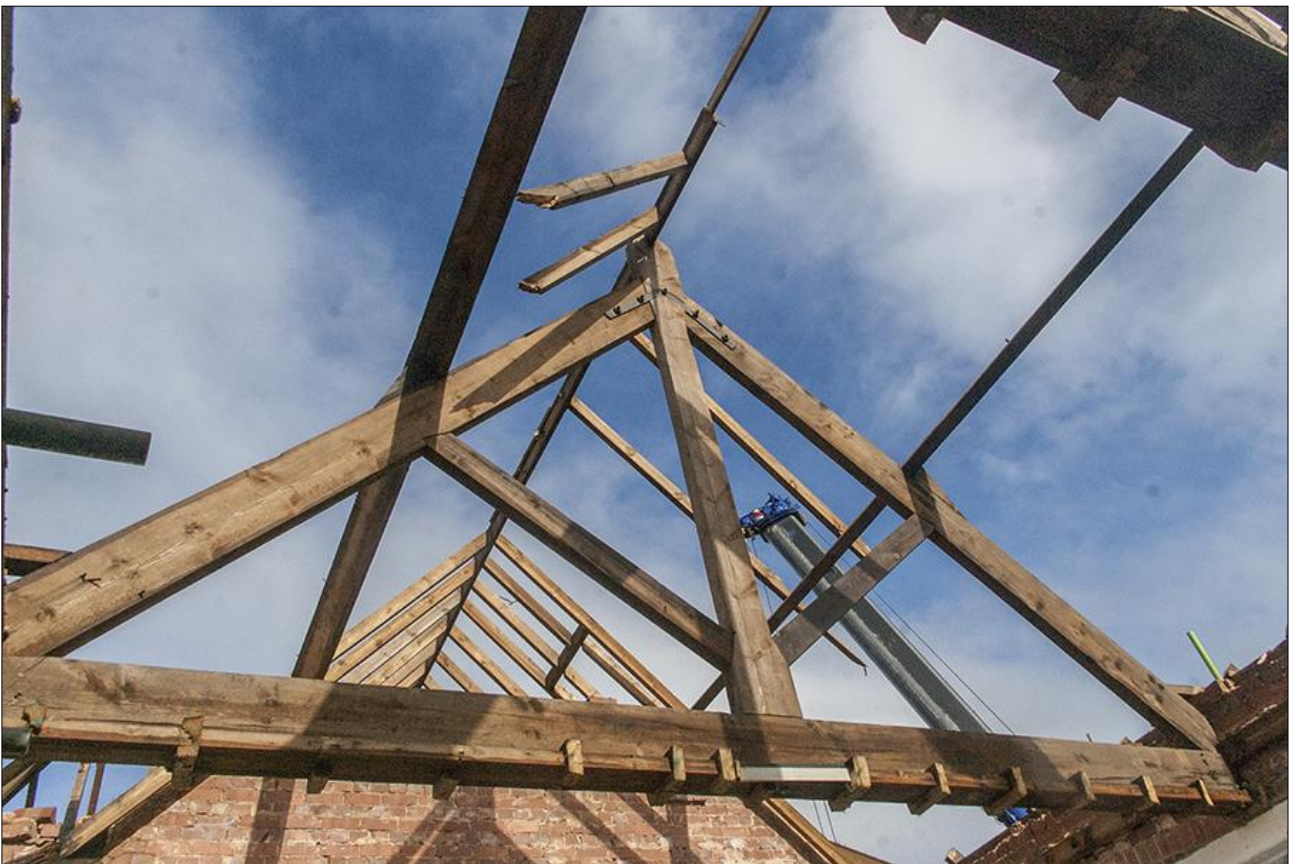
115. THE HEAVY KINGPOST ROOF TRUSSES ABOVE ROOM F26; VIEWED FROM THE NORTH-WEST.
