HIGHER PARK FARM

CREDITON

DESK-BASED ASSESSMENT WITH HISTORIC BUILDING RECORDING

Higher Park Farm, Crediton, Devon Desk-Based Assessment with Historic Building Recording

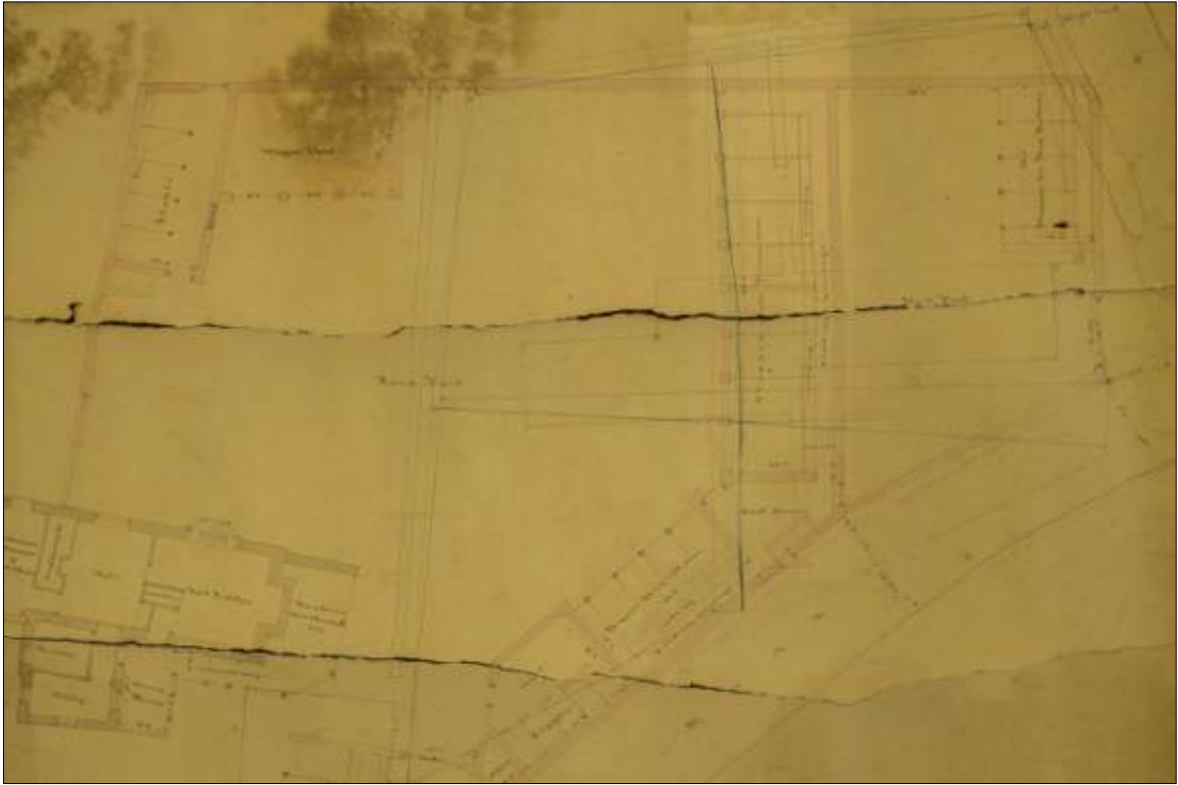
FIGURE 7: PLANS FOR THE REBUILDING OF THE FARMSTEAD AT 'PARK FARM' DRAWN UP BY R.S. CORNISH (DHC 2065ME3/26).

The sale in 1837 was immediately followed by a period of sustained investment. The maps show the current access lane to the farm (shown as a pencil annotation on the 1837 map) was created in the period 1837-1839, and plans of 1852 (Figure 7) indicate the Pound House and Shippon were built in the period 1839-1852. A contract (*articles of agreement*) dated to 2nd July 1851, drawn up between James and John Guscott Thomas of Crediton (the contractors) and James Wentworth Buller, would indicate B3-B6 were constructed in the early 1850s. The contract was to *...execute certain works and make certain alterations and additions to the dwellinghouse on Higher Park Farm and to erect certain buildings in the farm yard... according to certain plans, elevations and sections marked A.B.C. and according to the provisions of a specification of the said works... prepared by Robert Stribling Cornish of Exeter aforesaid architect... for the princely sum of £305 (DHC 2065M/E10/16a). Robert Stribling Cornish (1788-1871) was the Cathedral Architect, Mayor of Exeter in 1852-3, and provided the designs for the 1819 Exeter Prison amongst other Exeter commissions (Colvin 2008).*

This period of investment was quite dramatic: with the exception of the farmhouse, almost all of the buildings standing in 1839 were swept away and replaced by the two new ranges extant today (see Figures 6-10). However, the plan of 1852 was not fully implemented: the intended plans would have taken in most of the garden and included a second (stack) yard to the west. The buildings on this plan are helpfully labelled by function.

The Phase 2+ function of the building is ostensibly as a shippon with a loft above. However, all of the surviving windows have (or had) mullions, bars and shutters, and there are no first-floor loading doors. The floor would have drained any effluent into the Pound House. In addition, the 1852 plan (Figure 7) labels this as *Cellar*. Therefore on balance it is more likely this was a building for stored goods, and perhaps even semi-domestic at first-floor level, with direct access to the Farmhouse.

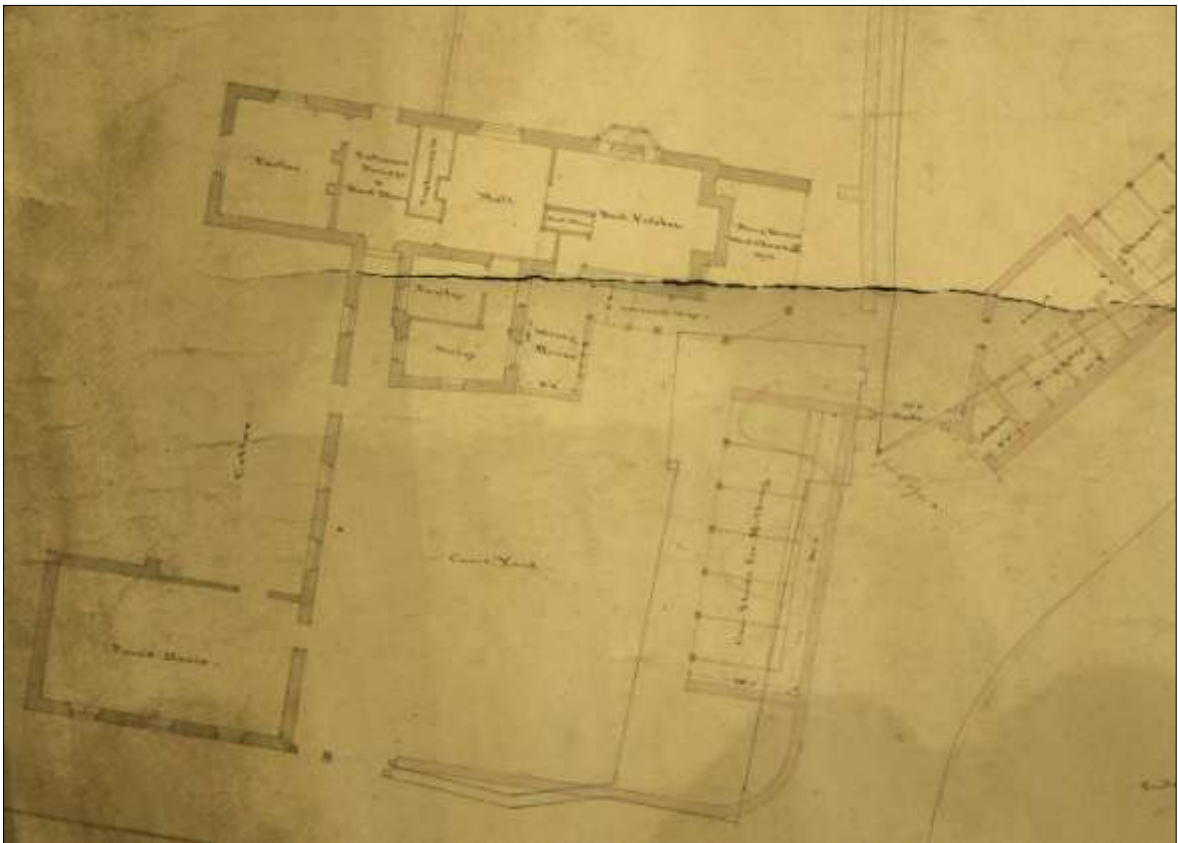
FIGURE 8: AS ABOVE, DETAIL OF THE FARMHOUSE, POUND HOUSE AND SHIPPON ('CELLAR').

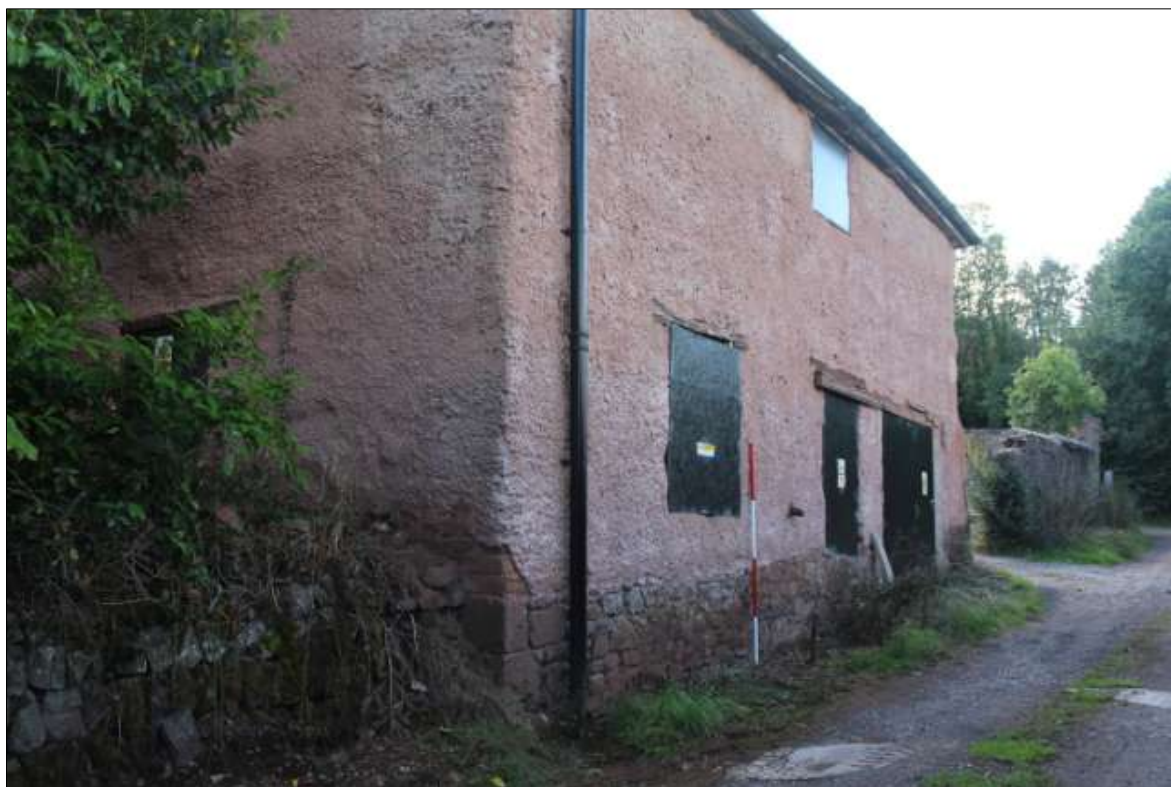
FIGURE 13: THE NORTH ELEVATION OF THE POUND HOUSE; VIEWED FROM THE NORTH-EAST (SCALE 2M).

The Pound House part of the cob range lies to the north, contiguous with the Shippon to the south but separated by an internal brick wall. It is a two-storey rectangular building with walls of cob on a plinth of roughly-coursed slatestone blocks. The stonework of the plinth to the north-east side is noticeably better in terms of quality. The composition and texture of the cob would suggest either a lower building, or one with a steeper roof, as the walls appear to have been raised to two storeys. The north-west corner has been repaired in cob block, and part of the east wall in cob block and concrete block. The exterior is rendered with a spray-applied modern treatment, coloured light pink to mimic the colour of the local cob. The roof is hipped to the east and contiguous with that of the Shippon to the south; to the west and north the roof is covered with box-section plastic-coated steel sheets, to the east and south with ‘big six’ asbestos sheets. The roof is carried on a complex roof structure consisting of one mid 19th century king-post truss to the hip, and one long composite double king-post truss that stretches from corner to corner diagonally across the building. The latter – over extended – truss has been repaired with modern bolted tanalised timbers. All the ground-floor openings have thin oak lintels that rest on short oak pads.

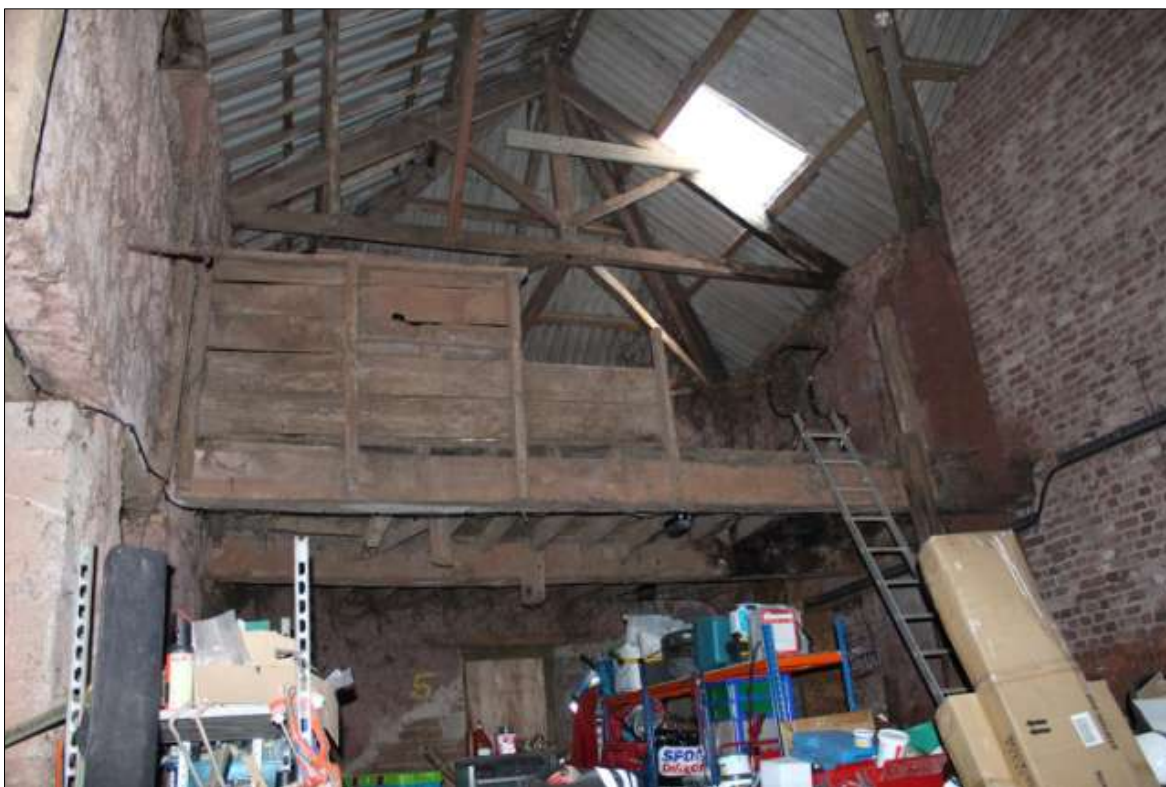
FIGURE 14: THE INTERIOR OF THE POUND HOUSE, SHOWING THE GALLERY; VIEWED FROM THE WEST.

The interior of the Pound House has been heavily altered, stripped of most historical features, and was full of clutter when inspected. The cob of the walls is visible, as are the various repairs. The wall separating the Pound House from the Shippon rises up into the roofspace and is of pale pinkish-red brick laid, for the most part, in a header bond. It is pierced by a single ground-floor doorway (D4) with timber lintel. The internal floor level appears to have been lowered and replaced with modern concrete, and steps up irregularly to the Shippon; however, the reveals to D2 respect this lower level so the height of the floor may be genuine, and the *yard* may have been raised. The western part is open to the roof, but there are sockets in the north and south walls for beams and/or joists. The eastern part has a first floor carried on two heavy, transverse beams with deep but narrow joists. The floor is of even-width floorboards. There is a hatch to the north-west side, and the remnants of other timber fittings that would once have belonged to a mechanism. To the front and enclosing the loft, facing onto the void, is a rail-and-plank boarded screen that is spiked to the beam below.

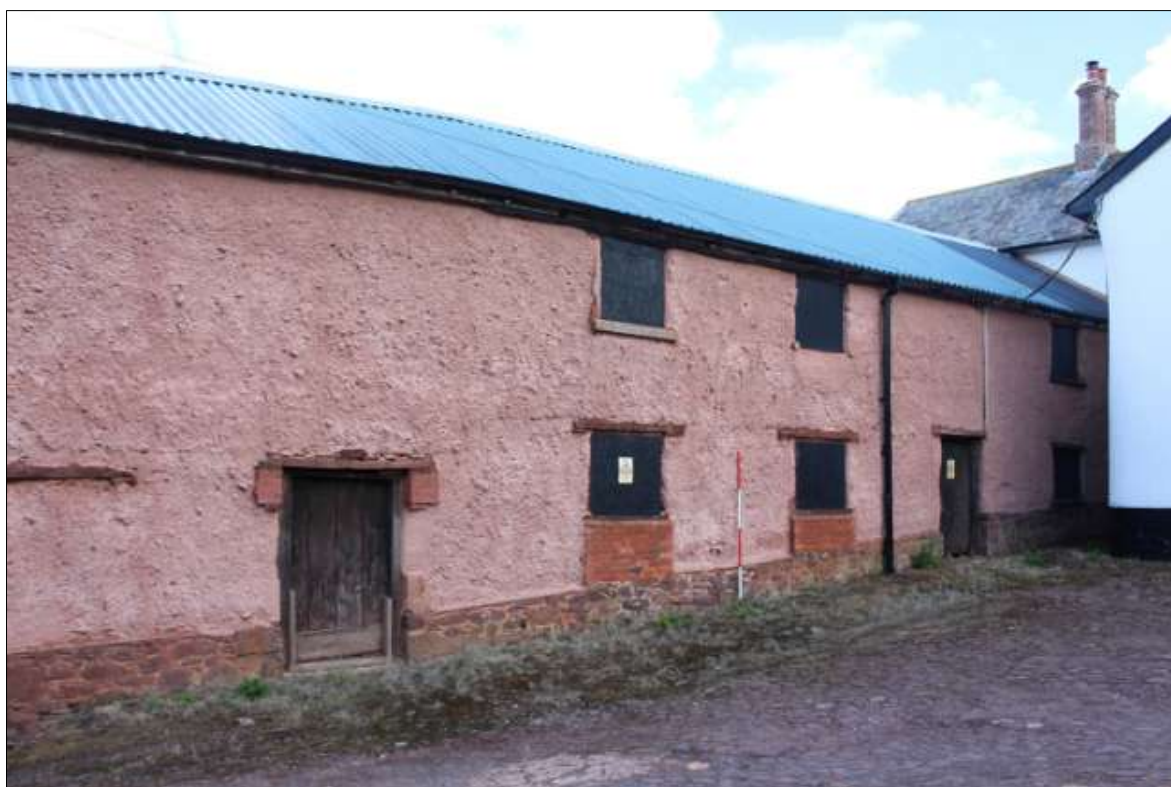
FIGURE 15: THE WEST ELEVATION OF THE SHIPPON, WITH POUND HOUSE TO THE LEFT; VIEWED FROM THE NORTH-EAST (SCALE 2M).

The west elevation faces on the yard behind the Farmhouse and is contiguous with the west elevation of the Pound House. There are seven openings in this elevation: a door and six windows, the windows forming a symmetrical 2/2/2 arrangement. The doorway (D1) has a narrow timber lintel with a chunky beaded doorframe; the door is a lightweight, even-width, plank door with an iron thumb latch. The frame matches D2 to the north; the door itself is a boarded door of rustic 19th century style. The stone reveals of the door are messy to the north, but some dressed stone has been used to the reveals. Most of the windows have been subject to repair: the walls below W2 and W3 have been rebuilt in red brick, the wall below W12 has been patched in cob, and W13 has a concrete sill. The three windows on the ground-floor all retain their 19th century pegged two-light timber frames. W3 has one shutter, of thin boards painted black, on small strap hinges with spearhead terminals. W2 has two shutters on simple strap hinges with spearhead terminals; both shutters are built of repurposed 17th century, narrow, raised and fielded panels. W1 is boarded and the opening is braced by mid 20th century timbers; laid horizontally within the opening is another shutter made from a section of 17th century panelling. On the first floor, W12 has lost its historic frame, but W11 and W13 retain their 19th century pegged two-light timber frames, bars and shutters; the shutters feature reused scratch-moulded 17th century timbers as ledging bars.

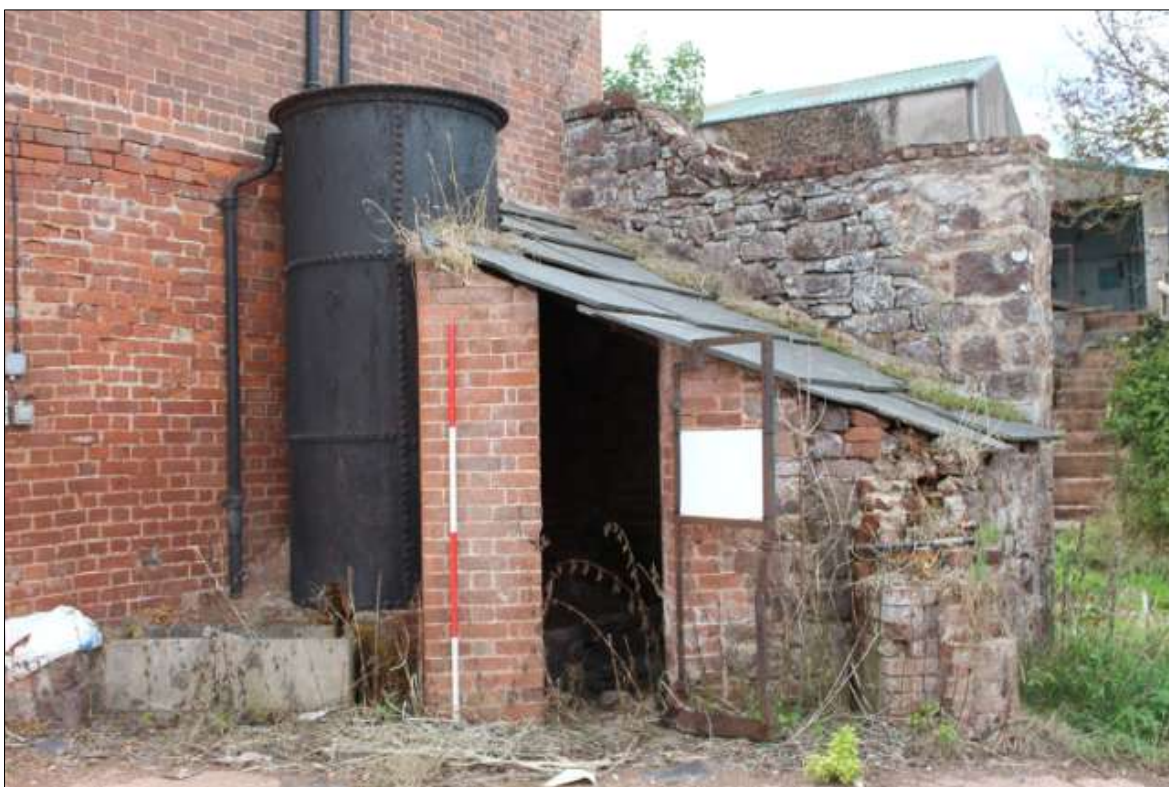
FIGURE 17: B3 WITH LARGE BOILER; VIEWED FROM THE SOUTH-EAST (SCALE 2M).

A small, single-storey lean-to structure built into the angle between the yard wall and B4. The north-west and north-east (yard) walls are of coursed stone rubble in a white lime mortar, with brick quoins to the doorway. The south-east wall comprises a heavy cylindrical iron water tank c.1.2m in diameter and c.2.5m high, partly encased in a block of mortared brickwork. To the north side is a small opening at ground-floor level, probably a stoke hole. The iron tank is comprised of heavy iron sheets, closely riveted, with a reinforced rim. The base sits on a brick plinth, and there is a tap at the base over a concrete water trough. A redundant set of guttering and downspouts fed water from the roof of B4 into the tank, and the tank has a separate overflow pipe. The lean-to roof is of very large slate slabs, probably flagstones but perhaps reused walling from a pigsty, carried on corroded iron beams; the floor is cobbled, with a later trough formed up against the west wall.

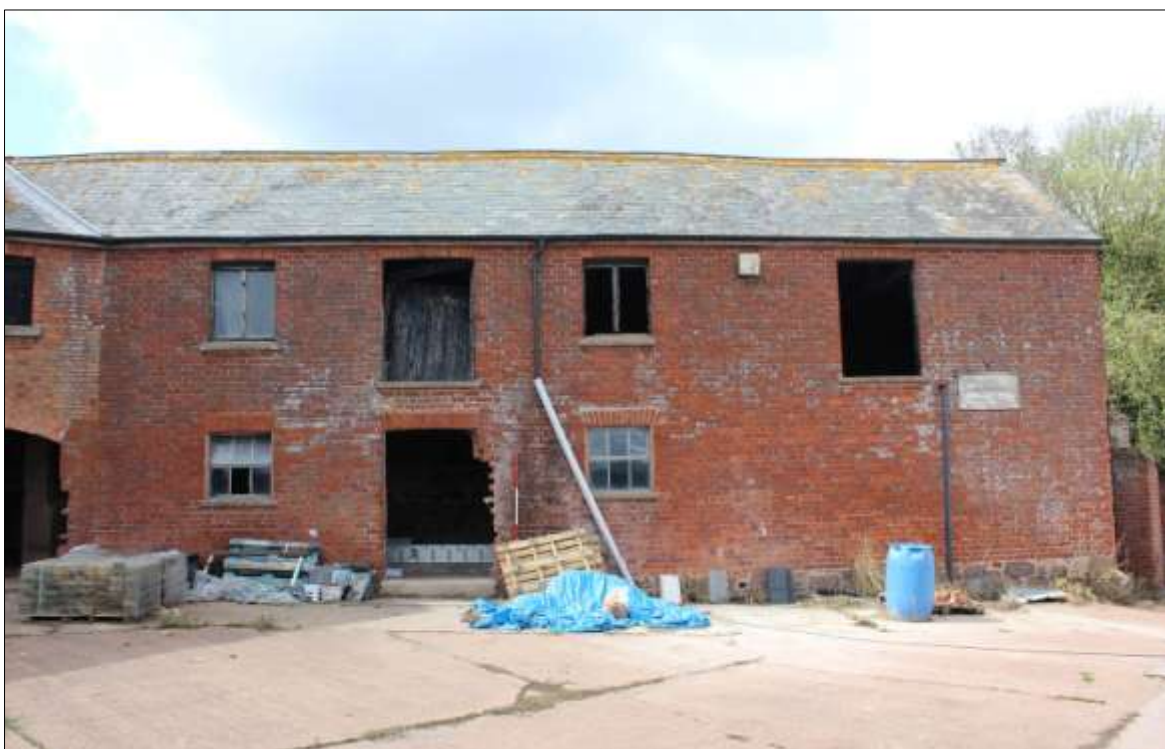
FIGURE 18: THE SOUTH-EAST ELEVATION OF B4; VIEWED FROM THE SOUTH-EAST (SCALE 2M).

The Barn and Milking Parlour is a long, rectangular, two-storey structure of brick and stone with a pitched roof of slate with black roll-top ridge tiles carried on four later 19th century bolted kingpost trusses. This later 19th century structure is relatively complex and a number of the structural elements have been rebuilt or re-purposed. All the brick elements are laid in a Flemish bond. The south-east elevation is of dark red brick on a stone plinth. There are seven openings: a door with a window to each side to the ground floor, a matching loading door with windows at first-floor level, and a second loading door to the north-east. All the openings have concrete sills and shallow segmental brick arches; the ground-floor door has been forcibly widened, leaving a ragged side to the north-east. The ground-floor doorway has lost its frame and door; the first-floor loading door above has a simple braced-and-ledged plank door in a simple frame. The windows to the ground floor are fitted with crittal-style hopper casement windows; the first-floor windows have simple two-light wooden frames, the one to the south-west is still glazed.

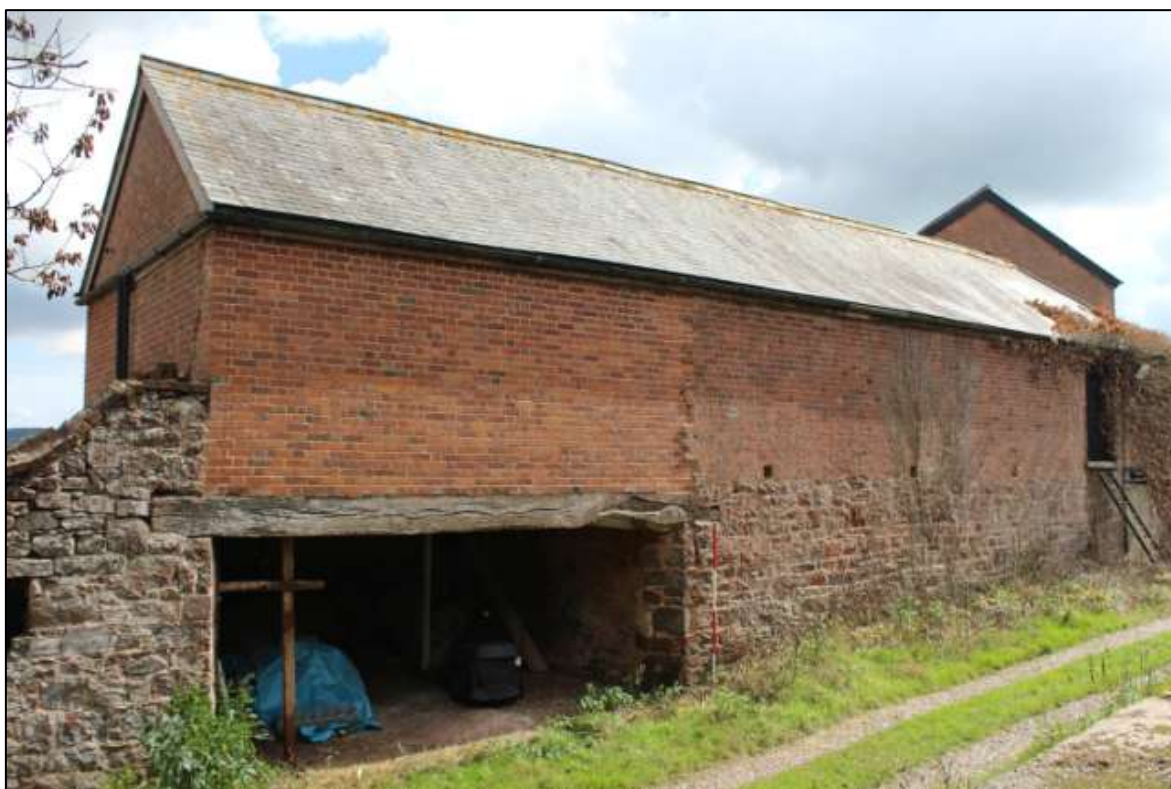
FIGURE 19: THE NORTH-WEST ELEVATION OF B4; VIEWED FROM THE NORTH (SCALE 2M).

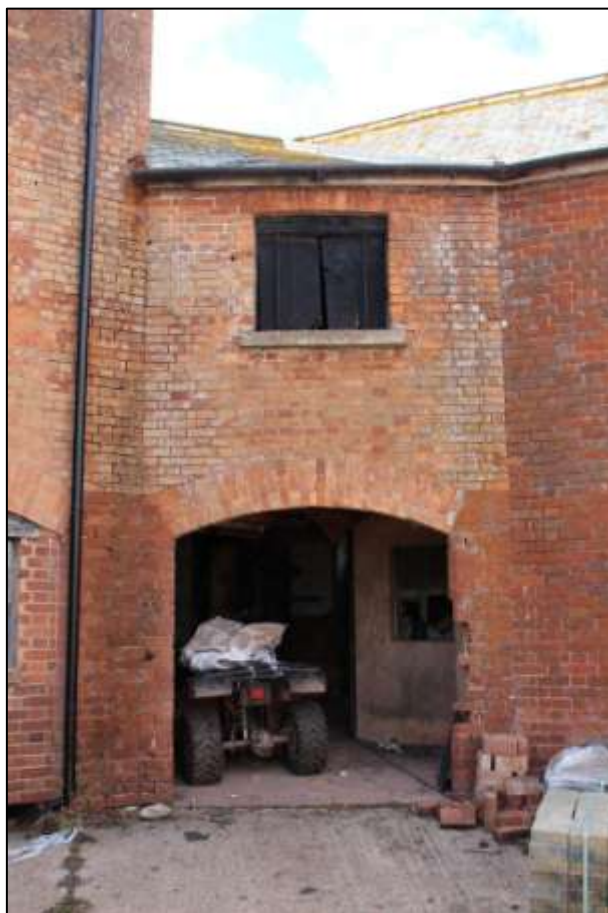
FIGURE 20: THE SOUTH-EAST ELEVATION OF B5; VIEWED FROM THE SOUTH-EAST.

This building is located in the angle between B6 and B4, with walls of coursed blocky stonework to the ground floor and pale orange to the first floor. The pitched roof of slate with black roll-top ridge tiles is carried on a single long bolted king-post truss that crosses the building diagonally; the tie beam is supported on a RSJ dragon-tie in the north-west corner. All the brick elements are laid in a Flemish bond. The south-east elevation faces onto the yard. As with B6, the bricks used at ground-floor level differ from those above: red brick below, pale orange above. The ground-floor features a single wide cartshed opening under a segmental brick arch; the reveals are chamfered, and there is some damage to the north-east side. At first-floor level there is a single window with concrete sill and segmental brick arch; the window retains a pegged frame with bars and plank shutters on simple strap hinges.

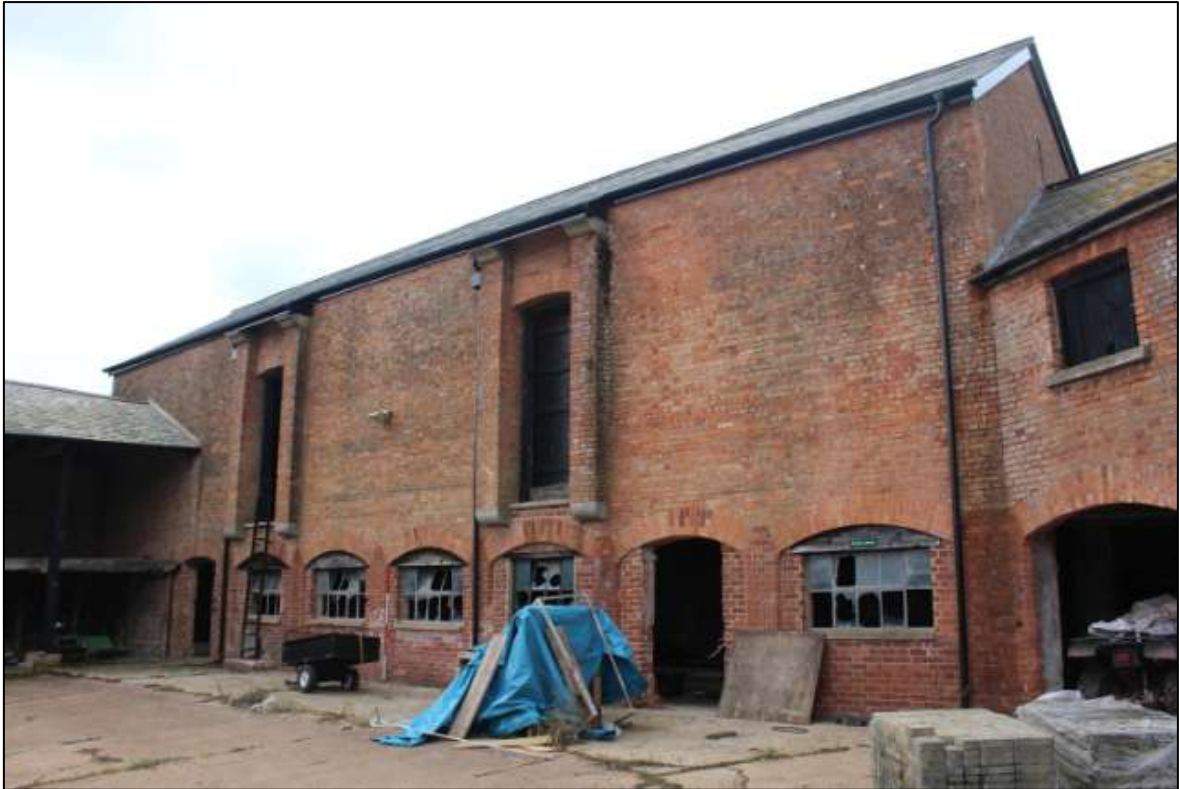
FIGURE 21: THE EAST ELEVATION OF THE B6 THE THRESHING BARN; VIEWED FROM THE NORTH-EAST (SCALE 2M).

The east elevation faces onto the yard and is the most elaborate. As with B5, the bricks used at ground-floor level differ from those above: red brick below, pale orange above. At ground-floor level there are eight wide openings separated by narrow brick piers with chamfered corners. At the southern end of the elevation there is a regular door opening. The piers and springers are of red brick but the wide segmental arches above the openings are of pale orange brick, identical to that of the wall above. The southernmost openings (abutting B7) are blocked in concrete block. Two of the other openings are narrowed in brick to form doorways; wooden frames survive in

these openings. The other five openings have been part-blocked in brick and crittal-style windows installed. Three of these windows are of ten panes with three-pane hopper casements, one is of eight panes with a four-pane hopper casement, and one is of eight panes with a four-pane, central, horizontally-pivoted casement. The northernmost window has an ALFA LAVAL sign fixed to the lintel.

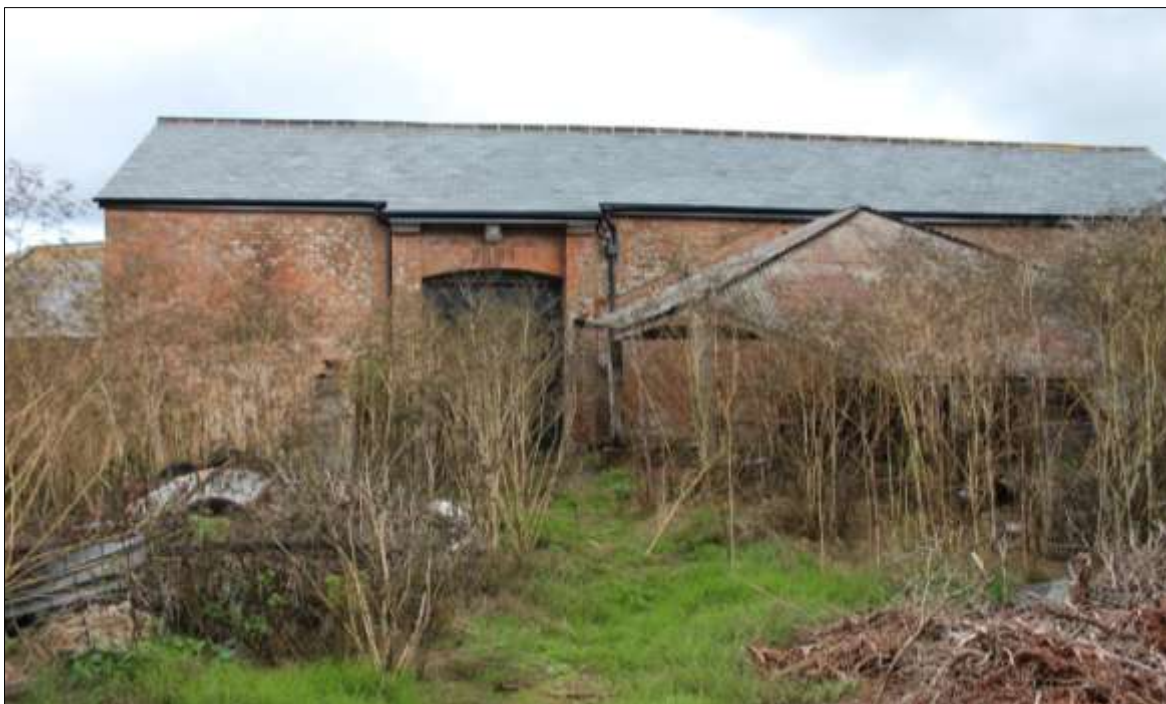
FIGURE 22: THE WEST ELEVATION OF B6 THE THRESHING BARN; VIEWED FROM THE WEST.

The west elevation is contiguous with B5, and is abutted by B8 and the surviving wall of B9. The main features are two, double-width, symmetrical doorways with porches and pentice roofs with granite corbels, as per the east elevation. These doorways feature segmental brick arches, with timber lintels to the interior. Both doorways retain their frames but are currently boarded to the exterior; on the interior, framed, braced and ledged doors survive to the south doorway. The cheeks of the south porch have been truncated by the roof of B8 and the pentice has been removed. The upper part of the south doorway has been blocked in brick, with an iron railway rail used as a lintel. Positioned centrally, between the two doorways, is a small blocked opening with a brick segmental arch at ground level; this was the original opening for a horse engine shaft. Just to the south is a small ragged forced opening for a horse engine shaft that corresponds with B8. Vents have been forced into this elevation.

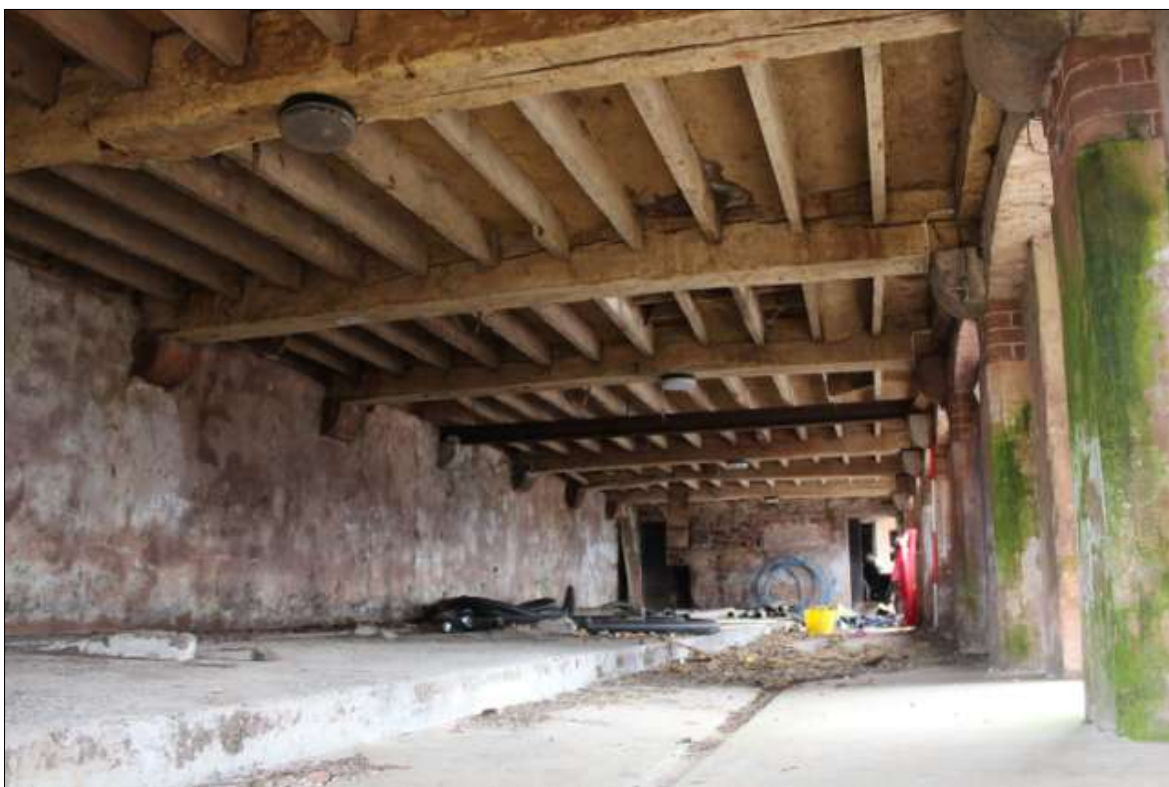
FIGURE 23: THE INTERNAL GROUND-FLOOR OF B6 SHOWING THE HEAVY ROOF STRUCTURE; VIEWED FROM THE SOUTH (SCALE 2M).

The interior comprises a single large room on each level. On the ground floor, the floors are concrete and the wall rendered up to c.1.5m above internal floor level. The interior is lit by the crittal-style windows in the blocked openings in the east elevation, and there are doors in the south, east and north walls. The concrete floor indicates the interior was used as a milking parlour, with a feed passage along the west wall, a drain along the east wall, with room for eight stalls for 16 cows. The walls of the stalls, feed troughs and passage wall have been removed. The floor above is carried on eight, heavy transverse beams, one replaced with an RSJ, sat on corbels that project from the east and west walls. The joists are deep but narrow, and beneath the opposing doors, at first-floor level, those joists support a second set of smaller joists. The floorboards are not visible from beneath, as chipboard has been affixed to the underside. The only other feature of note here was an *ex situ*, early 19th century, domestic, six-panel door from the Farmhouse. At first-floor level, the interior has lost all historic detail, save for the surviving doors and the roof structure, noted above. The floorboards were concealed beneath a layer of detritus, but had failed to the inside of the south doorway on the west side. The only other feature of note is the salt-glazed ceramic pipes that line the west wall, linking the ground-floor room to the forced vents in that wall.

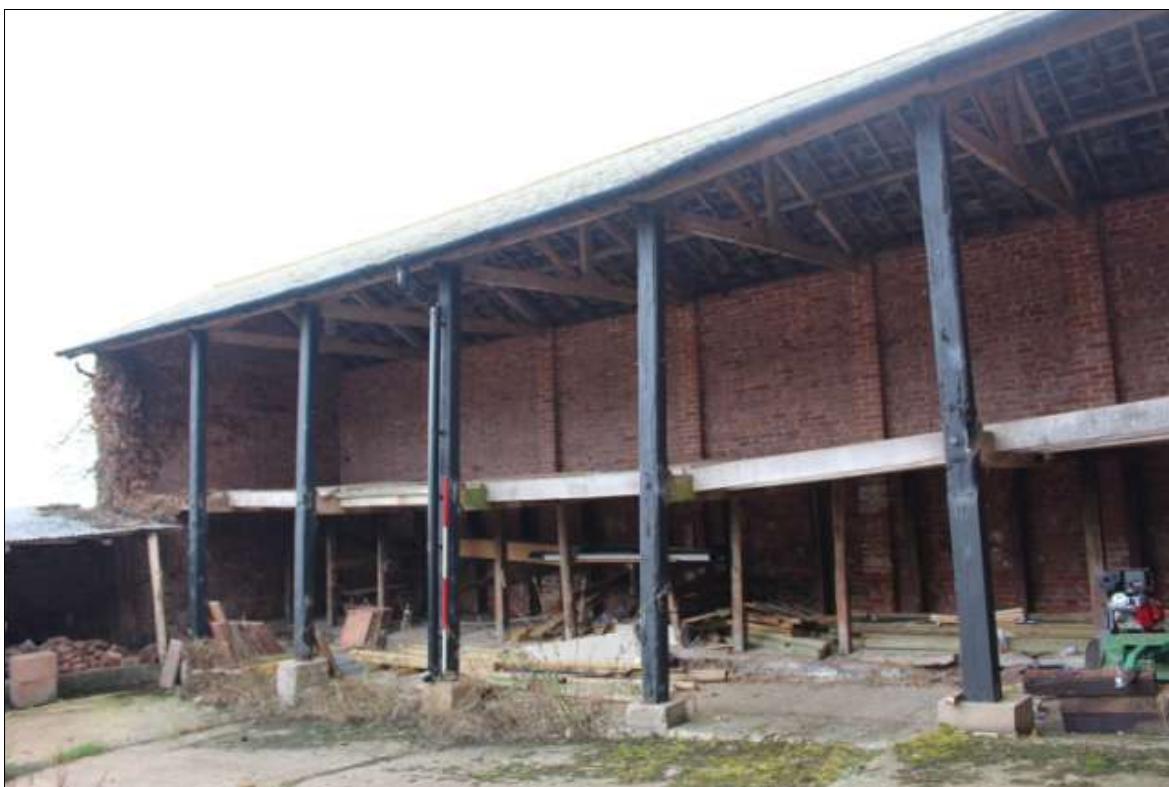
This is clearly a linhay, i.e. an open-fronted barn for cattle on the ground floor with fodder above. The ground floor was modified in the 20th century to form cattle cubicles.

FIGURE 24: THE NORTH ELEVATION OF THE LINHAY; VIEWED FROM THE NORTH-WEST (SCALE 2M).

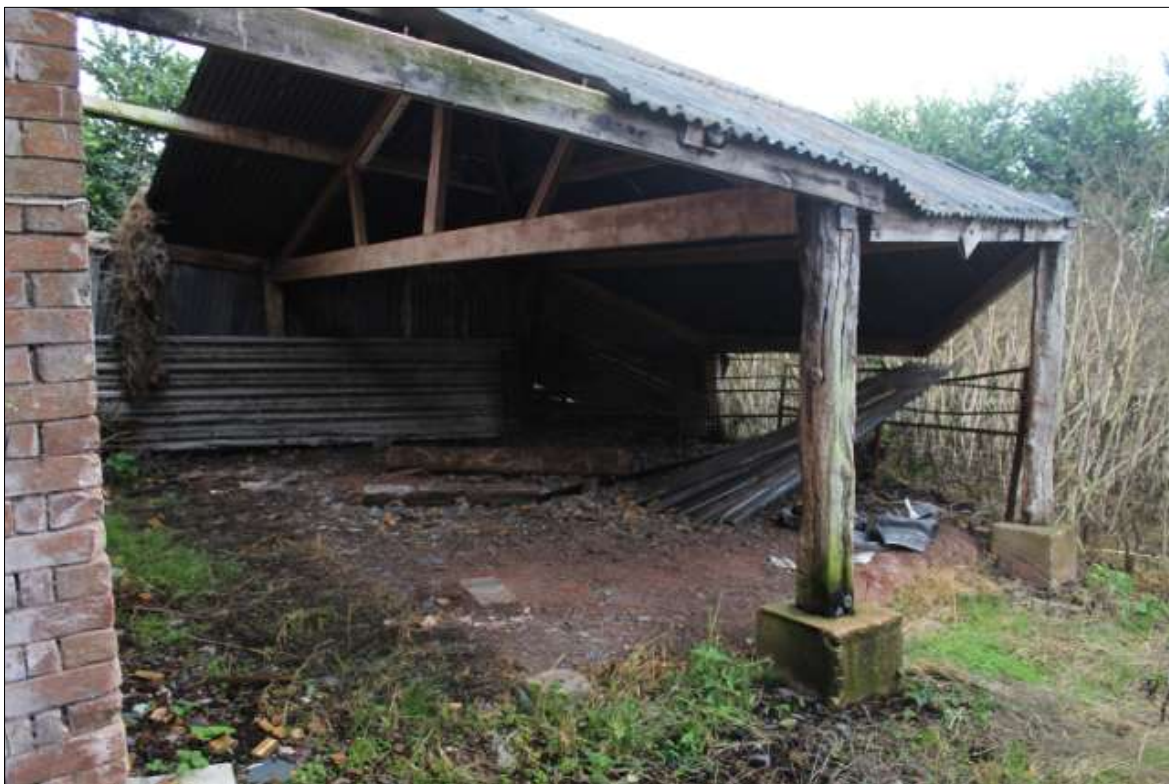
The horse engine is a small, polygonal, open-sided structure attached to the west wall of B6. This replaces an earlier horse engine on a similar footprint, as the blocked and forced openings in B6 would demonstrate. This simple structure comprises four reused oak posts, the bases encased in concrete where they have rotted out, which support a single, poor-quality, kingpost truss. The roof is hipped and is covered in corrugated iron sheets. No other details are apparent, but a single stone post-pad from an earlier structure was noted just to the north.

FIGURE 25: B8 THE HORSE ENGINE; VIEWED FROM THE NORTH-EAST.

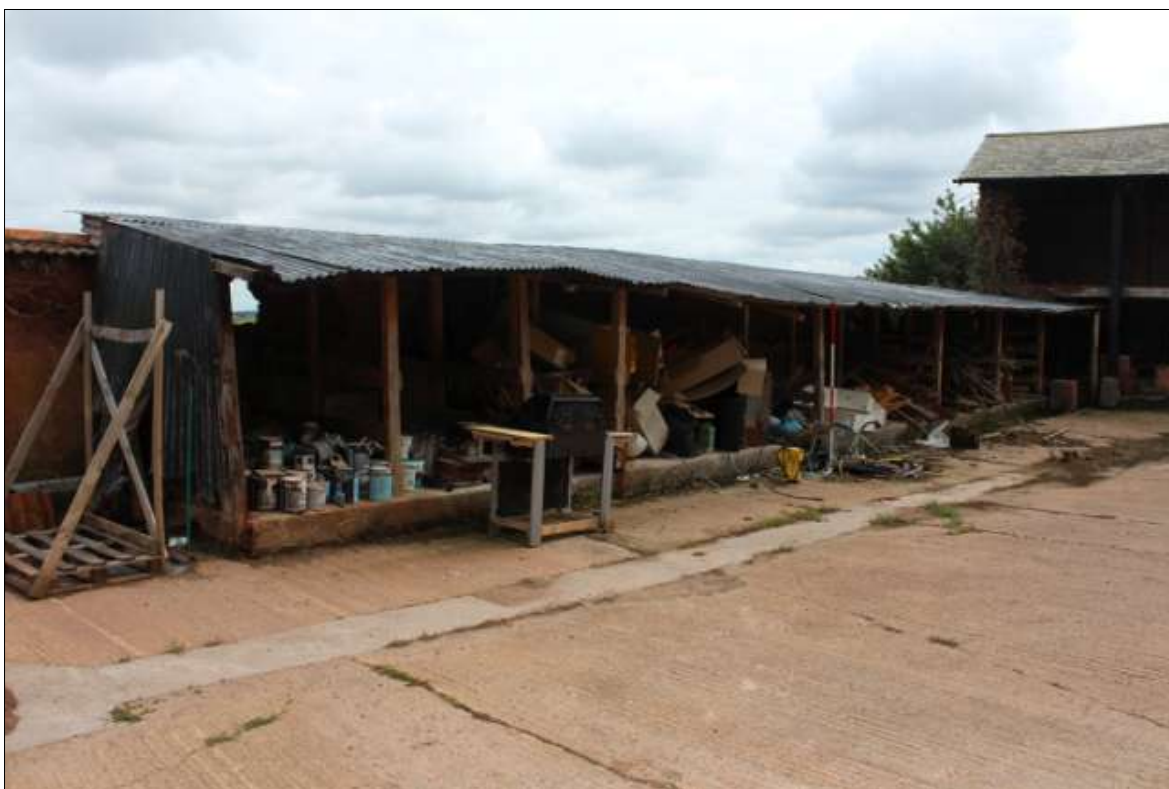
FIGURE 26: B10 THE COW CUBICLES IN THE YARD; VIEWED FROM THE NORTH-WEST (SCALE 2M).

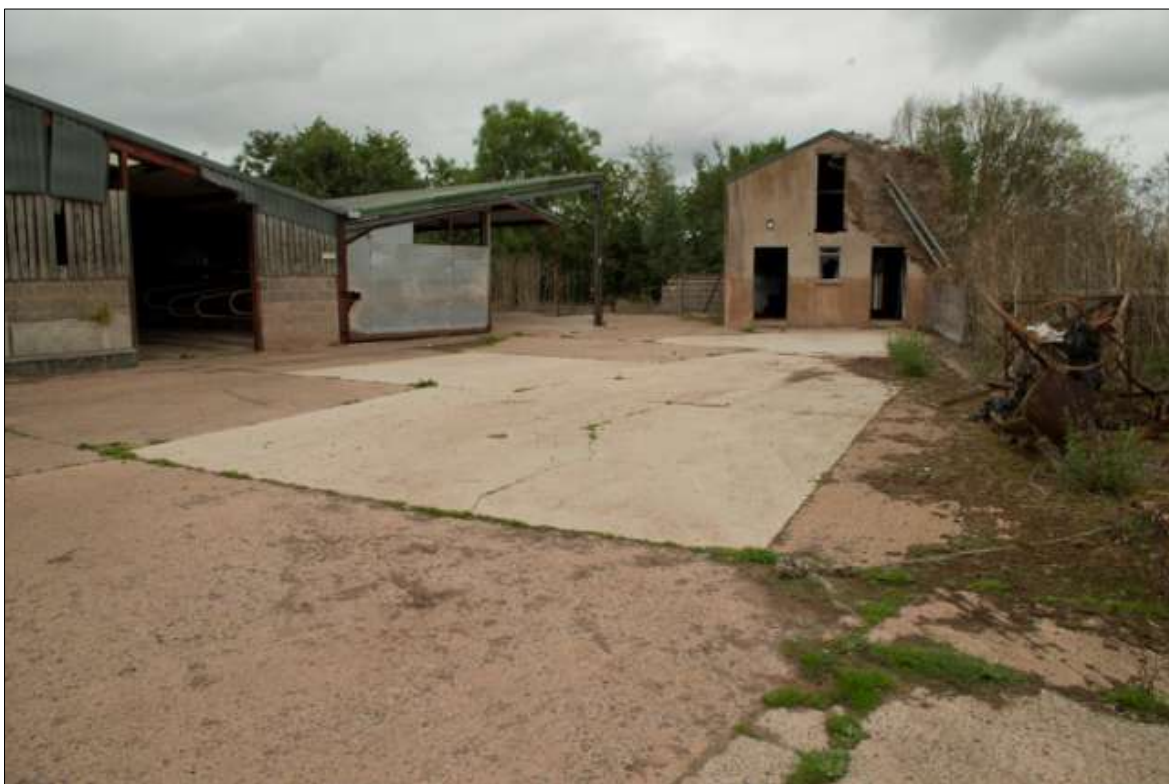
A large, late 20th century steel portal-framed shed, with concrete floors, concrete block walls with Yorkshire boarding above, with a roof of box-section, plastic-coated steel sheets. It contains two double-rows of cow cubicles with an area of loose housing beyond.

FIGURE 27: B11 THE MODERN COW CUBICLES (LEFT) AND B12 MILKING PARLOUR (RIGHT); VIEWED FROM THE SOUTH-WEST.

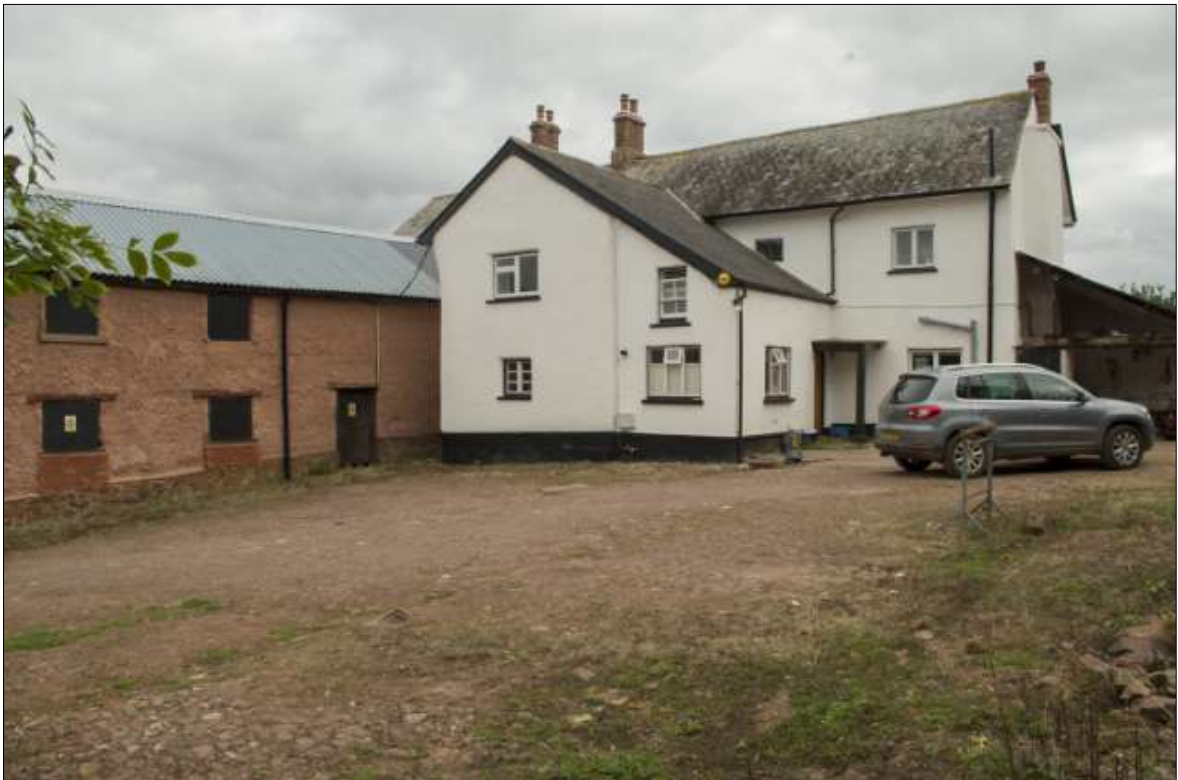
FIGURE 29: THE NORTH ELEVATION OF THE FARMHOUSE; VIEWED FROM THE NORTH-WEST.

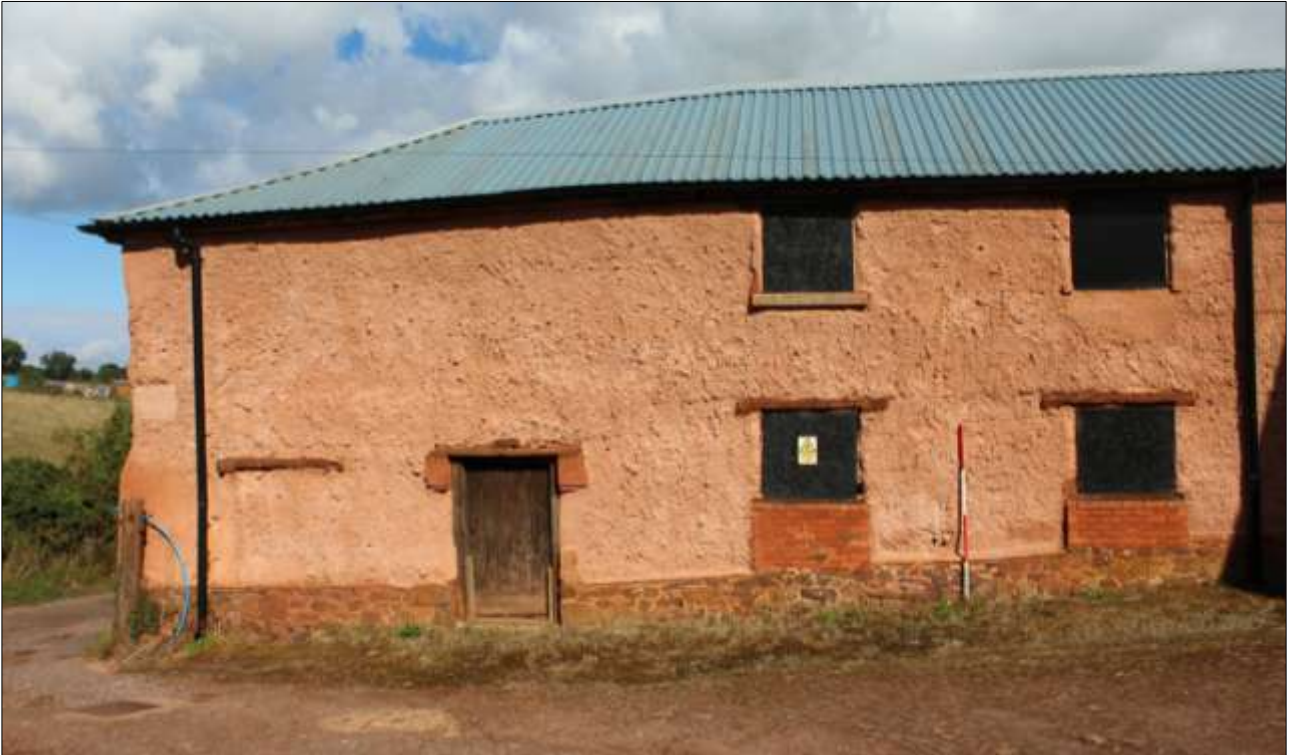
B1 EXTERIOR, THE WEST ELEVATION; VIEWED FROM THE WEST (SCALE 2M).

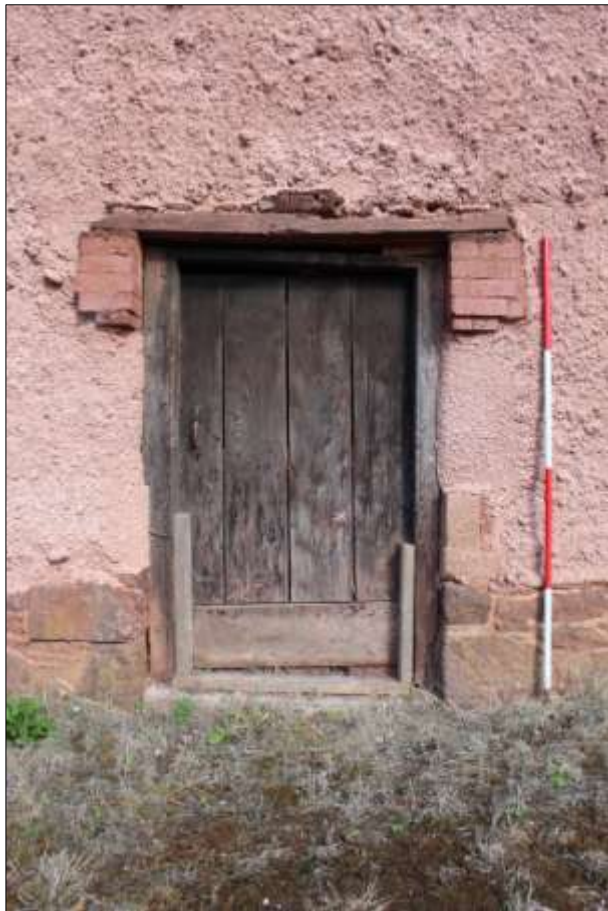
LEFT: B1 EXTERIOR, DETAIL OF D2; VIEWED FROM THE WEST (SCALE 2M).

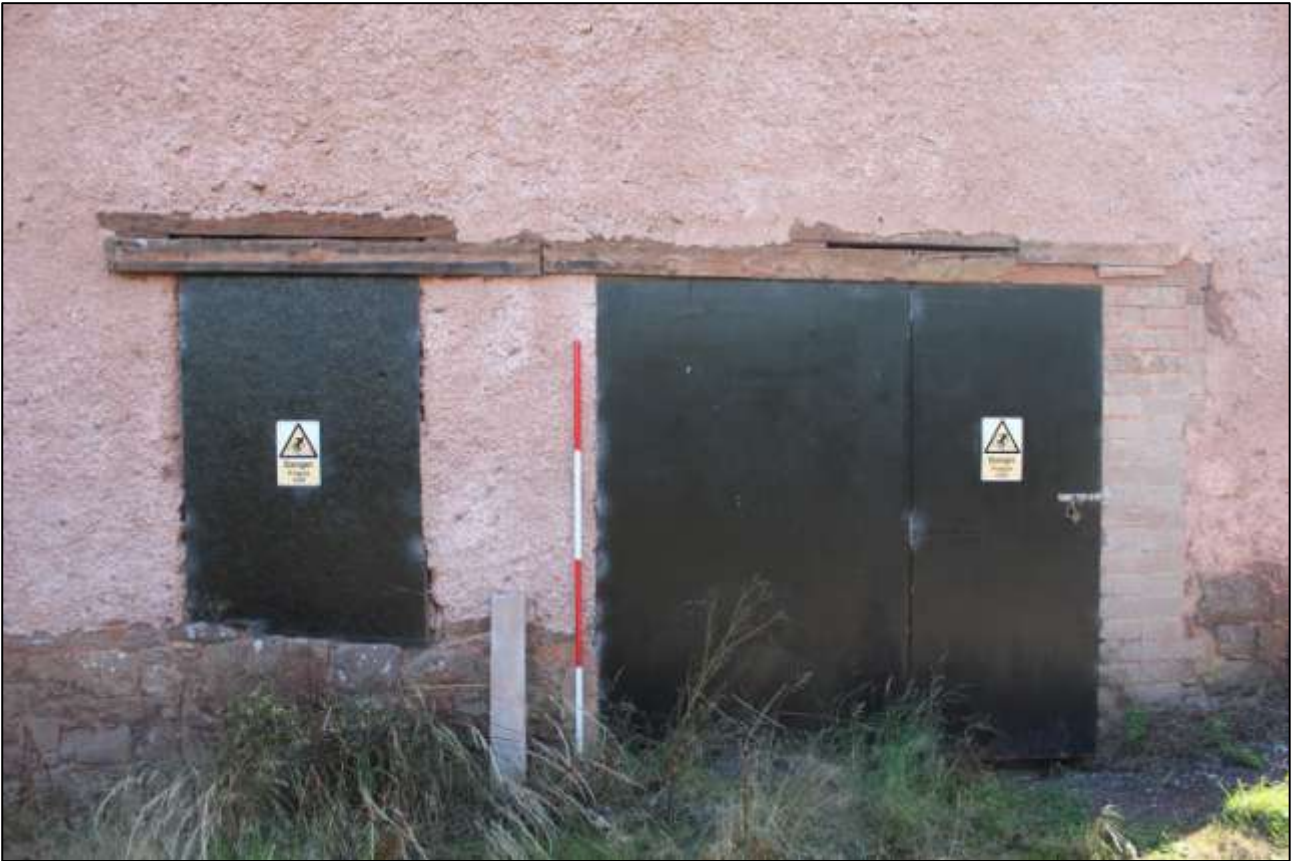
B1 EXTERIOR, NORTH ELEVATION, DETAIL OF D3 AND W4; VIEWED FROM THE NORTH (SCALE 2M).
