HIGHER PARK FARM

CREDITON

DESK-BASED ASSESSMENT WITH HISTORIC BUILDING RECORDING

Higher Park Farm, Crediton, Devon Desk-Based Assessment with Historic Building Recording

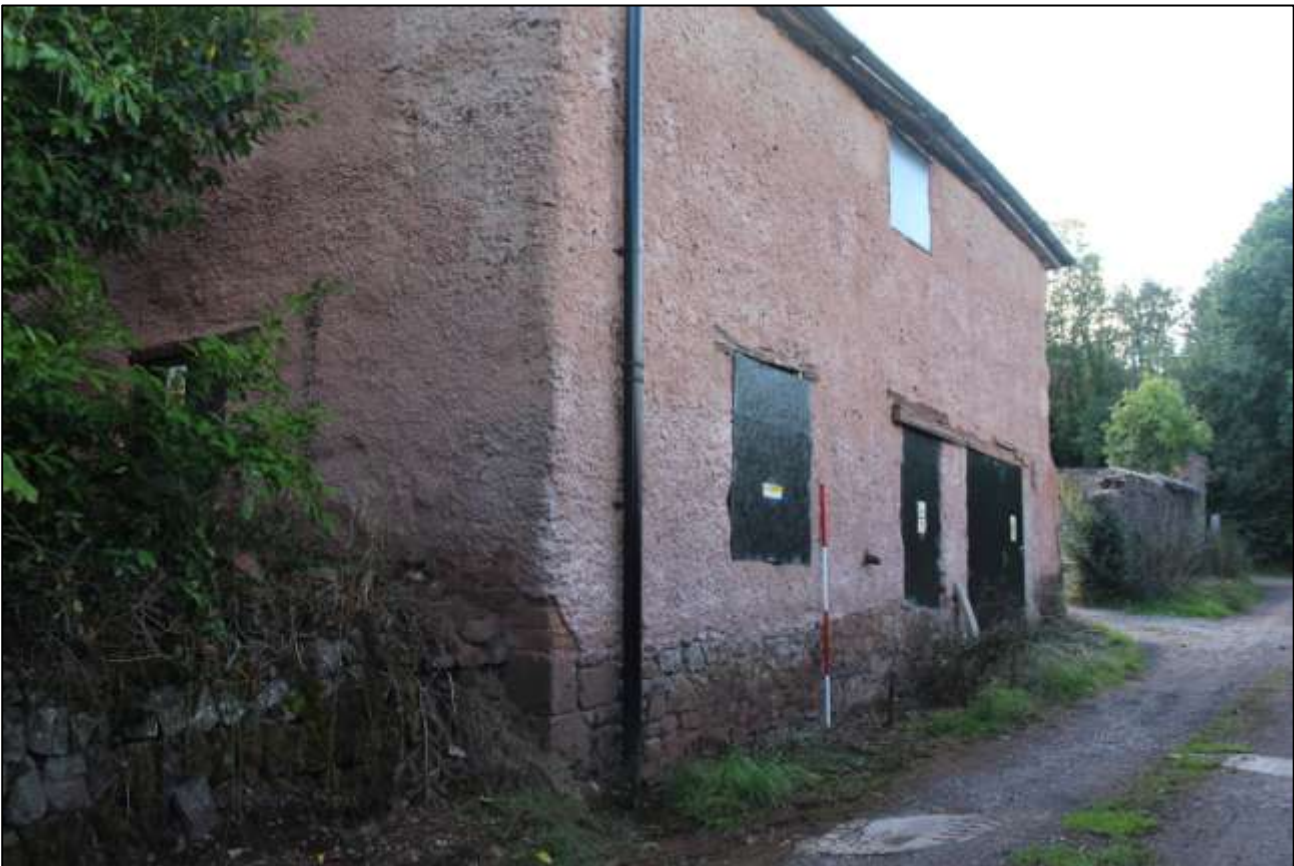
B1 EXTERIOR, THE NORTH AND EAST ELEVATIONS; VIEWED FROM THE NORTH-EAST (SCALE 2M).

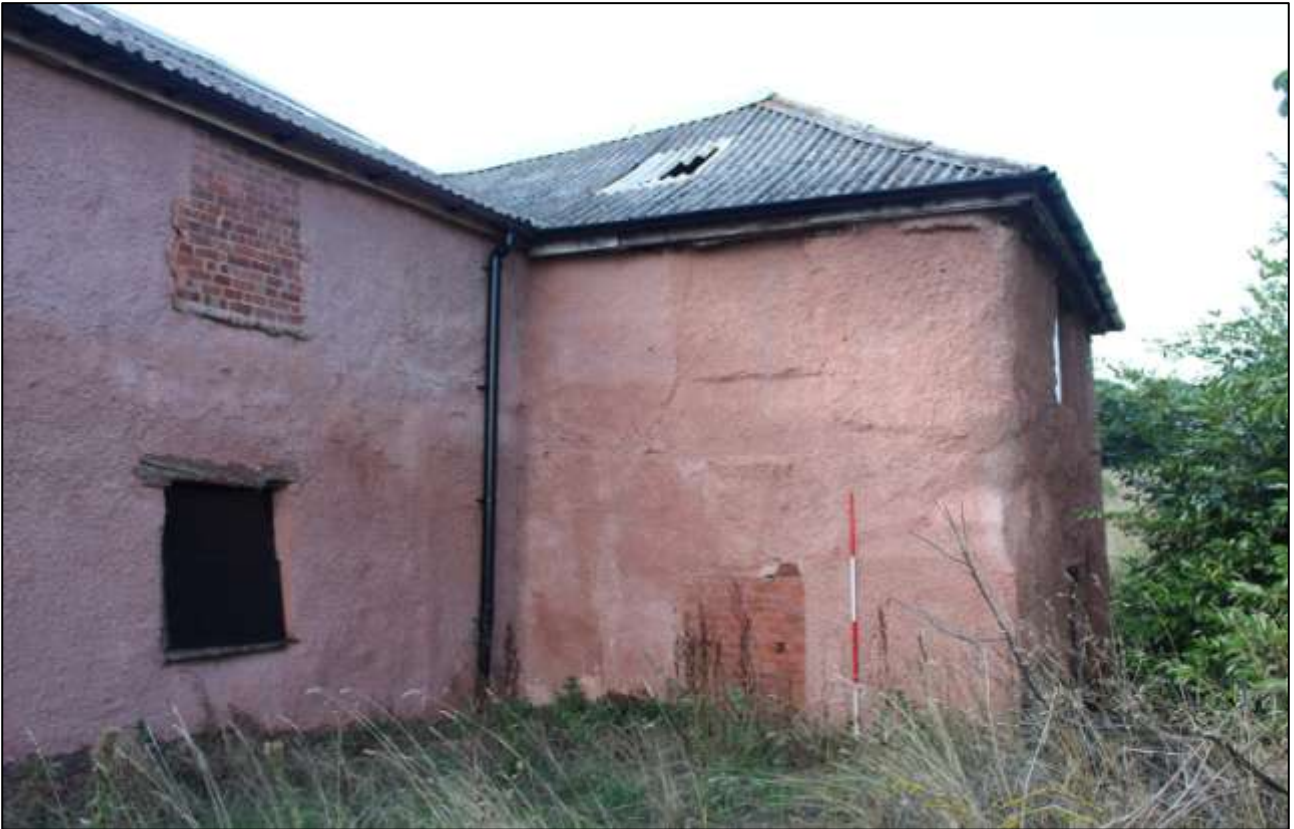
B1 EXTERIOR, THE SOUTH ELEVATION; VIEWED FROM THE SSE (SCALE 2).

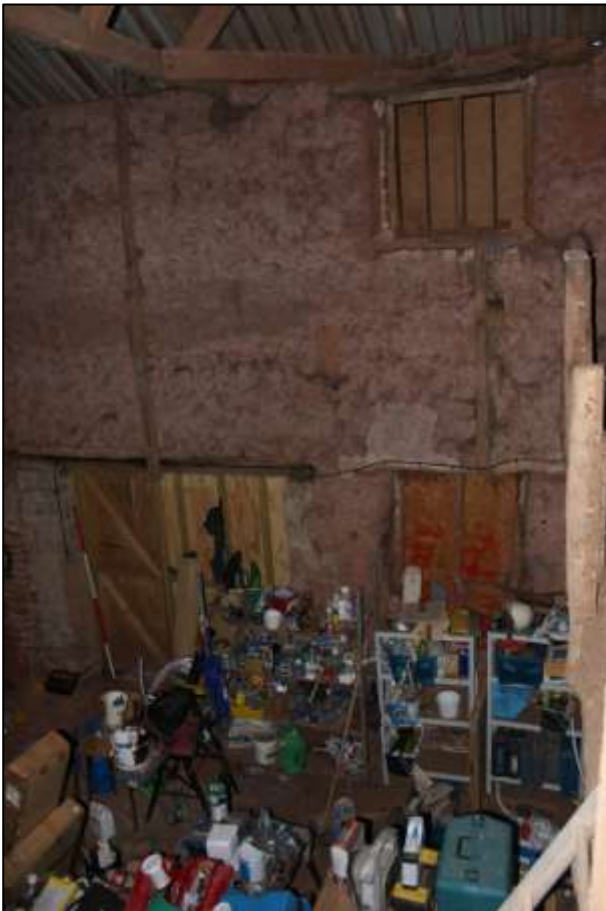
LEFT: B1 INTERIOR, NORTH WALL; VIEWED FROM THE SSE.

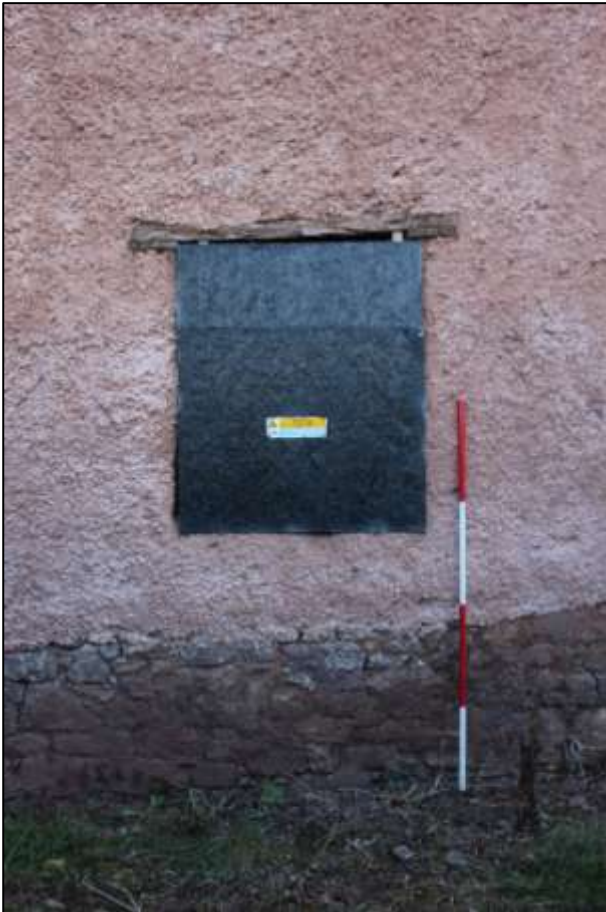
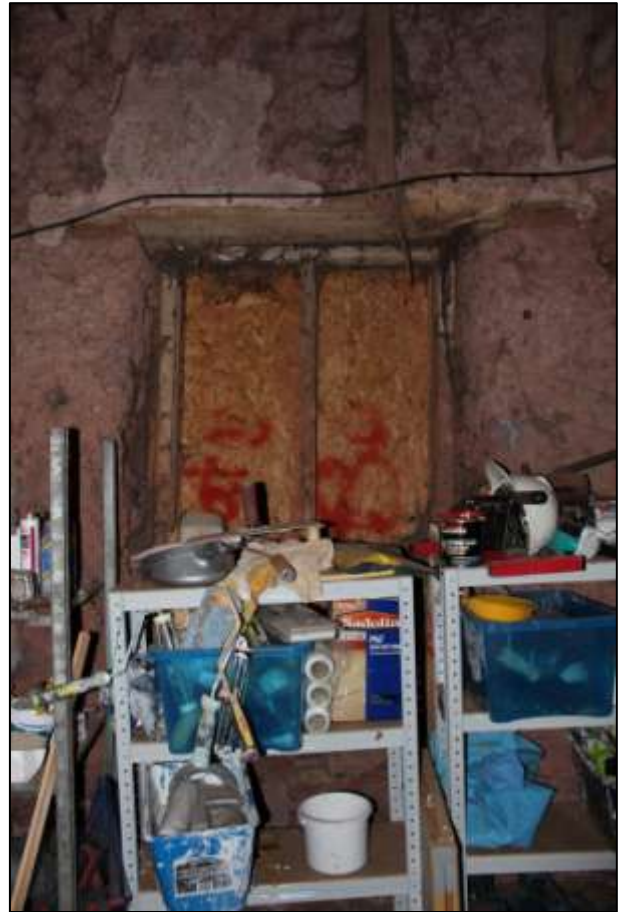
LEFT: B1 EXTERIOR, NORTH ELEVATION, DETAIL OF W5; VIEWED FROM THE NORTH (SCALE 2M).
RIGHT: B1 GF INTERIOR, NORTH WALL, DETAIL OF W4; VIEWED FROM THE SOUTH.

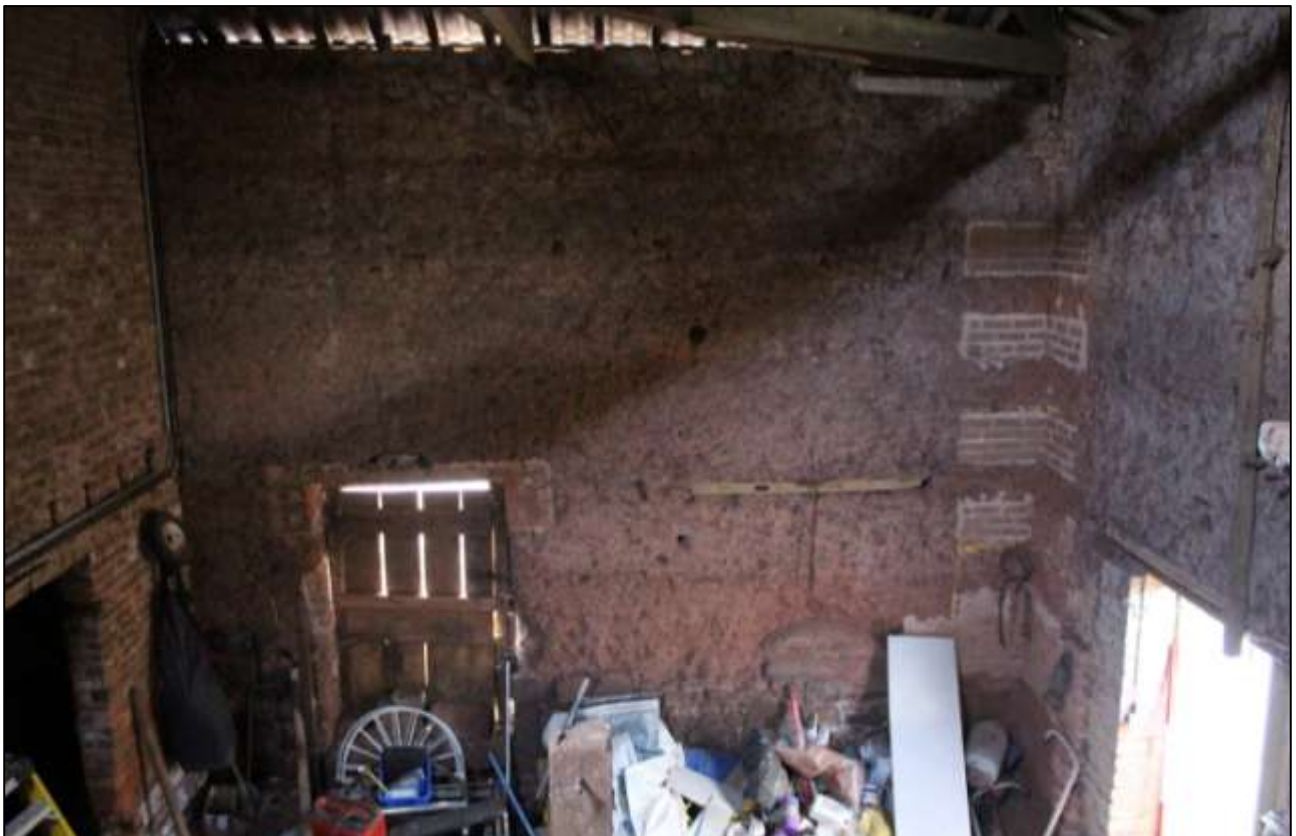
B1 INTERIOR, WEST WALL WITH D2 AND BO1; VIEWED FROM THE EAST.

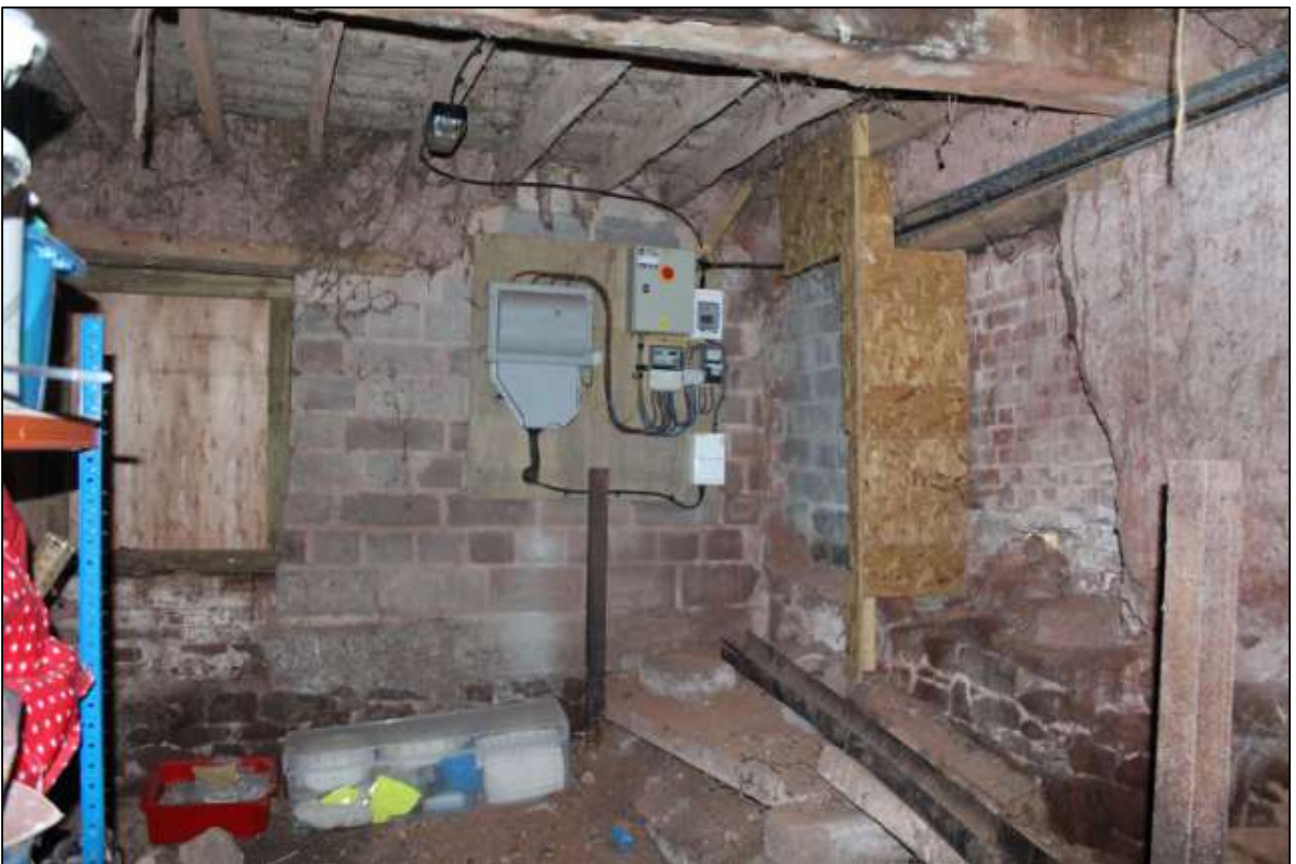
B1 GF INTERIOR, EAST WALL SHOWING W6 AND W7; VIEWED FROM THE WEST.

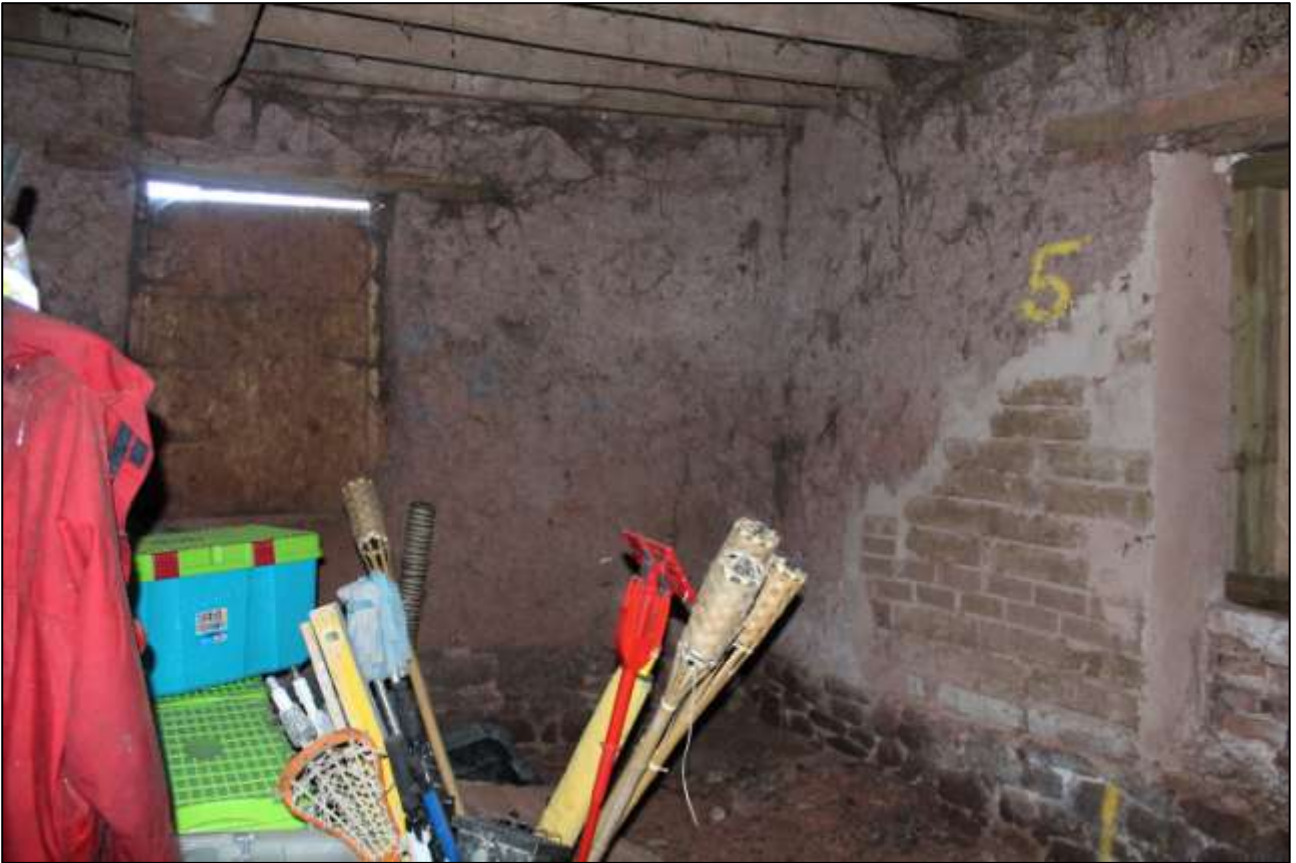
B1 GF INTERIOR, NORTH-EAST CORNER, SHOWING W5 AND W6; VIEWED FROM THE SSW.

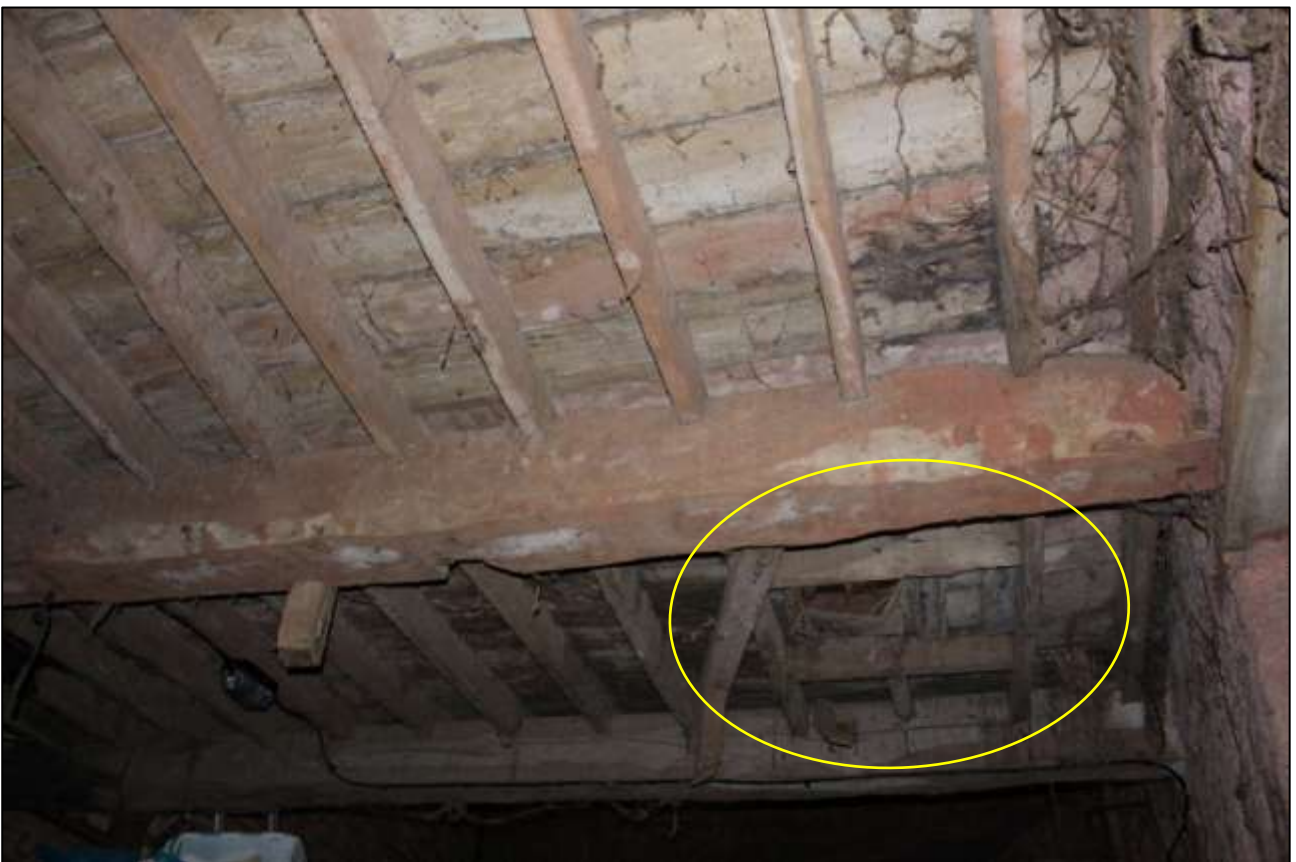
B1 GF INTERIOR, STRUCTURE OF THE GALLERY SHOWING THE HATCH (INDICATED); VIEWED FROM THE ENE AND BENEATH.

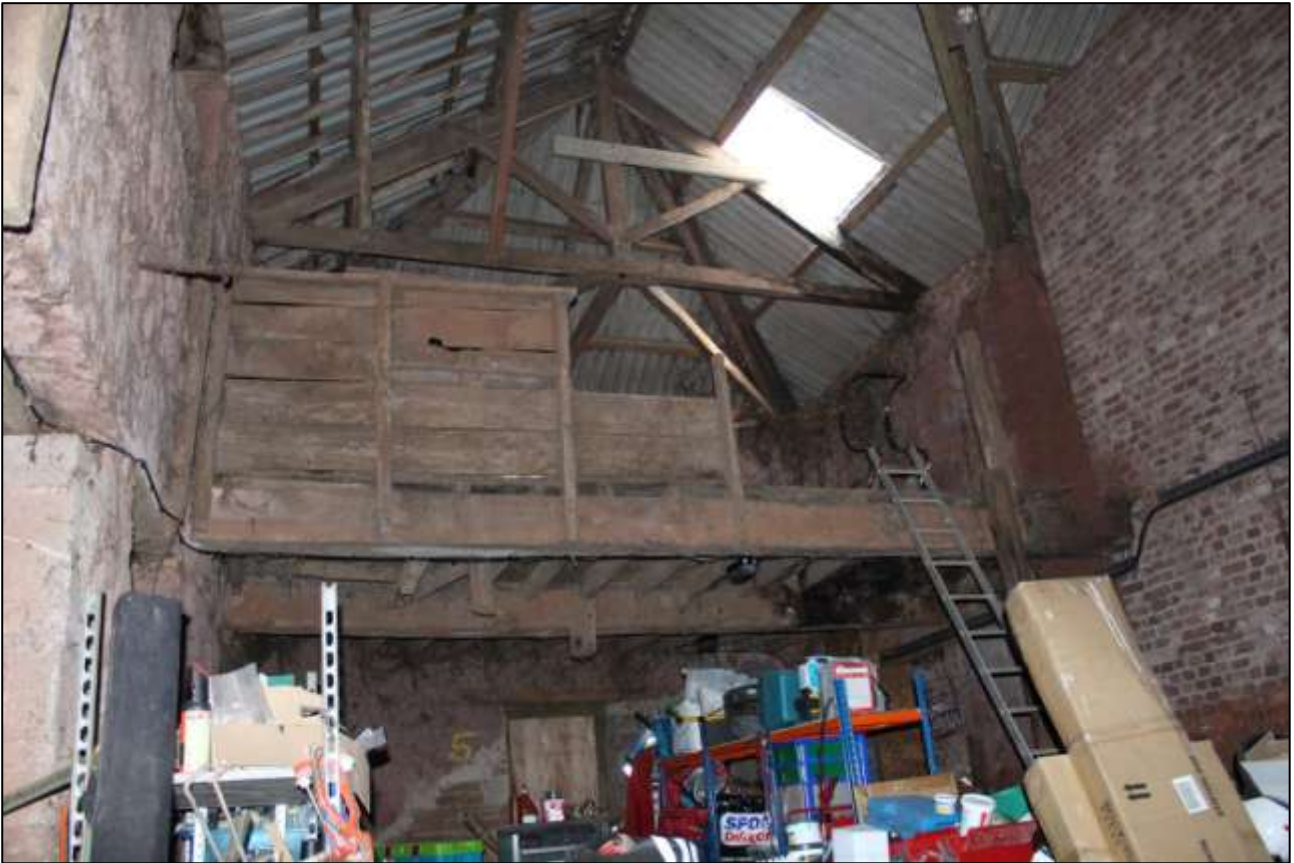
B1, INTERIOR, SHOWING THE GALLERY AND RAILINGS; VIEWED FROM THE WNW.

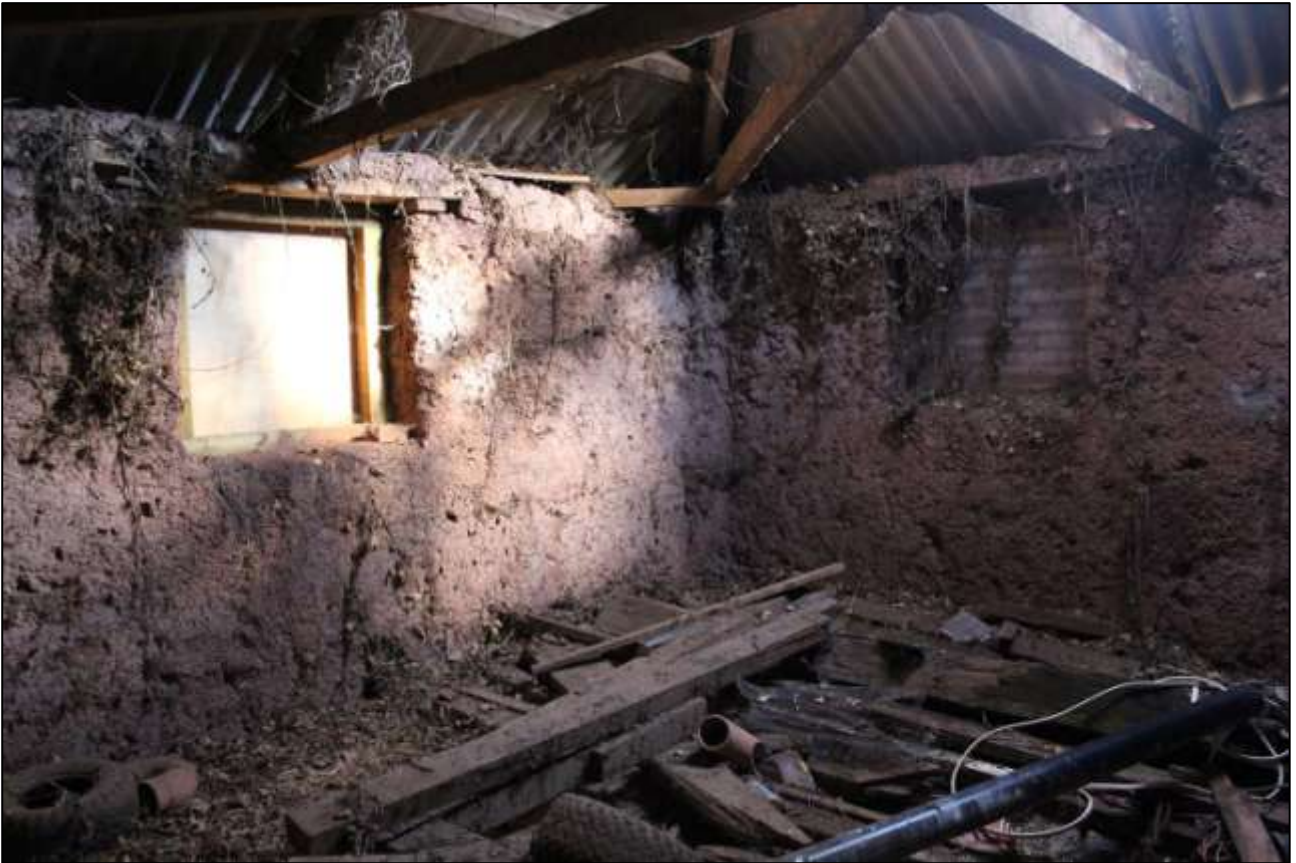
B1 INTERIOR, FF GALLERY SHOWING W16 AND W17; VIEWED FROM NORTH-WEST.

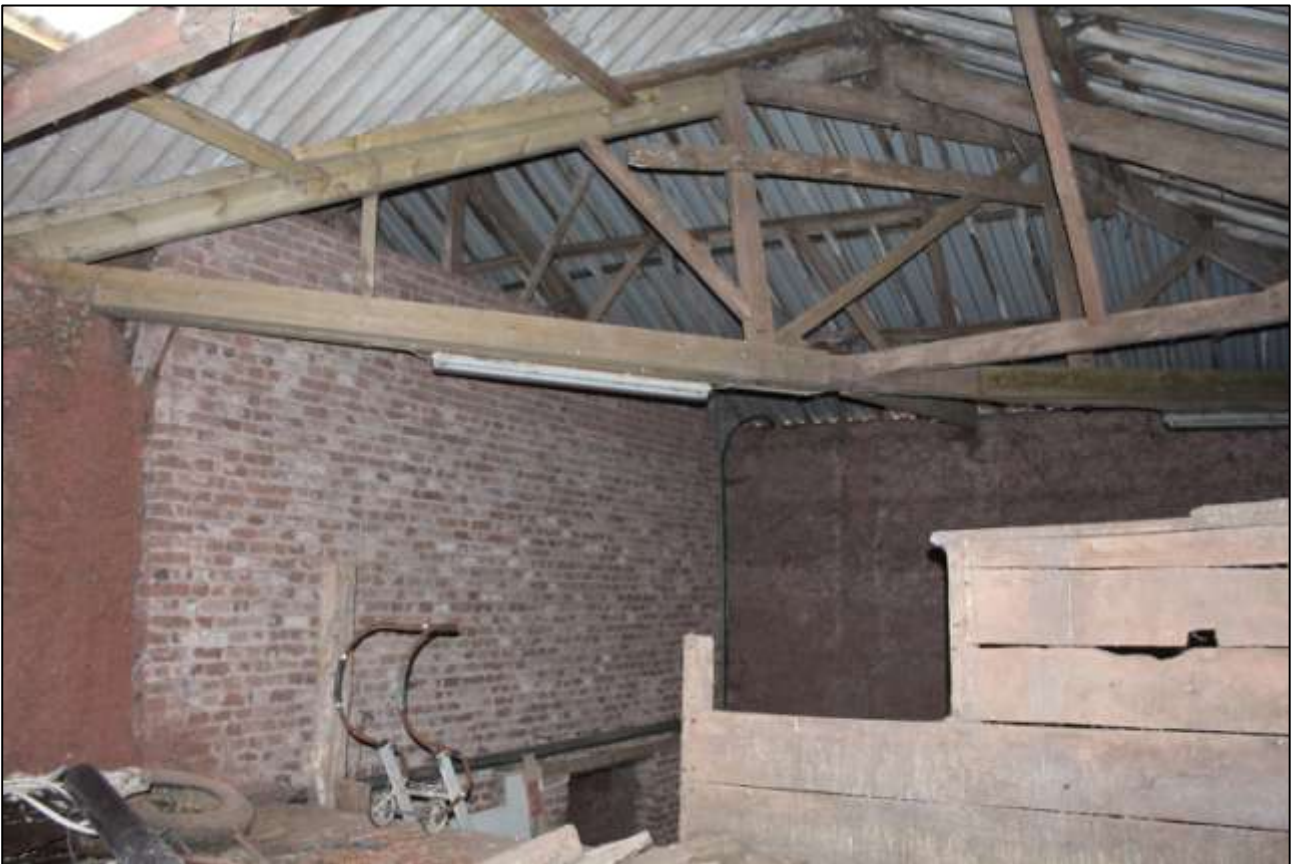
B1 FF INTERIOR, SHOWING THE BRICK WALL BETWEEN B1 AND B2; VIEWED FROM THE NORTH-EAST.

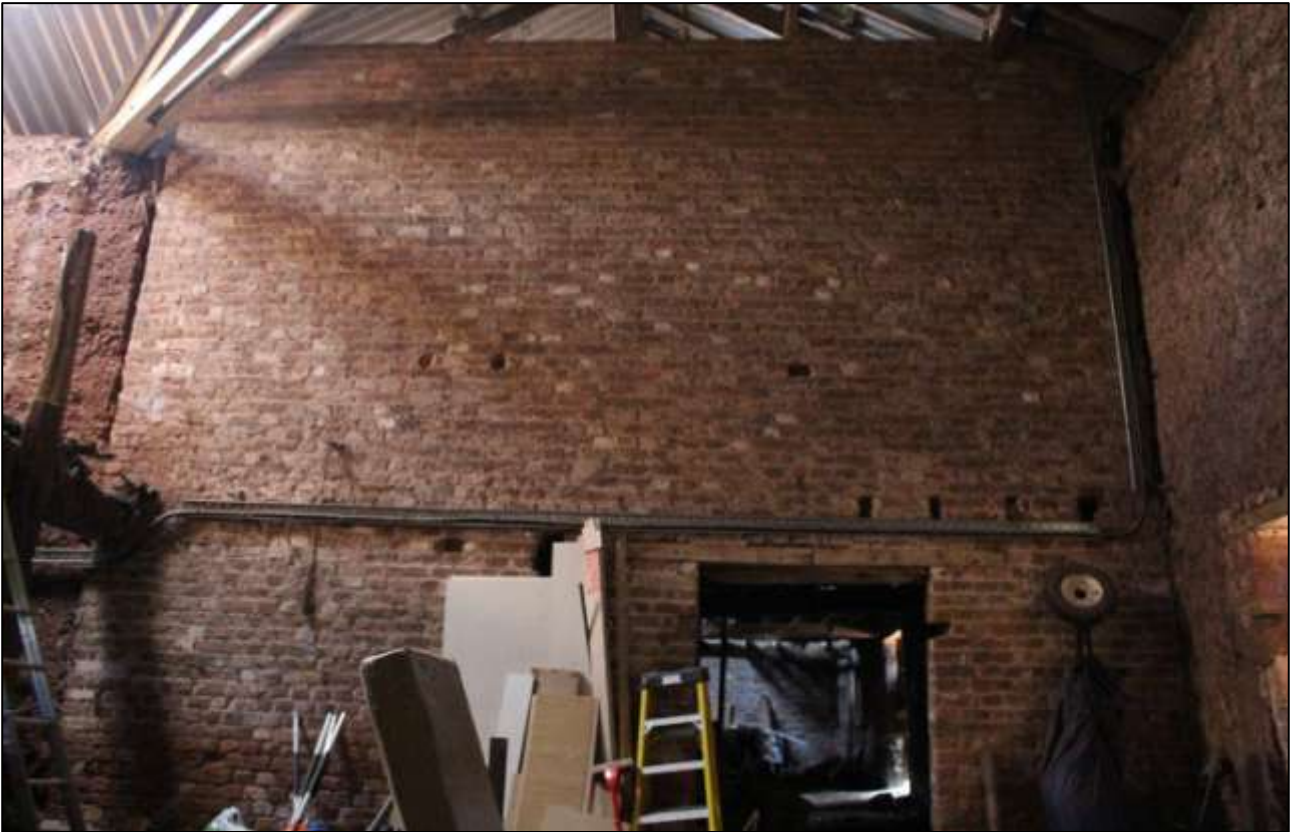
B1 GF INTERIOR, SHOWING THE BRICK WALL BETWEEN B1 AND B2; VIEWED FROM THE NORTH.

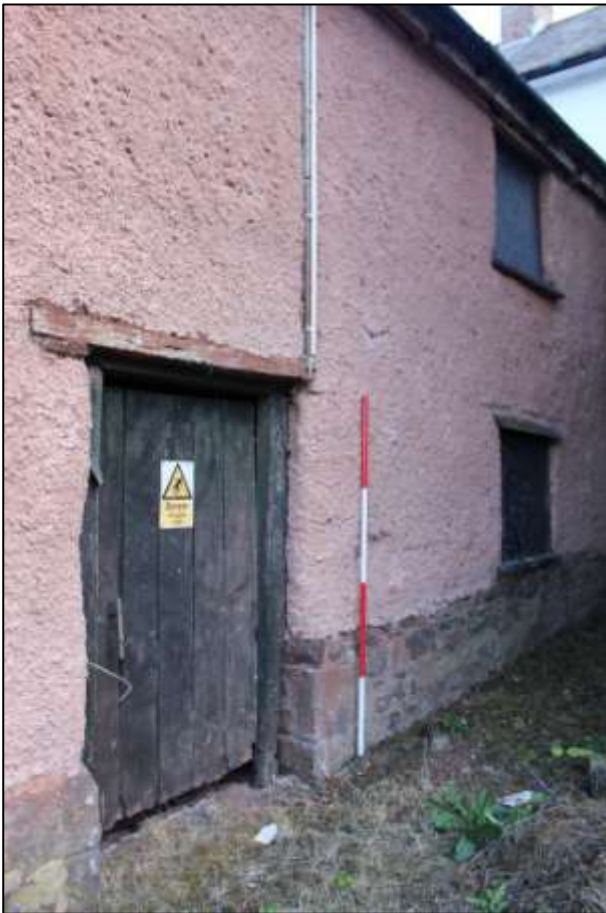
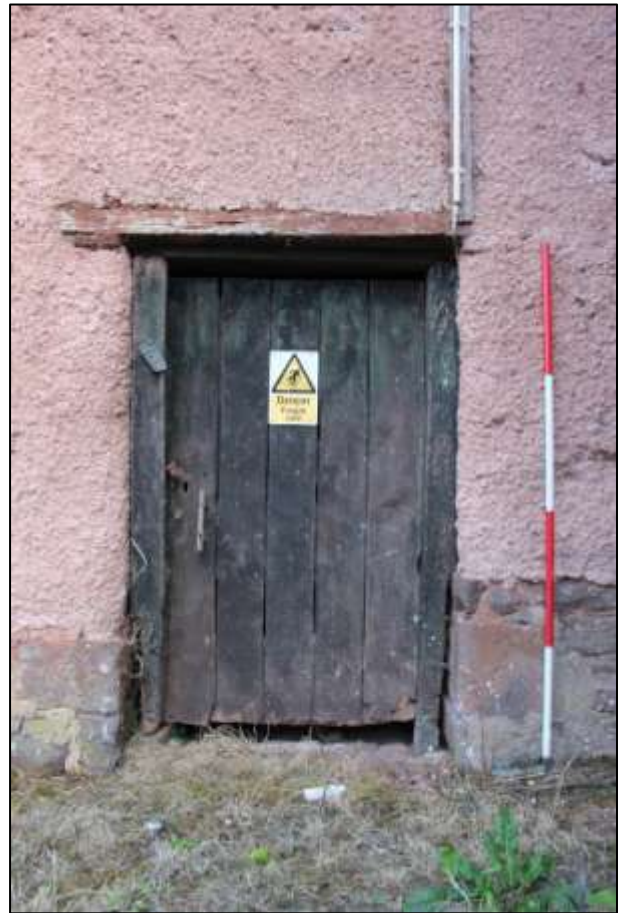
LEFT: B2 EXTERIOR, THE WEST ELEVATION SHOWING D1, W1 AND W11; VIEWED FROM THE NNW (SCALE 2M).
RIGHT: B2 EXTERIOR, WEST ELEVATION, DETAIL OF D1; VIEWED FROM THE WEST (SCALE 2M).

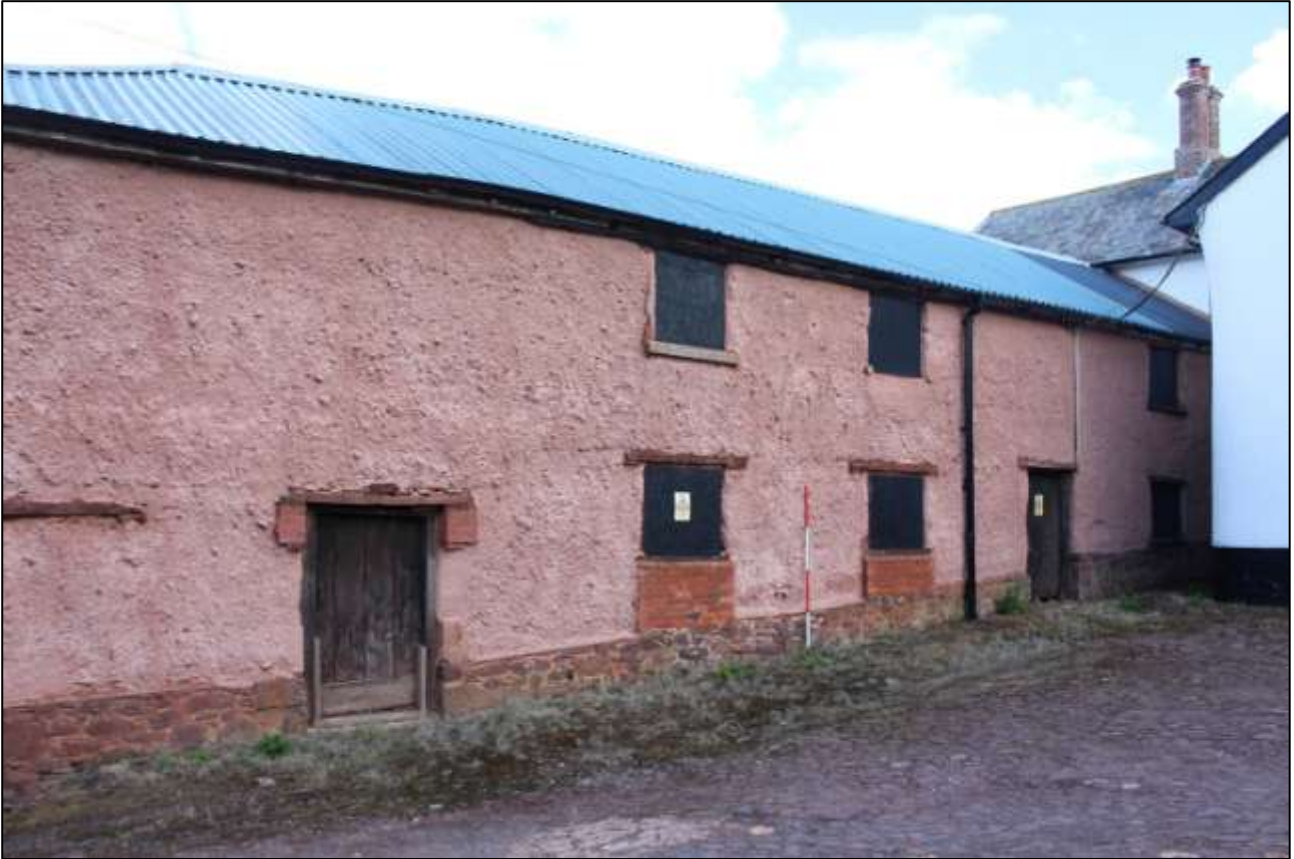
B2 EXTERIOR, WEST ELEVATION; VIEWED FROM THE NORTH-WEST (SCALE 2M).

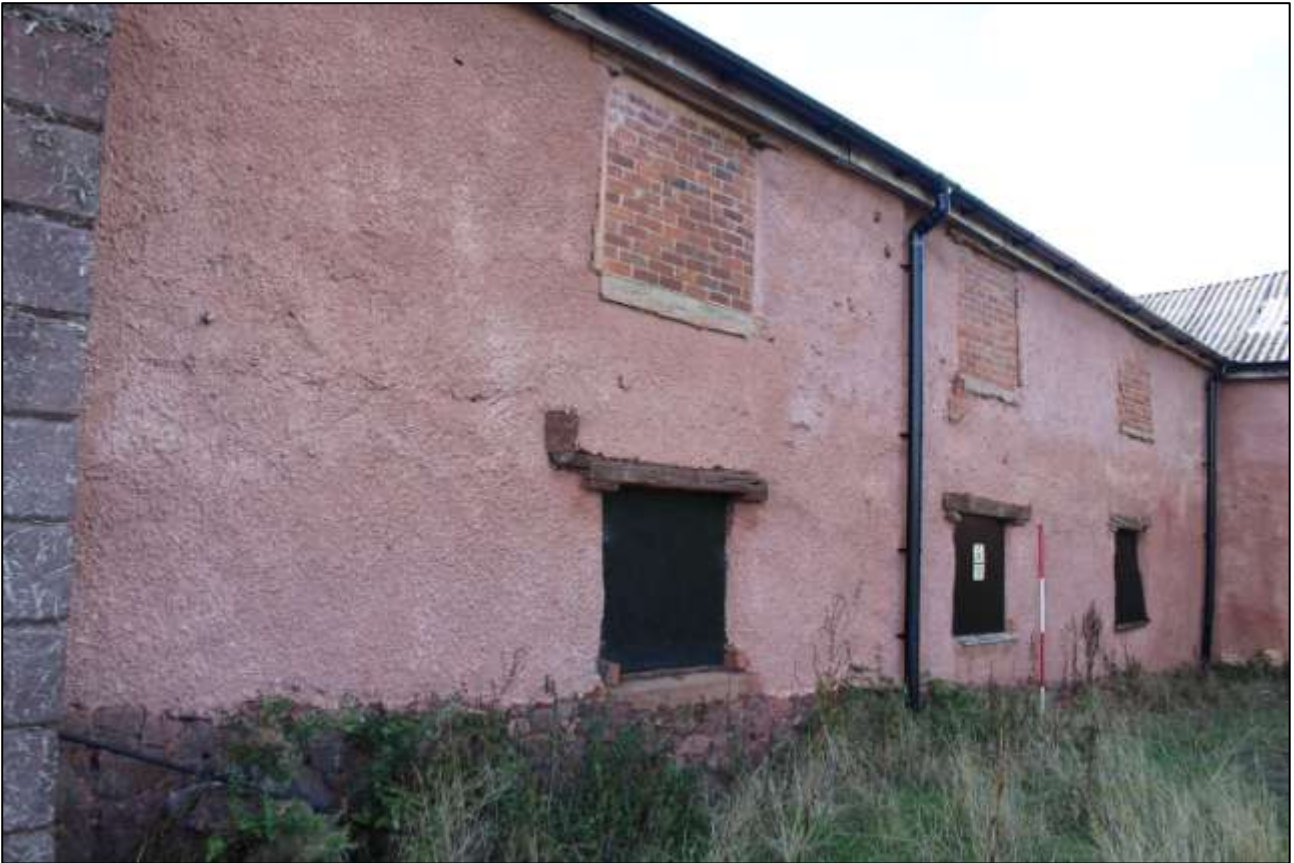
B2 EXTERIOR, EAST ELEVATION; VIEWED FROM THE SOUTH-EAST (SCALE 2M).

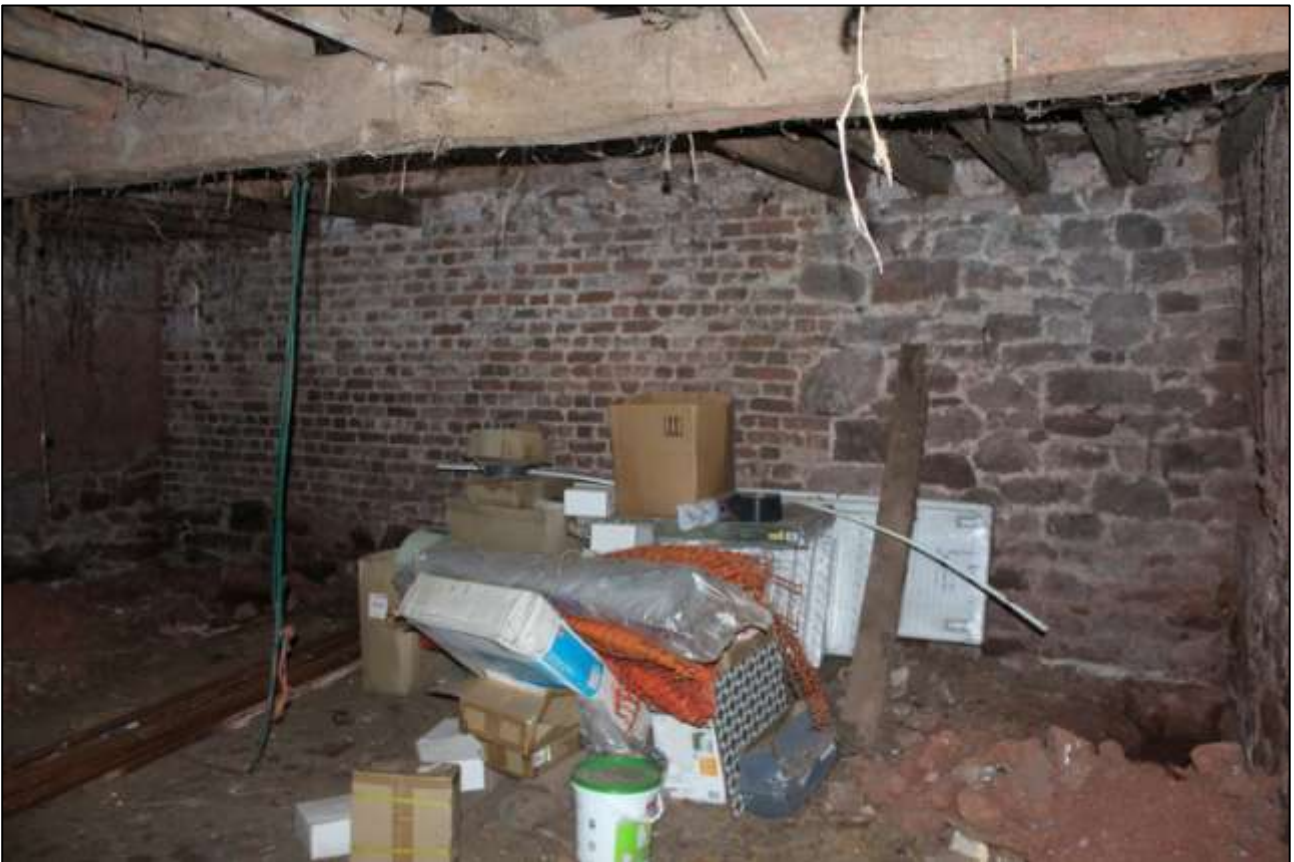
B2 GF INTERIOR; THE WALL OF THE FARMHOUSE AT THE SOUTH END OF THE BUILDING; VIEWED FROM THE NNW.

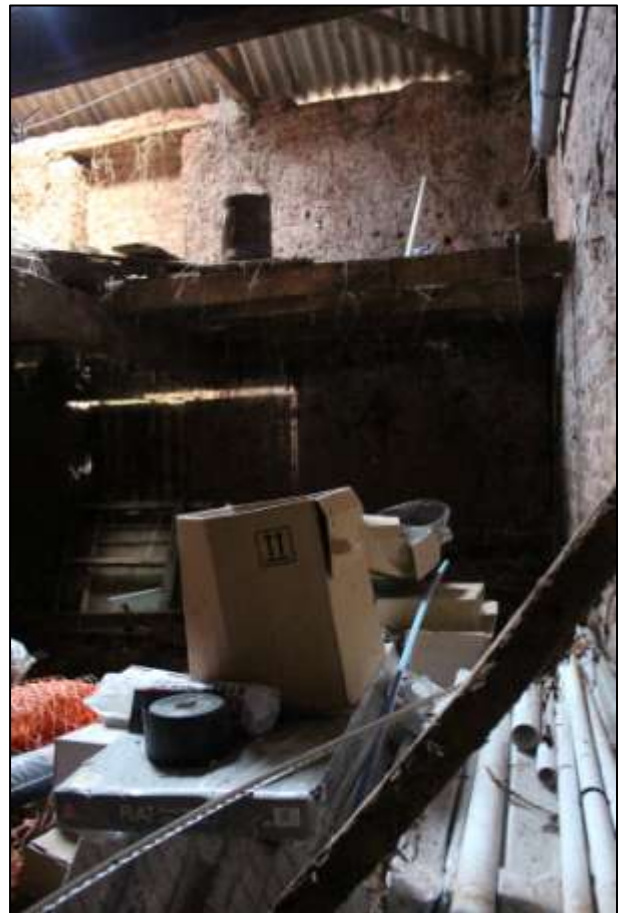
RIGHT: B2 GF INTERIOR, SHOWING THE GAP IN THE FLOORBOARDS; VIEWED FROM THE WEST.

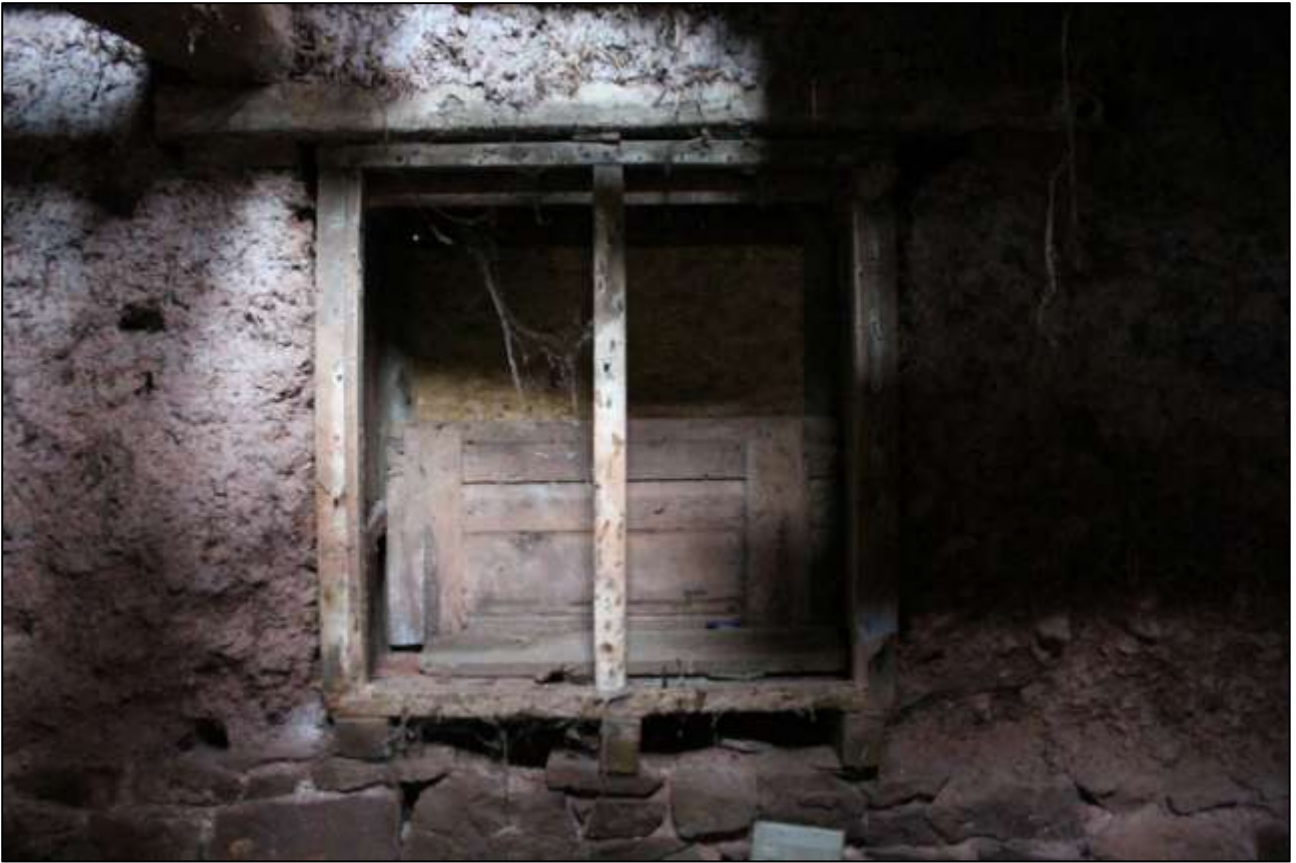
B2 GF INTERIOR, WEST WALL, DETAIL OF W1; VIEWED FROM THE EAST.

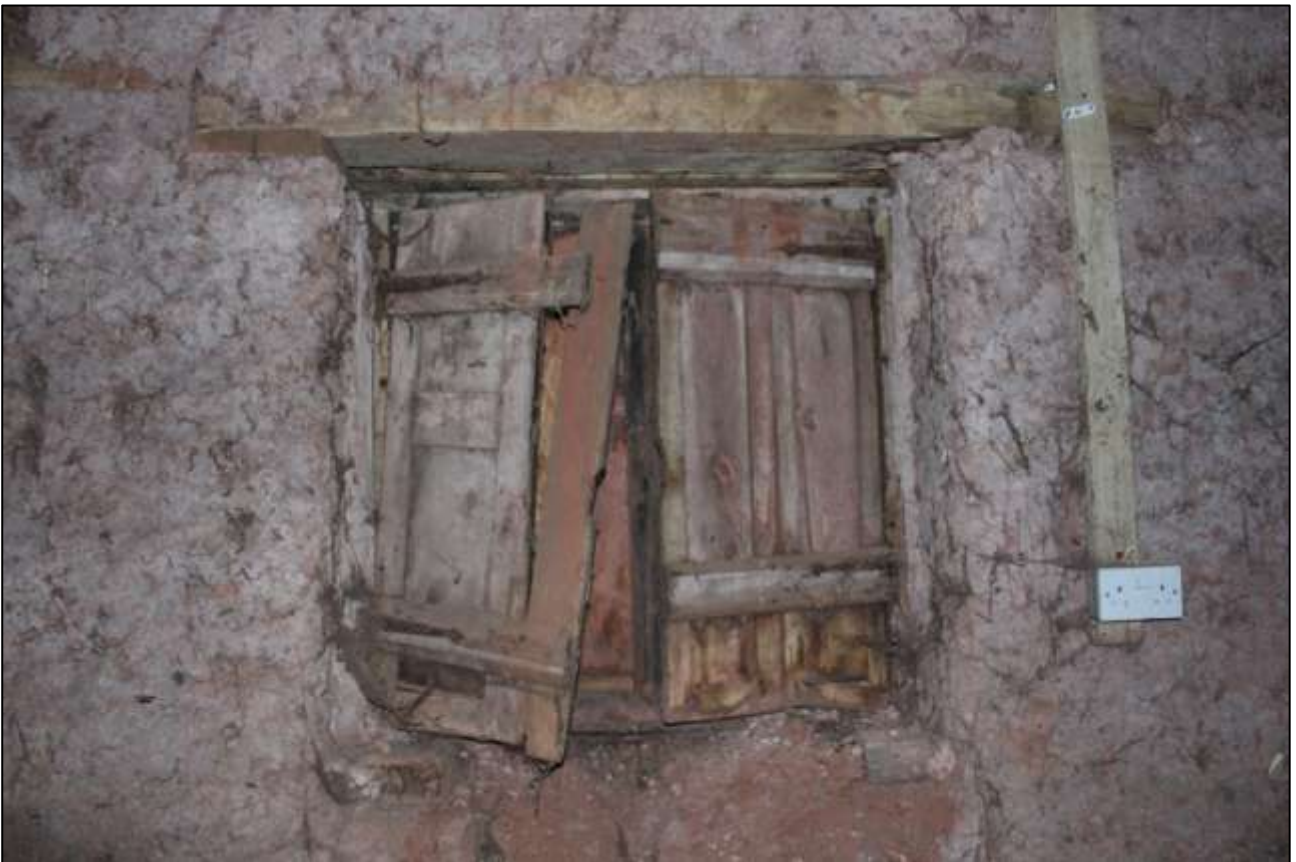
B2 GF INTERIOR, WEST WALL, DETAIL OF W2; VIEWED FROM THE EAST.

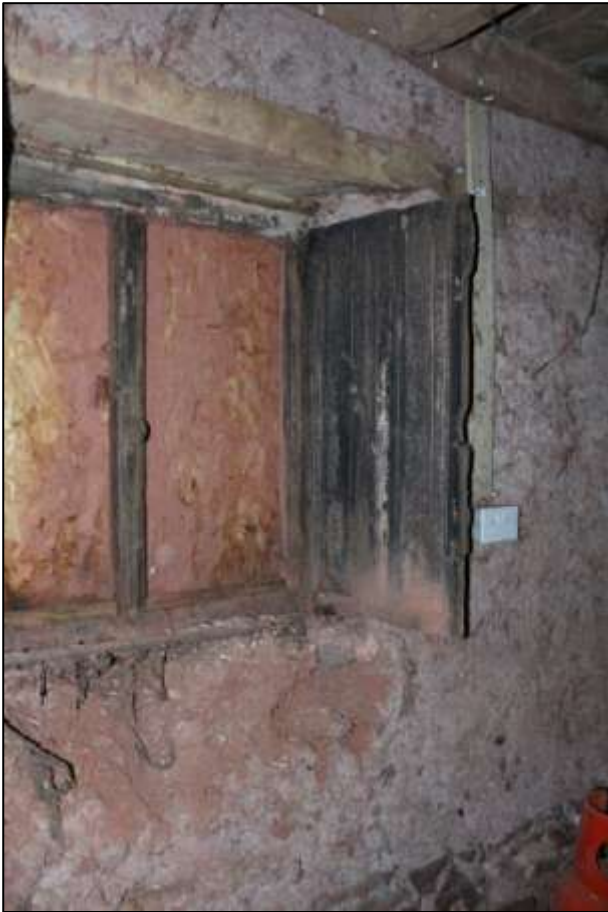
LEFT: AS ABOVE, DETAIL OF THE RIGHT SHUTTER.

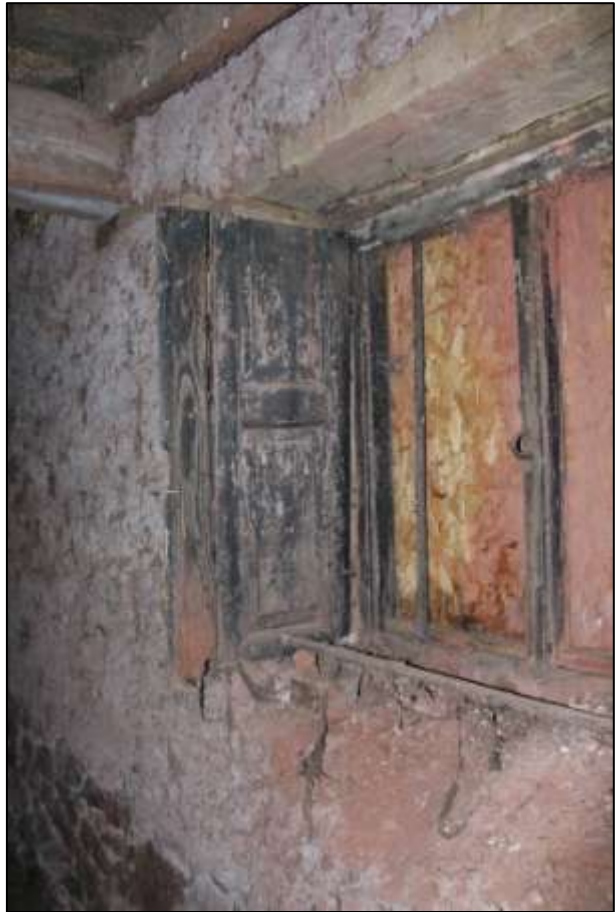
RIGHT: AS ABOVE, DETAIL OF THE LEFT SHUTTER.

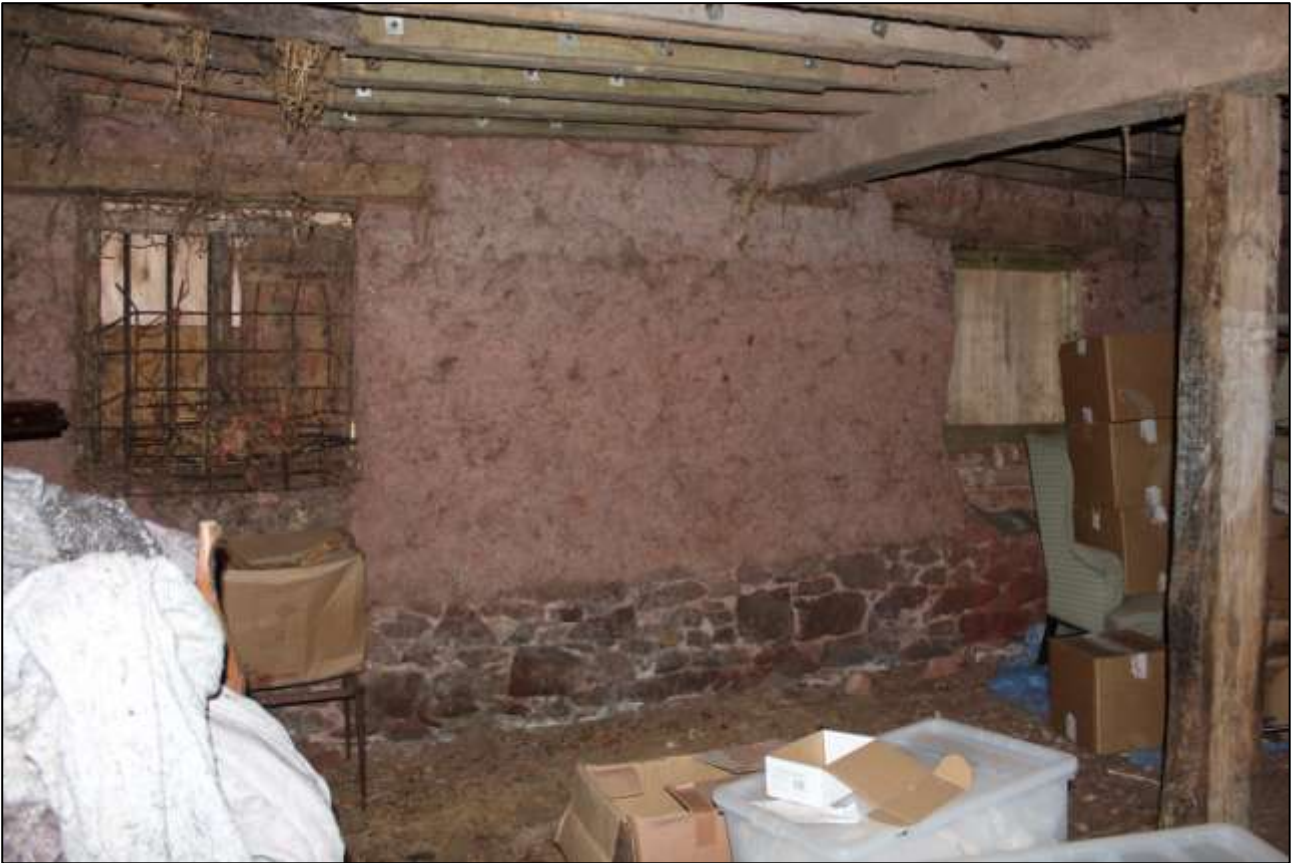
B2 GF INTERIOR, EAST WALL, SHOT ACROSS TO W8 AND W9; VIEWED FROM THE WNW.
