HIGHER PARK FARM

CREDITON

DESK-BASED ASSESSMENT WITH HISTORIC BUILDING RECORDING

Higher Park Farm, Crediton, Devon Desk-Based Assessment with Historic Building Recording

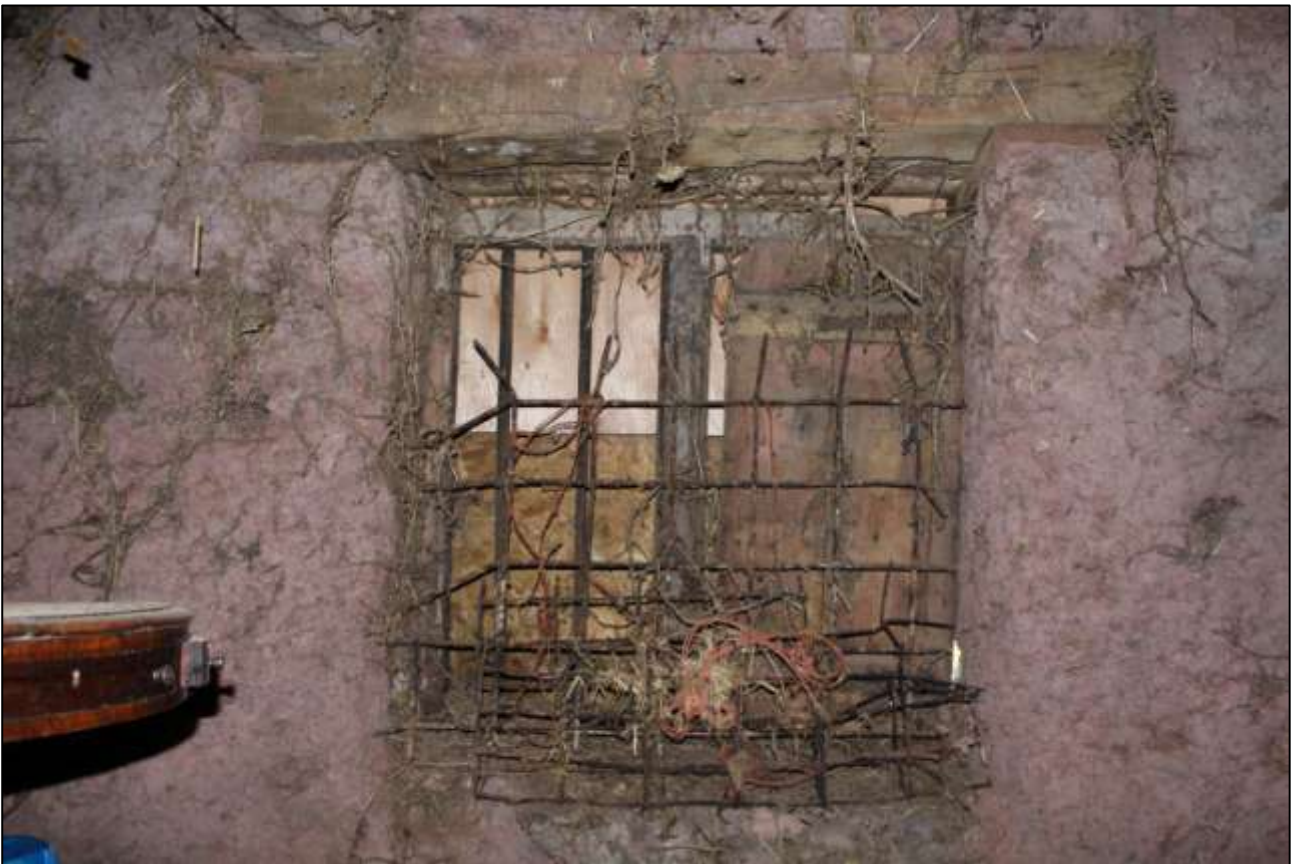
B2 GF INTERIOR, EAST WALL, DETAIL OF W8; VIEWED FROM THE WEST.

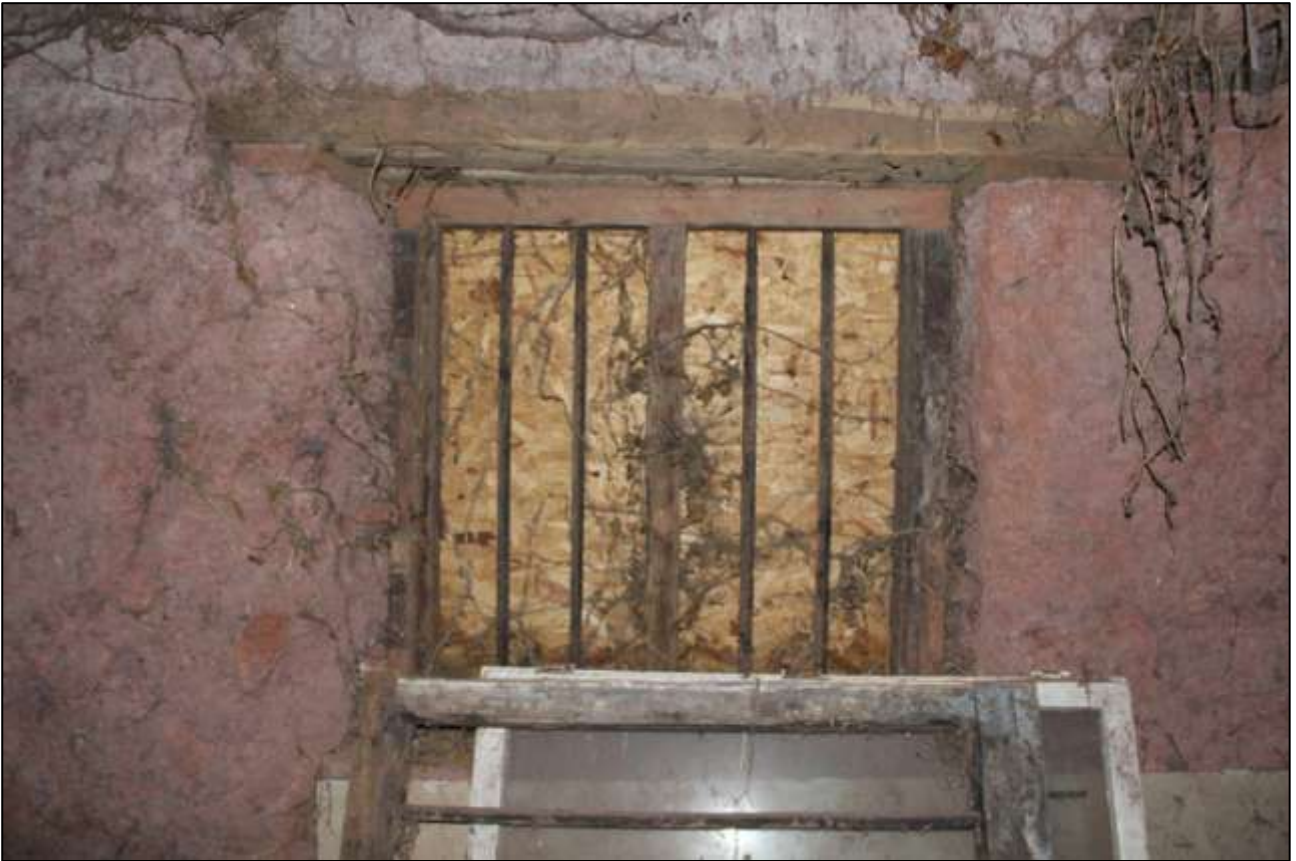
B2 GF INTERIOR, EAST WALL, DETAIL OF W10; VIEWED FROM THE WEST.

W10	GF window in east wall. Square window, boarded externally. Straight cob sides, reused timber lintel on timber pads, thin plank sill. Cob below the opening repaired, with projecting bricks to each side. Surviving timber two-light frame, two iron bars to each light. Later C20 iron mesh. Ex-situ historic frame leaning up in front of this window.
Significant Features:		Stairs rising from the ground floor in front of D1 to FF level. The broad shallow wide steps thick plank treads and plain plank stair plate. The stair has eight surviving treads with sockets for three more to the base that have been lost/rotted out; the stairs are braced by several vertical timbers that may once have been boxed in
B2 First Floor		Description
Floor:		Floor of even-width planks, pierced by a single stairwell. The floor is missing to the south-west (rotted out?), but there are joist sockets in the wall of the Farmhouse.

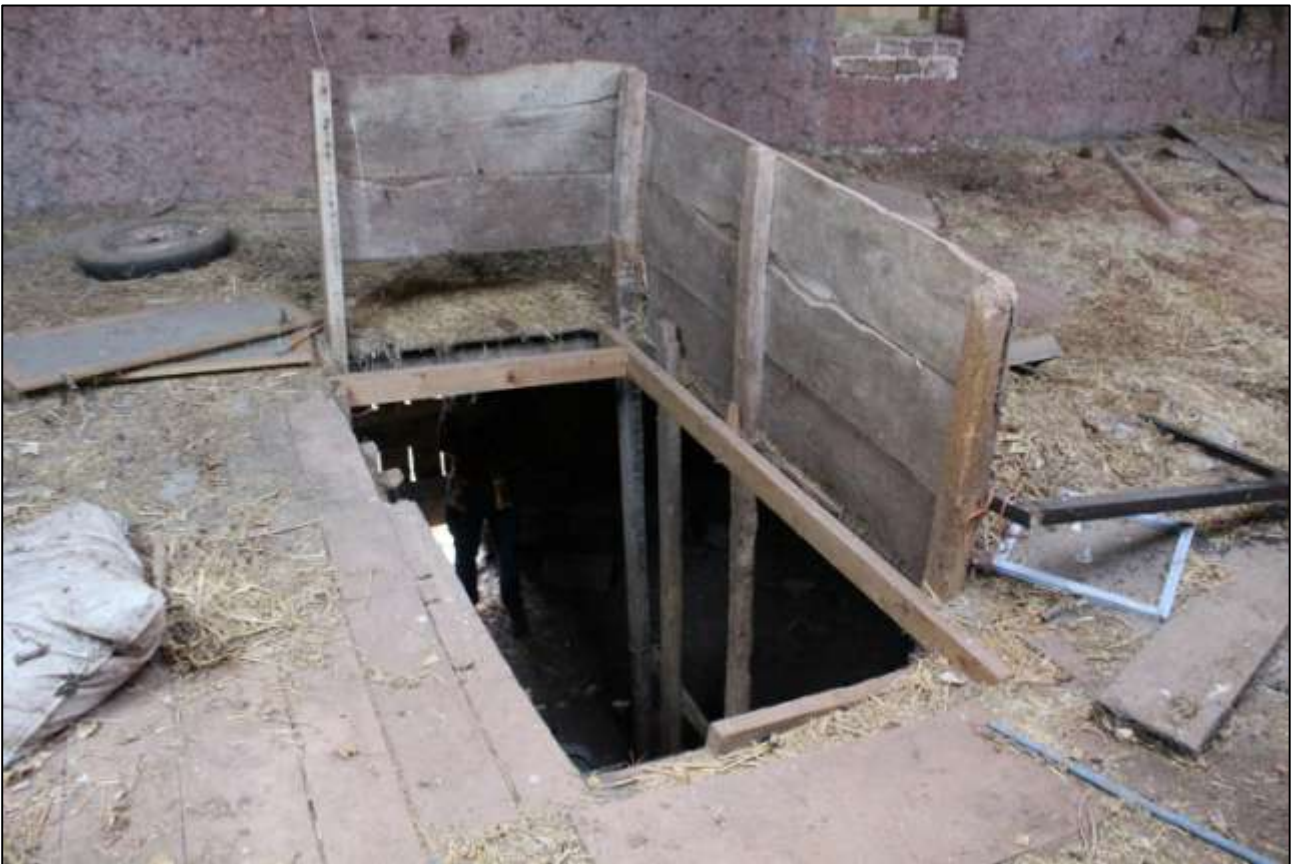
B2 FF INTERIOR, DETAIL OF THE RAIL AROUND THE STAIRWELL; VIEWED FROM THE EAST.

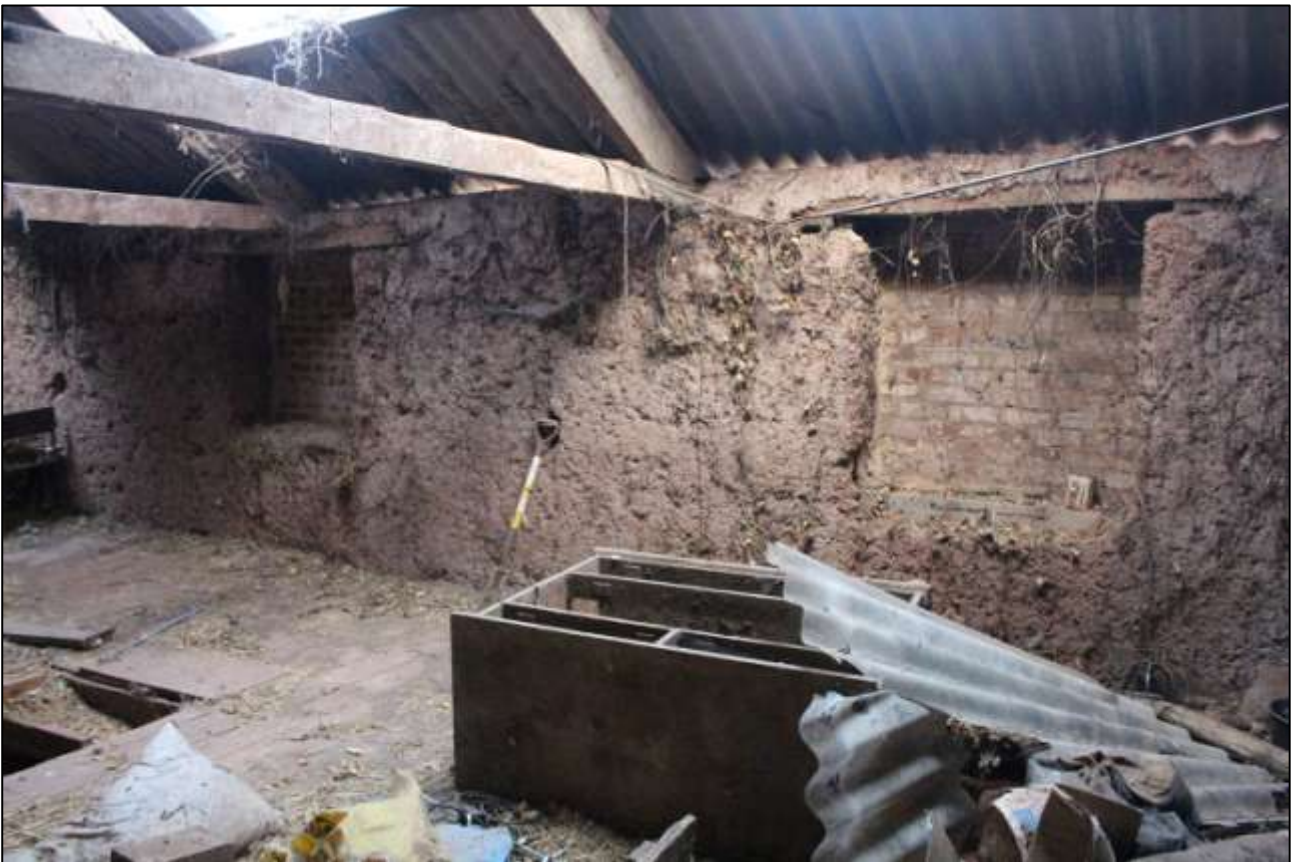
B2 FF INTERIOR, DETAIL OF THE EAST WALL AND W18 AND W19; VIEWED FROM THE WSW.

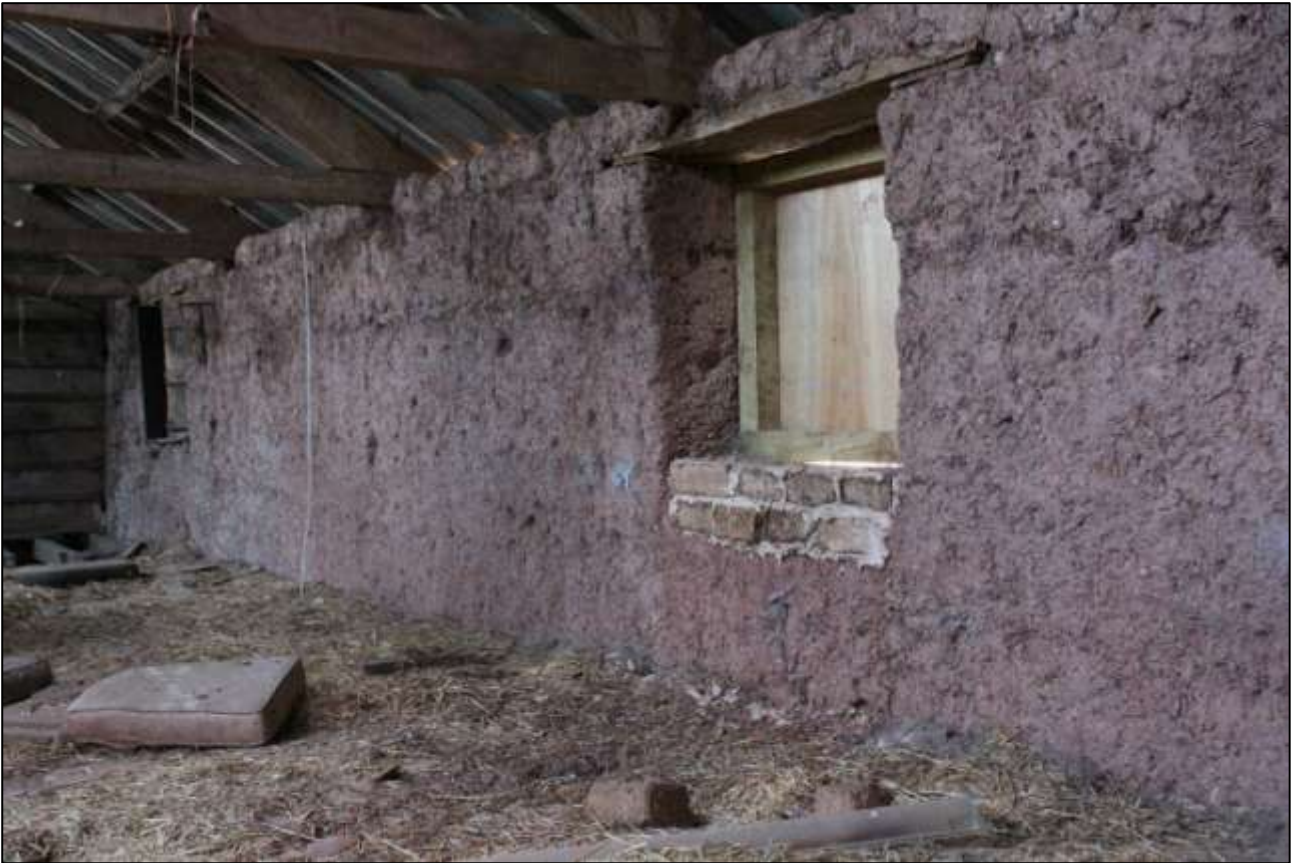
B2 FF INTERIOR, WEST WALL, SHOWING W12 AND W11 AND RAISES IN THE COB; VIEWED FROM THE NNE.

No frame.
Other Details:		To the north end, past W9/W18 as far as the join with B1, there is a clear build line at one-and-a-half-storeys; this indicates a raise, possibly a thatched steeper former roofline, before it was replaced in slate in the C19.
Relationships:		The elevation abuts the Farmhouse to the south and B1 to the north; the north end of the elevation is older than the southern part.
B2 Elevation SOUTH		Description
Relationships:		B2 is built up against the Farmhouse at its south end. Two-phase Farmhouse wall: the west section is of good blocky stonework in a white lime mortar, the east section in pale red brickwork in an English bond with a white lime mortar. As the easternmost room of the farmhouse was been extended in brick the cob walls must be mid-to-late C19 as they abut a structure built after 1839. This wall is pierced by a door at FF level providing access to the toilet; this is a later C19 plain four-panel door.

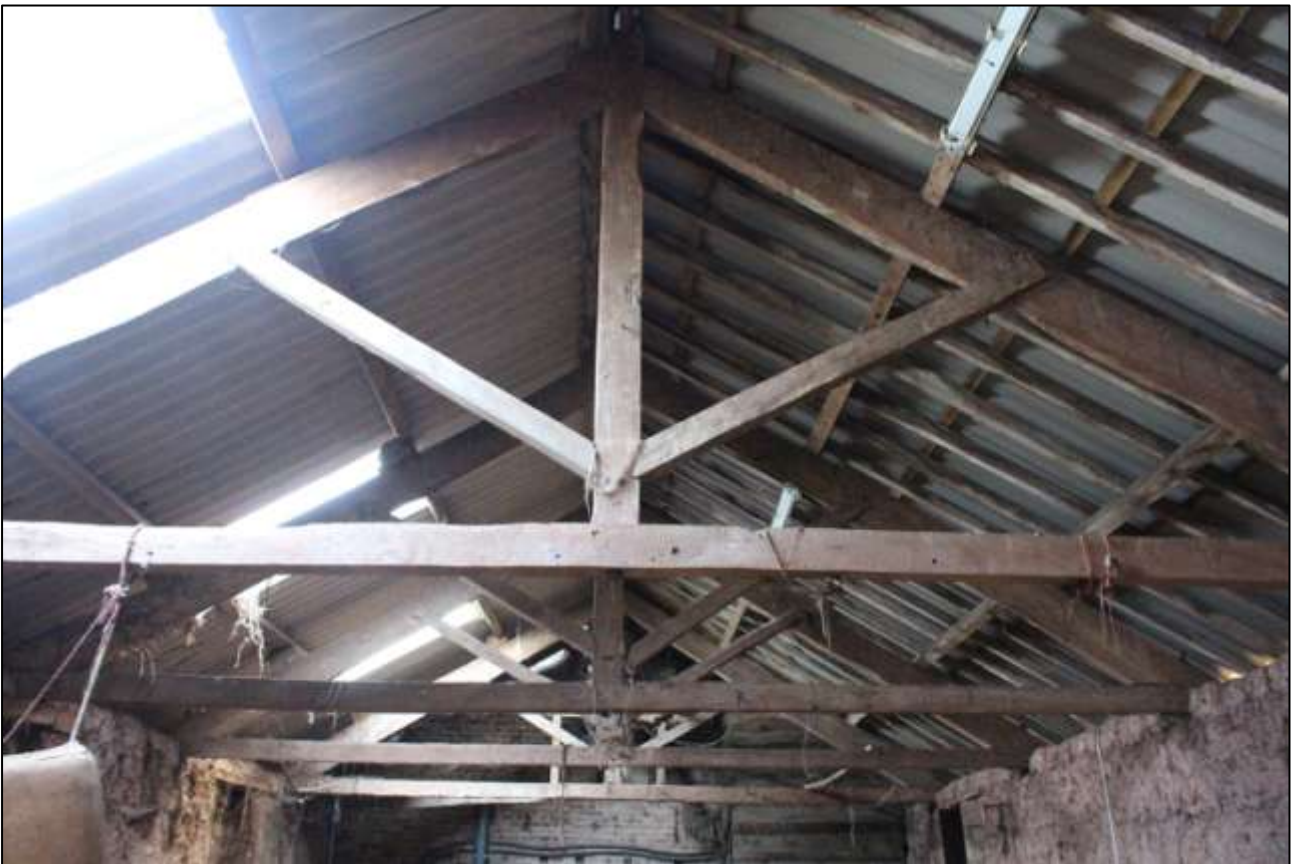
B2 FF INTERIOR, SHOWING THE KINGPOST ROOF TRUSSES; VIEWED FROM THE SOUTH.

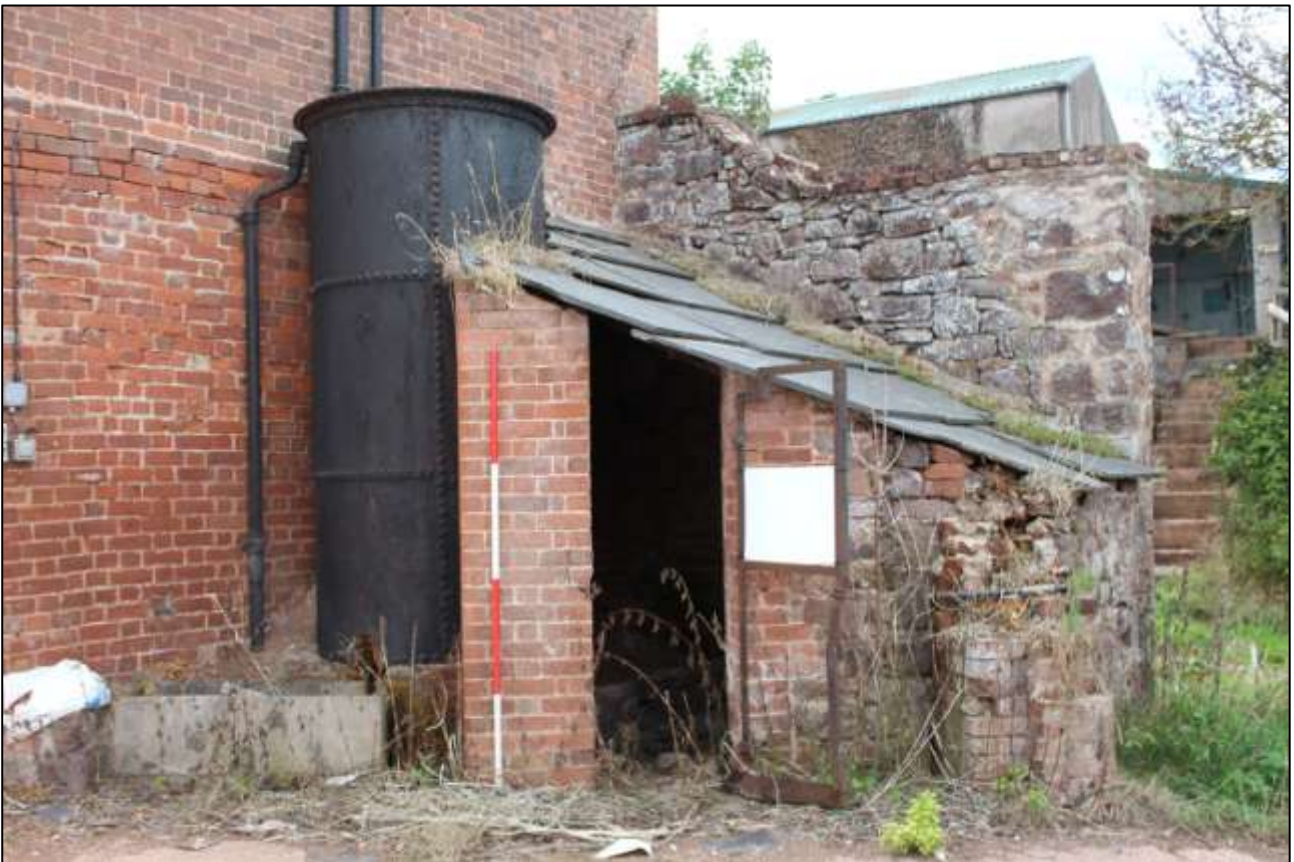
B3, EXTERIOR ELEVATION, EAST WALL AND BOILER; VIEWED FROM THE EAST (SCALE 2M).

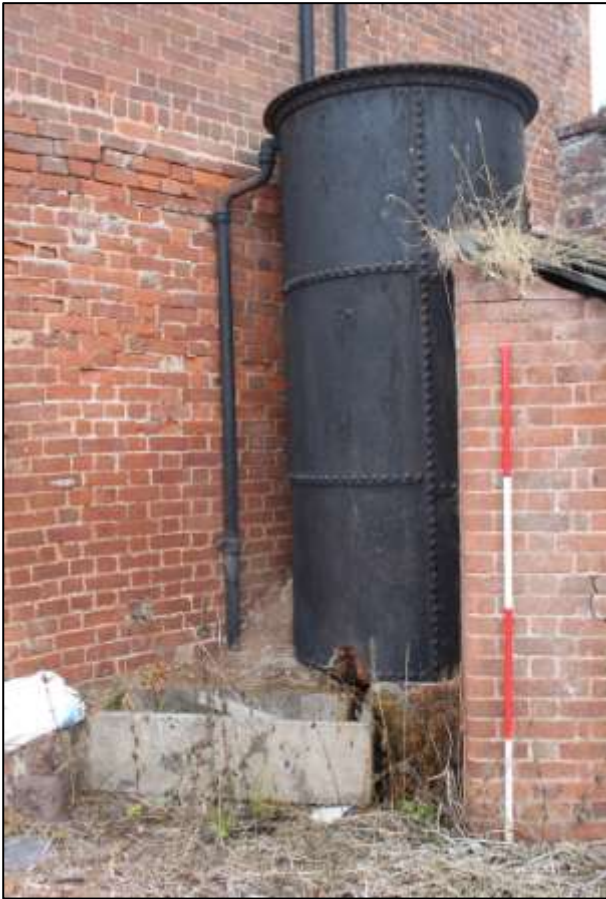
LEFT: AS ABOVE; DETAIL OF THE BOILER (SCALE 2M).

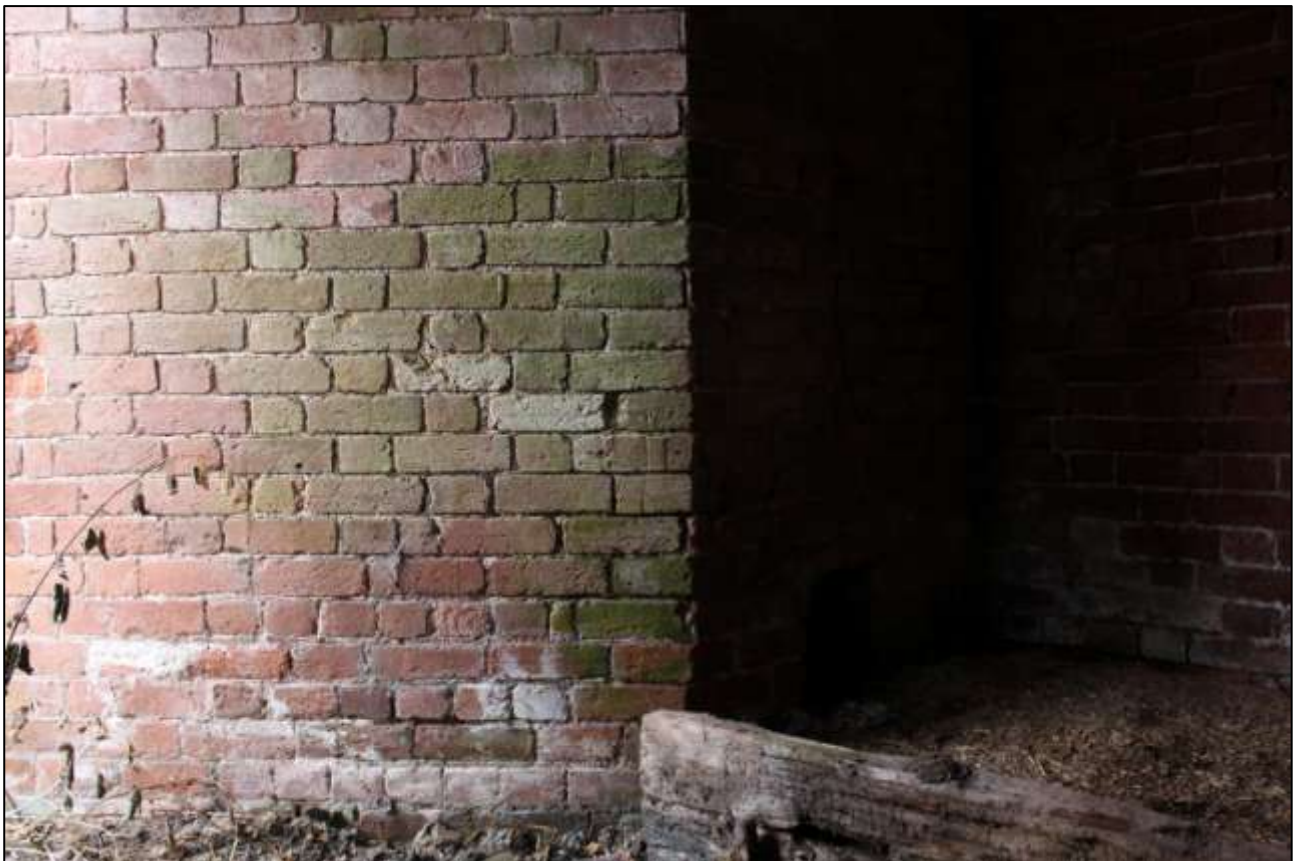
B3, INTERIOR, THE BRICKWORK ENCASING THE BOILER; VIEWED FROM THE NORTH-EAST.

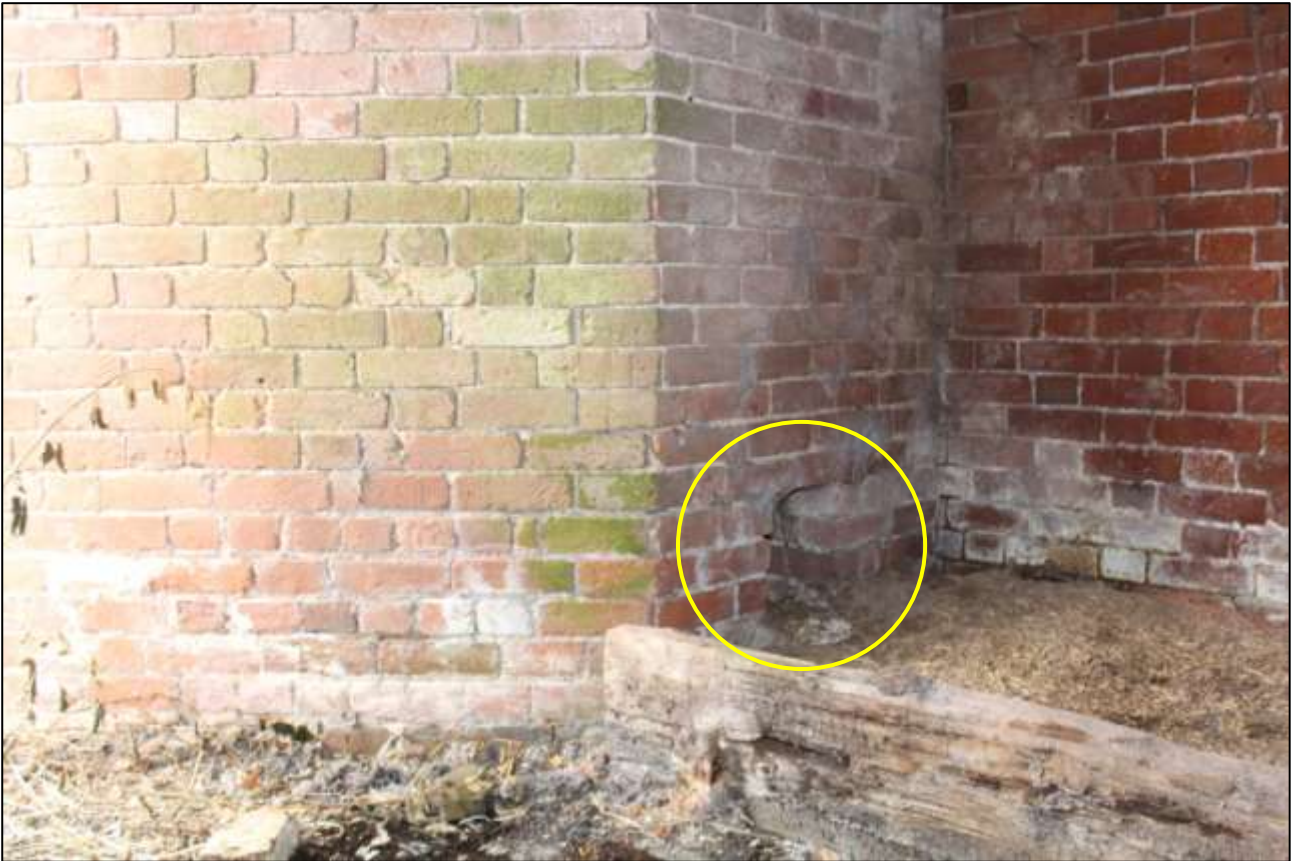
AS ABOVE, WITH FLASH ILLUMINATING THE STOKE HOLE (INDICATED).

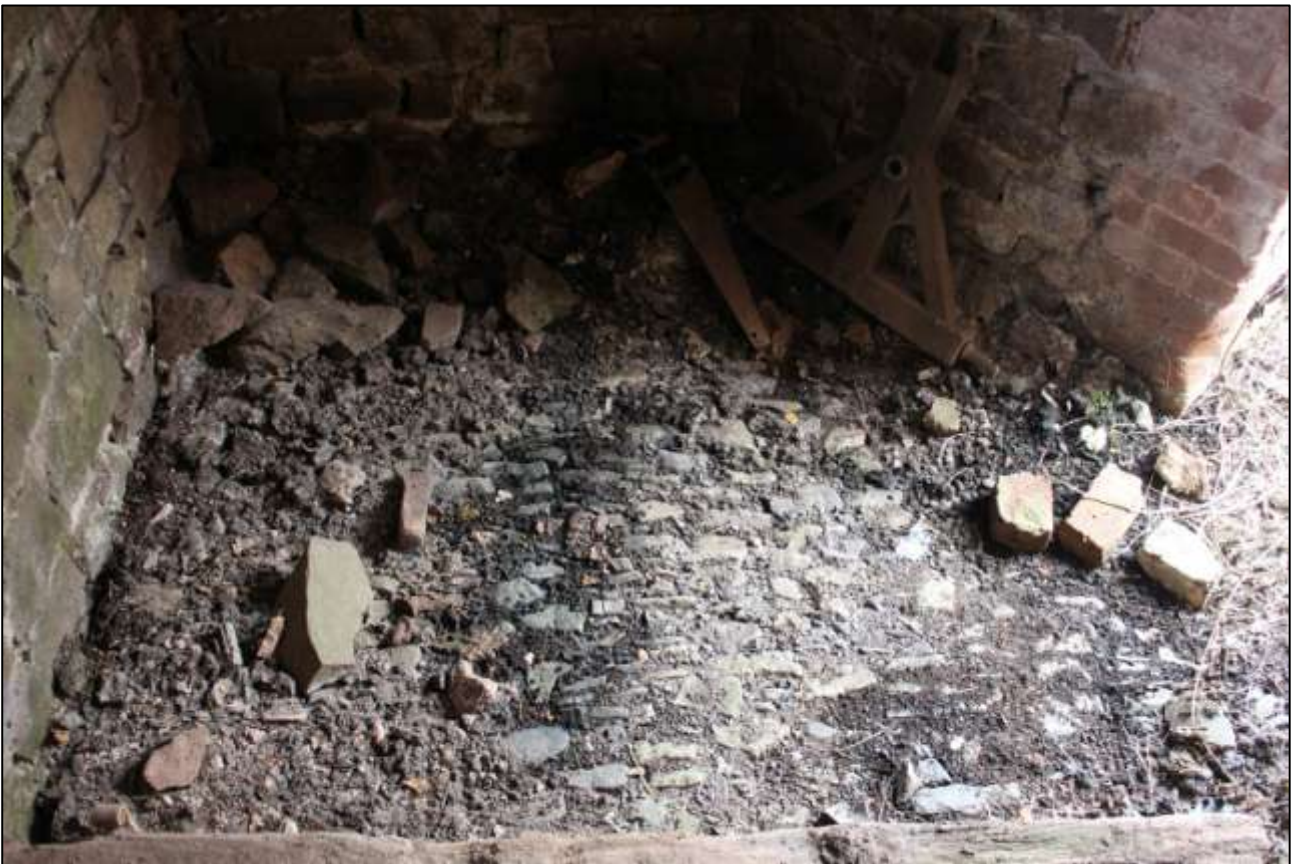
B3 INTERIOR, THE COBBLED SURFACE; VIEWED FROM THE SOUTH-WEST.

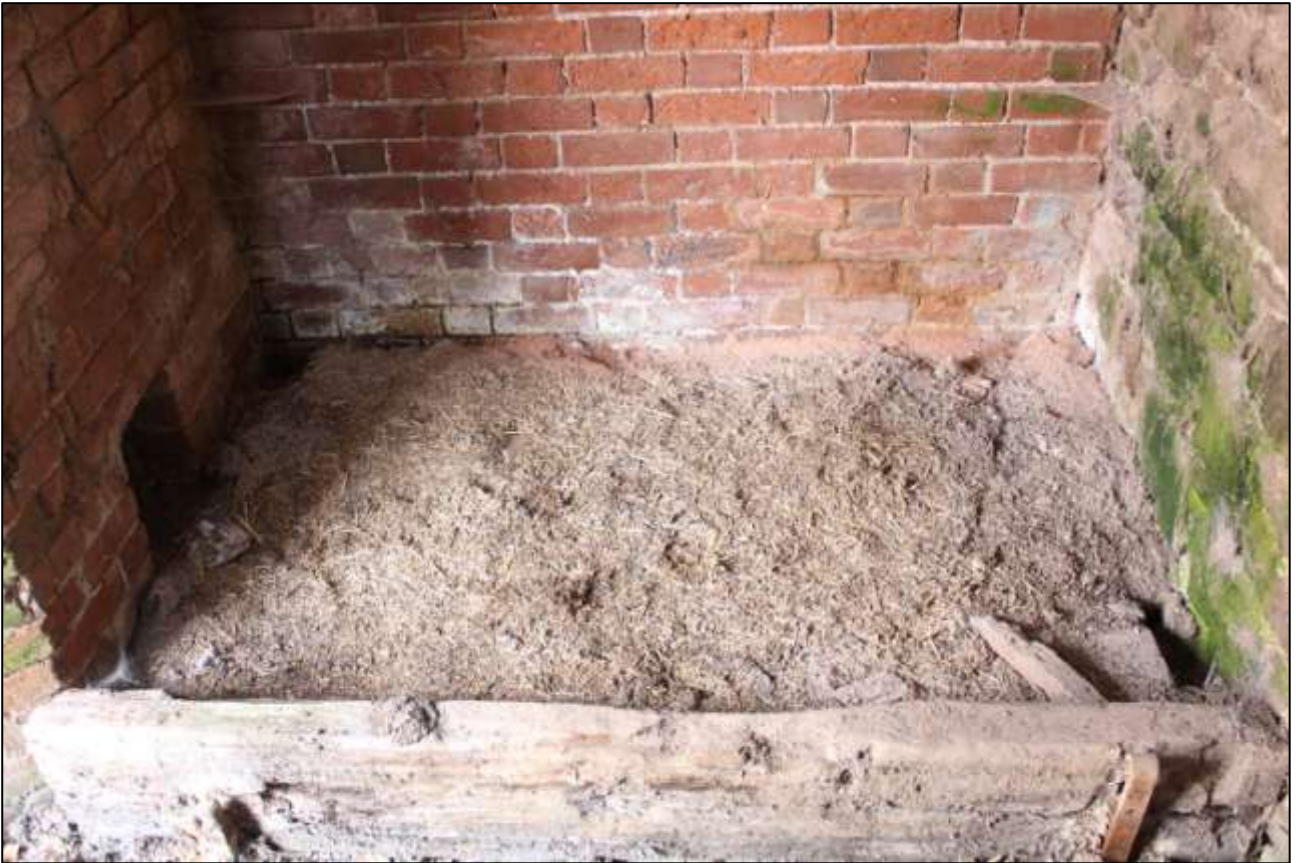
B3 INTERIOR, THE LATER TROUGH; VIEWED FROM THE NORTH-EAST.

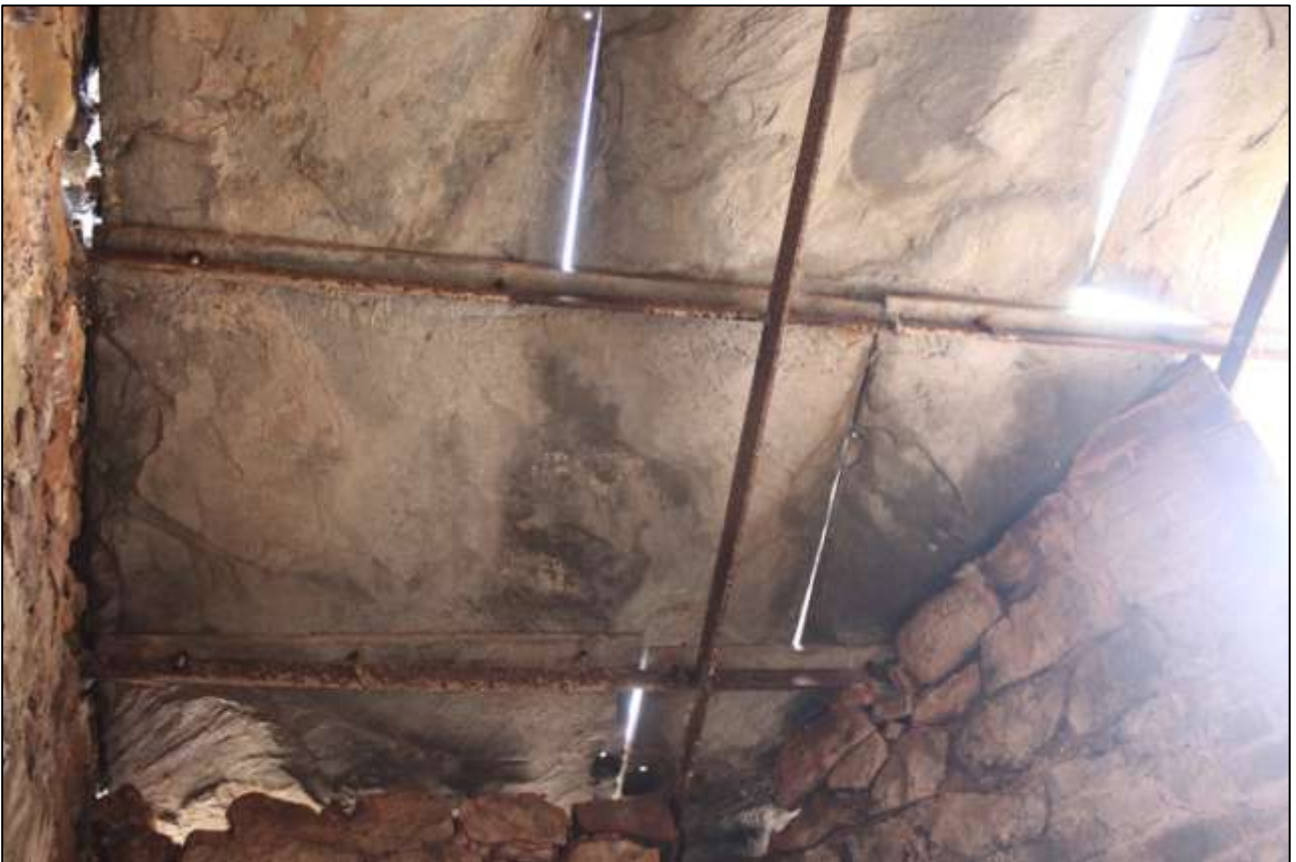
B3 INTERIOR, THE ROOF OF SLABS ON IRON BEAMS; VIEWED FROM THE SOUTH-WEST AND BENEATH.

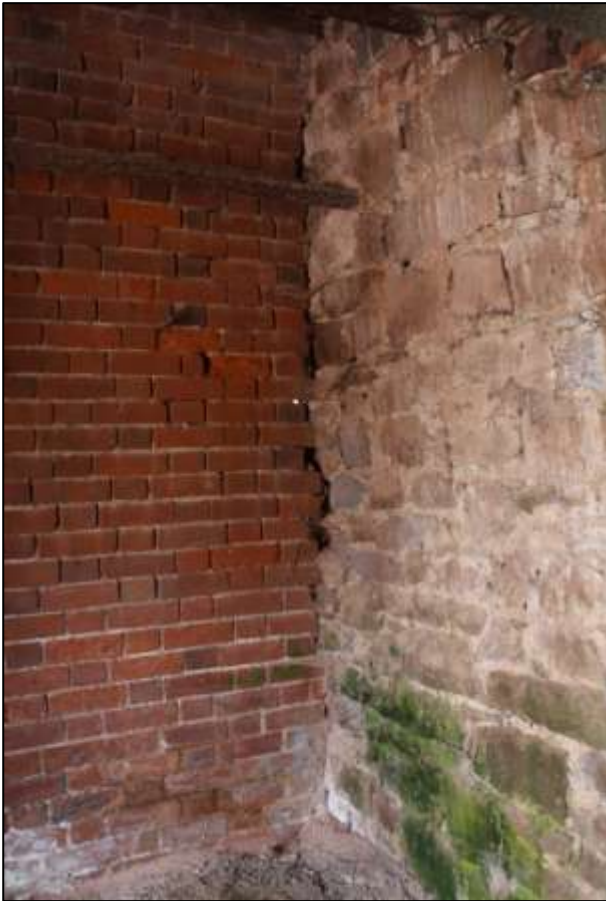
LEFT: B3 INTERIOR, SHOWING THE GABLE WALL OF B4 ABUTTING THE EXTERIOR STONE YARD WALL; VIEWED FROM THE EAST.
RIGHT: B4 EXTERIOR ELEVATION, SOUTH-EAST WALL; VIEWED FROM THE NORTH-EAST (SCALE 2M).

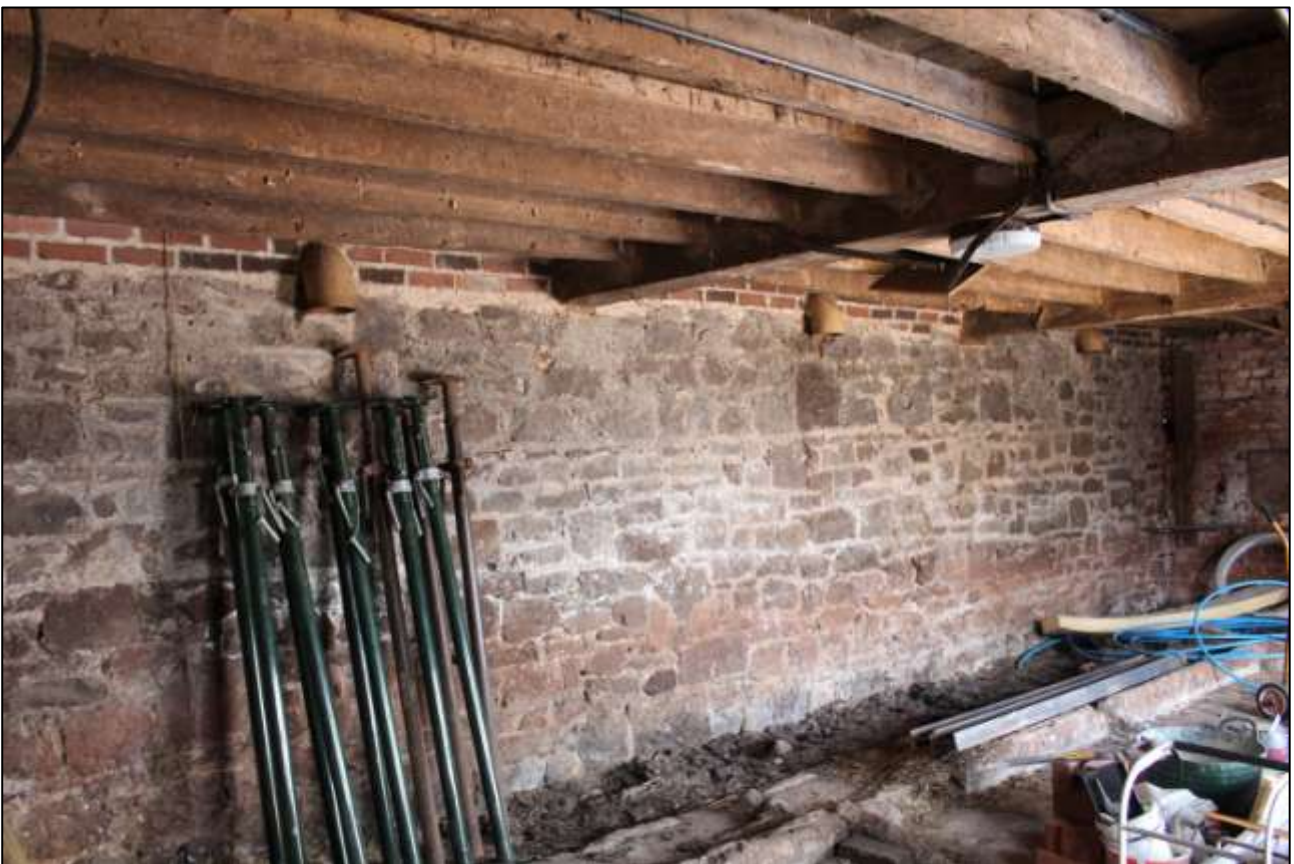
B4A INTERIOR, SHOWING THE ROUGHLY-COURSED EXTERIOR STONE YARD WALL; VIEWED FROM THE SOUTH.

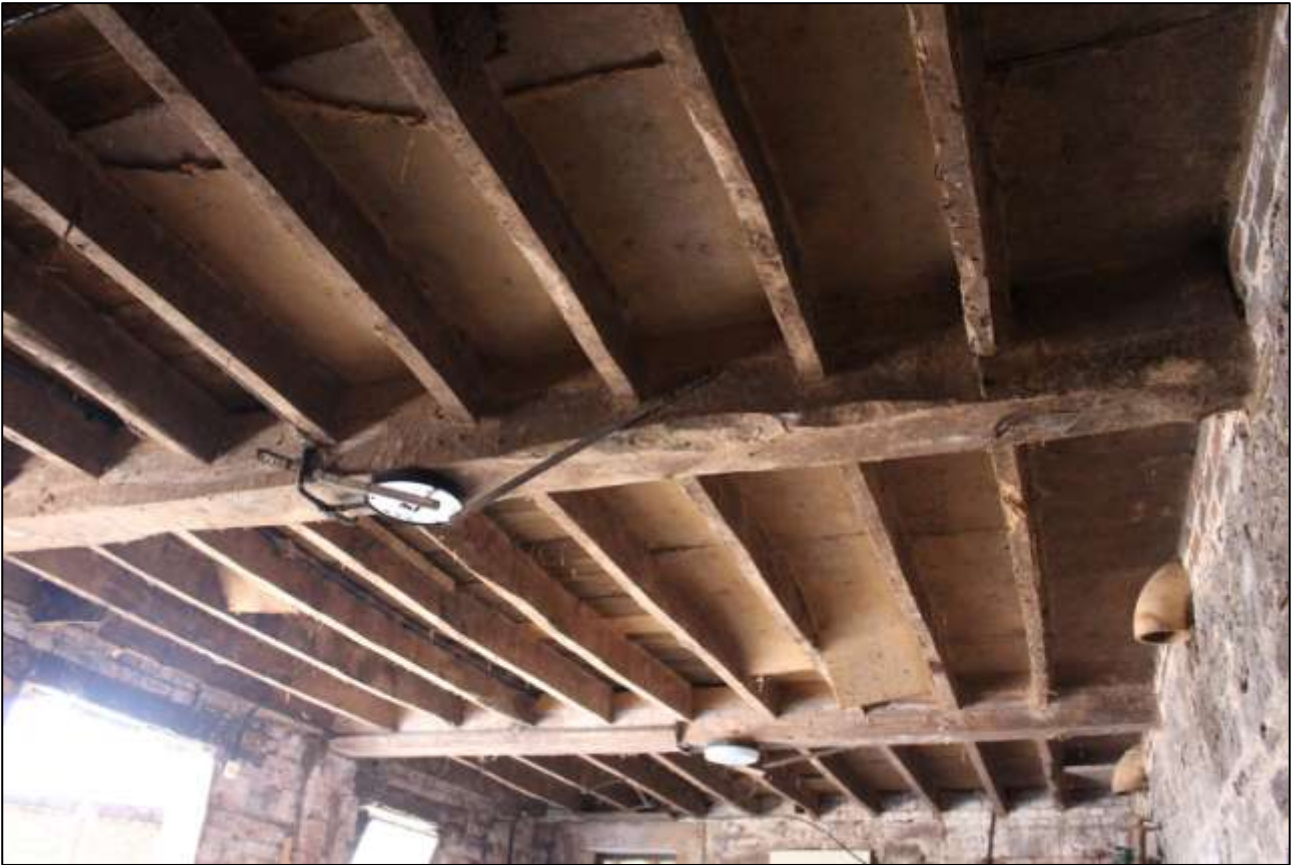
B4A INTERIOR, DETAIL OF THE CEILING; VIEWED FROM THE NORTH-EAST AND BENEATH.

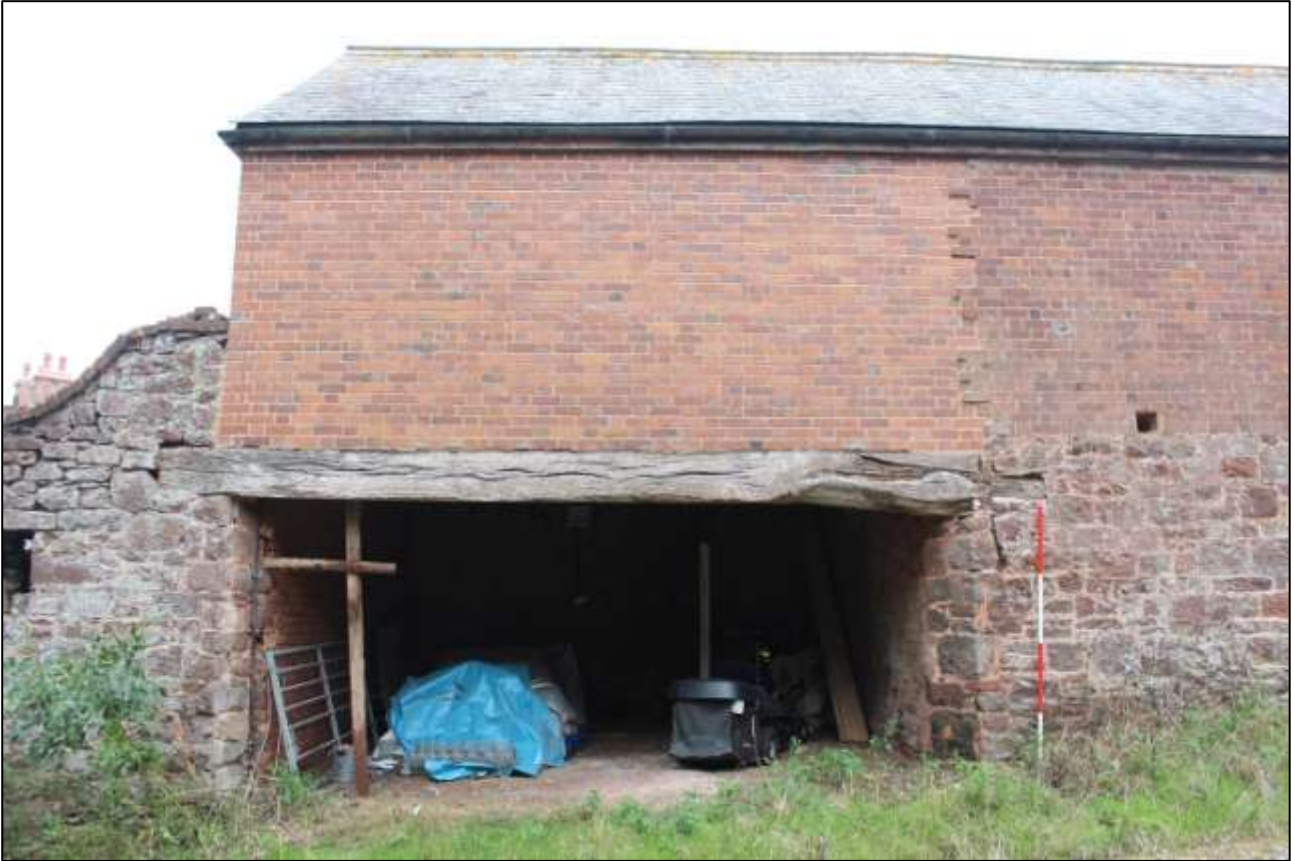
B4 EXTERIOR, NORTH-EAST END, SHOWING THE REBUILT WALL OVER THE CARTSHED OPENING TO B4B; VIEWED FROM THE NORTH-WEST (SCALE 2M).

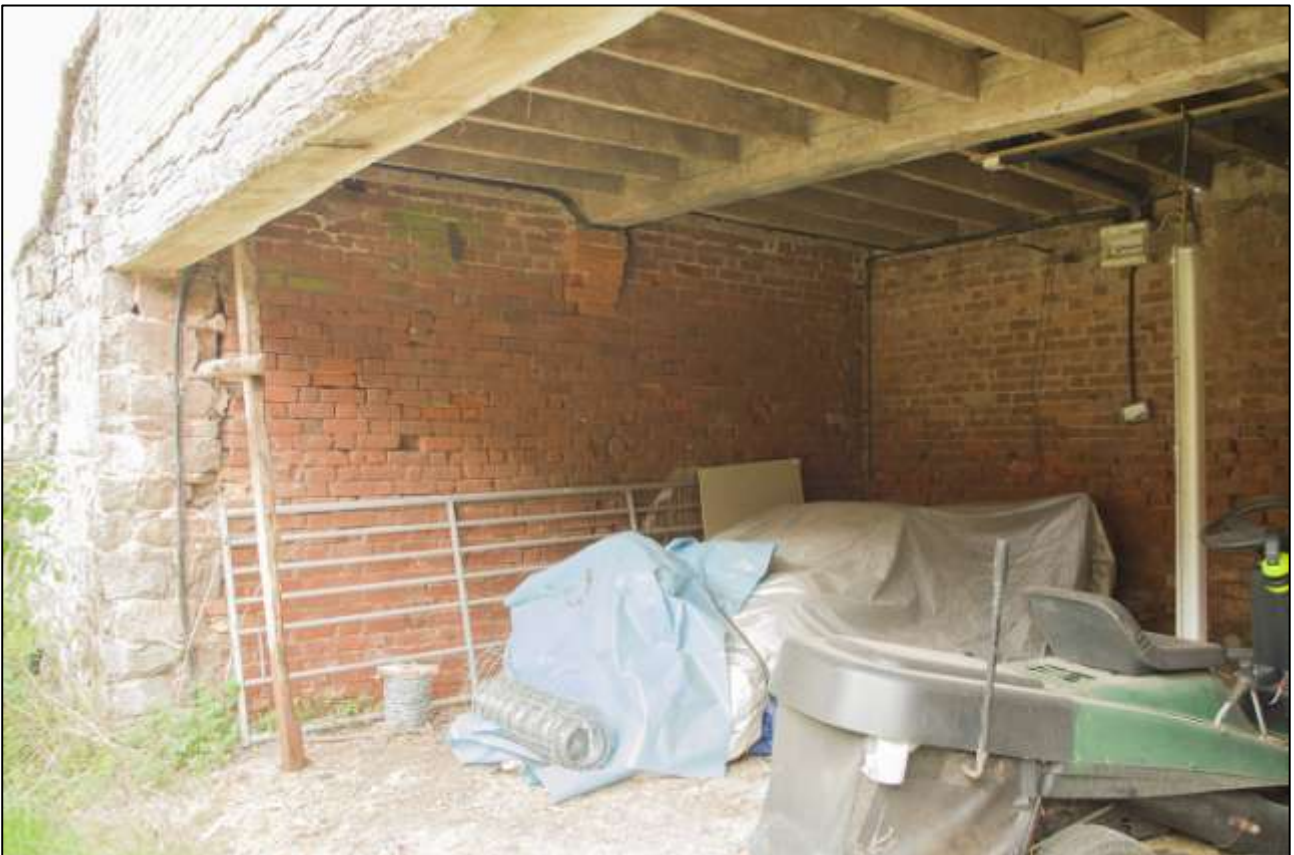
B4B INTERIOR; VIEWED FROM THE WSW.

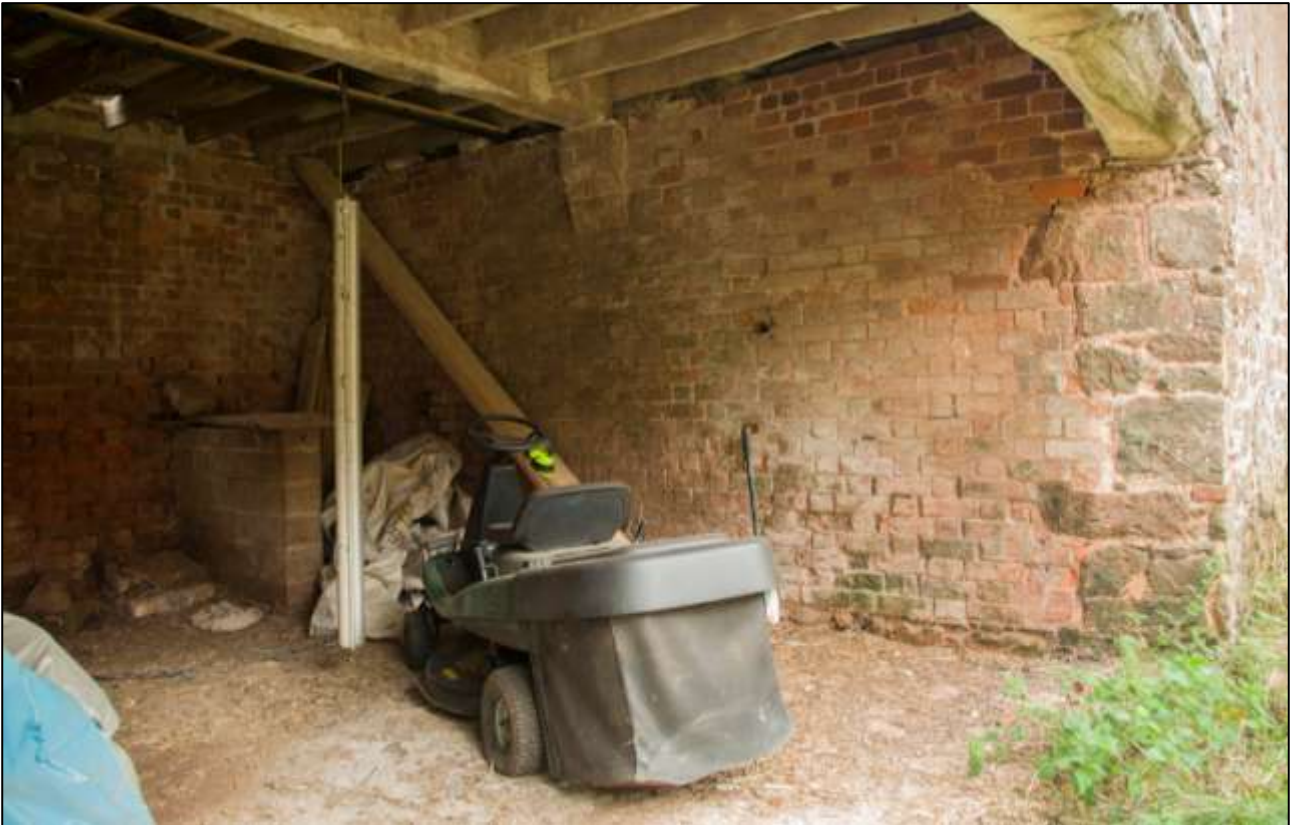
B4B INTERIOR; VIEWED FROM THE NORTH.

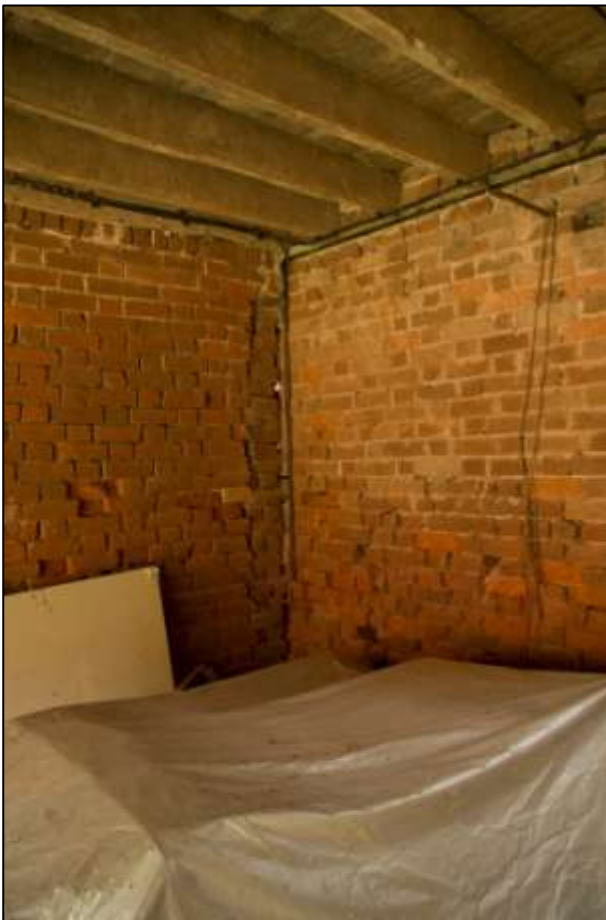
LEFT: B4B INTERIOR, DETAIL OF THE AWKWARD JOIN BETWEEN THE GABLE WALL AND THE SOUTH-EAST WALL; VIEWED FROM THE WEST.

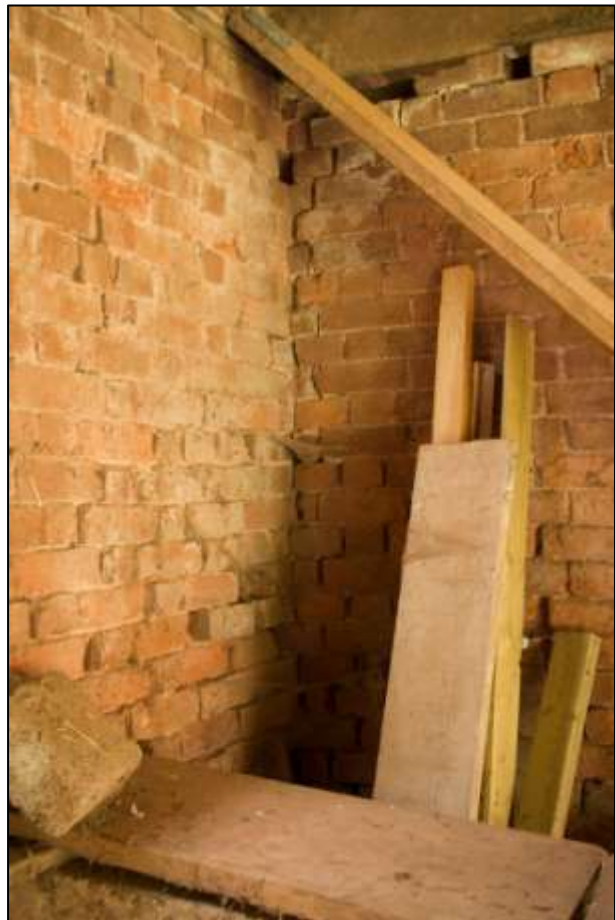
RIGHT: B4B INTERIOR, DETAIL OF THE AWKWARD JOIN BETWEEN THE SOUTH-EAST AND THE PARTY WALL WITH B4A; VIEWED FROM THE NORTH.

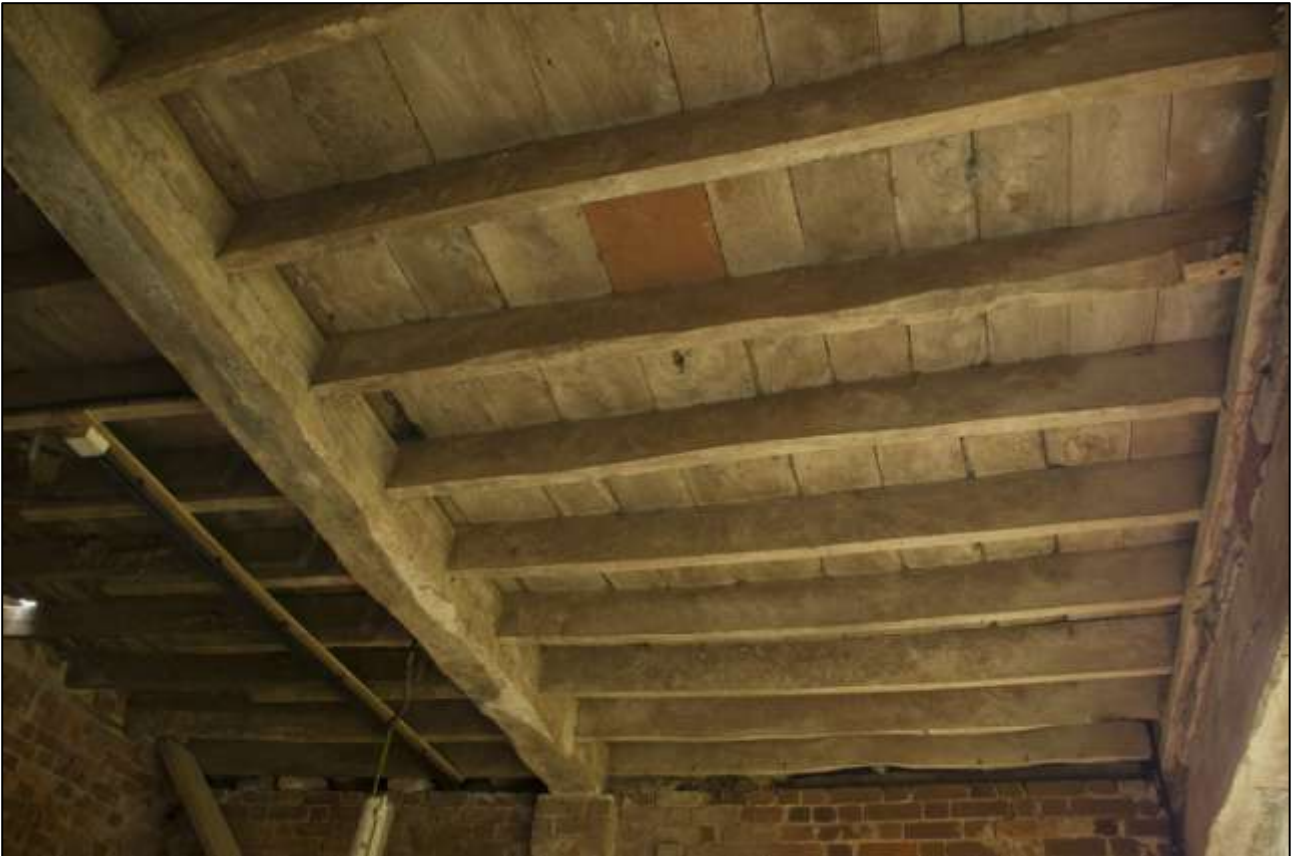
B4B INTERIOR, DETAIL OF THE CEILING; VIEWED FROM THE NORTH-EAST AND BENEATH.
