HIGHER PARK FARM

CREDITON

DESK-BASED ASSESSMENT WITH HISTORIC BUILDING RECORDING

Higher Park Farm, Crediton, Devon Desk-Based Assessment with Historic Building Recording

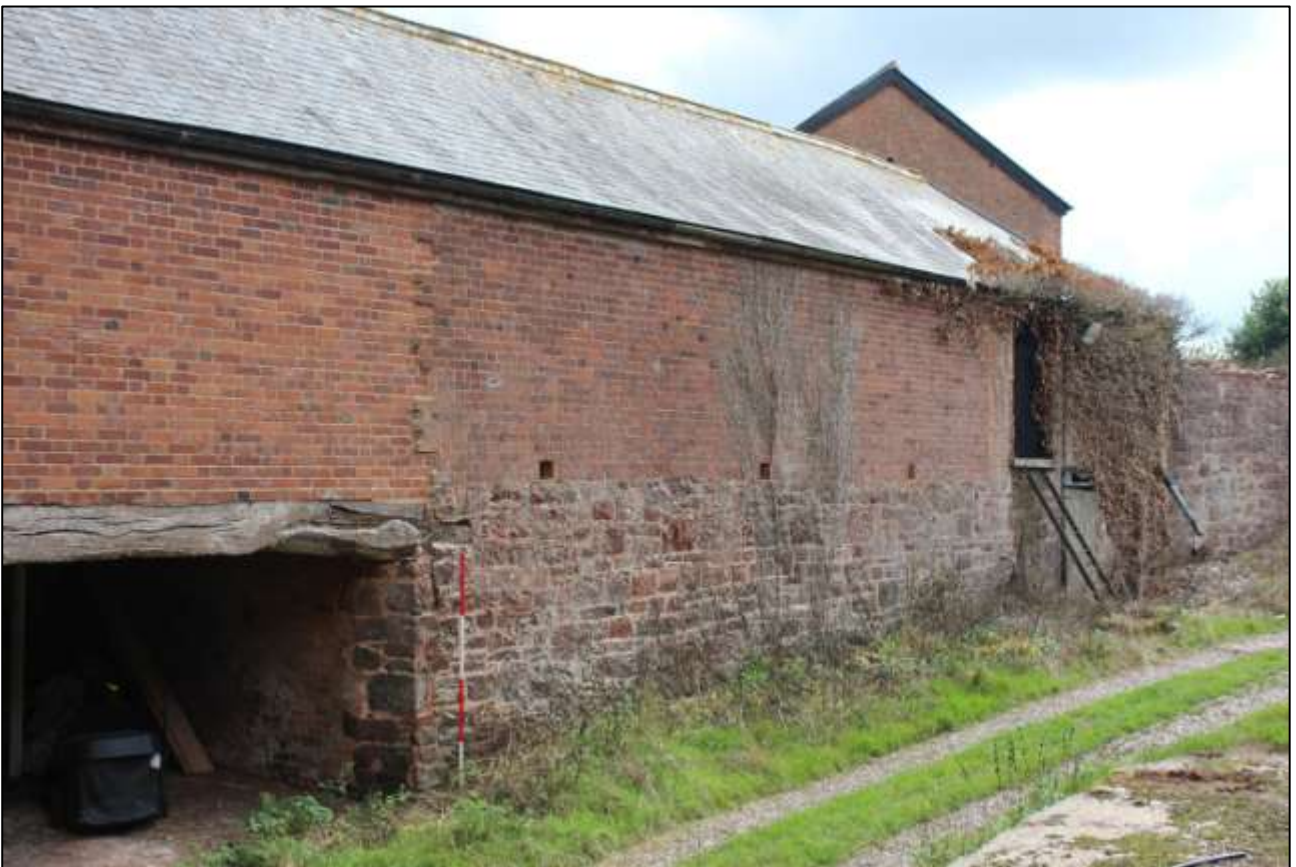
B4 EXTERIOR, NORTH-WEST WALL; VIEWED FROM THE NORTH (SCALE 2M).

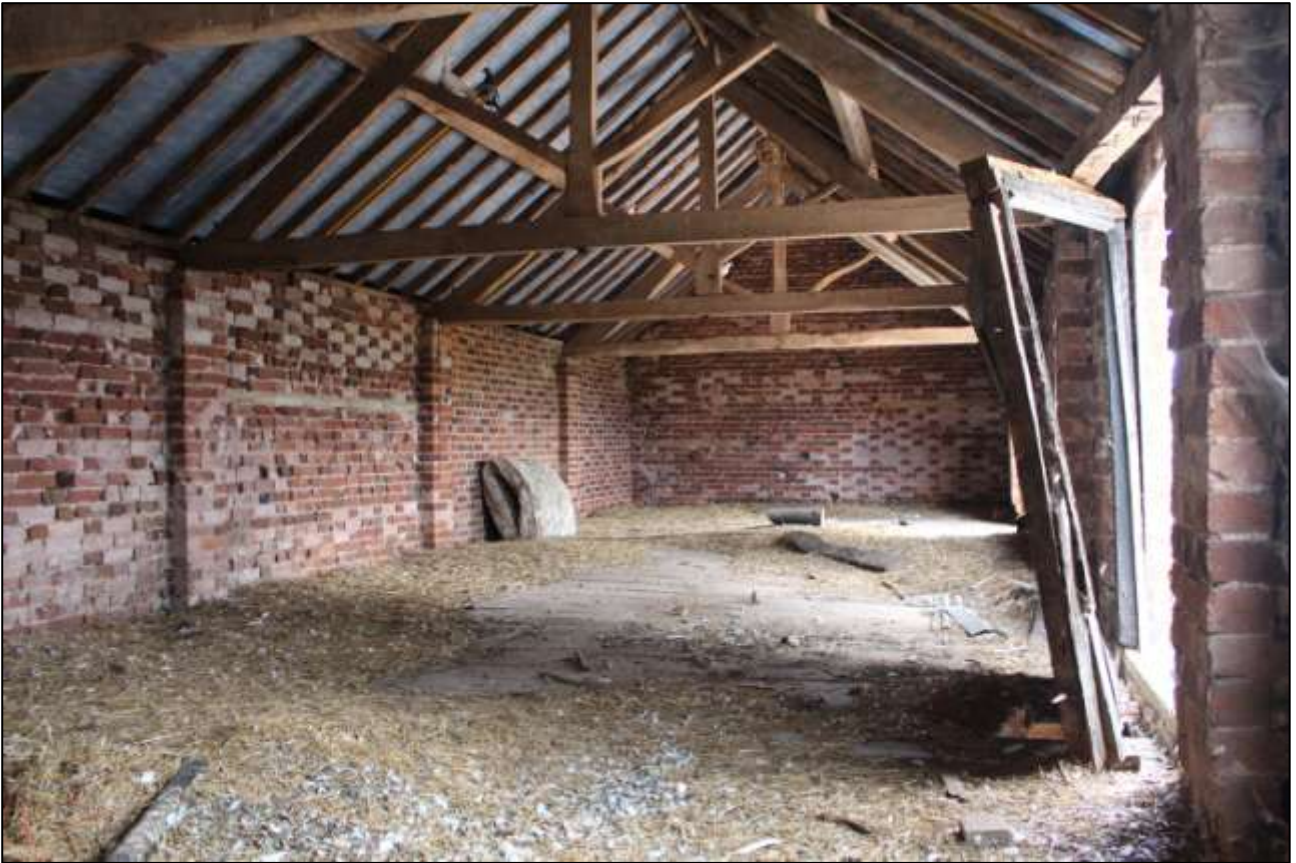
B4 FF INTERIOR; VIEWED FROM THE SOUTH-WEST.

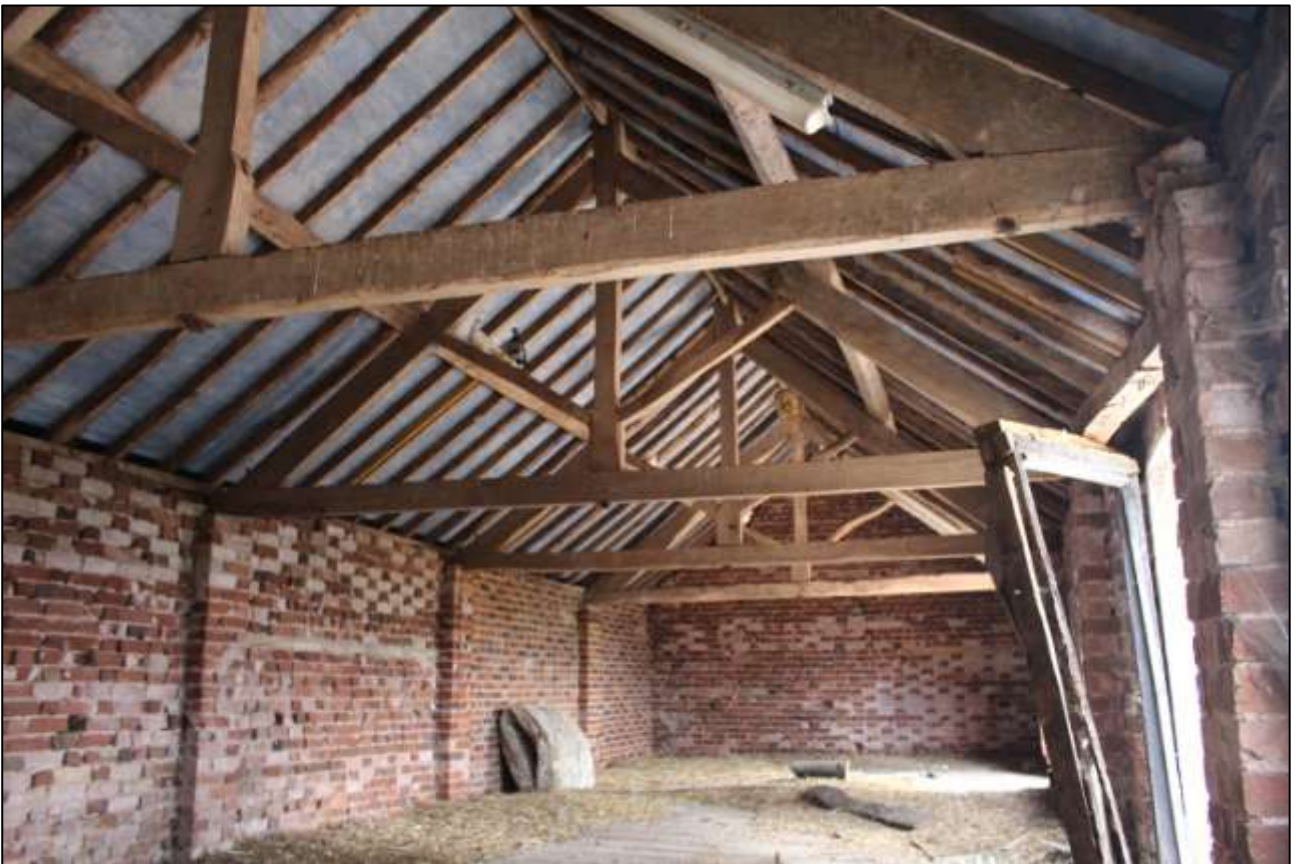
AS ABOVE, SHOWING MORE DETAIL OF THE ROOF TRUSSES.

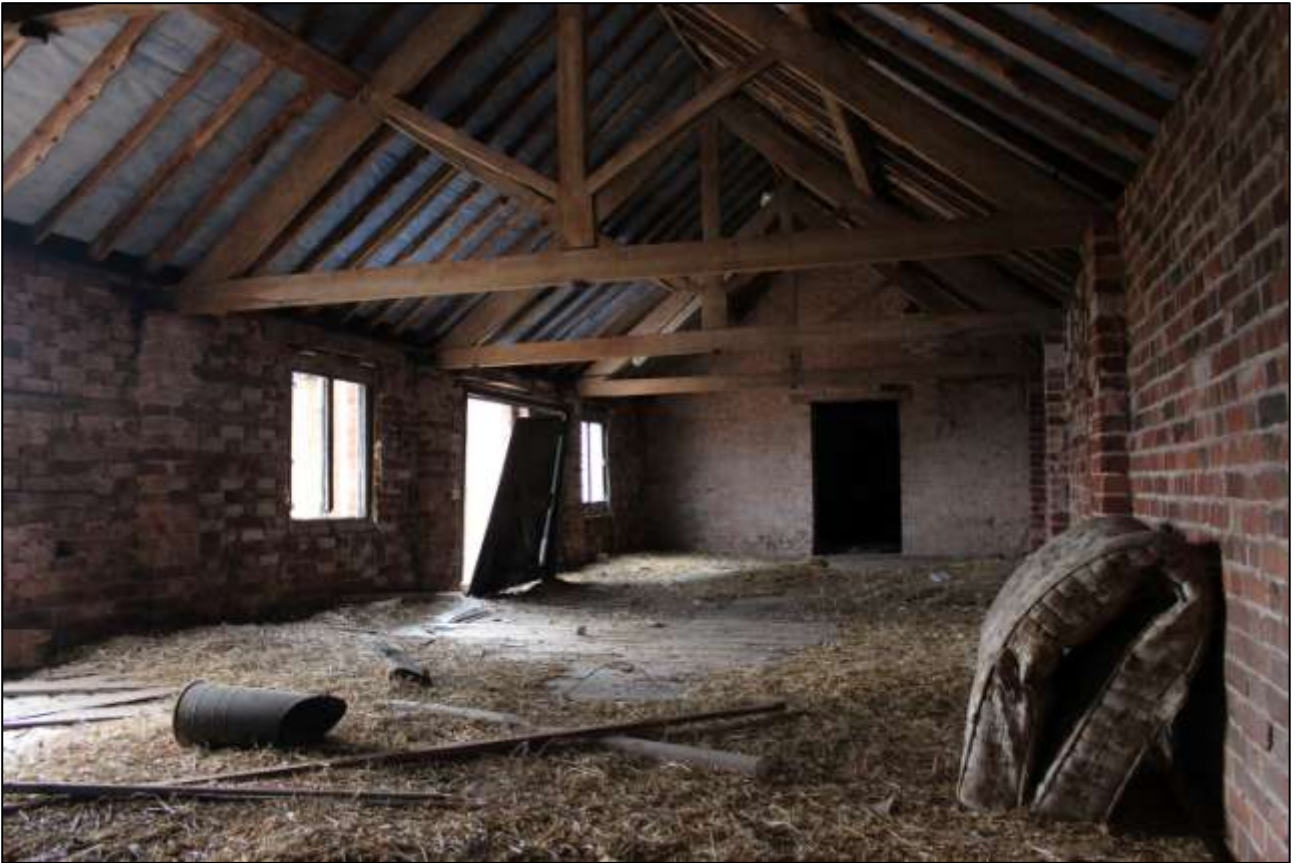
B4 FF INTERIOR; VIEWED FROM THE NORTH-EAST.

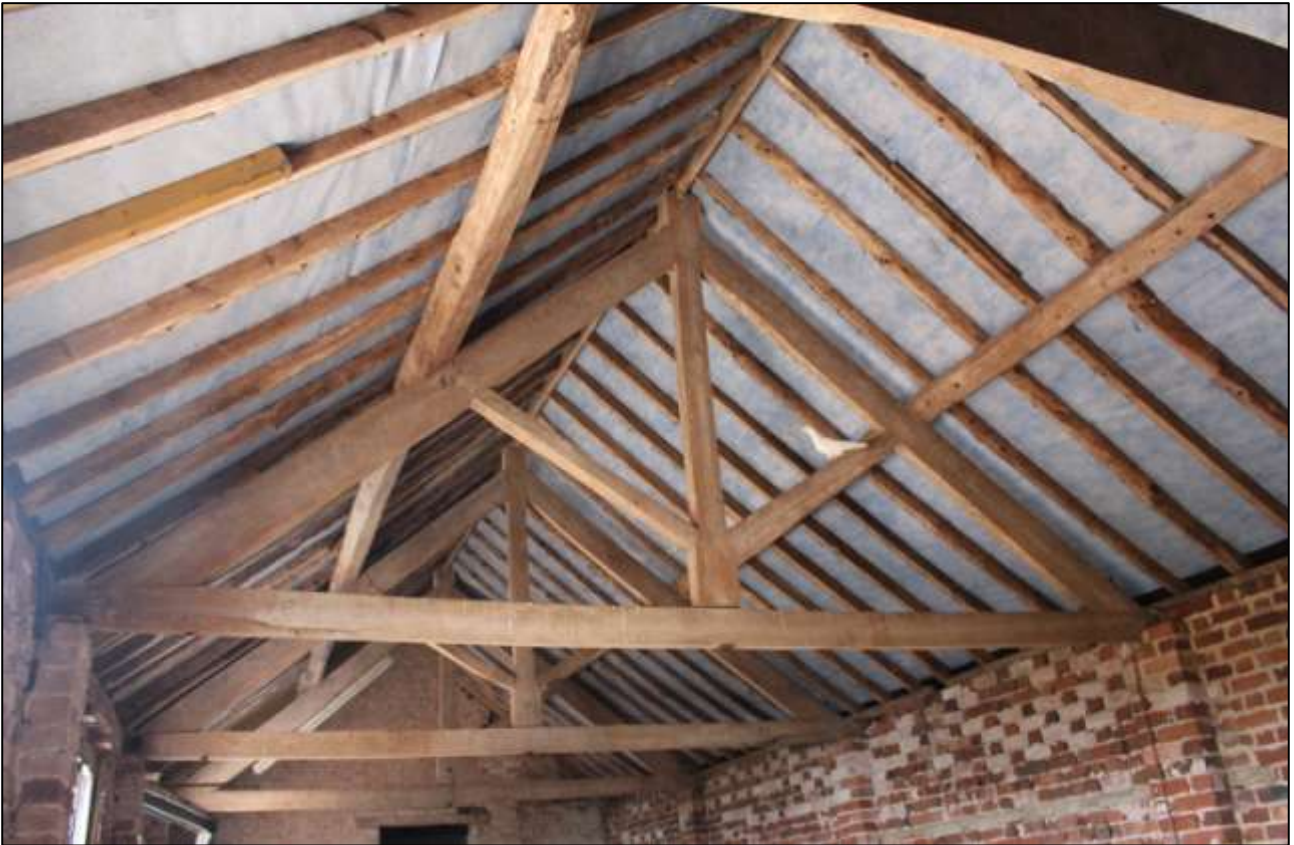
AS ABOVE, SHOWING MORE DETAIL OF THE ROOF TRUSSES.

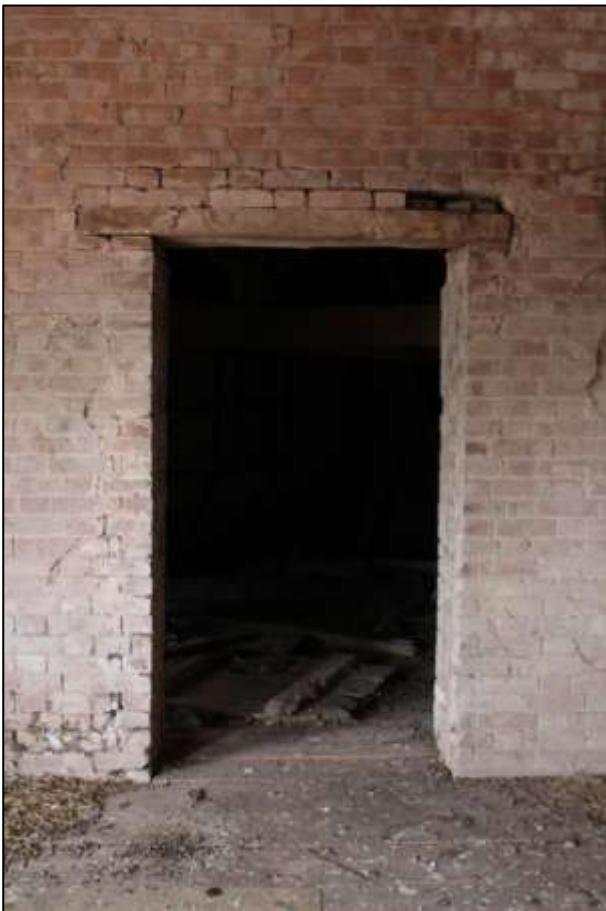
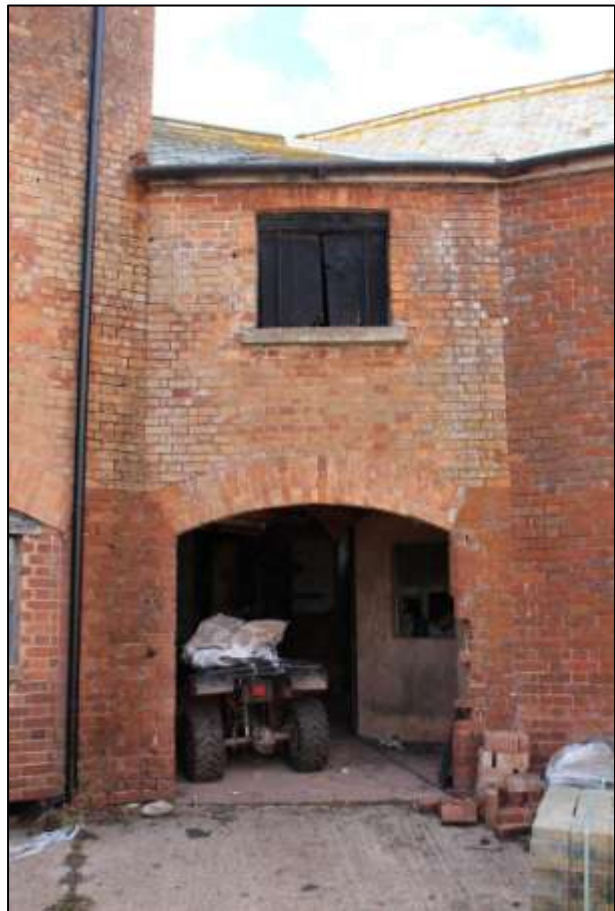
LEFT: B4 FF INTERIOR, DETAIL OF THE FORCED DOORWAY TO B5; VIEWED FROM THE NORTH-EAST.
RIGHT: B5 EXTERIOR; VIEWED FROM THE SOUTH-EAST.

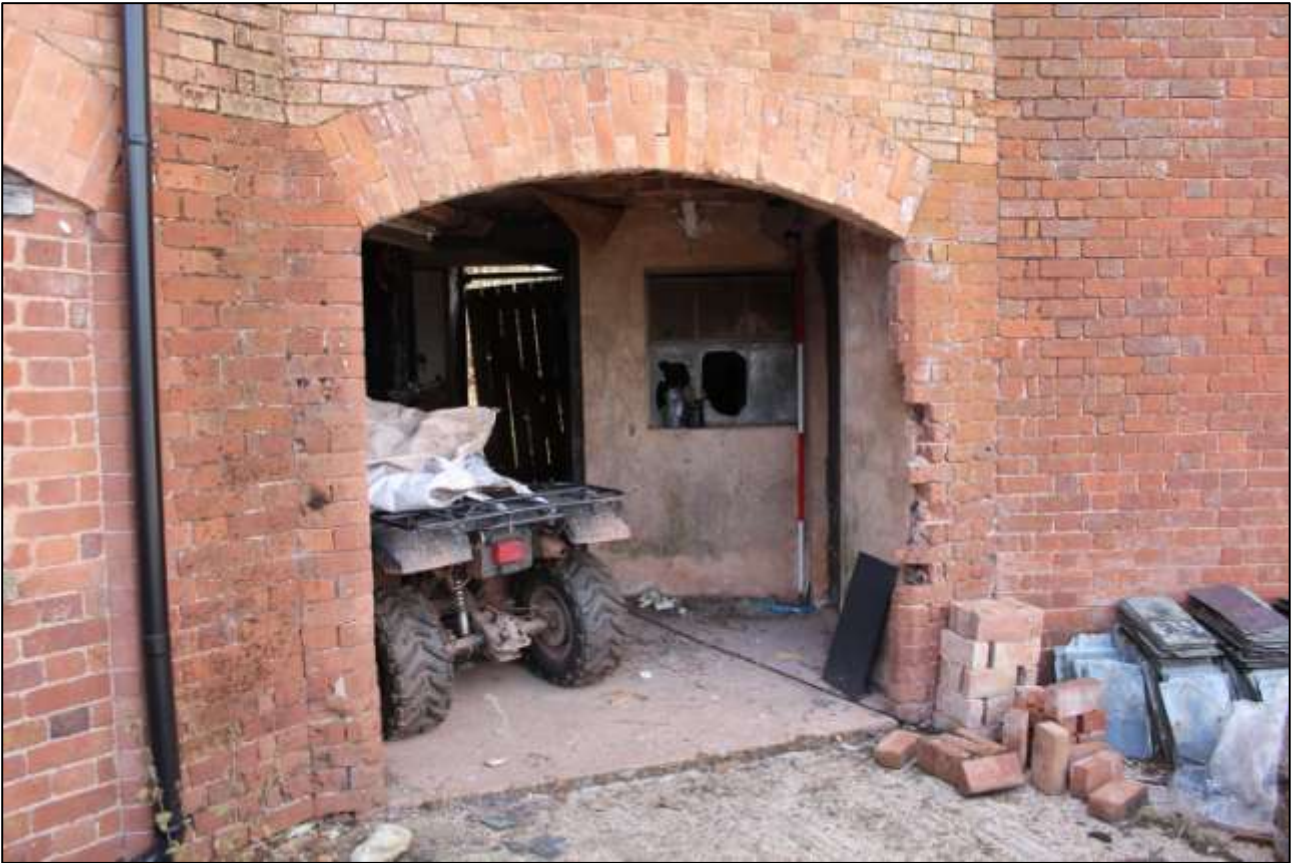
AS ABOVE, DETAIL OF THE GF OPENING; VIEWED FROM THE ESE.

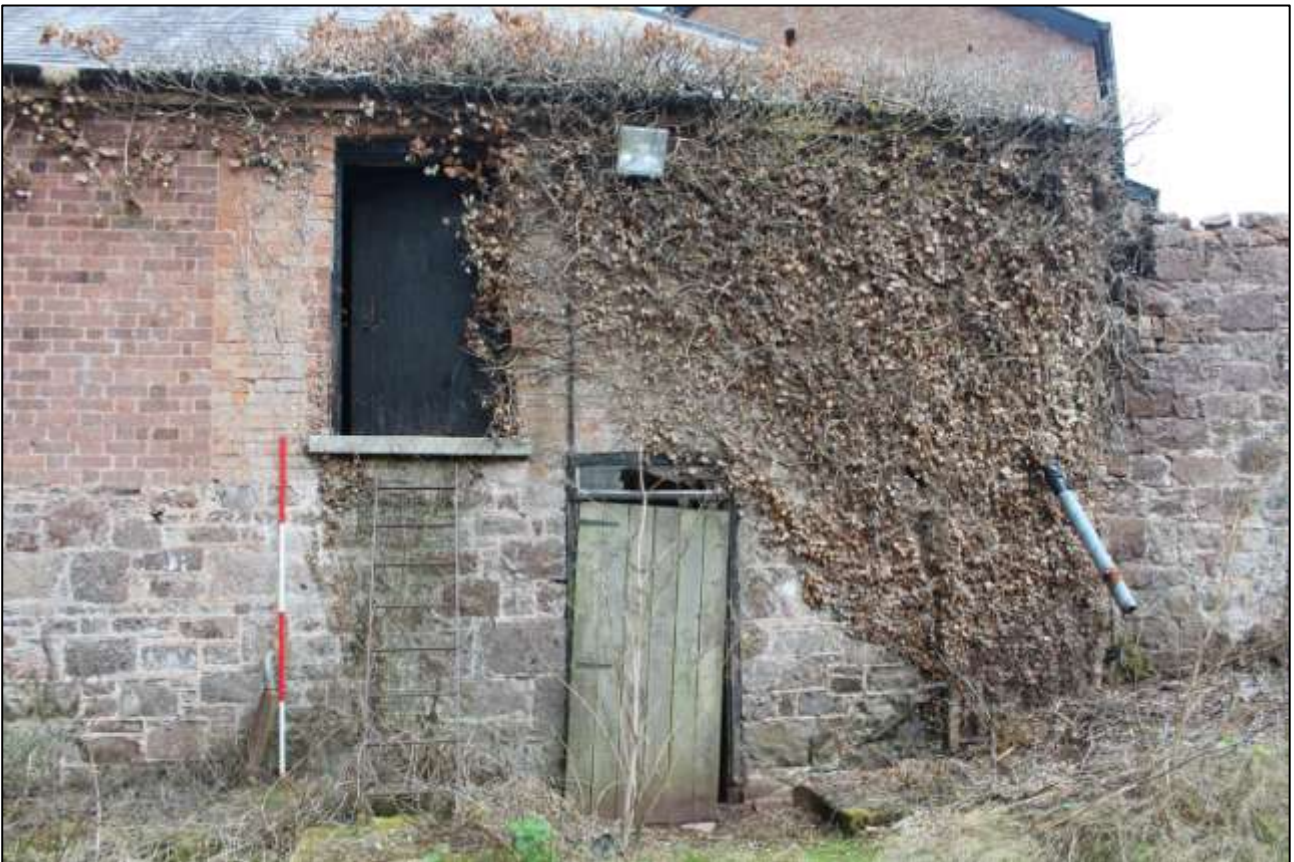
B5 EXTERIOR, NORTH-WEST WALL SHOWING GF DOOR AND FF FORCED LOADING DOOR; VIEWED FROM THE NORTH-WEST (SCALE 2M).

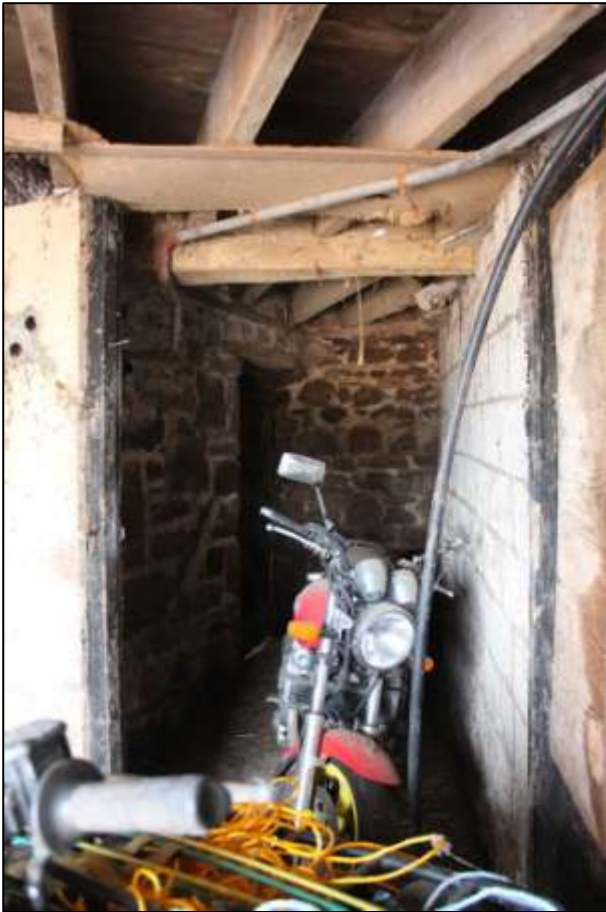
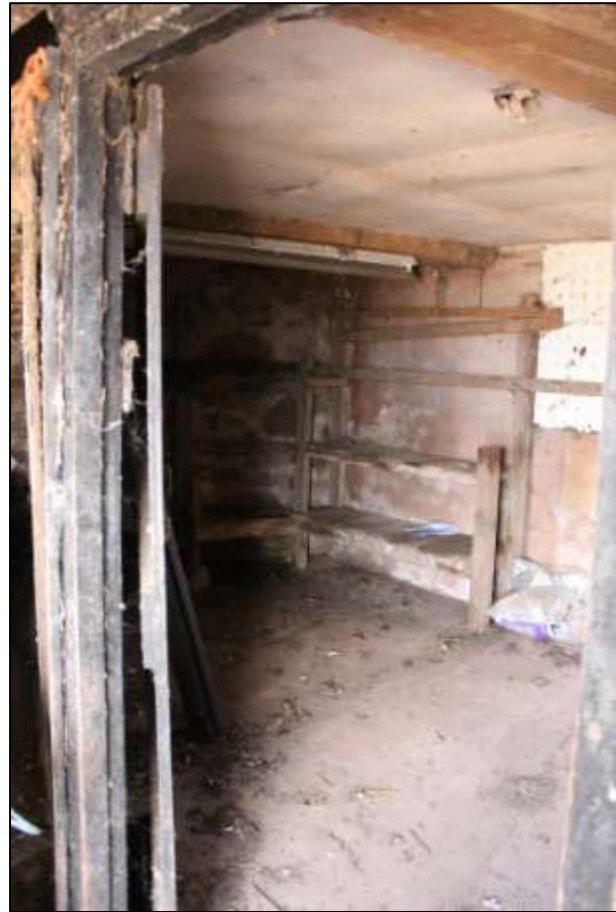
LEFT: B5 GF INTERIOR, THE CORRIDOR LEADING TO THE FEED PASSAGE IN B6; VIEWED FROM THE EAST.
RIGHT: B5 GF INTERIOR, LOOKING THROUGH INTO THE FORMER DAIRY FROM THE EAST.

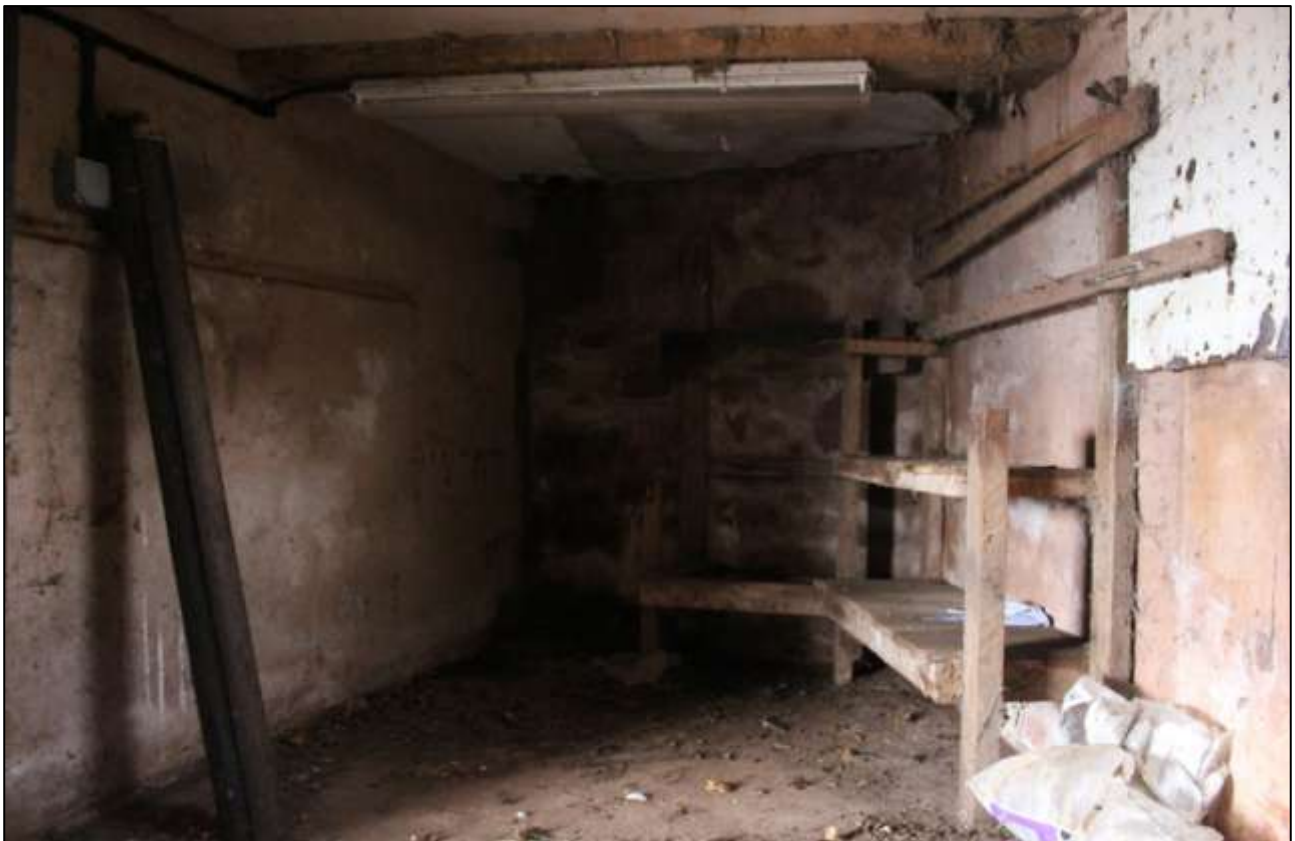
B5 GF INTERIOR; THE DAIRY; VIEWED FROM THE NORTH-EAST.

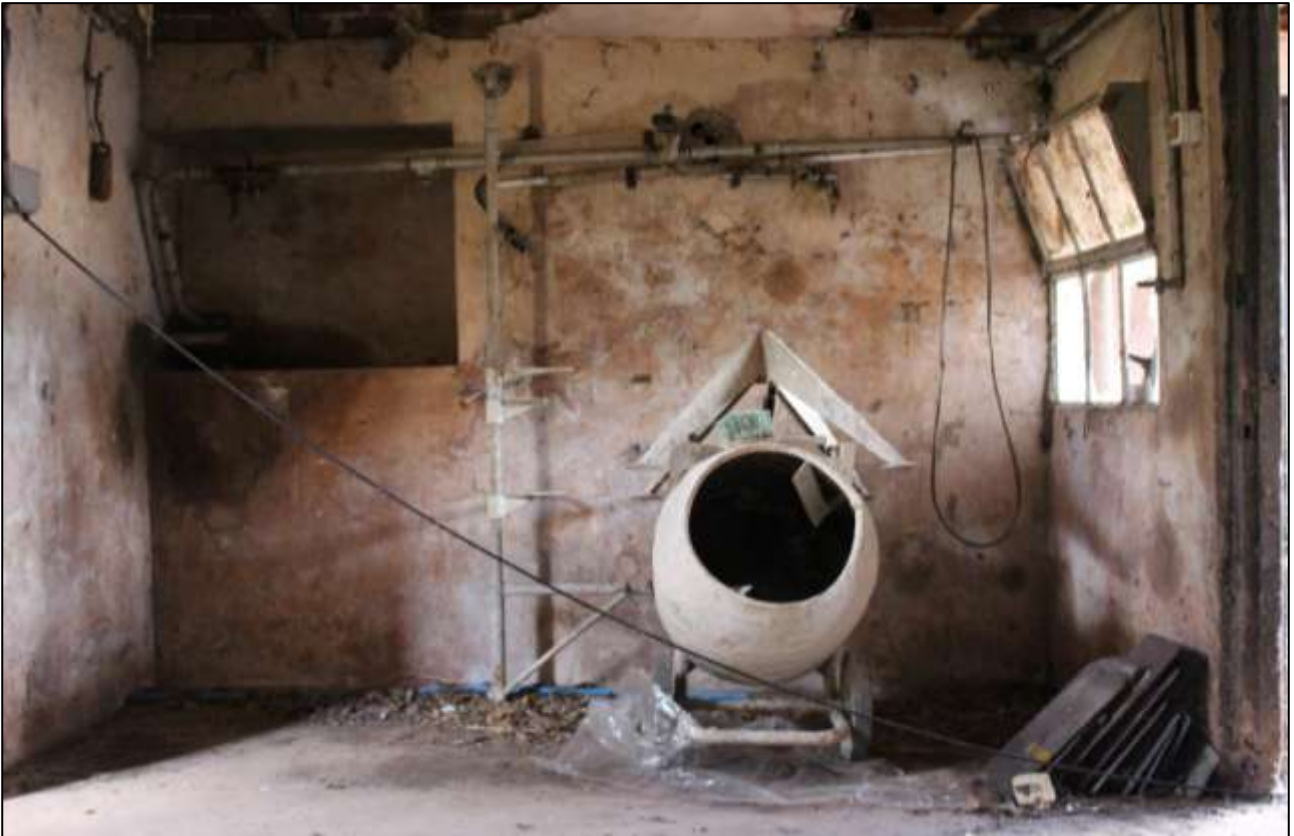
B5 GF INTERIOR, THE DAIRY, SHOWING THE BLOCKED DOORWAY TO B4A; VIEWED FROM THE SOUTH-WEST.

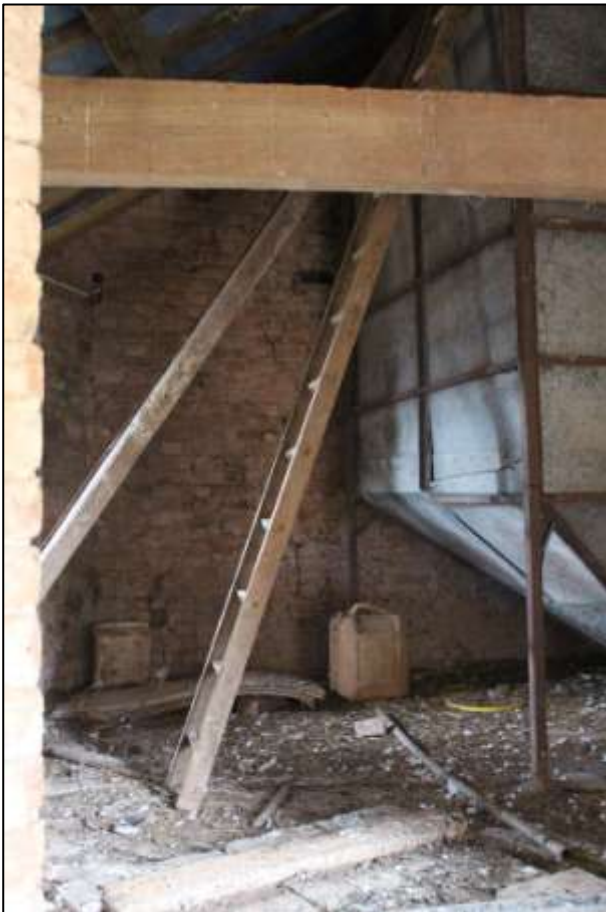
LEFT: B5 FF INTERIOR, THE SOUTH-EAST CORNER; VIEWED FROM THE NORTH.

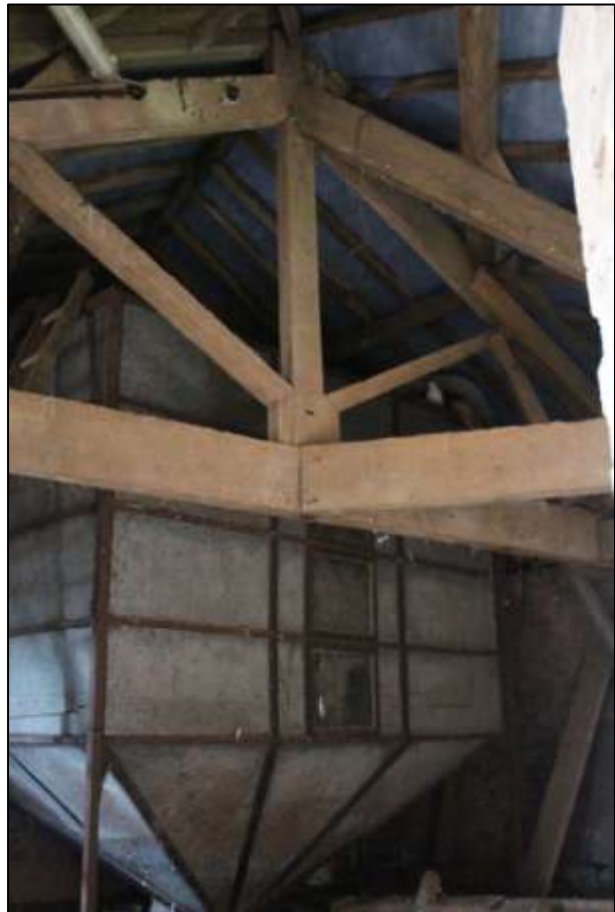
RIGHT: B5 FF INTERIOR, DETAIL OF THE FEED HOPPER AND THE KINGPOST ROOF STRUCTURE; VIEWED FROM THE NORTH-EAST.

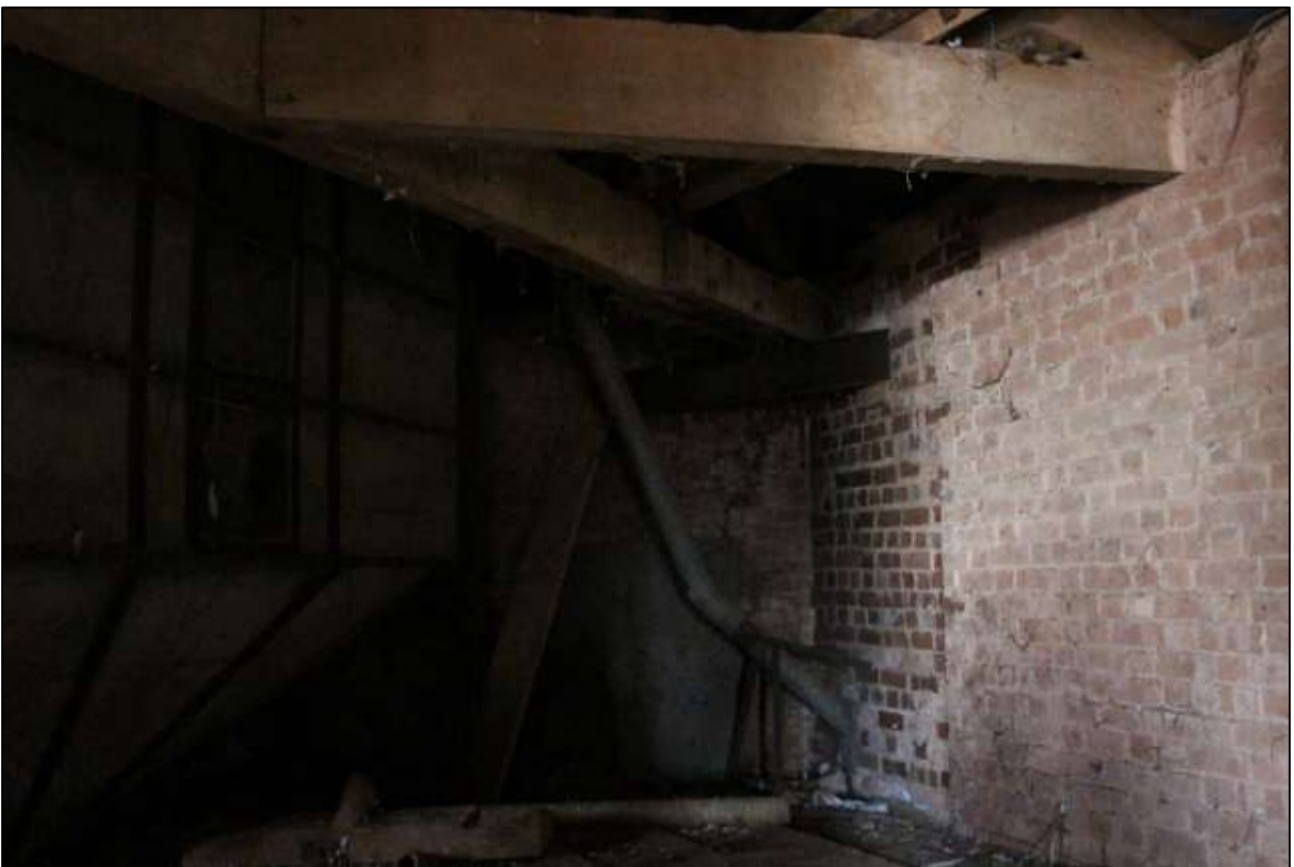
B5 FF INTERIOR, THE NORTH-WEST CORNER SHOWING THE BLOCKED LOADING DOOR; VIEWED FROM THE ENE.

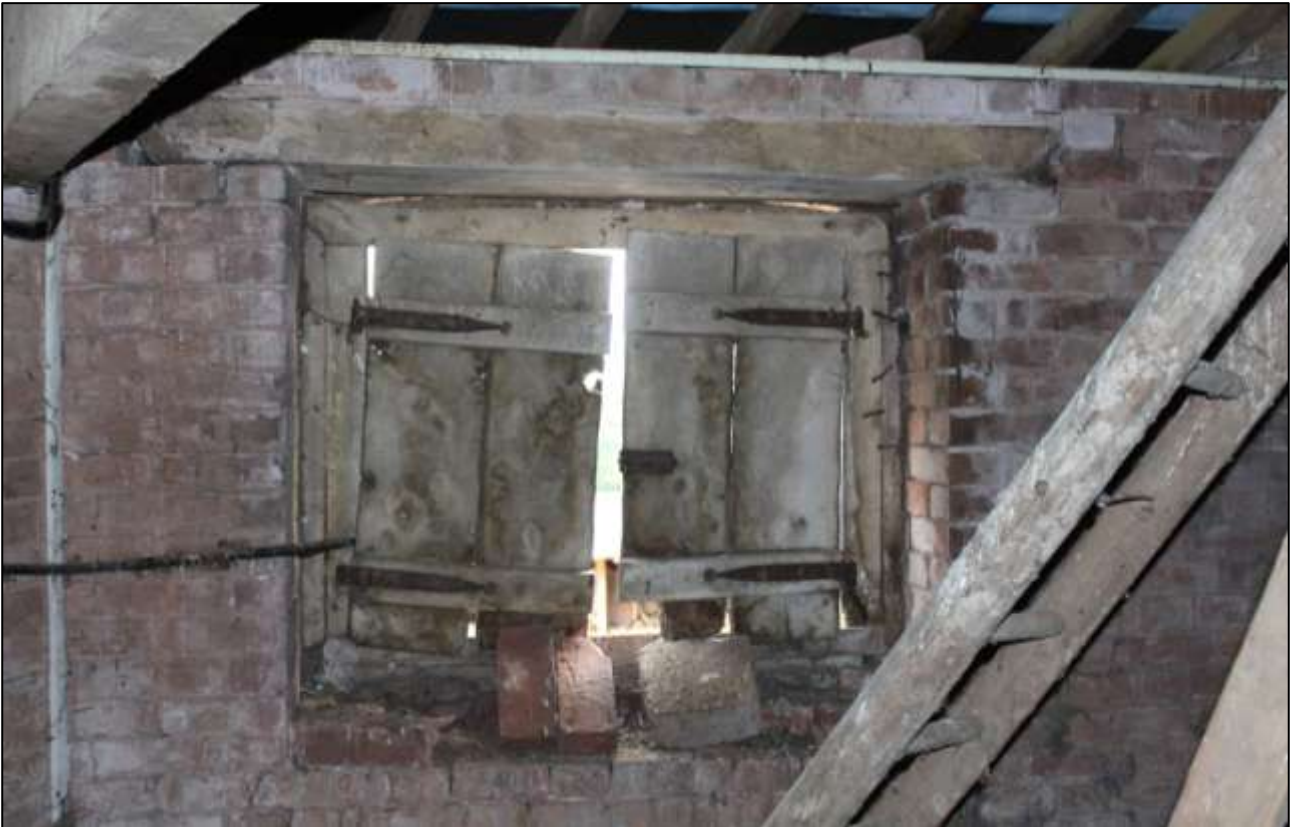
B5 FF INTERIOR, DETAIL OF THE SHUTTERED WINDOW IN THE SOUTH-EAST WALL; VIEWED FROM THE NORTH-WEST.

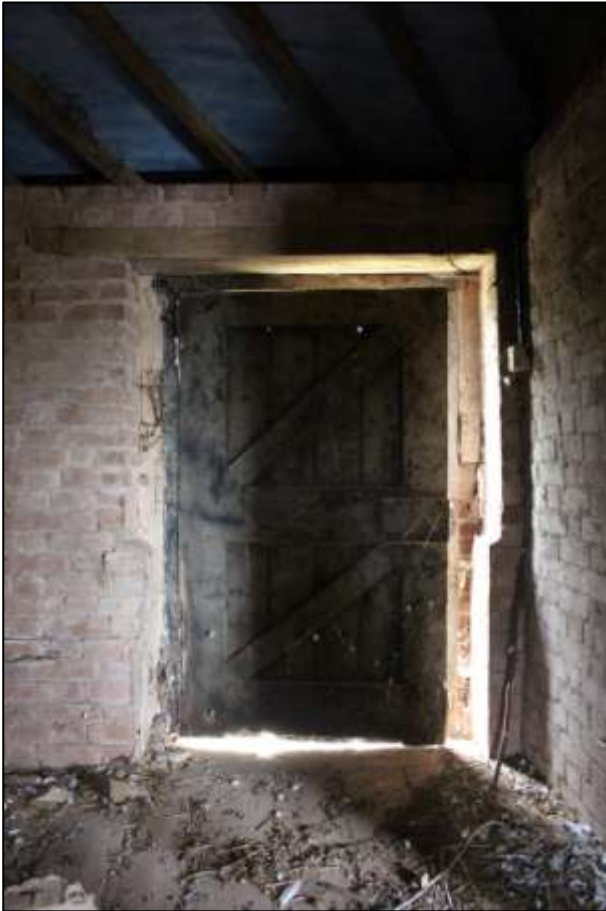
LEFT: B5 FF INTERIOR, THE FORCED LOADING DOOR IN THE NORTH-WEST WALL; VIEWED FROM THE SOUTH-EAST.

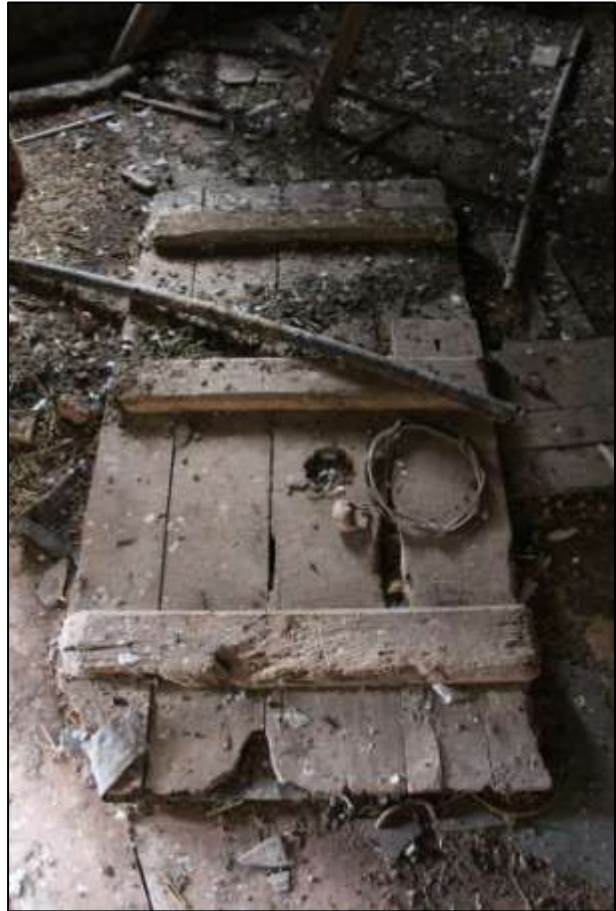
RIGHT: B5 FF INTERIOR, *EX SITU* DOOR ON THE FLOOR; VIEWED FROM THE NORTH.

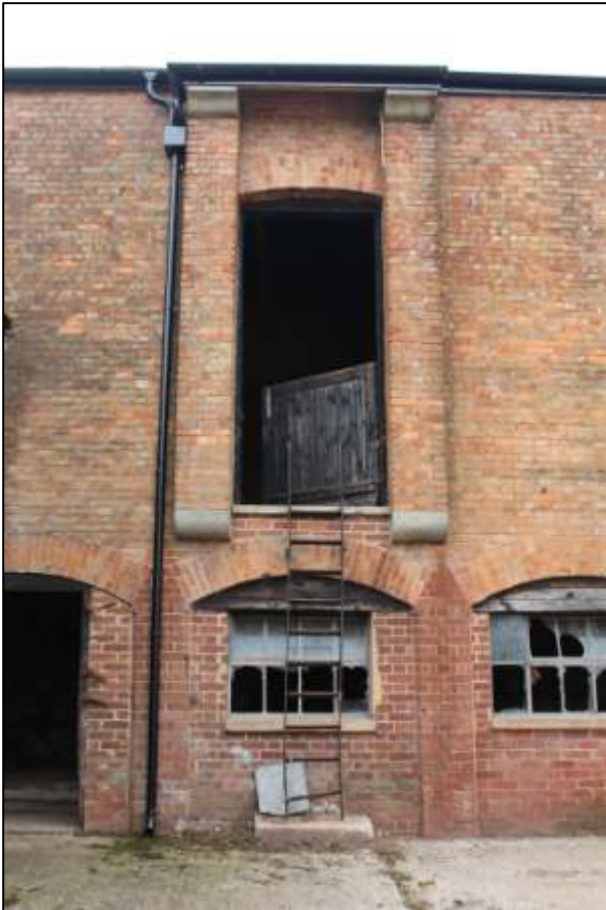
LEFT: B6 EXTERIOR, EAST WALL, DETAIL OF THE SOUTH WINNOWING DOOR; VIEWED FROM THE EAST.

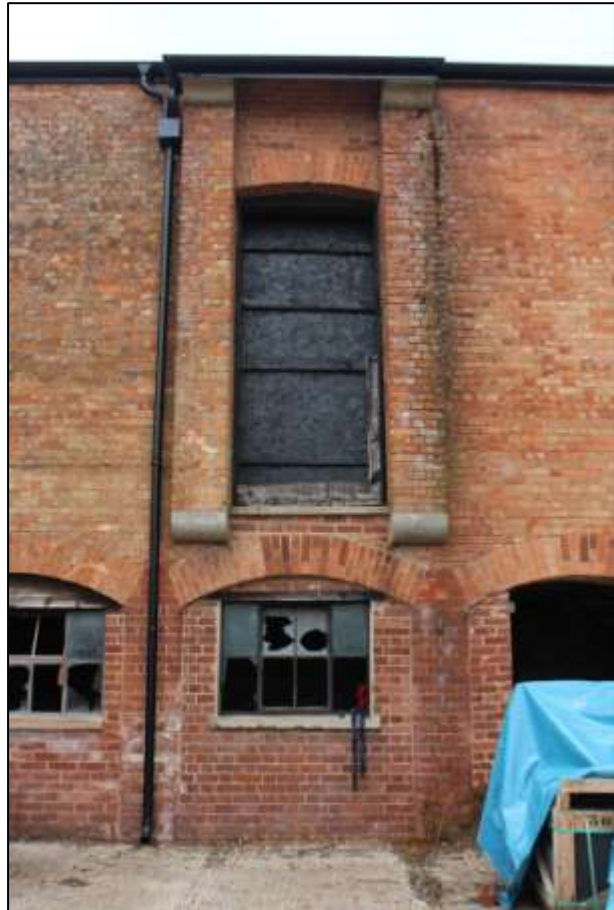
RIGHT: B6 EXTERIOR, EAST WALL, DETAIL OF THE NORTH WINNOWING DOOR; VIEWED FROM THE EAST.

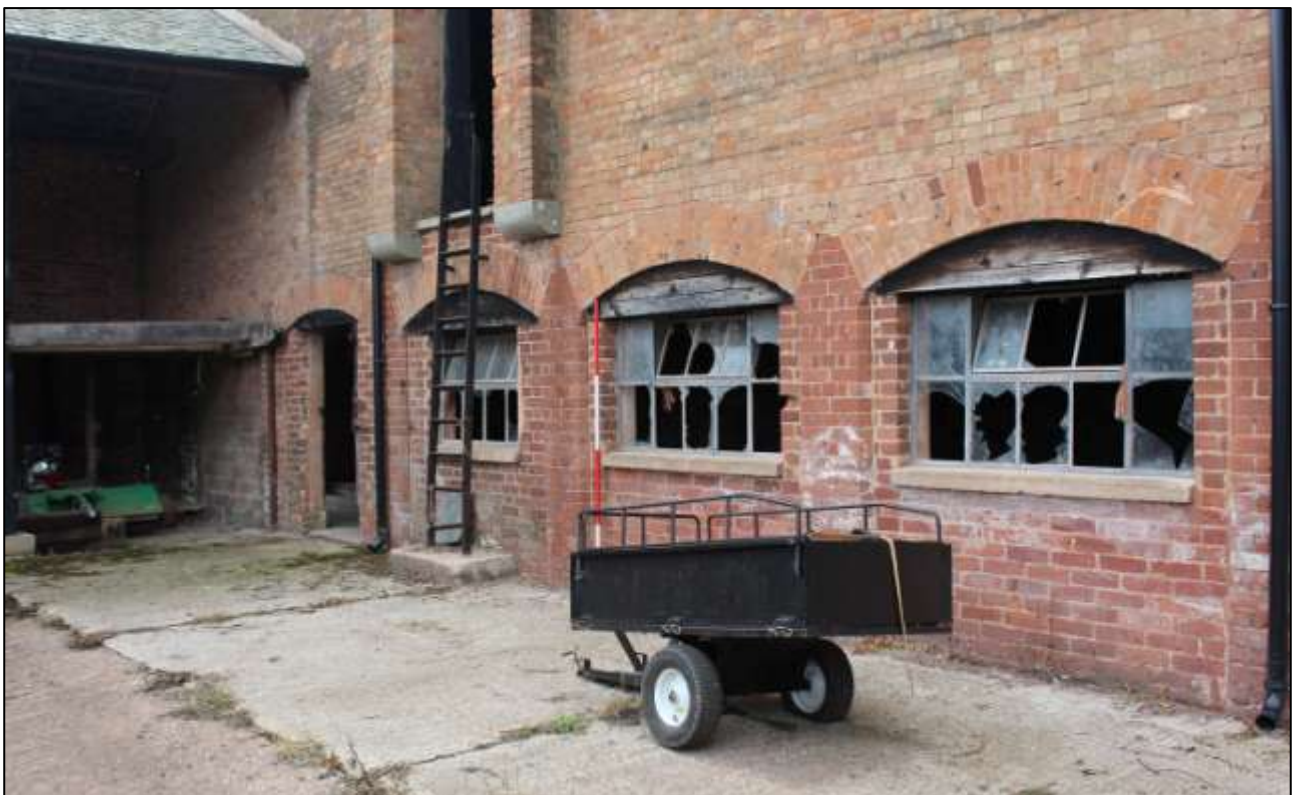
B6 EXTERIOR, EAST WALL, DETAIL OF THE BLOCKED GF OPENINGS; VIEWED FROM THE NORTH-EAST (SCALE 2M).

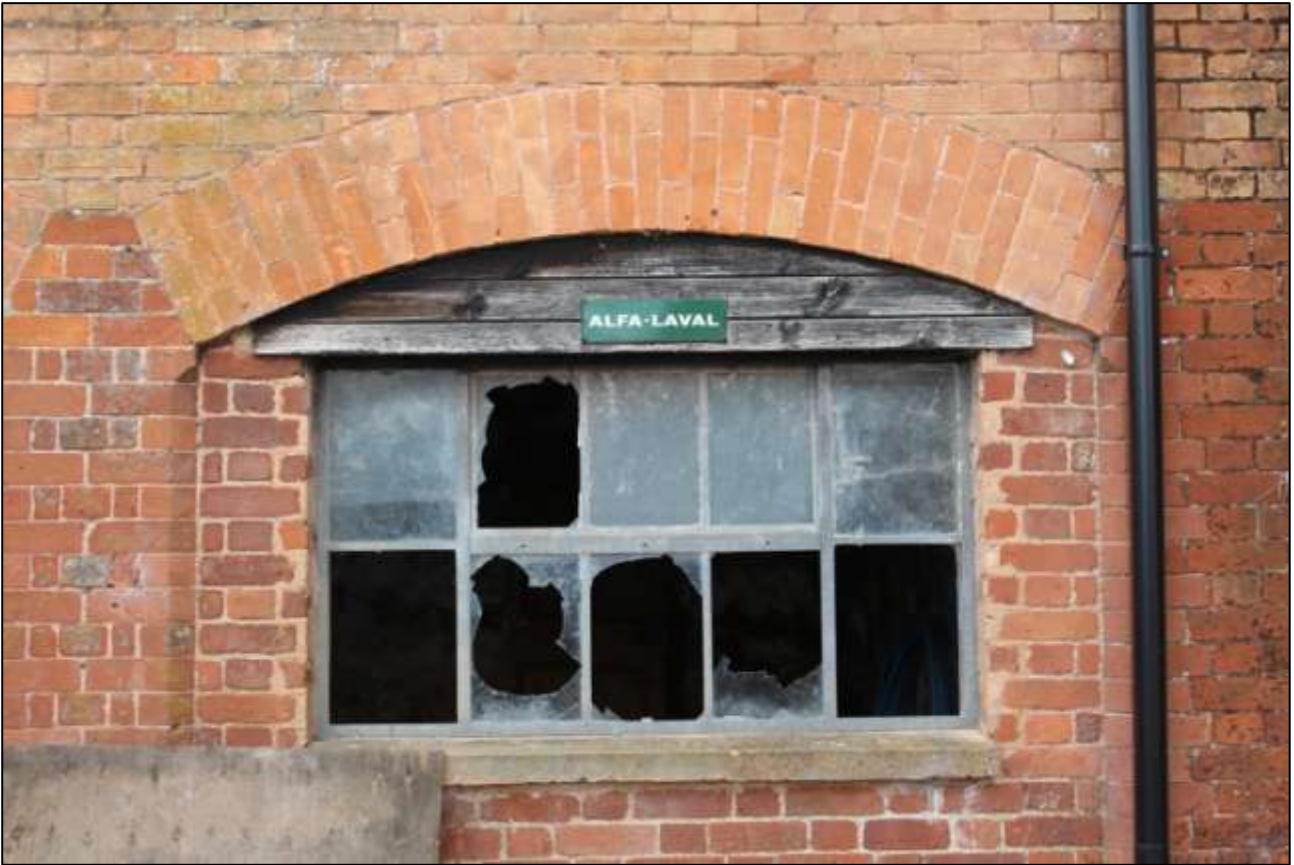
B6 EXTERIOR, EAST WALL, DETAIL OF THE CRITTAL-STYLE WINDOW AND ALFA LAVAL SIGN; VIEWED FROM THE EAST.

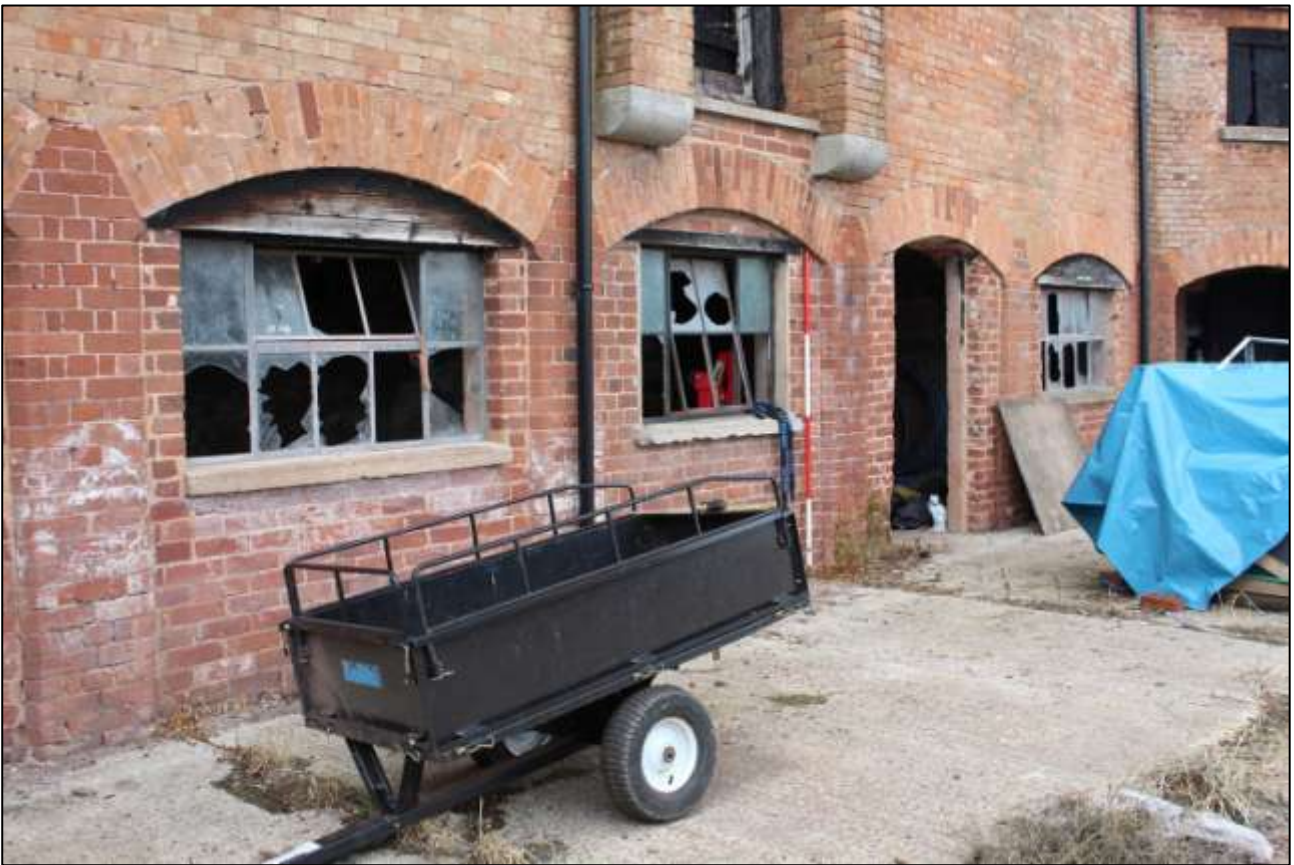
B6 EXTERIOR, EAST WALL, DETAIL OF THE BLOCKED GF OPENINGS; VIEWED FROM THE SOUTH-EAST (SCALE 2M).

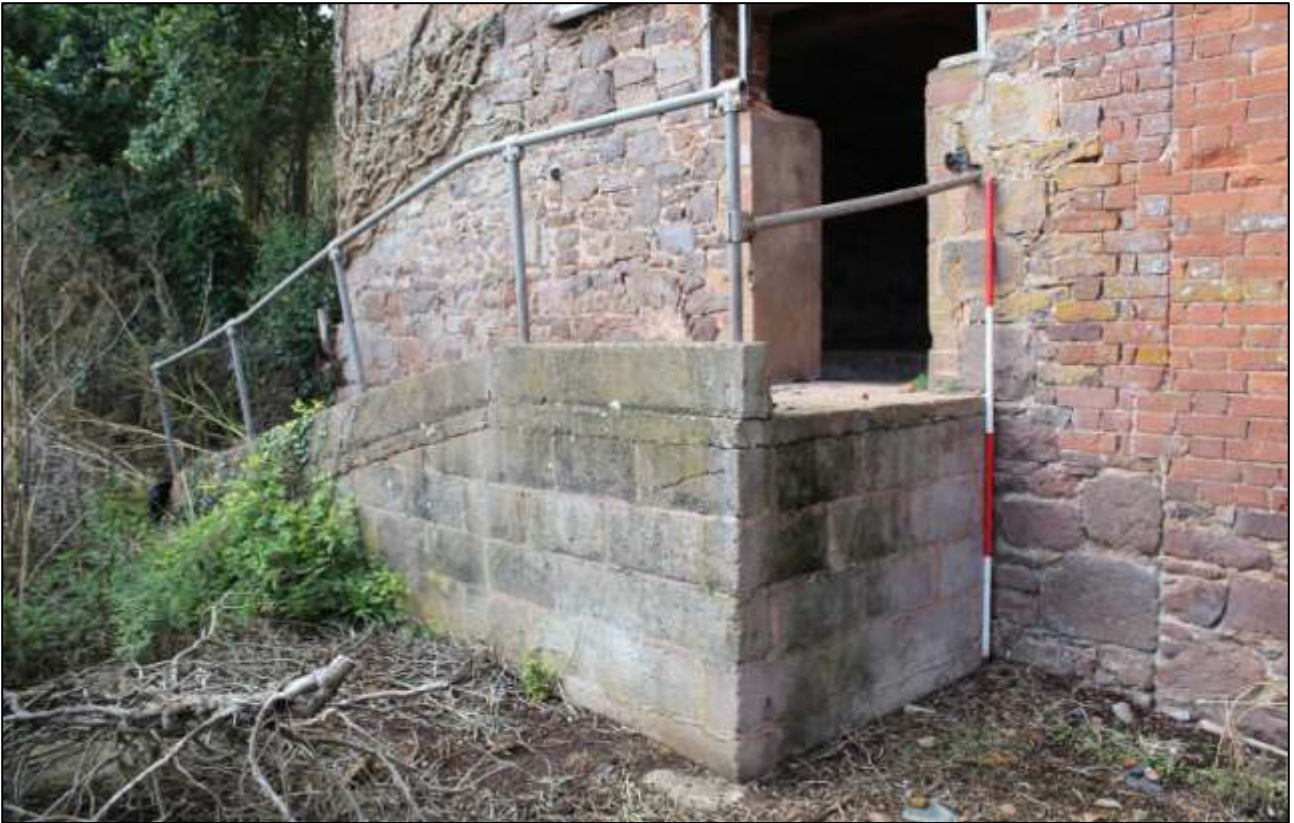
B6 EXTERIOR, SOUTH WALL, DETAIL OF THE CONCRETE RAMP PROVIDING ACCESS TO THE FORCED DOORWAY; VIEWED FROM THE SOUTH-EAST (SCALE 2M).

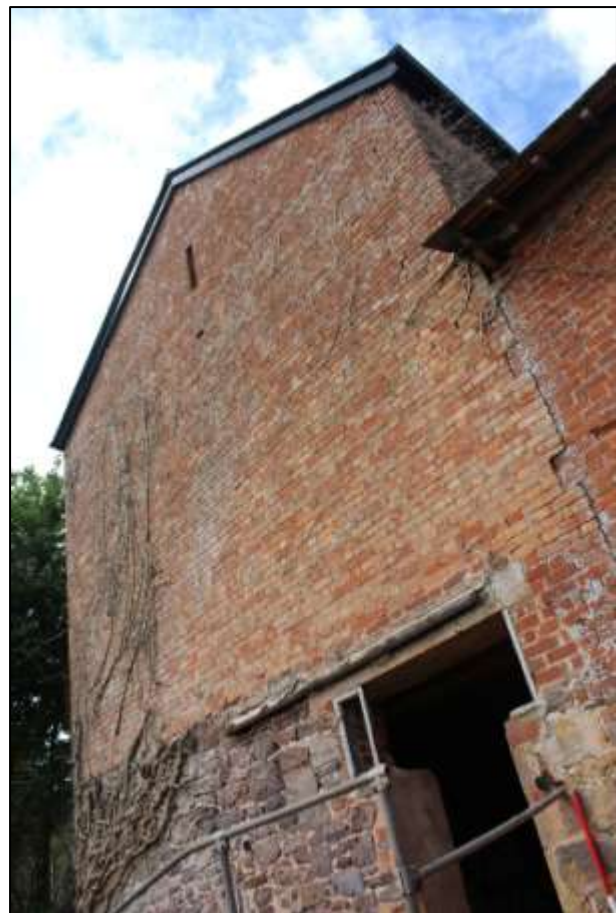
RIGHT: B6 EXTERIOR, SOUTH WALL, SHOWING THE TALL BLIND ELEVATION; VIEWED FROM THE SOUTH-EAST (SCALE 2M).
