HIGHER PARK FARM

CREDITON

DESK-BASED ASSESSMENT WITH HISTORIC BUILDING RECORDING

Higher Park Farm, Crediton, Devon Desk-Based Assessment with Historic Building Recording

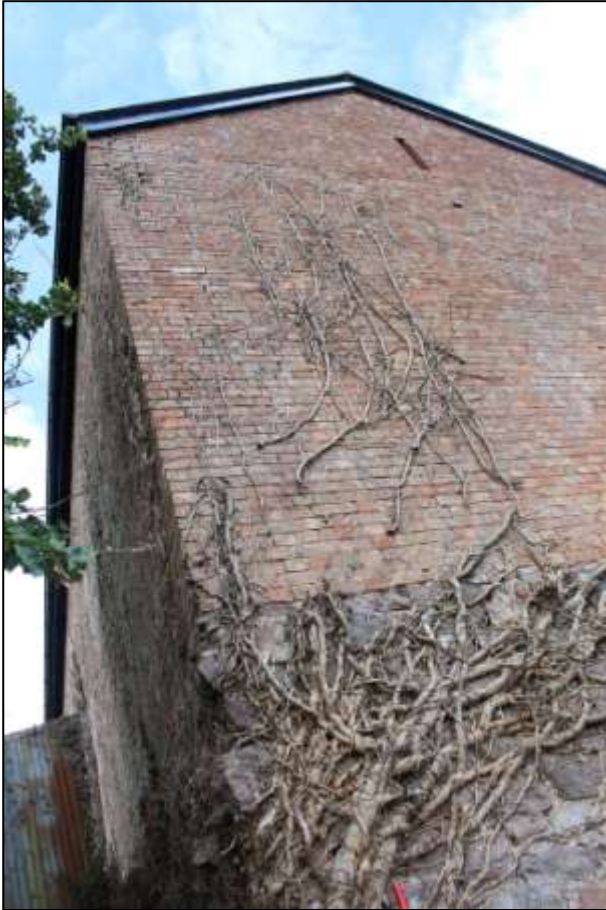
LEFT: AS ABOVE, VIEWED FROM THE SSW.

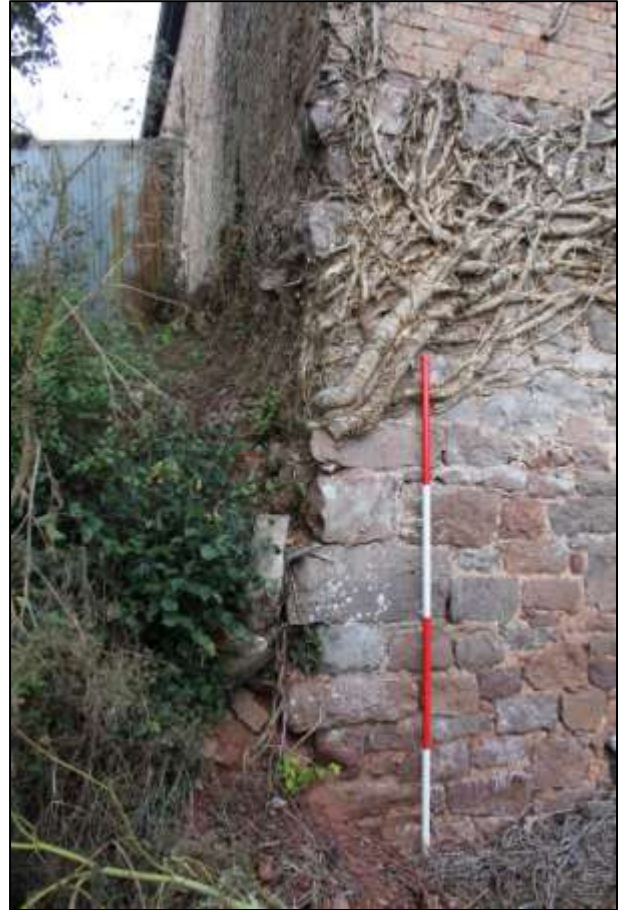
RIGHT: B6 EXTERIOR, SHOWING THE RAGGED CORNER TO THE STONE PLINTH; VIEWED FROM THE SOUTH (SCALE 2M).

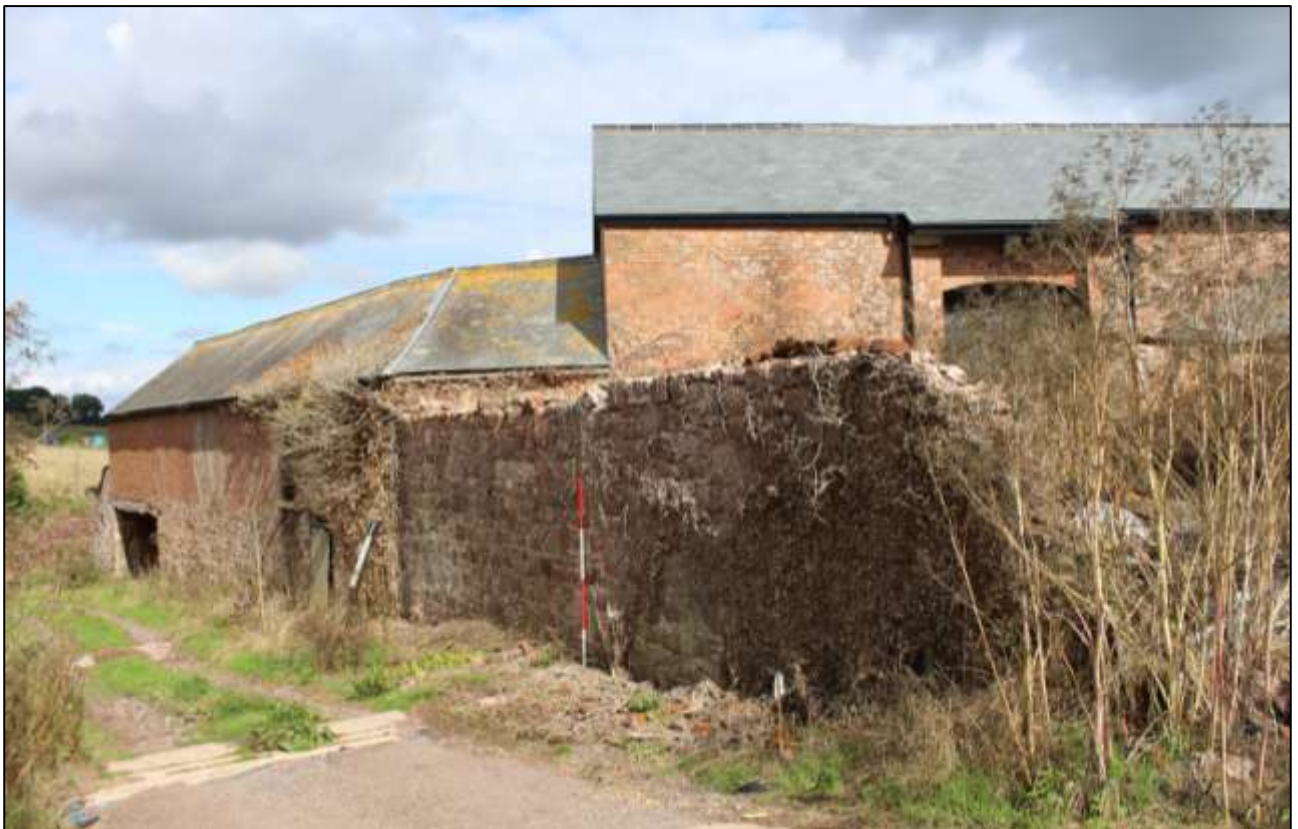
B6 EXTERIOR AND YARD WALL; VIEWED FROM THE WEST (SCALE 2M).

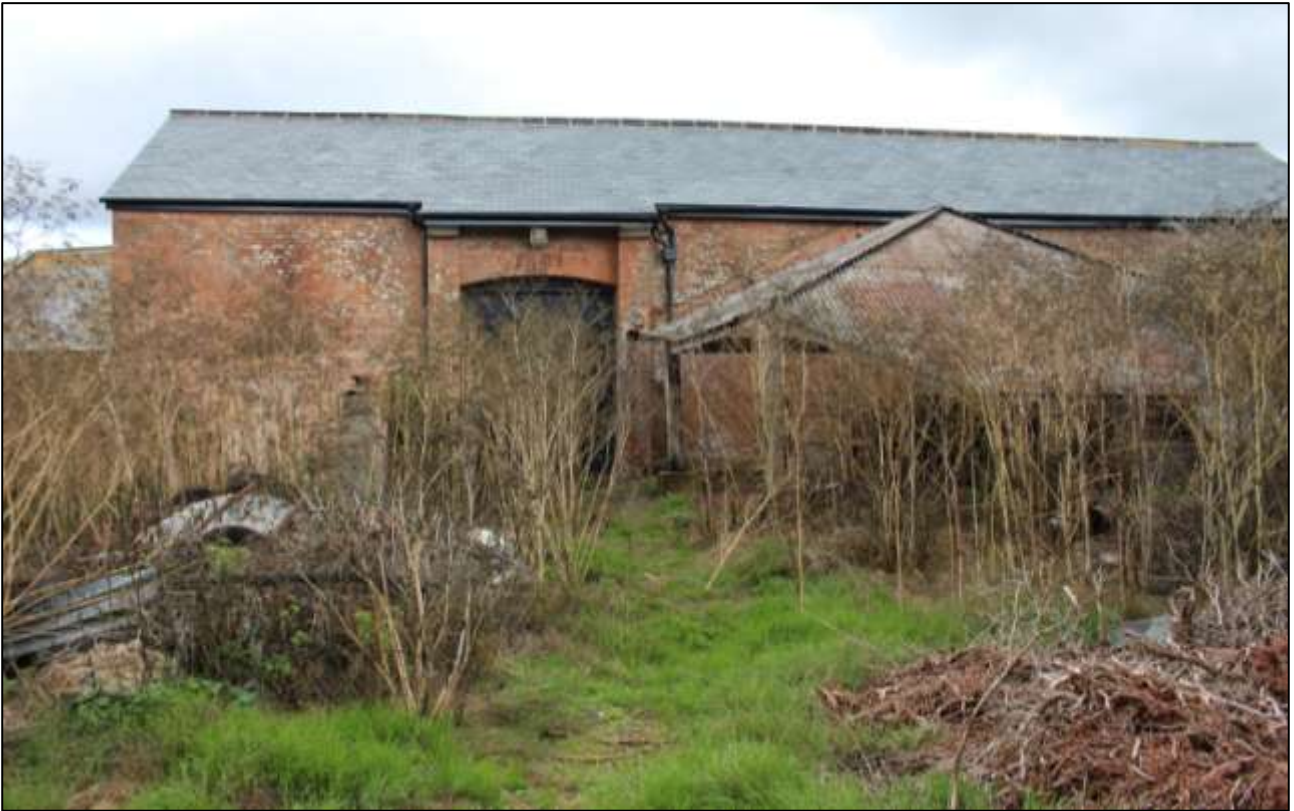
B6 EXTERIOR WITH B8, WEST WALL; VIEWED FROM THE WEST.

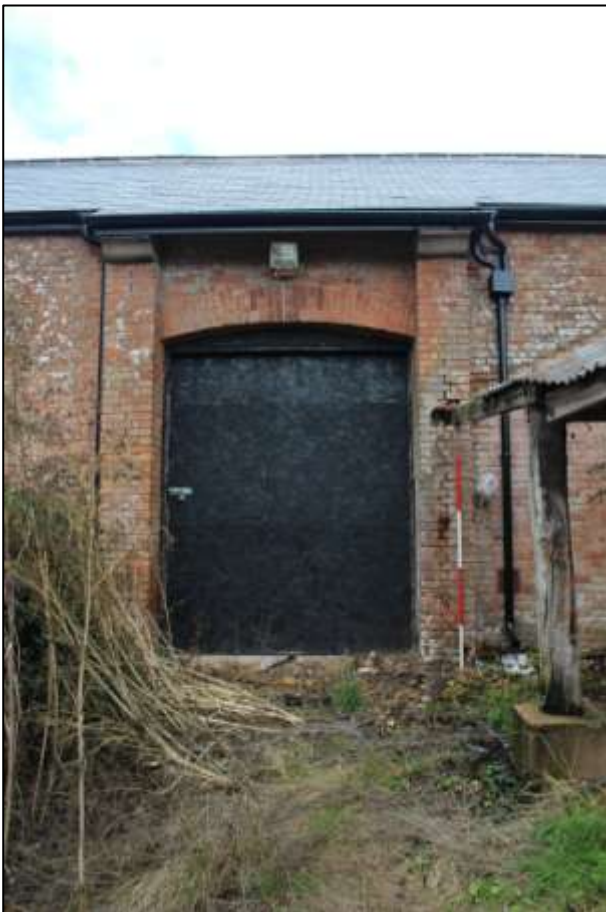
LEFT: B6 EXTERIOR, WEST WALL, DETAIL OF THE NORTH WINNOWING DOOR; VIEWED FROM THE WEST (SCALE 2M).

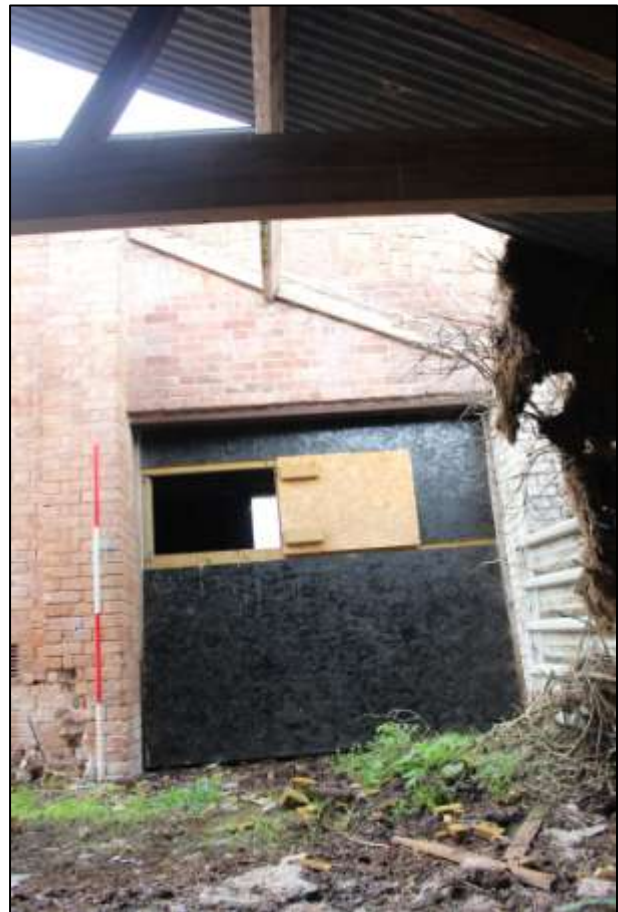
RIGHT: B6 EXTERIOR, WEST WALL, DETAIL OF THE SOUTH WINNOWING DOOR; VIEWED FROM THE WEST (SCALE 2M).

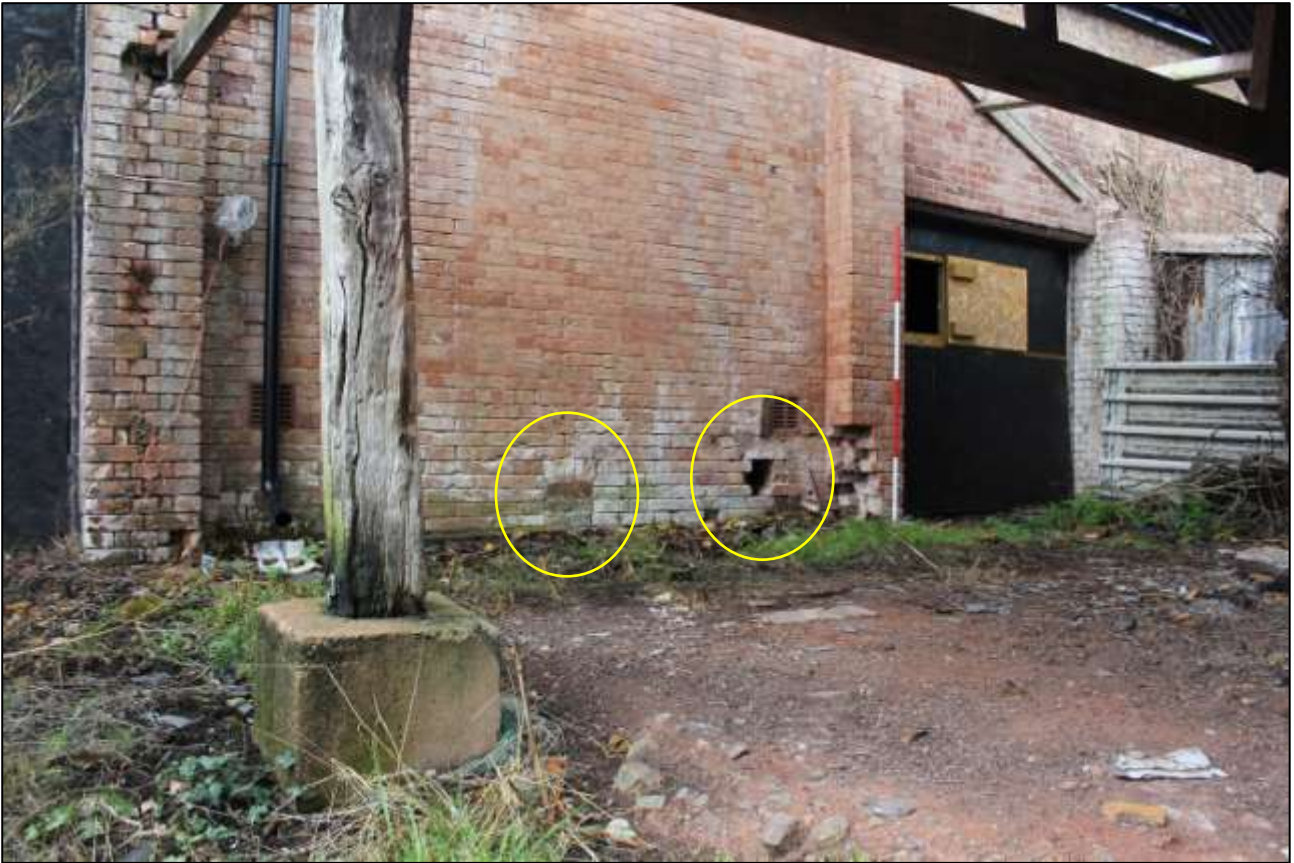
B6 EXTERIOR, WEST WALL, SHOWING THE BLOCKED AND FORCED SHAFT OPENINGS (INDICATED); VIEWED FROM THE WNW.

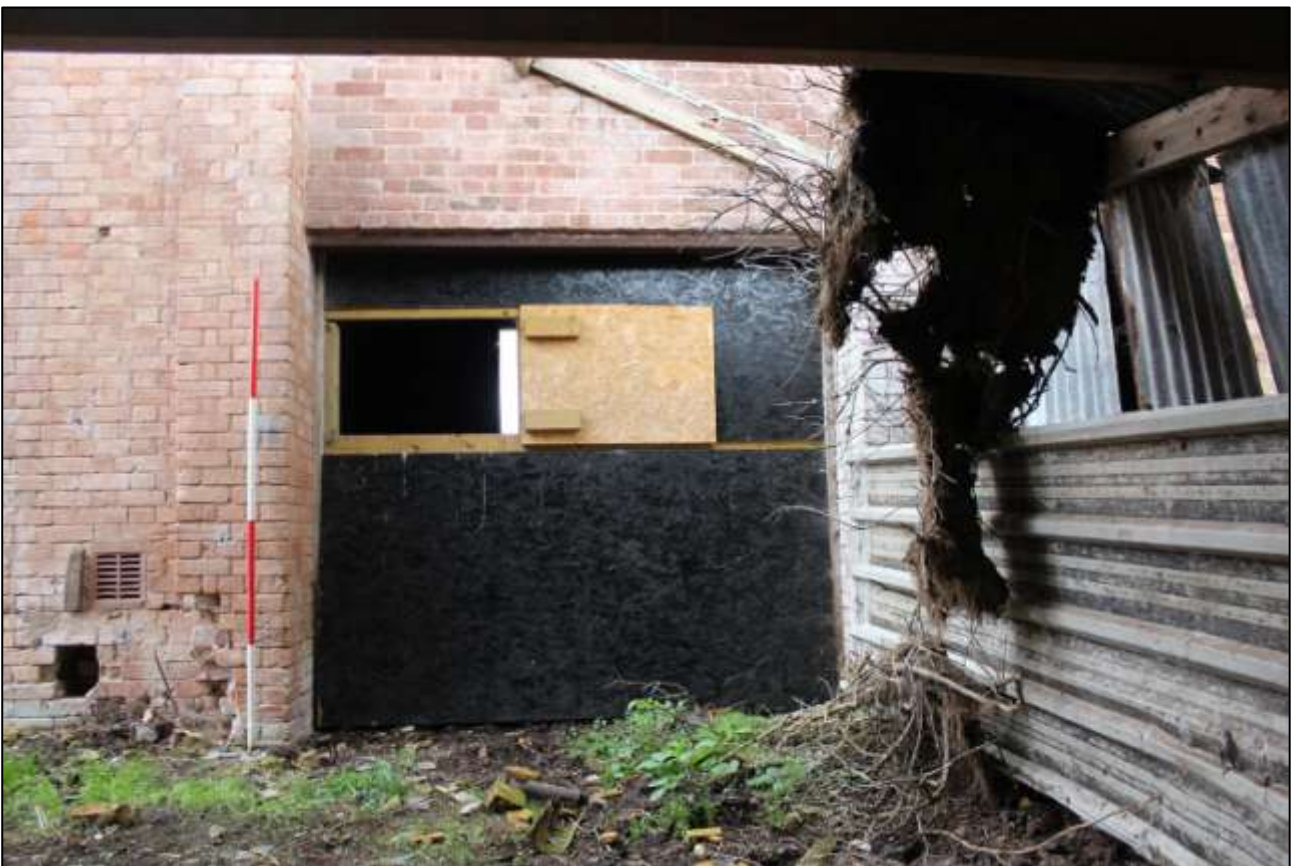
B6 EXTERIOR, WEST WALL, DETAIL OF THE SOUTH WINNOWING DOOR; VIEWED FROM THE WEST (SCALE 2M).

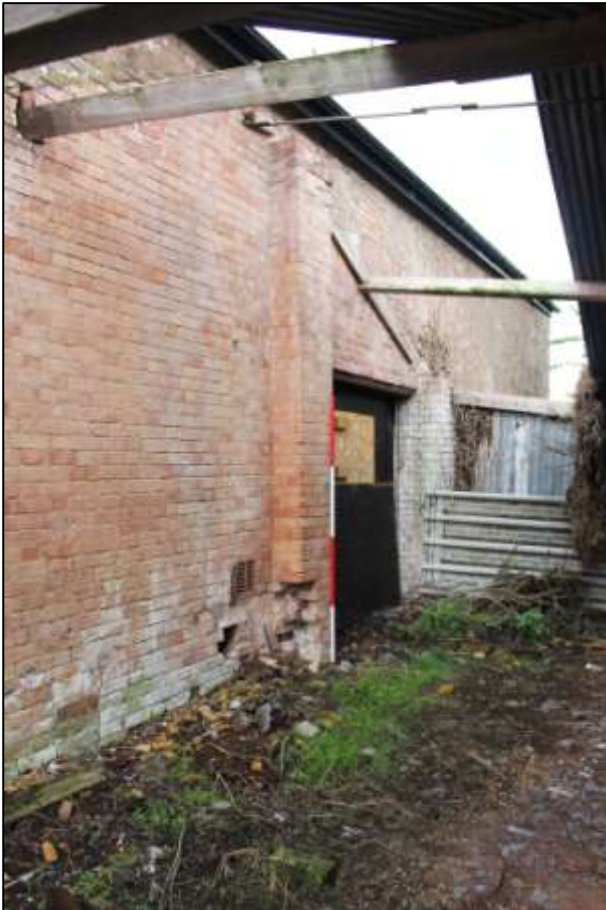
LEFT: B6 EXTERIOR, WEST WALL, DETAIL OF THE SOUTH WINNOWING DOOR; VIEWED FROM THE NNW (SCALE 2M).

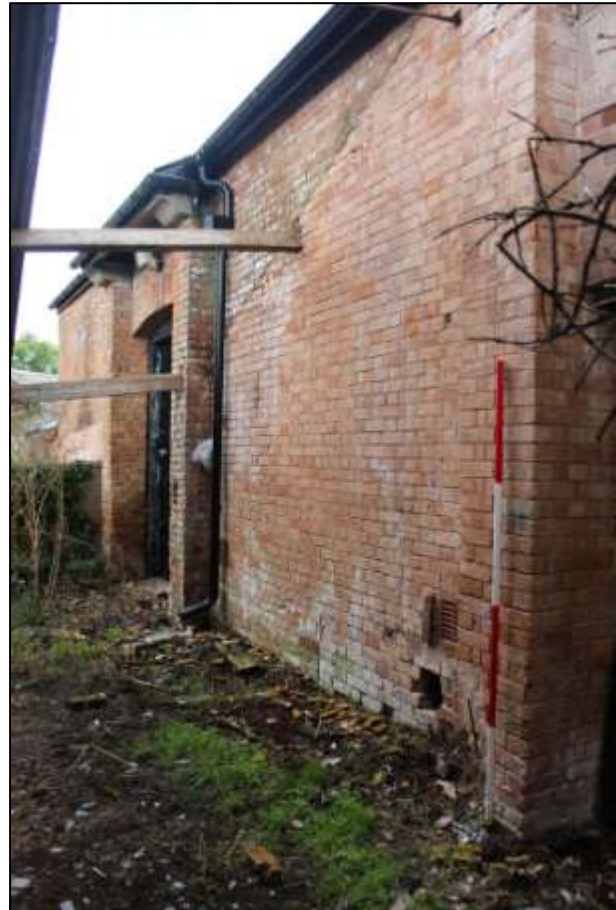
RIGHT: B6 EXTERIOR, WEST WALL, DETAIL OF THE NORTH WINNOWING DOOR; VIEWED FROM THE SSW (SCALE 2M).

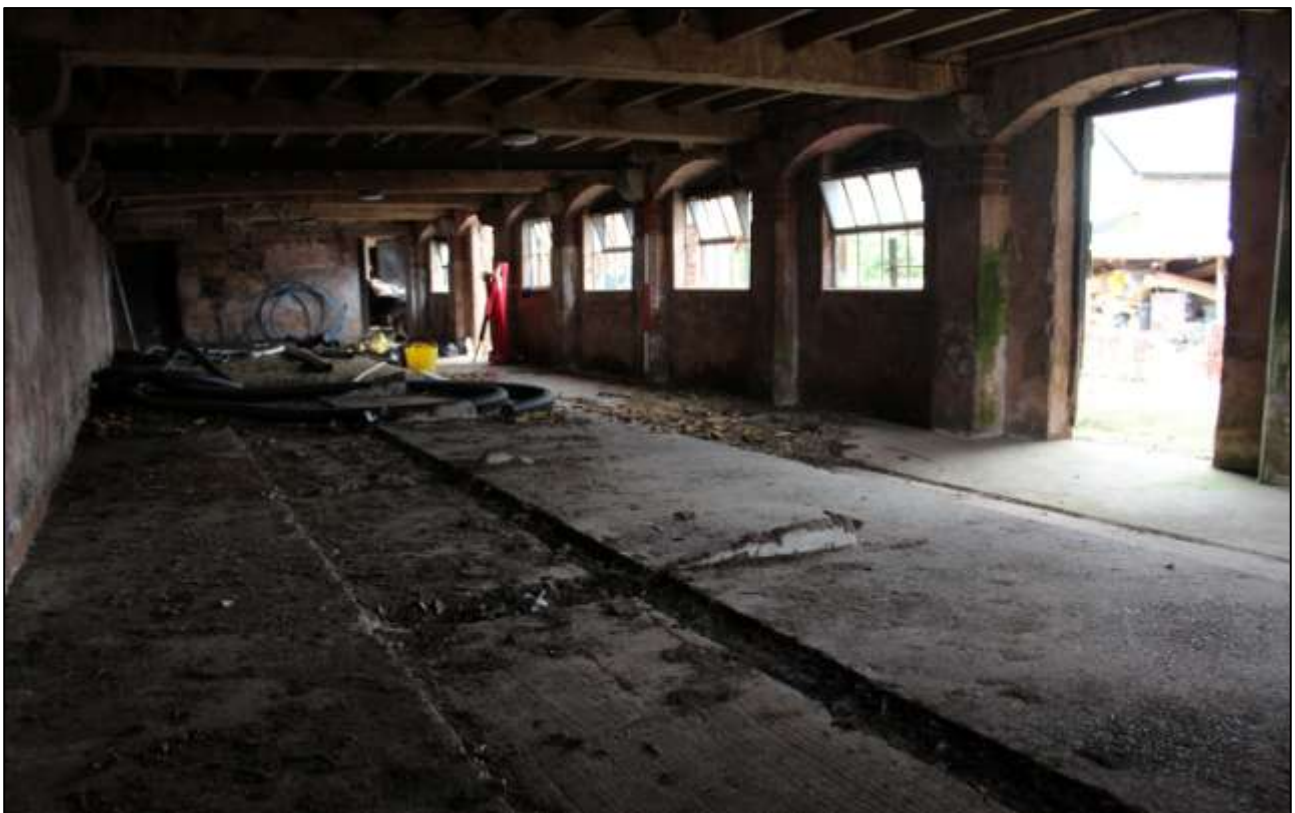
B6 GF INTERIOR; VIEWED FROM THE SSW (SCALE 2M).

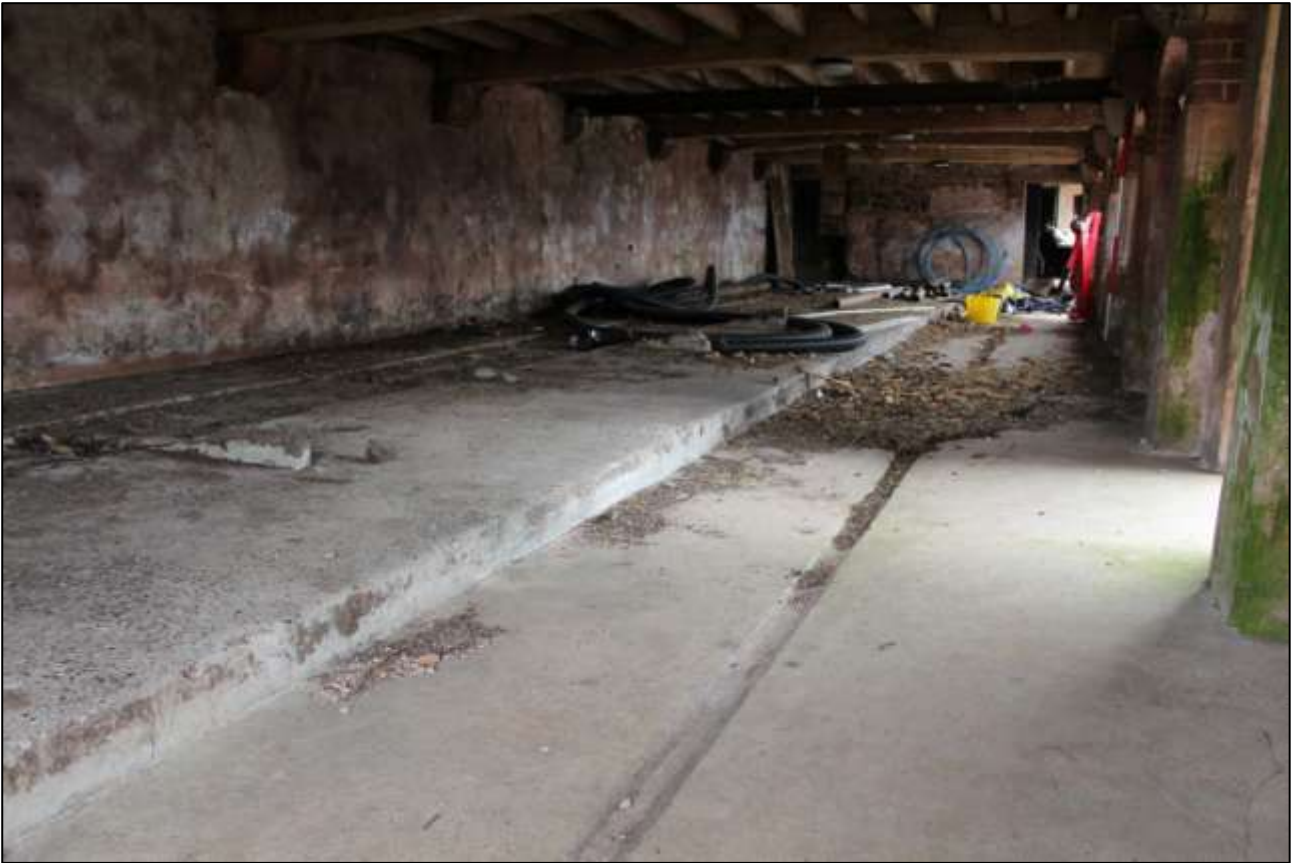
B6 GF INTERIOR; VIEWED FROM THE SSE (SCALE 2M).

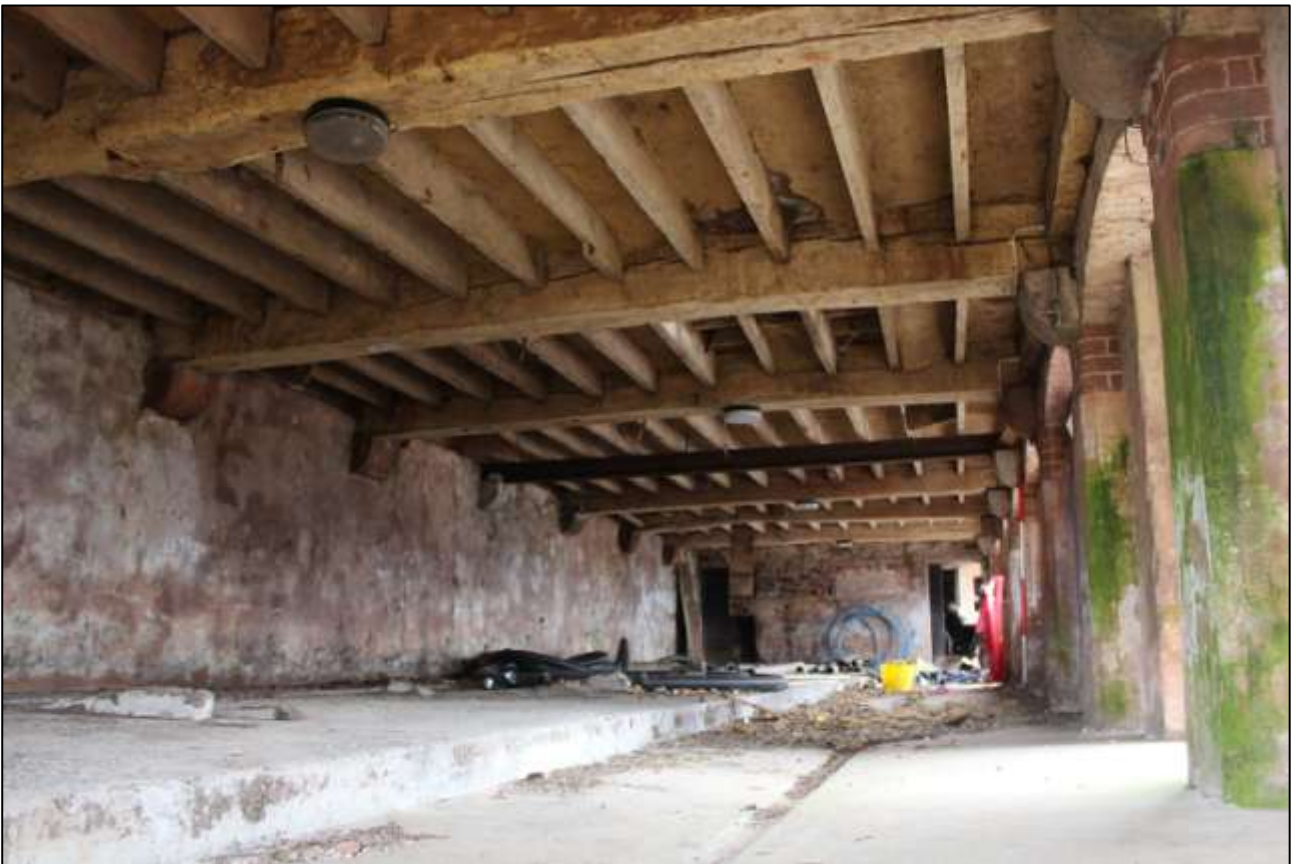
AS ABOVE, DETAIL OF THE CEILING.

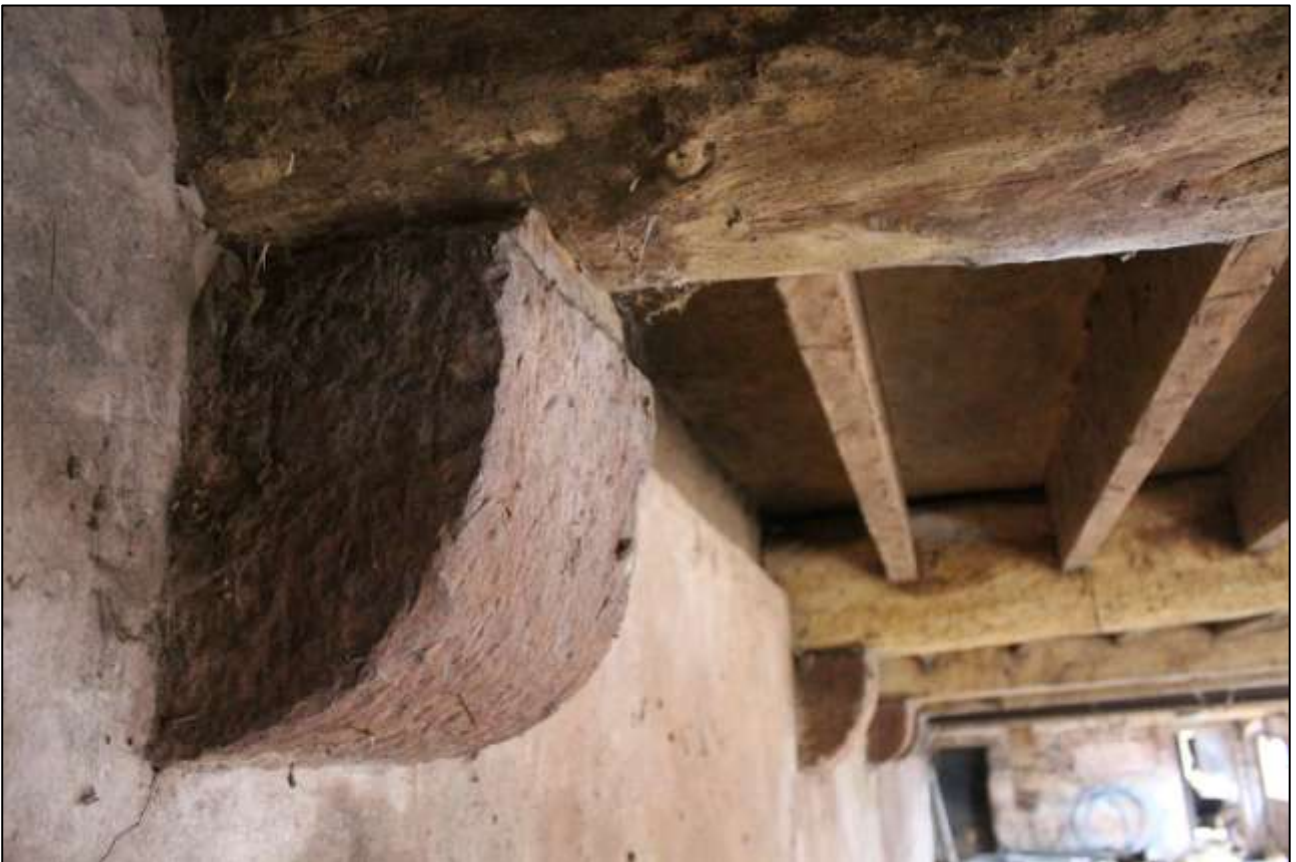
B6 GF INTERIOR, DETAIL OF ONE OF THE CORBELS SUPPORTING THE BEAMS; VIEWED FROM THE SOUTH.

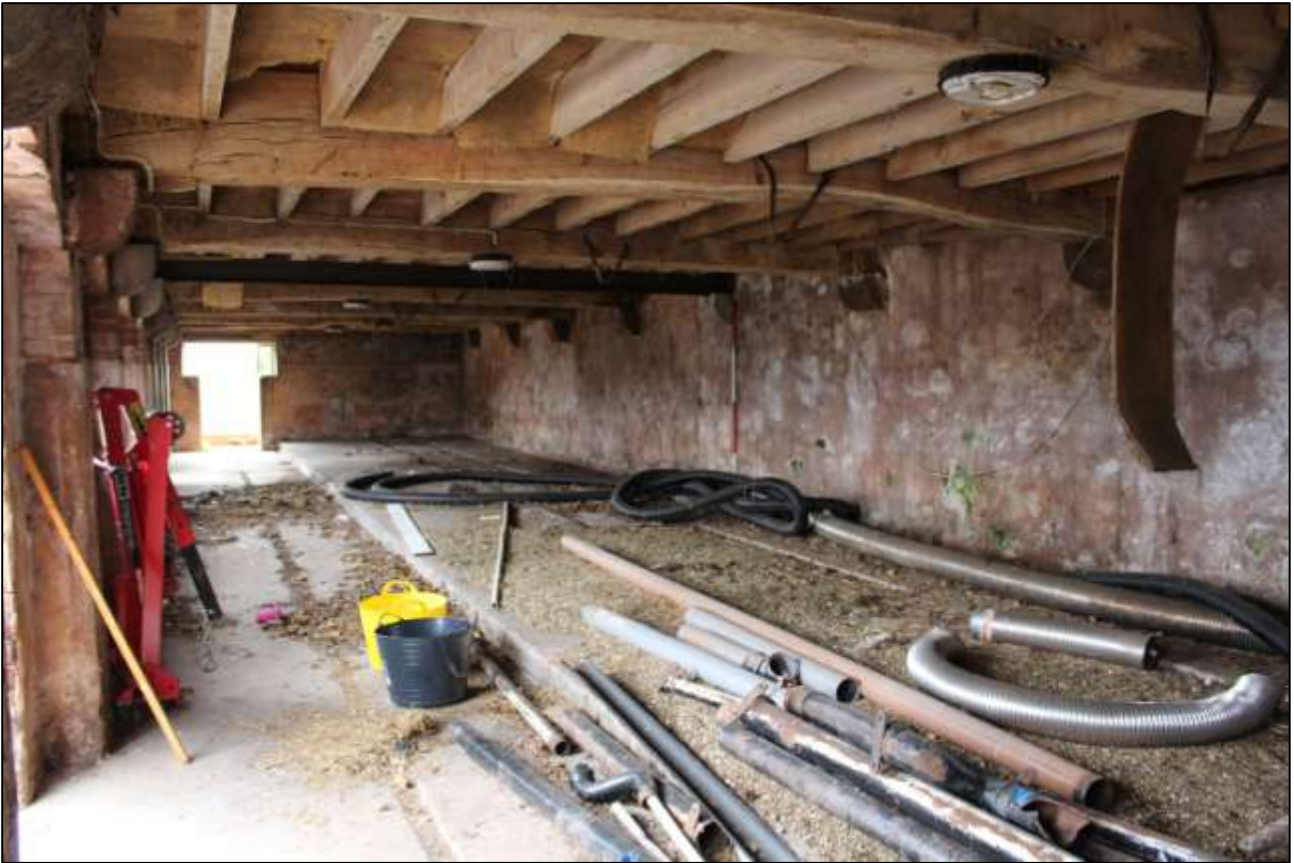
B6 GF INTERIOR; VIEWED FROM THE NNE (SCALE 2M).

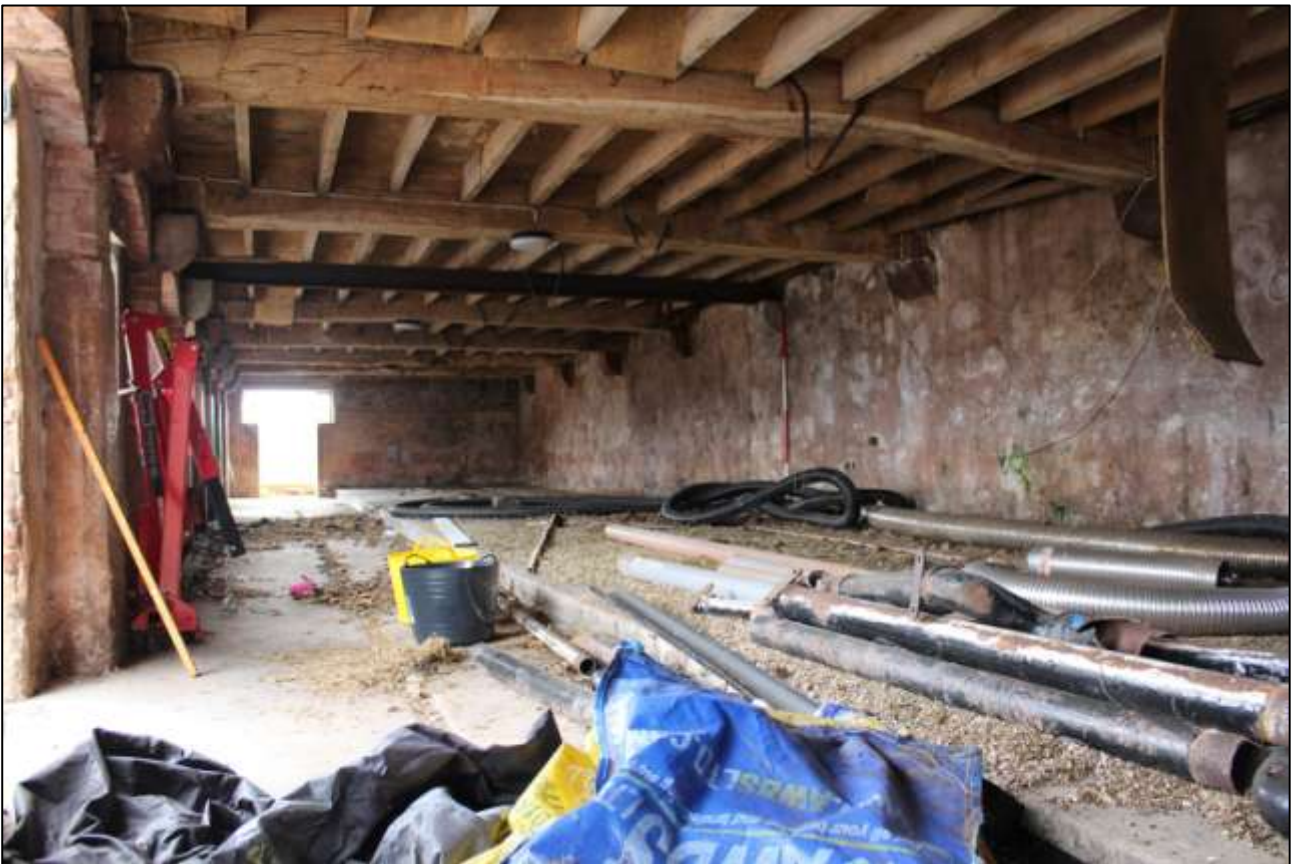
AS ABOVE, WITH DETAIL OF THE CEILING.

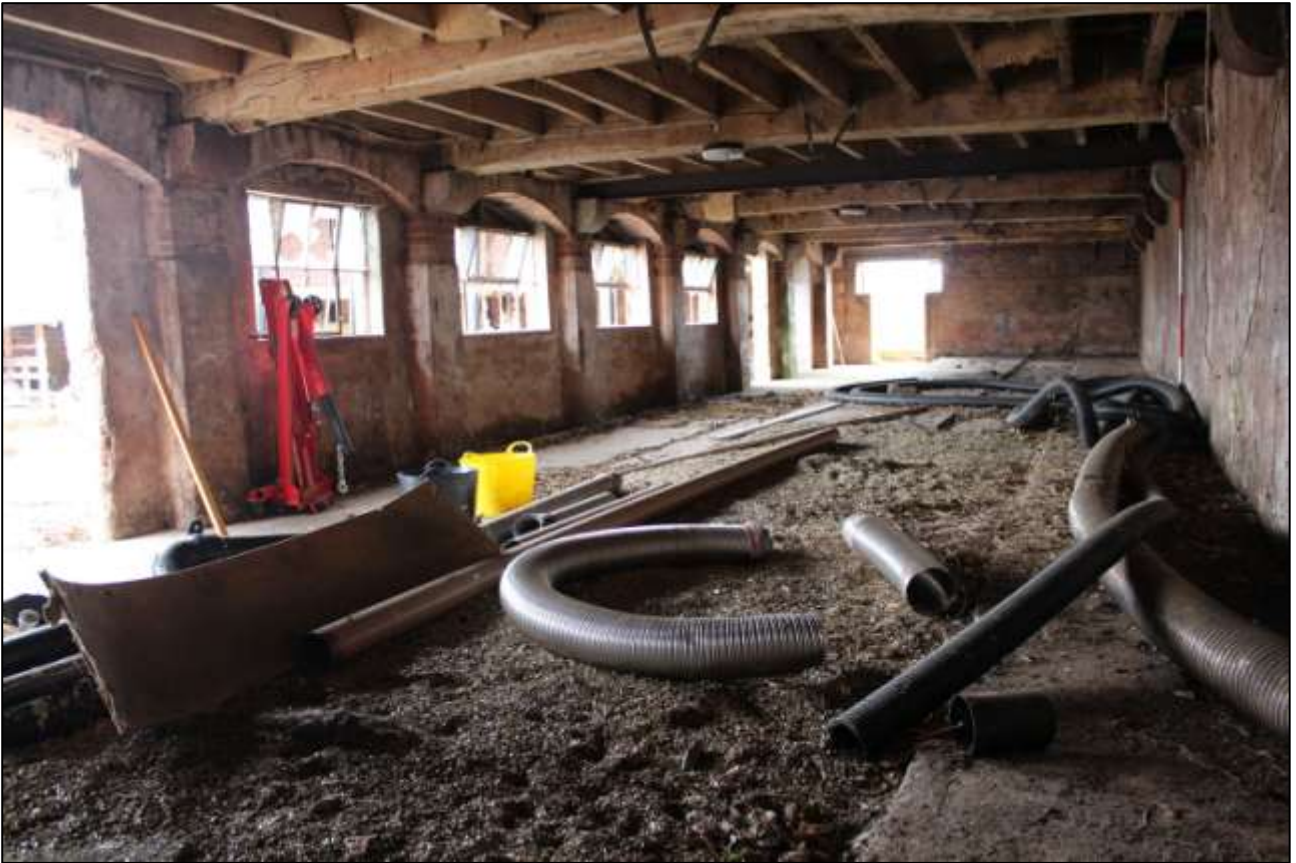
B6 GF INTERIOR; VIEWED FROM THE NNW (SCALE 2M).

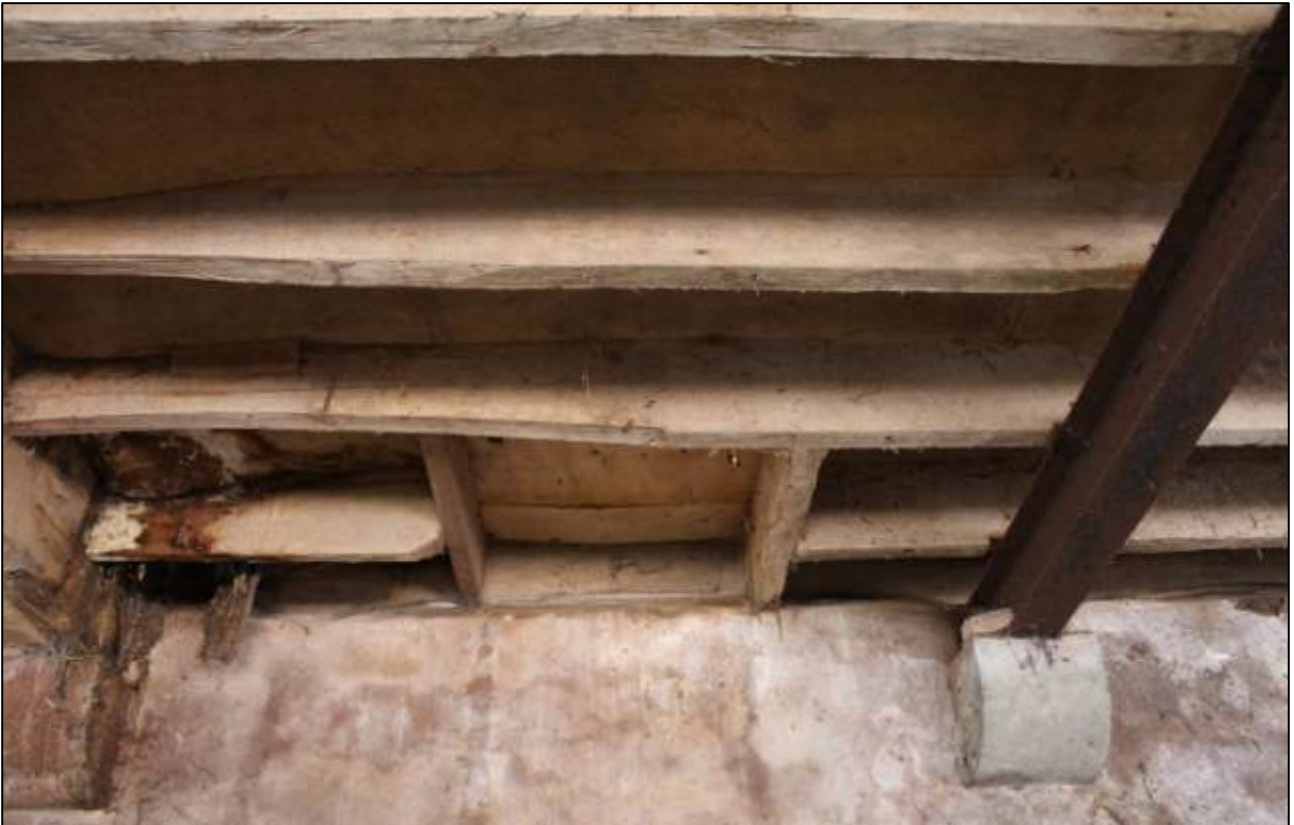
B6 GF INTERIOR, DETAIL OF A HATCH IN THE CEILING; VIEWED FROM THE EAST.

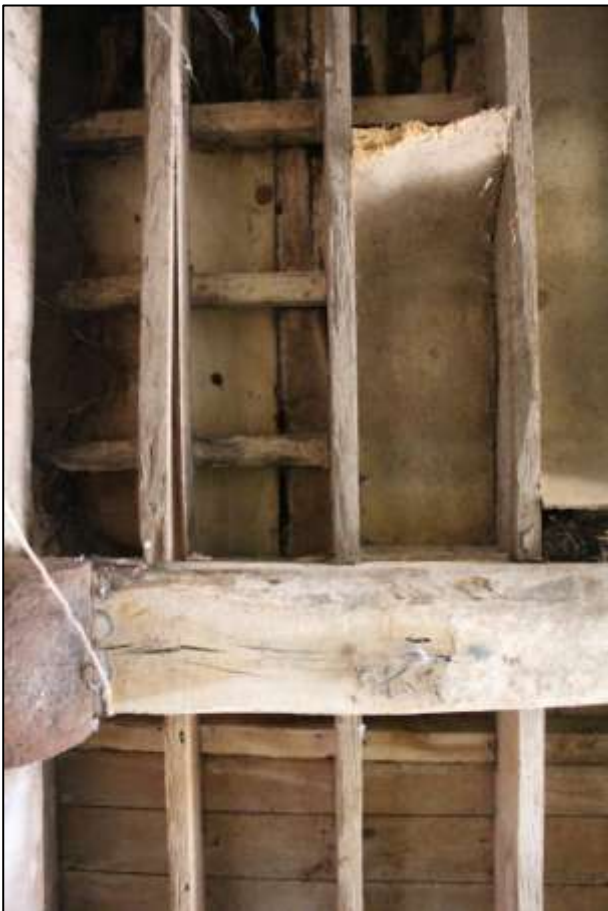
B6 GF INTERIOR, DETAIL OF THE REINFORCED FLOORS BENEATH THE THRESHING FLOORS BETWEEN THE WINNOWING DOORS, NORTH DOOR ON THE WEST SIDE; VIEWED FROM BELOW.

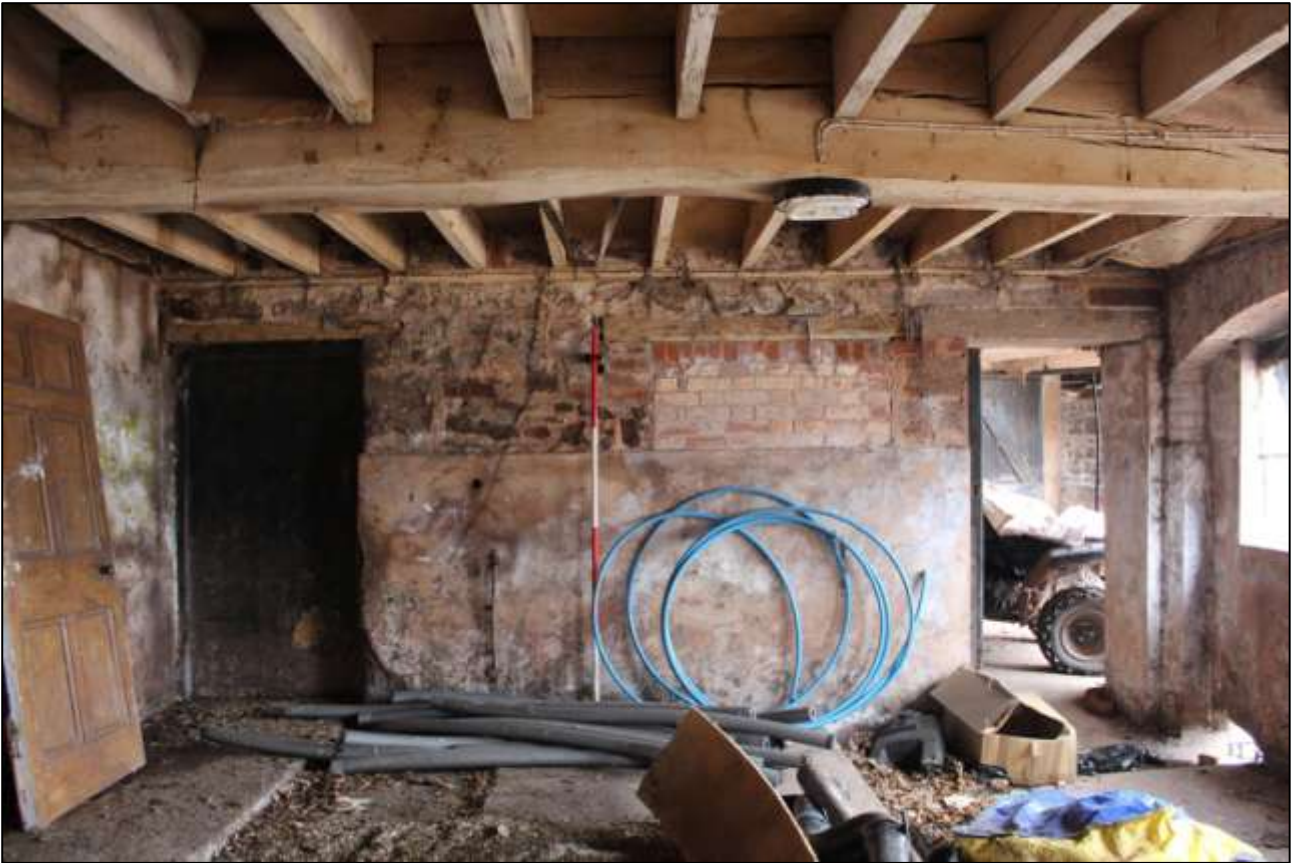
B6 GF INTERIOR, DETAIL OF THE NORTH WALL; VIEWED FROM THE SOUTH (SCALE 2M).

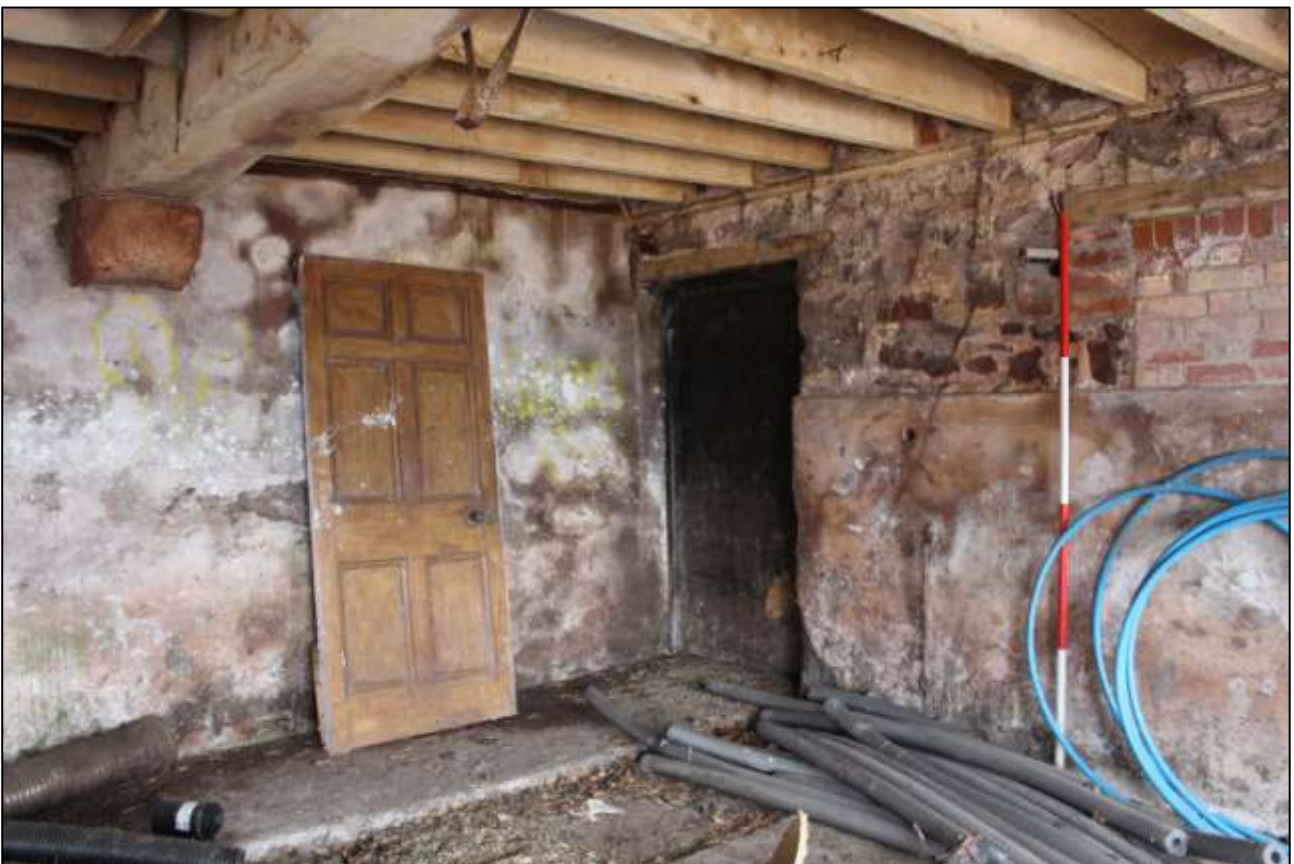
AS ABOVE; VIEWED FROM THE SOUTH-EAST. NOTE THE *EX SITU* DOMESTIC DOOR FROM THE FARMHOUSE.

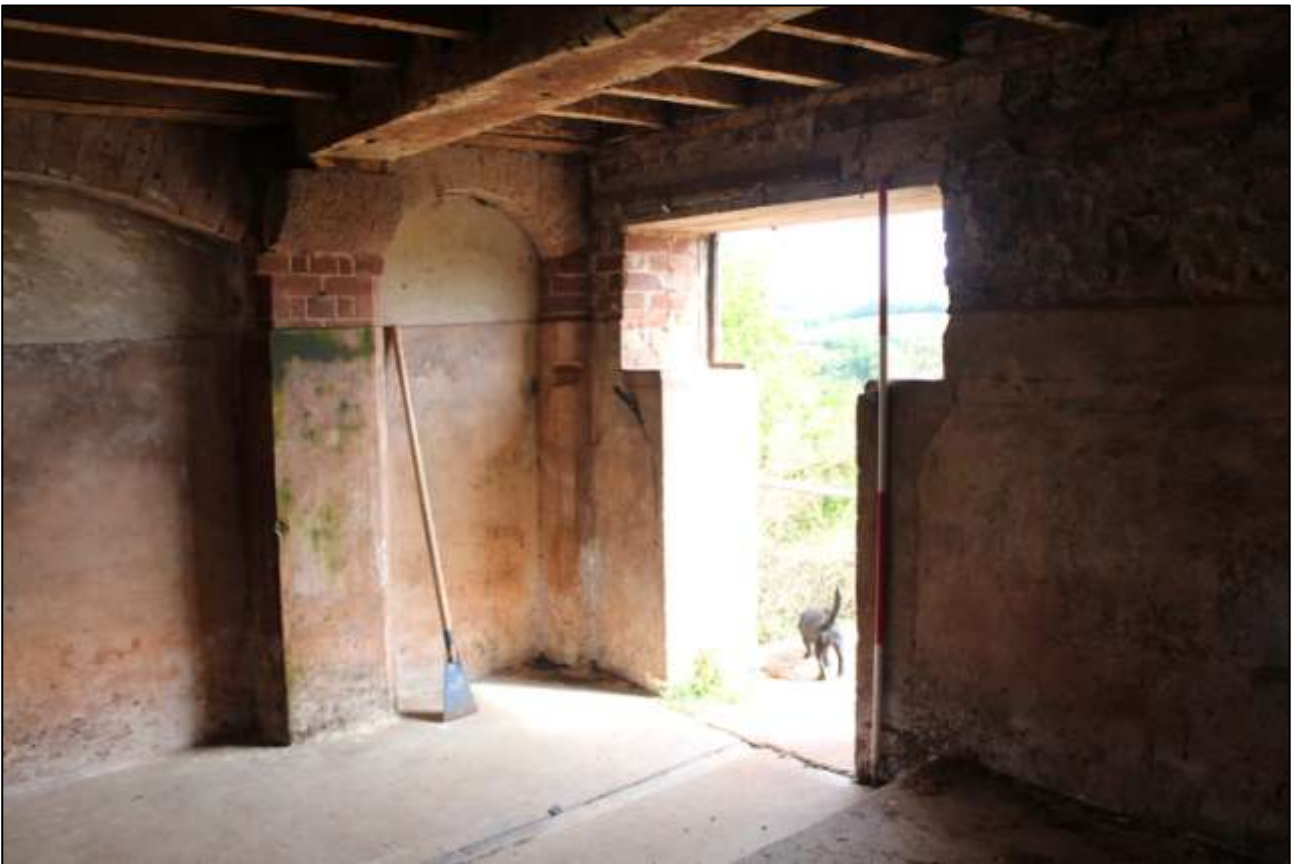
AS ABOVE; VIEWED FROM THE NORTH-WEST.

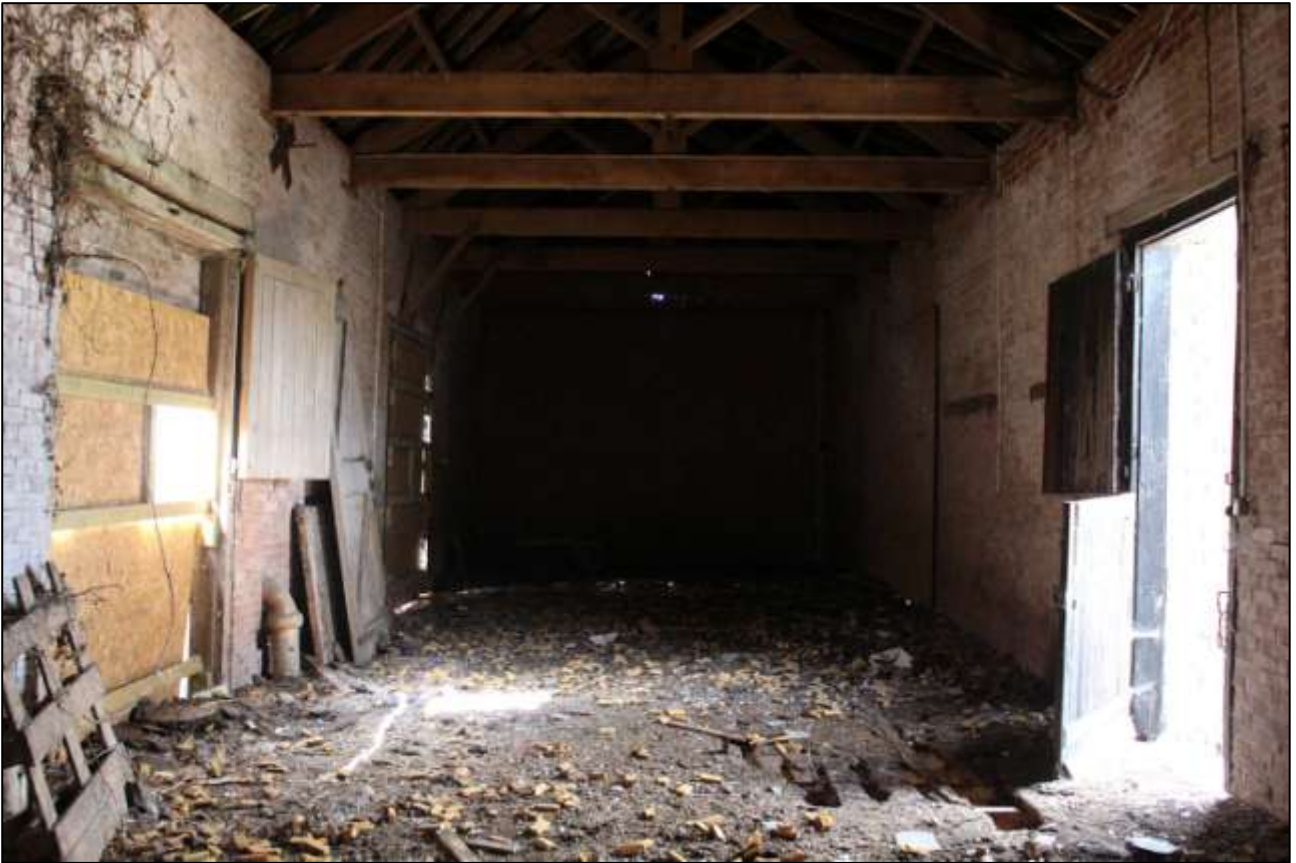
B6 FF INTERIOR; VIEWED FROM THE SOUTH.

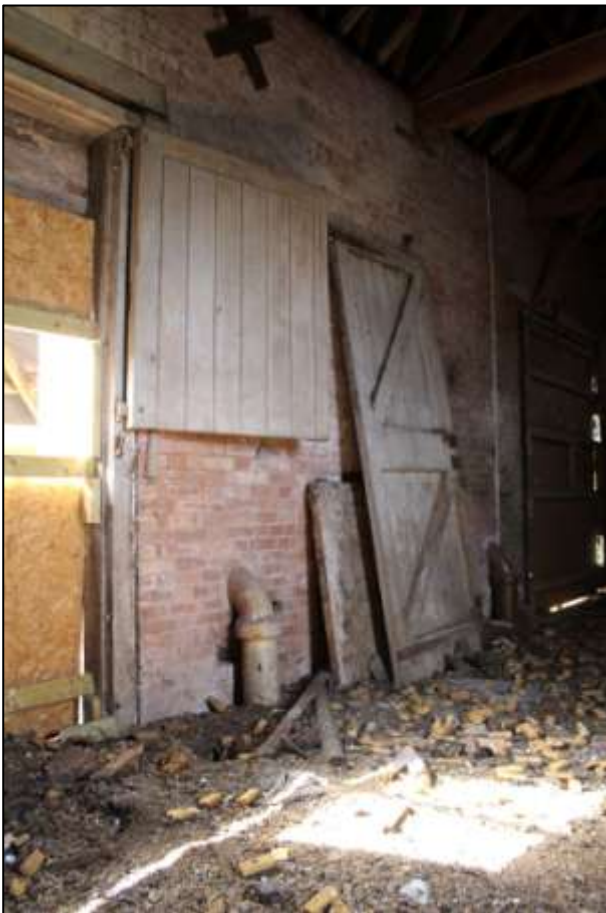
LEFT: B6 FF INTERIOR, DETAIL OF THE DOORS TO THE WEST WINNOWING DOORWAYS; VIEWED FROM THE SOUTH-WEST.

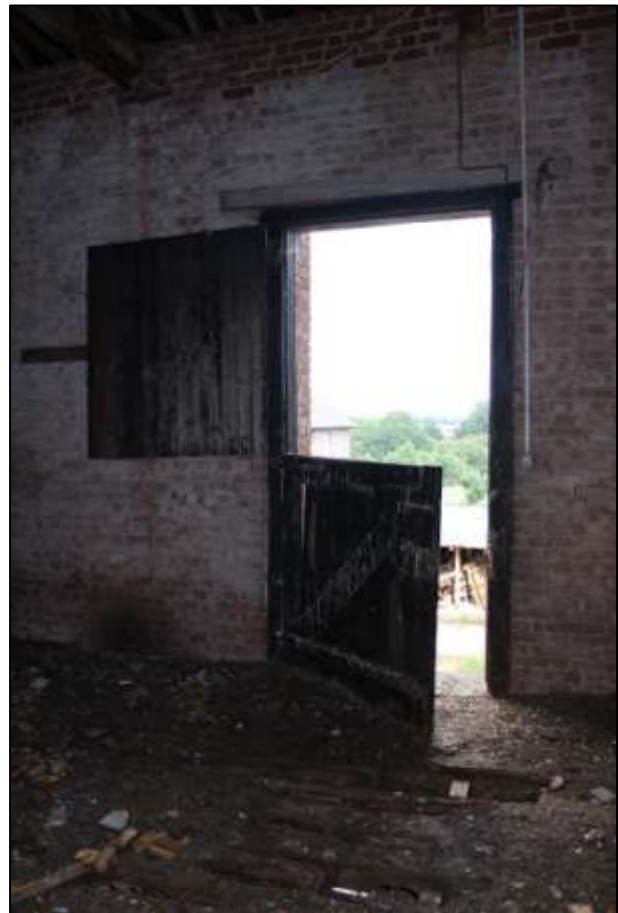
RIGHT: B6 FF INTERIOR, DETAIL OF THE DOORS OF THE SOUTHERN WINNOWING DOOR IN THE EAST WALL; VIEWED FROM THE WEST.
