HIGHER PARK FARM

CREDITON

DESK-BASED ASSESSMENT WITH HISTORIC BUILDING RECORDING

Higher Park Farm, Crediton, Devon Desk-Based Assessment with Historic Building Recording

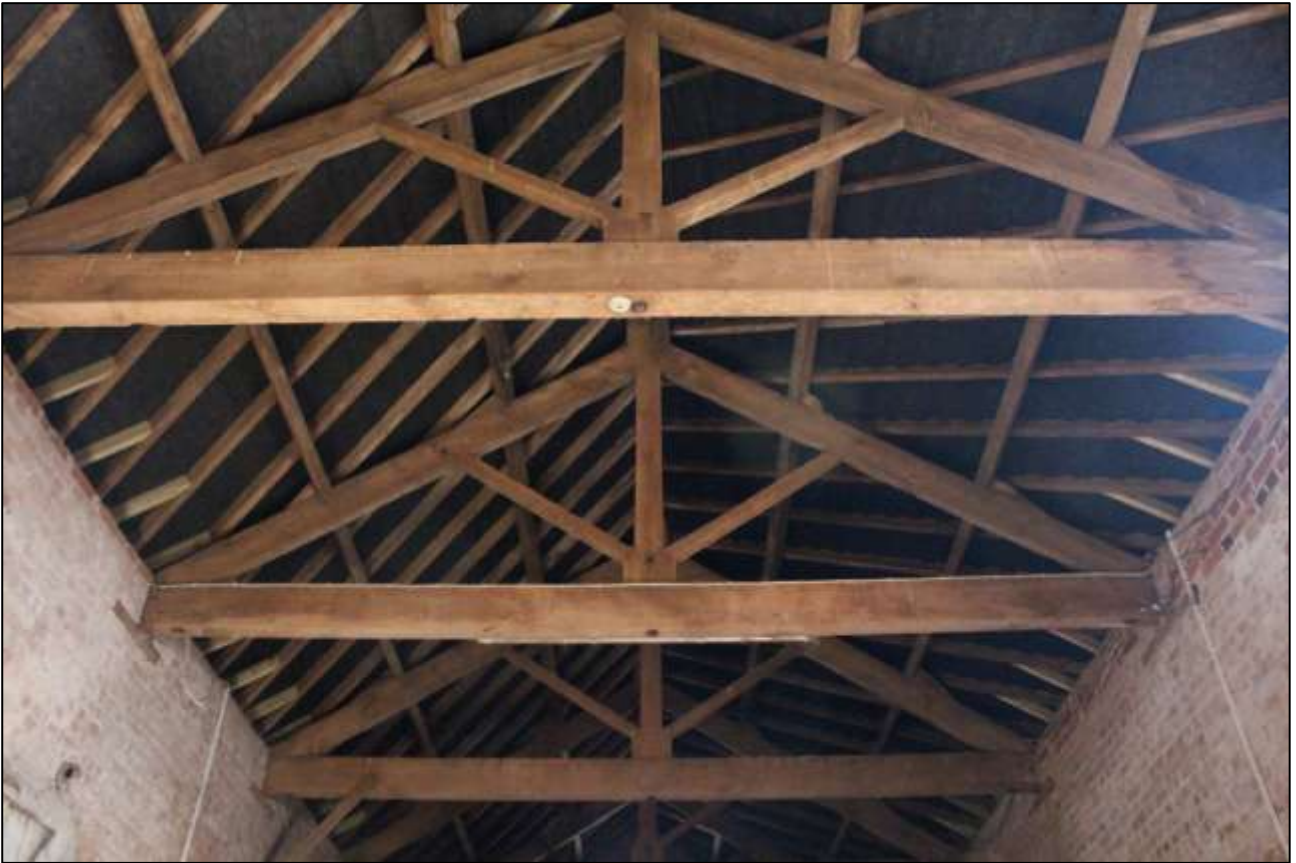
B6 FF INTERIOR, DETAIL OF THE FINE KINGPOST ROOF; VIEWED FROM THE SOUTH.

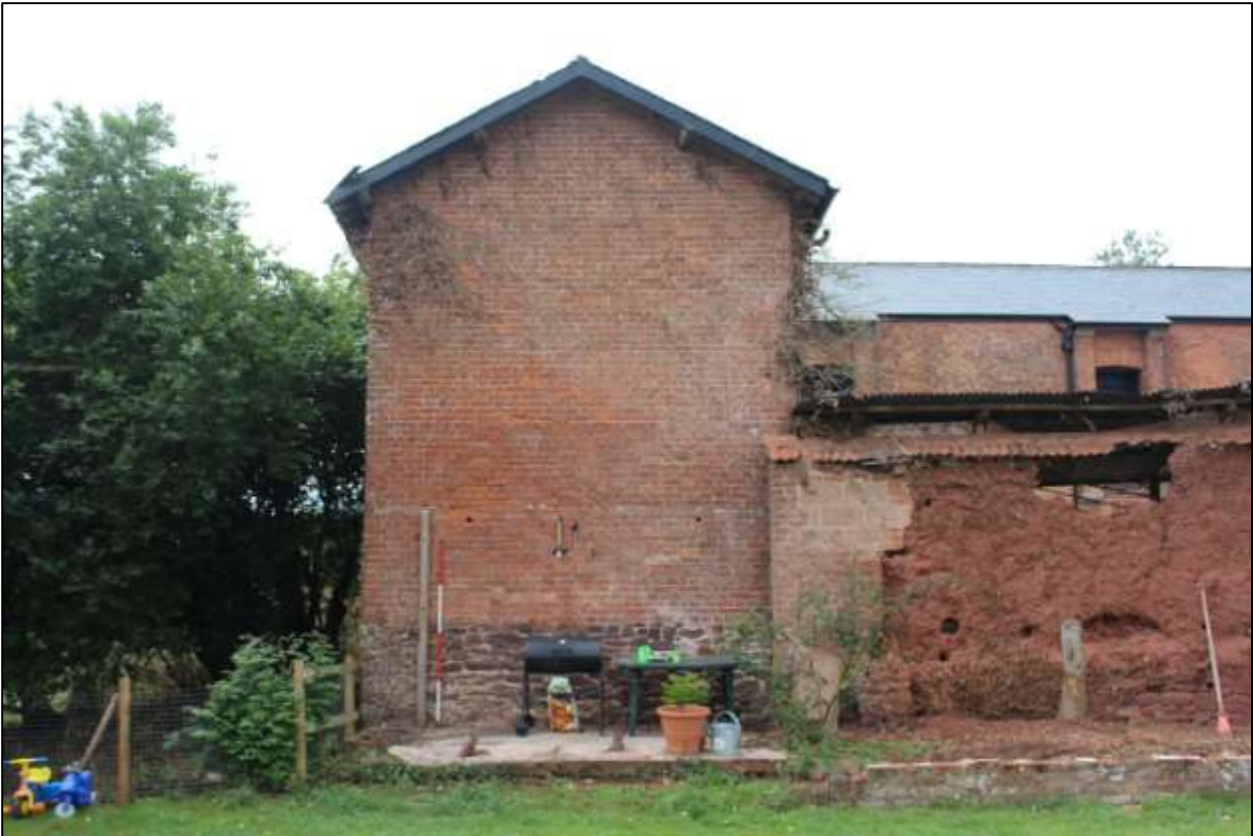
B7 EXTERIOR, EAST GABLE WALL; VIEWED FROM THE EAST (SCALE 2M).

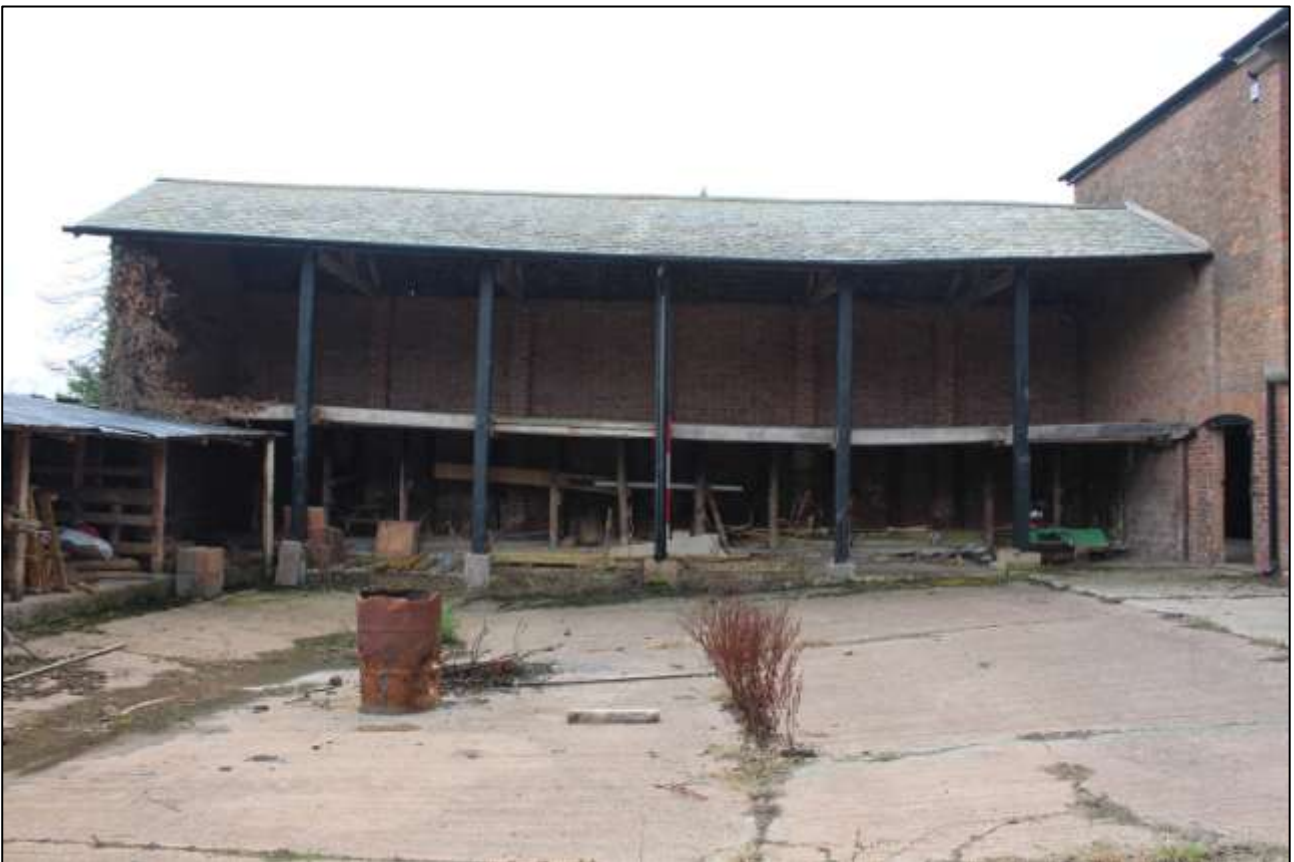
B7 EXTERIOR, NORTH OPEN-FRONTED ELEVATION; VIEWED FROM THE NORTH (SCALE 2M).

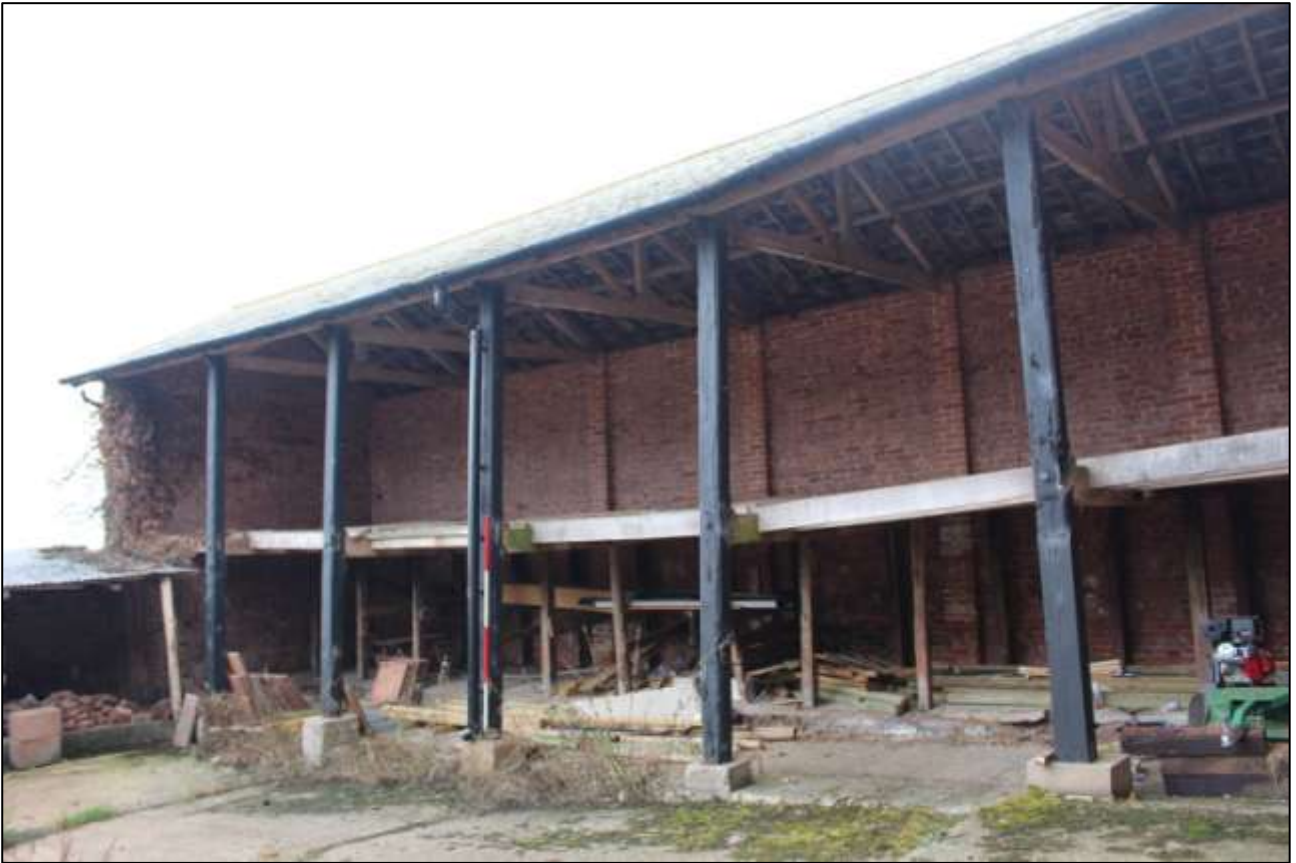
AS ABOVE; VIEWED FROM THE NORTH-WEST (SCALE 2M).

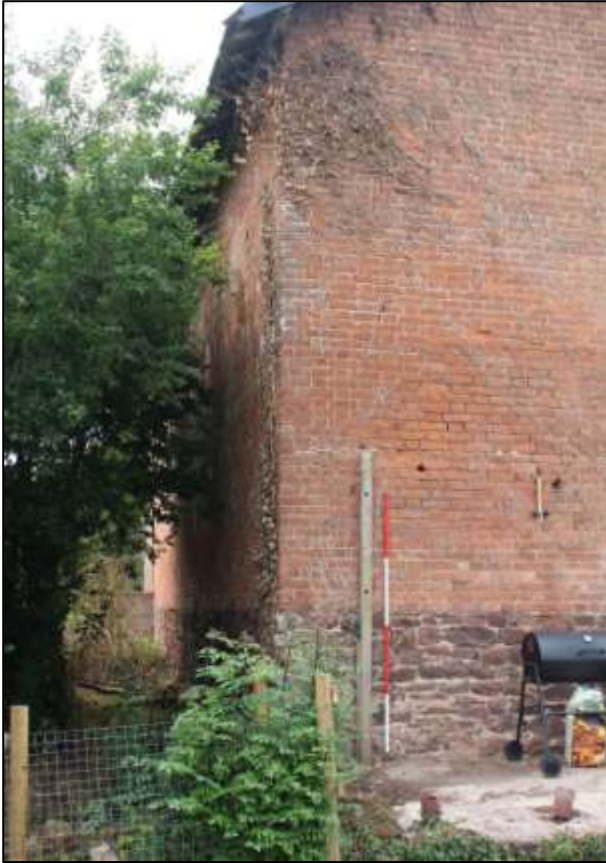
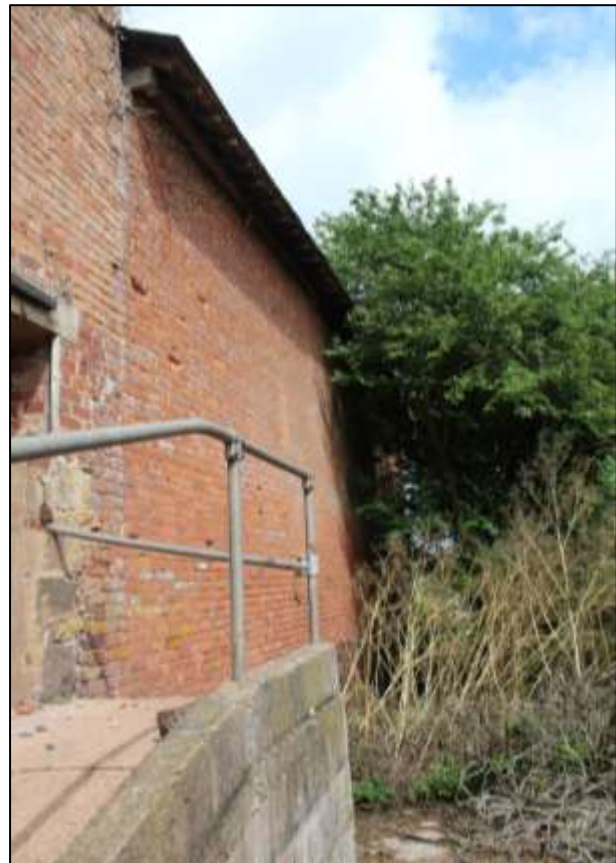
LEFT: B7 EXTERIOR, EAST AND SOUTH WALLS; VIEWED FROM THE ESE (SCALE 2M).
RIGHT: B7 EXTERIOR, SOUTH WALL; VIEWED FROM THE WSW.

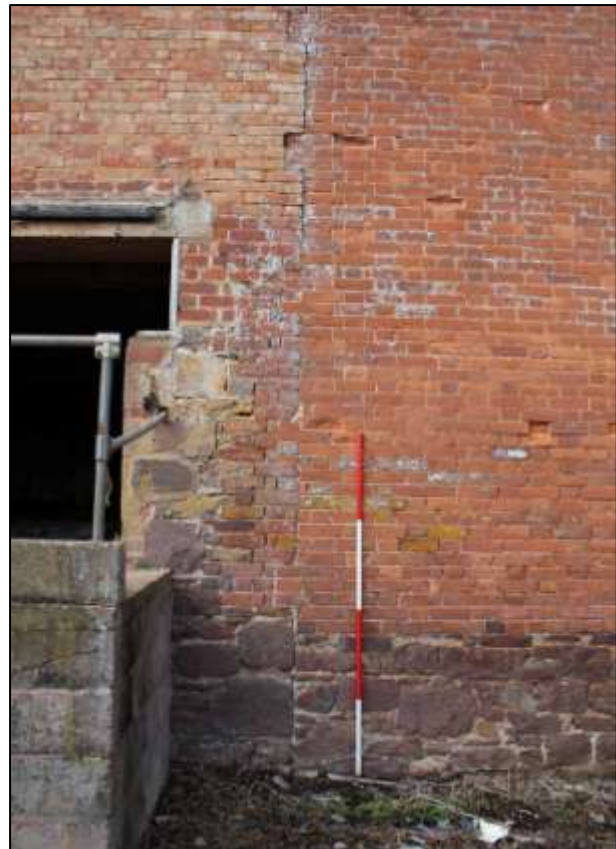
LEFT: AS ABOVE.
RIGHT: B7 EXTERIOR, SOUTH WALL, SHOWING HOW THIS ELEVATION ABUTS B6; VIEWED FROM THE SOUTH (SCALE 2M).

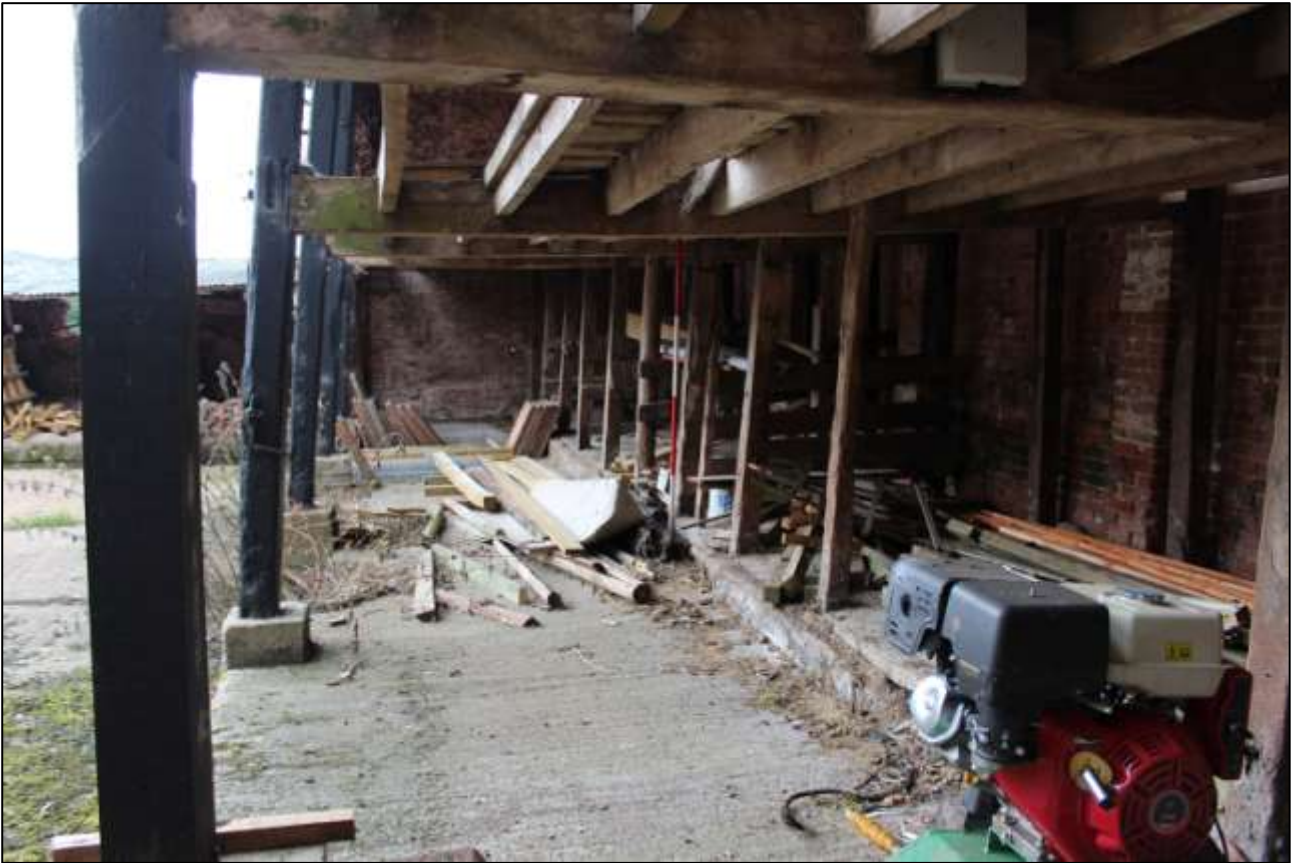
B7 GF INTERIOR; VIEWED FROM THE WEST (SCALE 2M).

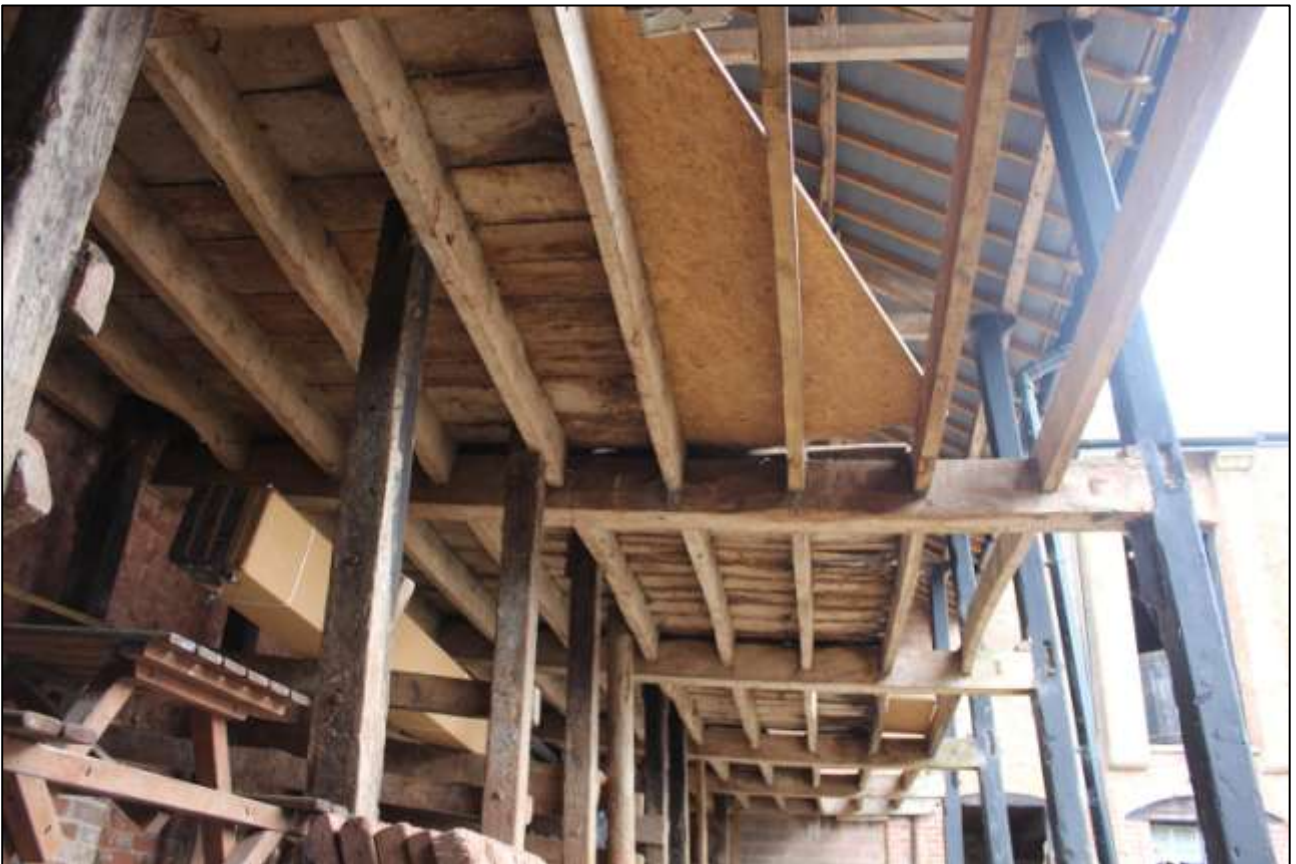
AS ABOVE, SHOWING DETAIL OF THE CEILING.

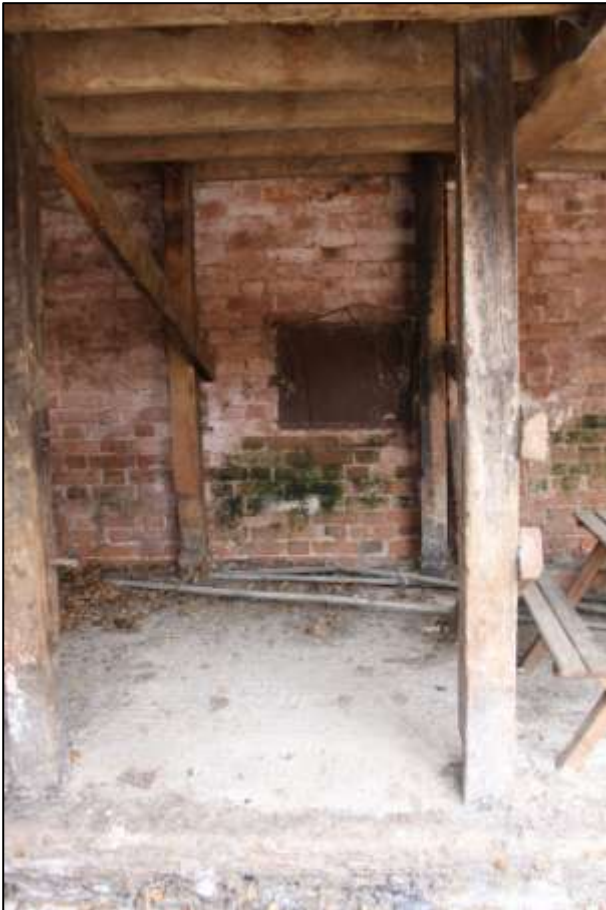
B7 GF INTERIOR, SURVIVING IRON HAY RACK AT THE EAST END; VIEWED FROM THE NORTH.

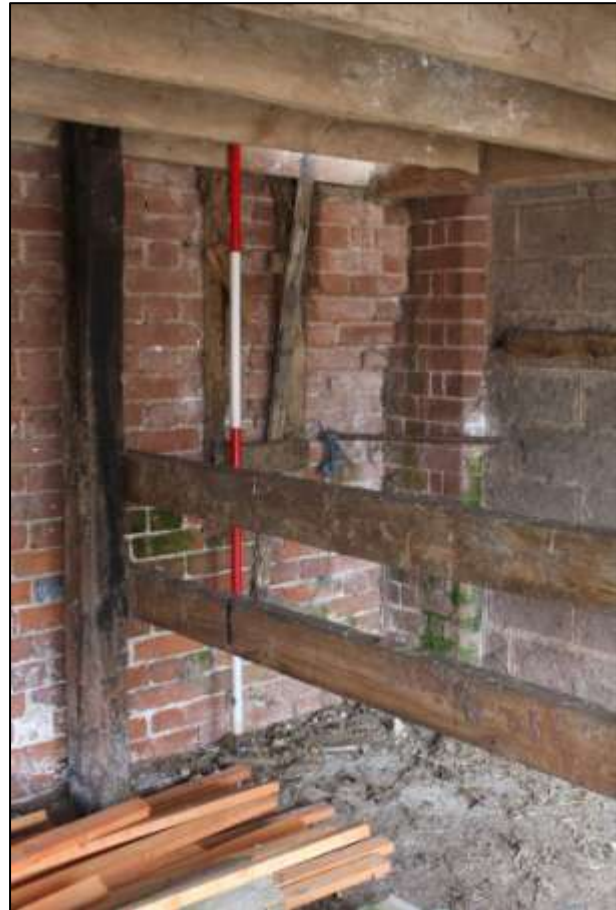
B7 GF INTERIOR, BRICK CORBEL AND REMNANTS OF FIXED LOFT LADDER; VIEWED FROM THE NORTH-EAST (SCALE 2M).

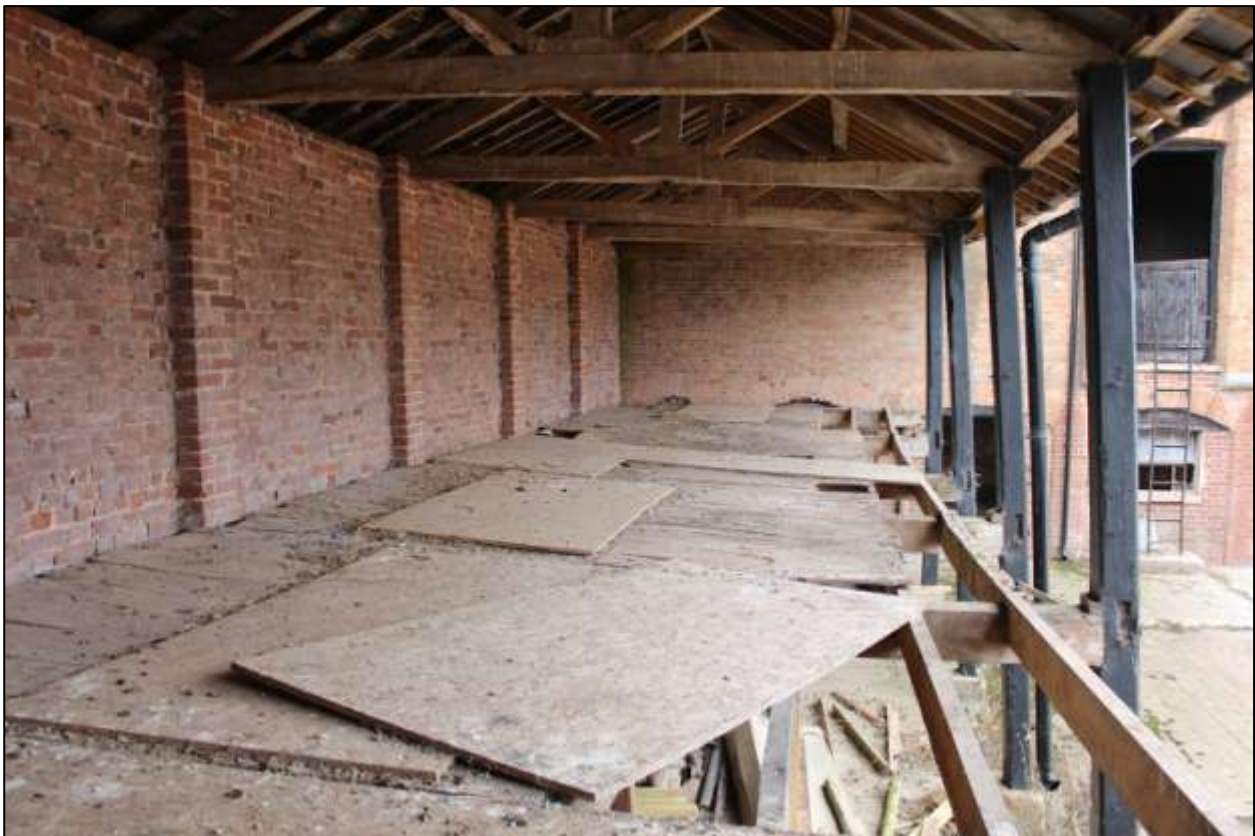
B7 FF INTERIOR; VIEWED FROM THE EAST.

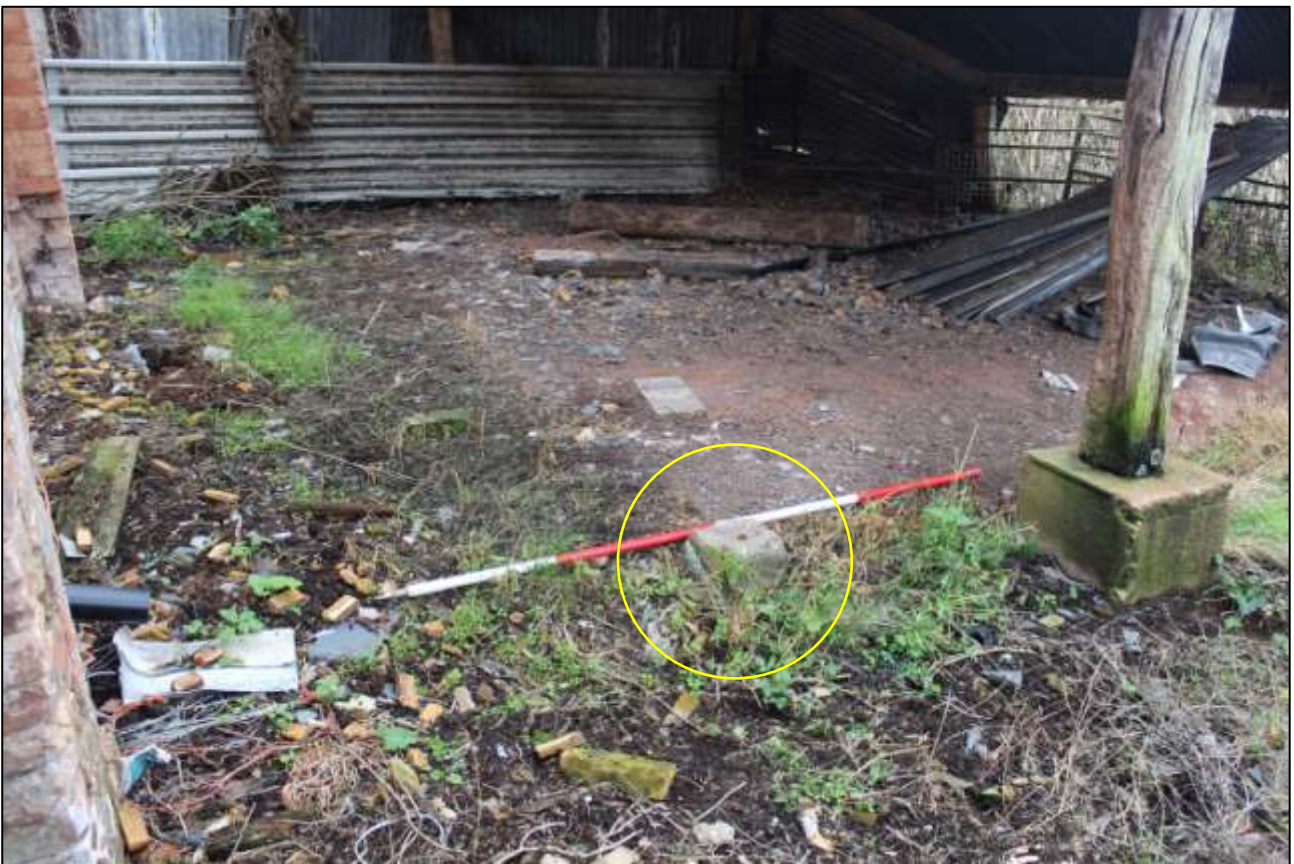
AS ABOVE, SHOWING THE PAD STONE FROM AN EARLIER PHASE (INDICATED); VIEWED FROM THE NNE (SCALE 2M).

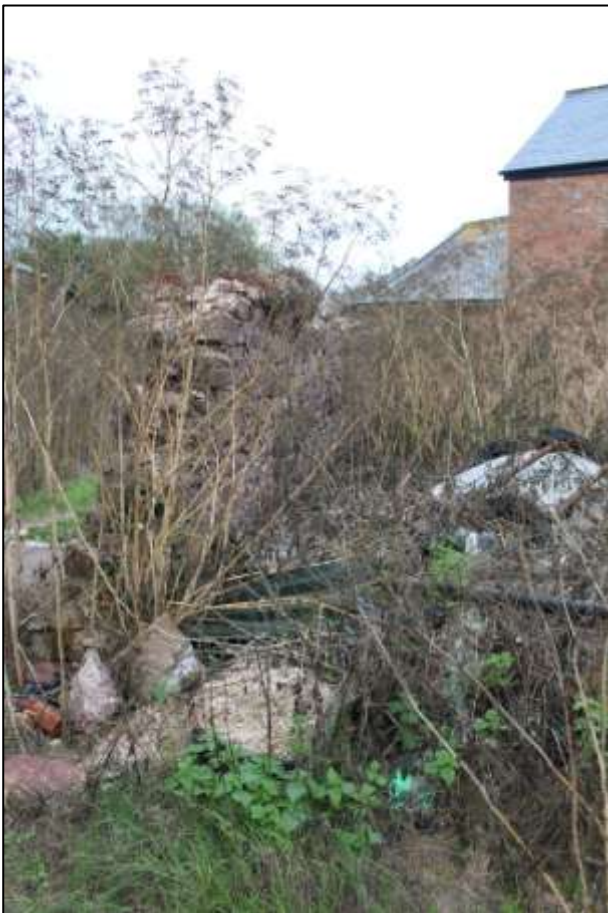
B9 EXTERIOR, VIEW OF THE UTILISED STONE YARD WALL; VIEWED FROM THE SOUTH-WEST.

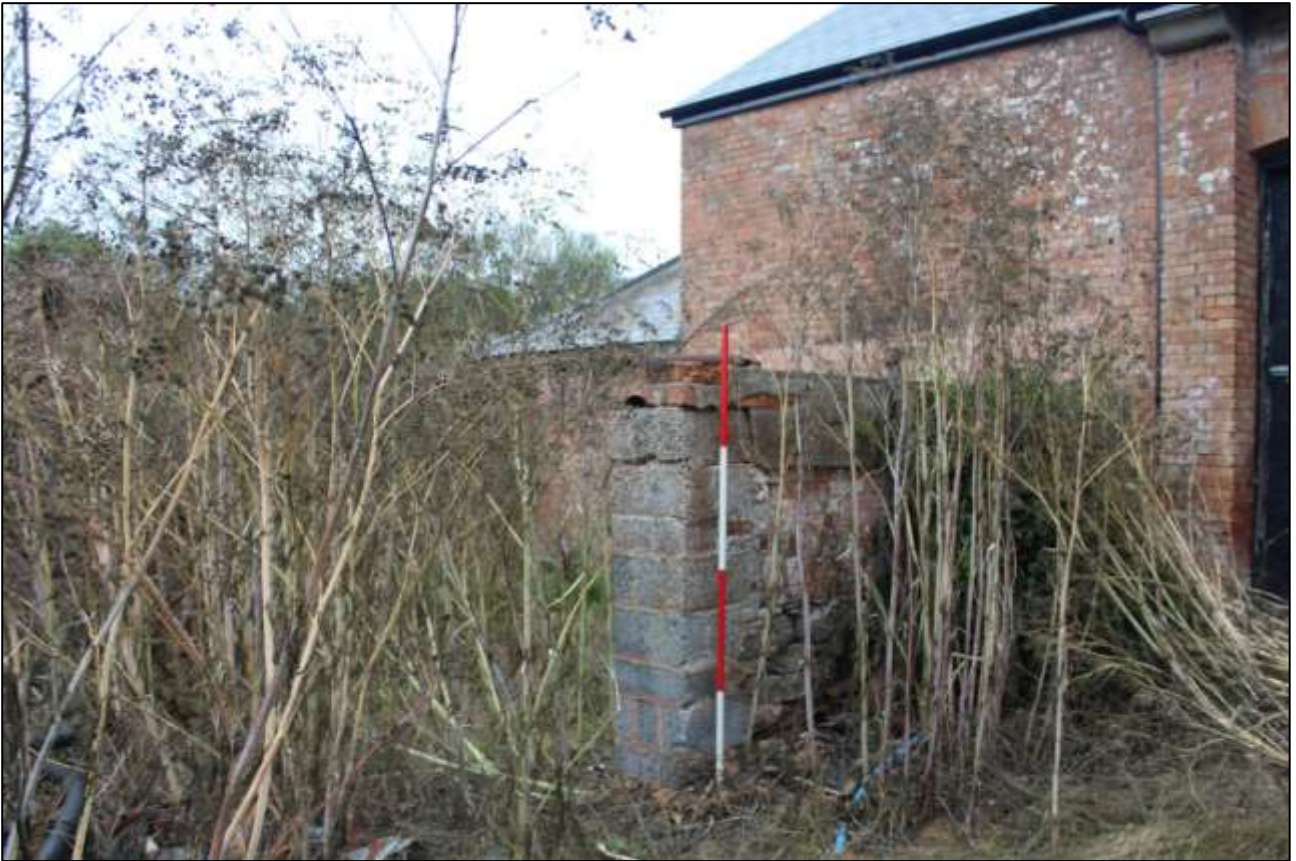
B9 EXTERIOR, THE REBUILT END OF THE BRICK AND STONE WALL; VIEWED FROM THE WEST (SCALE 2M).

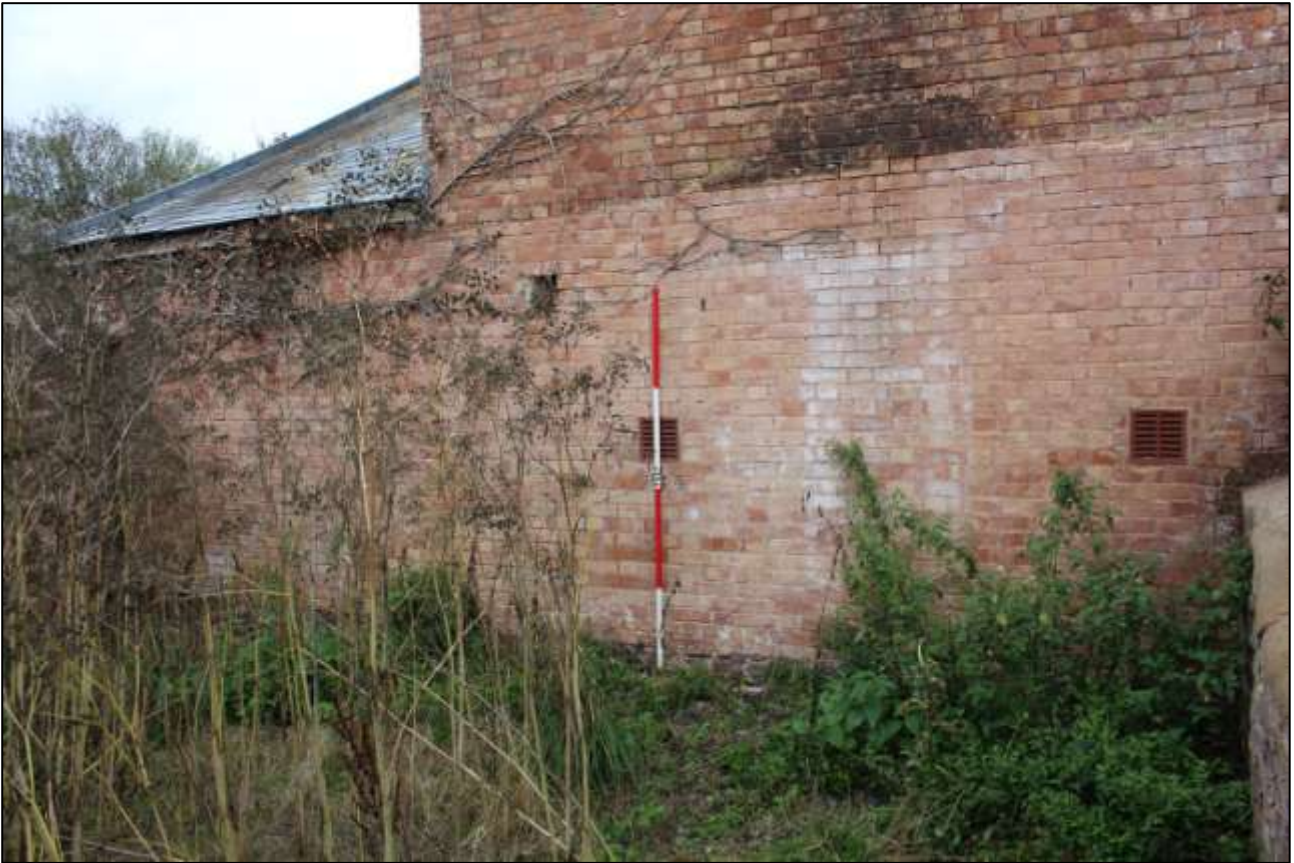
B9 'INTERIOR', THE WEST WALL OF B5 AND B6; VIEWED FROM THE WEST (SCALE 2M).

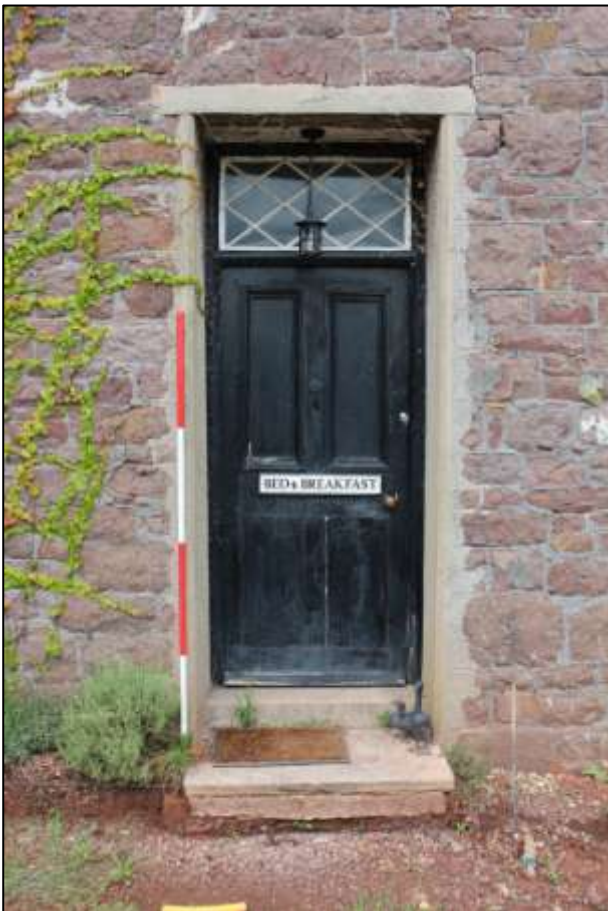
DETAIL OF THE FRONT DOOR OF THE FARMHOUSE; VIEWED FROM THE SOUTH (SCALE 2M).

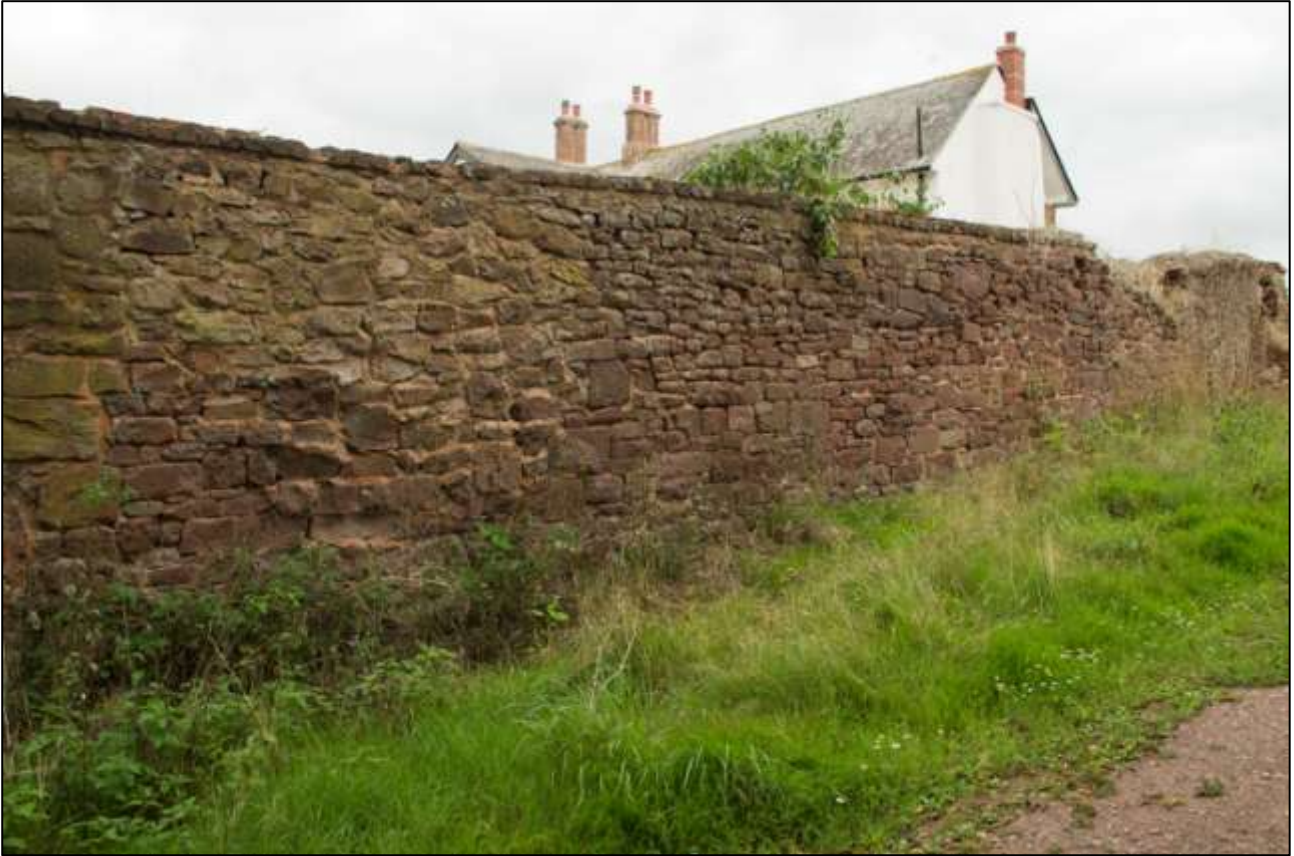
THE WALL OF THE YARD ATTACHED TO THE REAR OF THE FARMHOUSE, NOTE THE GOOD QUALITY STONEWORK; VIEWED FROM NORTH-WEST.

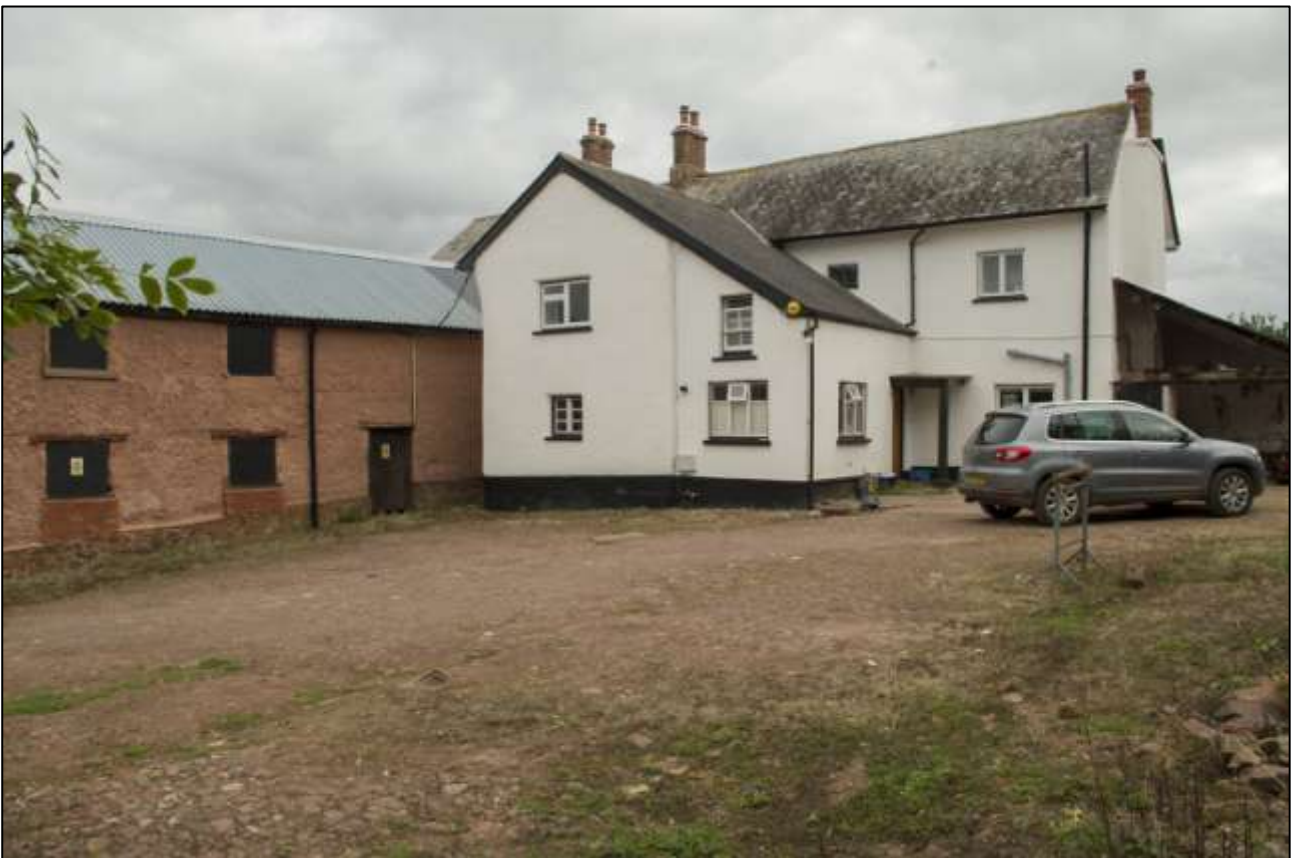
THE FARMHOUSE FROM THE REAR, WITH ITS 17TH CENTURY CROSSWING AND COBBLED YARD; VIEWED FROM THE NORTH.

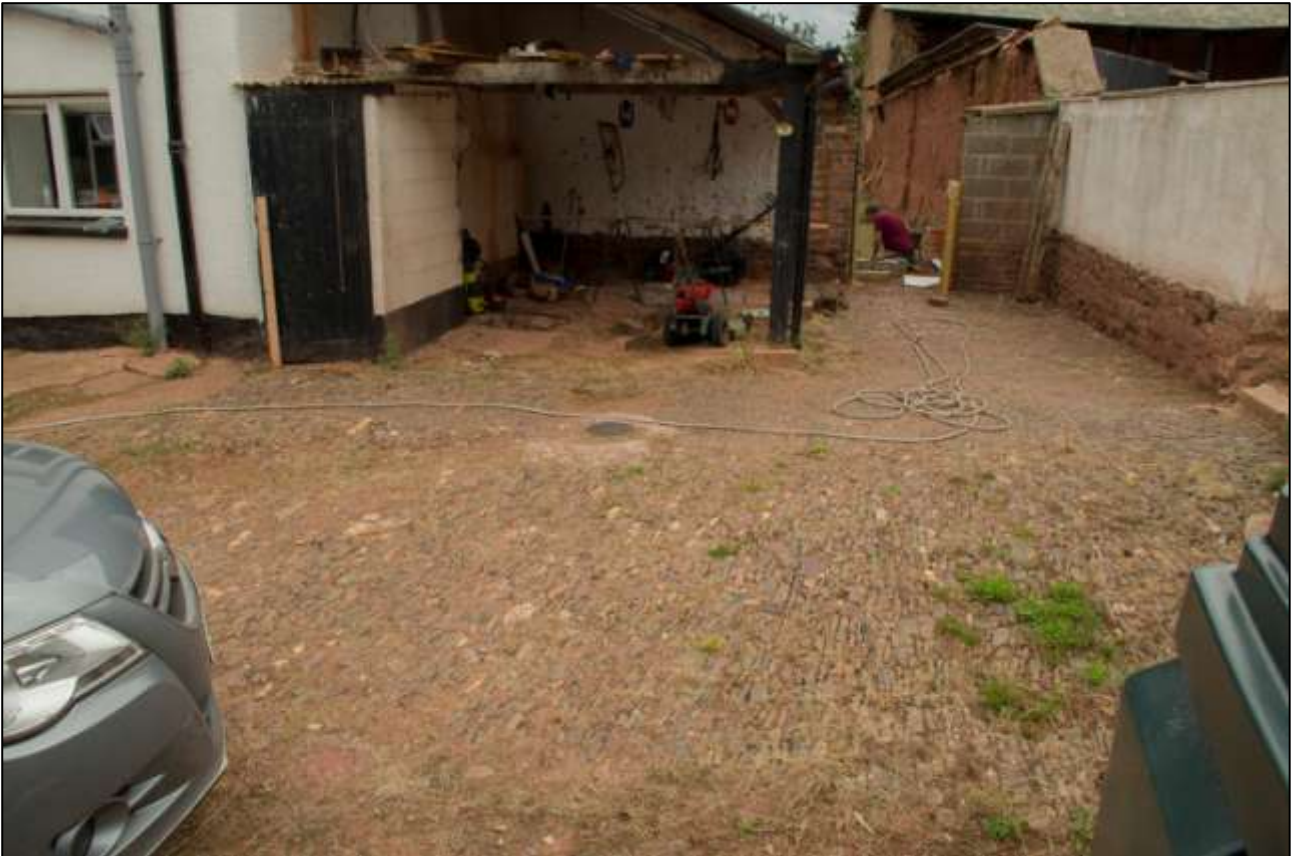
DETAIL OF THE FINE COBBLING AROUND THE FARMHOUSE; VIEWED FROM THE NORTH.

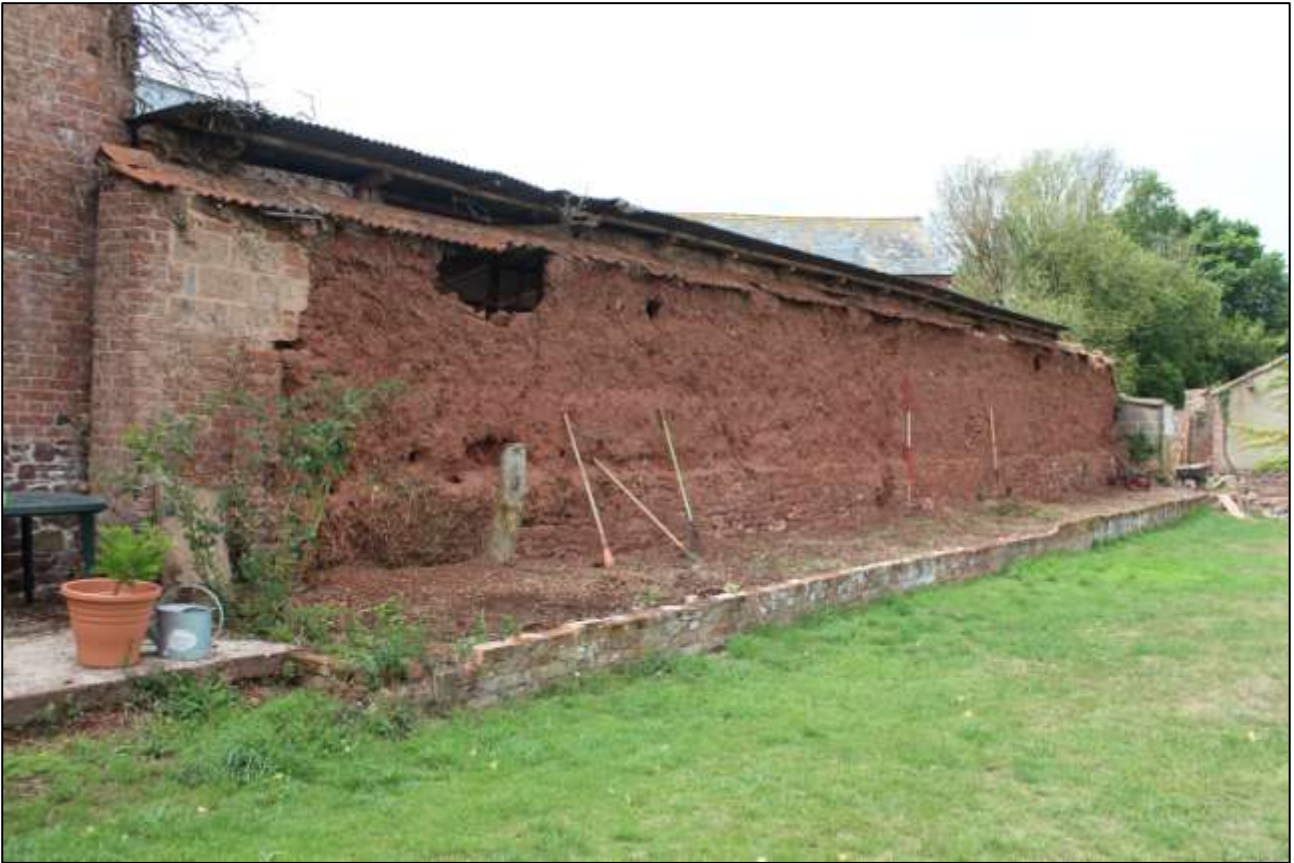
DETAIL OF THE COB GARDEN WALL; VIEWED FROM THE SOUTH-EAST (SCALE 2M).

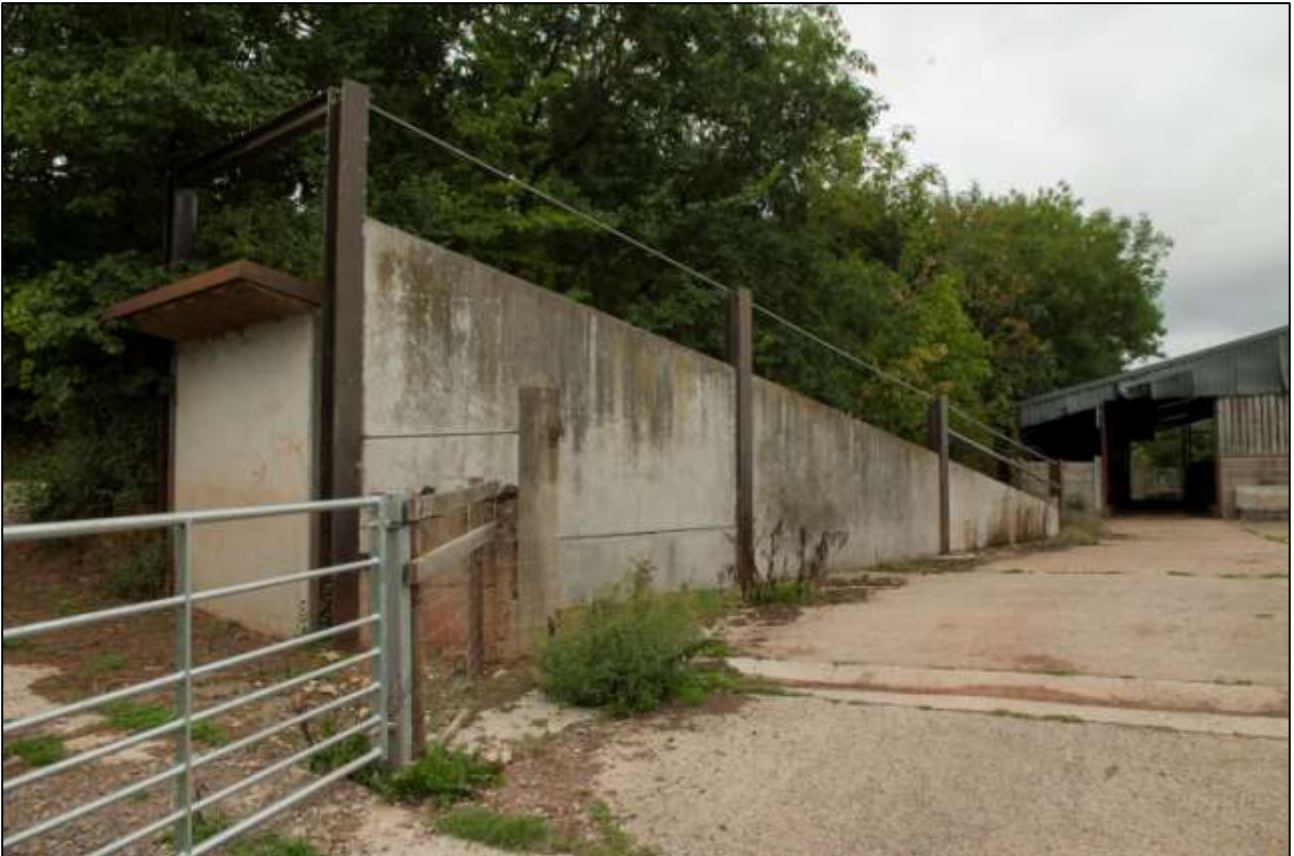
CONCRETE AND STEEL RAMP TO THE WEST OF THE MODERN FARM BUILDINGS; VIEWED FROM THE SOUTH-EAST.

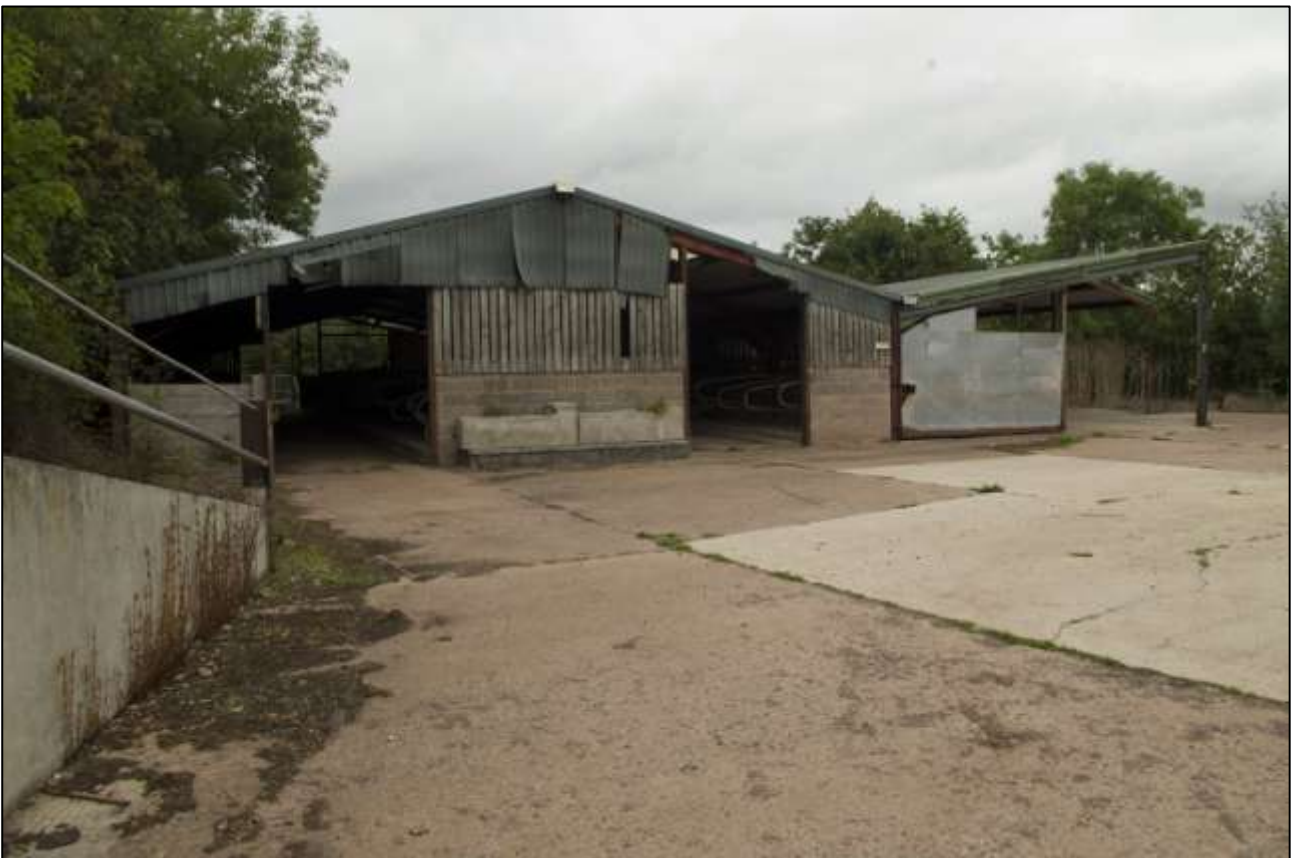
B11 EXTERIOR, THE MODERN COW CUBICLES; VIEWED FROM THE SOUTH.

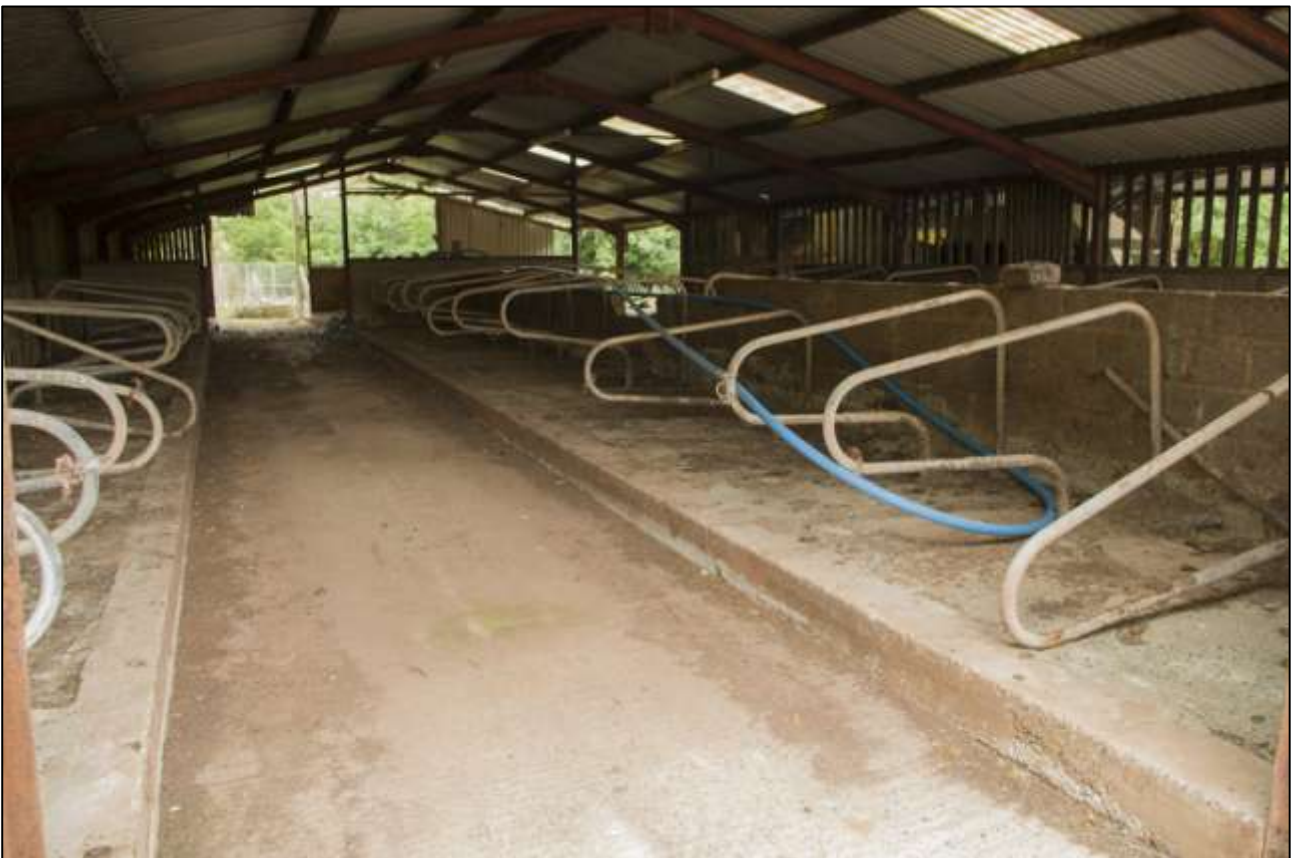
B11, THE INTERIOR OF THE MODERN COW CUBICLES; VIEWED FROM THE SOUTH.
