HIGHER PARK FARM

CREDITON

DESK-BASED ASSESSMENT WITH HISTORIC BUILDING RECORDING

Higher Park Farm, Crediton, Devon Desk-Based Assessment with Historic Building Recording

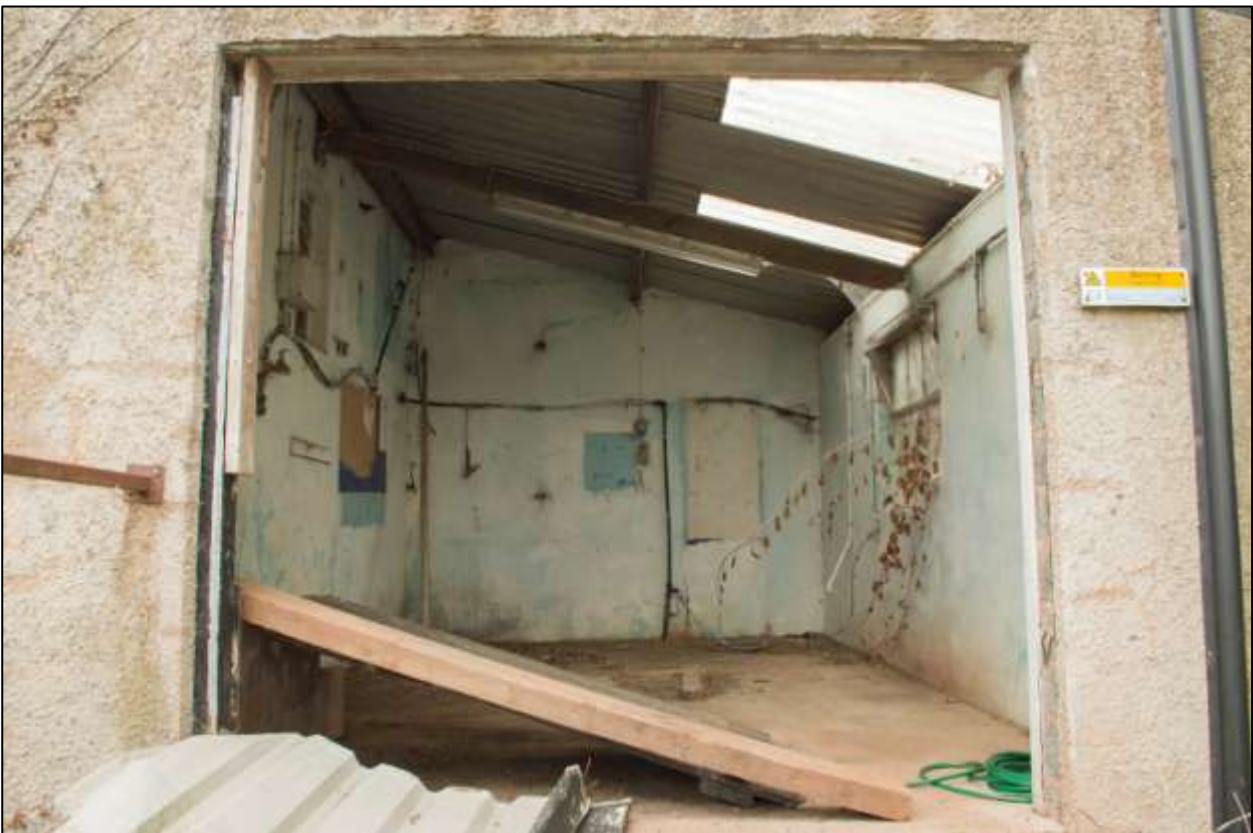
B12, THE INTERIOR OF THE DAIRY; VIEWED FROM THE SOUTH-EAST.

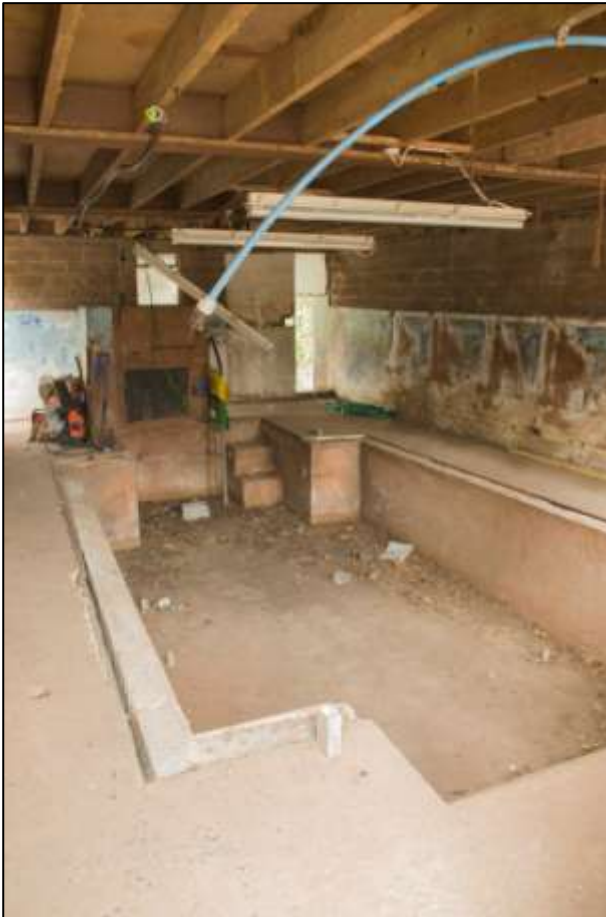
B12, THE INTERIOR OF THE MODERN MILKING PARLOUR; VIEWED FROM THE SOUTH-WEST.
