**FORMER UNITED REFORM CHURCH
BICKINGTON
FREMINGTON
DEVON**

Historic Building Recording

South West Archaeology Ltd. report no. 190930

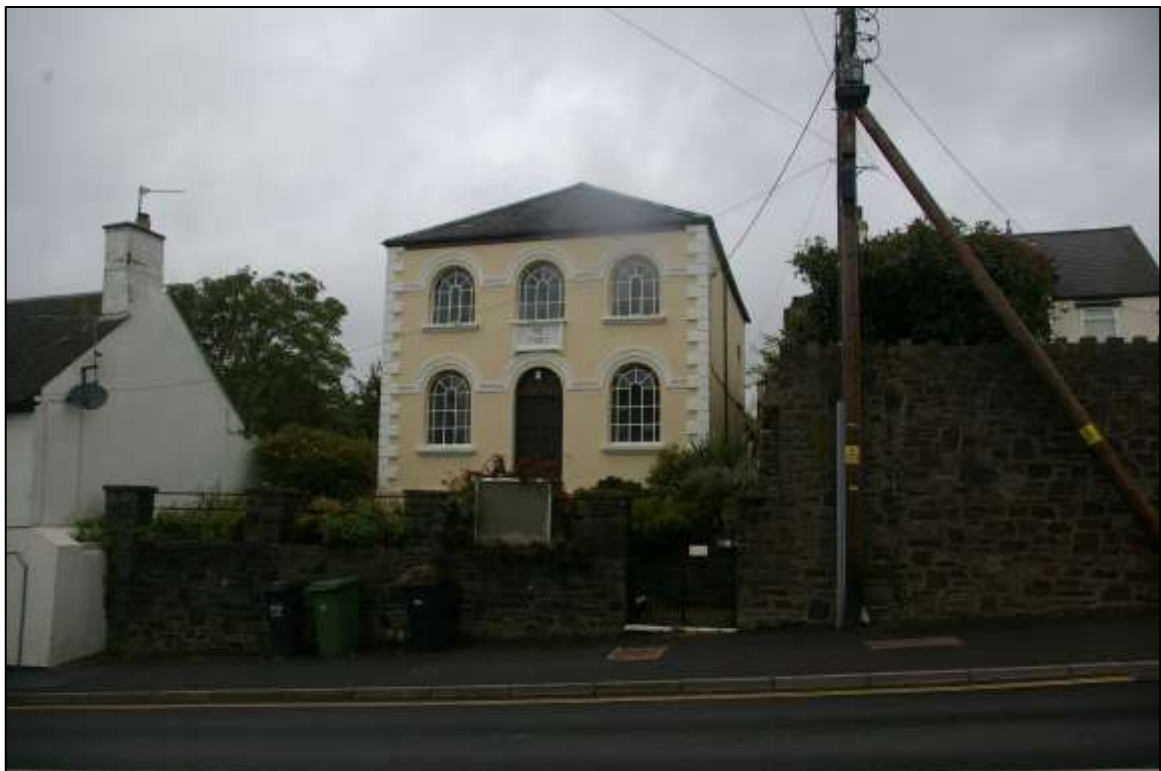
Cover plate: The south front elevation of the building; from the south-east.

The south front is of two stories, three bays wide, symmetrical, with decorative raised rusticated quoins to the south-east and south-west corners. The elevation has a shallow projecting plinth, with a roll moulded band to the top. There are two decorative moulded string courses, which run contiguously over the ground and first floor openings, forming hoodmolds. The windows, three to the first floor and one either side of the central doorway at ground floor, are round arched with metal windows. The windows have six panes with sidelights beneath a quadripartite fanlight, the sills are carried on moulded brackets. The first floor windows to east and west have two central panels which are tilting hopper casements. The central doors are three panelled, modern replacements in a chunky beaded frame, with a plain boarded infilled fanlight above within the round-arched head of the opening. The doorway is served by a set of slate steps, laid over a replacement brick structure, with crudely soldered iron handrail. Above the doorway is a rectangular plaster plaque carried on ovolo moulded brackets, with a construction date and restoration date, 1835; 1896.

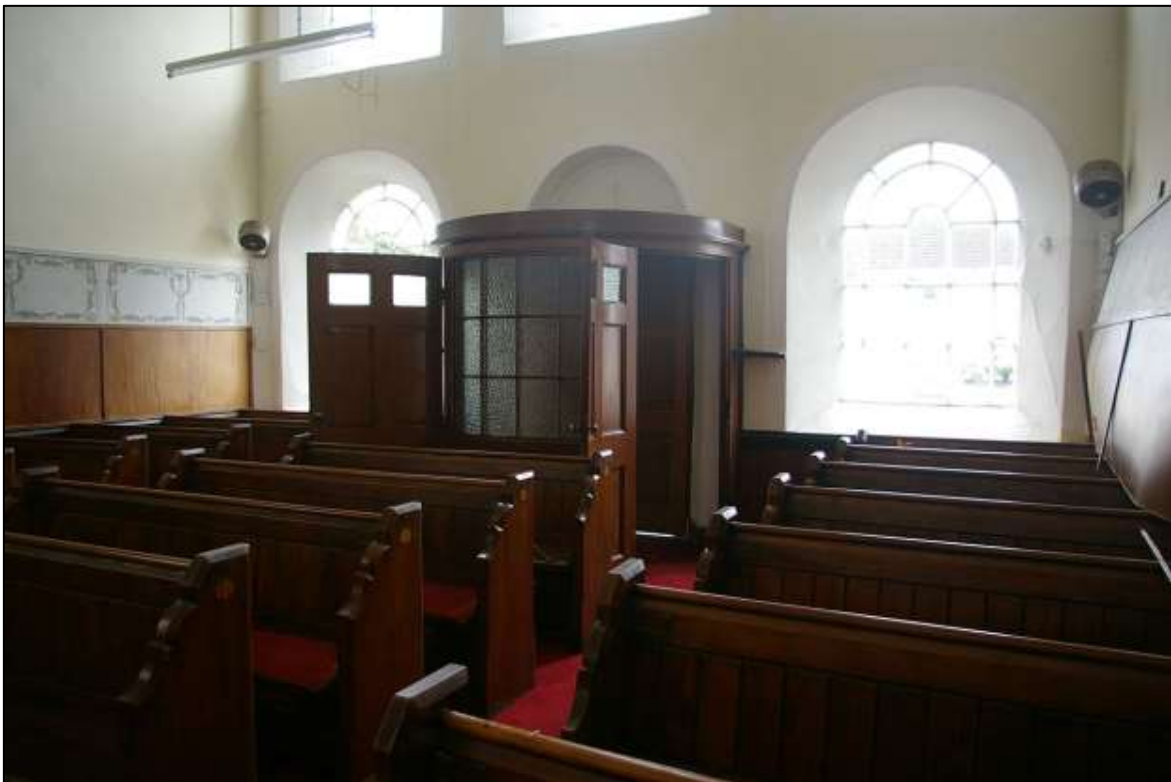
FIGURE 3: THE WEATHER PORCH; FROM THE NORTH-WEST.

The interior of the building is accessed from the southern front, entering a semi-circular bowed weather porch, made of beaded planks. This has a fixed 12 pane window facing into the auditorium and two curving six panel doors to east and west, serving two short aisles within the chapel. The lower part of the walls of the double height space are plank panelled, with modern wood veneer sheeting panelling, c.1960s/1970s, above. The walls above are plastered and painted, the ceiling plastered and painted, with modern strip lighting. The floor is suspended timber boards, carpeted; there are three raised dais to the north end of the room, the central one carrying the pulpit and communion railed area, the east and west having previously carried an electric organ/piano and the choir chairs. There are three rows of pews, nine to the west, eight to the east, with four central pews between. The pews are of chunky pitched pine, with roll moulded tops. The pulpit is a plank boarded stepped platform, with metal screen to front, with carved lectern and a bench storage seat behind.

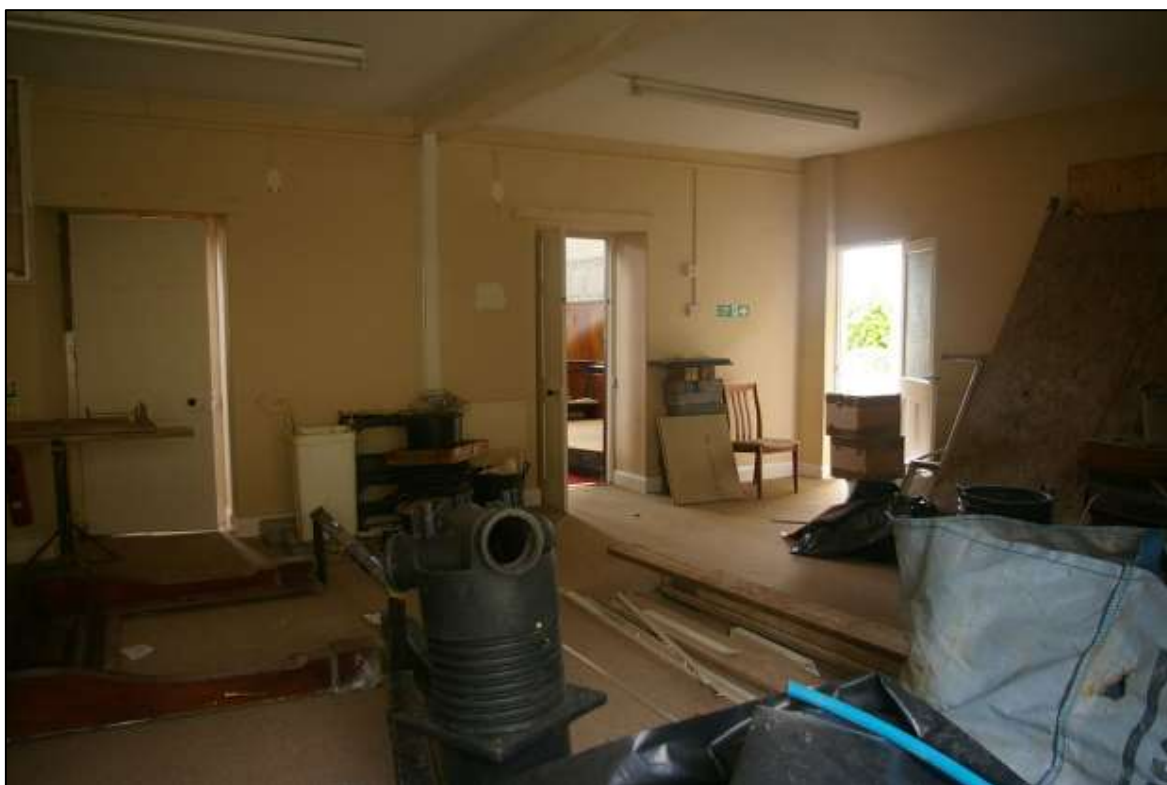
FIGURE 4: THE COMMUNITY HALL, BUILT IN 1949; FROM THE NORTH-EAST.

This community hall is ultimately a U-shaped structure, of single storey height, flat roofed with bitumen sheeting. The building is solidly built, brick or concrete blocks, painted render to the exterior walls. The west elevation has two plastic white PVC windows to the south end, with a wooden plank door between to a male external urinal. The north wall has two plastic white PVC windows and a small projection to the north-east with an external plank fire exit doorway. The east wall of the extension is U-shaped, with a small courtyard formed against the east stone wall of the plot. There are two windows looking into this small courtyard, also white plastic PVC windows.

The interior of the 1949 community hall also has plain plastered walls, the solid floor carpeted. A small lobby to the west serves a toilet and back door to the west yard, a kitchen lies just to the north-west. Large glazed double doors lead north to a rear lobby, with lots of cork notice boards and two small clerical offices, one with a plank boarded fire escape door to the north-west yard.

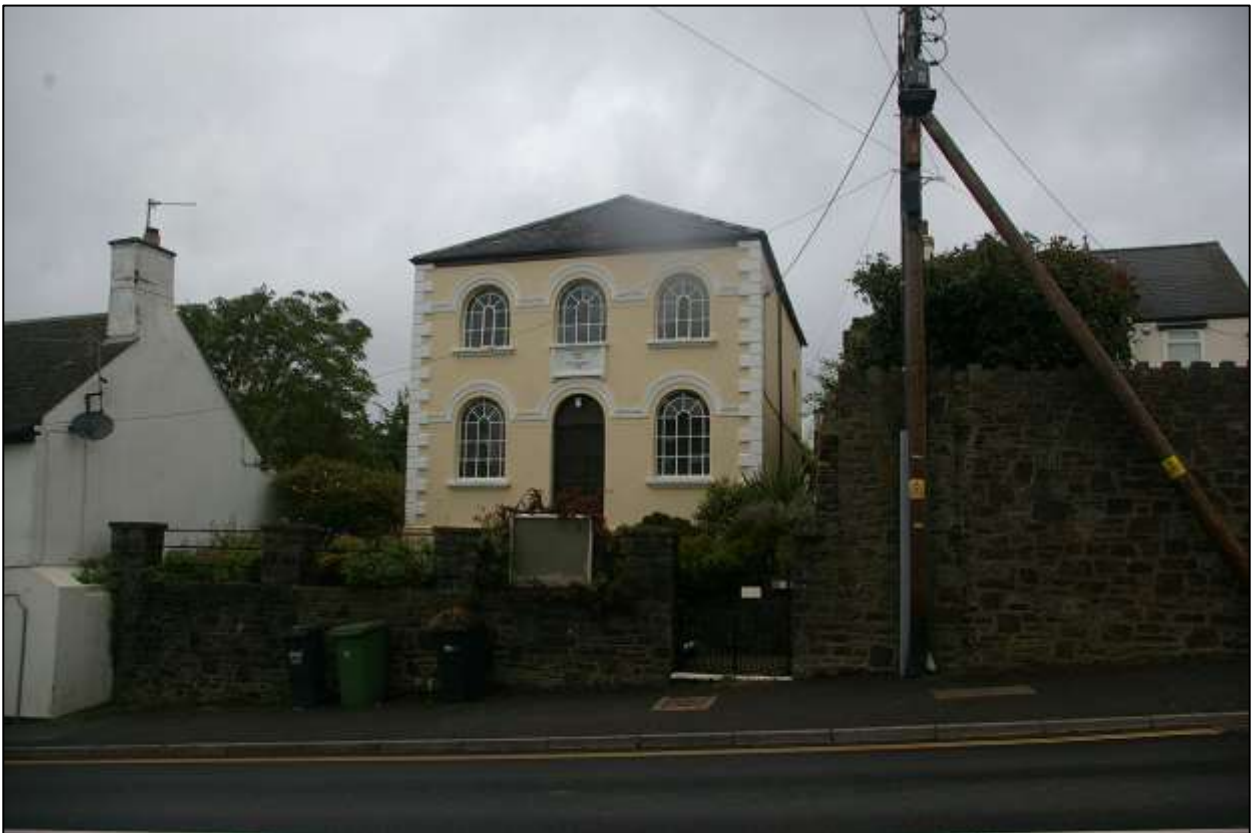
2. THE PRESENTATION SOUTH FRONT OF THE CHAPEL; FROM THE SOUTH-EAST.

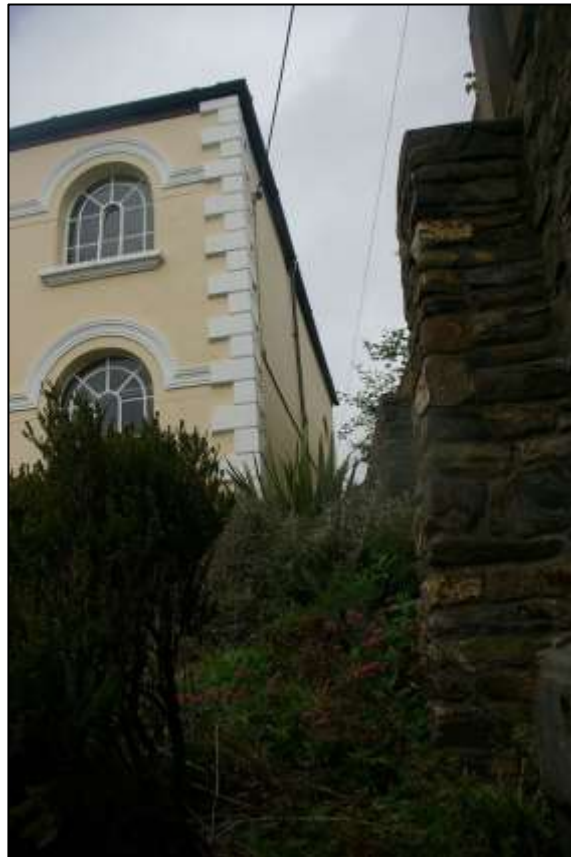
4. THE EAST ELEVATION OF THE CHAPEL BUILDING; FROM THE SOUTH.

The east long elevation is plain, of two storeys, painted stucco, with raised decorative quoins to the south-east end, with a plain plinth to the base of the wall. To the north end is a single round arched window to the first floor. This is a metal window, identical to those on the south front, with a projecting stone sill, the window slightly inset into a recessed opening. The west long elevation is plain, of two storeys, painted stucco, with raised decorative quoins to the south-west end and a plain plinth to the base of the wall. To the north end is a single round arched window to the first floor. This is a metal window, identical to those on the south front, with a projecting stone sill, the window slightly inset into a recessed opening. There are two other blocked

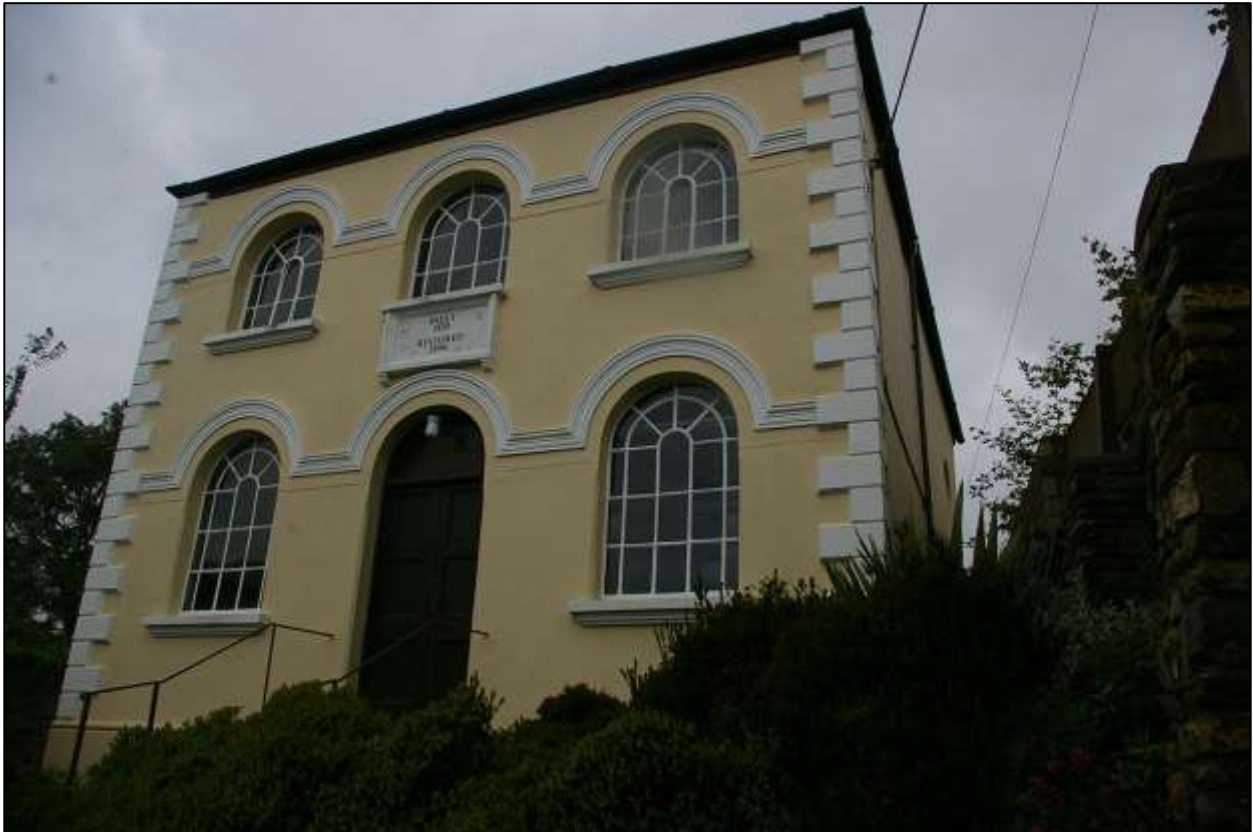
5. DETAILED VIEW OF THE SYMMETRICAL CLASSICALLY INSPIRED ARCHITECTURE OF THE FRONT ELEVATION OF THE CHAPEL; FROM THE SOUTH-EAST.

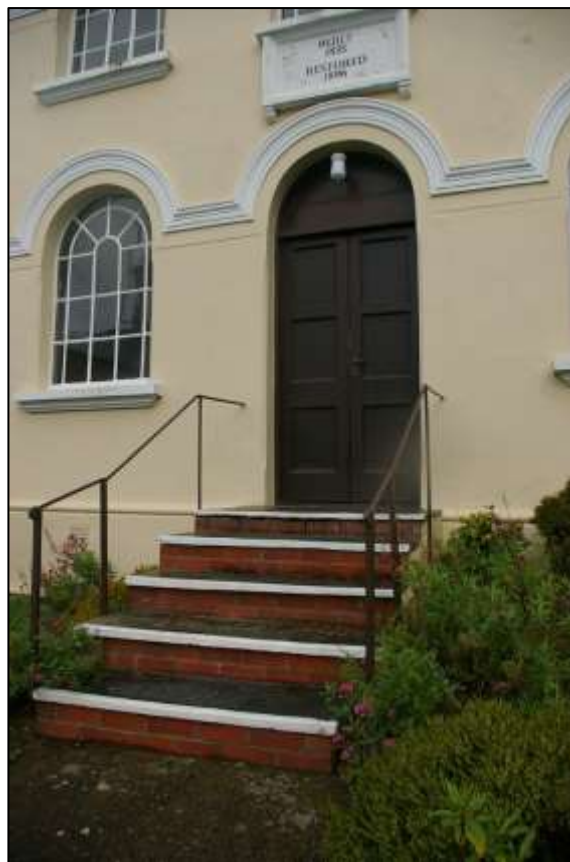
6. THE STEPS UP TO THE FRONT DOOR (D1), THE ORIGINAL SLATES LAID OVER A REPLACEMENT BRICK STRUCTURE; FROM THE SOUTH-EAST.

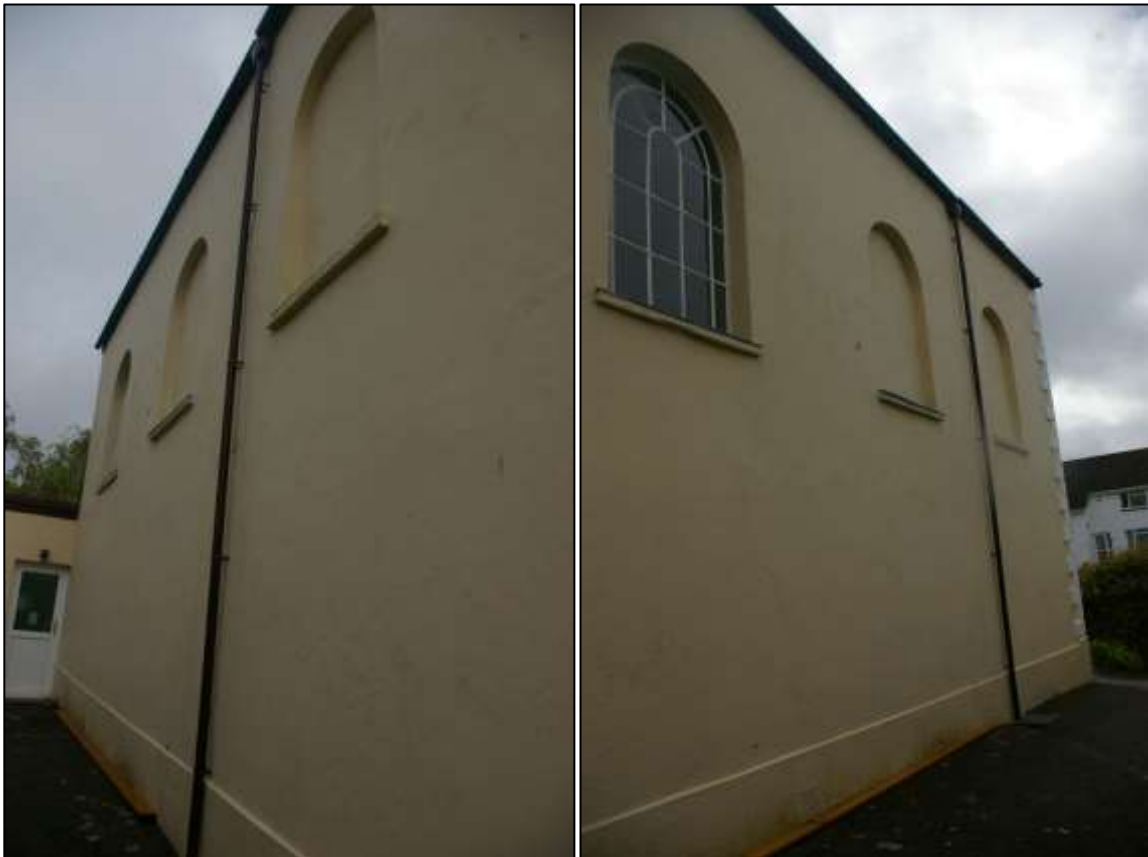
8. LEFT: VIEW OF THE WEST ELEVATION OF THE CHAPEL; FROM THE SOUTH.

9. RIGHT: VIEW OF THE WEST ELEVATION OF THE CHAPEL, SHOWING THE THREE OPENINGS, THAT TO CENTRE AND SOUTH BLOCKED; FROM THE NORTH-WEST.

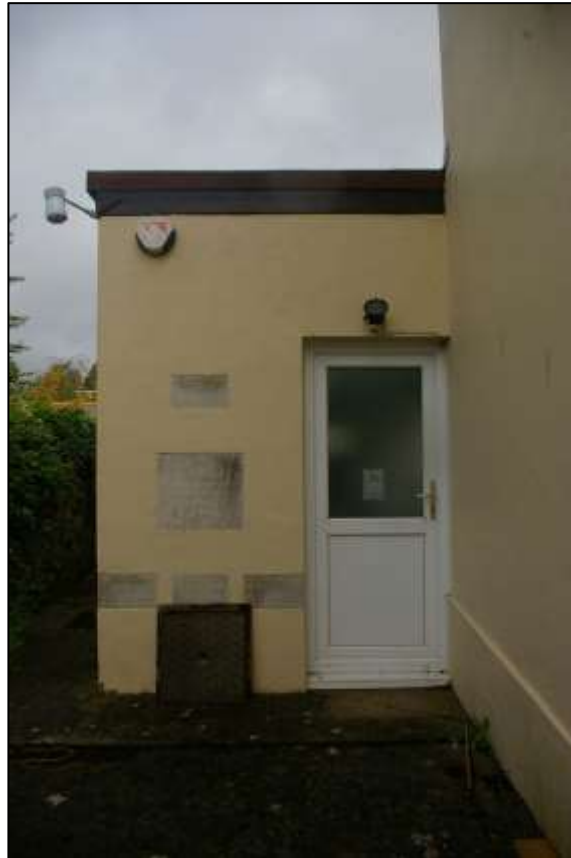
10. D8 – THE REAR ENTRANCE TO THE 1949 COMMUNITY HALL, NOW A MODERN WHITE PVC DOUBLE-GLAZED DOOR. ON THE SOUTH-WEST CORNER ARE A SERIES OF COMMEMORATIVE LIMESTONE PLAQUES TO MEMBERS OF THE CONGREGATION; FROM THE SOUTH.

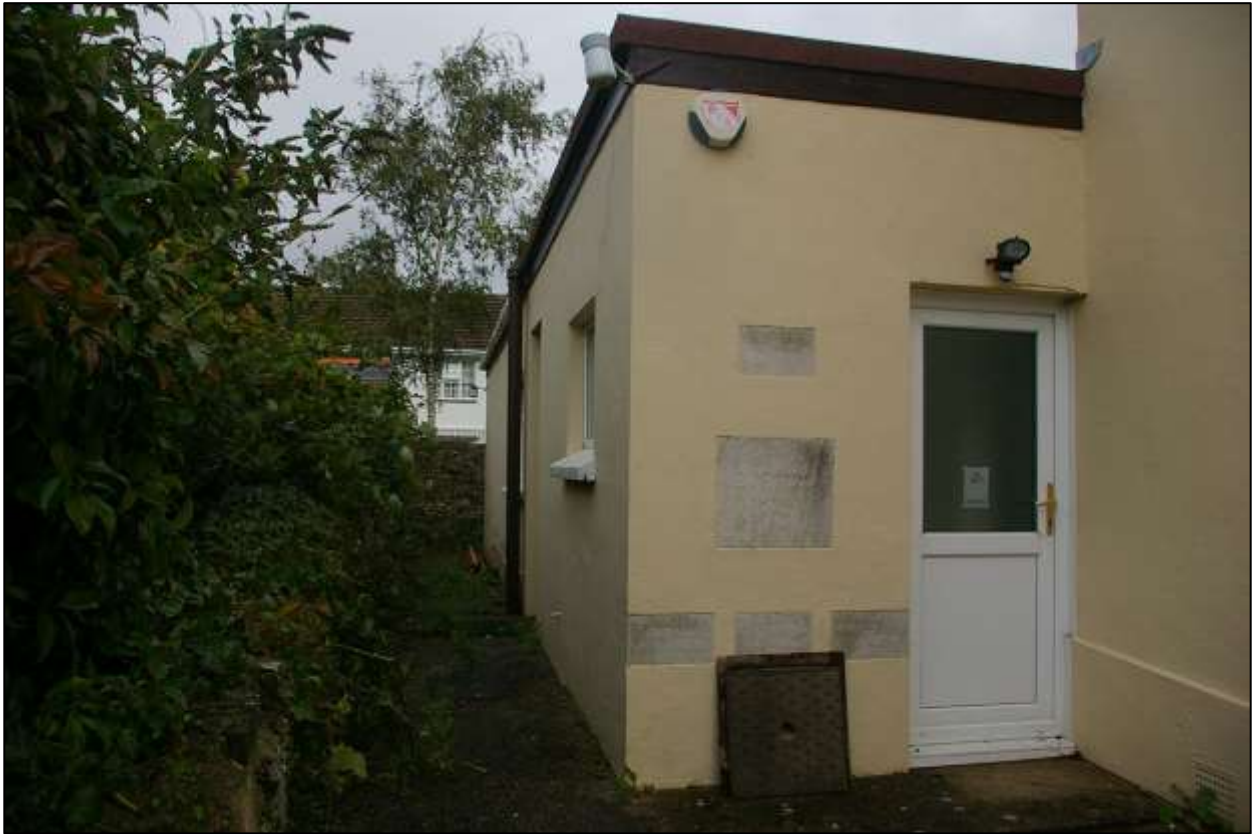
16. THE SOUTH-WEST CORNER AND WEST ELEVATION OF THE LARGE SINGLE STOREY 1949 BUILT COMMUNITY HALL; FROM THE SOUTH, SOUTH-WEST.

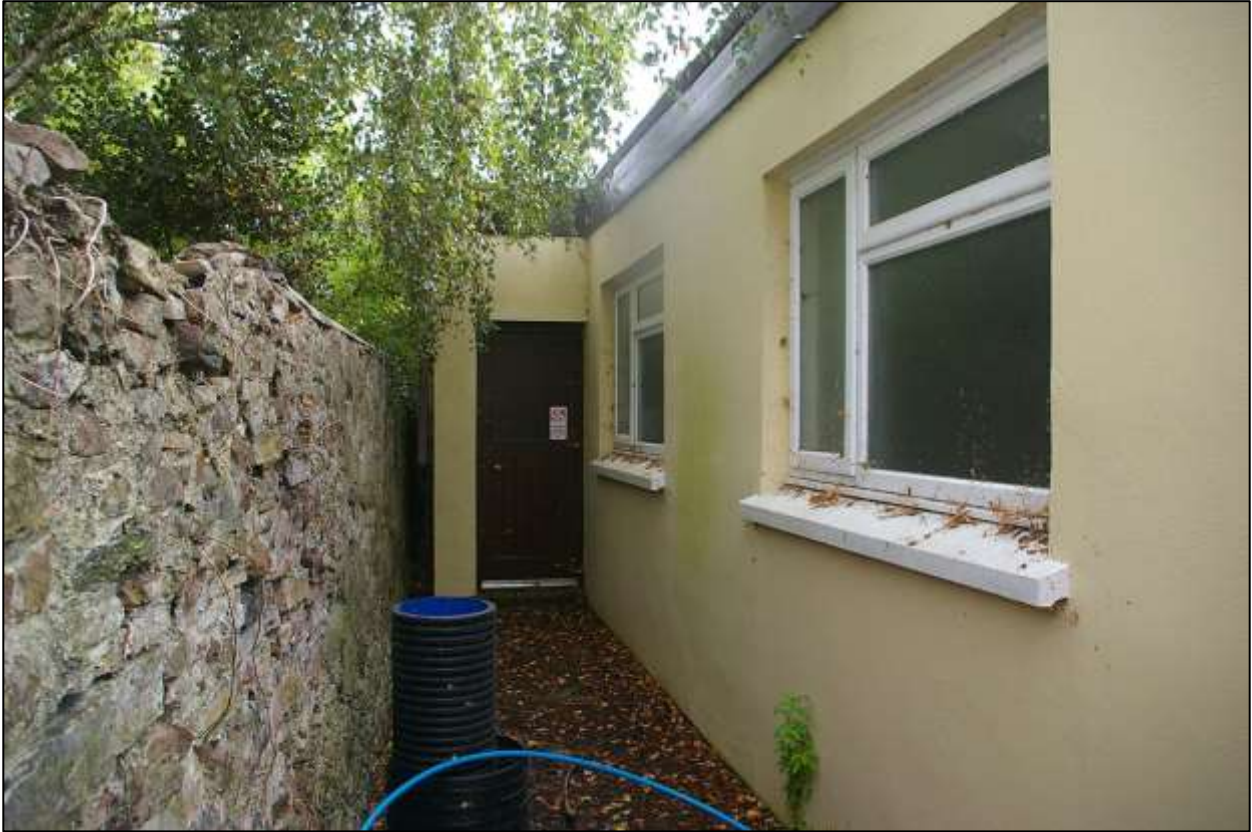
18. THE NORTH ELEVATION OF THE COMMUNITY HALL BUILDING AND REAR FIRE ESCAPE DOOR (D13); FROM THE WEST.

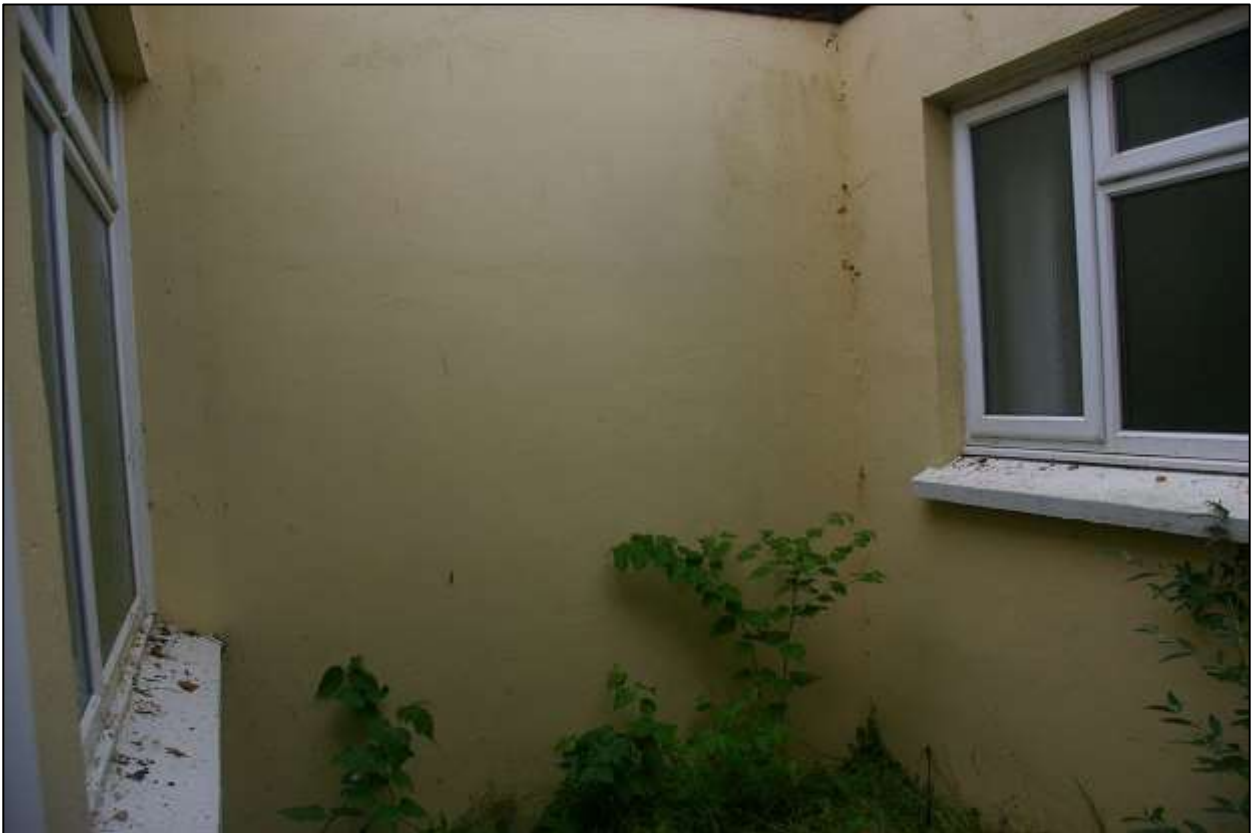
19. THE SMALL INSET COURTYARD ON THE EAST SIDE OF THE COMMUNITY HALL BUILDING, TO ALLOW ENOUGH LIGHT INTO THE REAR OF THE PLOT; FROM THE EAST, SOUTH-EAST.

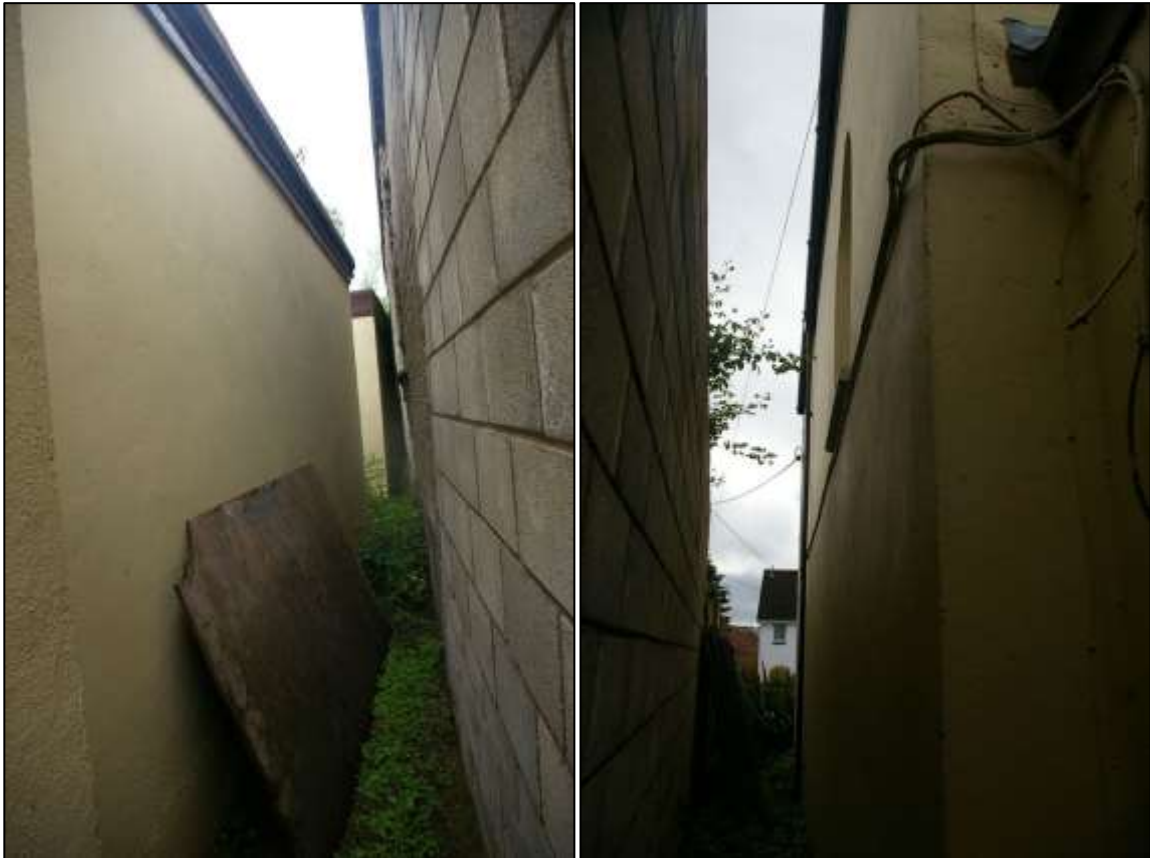
20. LEFT: THE TWO SECTIONS OF THE EAST WALL OF THE COMMUNITY HALL BUILDING; FROM THE SOUTH, SOUTH-EAST.
21. RIGHT: THE EAST WALL OF THE CHAPEL BUILDING, SHOWING THE SINGLE WINDOW OPENING; FROM THE NORTH, NORTH-EAST.

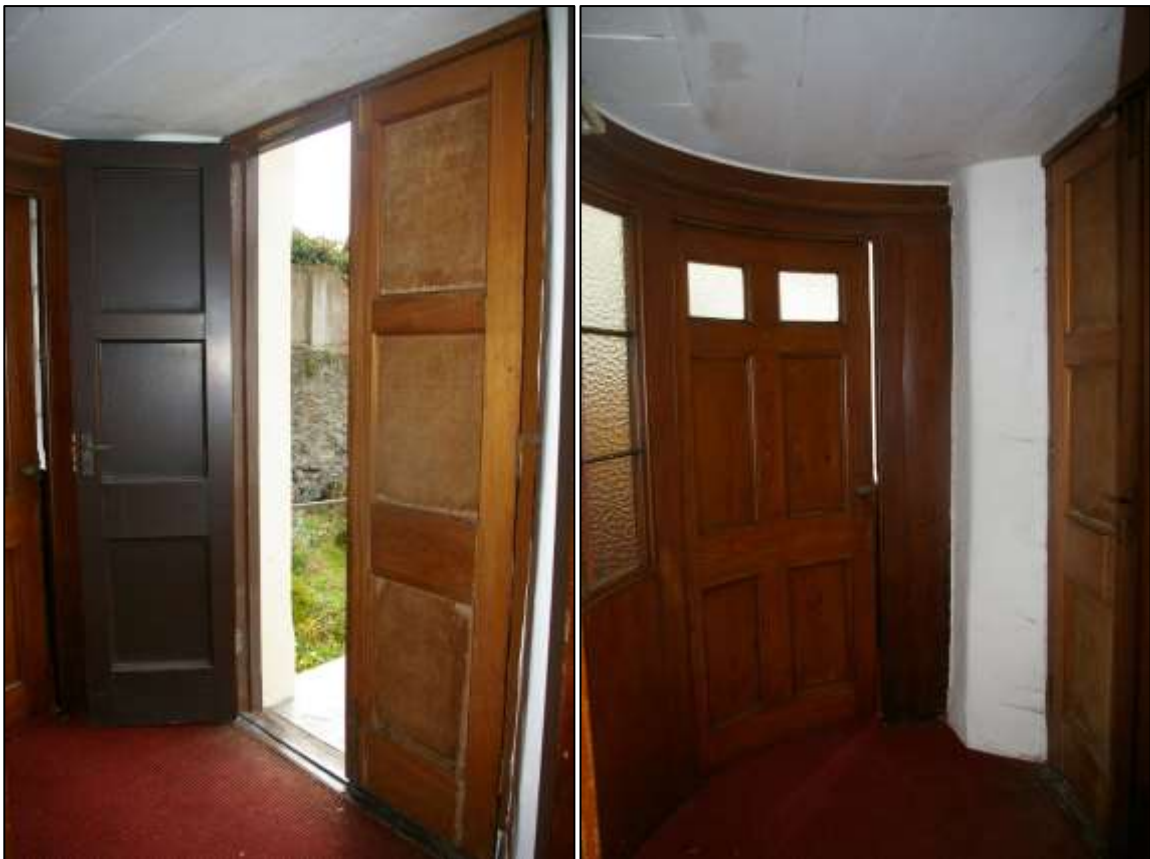
22. LEFT: D1, THE DOUBLE FRONT DOORS TO THE CHAPEL; FROM THE WEST.
23. RIGHT: THE SEMI-CIRCULAR WEATHER PORCH WITHIN THE CHAPEL AUDITORIUM AND D3; FROM THE WEST.

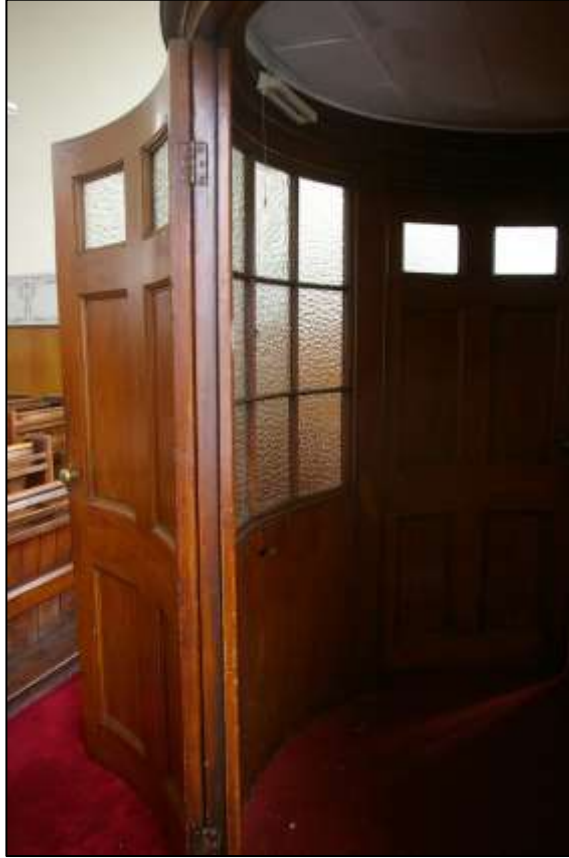
24. THE SEMI-CIRCULAR WEATHER PORCH STRUCTURE, A FINE REGENCY DETAIL; FROM THE WEST, SOUTH-WEST.

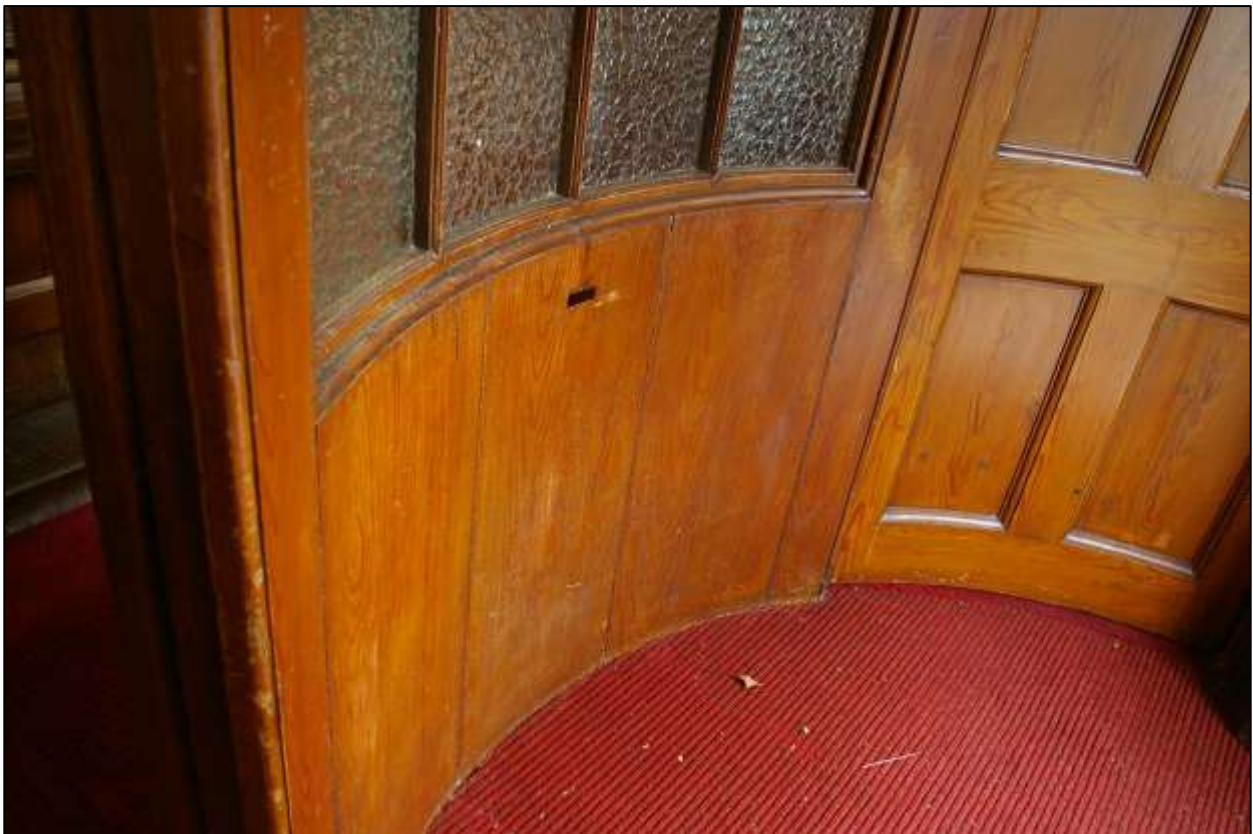
25. THE BEADED PLANK STRUCTURE OF THE WEATHER PORCH AND SLOT FOR THE COLLECTION BOX BUILT INTO IT; FROM THE WEST.

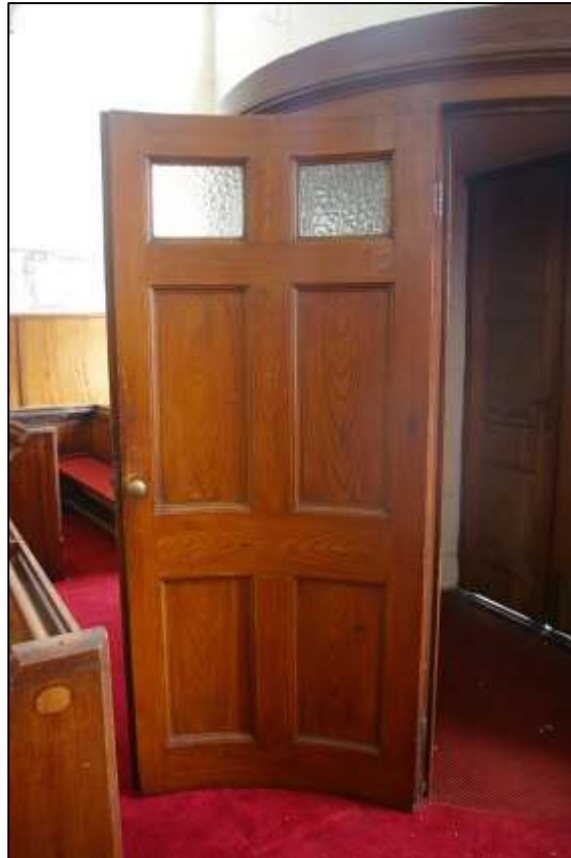
26. D2, SHOWING THE FLAT PANELS ON THE PORCH SIDE OF THE DOORS; FROM THE WEST, NORTH-WEST.

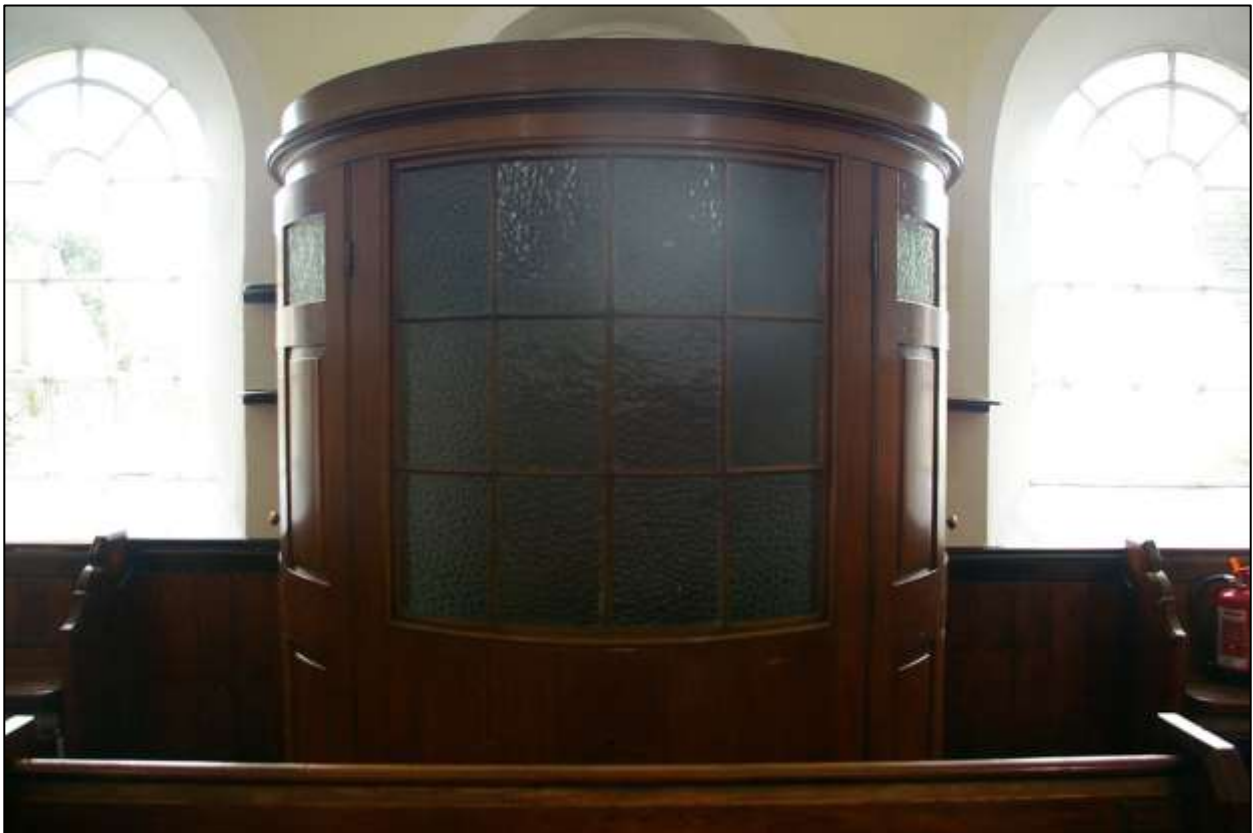
27. THE 12 PANE PANEL IN THE NORTH SIDE OF THE WEATHER PORCH, LIGHTING IT FROM THE AUDITORIUM; FROM THE NORTH.

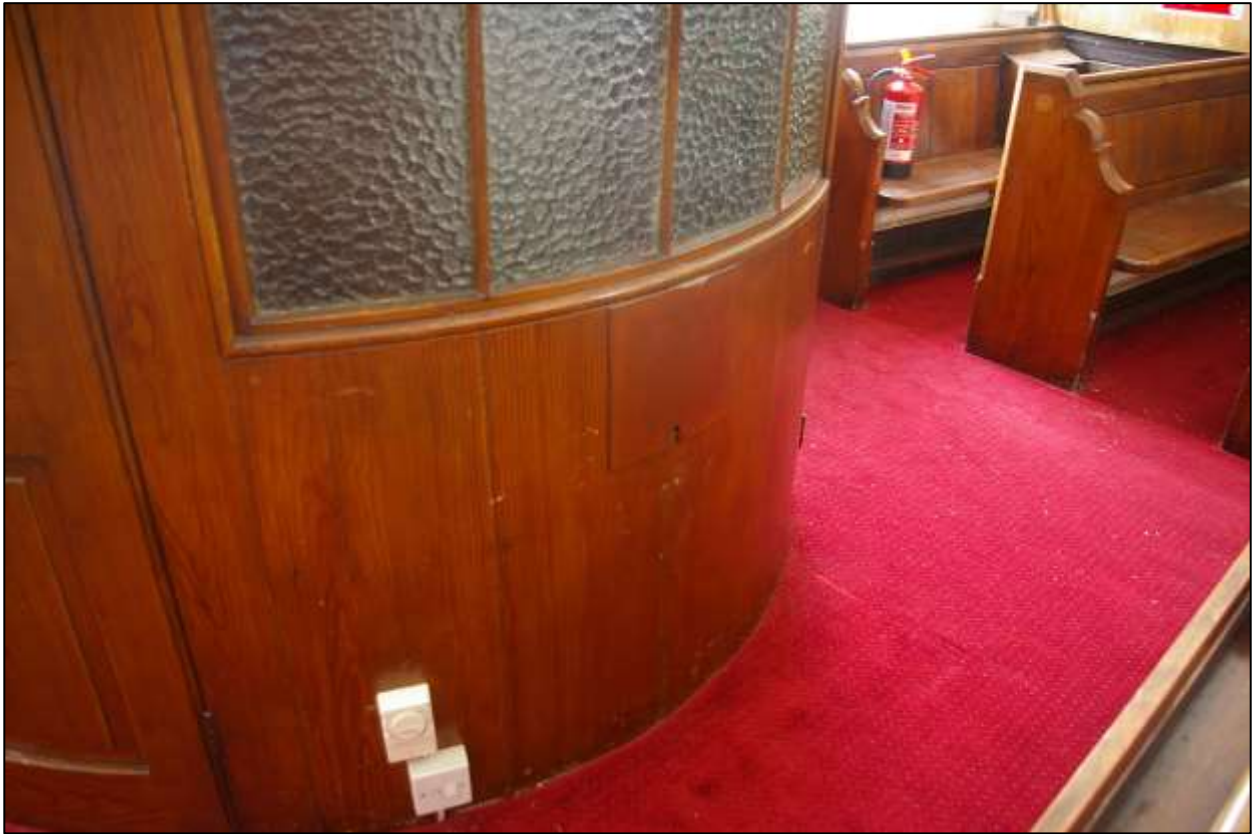
28. THE REAR SIDE OF THE COLLECTION BOX, NOW BOARDED OVER, A METAL BOX OR CASE OR SIMILAR LIKELY REMOVED; FROM THE NORTH-EAST.

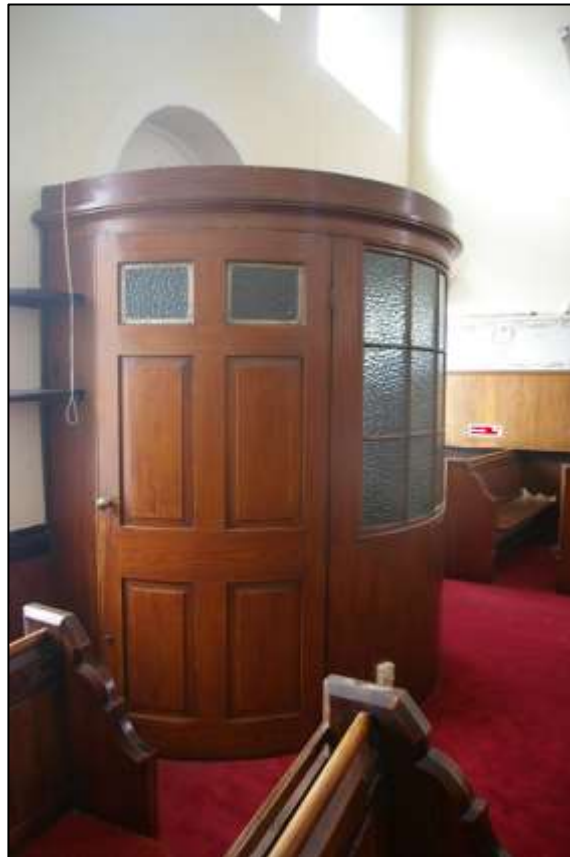
29. VIEW SHOWING THE CURVING SHAPE OF THE WEATHER PORCH, ITS FLAT ROOF AND RELATIONSHIP WITH THE BLIND UPPER ARCH OF D1 ON THE SOUTH WALL; FROM THE EAST, NORTH-EAST.

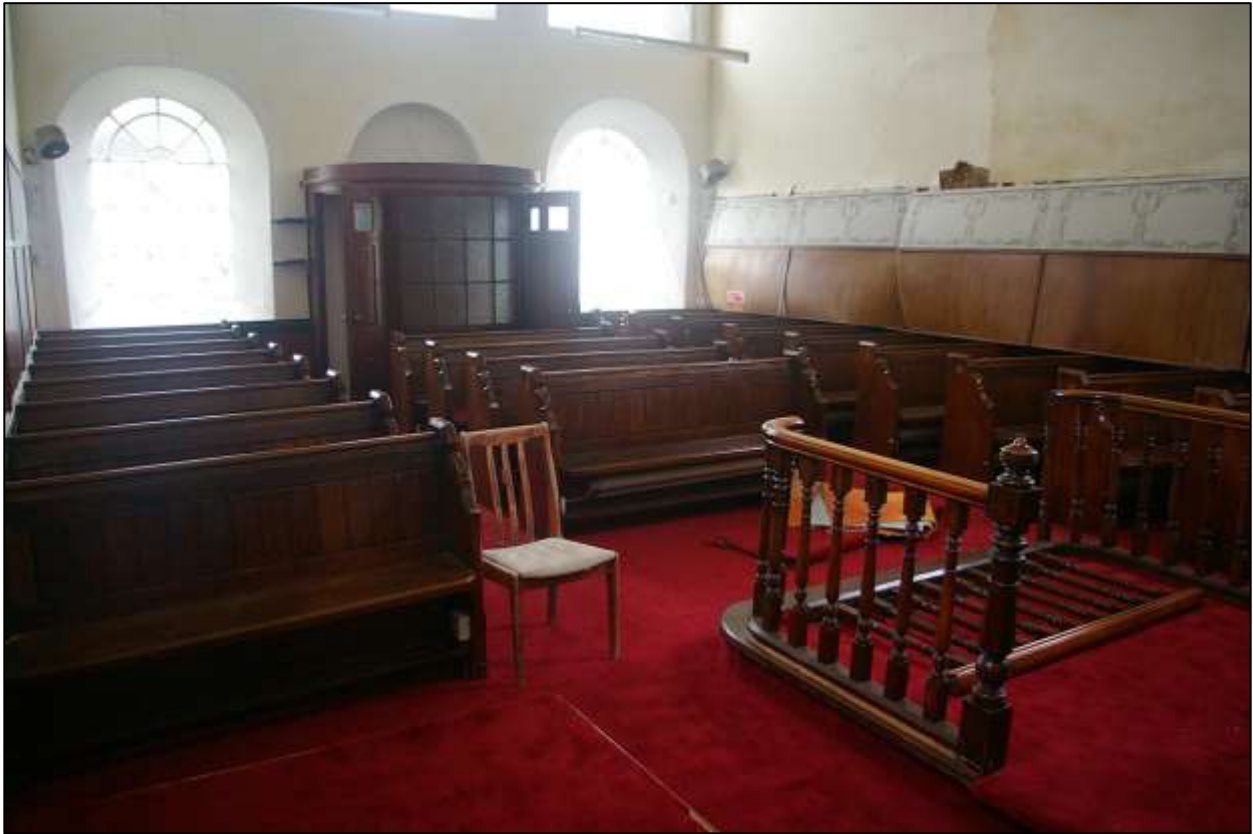
32. THE INTERIOR OF THE CHAPEL AUDITORIUM, SHOWING THE LAYOUT OF PEWS; FROM THE NORTH-EAST.

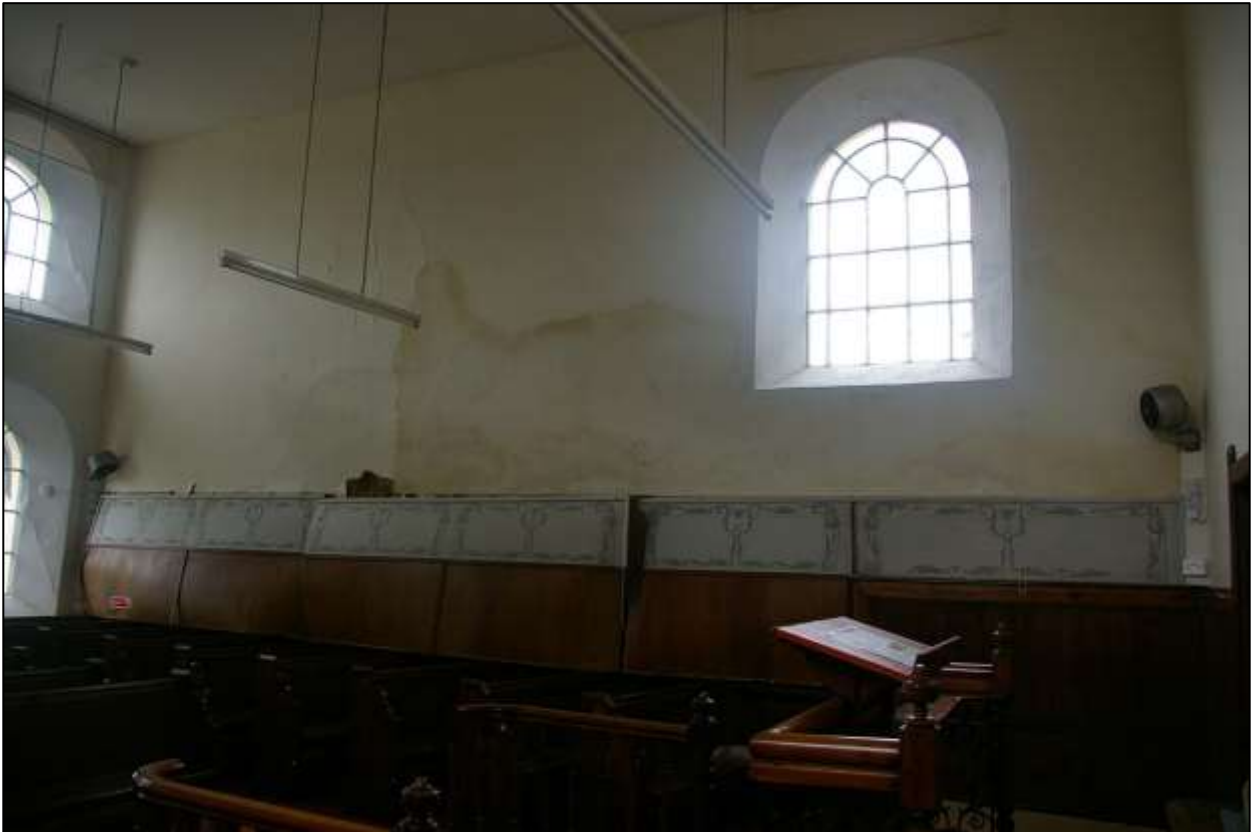
34. VIEW OF THE WEST WALL OF THE CHAPEL, THE INTERIOR FACE, SHOWING THE SURVIVING WINDOW AND MODERN PANELS ABOVE THE PINE PLANK PANELLING, AS WELL AS THE DAMP DAMAGE; FROM THE NORTH-EAST.

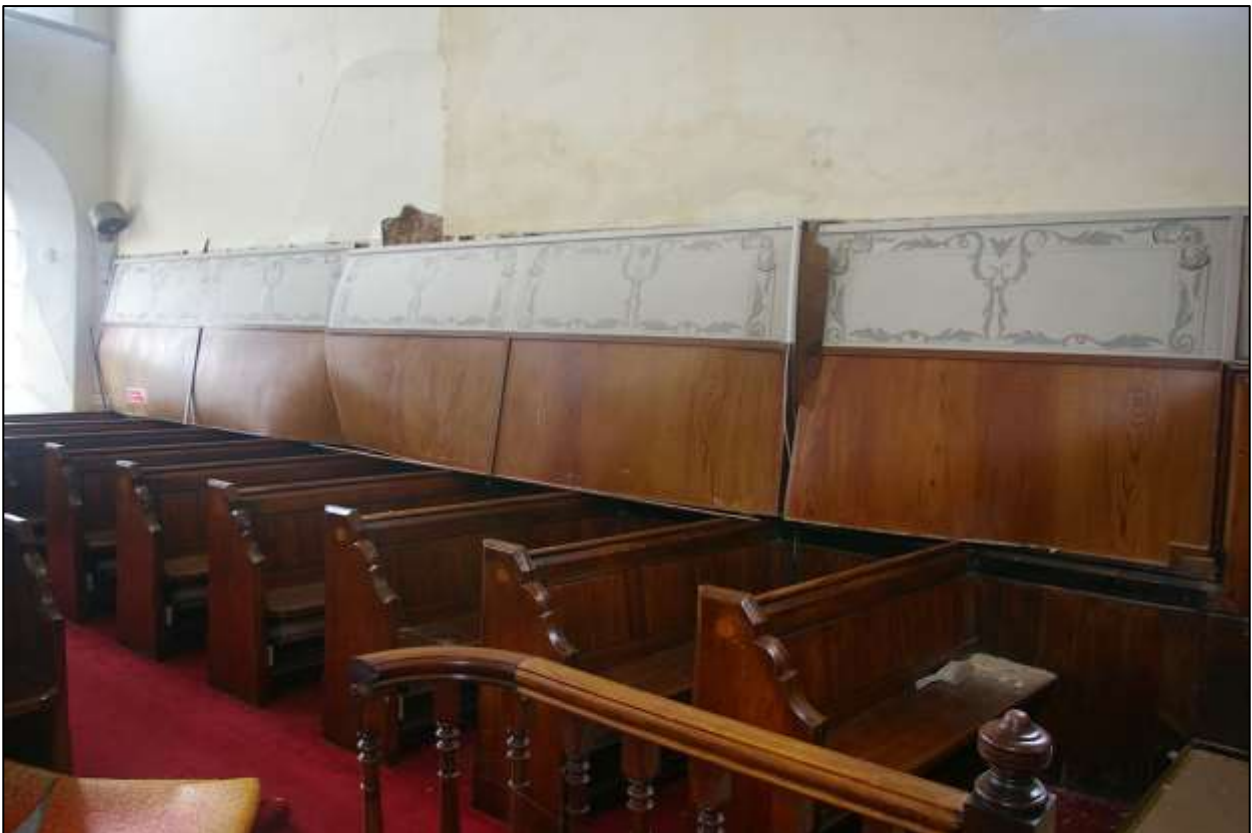
35. THE WOOD VENEER AND PAINTED MODERN PANELLING TREATMENT TO THE LOWER PART OF THE CHAPEL WALLS; FROM THE NORTH-EAST.

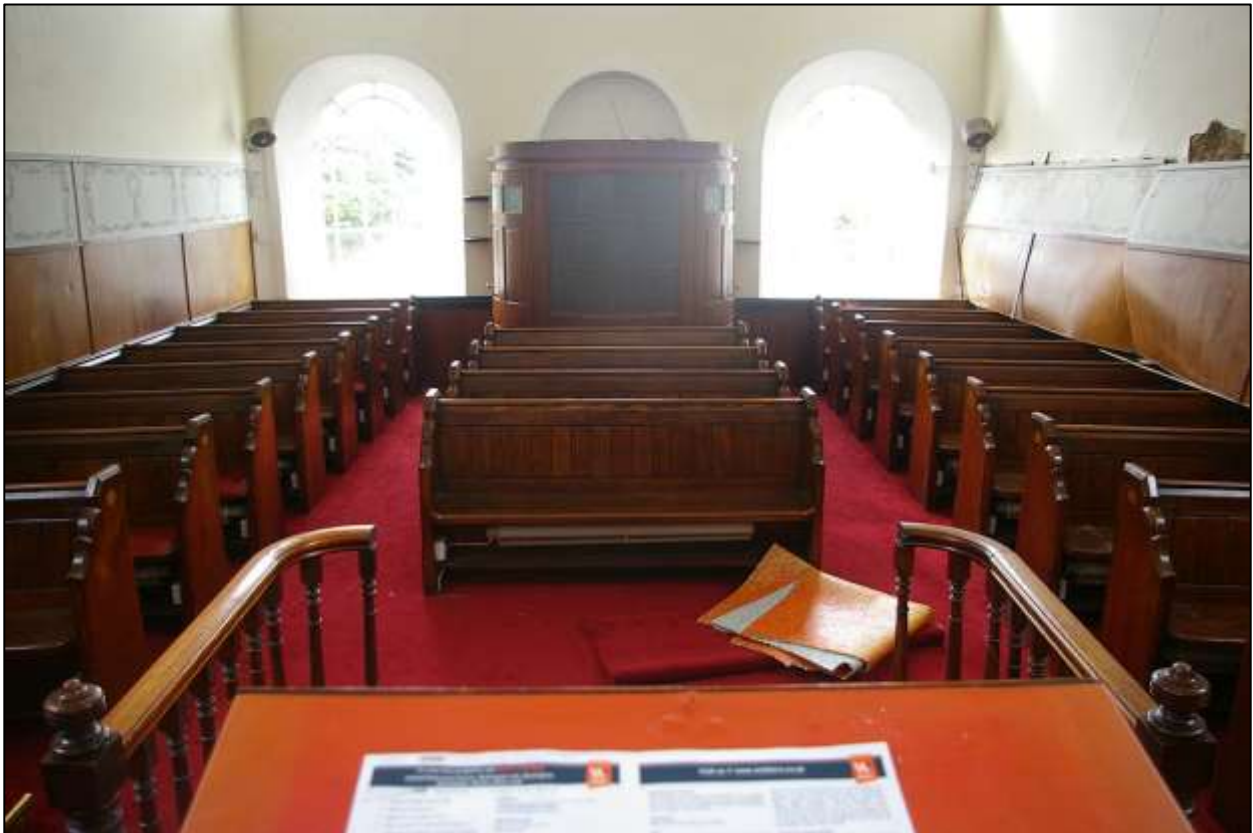
37. THE INTERIOR OF THE CHAPEL; FROM THE PULPIT, FROM THE NORTH.
