**FORMER UNITED REFORM CHURCH
BICKINGTON
FREMINGTON
DEVON**

Historic Building Recording

South West Archaeology Ltd. report no. 190930

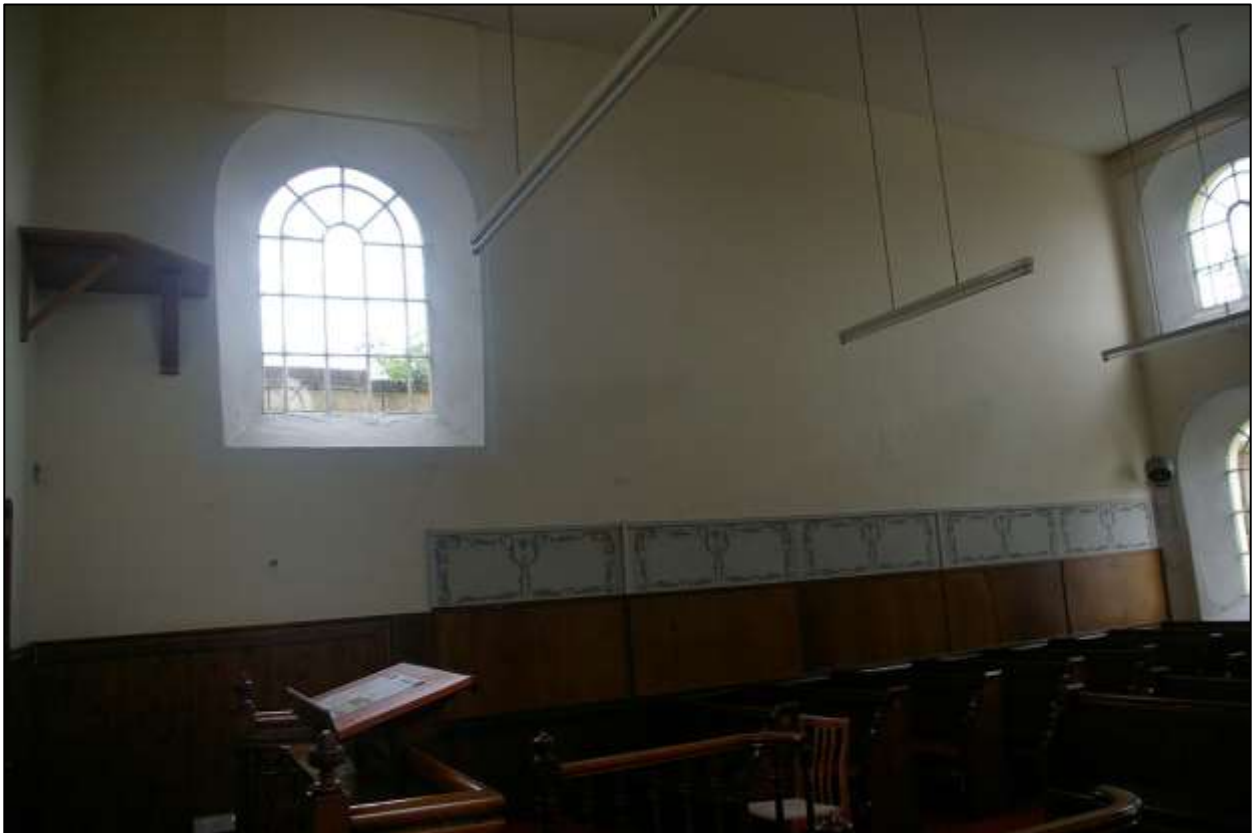
39. THE EAST WALL OF THE CHAPEL, INTERIOR FACE, SHOWING THE WINDOW TO THE NORTH, WHICH APPEARS TO BE THE ONLY ONE ON THIS SIDE; FROM THE NORTH-WEST.

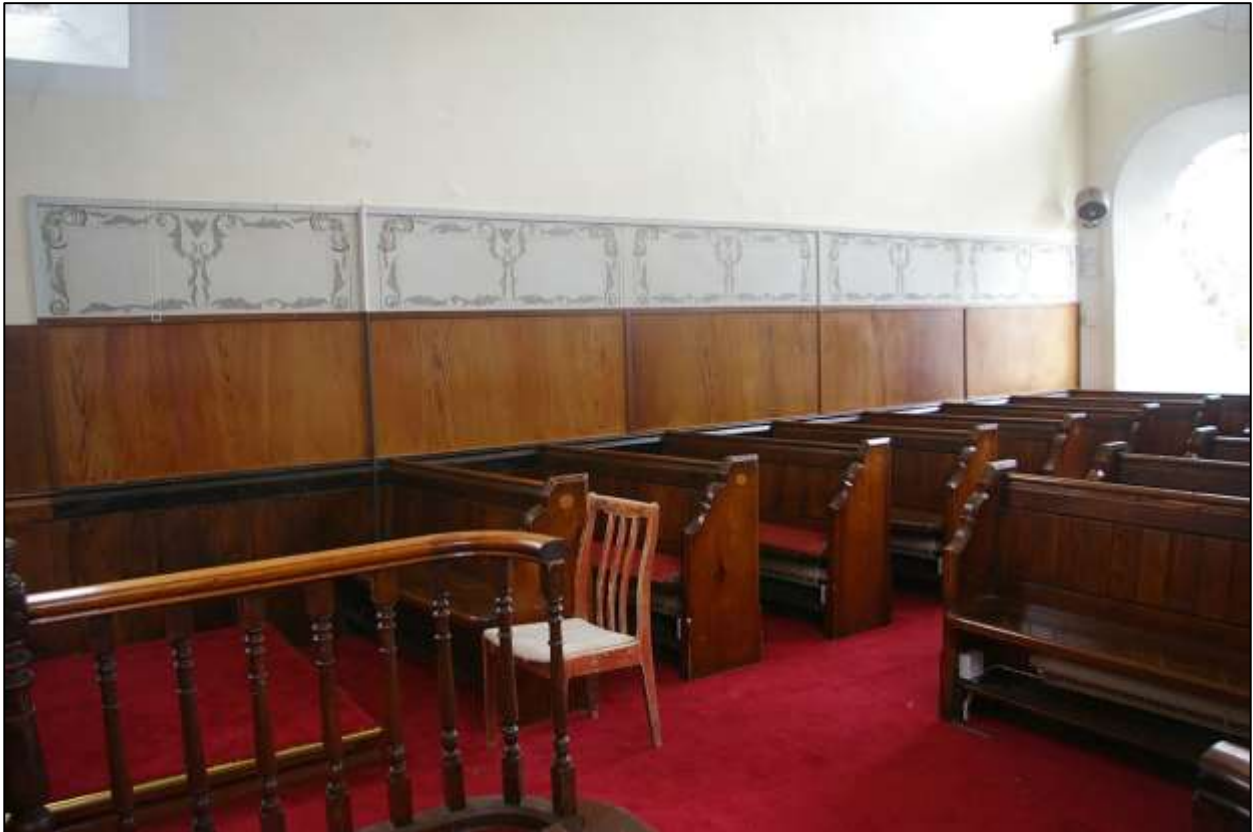
40. THE WOOD VENEER AND PAINTED MODERN PANELLING TREATMENT TO THE LOWER PART OF THE CHAPEL WALLS; FROM THE NORTH-WEST.

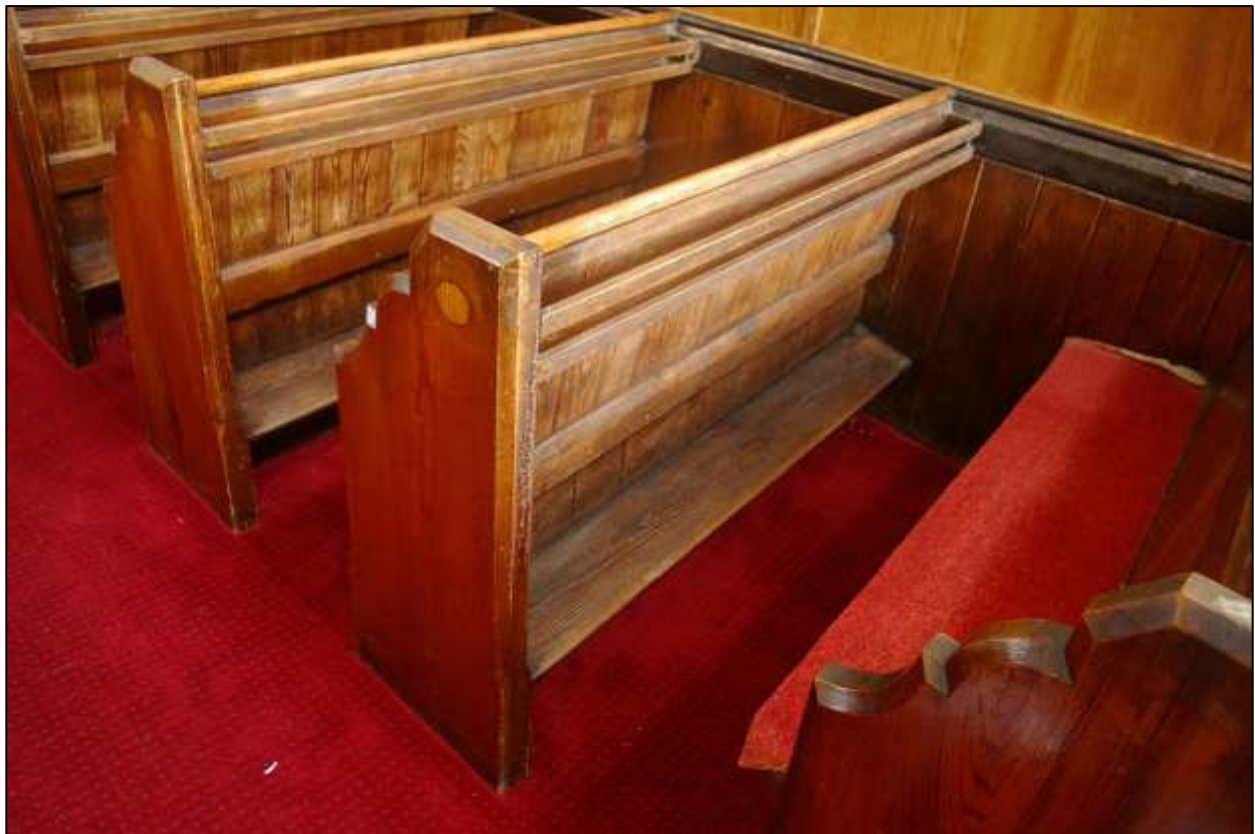
44. THE REAR OF THE PEWS, WITH BOOK RESTS AND FOOT RESTS; FROM THE WEST, SOUTH-WEST.

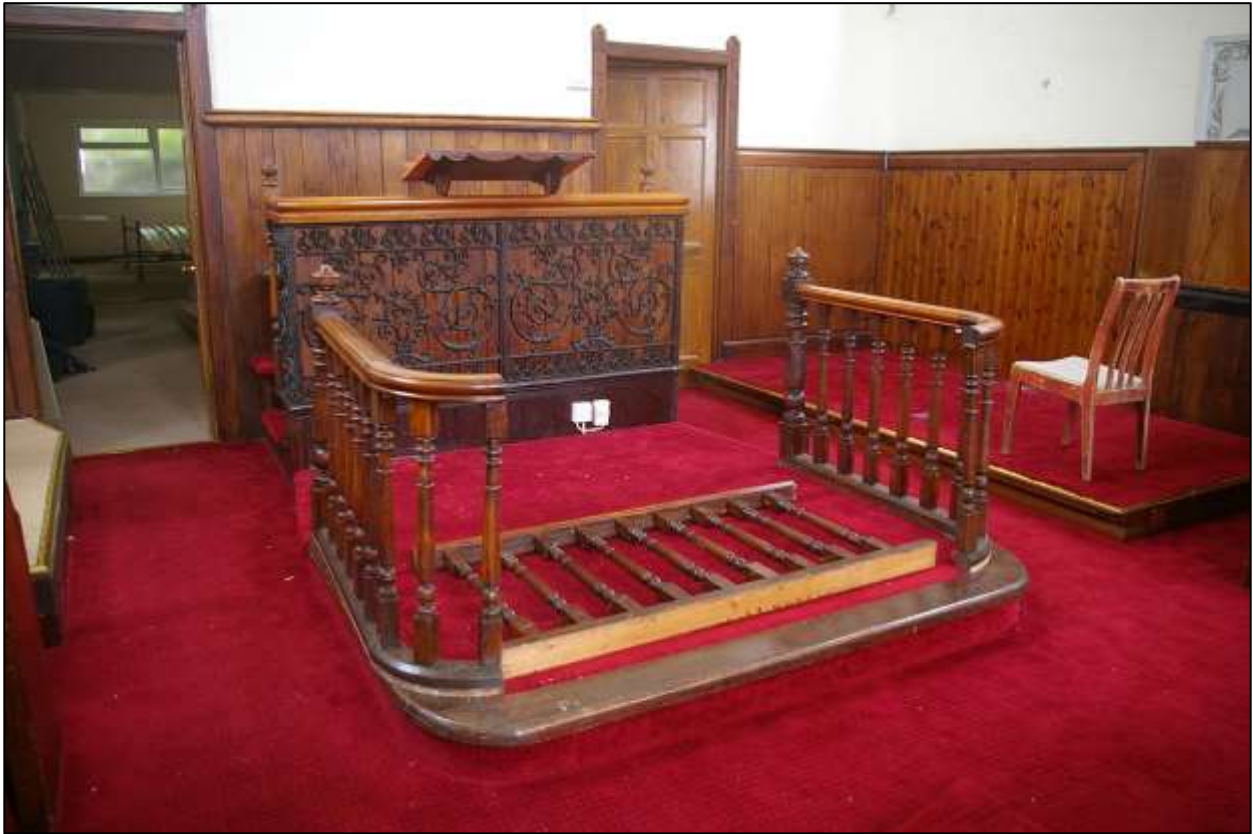
45. THE PULPIT AND RAISED DAIS WITH COLLAPSED COMMUNION RAIL; FROM THE SOUTH-WEST.

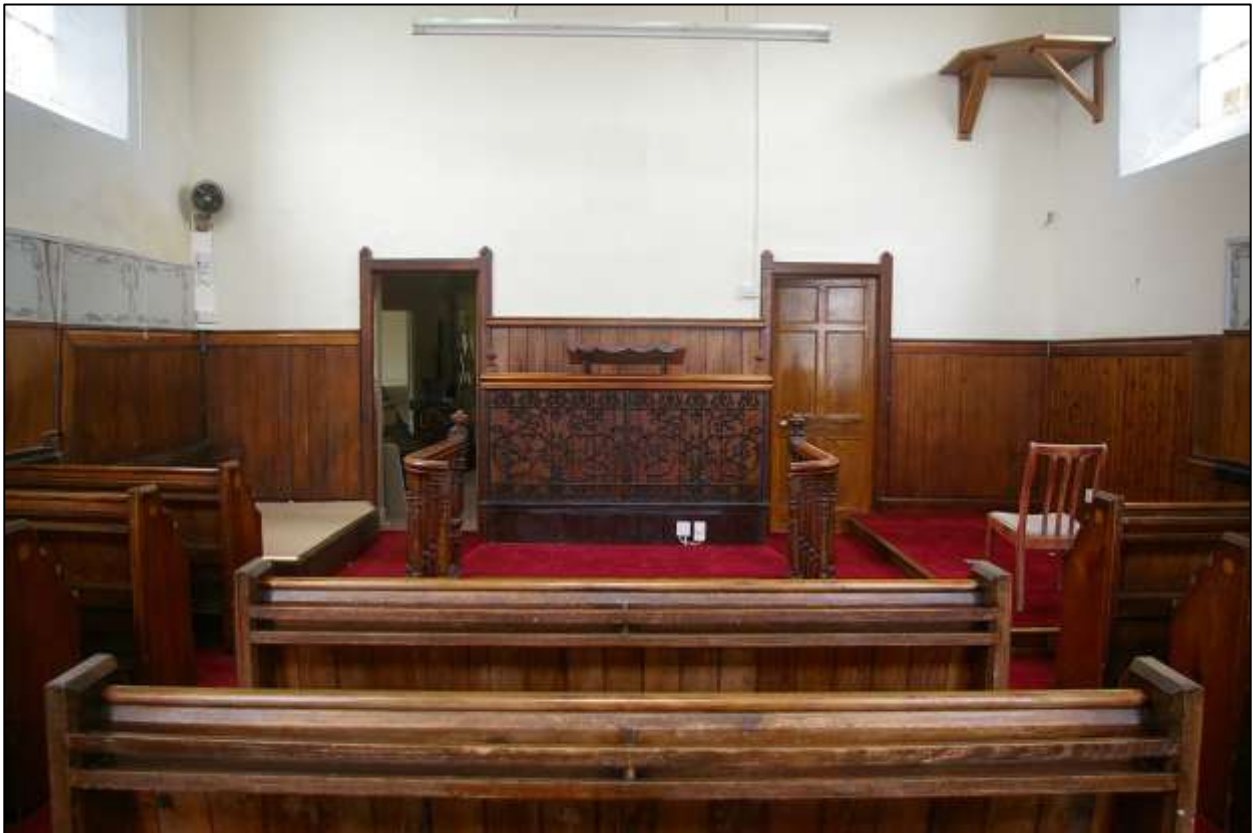
46. THE PULPIT, DAIS, COMMUNION RAIL AND TWO RAISED AREAS TO EAST AND WEST; FROM THE SOUTH.

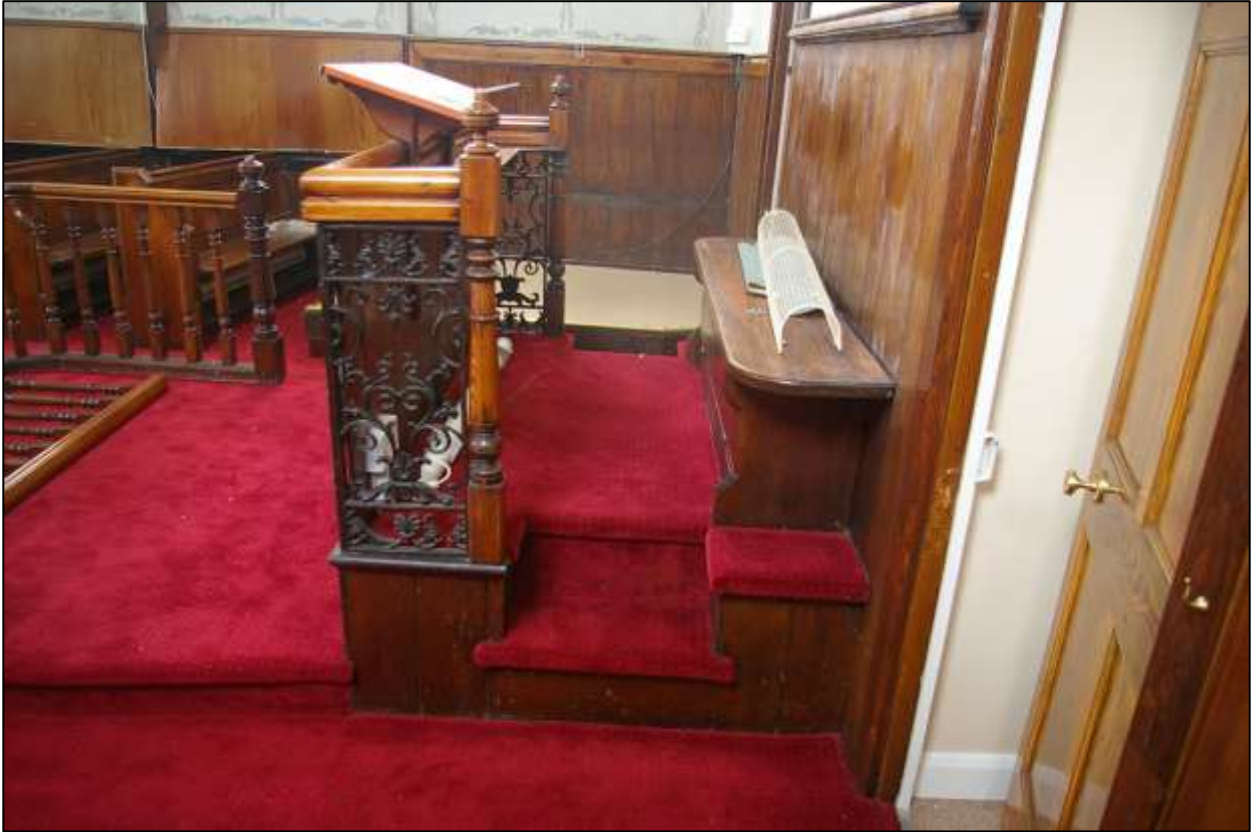
47. THE RAISED PLANK BOARDED PULPIT STEPPED STRUCTURE; FROM THE EAST.

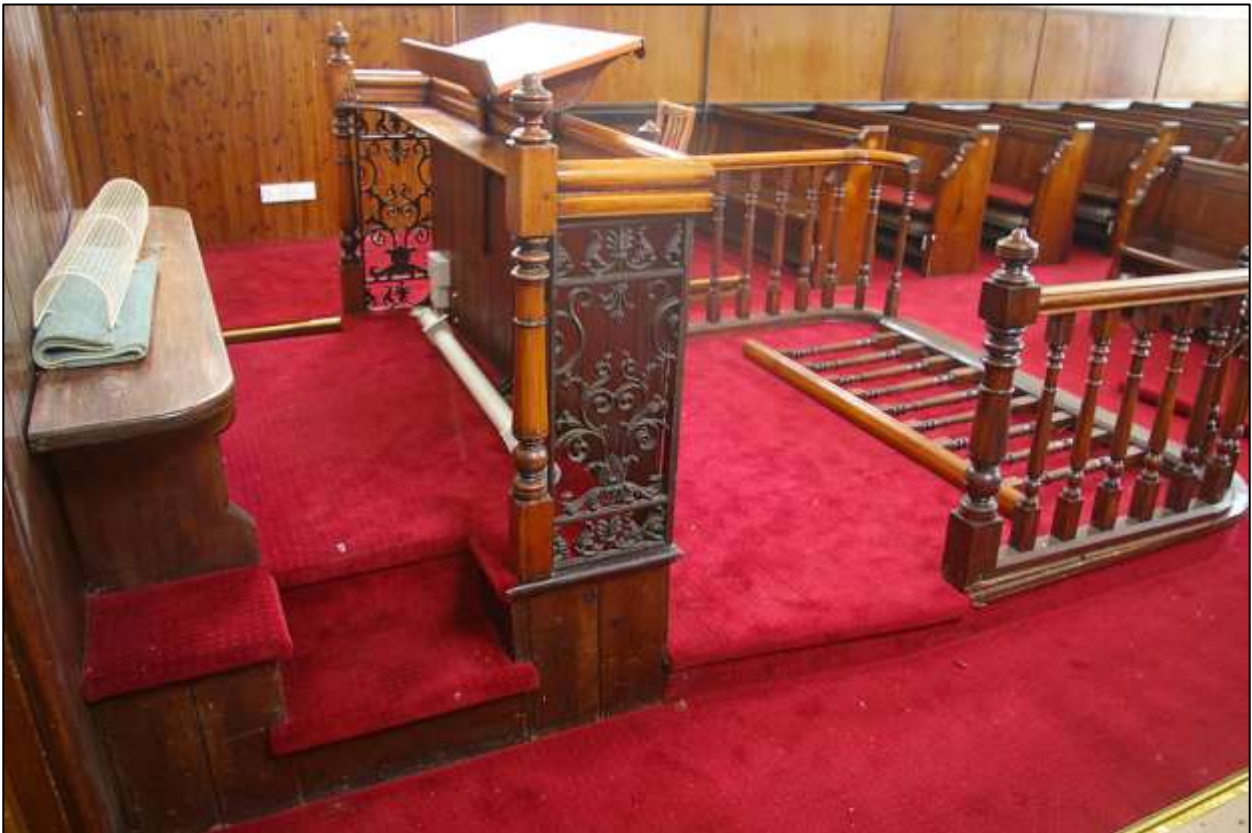
48. THE PULPIT AND RAISED DAIS FOR THE COMMUNION ENCLOSURE; FROM THE WEST, NORTH-WEST.

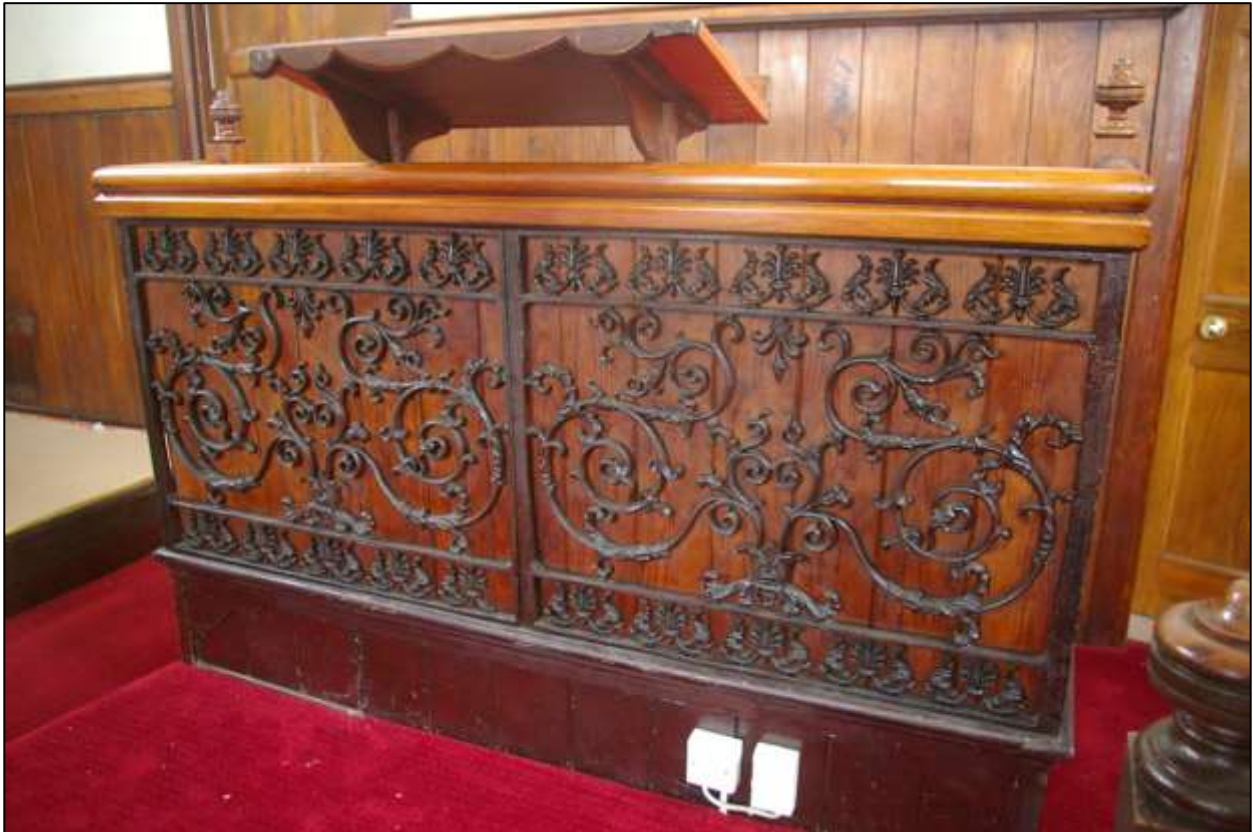
52. CAST IRON PULPIT FRAME, A LATER EDITION ENCLOSING THE PLAIN PLANK UPRIGHTS, LIKELY AN 1896 ADDITION; FROM THE SOUTH-EAST.

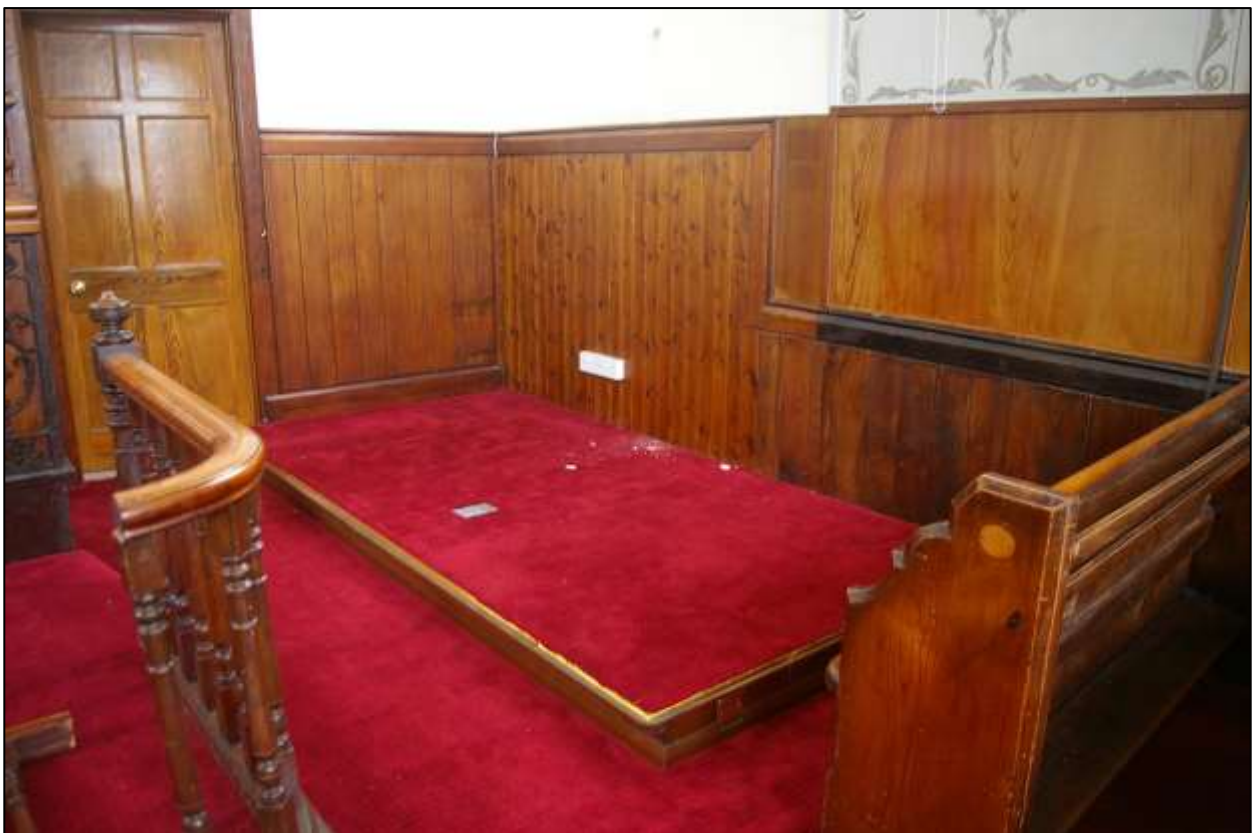
53. THE RAISED DAIS TO THE EAST OF THE PULPIT; FROM THE SOUTH-WEST.

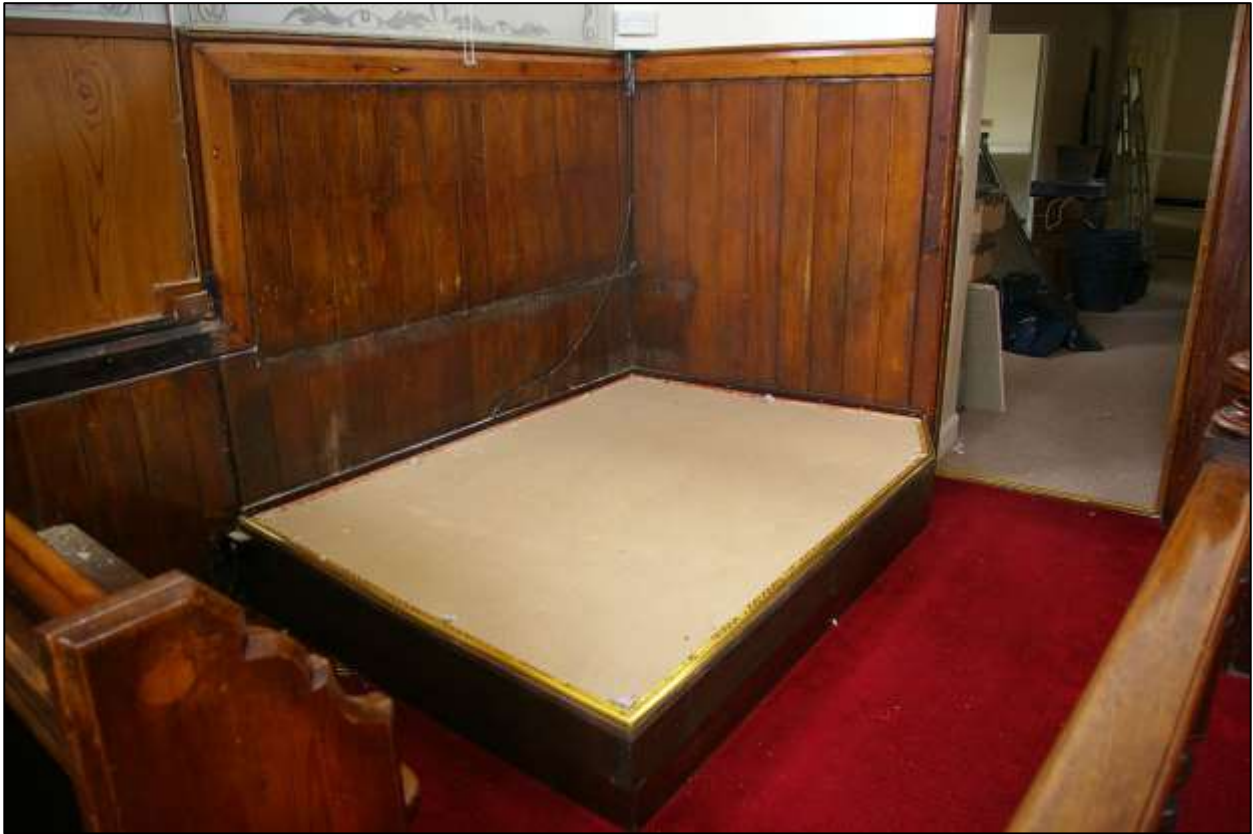
54. THE TALLER RAISED DAIS TO THE WEST OF THE PULPIT; FROM THE SOUTH-EAST.

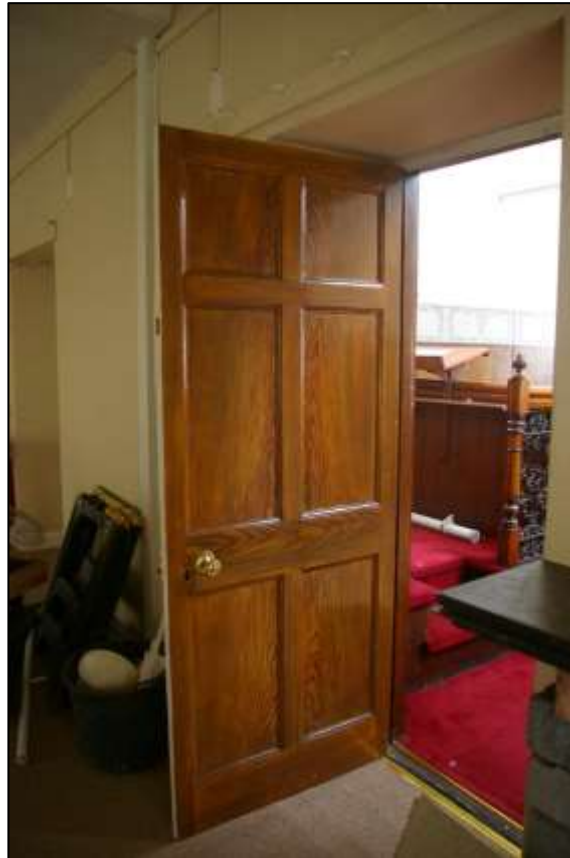
57. THE SIX PANEL D5, A REPLACEMENT DOOR; FROM THE NORTH-WEST.

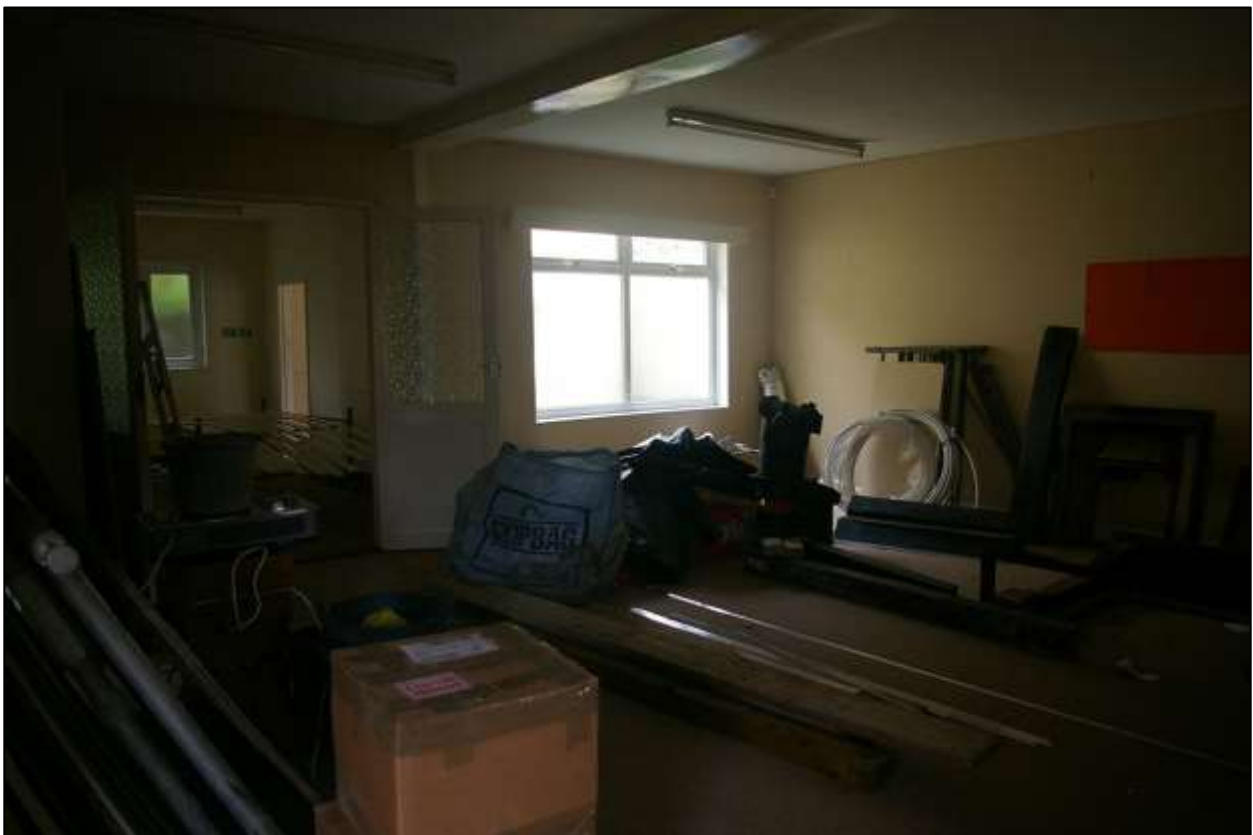
58. THE COMMUNITY HALL, BUILT IN 1949; FROM THE SOUTH-WEST.

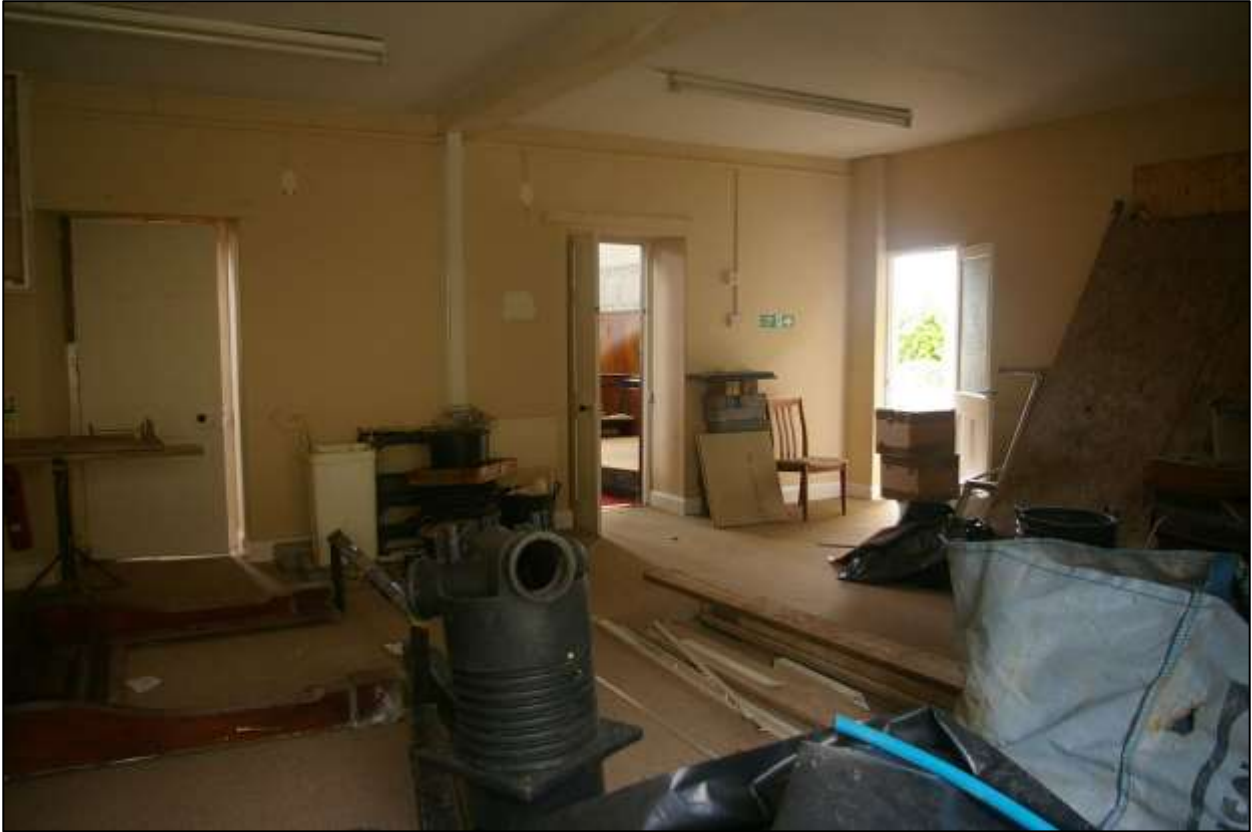
59. THE COMMUNITY HALL, BUILT IN 1949; FROM THE NORTH-EAST.

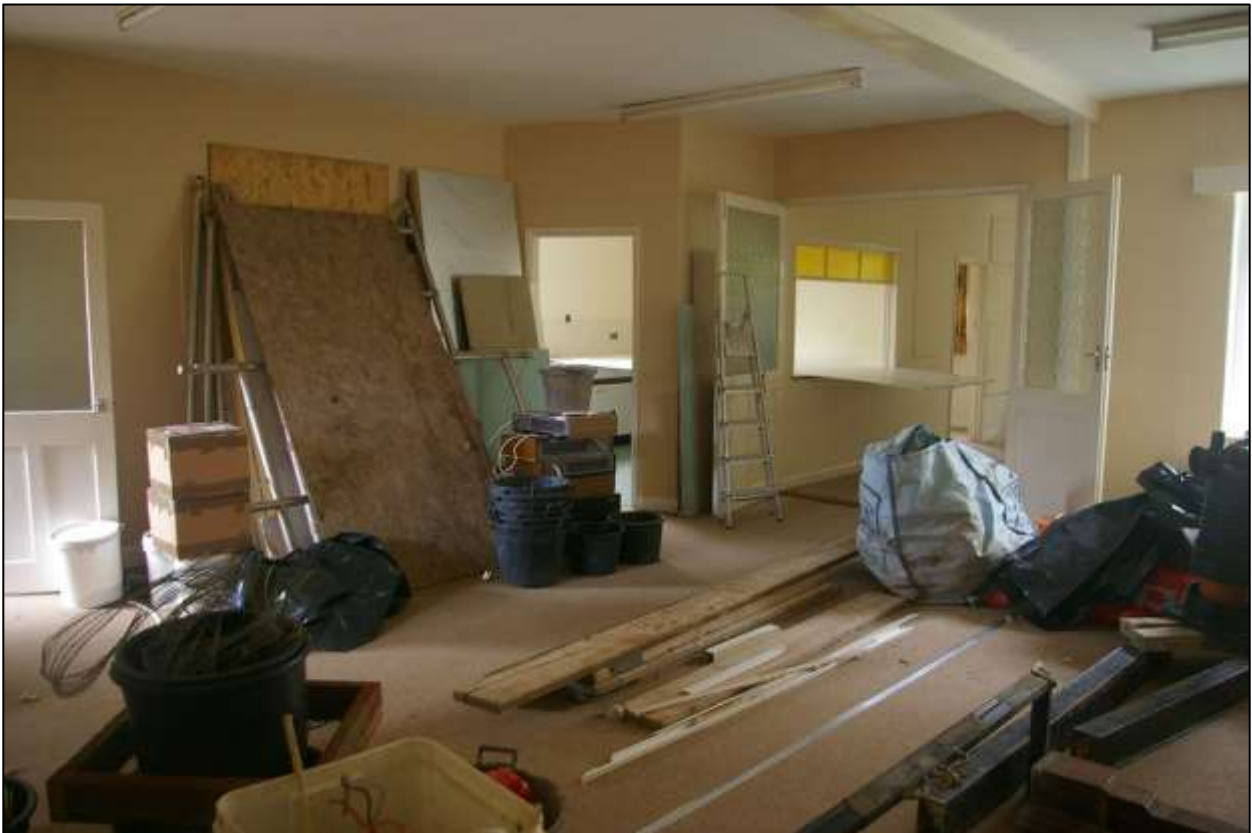
60. THE COMMUNITY HALL, BUILT IN 1949; FROM THE SOUTH-EAST.

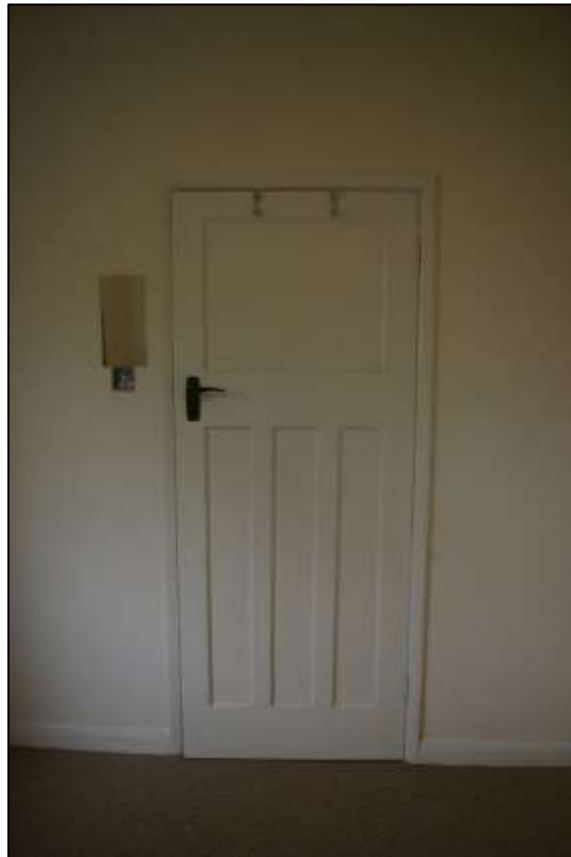
70. D11, A GOOD MID-20TH CENTURY DOOR; FROM THE WEST.
