VENN FARM, EAST PUTFORD, DEVON

Report K721

The Brief

Keystone Historic Buildings Consultants are contracted by Rosemary and Jeremy Jessel to provide an assessment of the farm from an historic and archaeological point of view. The report comprises a description of the fabric of the buildings, their layout, features, dating and development. It is accompanied by a photographic record. It also includes the documentary history of the property.

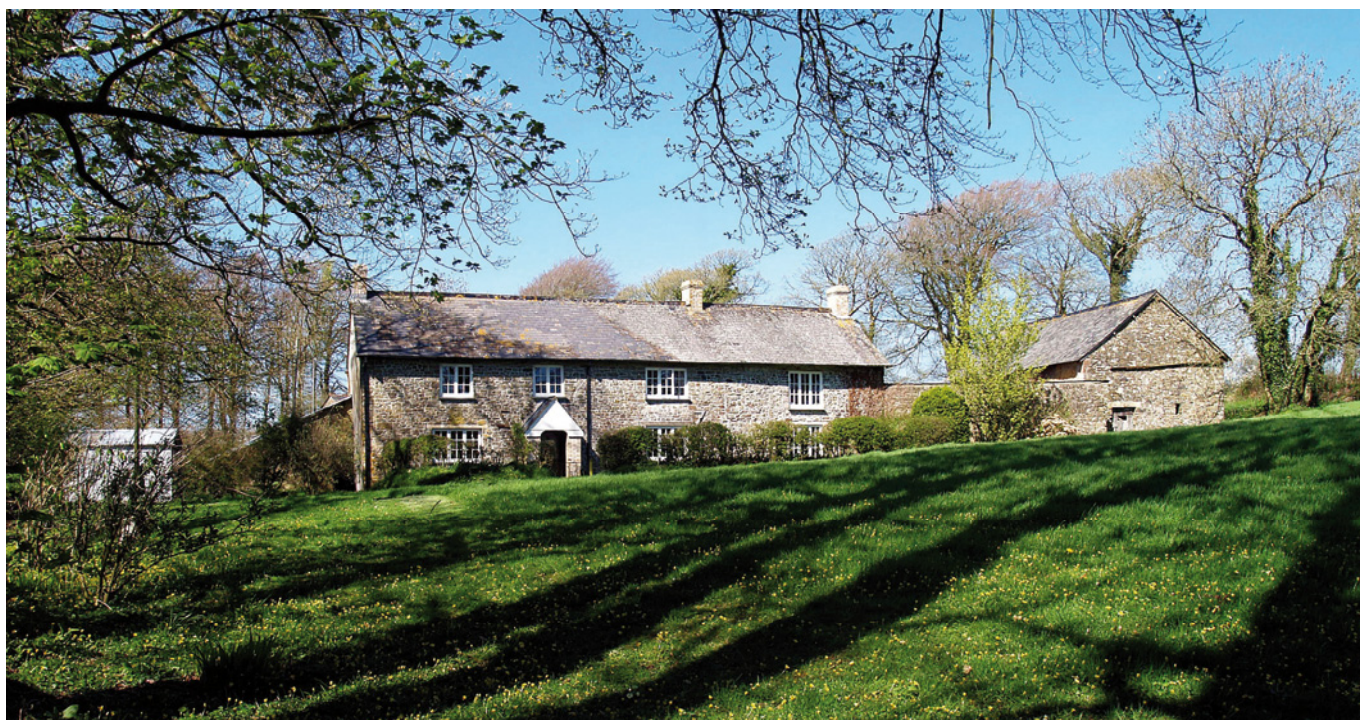
[1] *Venn from the south with the farmhouse backing onto the yard. The stone wall immediately to right of the house is the back of the cartshed, with the southern gable end of the barn beyond.*

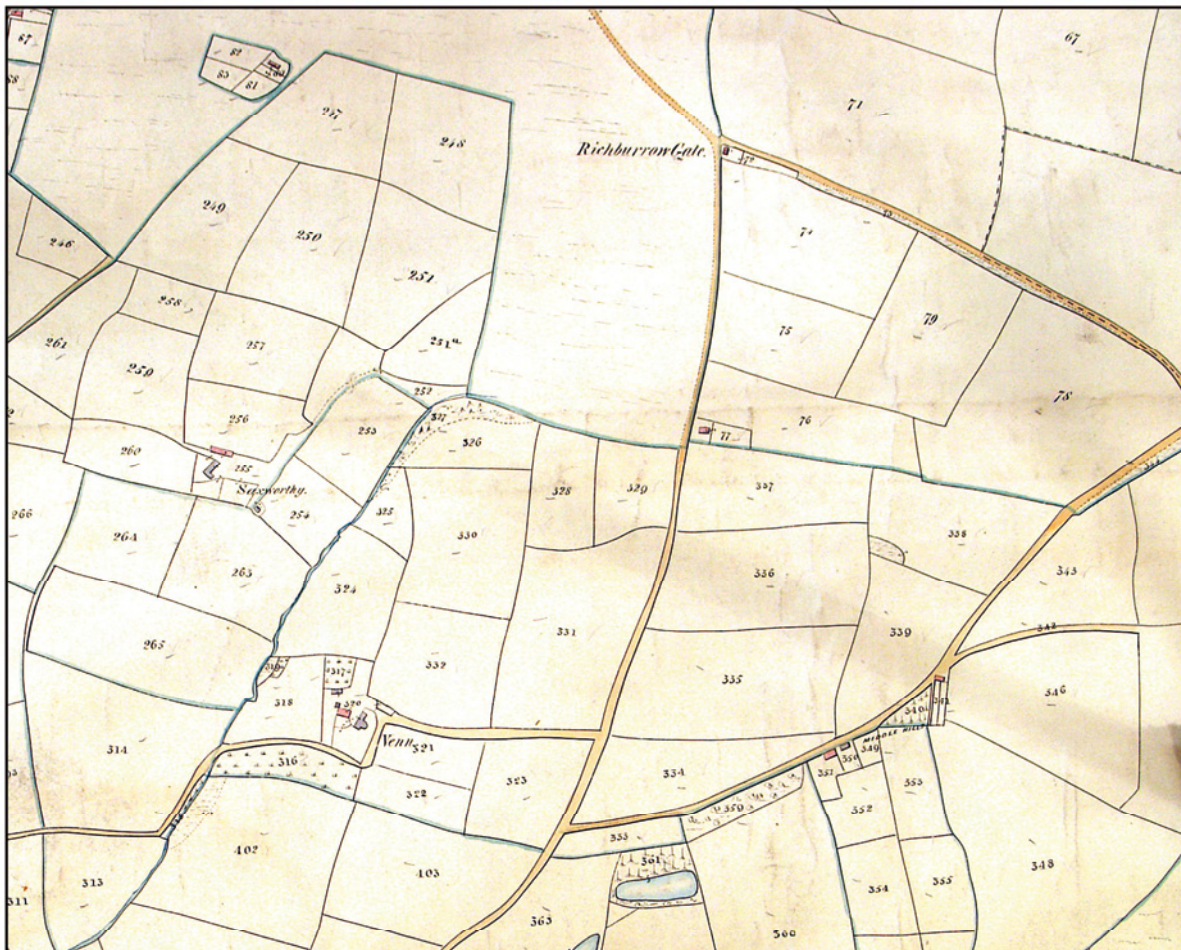
[2] The Venn holding (missing the extreme east end) on the East Putford parish tithe map of 1842. Someone later has outlined the boundaries of the various farms in blue, but not always according to the fields listed in the accompanying apportionment.

The earliest map of the farm is the parish tithe map of 1842 (Figs.2 & 3) with its

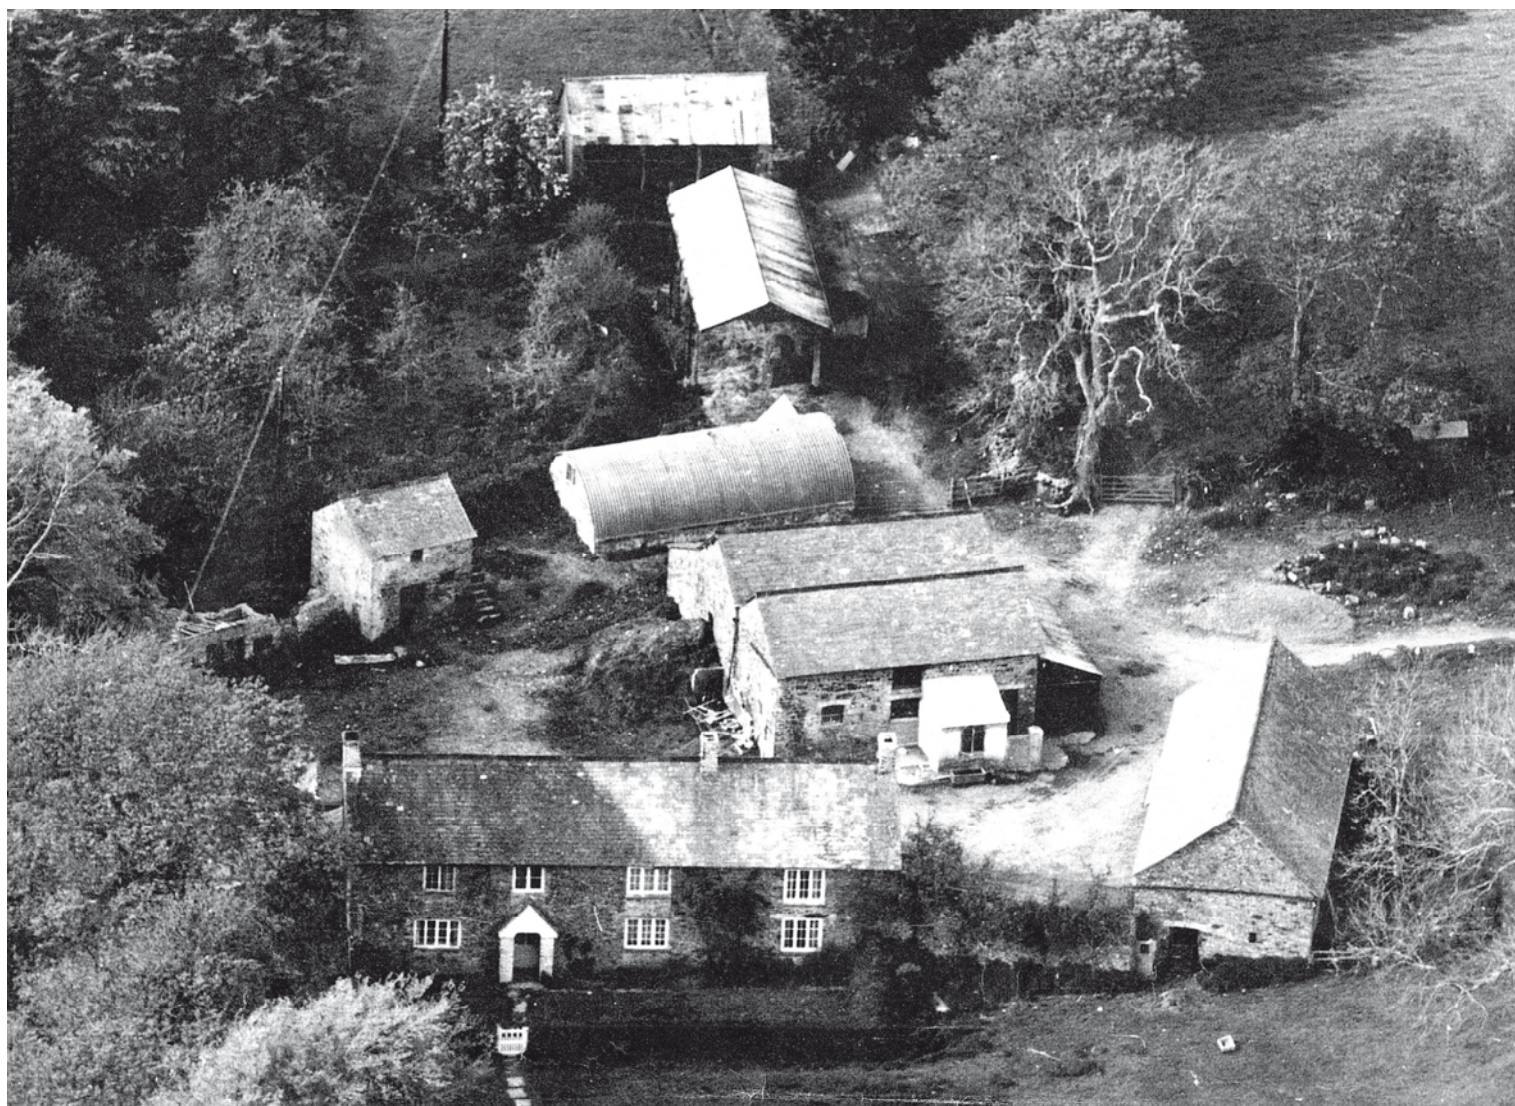
[7] *An aerial photograph of the farm from c1960, showing all the traditional buildings, plus a Nissen hut and pole barn. The pigsties are ruinous, and a c.1950s dairy is built in front of the old stable.*

The farmhouse includes some fabric which dates back to the 17th century, but it was massively rebuilt in the mid-late 19th century (c1880 as it is argued below), along with all the buildings in the yard. Despite the fact that it was built in a single phase the arrangement of farm buildings appears fairly random. The extent of the mid 19th century farm is recorded in the first edition OS map of 1886 (Fig.4). A couple more buildings had been added by 1905, the date of the second edition OS map (Fig.5). An old photograph show that all the buildings survived with a few later accretions up until the 1960s (Fig.7) when the pigsties were clearly ruinous. Others were demolished in 1994.

An aerial photograph of the place from c1960 shows a mid 20th century pole barn to the north of the yard (within that northern arm), and a Nissen hut in front and at right angles to it (in the yard proper), both of which have been demolished (Fig.7). Apparently the Nissen hut had collapsed under the weight of one winter's snow, presumably 1963.

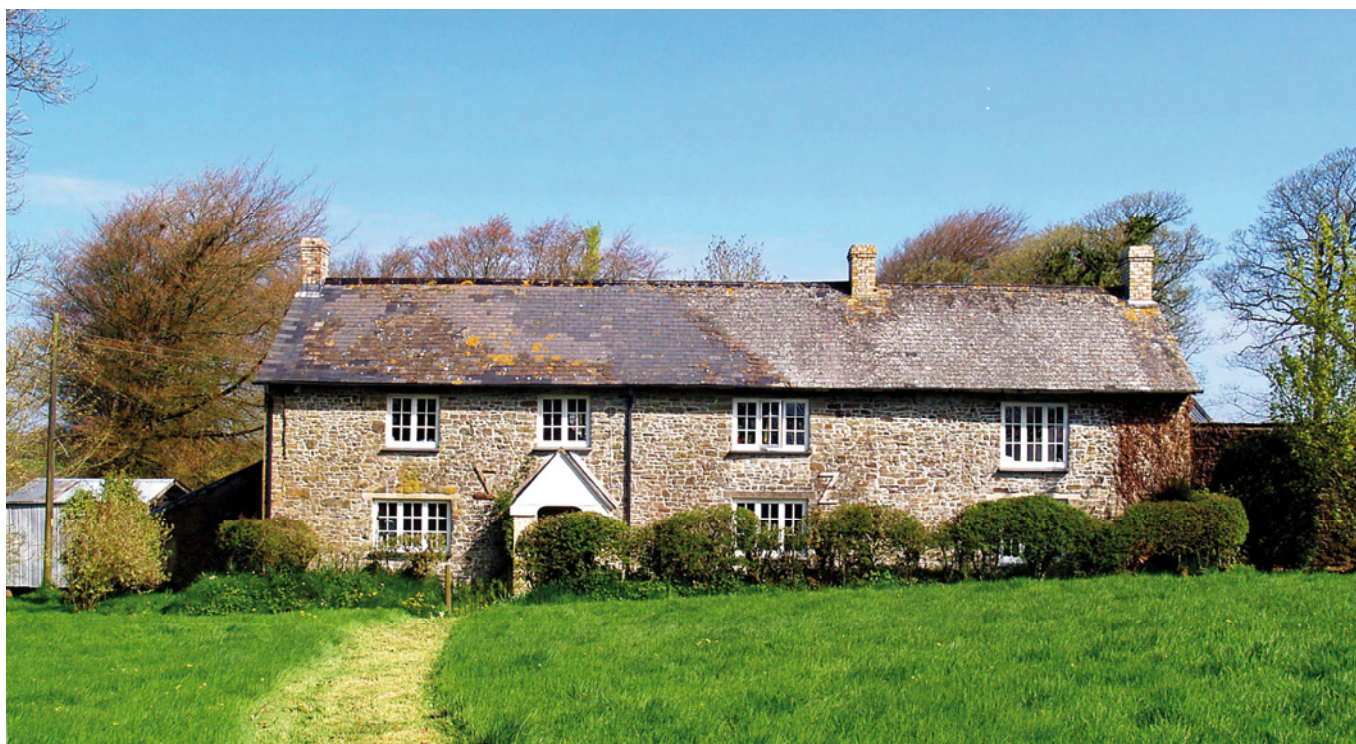
[8] *The south front of the farmhouse.*

The house is built down the hillslope on an east-west axis and is terraced into a gentle slope at its east end. It faces south (Fig.8). Unusually for a Devon farmhouse it backs onto the yard (Fig.10). The main block has a linear plan of three rooms and a cross passage which is the traditional layout of Devon farmhouses with early origins. This appears to have survived the massive rebuilding of c1880. The historic maps suggest that the whole steading was rebuilt between 1842- 86. In the 1881 census the house is described as uninhabited, which may indicate building works in progress. This may be speculation but it fits nicely with the facts.

The south front is the main elevation of the house (Fig.8). It overlooks a small garden to the fields beyond. It extends the full length of the house, and is hedged with hawthorn. This is the show front of the c1880 house. It was extensively re-faced in the 19th century, but clearly includes older masonry. Some of the lower masonry, particularly towards the east end looks as well

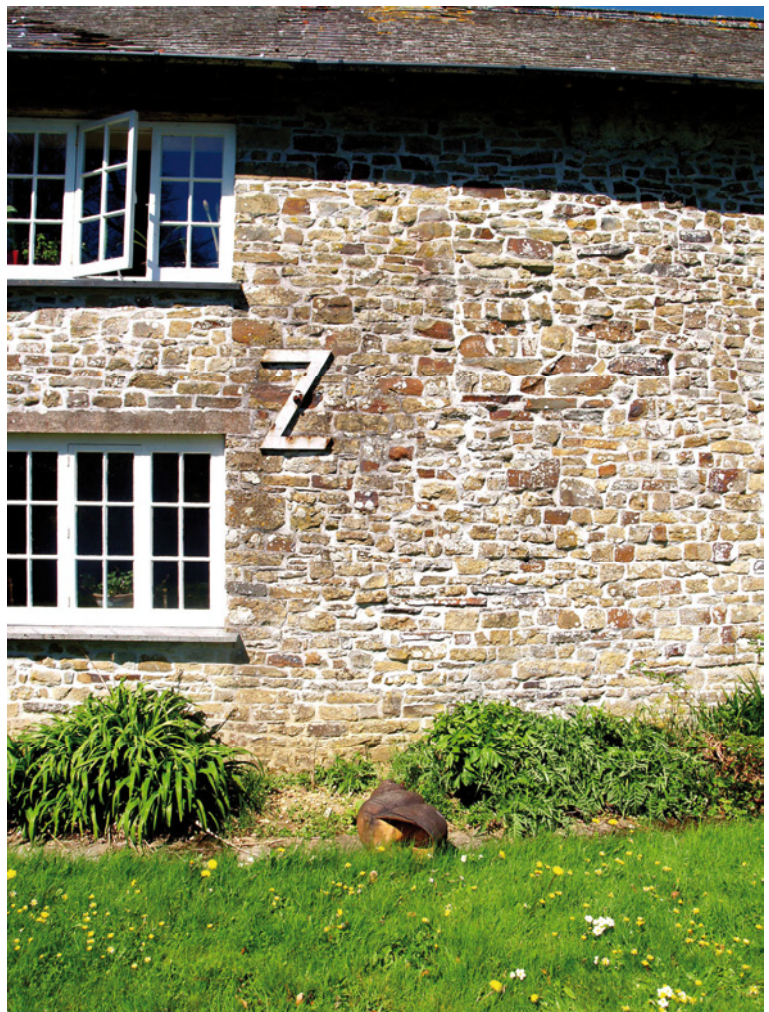
[9] Detail of the south front showing the vertical butt join in the masonry between the two eastern first floor windows. Notice too the Z-shaped plate of the c1880 tie-rod.

coursed as the 17th century masonry in the east end wall (see below), but this is not flattered by the cement pointing from the 1990s. There is also an anomaly in the masonry right (east) of centre at first floor level (Fig.9). It includes a vertical straight join. This does not seem to relate to some blocked opening or feature, but it does coincide with the break between the thicker wall of the parlour chamber to right, and thinner first floor front wall of the hall/ dining room chamber to left. The wall to east has a cob walltop and so does the west end. In the middle the masonry rises to the eaves, presumably relating the the internal crosswall associated with the hall/ dining room chimneystack. The butt join is rather ragged which is consistent with the rebuilding of the first floor level only as

far as the front wall of the parlour chamber. That is to say that rebuilt section of masonry to left (west) had to make good against the thicker stub of old masonry retained to right (east). It is the masonry of the east wall which appears to rise up to the eaves and over the top of the eastern masonry. Its position in relation to the internal crosswall is actually off centre to east, which suggests that the upper part of the crosswall was rebuilt with the newer masonry to east of the break. It looks like this was done to accommodate the new roof of c1880.

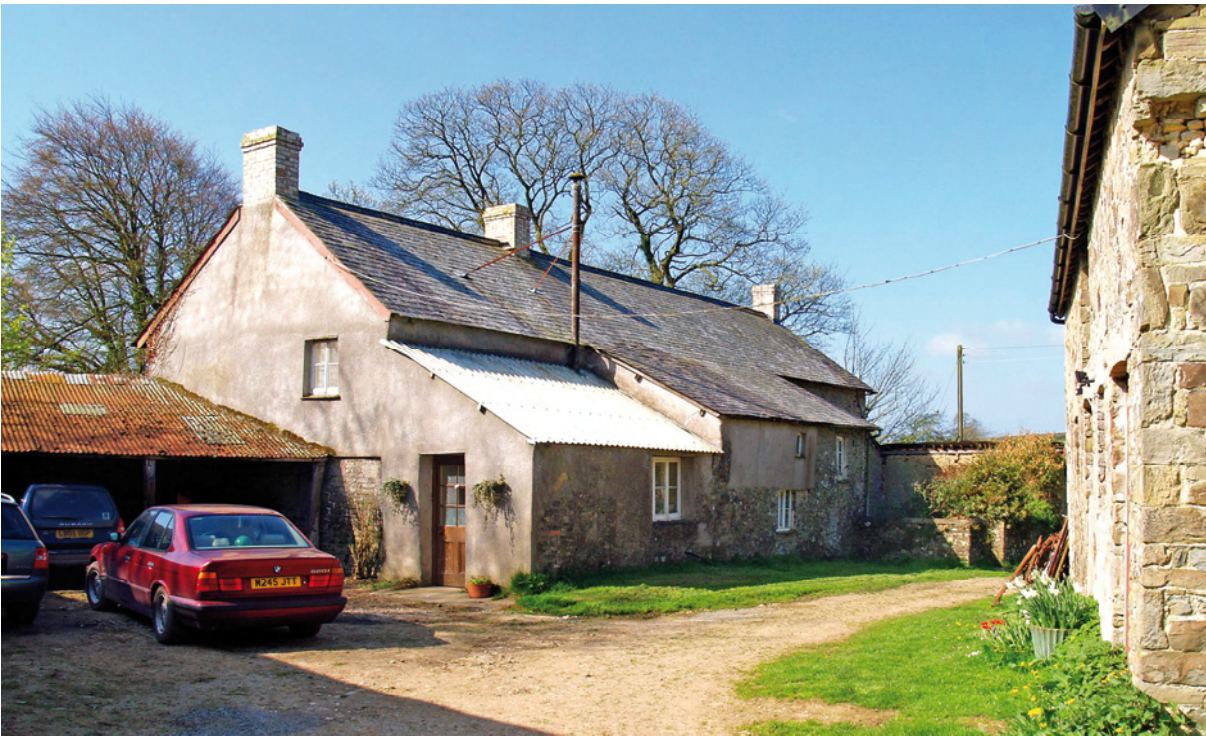
[10] *The back of the house from the northeast. The nearest and lowest of the rear lean-tos is the potato store and, beyond is the dairy and then the stairblock under the same roof.*

The north wall backs onto the farmyard (Fig.10). Most of the wall of the main range is hidden behind later additions but the kitchen end and rear doorway is exposed to west of the stairblock. This is rear doorway of cross passage and directly opposite the front one. It is therefore off centre to the west in relation to the main range as a whole, but up against the west side of the projecting stairblock. As with the front doorway the opening could

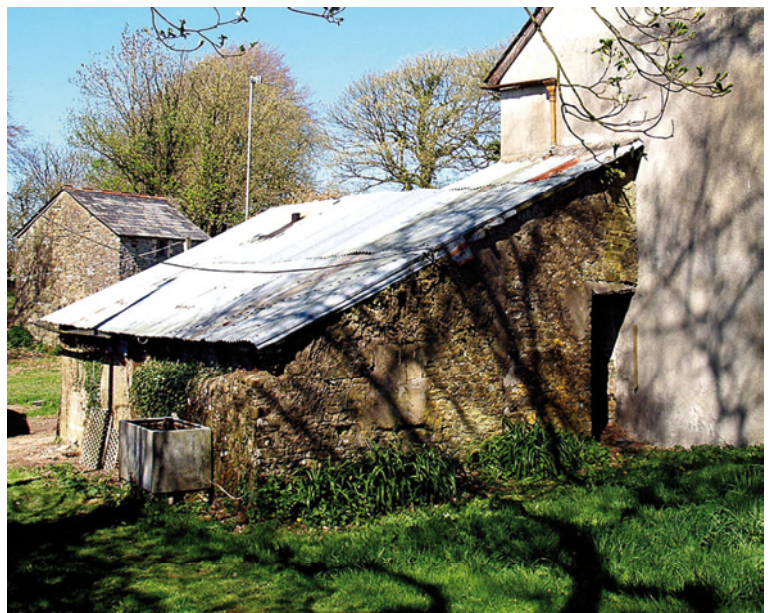
[11] *The privy and workshop/ implement shed off the west end of the main house shown from the southwest. All seems to be part of the c1880 rebuild, but there is a sequence. The privy, shown here against the gable-end wall of the house, is built against the house. The shed is built up against it.*

The privy is accessible from the south through an opening which is now lacking a door and frame. The lower sections of the privy walls are of rubblestone construction but the upper sections are cob. It has a monopitch roof, covered in corrugated iron, which is continuous with the roof of the workshop. The north side of the privy is flush with the rear wall of the house with a straight join between the two. It is interesting to note that its position and ready (in)accessibility in relation to the main chambers must have made the use of chamber-pots obligatory, and implies the employment of servants.

The workshop/ former implement shed is partly constructed from random rubblestone and partly cob (Fig.11). Its monopitch roof is covered in corrugated iron. The blind taller east wall, butts up to the privy and is cob on stone rubble footings, the base of which projects inside as a plinth. The south end wall is also stone rubble and includes a blocked window. The rubblestone continues round the corner along the southern half of the western front, finishing with a neat jamb to a blocked doorway within the rest of the front, which has been reconstructed in mid 20th century concrete blockwork. A post remaining on the inside in the northwestern corner suggests that this blockwork filled a former open front. The north end wall is a rudimentary construction of timber framing and corrugated iron, and contains a full-width 20th century metal door. These 20th century alterations are dated to March 1961 by an inscription in the cement inside. The interior is a single long space, which is narrower at the south end where the privy intrudes a short distance. There is a drain through the rear (east) wall of the workshop, from the small yard to the north of the kitchen part of the house. As mentioned above there was formerly a wash house here. Presumably the drain was from the wash house and continued westwards through the workshop issuing through the open front of the workshop to falling ground beyond.

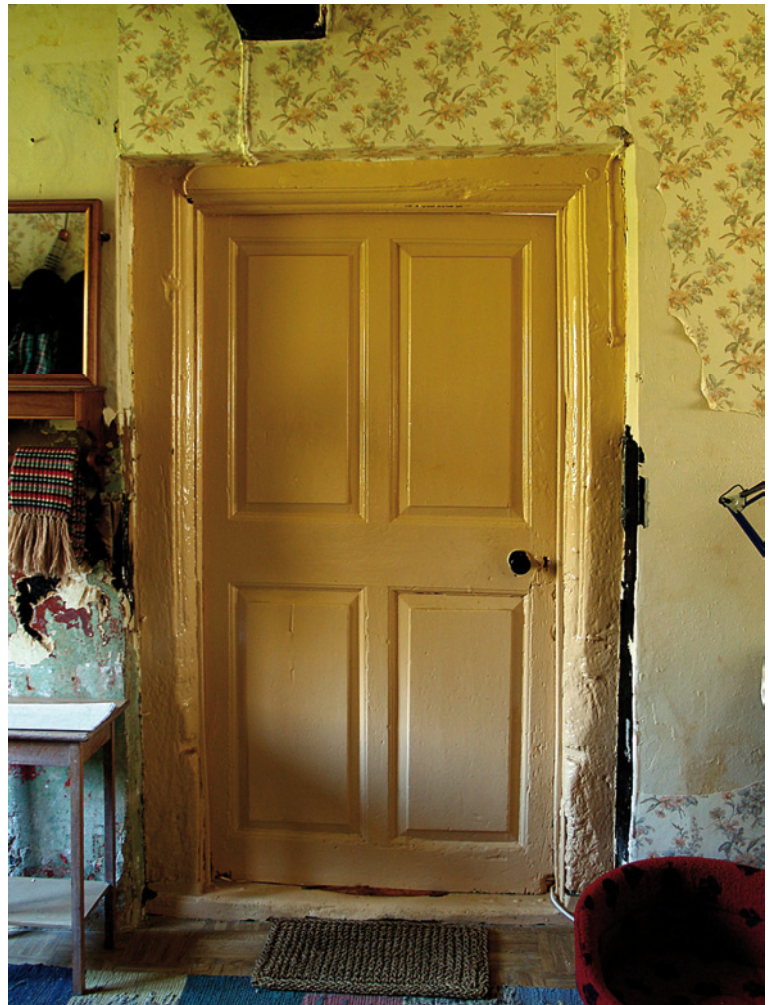
[12] The 17th century oak doorframe from the cross passage to the hall/ dining room. It contains an 18th century fielded-panel door.

The doorway off to the east, which leads to the hall/ dining room, contains a 17th century oak frame (Fig.12). It is a fairly heavy and well-worn frame, which includes a threshold. The frame is joined by pegged mortise- and-tenon joints which are true mitres on the front (to the passage). The moulded surround is a fillet to an ovolo moulding down to worn stops, which appear to have been a chamfer to a bar and scroll form. It is common in North Devon to find carved decoration on the stops of 17th century main doorframes. It looks as though the surfaces of the chamfer, bar and scroll here may have received some decoration, though they are so worn that the pattern

cannot be recognised. The applied moulding to the inner edge of the frame was added as a doorstep when the door was adapted in c1880. The doorleaf is 18th century with four fielded panels on the passage side (Fig.12). It is hung on late 19th century strap hinges with tiny round finials. On the plainer hall side it is grained. The doorframe may have always been in this position, but the authors suspect that it was reused here in c1880. This is partly down to the level of its ornament, but mostly the degree of wear which might suggest it was an outer door originally, presumably from one end of the cross passage.

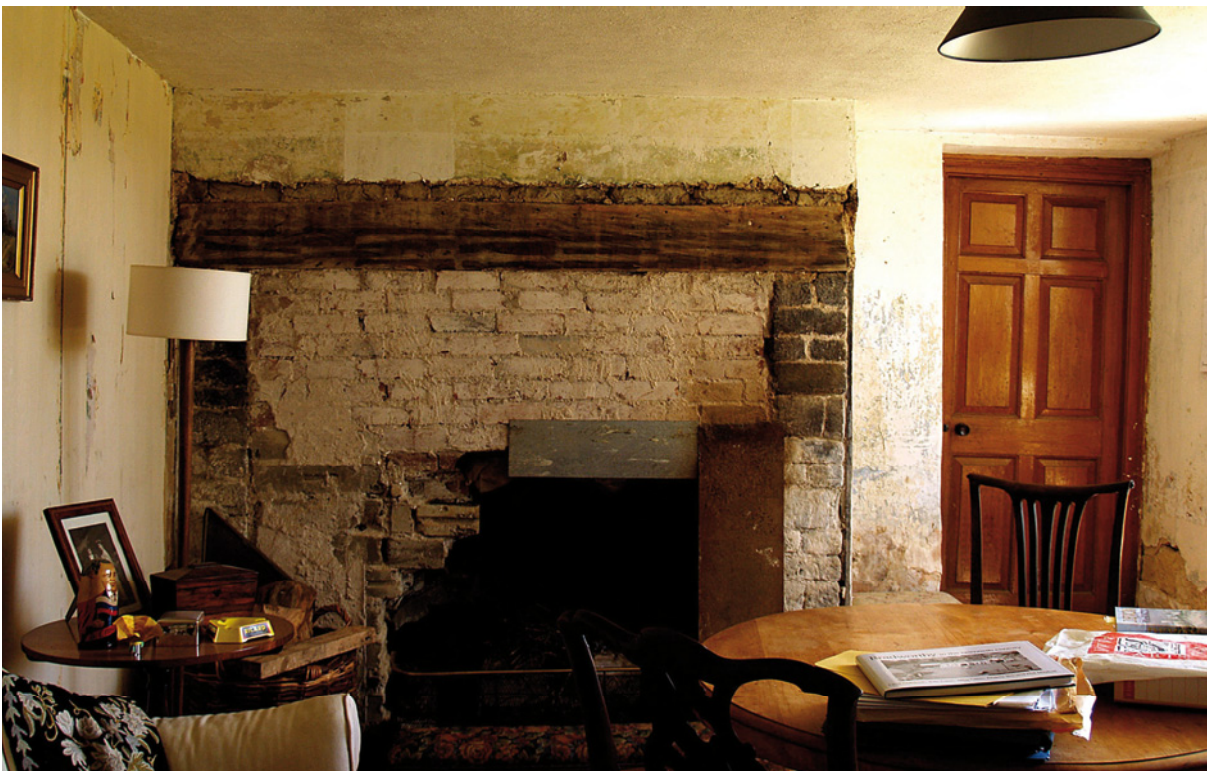
[13] *The east end of the hall/ dining room contains the probably 18th century large fireplace, and there is an 18th century door through to the parlour to the right.*

The hall/ dining room is heated by a fireplace in the eastern crosswall (Fig.13). It is of large size and dates from before c1880. This is described as a kitchen in 1911 (see documentary history above). This suggests that the large fireplace was open then, but, with the “back kitchen” at the west end. It may seem incongruous that the greater part of the farmhouse was taken up by two kitchens. However the back kitchen might be regarded as the more industrial space. It includes evidence for a large bread oven, and there was once a wash house off the north side. It was the workaday kitchen, and also the place where the men from the fields would come in for food and drink. This room, the hall/ dining room, was probably a more private and formal multi-purpose dining room, a more low-level familykitchen and general living room. Since the mid 20th century the fireplace has been mostly blocked in brick, and the lintel covered with lath and plaster, to create a much smaller fireplace. The original has jambs of neatly- finished sandstone blocks and an unchamfered oak lintel. If this plain lintel is the original, it is unlikely that the fireplace was built before c1700, since it seems to have been designed for an applied

The doorway to the parlour, through the south end of the east wall, has a solid pegged frame with an applied ogee architrave, which dates from the 18th century (Fig.13). The door has six fielded panels on the hall side, and plain panels on the other. It is grained on the hall side. At first sight it may seem surprising that the best face of the door faces to hall, rather than the higher status parlour beyond. This may lead some to suspect that it has been re-hung the other way round. However, this is quite normal. The door advertises the high status of the room beyond, rather than keeping it secret within.

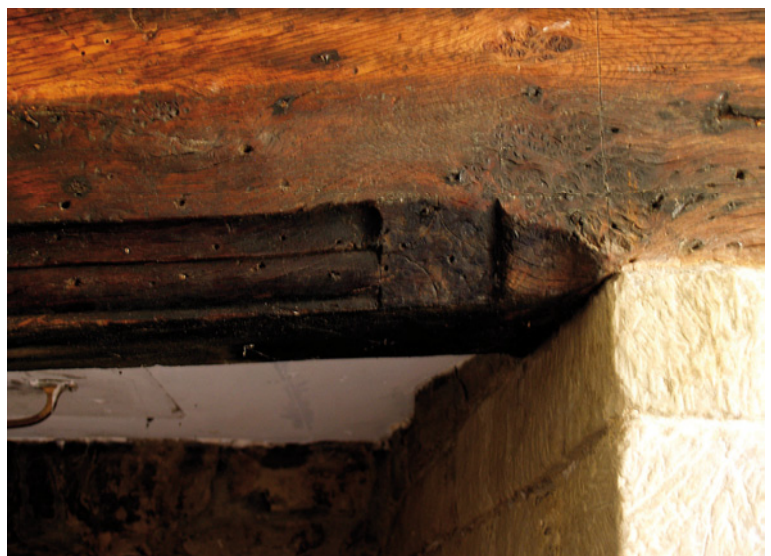
[14] Detail of the 17th century parlour fireplace showing the stop to the moulding on the oak lintel.

The parlour is full-width and heated by a fireplace in the east-end wall and is lit by a window to the south. The fireplace is a typical parlour example from the early or mid 17th century. It has neatly-squared sandstone block jambs, with an oak lintel, which has, along the lower edge, a hollow to an ovolo moulding with chamfer to scroll stops (Fig.14). The grain of the oak is shot through by burrs. To the left of the fireplace there is a small oak lintel to a

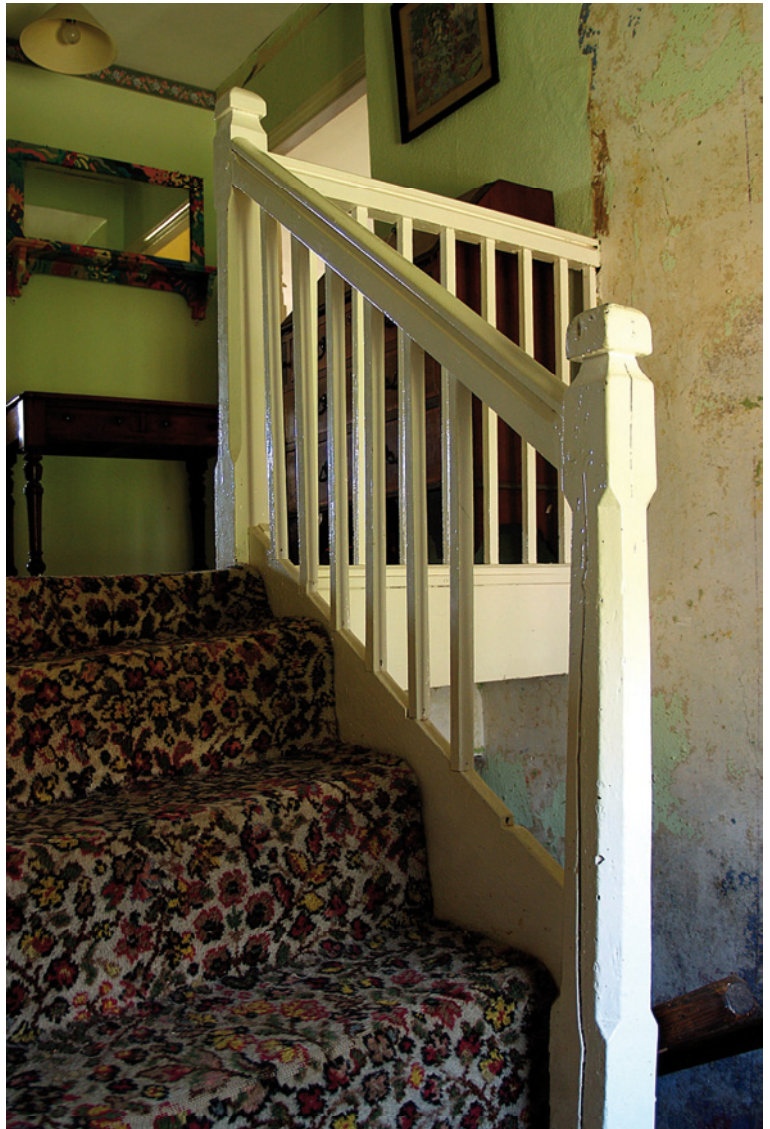
[15] *The main stair was refurbished c1880, but the lower newel post may survive from the 18th century.*

The main stair possibly dates from first half of the 18th century with some repairs from c1880 (Fig.15). It is a dogleg stair with a balustrade from the half landing to the first floor. There are two newel posts. Both are chamfered posts with faceted mushroom-shaped finials. The stair has a narrow closed string (little more than a board) with stick balusters to a simple handrail. It is difficult to date such plain and rustic joinery. However it does seem that the stair has been repaired. The lower newel post has straight cut stops to the chamfers and looks more worn than the upper one, which has runout stops. Assuming the repair dates from c1880 the stair must be older.

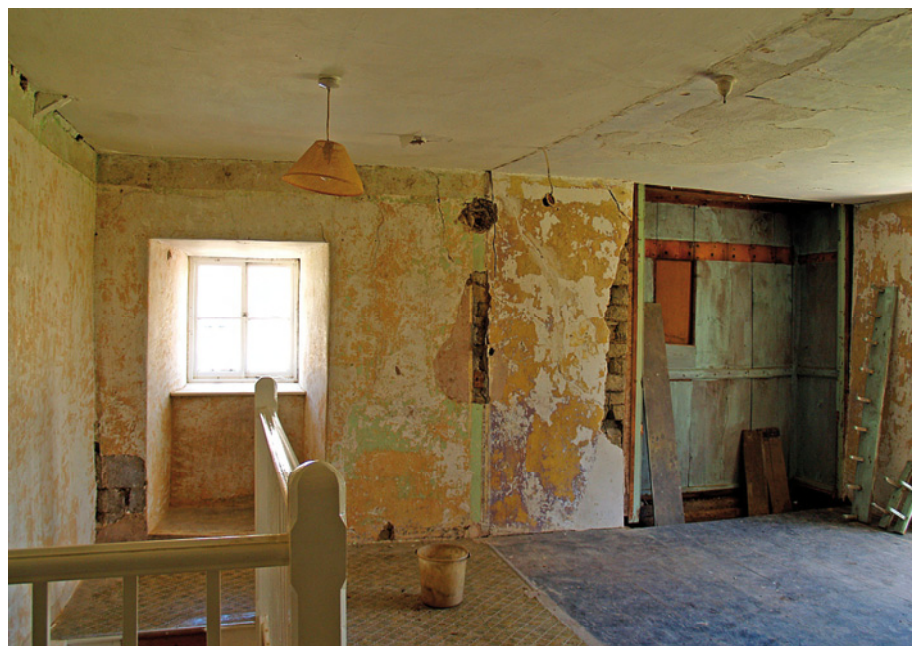
[16] *The first floor chamber at the east end of the first floor level, looking east. A scar along the ceiling shows that there was once an axial partition dividing the space into two.*

The largest chamber is the one at the east end, over the parlour (Fig.16). It is also accessible by means of the 1950s stair. There is no sign of a recent fireplace or the blocking of one in the east end wall. However the deep embrasure of the eastern window

includes some neatly dressed limestone blocks which look as though they might have been the jambs of a 17th century fireplace. In the same wall, to the south, there is an alcove, which previously housed a built- in cupboard probably dating from c1880. It has been recently (April 2006) opened up and although it has lost its doors it still has rows of wooden hooks on boards. The window to the south has a full-height embrasure and is deeply recessed, with a seat.

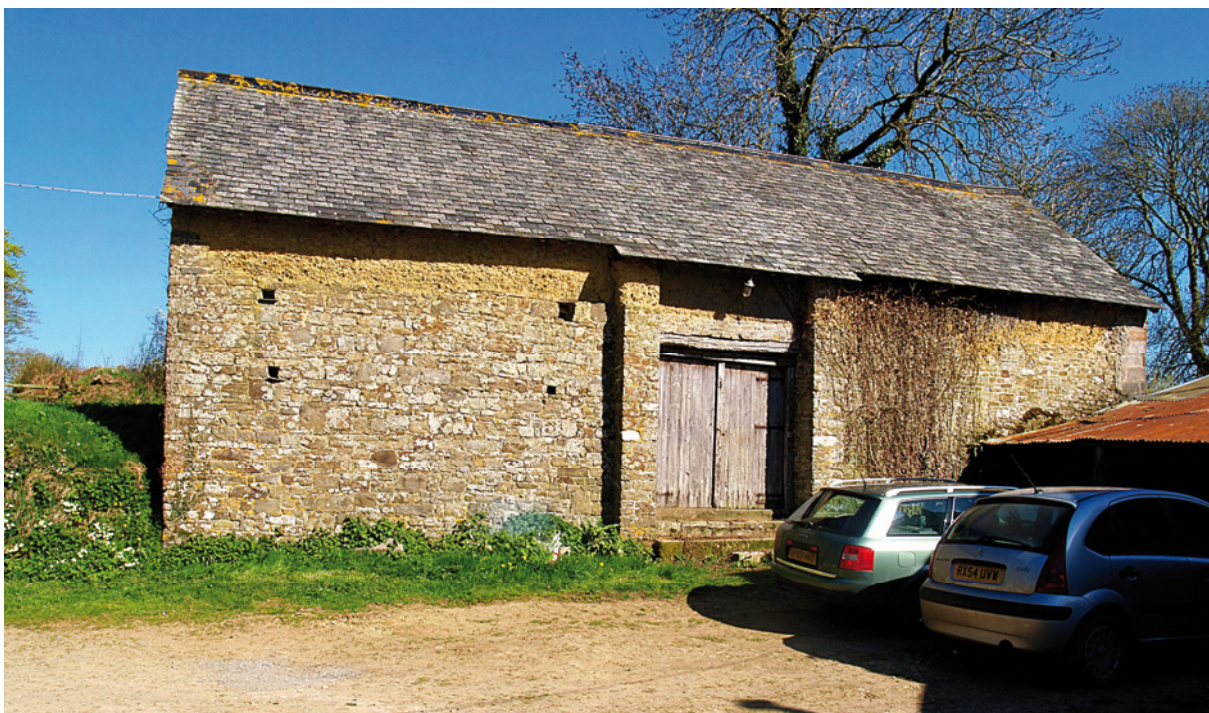
[17] *The west front of the barn.*

.Exterior: The west front has a central large threshing doorway flanked by projecting midstreys cheeks (like pilaster buttresses) (Fig.17). The roof-pitch continues forward between the cheeks to provide a narrow hood over the doorway. The doorway, up three stone steps, is full-height and takes double doors in a sturdy, solid and plain frame, joined with pegged mortise-and-tenon joints. There is a central, removable post which acts as a doorstep when the doors are closed but can be removed when the doors are open. The double doors are of plank-and-ledge construction hung on strap hinges, although the left door is largely a 20th century mend.

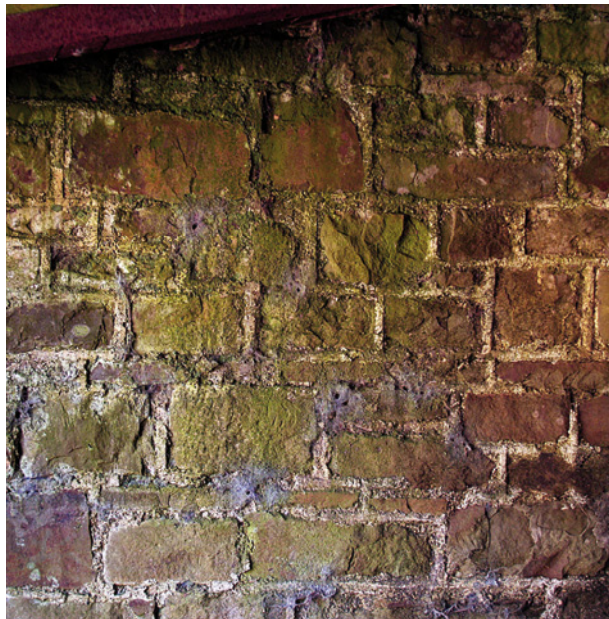
[17] *Detail of the original pointing on the south end of the front, preserved within the cartshed.*

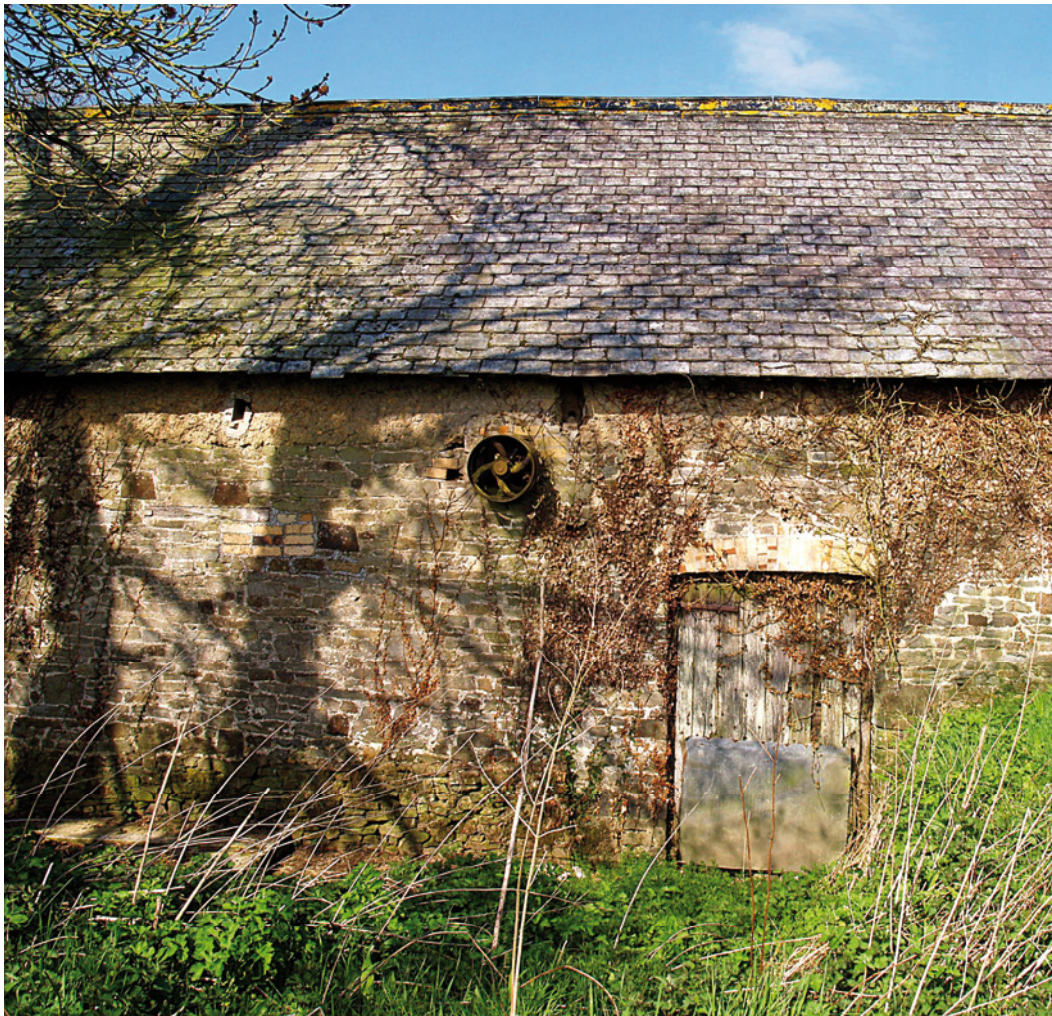
[19] *The centre of the north wall, showing the man-sized doorway to the threshing floor, with the driveshaft and belt drive for an external source of power.*

The east long wall to the rear has a central man-sized door to the threshing floor which is formed under a segmental arch of Marland bricks (Fig.19). The frame is solid and pegged, and it contains a door of ledge-and-brace construction, hung on strap hinges. To the left of the door there is a hard standing, apparently on the site of the former horse-engine house. The wall above contains the evidence for a powered machinery inside the barn. There would have been a steam engine on the hard standing (maybe a traction engine that toured the smaller farms after the harvest), and agricultural machinery inside.

The wall contains a cast-iron driveshaft with a wheel for a belt drive. Further to the left, a small area of blocking indicates the position of a shouting hole, where those working the engine outside could communicate instructions with those on the machines inside. There is a small rectangular hole close to the drive shaft hole. Its purpose is not clear, but could have been provided for another driveshaft. Nicholas Cooper speculates that this was “an opening for some kind of simple control (a string or a chain) whereby someone inside the building could operate a brake or a valve or a reverse on the steam engine.” (letter 02.01.07)

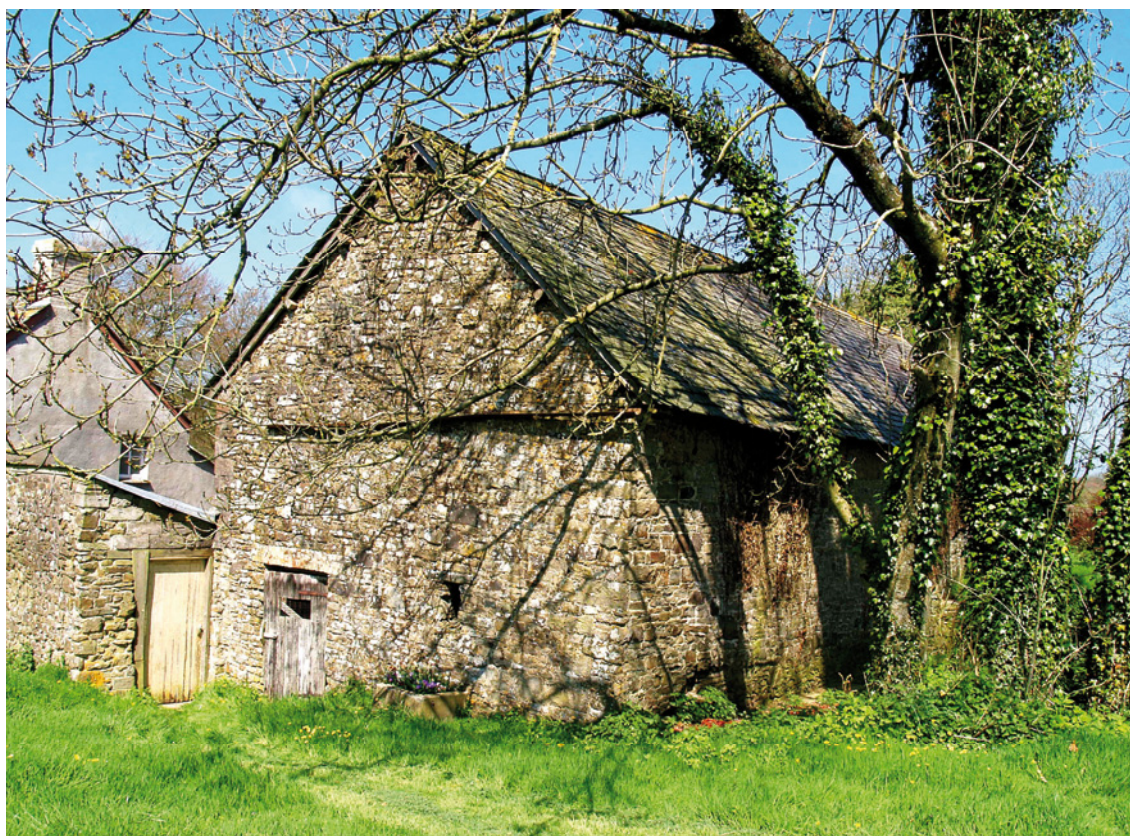
[20] *The southern gable end of the barn. This is all stone rubble, and this end includes a calf-house.*

The south gable-end wall has a doorway to the left, into a calf house, with a segmental arch head made up of Marland bricks (Fig.20). The doorframe is plain solid timber and pegged. The door is of plank-and-ledge construction and hung on strap hinges with one splayed and one teardrop finial. The door has a timber latch. There is also a narrow ventilation slot to the right of the door.

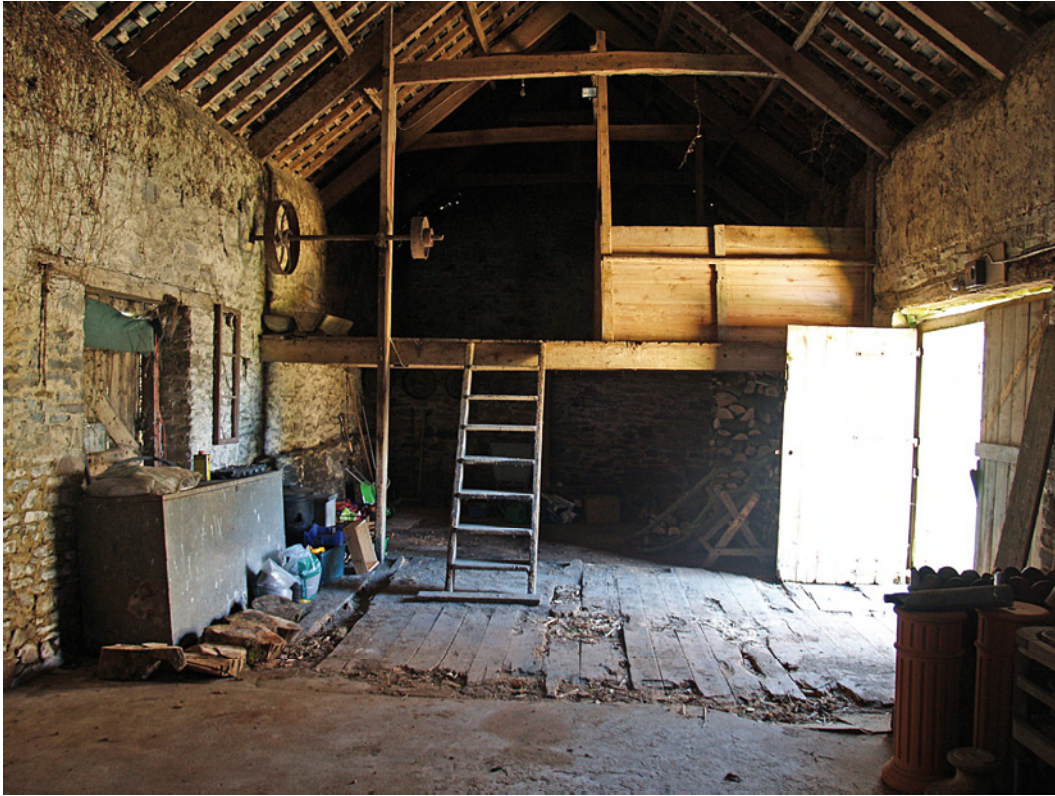
[21] The inside of the barn, looking south towards the lofted end, and showing the threshing floor in front. The driveshaft with belt drives and gearing comes through the the right-hand (east) side just beyond the threshing floor.

Interior: The remains of the threshing floor survive between the two doors (Fig.21). It consists of hefty timber (probably elm) planks laid between the opposing doorways. They needed to be heavy to withstand the repeated impact of the hand flails. Conventionally they were constructed from either oak or elm. Alongside the front

The rear also includes the inside end of the iron driveshaft with a wheel for a belt drive and a gear train, and alongside is the blocked shouting hole (Fig.21).

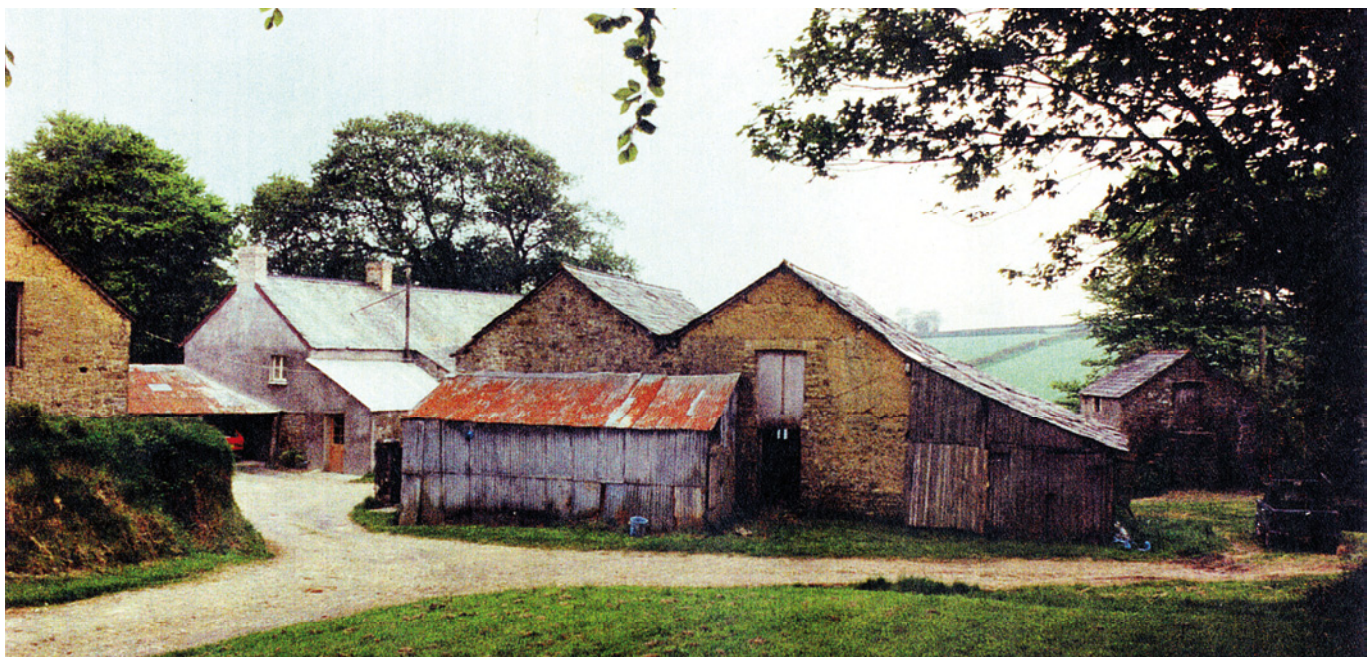
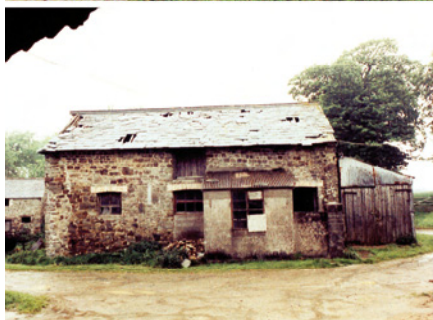
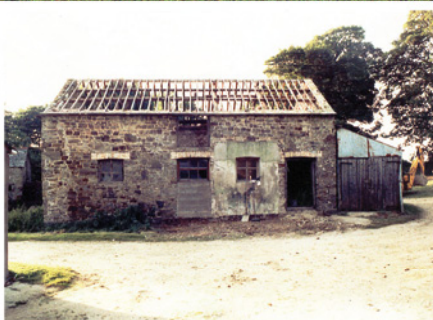
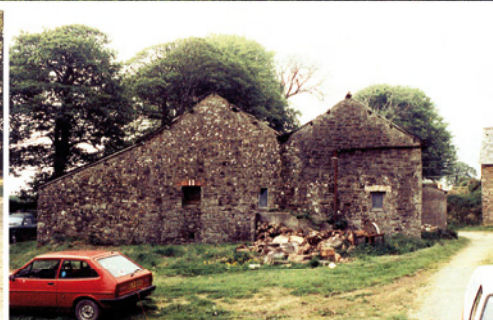
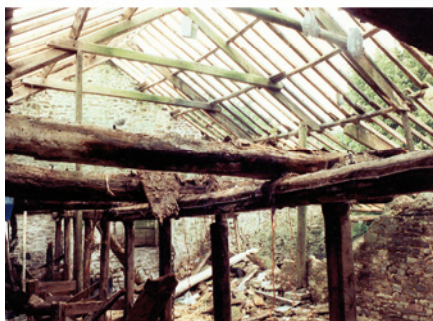
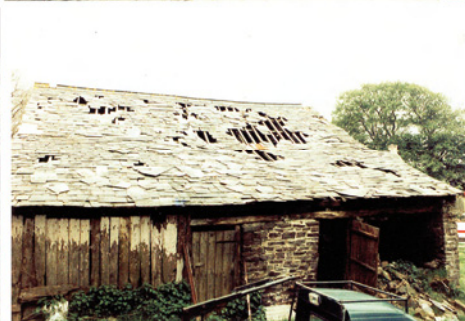
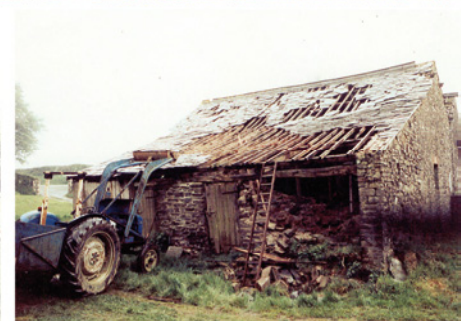
THE c1880 MULT-PURPOSE BLOCK IN THE CENTRE OF THE YARD IN 1994.

- [22] The complete stable, shippon, calf house and root store block from the east. The right hand gable, to the shippon, includes a load of cob.*
- [23] By 1994 the south range was a milking parlour with a mid 20th century concrete blockwork lean-to in front for the milk tank.*
- [24] The 20th century lean-to was removed.*
- [25] The west end elevation with the stable, shippon and calf house still standing.*
- [26] A photograph taken within the shippon, looking west, during demolition. Although part of the north wall has gone, the roof structure is still there.*
- [27] The north side of the range was the leanto calf house (taking up the right hand two thirds or so) with the boarded root store to left. A photograph taken during demolition.*
- [28] Another view of the same.*

This stable was built c1880 and is the only surviving part of a larger building complex which originally comprised a double gable-ended block with the stable to the south, a shippon to the north and a further lean-to to the north of the shippon, which was another calf house with one end walled off as a root store. It is shown complete on the first and second edition OS maps of 1886 and 1905 (figs.4 & 5) in its three parts, and was recorded as part of the 1911 Inland Revenue 'Domesday' survey (by which time calves also occupied the eastern end of the stable) (Fig.6). It survived in this complete form, with additional lean-tos off the west, east and south side, until 1994, when the northern sections (and lean-tos) were pulled down. It is recorded complete on the aerial photograph of the farmstead from c1970 (Fig.7), and its demolition was recorded in a series of photographs taken by the Piper family (Figs.22-28). The last agricultural use of the stable was as a shippon, and it had been used for this purpose for a considerable number of years.

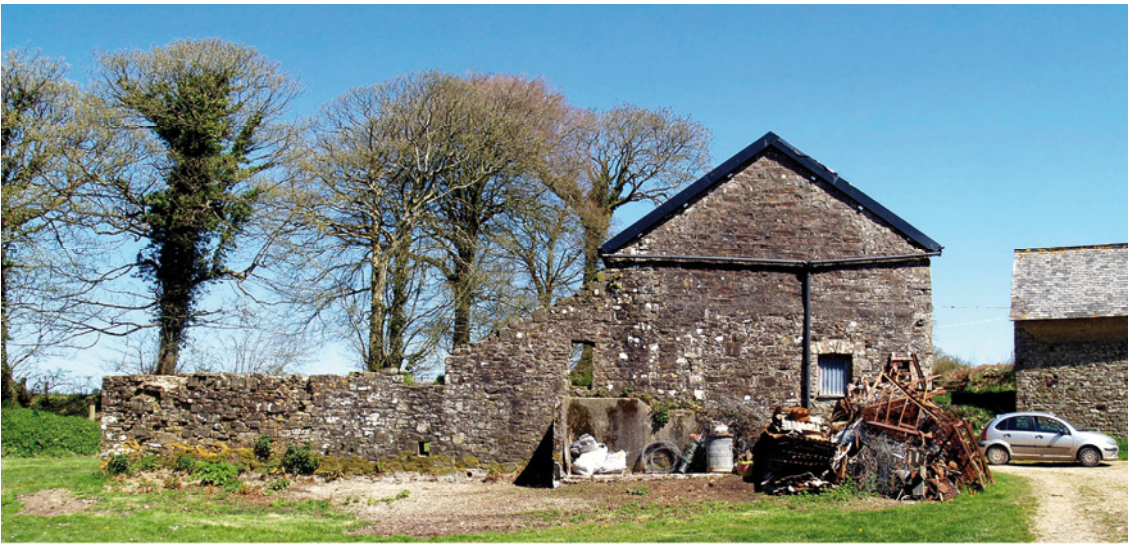
- [29] *The west end of the working horse stable/ the later shippon and milking parlour showing the low wall extending to left (north) across the ends of the former shippon and calf house.*
- [30] *The south front of the former working horse stable in 2006.*
- [31] *The roof of the former working horse stable looking west.*

The building is five bays long and constructed from local mudstone and sandstone rubblestone, some of which is semi-dressed and roughly brought to course in places. The arches above the ground floor doors and windows are constructed in Marland brick. It is gable-ended and the roof is covered with corrugated sheeting (replacing the slate shown on the old photographs). Besides the blind rear wall of the stable which was the shared division, all that remains of the shippon to the rear is the lower part of the west end wall, with a central drain-hole, with the remains of an original window above and a secondary window to the south. It extends northwards as a low wall as far as the end of the former calf house (Fig.29).
