VENN FARM, EAST PUTFORD, DEVON

Report K721

The Brief

Keystone Historic Buildings Consultants are contracted by Rosemary and Jeremy Jessel to provide an assessment of the farm from an historic and archaeological point of view. The report comprises a description of the fabric of the buildings, their layout, features, dating and development. It is accompanied by a photographic record. It also includes the documentary history of the property.

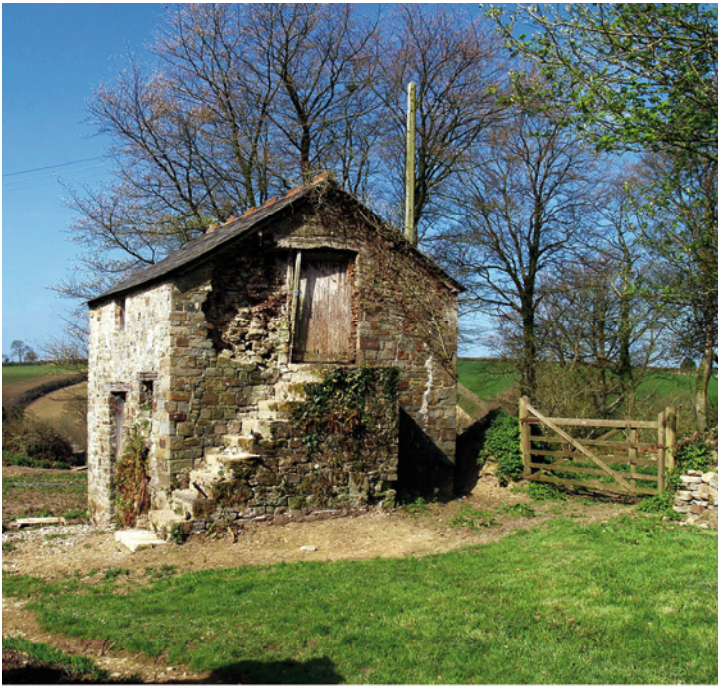
- [32] *The east end of the granary over the putative riding horse stable, showing the external stairs up to the first floor granary.*
- [33] *The south front and west end of the granary over the putative ridinghorse stable.*
- [34] *A detail of the blind west wall of the granary block showing the surviving remnants of its lime plaster render.*

It is a two-bay, two-storey building with the granary above, reached by a flight of external stone steps to the east, and a small stable below (Fig.32). It is constructed from mudstone and sandstone rubblestone and quoins bonded in mud mortar. A patch of original lime render survives on the west wall (Fig.34). The northeast corner was reconstructed in concrete block in the 20th century. It is gable ended with a slate roof and red earthenware ridge tiles consisting of alternate plain and roll moulded tiles.

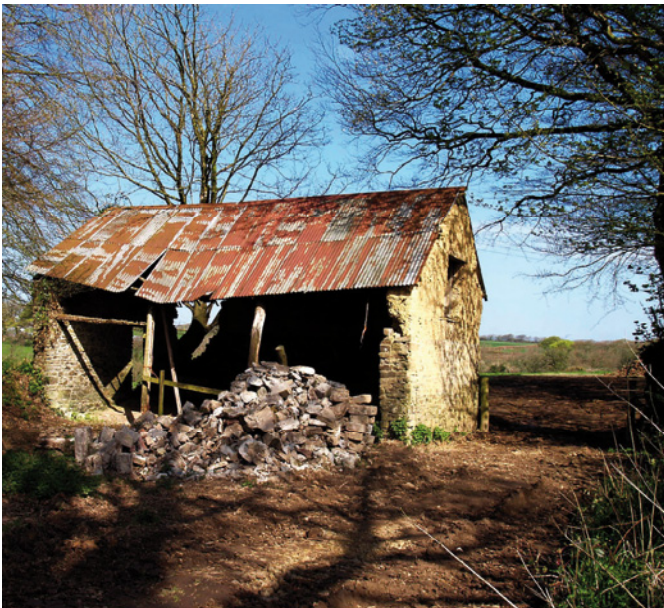
[35] *The south front of the linhay.*

two. It is three bays long, gable-ended and faces south (Fig.35). Linhays are a particular type of shelter shed found in Devon. Conventionally they consist of an open front, with shelter for cattle below a tallet, which was used for storing hay. The tallet was usually open, but sometimes it could be boarded. Later alterations have removed just about all evidence of the tallet floor, except for a couple of holes on the cob at loft level. It is also tall enough to accommodate a tallet, and the loft hatch would suggest that there must have been one.

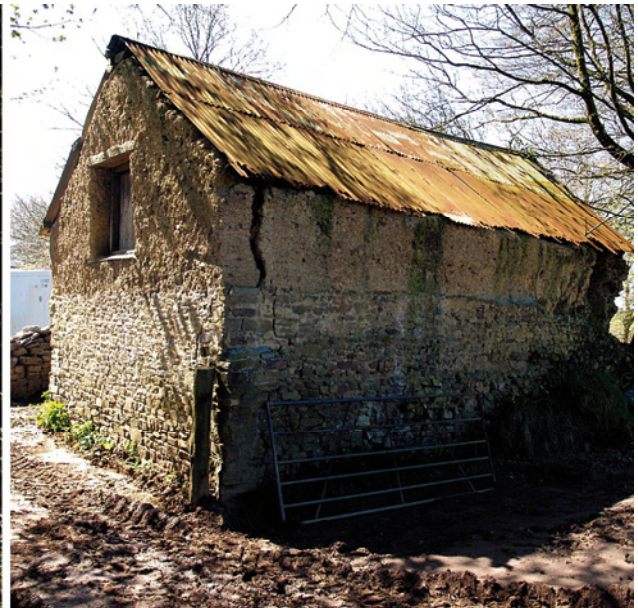
[36] *The linhay from the northeast showing the rear wall and the east end containing the hayloft loading hatch.*

It is constructed from local rubblestone and cob. The east gable and back wall are cob over tall stone rubble footings (Fig.36), and the north gable is all rubblestone (maybe a rebuild). There is a loft hatch in the east gable end. It has a ledge and brace door and is hung on strap hinges with teardrop finials. It has a solid pegged frame, lintel and sill. There is a doorway through the north end wall (from the orchard). The south front is open and supported on secondary timber posts. There is a stone trough and the remains of a hayrack along the back wall.

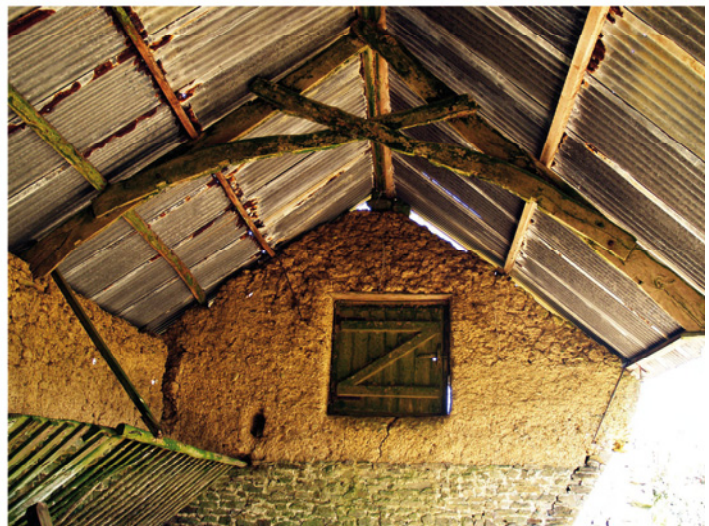
[37] *The roof structure of the linhay looking east. The end wall contains a socket towards the left hand side which, with others, suggests an original lofted building.*

The roof is three bays of waney principals with halved, lap-jointed scissor braces (Fig.37). The feet of the principals rest on timber pads in the cob wall to the rear and onto the tops of the posts to the front. The timbers are pegged and nailed. There is no evidence of the original purlins. The common rafters are 20th century replacements for the corrugated iron roof.

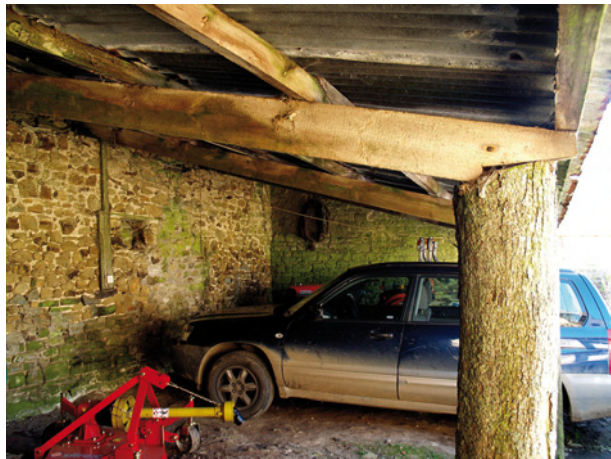
[38] The inside of the cartshed looking west from the barn end towards the end of the house. the rear wall to left includes a keeping place. The capentry is rather rudimentary.

It is three wide bays long and open-fronted (Fig.38). The roof is monopitch and covered with corrugated iron. The rear (south) wall is constructed from mudstone and

The north front is open, with waney, square-section posts supporting the roof timbers.

Inside there is a keeping place under an oak lintel in the back wall. This would have been used for storing small tools and materials for the carts, such as grease. The floor is cobbled.
