**ARCHAEOLOGICAL EVALUATION:
VICARS WALK
GOLDINGTON
BEDFORD
BEDFORDSHIRE**

NGR: TL 0748 5081

on behalf of Futurebuild Contractors Ltd

November 2013

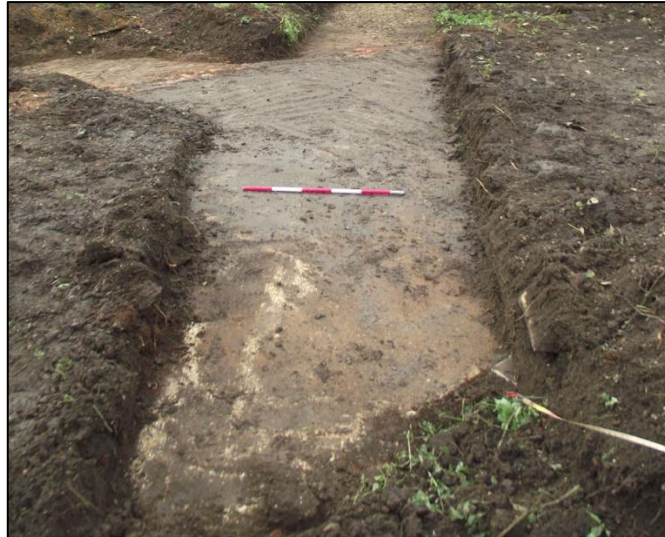
Plate 1: Building 133, concrete floor (centre), wall 105 (top left), wall 116 (bottom right), looking southwest, 1x1m scale

4.4.4 An internal concrete floor surface (106) was identified between walls 105 and 116 (Plates 1&2).

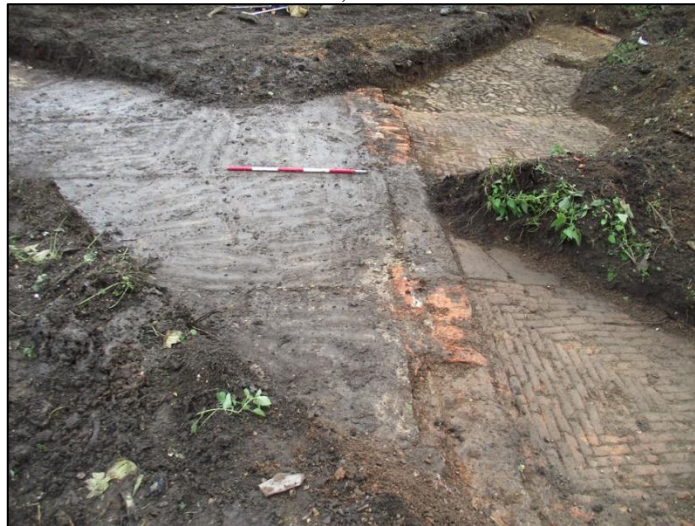
Plate 2: Wall 105 (centre), brick paving 104 & flagstones 107 (bottom right), brick paving 108 & cobbles 109 (top right), 1x1m scale

4.4.3 A break in the southern brick wall footing 105 was filled by a worn rectangular stone slab indicating that a doorway was located at this point (Plate 2).

- 4.5.1 To the south of wall footing 105 and adjacent to the stone slab step was a path constructed of stone flagstones (107) flanked on either side by a surface of small red handmade bricks (104) & (108) (190x85x70mm). Occasional concrete repairs were noted (Plate 2).

- 4.5.2 At the western limit of trench 1 and southern limit of trench 2, abutting brick surfaces (104) & (108), were two areas of cobbles, (103) & (109) (Plate 2).

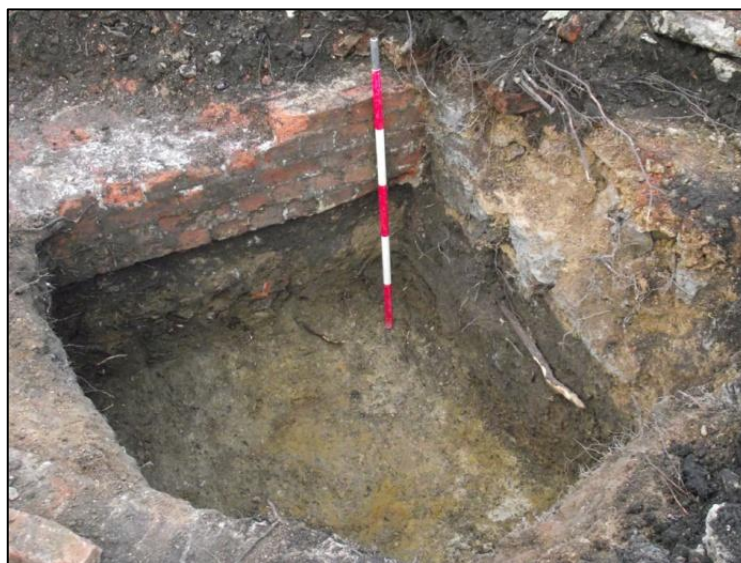
Plate 3: Test pit 5: Wall 116 (left), wall 118 (right), 1x1m scale

4.4.5 A test pit (TP 5; 1x1m and 1.25m deep) was excavated through the concrete floor surface and against the southern face of wall 116 at the north-eastern end of trench 1. The pit was excavated to determine whether any earlier floor surfaces, structures, or cut features survived below (Plate 3).

Four courses of brick survived in wall 116 below the current ground level. The wall was supported by a solid mortar footing, (117), which cut through a buried topsoil (119) and subsoil (120) (Plate 3).

An internal north-south orientated wall footing, 118, was identified within the test pit, abutting the southern face of wall 116. The wall footing was sealed by the concrete surface and contemporary with the original brick floor surface, (115). The wall footing comprised three courses of clunch blocks (Totternhoe stone) bonded with cream-yellow mortar. The wall was supported by a foundation of solid mortar (127) which cut through the buried topsoil layer (119) (Plate 3).

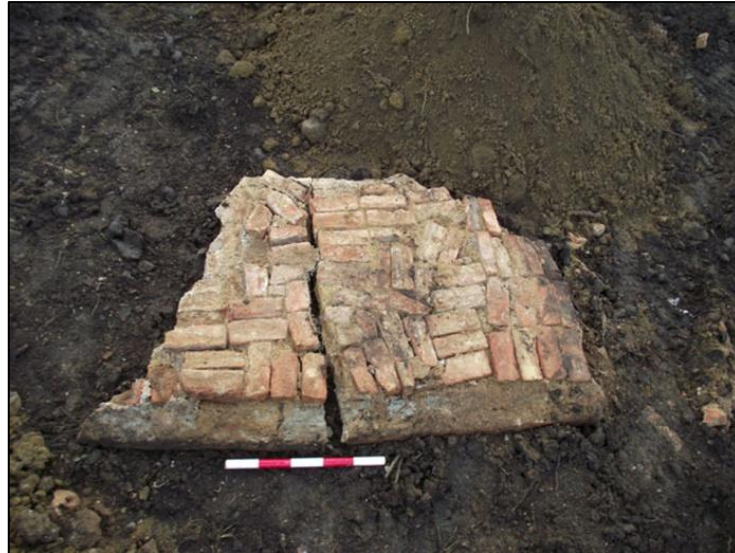
Plate 4: Original brick floor surface 115 stuck to concrete 106, 1x0.5m

Beneath the concrete floor was an earlier floor surface (115), constructed of small red handmade bricks (190x85x70mm) (Plate 4).

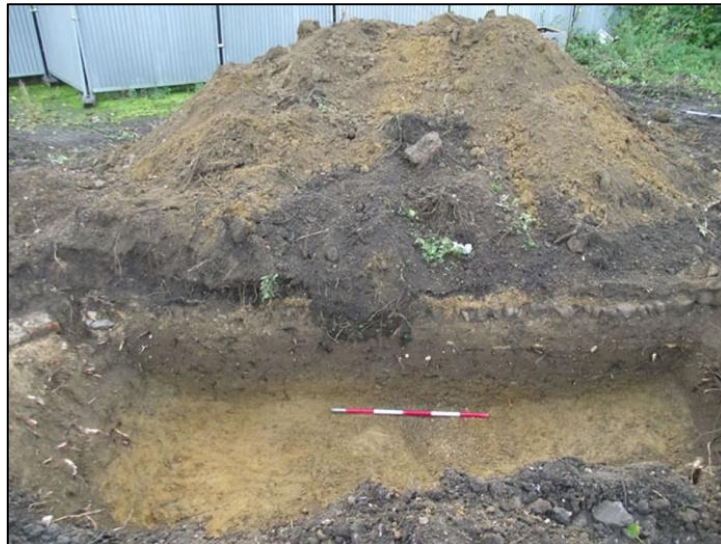
Plate 5: Test pit 3-section 2, looking southwest, 1x1m scale

- 4.5.4 Two test pits, (TP 3 & 4; 1.8m wide x 3.5-5m long) were excavated through the cobbled surfaces (103 & 109) to determine whether any earlier floor surfaces, structures, or cut features survived below (Plates 5 & 6).

The test pits revealed a made ground deposit (102) and (110), into which the cobbles had been set, which in turn overlay a buried topsoil (131 & 124) and subsoil (132 & 125). No significant archaeological features were noted in either test pit: the only features comprised a modern cable trench [122] and a modern pit within Test pit 3-Trench 2.

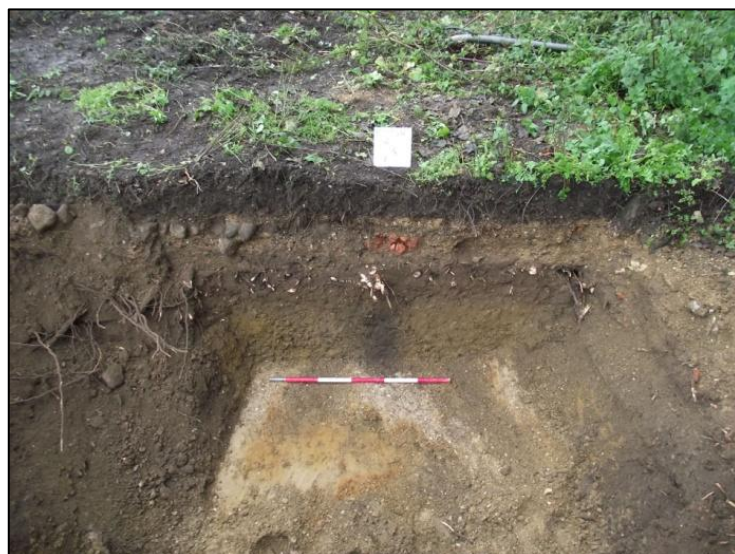
Plate 6: Test pit 4-section 4, looking southeast, 1x1m scale
