# Archaeological Services & Consultancy Ltd

**HISTORIC BUILDING RECORDING:  
THE BARN  
MICKLEFIELD HALL  
SARRATT  
HERTFORDSHIRE**

November 2008

ASC: 1125/SMH/1

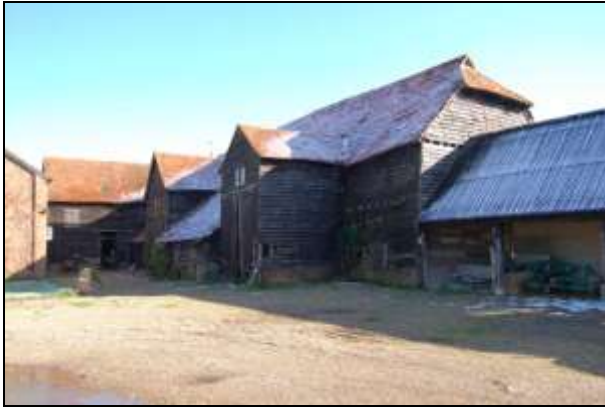
**Plate 1:** Barns form the northwest

*This L-shaped building consists of a large, 7 bay barn with two midstreys and two outshuts to the north, and a smaller barn set at right angles at the eastern end. The smaller barn has had an upper floor inserted, which is only accessible by a door at first floor level. The main barn appears to have been built in the 17<sup>th</sup> century using parts from earlier structures. The smaller barn, which may be 16<sup>th</sup> century, was added on to this at a later date, possibly at the same time that the first floor was inserted. The barn is suffering a great deal of lateral movement, particularly to the rear, and a substantial amount of repair work is required to prevent its complete decline.*

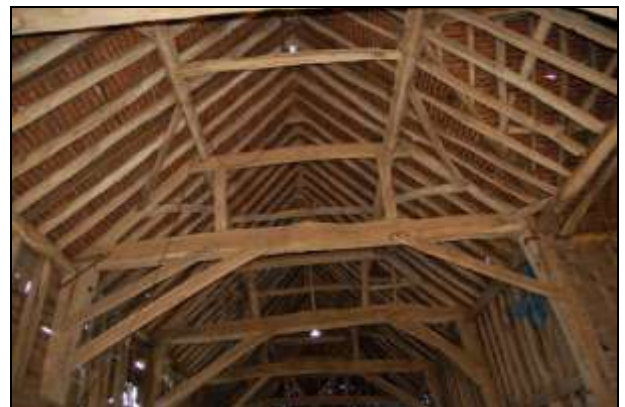
**Plate 24:** Main barn: Roof truss

The roof is a clasped purlin roof with queen posts and straight braces. Some of the braces are tenoned and others jointed. In some trusses both types of braces are present, and occasionally a single brace is tenoned into the post and jointed to the tiebeam. Despite the missing tiles, the rafters indicate that the building has clearly been re-roofed.

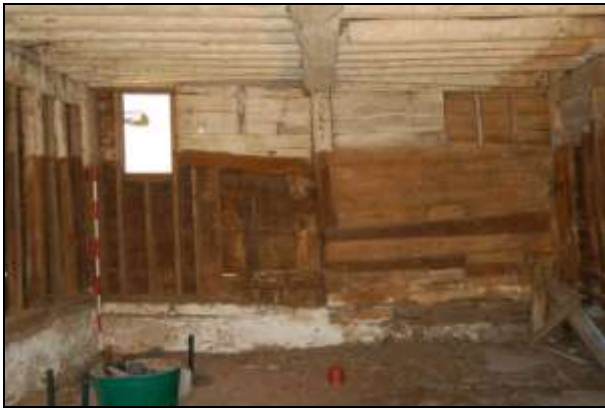
**Plate 31:** Eastern barn north wall

The frame has close studding and arched braces, and it also rests on a brick supporting dwarf wall. The clasped purlin roof has queen struts and the only carpenters assembly marks observed throughout the survey were those in the central roof truss in this barn.

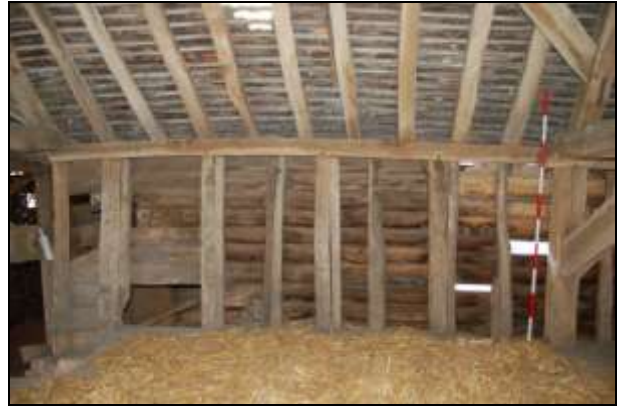
**Plate 38:** Upper floor southern end of west wall

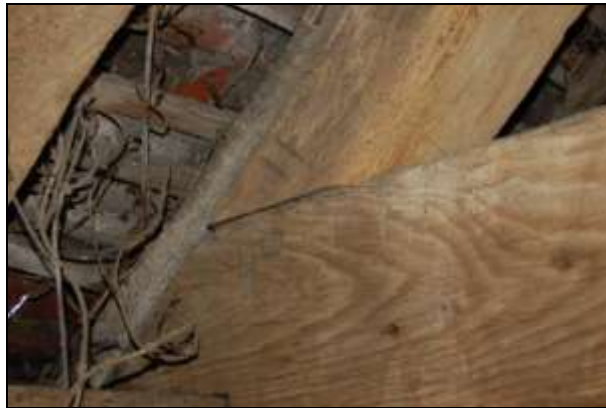
**Plate 39:** Carpenters assembly mark on roof truss

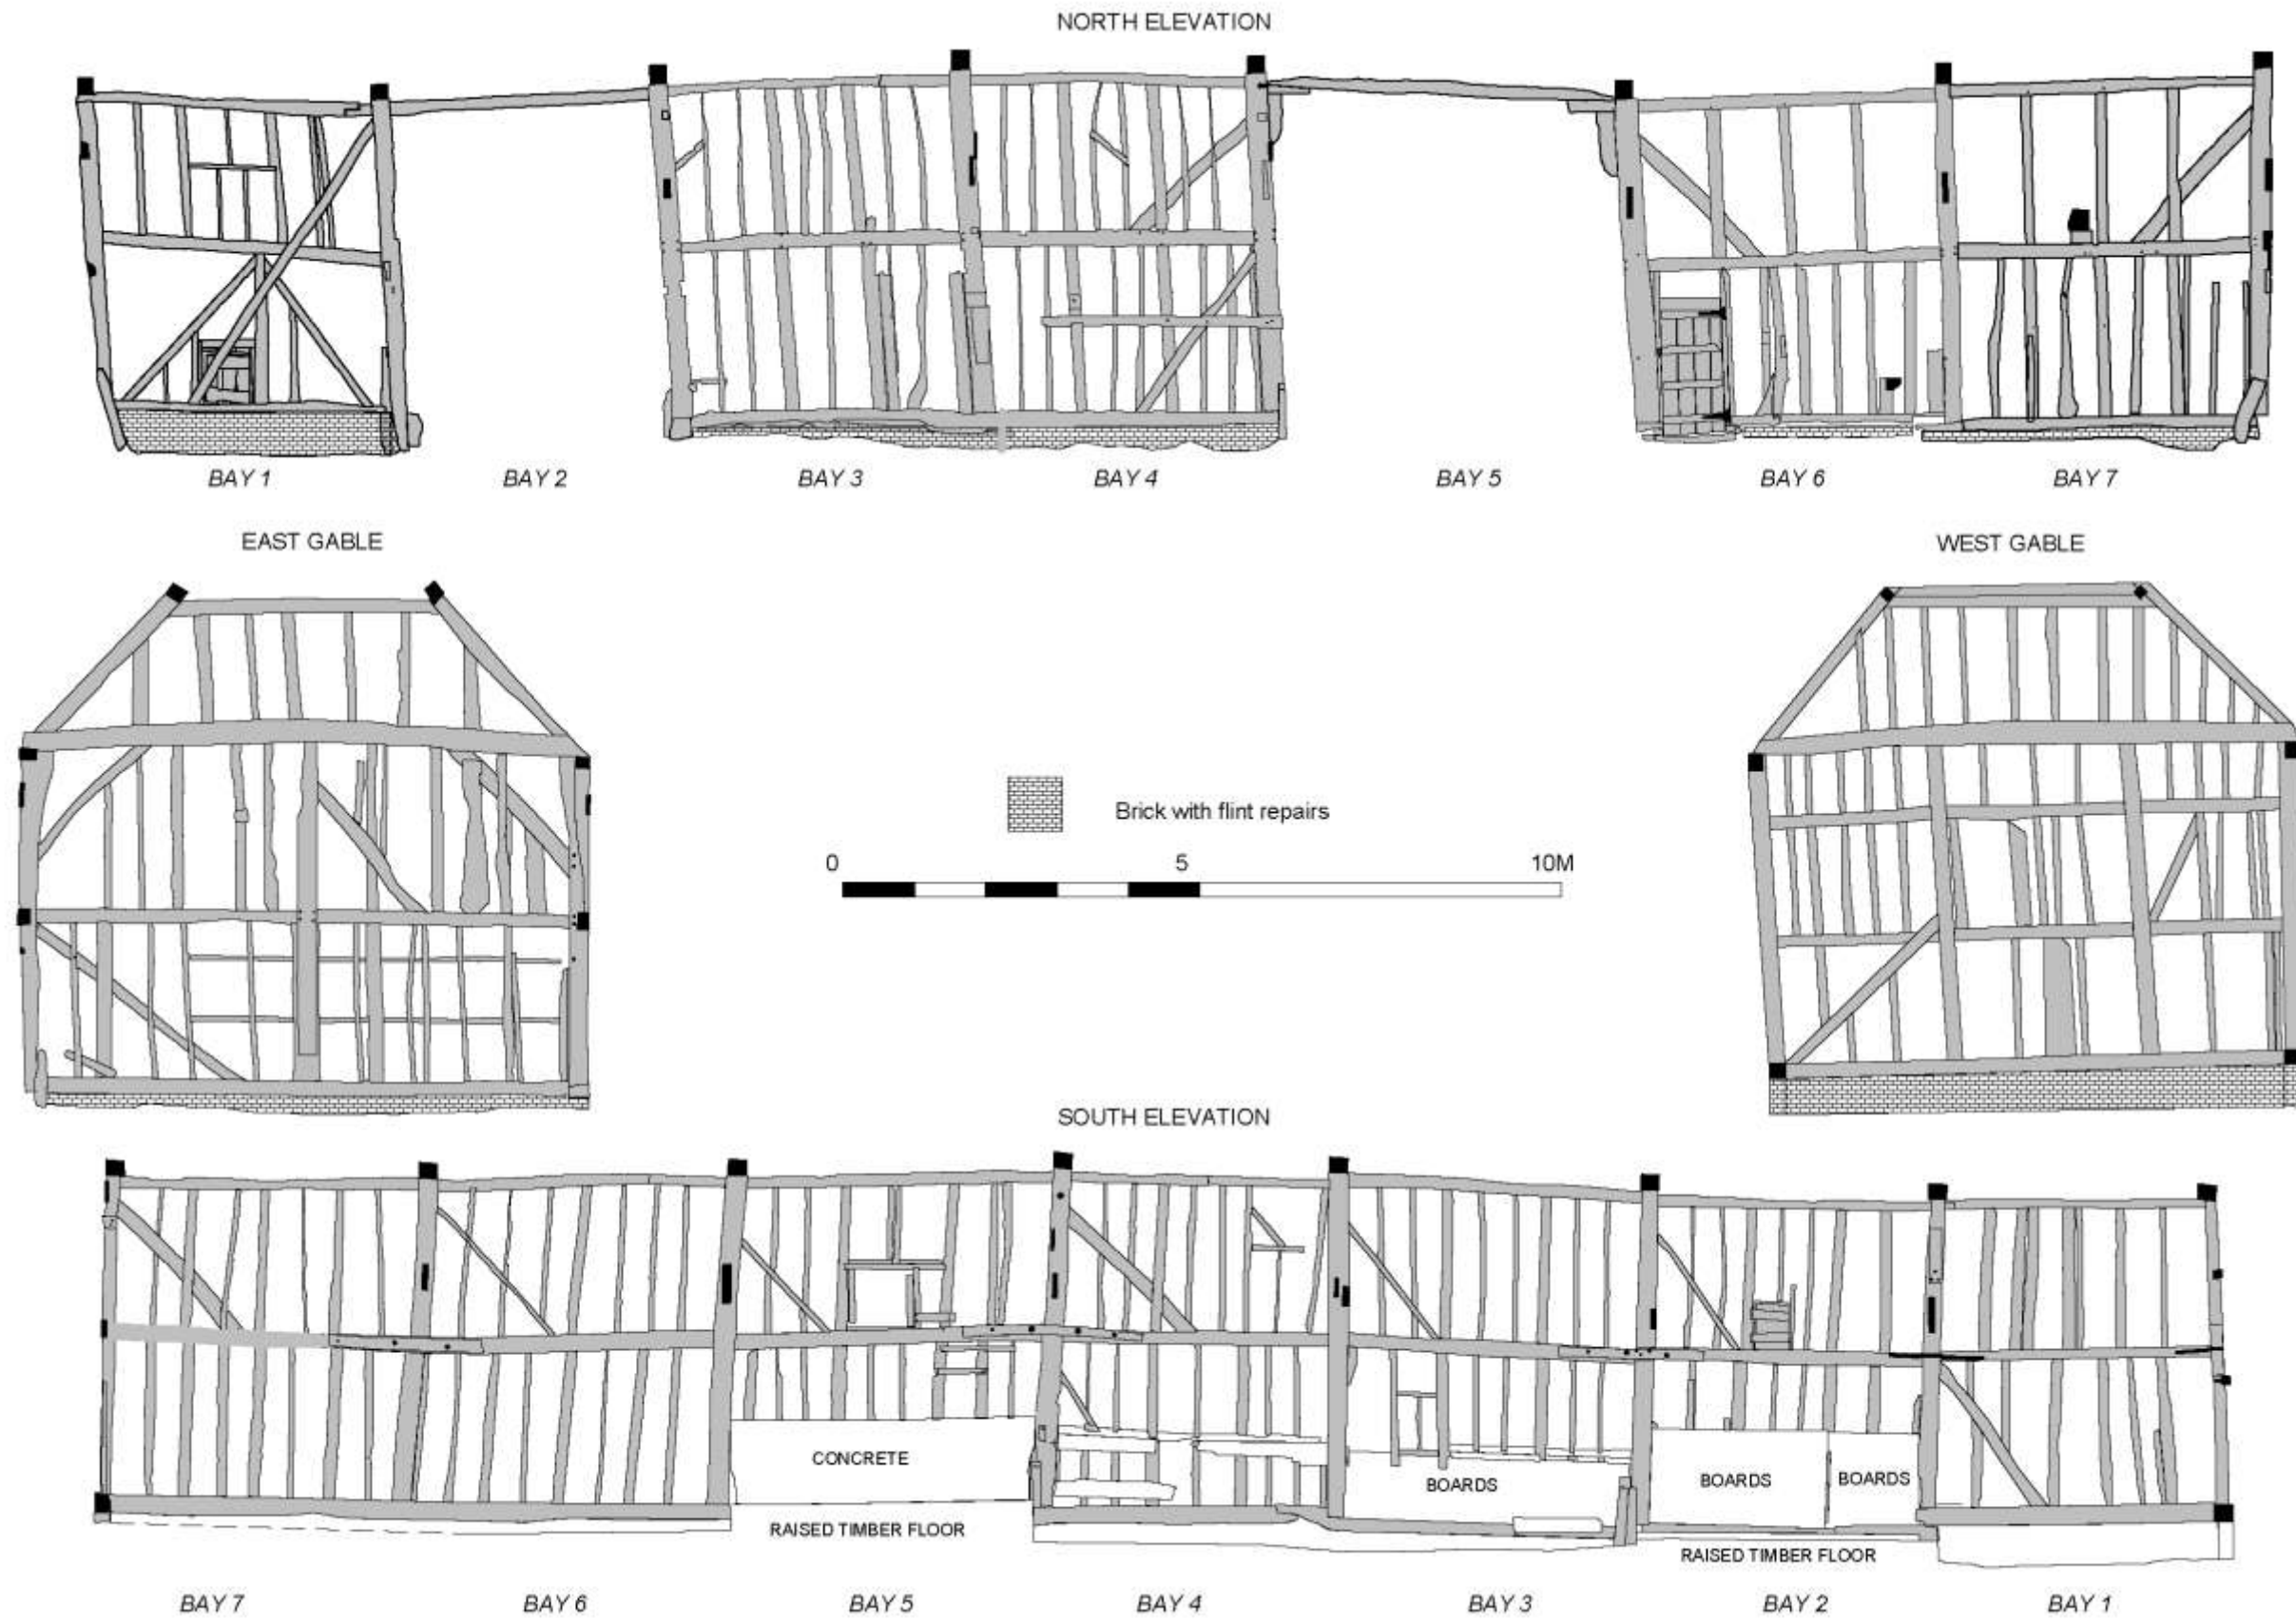
Figure 3: Main barn elevations (scale 1:100)

The main barn is a timber-framed structure under a clay-tiled roof. The frames have a mixture of primary, external and internal bracing, which suggests that it has been constructed from parts of several earlier buildings. This is further suggested by the re-used timbers with redundant mortices, the presence of different types of scarf joints in the wallplates and the different types of braces used in the roof trusses. The timbers are mainly oak, with some elm and softwood used in the weatherboarding and later repairs.

Earlier repairs to the barn are evident in the iron ties and clamps, but these have not prevented the serious listing of the building in several directions.
