The Thirteenth-century Roofs and Floor of the Blackfriars Priory at Gloucester

By O. RACKHAM, W. J. BLAIR and J. T. MUNBY

THE BUILDINGS of the Blackfriars priory in Gloucester are in the course of restoration by the Ancient Monuments Branch of the Department of the Environment. This provides an unusual opportunity to examine in a dismantled state an important series of scissor-braced roofs, to compare many timbers and joints, and thereby to consider the finer points of the 13th-century carpenter's workmanship and engineering sense, and the ways in which he reacted to variations in the timber. The value of such a study is increased by the existence of contemporary records about the origin of the timber.

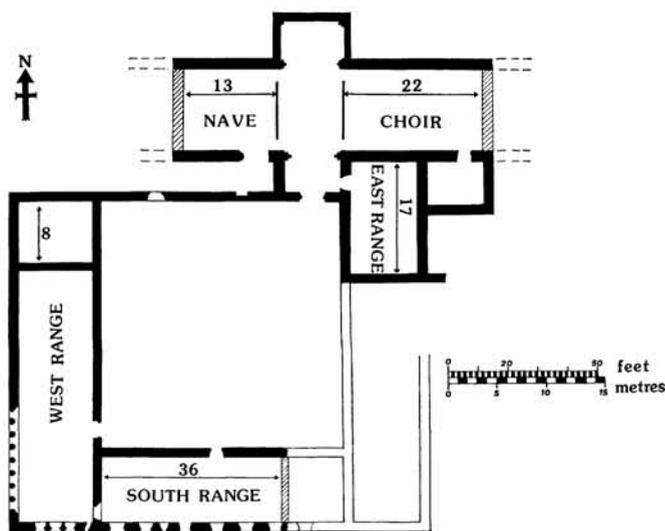
FIG. 1

GLOUCESTER BLACKFRIARS

Plan of site (after Knowles). Black — standing walls; white — known foundations; hatched — post-medieval additions. Numbers show how many original roof trusses survive in each range. The recently discovered N. aisle is not shown

THE EXTANT BUILDINGS (FIG. 1)

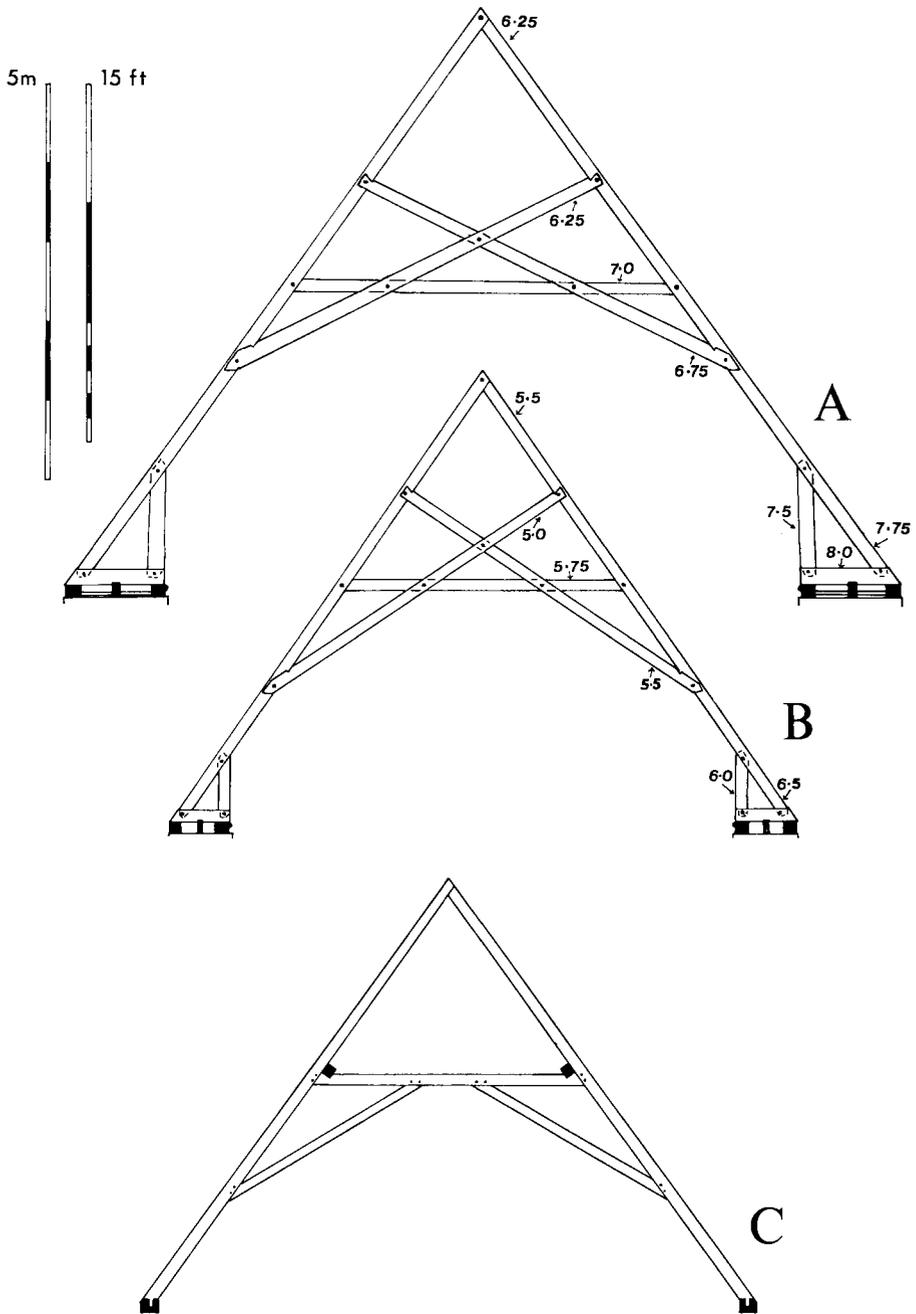
FIG. 2

GLOUCESTER BLACKFRIARS, ROOF-TRUSSES

A, choir and *B*, S. range, viewed from W.; *C*, N. transept. Numbers indicate average scantling in inches; all timbers are approximately square in section

The surviving trusses in the church and S. range are identical in form (FIG. 2, a, b, and Hewett,⁴ fig. 12); each has one collar and two scissor-braces. The sole-pieces rest on outer and inner wall-plates linked at intervals by cross-pieces to a batten set medially between them. In the choir and south range (though not in the nave) the inner wall-plate is decorated with a plain roll-moulding. The roofs of the E. and W. ranges are similar save that two trusses in the W. range have two collars and no scissors. None of the roofs ever had a collar-purlin. The trusses are closely set (average 2 ft. (0.61 m.) between centres in the S. range).

THE NORTH TRANSEPT ROOF (FIG. 2, c)

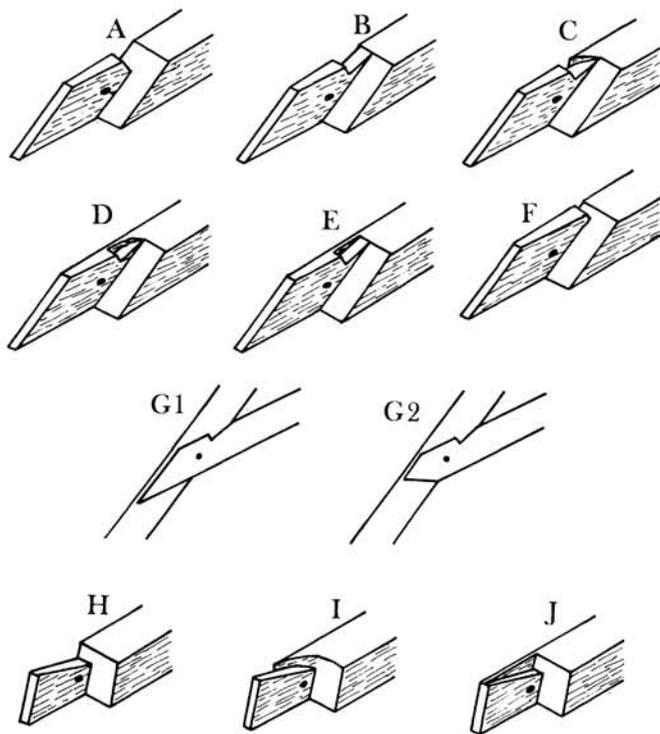
FIG. 3

GLOUCESTER BLACKFRIARS, ROOF DETAILS

DETAILS OF JOINTS (FIGS. 3, 4)

The lap-joints are of particular interest because of the numerous variations which occur randomly intermixed in the roof. Those of the choir were examined in a dismantled state and those of the S. range by probing. The two commonest notch-lap variants are the open forms shown in FIG. 3, a, b. Mixed with them are a few secret notch-laps, some of the type usual in the 13th century (FIG. 3, e), but others cut with an unusual curved shoulder (FIG. 3, c, d). The size of the notch varies widely; in a few joints of the S. range it is so small as hardly to have any structural value (FIG. 3, f). The toe of the scissor also varies in shape (FIG. 3, g).

The lap-dovetails at the heads of the scissors vary in the same way: most are open (FIG. 3, h), some are 'semi-secret' and cut on a curve (FIG. 3, i), and a few are fully secret (FIG. 3, j).

It has been widely supposed that medieval carpenters varied their joints out of regard for changing fashion rather than for structural reasons. For instance, it is claimed that the 'early', 'advanced', and 'secret' lap-joints (FIG. 3, a, b, c) form a typological progression in which the secret variant is the latest in time and is intended purely for appearance. The Blackfriars roofs do not accord with this proposition. They form a utilitarian piece of carpentry in which several ways of joining timbers end-to-side are intermingled at the same time in the same roof. The choice of joint is strongly influenced both by the stresses expected and by the vagaries and imperfections of individual timbers.

The choice of the three variants of notch-lap is connected with the properties of the timber. The strength of any notch-lap under tension depends on the integrity of the triangular tooth of the rafter's timber which engages with the notch on the scissor. With the variant of FIG. 3, a, this tooth is formed right on the arris of the rafter. In many cases this arris is formed of sapwood or oblique-grained, so that such a joint would be weak; in waney rafters the arris may be missing altogether, so that the joint could not be cut at all. Not surprisingly, most of the notch-lap joints are of FIG. 3, b type, in which the tooth is formed away from the arris on a part of the rafter more likely to be capable of bearing the stress; this variant, however, is more difficult to cut and weaker as regards the scissor.

Nearly all the secret and semi-secret notch-laps, and the parallel variants of lap-dovetails, occur in conjunction with waney rafters. Where there are internal curves they have been cut to fit the waney surfaces and to avoid gaps leading to structural weakness. The size of the web of timber left over the notch, and thus the degree of 'secrecy' of the joint, varies with the amount of wane on the rafter (FIG. 3, c, d, i).

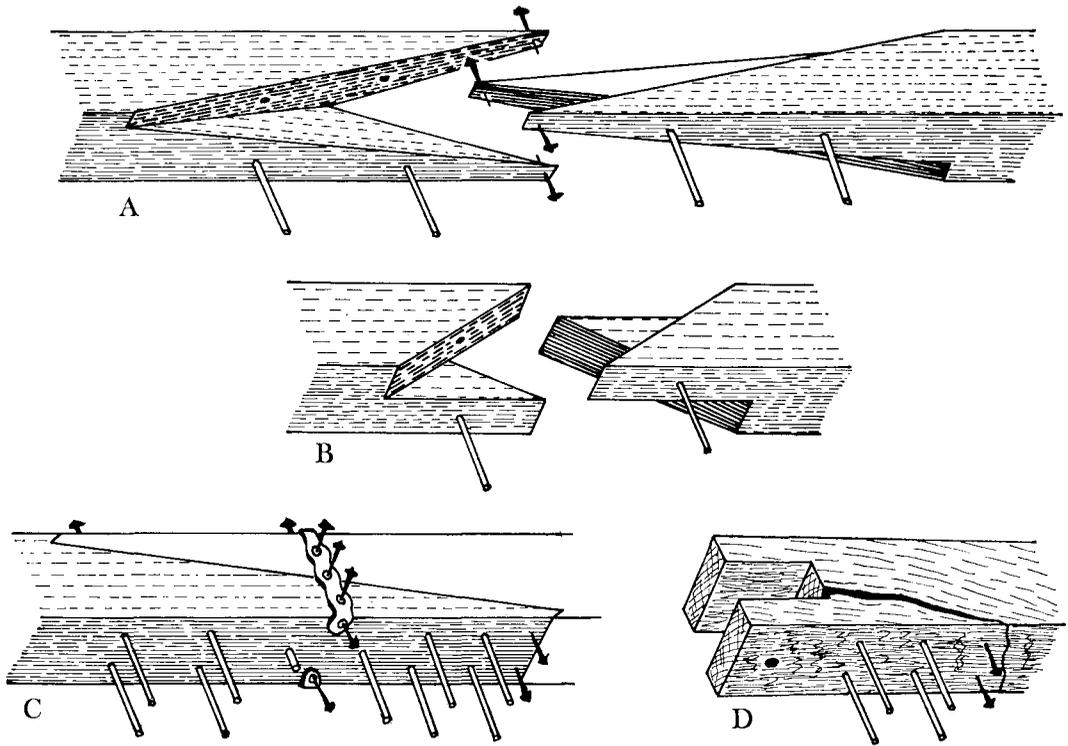
FIG. 4

GLOUCESTER BLACKFRIARS, ROOF DETAILS

Scarf-joints, etc. *A*, rafter scarf, 3 ft. 6 in. (1.07 m.) long; *B*, wall-plate scarf, 10 in (0.25 m.) long; *C*, rafter scarf, 5 ft. (1.52 m.) long; *D*, repair to rafter apex

Scarf-joints are few, but of three unusual types. One of the choir rafters is made from two short lengths of timber scarfed together by means of pairs of long, tapering prongs (FIG. 4, a). The two pairs of prongs interlock and are held with four pegs, and with a nail at each of the four points. This joint, which is easy to cut with the saw alone, occurs also in the S. range. A shorter and less elaborate version of the same joint (FIG. 4, b) was noticed twice in the outer wall-plate of the choir (one on each side) and was presumably repeated at intervals. The third scarf (FIG. 4, c) is the same as that described by Hewett⁶ (FIG. 72) for the top-plates of a barn at Belchamp St Paul's, Essex; he calls it 'stop-splayed with under-squinted butts' and attributes it to a period before 1225. The Gloucester example, in a choir rafter, has ten face-pegs, four nails, and an iron strap attached by further nails countersunk into the thickness of the strap.

FIGURE 4, d, shows the reattachment of one cheek of the apex-mortise of a rafter, which had split away owing to the obliquity of the grain liable to occur in sawn timber (see below). Similar fractures have occurred with the base-tenons of rafters. Two cases of each type of repair, involving up to four pegs and up to four

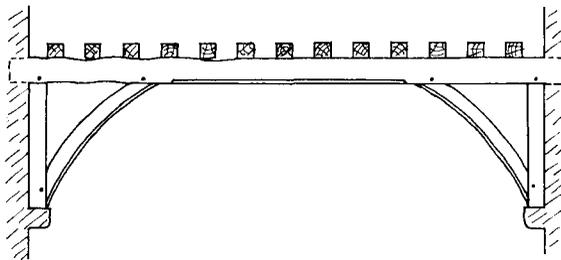
FIG. 5

GLOUCESTER BLACKFRIARS, S. RANGE

The floor of the S. range (FIG. 5) has massive bridging-joists, built into the wall (and therefore original) and supported additionally by wall-posts resting on stone corbels and provided with braces. The braces are the only example in Blackfriars of the deliberate use of naturally curved timbers. Joints are mortise-and-tenon. The braces are chamfered, and the bridging-joists (which are slightly broader than deep) provide an unusually early example of stop-chamfering. The common-joists rest on the bridging-joists without any joint: whether they are pegged cannot yet be ascertained.

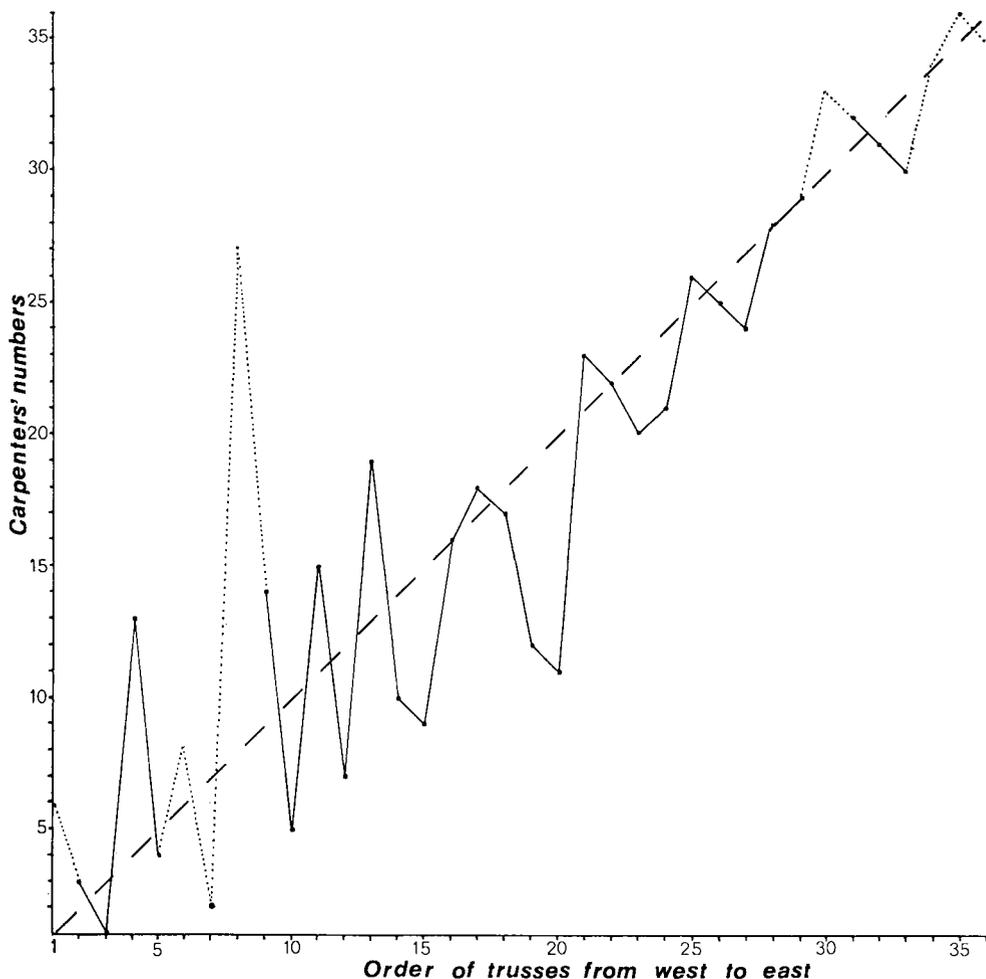
FIG. 6

GLOUCESTER BLACKFRIARS, ROOF-TRUSSES

member and in roughly the same position. In the S. range there is an almost complete series from I to XXXVI running from W. to E., the numbers being consistent within each truss. The first twenty trusses are very much out of order whereas the rest correspond fairly closely to the numerical sequence (FIG. 6). This suggests that the trusses were made elsewhere and delivered to the site in at least two batches. I to XX became disordered, perhaps through being left for a time until the completion of the walls, and were erected as they came to hand; the order of numbering was regarded as immaterial. The others, XXI to XXXVI (and presumably more in the portion of the roof now destroyed), were used in an order closer to that in which they were made.

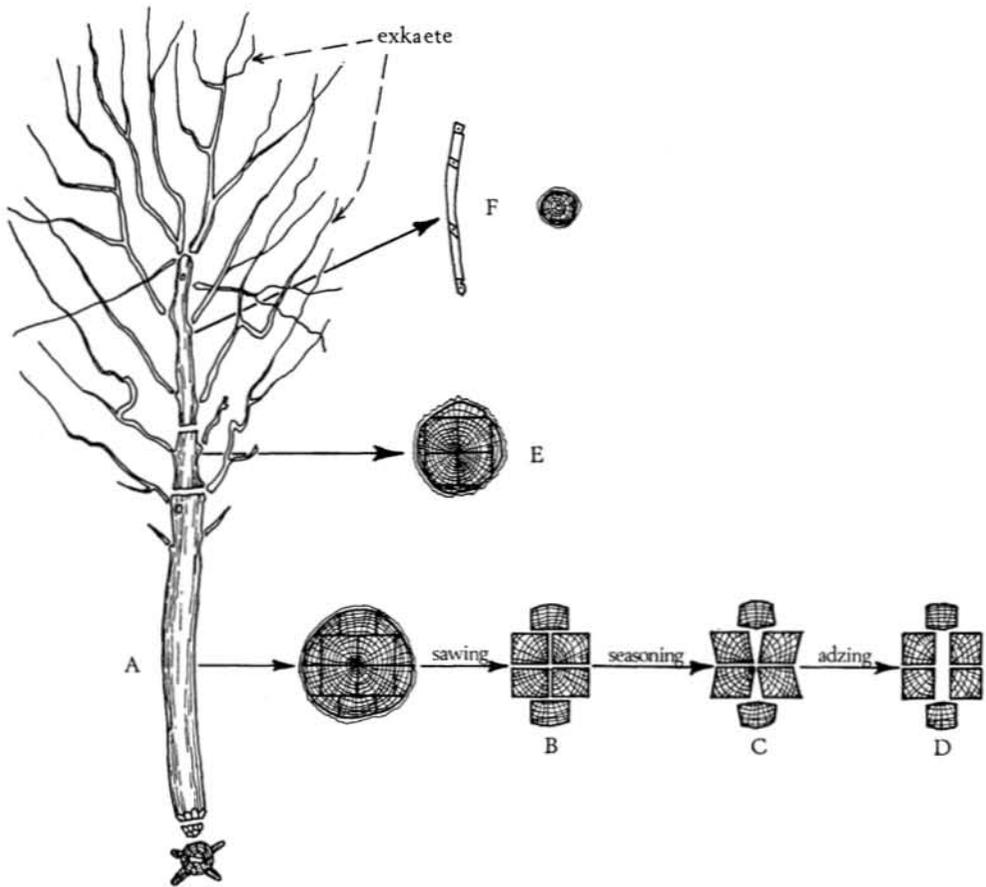
FIG. 7

GLOUCESTER BLACKFRIARS, TIMBER

Some faces have saw-marks and others have adze-marks. Evidently each log was sawn into a number of timbers, which were later finished with an adze or a broad-axe, leaving some of the sawn faces untouched; cleaving with wedges would have been too inaccurate a method. The absence of shakes — cracks that arise when timber dries out in the round — indicates that the sawing was done soon after felling; the rectangular cross-section indicates that the final shaping was done after the timber had ceased to distort during seasoning. FIGURE 7 is a suggested reconstruction of the process.

These observations indicate that the typical tree used (FIG. 7, a) had a trunk some 30 ft. (9 m.) high to the lowest big branch and continuing reasonably straight, though diminishing in size, for a further 20 ft. (6 m.). It would have been about 2 ft. 3 in. (0.68 m.) diameter under bark at 15 ft. (4.5 m.) from the ground and something like 75 ft. (23 m.) in total height, and would have contained about 150 true cubic feet (42 cu. m.) of timber. The 30 ft. (9 m.) long butt log, weighing about 2½ tons (2.5 tonnes), was sawn (FIG. 7, b) usually into four rafters and a number of off-cuts, some of which were made into collars and scissors. The upper, more crooked and knotty, parts of the tree provided the ashlar, sole-pieces, and other timbers (FIG. 7, e, f).

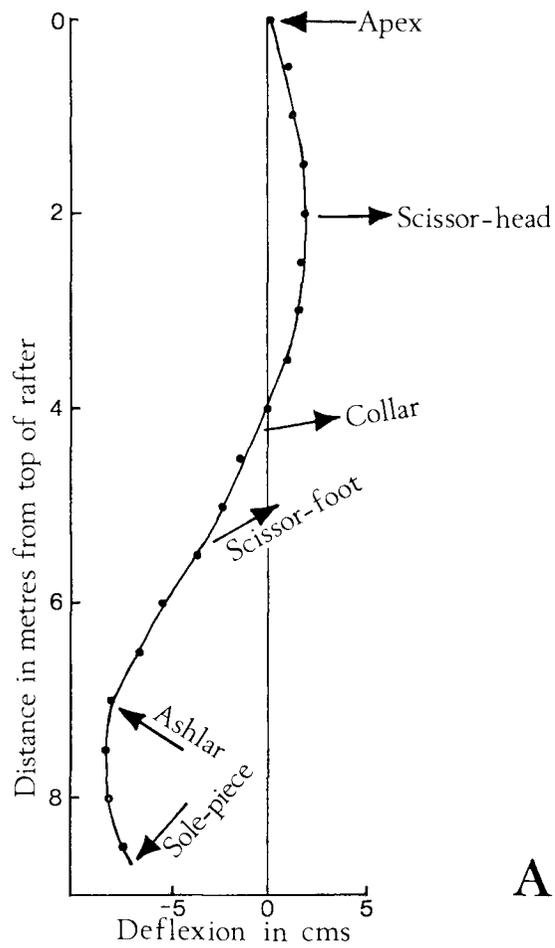
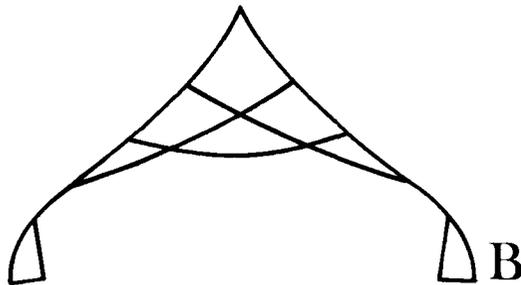
FIG. 9

A

B

Two rafters from the nave, made of very uniform timber little affected by knots, wane, or decay, were measured for deflections in a vertical plane, which are plotted in FIG. 9, a. To a first approximation, the curvature at any point will be proportional to the bending moment. The rafters are bent into an s-shape; the biggest bending moment is where they are pushed outwards by the ashlar and the second biggest is where they are pulled inwards by the scissor-heads. The ashlar are strongly in compression and the scissors strongly in tension. The collars are bent downwards at the scissor passing-joints (FIG. 9, b) and are slightly in tension. The sole-pieces pull the rafter-feet inwards.

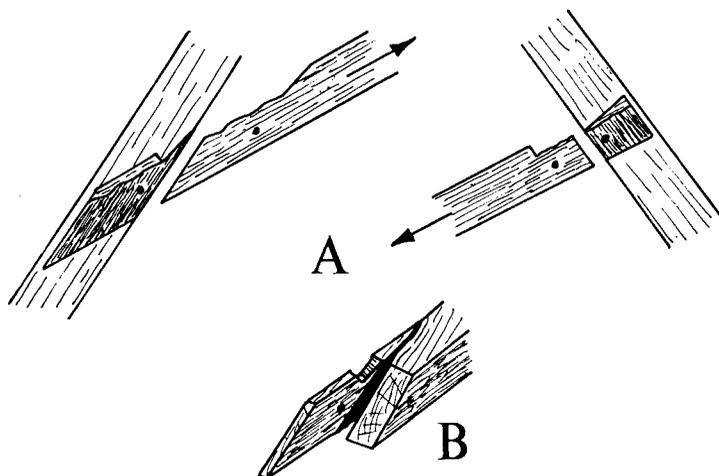
FIG. 10

GLOUCESTER BLACKFRIARS, ROOF DETAILS

For the first time we thus have a logical explanation of how secret lap-joints may have been invented. Once devised, they have the structural advantage that the web of timber providing the 'secrecy' prevents the end of the scissor, beyond the notch or dovetail, from shearing off along the grain (FIG. 10, a). Such a failure is most likely to occur with 'advanced' notch-laps, and it is not surprising that the

The tapering of the laps is a further refinement. The thick base makes the lap less likely to split away from the rest of the scissor (FIG. 10, *b*); the thin tip avoids weakening the rafter by cutting into it unduly on the compression side.
