Newhouse Farm, Purton End, Debden, Essex.

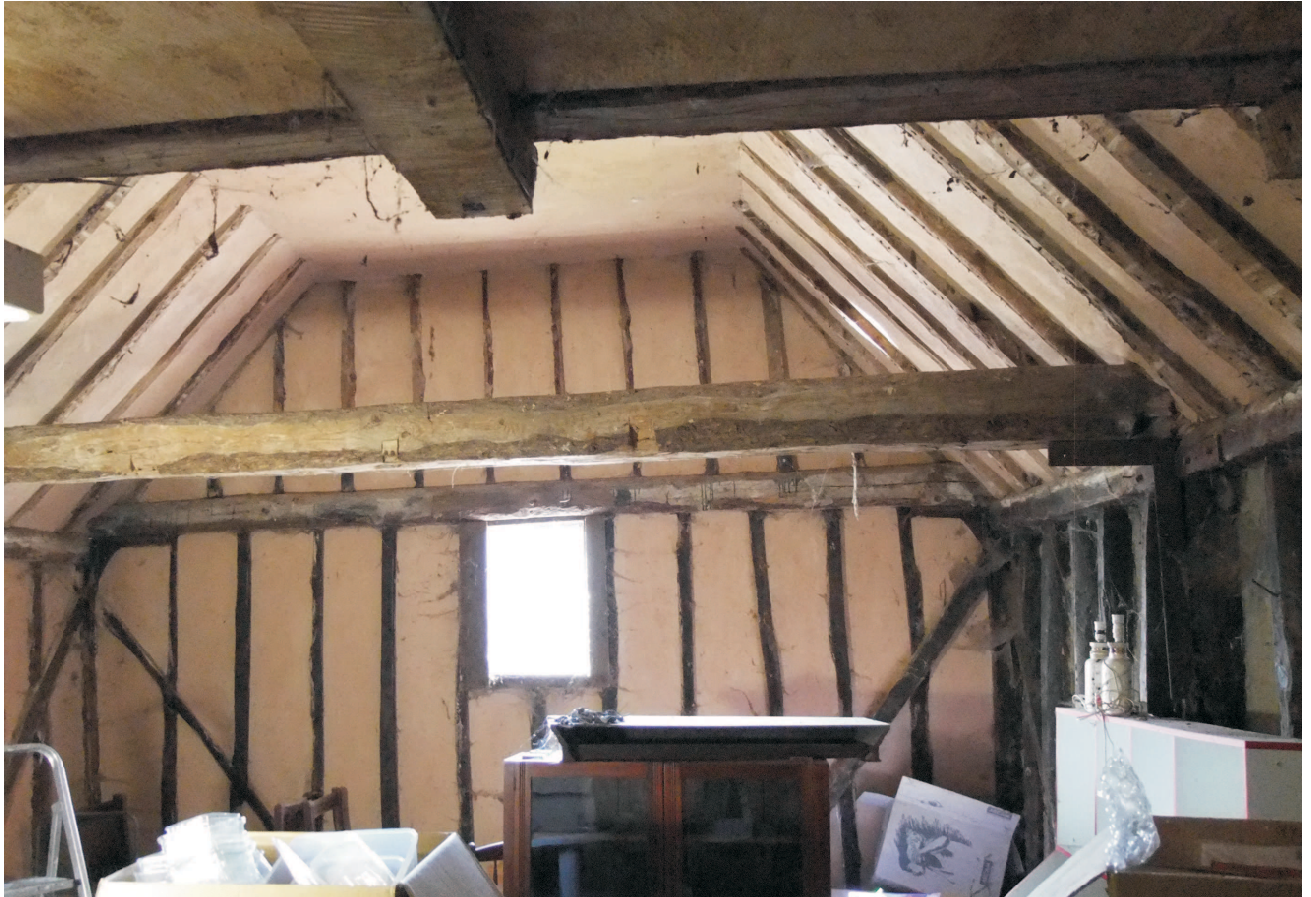
Granary long inside view to west from under inserted floor of first bay. Visible tiebeam ends have iron brackets. Primary bracing to the walls. Ceiling plastered under collar level. Inserted window in west wall.

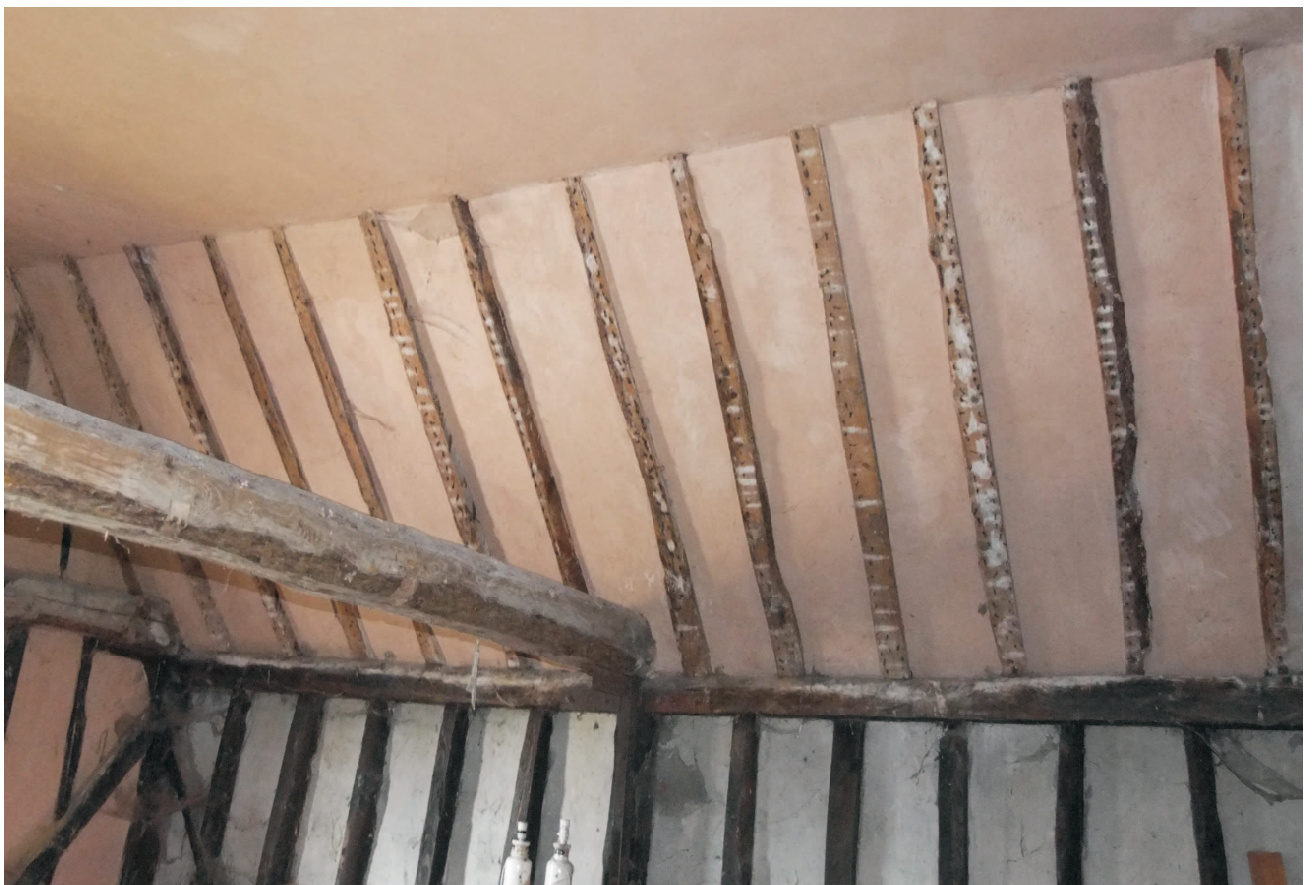
Granary view to north wall showing wall studs and wallplate. Above are rafters set evenly along the roof with no principle trusses.

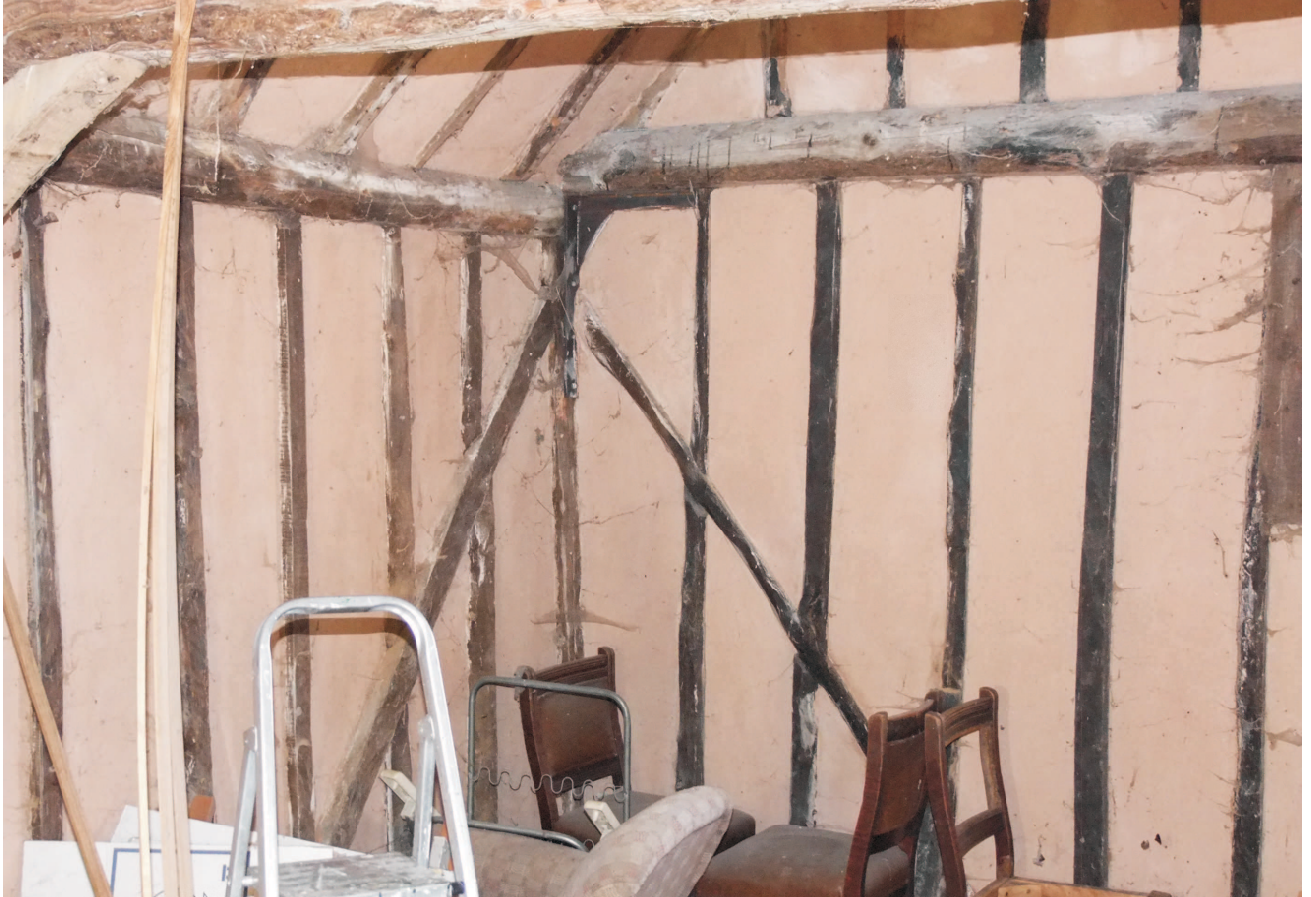
Granary view to south west corner showing wallplate and tiebeam joint with iron bracket. Primary bracing to walls

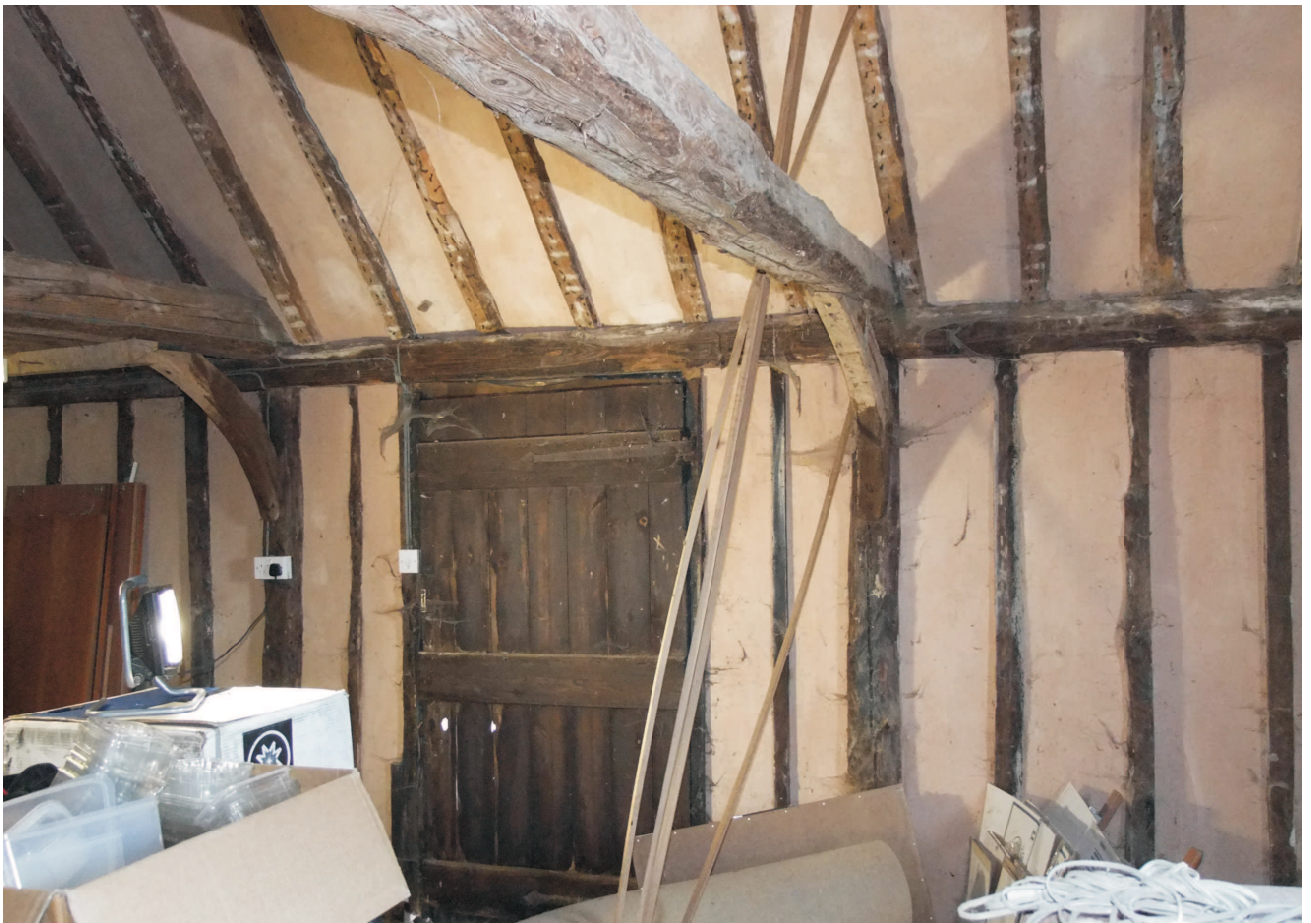
Granary view to south entrance wall. Board door in central bay. Oak arch braces between tiebeam and post.
