# THE PARKLANDS HOTEL, BOULTHAM PARK ROAD, LINCOLN

## PHOTOGRAPHIC BUILDING SURVEY (LEVEL 1)

Report prepared for  
Derek Morris Architects Ltd. by  
S. A. Savage

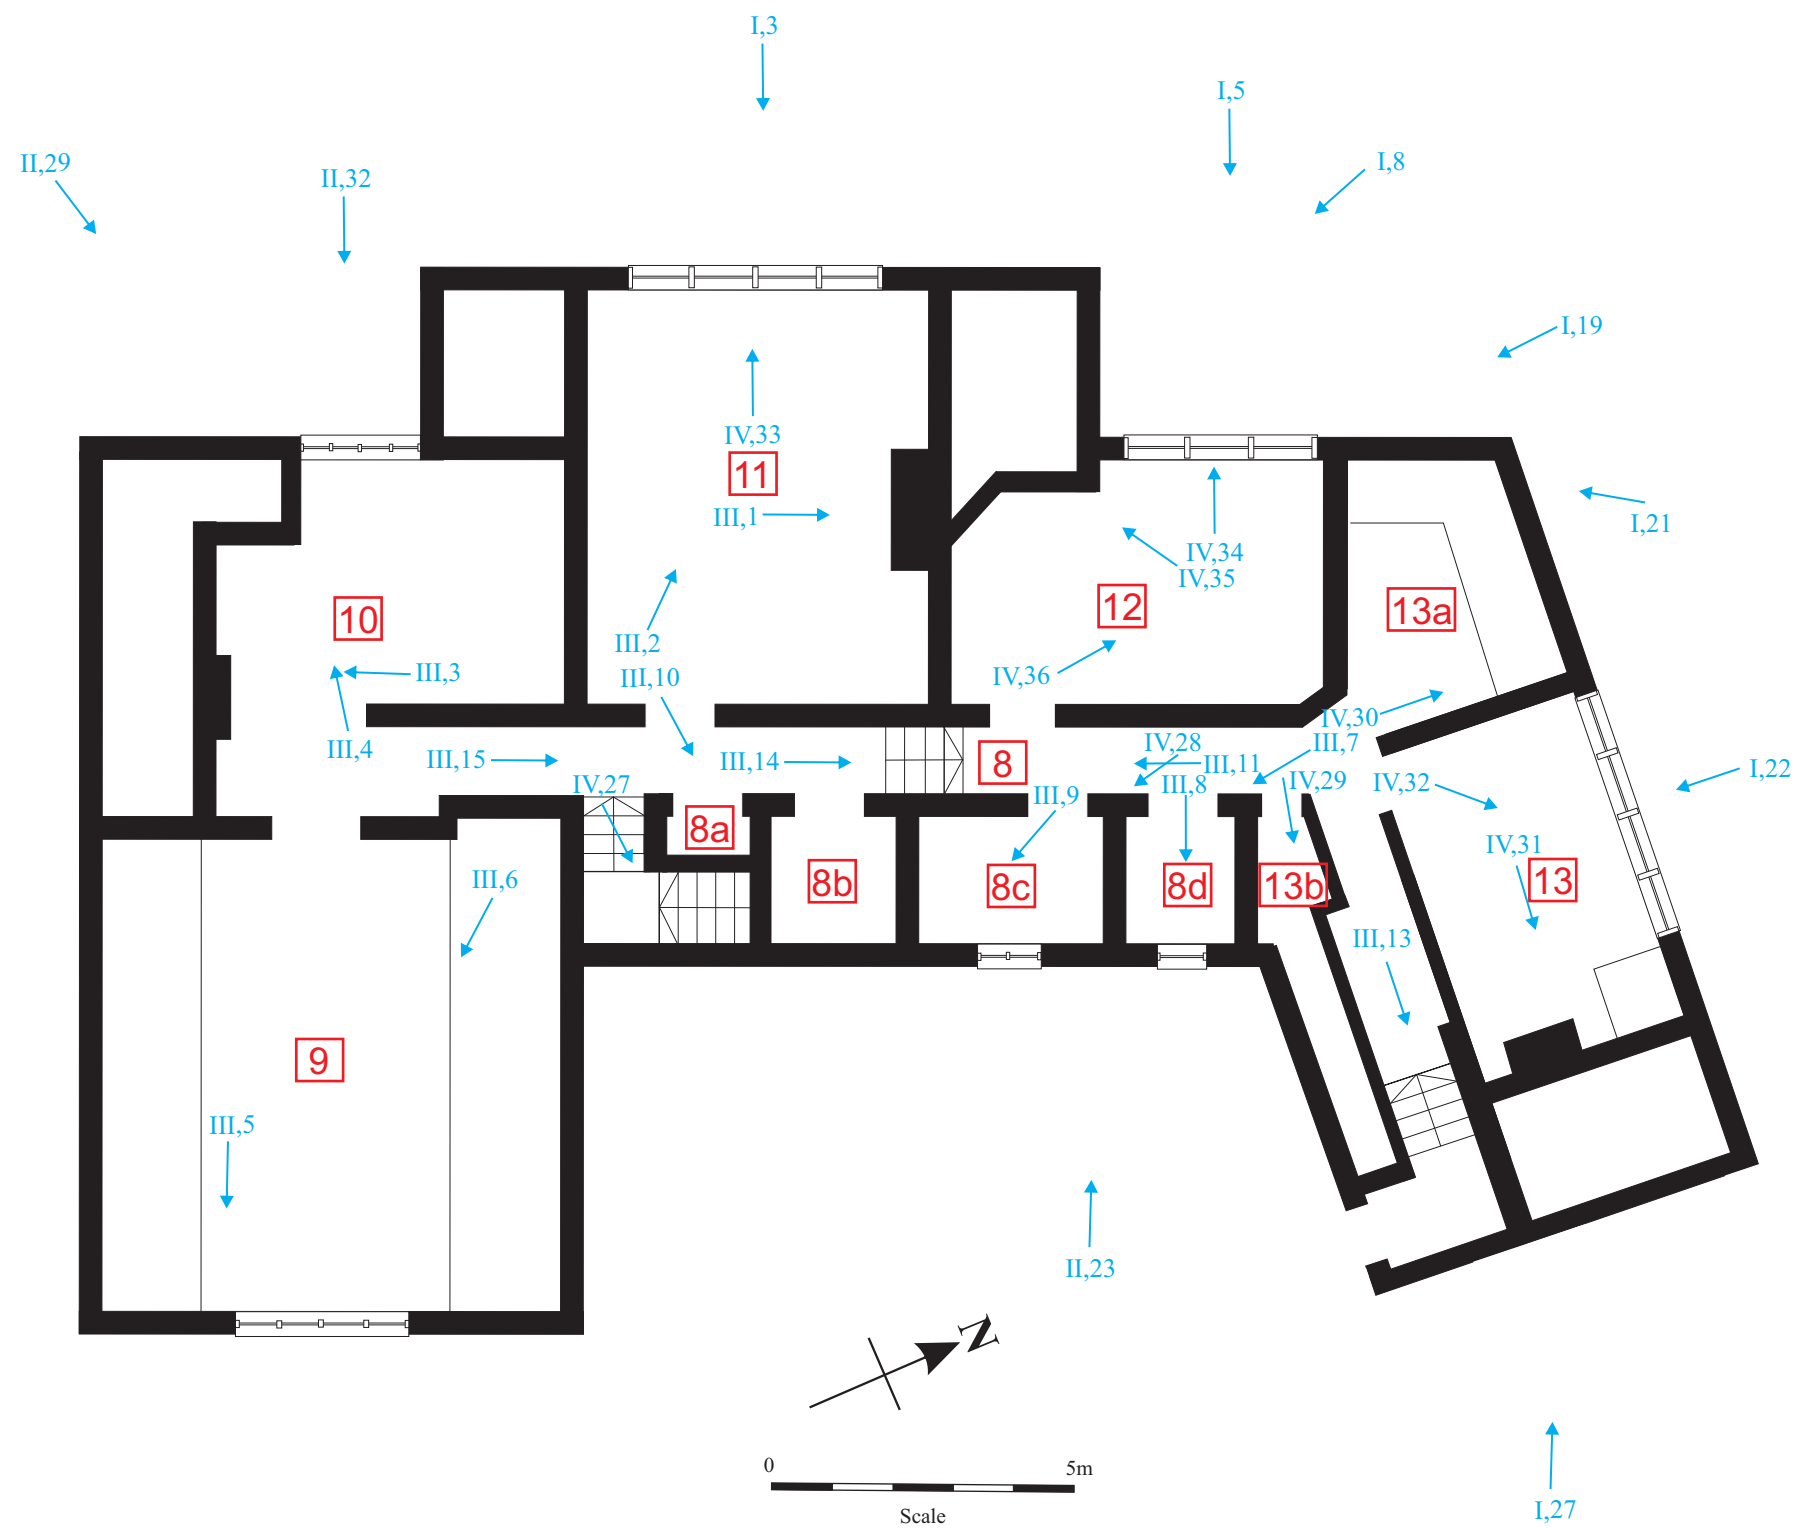
**Fig. 4:** Plan showing the layout of the first floor of the Parklands Hotel, the room numbering (in red) and the position and direction of the photographs forming the archive (in blue). Scale 1:100.

## **Results (Figs 2 to 4)**

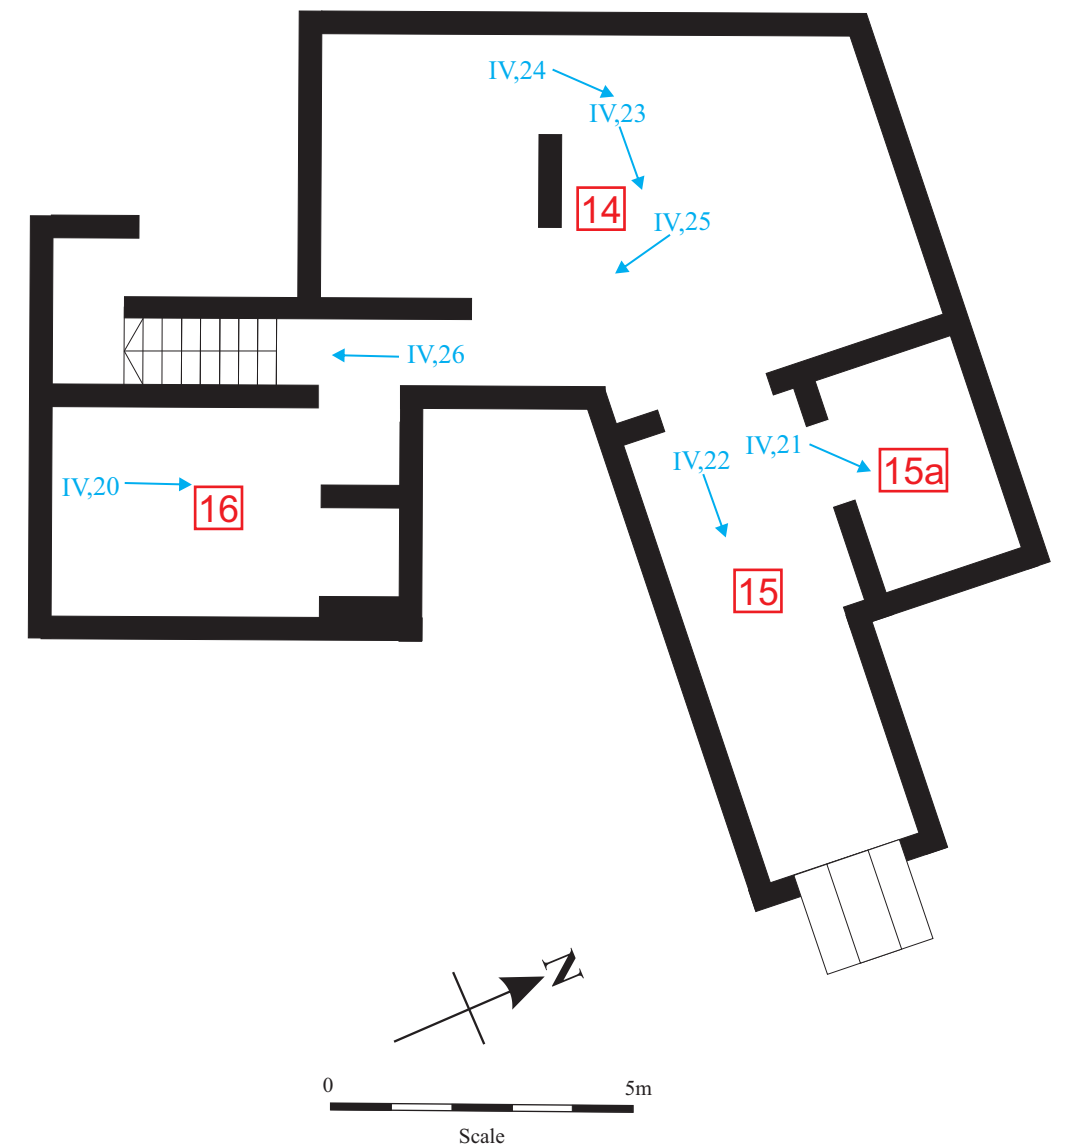
**Fig. 5:** Plan showing the layout of the cellars of the Parklands Hotel, the room numbering (in red) and the position and direction of the photographs forming the archive (in blue). Scale 1:100.
