NEW RESIDENTIAL DEVELOPMENT, 'SPRING BARNS', UPTON, LINCS.

**WRITTEN SCHEME OF ARCHAEOLOGICAL INVESTIGATION:
ARCHAEOLOGICAL MONITORING AND RECORDING**

NGR: SK 8710 8676
WLDC Planning Ref.: 120926
LCNCC Accn Code: 2010.41
Site Code: SBUL 10
PCA Job Ref.: 631

June 2010

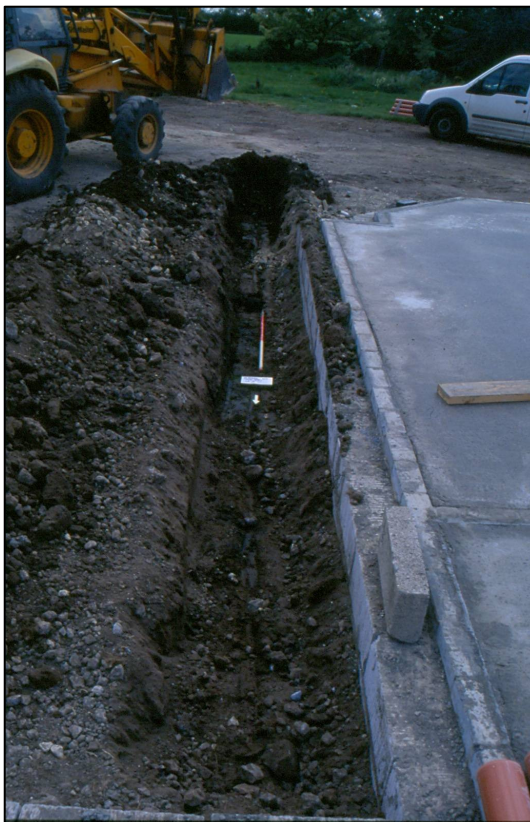
Pl. 6 A shallow trench was excavated for drainage on the eastern side of the house footprint (looking south, scale 1m).

The excavation of a shallow drain trench along the eastern side of the new foundations was monitored. The imported layer (001) had been removed in this area, revealing a 0.3m thick dark brown sandy clay with occasional limestone rubble inclusions (008) which may have been a surviving topsoil. This layer covered (002) at the trench base.

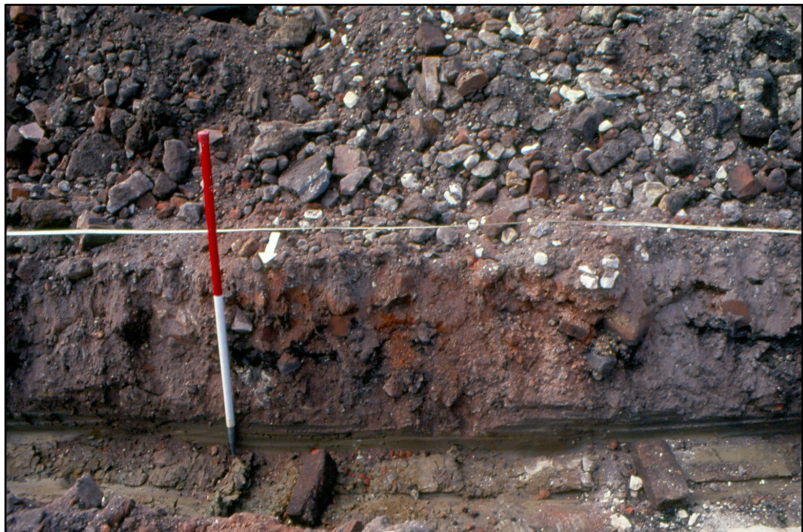
Pl. 8 Imported brick rubble layer (001) directly above weathered boulder-clay natural in the southern drainage trench (looking south, scale 1m).

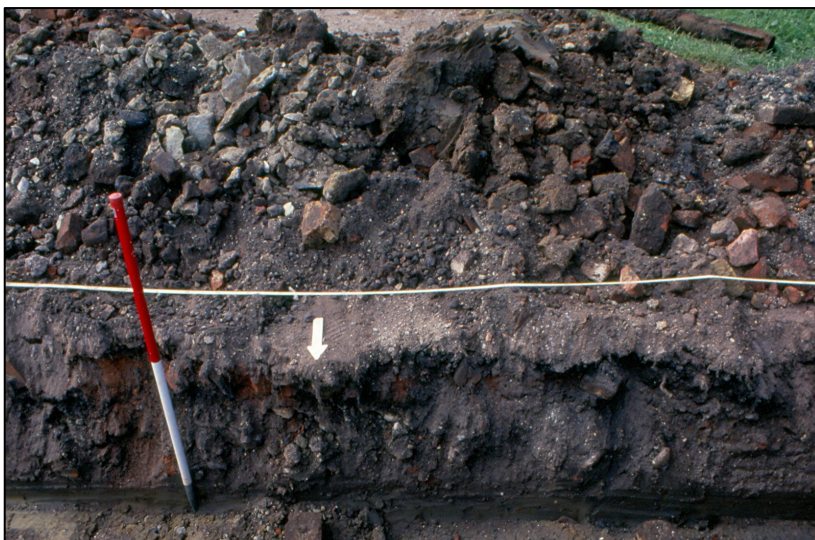
Pl. 9 Beneath the imported rubble, grey clay (009) at the base of the southern drainage trench may represent fill of a ditch [010]. Looking south, scale 1m).

The identification of gleyed clay in two possible ditches at the base of the drain trench to the south and west of the new building may explain the introduction of the rubble. The ditch fills indicate wet ground and the ditches may have been an attempt to drain it – although there remains the possibility that these undated features served another function and that their presence caused a drainage problem in the first place.

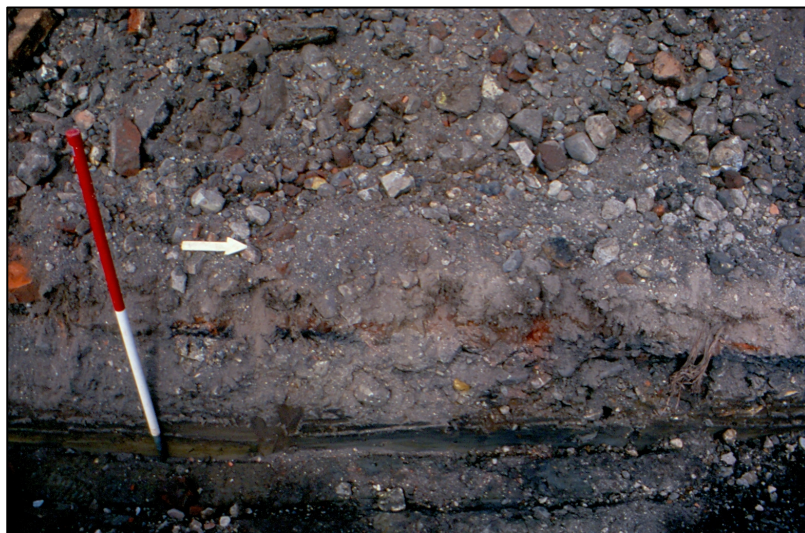
Pl. 10 A second feature with a grey clay fill (011) crossed the western drainage trench. This possible ditch [012] was only visible at the trench base below imported rubble. The rubble is thought to have been laid to replace wet ground. Looking west, scale 1m).

Around the trench corner, to the west of the new building, another similar probable ditch [012] was noted, approximately 6m from the south-west corner of the trench. It was 1m wide and aligned west-east (Pl. 10).

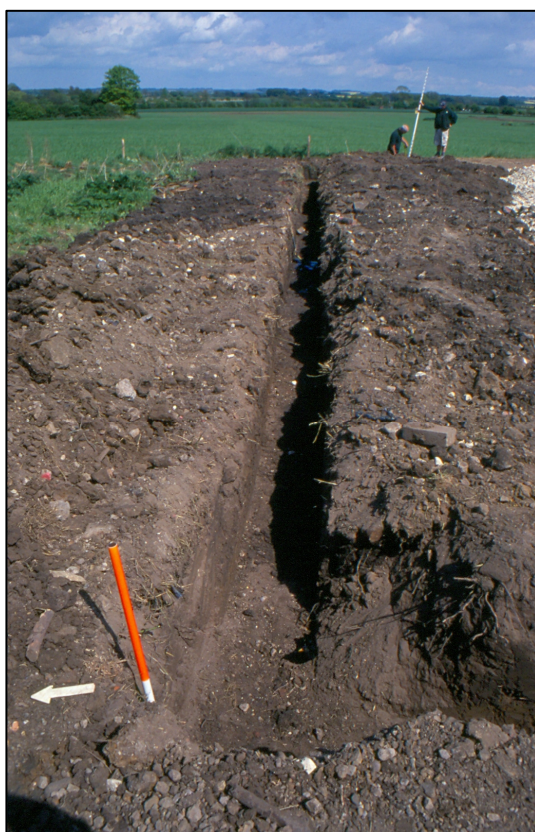
Pl. 11 Construction trench for a new garden wall at the northern end of the house (looking east, scale 1m). The trench cut through thick brown soil, which may have been redeposited topsoil.

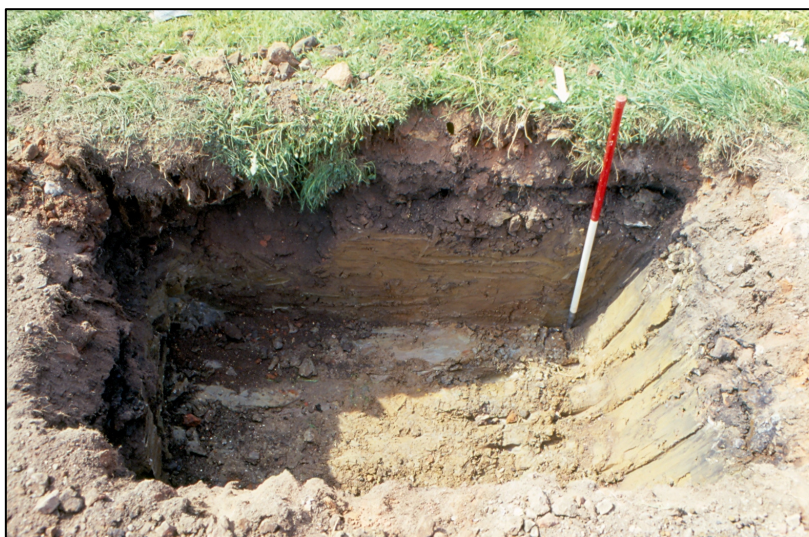
Pl. 12 To the south of the house, a percolation test pit encountered thick imported rubble directly above weathered boulder-clay natural. Scale 1m).
