**Cotswold Community
Ashton Keynes
Wiltshire**

Historic Building Analysis

CA Project: 4474
CA Report: 13671

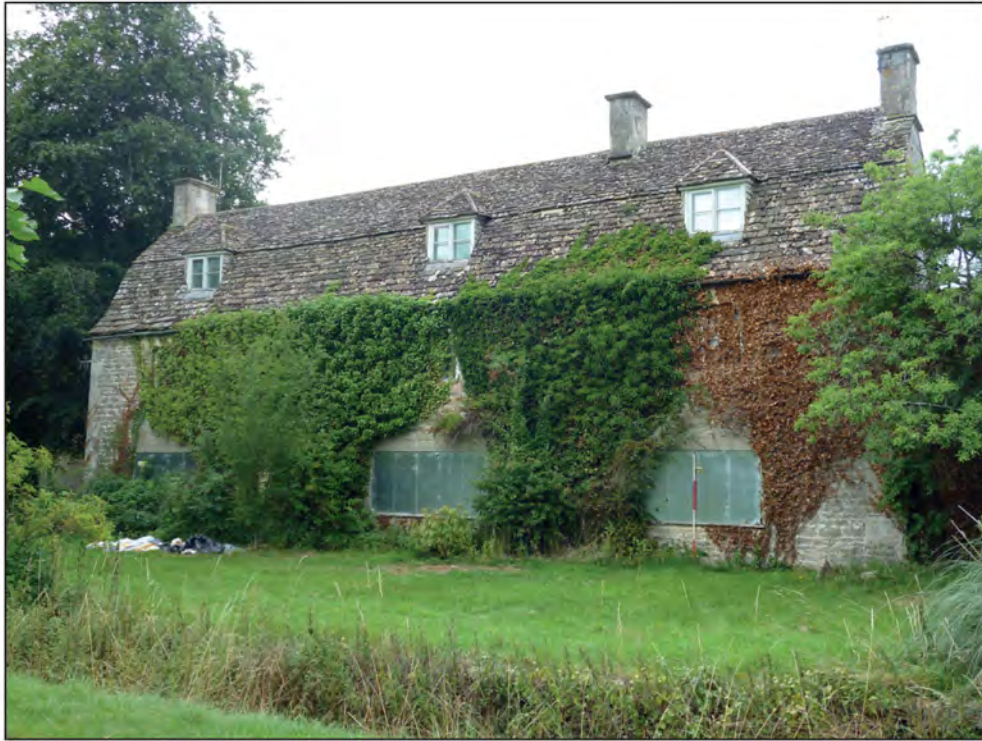
10 The south elevation of the farmhouse, looking north-west (scale 2m)

- 5.10 The farmhouse was built in neat local limestone rubble, with large, roughly squared but faced quoins (Fig. 10). It was of two storeys, plus a third in the gambrel roof with small dormers. The east and west gable ends were plain except for garret windows (Fig. 11). A similar window on the first floor at the west end may have been an insertion. A tall irregular repair in the ground floor of the west end was effected with 20th-century bricks. An entrance in the east gable end may be an insertion, but this was not clear.
- 5.11 The exterior of the north elevation was almost entirely obscured by the added second pile and the range projecting from the east end of this elevation (Fig. 11). The south elevation, the main entrance façade, was almost as obscured with ivy (Fig. 10). However, enough could be seen to be fairly sure that the elevation was of

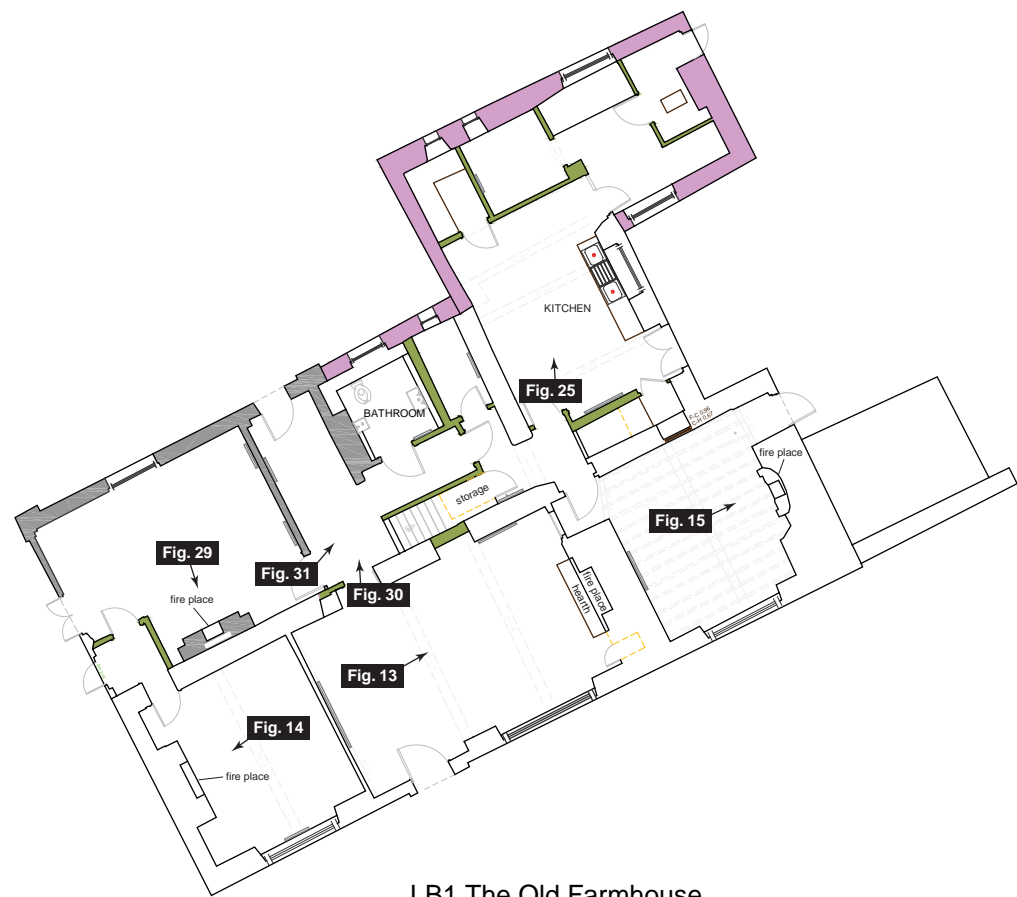
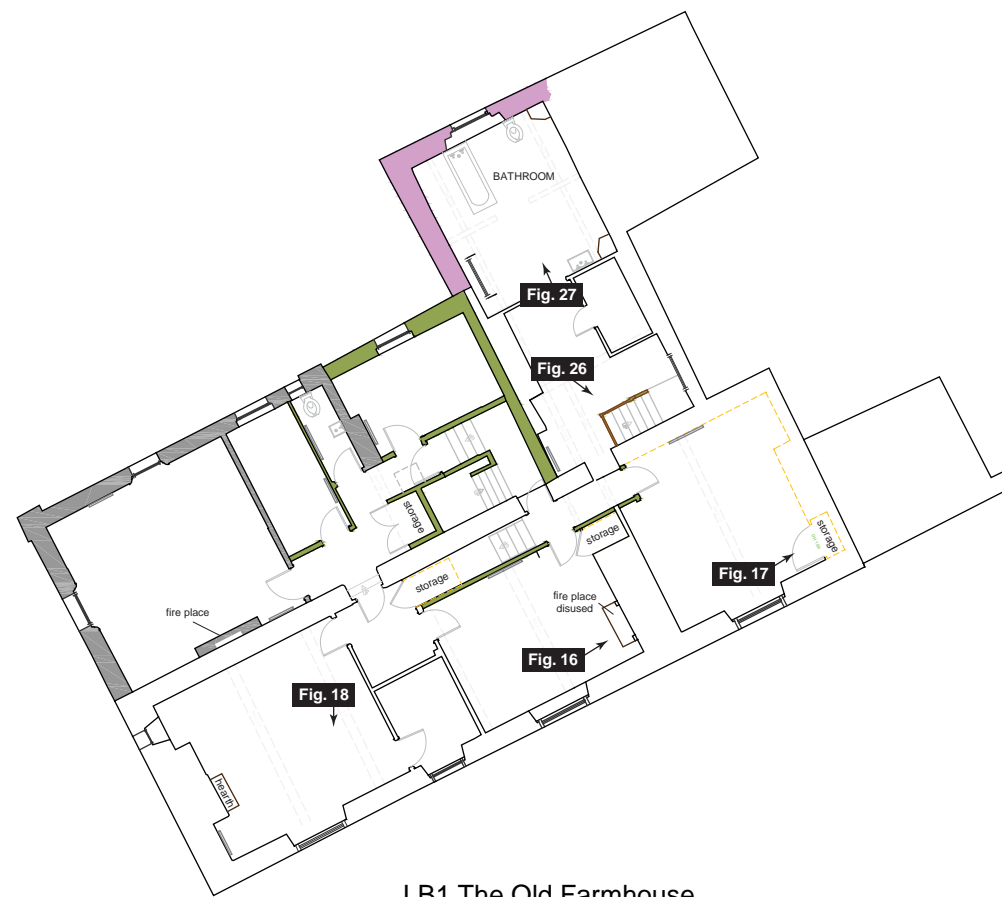
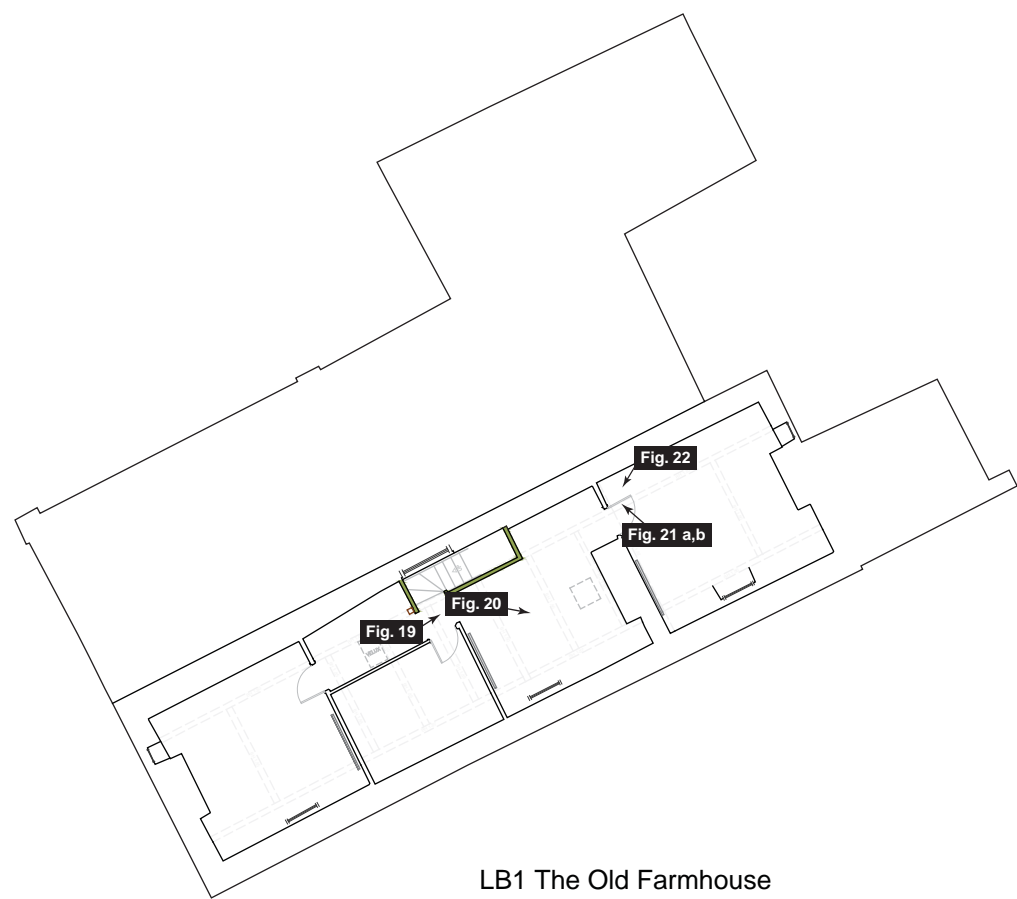
FIGURE TITLE
 The Old Farmhouse floor plans

LB1 The Old Farmhouse
Ground floor

LB1 The Old Farmhouse
First floor

LB1 The Old Farmhouse
Second floor

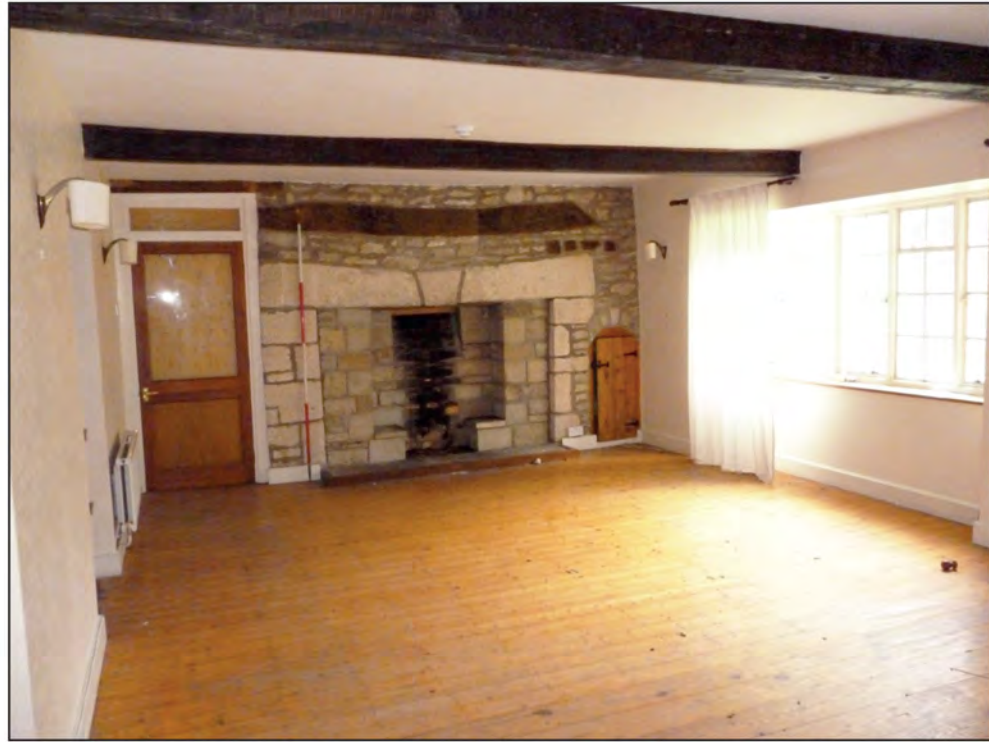
- 13 The central room on the farmhouse ground floor, to the east (scale 2m)
- 14 The chimney piece in the farmhouse ground floor western room (scales 1m)
- 15 The east side of the eastern ground floor room in the farmhouse, with 1930s fireplace and 18th/19th century oven (scale 2m)
- 16 Chimney piece in the farmhouse first floor central room, east wall (scales 1m)

- 5.17 All doors except where otherwise noted were Victorian type 4-panel examples.
- 5.18 The easternmost room was not heated via the main stack but had a brick-built oven, still with cast-iron fittings, set in the south-east corner with its own gable stack (Fig. 15). This had what appeared to be a faggot oven, but the flue (with an adjustable baffle plate) had been blocked and plastered over; a bread oven and a closeable grate under it (or possibly oven: it could not be opened). A stone 1930s fireplace next to it in the east wall had presumably replaced an earlier one, or may have been a new insertion. A doorway gave access to this room from the north side of the stack in the central room. This had been blocked but the door was still in place and was a post-war feature (Fig. 13). The external door appears to have been an insertion.

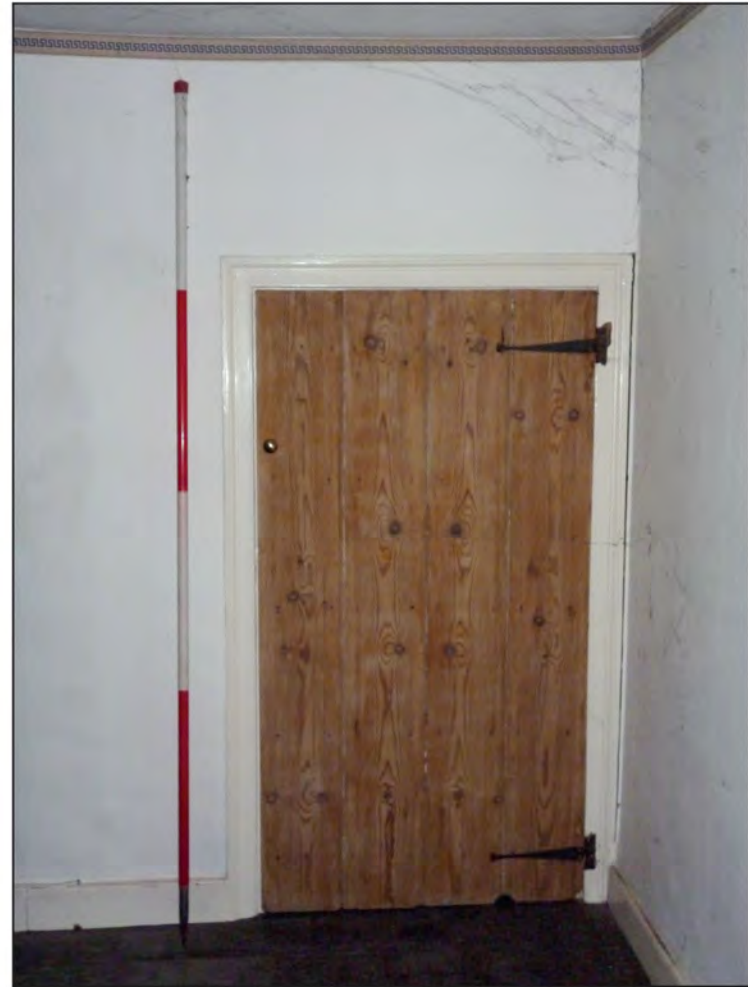
- 17 The ledged door and moulded architrave to the cupboard in the farmhouse first floor east room (scale 2m)
- 18 The unusual bare-faced dovetail joints of the joists and beam on the first floor of the farmhouse
- 19 The stair enclosure and handrail to the garret stair in the farmhouse (central room), looking east (scale 2m)
- 20 The farmhouse garret central room, looking south-east (scale 2m)

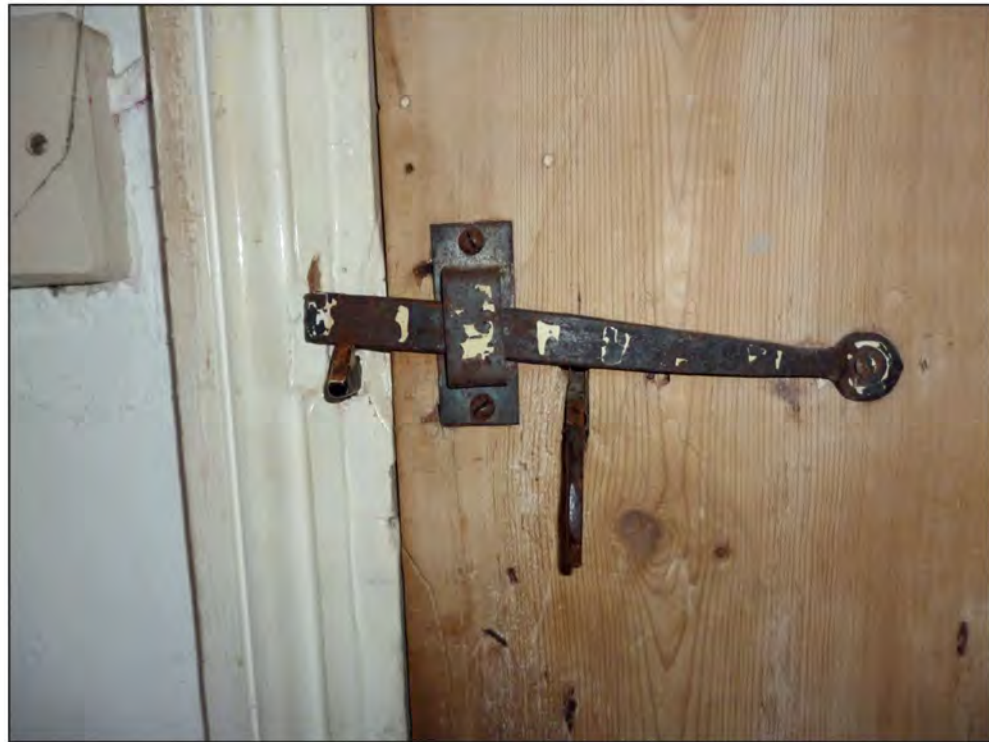
- 21 The "Norfolk latch" on the ledged door in the garret
- 22 The wooden lock box on the ledged door in the farmhouse garret
- 23 The rear wing to the farmhouse in 1936
- 24 The rear wing to the farmhouse, looking south-west (scale 2m)

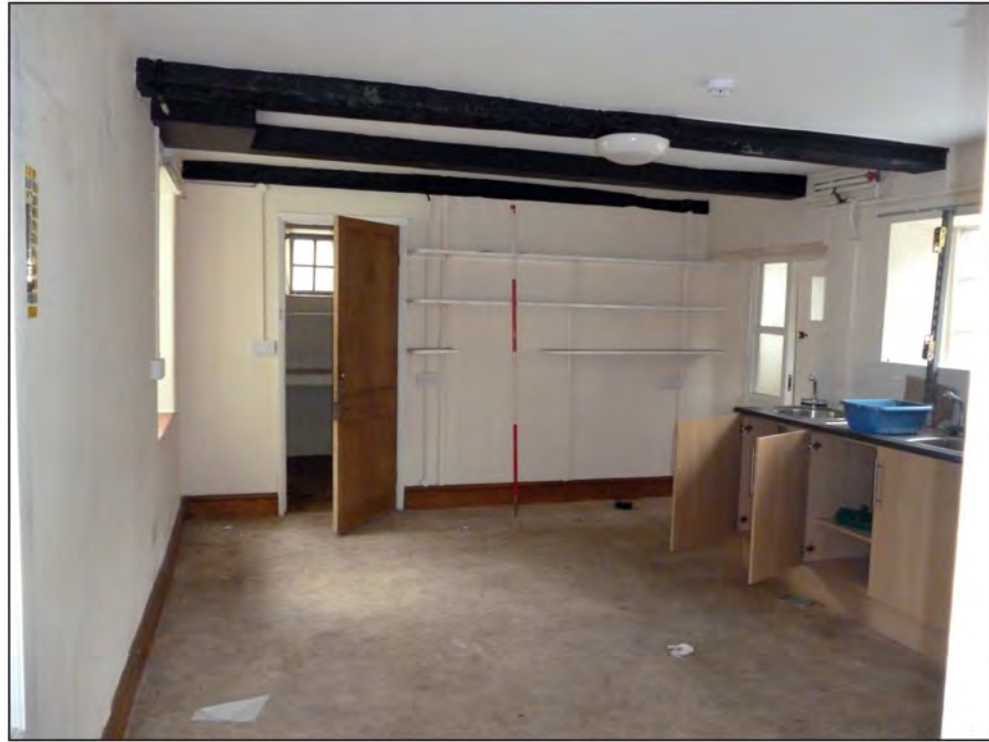
- 25 The ground floor room in the rear wing of the farmhouse, looking north (scale 2m)
- 26 The stair in the rear wing of the farmhouse, first floor, looking south-east (scale 2m)
- 27 One of the pair of cruck blades in the rear wing to the farmhouse, looking north (scale 1m)
- 28 The north elevation of the farmhouse north range, looking south

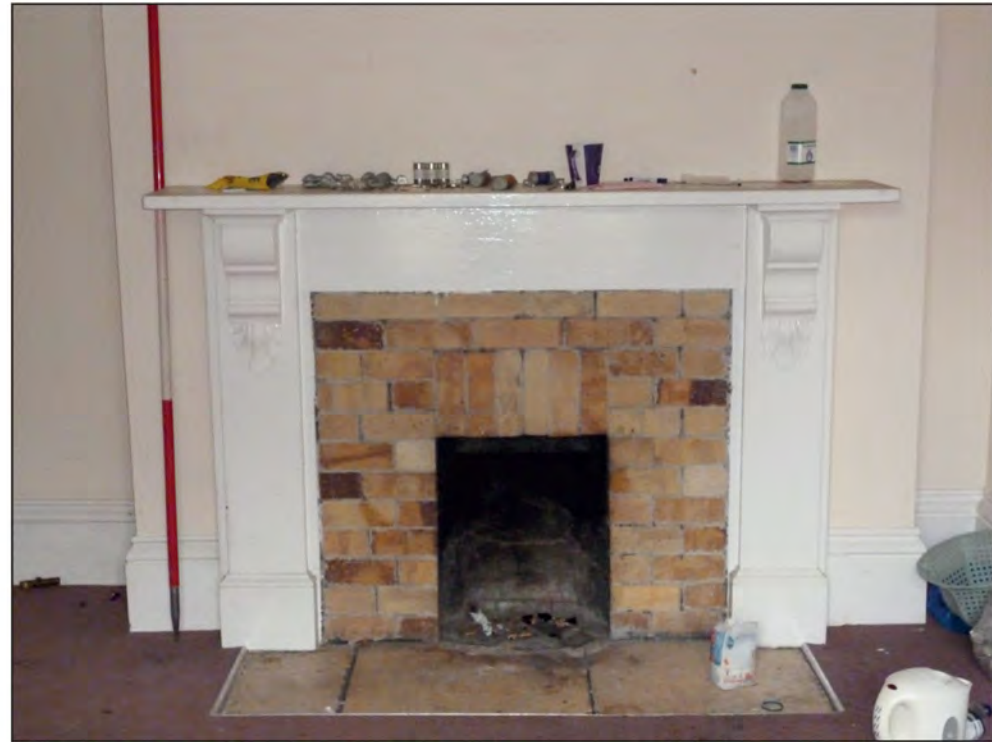
- 29 Victorian fireplace in the farmhouse northern range, ground floor western room, looking south, modern brick infill (scale in 0.5m divisions)
- 30 The front door and hall in the farmhouse north range, looking north (scale 2m)
- 31 The stone flagging of the hall continuing under the stair and the wall with the door in it, looking east-north-east (scale 2m)

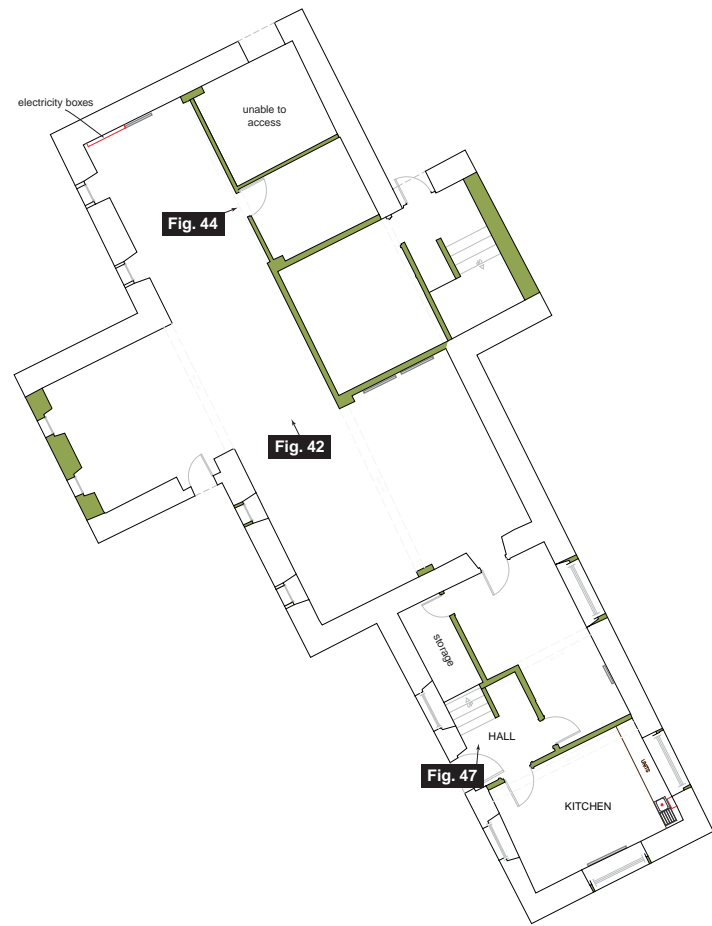
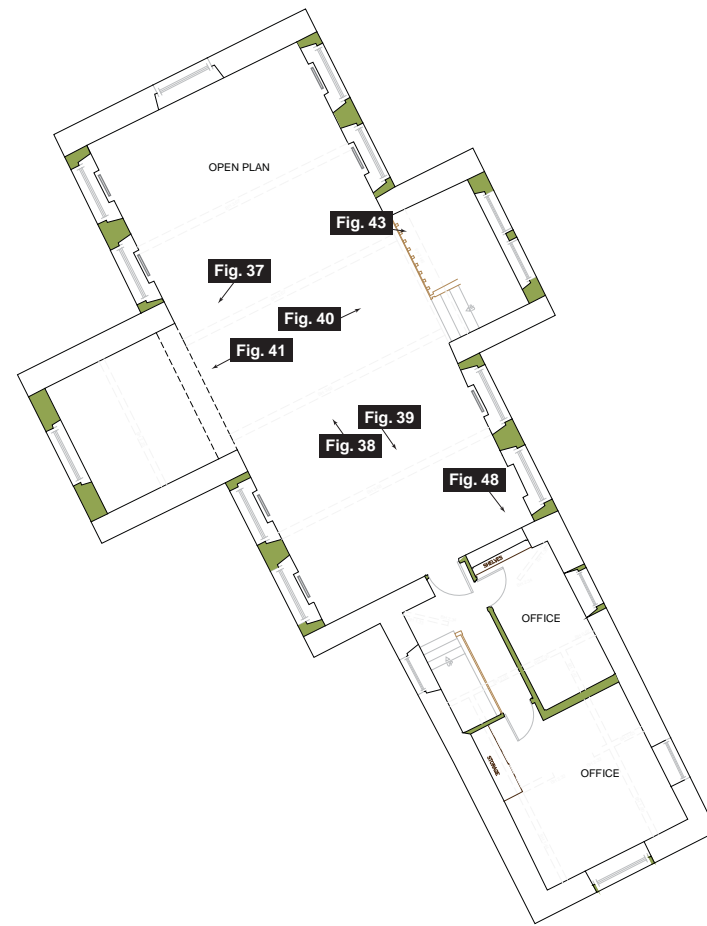
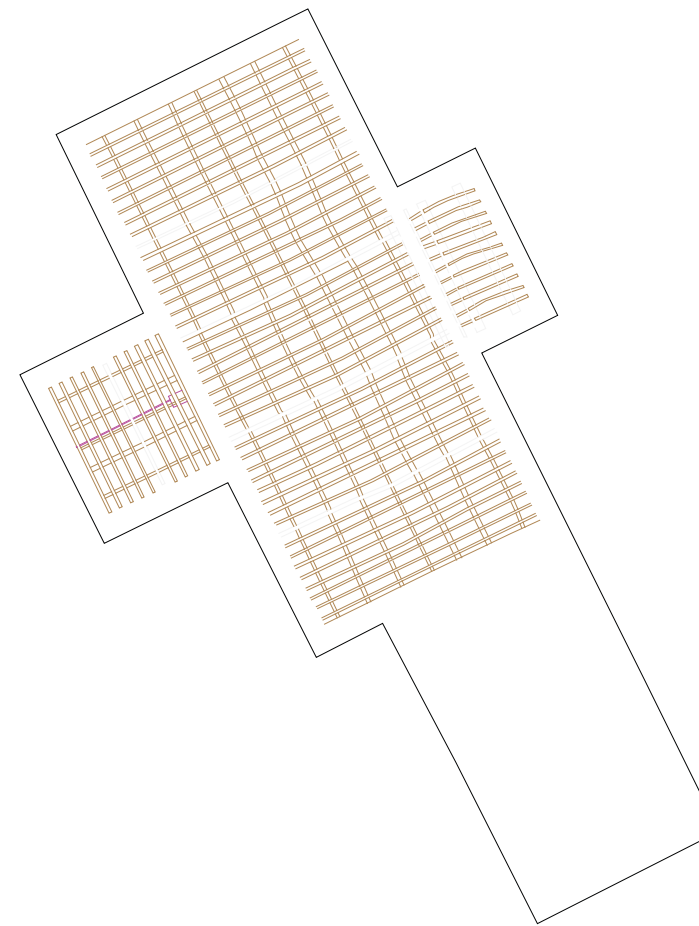
FIGURE TITLE
 Barn and Cottage floor plans

LB4 Barn and Cottage
Ground Floor

LB4 Barn and Cottage
First Floor

LB4 Barn and Cottage
Second Floor

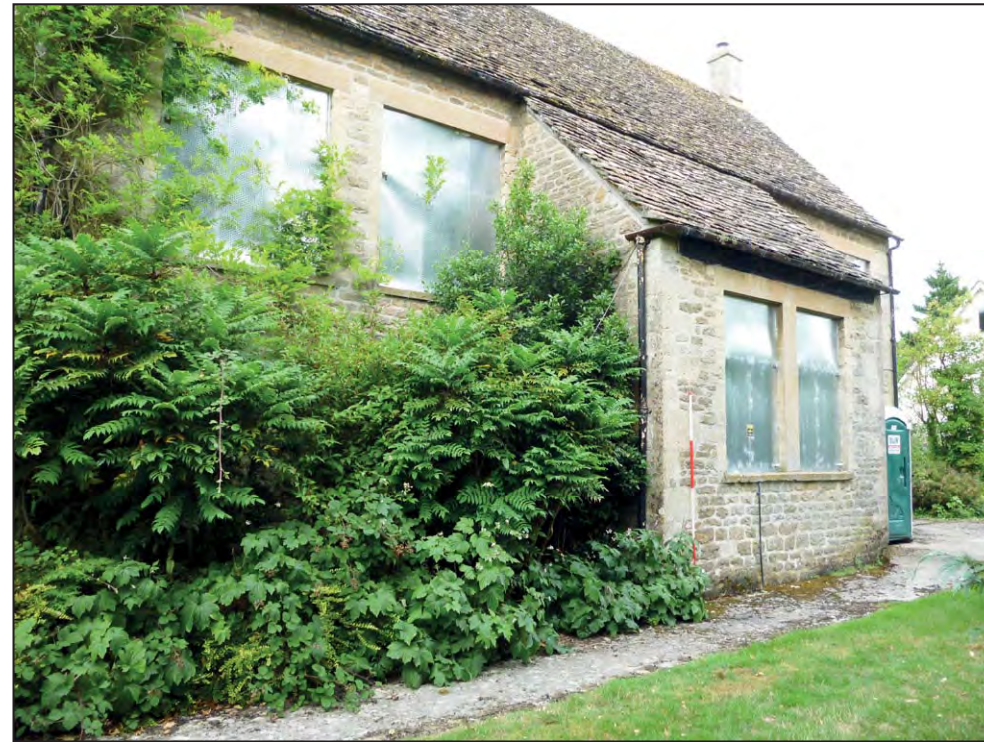
- 33 West elevation looking east (scale 2m)
- 34 Looking north-west (scale 2m)
- 35 Looking south-west, roof timber pockets visible below the windows (scale 2m)
- 36 Scars of removed wall and roof on the south side of the west porch (scale 2m)

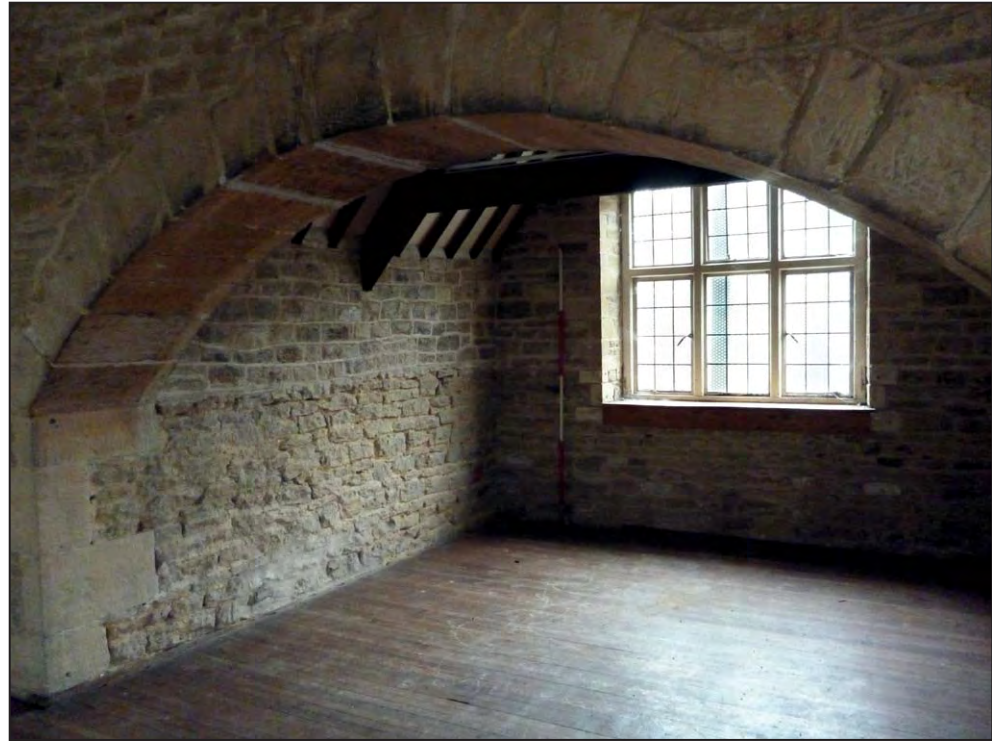
- 37 The rebuilt upper walls of the western barn porch, looking south-west through the arch from the first floor (scale 2m)
- 38 Truss 2 in the roof, collar and braced kingpost, looking north, added arched brace behind
- 39 The south gable, blocked window and joist pockets
- 40 The opening into the east porch, roof and the painted inscription on the beam over it, looking east (scale 2m)

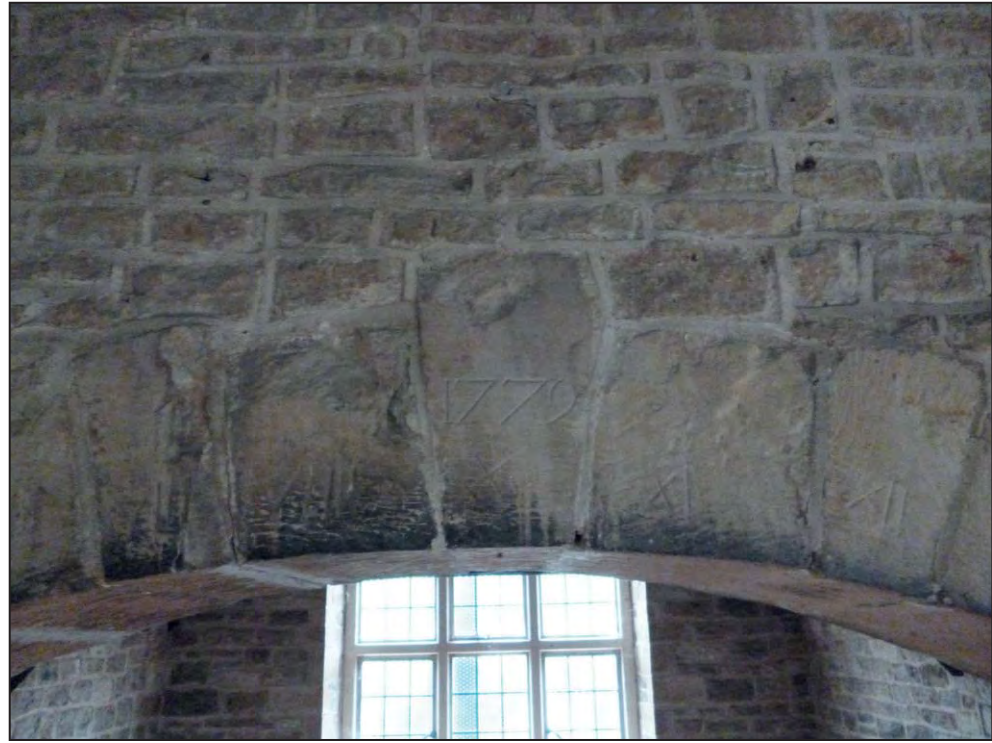
- 41 Date and assembly numbers incised on the arch voussoirs of the western porch
- 42 The ground floor, looking north, spine wall to right (scale 2m)
- 43 The stair in the east porch, looking south-east (scale 2m)
- 44 Ventilation window in a door in the ground floor (scale in 0.5m divisions)

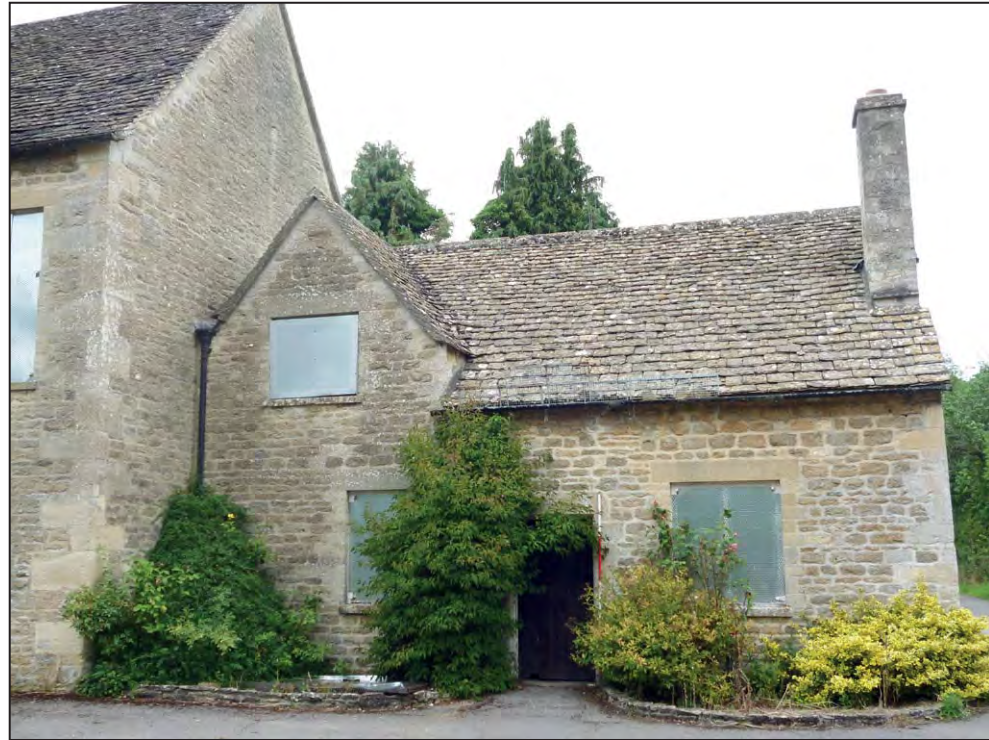
- 45 The Cottage, west elevation looking east (scale 2m)
- 46 The Cottage, east elevation/south gable end, looking north of west (scale 2m)
- 47 The stair in the Cottage, looking north-east (scale 2m)
- 48 The wide opening in the south gable at first floor, looking south (scale 2m)

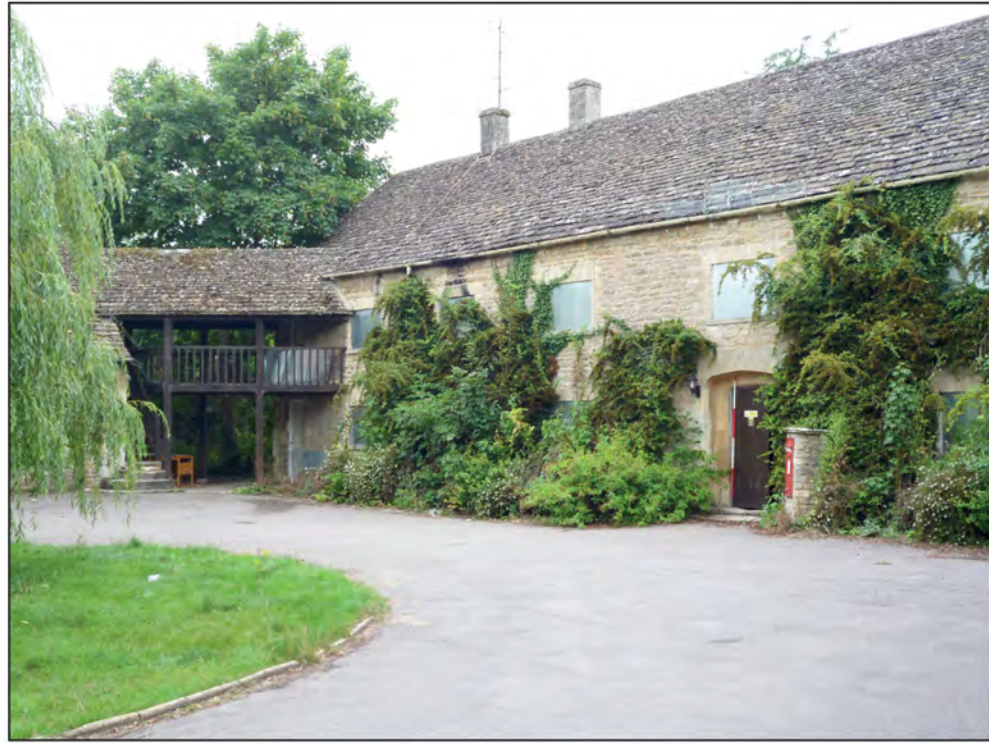
- 49 The northern range, south elevation, looking north-west (scale 2m)
- 50 The northern range, north elevation, looking south-west (scale 2m)
- 51 The 1930s front door to the northern range lying on the quarry-tiled floor of the hallway (scale 2m)
- 52 The northern range hallway looking south-west to the stair (scale 2m)

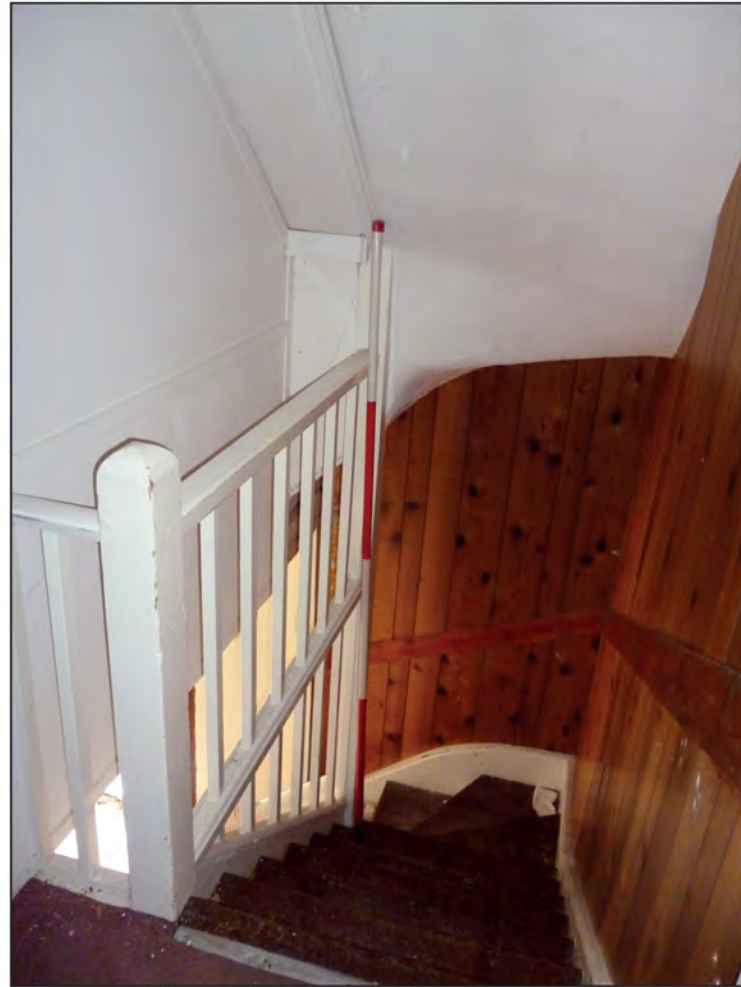
- 53 The stair in the northern range looking down from the first floor (scale 2m)
- 54 The fluted door with a hare, from the northern range hall to the room to its east (scale 2m)
- 55 The panelled room east of the hall in the north range, looking south-east
- 56 The northern range: stair from the roof space to the first floor (scale 2m)

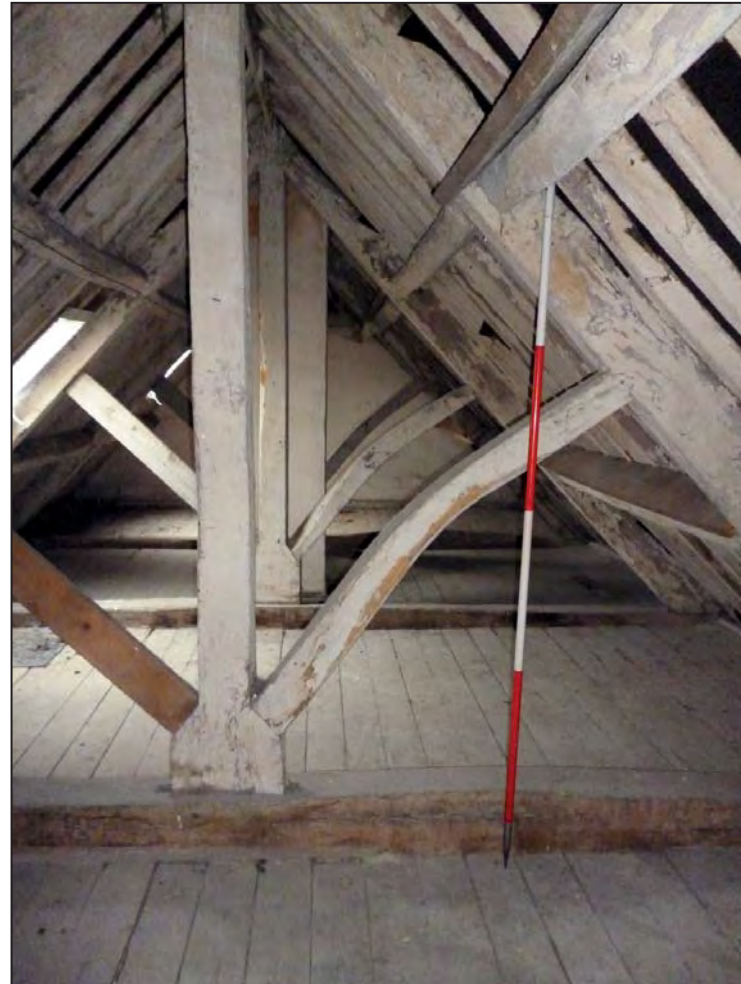
- 57 The curved braces to the kingpost trusses in the roof of the northern range, looking east (scale 2m)
- 58 The east elevation of the Cart shed and stables north end (scale 2m)
- 59 The west elevation of the Cart shed and stables north end, looking south-east (scale 2m)
- 60 The west elevation of the Cart shed and stables north end, looking south-east (scale 2m)

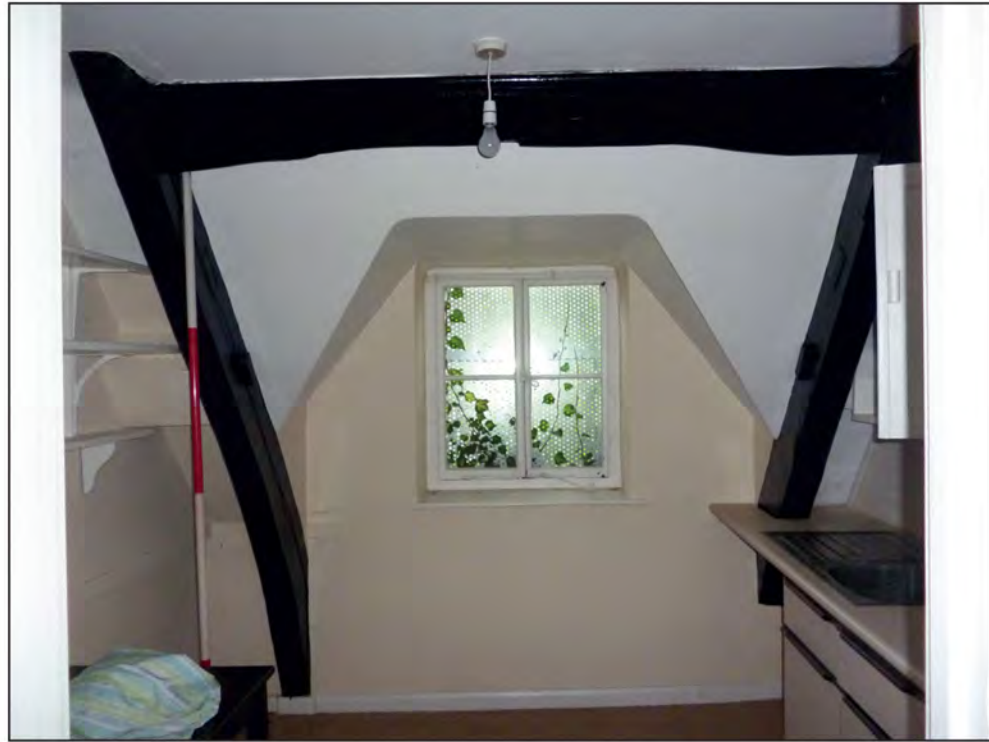
- 61 The central dormer of the western range north end, looking east, showing the cruck blades and raised purlin (scale 2m)
- 62 Western range stable, unpainted sections of cruck blade in a cupboard (southern truss of four)
- 63 The western range southern end, originally open-fronted sheds and stone bay, east elevation, looking west (scale 2m)
- 64 The corridor in the 5th bay of the open-fronted shed in the western range, stone bay to left, looking west (scale 2m)

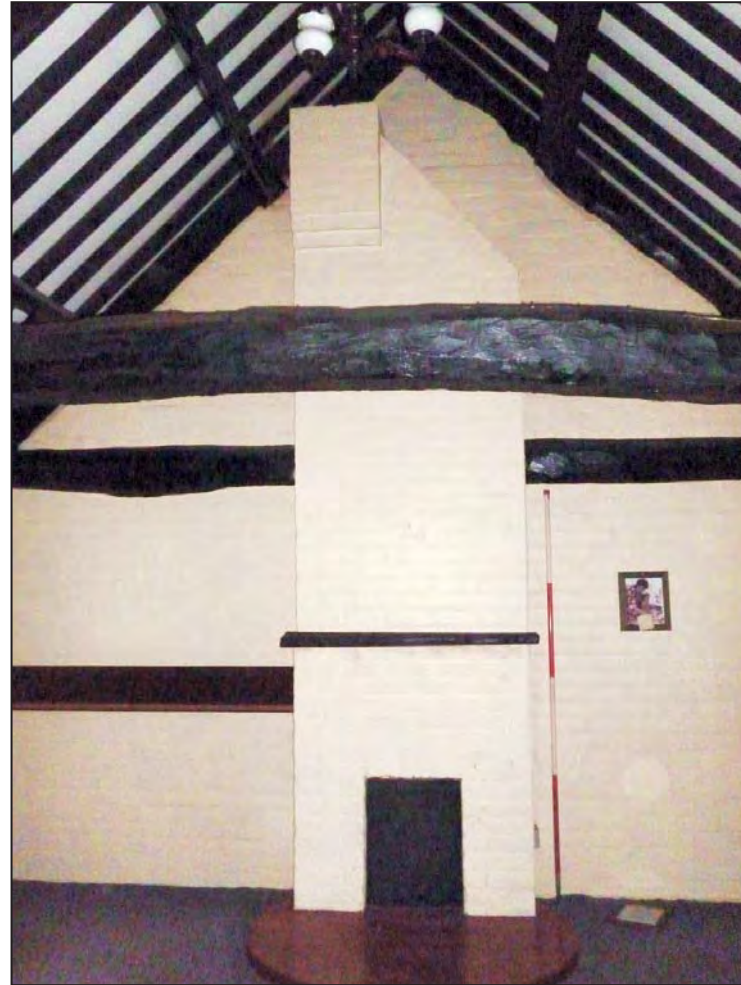
- 65 The new wall and stack in between bays 1 and 2 of the open fronted shed in the western range, looking north (scale 2m)
- 66 The added curved collars in the trusses of the open-fronted shed, looking north
- 67 The brick oven and fireplace in the south-east corner of the stone bay of the cart shed and stable, looking south-east (scale 2m)
- 68 The north and west ranges of the three accommodation blocks north of the listed farmyard, looking north-west

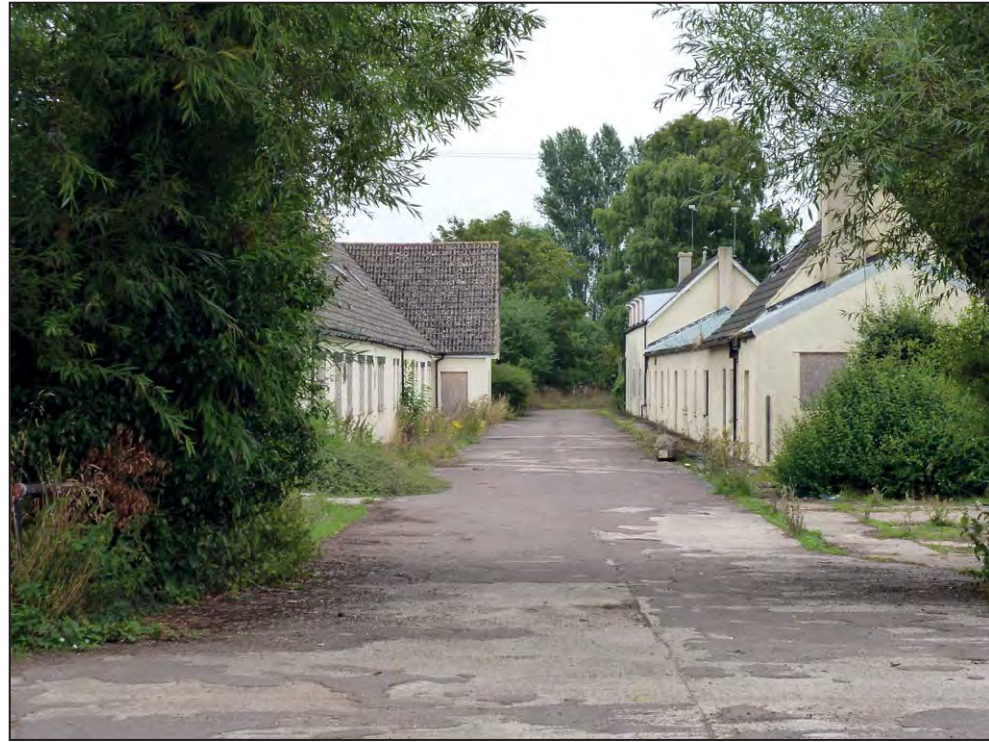
- 69 The 1936-42 ranges along the eastern end of the main east/west road, looking east
- 70 The cross wing with loading door at the east end of the north range of the eastern farm buildings, looking north-east
- 71 The north (rear) side of the north range of the eastern farm buildings, showing added porch looking south-west
- 72 The east end of the south range of the eastern farm buildings, looking south-east

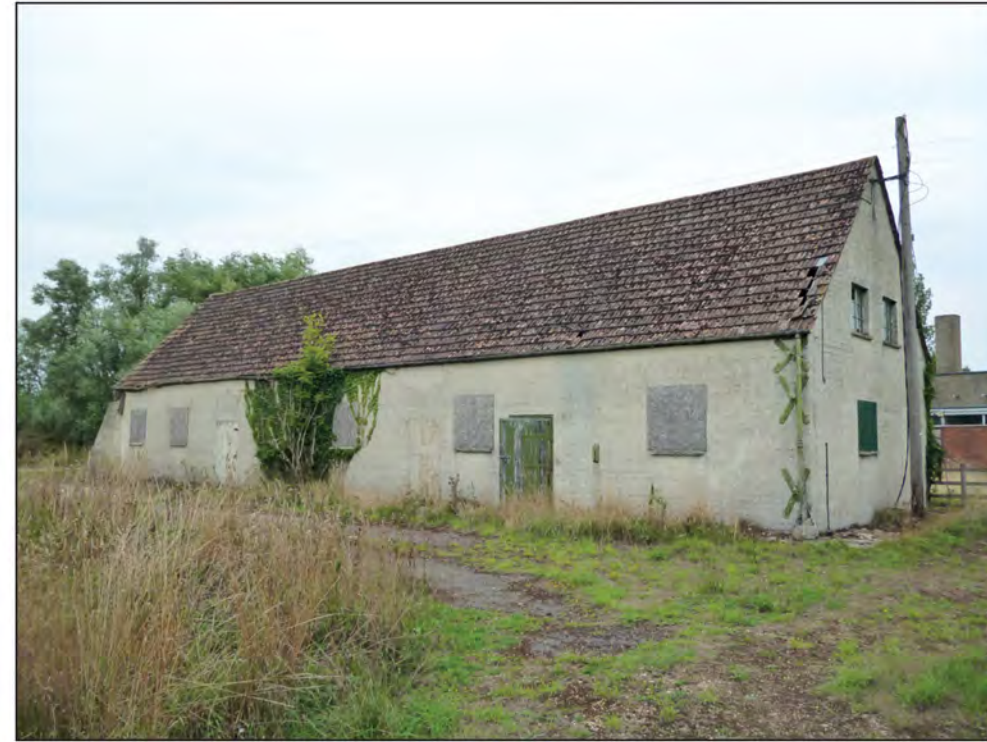
- 73 The large "farmhouse" at the eastern end of the site, looking south-east
- 74 The barn on the east side of the yard laid out at the western end of the site in 1936, looking north-east
- 75 The interior of the western shed of the western farmyard, looking south
- 76 The two added sheds on the west of the original west range of the western farmyard, looking south-east, note the steeply pitched and tiled roof of the far building dating to the Bruderhof period

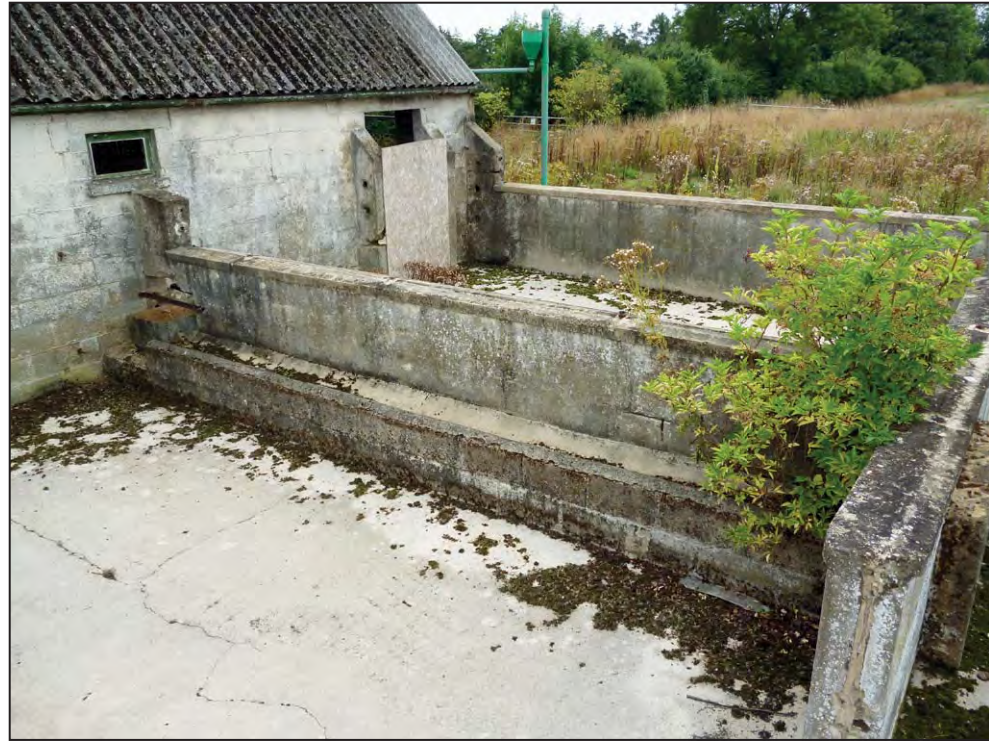
- 77 Part of the westernmost shed and two of its attached pens, looking south-west
- 78 One of the two rectangular weatherboarded structures south-west of the farmyard, looking south-east
- 79 The single gabled bay structure south west of the farmyard, looking south-west
- 80 The double-bayed building south-west of the farmyard, looking north-east

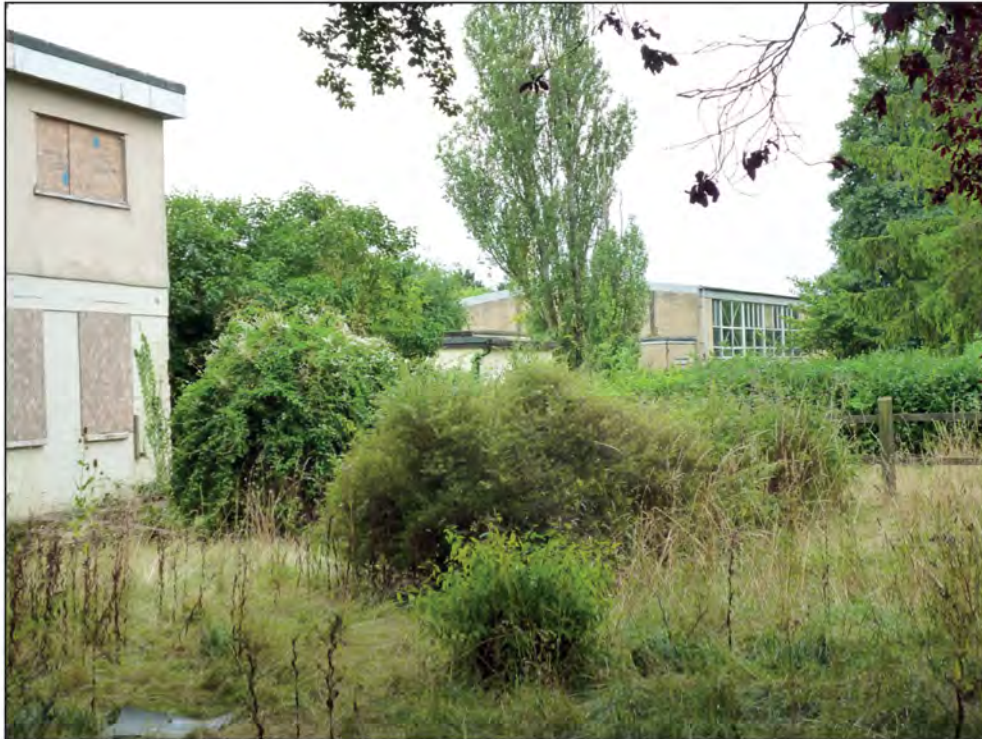
81 A large 1950s or 60s block between the northern courtyard of Bruderhof houses and the western farmyard (middle distance); the block on the left is one of the early flat-roofed additions to the Bruderhof courtyard
