Cedar House, Blackberry Hill Hospital

Historic Building Recording (Level 2)

CA Project: CR0778

December 2021

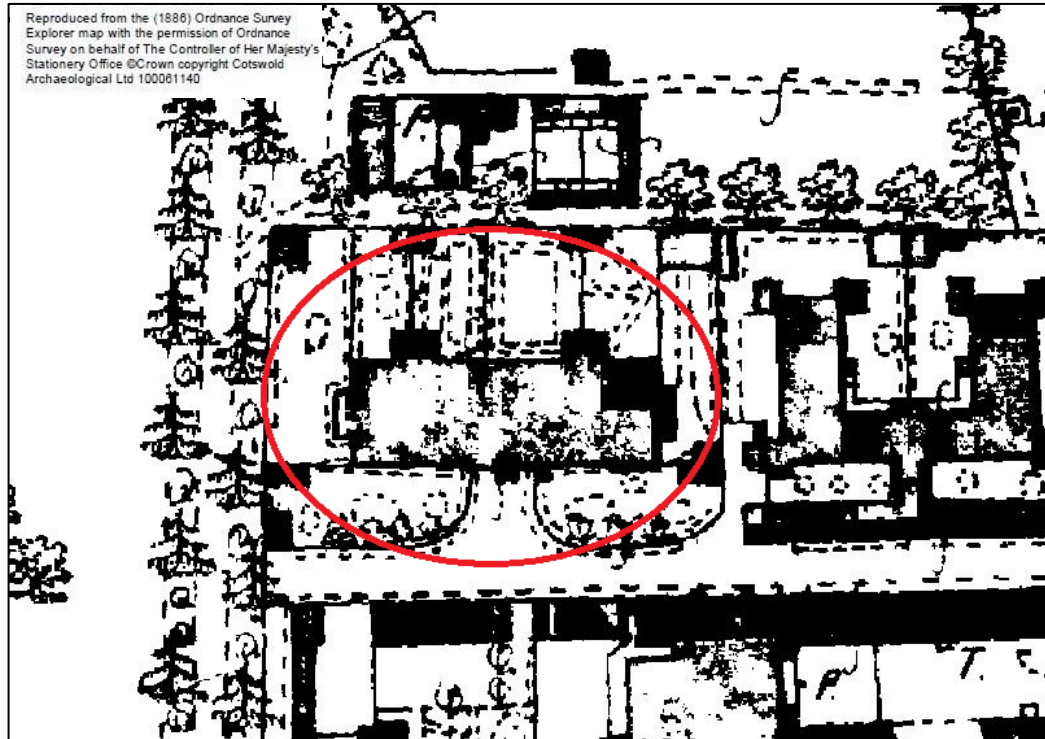
Fig.2 1882 Ordnance Survey Map

- 3.5. Cedar House was purpose built in the 1860's as part of the major works to create a workhouse complex. It first appears on maps of the site in 1882 (the 1st Edition Ordnance Survey map). Fig.2 below illustrates the Building in the map. Those areas

to the south and east of the Building comprise the wider Blackberry Hill site which has now been recorded and is in the process of being redeveloped. This shows the Building as a simple rectangular block with two small projections to the rear (north).

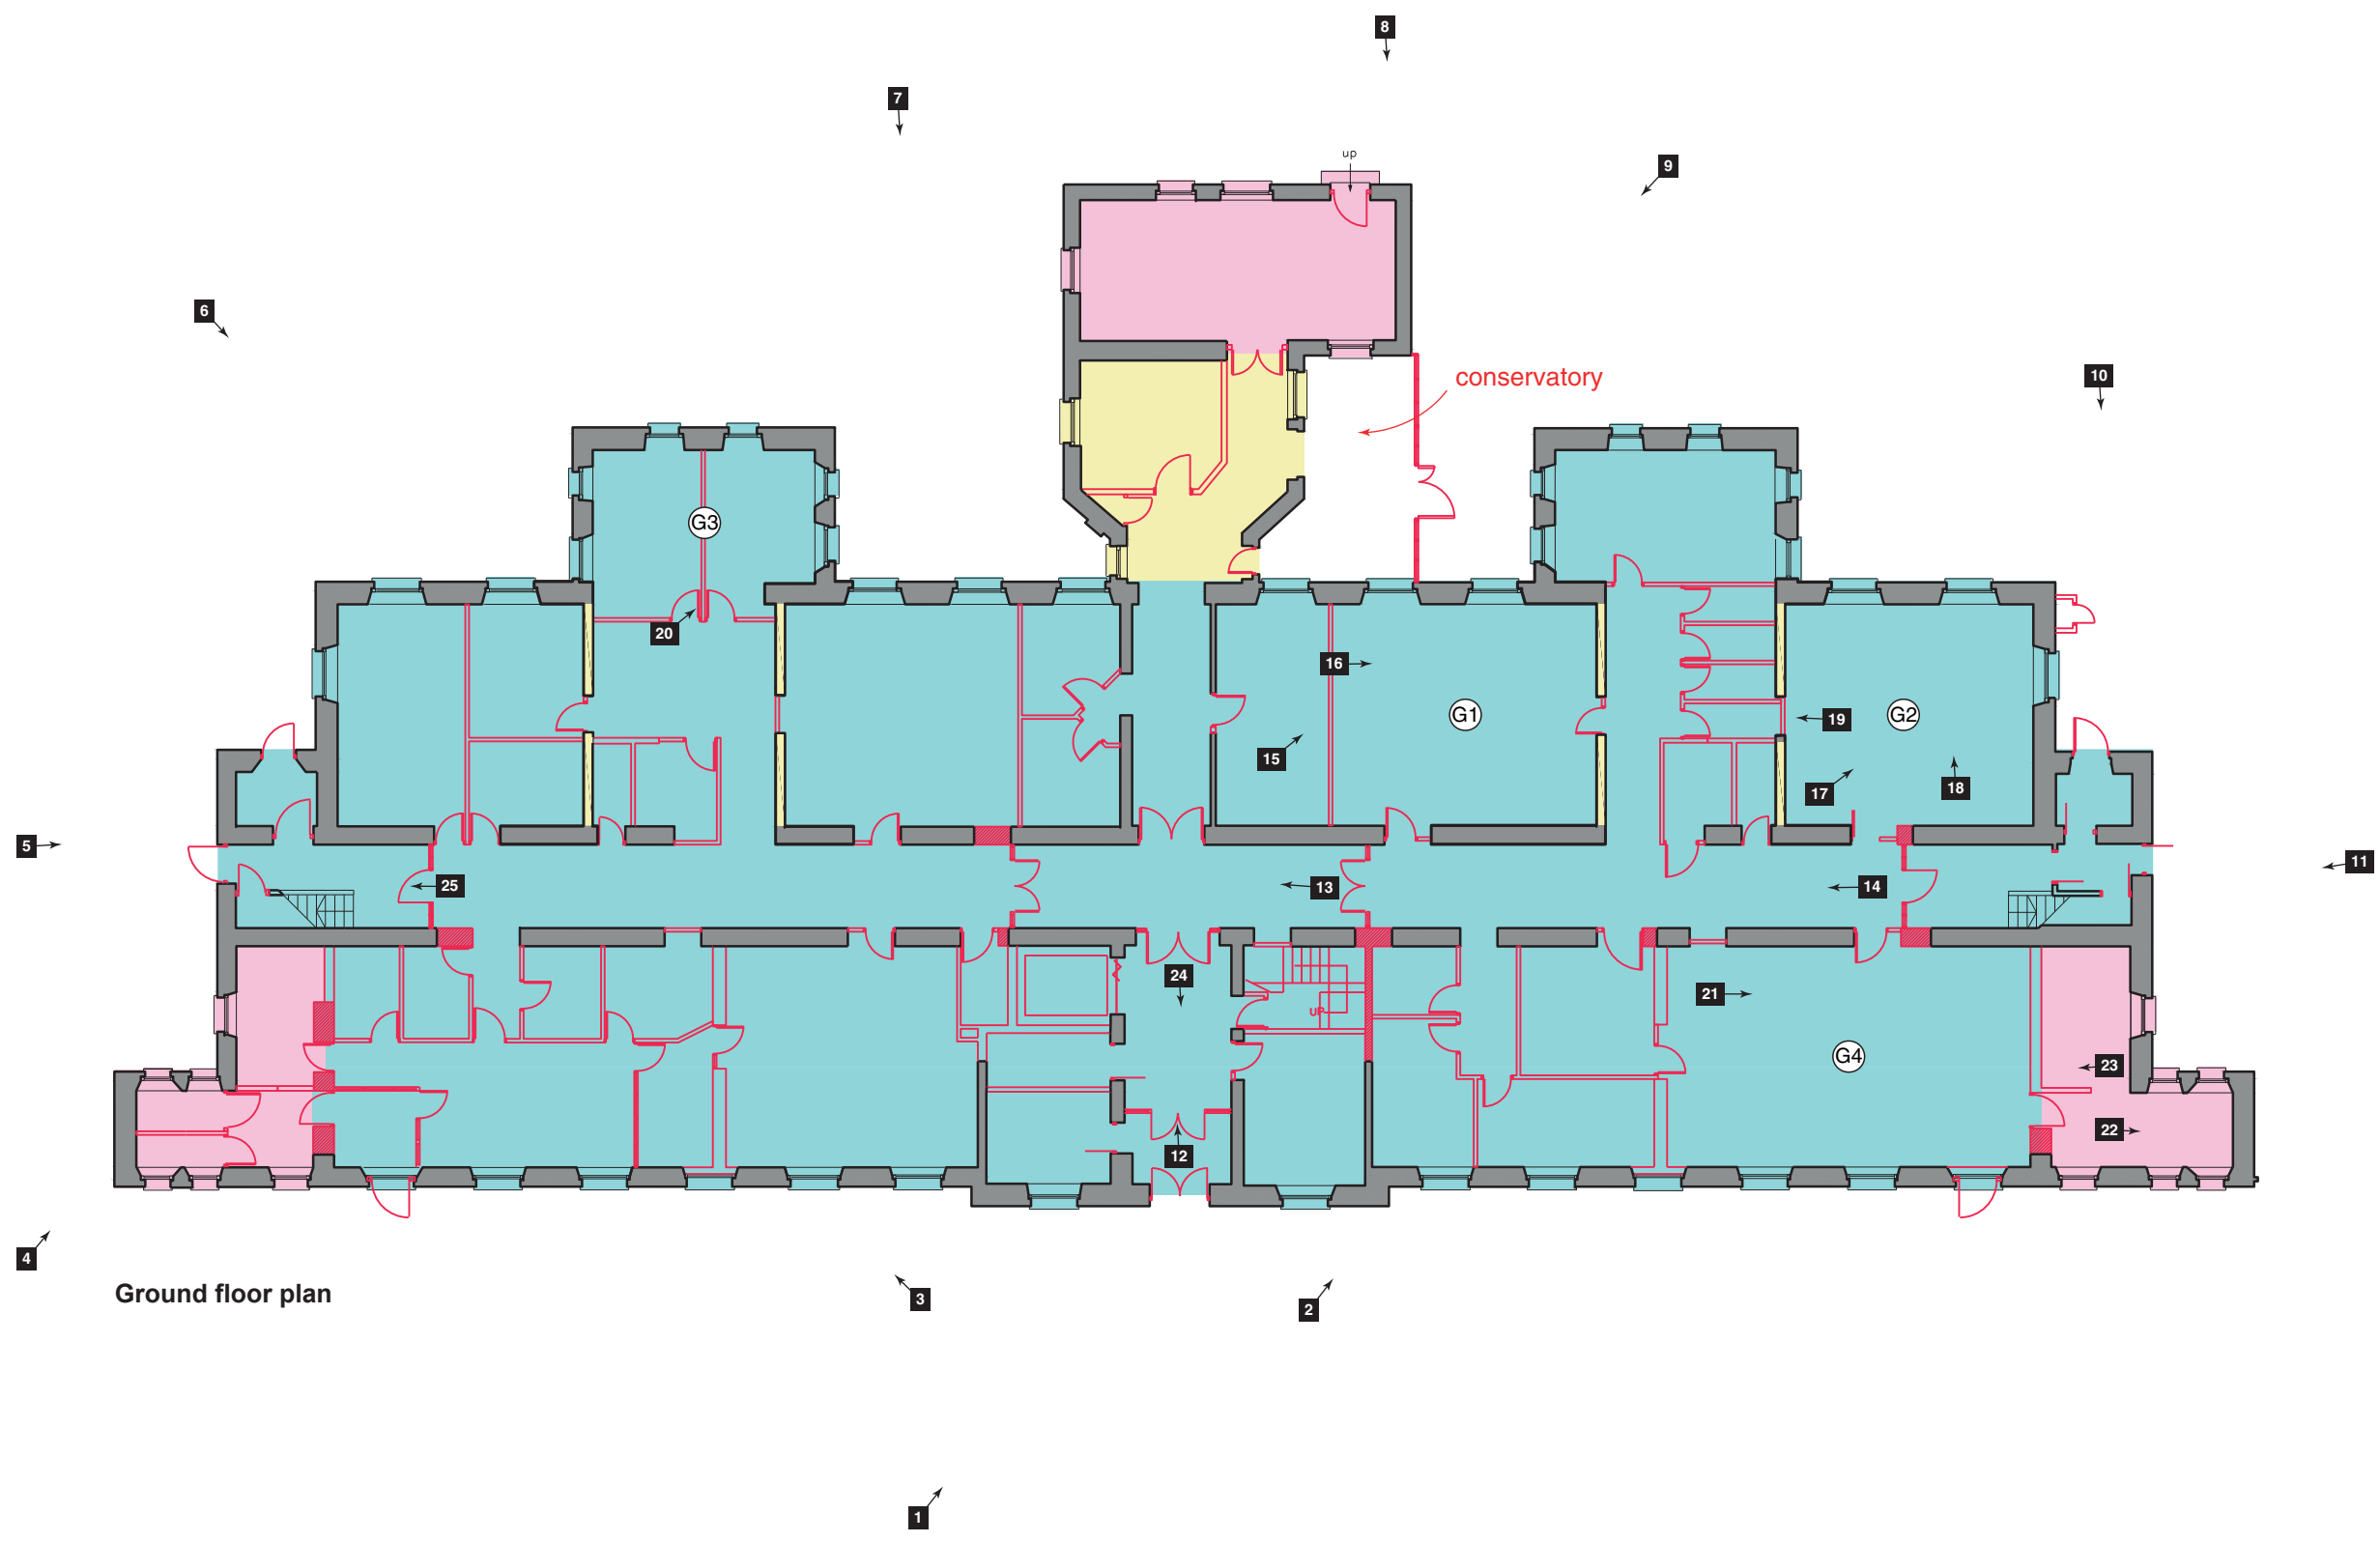
FIGURE TITLE
Annotated floor plan of ground floor
with photographic location points

- Building phases**
- Original 1860 building plan
 - Late 19th century extension
 - Early 20th century extension
- ① Room number
- ➔ 1 Direction of photograph
- Existing wall retained
 - Existing wall removed
 - Original structure removed but extant at site visit
 - Existing stair retained
 - Existing stair removed

Ground floor plan

3.9. During the 20th century, as the Building moved into NHS hospital use alongside the main buildings on the site, it became heavily altered and subdivided in plan form. These new partitions were formed of both brick and stud walling, and were constructed to create offices and doctor/patient accommodation to suit the modern use of the Building, which was a Psychotherapy Unit during the late 20th and early 21st centuries. This is best illustrated in Fig.4, which are As Existing floorplans of the Building, and which have been annotated to show the extent of modern subdivision, with the majority of the thinner walls comprising modern partitions. These floorplans also illustrate the location of photographs taken at the site visit. It should be noted that at the time of the site visit, all of the stud modern partitions had been removed to reveal the original building envelope, some modern brick partitions were still evident and will be identified in the building recording narrative and in Fig.4.

- 4.7. The eastern side of the northern (rear) elevation is identical to that seen on the western side, with a two-storey gabled wing and largely regular fenestrations with string course (Photo 8). A conservatory has been added in the area between the off centre one storey rear building and the original rear wall, this is annotated in Fig.4 and illustrated in Photo 9.

- 4.10. Fig.4 details the walls that have been removed as part of the building strip out, these are coloured red and as can be seen from comparison with the original walls illustrated on Fig.4, these structures are largely modern subdivisions. Fig.4 also details the original plan over the extant plan (including walls that have been removed) and provides information on phasing as far as can be discerned from historic mapping and building fabric. It is clear that numerous door openings have been inserted into the spine walls to provide access to newly created rooms as the larger wards within the Building were subdivided to suit the 20th century hospital use.

- 4.11. The basic historic plan is still readily discernible in the current floor plan, particularly as the historic walls are thicker than modern screens. The main plan is formed of a central spine corridor at ground and first floor levels, off which are accessed large spaces (former wards) and smaller office and ancillary space (generally to the south of the Building). The first floor is accessed via two sets of original cantilevered stairs with modern handrails, these are located at each end of the central corridor as seen on Fig.4.

which suggests that presence of chimney stack in this location (see Fig.4 for specific location). Chimney stacks have been comprehensively removed from the Building so this is rare survival.

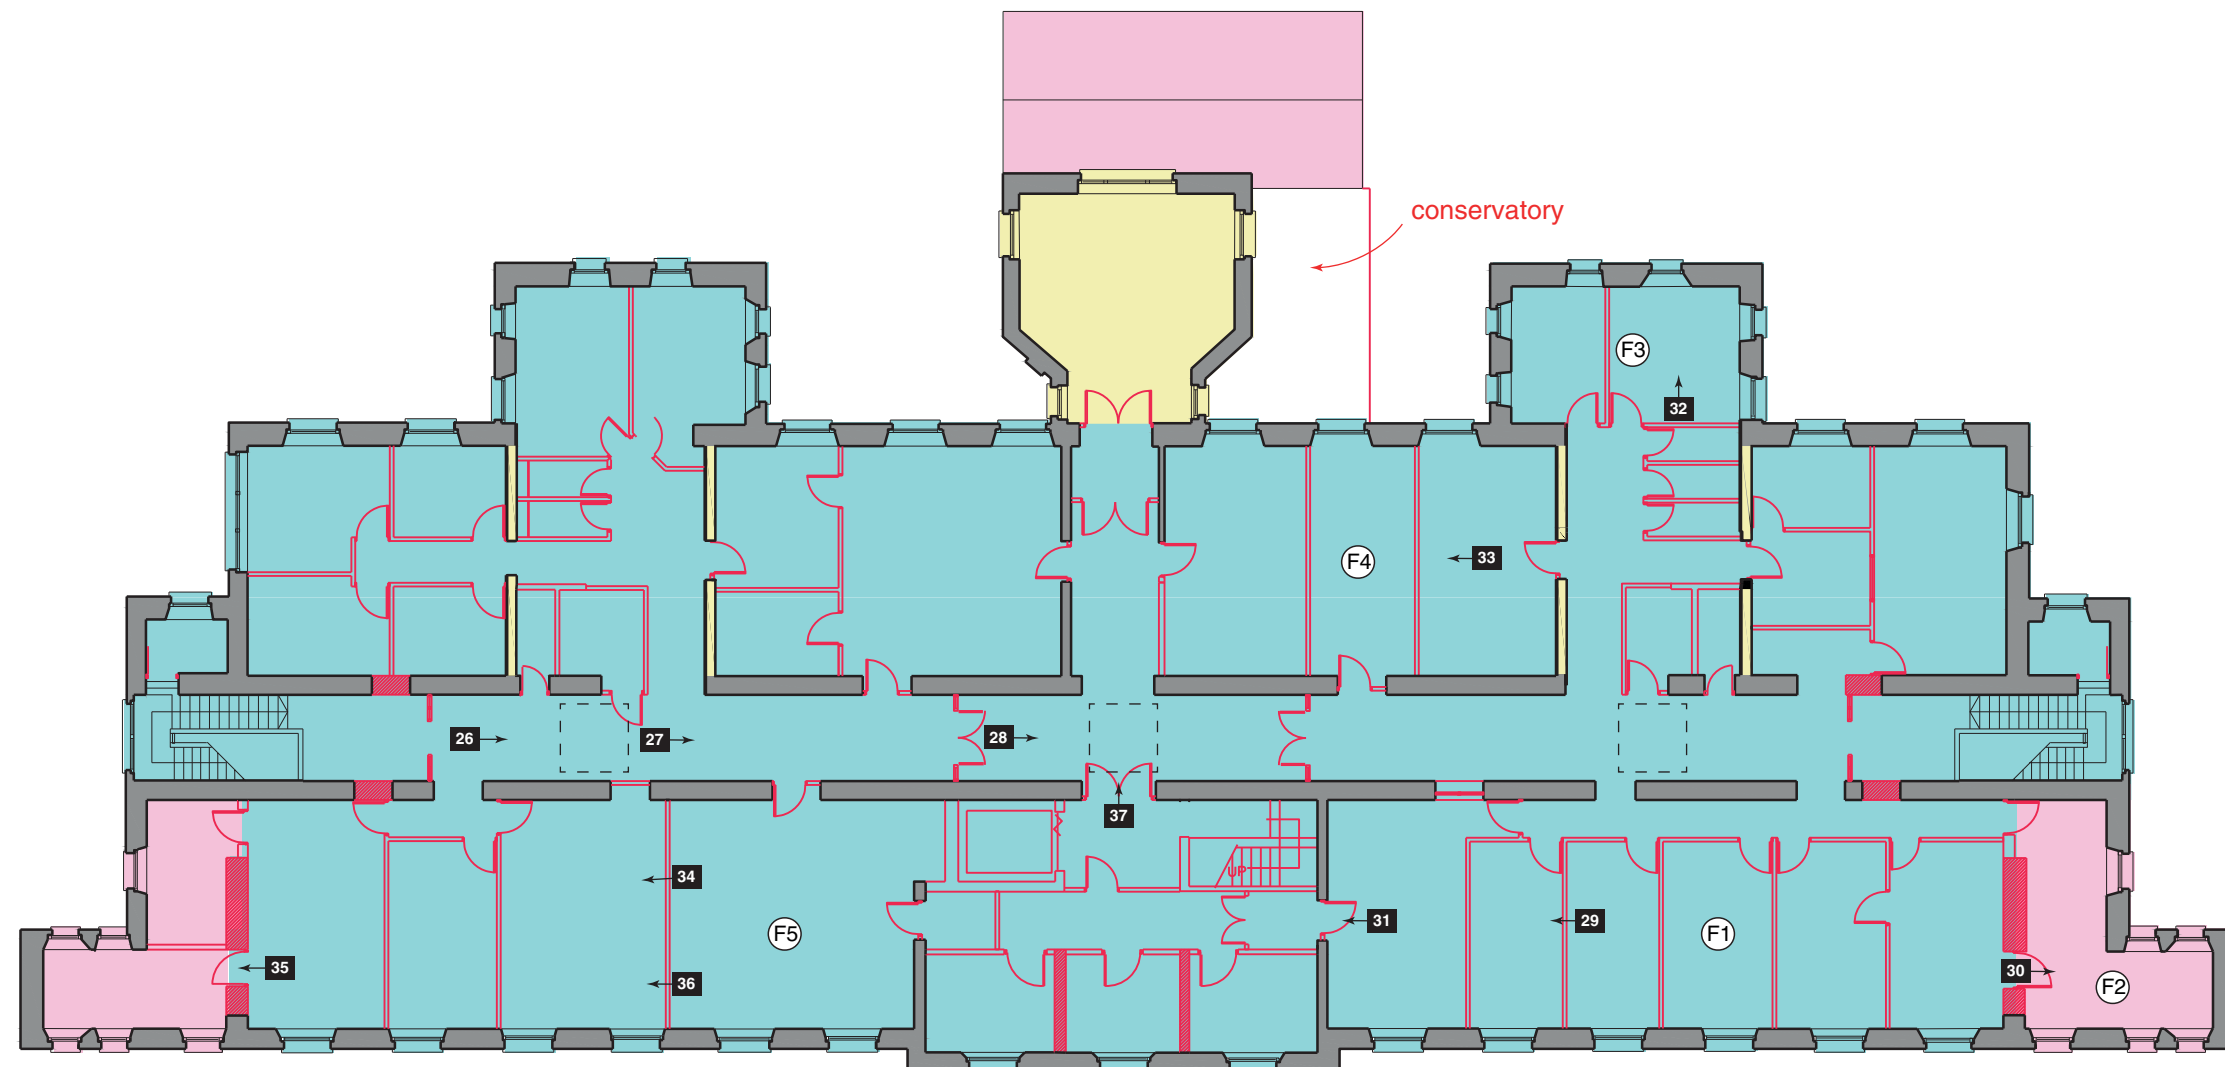
FIGURE TITLE
 Annotated floor plan of first floor with
 photographic location points

First floor plan

- Building phases**
- Original 1860 building plan
 - Late 19th century extension
 - Early 20th century extension
- 1 Room number
 - Direction of photograph
- Existing wall retained
 - Existing wall removed
 - Original structure removed but extant at site visit
 - Existing stair retained
 - Existing stair removed
 - Rooflight over

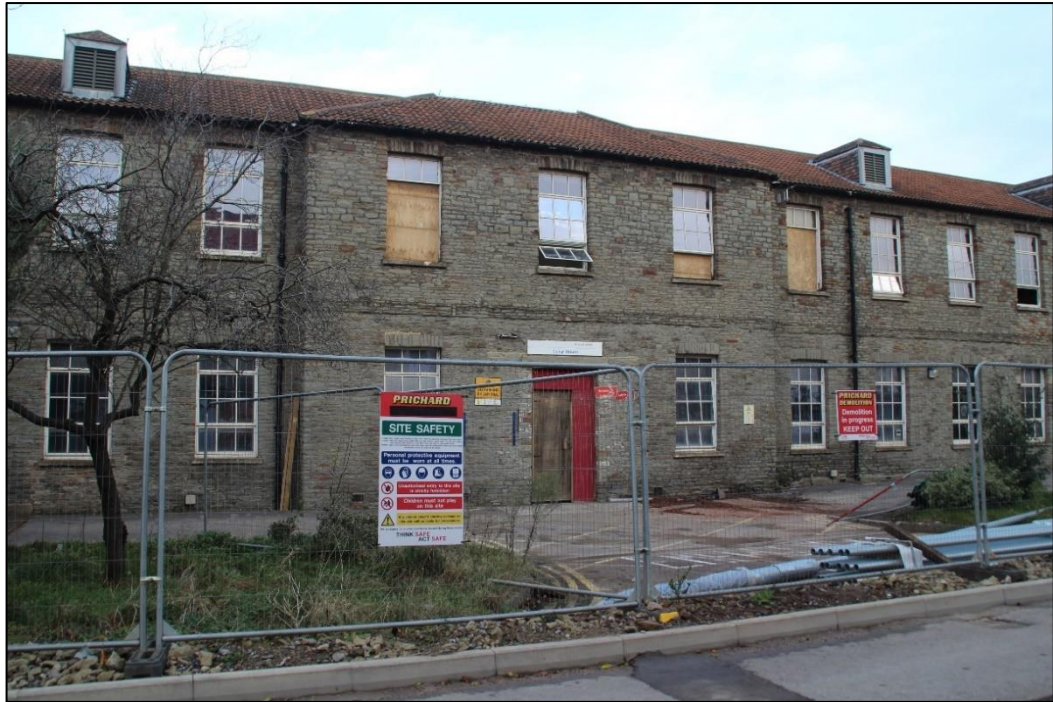
Photo 1 **The front (southern) central section of the Building**

- 4.4. The southern elevation is formed of the main central entrance section (Photo 1) of three bays. The main entrance door has a wide stone lintel with stone dressings. This central section, which sits forward of the main building line (including the roof), is flanked by two wings of eight bays each (Photos 2 and 3) with a doorway at ground floor in the sixth bay of each side. The three bays to each end have brick dressings, brick quoins and no string course, indicating they are of a different phase to the original Building (Photo 4). Examination of the mapping for the site shows that the Building did not have these flanking bays in the 1882 1st Edition Ordnance Survey Map, but did in 3rd Edition Ordnance Survey Map of 1934, indicating they were added in the early 20th century.

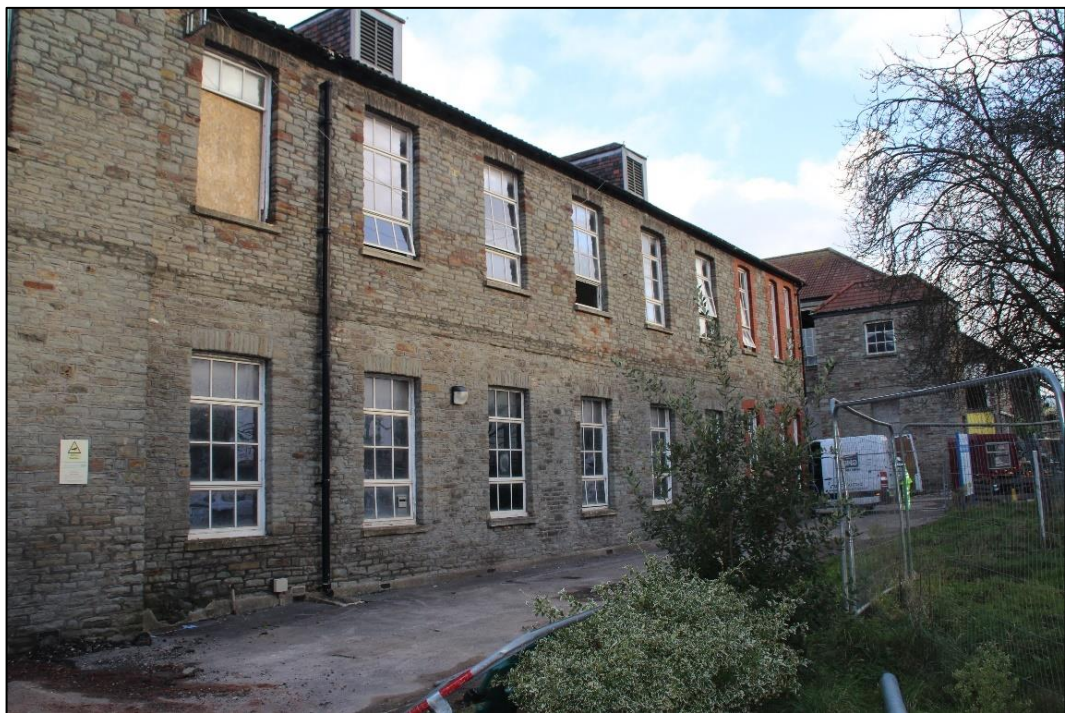
Photo 2 **The front (southern) western section of the Building**

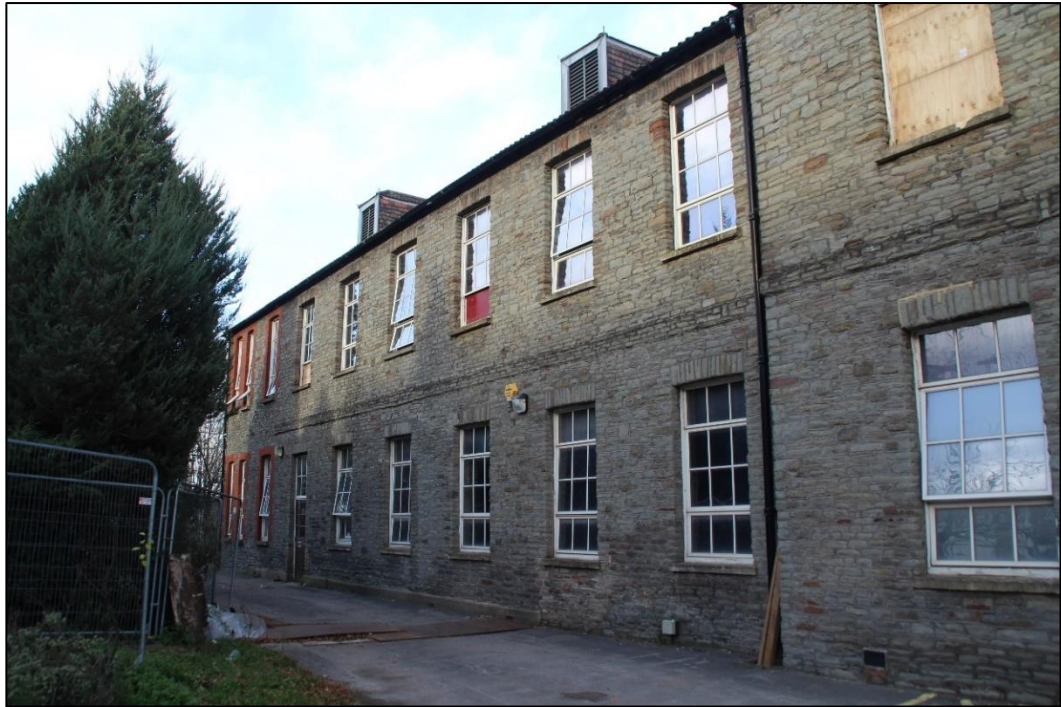
Photo 3 The front (southern) eastern section of the Building

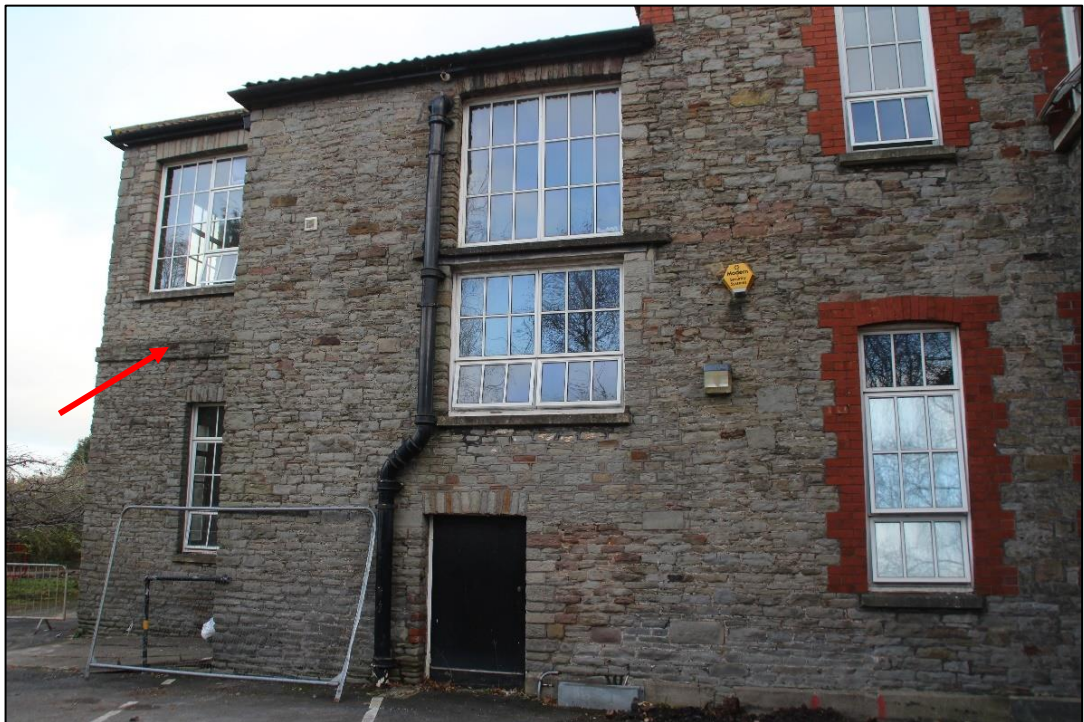
Photo 5 **The western elevation of the Building (string course arrowed)**

4.5. The western elevation of the Building comprises the flanking side walls which step back as seen in Photo 5 in line with the Building's footprint. Fenestration is less regular, with large multi-pane windows dominating sections of the façade. As with the main façade, window and door openings have brick headers and pennant stone dressings. The string course is absent in areas of this elevation, which suggests that the areas where it is missing may comprise newer, but still historic additions as identified in historic mapping or phases of façade rebuilding. This is illustrated through annotation in Photo 5. Fenestration is more regular to the rear of the Building (Photo 6) and the string course is present.

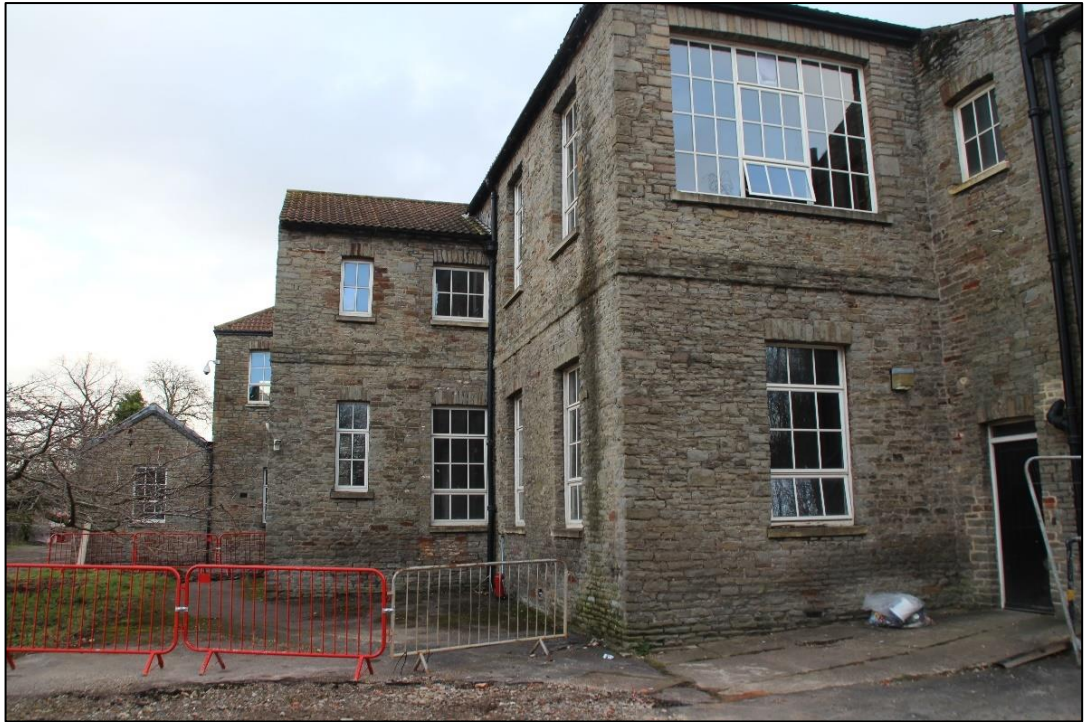
Photo 6 **The rear western section the Building**

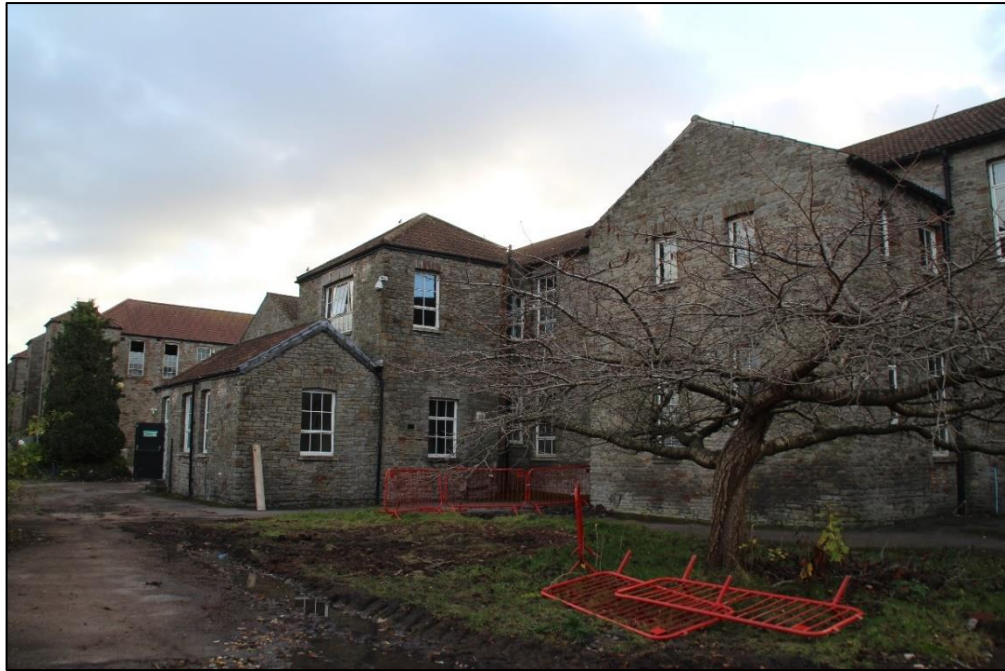
Photo 7 The rear of the Building taken looking east

- 4.6. At the rear of the Building (north) there are two gabled wings oriented north-south as seen in Photo 7 (the western wing). Fenestration is again regular, and the junction between roof and gable is flat and without embellishment. In the centre of this elevation is a hipped central structure reminiscent of a tower. On plan this has two diagonal southern walls which orient inwards to link with the main Building (see Fig.4). A simple one storey structure is appended to this 'tower' on its northern side as seen in Photo 8; according to cartography this was added after 1921.

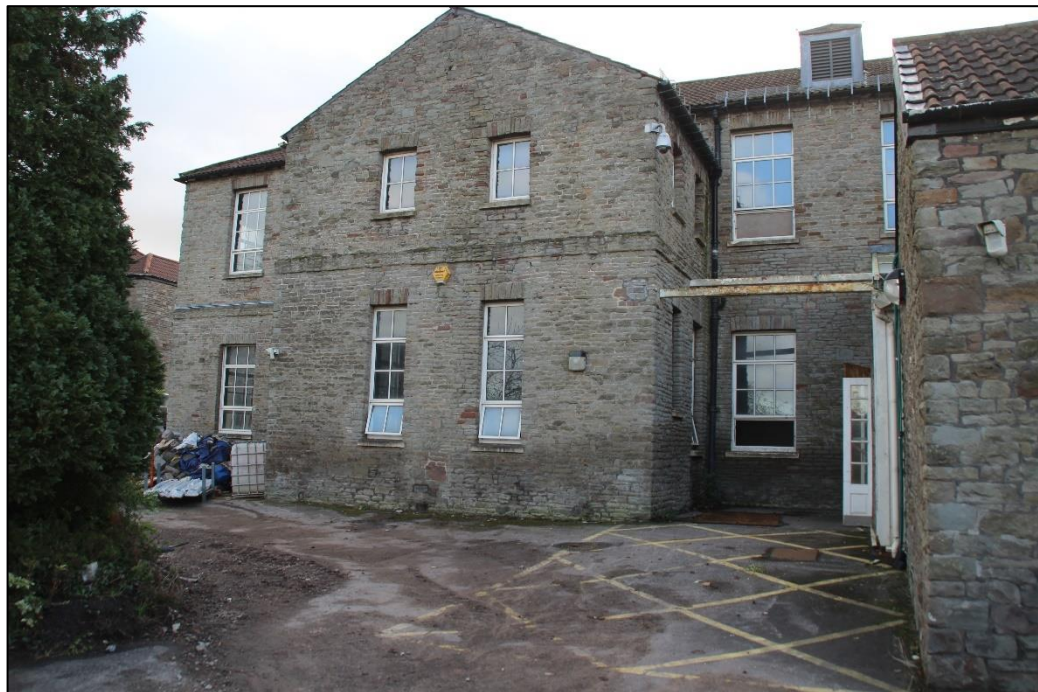
Photo 8 The rear eastern section of the Building

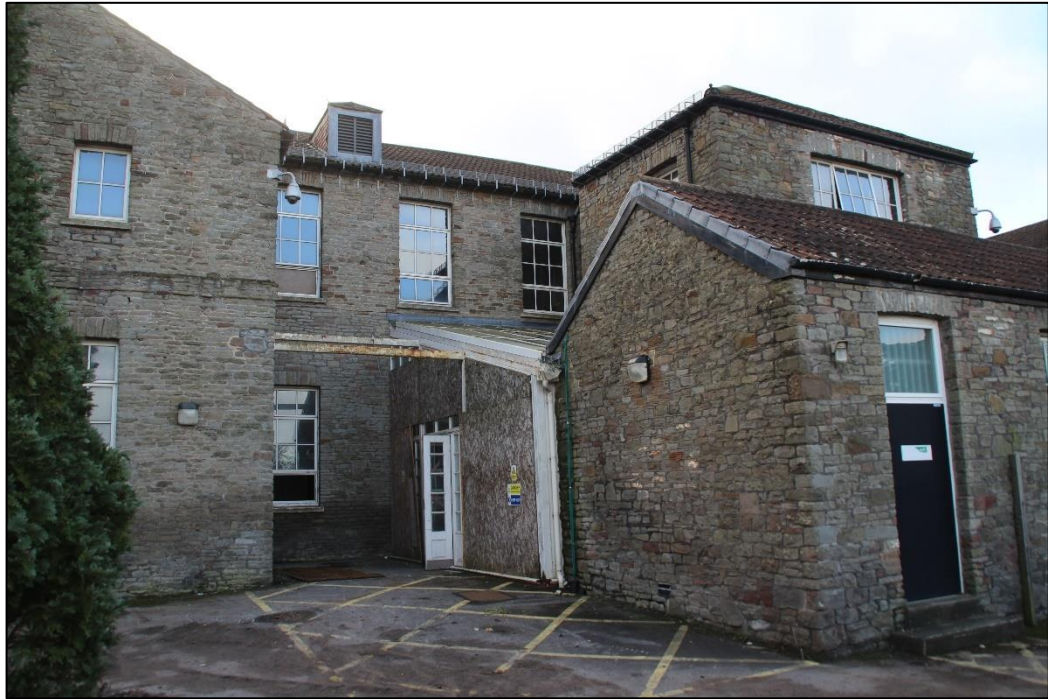
Photo 9 View looking towards the central 'tower' and the conservatory

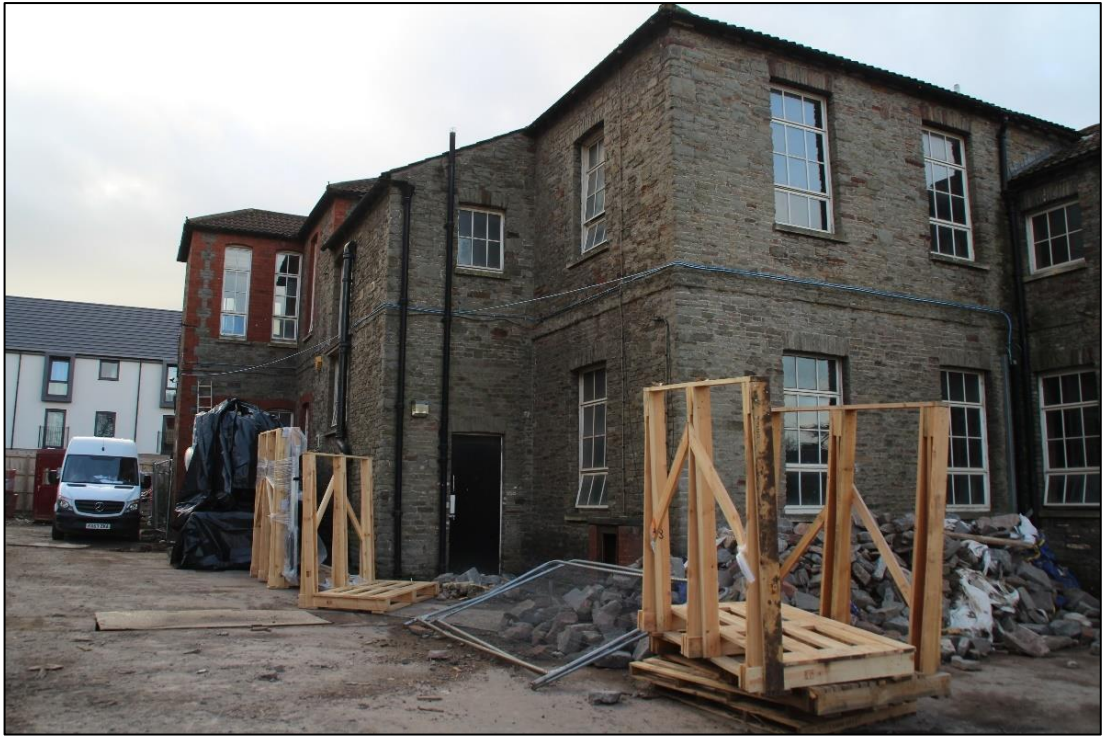
Photo 10 **The western elevations of the Building**

- 4.8. The eastern elevation is identical to that of the western, with a series of set back and break forward elements of differing phases of development of the Building (Photo 10). From this viewpoint, there is evidence that the newer sections with red brick dressings involved some rebuilding of the original façade on this side, this is illustrated by the difference in roof treatment and finish between one section of the side wall and the other and there is faint evidence of stone knitting between the newer (red brick dressed) section and the original section (right of Photo 11). It is unlikely that the Building was originally built with windows as large as seen in Photo 11, and this suggests that the two are newer insertions, though as these windows light the staircase, it is likely that the original windows here were larger than normal and this is evidenced by the length of the stone header.

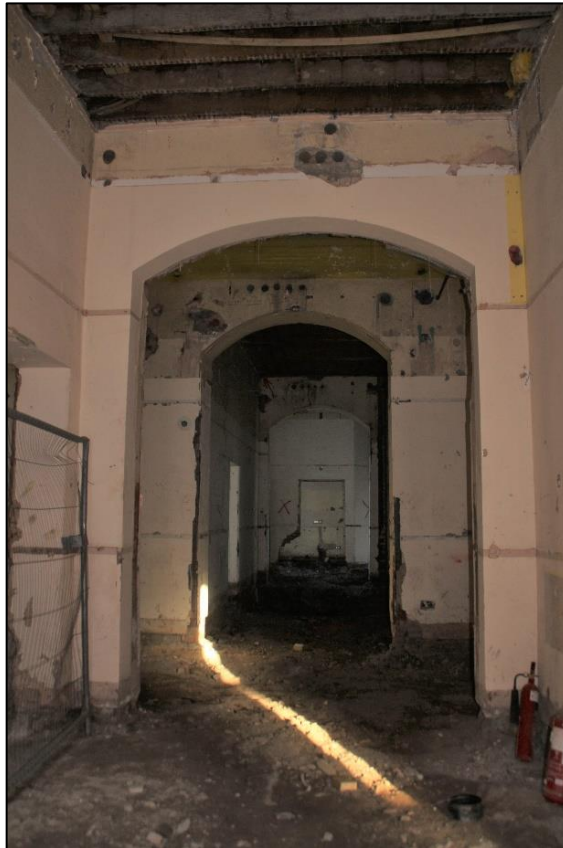
Photo 12 **The entrance hall taken looking north**

4.13. The building is entered via the main southern entrance. Two large original chamfered archways provide access to the main corridor, as seen in Photo 12. The high ceiling to the corridor is brick and shallow vaulted with brick ribs, as seen Photo 13, with modern insertions of glass brick sections to bring some natural light to the ground floor space. The corridor itself, which has been stripped of all features and fixtures, provides a series of squared openings into the rooms each side of the corridor, as seen in Photo 14.

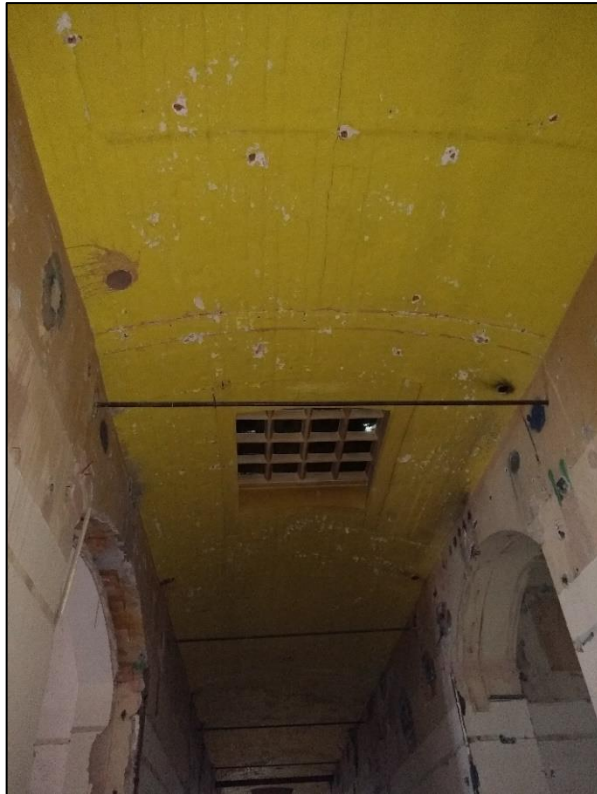
Photo 13 **The ribbed shallow arch to the corridor of the Building**

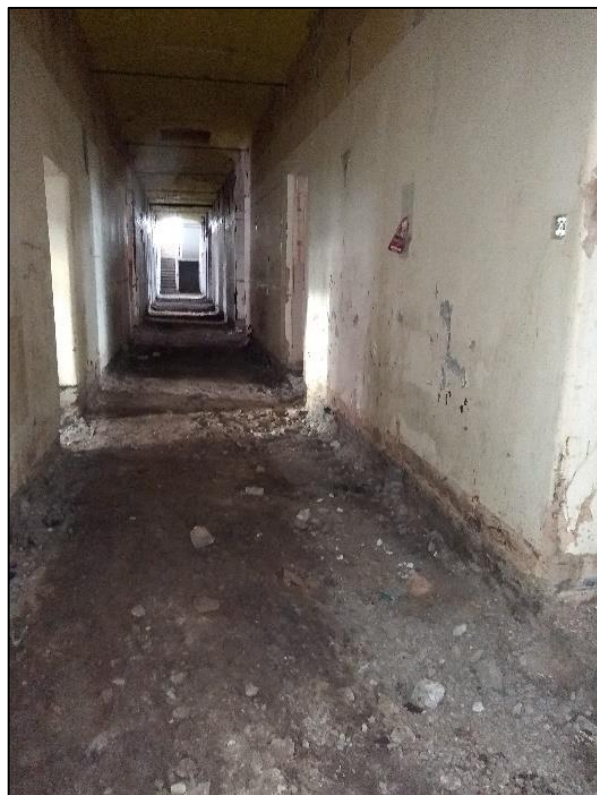
Photo 14 **View looking west along the ground floor corridor**

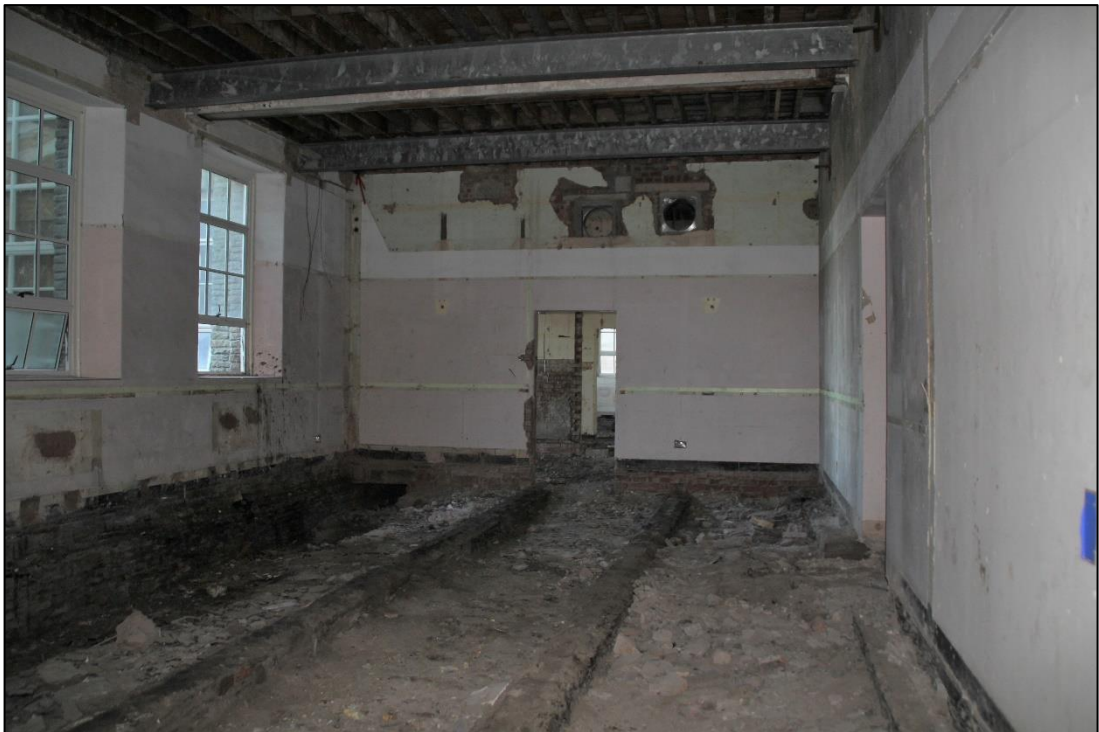
Photo 15 **Room G1 looking east**

-
- 4.14. Room G1 as seen in Photo 15 is typical of the appearance of the ground floor rooms in their current stripped out state. The central brick floor piers are visible running longitudinally across the length of the room. Rubble and earth has been infilled between them. Services and drainage have been removed, including large venting holes as seen in the image, which would have been hidden by the suspended ceiling. Door openings are plain and without mouldings. The ceiling has been strengthened with the addition of steels as seen in Photo 16, which also shows the original joists of the upper floor running east-west and showing evidence of former lathe fixings.

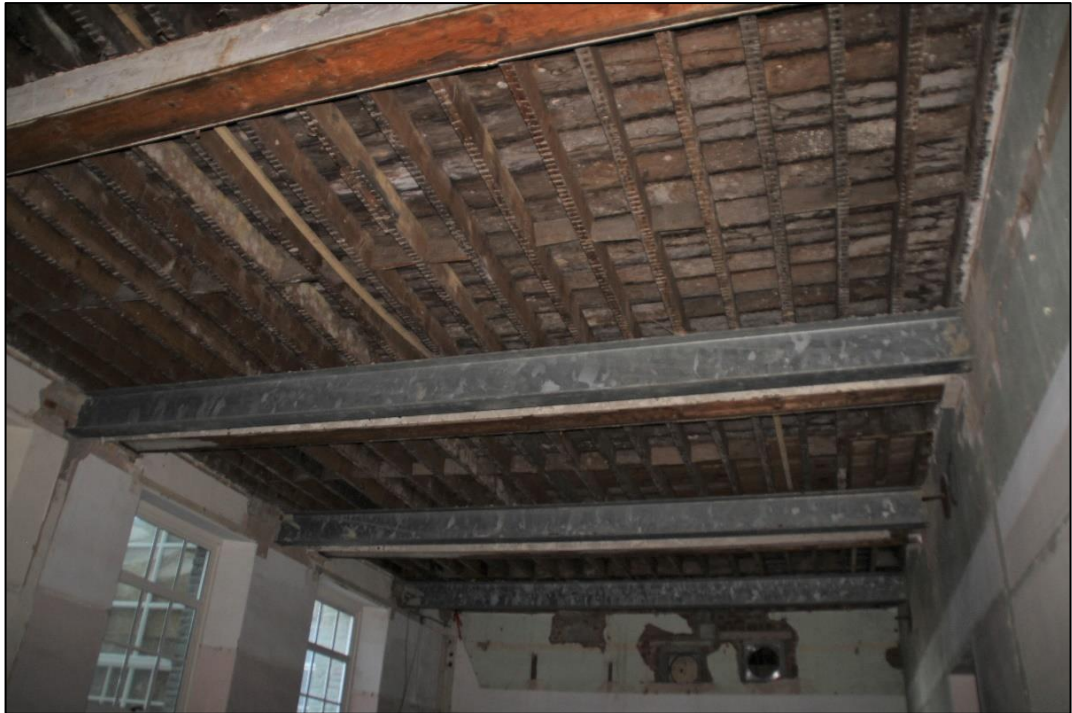
Photo 16 **Room G1 looking up**

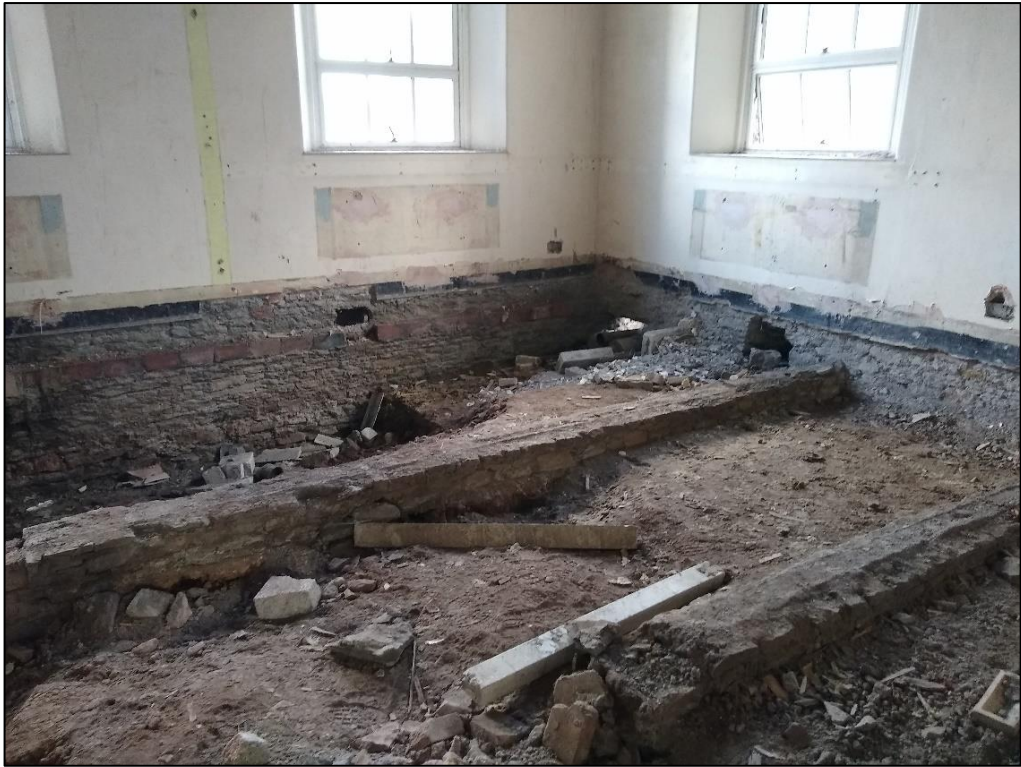
Photo 17 Room G2 looking north-east

- 4.15. Room G2 provides a little more information on the building envelope as seen in Photo 17. The foundations are formed of rubblestone, with a single course of thick red sandstone ashlar inserted on the north wall. There is evidence of a damp proof course, which given the original date of the Building must have been inserted some years after construction (i.e. post 1875, when damp proof courses were first introduced into building construction). In this room two further steels have been inserted, alongside two steels cradling what appear to be historic i.e. original, timbers beams (Photo 18).

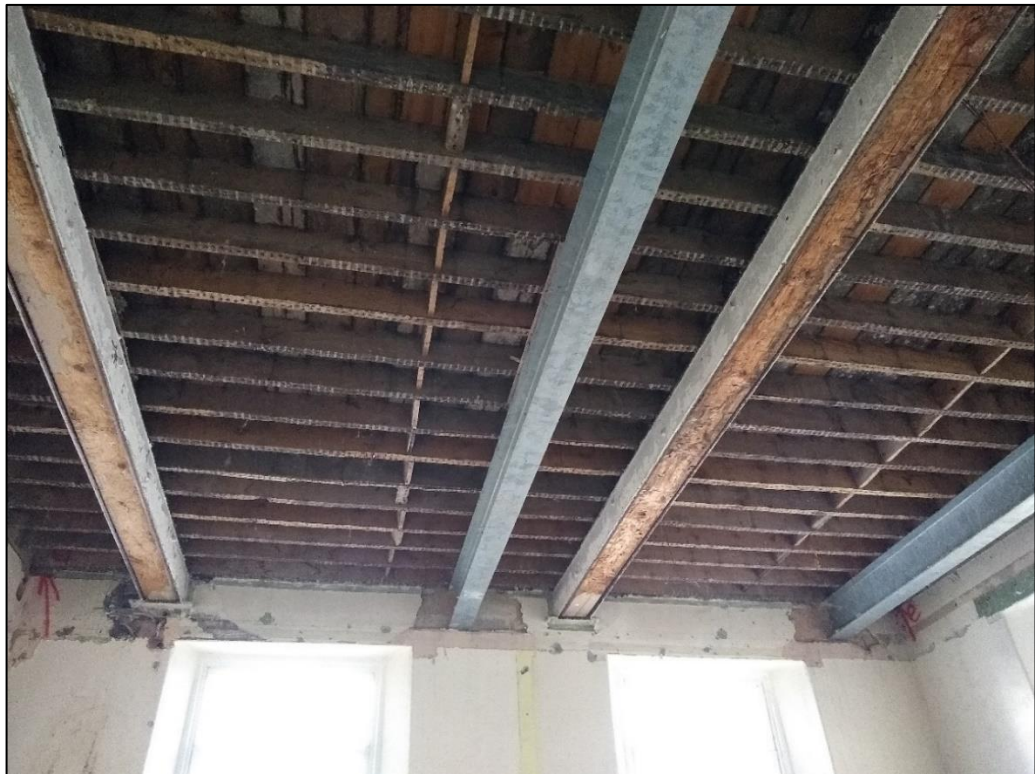
Photo 18 Room G2 looking up

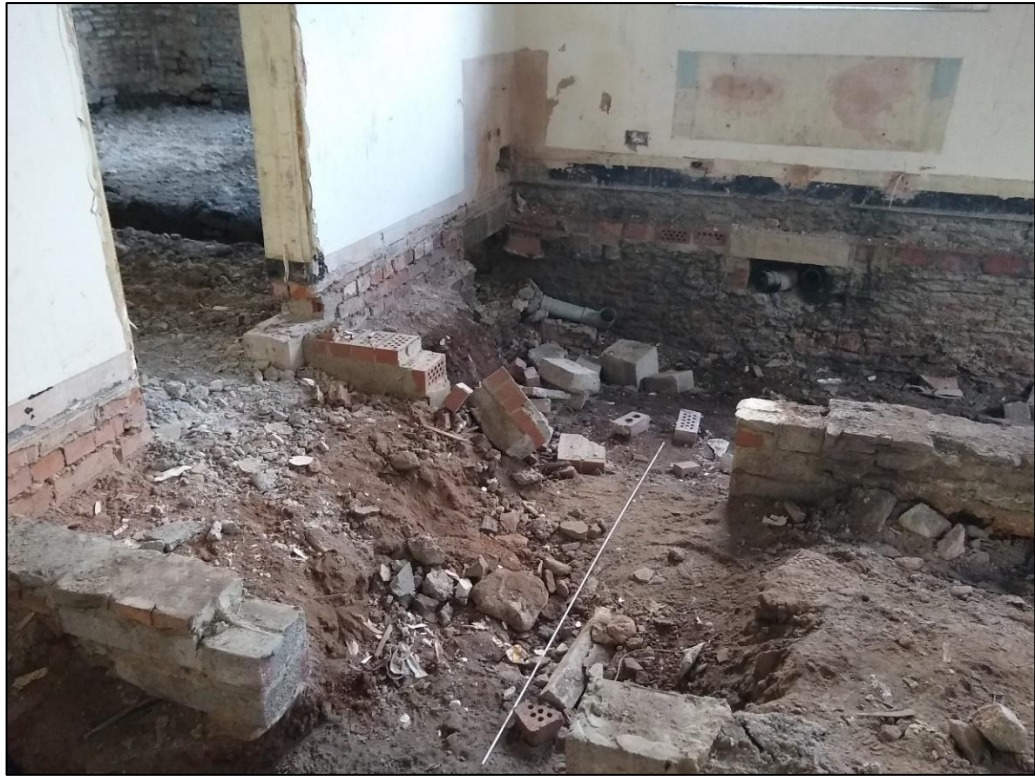
Photo 19 Room G2 looking down and to the north-west

- 4.16. Photo 19 shows how a modern brick wall has been inserted into the structure, with associated alterations to the brick floor piers (which display both historic and modern material). As can also be seen in the image, drainage has been installed through the external wall, with the drainage conduit opening being supported by a stone lintel.

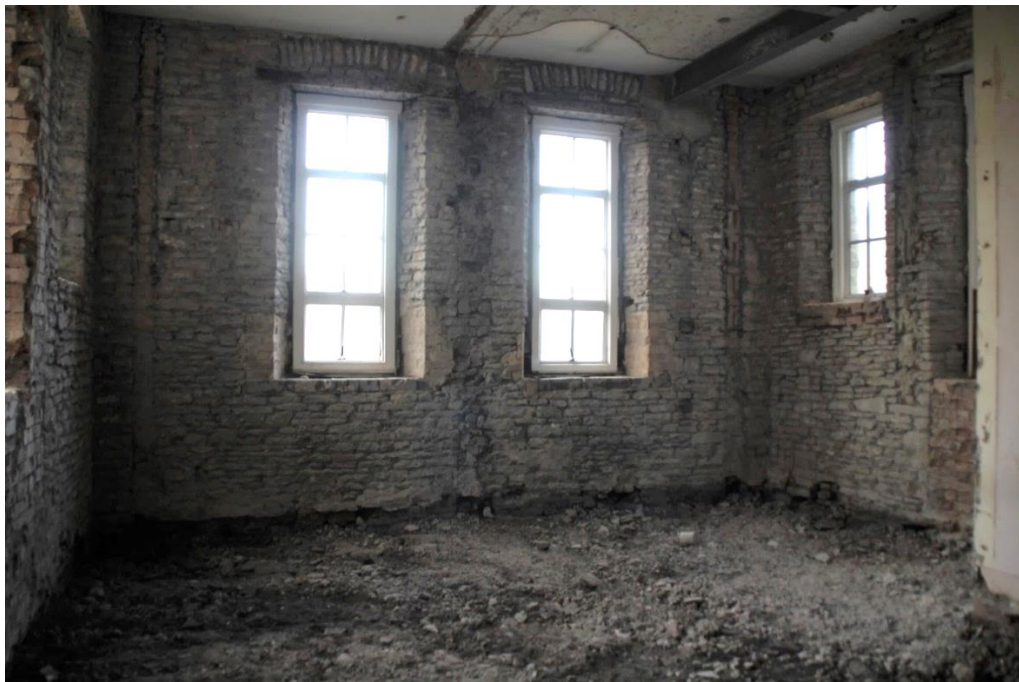
Photo 20 Room G3 looking north

- 4.17. The majority of the rooms within the ground floor appear in the same manner and with the same fabric as seen in G1 and G2. In some areas plaster has been removed to reveal the masonry structure underneath, as seen in Photo 20, in Room G3 where there is evidence of window lowering through the use of brick.
