Cedar House, Blackberry Hill Hospital

Historic Building Recording (Level 2)

CA Project: CR0778

December 2021

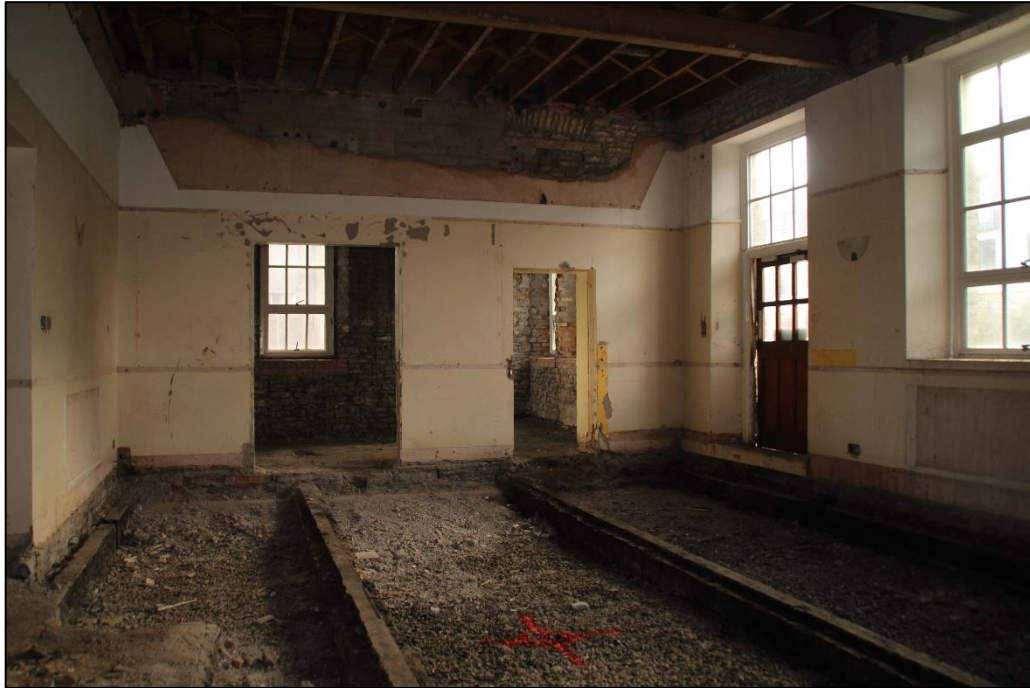
Photo 21 **Room G4 looking east**

-
- 4.18. Photo 21 illustrates Room G4, adjacent to the small eastern extension (with brick dressings). This space, one of the former wards, features brick floor piers and a doorway to the southern elevation as seen externally. An area of modern plaster has been removed to show an historic relieving arch (perhaps once indicating a window in this location prior to the building of the small wing extensions).

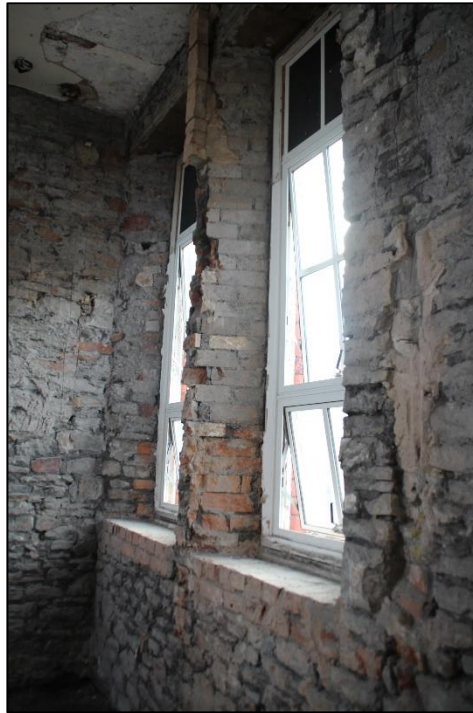
Photo 22 Room east off G4, looking south-east

- 4.19. Photos 22 and 23 illustrate the masonry of the eastern small extension wing, which is constructed in a mixture of brick and rubblestone. A further brick arch sits above a double brick and stone lintel, which suggests that window may also have been located here prior to the extension, which indicates potentially two windows in this location on the ground floor.

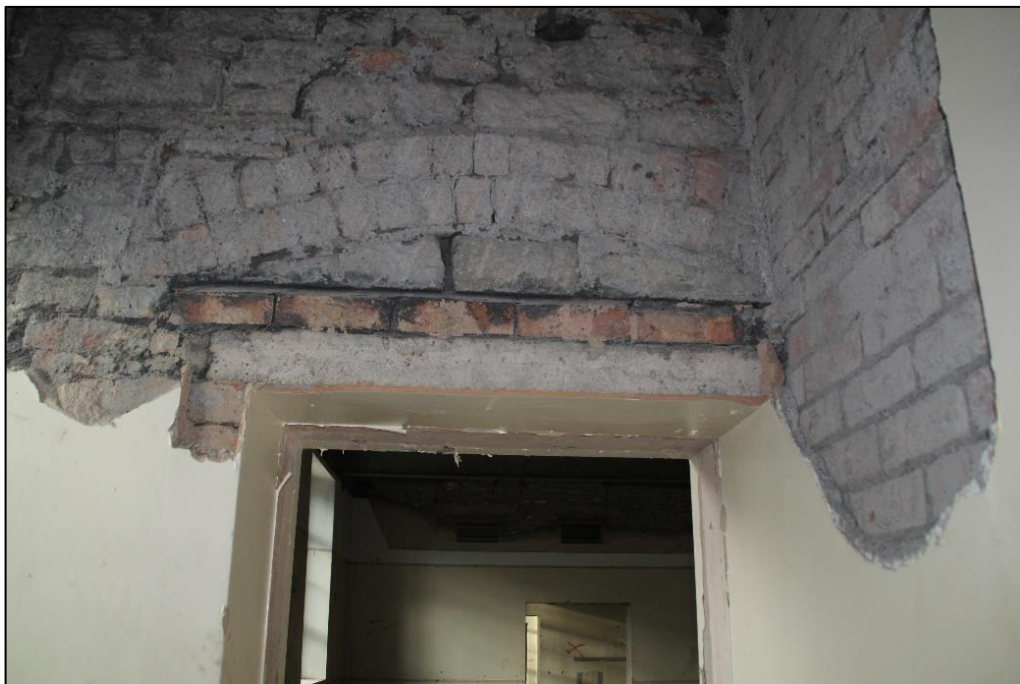
Photo 23 Detail of doorway going into Room G4 from the east

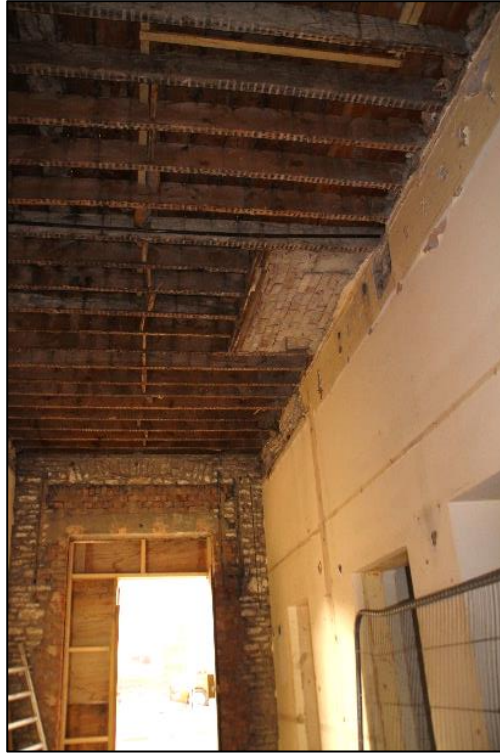
Photo 24 The front entrance hall with possible brick hearth above, looking south

4.20. Returning to the corridor, the entrance hall can be seen internally looking externally as seen in Photo 24. Of interest here is the stone arch above to the doorway, which is either relieving or indicates a once larger opening entrance here. Also seen here and nowhere else in the Building is what appears the underside of a brick hearth,

which suggests that presence of chimney stack in this location (see Fig.4 for specific location). Chimney stacks have been comprehensively removed from the Building so this is rare survival.

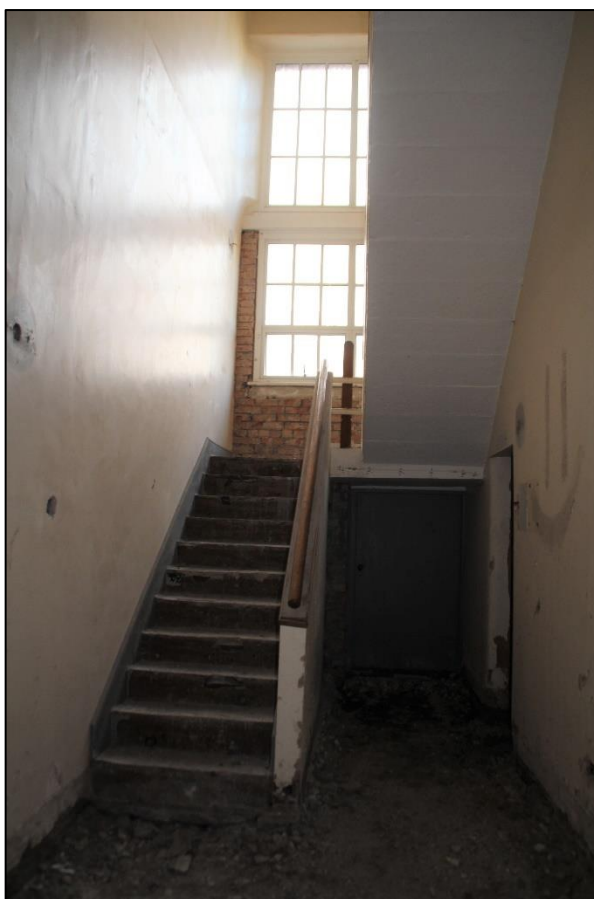
Photo 25 **The eastern staircase**

4.21. Photo 25 illustrates the western stairs accessing the first floor. As already indicated they are like to be original but with modern brick balustrade and handrail. The window is bordered with brick infill, which suggests, as already indicated, that the presence of two large windows here is not as historic.

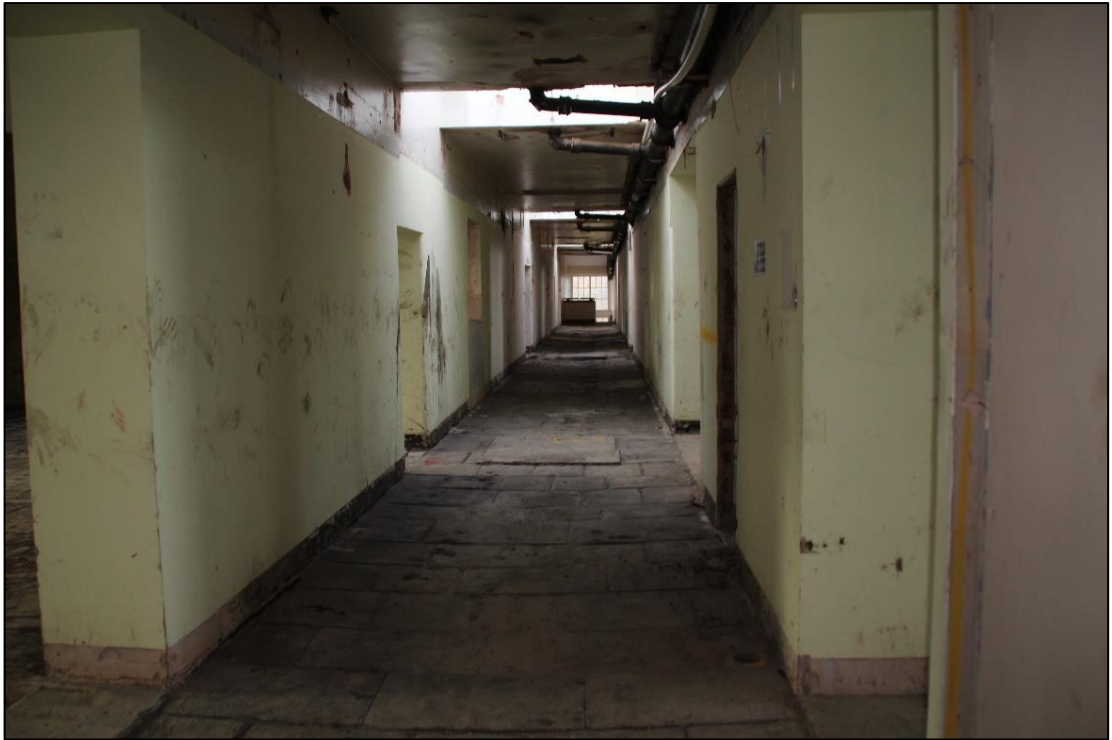
Photo 26 **The flagstone upper corridor**

- 4.22. The first floor is largely in the same plan as the ground floor, that is to say large ward rooms accessed from a central corridor. The corridor is formed of stone flagstones supported on the ribbed brick arched vaulting seen in the corridor below. This is punctuated by areas of metal framed glass inserts, presumably inserted in the 20th century to throw some light into the lower corridor (Photos 26 and 27). The upper corridor itself is lit by three roof lanterns placed at regular intervals (Photo 28). These are modern versions, and likely replaced timber structures. Given the need for natural light in the 19th century, it is likely some form of lantern structure was constructed at the same time as the Building.

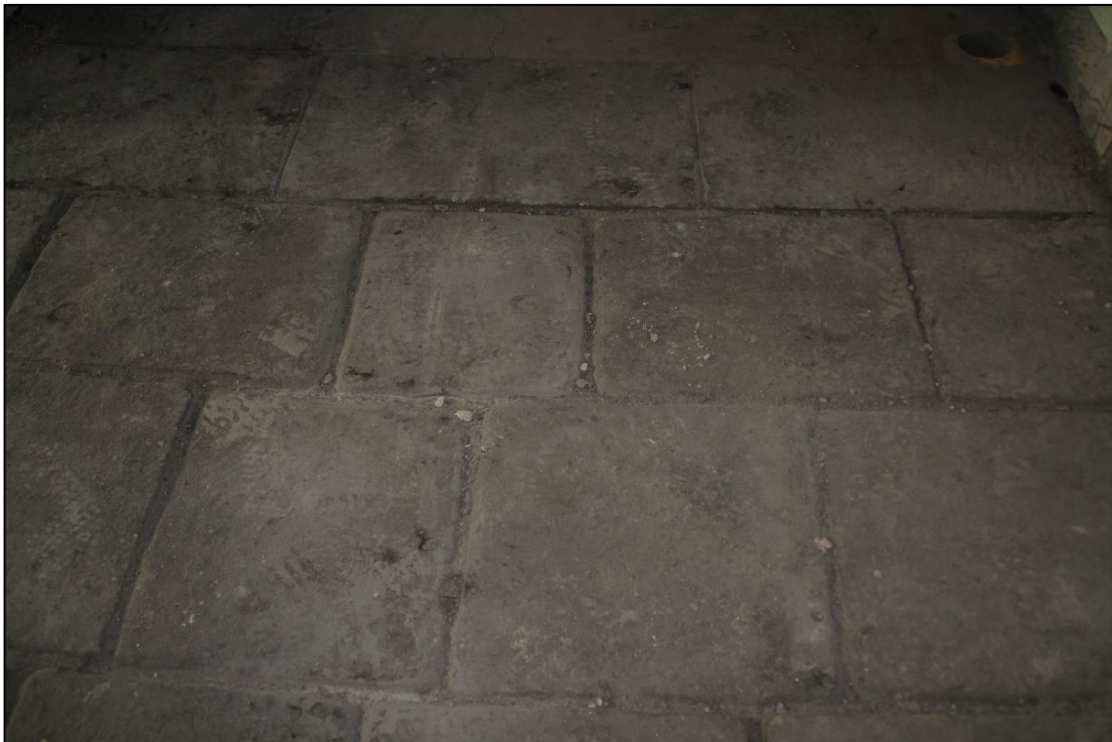
Photo 27 **Detail of flagstones, upper corridor**

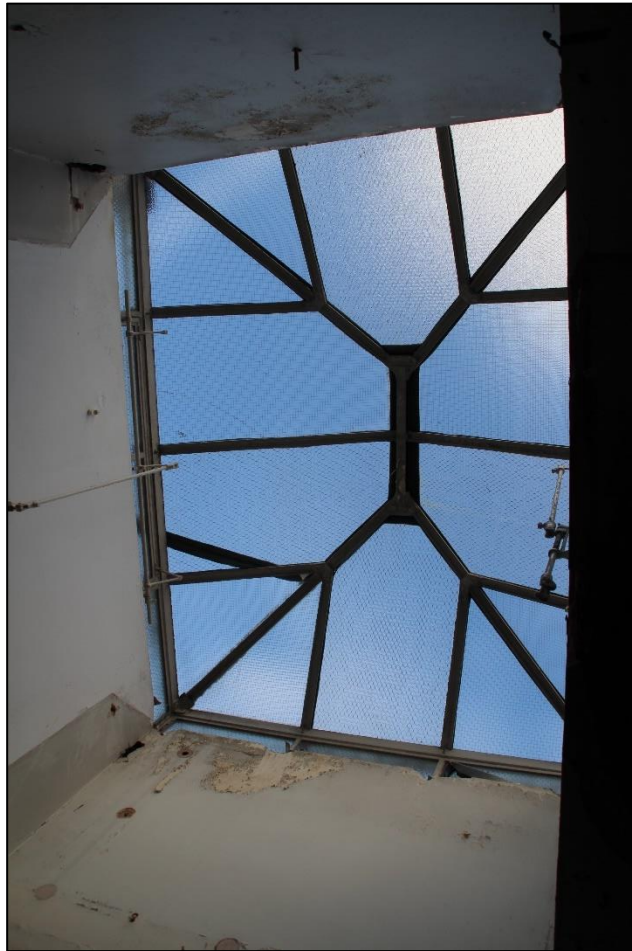
Photo 28 **Modern metal framed lantern above central corridor**

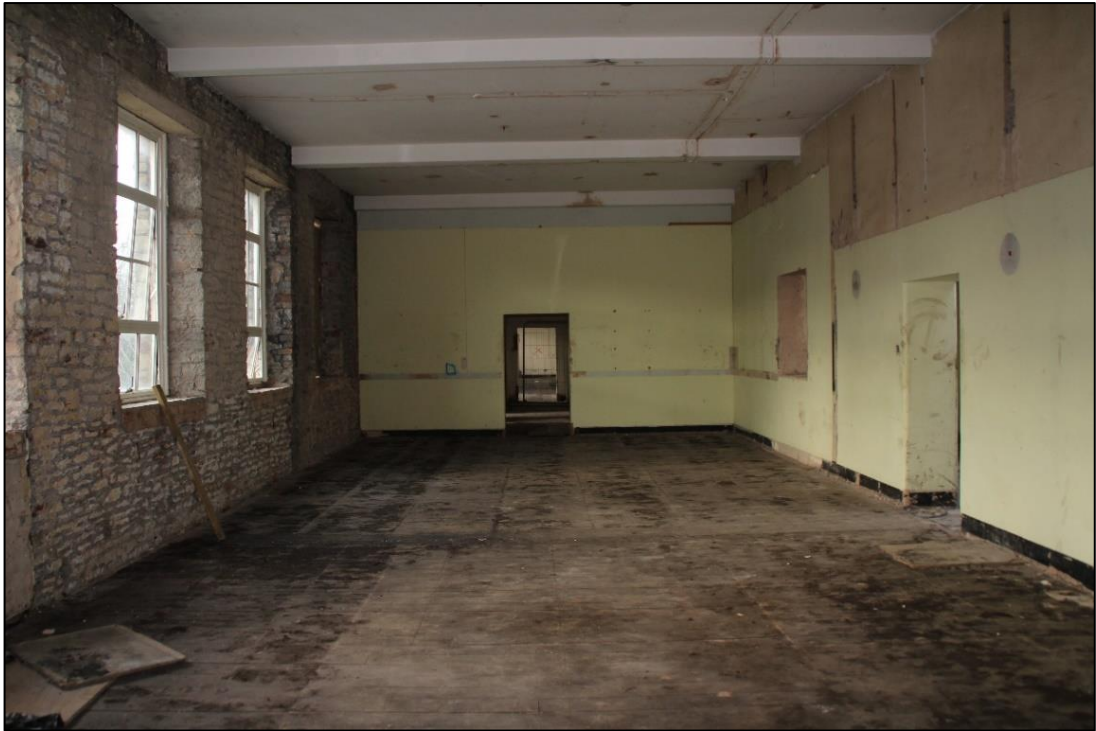
Photo 29 **Looking west in Room F1**

4.23. As with the ground floor, large rooms are accessed off the main corridor. These retain their original timber floorboards and as seen in Photo 29 of Room F1, the ceiling structure is intact showing tie beams resting in the wall plate. There is no evidence of the lowering of windows on this floor, as can be seen on Photo 29 of the uncovered masonry though brick repair is evident. The brick and stone eastern extension (F2) presents in much the same way as the ground floor room below it, with a rather ad-hoc blend of brick and masonry construction.

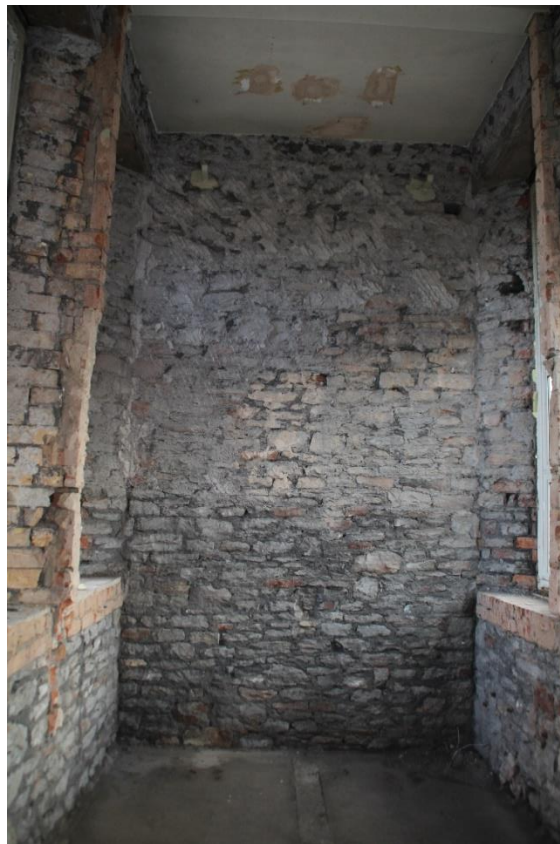
Photo 30 **Looking east in Room F2**

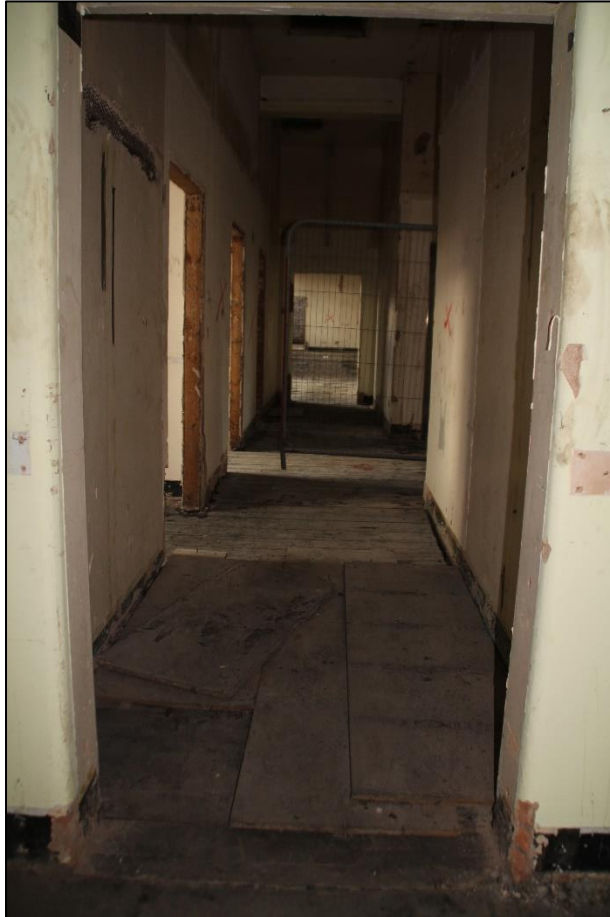
Photo 31 **Looking west through subdivided central area**

-
- 4.24. Photo 31 illustrates the more subdivided layout of the area over the entrance structure, which is known to have been altered with the insertion of a lift and staircase in the 20th century.

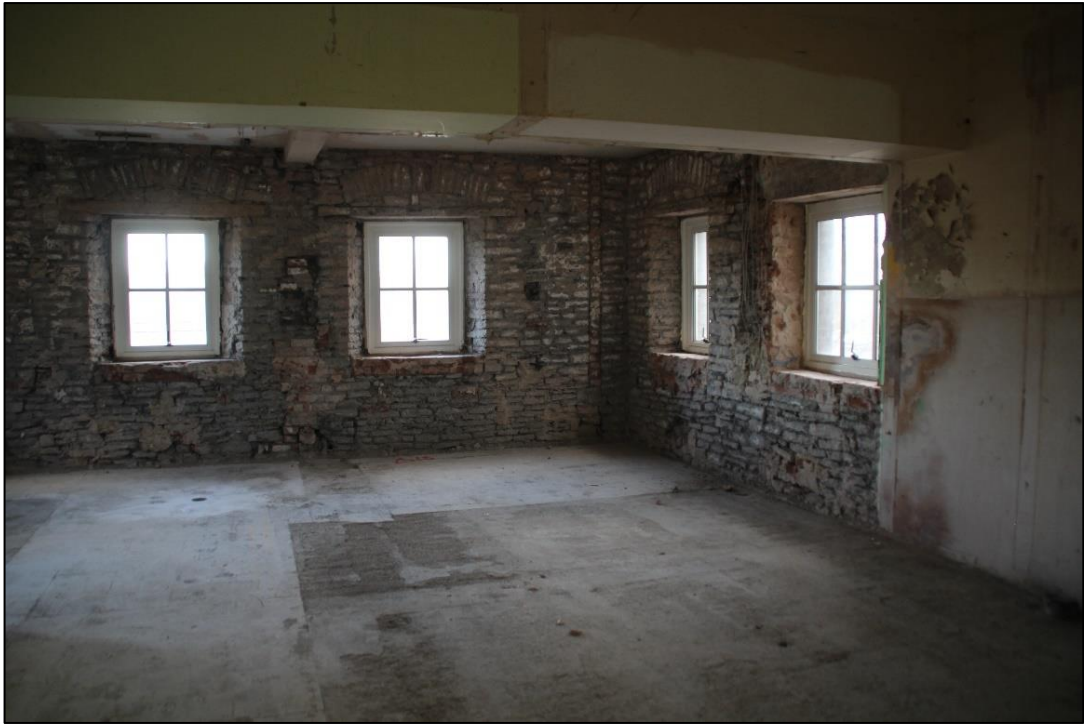
Photo 32 **Looking north in Room F3**

- 4.25. Areas within the first floor of the rear gabled wings have been stripped of plaster as seen in Photo 32 of Room F3. The relieving arches of the windows are in evidence here. Photo 33 gives a long-range view through the northern side of the Building, looking east to west, and allowing a good understanding of the symmetrical layout of the original plan. Likewise Photo 34 gives a long view in Room F5 of the south-western ward, leading to the western brick and stone extension (Photo 35). The original construction of the windows is evident here in Photo 36, though clearly the windows themselves are newer insertions.

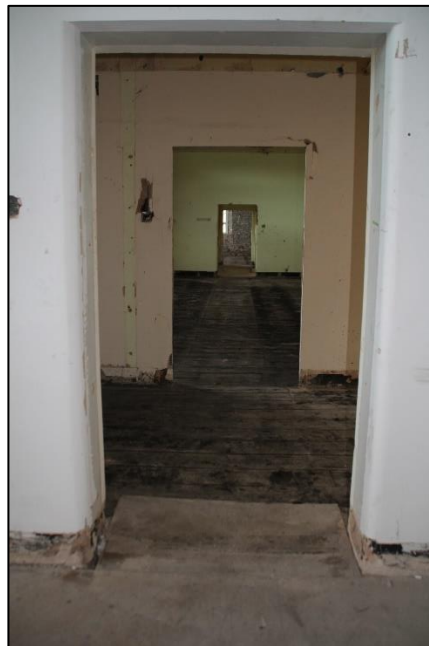
Photo 37 **Detail of chamfered doorcases**

4.26. Original or principal doors are chamfered to provide a curved edge as seen in Photo 37 below.

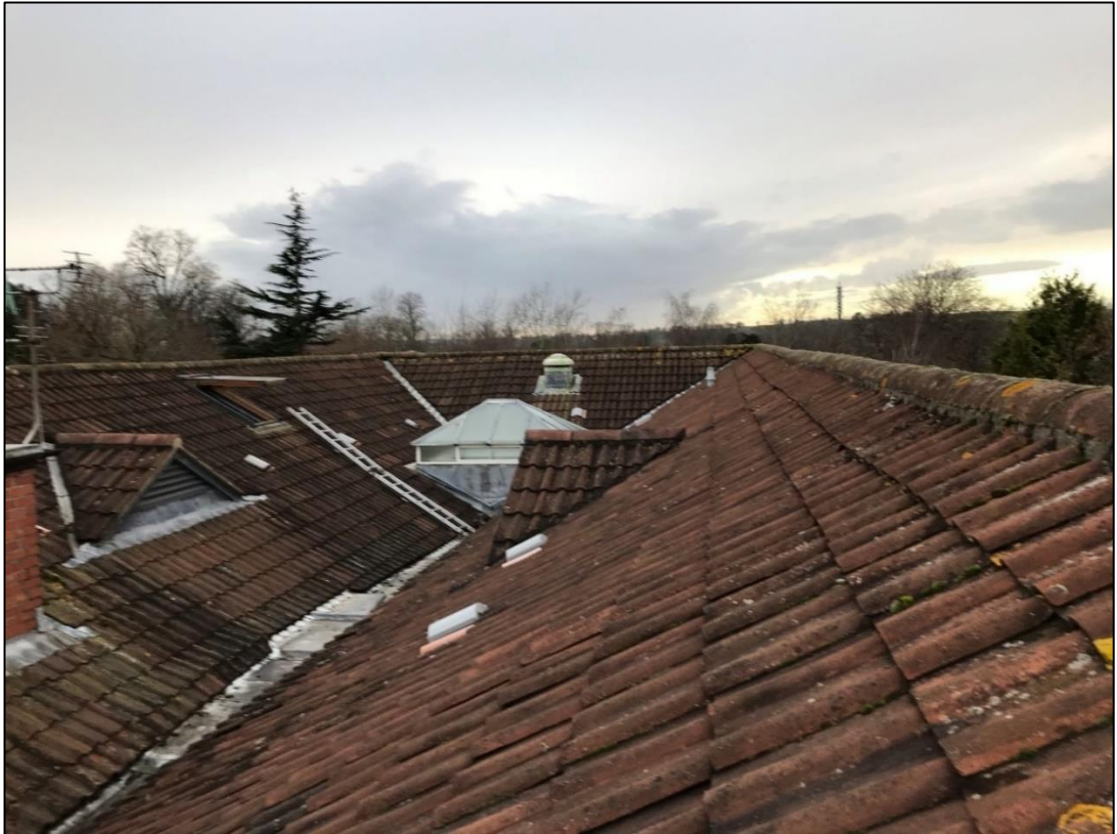
Photo 38 **Roofscape looking west**

-
- 4.27. The roofspace is formed of a double pitched intersecting hipped roof with central valley, punctuated by the rooflights seen in the upper corridor as seen in Photo 38. Gables housing ventilation grilles are seen on both the inner and outer roof slopes, with those on the inner slopes being relatively shallow as seen in Photo 38. A newer addition dormer has been inserted as seen on Photo 39, this presumably provides light and access into the attic roof space.

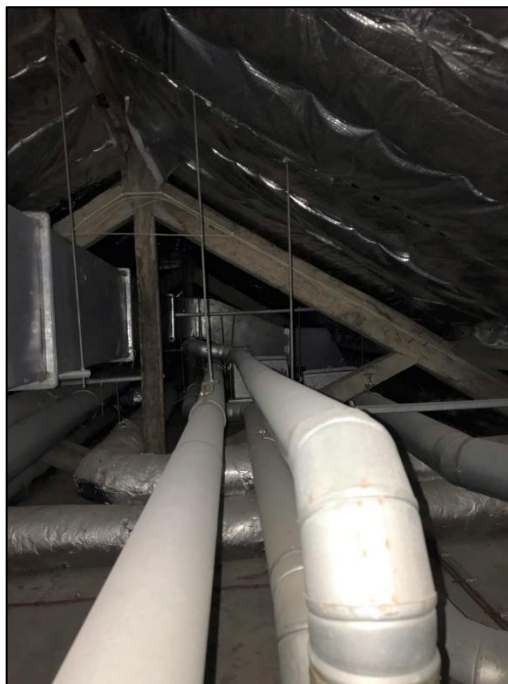
Photo 40 **The roofspace with roof structure in view**

4.28. Internally the roof void holds various ducting for services and air-conditioning as seen in Photo 40. The roof structures comprise king trusses with raked struts and the main timbers appear to be original. Thermal upgrading and other new work has occurred in this area as seen in Photo 41, with new beams run alongside older ones.

- 4.31. The roof structure, though refurbished, appears to retain its original timber trusses. Fenestration openings are largely as original, but 20th century metal windows in a multipane design have been inserted. Historic high door archways, chamfered doorway reveals, and the ribbed shallow brick vaulted corridor were noted, as well as the flagstone finish to the upper corridor. The wall surfaces were noted, where plastered, to be covered in either lime plaster or modern gypsum or cement, depending on whether alteration had occurred in the area.
- 4.32. Fig.4 & 5 provides an annotated plan of the Building, showing the original plan and modern subdivision, most of which had been removed at the site visit.
