257 Ordsall Lane  
Salford  
Greater Manchester

Archaeological Evaluation and Excavation

Report No. Y376/18

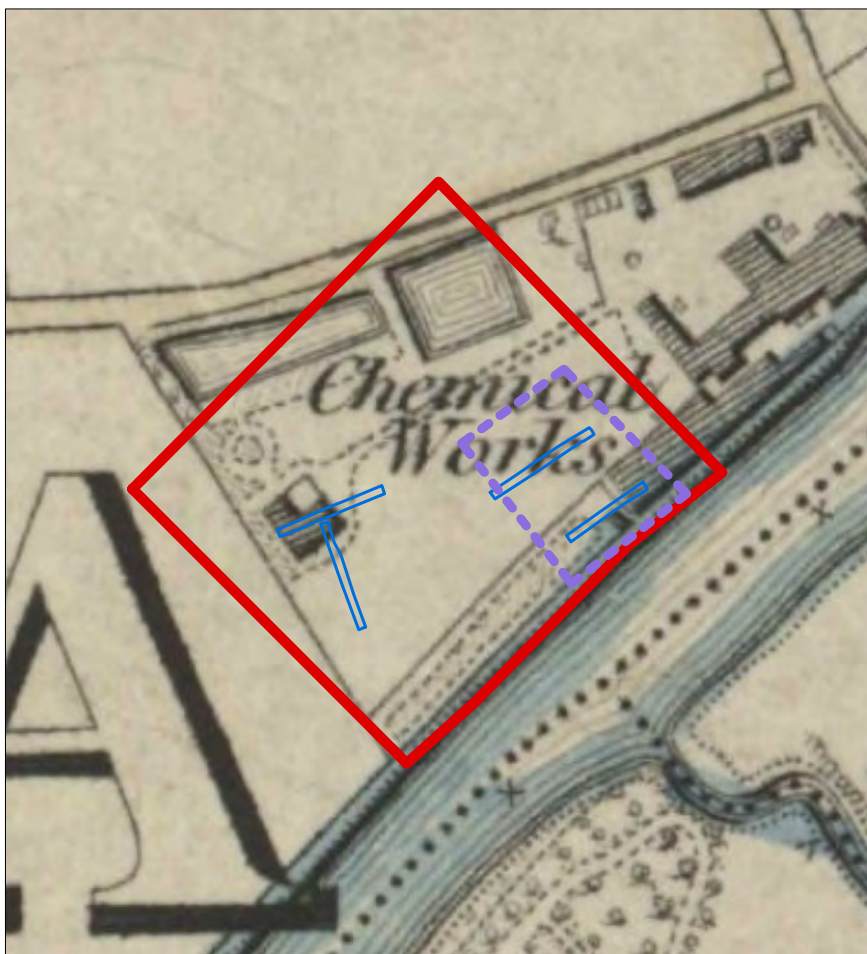
Fig. 3.1 - OS Six-inch to the mile map, Lancashire CIV, published 1848, showing areas of archaeological investigation

#### ***OS Six-Inch Lancashire CIV, published 1848 (Fig. 3.1)***

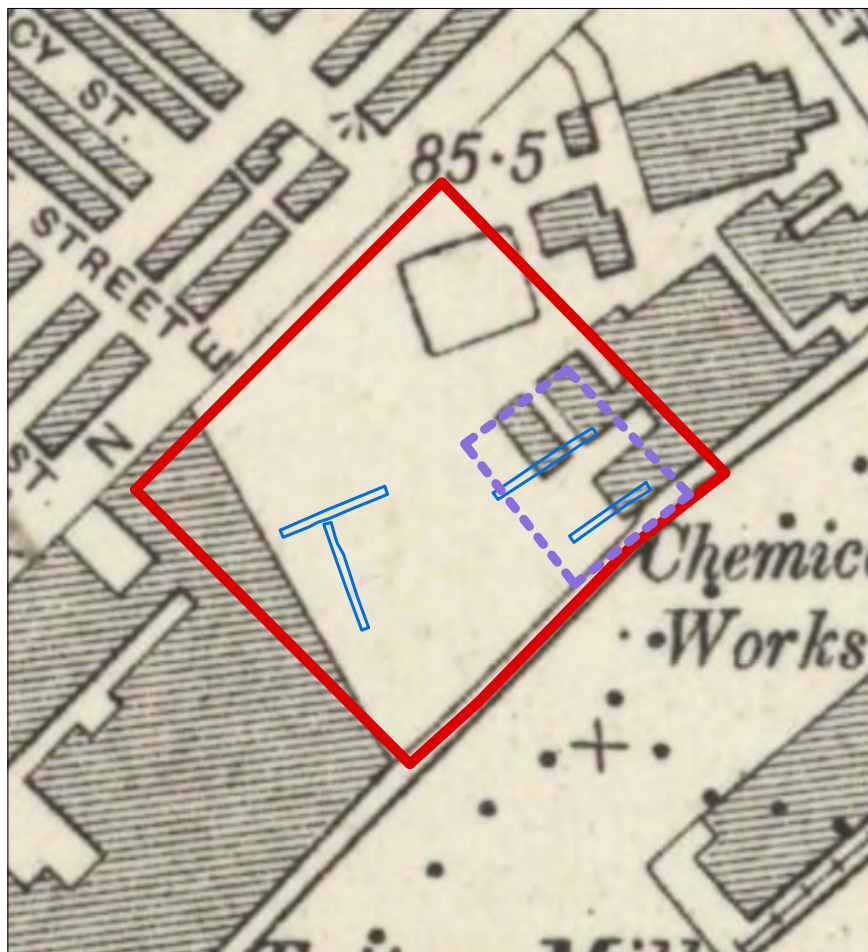
Fig. 3.4 - OS Six-inch to the mile map, Lancashire CIV.SW, published 1909, showing areas of archaeological investigation

***OS Six-inch to the mile map, Lancashire CIV. South-West, published 1909 (Fig. 3.4)***

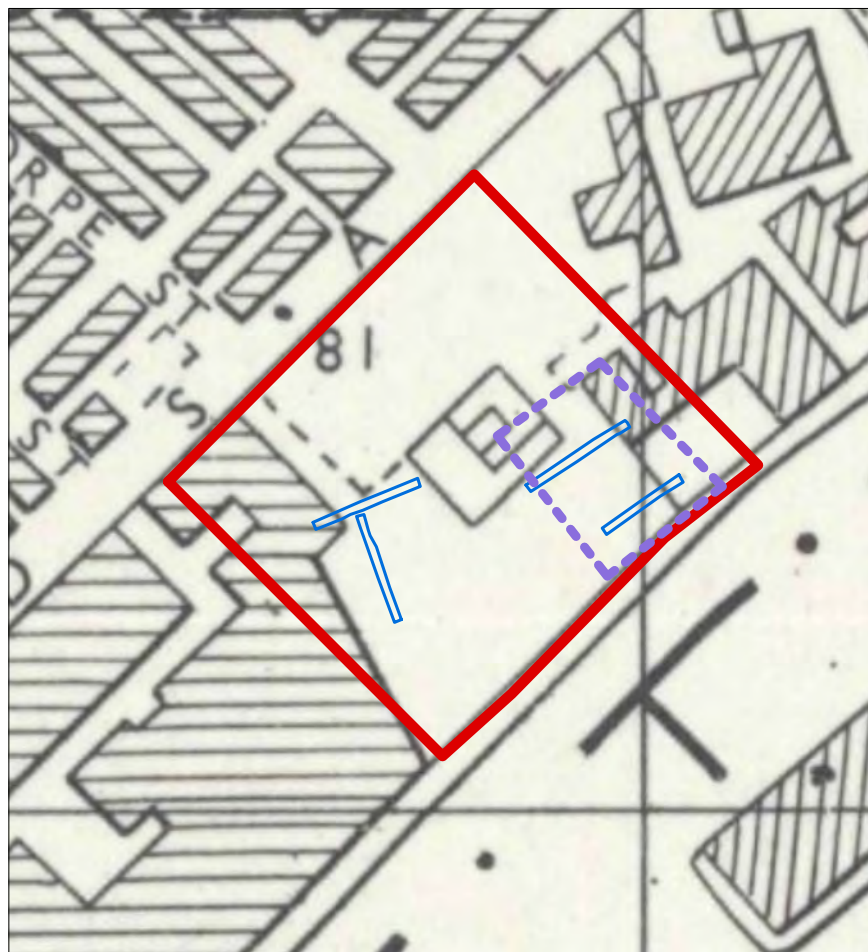
Fig. 3.5 - OS 1:10,560 Sheet SJ 89 NW (Includes: Manchester; Salford; Stretford), published 1956, showing areas of archaeological investigation

***OS 1:10,560 Sheet SJ 89 north-west (Includes: Manchester; Salford; Stretford), published 1956 (Fig. 3.5)***

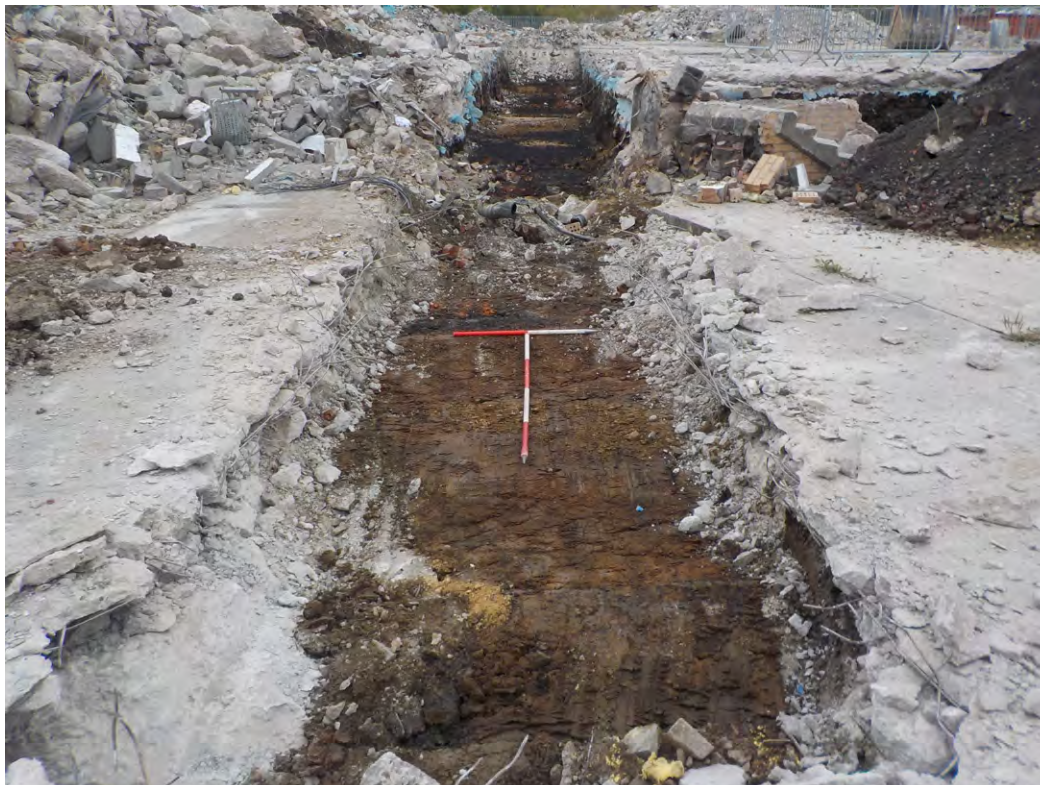
Fig. 4.1 - Trench 1 looking north-east

Trench	Description
1	<p>The trench was orientated north-east to south-west. The western third of the trench was at ground level, with the eastern two thirds located across the raised podium of the former warehouse (Fig. 4.1).</p> <p>No topsoil or subsoil was observed. The natural substrate was observed in small areas along the base of the trench.</p> <p>A modern pipe trench aligned north-east to south-west cut across the west end of the trench. Foundation trenches associated with the former modern warehouse cut across the width of the trench on a north-west to south-east orientation.</p> <p>A brick built inspection chamber was located in the western half of the trench. A ground-raising dump (026) was present across the raised warehouse podium. A layer of cinders (027) underlay the dump (026) in the central part of the trench.</p> <p>A surface comprising unmortared, pitched bricks, concrete edging and compacted cinders (028), underlay layer 027 in the central part of the trench. A similar feature (029), was observed in Trench 2.</p> <p>A layer of cinders (035) extended across the eastern end of the trench.</p>

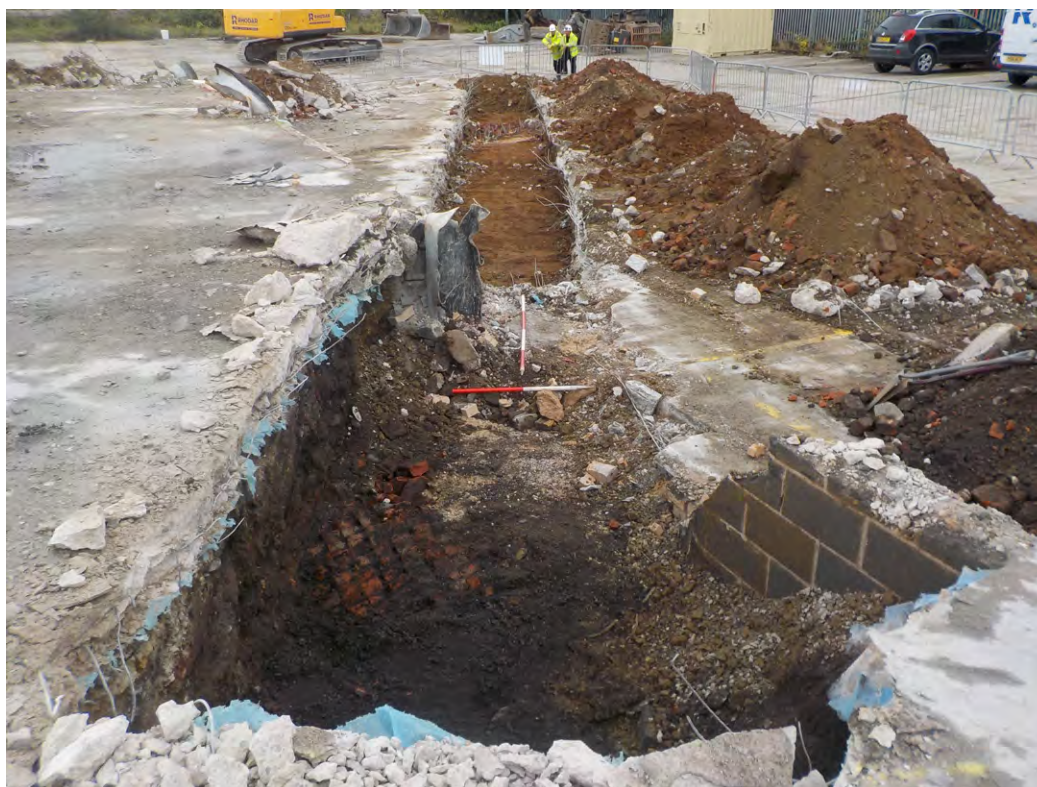
Fig. 4.2 - Trench 2 looking south-east

2	<p>The trench was orientated north-north-west to south-south-east. The north end of the trench was dug through the raised warehouse podium; the rest of the trench lay across the flat, concrete yard surface (Fig. 4.2).</p> <p>No topsoil or subsoil was observed. The natural substrate was observed across the base of the trench in the area to the south of the warehouse podium.</p> <p>A wide construction cut for the western elevation of the warehouse and a modern pipe crossed the north end of the trench on a north-west to south-east alignment.</p> <p>The south-west corner of a brick and reinforced concrete structure was located towards the southern end of the trench. The internal space had been backfilled with brick rubble.</p> <p>A surface comprising unmortared, pitched bricks, concrete edging and compacted cinders (029) was located at the north end of the trench. A similar feature (028), was observed in Trench 1.</p>

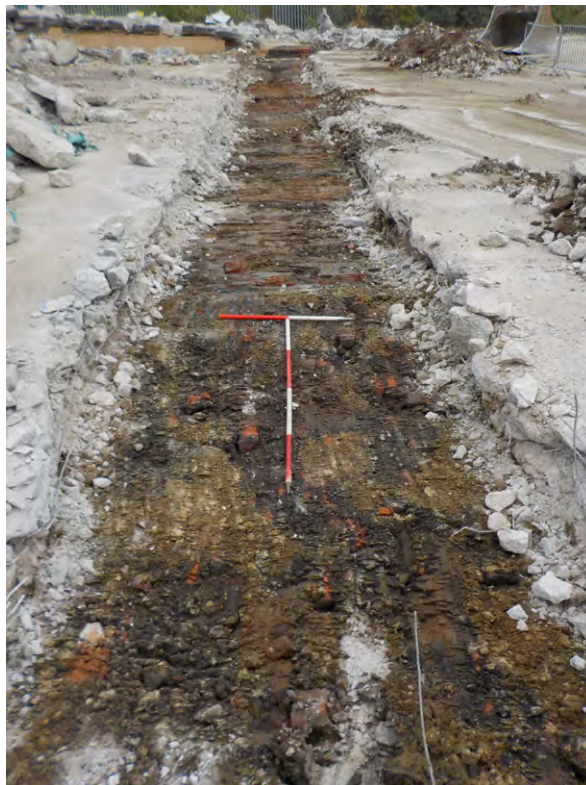
Fig. 4.3 - Trench 3 looking north-east

Trench	Description
3	<p>The trench was orientated south-west on level ground in the concrete delivery yard area (Fig. 4.3).</p> <p>No topsoil or subsoil was observed. The natural substrate was observed along the base of the trench in areas between modern intrusions and archaeological features.</p> <p>An area of redeposited natural containing modern rubble was present across the western end of the trench.</p> <p>A reinforced concrete lined structure (internally backfilled with demolition rubble) was located in the centre of the trench, orientated north to south.</p> <p>A sub-oval intrusion was cut into the natural substrate and part of a brick pad (022), immediately east of the concrete structure.</p> <p>A north-west to south-east aligned foundation cut (for the ramp up to the former warehouse podium) crossed the trench towards its eastern end, with an associated shallow, north-east to south-west orientated cut extending from its eastern side along the north edge of the trench.</p> <p>A north-north-west to south-south-east orientated flagstone path (011) was located at the eastern end of the trench. A surface (012) comprising bricks was laid on edge, butting up to the west side of the path (011). Curved brickwork (013) continued below the brick surface (012). A brick wall (014), orientated north-east to south-west, butted up to the western face of curved brickwork (013).</p> <p>A worked stone block (016) was located in the far northern corner of the trench, at a lower level than surfaces 011 and 012.</p> <p>A layer of black cinder (015) extended below Surface 012 and covered an underlying brick feature (030). A north-west to south-east aligned brick wall (017) crossed the trench to the west of the features described above. A brick drain inspection chamber (019) filled by debris (018) was constructed against the west face of Wall 017. A partially truncated brick pad (022) was located two thirds of the way along the trench (from the west end).</p> <p>A north-west to south-east aligned brick wall (021) and associated buttress (020), crossed the western end of the trench.</p>

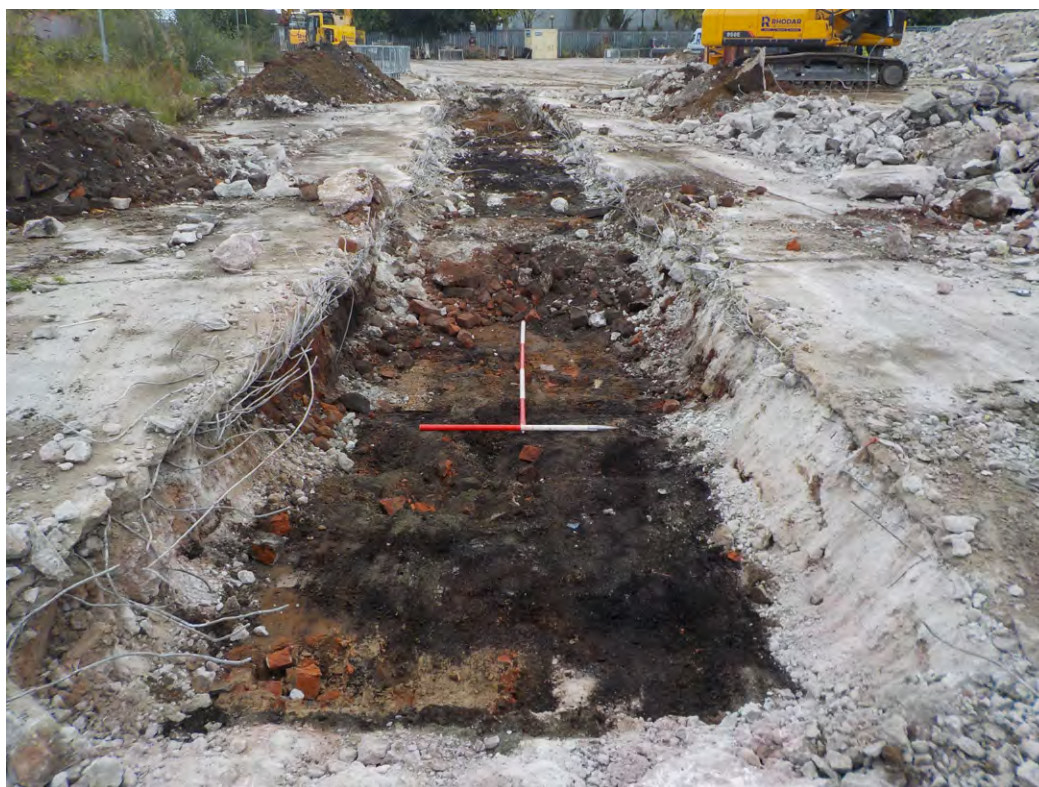
Fig. 4.4 - Trench 4 looking south-west

4	<p>The trench was orientated north-east to south-west on level ground in the concrete delivery yard area (Fig. 4.4).</p> <p>No topsoil or subsoil was observed. The natural substrate was observed along the base of the trench in areas between modern intrusions and archaeological features.</p> <p>An east to west orientated, reinforced concrete-lined structure (internal space backfilled with brick and tarmac rubble) crossed the western half of the trench.</p> <p>Mid-way along the trench, a large modern intrusion truncated archaeological deposits and features along the north side of the trench.</p> <p>Two rectangular brick pads (004 and 005) were identified at the east end of the trench, cutting through a thin spread of cinder (003).</p> <p>A north-west to south-east aligned brick wall (007) crossed the trench to the west of pads 004 and 005. Surface 006, comprising bricks laid on edge, butted up to the east side of Wall 007. A cinder deposit (023) extended below Surface 006. The north corner of an area of brickwork (024) was recorded to the east of Wall 007.</p> <p>A north-west to south-east aligned brick wall (009), with associated brick surface (025) along its east face, extended across the trench, mid-way along its length. A dump of mixed material (008) lay between walls 007 and 009. A thin layer of black granular cinders lay to the west of wall 010.</p>

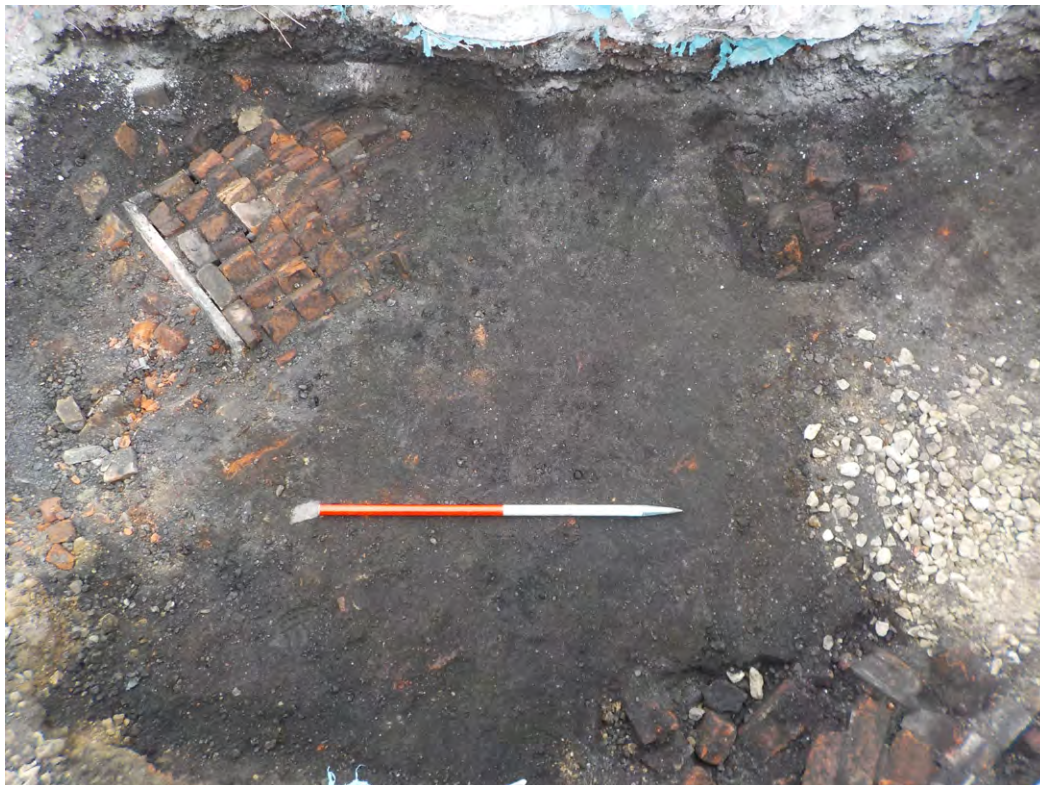
Fig. 4.5 - Trench 1; brick and cinder surface 028

Trench 1 did not identify remains of the structure identified on historic mapping as Ordsall House. An area of neatly aligned pitched bricks (Fig. 4.5; 028), with a flat upper surface of compacted cinders, was part of a carefully laid external surface that may have been associated with the building labelled as 'Day Nursery' on 1949 OS mapping of the site. However, No walls were present to correlate the position of the surface to the location of the day nursery. A record was made of extensive overburden (026) which had been laid down in preparation for the construction of the modern warehouse.

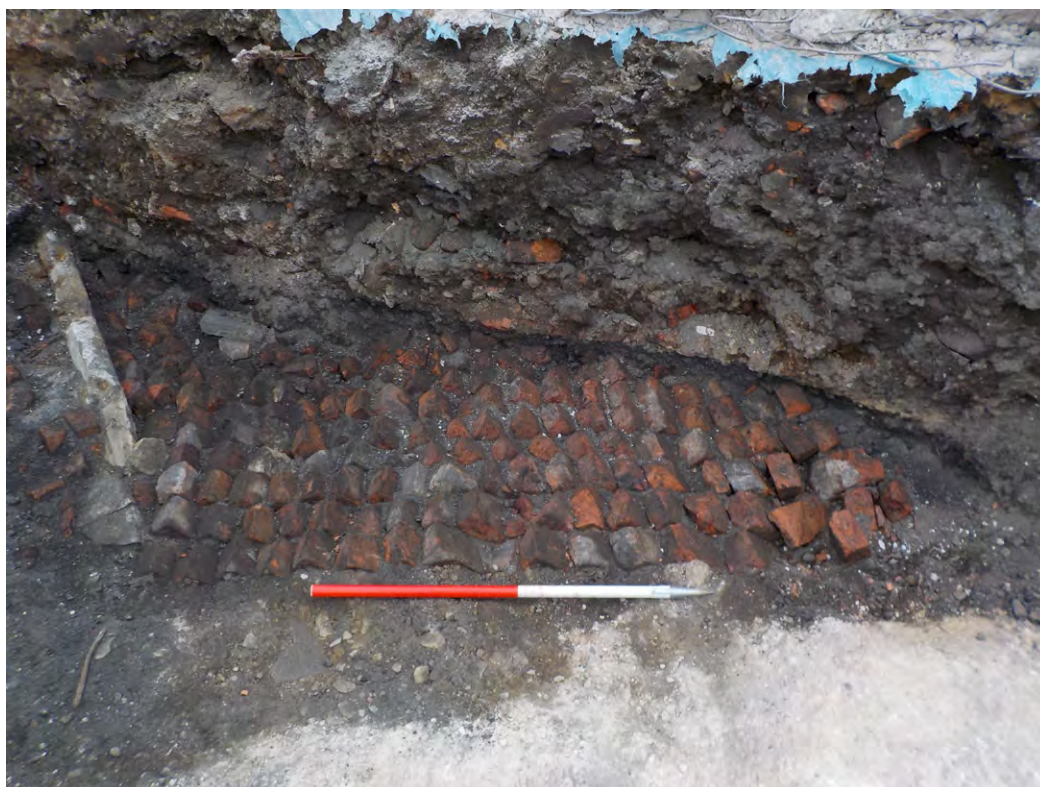
Fig. 4.6 - Trench 2; brick and cinder surface 029

No remains were observed to confirm the presence of Ordsall House. Trench 2 contained one archaeological feature; a cinder and brick surface (Fig. 4.6; 029), which was identical in form to Surface 028 to the north in Trench 1. This feature post-dates Ordsall House but its function and connection to the development of the site is unclear.

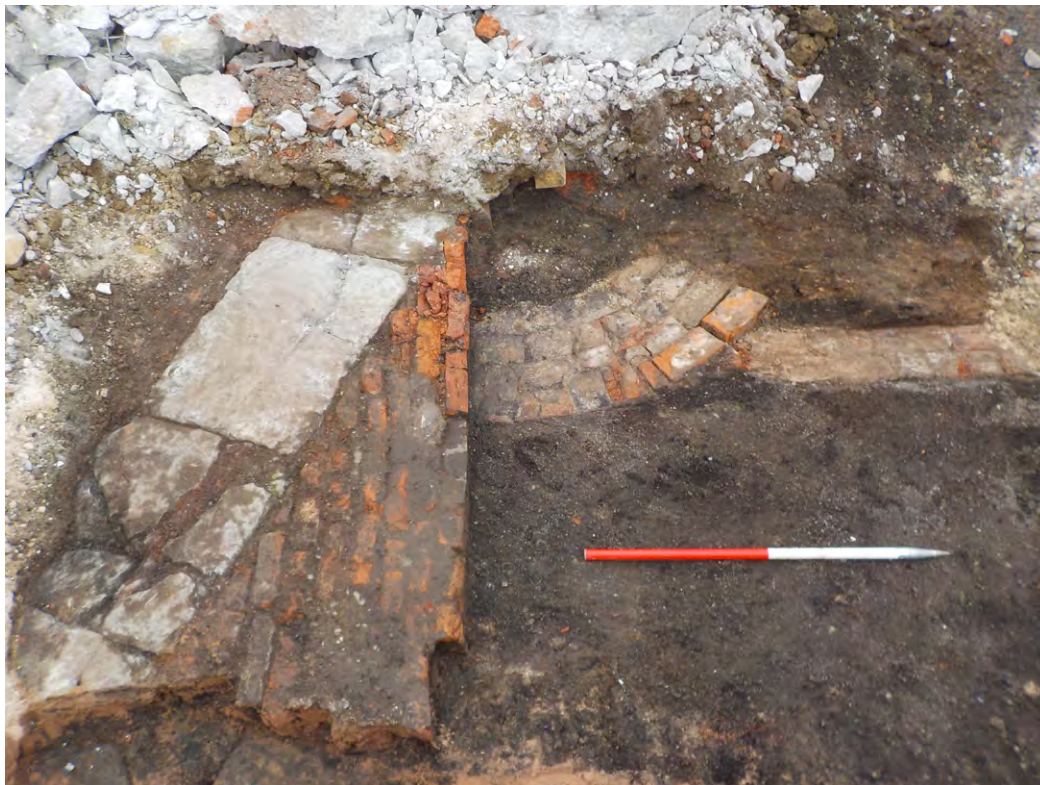
Fig. 4.7 - Contexts at eastern end of Trench 3

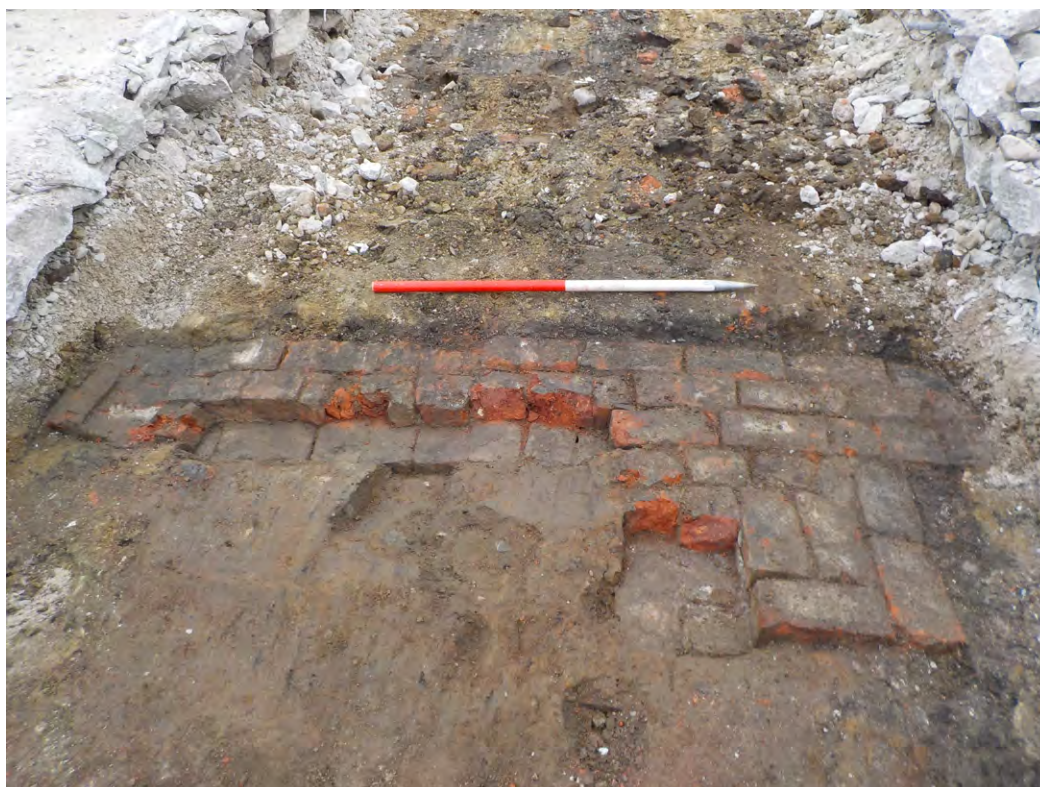
Fig. 4.8 - Trench 3; north-west to south-east aligned wall 021 and butress 020

The central area of the trench was badly affected by modern truncation, and only the partial remains of a rectangular brick pad or base (022), survived. Towards the western end of the trench, a north-west to south-east aligned brick wall (021), three bricks wide, featuring an accompanying buttress (020) supporting the wall on its eastern side, were the only remains observed (Fig. 4.8), with no floor surfaces or deposits surviving to the same depth.

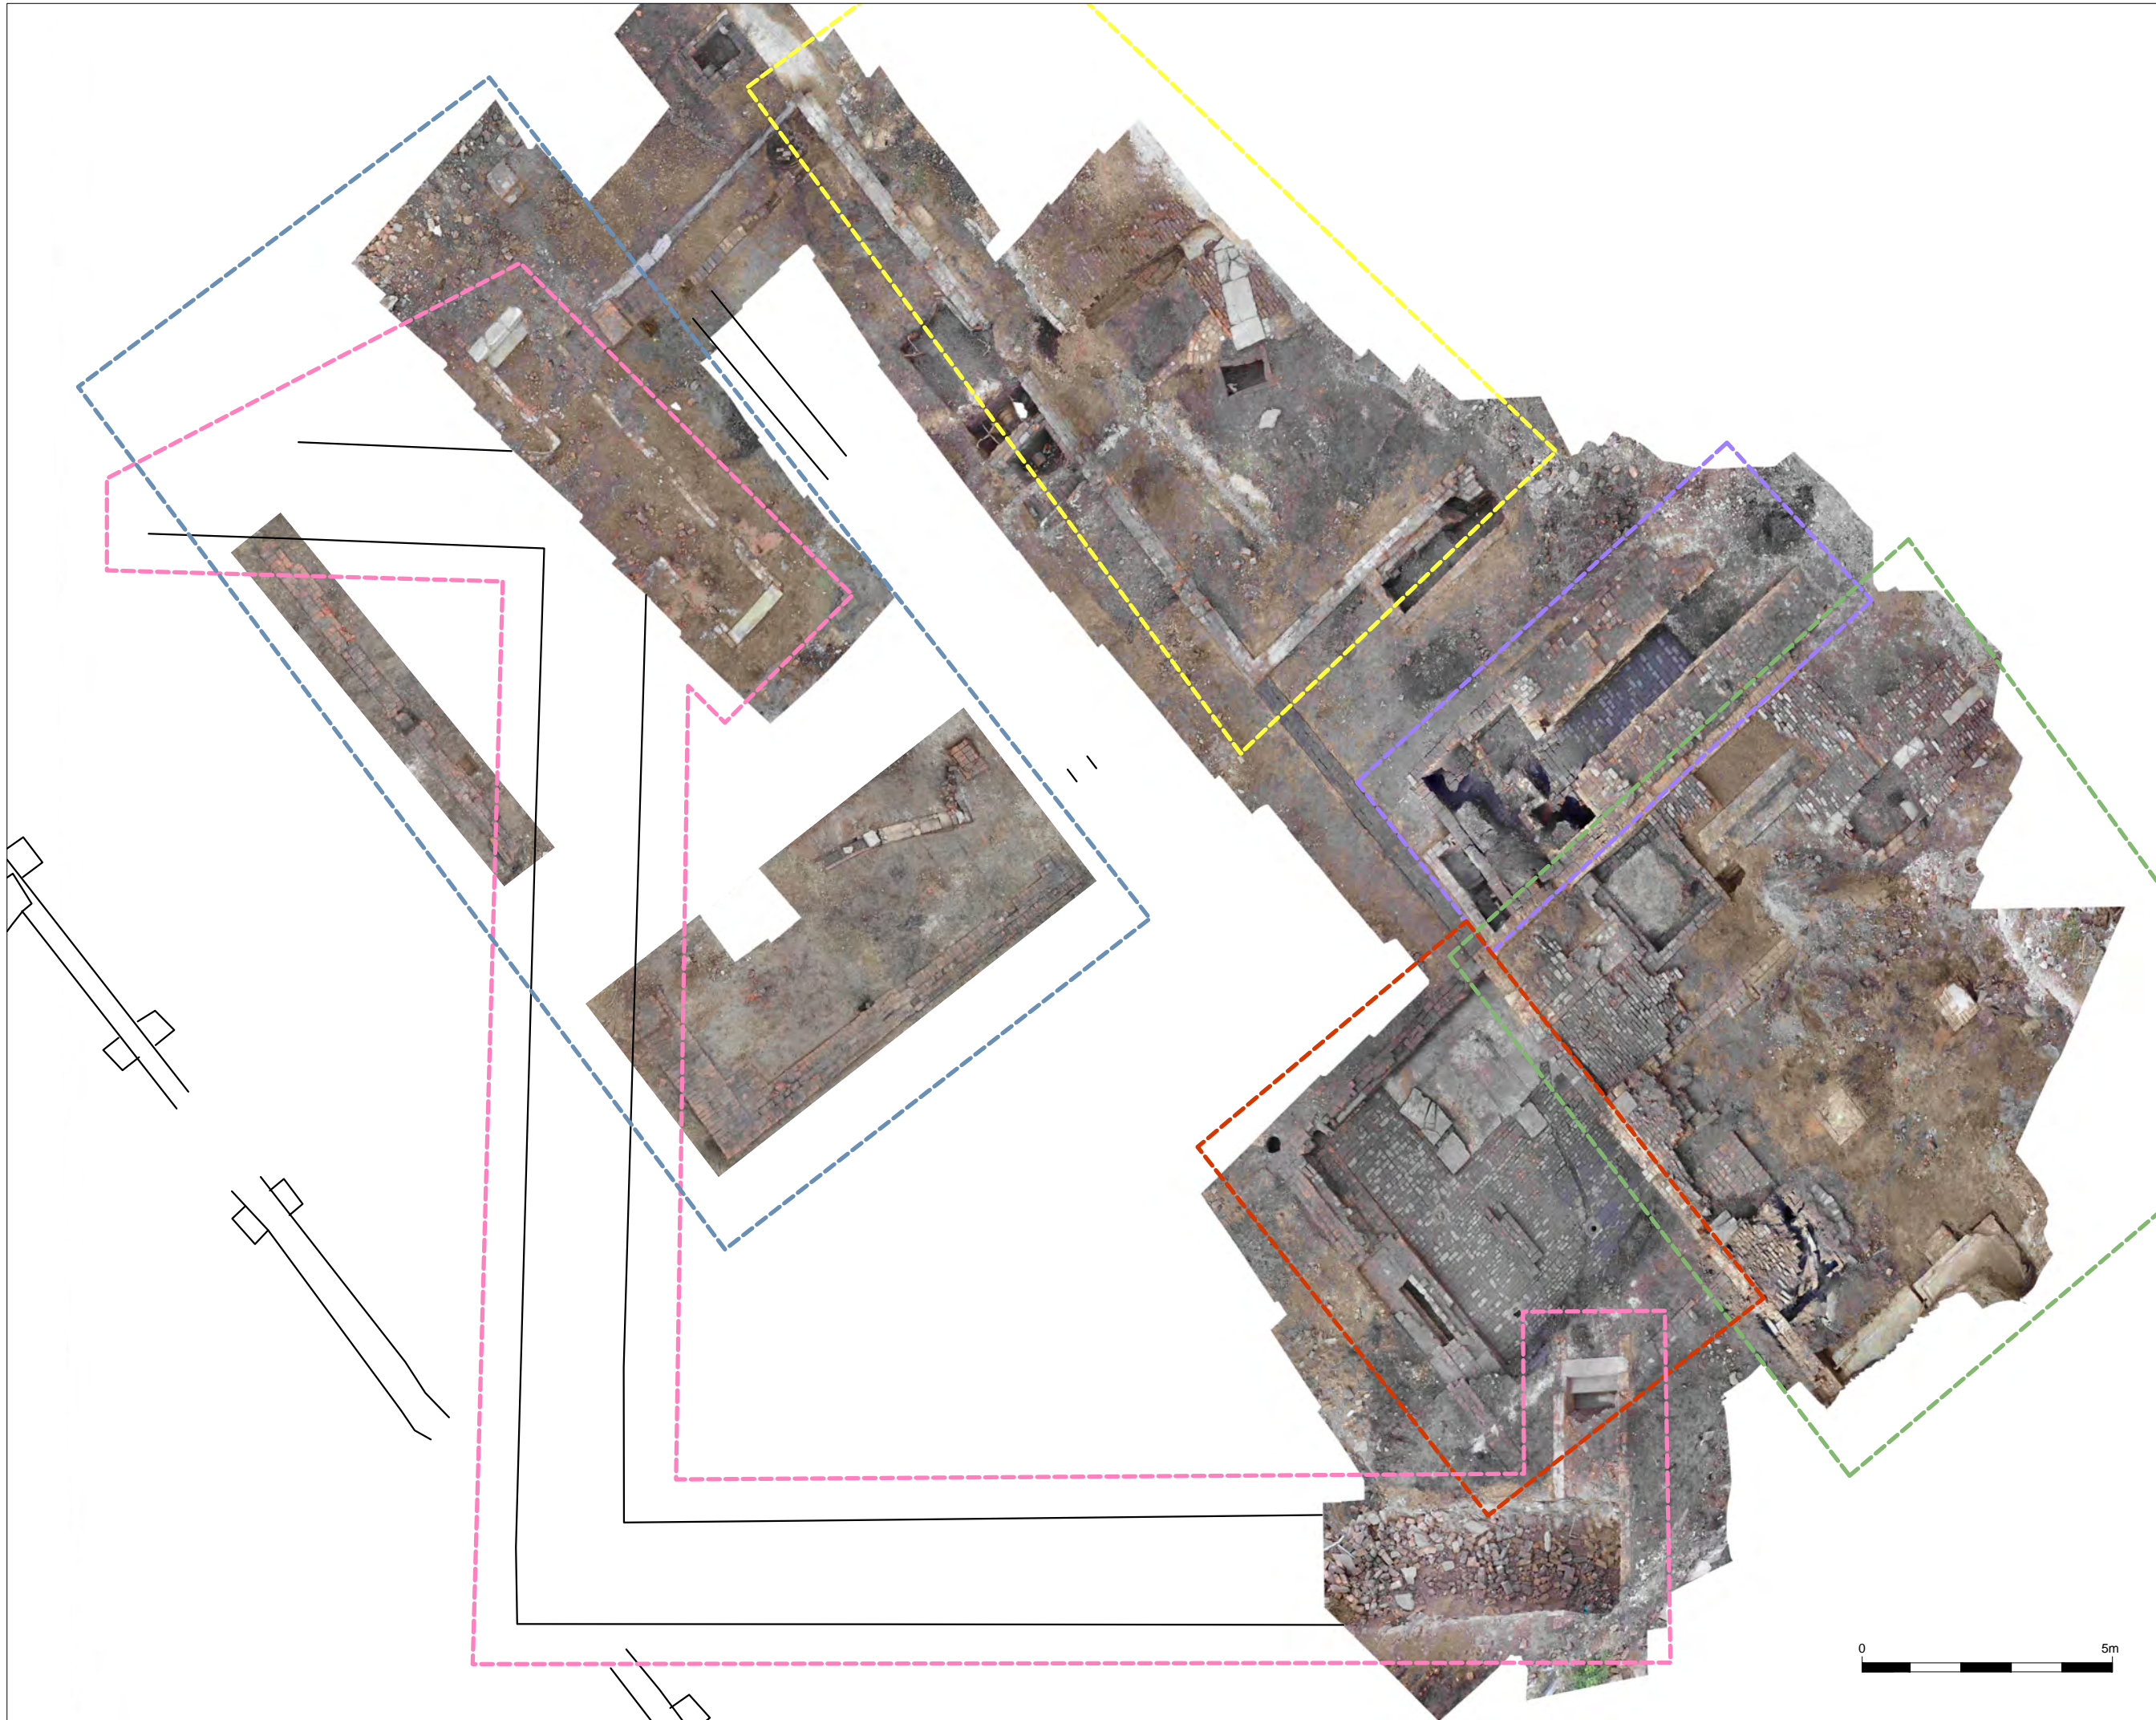
<b>Report No.:</b> Y376/18	<b>Fig. No.:</b> 5
-------------------------------	-----------------------

- Structure 1
- Structure 2
- Structure 3
- Structure 4
- Structure 5
- Structure 6

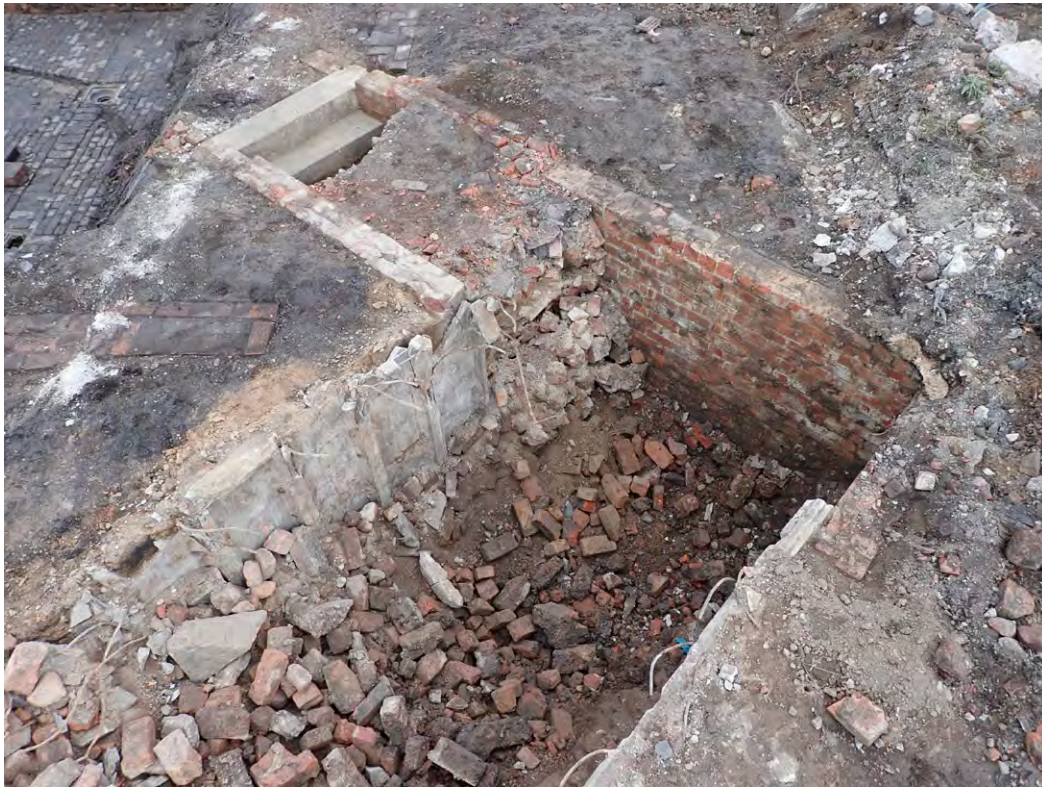
Fig. 6.3 - Entrance to south-eastern end of air raid shelter, looking north-east

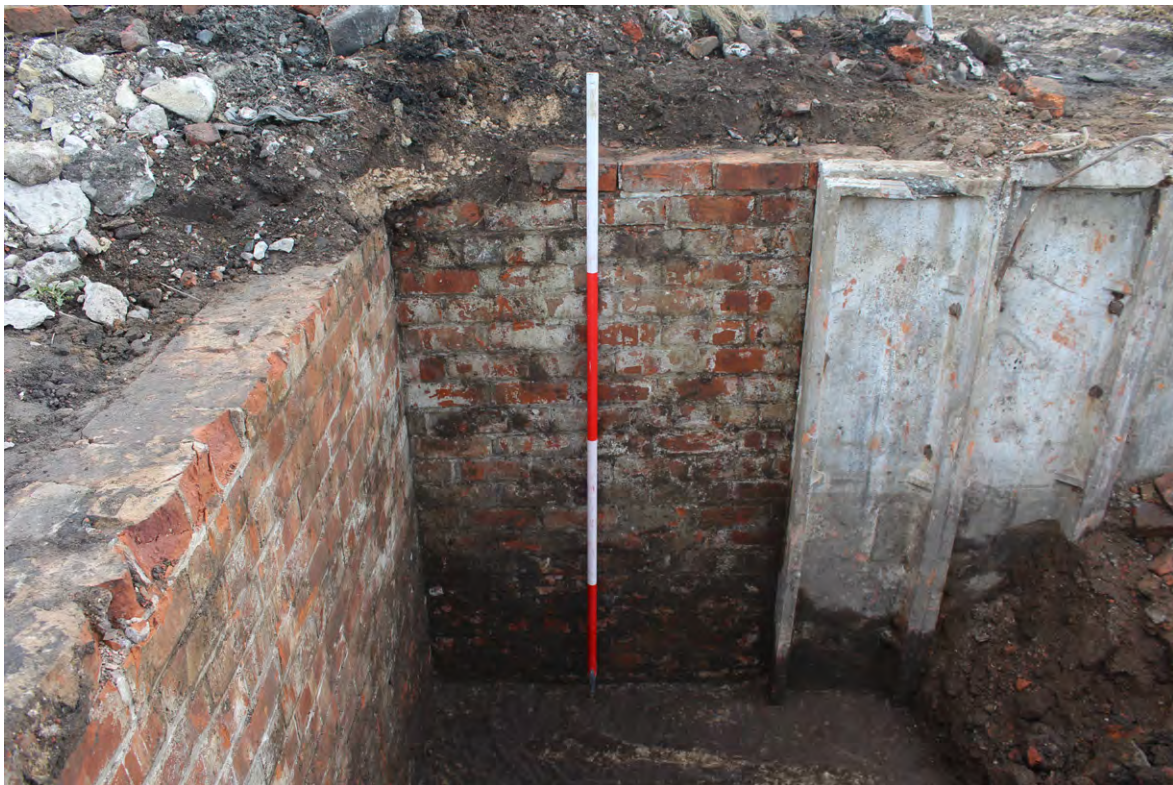
Fig. 6.4 - Construction detail at base of steps at south-eastern entrance of air raid shelter, looking south

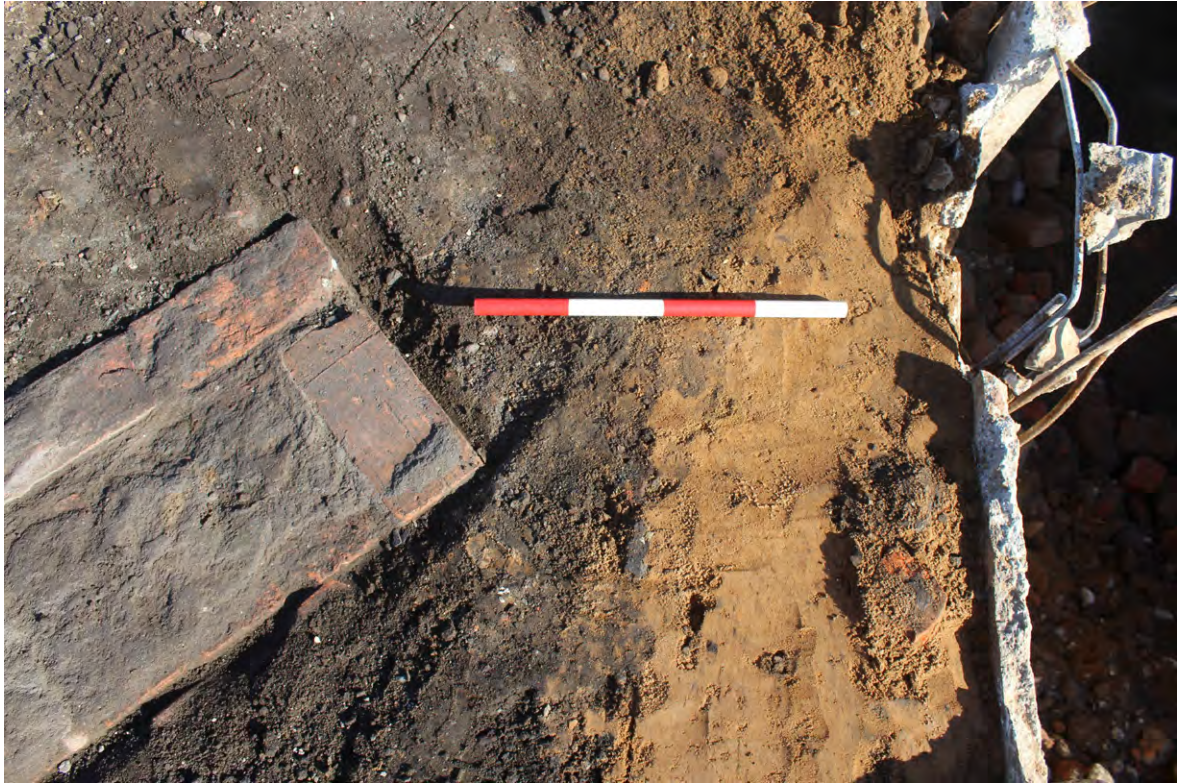
Fig. 6.5 - Construction cut 197 for air raid shelter side wall 191, truncating brick wall 165

The side walls of the structure were built from numerous tall, narrow pre-fabricated panels of reinforced concrete, with adjacent panels bolted together to form the required length of walling. Clearance of a small area of backfill within the passage showed that the panels had been set in position prior to the laying of the poured concrete interior floor surface (Fig. 6.4; 189). The upper part of the concrete side walls had been truncated at or just above a level where the panels angled inwards towards the opposite side of the passage, probably indicating the base of a roof structure. It was not clear if such a structure would have comprised a single continuous piece with the two side panels, or if the roof would have been formed from a separate concrete section fixed onto the top of the walls. The floor level within the passage was 1.78m below the present ground level, with clear evidence of a construction cut (197) indicating that the structure had been built inside a wide, deep trench excavated through natural deposits (Fig. 6.5).

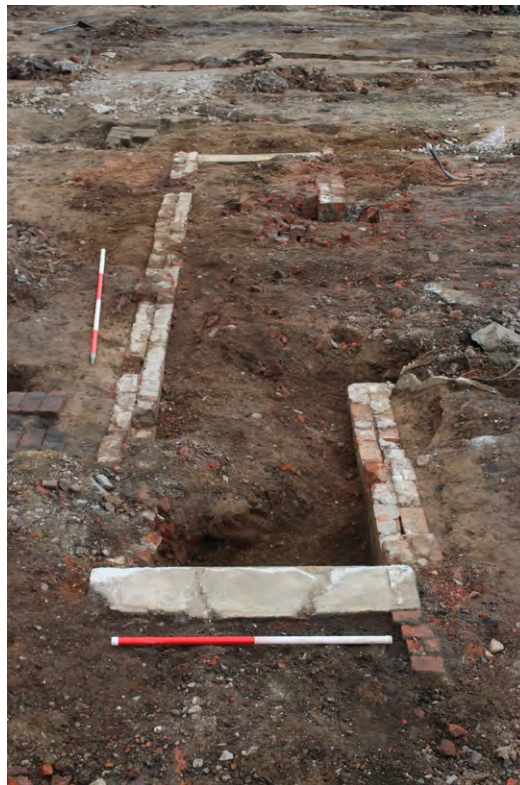
Fig. 6.6 - Double entrance to north-western part of air raid shelter, looking south-east

A second entrance with two flights of stairs (158 and 162) directly opposite each other was located at the north-west extent of the excavation area (Fig. 6.6). This entrance was a right-angled change in direction of the subterranean passage, with a return to the west extending from the steps and continuing beyond the limit of excavation. The steps down into the structure were made of individually cast concrete elements, built into brick side walls (159, 160 and 161), with the front edge of each step resting on the rear edge of the step below (Fig. 6.7). Construction of side walls (159 and 161) involved the use of bricks with rounded edges where the staircases opened into the concrete-lined corridor (Fig. 6.8).

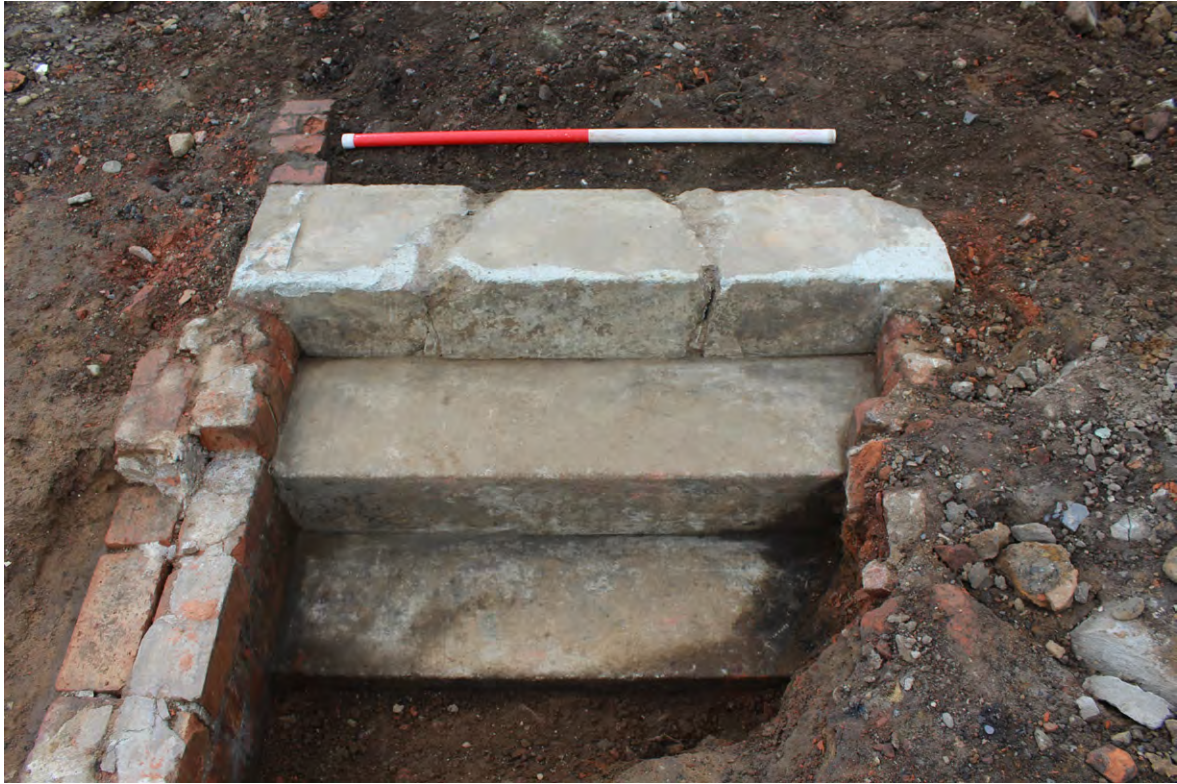
Fig. 6.7 - Steps (158) at north-western entrance to air raid shelter, looking north-west

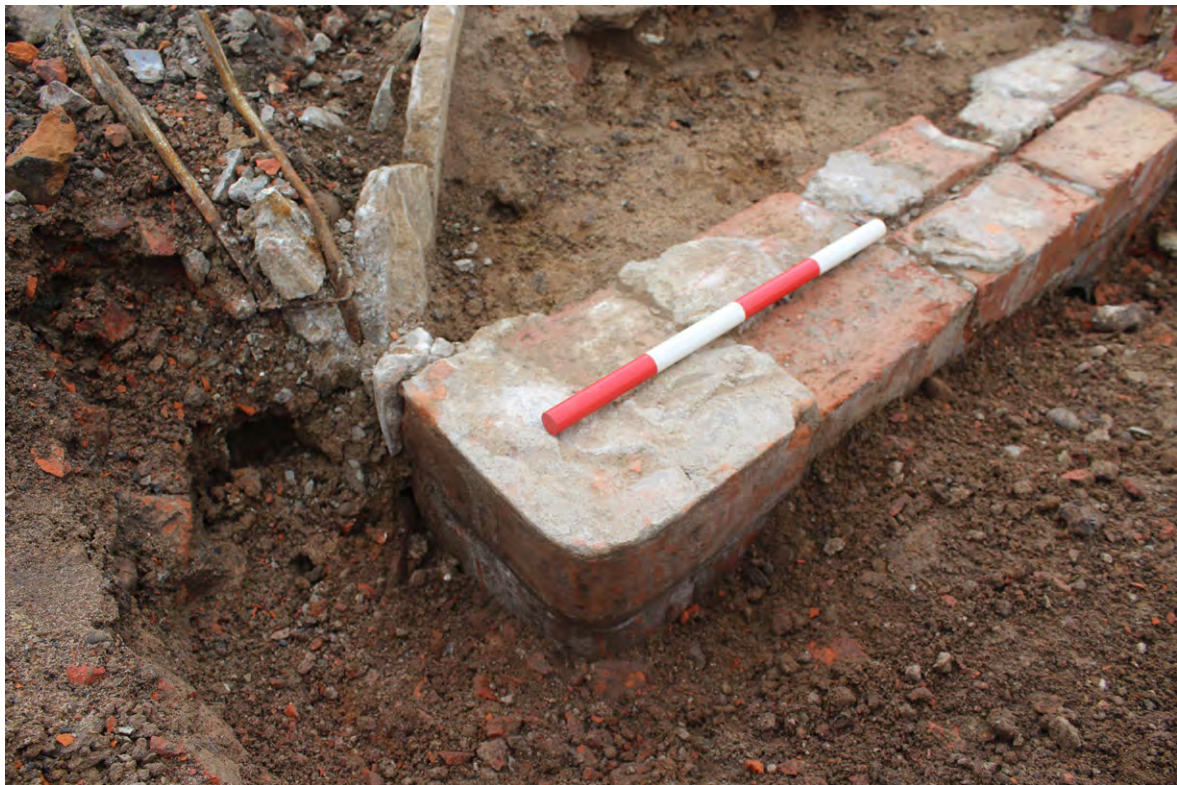
Fig. 6.8 - Detail of rounded corner on wall 083 at entrance to air raid shelter, looking west

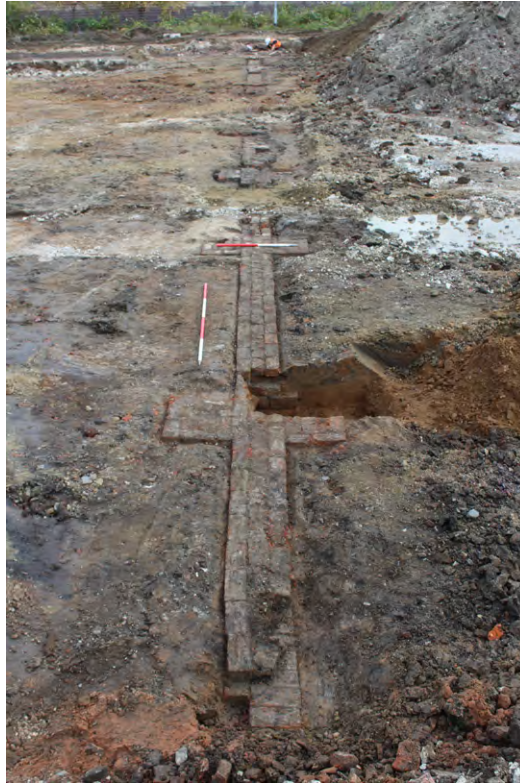
Fig. 6.9 - View along boundary wall 105 looking south-east

A north-west to south-east aligned brick wall foundation (105) extended for 36m across the western extent of the excavation area (figs 2.3 and 6.9). The foundation was three bricks wide, with additional support provided by pairs of buttresses spaced 3.70m apart along the full length of the structure (Fig. 6.10). The buttresses were cut down through natural deposits to the level of the base of the foundation, and featured an offset bottom course (Fig. 6.11).

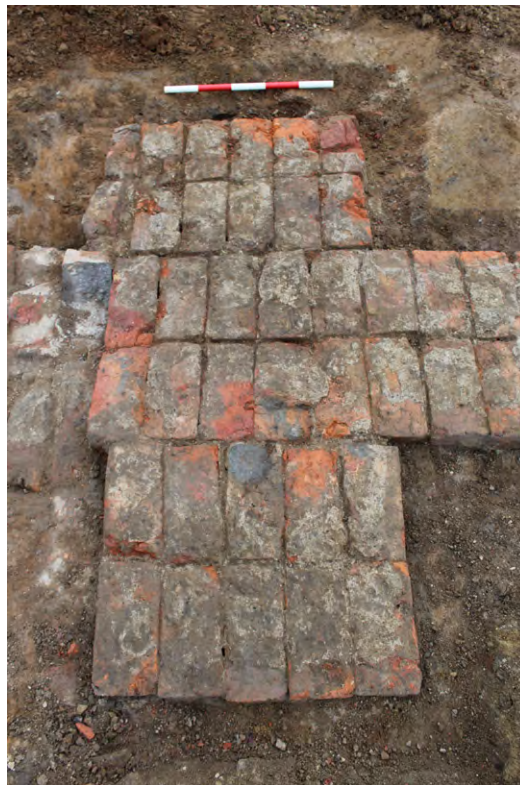
Fig. 6.10 - Detail of double butress along wall 105, looking north-east

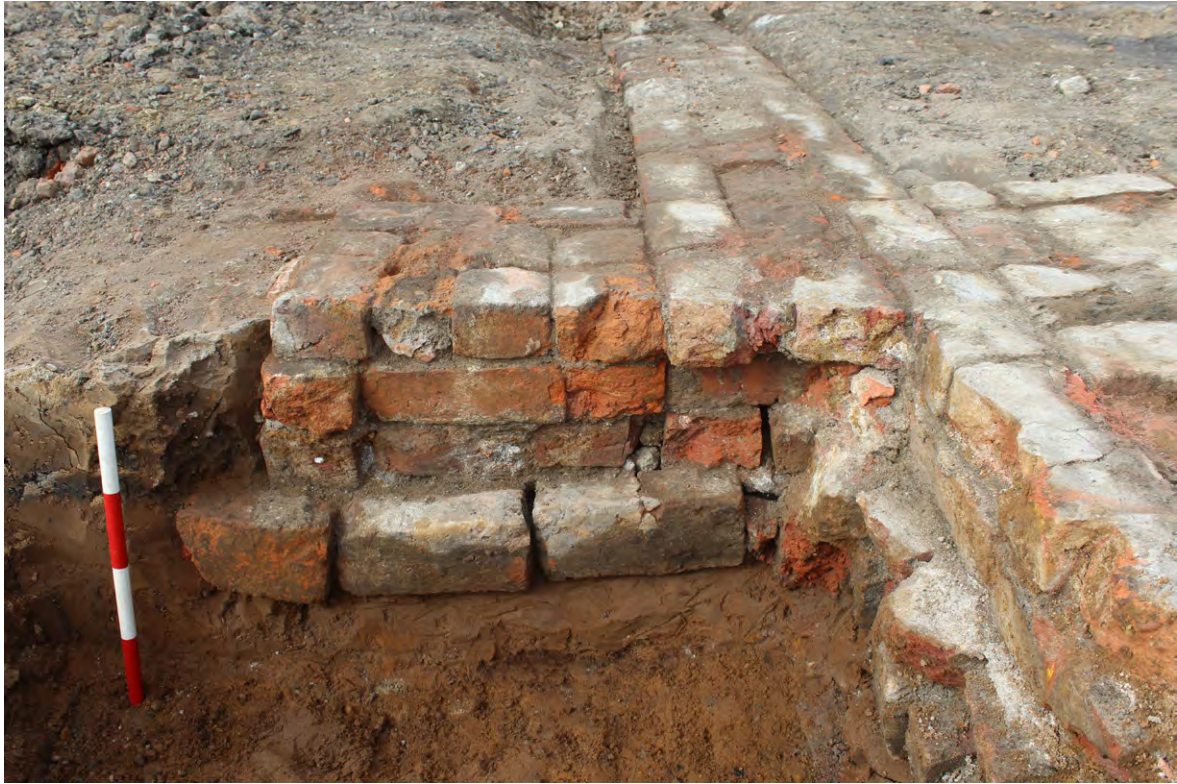
Fig. 6.11 - Profile through butters at west side of wall 105, looking north-west
