257 Ordsall Lane  
Salford  
Greater Manchester

Archaeological Evaluation and Excavation

Report No. Y376/18

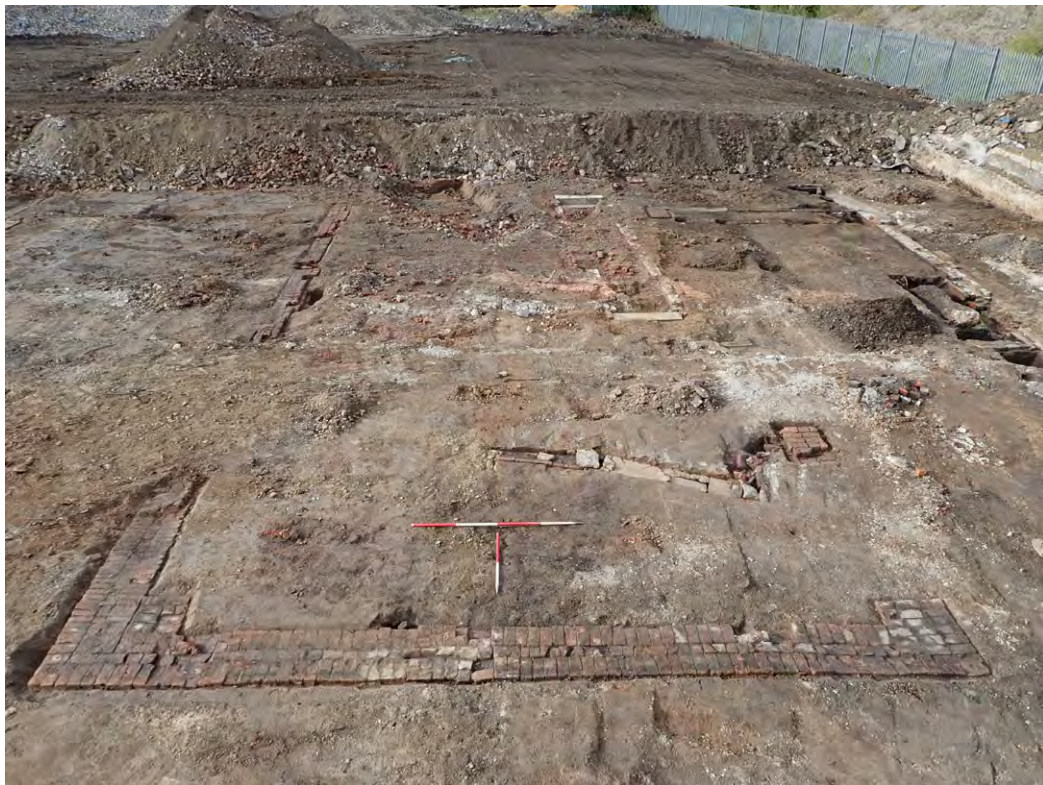
Fig. 6.12 - Overall view of foundations to the Cooperage, looking north-west

Wall foundations were identified in the north-western quarter of the excavation area, defining three sides of a rectangular building measuring at least 15m long by 8.85m wide (figs 2.3 and 6.12). The south-western wall (100) had been truncated at its northern end and mid-way along its length by the concrete walls of the later subterranean passage. Two shallow internal buttresses were located along the east side of the foundation (Fig. 6.13) and brickwork possibly forming the base to an additional support was located at the south end of the wall where it joined the south-eastern wall (101) of the structure. The east end of Wall 101 terminated with a short return to the north-west (Fig. 6.14). Four rectangular brick pads (022 from Trench 3, 102, 148 and 149) were observed in a line extending north-west from the return at the east end of Wall 101. Each pad measured 0.49m by 0.74m and was 2.80m away from the adjacent pad. Pad 148 was excavated to its base, showing the brickwork to have been built within a rectangular construction cut, and the main body of the structure sitting on two offset courses at the base of the feature (Fig. 6.15).

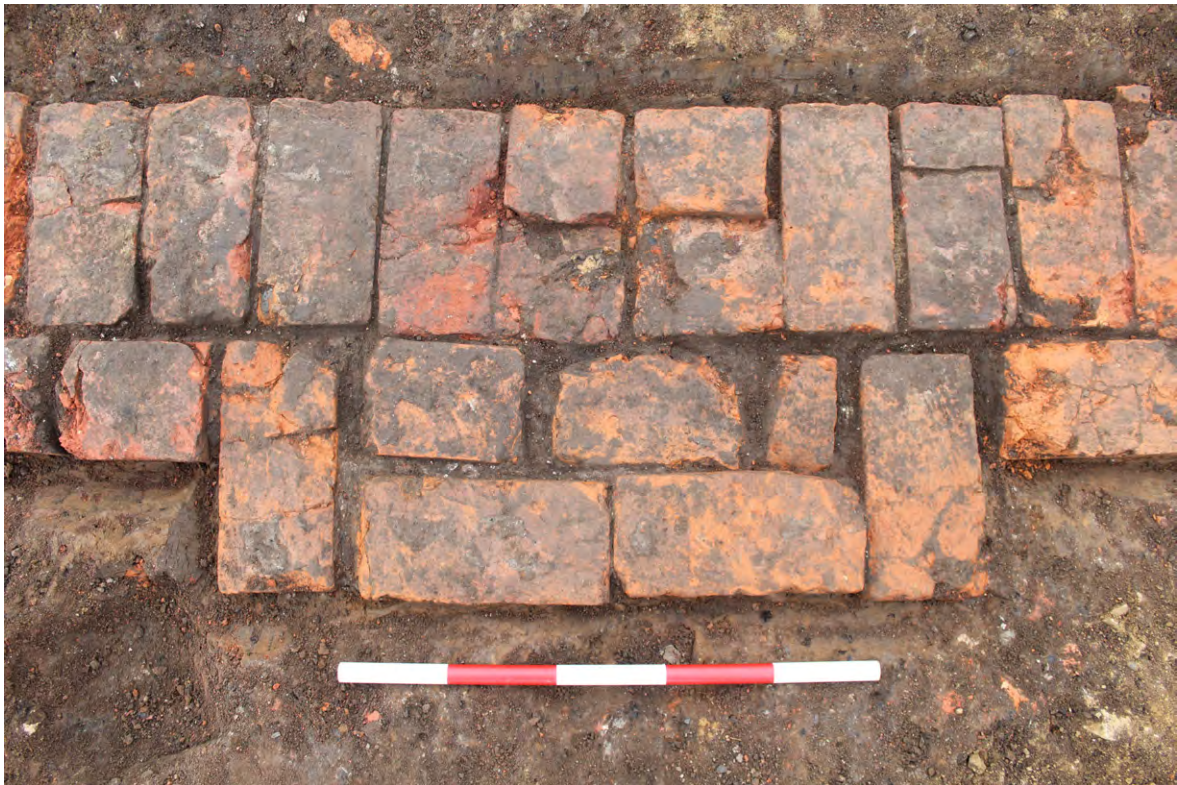
Fig. 6.13 - Detail of internal buttress to west wall 100 of the Cooperage

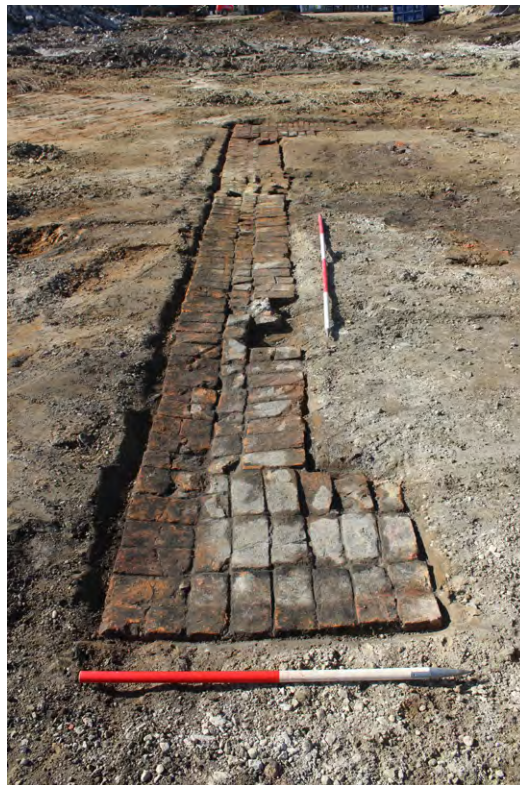
Fig. 6.14 - View along south wall 101 of the Cooperage, looking south-west

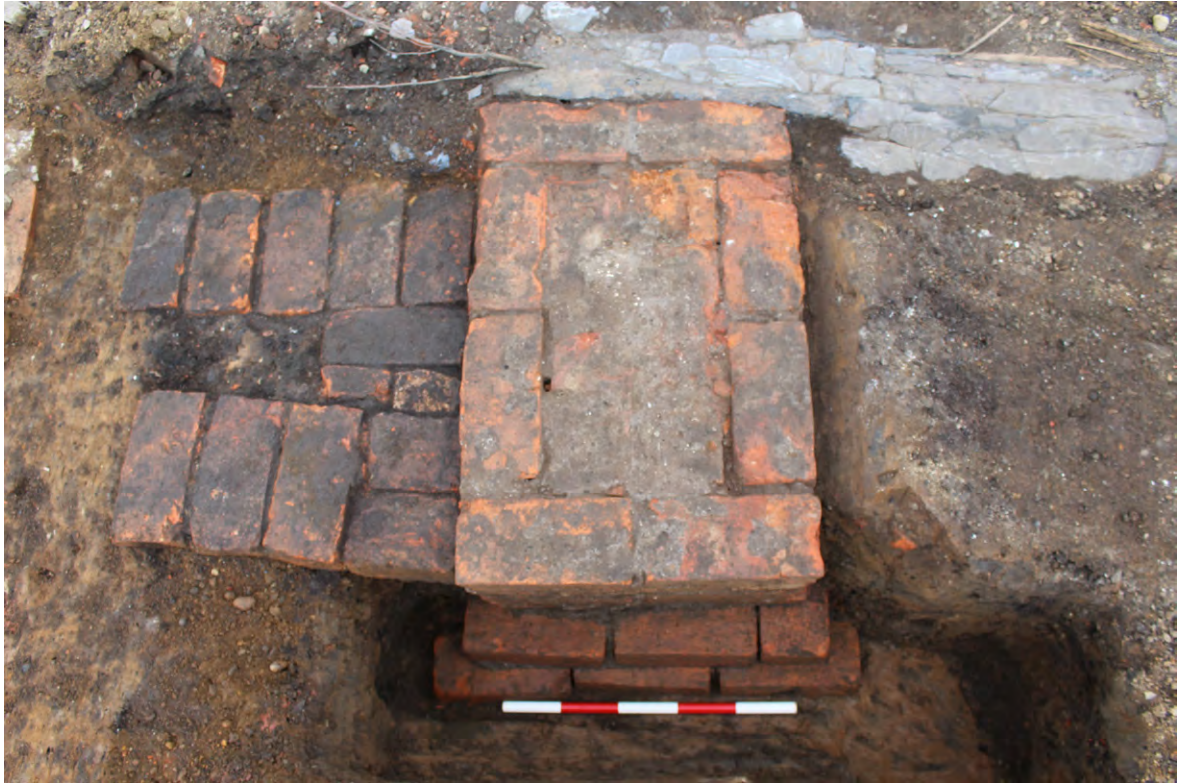
Fig. 6.15 - Detail of brick pier base 148 forming part of east side of the Cooperage

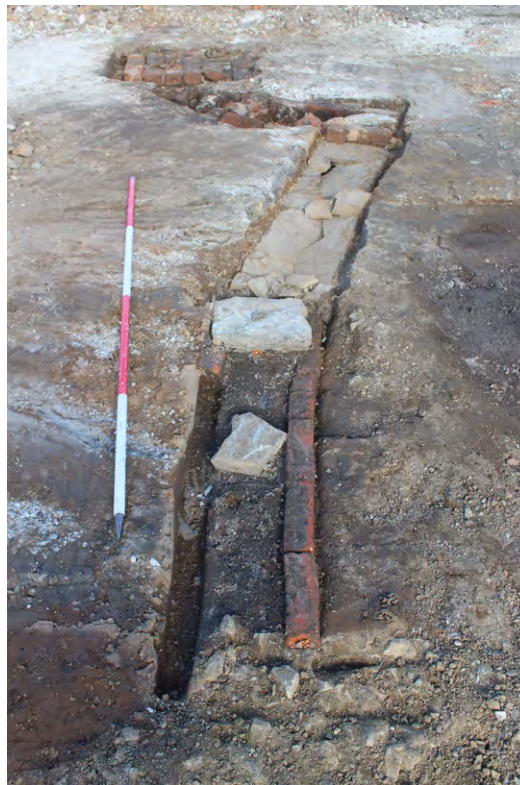
Fig. 6.16 - Brick and stone built drain 154 within the Cooperage, looking east

No internal floor surfaces survived within the building: the only structures recorded inside the foundations being a small area of brickwork (150) adjacent to a foundation pad (148) and a brick and stone drain (154). Only one course of Brickwork 150 survived, and the western extent had been truncated by a construction cut (164) for brick and concrete stairs (Fig. 6.15; 158, 159 and 160). Mortar across the upper surface of Brickwork 150 indicated that additional masonry had formerly been present, but no evidence of the form of those elements survived. A Drain (154) comprised brick side walls resting on a slate lined base, capped by stone slabs (Fig. 6.16), with the eastern extent of the feature, either associated with or truncated by, a brick pad (102).

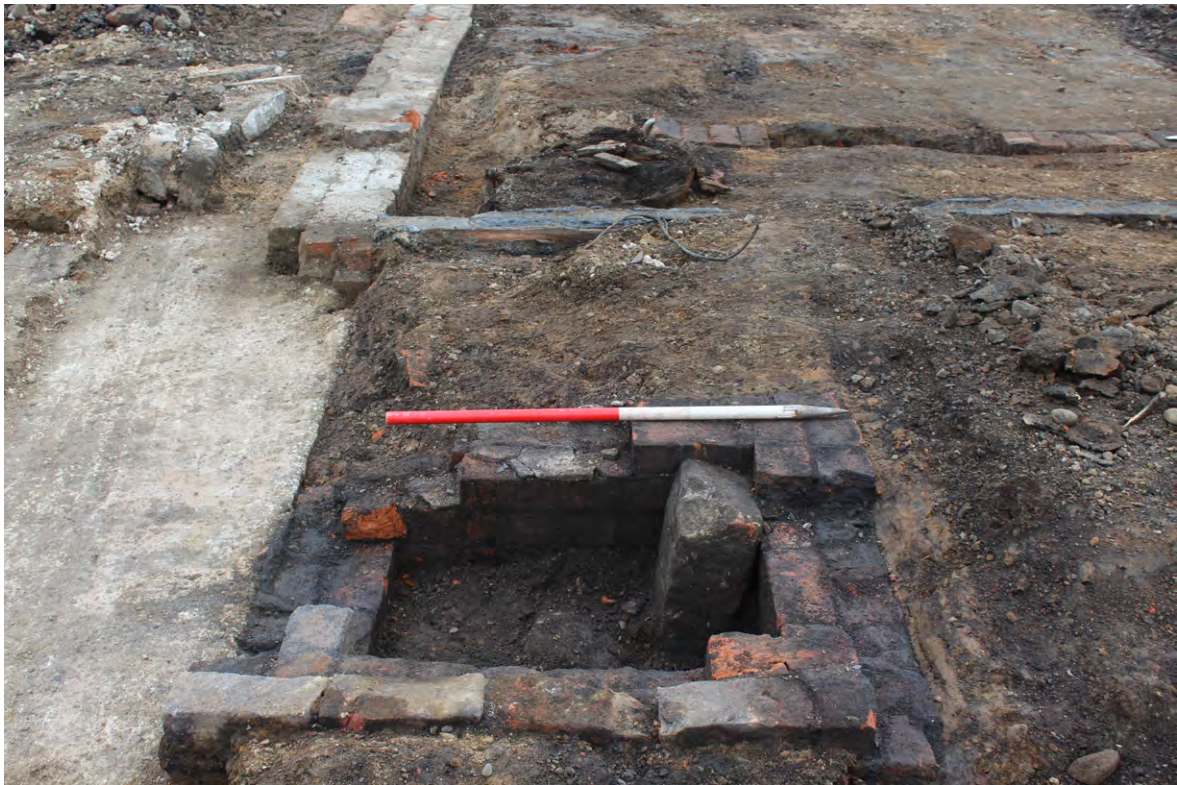
Fig. 6.17 - Brick built inspection chamber 120, looking south-east

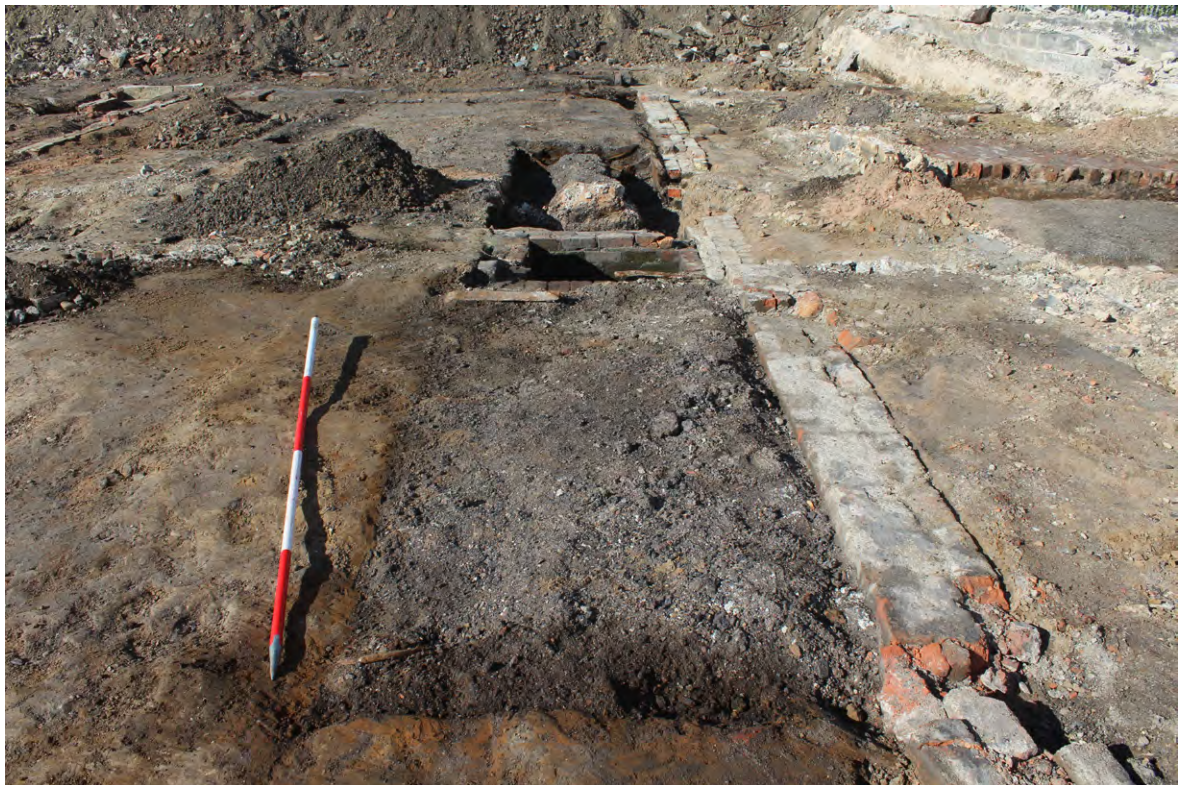
Fig. 6.18 - Two rectangular tanks flanking inspection chamber 019, looking north-west

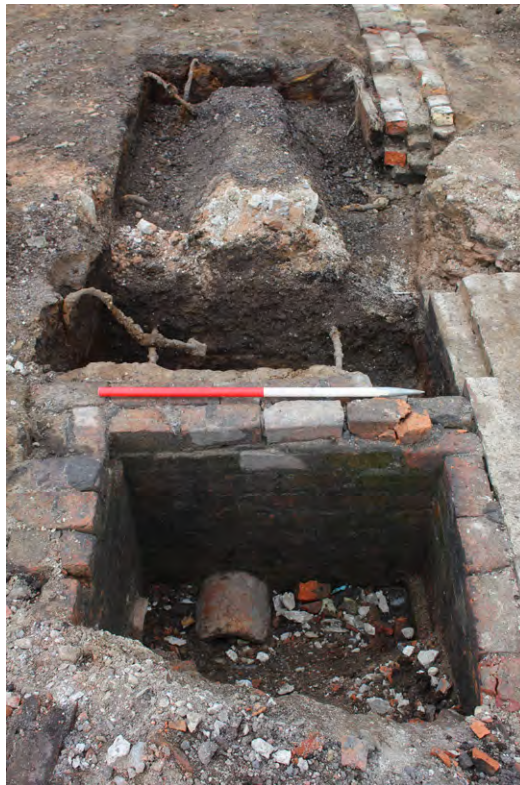
Fig. 6.19 - Brick inspection chamber 019 and timber lined tank 115, looking north-west

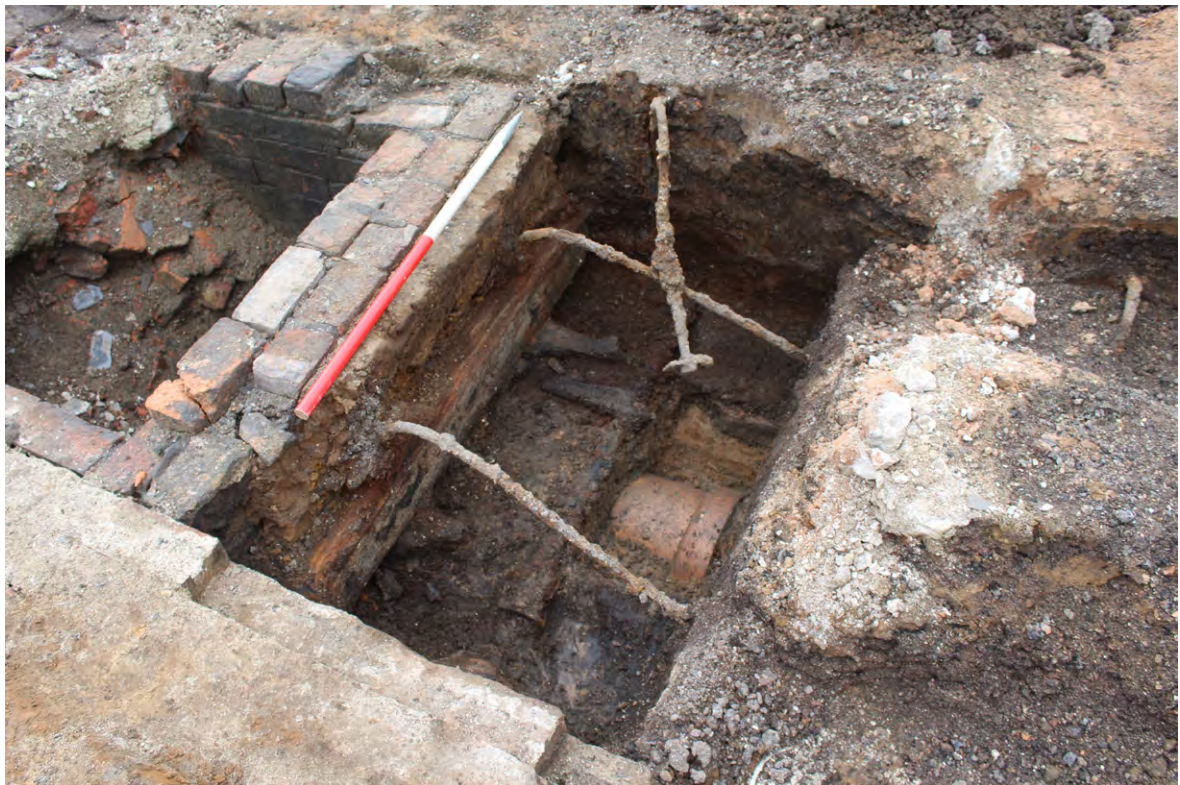
Fig. 6.20 - Timber lined tank 115 showing metal fixtures and ceramic pipe, looking south

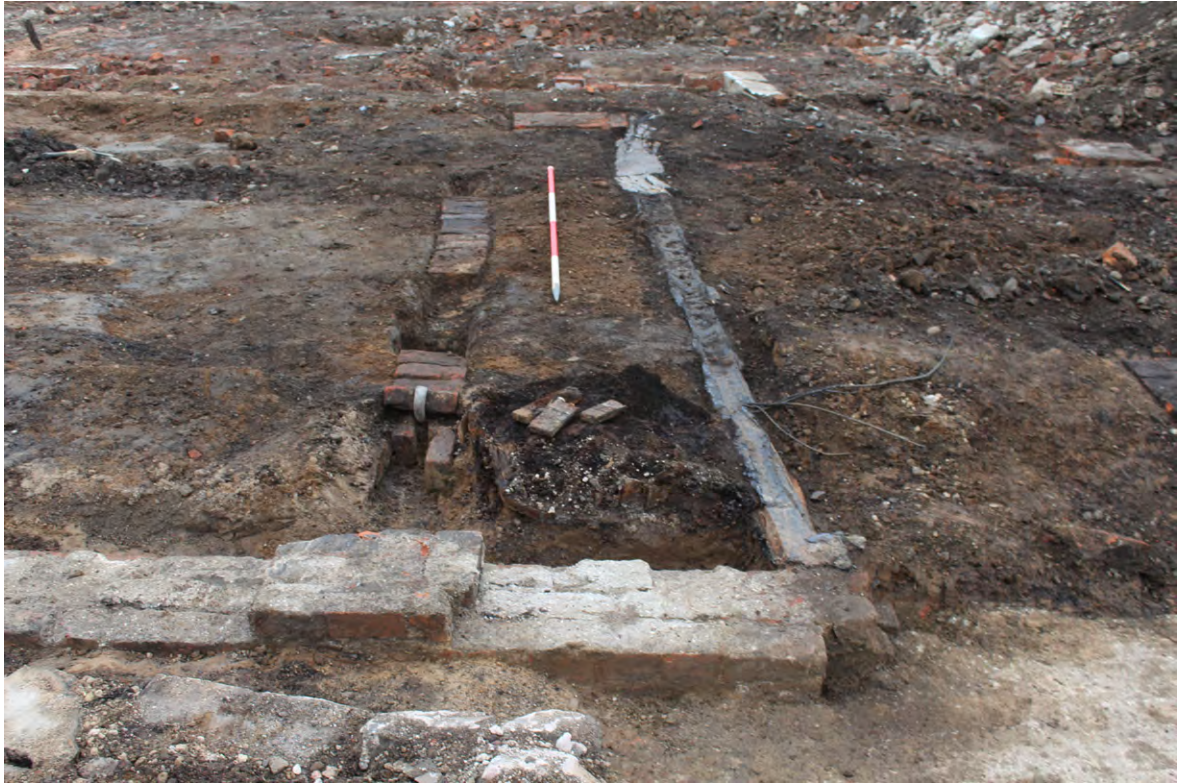
Fig. 6.21 - Brick capped pipe trench 110, barrel 118 and cable run 117, looking south-west

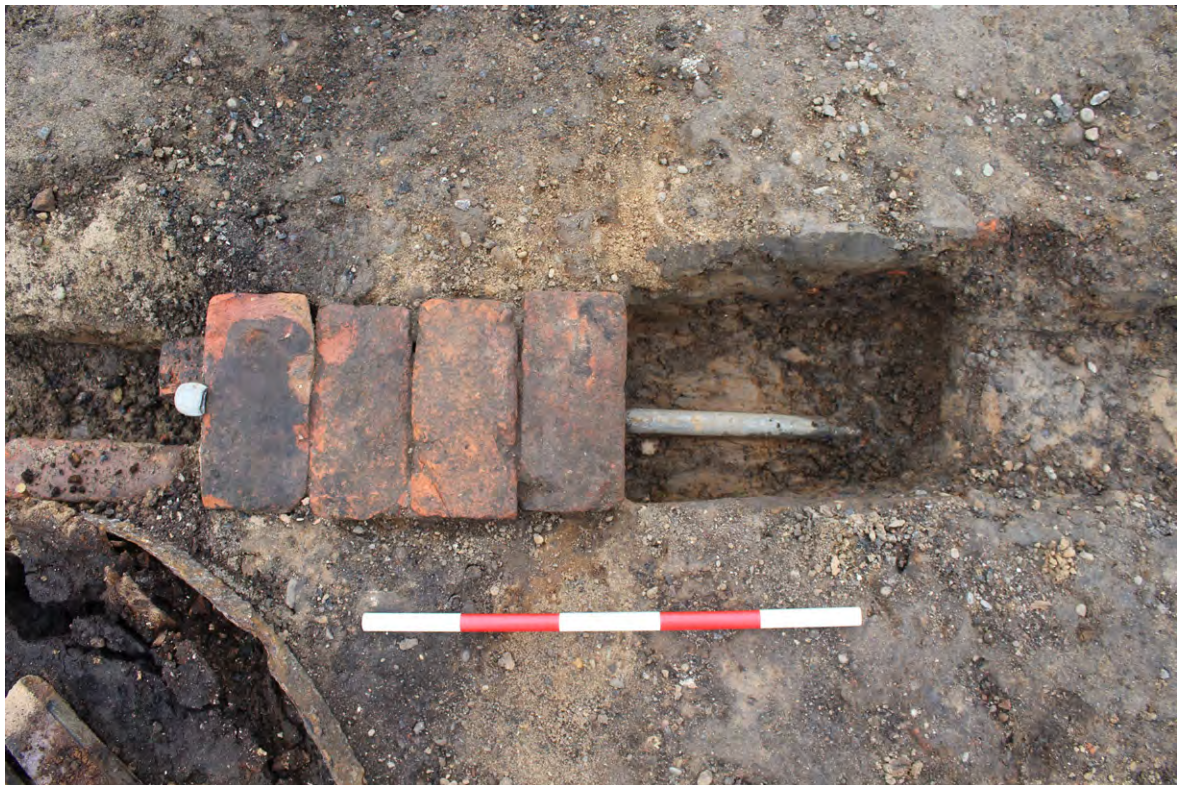
Fig. 6.22 - Brick capping 106, over lead pipe in trench 110

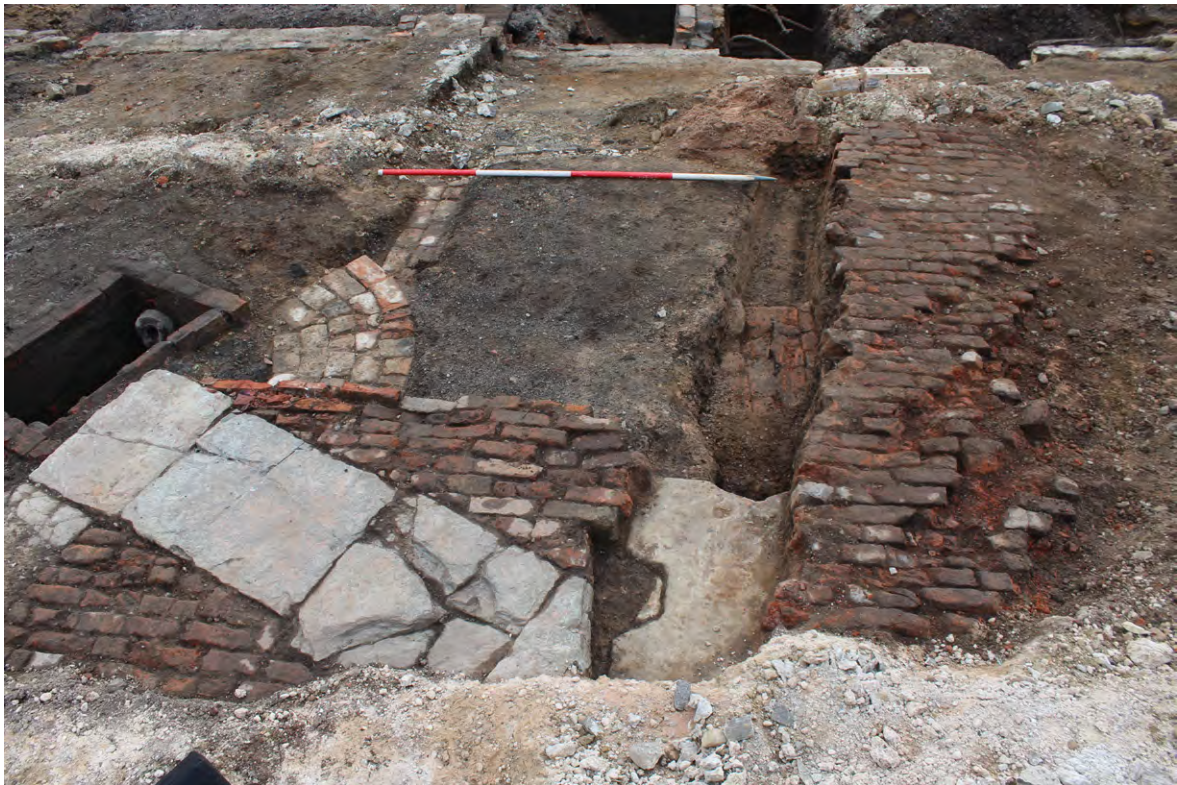
Fig. 6.23 - Brick floor 123 with associated surfaces and structures, looking south-west

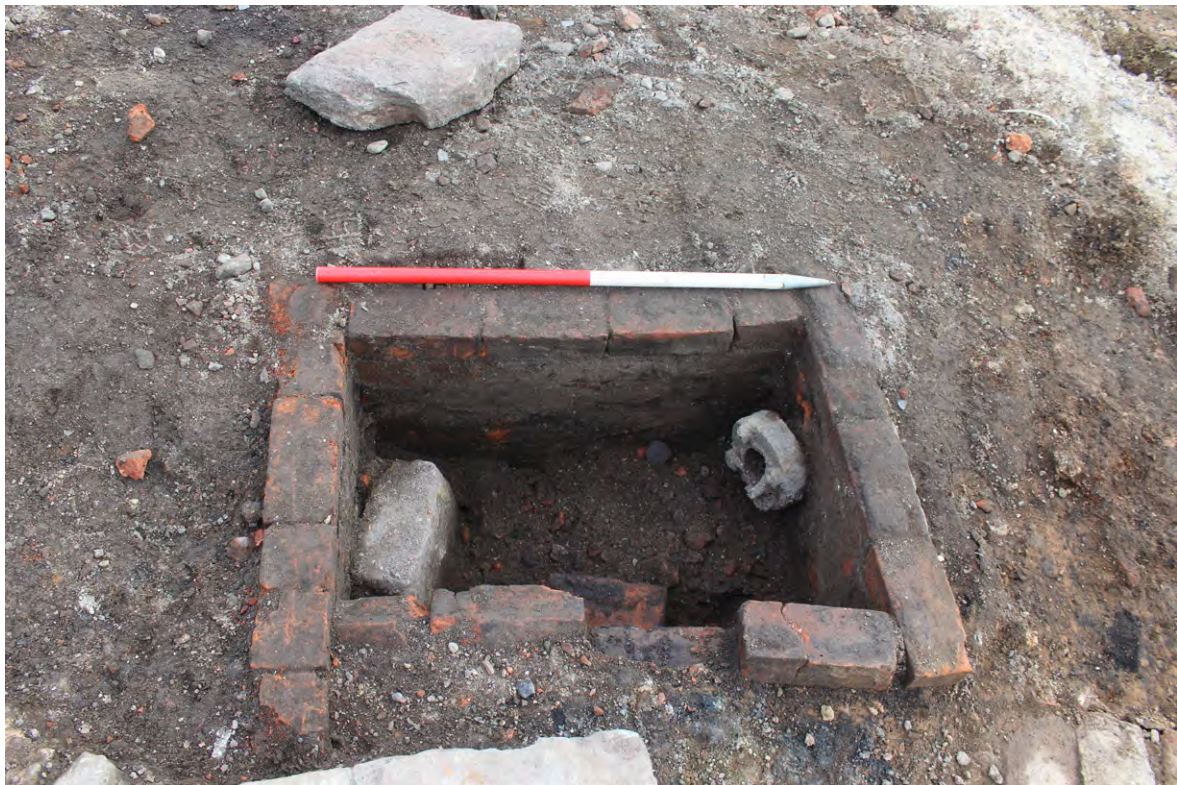
Fig. 6.24 - Brick built inspection chamber 125, looking south

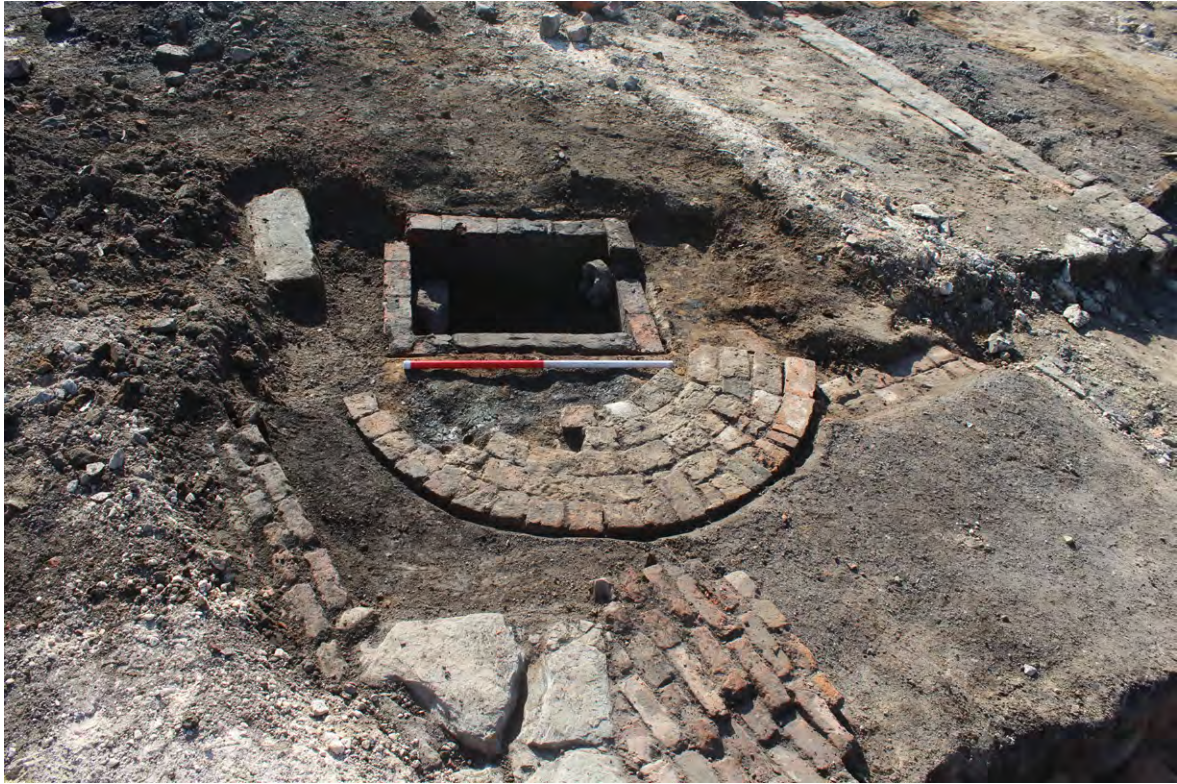
Fig. 6.25 - Semi-circular brick structure 192, looking south

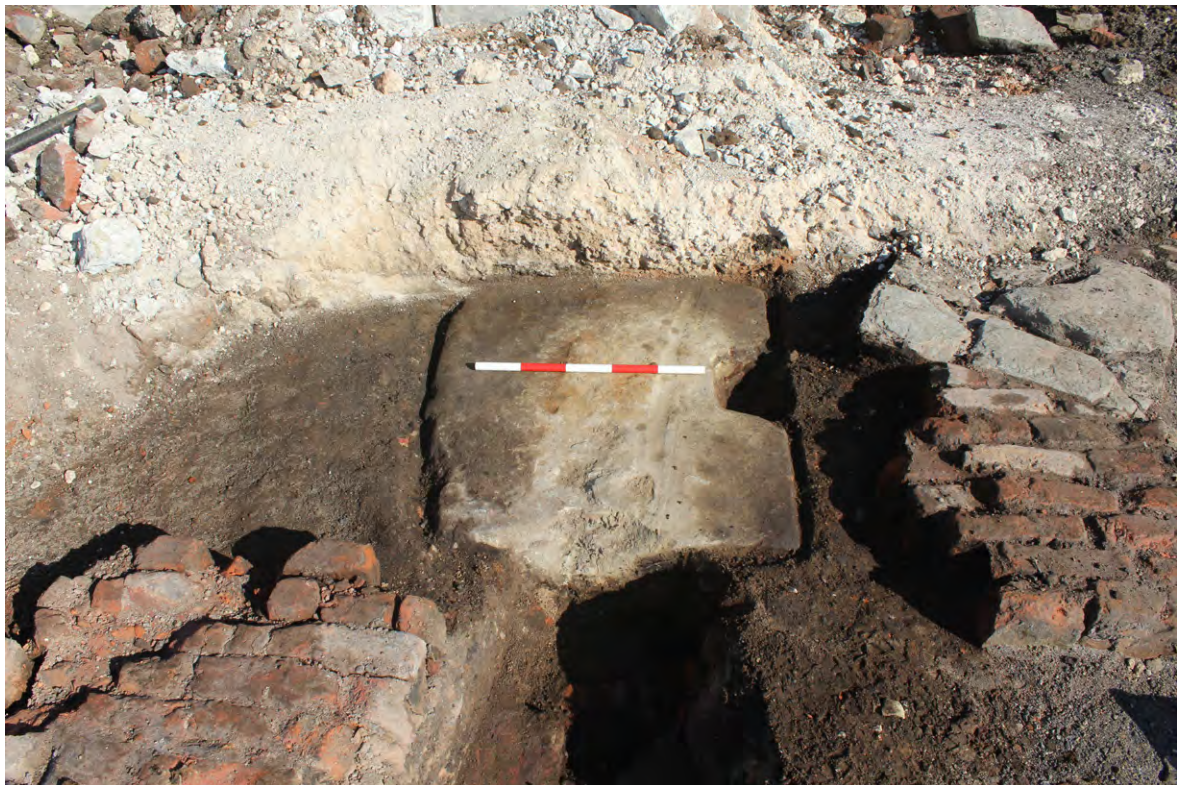
Fig. 6.26 - Worked stone block 016, looking north-east

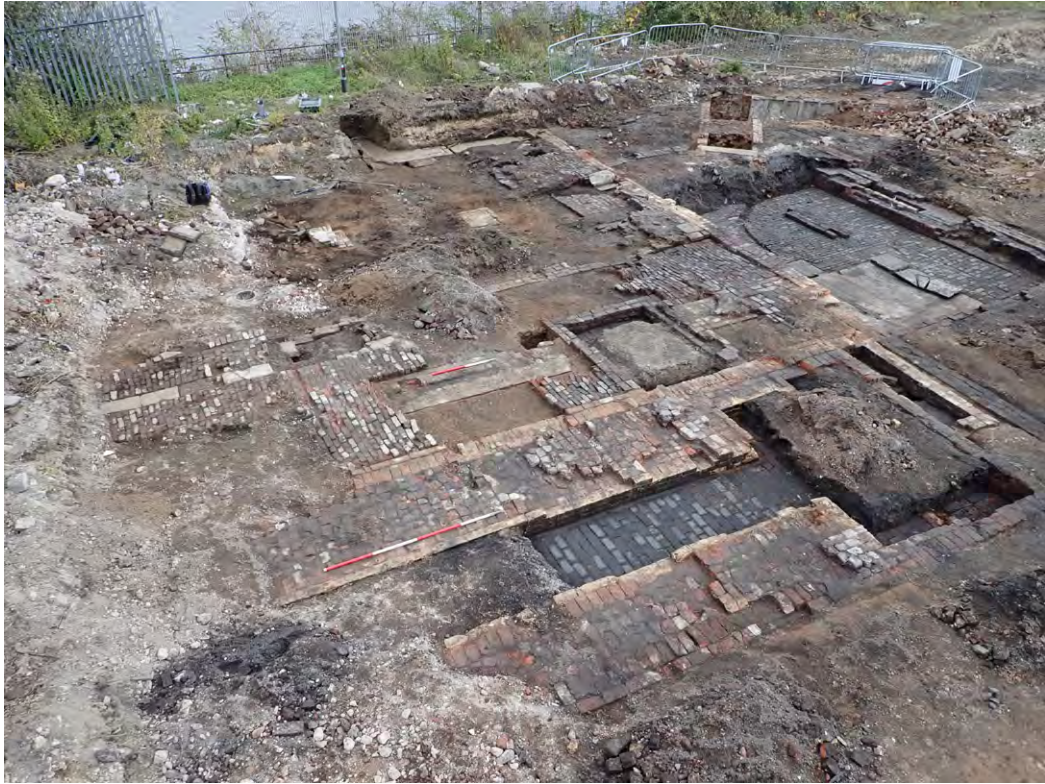
Fig. 6.27 - Overall view of structures in the south-east corner of site, looking south

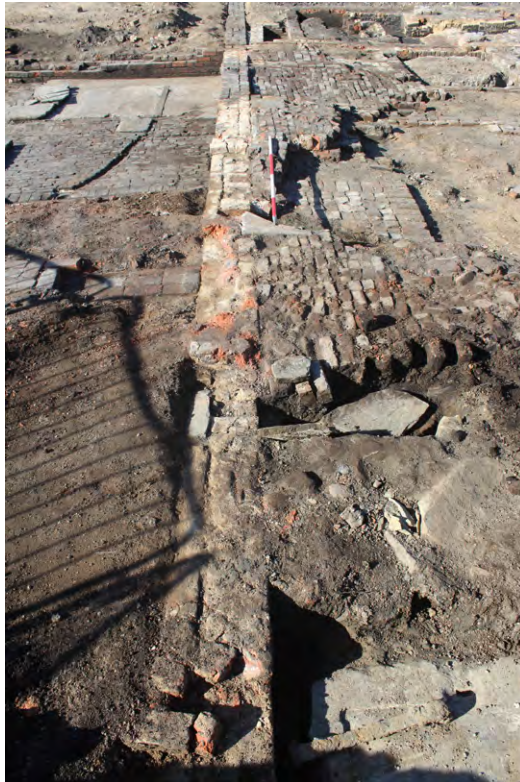
Fig. 6.28 - West wall 121 of structure at south-east corner of site, looking north-west

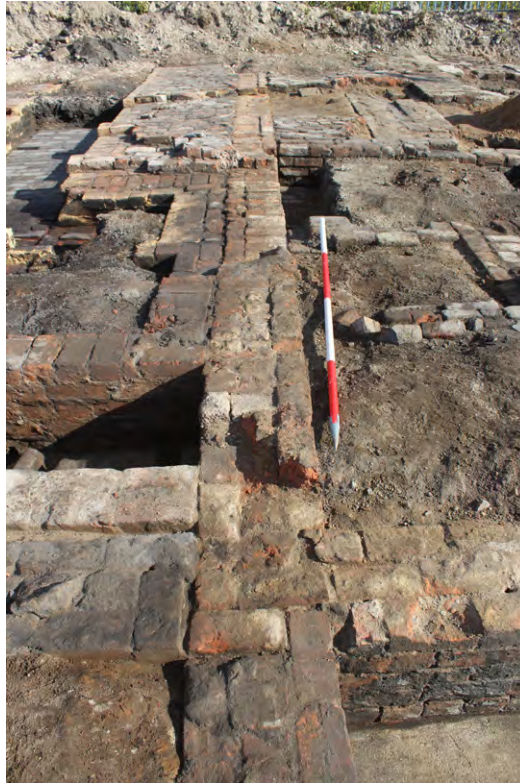
Fig. 6.29 - North wall 122 of structure at south-east corner of site, looking north-east

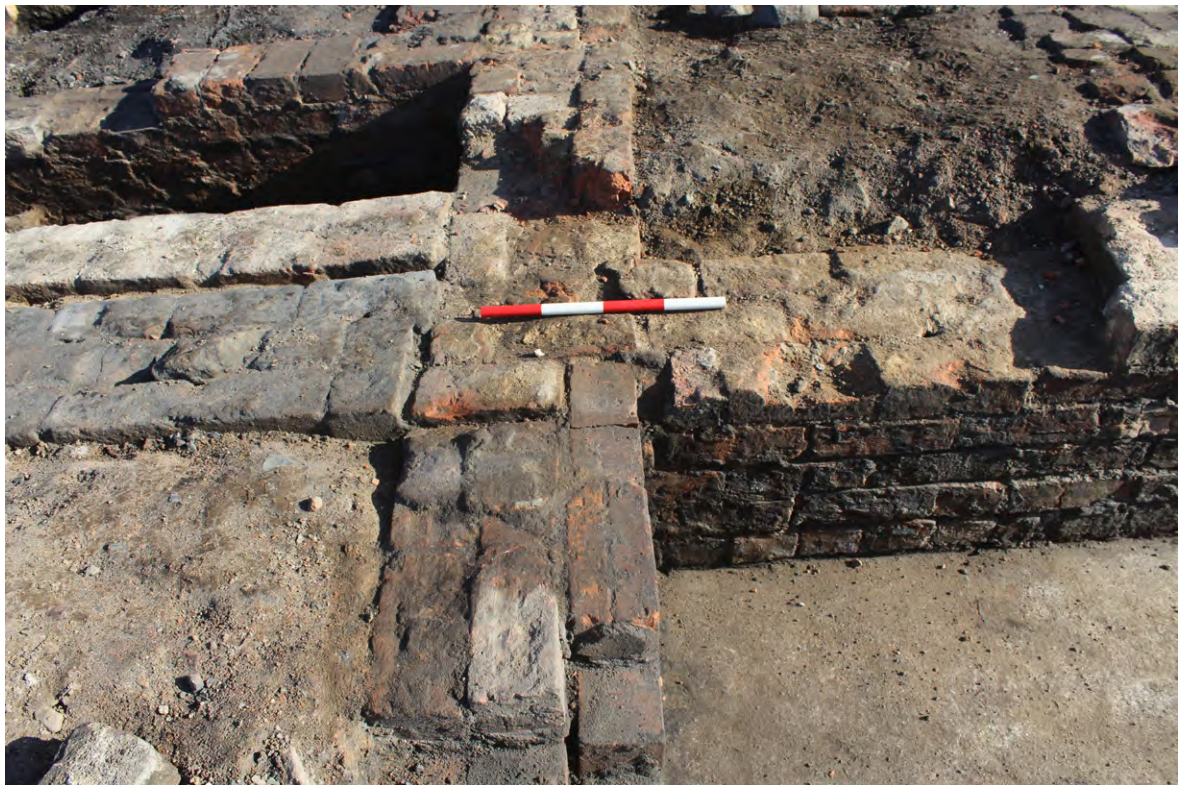
Fig. 6.30 - Detail of corner formed by walls 121 and 122 and relationship with later walls 128 and 167, looking north-east

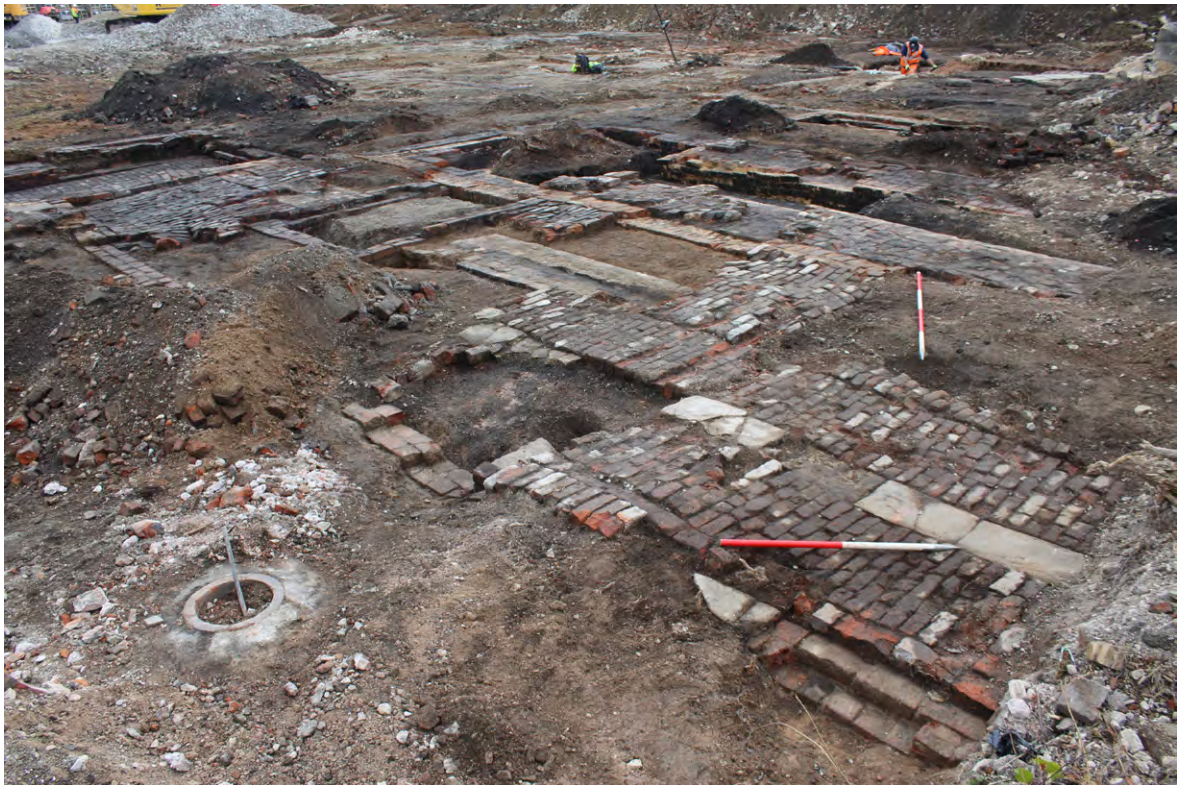
Fig. 6.31 - Overall view of features, including surface 157 (foreground) across south-east corner of site, looking west

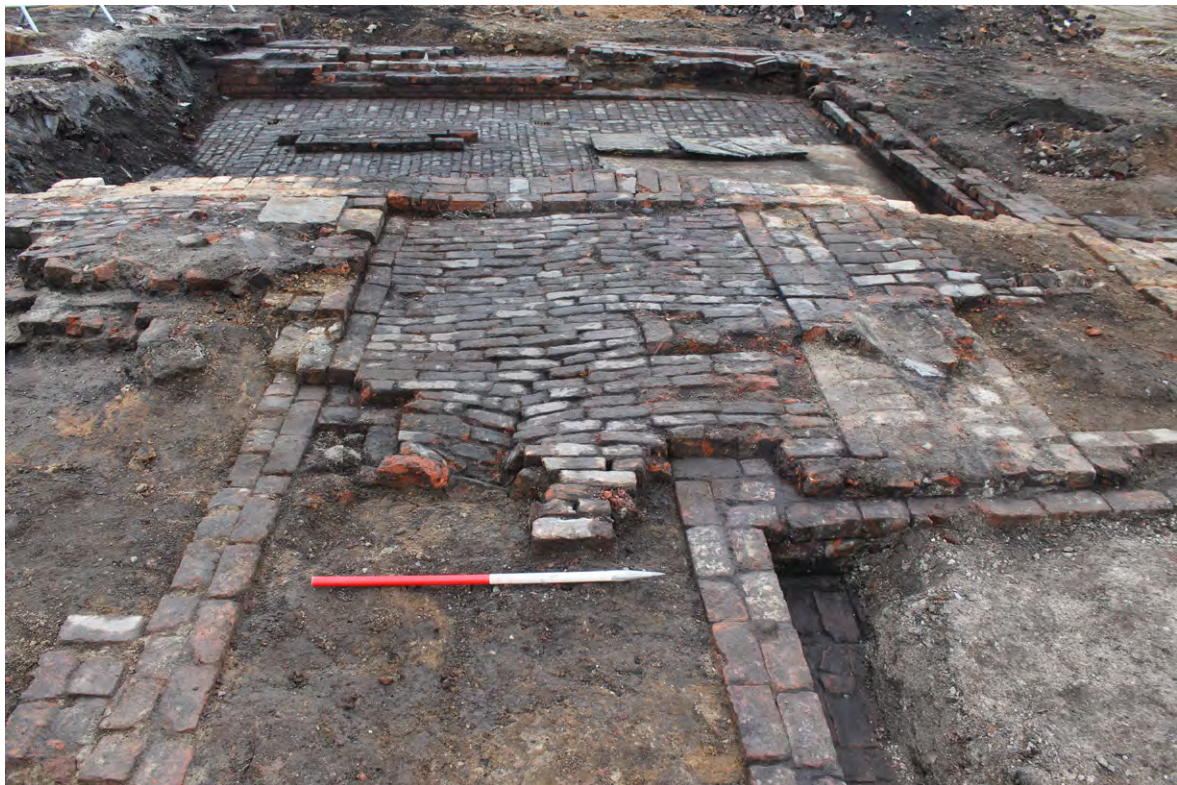
Fig. 6.32 - Brick floor 172, forming the western extent of floor 157, looking south-west

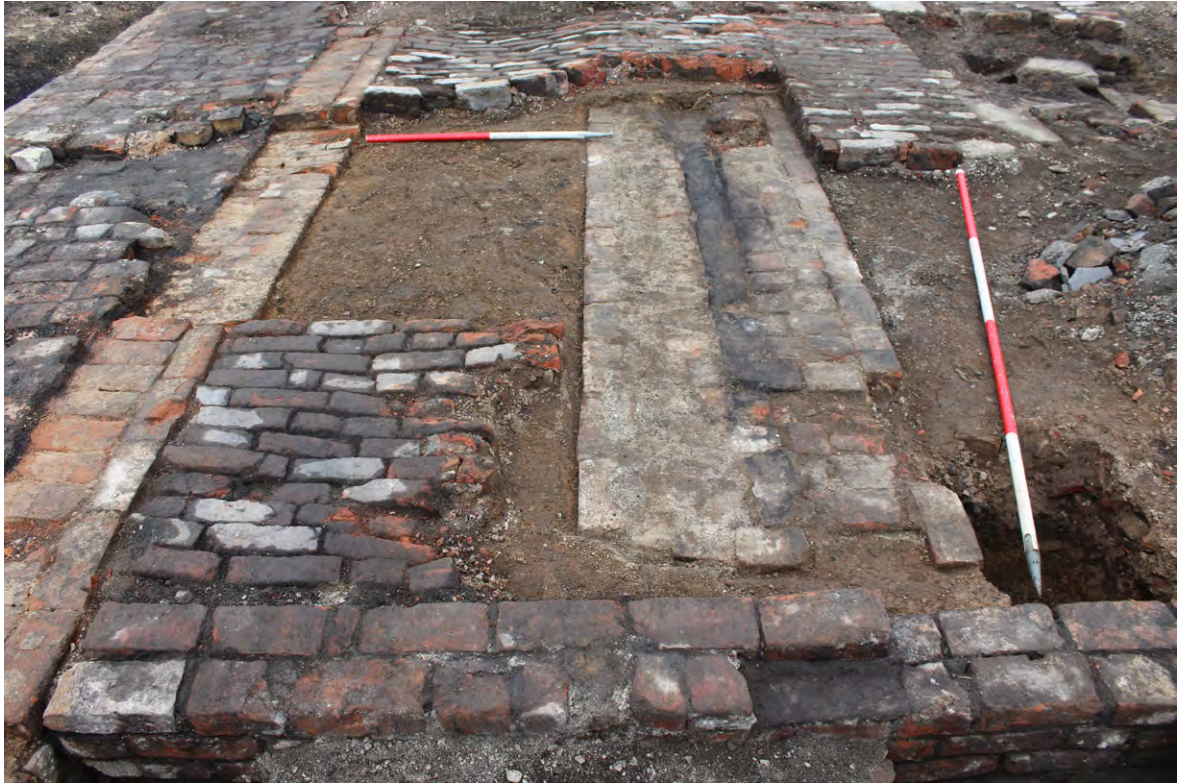
Fig. 6.33 - Brick floor surface 145, overlying foundation 147, looking north-east

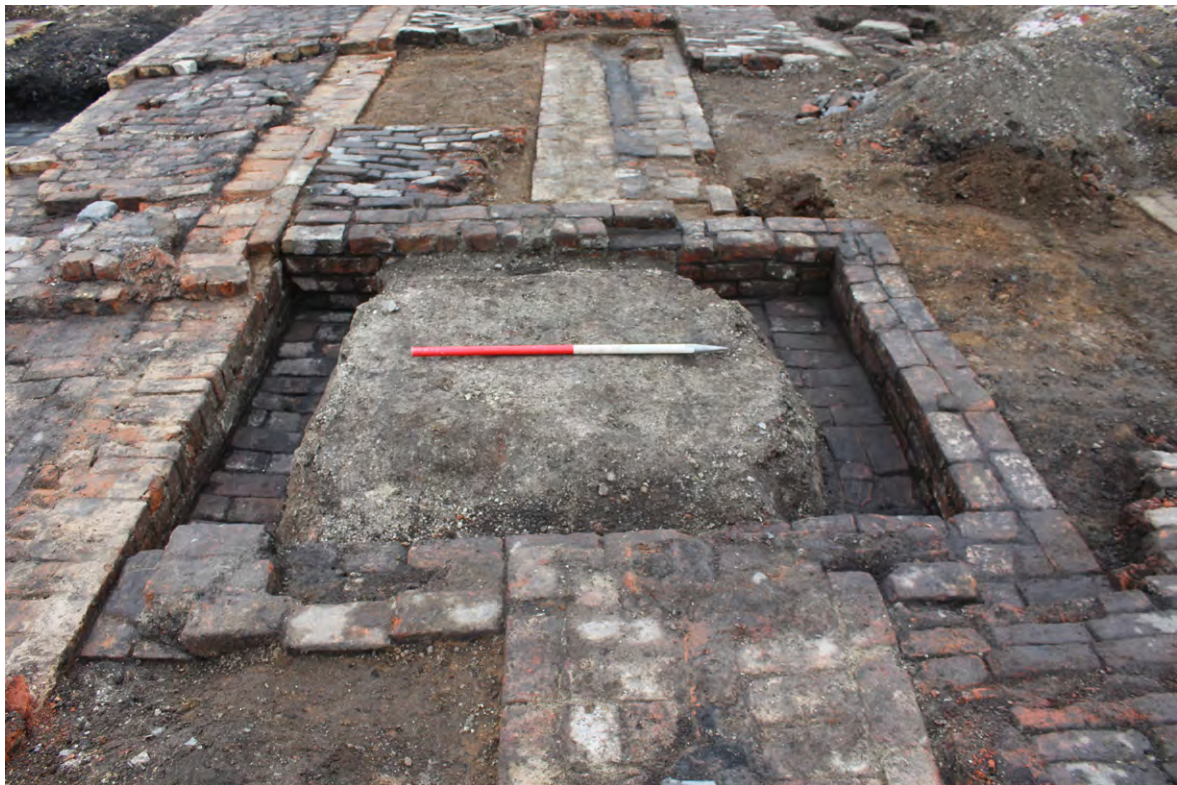
Fig. 6.34 - Brick structure constructed against south face of wall 122, looking north-east

A rectangular structure comprising brick walls (137, 138 and 139) and brick floor (140) had been constructed against, but not bonded into, the south side of foundation 122 (Fig. 6.34). The floor level inside the structure was up to 0.32m below that of surviving floor surfaces within the building, and sloped down slightly to the north-east. Although all three side walls were contemporary, and had been keyed into each other at their corners, the south-eastern wall appeared to have been built directly on top of and neatly in line with the bricks used in the floor, whereas walls 138 and 138 featured uneven gaps between their lowest courses and the floor surface. The construction of this rectangular structure had truncated an earlier wall foundation, creating two separate sections of brickwork (147 and 177).

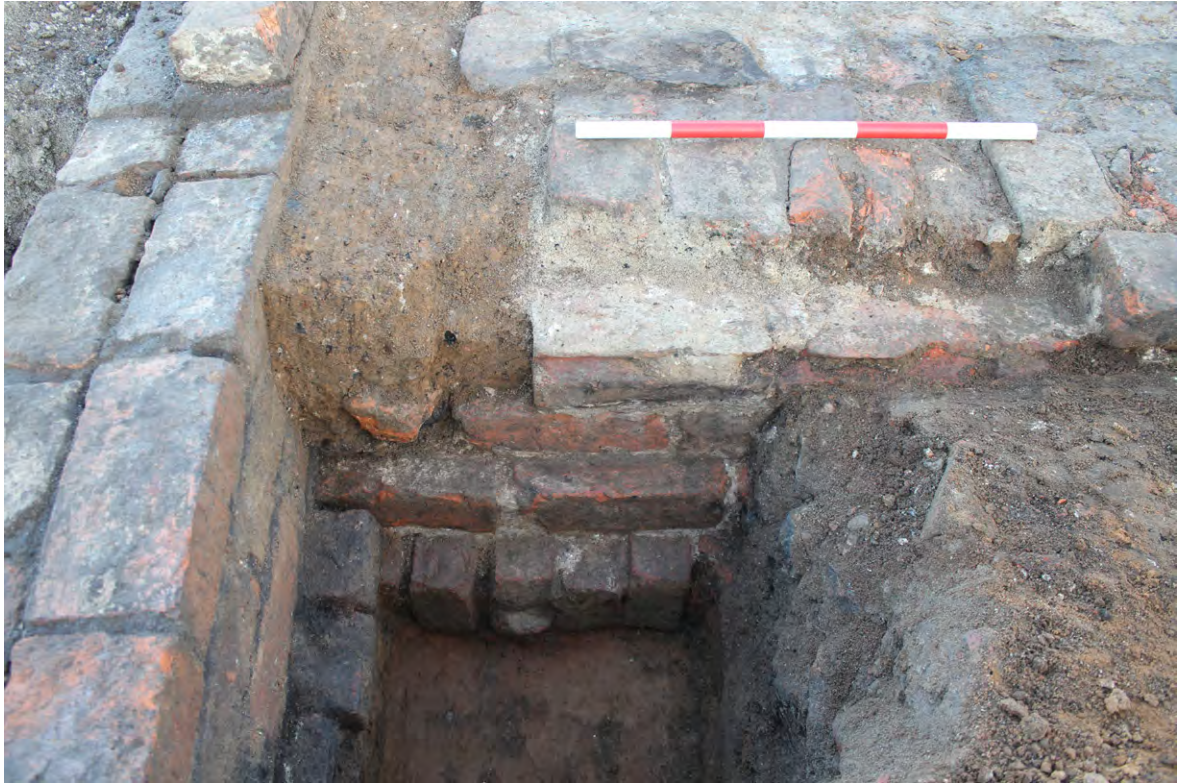
Fig. 6.35 - Truncated west extent of foundation 147, looking north-west

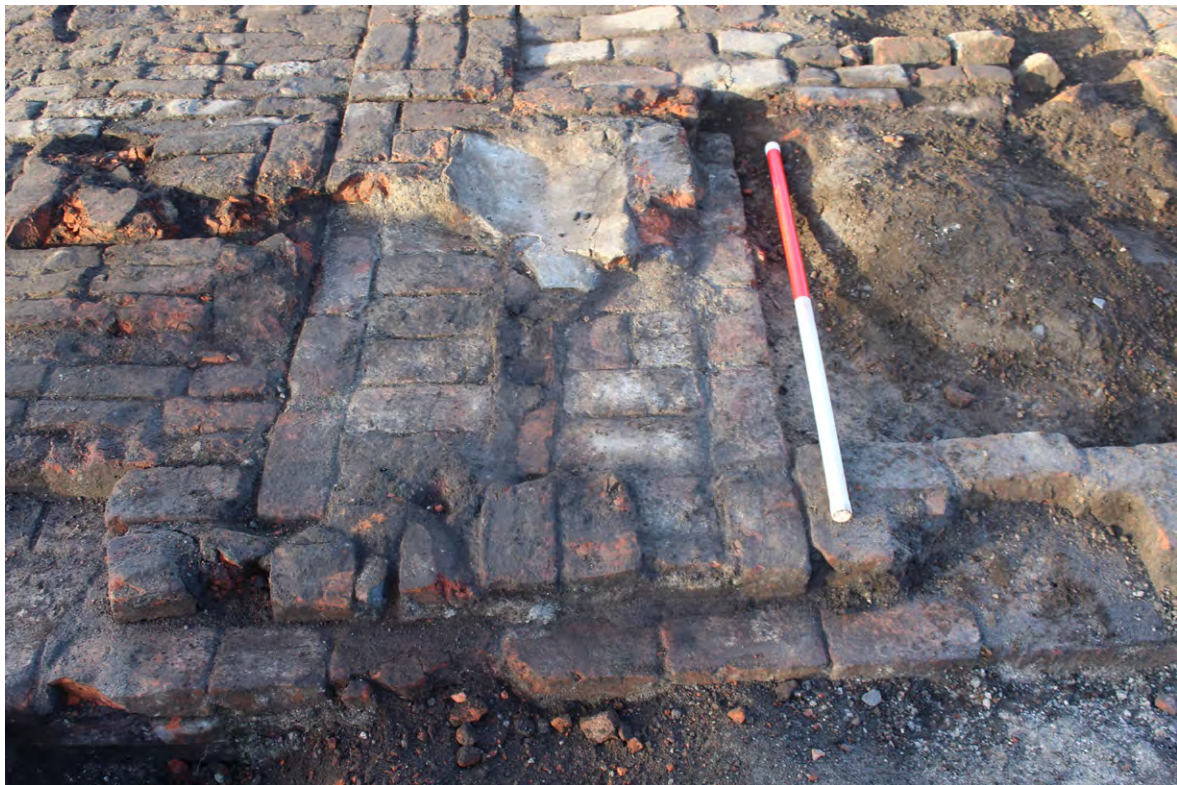
Fig. 6.36 - Brick foundation 177 with integral channel, looking south-west

A north-east to south-west aligned wall foundation, recorded in two sections (147 and 177) ran parallel and to the south of Wall 122. The upper (truncated) surface of foundations 147 and 177 featured the remains of a channel along their centre line, most likely to house a drain or flue within the structure of the foundation. Foundation 147 was no longer in use by the time brick floor surface 145 was laid across it (Fig. 6.33). The foundation was also truncated by the north-east wall (138) of a square, sunken floor structure, which cut through the full width of Foundation 147, with parts of Wall 138 and associated floor (140) being constructed on top of the lowest courses of the redundant foundation (Fig. 6.35). At the west side of the sunken floored structure, a further fragment of the disused foundation (177) had again been incorporated into the side wall (139) of the later structure (Fig. 6.36). The truncated upper surface of Foundation 177 retained a

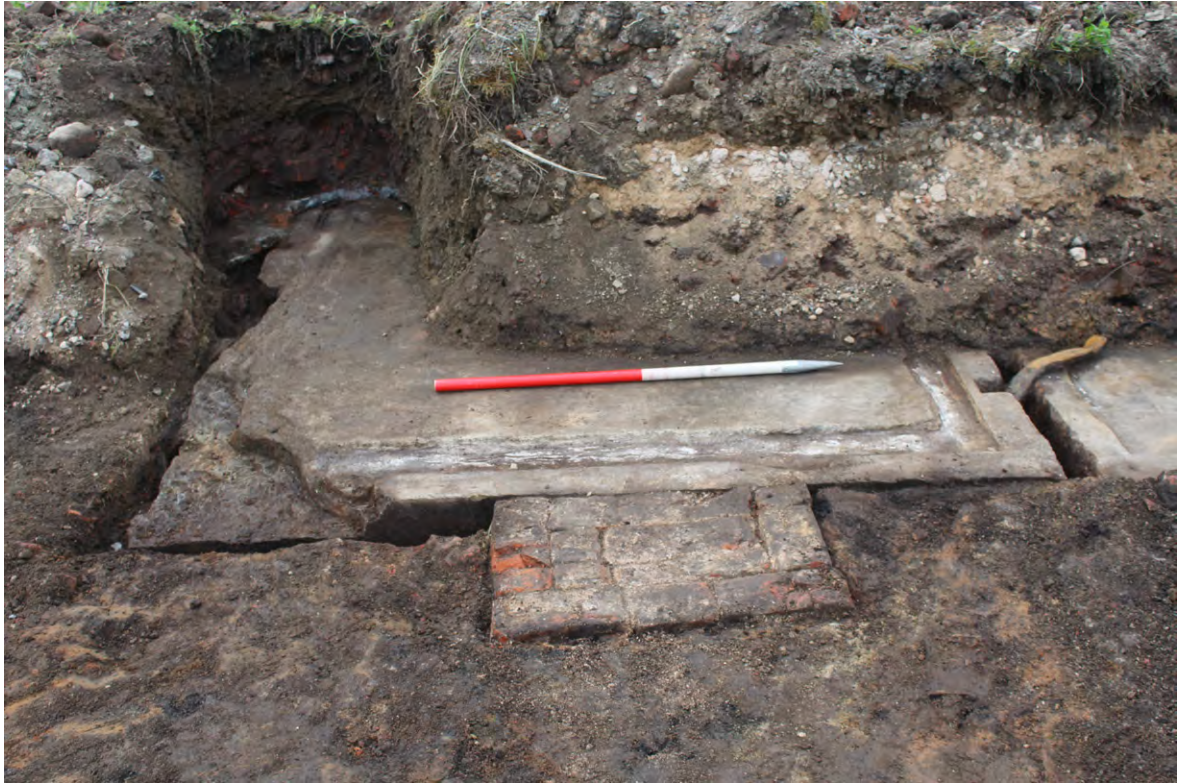
Fig. 6.37 - Stone base 107 and brick pad 108, looking south-east
