257 Ordsall Lane  
Salford  
Greater Manchester

Archaeological Evaluation and Excavation

Report No. Y376/18

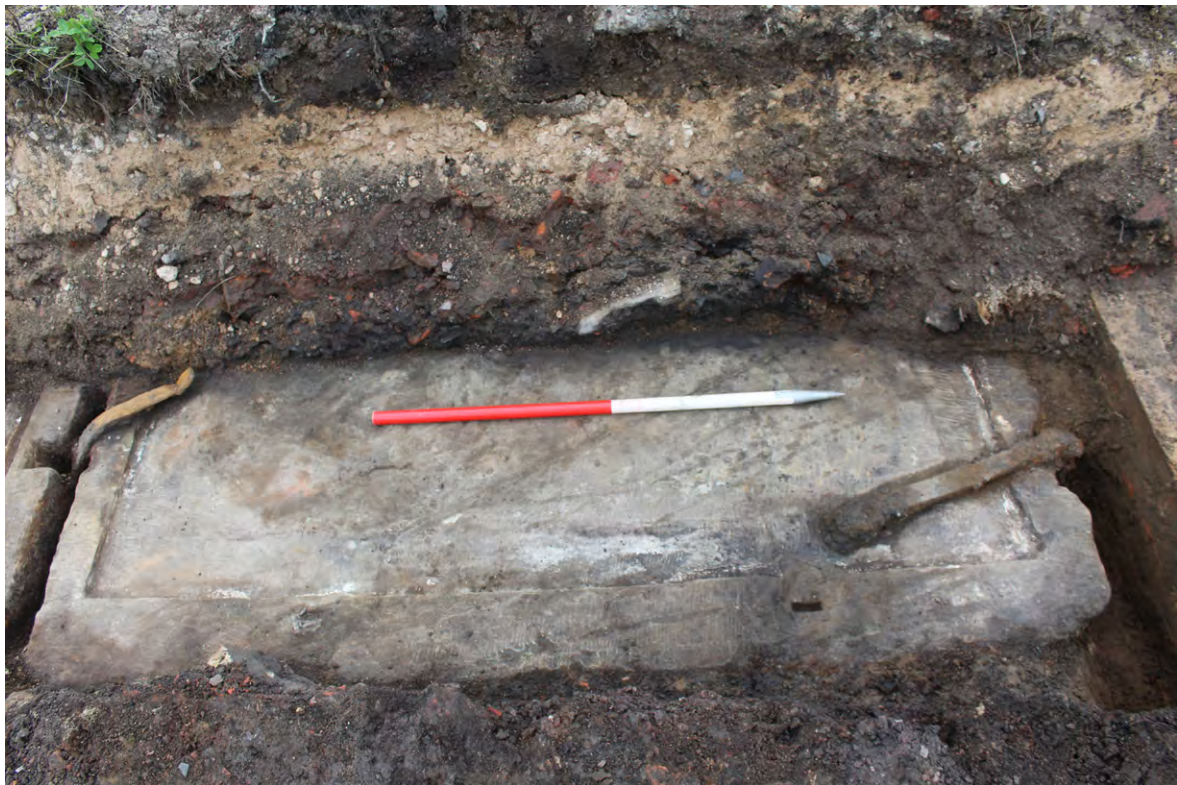
Fig. 6.38 - Stone base 109 with metal fixture, looking south-east

The internal space within Structure 4 was subdivided by a north-east to south-west aligned wall foundation (171), with the area to the south of the dividing wall being more heavily truncated than that to the north. Two large stone bases were located at the south eastern extent of the excavation area; both had been neatly finished with square edges and flat upper surfaces. Base 107 measured 2m north east to south-west and at least 2m north-west to south-east. It featured a shallow chamfered groove cut parallel to the outer edge of its upper surface, and a metal strap fixed within a square recess along the western edge of the block (Fig. 6.37). Immediately to the west of Base 107 another stone base (109) was of similar dimensions and finish (Fig. 6.38).

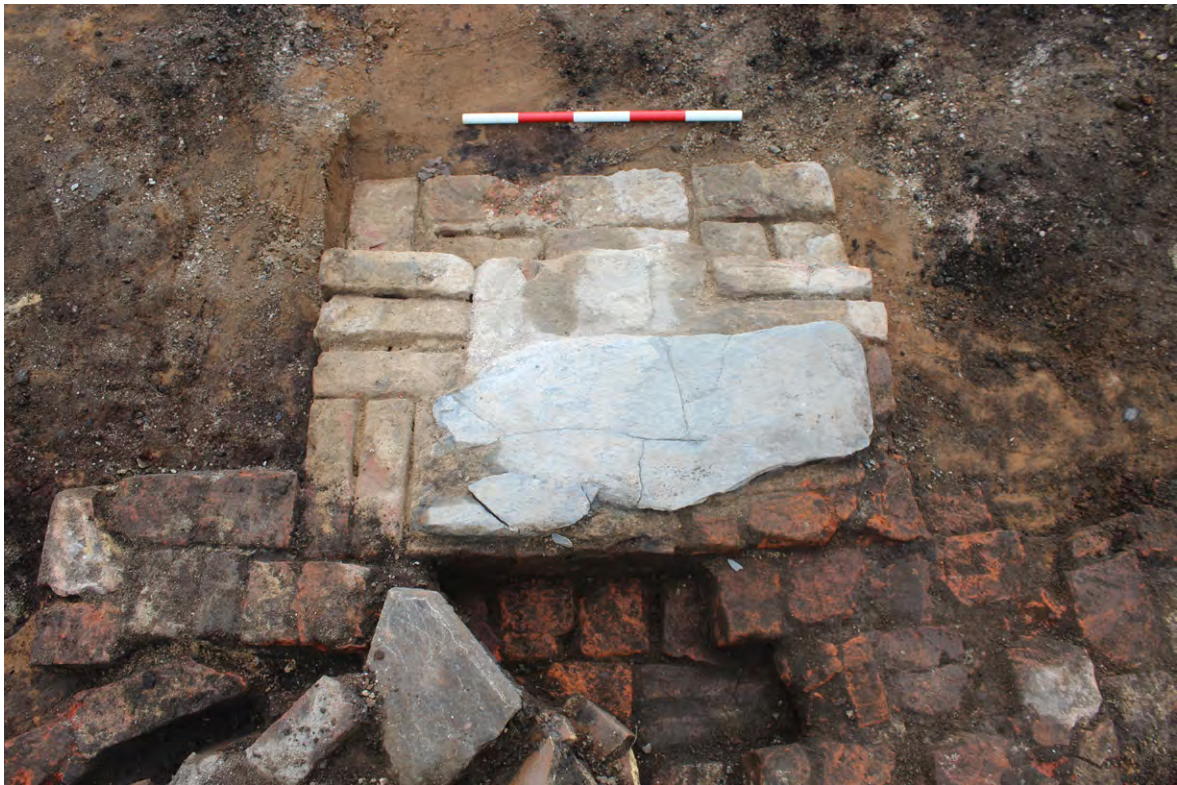
Fig. 6.39 - Brick pad 124, looking south-west

The area to the south of Foundation 171 contained evidence for the support of an upper storey or roof, in the form of buttresses and foundation pads laid out in a regular grid pattern. Foundation 171 incorporated a projecting buttress along its southern side, which aligned along a north-west to south-east axis with brick foundation pads (119 and 108) partially truncated by a stone base (Fig. 6.37; 107). A north-east to south-west aligned series of supports included a large stone block incorporated within the build of the main outer wall (121) of the building, and a brick foundation pad (Fig. 6.39; 124) which aligned with Pad 119. One foundation pad (124) retained a large fragment of slate across its upper surface, possibly used as a damp proof course.

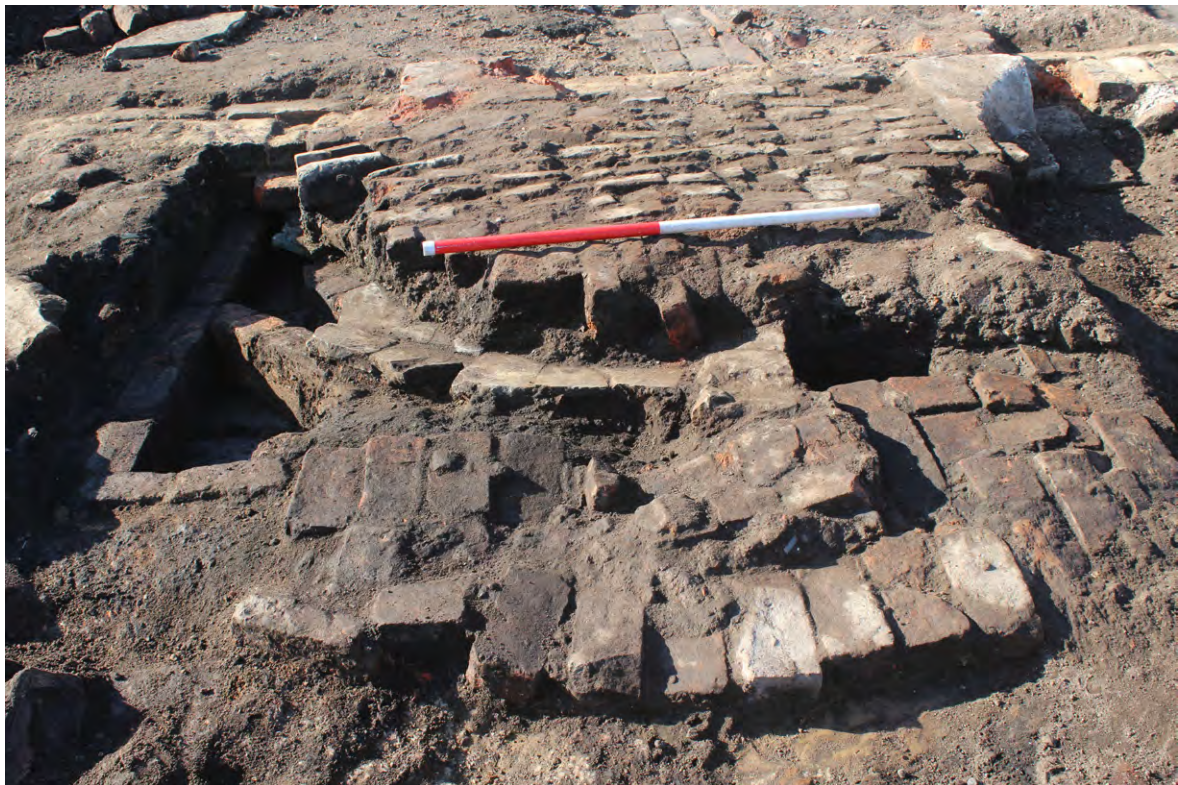
Fig. 6.40 - Floor surface 178 overlying drain 195, looking south-west

Fragmentary remains survived of a brick floor surface (178) which had been built against the east side of Wall 121 (Fig. 6.40). This surface overlay a brick-built drain (193), incorporating a later alteration (195), with Drain 193 passing through Wall 121.

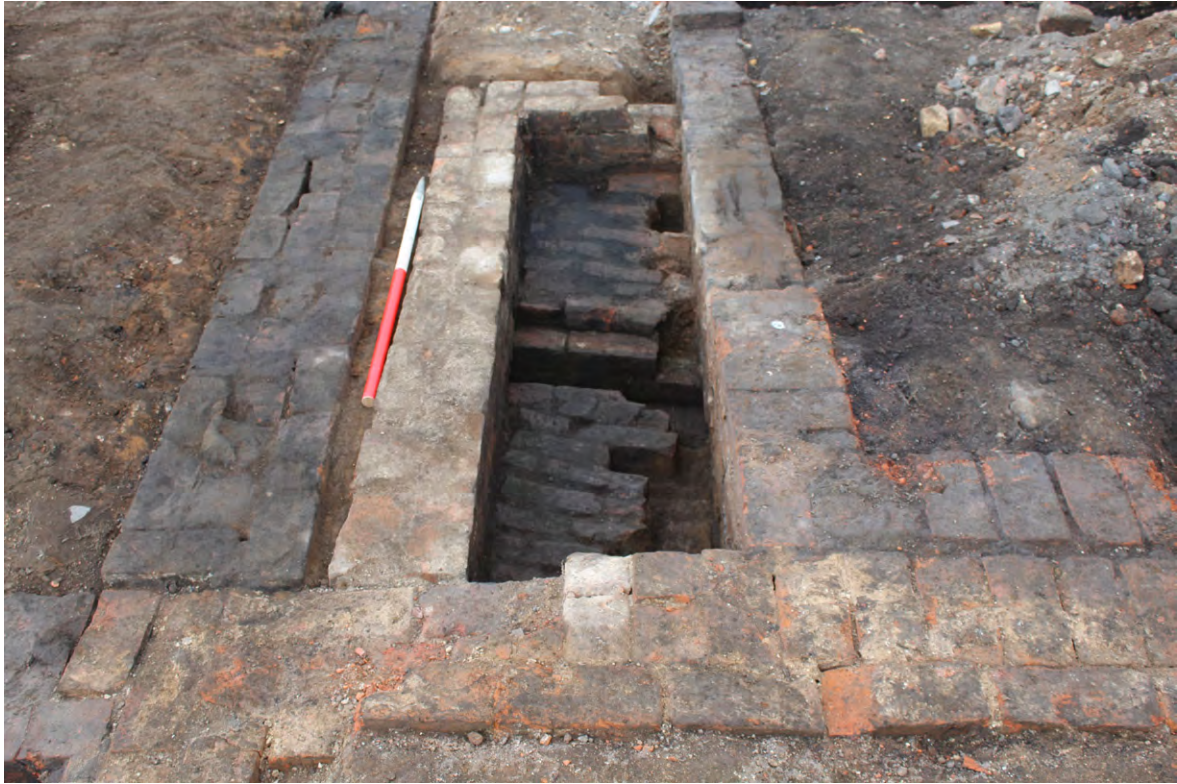
Fig. 6.41 - Wall 142 and brick floor surface 143, looking north-west

A short 'L'-shaped length of brick wall (142) with associated brick floor (143) was recorded in the space between structures 3 and 4, but the original extent of the structure was unclear due to later truncation by a boiler-base wall (Fig. 6.41; 129). The south end of Wall 142 abutted the north elevation of Wall 122, indicating that it was built as a later addition. Floor 143 incorporated a brick-lined drain (144), which passed through Wall 142 but was truncated by later walls (128 and 129).

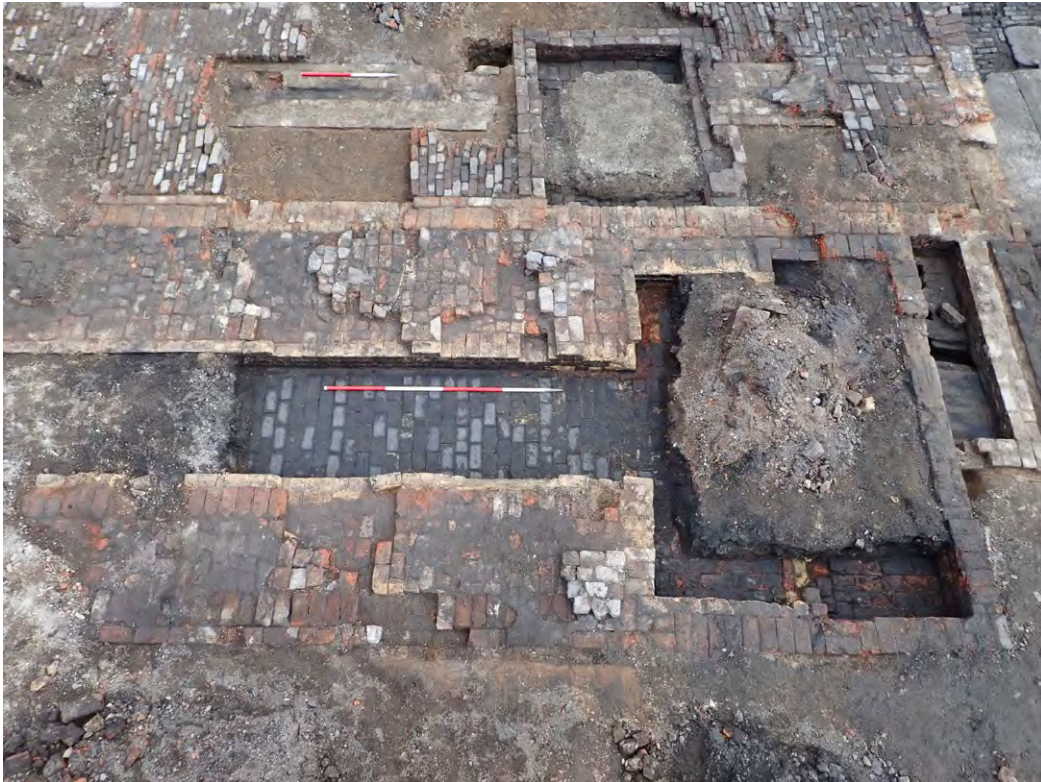
Fig. 6.42 - Overall view of western end of boiler base, looking south-east

A north-east to south-west aligned rectangular boiler base comprising two brick platforms flanking a central flue channel was located against the north side of Wall 121 (Fig. 6.42). The structure measured at least 8.80m long by 3.30m wide and the central flue channel was 1.08m wide. The eastern extent of the structure had been truncated, but the central and western parts (Fig. 6.43) were well preserved, having been backfilled with loose, coarse granular industrial waste and demolition material after it went out of use. Platforms (134 and 135) were constructed from a mix of half and whole bricks, laid without a regular bonding pattern. The platforms featured a lining of yellow refractory bricks (132 and 133) along the sides of the central flue channel and around the two small side chambers. The refractory brick lining and the surface of the non-firebrick floor in the two side chambers at the western end of the boiler base, was badly degraded as a result of contact with intense heat. Clearance of backfill from within the central flue channel did

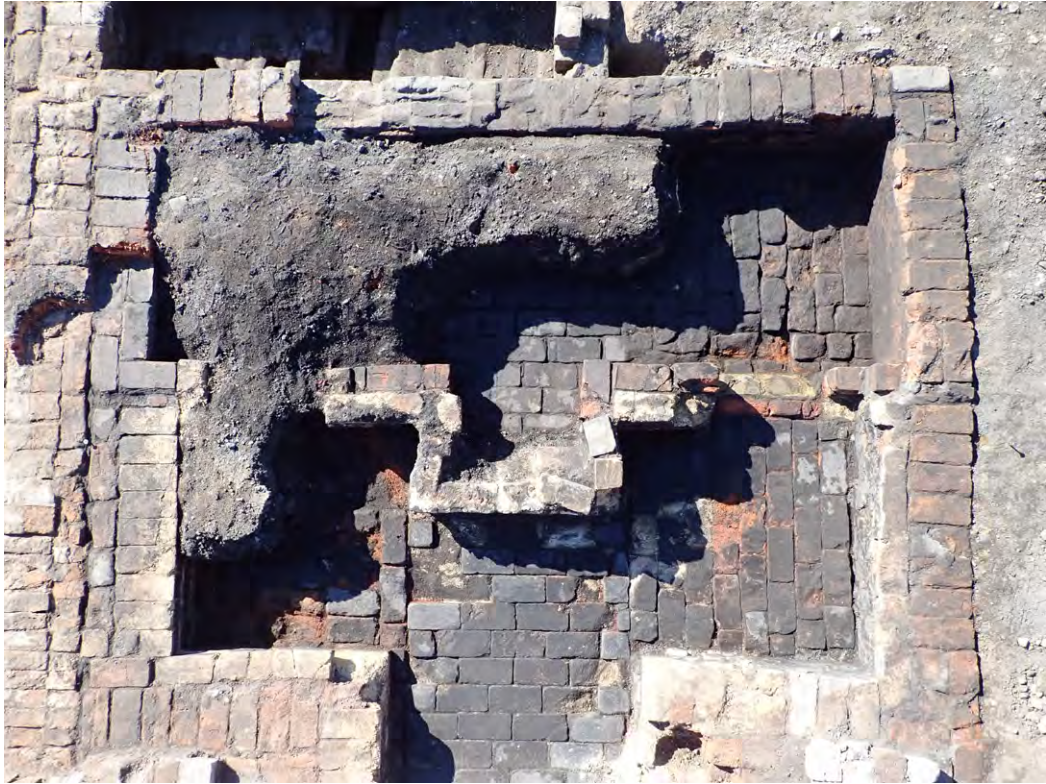
Fig. 6.43 - Vertical shot of the western end of the boiler base

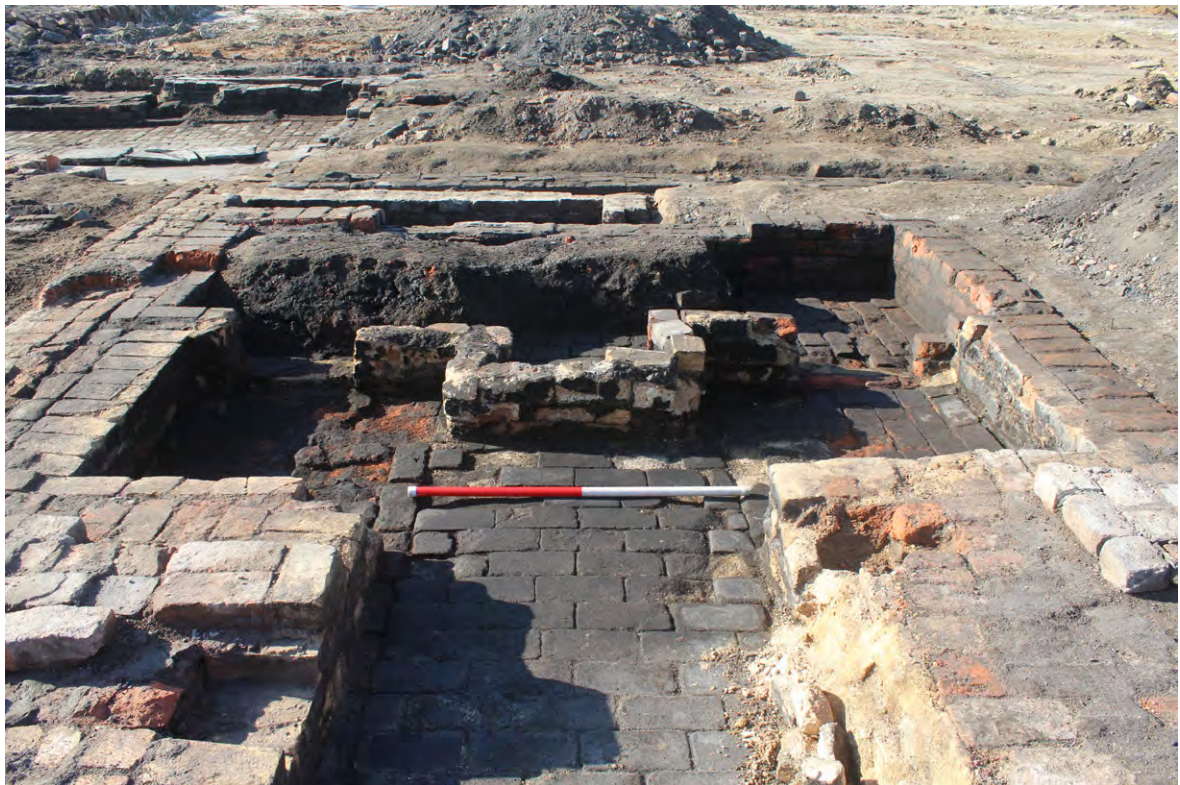
Fig. 6.44 - West end of the boiler base, looking south-west

At the western end of the boiler house, a narrow partition wall (130) built mainly of refractory bricks contained two small square openings (Fig. 6.44) which retained the corroded remains of metal frames, probably functioning as inspection hatches for the void spaces below the boiler. Wall 130 also incorporated an alcove to accommodate the blow down valve at the base of the boiler shell (Fig. 6.45).

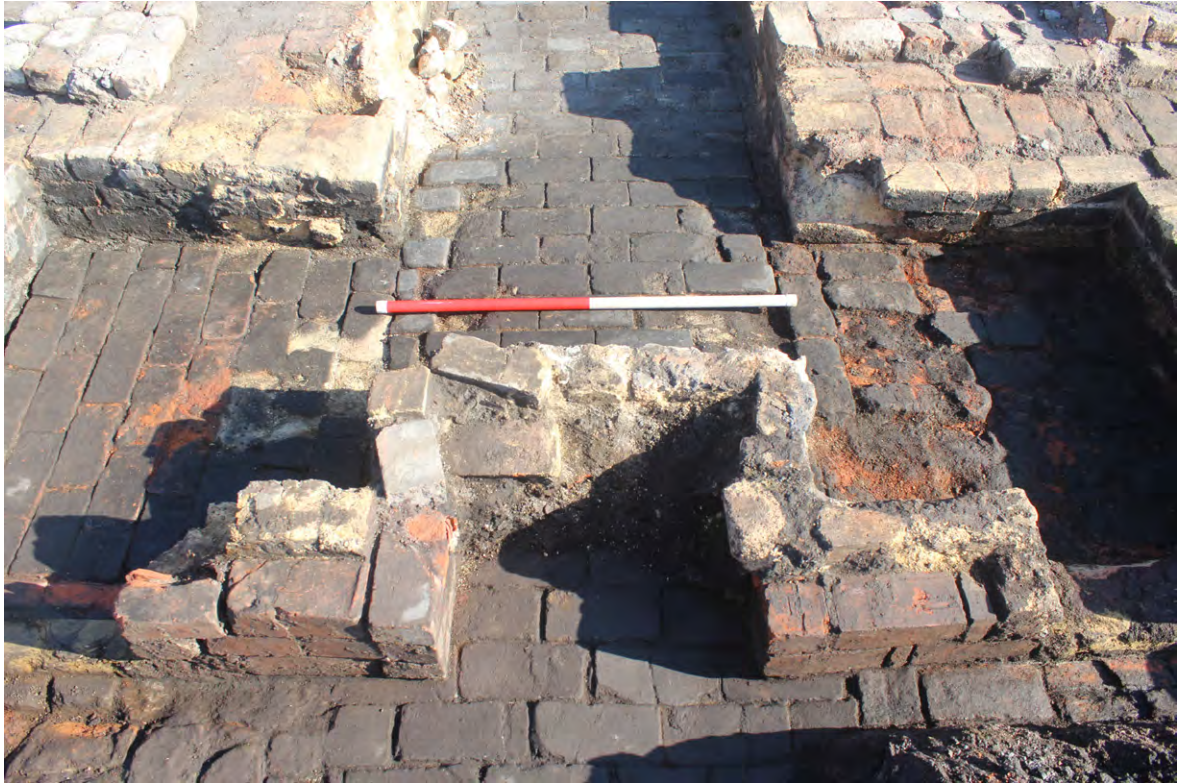
Fig. 6.45 - Wall 130 showing alcove for blow down valve, looking north-east

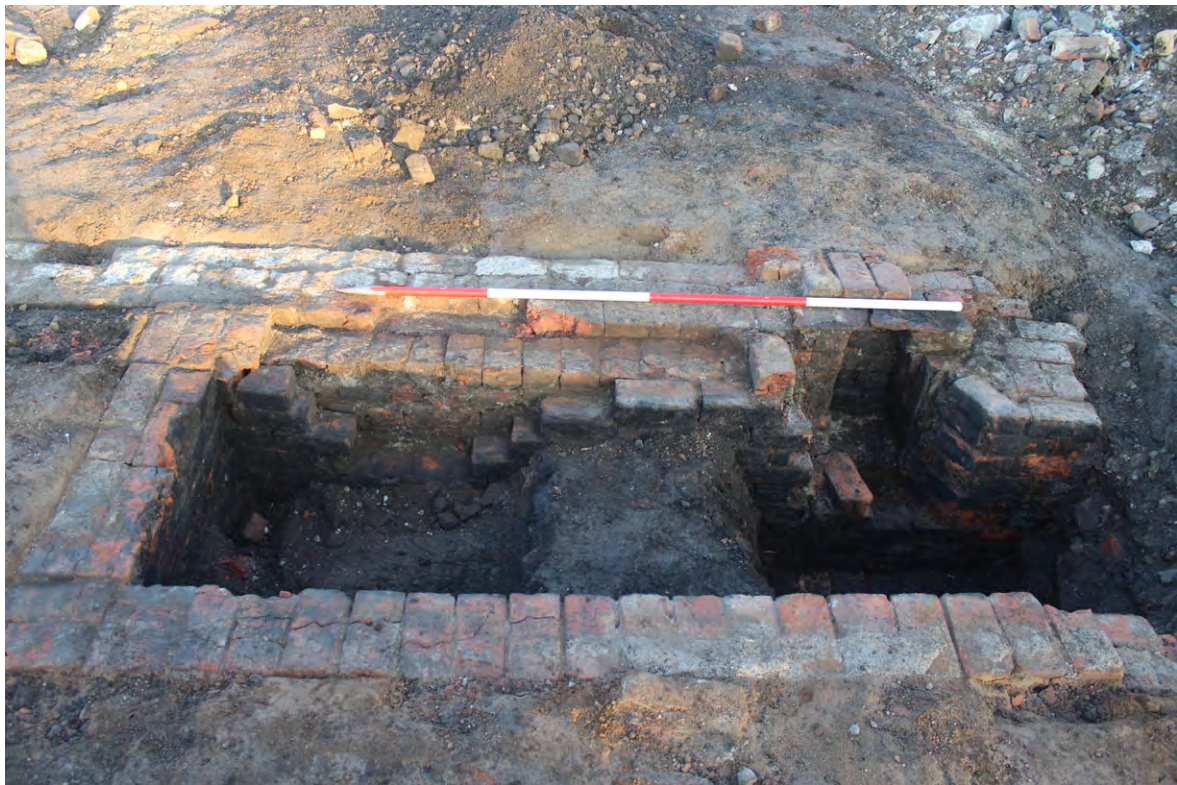
Fig. 6.46 - Rectangular brick structure built against foundation 104, looking north-west

Directly to the north-west of the boiler base, a narrow rectangular, brick built structure had been constructed against the south side of Wall 104 (Fig. 6.46). The internal space within the structure was 0.78m wide and 0.86m deep, with a concave base of bricks: the face of the brickwork was covered with black soot. A narrow opening in the north-west wall (182) was built at an angle to the line of the wall with a metal lintel supporting brickwork along the north edge of the wall. The eastern extent of the structure had been truncated by modern activity.

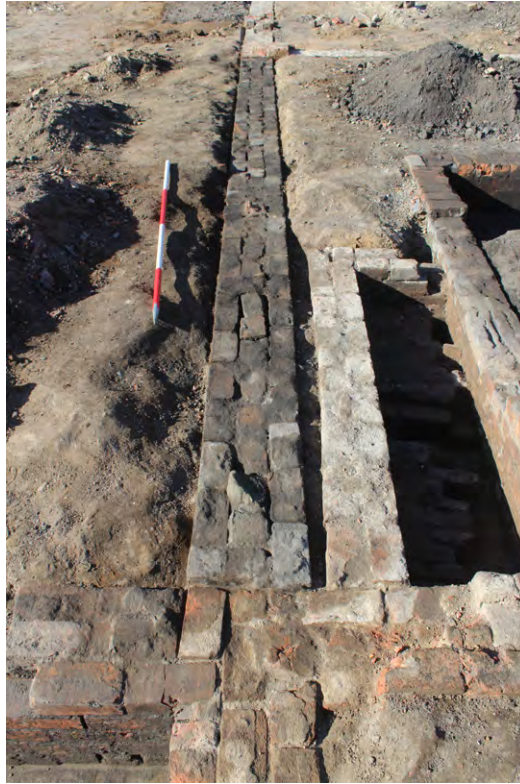
Fig. 6.47 - Foundation 128, to west of boiler base, looking north-west

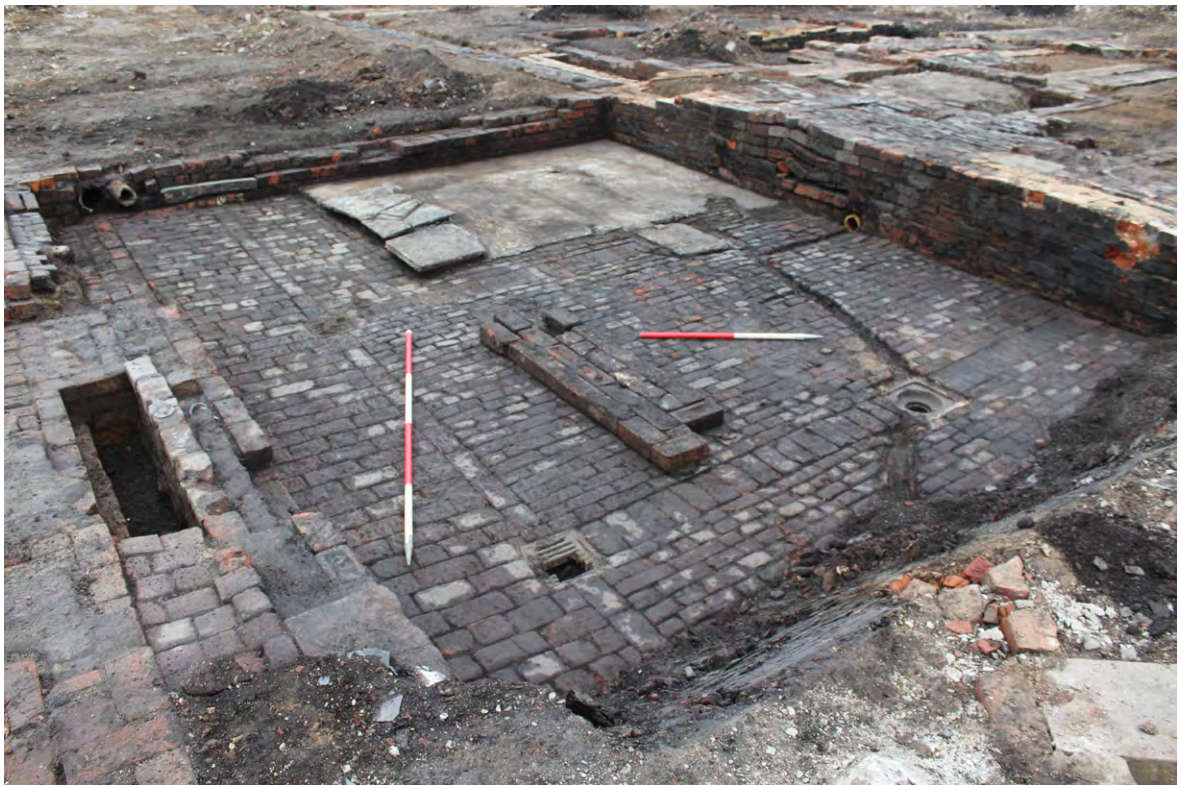
Fig. 6.48 - Cellar floor 169, looking north

A later addition had been made to the south-western end of Structure 5, in the form of a rectangular room with a floor surface constructed below ground level. (Fig. 6.48). The room had internal dimensions of 7.75m north-west to south-east by 4.45m north-east to south-west, and the floor was 0.61m below the adjacent surviving floor surfaces. The north-western and south-eastern walls of the structure (167 and 165) were built against, but not bonded into, the west face of Wall 121. The south-western wall of the room (165) appeared to have been modified by the later addition of a brick wall (166) along its eastern side, possibly as part of works to lower the floor level. Floor 169 had been built incorporating a series of sub-surface drains laid out on a grid system, but was modified at a later stage by the crude cutting of a surface channel across the south-eastern part of the floor, serving a ceramic pipe which had been inserted through the base of Wall 121. A rectangular area at the northern corner of the floor surface had been rendered (170), and a low platform capped by sandstone slabs had been built.

Context	Type	Length (m)	Width (m)	Max Depth (m)	Description
170	Surface	3.00	2.25	n/a	Rectangular area of cement render over northern corner of brick floor 169. A low, raised plinth capped by sandstone paving slabs is built along the west extent of the surface.
171	Structure	>10.50	0.22	>0.23	North-east/south-west aligned wall foundation constructed from bricks bonded with pale grey mortar. A small buttress projects from the south side of the foundation: floor surface 157 is built against the north side.
172	Surface	2.53	1.78	0.11	Floor surface laid between foundation 173 to the north and 171 to the south, and up to the east side of wall 121. Constructed from bricks laid on edge, bedded on a layer of sandy material. Probably a continuation of floor surface 157 (to the north-east).
173	Structure	1.40	0.37	n/a	North-east/south-west aligned brick wall foundation. A small rectangular buttress (174) projects from the south side of the foundation into floor surface 172: floor surface 175 is built against the north side of 173.
