**Coldingham Priory Church,  
Coldingham,  
Scottish Borders**

**Archaeological Watching Brief**

**Report No. 2149**

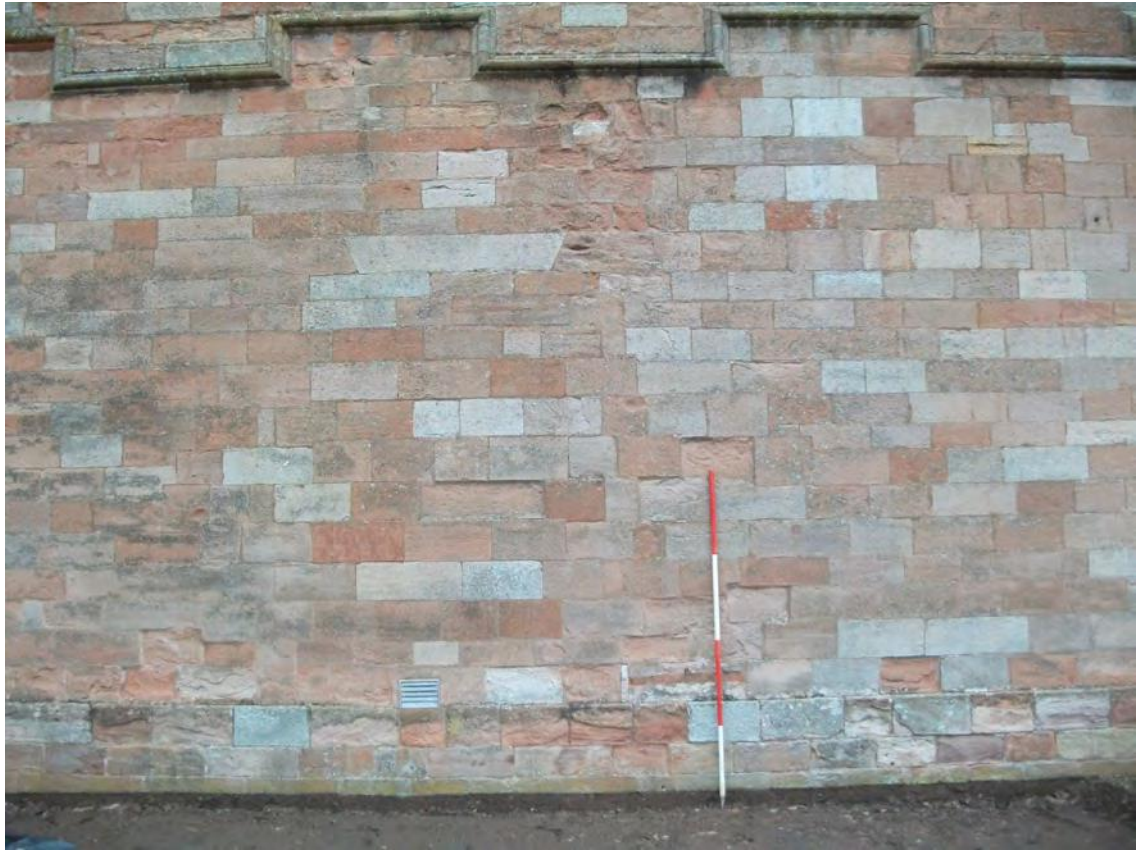
Fig.3 : South-facing external elevation prior to new door slapping

The wall was constructed with an exterior and interior skin, with a rubble-filled core (Fig. 6-7). The exterior wall face comprised ashlar red sandstone (**008**) (Fig. 3). On the outward facing side the blocks were dressed, and were unworked on the side within the wall core.

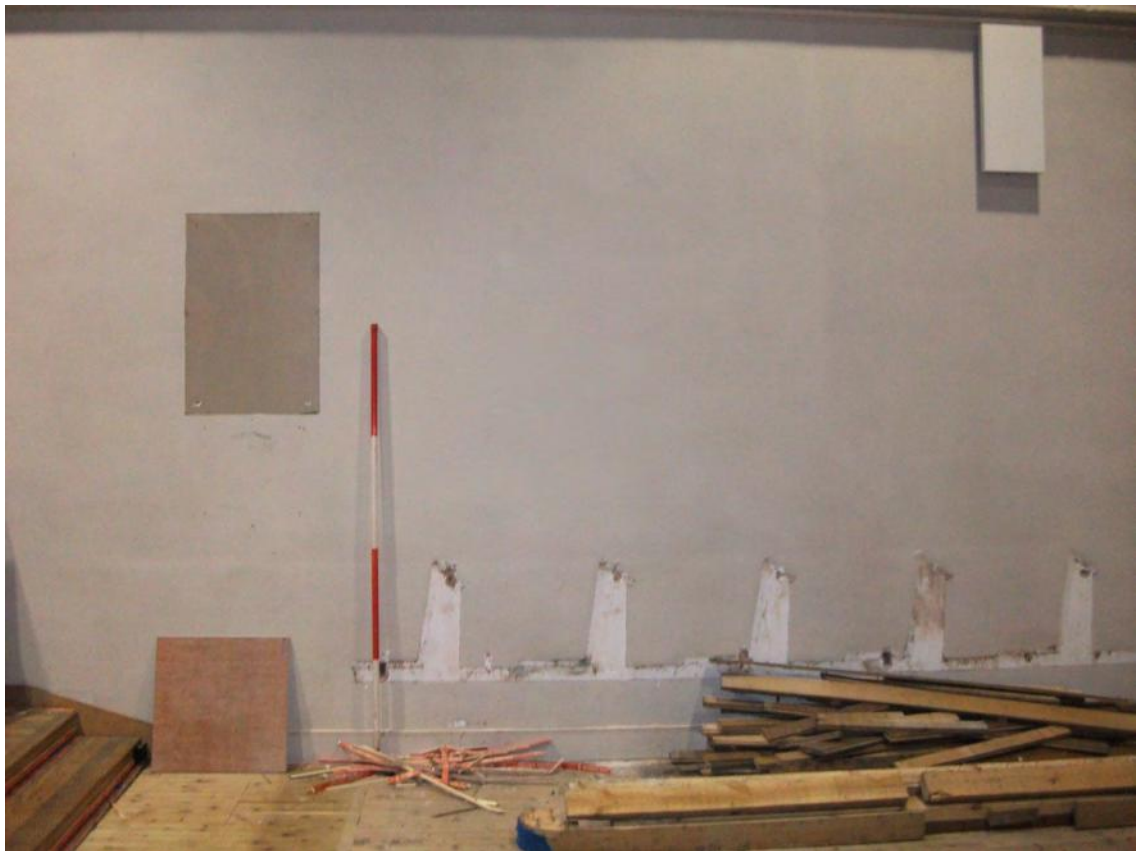
Fig.4 : North-facing internal elevation prior to new door slapping

The interior face of the wall was made using irregular-sized dressed sandstone blocks (**010**). Over this was rendered a 0.05m thick layer of plaster (Fig. 4).

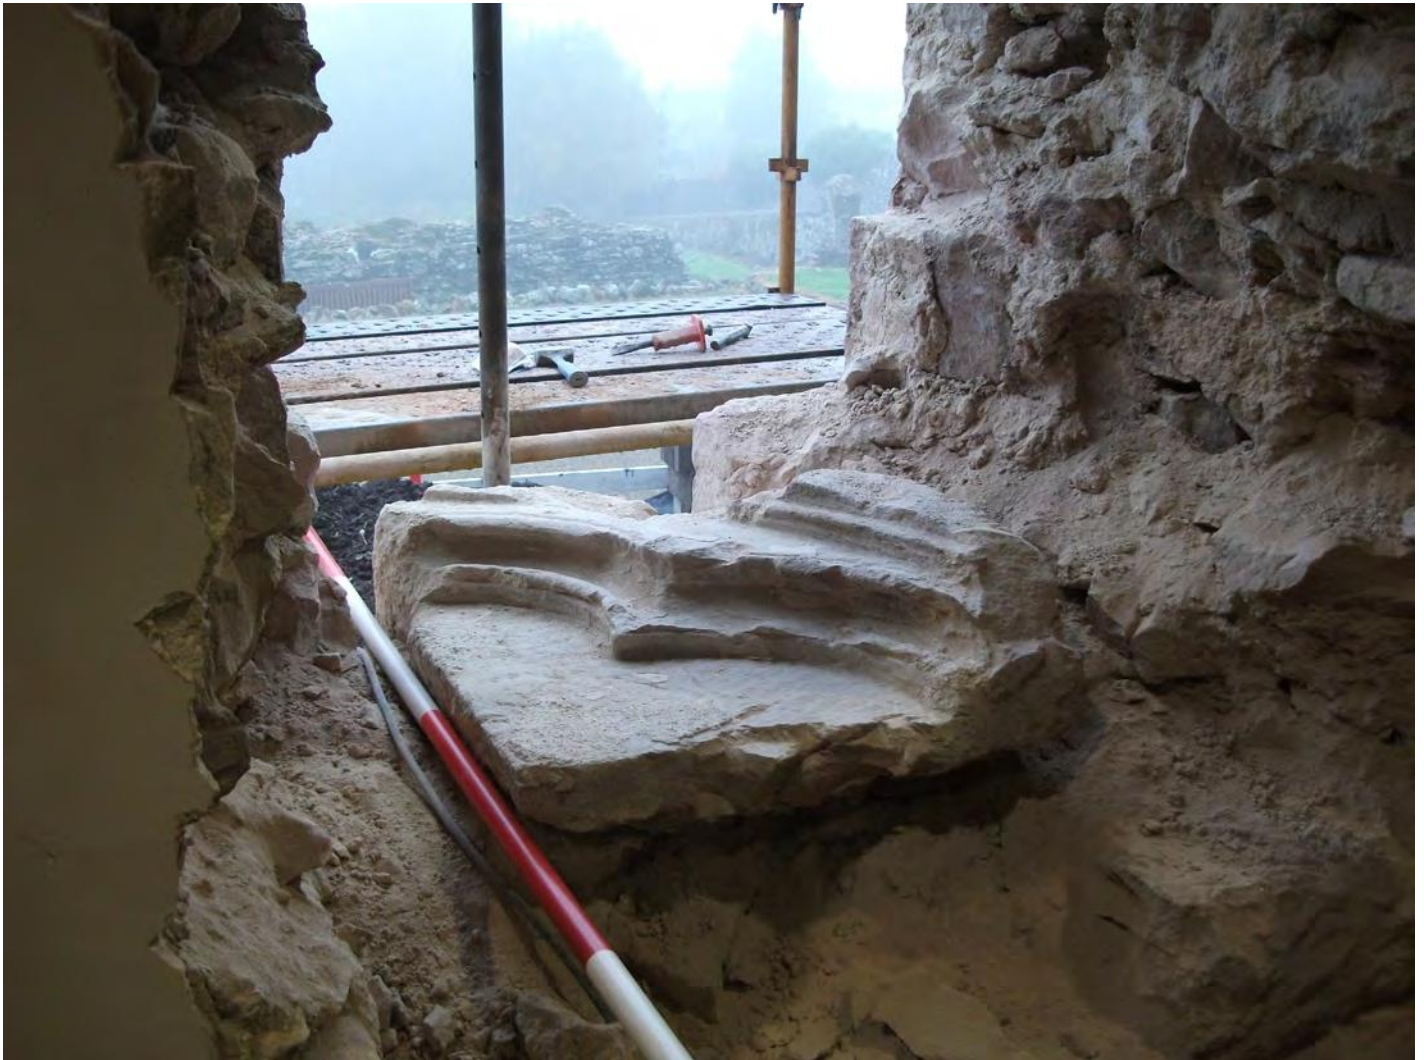
Fig.5 : Large masonry sedilia fragment in situ within wall

The core comprised irregular sandstone rubble and occasional white stone blocks (**009**) set within a limestone mortar matrix. Within the core, a quantity of worked architectural stone fragments were recovered (Fig. 5, 8). Two of the pieces of stone, including the sedilia fragment (Fig. 5), had been placed so that a flat edge formed part of the inner face of the wall.

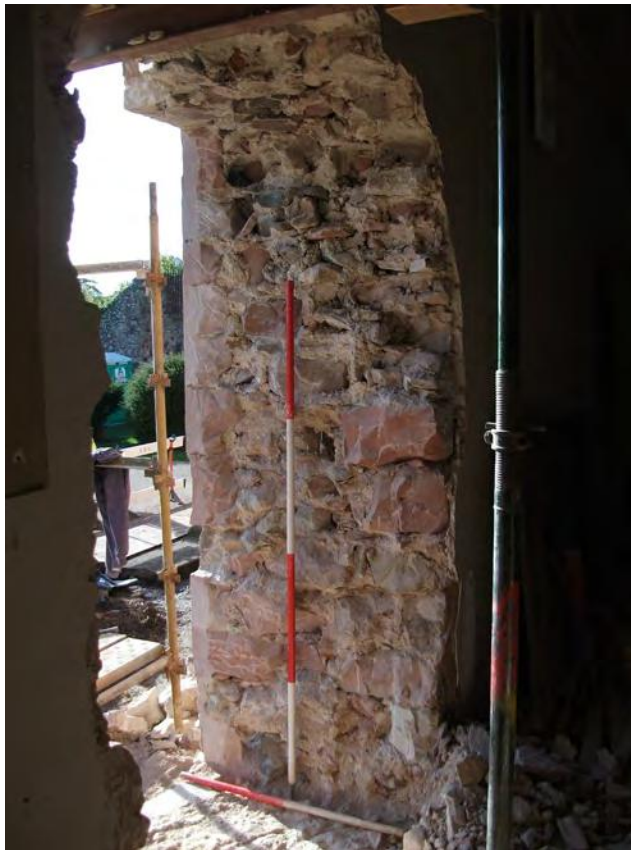
Fig.7 : East-facing section of new door slapping

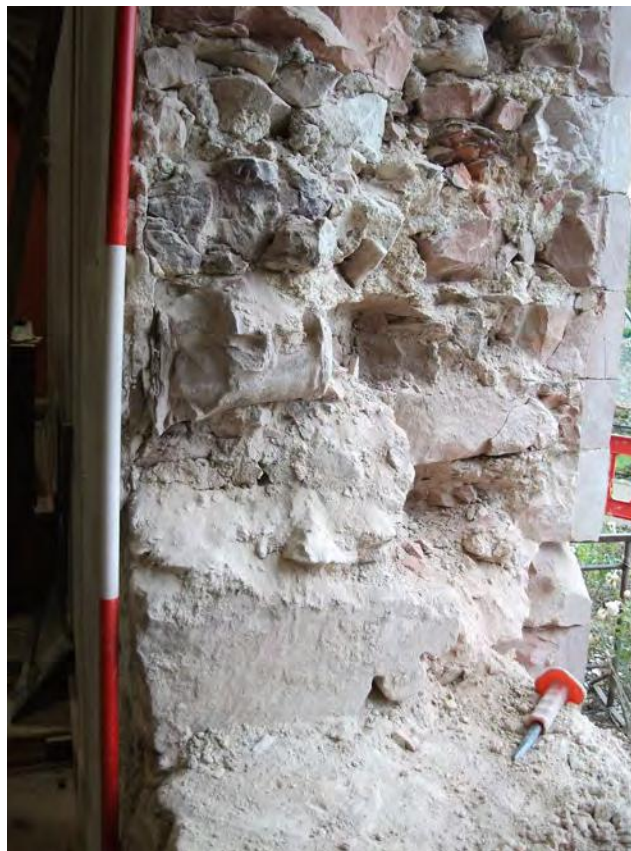
Fig.8 : Detail of west-facing elevation of new door showing architectural fragments in situ

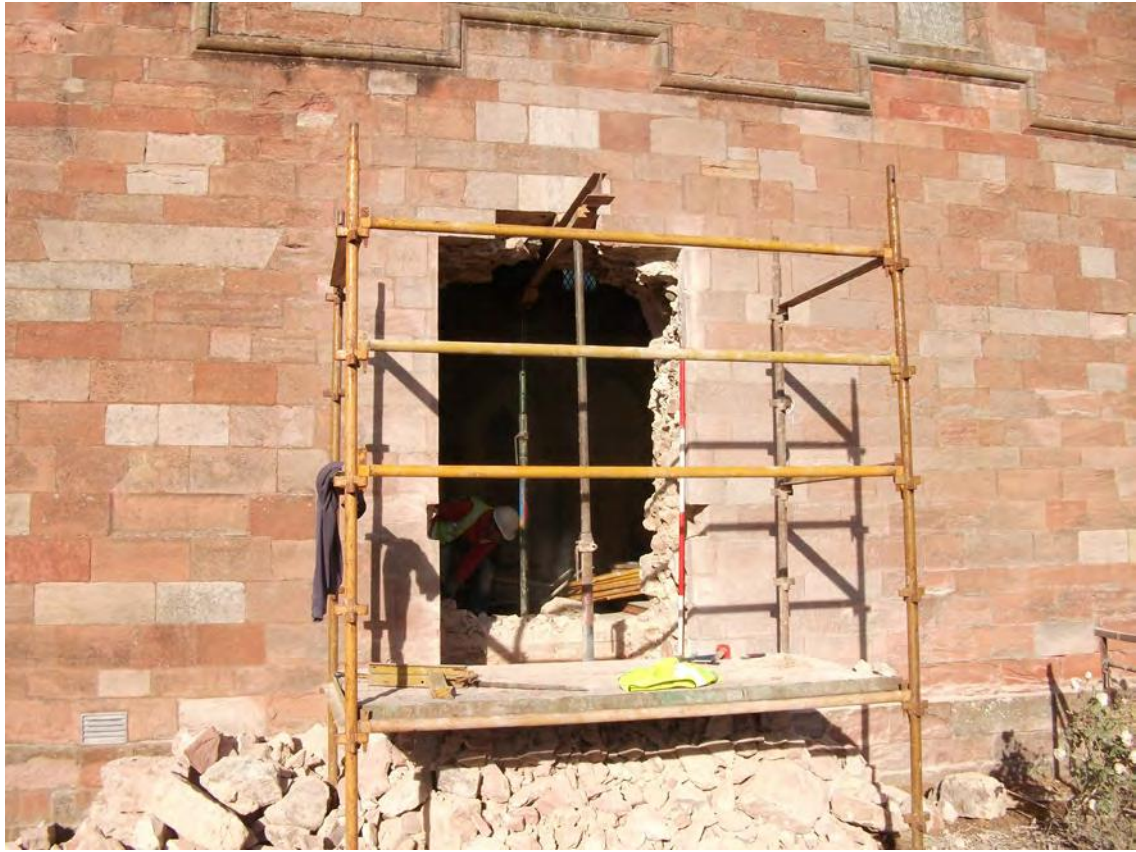
Fig.9 : Completed door slapping from the exterior

The new door was cut through the south wall of the church. The new doorway was cut 0.7m above the exterior ground level, through the 1.1m thick southern wall of the Church, and measured 1.5m wide and 2.6m high (Fig. 9).

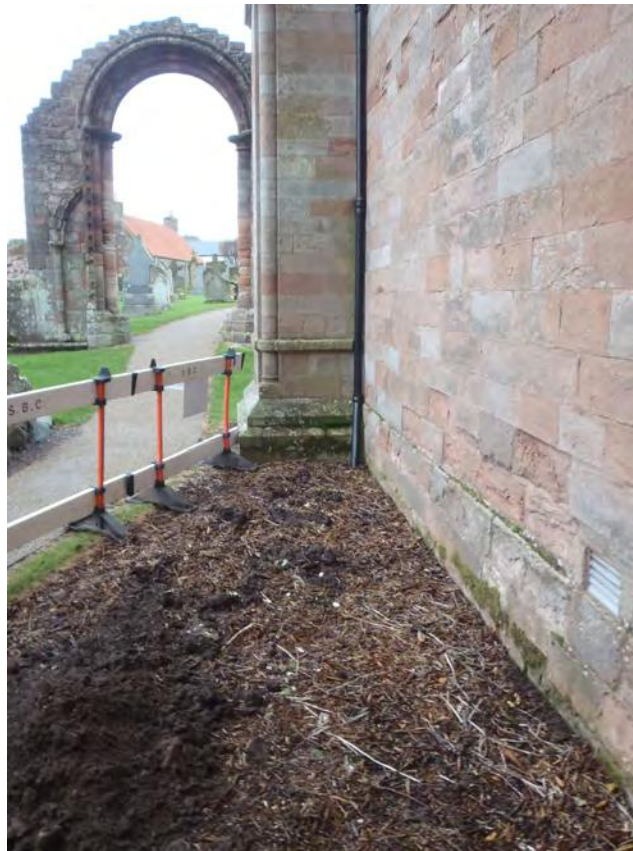
Fig.10 : South-facing external elevation prior to slapping for drainage pipe

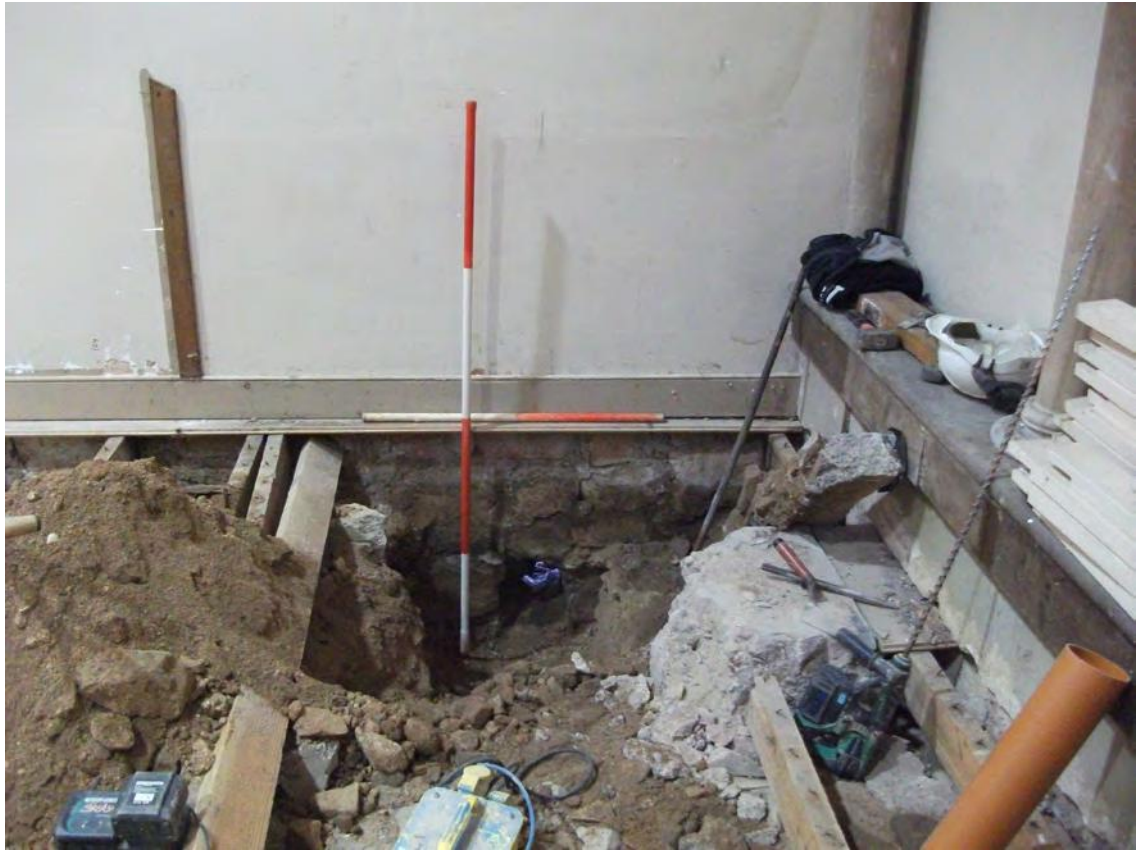
Fig.11 : Internal elevation showing slapping for drainage pipe

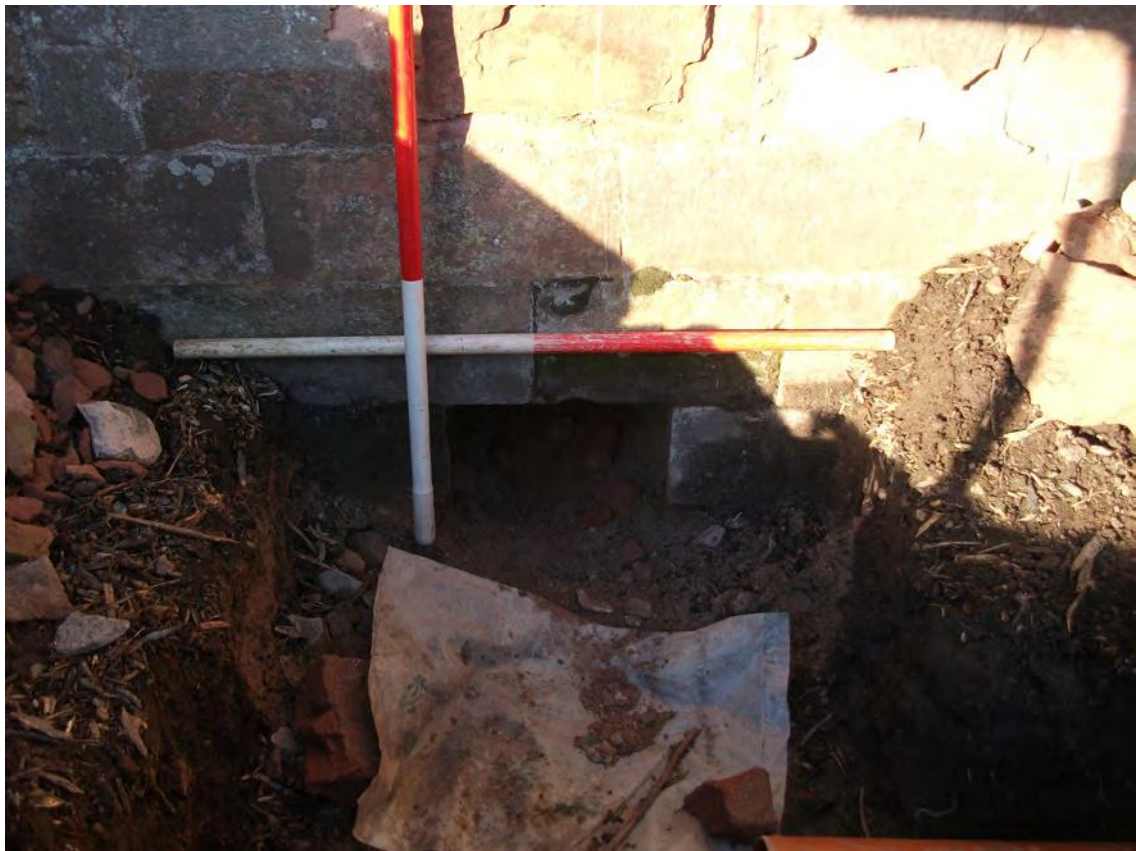
Fig.12 : External elevation showing slapping for drainage pipe

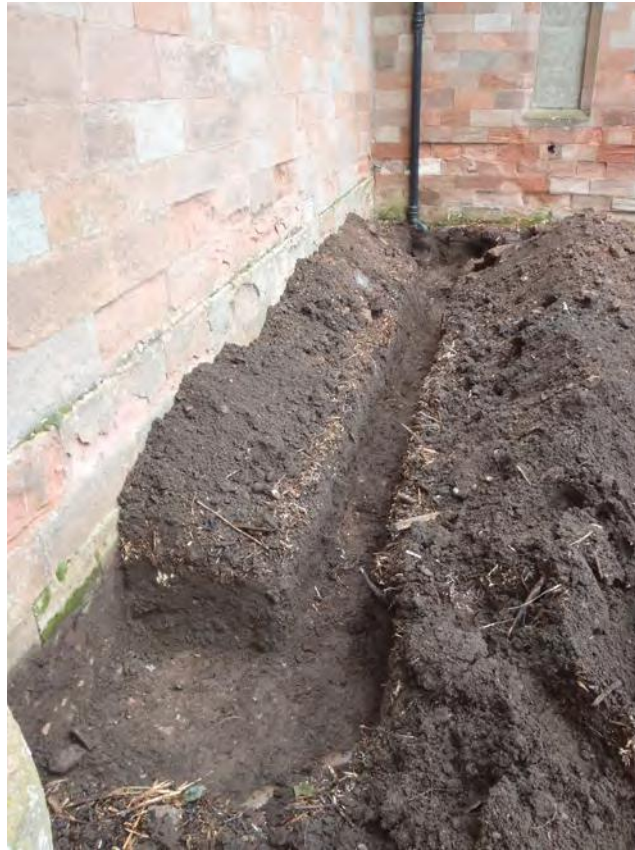
Fig.13 : Drainage trench

The trench for the foul drain was aligned east-west along the south wall of the church and measured 6m long, 0.3m wide and between 0.3-.07m deep (Fig. 13). The stratigraphy consisted of 0.3m of topsoil (006) which overlay a layer of brown sandy silt with mortar inclusions (007); natural geology was not reached. No finds or artefacts or human remains were recovered during the construction of the pipe trench.

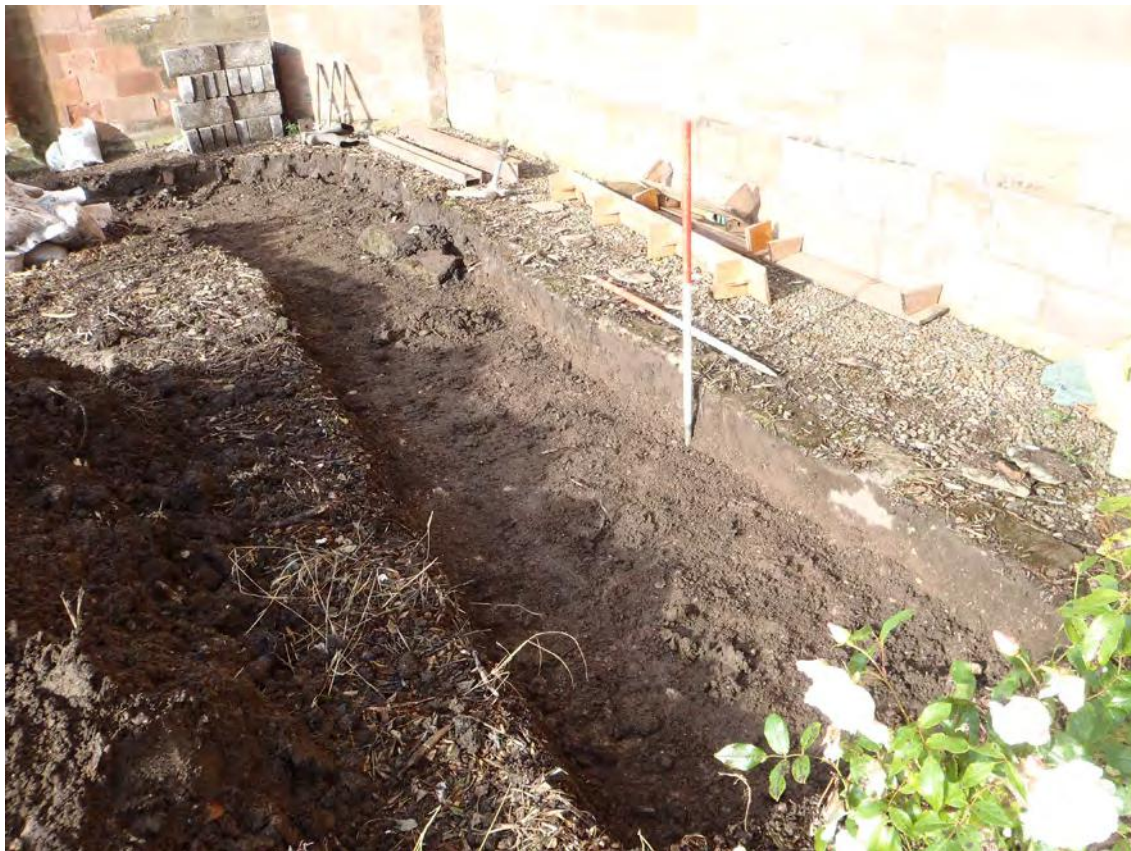
Fig.14 : Excavation in progress for platt and new path on east side of porch, showing kerb stones in situ

Ground reduction took place for a new hardstanding surface along the southern wall of the church and the east side of the porch, for accessing the new door. A trench was excavated which measured 8m long, 2m wide and 0.25m deep and cut through a previous existing path (**003**) (Fig. 15). Parallel to the wall were found re-used rectangular worked red sandstone blocks (**004**); these formed a rough kerb for the previous path and were removed (Fig. 14).

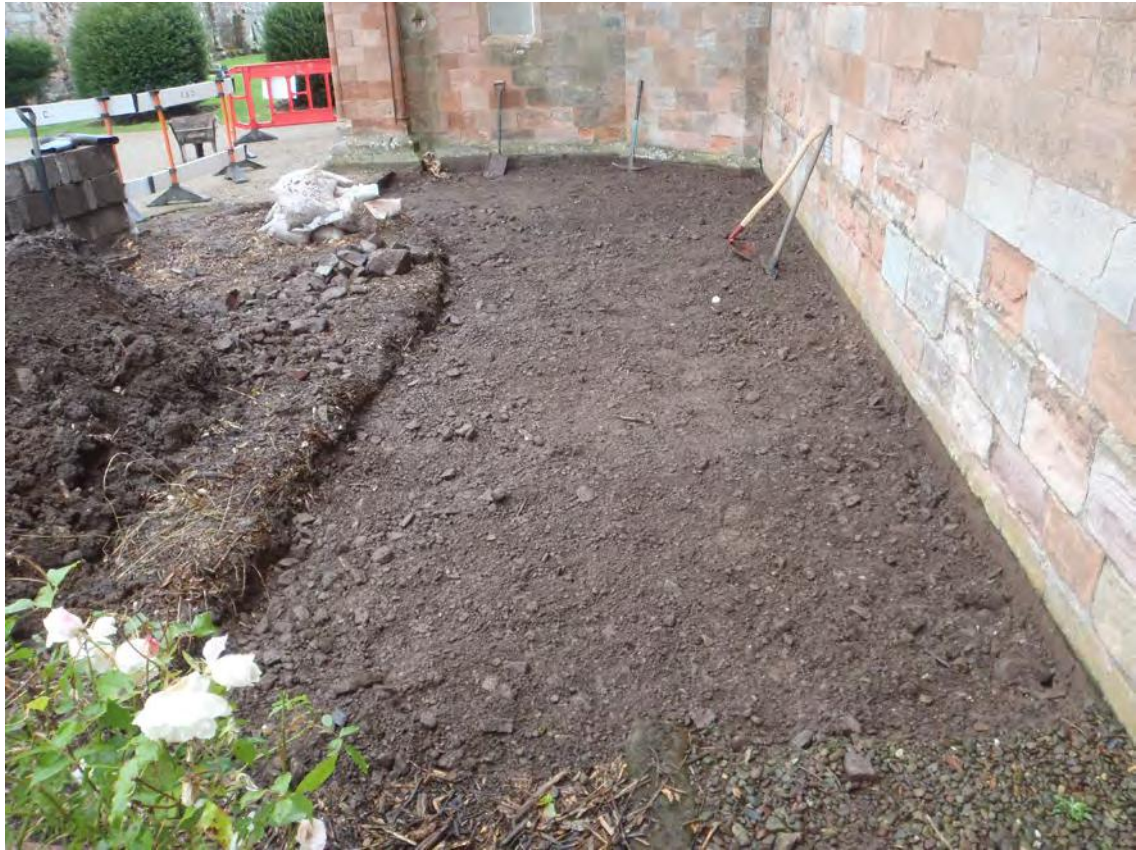
Fig.15 : Completed ground reduction for platt and new path on the east side of porch

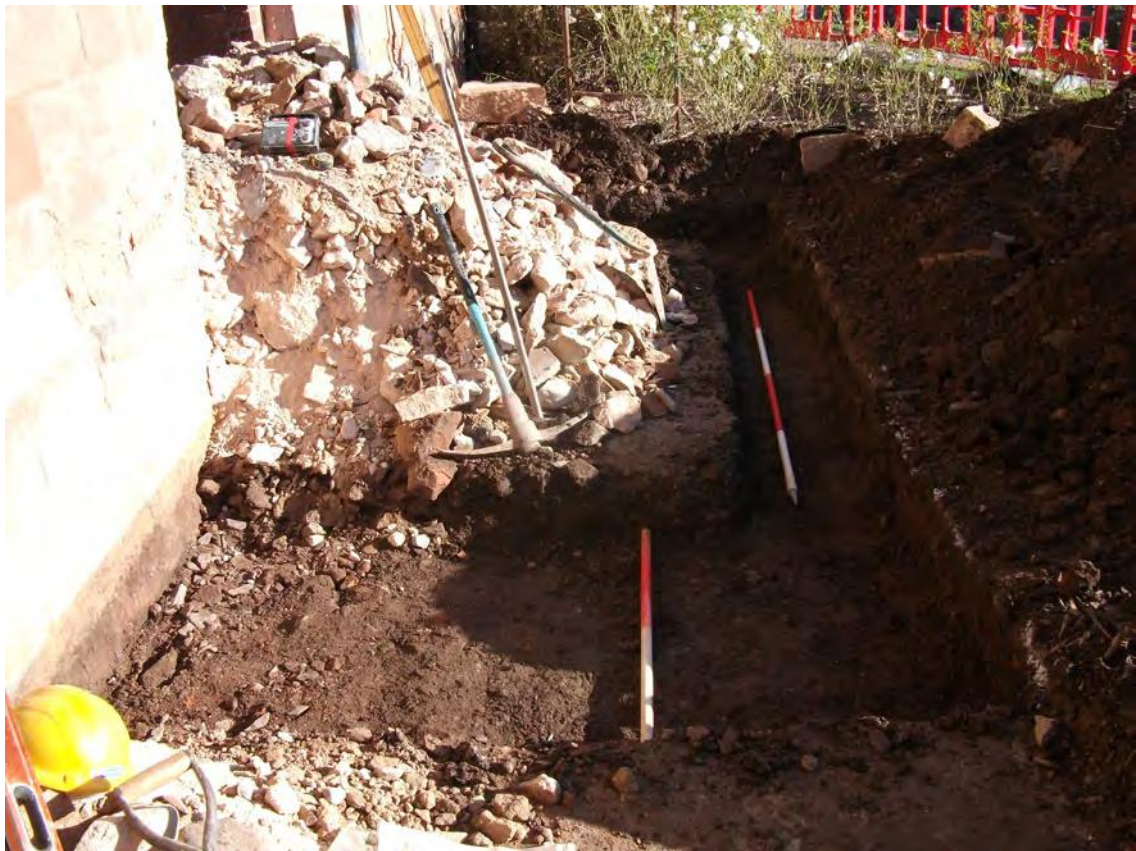
Fig.16 : Foundation excavations for platt

Deeper foundation were excavated within the above-mentioned trench for the construction of stairs (platt) for accessing the new door (Fig. 16). These extended to 0.5m below existing ground surface through made ground (**002**). Natural geology was not reached.

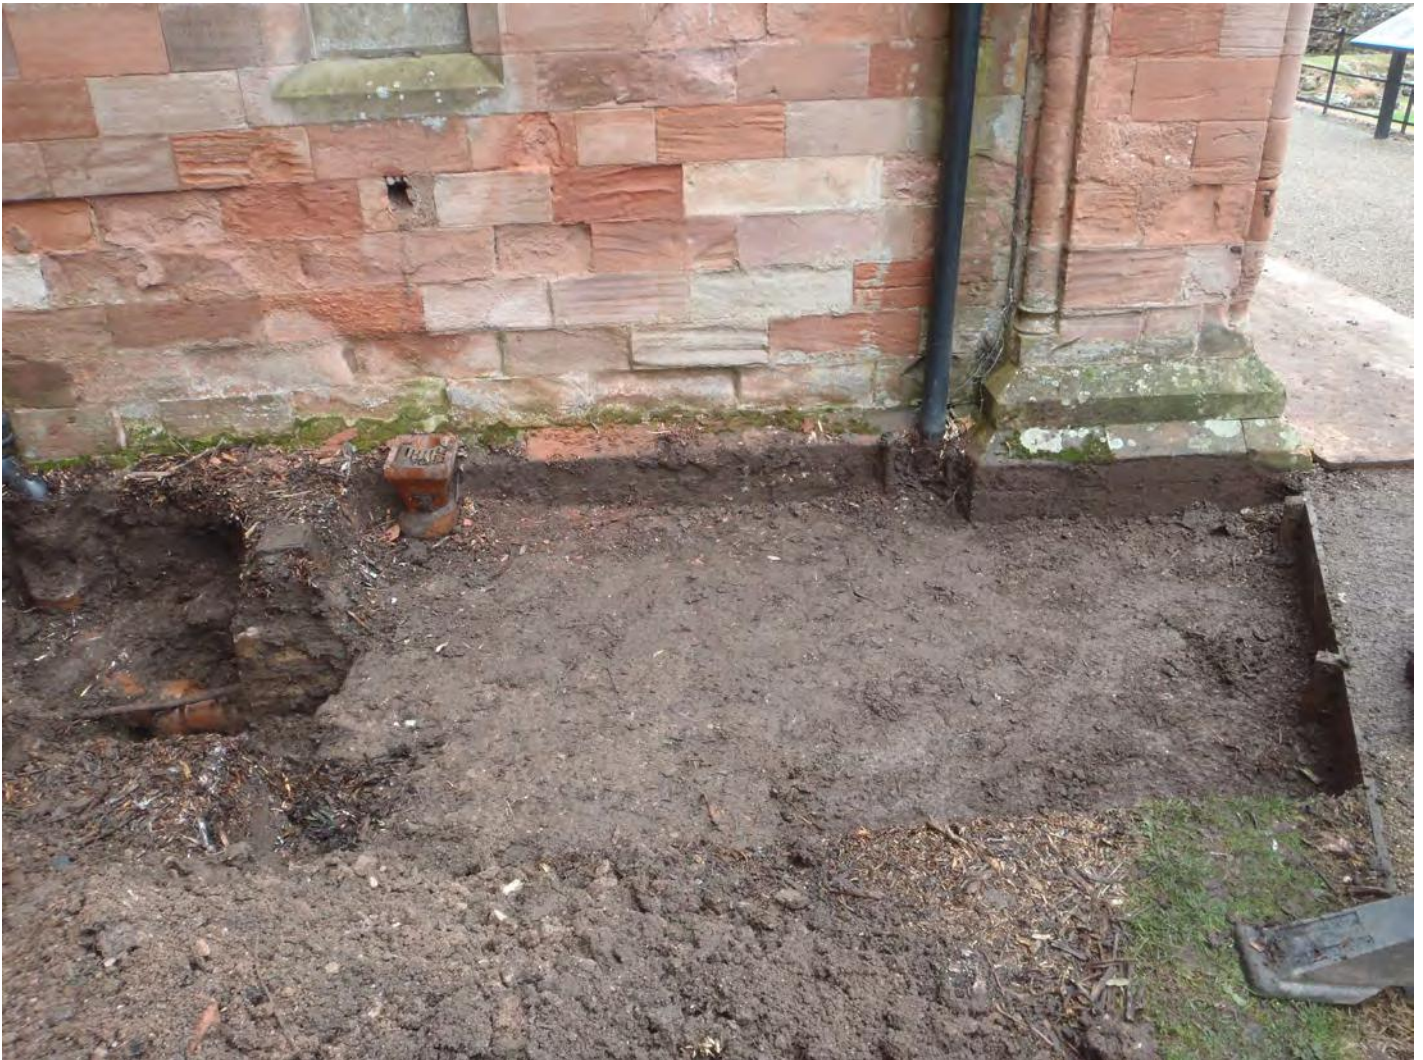
Fig.17 : Completed ground reduction for new path and drainage connection on the west side of the porch

A rectangular area for the new hardstanding surface on the west side of the porch was excavated and this measured 2.8m long, 1.7m wide and 0.25m deep (Fig. 17). Excavations did not extend through the topsoil (005) and no artefacts, deposits or human remains were found.
