**The Commonwealth Games Athletes Village,  
Dalmarnock, Glasgow**

**Archaeological Works**

**Report No. 2181**

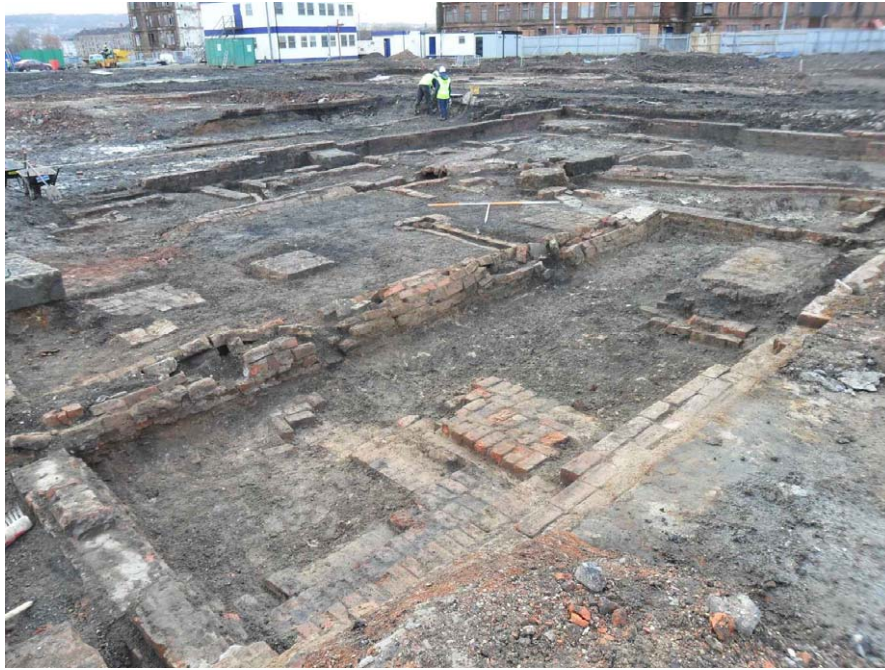
*Plate 1. Room 1, Structure 1*

Room 1 measured 16.7 x 11.4m and was formed by brick walls (1006, 1023, 1074, 1076) (Plate 1). These walls constituted the brick foundations of the structure as depicted on the 2nd Edition OS map (Fig. 4). A partition wall (1059) running N-S divided the room roughly into two halves and probably supported a floor above. The main features of Room 1 were sub-surface features associated with the dyeing process and in particular the under-floor channelling of waste water. These features were recorded as two sets of opposing troughs (1031, 1032, 1036, 1037, 1077) and a series of brick-constructed, barrel-vaulted, sub-surface drains (1033, 1067, 1053, 1038, 1026), which were part of the network of interconnecting services designed to channel water away from this area.

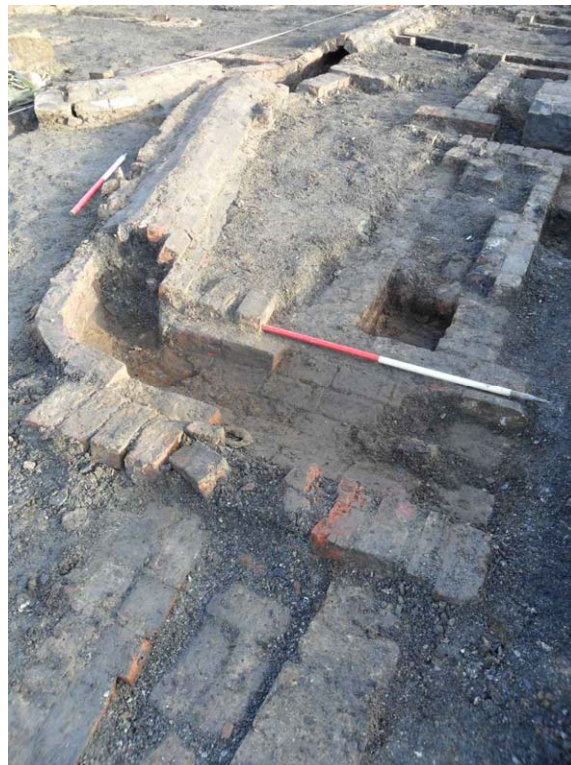
*Plate 2. Brick troughs (1036, 1037) converging into drain (1038), Structure 1*

The best examples of this were drains (1033) and (1038) which were situated between troughs (1031, 1032) and (1036, 1037) respectively. Both drains converged into the main drain 1053 (Plate 2). A number of sandstone plinths (1072, 1052, 1051, 1047, 1042) may have supported machinery or, more likely, a surface or columns for roof support. A large square sandstone block (1042) with tie down anchors was probably a machine base or plinth for dye work apparatus.

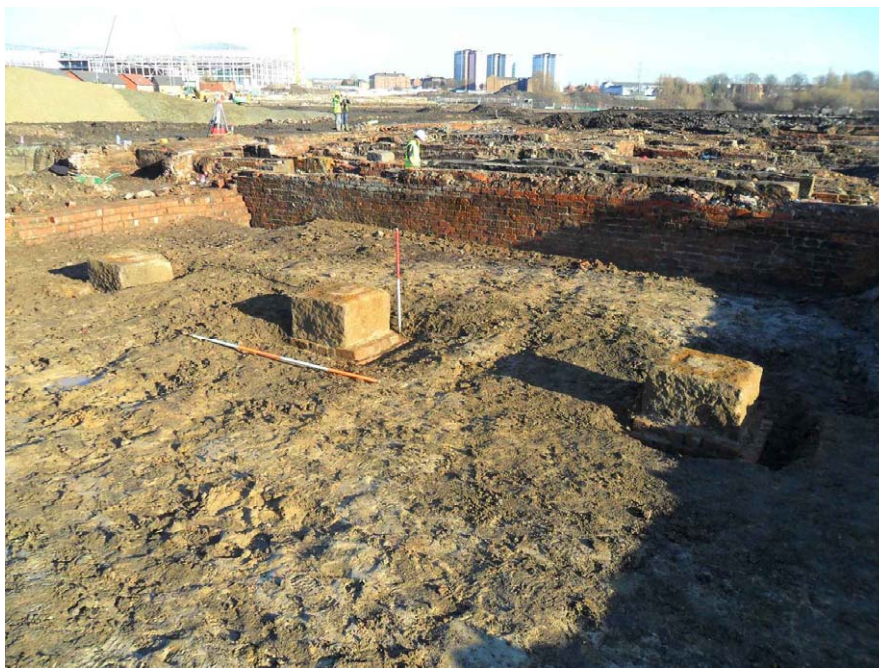
*Plate 3: General shot of Room 2, Structure 1*

foundations of the earlier building had been reused. The room, which measured 17 x 9.6m contained a central row of sandstone support pads (1081, 1082, 1083) situated on brick foundations (1084, 1085, 1086) (Plate 3). This masonry provided the central support for the roofing in this room.

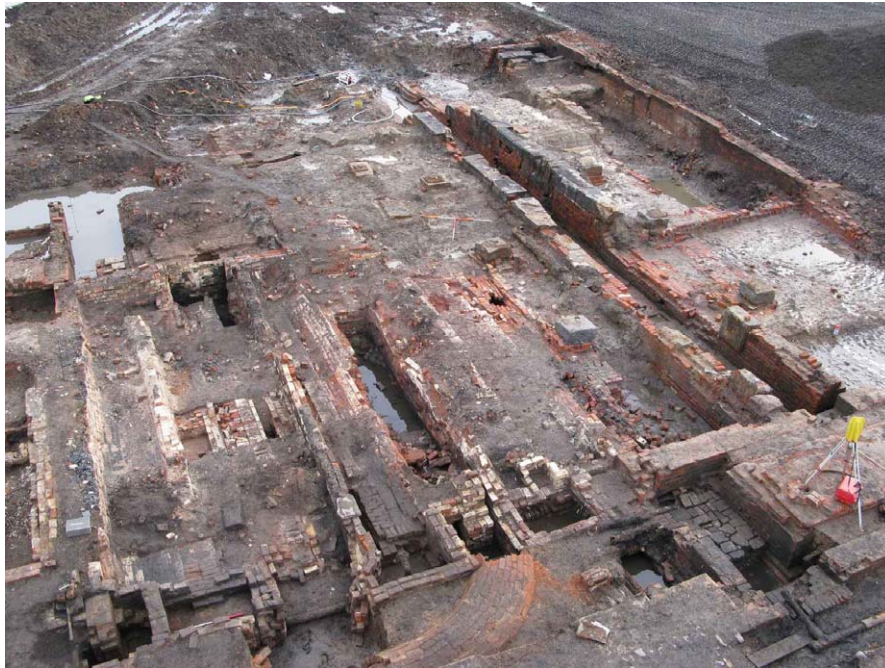
*Plate 4. Rooms 1 and 2, showing brick channel 2131, Structure 2*

Room 1, in the east of Structure 2, was defined by walls (2182, 2035, 2030 and 2013) and measured 31 x 15.5m. Wall 2182 to the north is depicted on the 1895 2nd Edition OS map. Walls (2030) and (2035) were internal supporting walls. The orientation of the west wall (2013, 1078) correlated with the footprint of the earlier 1858 edition depiction and was reused by later building phases. The primary function of Room 1 was probably housing for a large engine or machine, which was situated on a large brickwork base (2295), located to the north of an elongated brick channel (2131 etc), which was part of the housing (Plate 4). To the south of the machine base was brick wall (2151), which incorporated three sandstone blocks into its fabric and two horizontal recesses housed in the south elevation. The recesses had two large metal rods, which would have acted as anchor points for the engine above. The south facing elevation of wall (2151) and wall (2131) formed the sides of the brick channel 24.7m long. The west-facing elevation of (2131) is depicted in Fig 7b.

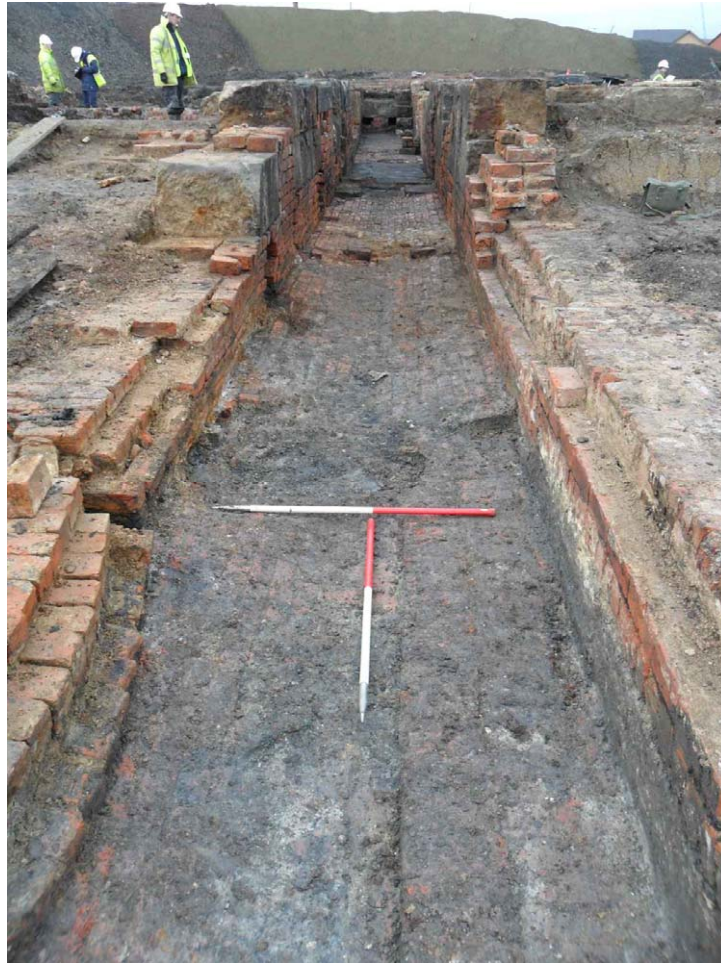
*Plate 5. Brick channel 2131, Structure 2, Room 1*

Wall (2131) incorporated a series of very large sandstone blocks, the position – and presumably the function – of which were mirrored on the opposing elevation. The blocks featured residual tie down locations and recesses, which had been exaggerated by abrasion. Context (2141) comprised three component parts with overlapping scars seen in section. On the upper facing of the stones there were vertical sockets, and protruding metalwork. These probably acted as anchor points or possibly locating rods for further sandstone masonry. An example of this was masonry (2139), which was one of two probable blocks in this position. Context (2143) featured four blocks with two sets of anchor points visible in elevation. The construction of the base of the channel varied. From north to south, it had a flat brick surface (2149), which had been repaired using refractory bricks. There was a centrally located bituminous deposit (2150), which was poured around a series of large sandstone blocks (2142), all of which had depressions, residual tie down bolts and abrasion scars. The purpose of this centrally located stonework would have been closely associated with the primary function and it is closely related to masonry (2141) in the elevation. Beyond deposit (2150) the base of the channel was brick and had a concave profile (2142); presumably for drainage purposes (Plate 5). The brick channel was flanked by a parallel arrangement of opposing sandstone blocks on brick footings. Circular abrasions on the upper surfaces of the blocks indicated that they may have provided columnar support for an upper walkway or loft (e.g. 2021, 2064), possibly on cast iron stanchions.

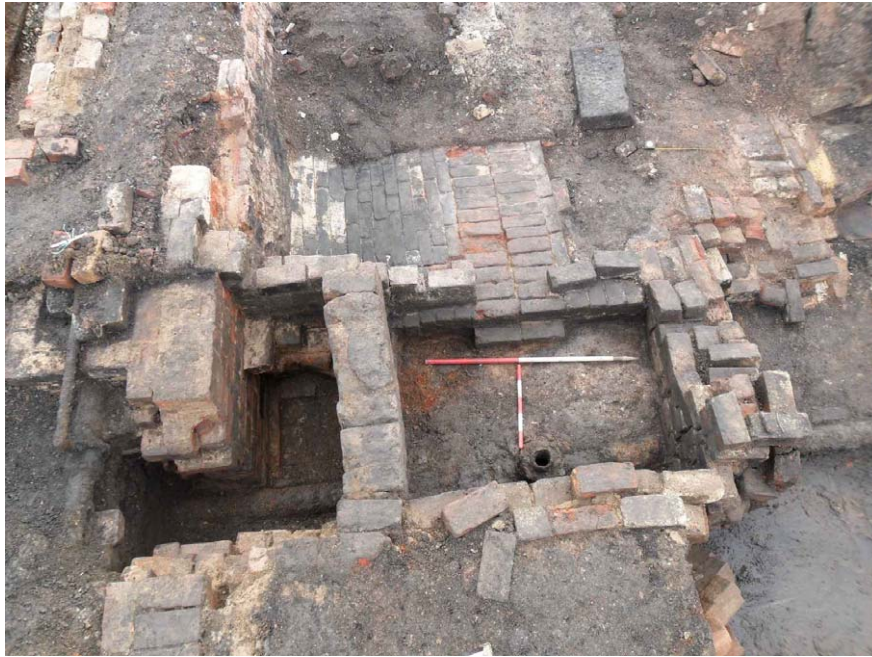
*Plate 6: Boiler house fire box and pipe (2167), Structure 2, Room 2*

Room 2 was the remains of a boiler house of red and refractory brick construction (Fig 7a). It probably housed two parallel boilers situated on plinths (2059, 2070) and measured 13.9 x 5.7m. The boiler house had two curved outer skins of refractory brickwork (2086, 2069) designed to convect heat back towards the boilers. Each boiler housing had a fire box structure at the northern end of Room 2 (Plate 4). The insertion of an east-west orientated cast iron pipe (2167) had resulted in modifications being made to the boiler head structures, but the masonry walls of each fire box had been repaired, indicating that the boiler house was still in use. Examples of this were walls and repairs (2233, 2235). The pipe had two flanged outlets, which would have been connected to the boilers (Plate 6).

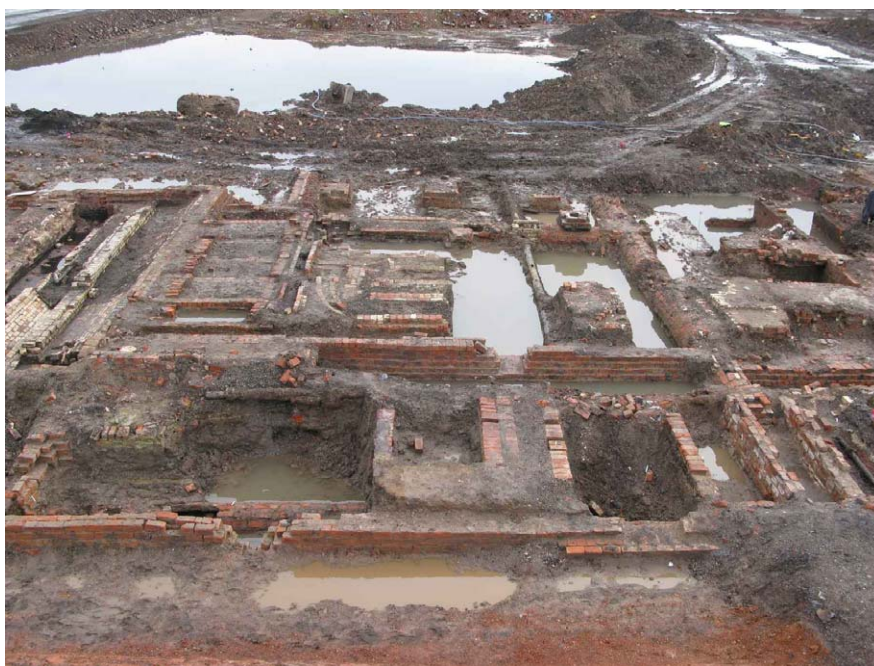
*Plate 7. Room 3, Structure 2, from above*

This area largely comprised underground services such as flues, drains and a series of residual low relief walls (Plate 7). The north of the room was delimited by a supporting wall (2037), which is depicted as part of the footprint of the building on both the 1st and 2nd Edition OS maps. The area measured approximately 13 x 16.5m. Low relief walls, such as (2042, 2044, 2047, 2087-2091) and (2094-2099), probably supported the working shop floor situated above. A network of interconnecting drainage channels would have carried waste liquids from the dye work shop floor. Smaller drains such as (2092) contained the remnants of pigmented industrial residues. The liquid waste flowed into larger channels (2093), which converged into main drains (2054) and (2115) and were then intersected by the largest drain (2344). Some drain channels (2051, 2054 and 2344) were clearly main arteries for the flow of waste liquids. Drainage from the working floors was through square apertures in the

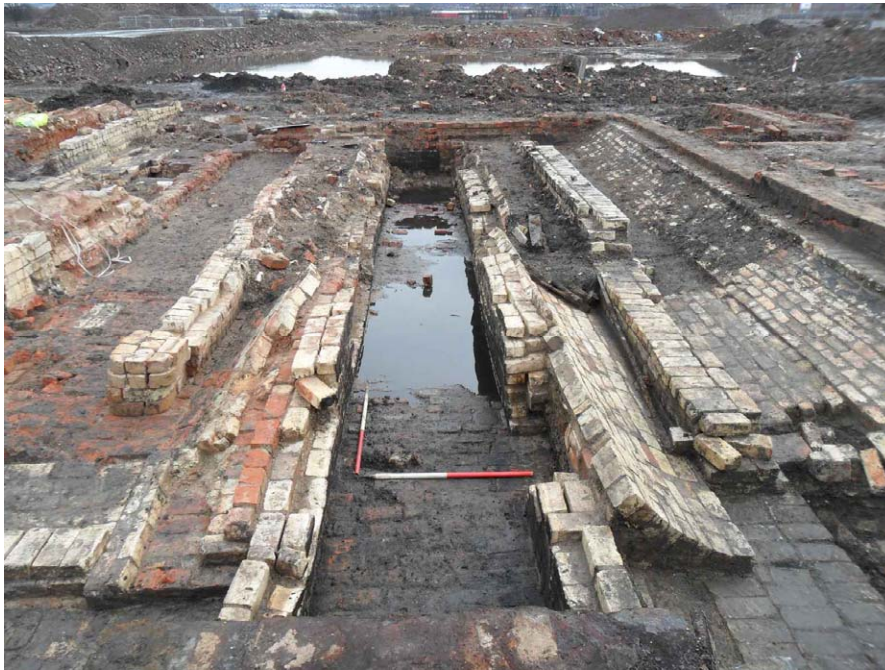
*Plate 8. Room 4, Structure 2*

Room 4 comprised the remains of a boiler house, which would have housed a parallel arrangement of boilers on firebrick plinths (2201, 2247) (Plate 8). It measured 10.5 x 6.35m. Plinth (2201) was flanked by concave (2200) and sloped (2202) brick surfaces. Boiler stance (2247) and the surrounding brickwork was heavily affected by heat, which had disaggregated the curved refractory brick skin (2248). The purpose of the refractory brick linings was to convect and conserve heat within the boiler house. The boiler house had a central brick flue (2296), delimited by walls (2203) and (2209), which showed evidence of being repaired. This central flue was the continuation of a curved flue system (2426, 2427), which probably linked to the main flue (2176) situated in the north yard. Both the interior elevations and surface (2420) of the flue were heavily sooted and the indication is that it acted as an exhaust for Room 4. Two iron lintels (2424, 2208) provided strength for the flue by capping the north wall of the boiler house. The flue channel had been blocked by refractory bricks (2213). The floor surface (2246) in the eastern boiler stance of Room 4 had been repaired (2253), mainly with red brick. Most of these repairs were to maintain the surface. However, the deposition of a large cast iron pipe (2445) had necessitated the removal of all but the residual elements of the eastern curved refractory brick skin (2190) and the original floor surface. The surface was then repaired by a further deposit of red bricks

The south wall of Room 4 (2254) had been cut to lay pipe (2445) and then repaired (2529). The re-laying of the boiler house surfaces and wall repairs indicated it was still in use and a thin skin of refractory bricks was deposited in a makeshift attempt at relining the east wall of the boiler house (2190). The east wall of the boiler house consisted of a sandstone wall (2152), possibly predating the 1858 OS map. The wall had been reddened by heat (Plate 8).

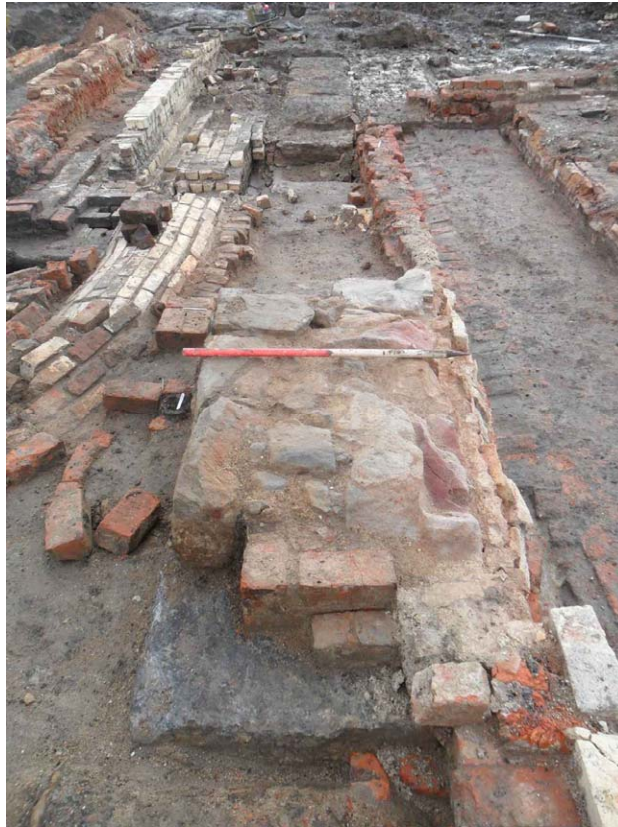
*Plate 9: Shot of 1st Edition wall 2152 east of Room 4*

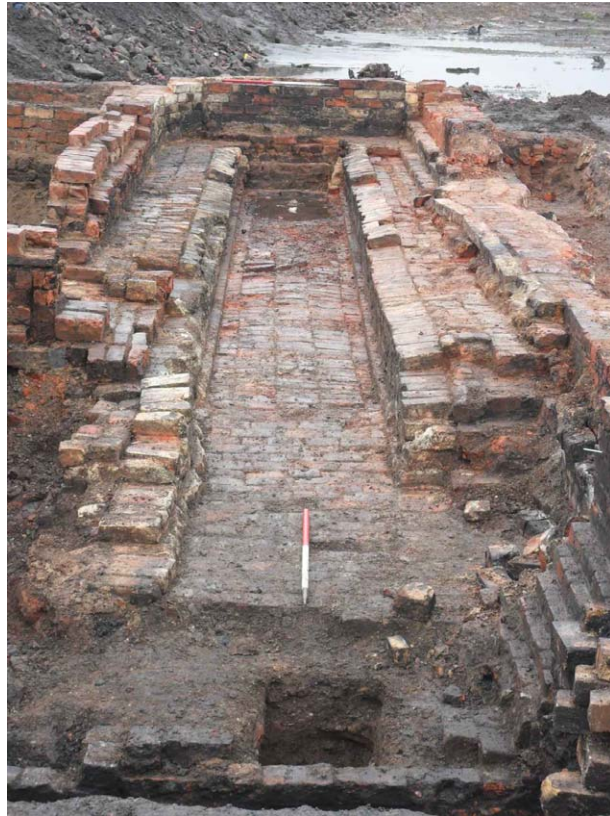
*Plate 10. Boiler house in Room 5, Structure 2*

This room incorporated a boiler room, constructed in a different style to other boiler rooms within Structure 2, a modified flue system to the north (2460, 2499, 2500) and the foundation walls for upper floors within the east end of Structure 2 (Fig. 8). The boiler house was for a single boiler (Plate 10) and was constructed of red brick with refractory brick linings. It measured 11.7 x 4.1m and had a series of substantial

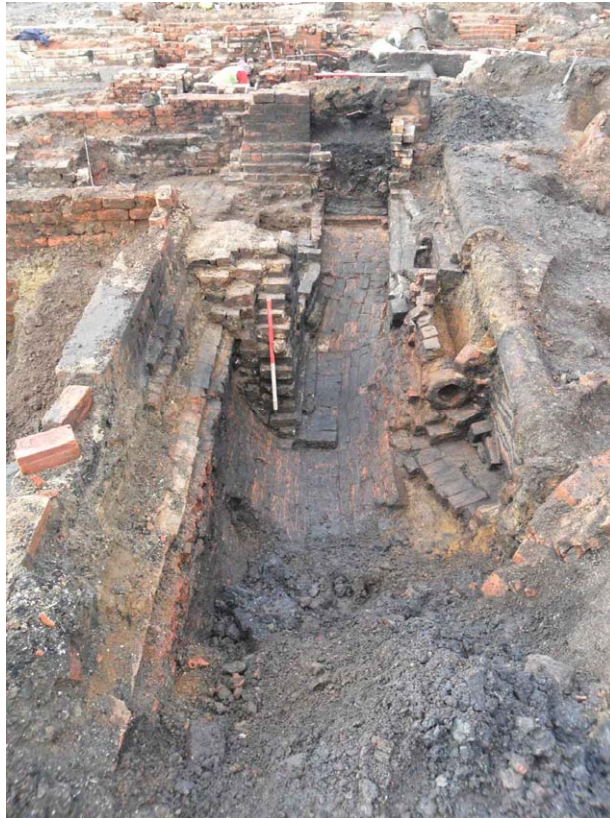
*Plate 11. Modified flue system and later truncation in Room 5, Structure 2*

interior supporting walls (2552, 2554, 2553, 2556). The floor had been re-laid due to heat damage at least twice (2551, 2550) and the southern end, which was originally curved, had been flattened and in-filled by later brickwork (2557). A heavily modified flue system (2460) had been partially blocked by a deposit of refractory bricks (2498) with further evidence suggesting the route of the flue had been diverted or further restricted (2499, 2500). Flue 2433 in the north yard also discharged into this flue, but both were redundant by the time pipes (2304) and (2501) had been installed. Further east were walls (2578, 2577, 2575), which would have supported and possibly partitioned the floor above. The remains of a curved wall (2576) would have been the foundation for a stairwell in this area.

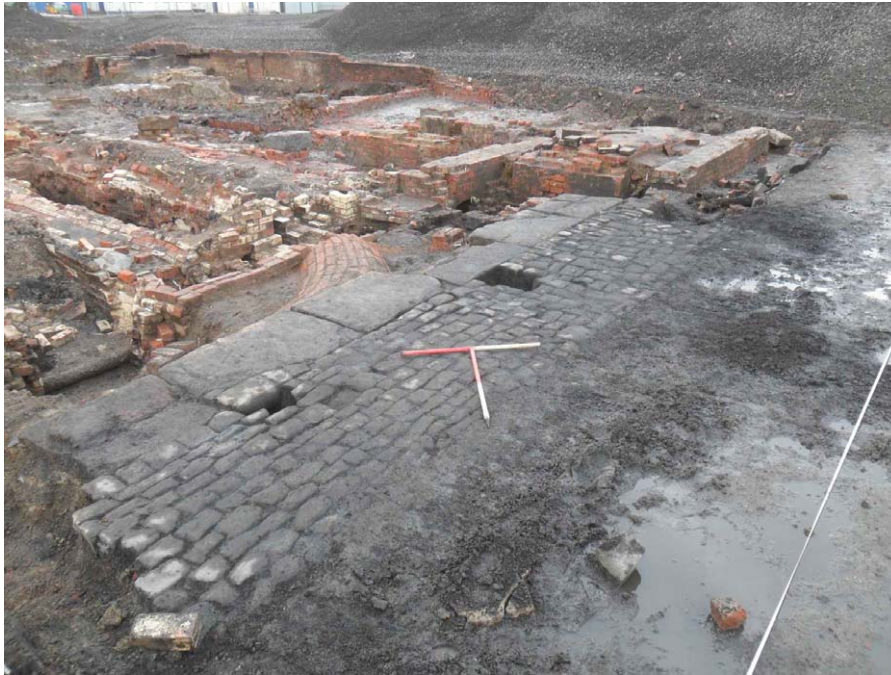
*Plate 12. Threshold and stone surface in North Yard, Structure 2*

The 2nd OS Edition map shows a yard area to the north of Structure 2. The yard comprised compacted cinder and ash and covered a series of service and flues, the largest of which was 1.8m in diameter and constructed of red brick (2176). This flue was the main artery for the transportation of hot gases from the boiler houses in Structure 2 and was fed by several smaller flues (2160, 2234), which served Room 2. A sandstone threshold was evidence of entrance (2468) and was abutted by an exterior yard surface of re-used stone setts (2469) to the north of Room 2. Two sockets with residual timber uprights may have supported an awning or other temporary entrance structure (Plate 12).

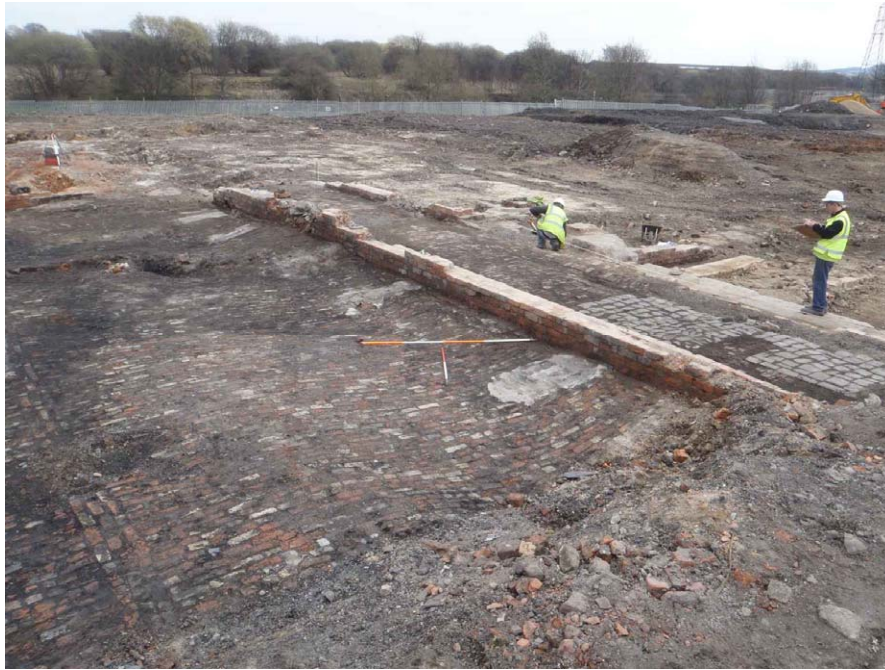
*Plate 13: Working shot of recording in Structure 4*

Structure 4 (Fig. 8) comprised the vestigial and heavily truncated remains of former dye works buildings. The footprint of the building remained relatively unchanged until the 3rd Edition OS map when the area is depicted as yard space. The remains therefore pre-date the 3rd Edition map and are probably those depicted on the 2nd Edition OS map as an elongated rectangular building (Fig. 4). The remains comprised supporting walls (4013) and (4014) and an interior brickwork surface (4012) divided by a central line of stretchers. The surface had a series of east-west orientated stone pedestals, which were the remains of stances (4007-4011). In the northern half of the structure, the stances were larger and had residual anchor points (4002-4006). Wall (4015) was an internal supporting wall beyond which a further surface (4074) was situated at a lower datum to the east. South of wall (4014) a sandstone sett (4063) and brickwork surface (4061) was the remnant of an external access route (Plate 13).

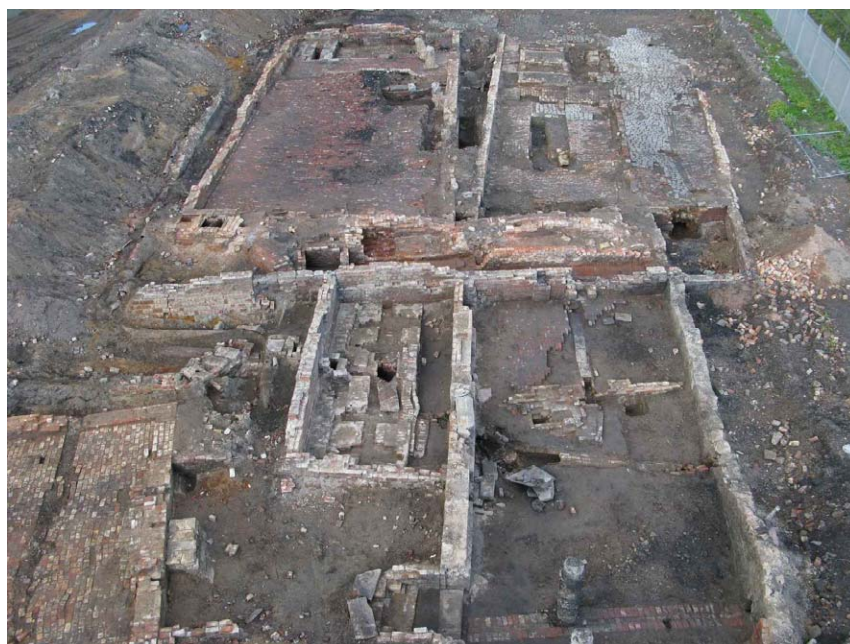
*Plate 14. Structure 6, from above*

The structure was first depicted on the 1st and 2nd Edition OS map but is absent on later editions. The surviving remnants of the building are associated with the Springfield Print and Dye works. The building as depicted on the 2nd Edition OS map (Fig. 4) consisted of an east-west orientated range (Rooms 1 and 2; Fig. 9), and a further two ranges of buildings seen as a V-shaped wedge orientated roughly north-south. Cartographic evidence shows that the footprint of the building changed very little during its use. Structure 6 was buried under c.3m of made ground and given the datum of the surviving surfaces (6058, 6198) at 7.53m OD the indication is the building was probably terraced into the landscape (Plate 14).

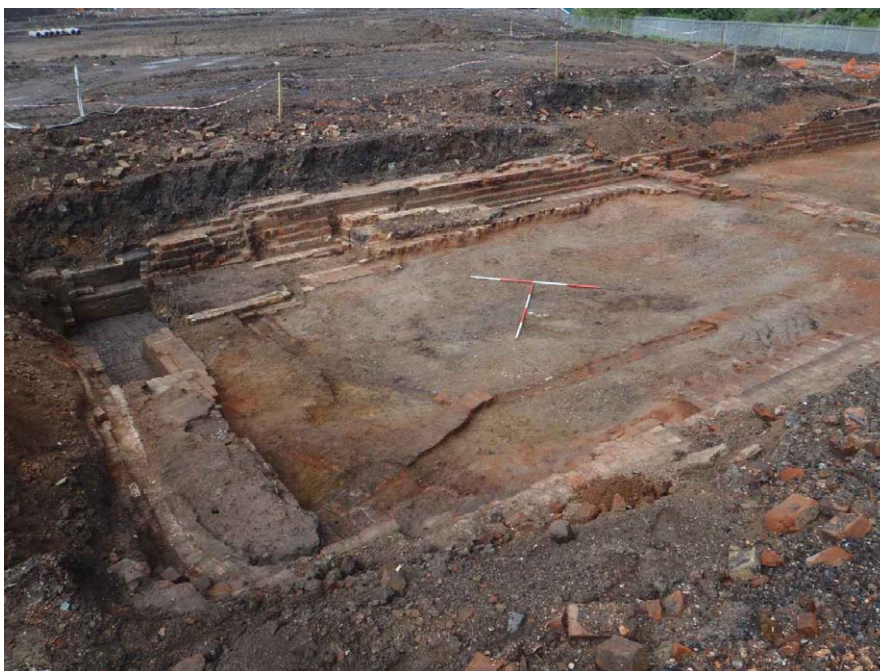
*Plate 15. Room 2, Structure 6*

Rooms 1 and 2 formed a rectangular building that measured 29.7 x 15.m and was formed by red brick supporting walls (6002) and (6025) (Fig. 9). The structure had an internal dividing wall (6006, 6009) which had the remains of a threshold (6014, 6010). The internal elevations of the supporting walls featured recessed slots, probably for uprights to support the roof. The north-west corner of Room 2 (Plate 15) had a brick constructed recess (6019) with a refractory brick step, and was the remains of a subterranean stairwell depicted on the 2nd Edition OS map. Some vestigial remnants of the red brick flooring survived (6011, 6003, 6004, 6005) and showed signs of exposure to heat. The floor had either been repaired or had been constructed with a mixture of refractory and red brick, all of which were re-used. A narrow under floor drain channel (6016) was also recorded in Room 2.

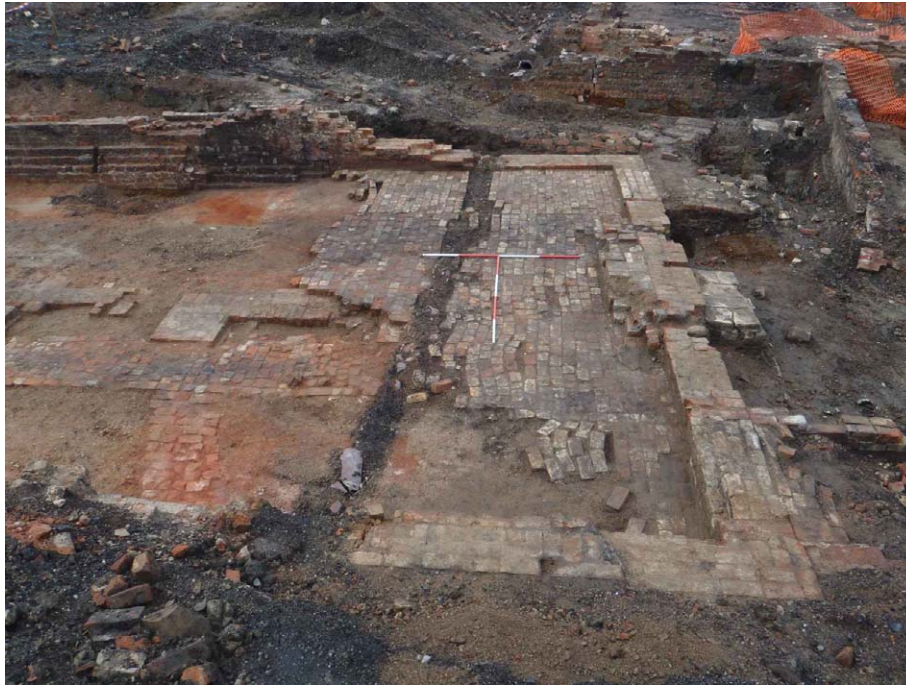
*Plate 16. Eastern end of Room 1, Structure 6*

Room 1 (Plate 16) contained two rows of offset square brick footings (6040-6049) that possibly supported the roof.

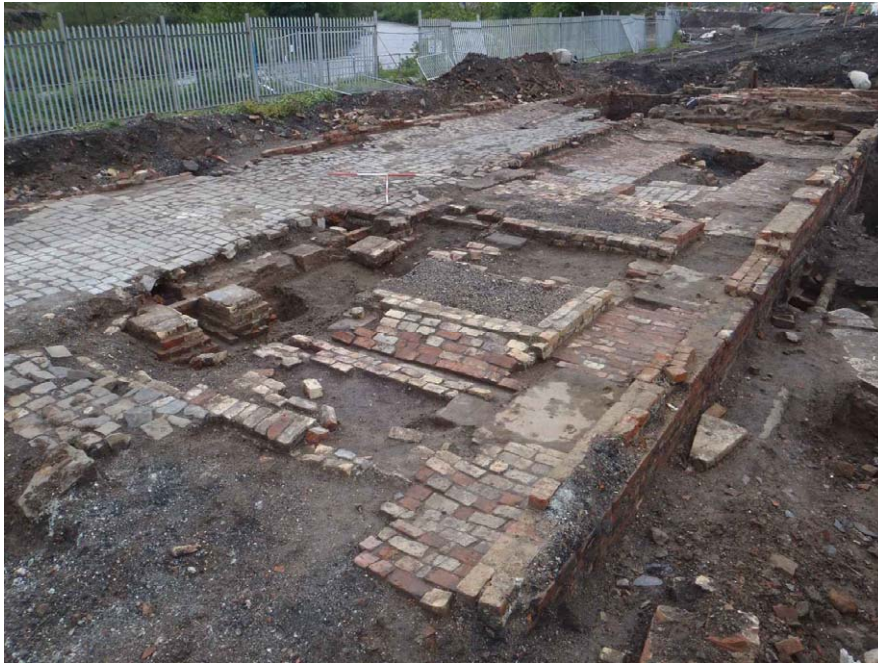
*Plate 18. Room 5, Structure 6*

The footprint of Room 5 was as depicted on the 1st Edition OS map with red brick walls (6275) and (6200) following the exact orientation (Fig. 10); both of which were constructed on earlier sandstone foundations. The room measured greater than 20m by 9m wide. The interior of the room had undergone many alterations and was an *ad hoc* assemblage of features and deposits (Plate 18). To the east, the extant surface was re-used stone setts (6198) although some brickwork repairs, mainly refractory material (6210) survived either side of a gutter channel (6208). The other surfaces to the west of the room comprised smaller areas of brickwork (6214, 6205, 6278, 6259, 6260, 6302) deposited with no attempt at continuing previous bonding patterns. The probability is that this part of the room had been much altered throughout its working

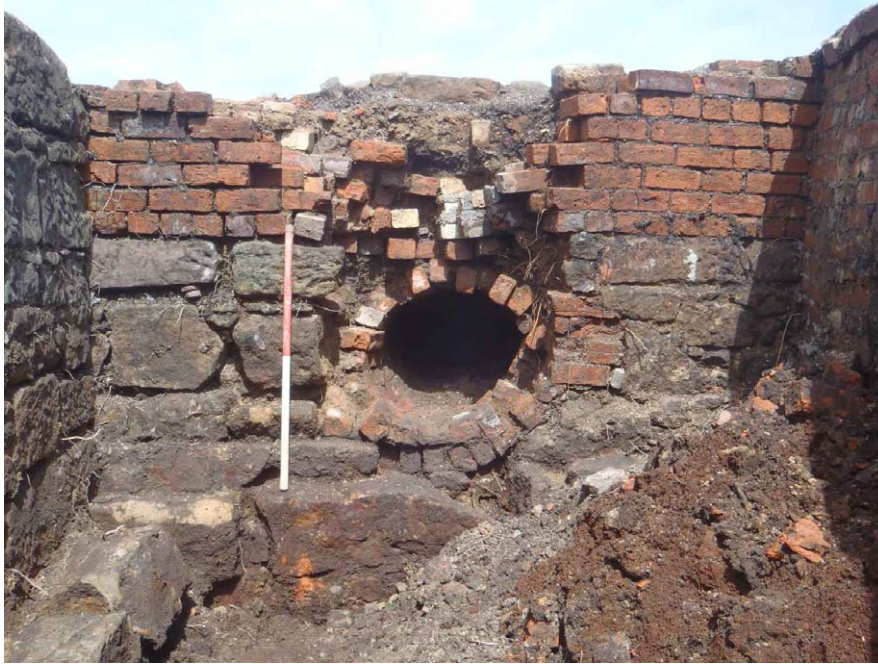
*Plate 19: Drain 6252 in reservoir of Structure 6*

Two rectangular features (6215/6213, 6230) to the north are interpreted as probable bases for dye work apparatus. A number of brick plinths (6218, 6219) and sandstone pads (6207, 6212, 6226, 6227, 6307, 6229) may have been support pads for more apparatus or possibly pads for supporting a floor or walkway. Drain (6363) was stained purple, which suggested that ‘turkey red’ dye was being produced or used in this area. Further excavation under surface (6198) help to define a large barrel-vaulted drain of red brick construction (6252), which ran north to south under Room 5 and discharged through an opening in sandstone wall (6251) into the former reservoir area (Plate 19). This work also helped to establish a greater extent of sandstone wall (6216). This wall does not respect the footprint of Structure 6 as depicted on any OS mapping and is probably earlier. It may have functioned as a revetment or flood wall. The northern end of Room 5 had been truncated.

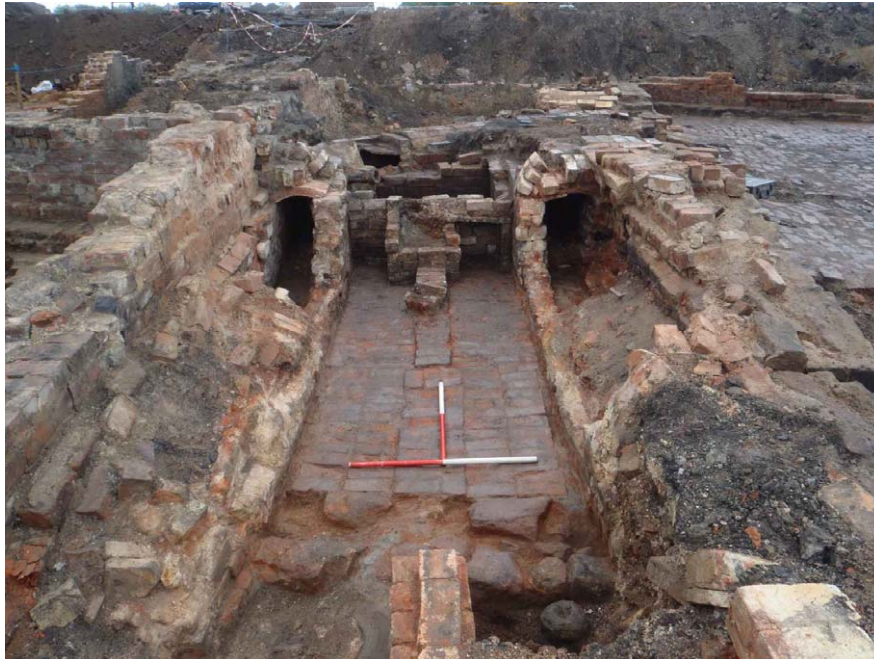
*Plate 20. Boiler House in Structure 6*

A boiler house (Plate 20), the outline of which can be seen on the 1st Edition OS map, was situated between Rooms 6 and 7 and Rooms 3 and 5. It measured approximately 11 x 3m. It consisted of a central boiler plinth (6140, 6142), a fire box at the western end (6104, 6105) and two exhaust flues. The two flues (6099, 6118) ran the length of the boiler house and were capped by rows of concave refractory slabs (6100, 6119). The south wall (6148, 6178), constructed in red brick, overlay earlier sandstone walls (6141) and (6083).

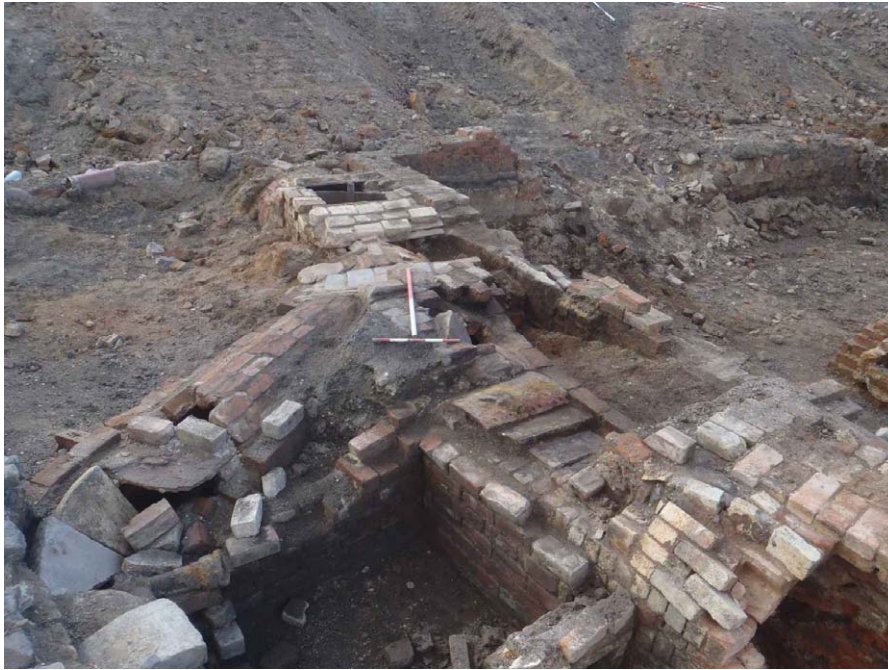
The flues beyond the fire box were barrel-vaulted and both converged into a square inspection chamber (6282). The inspection chamber had a cast iron sluice which would have been turned from above. It acted as a valve to manipulate the transference or re-use of hot boiler house gases (Plate 21). The boiler house unsurprisingly showed signs of intense exposure to heat, with the refractory brick lining being fused in places. Evidence of phasing was noticeable in the boiler house construction. It was probable that sandstone wall (6141) had been levelled to floor height as part of the primary phase of boiler house construction, as it was covered by the boiler plinth which ran the full length of the building.

*Plate 21. Converging flues, Structure 6*

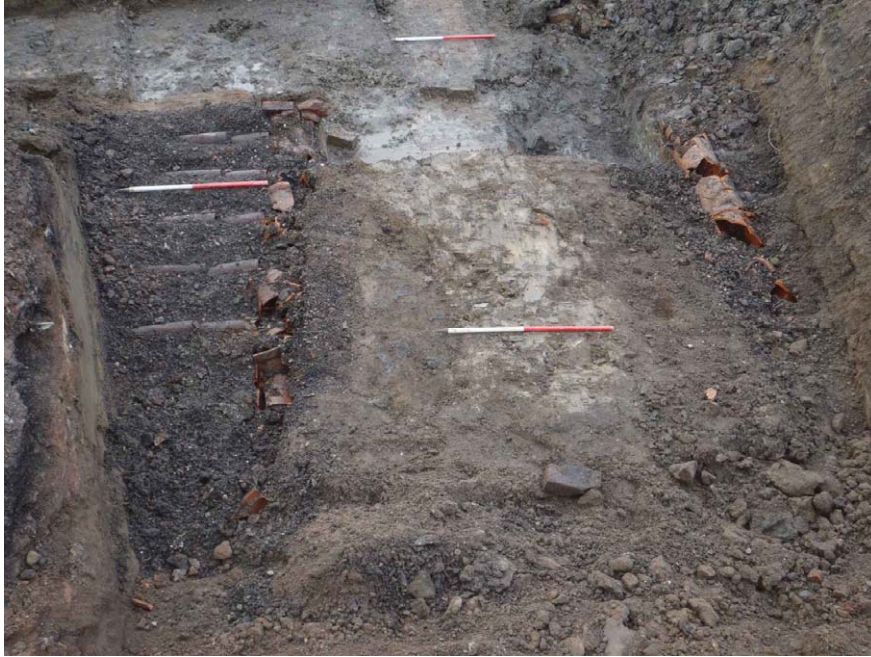
The excavation recorded a network of ceramic pipes (304, 305, 501, 510, 604) running parallel with the ponds. The ceramic pipes had been placed within deposits of cinder (336, 503, 509, 602) that overlay a bedding deposits of sand (504, 512). The purpose of these deposits was to create a permeable layer that could quickly filter and transport water. The best surviving example of this process could be seen in trenches 2, 3 and 5. Water would have been channelled into the pipe network by a series of larger header pipes situated at the terminals of each pond (502, 511) (Plate 22).

*Plate 22. Wall 505, header pipe 502, ceramic pipes 501, Trench 5, Structure 10*

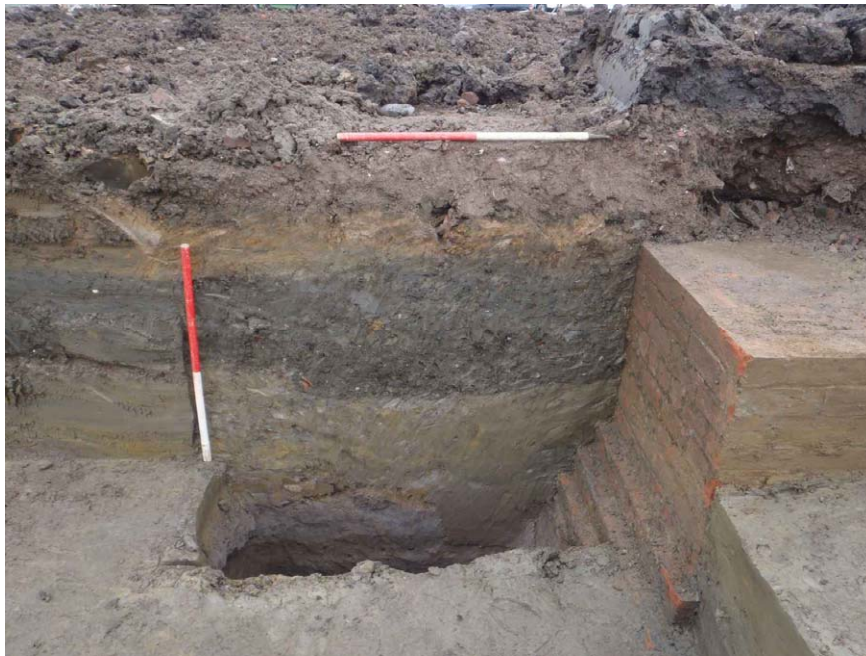
The central pond was further divided by two red brick walls (202/303, 505), which had been cut (208, 324, 516) in the natural substrate (Plate 23). No evidence of the sluices depicted on OS maps could be seen and they were presumably removed during the re-development of the site in the early 20th century.

*Plate 23. Wall foundation 202/303, Trench 2, Structure 10*

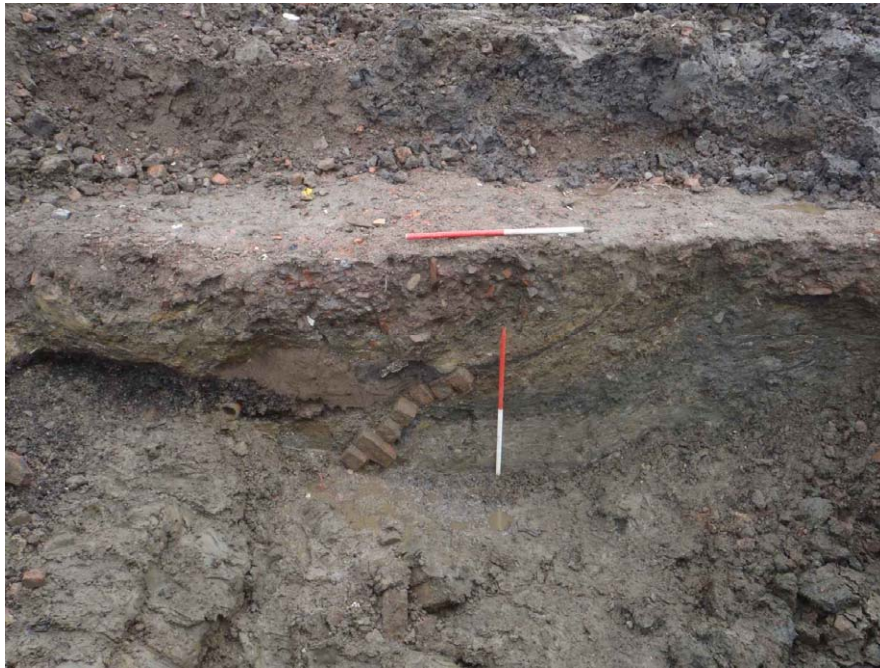
The edge and deposits of the central pond were visible in section. Trench 1 confirmed the pond was lined by mixed deposits of firm mottled clay (106-109, 119). This had been cut (115) to form the side and base of the pond before the deposition of ceramic pipes (111) within cinder (113). The north-facing section of Trench 1 revealed the cut (127) for the pond had been lined by a single skin of red bricks. Clay deposits 133 and

132 provided an impermeable interior lining to retain water within the pond (Plate 24). This brick lining was also visible in plan in Trench 6 (605). The foundations for tenement buildings were uncovered to the east of the filter pond and had removed any evidence of the former pond or sluice in that area. The natural substrate varied but was characterised as sterile fluvial deposits of soft clays, sands and gravels or a mixture thereof.

*Plate 24. Cut for edge of pond in north-facing section of Trench 1*

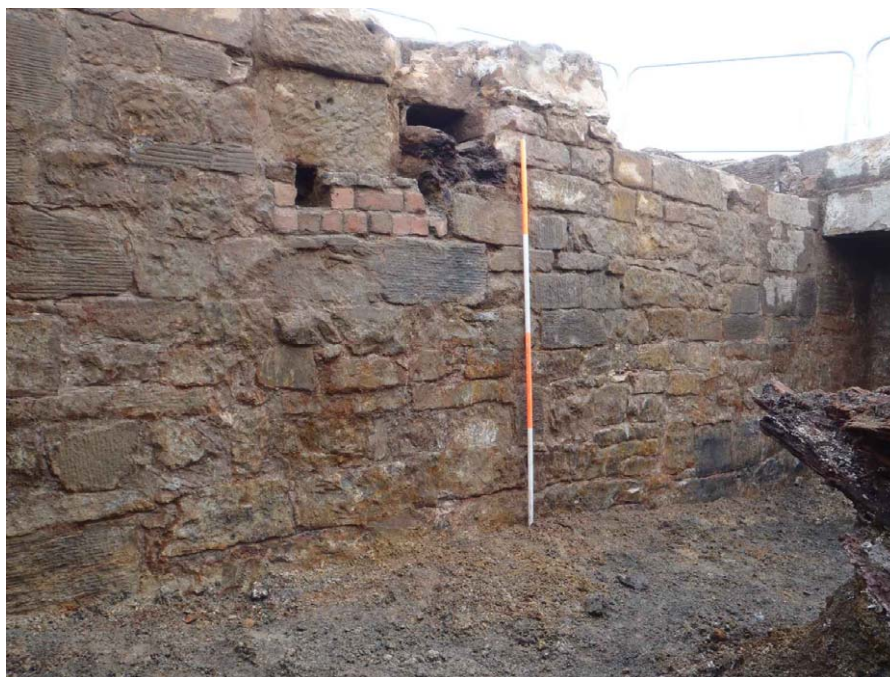
The initial construction of the Engine House featured three pillars constructed of dressed sandstone with grooving and well defined margins. These pillars abutted walls (5005), (5006), (5370) and (5371). Walls (5006) to the south and (5370) to the north formed the north and south internal elevations of Rooms 1 and 4 respectively. These elevations and walls (5003) and (5369) comprised the circuit of Rooms 1 and 4, both of which measured 5.8 x 3.3m. These rooms were partitioned by wall (5421), which incorporated fragmented and droved masonry and was built roughly to course. On both internal elevations there were cast iron housings (5034, 5384) for wooden beams, which would have spanned both rooms, aligning with sockets in the opposing elevations (5006, 5370) (Plate 25).

*Plate 25. Internal elevation of Room 1, Structure 5*

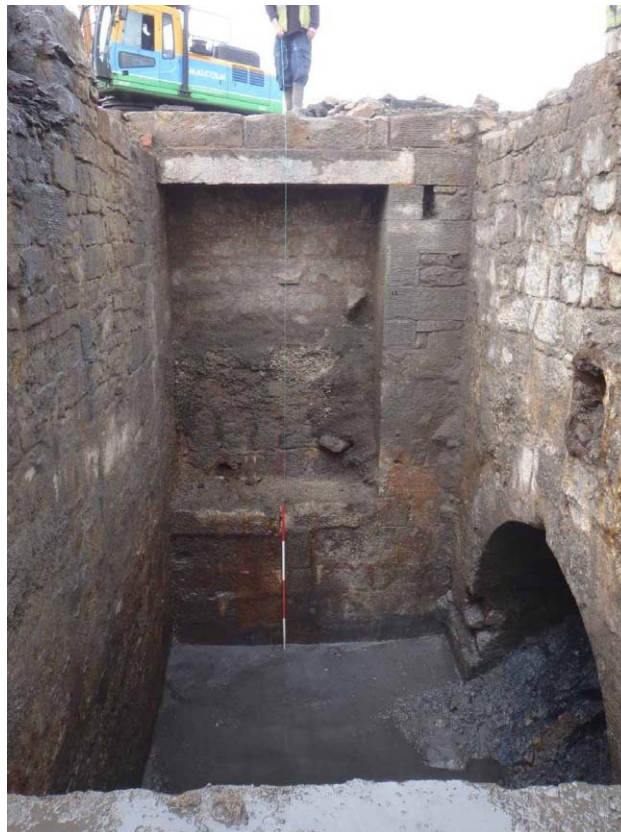
Two arches, constructed in dressed stone, were revealed in the north-facing elevation of Room 1 and south-facing elevation of Room 4. The arches passed through the supporting walls and into two semi-circular structures (5157, 5130) abutted to the outside elevations of Rooms 1 and 4 of the Engine House. A series of I-beams and cast iron pipes were keyed into the structures to provide support for a capping of sandstone flags (Plate 26).

*Plate 26. Internal south-west facing elevation, blocked opening and masonry arch in Room 1, Structure 5*

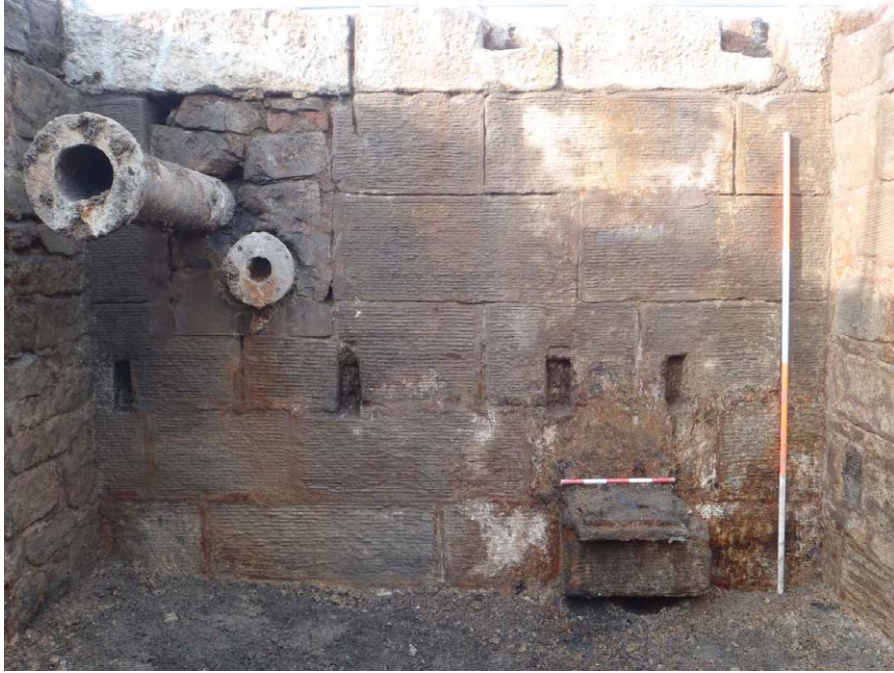
Situated roughly central to the Engine House was a large wall (5454) which provided the eastern elevations of Rooms 1 and 4, and the western elevation of Room 3. The massive supporting wall was probably the foundation for one or more beam engines. It was constructed using dressed stone blocks, which had well defined droving and margins on both elevations. The wall had two slappings in-filled by fragments of masonry and brick rubble, which would have allowed pipe work to pass from Room 3 into Rooms 1 and 4, although only two small sections of pipe had survived (5007, 5008). Both elevations had a number of cast iron plates and joist slots for a floor walkway, or machine support, and were a mirror image of one another. The top of the wall was series of granite blocks (5165-5173) all of which had tie down fittings and sockets, either for locating further masonry or for anchoring components of a beam engine to the foundations (Plate 27).

*Plate 27. Elevation 5003, Room 1, Structure 5*

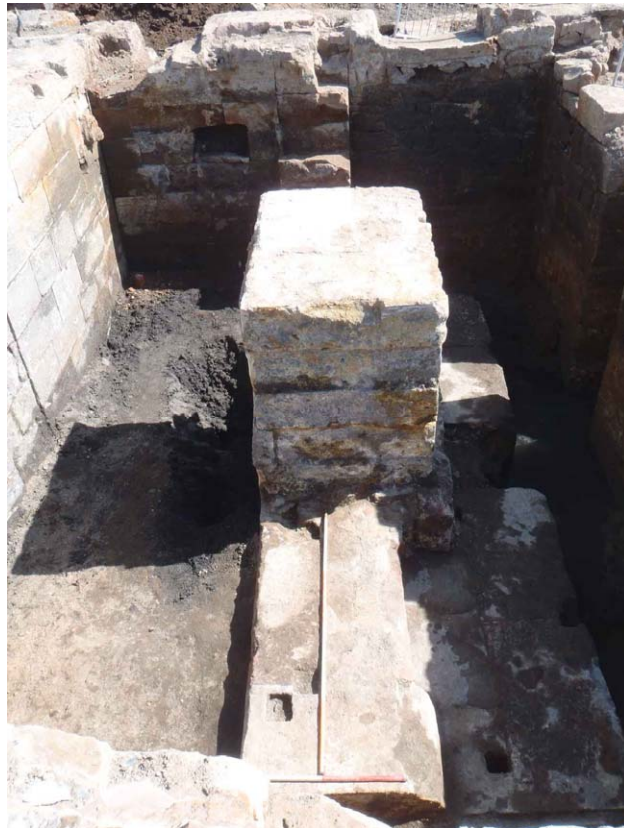
*Plate 28: Interior of Room 2 and 3*

This surface extended round two rectangular sandstone bases (5303, 5304), both of which were abutted by the residual remains of a former partition wall (5351) (Plate 28). The wall was constructed in droved sandstone masonry and, when extant, would have originally partitioned Room 2 and 3. The former elevations of this wall (5237, 5315) were visible as residual ‘buttresses’ on both the north and south elevations of these rooms (5307, 5352). Further partitioning of Room 3 was evident from a scar visible on wall (5351), which matched with a scar on the western elevation (5236) of wall (5454). A pedestal of re-used sandstone blocks, which probably supported a component of beam engine apparatus from a later phase of the water works (5048) was constructed over the remains of wall (5351) and was a further modification. Masonry (5303 and 5304) had a series of deep rectangular sockets of unclear function. These may have been to interlock and locate further masonry blocks for stability.

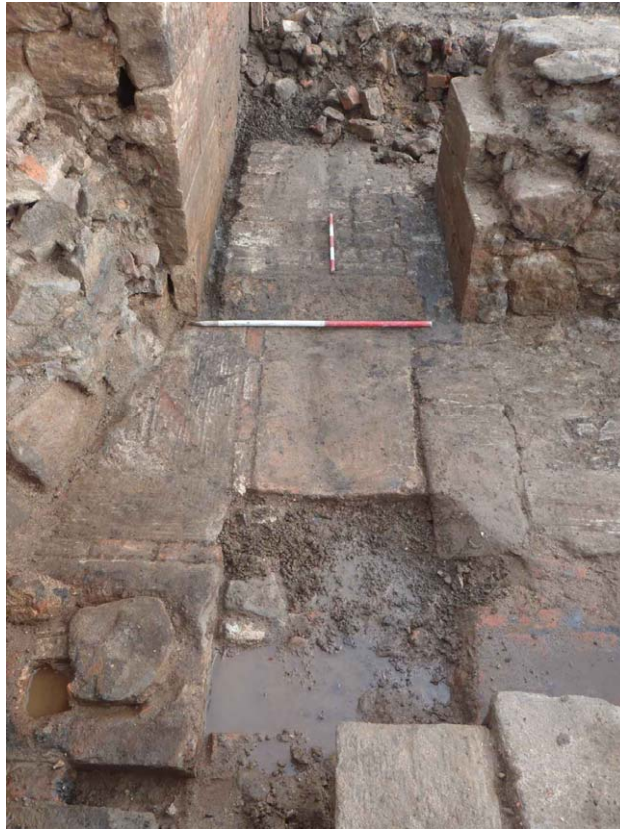
The Boiler House was rectangular in plan and measured 28.3 x 15.8m. Although clearly contemporary with the Engine House it was also a separate structure. This relationship was clear from the abutment of sandstone wall (5053) to the bulk head. The west wall (5333) was built of roughly coursed dressed sandstone and was abutted by a contemporary wall of similar construction (5051). These large sandstone walls were the exterior supporting walls for the upper levels of the Boiler House. Wall (5051) had been cut (5404) a minimum of 1.15m into the surrounding made ground and therefore these internal features were at least partially below ground when it was in use. Access to this level of the Boiler House was down a refractory brick ramp (5056 – 5055), which passed through an ashlar faced opening (5052) located between walls (5051) and (5053) (Plate 29). The internal area of the Boiler House was smaller than the external footprint depicted on the OS Town plan suggested (Fig. 3). The working interior was delimited by a north-south sandstone wall recorded in segments as (5441, 5331, 5359) to the western side of the Boiler House. This internal foundation would have supported the floor above. The construction of this wall provided a cavity to the west of the structure.

*Plate 29: Access to the Boiler House, Structure 5*
