**The Commonwealth Games Athletes Village,  
Dalmarnock, Glasgow**

**Archaeological Works**

**Report No. 2181**

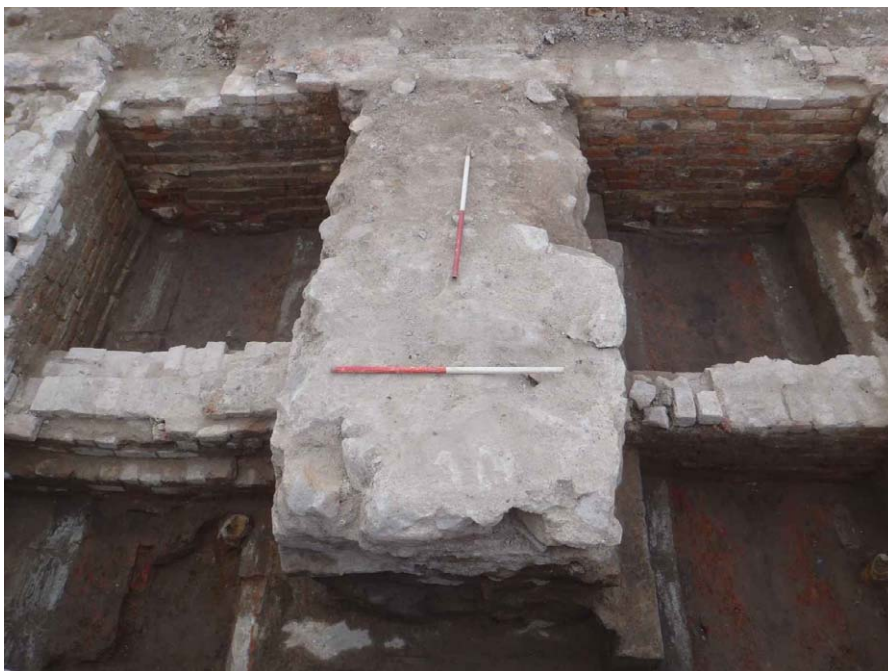
*Plate 30. Boiler plinth 5093, surfaces 5090, 5268 and wall 5065, Structure 5*

The rows of plinths were separated by a network of east-west concave red brick surfaces (e.g. 5430, 5070) with sandstone kerbing (e.g. 5329, 5433) and a central brick surface orientated north-south (5430, 5264, 5363). The concave design would have channelled condensation and other fluids towards a series of drains incorporated into the surfaces to the east (5057) (Plate 30).

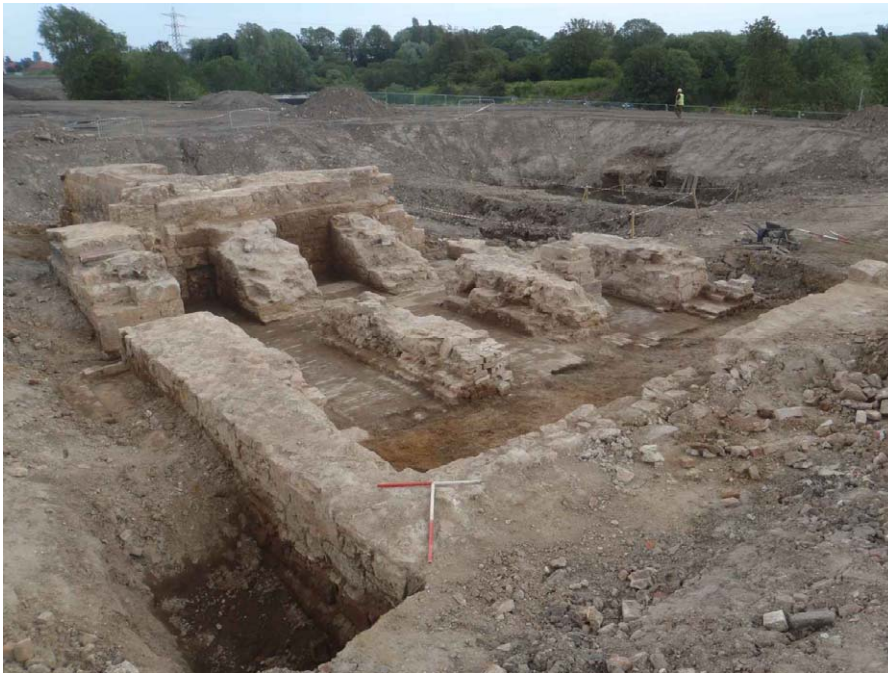
The surviving elements of the northern elevation of the Engine House (Fig. 13) comprised two courses of droved sandstone masonry (8003), below which was roughly coursed sandstone masonry (8004). The interface between the two types of masonry probably indicated the former ground surface. The wall was heavily truncated especially to the east where only the foundations footings, including cornerstone (8120) of the building had survived (Plate 32).

*Plate 32. Remains of Structure 8 with remediated area in the background*

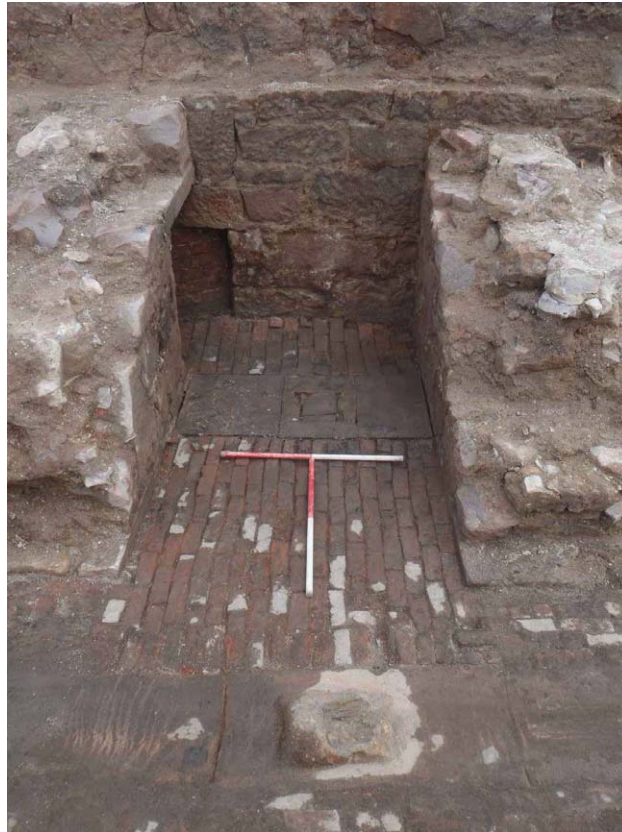
*Plate 33. Boiler House bay and blocked outlet, Structure 8*

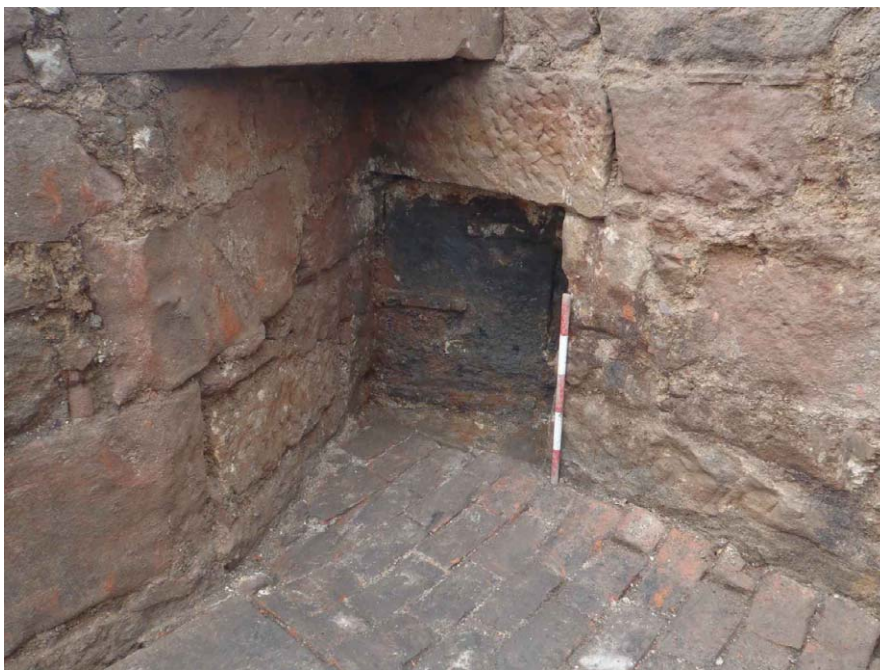
Structure 8, although heavily truncated in places, had not suffered from the intrusions or been modified by later building work. Therefore the relationship with the Boiler House and Engine House was clearer. There were distinct similarities between the design of this Boiler House and the one recorded in Structure 5. The excavation recorded two parallel rows of boiler plinths constructed in sandstone rubble with occasional red brick inclusions (8023, 8061, 8089, 8045, 8046, 8056). These plinths were less ostentatious than those previously recorded in Structure 5 and did not have dressed facing stones. The eastern plinths abutted the Engine House bulkhead (8009) and formed three distinct bays each with an outlet in the west-facing elevation (8042) (Plate 33). The construction work was all one phase and the plinths were built to allow the outlets to converge from opposing bays into vertical rectangular refractory brick flues (8014, 8017) fused by intense heat. The vertical flues were partitioned (8017) but would have converged into one of two probable chimneys. The flow of gases from the Boiler House through the outlet channels was regulated by cast iron doors (8077) (Plate 34).

*Plate 34. Boiler House outlet with cast iron door, Structure 8*

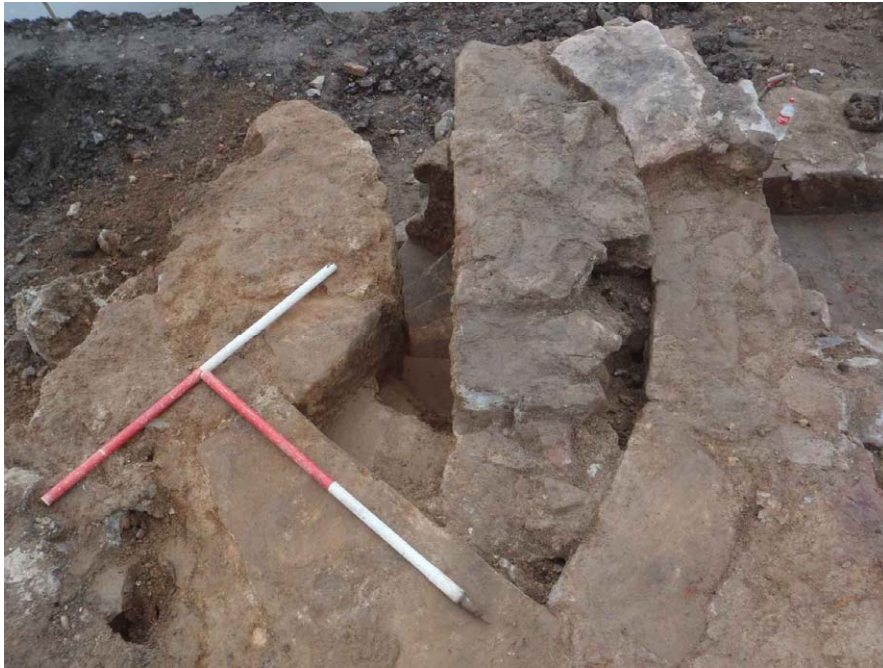
Incorporated into the construction of the bulk head were the remains of a sandstone spiral staircase (8010). This staircase had been partially blocked by a mortared sandstone infill (8012), which would have rendered the staircase virtually impassable (Plate 35). The purpose of the infill may have been to strengthen the surrounding

*Plate 35. Blocked spiral staircase (8010) Structure 8*

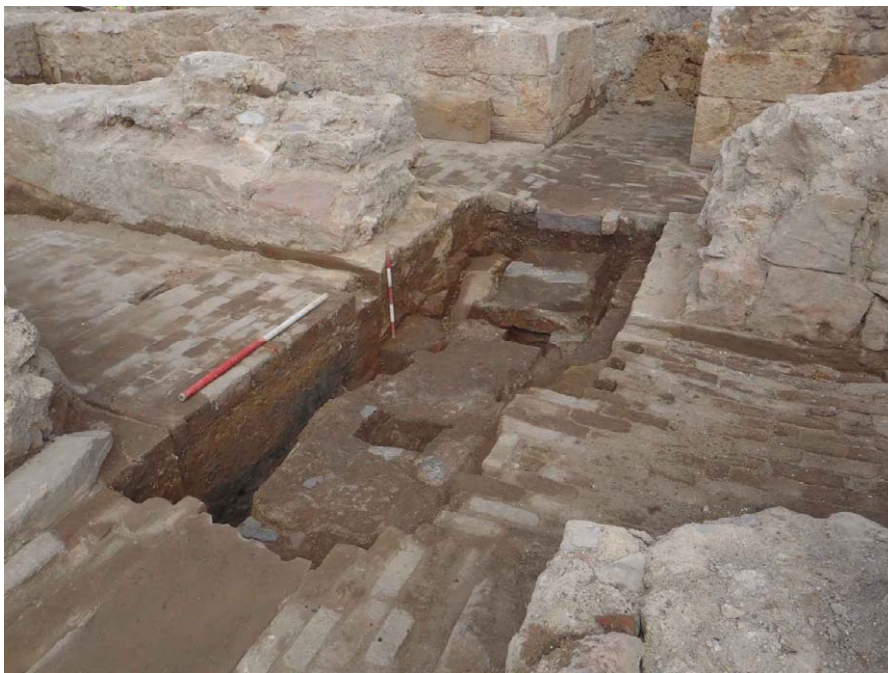
The floor of the Boiler House was constructed in red brick and had a dual purpose; to provide a functional walkway and to facilitate drainage. The drainage was achieved by a sub-surface culvert of refractory brick construction (8137) capped by large stone slabs (8095). Drainage was aided by a linear channel of dressed, concave sandstone slabs (8057). Further drainage ducts flanked on both sides by sandstone slabs were situated to the east of the Boiler House bays (8074, 8054, 8049) (Plate 36).

*Plate 36: Under-floor drainage and Boiler House access in background, Structure 8*

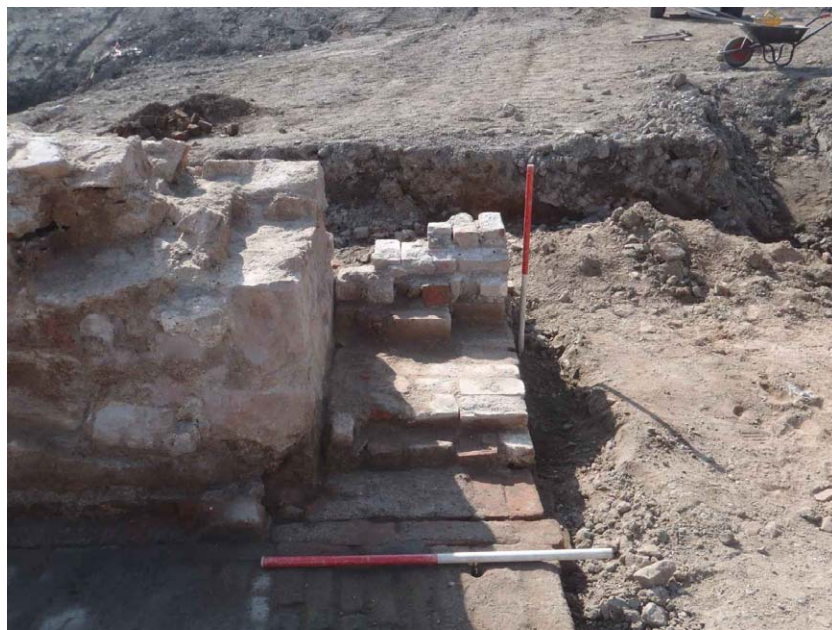
As recorded in Structure 5, the internal area of the later Boiler House was smaller than the external footprint depicted on the OS Town plan suggested (Fig. 3). A wall of sandstone construction (8034) would originally have delimited the working interior and created an internal cavity to the rear of the room between 8034 and the external supporting wall (8029). This internal foundation would have supported the floor above. At some point during the working life of the room, the rear internal wall had been demolished and was subsequently covered by further segments of brickwork (8059), which extended the internal flooring between the boiler plinths. A series of rudimentary brickwork extensions (8031, 8022, 8065) were added onto the western end of each sandstone plinth. These modifications increased the internal size of the Boiler House by using the ‘cavity’ and, the support capacity of the plinths. The purpose of the alterations was probably to allow for a configuration of large boilers to be installed (Plate 37).

*Plate 37. Brickwork extension to Boiler House plinth, Structure 8*

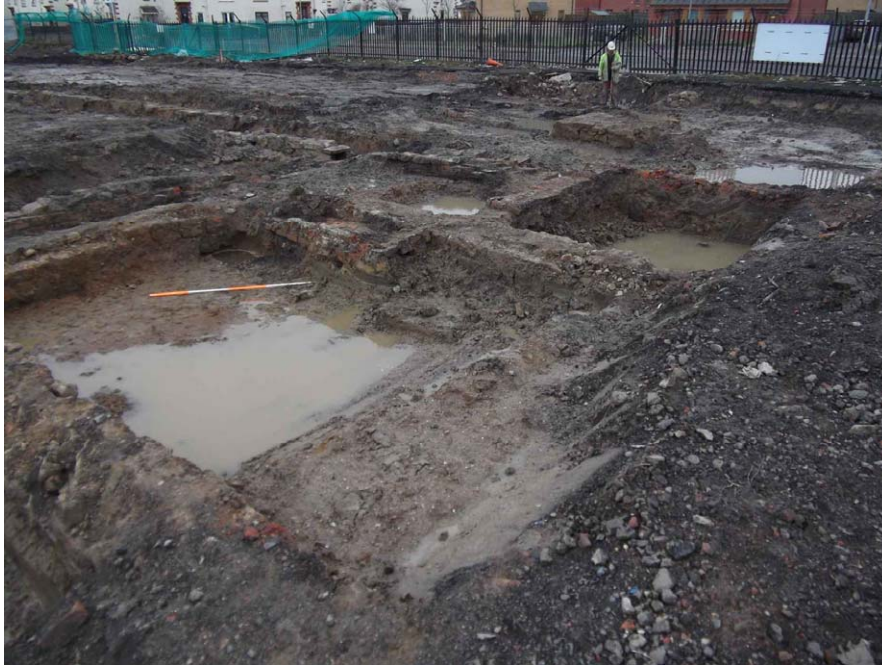
The heavily truncated remains of Structure 3 (Fig. 14) correlated with the former footprint of buildings depicted on the OS Town Plan. The foundations of sandstone walls (3002, 3005 and 3010) tied in with the locations of structures depicted on the

OS mapping (Plate 38). A deposit of bricks (3013) and a series of preparatory levelling deposits (3012, 3011, 3014) were the only discernible internal features but gave no indication as to what function the building might have served. The interpretation for the use of these buildings suggested they were closely related to the Glasgow Water Works situated nearby and may have functioned as offices and workshop premises

*Plate 38: General shot of excavated area of Structure 3*

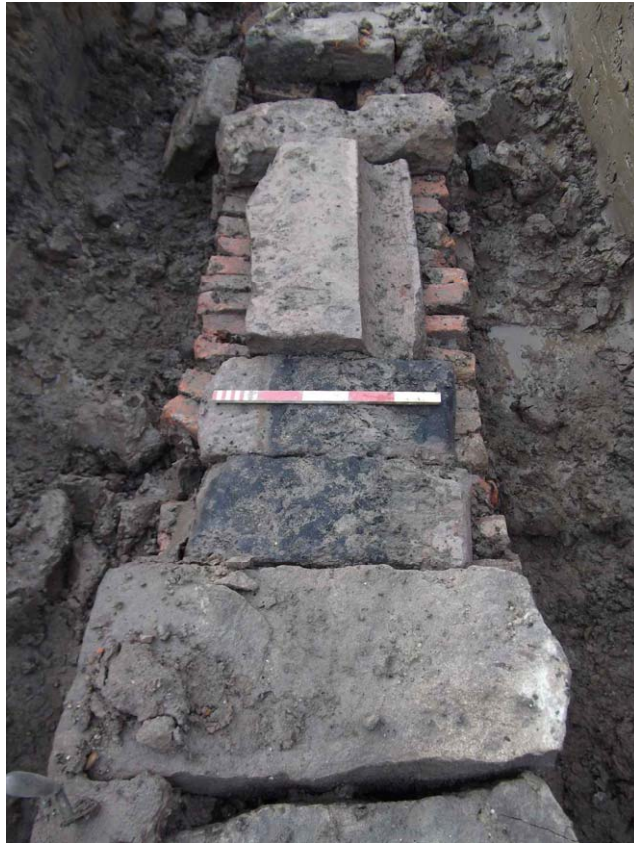
A network of brick constructed, sandstone capped culverts (3018, 3017, 3019, 3020) close to the modern ground level indicated the severity of truncation in this area. A large culvert of brick construction (3022, 3023) was recorded for a total length of 40.5m and was constructed to channel water in the direction of the Water Works Filter Ponds situated at lower datum to the south-west. It was capped by large blocks and slabs of roughly hewn and dressed sandstone masonry all of which had been re-used for the purpose. In total 18 blocks of worked masonry were recorded separately (3021a-r). The provenance of the blocks is unknown. Although some were roughly hewn with distinctive stugged faces, others included corbels, quoins and examples with concave channels and slots. All were evidently examples of substantial architectural masonry (Plate 39).

*Plate 39. Brick culvert 3022 and sandstone capping (3021), Structure 3*

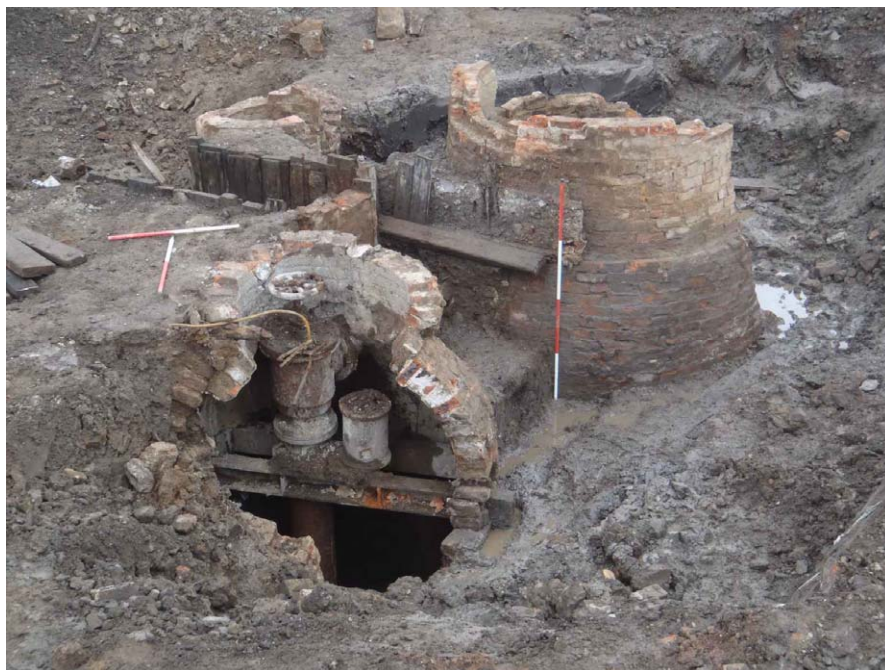
The excavation recorded the remains of three phases of structures used in the process of pumping water from reservoirs situated on the Cunnigar Loop, located on the opposite side of the River Clyde, to the Glasgow Waterworks (Fig. 13; Plate 40).

*Plate 40. Structures 9a–c*

These were three circular brick constructed wells or shafts (9a-c) of varying complexity with Structure 9a the earliest.

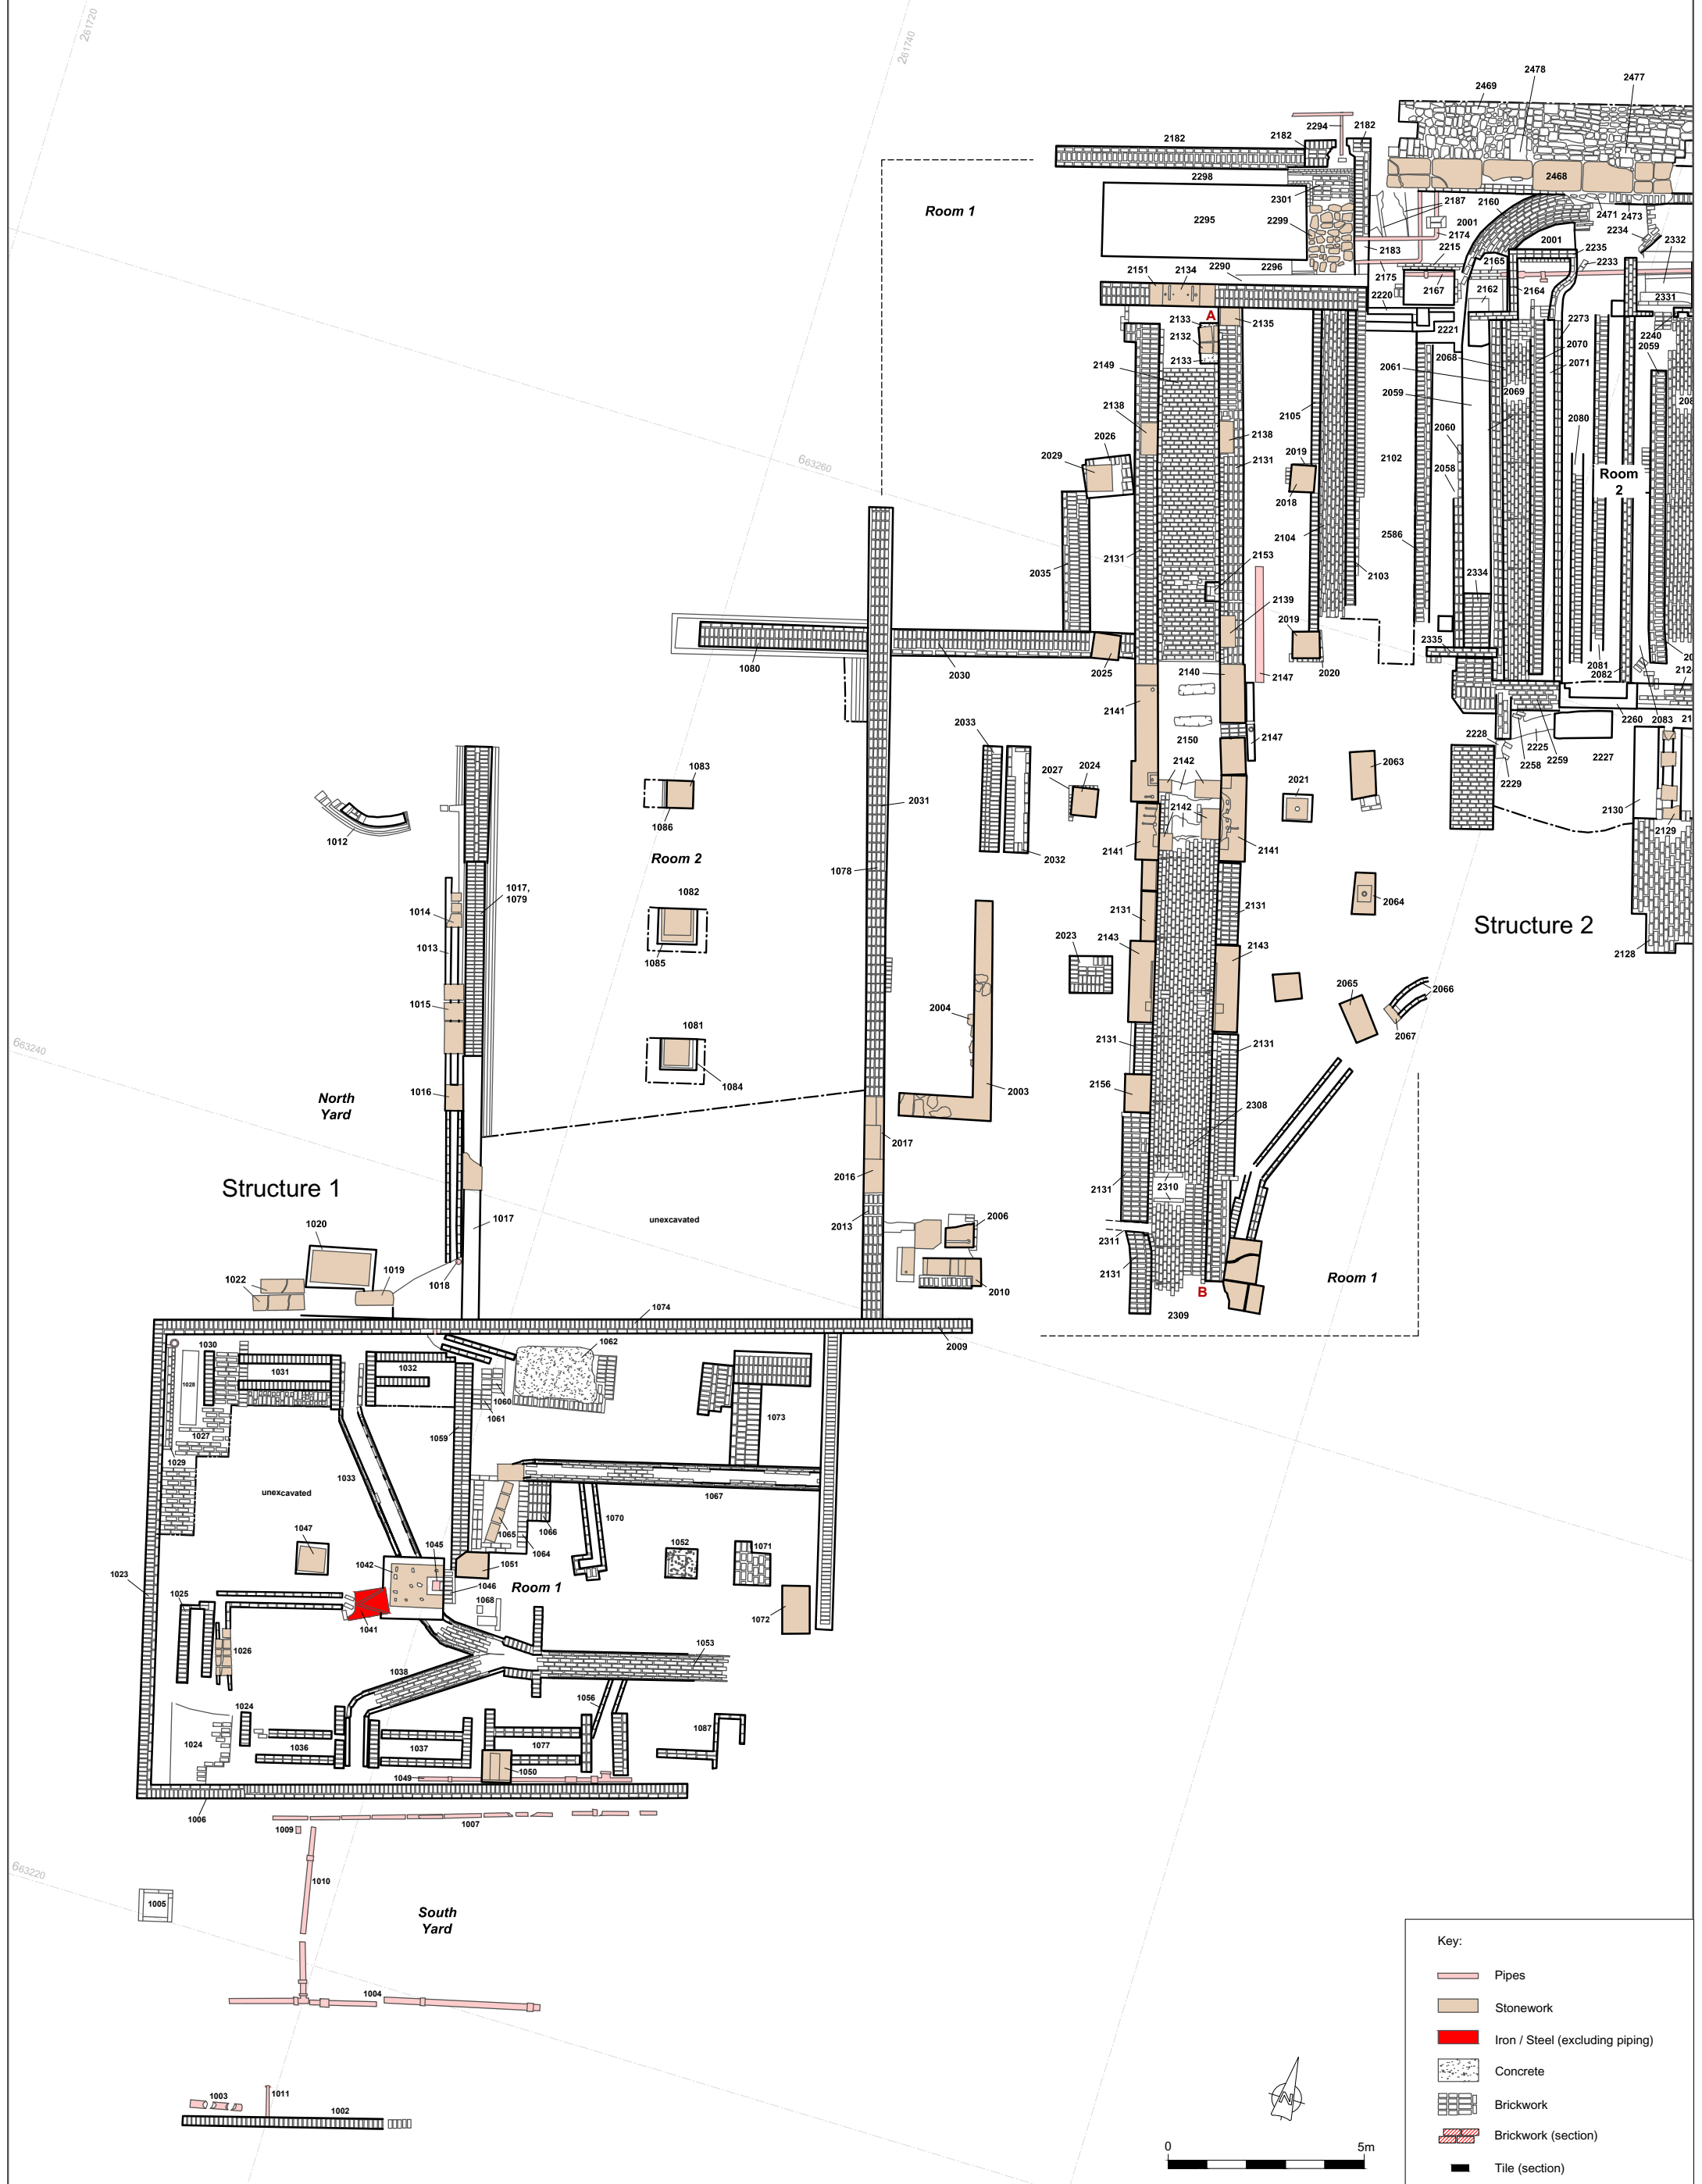
Fig. No: <b>6</b>	Revision: <b>A</b>	Drawn by: <b>TB</b>	Checked: <b>KH</b>	Report No: <b>2181</b>	Scale at A3: <b>1:150</b>
Title: <b>Structures 1 and 2 (W end)</b>			Project: <b>Commonwealth Games Village: Dalmarnock, Glasgow; Archaeological Excavation</b>		Client: <b>WSP Environmental Ltd</b>

foundations of the earlier building had been reused. The room, which measured 17 x 9.6m contained a central row of sandstone support pads (1081, 1082, 1083) situated on brick foundations (1084, 1085, 1086) (Plate 3). This masonry provided the central support for the roofing in this room.

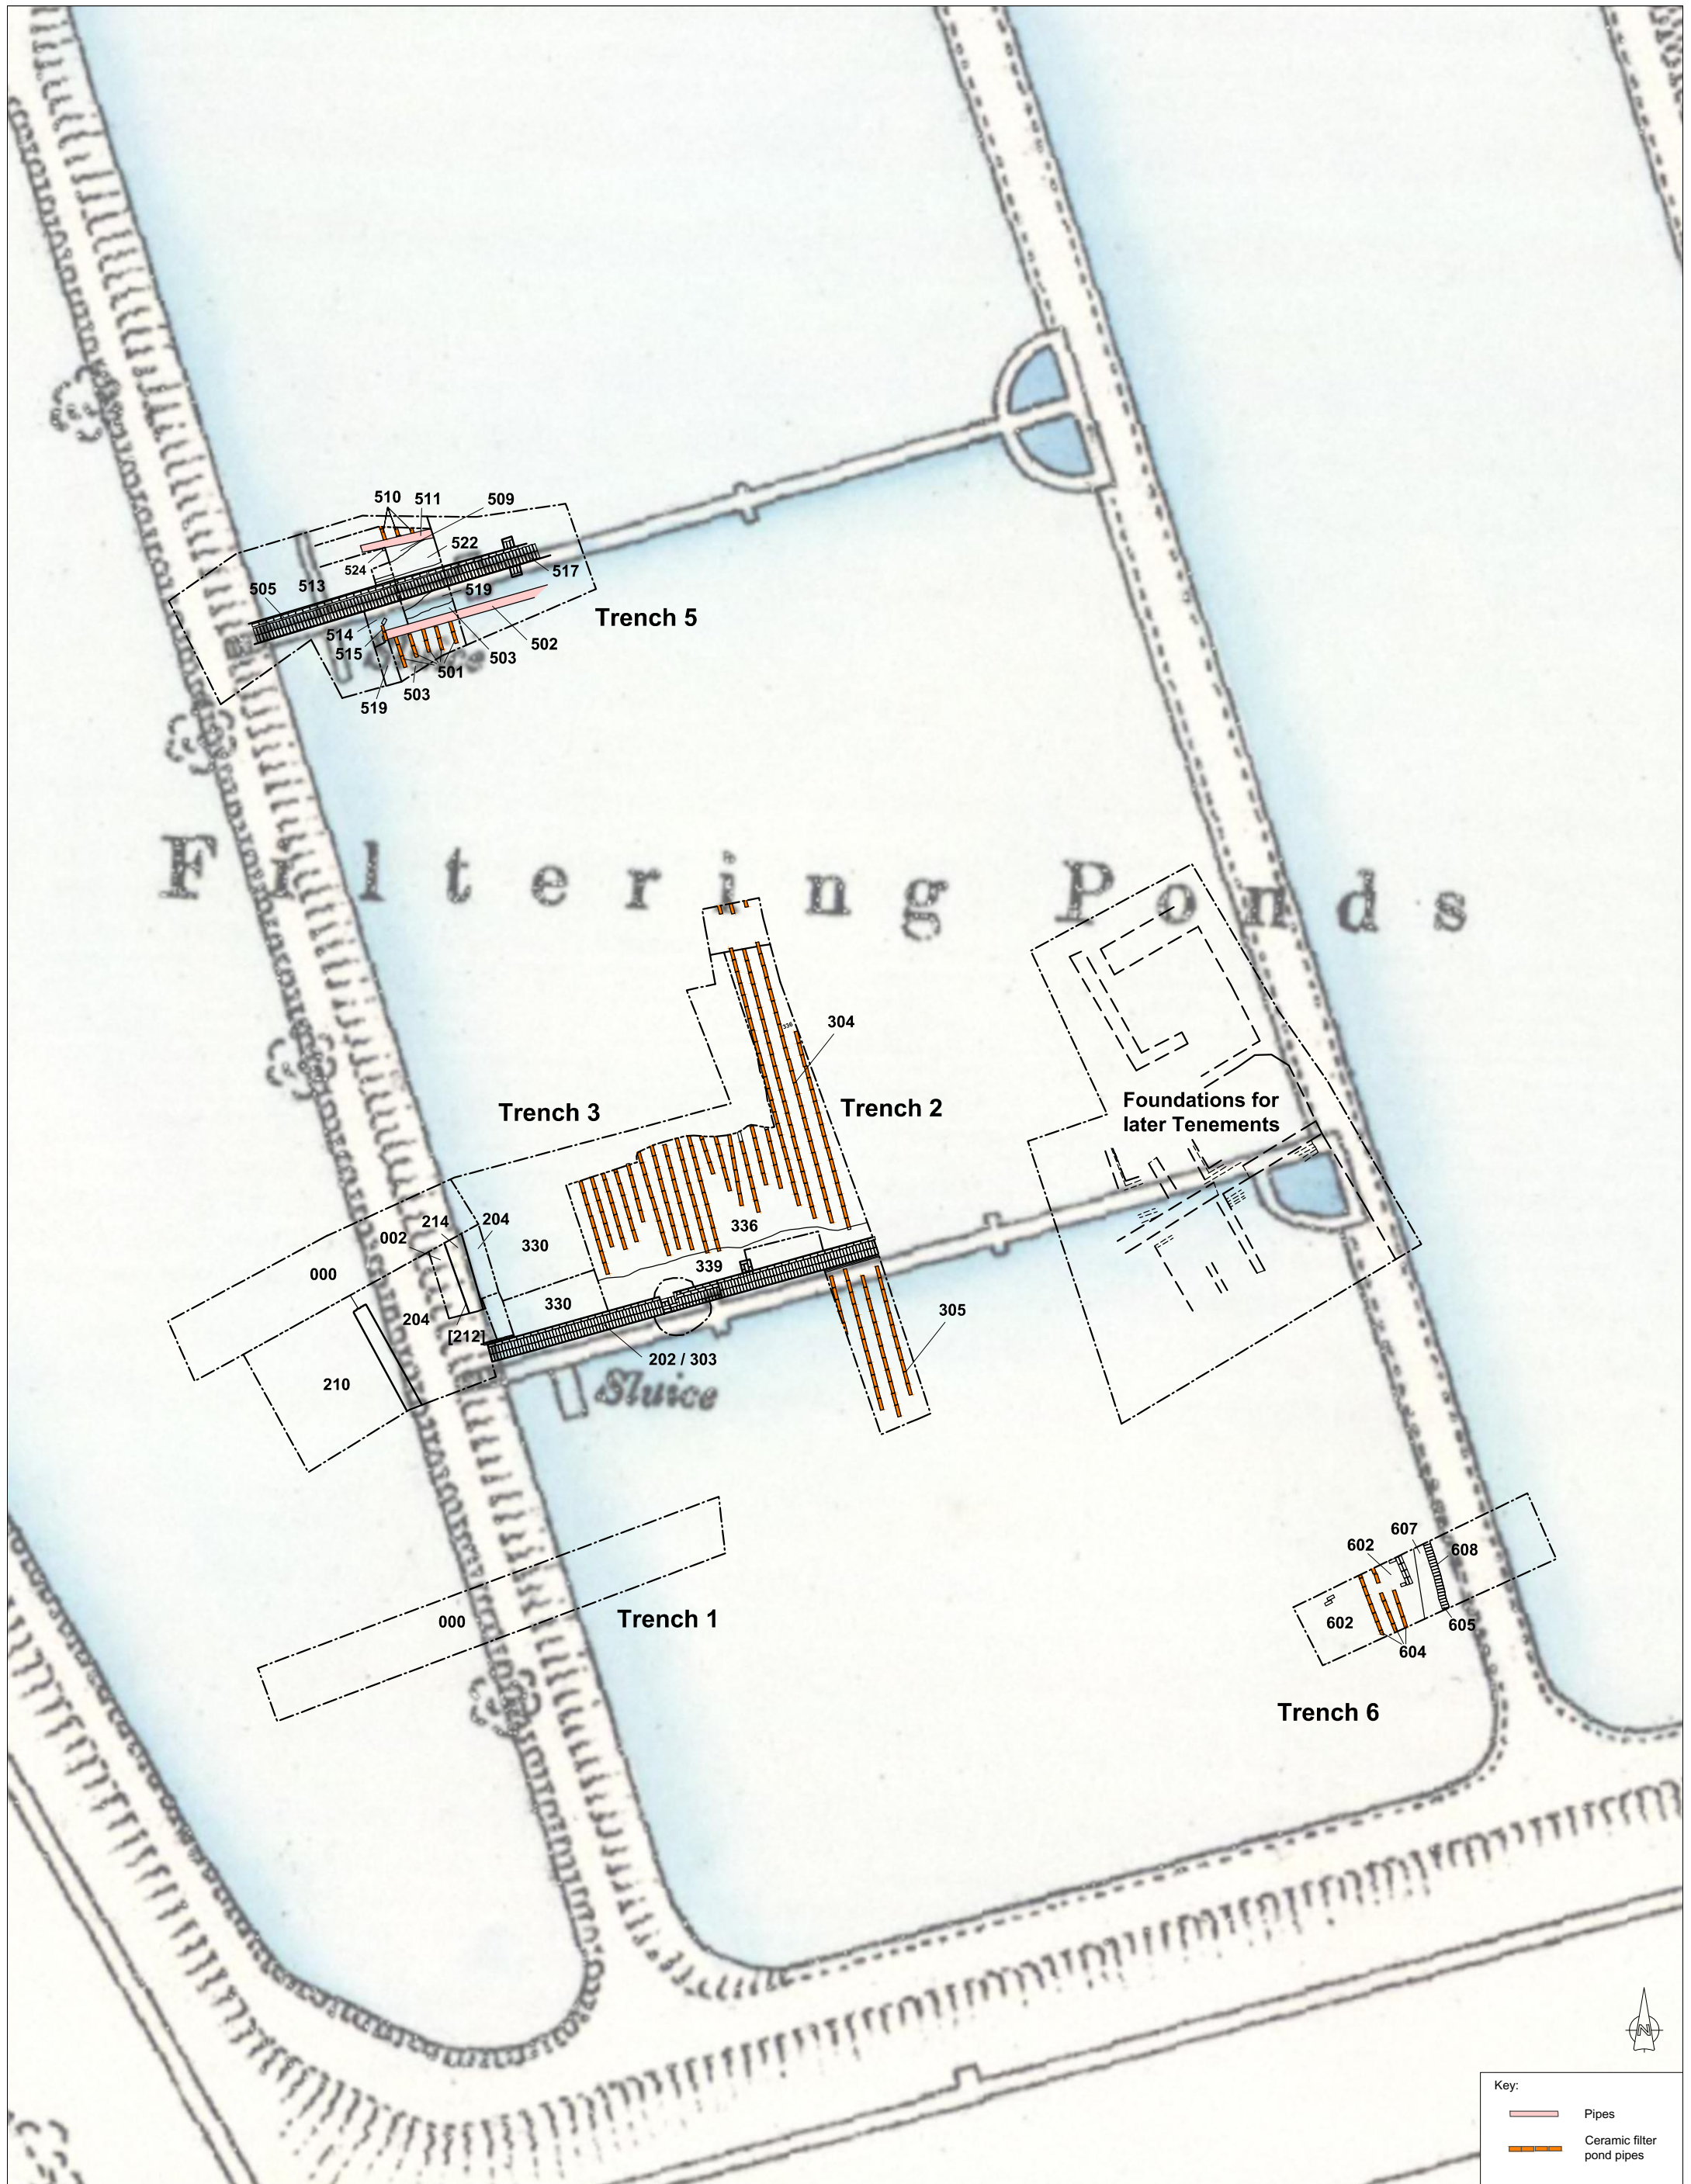
Fig. No:	11	Revision:	A	Drawn by:	TB	Checked:	KH	Report No:	2181	Scale at A3:	1:200
Title:	Structure 10 superimposed on the 1892-4 OS town plan					Project:	Commonwealth Games Village: Dalmarnock, Glasgow; Archaeological Excavation		Client:	City Legacy Consortium	
<p>The copyright in this document (including its electronic form) shall remain vested in CFA Archaeology Ltd (CFA) but the Client shall have a licence to copy and use the document for the purpose for which it was provided. CFA shall not be liable for the use by any person of this document for any purpose other than that for which the same was provided by CFA. This document shall not be reproduced in whole or in part or relied upon by third parties for any use whatsoever without the express written authority of CFA.</p>
