**Residential Housing Development,  
Chapel Lane, Galston,  
East Ayrshire.**

**Archaeological Evaluation**

**Report No. 3118**

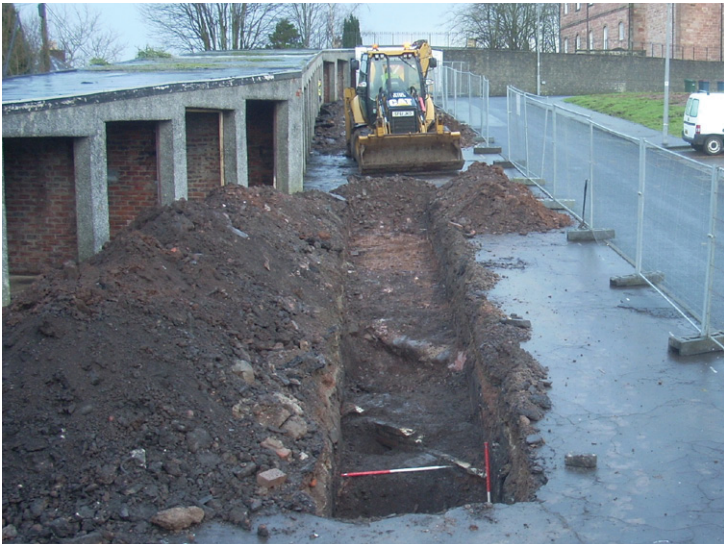
Fig. 5 - Trench 6, boundary walls 028, 029 and 030 from the west

This trench was located at the western end of the garages (Fig. 5). The eastern end of the trench contained deposits as in Trench 5 but to the west, the natural subsoil dipped steeply and up to 1.7m of deposits were present. Three features were recorded; the foundation course of a wall consisting of a mortar-bonded rubble (029) was orientated NE-SW with a second fragmentary alignment (030) parallel on its south-east side. Parallel on the north-west side, a brick wall and buttress (028), three courses high was recorded. On either side of wall (028), grey-black soils (031) were present and these were overlain by a mixture of soil and demolition rubble (032) from which modern and post-medieval finds including a carved column base (or top) were recovered. Natural subsoil (027) was a yellow-grey clay. Walls (028), (029) and (030) were between 1.1m and 0.5m below the modern site surface.

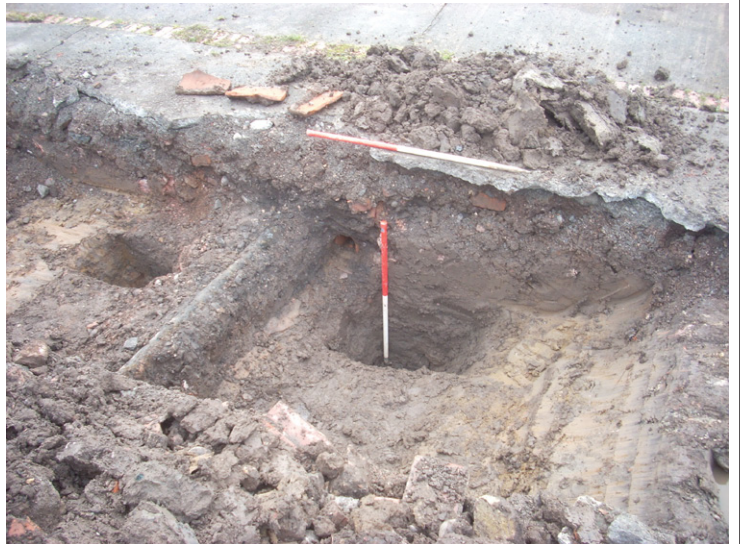
Fig. 6 - Trench 9, ditch 039 from the east with drain 045 and water main 047 through the upper fill

Concrete and modern overburden (042) was present across the trench to a combined depth of c. 0.4m. Below this and cut in to the natural was an east-west aligned ditch (039) (Fig. 6). This had a width of 2.3m and a depth of 1m. The sides were steep and the base appeared to be flat. It was filled with an homogeneous grey sticky clay containing black silty lumps and occasional coal fragments (040). No finds were recovered. The upper levels of this feature had been cut by a drain (045) and a cast iron water main (047). Other modern services were recorded. The natural subsoil (041) was 0.4m below the current site surface and consisted of yellow-grey clay.

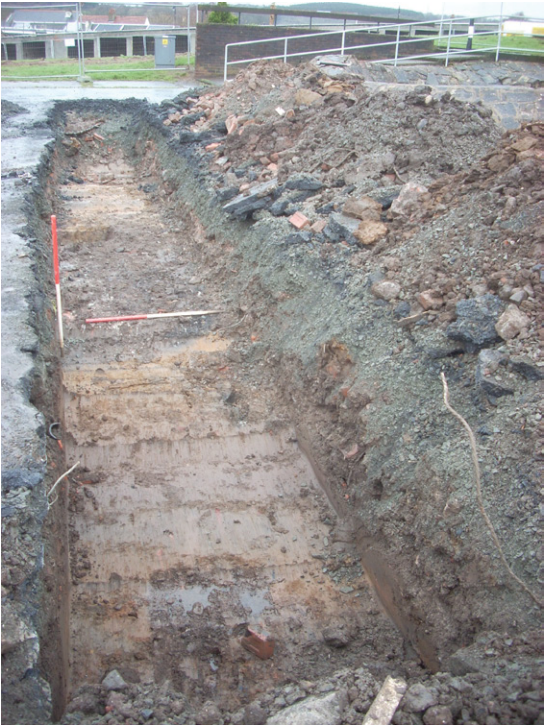
Fig. 7 - Trench 10, ditch (050) in the foreground with large circular feature (048) beyond from the south

Below tarmac and modern overburden (052) was a mixed deposit of soil, bricks and concrete (053). Below this and cut in the natural were two features; a linear ditch (050) (Fig. 7 foreground) which appeared to be a continuation of (039) in Trench 9 and a large possibly sub-circular feature (048) (Fig. 7). The ditch was 1.6m wide and the fill (051) was similar to (040). Just to the north of the ditch was a large possibly circular feature (048). The full extent of this was not uncovered as it ran out of the trench to the east and west. However, the exposed remains exhibited a width of c.4m. A sondage showed that it was over 0.7m deep and that the sides dipped at around 45°. It was filled with alternating layers of brown soil and grey-pink gritty clay-silt (049). Numerous post-medieval sherds of ceramic and glass were recovered. Natural subsoil (041) was identified at 0.5m below the current site surface and was a yellow-grey clay.

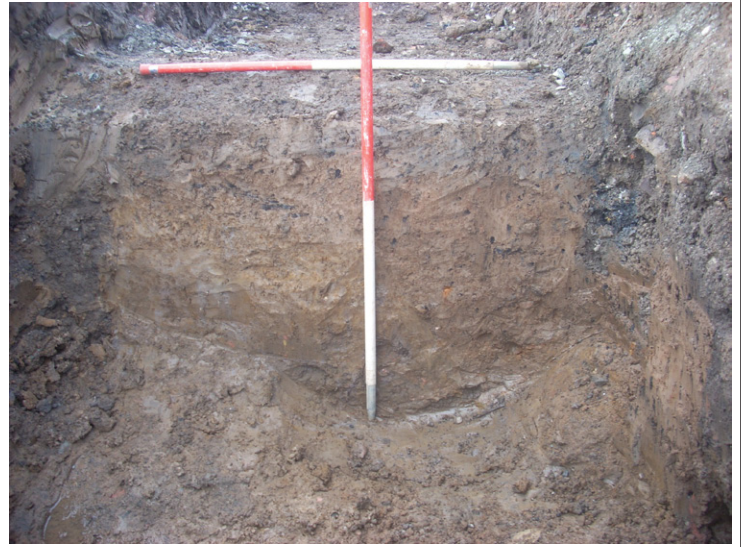
Fig. 8 - Trench 11, ditch 054 from the east

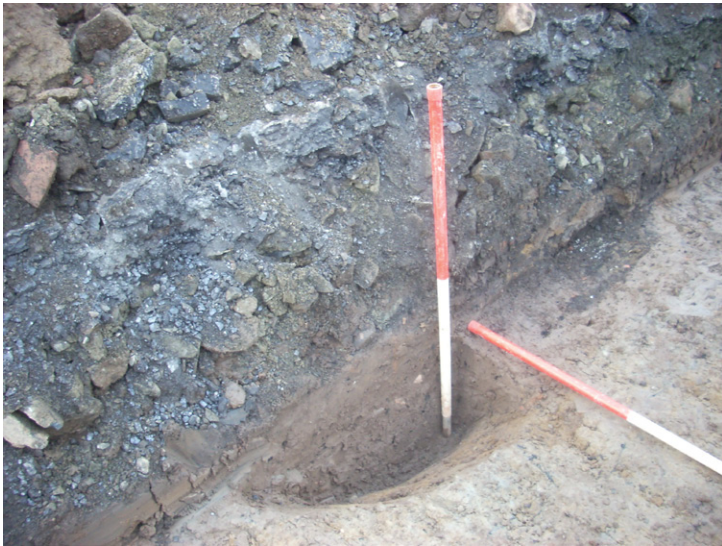
Fig. 9 - Trench 12, east-facing section pit 067

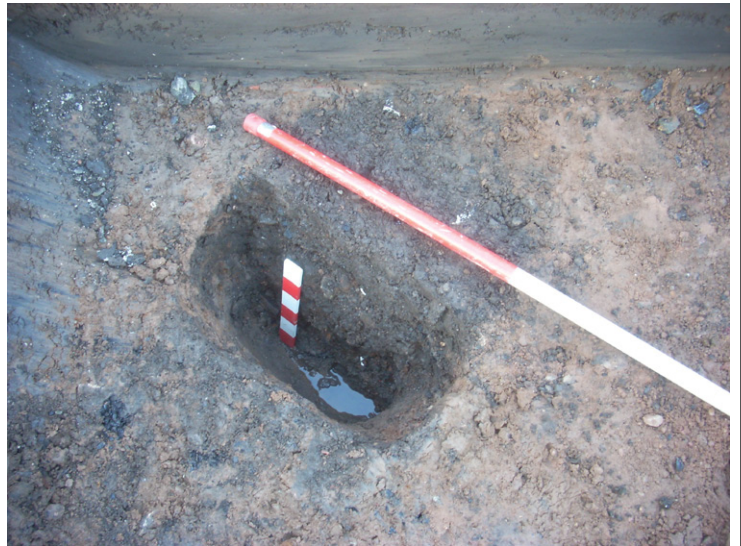
Fig. 10 - Trench 13, pit 077 south-west-facing section

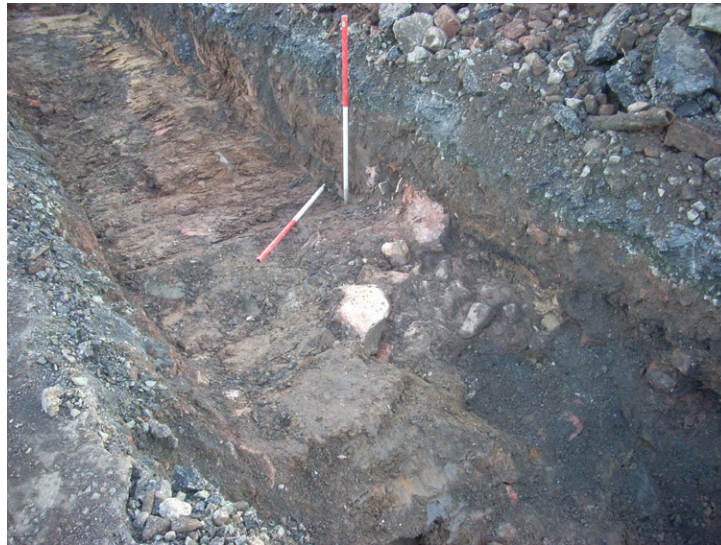
Fig. 11 - Trench 13, boundary wall 081 from the north-west

In eastern end of the trench modern demolition rubble (**080**) was present and covered the remains of the base of a mortar bonded rubble wall (**081**) (Fig. 11) that was founded on natural and a truncated probable ditch (**082**) that cut natural were identified. Wall (**081**) was aligned NNW-SSE. Tightly packed cobbles with a clay matrix (**091**) were preserved on either side of the wall and this deposit contained both modern glass and a sherd of green-glazed late medieval ceramic. The probable ditch (**082**) appeared to be aligned close to east-west. It had been truncated by a modern cut (**084**) on its northern side.

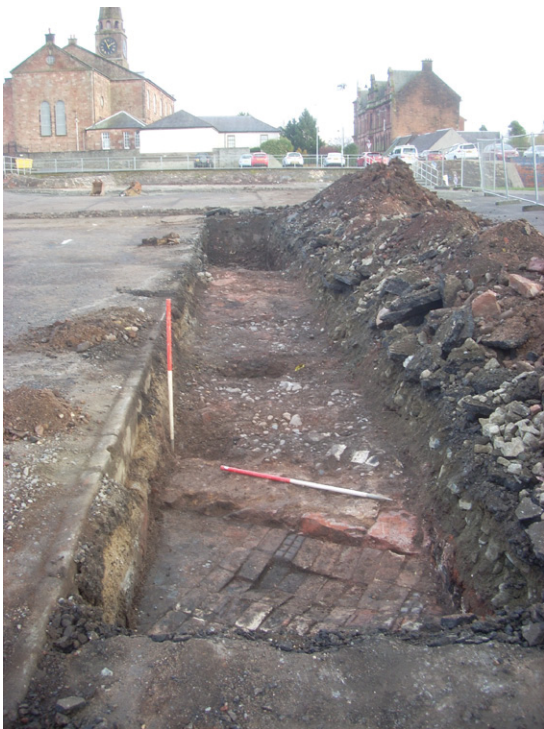
Fig. 12 - Trench 14, brick surface 095 and wall 097 with cobbled surface 098 beyond

A deposit of compacted rubble containing crushed sandstone was present across the trench. It varied in depth from 0.5m at the western end of the trench and 1.1m at the eastern end. At the eastern end it lay directly over natural but at the western end it lay over the truncated remains of a building (Fig. 12). The east and west walls of the building (**097** & **099**) were mortared sandstone. An external brick (**095**) and cement (**096**) surface abutted the western wall (**097**). The bricks were frogged and stamped and presumably 20<sup>th</sup> Century in date. Between the walls a rough rammed surface containing stones was present (**098**) (Fig. 12). Set just out from the eastern wall a large block of sandstone with a metal post in the centre (**100**) was present. This may be the remains of a gate post / fence post for a boundary fence in front of the building.

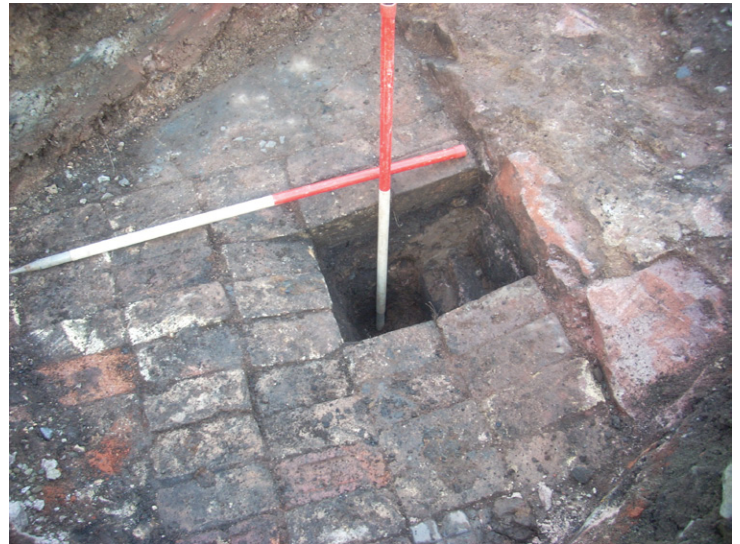
Fig. 13 - Trench 14, sondage through surface 095 showing the deposits 105-7 below

A section (Fig. 13) through the brick surface (**095**) showed that it overlay a dark brown silty sand containing chunks of coal (**105**) and a clay damp proofing deposit
