**Browside Road
Dearham
Cumbria**

Archaeological Strip and Map

Report No. Y137/14

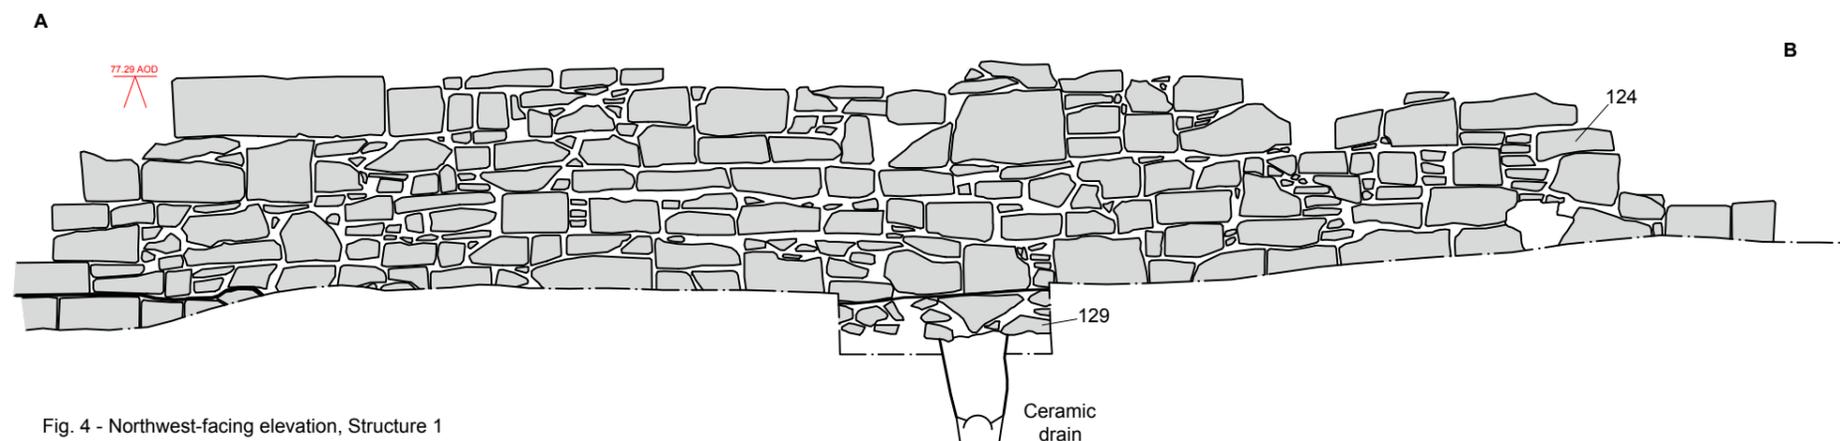
Fig. 4 - Northwest-facing elevation, Structure 1

Structure 1 was the larger of the two identified on historic OS maps (Mann 2013, Fig. 1). The structure was constructed of stone walls (Fig.3; 124 , 125, 126, 127, and 128) that formed a rectangular building measuring 19m by 10m, with three distinct internal rooms, Rooms 1, 2, and 3. The south-eastern wall of the structure continued beyond the excavation area.

The walls were in varying states of survival, with the north-western elevations of the building surviving to a height of 1.1m in places (Plate 2), while the south-western elevations only survived to a height of 0.34m. The walls were 0.60-0.65m wide and constructed from irregularly-sized blocks of stone, bonded by a crude cement mortar, with a slight facing to the exterior. The foundations were 0.2-0.25m in depth and constructed of similarly shaped, unbonded stone blocks (Plate 3).

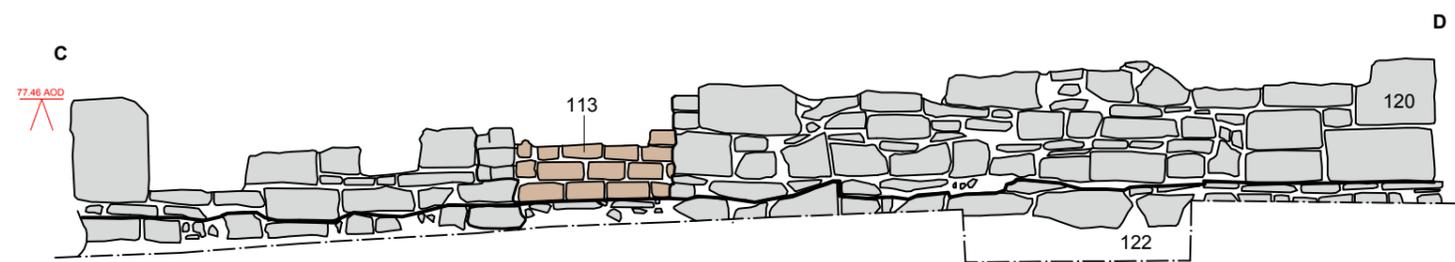
Fig. 5 - Southwest-facing elevation, Structure 2

Structure 2 was the smaller of the two excavated buildings (Plate 8) and was to the south-east of an old mine shaft identified on historic OS maps (Mann 2013, fig.1). The structure itself was constructed of stone walls (Fig.5; 103, 104, 119 and 120) that formed a roughly square building with measuring around 7.15 by 7.7m, with an internal area of 37m².

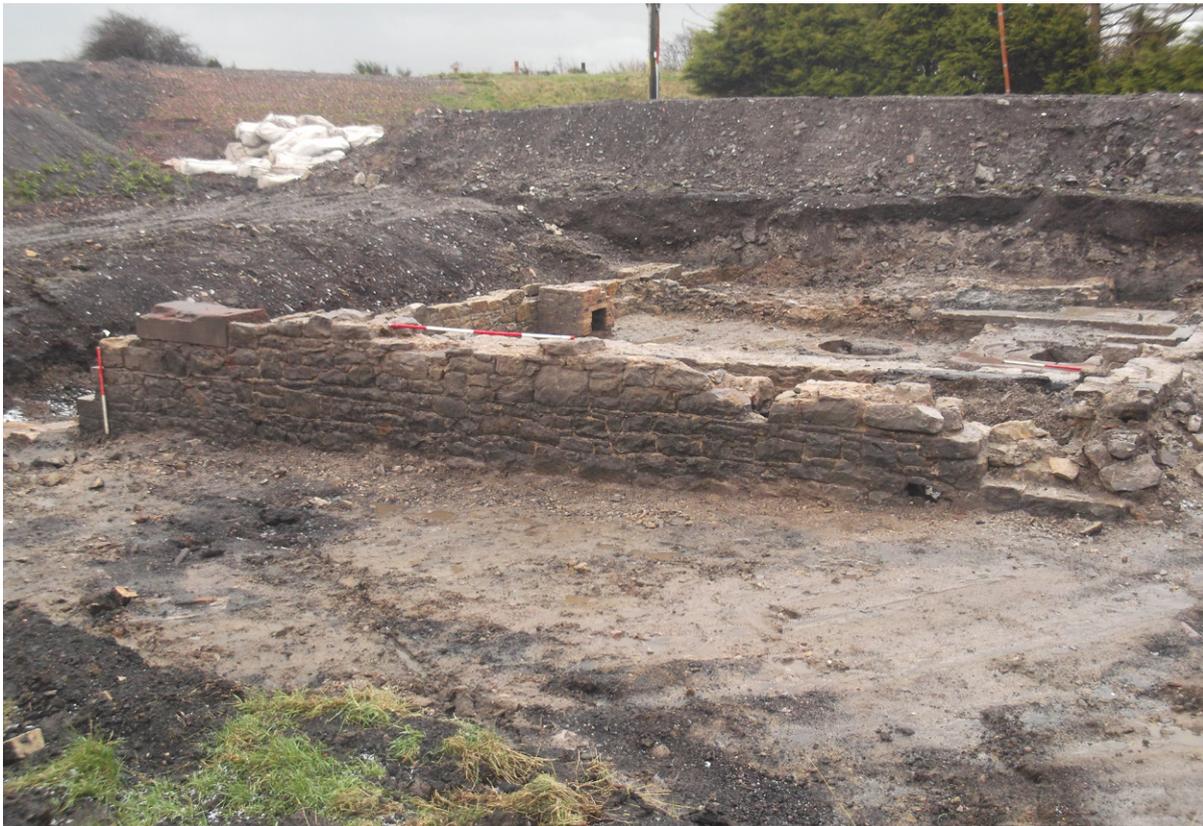
Plate 2: North-west facing elevation of Wall 124, Structure 1

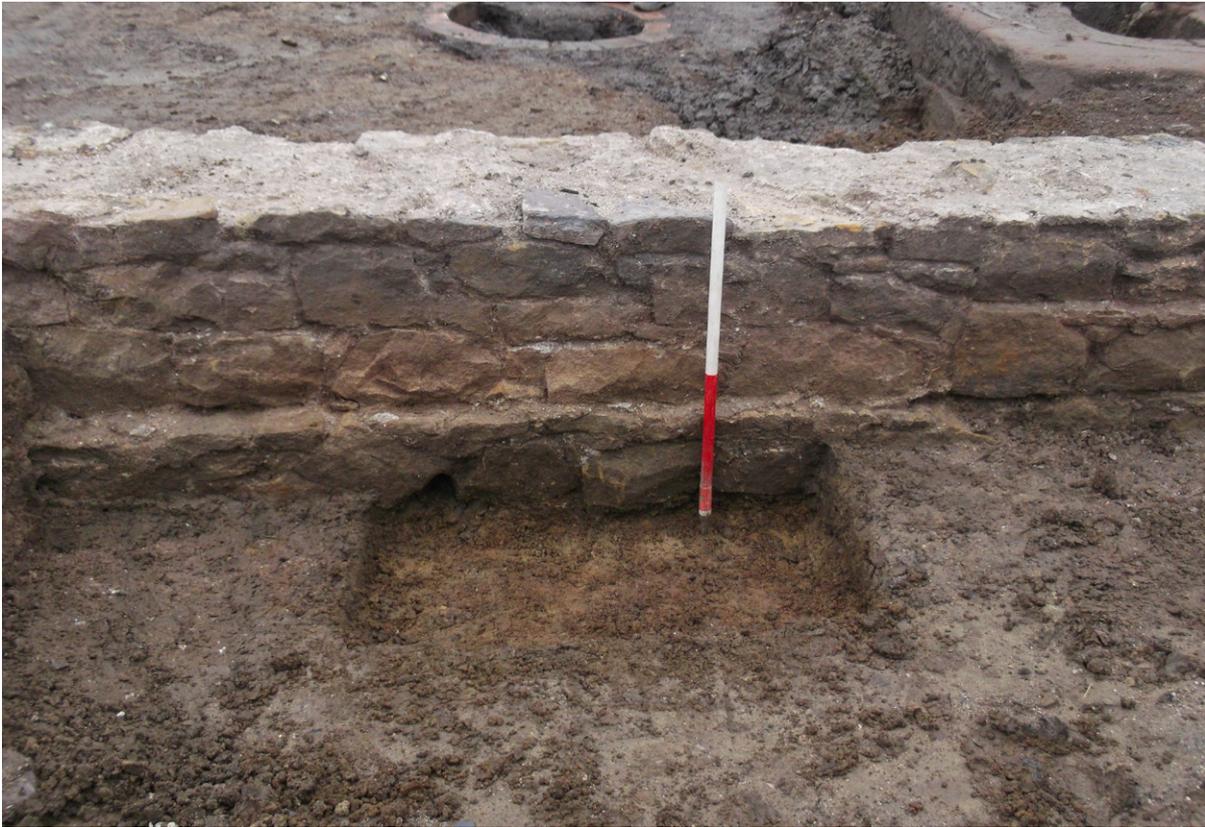
Plate 3: Foundations of north-west facing elevation of Wall 127, Structure 1

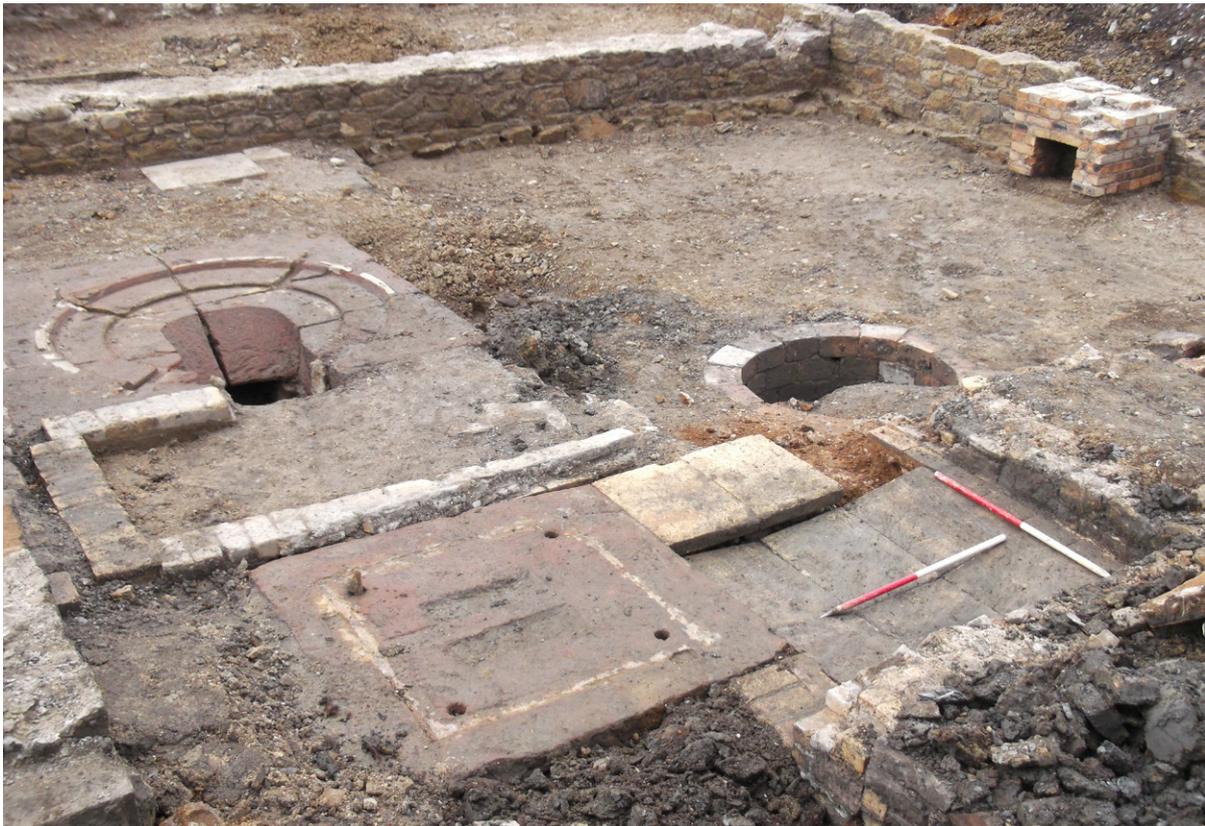
Plate 4: Machine bases 134 and 138, Well 135, and Floor 139, interior of Structure 1

Of the two internal rooms, the larger, Room 1 contained a number of structural features relating to mining (Plate 4). Butting Wall 128 towards the southwest of the building, and adjacent to the likely entrance to the structure, was an area that contained two large machine bases (134 and 138), a well (135), and associated floor surfaces. The two machine bases were constructed of large, shaped sandstone blocks with carved/grooved areas for the fixing of machinery.

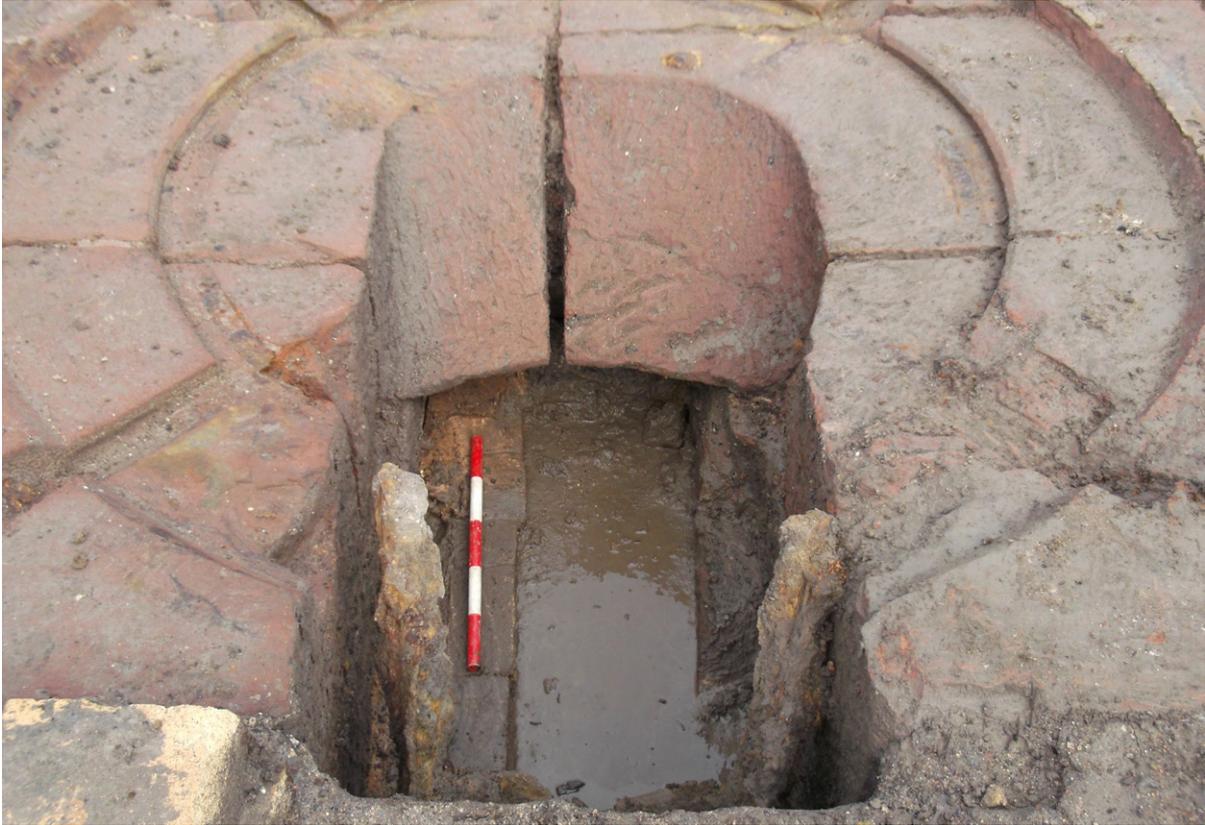
Plate 5: Machine base 134, close up of interior

The largest of the two, base 134, measured 2.45m in length by 2.3m in width and had two courses of the sandstone blocks with a height of 0.8m. The top of the base was carved with a roughly circular groove, with a deeper cut to the southeast of the feature into which machinery could have been fixed (Plate 5).

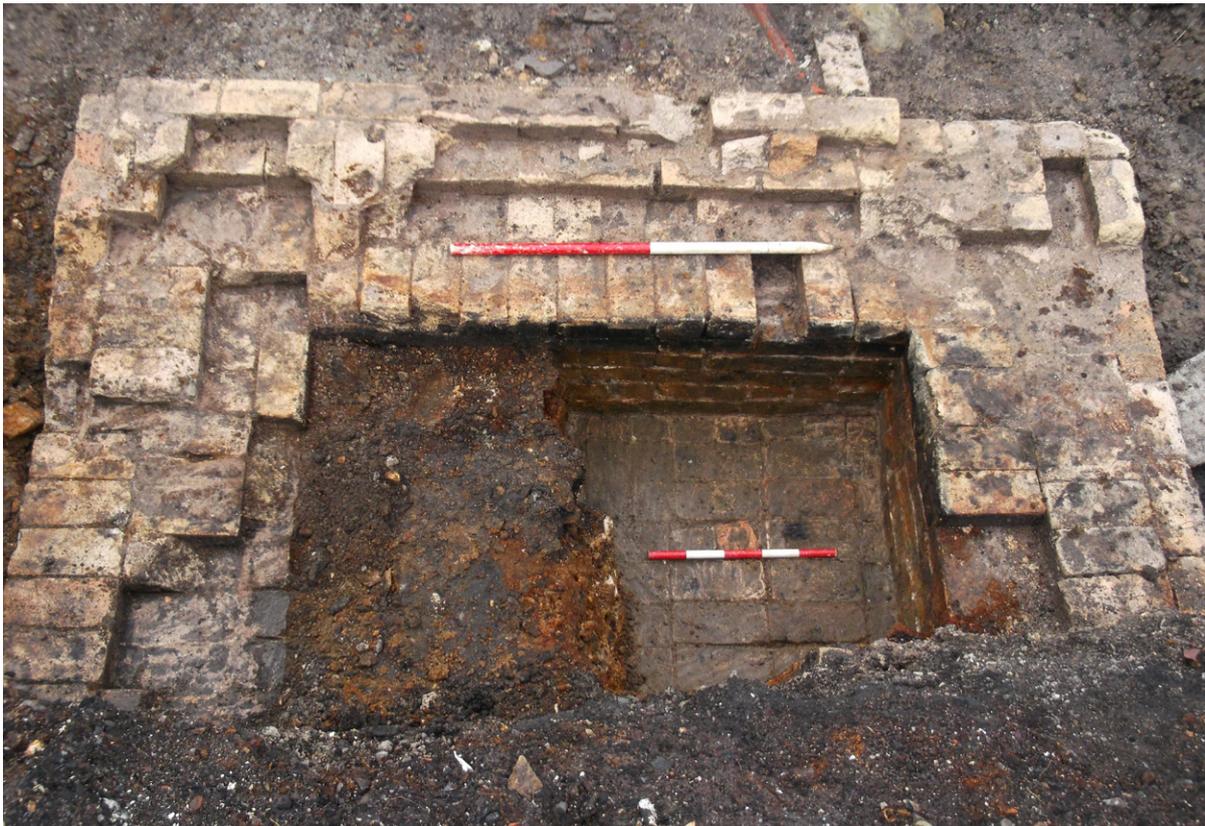
Plate 6: Chimney base 123, exterior of Structure 1

Adjacent to the north-eastern corner of the Structure 1 were the foundations of what appeared to be a brick-lined chimney/fireplace (123) measuring 2.73m by 1.7m. This was not part of the original fabric of the building, rather a later addition (Plate 6).

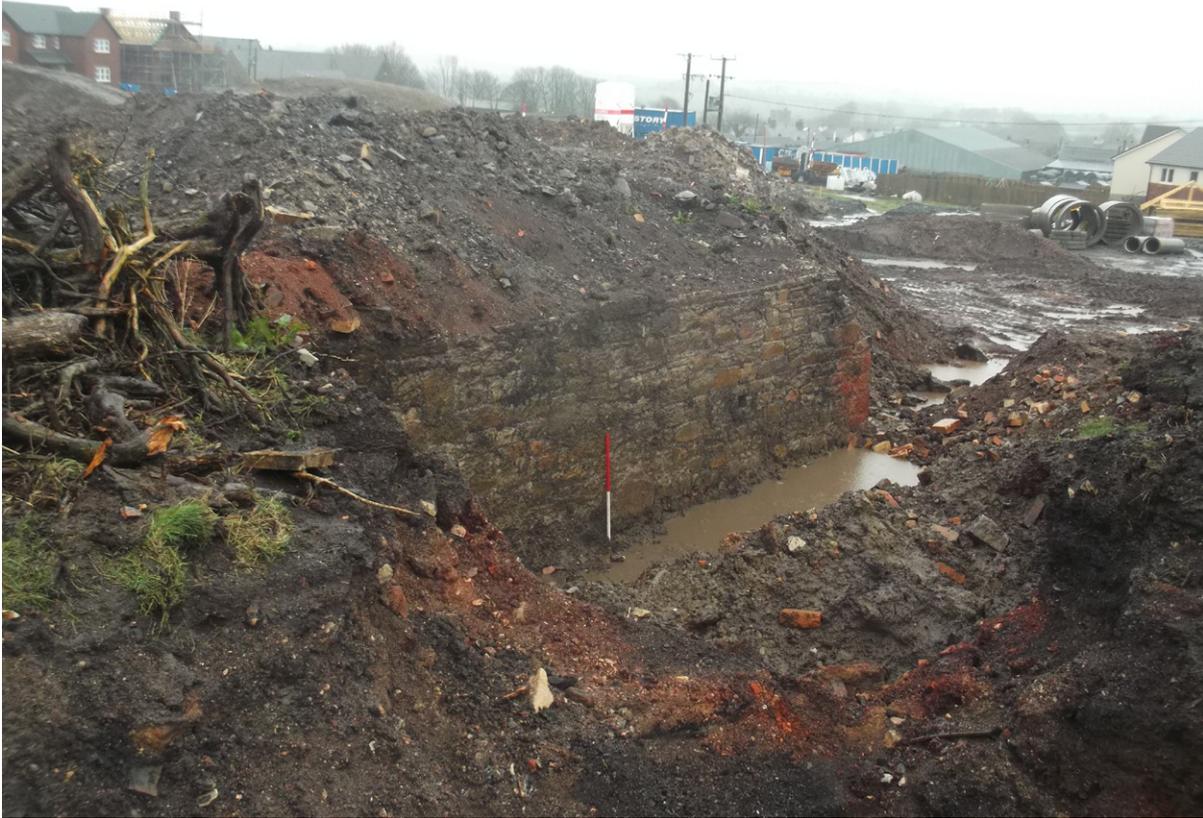
Plate 7: Large wall to north-east of excavation areas

Other remains included a brick-lined drainage channel (137) on a north-west to south-east orientation, south of Structure 1 and a large stone wall to the northeast revealed below the spoil mound (Plate 7). This wall, which survived to a height of 4m ran north-east to south-west before turning north-west

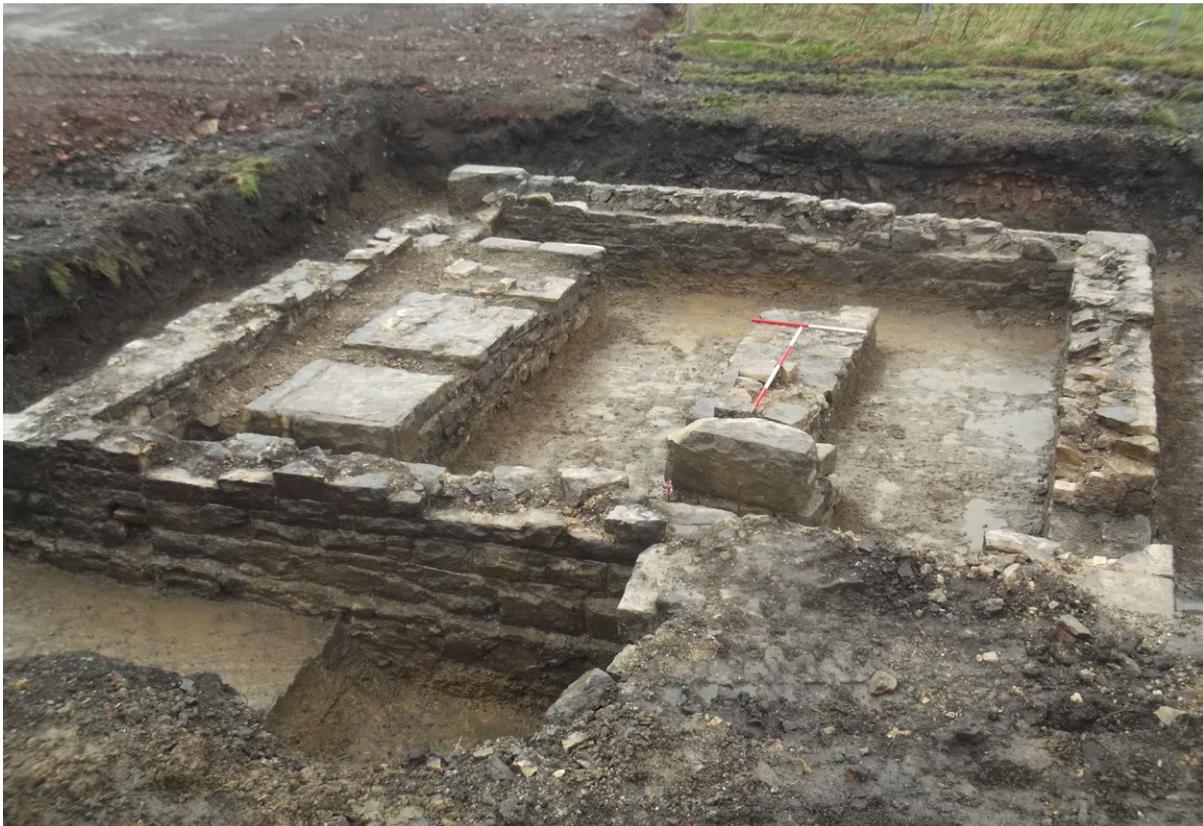
Plate 8: Structure 2, looking to the north-west

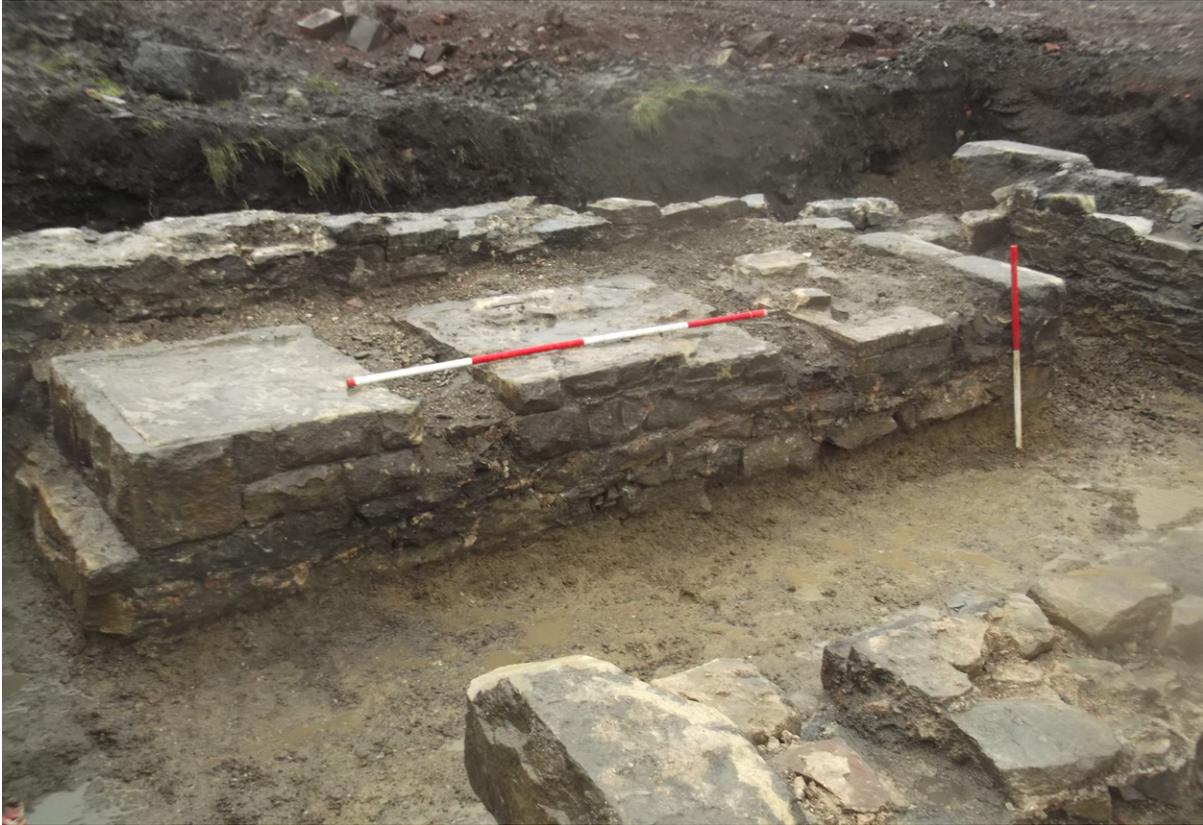
Plate 9: Probable machine base formed by walls 108-112, interior of Structure 2

Within the structure were two large stone built foundations or platforms. The best preserved of these was towards the south-western side of the structure and was formed by stone walls (108-111) resting on a flat, stone foundation course (Plate 9, 112). The platform itself measured 4.5 by 1.2m and survived to a height of 0.6m. The stone walls formed a series of grooves or channels within which it is possible machinery or large pieces of mining equipment could have been mounted.

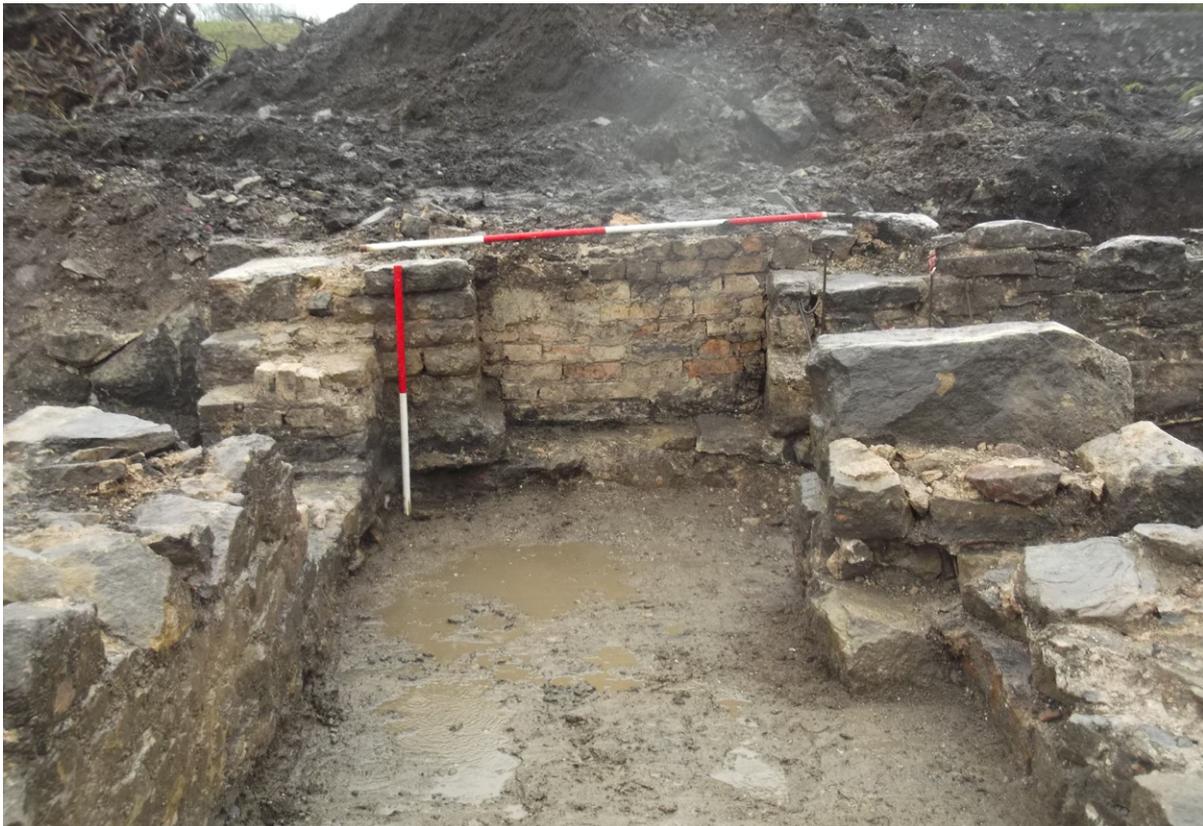
Plate 10: Blocked doorway (114), interior of Structure

There appeared to have been some re-use or later alterations to the structure. The original entrance to the structure, as indicated on the old OS maps of the area, to the south-east had been blocked up with bricks (Plate 10, 114), while the south-west facing elevation of the wall also appeared to have a bricked up window/entrance (113). In addition to this a portion of the north-eastern facing elevation of the wall had been removed, possibly to form a new entrance to the structure at this point (Plate 11).

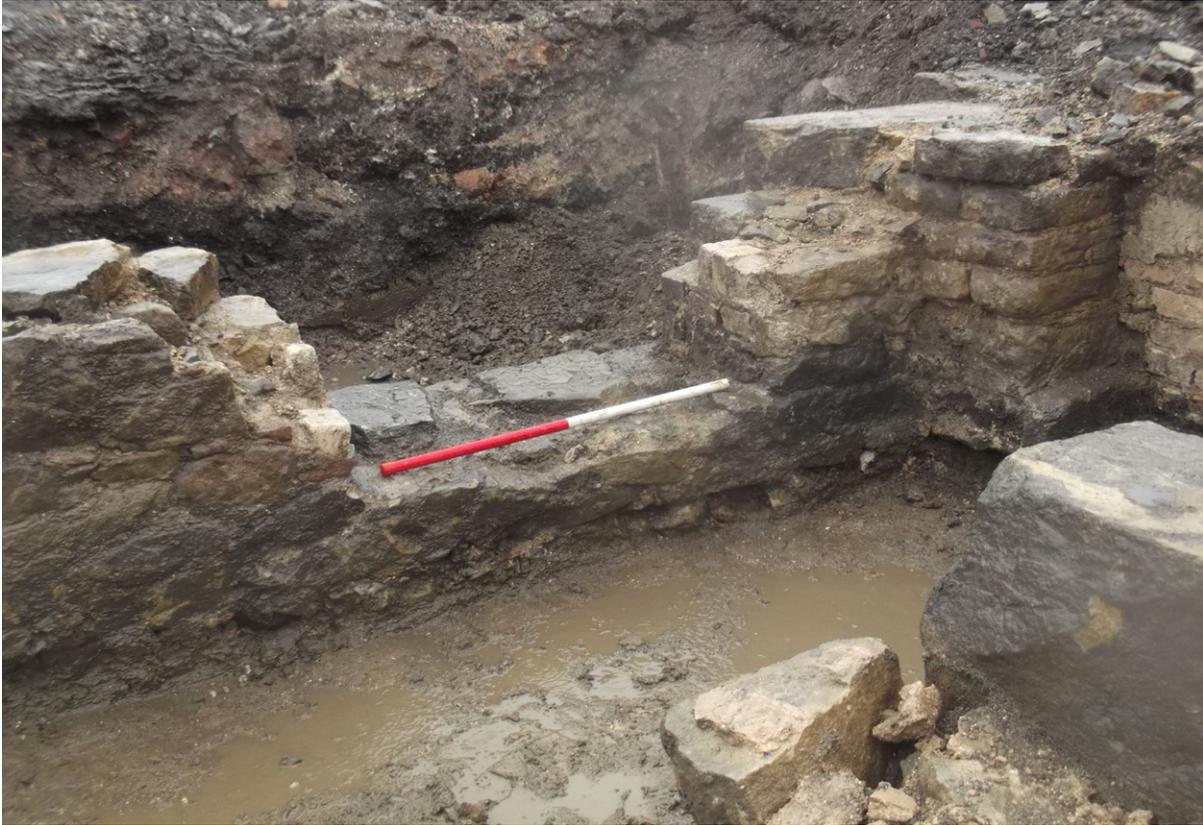
Plate 11: Probable entrance within Wall 119

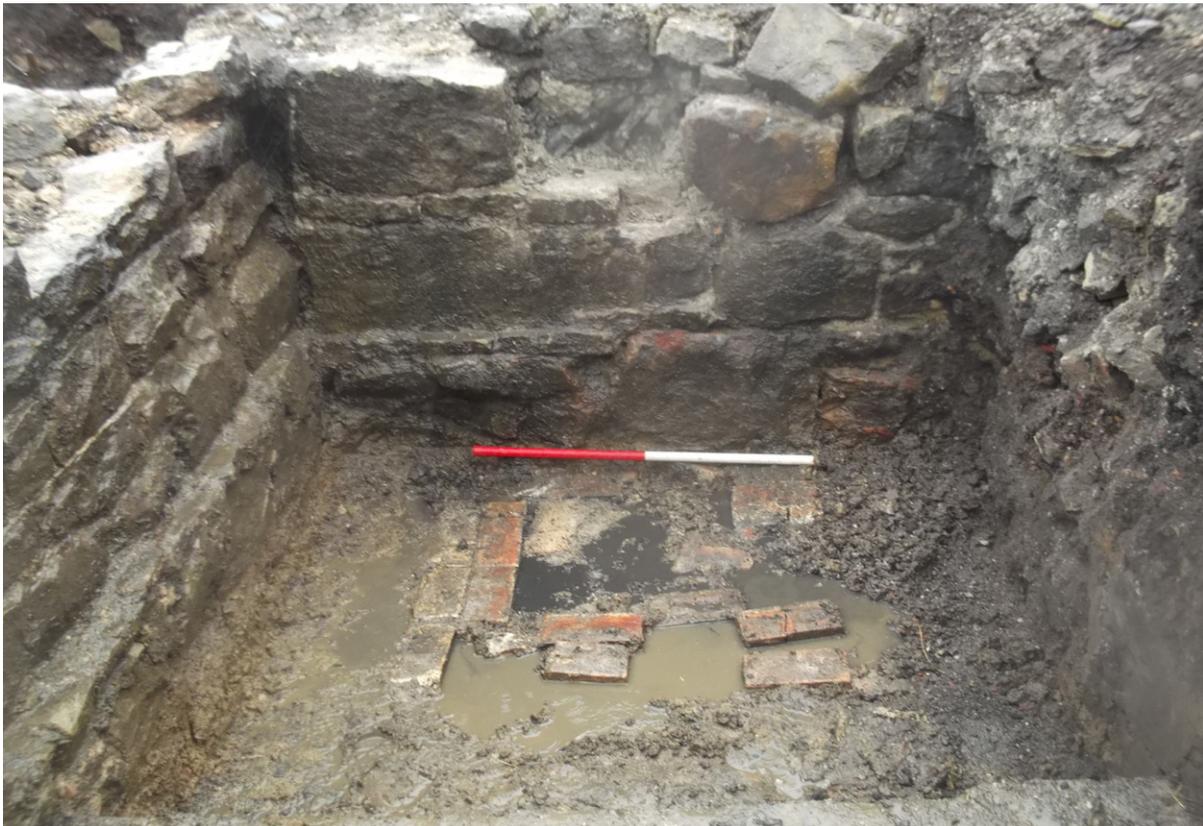
Plate 12: Brick drain 117 and Wall 118, exterior of Structure 2

These changes may have been made during the construction of a possible later building to the south-east, portions of which were excavated. Walls 115 and 118 formed two sides of a possible building that butted Structure 2 on its south-east facing elevation and continued beyond the limits of the excavation, while a likely brick drain/outhouse (117) was excavated to the immediate south-west of wall 118 (Plate 12).
