5, 15 and 15A Bonnington Road Edinburgh

Archaeological Evaluation

Report No. 3503

CFA ARCHAEOLOGY LTD

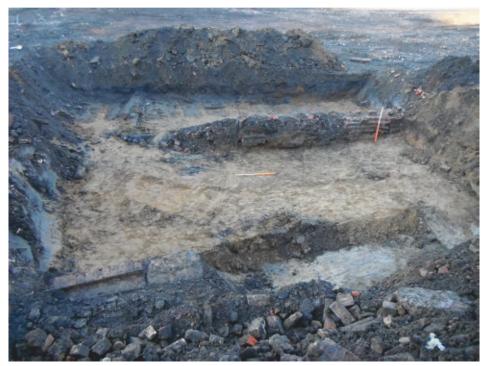
Fig. 17 - General view of Trench 1 from the south

Trench 1 measured 10m by 10m and was excavated to natural sand at a depth of 0.9-1.4m (Fig. 17). Consultation of the early map editions suggested that this part of the area had been developed by 1908 (Ordnance Survey 1908) and was occupied by buildings associated with the Albion Boiler Works. Prior to the development of the Albion Boiler Works, this area was part of the formal garden associated with Bonnington House (Ordnance Survey 1852 (Fig. 2).

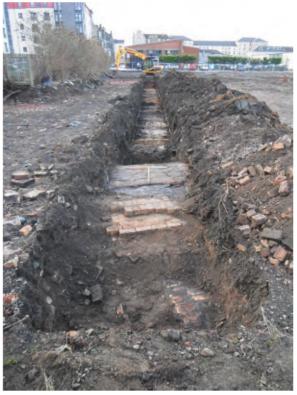
Fig. 19 - General view of Trench 2 from the north-east

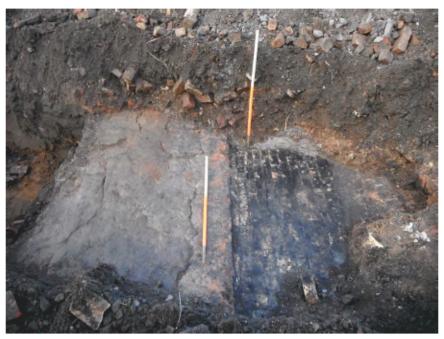
Fig. 20 - Edge-set bricks 201 and wall foundation 203 from the south-east

This trench contained a number of features probably associated with the Albion Boiler Works including brick features, possibly surfaces or upper parts of flues (201 & 202), (Fig. 20) and 210 (Whitehill and re-used unfrogged bricks), a stone wall foundation (203) (Fig. 20) and two concrete surfaces (204 & 206). A mortar bonded stone culvert (205) and a clay-piped drain (209) are probably earlier features associated with Bonnington House gardens as are a number of narrow cut linear features (207) (Fig. 21) which were similar in nature to 102.

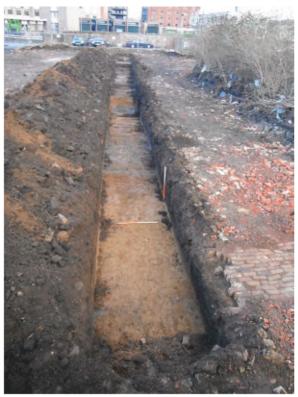
Fig. 21 - General view of Trench 2 from the south-west showing the narrow linear features (207) similar to 102 in Trench 1

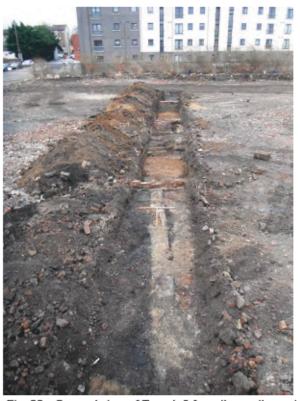
Fig. 22 - General view of Trench 3 from the north-west

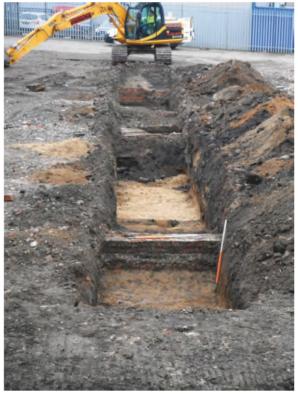
Fig. 23 - Wall 301 from the south-east. Same as wall 101 in Trench 1

This trench contained a number of features including a brick wall foundation (301) (Fig. 23) (Hunter bricks), a narrow ditch (302) (Fig. 24) a recent brick and cement wall foundation (306), two mortar-bonded sandstone wall foundations (307) (Fig. 25) and 312 (Fig. 26), a concrete slab (308), a sandstone plinth (309), a single layer of bricks (310) (Prestongrange bricks), a further brick wall foundation (311) (Newbattle bricks), and a stone built culvert drain (313). Features 307-312 are considered most likely to relate to the bonded store, while Wall 301 was of the same construction as Wall 101 (Trench 1) and is considered likely to relate to the Albion Boiler Works. Wall 306 related to the recently demolished buildings which sat on a similar footprint to the earlier bonded store / warehouse.

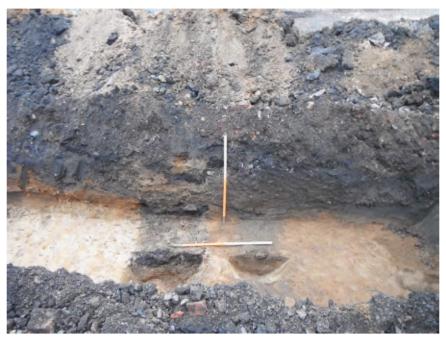
Fig. 24 - Ditch 302 cut by drain 304 from the south-west

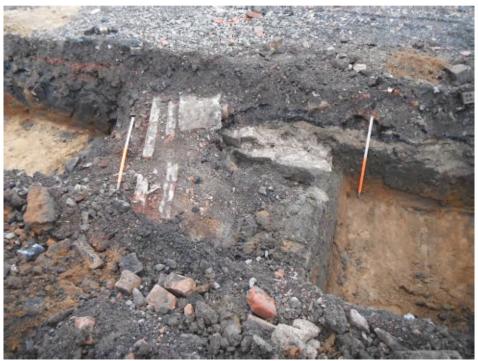
Fig. 25 - Mortar-bonded sandstone wall 307 running under brick and concrete wall 306 from the east-north-east

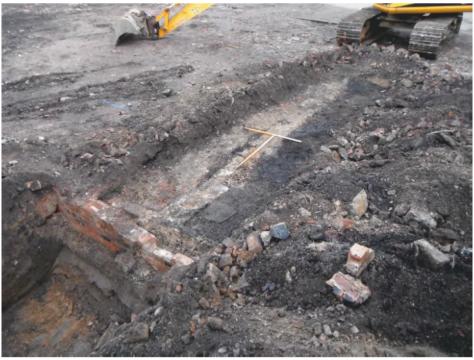
Fig. 26 - The north-west end of the trench from the south-east. Mortar-bonded sandstone wall 312 running alongside brick and concrete wall 311

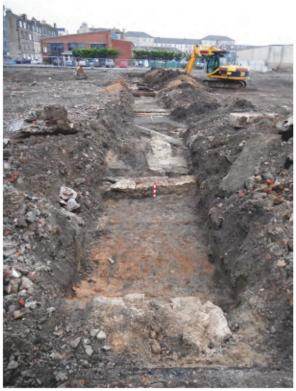
Fig. 27 - General view of Trench 4 from the north-east

A number of features were identified including mortared sandstone wall foundations (401, 403, 406, 412, 422 & 424) (Figs. 27 & 28). A mortar or plaster floor foundation (409) (Fig. 29) abutted wall 412. The trench also contained two sandstone plinths (418 & 419), the former (Fig. 30) was topped by a circular base for a metal column. Two brick wall foundations (410 & 415), and concrete surfaces (411 & 428) completed the features. The stone wall foundations and plinths are thought to relate to the bonded store. The brick walls were constructed from bricks stamped Whitehill which were produced between 1890 and 1950 and consequently are unlikely to have been part of the original fabric of the building (first depicted on 1852 Ordnance Survey Town Plan).

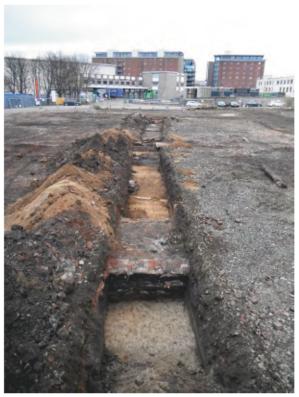
Fig. 28 - General view of Trench 4 from the south-west with parallel walls 422 and 424

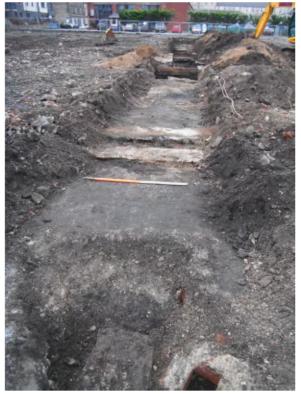
Fig. 29 - Mortar floor 409 cut by brick wall 410 and overlain by concrete 411

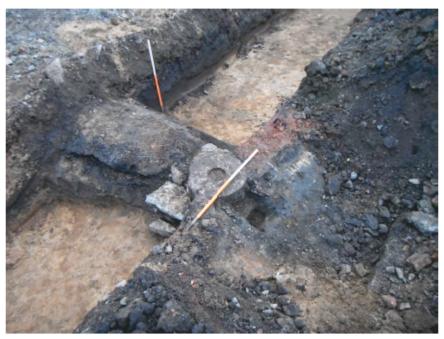
Fig. 30 - Mortar-bonded sandstone plinth 418 from the north-east

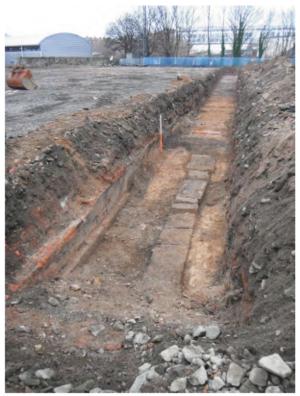
Fig. 31 - General view of Trench 5 from the south-east

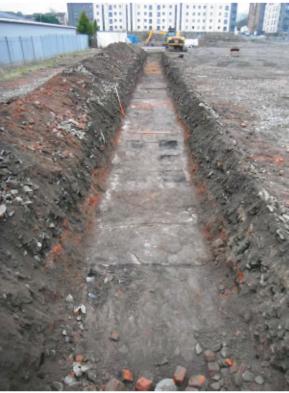
Fig. 32 - General view of Trench 5 from the north-west

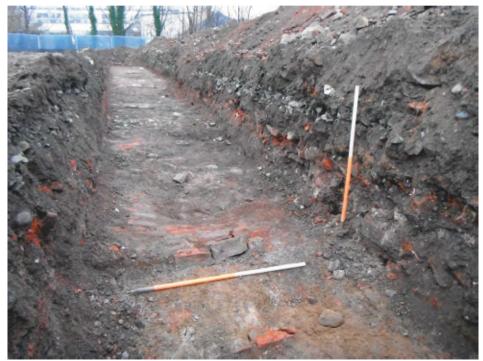
Fig. 33 - Brick wall 516? and possible circular brick feature 517 from the south-east

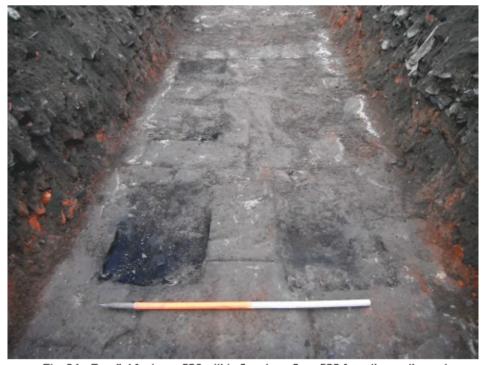
Fig. 34 - Parallel features 526 within flagstone floor 520 from the north-west

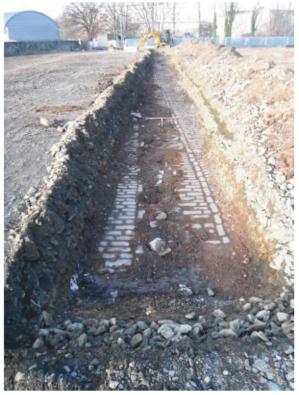
Fig. 35 - General view of Trench 6 from the south-east

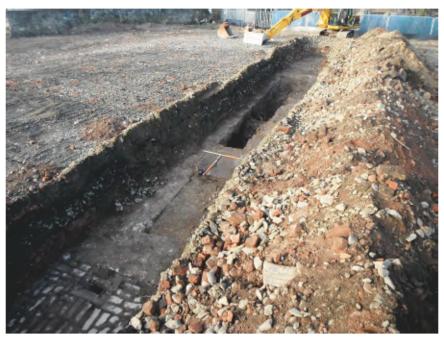
Fig. 36 - The northern end of Trench 6 from the south-east

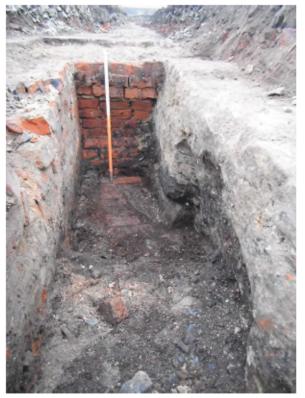
Fig. 37 - Brick-lined pit 604 within the mortared sandstone building foundations from the north-west

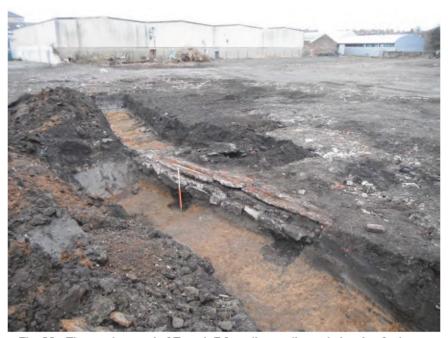
Fig. 38 - The western end of Trench 7 from the south-west showing features 711, 713 underlying mortared sandstone wall 709 which is under brick and concrete wall 710

At the western end of the trench, outside the area of the bonded store, four shallow cut drains (701, 703, 705 & 707) were filled with pebbles, ash and broken pantiles. Underlying the sandstone wall foundation of the bonded store (709) were the terminals of two very similar features (711 & 713) (Fig. 38) containing shale, ash and stone fragments. No finds were recovered. Several of the bonded store's internal wall

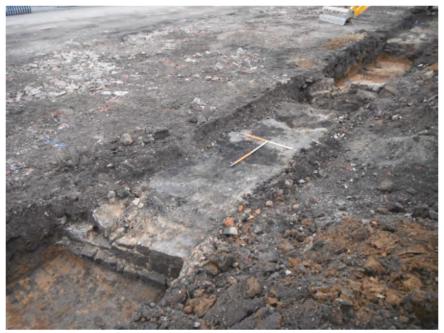
Fig. 39 - Sandstone walls 715, 717 on either side of mortar floor 716 from the west-south-west

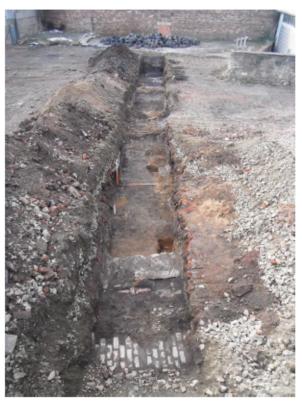
Fig. 40 - General view of Trench 8 from the north-east

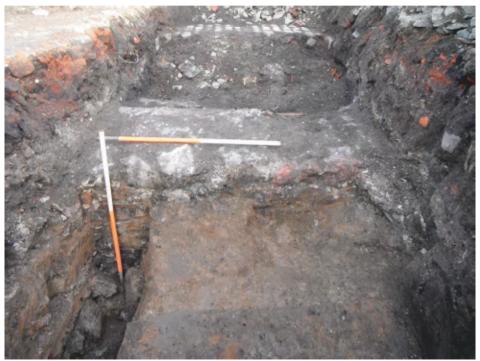
Fig. 41 - Mortar bonded sandstone wall 802 from the south-west

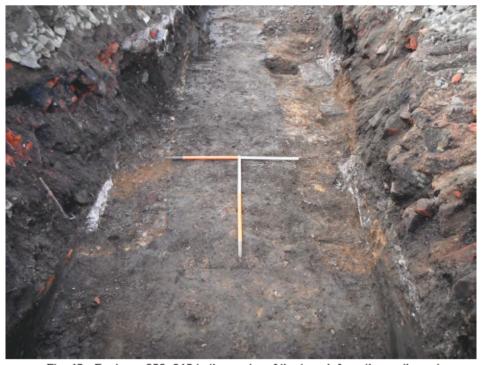
Fig. 42 - Features 809, 810 in the centre of the trench from the north-east

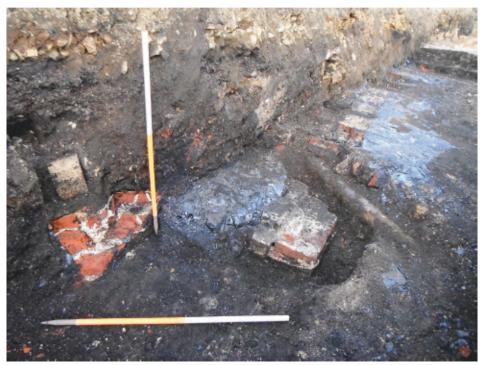
Fig. 43 - Brick-lined Tar Tank 828, 833 from the south-west

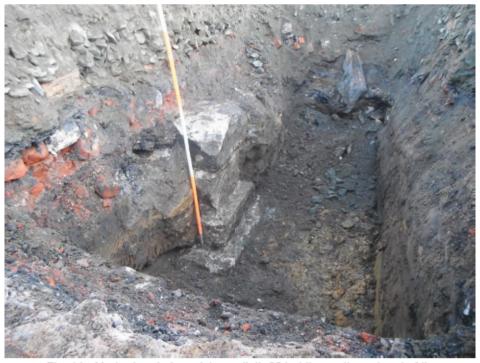
Fig. 44 - Mortar bonded sandstone plinth 904 at the north-east end of the trench from the west

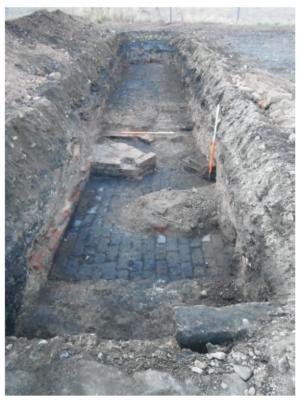
Fig. 45 - Mortar-bonded sandstone walls 906, 907, brick floor 910 and brick walls 908, 909 at the south-west end of the trench from the north-east

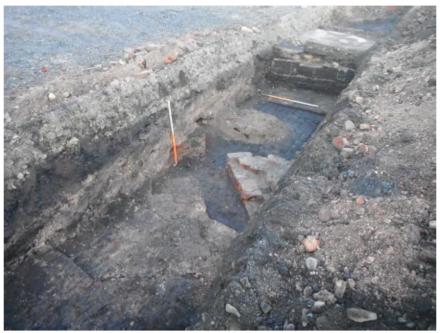
Fig. 46 - Mortar-bonded sandstone walls 906, 907, brick floor 910 and brick walls 908, 909 at the south-west end of the trench from the south-west

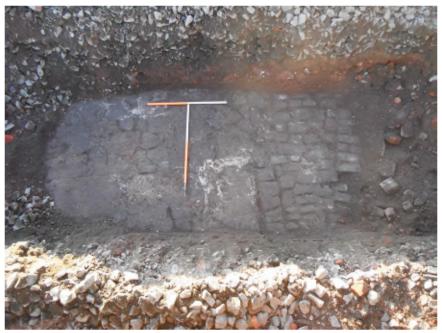
Fig. 47 - Plan view of paving 1001, wall 1002 and cobbles 1003 from the north-east

The features identified within this trench consisted of a mortared sandstone wall foundation (1002), probably representing part of the external wall of Bonnington Mill. To the north-west of this wall was an external cobbled surface (1003) and to the south-east there was an internal floor surface consisting of sandstone paving (1001) (Fig. 47). The test-pit cut through the external cobbled surface and identified that these had been constructed on top of railway sleepers laid on an ash ballast deposit (1005) which overlay made ground (1004) and building rubble (1006) at a depth of 2m (Fig. 48). The ash and railway sleepers are assumed to be part of a railway line shown in 1933 and if this is the case, the cobbles above must have been laid after this. By extension this would suggest that the cobbles at the northern ends of Trenches 5 & 6 were also probably post 1933. Waterlogged natural sand with a strong hydrocarbon smell was identified within the test-pit at a depth of c.3.3m.

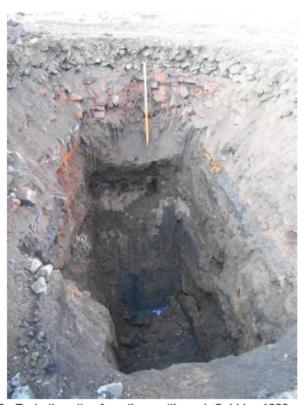
Fig. 48 - Test-pit section from the souith-east. Cobbles 1003 are under the brick layer

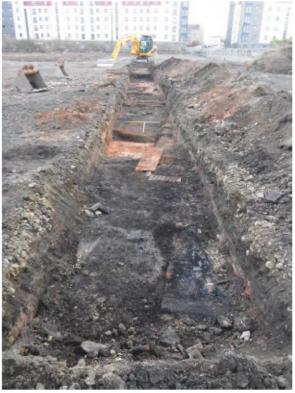
Fig. 49 - General view of Trench 11 from the north-west

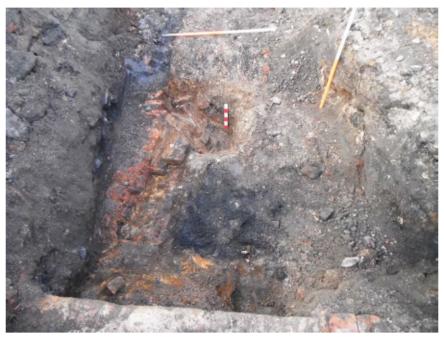
Fig. 50 - Features at the south-east end of the trench from the south-east. Including brick walls 1102, 1103 and the curve of bricks (flue) 1104 sweeping upwards into a possible chimney

This trench contained numerous features including brick wall foundations (1102 & 1103) (Fig. 50), (1120) (Fig. 54), (1125 & 1127) (Fig. 55) and (1132) (Fig. 57) brick surfaces (1101 & 1115) (Fig. 52), a flue system (1104 & 1108) (Fig. 51) and (1126) (Fig. 56), brick/stone structures (1110 & 1113), and two buried metal containers (1116 & 1122). One of these (1116) (Fig. 53) was tar lined or tar filled and the other was represented by a circular rusty stain (1123). A tar lining/filling was also identified in association with a brick and stone built feature (1110) and there were also a number of other tar deposits (1128, 1135 and 1139) identified elsewhere within the trench. The Bonnington Chemical Works dealt with the by-products from Edinburgh's gas-works, of which coal-tar formed a significant proportion. These features are considered most likely to relate to the buildings depicted on the 1852 & 1877 OS Town Plan.

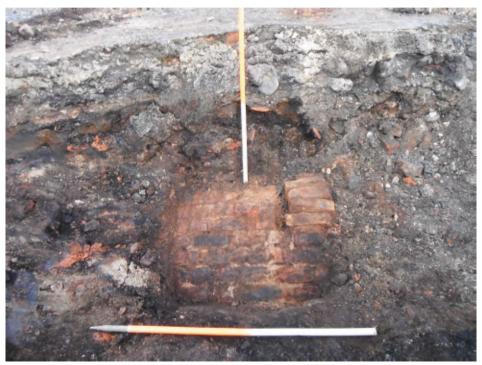
Fig. 51 - The upper surface of flue 1108 from the south-west

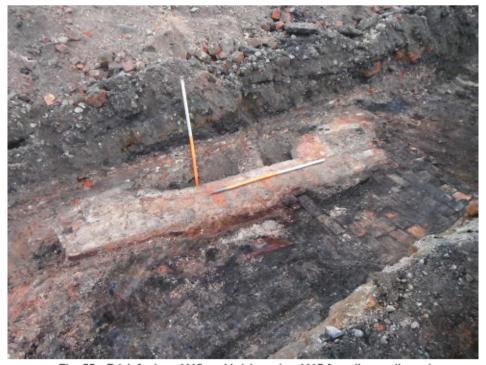
Fig. 52 - Brick feature 1113 and brick paving 1115 from the south-east

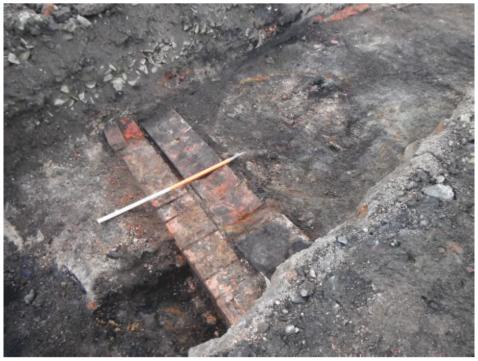
Fig. 54 - Brick wall 1120, drain 1121 and circular feature 1122 from the south-east

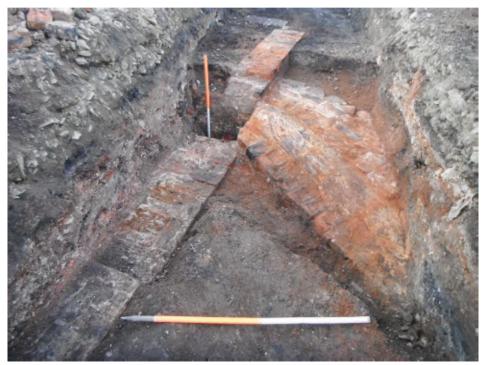
Fig. 55 - Brick walls 1125, 1127 and access to flue 1126 from the south-southeast

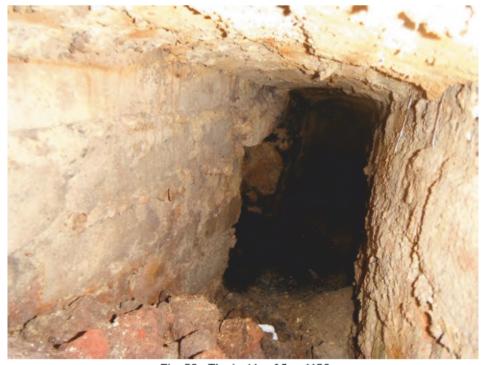
Fig. 56 - The inside of flue 1126

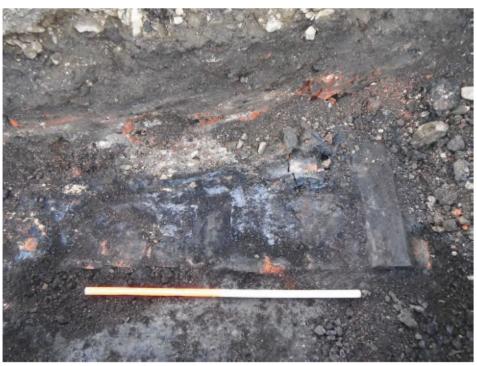
Fig. 57 - Brick wall 1132, wooden feature 1134 and sticky tar 1135 at the north-west end of the trench
