11 Kirkton Street and 9 Union Street, Carluke, South Lanarkshire

Archaeological Evaluation Report No. 3662

Archaeological Evaluation

Report No. 3662

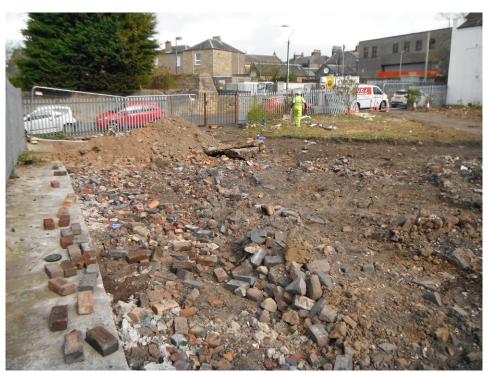
Fig. 2 - The western part of the site at 9 Union Street from the South-East

On the Union Street site (Fig. 2, Trenches 1-4), deep deposits were encountered, ranging from 0.8m at the northern corner of the site, to around 3m at the eastern end of Trench 1. In general, modern demolition rubble overlay made ground which overlay former garden soils. Natural boulder clay was below the soils.

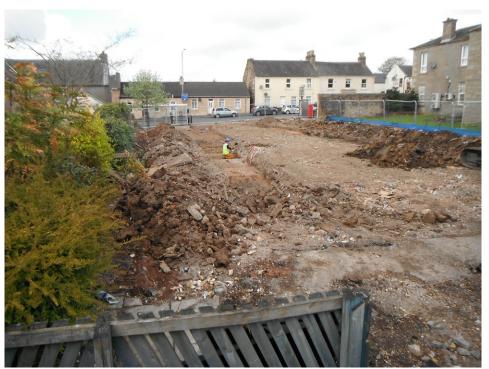
Fig. 3 - The southern part of the site at 11 Kirkton Street from the East

On the Kirkton Street site (Fig. 3, Trenches 5-7), shallow deposits were encountered, ranging from 0.1m to 0.9m. There, modern demolition rubble overlay the remnants of former garden soils with natural clay below.

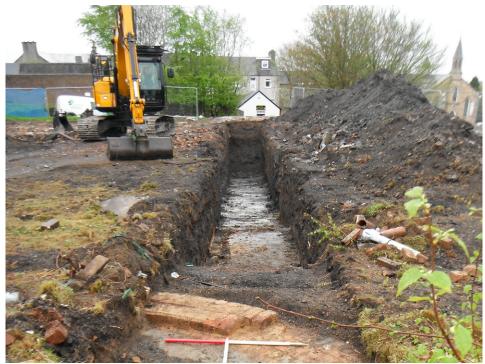
Fig. 4 - Trench 1 excavated from the North-West with wall 101 in the foreground

At the western end of the trench, a curving brick wall (101) (Fig. 4) with a width of 0.65m was formed from poor quality unfrogged bricks. This was recorded and removed to expose natural subsoil. It was founded on a bed of lime mortar and had a foundation of crushed sandstone, all within a cut (109).

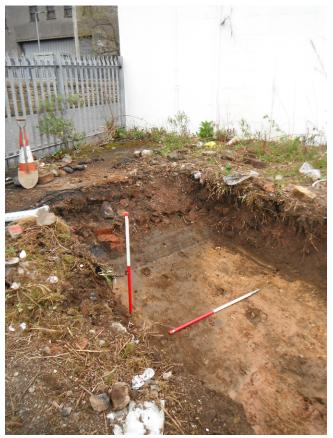
Fig. 5 - Trench 2, ditch 201 from the South

Demolition rubble (207) was extensive in this trench, with little made ground (206) below. Under the made ground, garden soils (205) with a depth of around 0.4m were recorded. Two linear ditches were sealed by the soils. Ditch 201 (Fig. 5) was 0.8m wide and less than 0.1m deep. It was filled with a grey-brown slay-silt and occasional

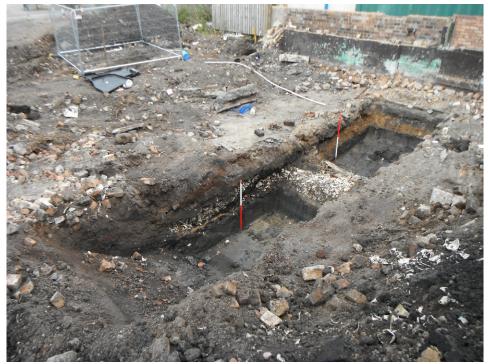
Fig. 6 - Trench 3, from the South

Modern demolition rubble (**304**) was shallow. Below this were the foundations of a brick wall (**301**), with a width of 0.45m and a height of 0.8m, bonded with lime mortar. To the N of this wall, demolition rubble (**304**) overlay made ground (**307**) consisting of layers of ashy soil and broken sandstone rubble. This sealed garden soils (**305**) with a depth of 0.3m. Excavation in this area was curtailed by the discovery of a cast iron water main (**303**) but natural clay (**001**) was revealed. To the S of wall **301**, demolition rubble (**304**) overlay made ground (**302**) consisting in the main of ashy soil containing a concentration of broken ceramic marmalade jars (Fig. 6) with further garden soils below. These sealed no negative features.

The deposit of stoneware vessels contained within the made ground in Trench 3 may well be associated with R&W Scott Ltd, Fruit Growers & Preserve Makers of Carluke, as a couple of vessels had fragmentary jam labels adhering to them. The company was founded in 1873 and still operates. One of the vessels was made by W A Gray & Sons of the Midlothian Pottery at Portobello, Edinburgh (1856-1930s), a company well known for the production of patented white marmalade jars.

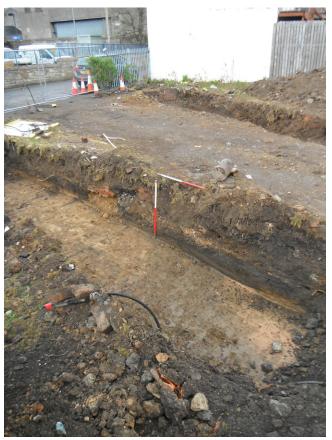
Fig. 7 - Trench 4, ditch 401 from the South

There was little modern demolition rubble (406) in this trench (Fig. 7), with made ground (407) overlying buried garden soils (405) with a depth of 0.3m.

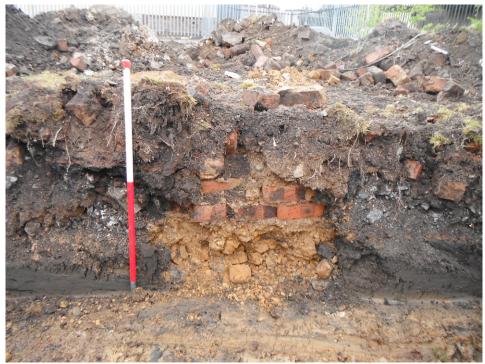
Fig. 8 - Trench 4, brick wall 404

A brick wall (404), continuing 101 in Trench 1 ran through this trench, cutting (403) the made ground (Fig. 8). It was 0.65m wide, lime mortar bonded and was founded on a thin layer of lime mortar, with crushed yellow sandstone below. A total depth of 0.75m was recorded. This also cut the garden soils (405).

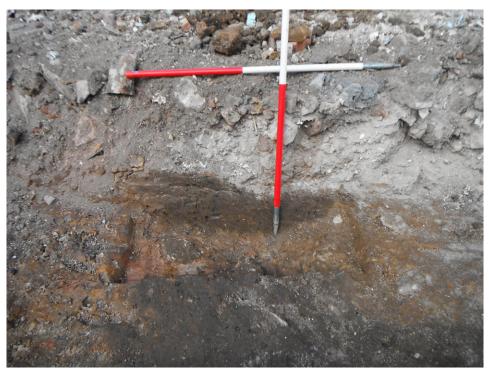
Fig. 9 - Trench 5, ditch 506 section from the South

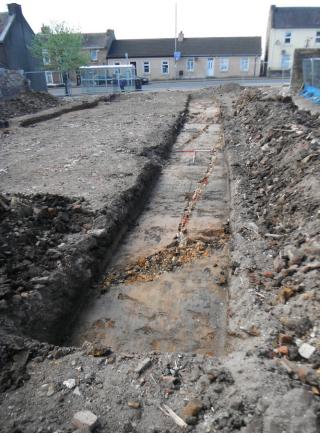
Fig. 10 - Trench 6 general view from the East

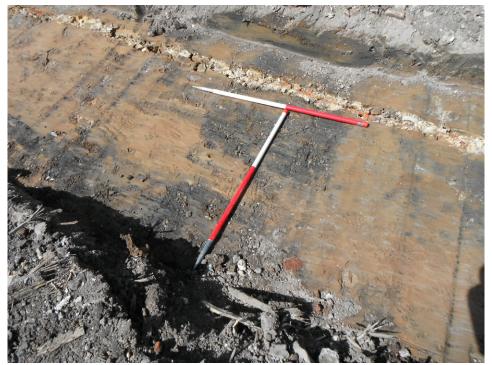
Fig. 11 - Trench 6, ditch 604 from the South

A single linear ditch feature (604) was recorded, cut by a clay-piped drain (601). Ditch 604 had a width of 0.8m appeared to be badly truncated (Fig. 11). It was aligned N-S and continued into Trench 5 (508).

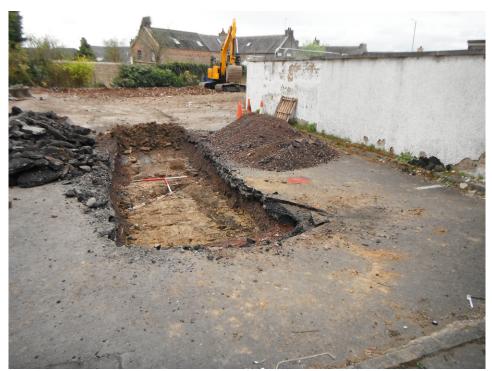
Fig. 12 - Trench 7 and the northern part of the site at 11 Kirkton Street from the NNE
