Braid Burn Flood Prevention Scheme (WU12) Adelphi Place, Edinburgh

Archaeological Watching Brief

Report No. 1727

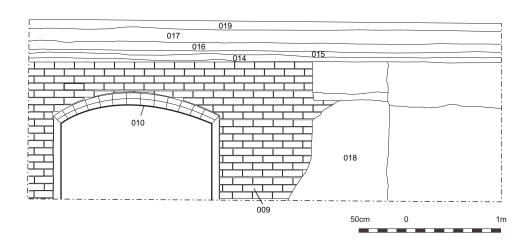
Кеу:	Fig. No:	Revision:	City of Edinburgh Council		CIFA ARCHAEOLOGY LTD. The Old Engine House
		Section showing Buried Walls and Arched Doorway			Esimile Park Musseburgh East Lothian, EH21 7PQ t: 0131 273 4380 t: 0131 273 4381
Scale: 1:40	Project: Leit 4 \	Project: Leit 4 WU12			e: info@cfa-archaeology.co.uk w: www.cfa-archaeology.co.uk age No: Report No:

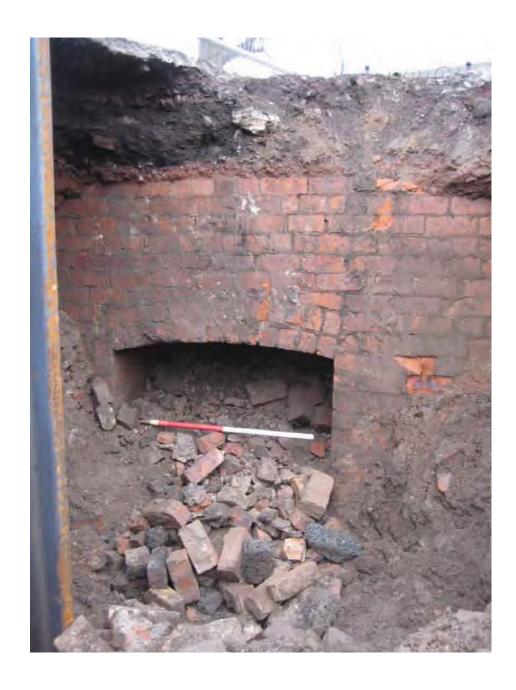
Key:	Fig. No:	Revision:	Client: City of Edinburgh Council	OF	The	A ARCHAEOLOGY LTD. Old Engine House	
	Buried walls and Arched Doorway				Mus East t: 01	Eskmills Park Musseburgh East Lothien, EH21 7PQ t: 0131 273 4380 t: 0131 273 4381	
	Project: Leit 4 WU12			ARCHAEOLOGY LTD e: info@icia-erchaeology.co.uk w: www.cfa-archaeology.co.uk			
Scale:				Drawn by: GC	Page No:	Report No: 1727

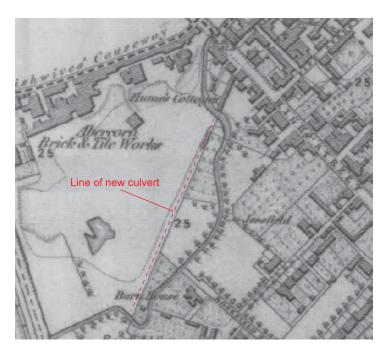
Fig. 4 Excert from 1st Edition Ordnance Survey Map, 1854

- 4.2 Building remains were found at the north end of the excavation. It is probable that these remains represent the basements or cellars of buildings depicted on the 1st and 2nd edition Town Plan (Figs. 4 and 5).

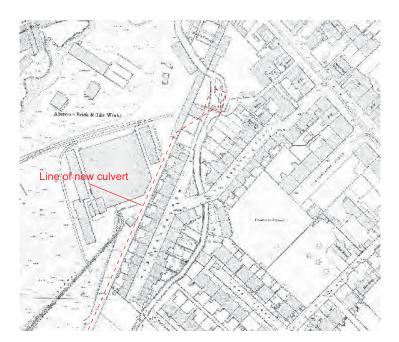
Fig. 5 Excert from 2nd Edition Ordnance Survey Map, 1893-94
