CAT Report 1875 issued October 2022

Historic building recording of an outbuilding at Bennett's Farm, Weald Road, South Weald, Brentwood: November 2022

Historic building recording of an outbuilding at Bennett's Farm, Weald Road, South Weald, Brentwood

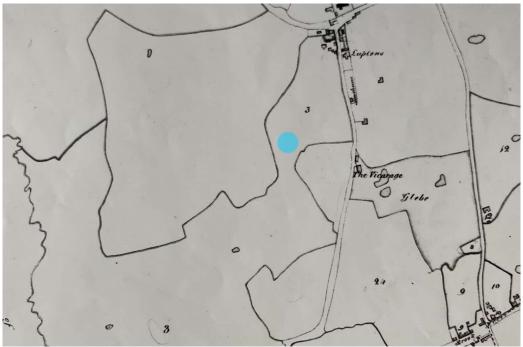
Map 3 Extract from the 1838 Tithe Apportionment map with the approximate location of the outbuilding highlighted in blue.

The tithe apportionment map of 1838 (Map 3) shows the area in more detail, as well as the division of land around Bennett's Farm. There do not appear to be any structures on this map around Bennett's Farm, which probably straddles the boundary between parcels 3 (Weald Meadow) and 24 (Bushy Pasture). There is no structure visible on the tithe map.

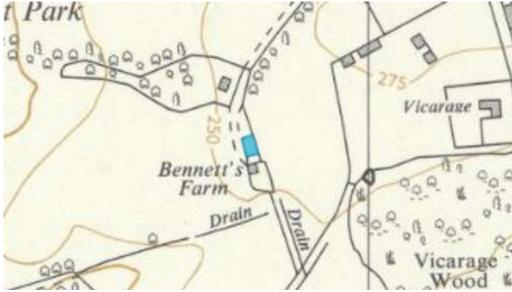
Map 8 Extract from the 1967 Ordnance Survey map showing the location of the outbuilding highlighted in blue.

The 1967 OS map labels the buildings as Bennett's Farm. By this time the U-shaped building has been altered – the northern wing of the building appears to have been demolished and the central yard infilled to make a rectangular building. The farmhouse remains to the south, but the additional small building immediately to the east of the farmhouse is not marked on the map, so has likely been demolished. A new building is marked on the map just to the north of Bennett's Farm, presumably a barn or shed. Since 1967, this building has been removed and a large barn has been added to the farmyard, to the west of the building that is the focus of this report.

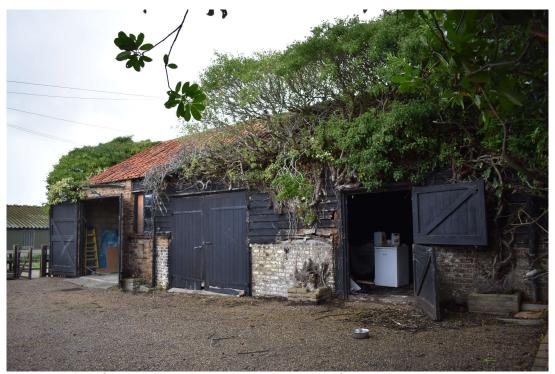
Photograph 1 South-east elevation. Photograph taken facing north north-west.

The south-east elevation is a combination of brick and black weatherboard. The south-western end of this elevation is a later extension, constructed of red brick laid in English-bond (brick dimensions: 225 x 110 x 65mm). The rest of the elevation is clad in black weatherboard with a brick plinth. Two sets of double doors and a single stable door are present on this elevation, and whilst the openings are original, the doors themselves are modern replacements. There is also a single window on this elevation, which would have been a six-light vertical awning window, but half has been removed and boarded up.

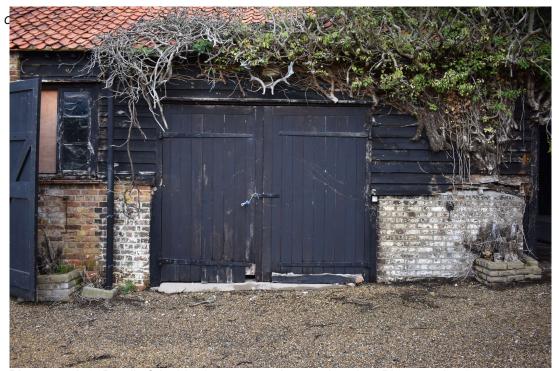
Photograph 2 Detail of double-doors on south-east elevation. Photograph taken facing north-west.

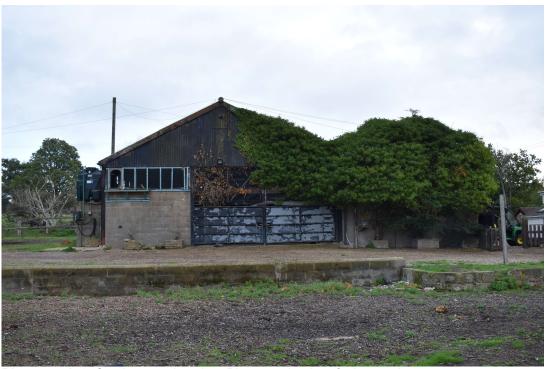
Photograph 3 South-west elevation. Photograph taken facing north-east.

The south-west elevation is dominated by a large set of modern double doors. There is a set of mesh-covered openings to the north-west of the doors along with a modern peacock door and ledge. This elevation is constructed of breeze blocks.

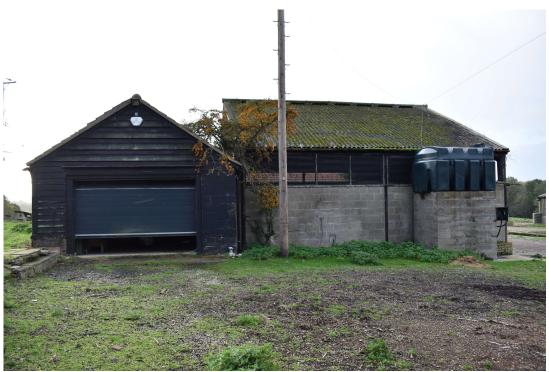
Photograph 4 North-west elevation. Photograph taken facing south-east.

The north-east end of the north-west elevation is clad in black weatherboard, around a modern Garage door, while the rest of the elevation is breeze blocks. A small amount of the brick plinth also survives on this elevation. There are also a number of mesh-covered openings at the top of the elevation.

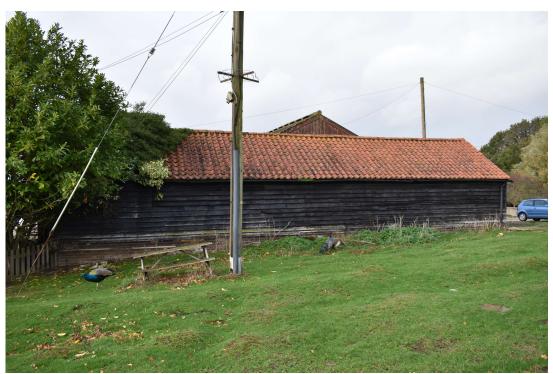
Photograph 5 North-east elevation. Photograph taken facing west.

The north-east elevation is featureless and clad in black weatherboard.

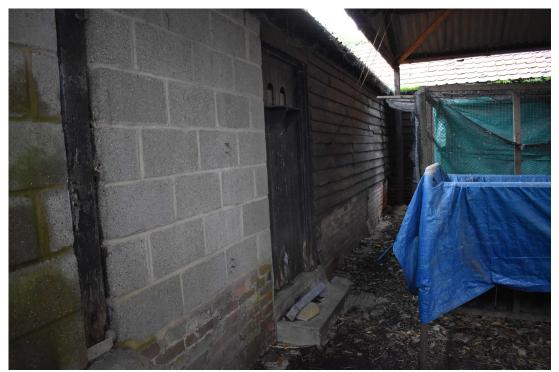
Photograph 6 Internal elevation in Store 5. Photograph taken facing south-east.

Within Store 5, the north-west and south-west elevations of the L-shaped building are visible. The north-west elevation is partially clad in black weatherboard below which the brick plinth is visible. A small door (probably avian related) is present in the weatherboarding. The rest of the elevation is breeze blocks.

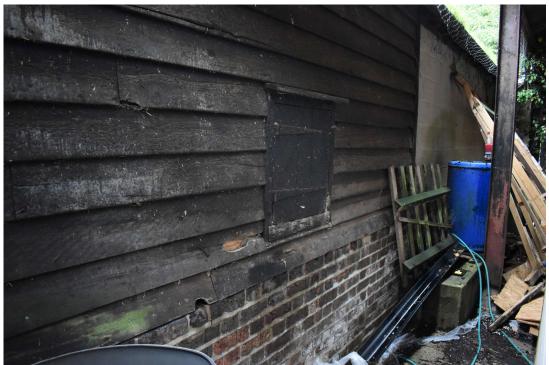
Photograph 7 Internal elevation in Store 5. Photograph taken facing south-west.

The brick plinth is visible the full length of the south-west elevation. Above this is a combination of black weatherboarding and breeze blocks. Two original timber posts are visible, both of which have modern concrete supports. A possible third may be

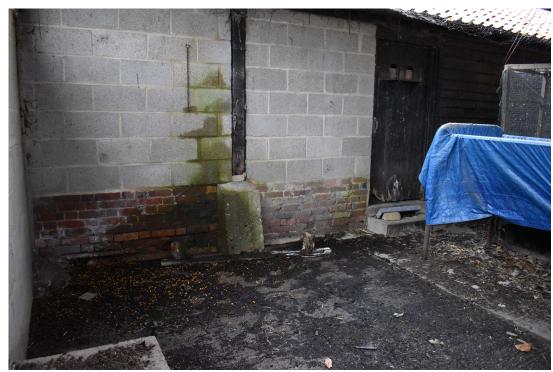
Photograph 8 Detail of original post and brick plinth in Store 5. Photograph taken facing south-east.

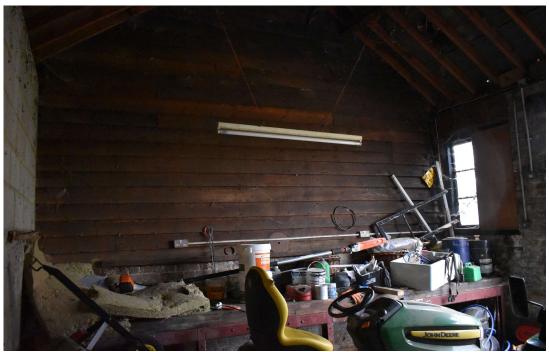
Photograph 9 Interior of Store 1.Photograph taken facing south-east.

Store 1 is located in the south-west wing of the L-shape building and is a later extension. The north-east wall of Store 1 is the original south-west elevation of the historic farm building, it is clad in brown weatherboard and has a red brick plinth. The north-west and south-west walls of Store 1 are breeze block and the south-east wall is dominated by a set of double doors and a single window.

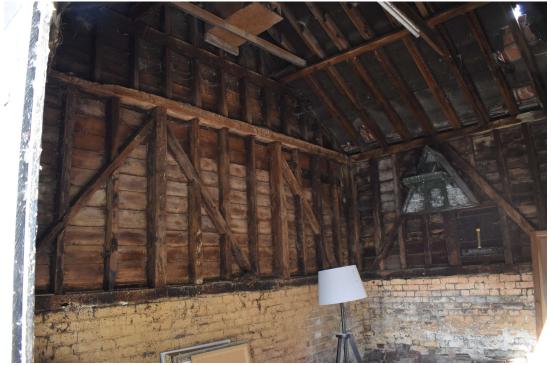
Photograph 10 Interior of Store 2. Photograph taken facing north-west.

The north-west and south-west walls of Store 2 are largely featureless, bar a small vertical-planked door located in the north-west wall. The north-east wall is almost entirely dominated by a set of double doors.

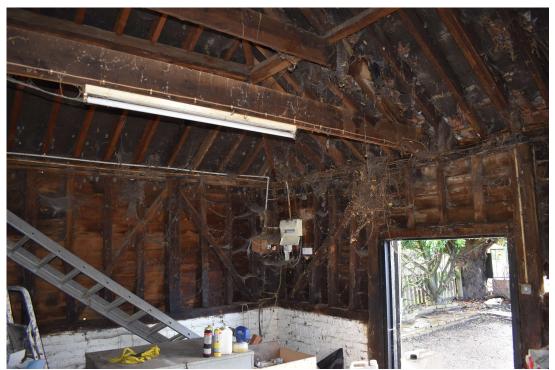
Photograph 11 Interior of Store 3. Photograph taken facing south-east.

Store 3 has a further two doors, one in the north-west wall which leads to Store 4 and an external door in the south-east wall. The timber-frame in this room has the most reused timbers, including posts, braces and the sill-beam. Two side-halved scarf joints

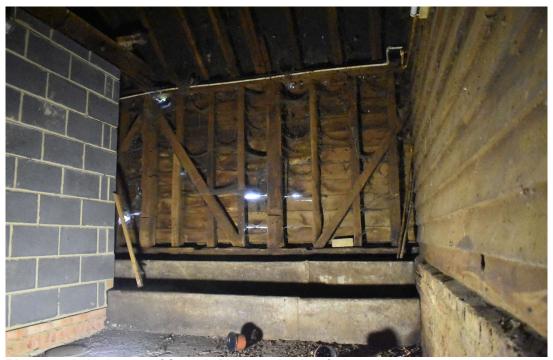
Photograph 13 Interior of Store 4. Photograph taken facing north-east.

The modern Garage has been constructed within the footprint of Store 4 and therefore obscured much of detail of the north-west and south-west walls. The timber-frame of the south-west wall was of a different style to the rest of the building and the plinth was slightly shorter, evidence the wall is inserted. On the north-east wall many of the timbers show signs of reuse and two side-halved scarf joints are present in the sill-beam. A modern feeding trough, now filled with concrete, occupies the gap between the Garage wall and the north-east wall of Store 4.

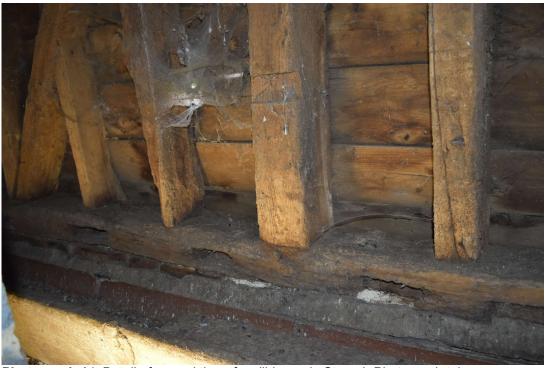
Photograph 14 Detail of reused timer for sill-beam in Store 4. Photograph taken facing north-east.

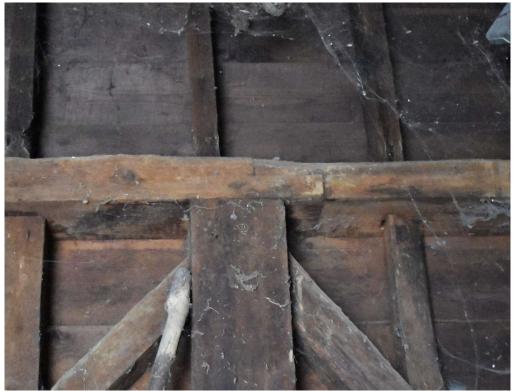
Photograph 15 Detail of scarf joint in wall plate of Store 3. Photograph taken facing north-west.

were also identified, one in the wall-plate on the north-west wall and one in the sill-beam of the north-east wall.

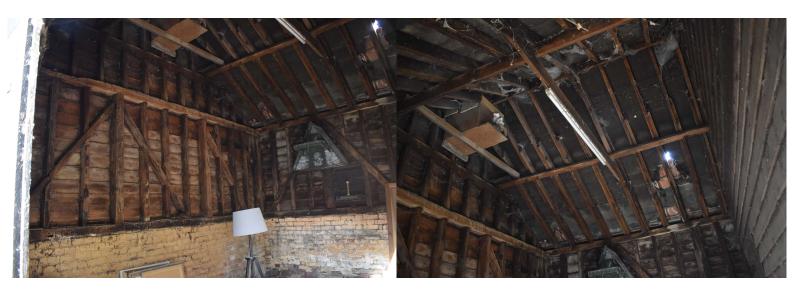
SOWBF22_Bennetts-Farm-South-Weald_HBR_Archive SOWBF22_Photograph_037Interior of store 2. Photograph taken facin... SOWBF22_Photograph_038Roof structure of store 2. Photograph take...

The roof of the L-shape building is a modern replacement, likely added when Store 1 was constructed. The roof consists of pairs of rafters that rise from the wall-plate to meet a ridge board. There is a single clasped purlin on each pitch and equally spaced collars and upper collars. Three tie-beams are present in the roof structure: one in the south-west wing, which has been incorporated into a dividing wall, and two in the north-west wing. These are secured with iron straps. The original timber walls are supported by through-bracing. What remains of the original timber-frame appears to be mainly machine-cut timbers, however some were too degraded to say for sure.

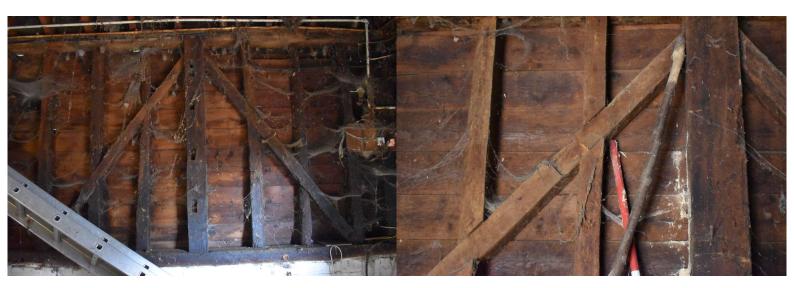
SOWBF22_Photograph_047Detail of reused timber in store 3. Photogr... SOWBF22_Photograph_048Detail of reused timber in store 3. Photogr...

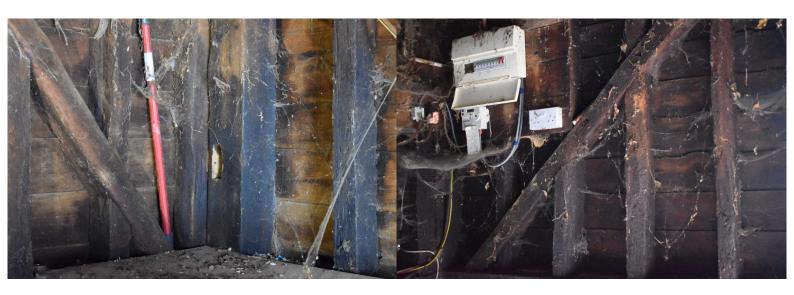
SOWBF22_Bennetts-Farm-South-Weald_HBR_Archive SOWBF22_Photograph_049Detail of scarf joint in wall plate of store 3.... SOWBF22_Photograph_050Detail of door between store 2 and 3. Pho...

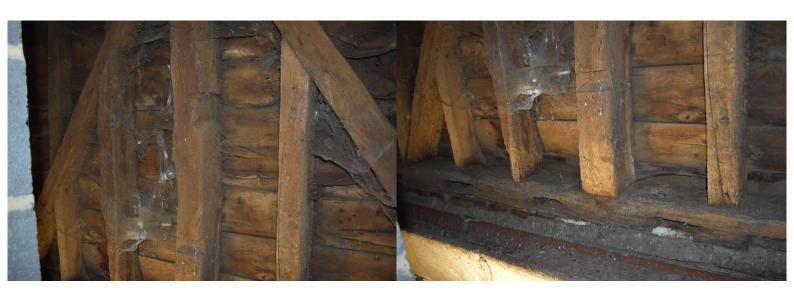
SOWBF22_Bennetts-Farm-South-Weald_HBR_Archive SOWBF22_Photograph_061Detail of scarf joint in sill-beam in store 4. ... SOWBF22_Photograph_062Detail of scarf joint in sill-beam in store 4. ...

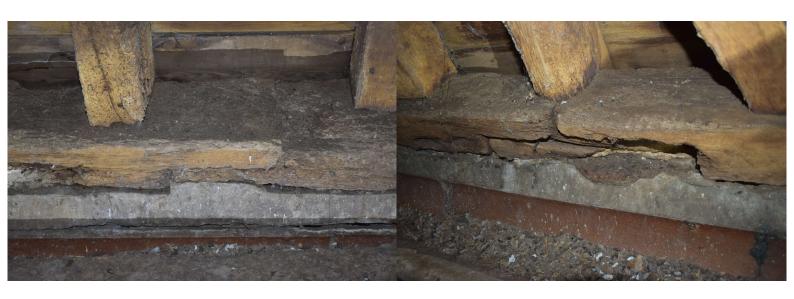
SOWBF22_Photograph_063Detail of cement-filled mortices on sill-bea...SOWBF22_Photograph_064Detail of timber frame in store 4. Photogra...
