**Historic building recording at Thrift Farm,
Moulsham Thrift, Chelmsford, Essex, CM2 8BP**

**CAT project ref.: 2022/08i
ECC code: CFTF22**

October 2022

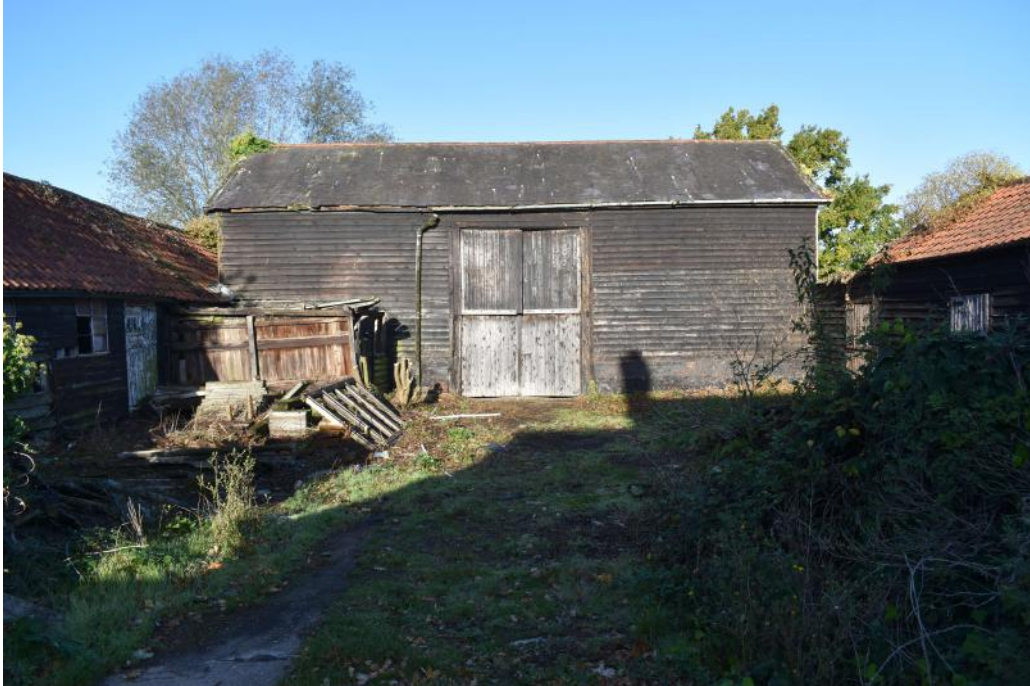
Photograph 1 Eastern elevation of barn. Photograph taken facing west north-west.

The eastern elevation (Fig 3) of the barn has a set of large central vertically-planked doors, which are replacements in the original opening. They mimic oversized stable doors and, unusually, open inwards. There are three pintles either side of the doors from the original barn doors. To the south of the doors, some possibly original weatherboarding survives behind store 6.

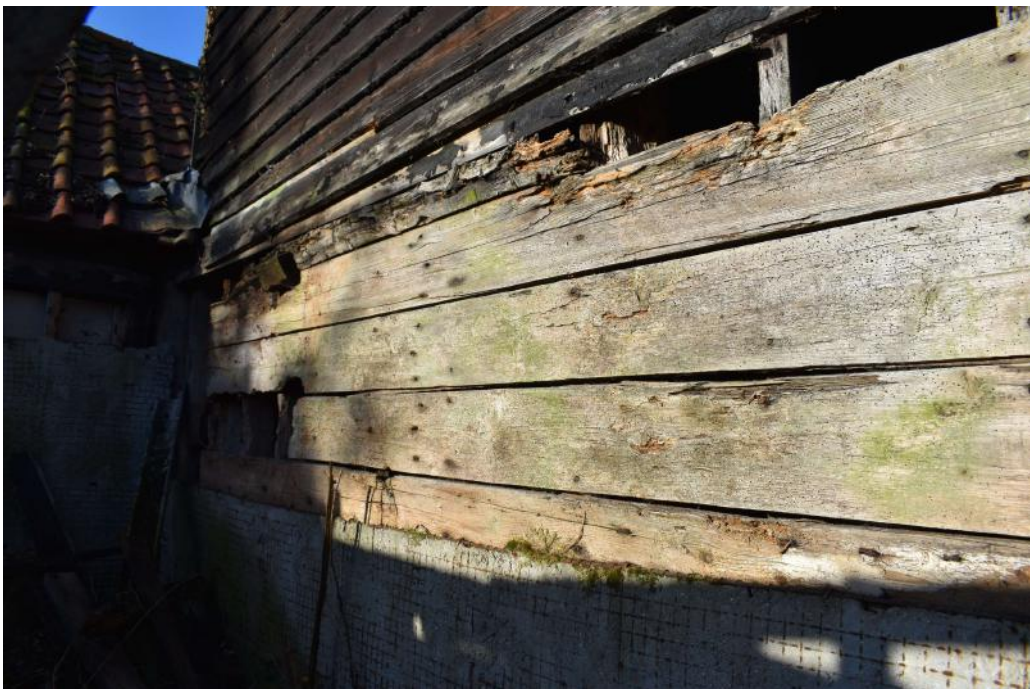
Photograph 2 Possible original weather-boarding on eastern elevation of barn (in store 6). Photograph taken facing south-west.

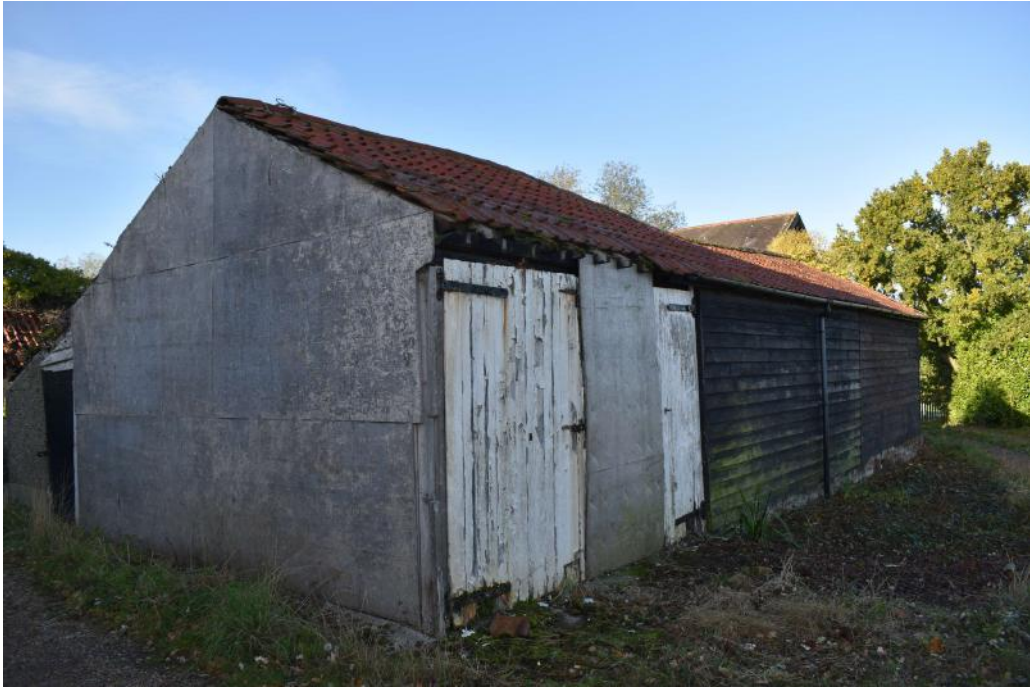
Photograph 3 Northern and eastern elevations of northern range (store 9 and 12). Photograph taken facing west.

The roof over stores 9 and 12 (northern wing) is gabled at both ends with a catslide over store 11 and clad in ceramic S-tiles. A red brick plinth (brick dimensions 205 x 115 x 65mm) is visible on the north and south elevations of store 9 and 12. Store 8 has a flat roof clad in corrugated sheets while stores 7 and 10 do not have roofs.

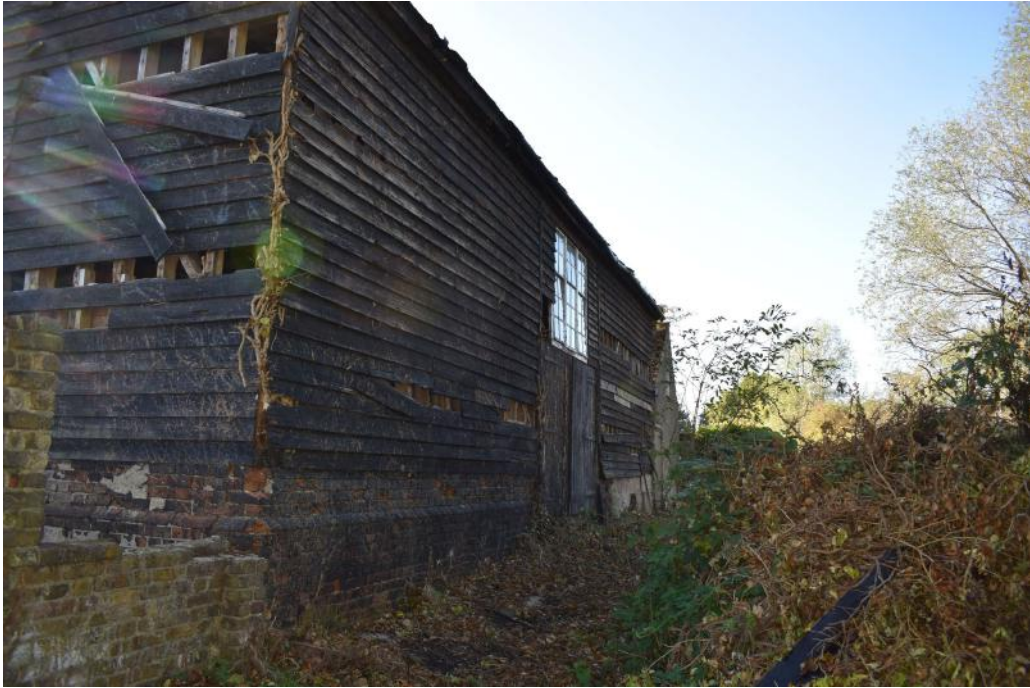
Photograph 4 Western elevation of barn. Photograph taken facing south

The western elevation (Fig 5) comprises black weatherboard, pebble-dash and brick. The barn is clad in weatherboard with a set of central replacement double doors. Above these are three re-used Crittall windows. They are four-over-six-light windows with the metal frame painted white. The outer two windows have the awning in the bottom six lights while the central window has it in the top four lights, all of which open on a central pivot. The double doors and Crittall windows are located in an original full-height opening. To the south of this, the brick plinth has been repaired with concrete render.

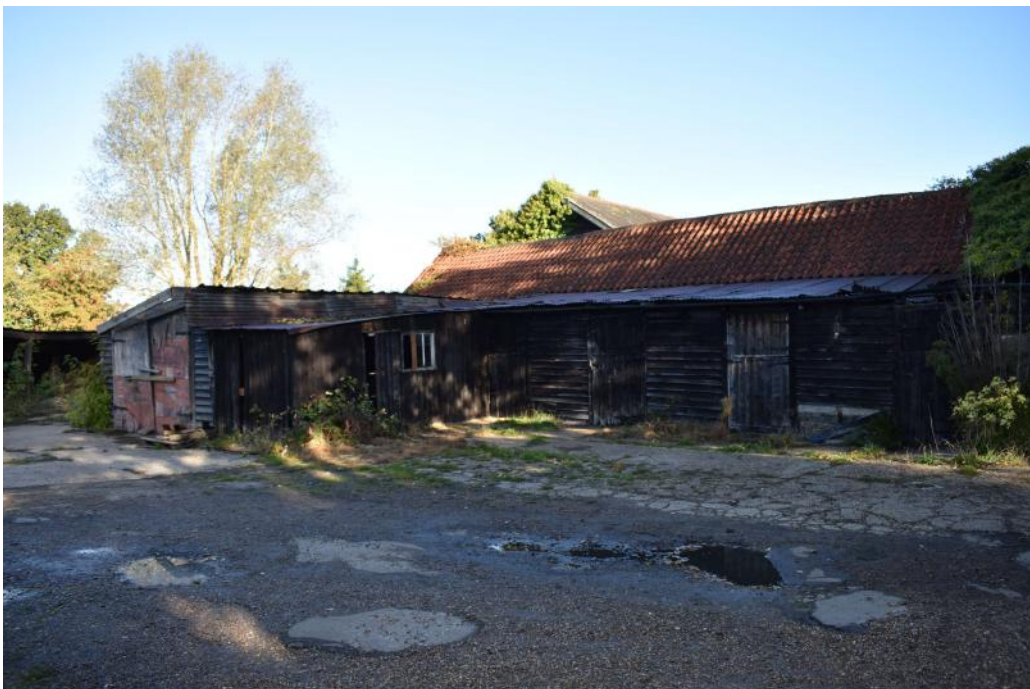
Photograph 5 Eastern and southern elevations of stores 1, 2 and 4. Photograph taken facing north.

The southern elevation (Fig 6) is completely clad in black weatherboard. Store 1 has a set of double-doors while store 4 has four single stable doors. Store 2 is featureless on this elevation and much of the barn is obscured by the southern wing.

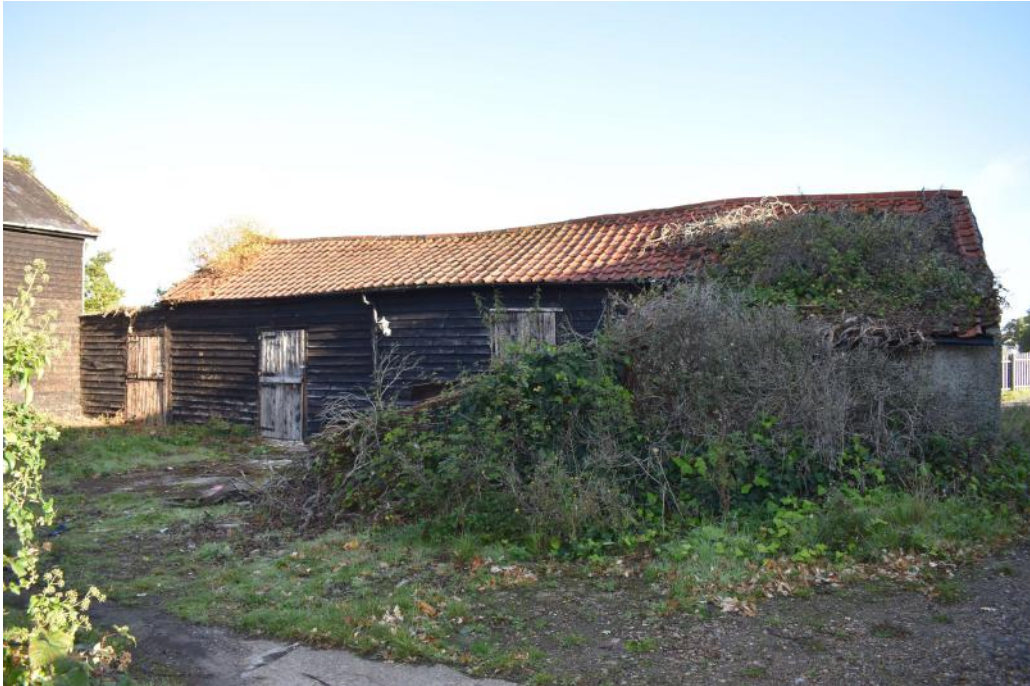
Photograph 6 Southern elevation of interior courtyard. Photograph taken facing north.

The southern elevation of the courtyard (Fig 7) is mainly clad in black weatherboard and has three stable doors: one on store 8 and two on store 9. Store 10 is constructed of red brick, with occasional yellow stock bricks, laid in a Flemish-bond. It is enclosed and around 1.15m tall. Store 11 is finished in pebble-dash render.

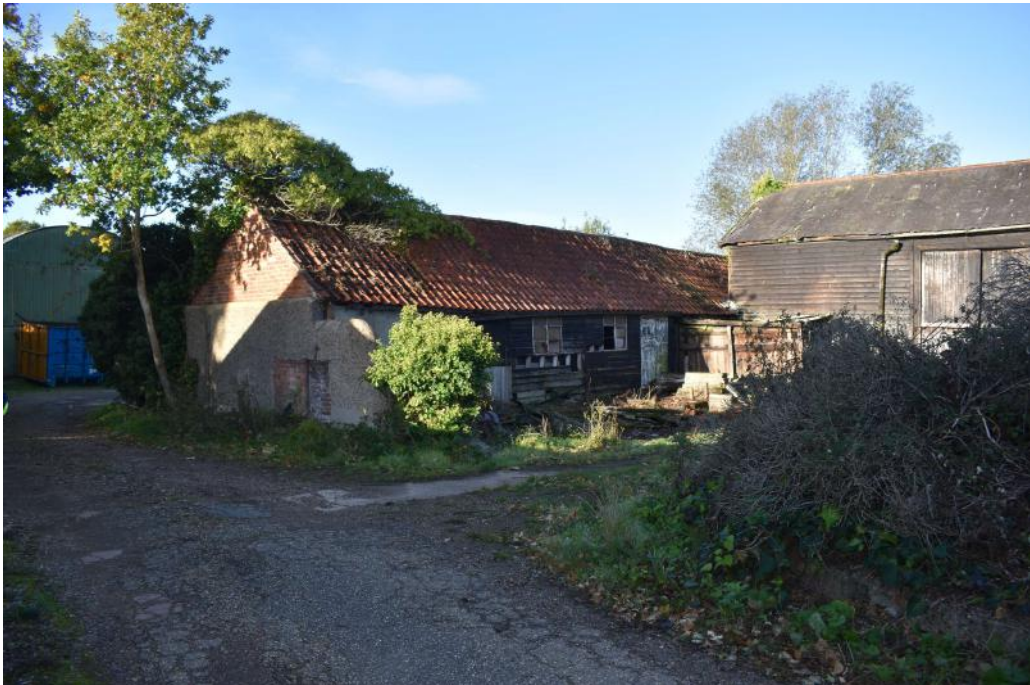
Photograph 7 Northern elevation of the interior courtyard. Photograph taken facing west.

The northern elevation of the courtyard (Fig 8) is rendered in pebble-dash at the south-east end and the rest clad in black weatherboard. Three doors, two on store 5 and one on store 6, and three windows, all on store 5, are present on this elevation. The doors are all stable doors. The southern-most window is a nine-light fixed window with a timber frame while the remaining two are metal-framed six-light awning windows. Store 6 also has two unglazed window openings.

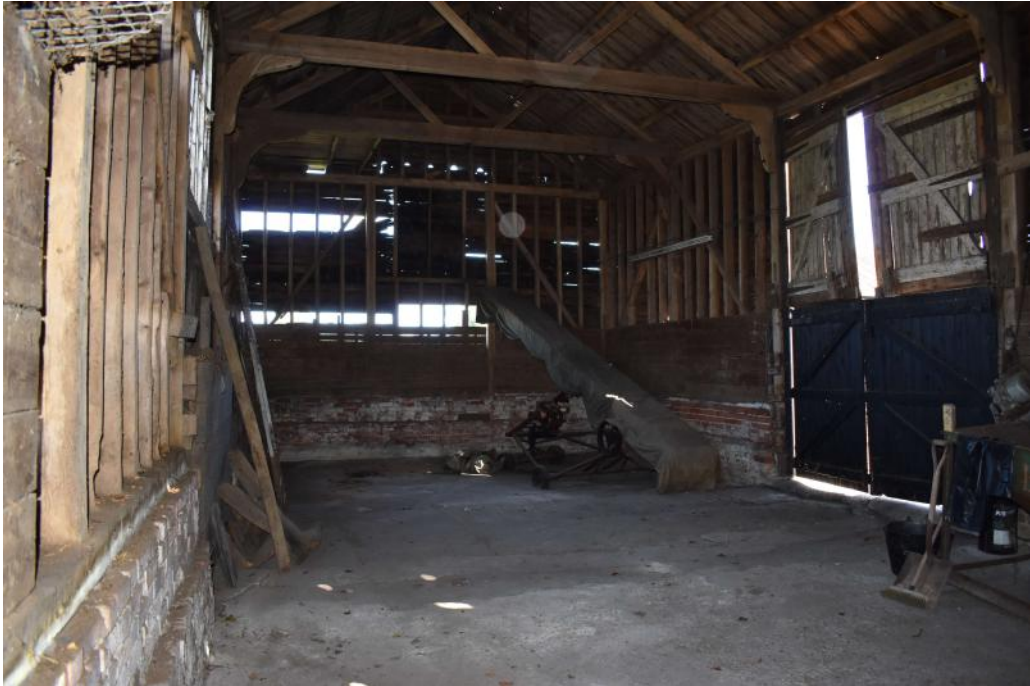
Photograph 8 Interior of barn. Photograph taken facing north-east.

The barn has five bays, labelled 1-5 from south to north. The outer four are roughly equal in width and the central bay is slightly wider.

The roof of the barn is gabled and comprises pairs of principal rafters rising from the wall-plate and meeting at a ridge-board. The rafters support four through purlins on each roof pitch. Every purlin has a splayed scarf joint, either between bays 2 and 3 or bays 3 and 4, arranged in an off-set pattern. There are four tie-beams, from which inclined struts rise to meet the principal rafters, with a central iron king bolt. The tie-beams are supported by knee-braces held in place with four bolts. In bays 1 and 5, there is a wind-brace present on both roof pitches. All of the timbers are machine-cut.

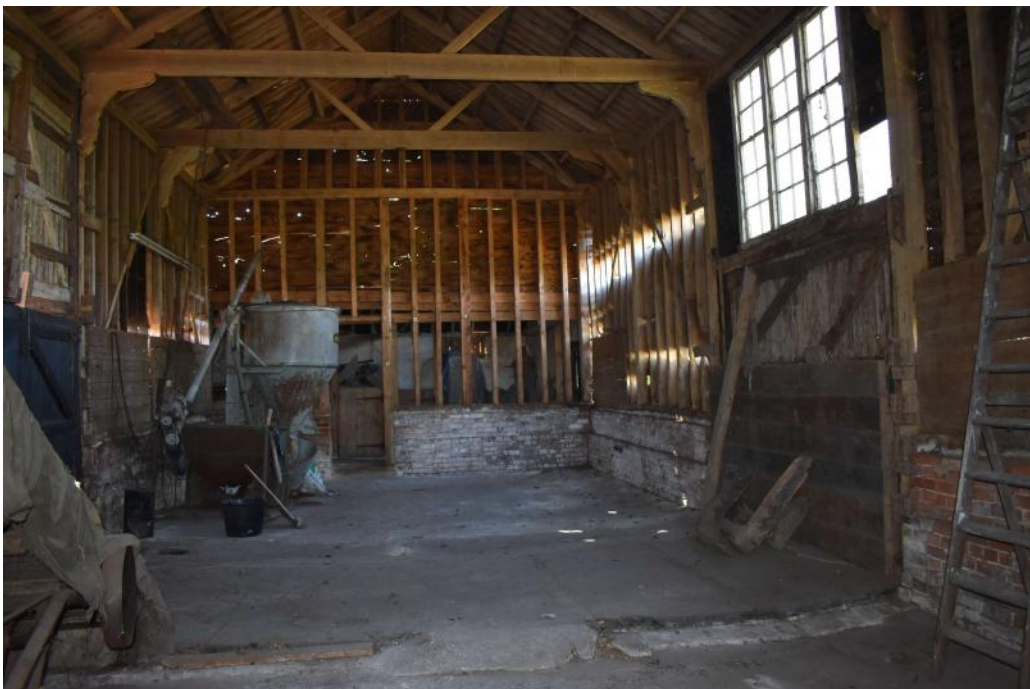
Photograph 9 Interior of barn. Photograph taken facing south-west.

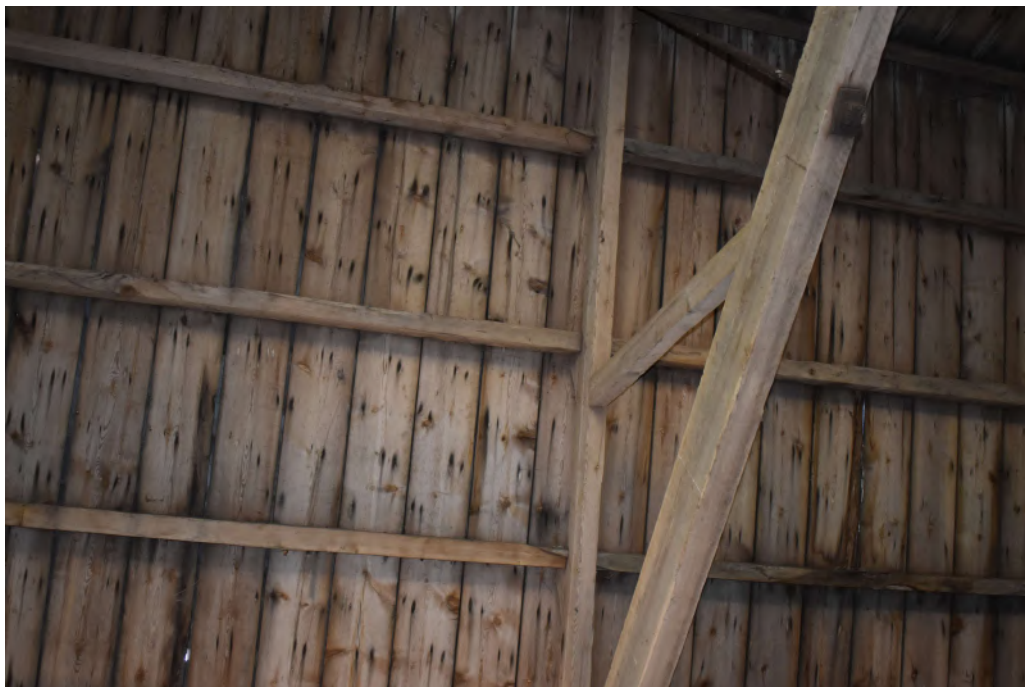
Photograph 10 Detail of scarf-joints in purlin in eastern roof pitch between bays 2 and 3 of the barn. Photograph taken facing south-east.

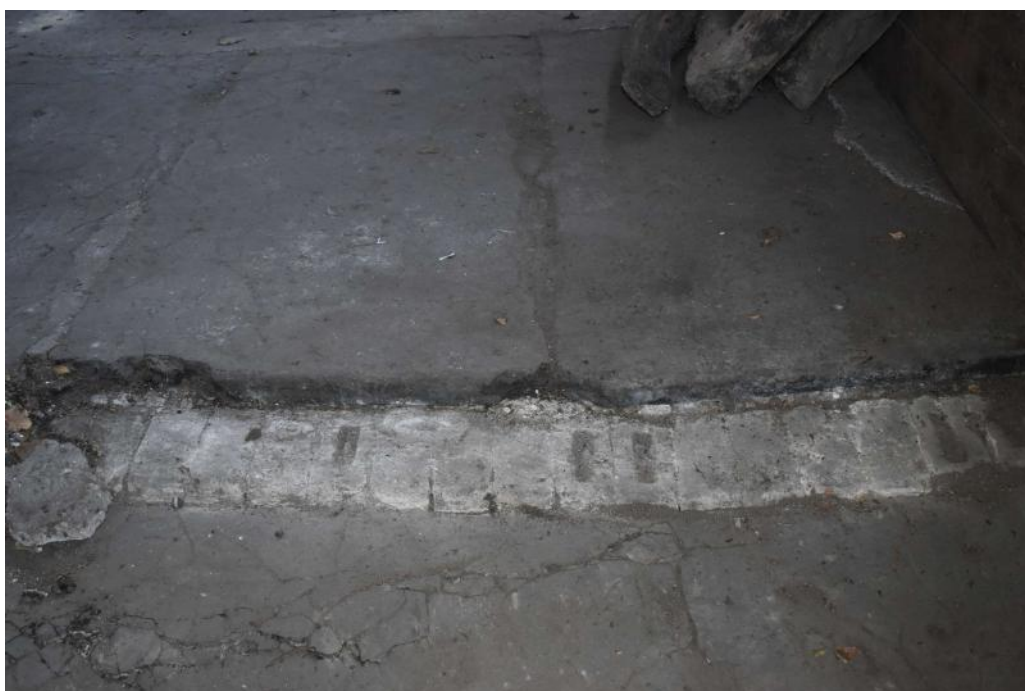
Photograph 11 Detail of shallow-frogged bricks in floor of bay 3 of barn. Photograph taken facing south.

In bay 3 of the barn, the edge of the brick threshing floor is visible beneath the concrete. It appears to be constructed from red bricks with shallow frogs laid flat.

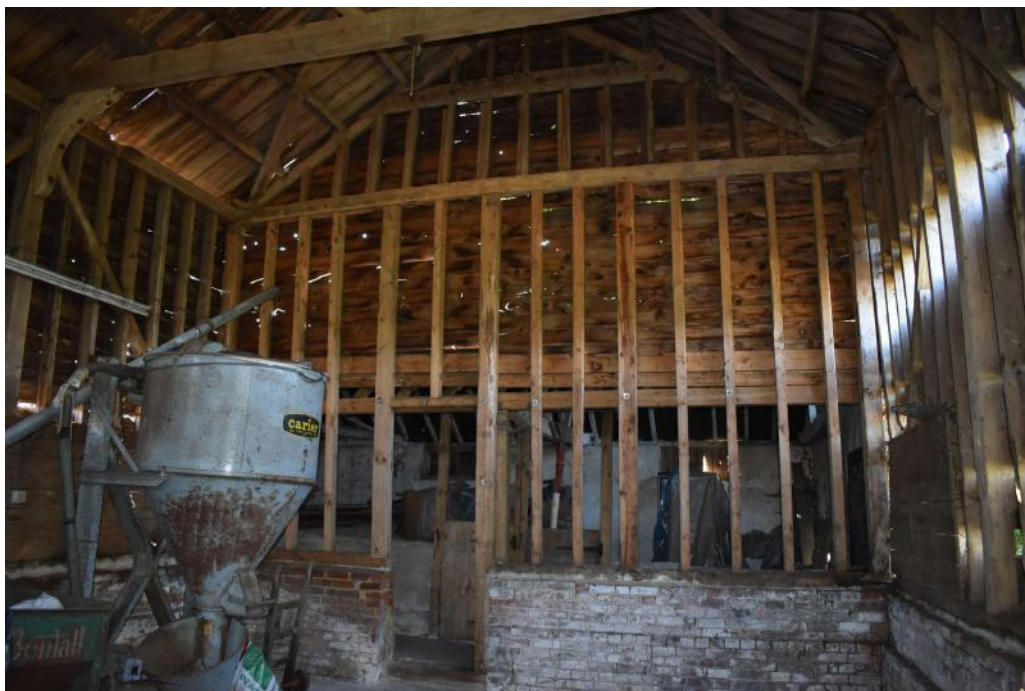
Photograph 12 Southern wall of barn. Photograph taken facing south.

Bay 1 is the southern-most bay of the barn. The brick plinth and sill-beam have been cut through to insert a doorway in this wall, which leads to store 5. All of the studs between the gable-tie and the sill-beam and the sill-beam to the east of the door have been replaced. There is an iron strap on the southern sill-beam to secure it to the western sill beam. There is a side-halved scarf joint in the eastern sill-beam in bay 1.

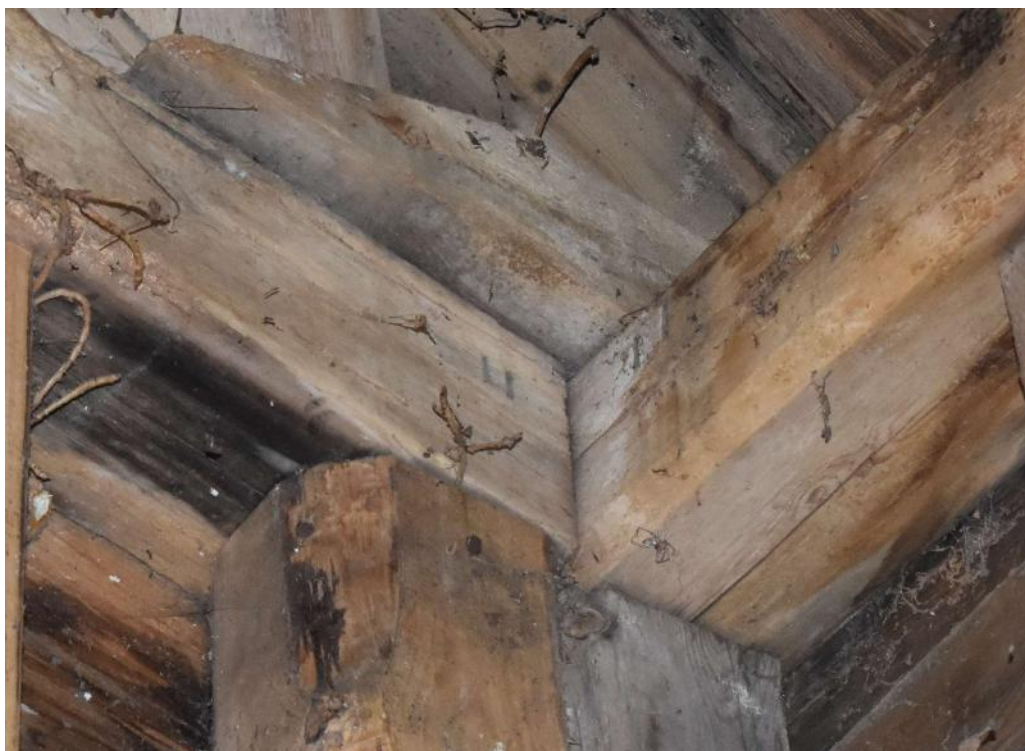
Photograph 13 Detail of carpenters' mark 'II' on gable-tie and wall-plate in north-west corner of bay 1 in barn. Photograph taken facing north.

Chiselled carpenters' marks 'II' are located in the north-west corner of this bay, on the gable-tie and on the wall-plate.

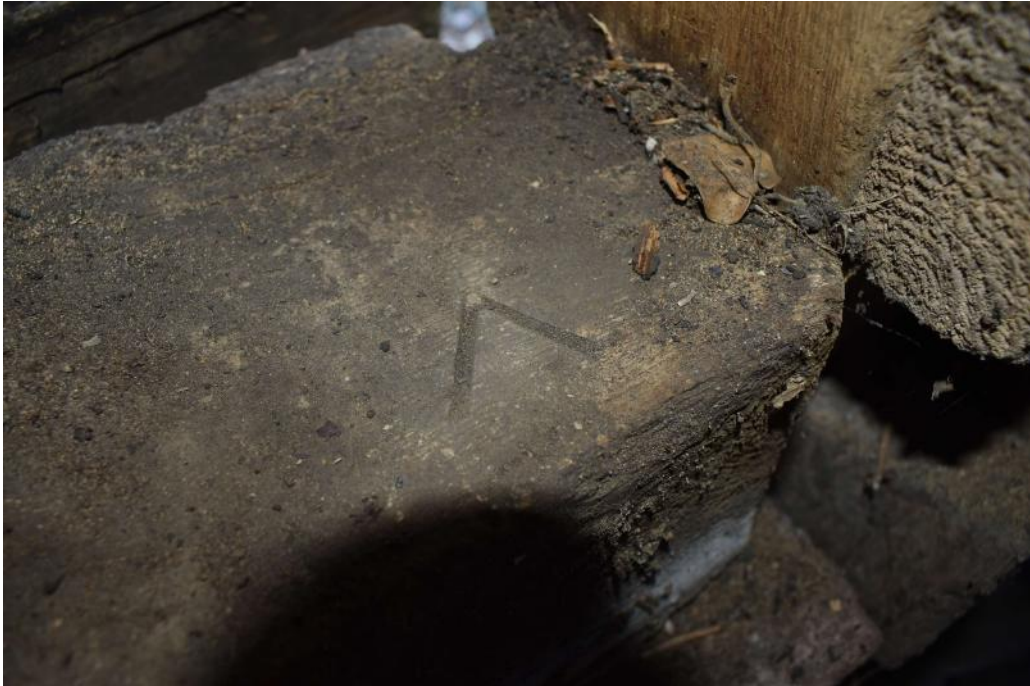
Photograph 14 Detail of carpenters' mark 'V' on sill-beam on western wall of bay 2 in barn. Photograph taken facing north.

Bay 2 has the carpenters' mark 'V' chiselled into the western sill-beam, next to the post between bays 2 and 3.

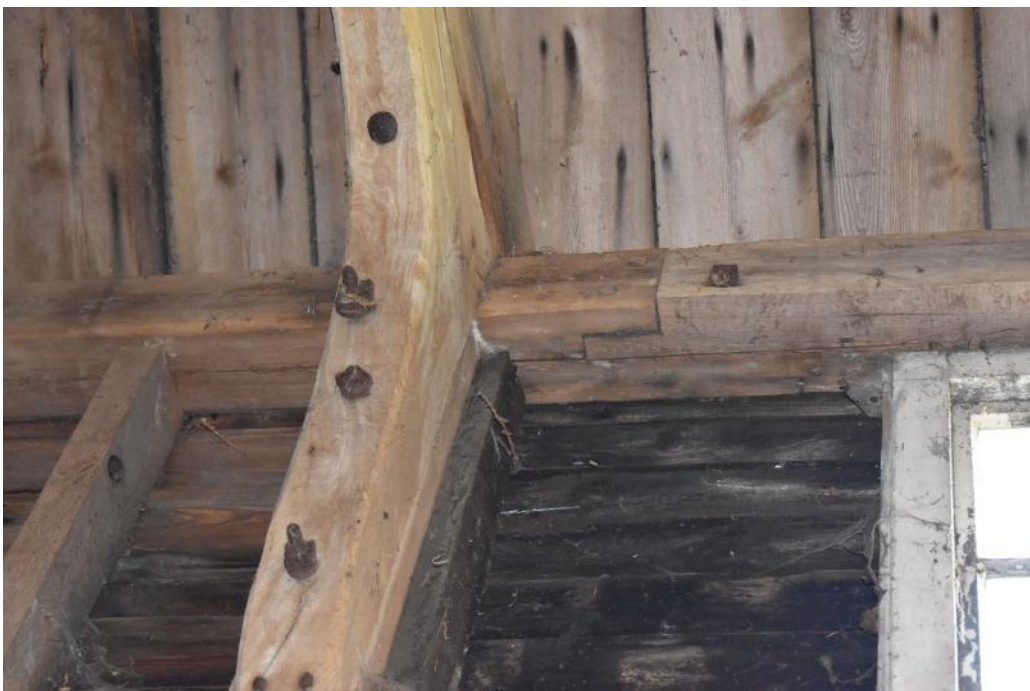
Photograph 15 Detail of scarf-joint in wall-plate of western wall of bay 3 of barn. Photograph taken facing south-west.

Bay 3 is the central bay of the barn. The eastern wall is dominated by a pair of replacement barn doors. The western wall contains a smaller pair of replacement barn doors above which three Crittall windows are located. On the posts either side of both sets of doors are blocks of timber arranged in several U-shapes. These may have been used to put up barriers to separate areas of the barn. There is also a face-halved and bladed scarf joint in the wall-plate of the western wall. This is also the only bay which does not have through bracing in the walls.

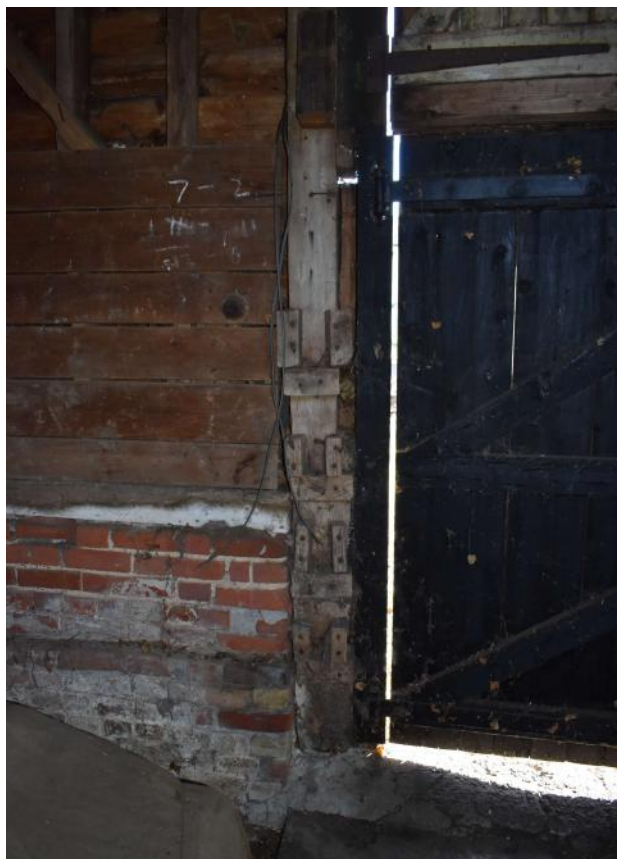
Photograph 16 Detail of wooden blocks adjacent to barn door on eastern wall. Photograph taken facing north-east.

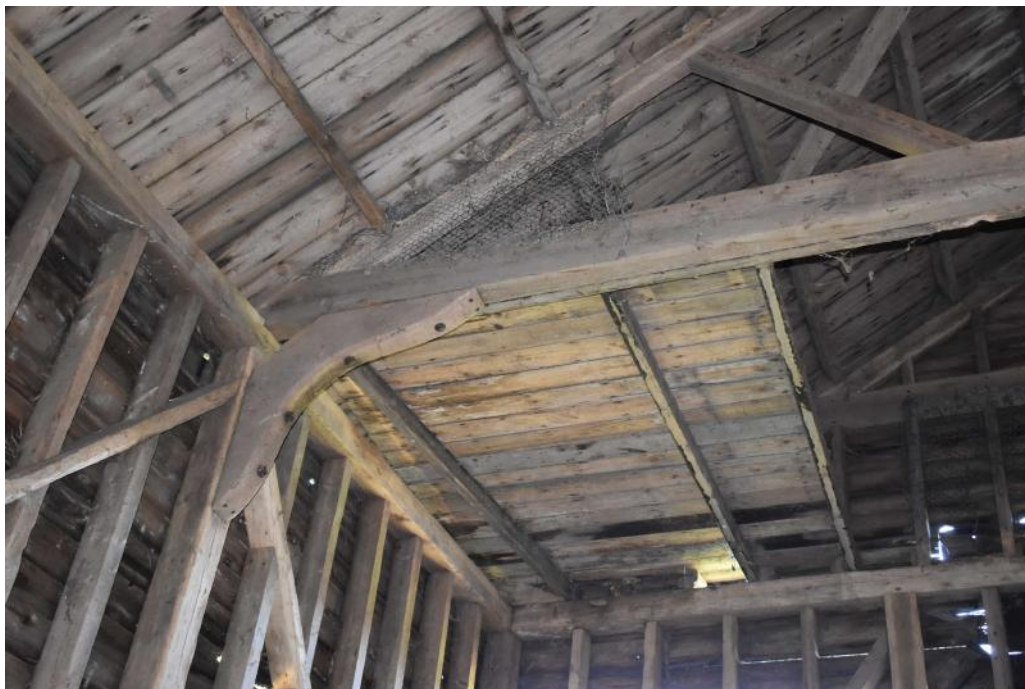
Photograph 17 Detail of inserted loft level in bay 5 of barn. Photograph taken facing north.

Bay 5 is the northern-most bay of the barn. There is an inserted loft level on the western side of bay and evidence this level once spanned the entire footprint of bay 5. In the northern wall there is evidence of an inserted, and now blocked, opening. Similarly to the sill-beam in bay 1, iron straps have been used to secure the sill-beam in the corners of bay 5. A side-halved scarf joint is located in the eastern sill-beam of bay 5. Also visible on the eastern wall is a Baltic timber mark on the post between bays 4 and 5.

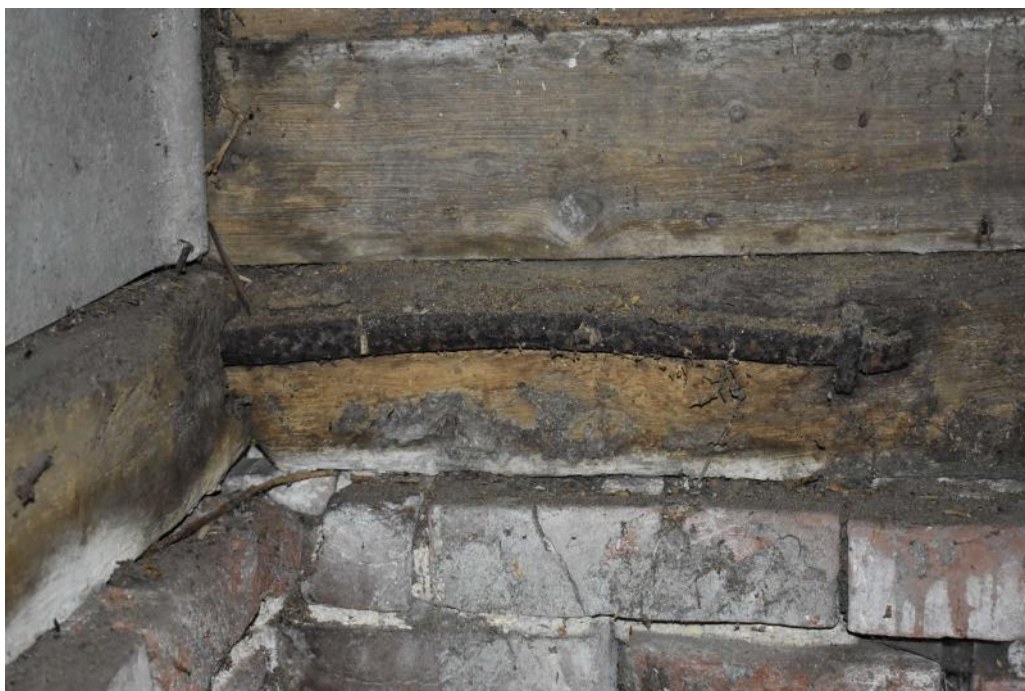
Photograph 18 Detail of iron strap on sill-beam of northern wall of bay 5 of barn. Photograph taken facing north.

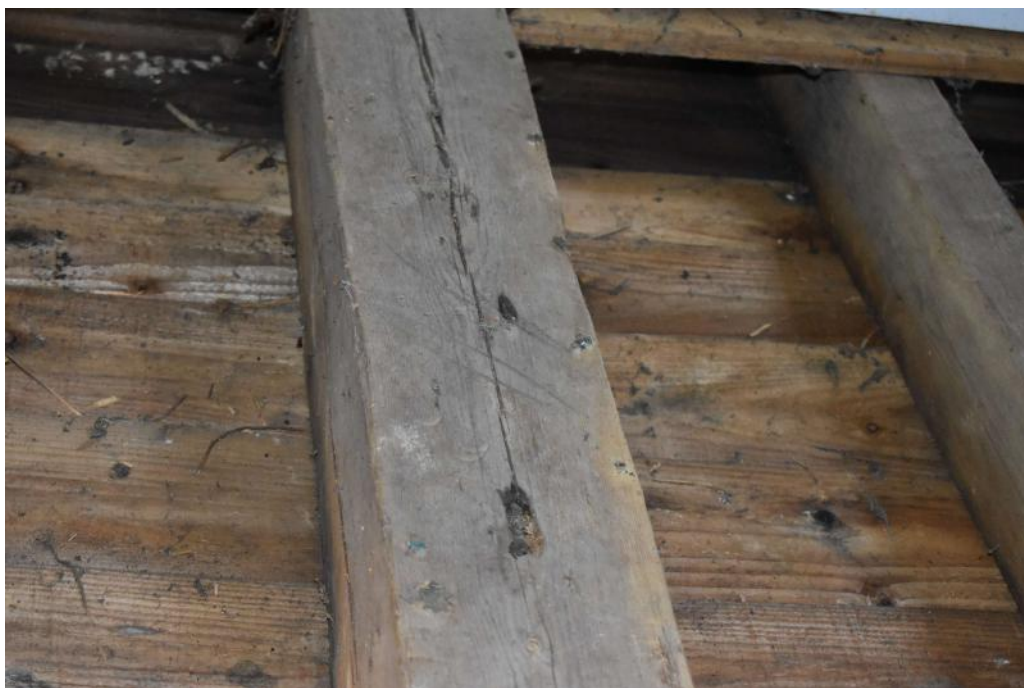
Photograph 19 Detail of Baltic timber mark on post of eastern wall between bays 4 and 5. Photograph taken facing south-east.

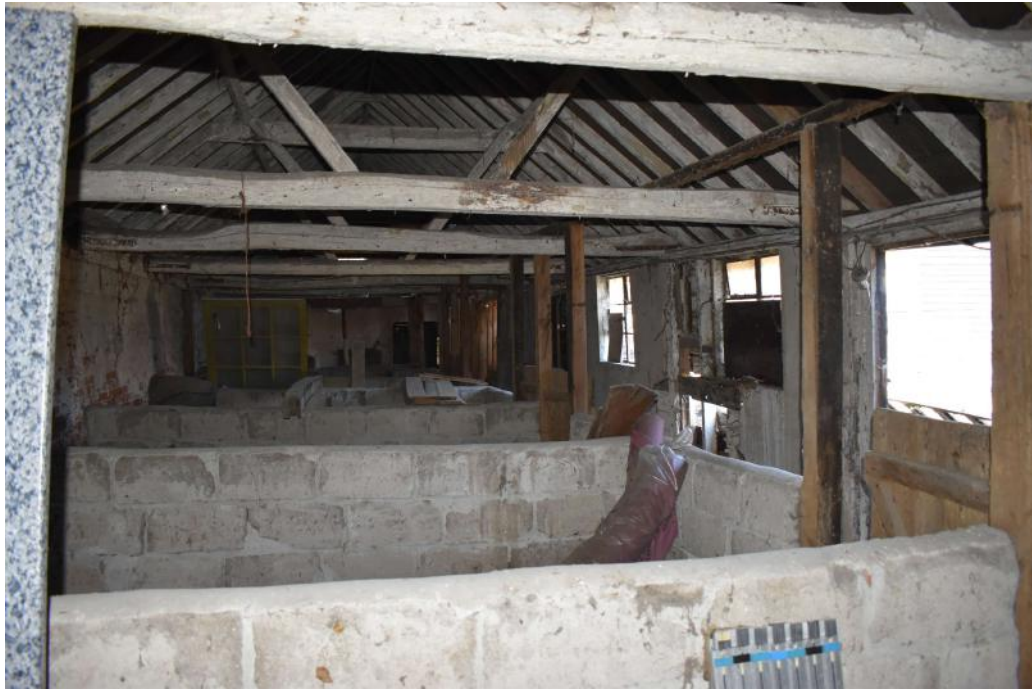
Photograph 20 Interior of store 5. Photograph taken facing north-west.

Store 5 has been divided into eight animal pens, using breeze-blocks (see Fig 2). Pens 1-6 are in the original part of the building while pens 7 and 8 are located in a later extension. Historic mapping indicates it was originally constructed between 1867 and 1881 and then extended between 1896 and 1921.

The roof of the original section of store 5 is constructed of pairs of rafters that rise from the brick wall in the south and the wall-plate in the north and meet at a ridge-board. Brick nogging has been used to fill the gaps between the feet of the rafters on the southern wall. There is a single purlin on each roof pitch which is clasped by an inclined strut, which rise from the tie-beams. The struts are supported by a lower collar and there is an upper collar just below the ridge-board. There are six equally-spaced tie-beams, which have been secured using iron straps. There is a wind-brace on the southern roof pitch above pens 1 and 6, the original ends of the building. The roof of the later extension mirrors this construction, minus the tie-beam straps and using different sized timbers.

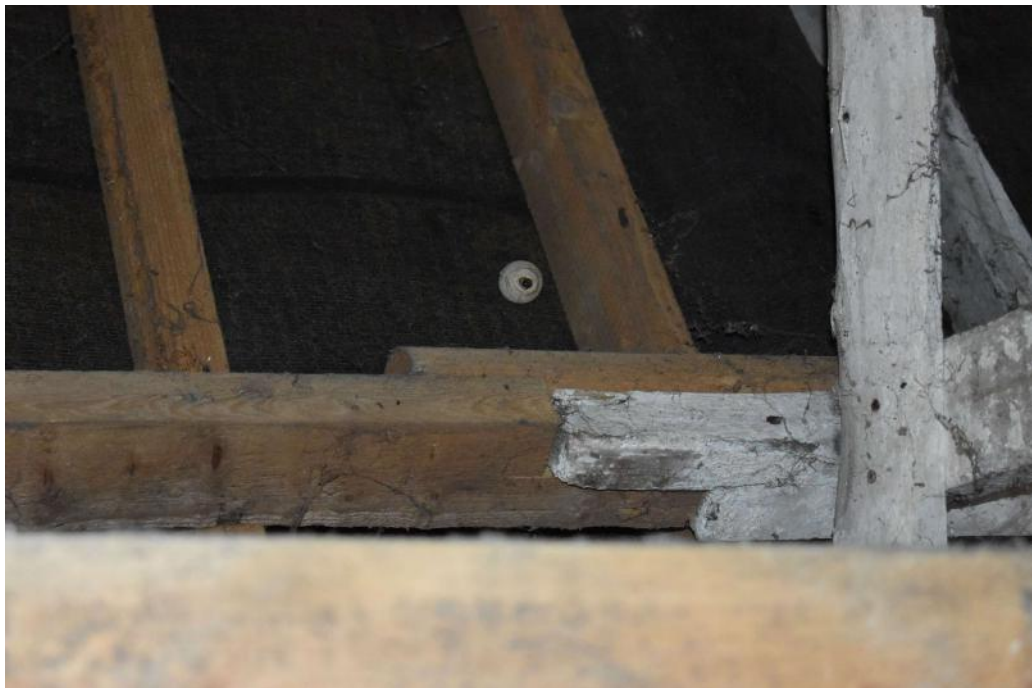
Photograph 21 Detail of scarf-joint in purlin on the northern pitch of the roof of the store 5. Photograph taken facing north.

Several side-halved and side-halved and bridled scarf joints have been used to join the wall-plate and purlins of the original part of store 5 to the extension.

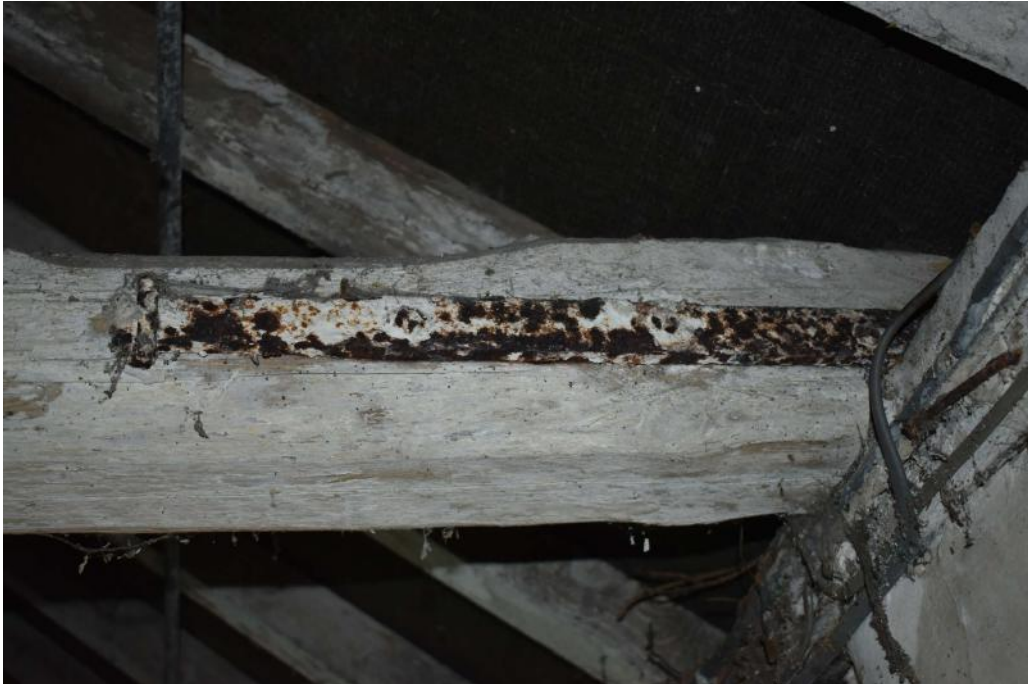
Photograph 22 Detail of iron-strap on tie-beam of store 5. Photograph taken facing north-west.

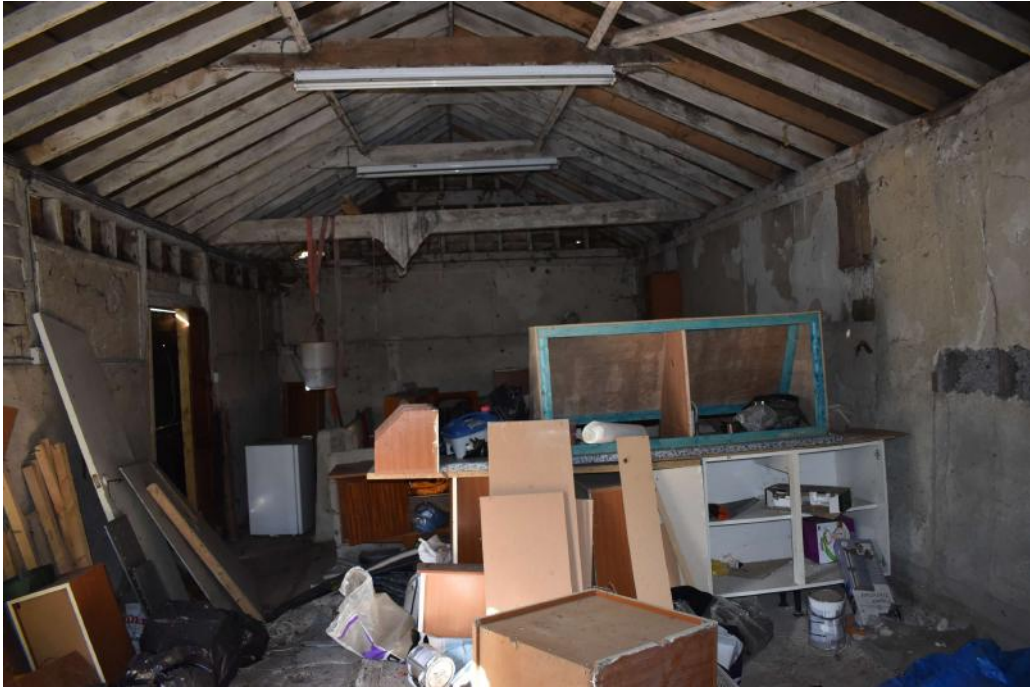
Photograph 23 Interior of store 9. Photograph taken facing north-west.

The walls of store 9 are mostly rendered with areas of wooden cladding. It appears that the southern wall was original closed and that the two windows (now boarded over) and two doors are all inserted. This indicates that the northern wall was probably originally open, and stores 9 and 12 were the original open-fronted cart-lodge.

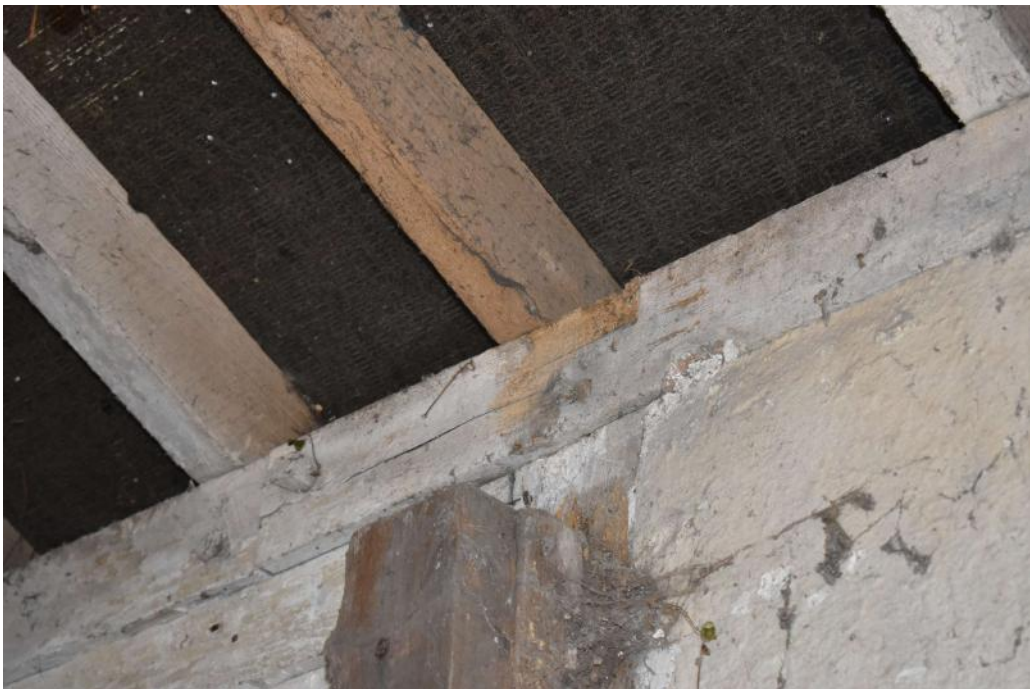
Photograph 24 Detail of removed tie-beam in store 9. Photograph taken facing north.

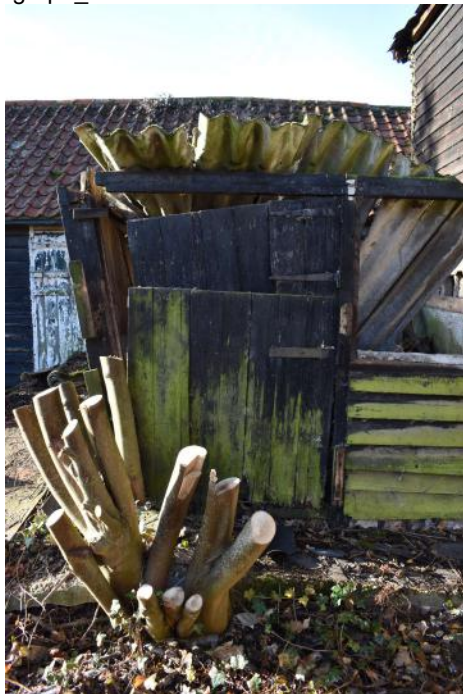
CFTF22_PhotoGraph_015Detail of door to store 6 in courtyard. Photog... CFTF22_PhotoGraph_016Eastern elevation of store 2. Photograph tak...

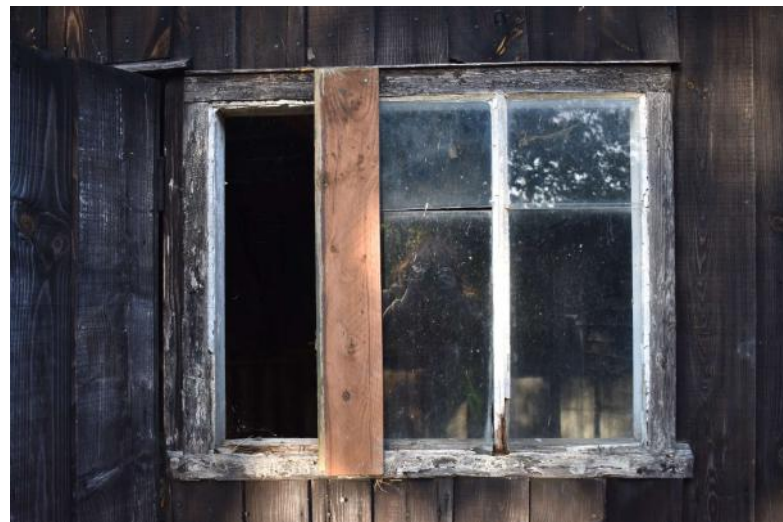
CFTF22_PhotoGraph_017Detail of window on eastern elevation of stor... CFTF22_PhotoGraph_018Detail of door eastern elevation of store 2. P...

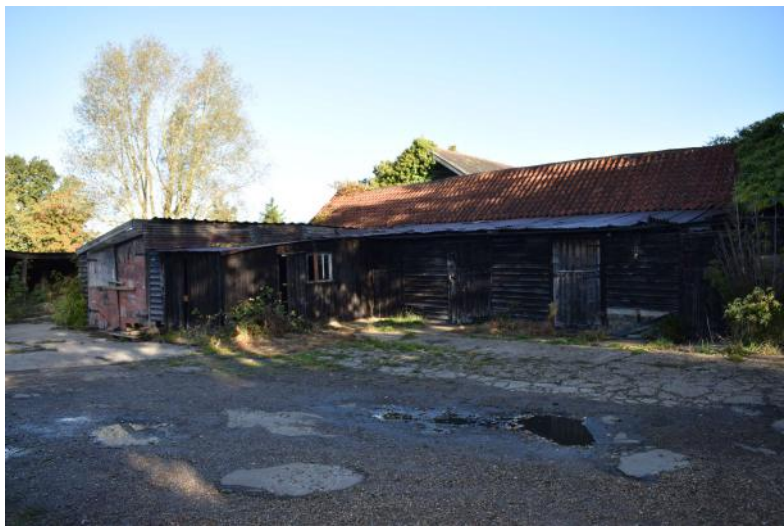
CFTF22_PhotoGraph_019Eastern and southern elevations of stores 1,... CFTF22_PhotoGraph_020Detail of door of store 4. Photograph taken f...

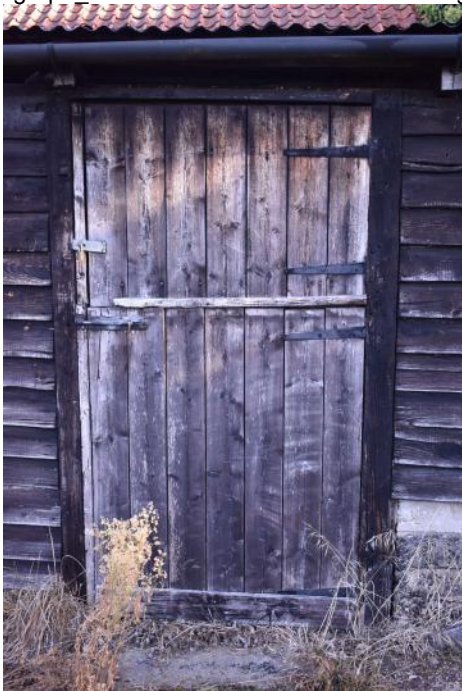
CFTF22_PhotoGraph_021Detail of door of store 4. Photograph taken f... CFTF22_PhotoGraph_022Detail of door of store 4. Photograph taken f...

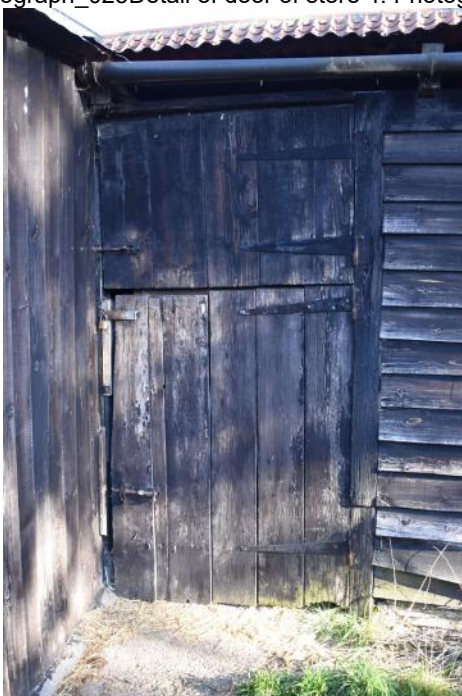
CFTF22_PhotoGraph_023Detail of door of store 4. Photograph taken f... CFTF22_PhotoGraph_024Interior of store 4. Photograph taken facing n...

Construction of stores 3 and 4 can be dated to between 1896 and 1921. Access to store 4 was limited due to collapse of the roof. From what could be observed, the north wall is constructed from red brick laid in Flemish bond while the eastern and southern walls were timber. Concrete walls have been used to divide the building into stables.

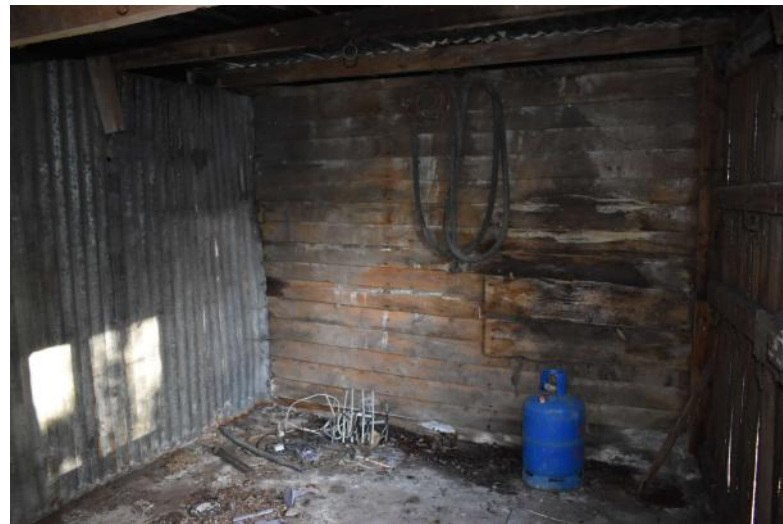
CFTF22_PhotoGraph_027Interior of store 2. Photograph take facing no... CFTF22_PhotoGraph_028Interior of store 2. Photograph take facing so...

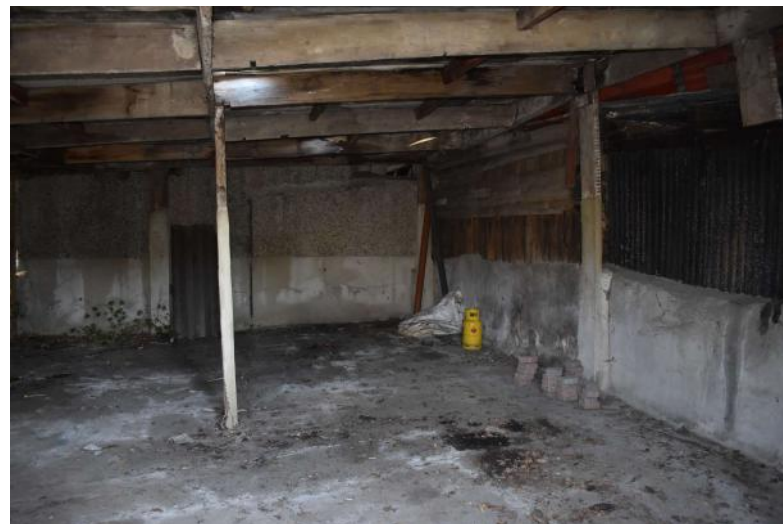
CFTF22_PhotoGraph_029Interior of store 1. Photograph taken facing n... CFTF22_PhotoGraph_030Interior of store 1. Photograph taken facing n...

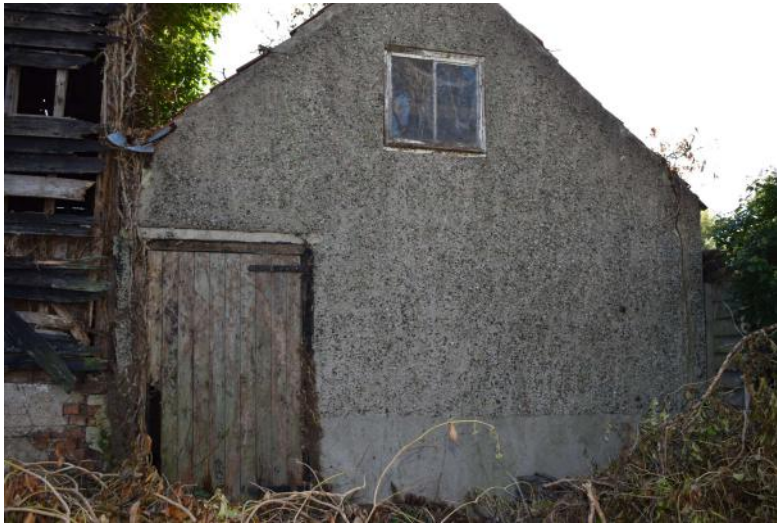
CFTF22_Photograph_039Western elevation of store 5. Photograph ta...
