**Historic building recording at Thrift Farm,
Moulsham Thrift, Chelmsford, Essex, CM2 8BP**

**CAT project ref.: 2022/08i
ECC code: CFTF22**

October 2022

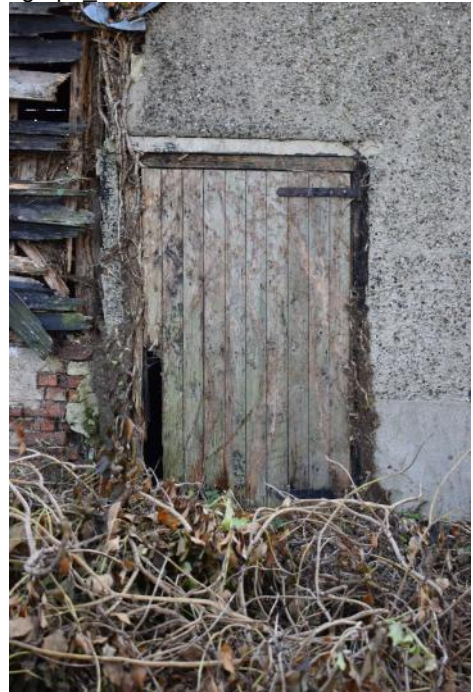
CFTF22_Photograph_040Detail of door on western elevation of store ...

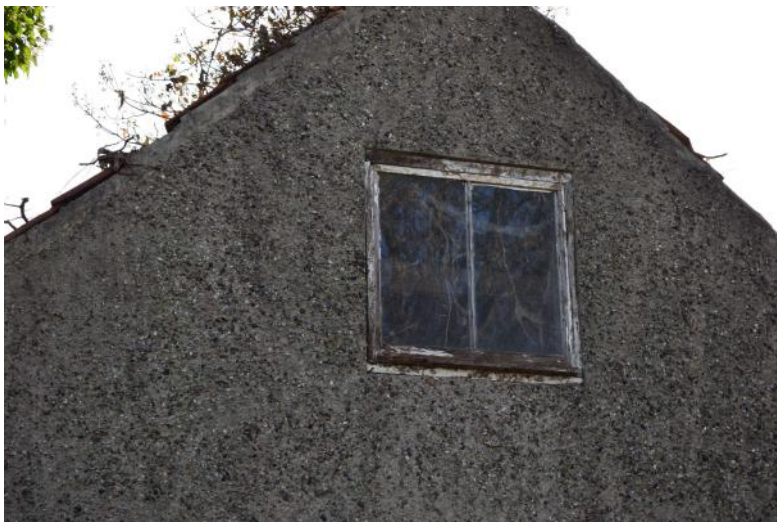
CFTF22_Photograph_041Detail of window on western elevation of stor...

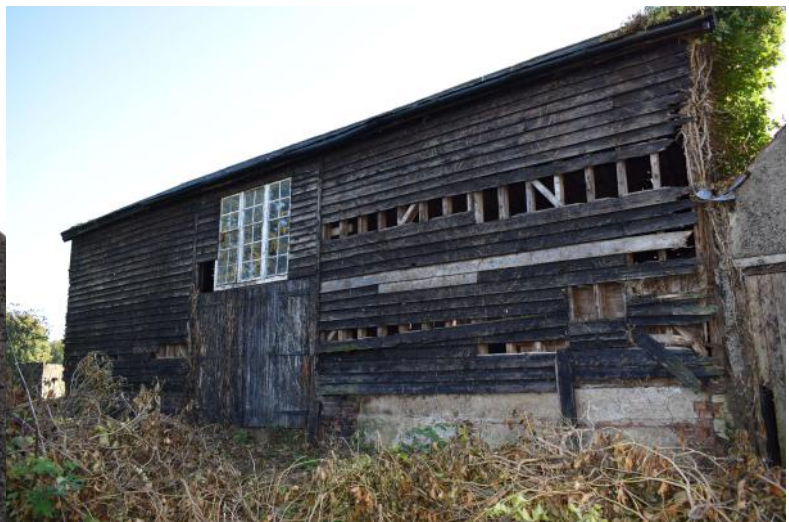
CFTF22_Photograph_042Western elevation of barn. Photograph take...

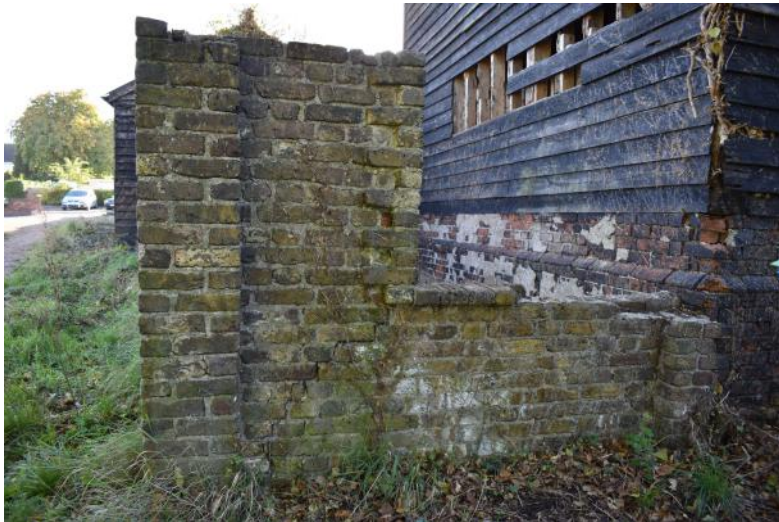
CFTF22_PhotoGraph_045Western elevation of store 7. Photograph ta... CFTF22_PhotoGraph_046Detail of brick wall of store 8. Photograph ta...

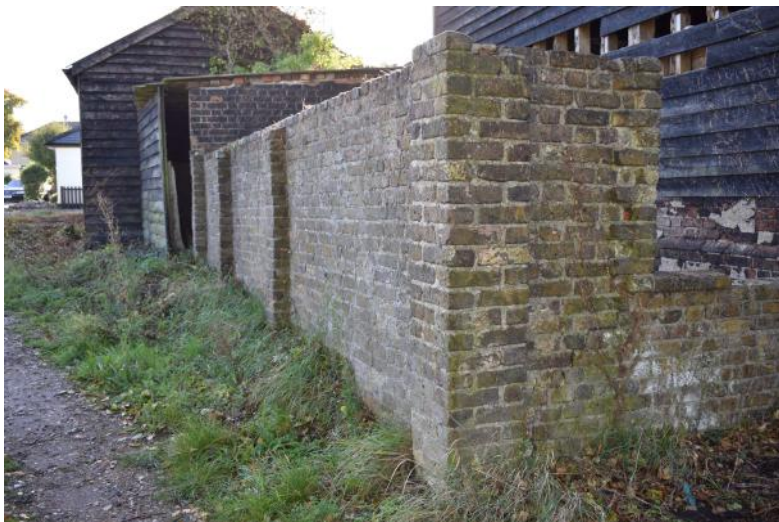
CFTF22_PhotoGraph_047Northern and western elevation of store 7. P... CFTF22_PhotoGraph_048Western elevation of barn. Photograph take...

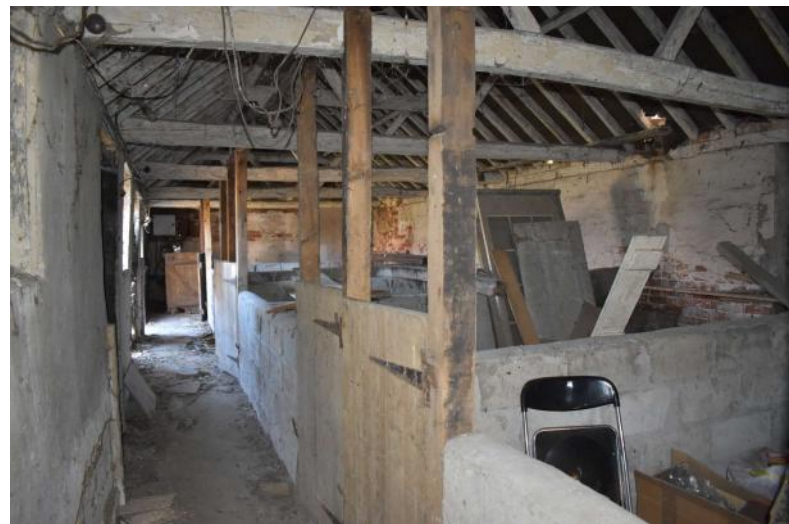
CFTF22_PhotoGraph_061Interior of store 5. Photograph taken facing s... CFTF22_PhotoGraph_062Detail of animal-pen doors in store 5. Photog...

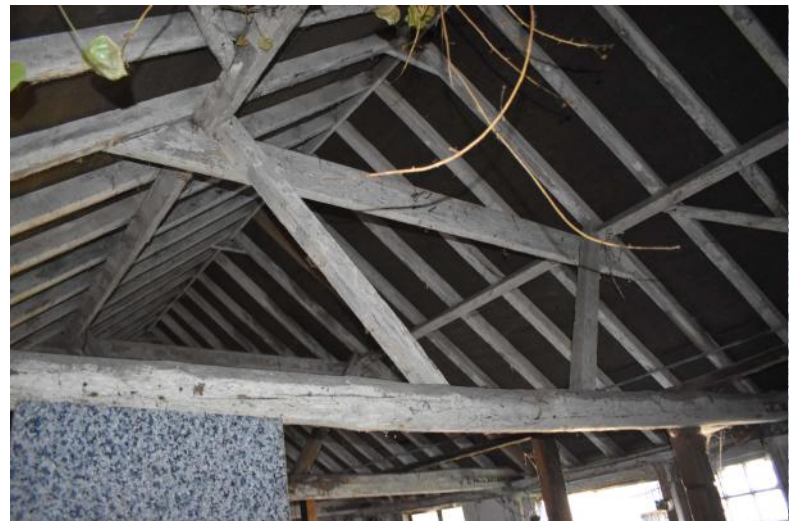
CFTF22_PhotoGraph_063Roof structure of store 5. Photograph taken f... CFTF22_PhotoGraph_064Interior of store 5. Photograph taken facing n...

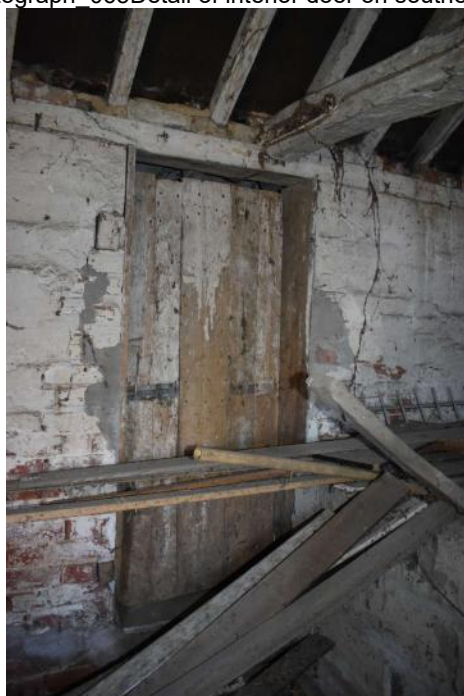
CFTF22_PhotoGraph_065Detail of interior door on southern wall of sto... CFTF22_PhotoGraph_066Detail of concrete trough in store 5. Photogr...

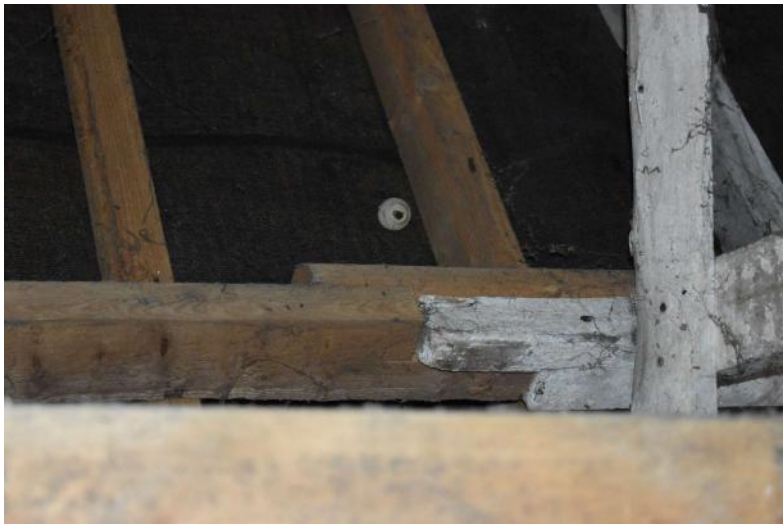
CFTF22_PhotoGraph_073Detail of scarf-joint in purlin on the northern ... CFTF22_PhotoGraph_074Detail of cut tie-beam and later timbers and ...

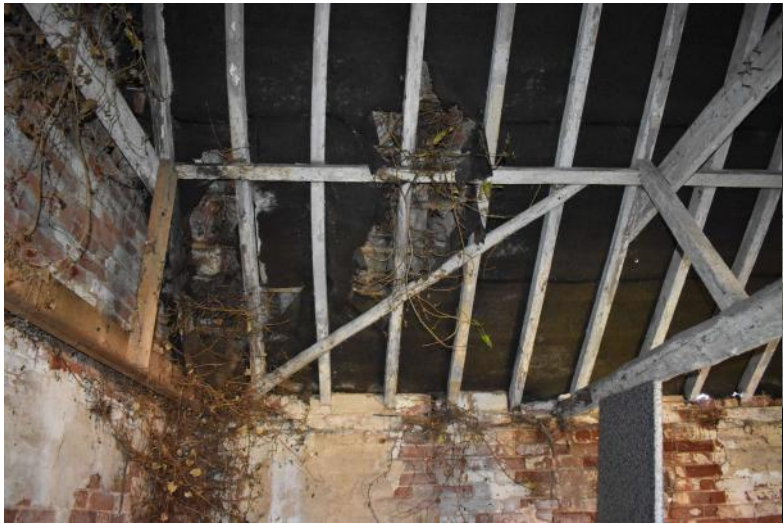
CFTF22_PhotoGraph_075Detail of windbrace southern pitch of roof of ... CFTF22_PhotoGraph_076Detail of iron-strap on tie-beam of store 5. P...

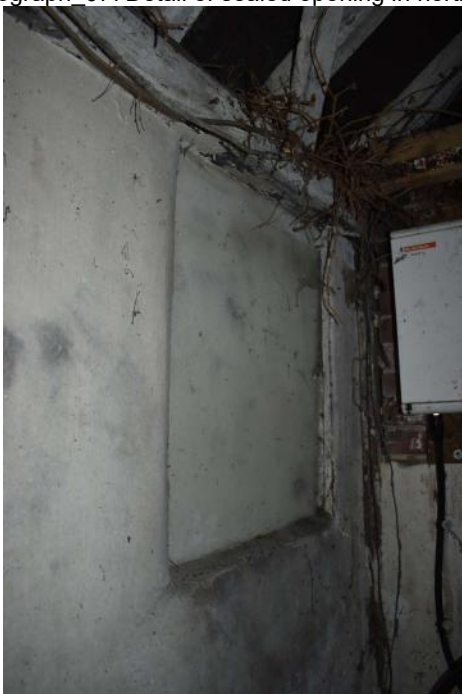
CFTF22_PhotoGraph_077Detail of sealed opening in northern wall of s... CFTF22_PhotoGraph_078Detail of cut bricks in inserted doorway betw...

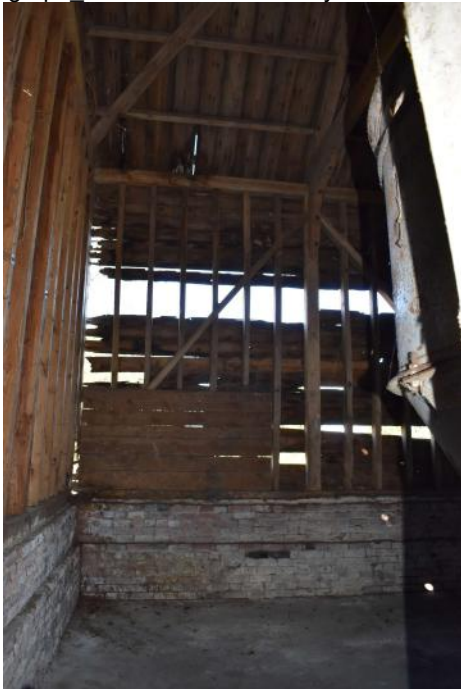
CFTF22_PhotoGraph_081Western wall of bay 1 of barn. Photograph ta... CFTF22_PhotoGraph_082Western roof pitch of bay 1 of barn. Photogr...

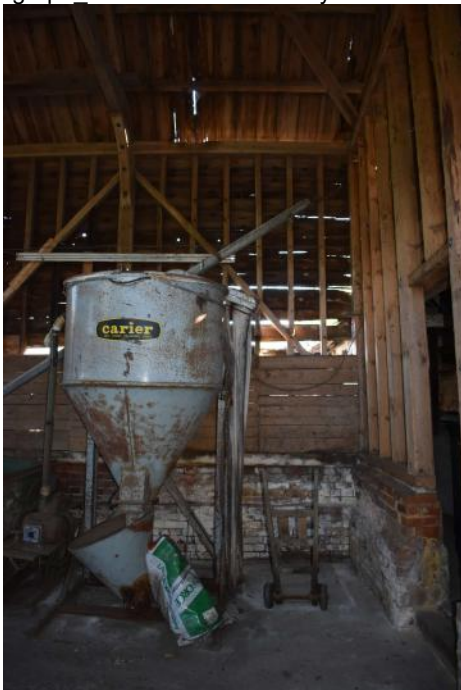
CFTF22_PhotoGraph_083Eastern wall of bay 1 of barn. Photograph ta... CFTF22_PhotoGraph_084Eastern roof pitch of bay 1 of barn. Photogra...

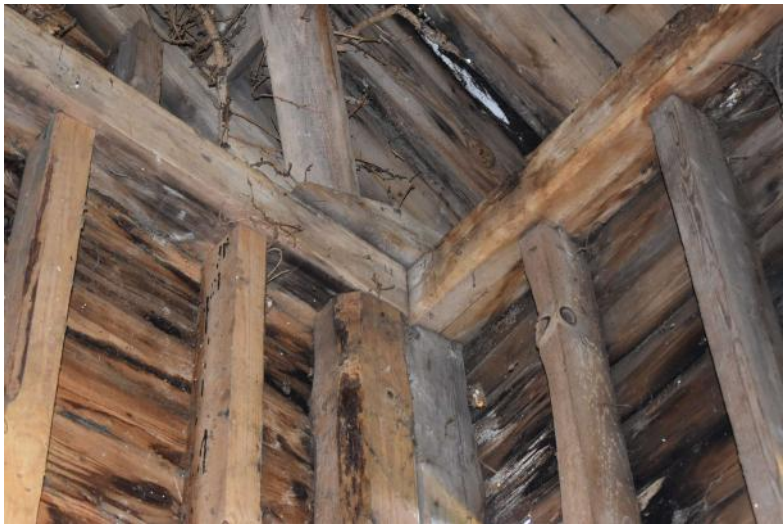
CFTF22_PhotoGraph_085Detail of carpenters mark 'll' on gable-tie an... CFTF22_PhotoGraph_086Eastern wall of bay 2 of barn. Photograph ta...

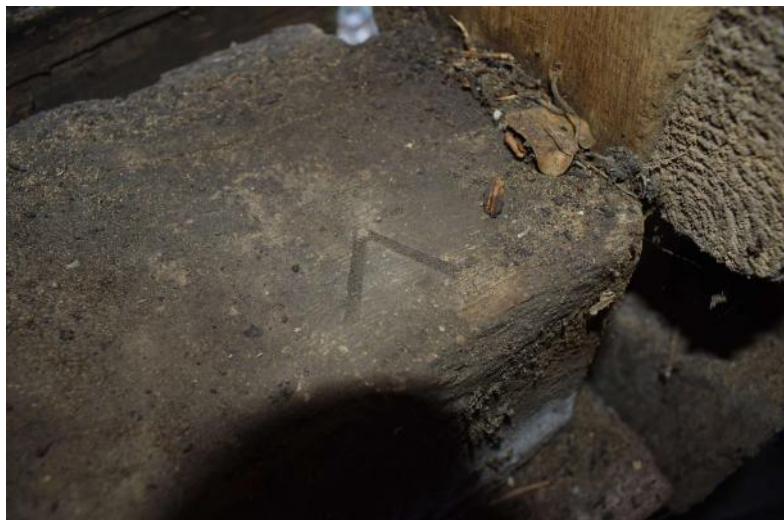
CFTF22_PhotoGraph_089Western roof pitch of bay 2 of barn. Photogr... CFTF22_PhotoGraph_090Detail of carpenters mark 'V' on sill-beam on...

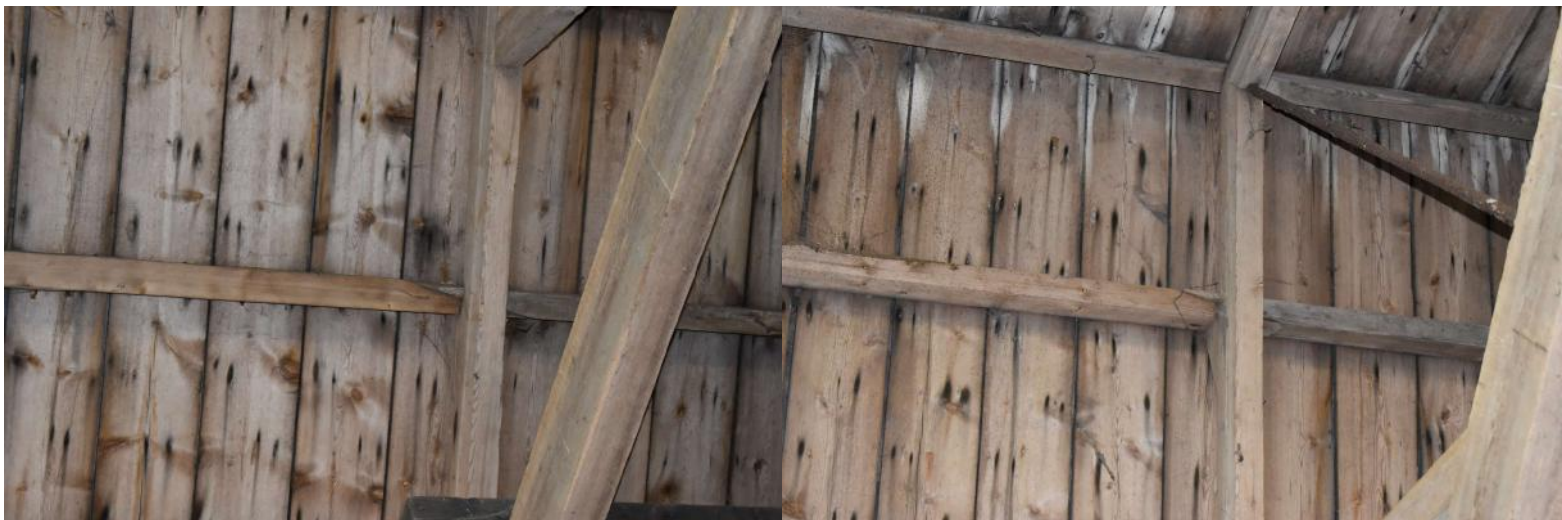
CFTF22_PhotoGraph_095Detail of lower scarf-joint in purlin in eastern ... CFTF22_PhotoGraph_096Detail of upper scarf-joint in purlin in eastern...

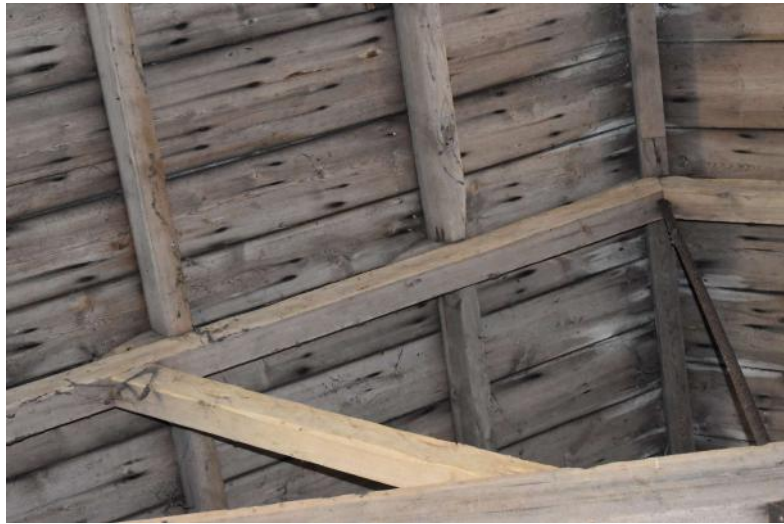
CFTF22_Photograph_117Detail of wooden blocks adjacent to barn do... CFTF22_Photograph_118Detail of upper scarf-joint in purlin in western...

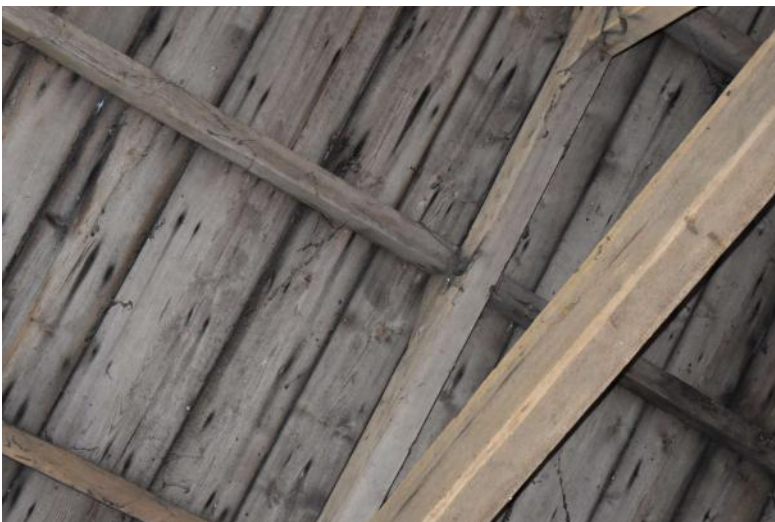
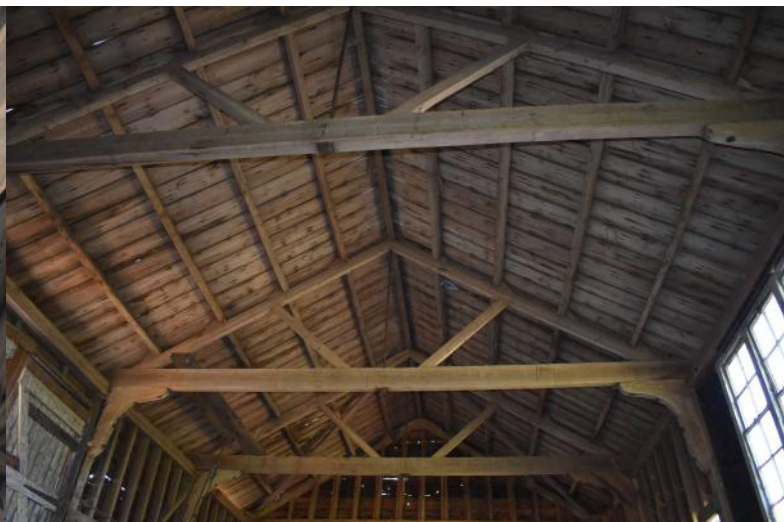
CFTF22_Photograph_119Detail of lower scarf-joint in purlin in western ... CFTF22_Photograph_120Detail of barn roof truss. Photograph taken f...

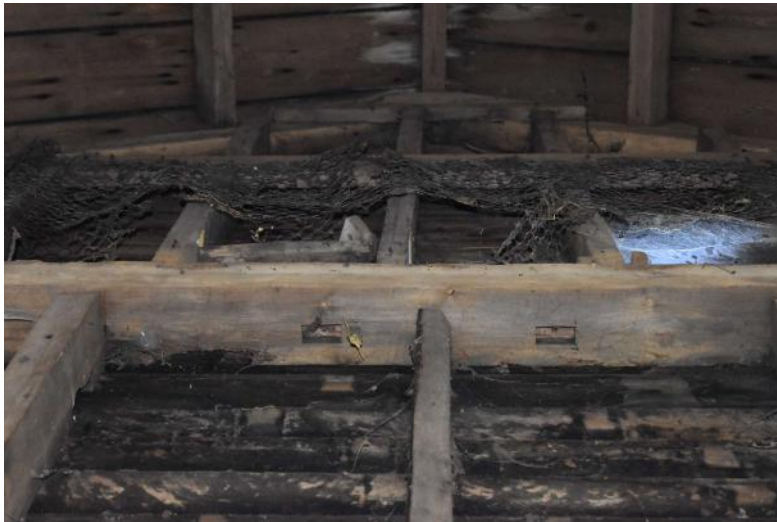
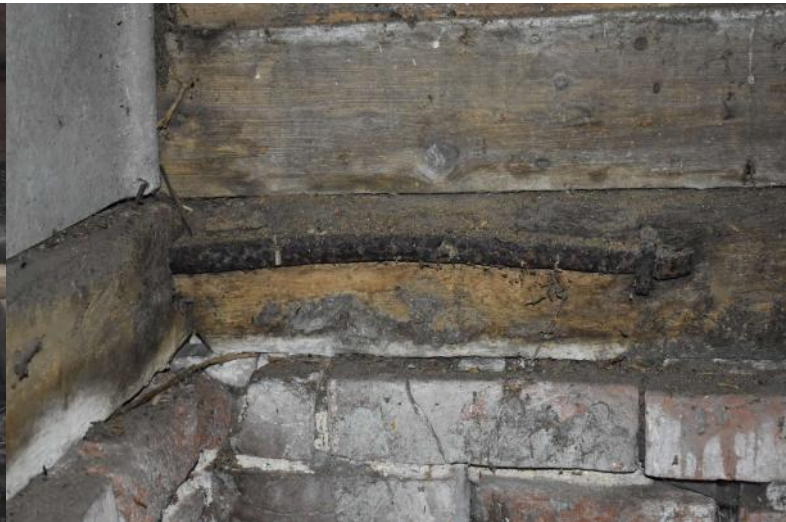
CFTF22_PhotoGraph_123Detail of empty mortices in gable-tie in bay 5... CFTF22_PhotoGraph_124Detail of iron strap on sill-beam of northern ...

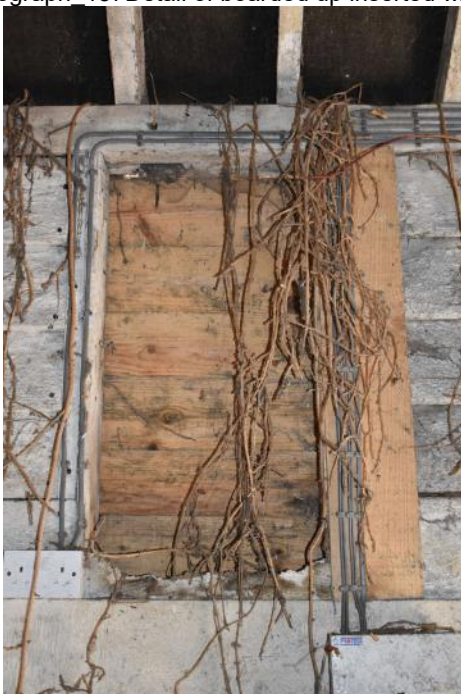
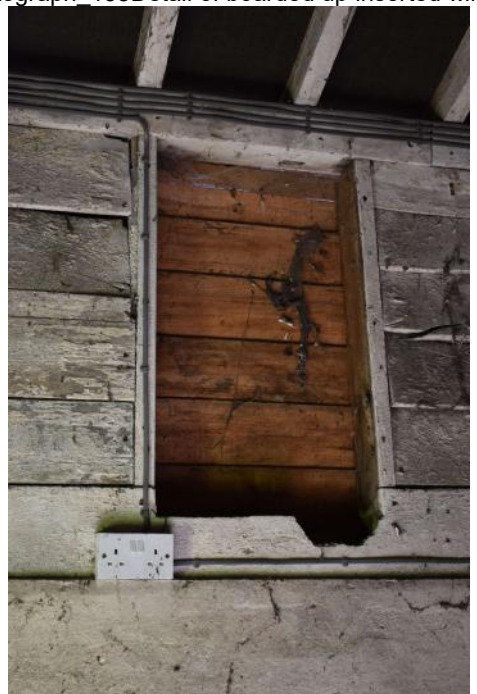
CFTF22_PhotoGraph_137Detail of boarded up inserted window on sou... CFTF22_PhotoGraph_138Detail of boarded up inserted window on sou...

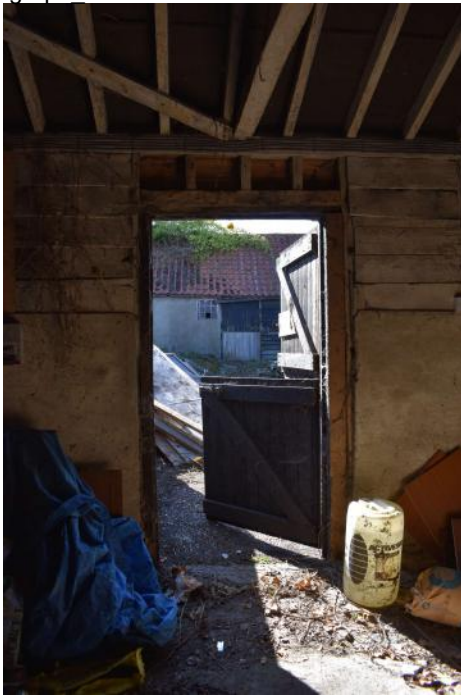
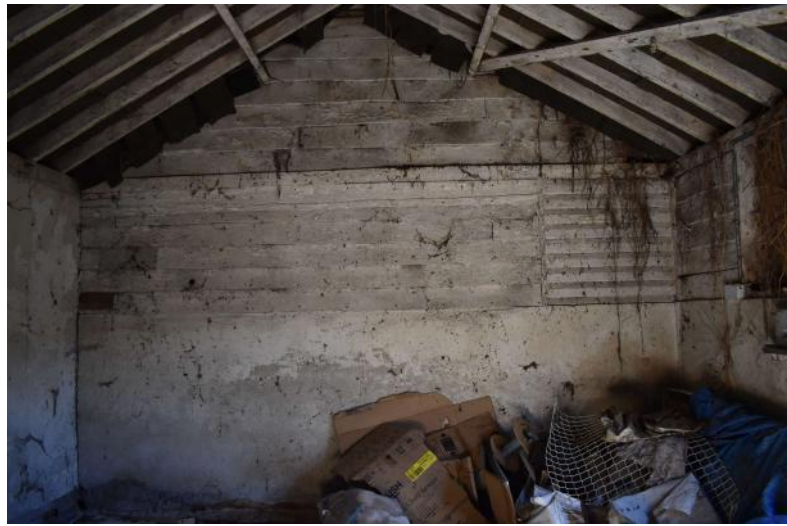
CFTF22_PhotoGraph_145Detail of door southern wall of store 9. Photo... CFTF22_PhotoGraph_146Inserted eastern wall of store 9. Photograph ...

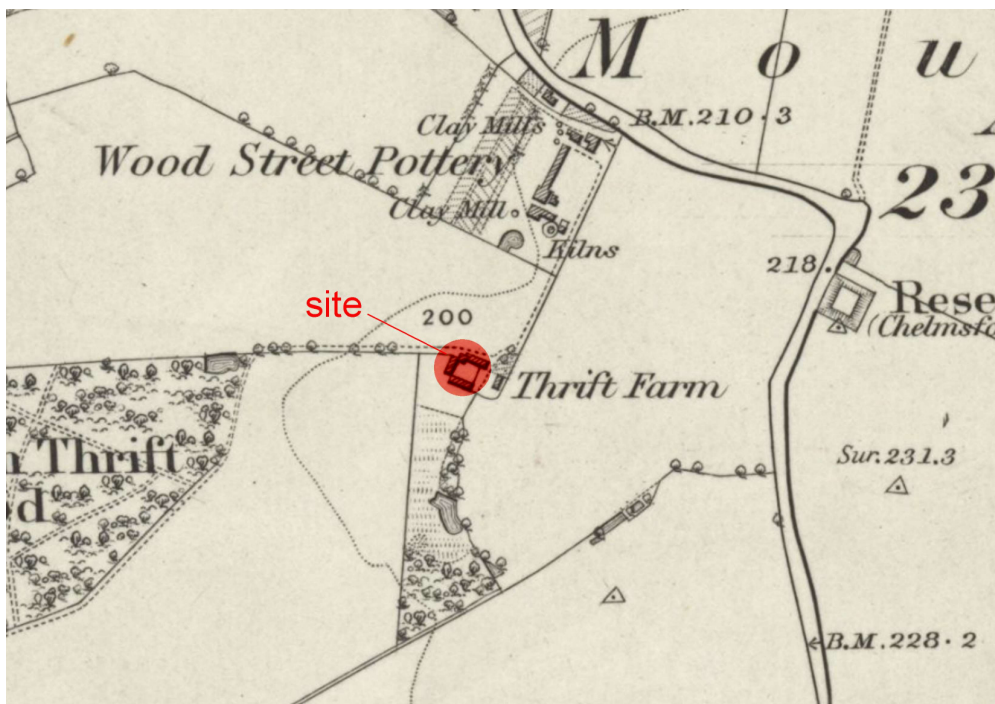
Map 1 Extract of the 1st OS map of England and Wales, Essex Sheet LII, surveyed 1874, published in 1881. Current site is highlighted red

Although recorded as replacing the earlier farm complex, the current farm structures form a complete group visible on the 1st edition OS map (see Map 1), and it is highly likely that elements of the original model farm survive within the fabric of the current buildings and foundations and framework of the original buildings may still survive belowground.
