Aldsworth Manor, Aldsworth, Gloucestershire

Heritage Statement and Impact Assessment

May 2021

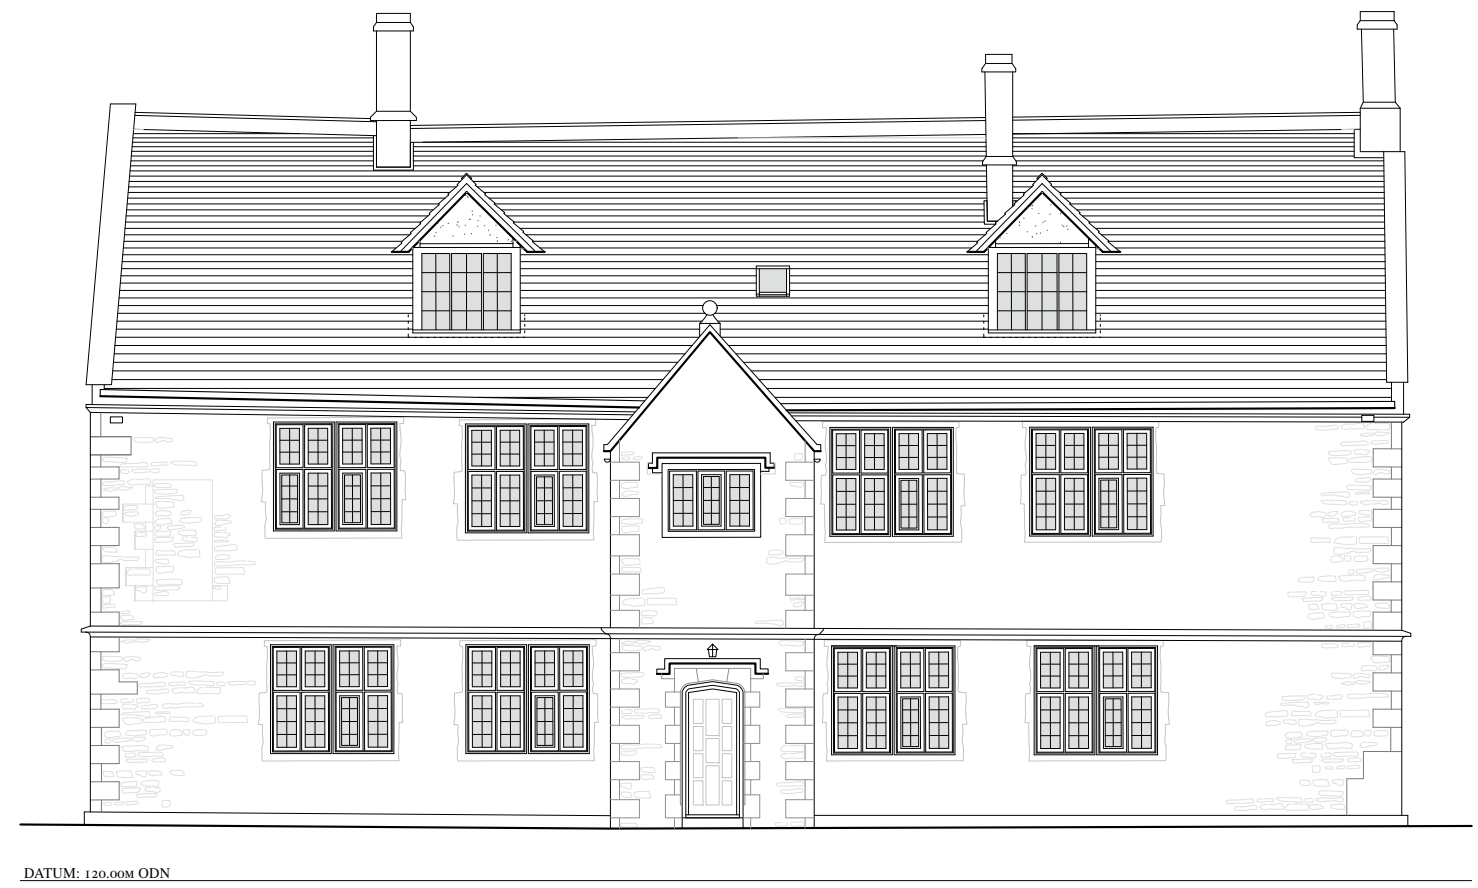
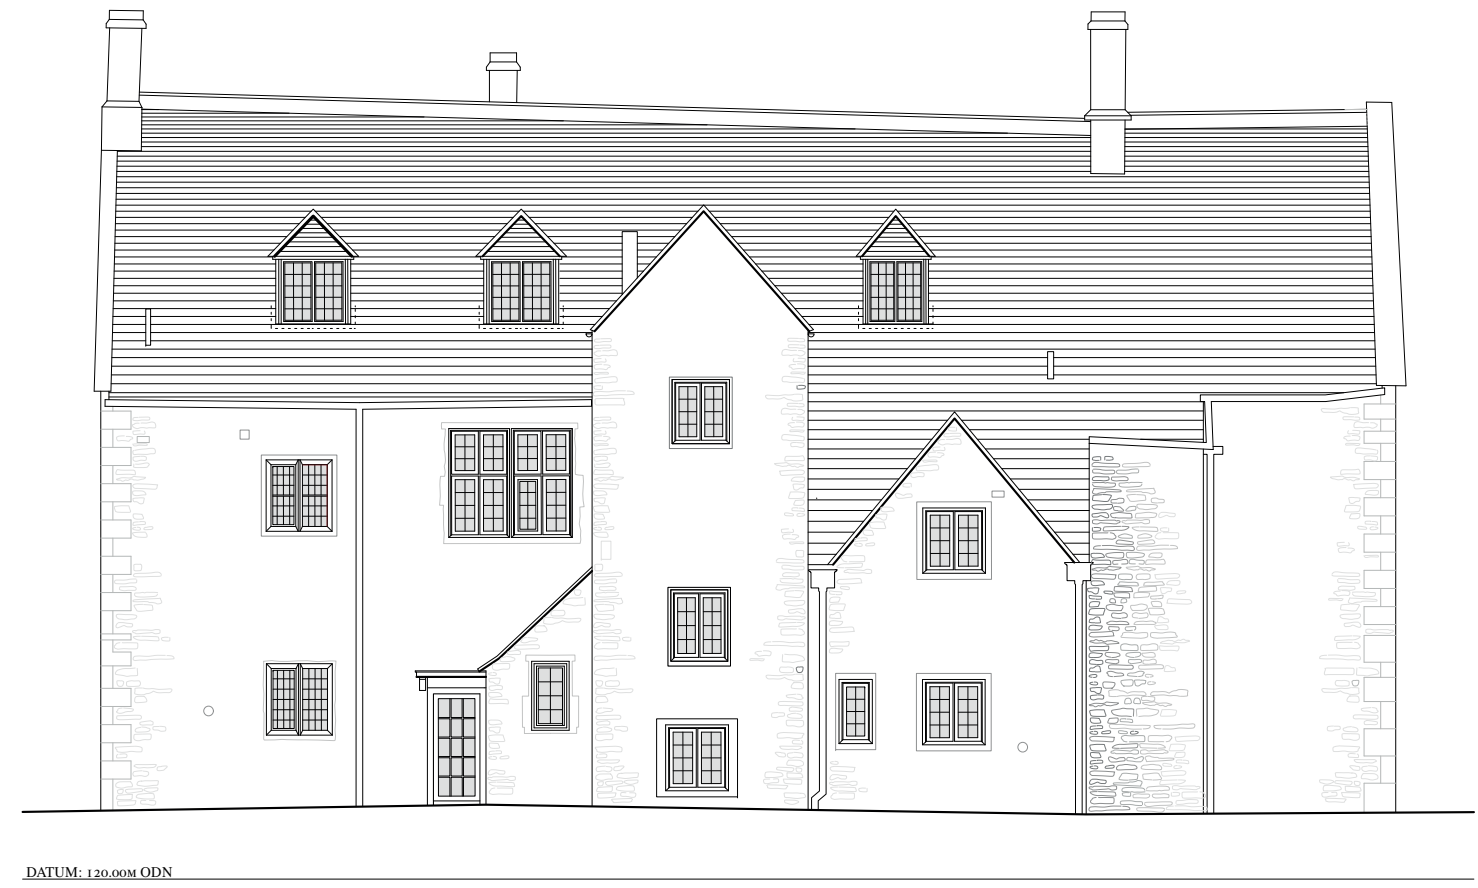
Figure 2: The east and west elevations of Aldsworth Manor

EAST ELEVATION

- 3.2.2 **The east elevation** is the façade of the house and faces over a lawn towards the village. It is a large, stone-built, double-fronted façade with a two-storey, central porch tower (Figure 2). There is a short plain, stone plinth and two stone string courses over the ground and first floors. There are two large, eight-light, casement windows to each side of the porch tower on both the ground and first floors (eight in total). The panes are leaded and the windows are 17th-century in character but the hollow mouldings of the stone mullions suggest an earlier date of perhaps the late 16th century. The porch tower is almost certainly a later addition to the house but it may replace an earlier, similar structure. In the ground floor of the east face of the porch tower is the entrance doorway to the house, which has a four-centred, arched opening with a decorative hood mould and a large, modern, panelled, wooden door. Above this in the first floor is a three-light casement window with leaded panes and

- 3.2.5 **The west elevation** has a much more irregular arrangement than the east façade, as is characteristic of 17th-century houses, and on the face of it, appears to be the most altered elevation of the house (Figure 2, Plate 4). In the centre of the elevation is a large, three-storey, gabled stair turret. This is offset slightly to the north so it is not in alignment with the porch tower to the east front. In each of the three floors of its west face are small, two-light casement windows with leaded panes. It is unknown if the stair turret is original to the 17th-century build but the straight joints would suggest that it is an addition, and perhaps replaced an earlier stair. A 20th-century addition to the elevation is the two-story, gabled structure abutting the south side of the stair turret, referred to as the back hall on plans. It is lower in height and a later catslide roof extends from the roof of the main house to meet its gable. In the ground floor of its west face is a single-light casement window and a two-light casement window, both with leaded panes. Over these, in the first floor, is a two-light casement window with leaded panes. In the ground floor of the south side of this structure is a door opening with a modern glazed door.

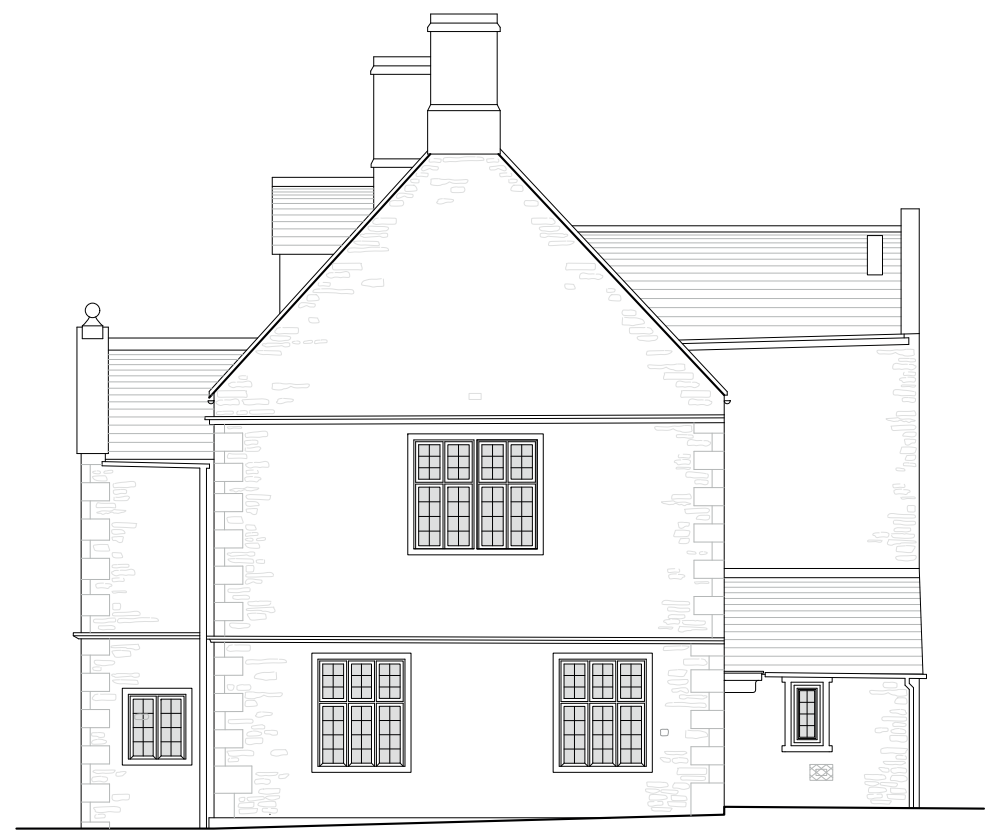
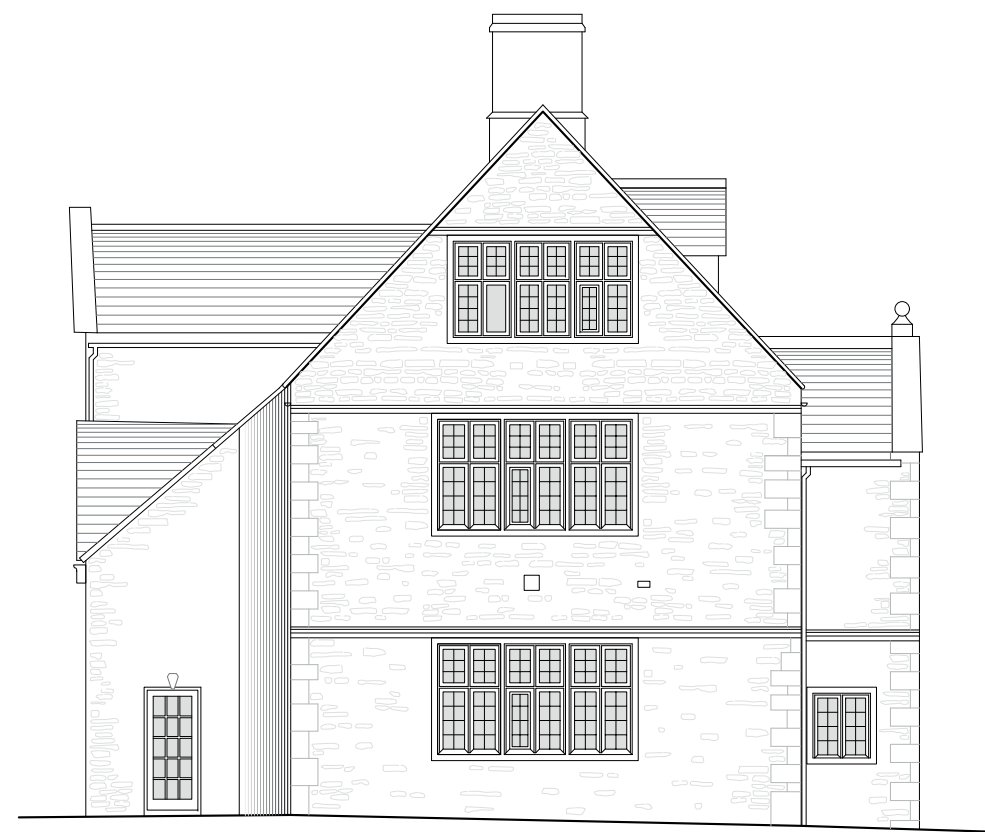
Figure 3: The north and south elevations of Aldsworth Manor

NORTH ELEVATION

- 3.2.8 **The south gable end** features a large twelve-pane casement window to each of its ground and first floors and a slightly shorter twelve-pane casement window in its attic level (Figure 3, Plate 2). The panes are leaded and the windows are 17th century in character but the hollow mouldings of the stone mullions suggest an earlier date of perhaps the late 16th century. The gable features three string courses and ashlar quoining to the corners.

- 3.2.9 **The north gable end** has two six-light casement windows with leaded panes in its ground floor and an eight-light casement window with leaded panes in the centre of its first floor (Figure 3). Like the casement windows throughout the other elevations, they appear to be 17th-century in character but the hollow mouldings may suggest an earlier date. The elevation has stone string courses to the ground, first and attic floor, and ashlar quoining to the corners.

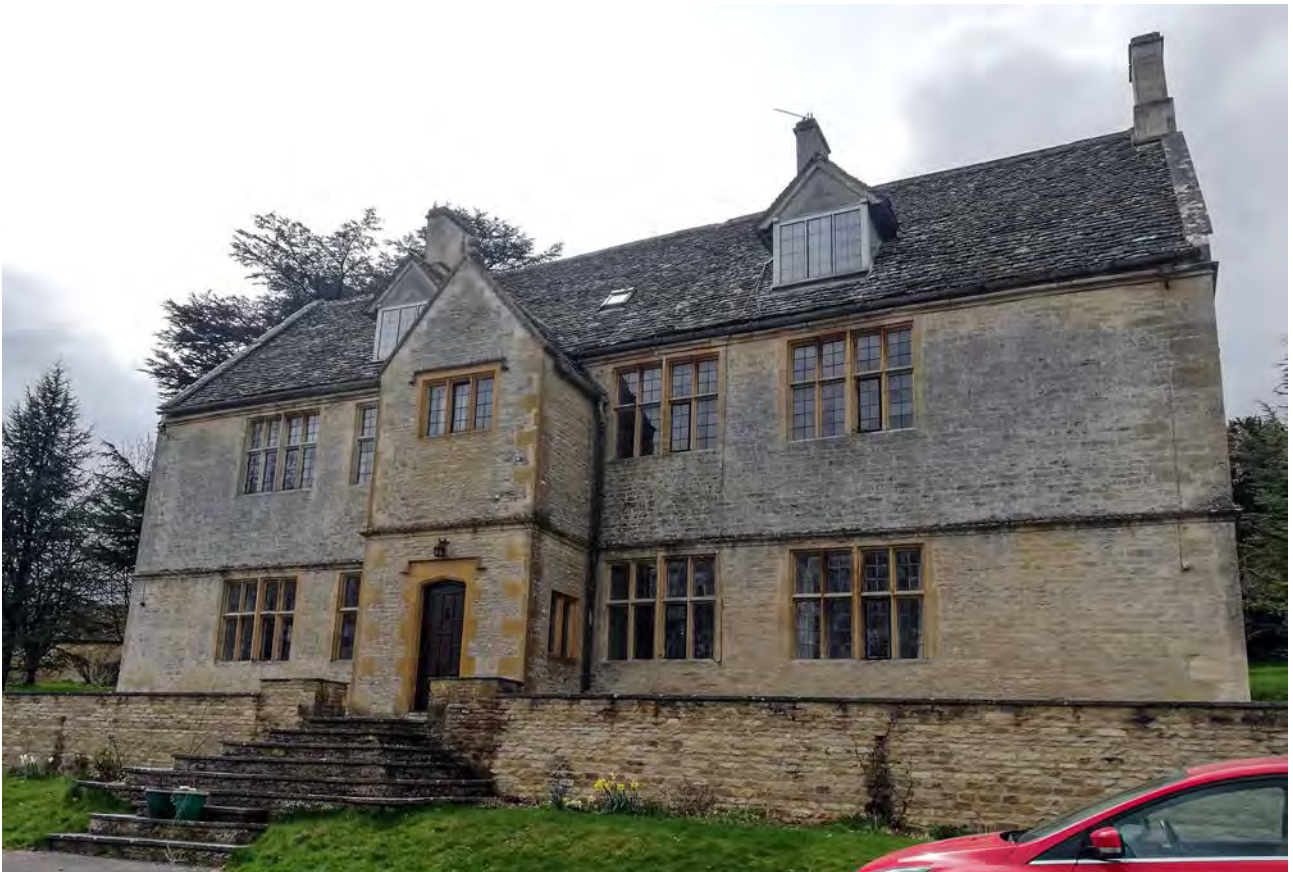
Plate 1: The east elevation of Aldsworth Manor, looking south-west

- 3.2.1 The manor house is built with irregularly sized, squared limestones with ashlar quoining to the corners and the openings (Plate 1). It features four bays over two storeys with a cellar and attic level. The roof is pitched and gabled, with smaller gables over the porch tower to the east front and the stair tower to the west rear. The roof structure is covered with stone tiles and there is a large stone chimney extending from the north gable, between the north bay and the bay to its south, and between the south bay and second bay from the south. There are two large, gabled dormer windows in the east side of the roof and in the west side are three smaller dormer windows with hipped roofs. The house sits on a stone paved terrace that was probably built in the 20th century (Plate 2). Around the front and sides of the terrace, where the house is built into an east to west incline, is a wall built with limestones that are more cobble-like than those of the house. On top of this wall is wide, flat, stone coping and ascending to the entrance on the east side is nine, wide, stone steps.

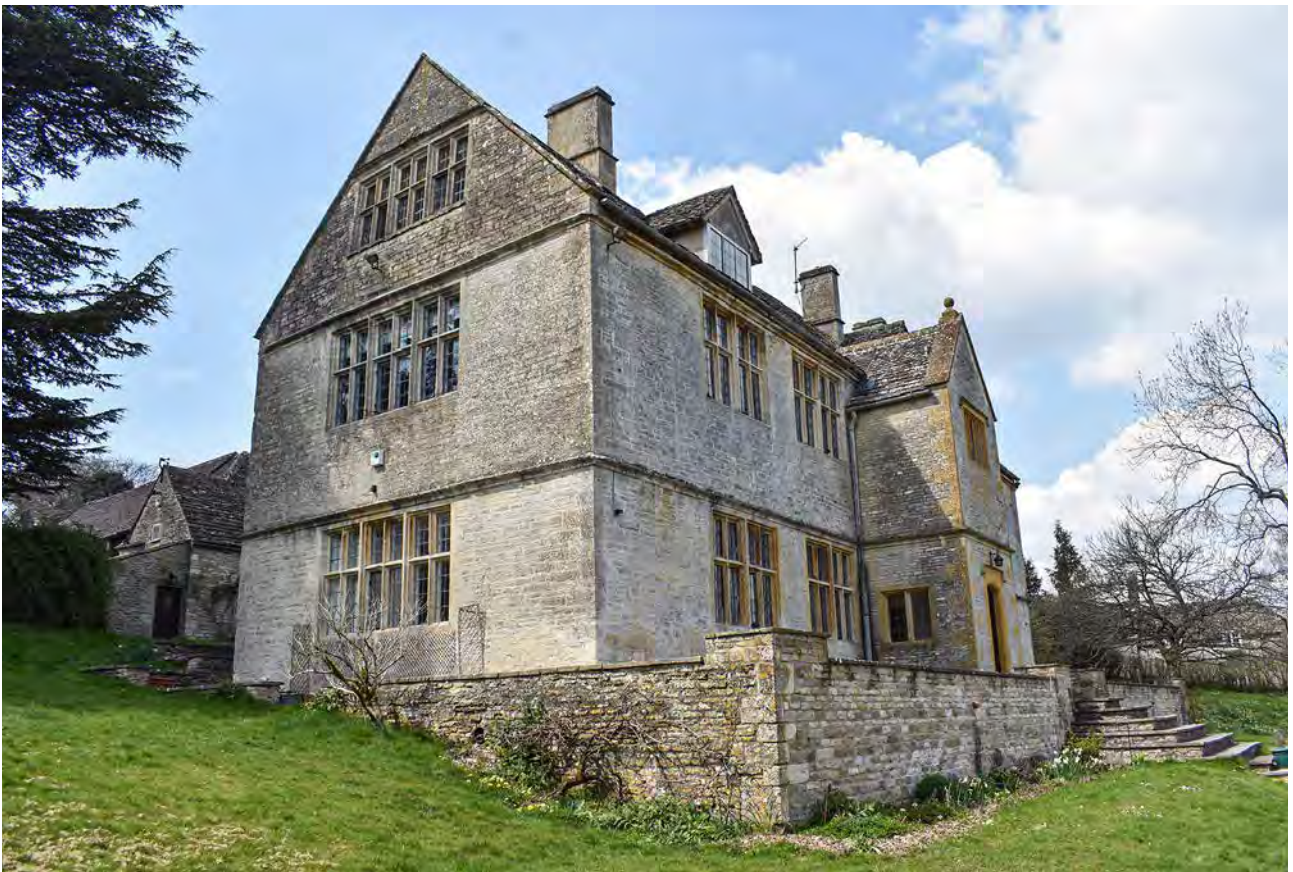
Plate 2: The east and south elevations of Aldsworth Manor, looking north-west

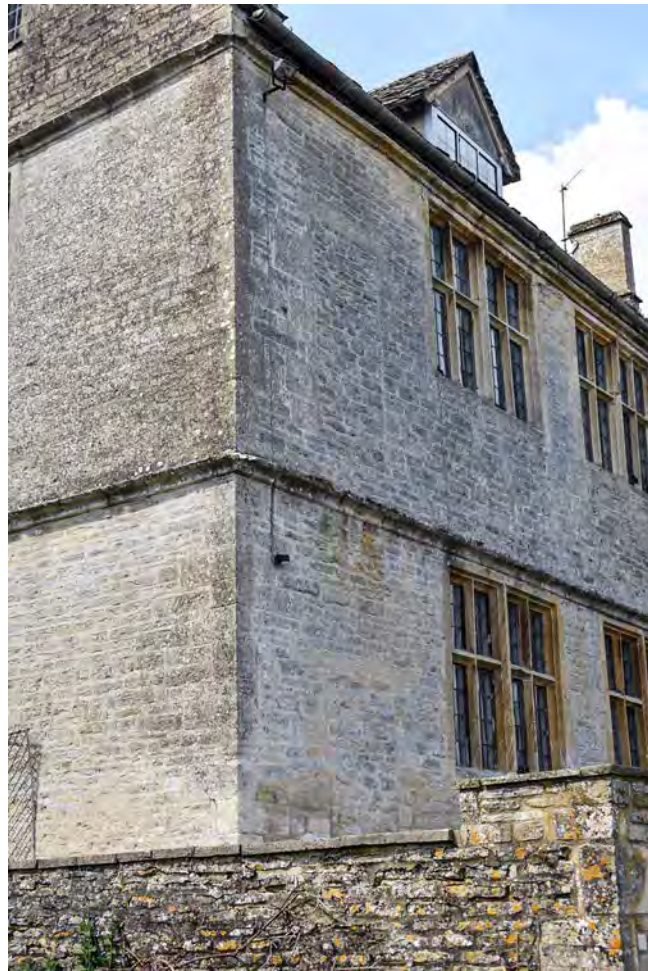
Plate 3: The south-east corner of Aldsworth Manor, looking north-west

- 3.2.4 On the extreme south side of the elevation, in the ground and first floors, are blocked openings that appear to be doorways (Plate 3). It would be unusual to have doors to the exterior in these positions in a house of this type with its current form, and so their use may date to an earlier phase when the architectural arrangement was substantially different.

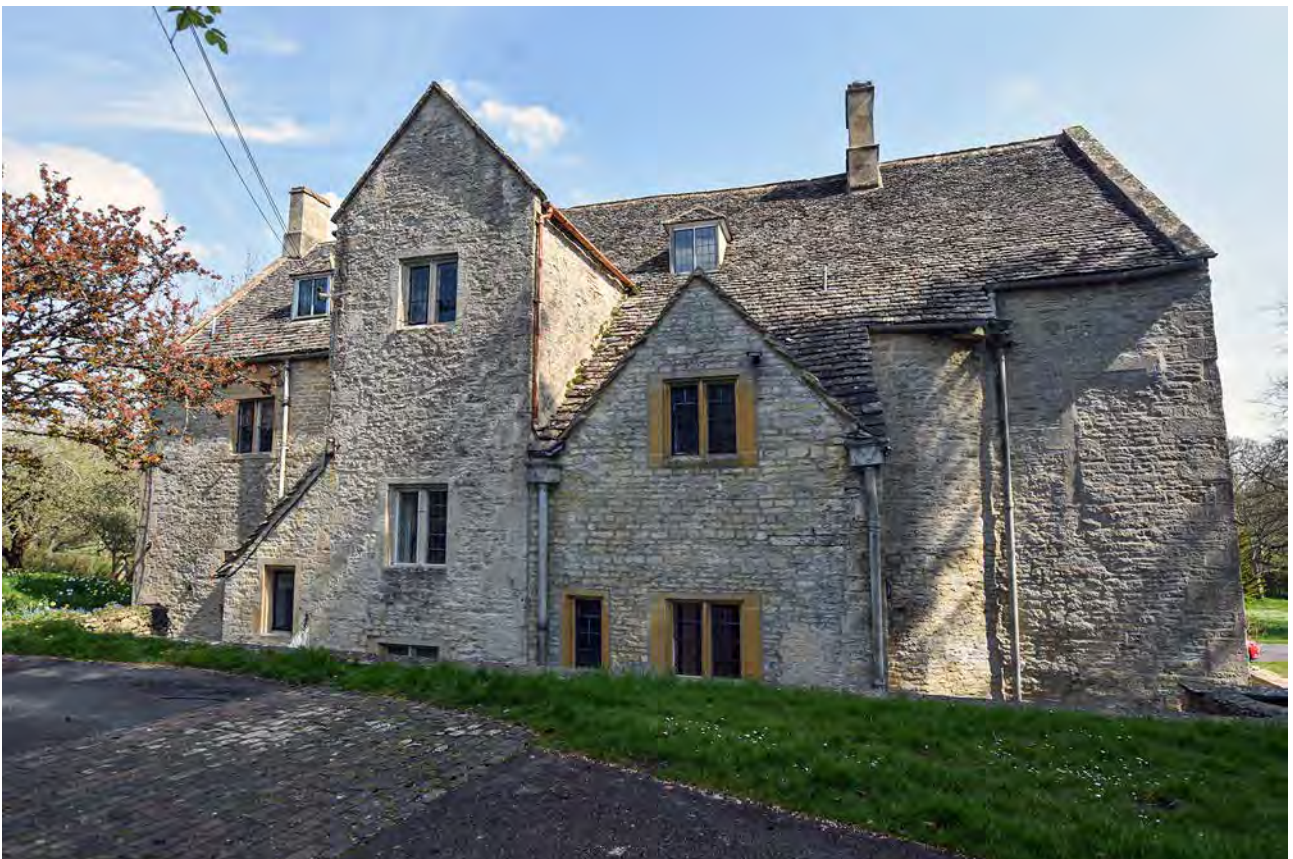
Plate 4: The west elevation of Aldsworth Manor, looking north-east

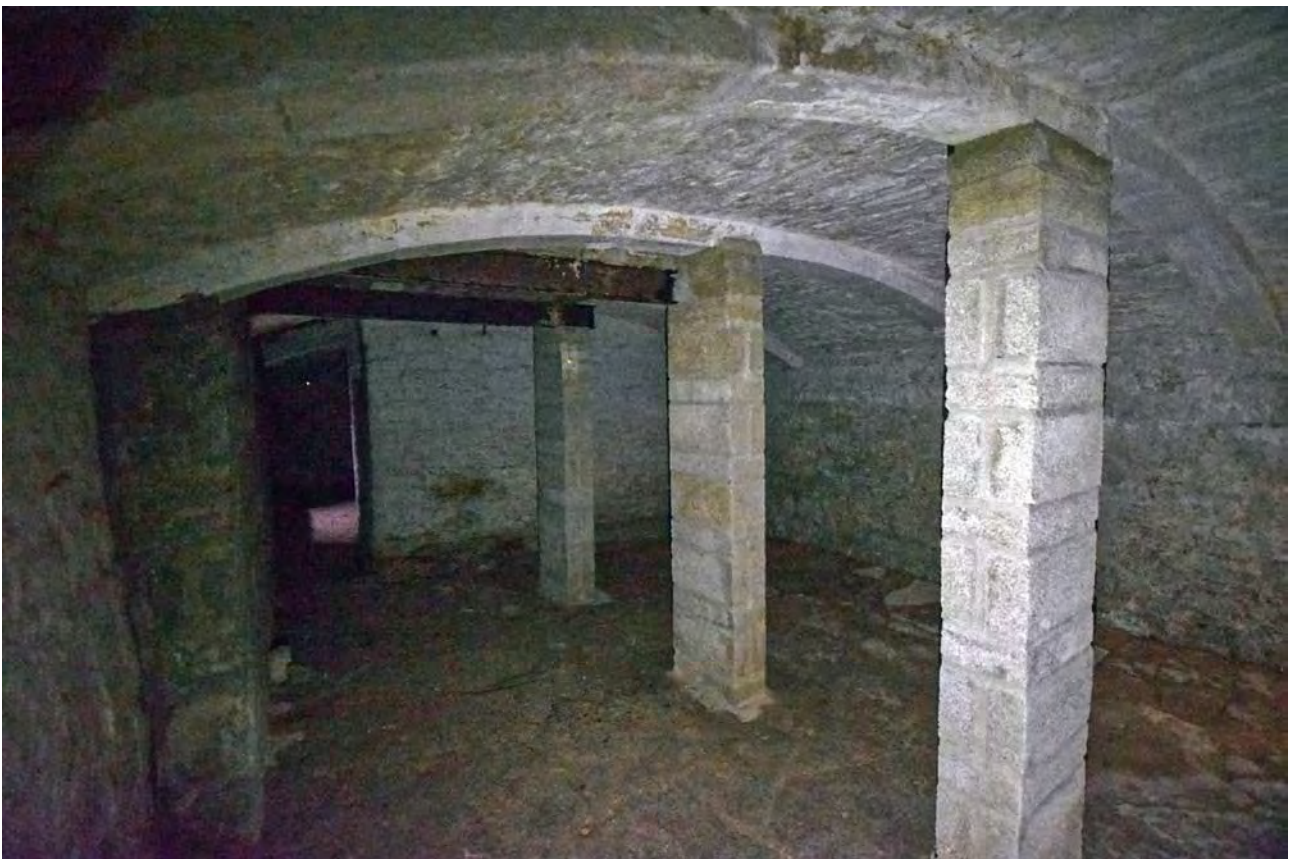
Plate 6: The north chamber of the cellar, looking south

- 3.3.1 Aldsworth Manor is built over four bays running north to south, and underneath the east side of the two southern bays is stone-built, rib vaulted cellar, which predates the house in its current form (Figure 4). It is reached by means of a trapdoor in the floor of the sitting room, situated in the second bay from the north. The trapdoor itself looks to date to the 20th century and is contemporary with the timber floor. However, the steps that ascend north to south from the opening are of some age, and deep hollows are worn into the stone treads (Plate 5). The treads start about half a metre below the opening on the north side and it can only be assumed that the opening once extended further north to accommodate more steps, reaching ground level. Timber ladder steps have been placed over the existing treads for ease of access. The steps lead to a stone door opening with a chamfered, four-centred arch that provides access into the north chamber of the cellar. This chamber is separated from the south chamber by the large, stone chimney stack situated between the two southern bays, and they are connected by a narrow passage on its east side. The chambers are stone built with irregularly laid flagstone floors and have stone, segmental rib vaulting with chamfers traversing the ceilings east to west (Plate 6).

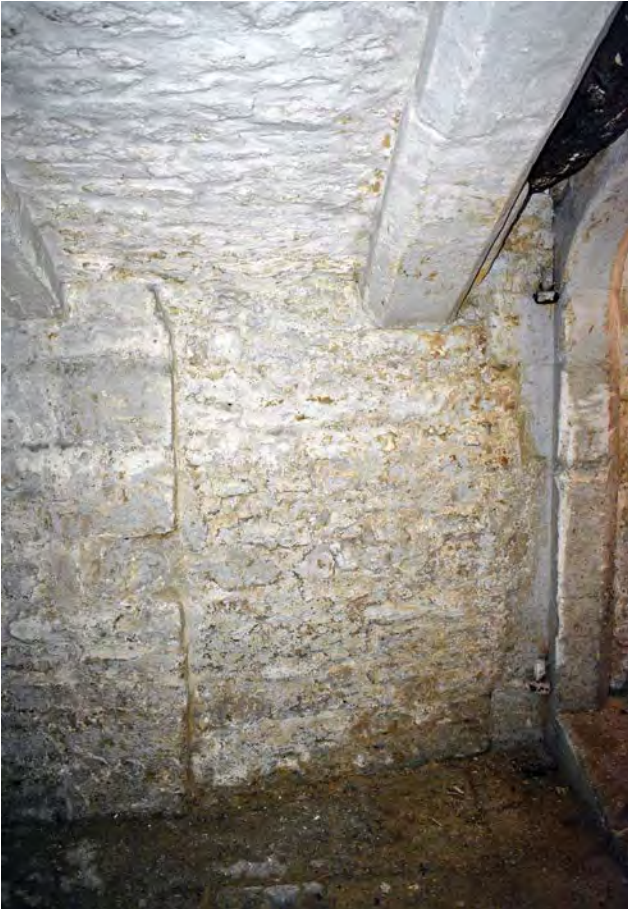
Plate 7: The north chamber of the cellar, looking west

- 3.3.2 Where the west end of the northern most rib in the north chamber meets the wall is lower than the opening of the doorway to its immediate north. Behind the rib is some ironwork in the jamb of the doorway that a door would once hung from but would now be obstructed by the rib. This could suggest that the doorway predates the rib vaulting. Furthermore, between the northernmost rib and that to its immediate south, there is a straight joint in the wall featuring what appears to be ashlar quoining on the south side, which is almost certainly evidence of an earlier phase (Plate 7).

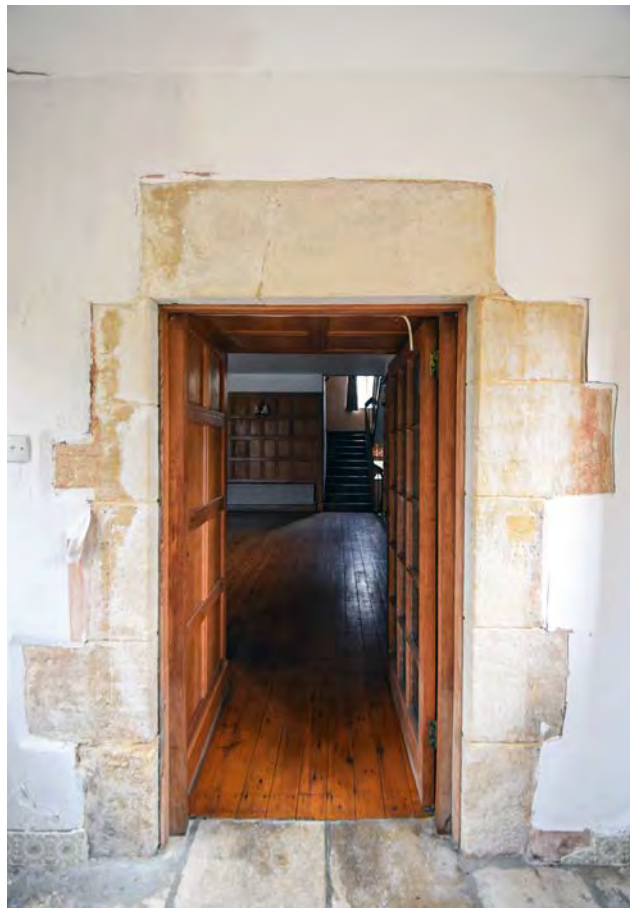
Plate 9: The ground floor of the porch tower, looking west

- 3.3.6 Aldsworth Manor is entered through the ground floor of the porch tower on the east side, and through the back door and the doorway in the back hall on the west side. The ground floor of the porch tower has small, two-light casement windows in its north and south walls and a door opening with a modern door in its east wall. The floor is laid with stone flagstones and the room is painted white except for the quoining around the openings. The stone of the windows and the door in the east wall is clearly later than that of the doorway in the west wall (Plate 9).

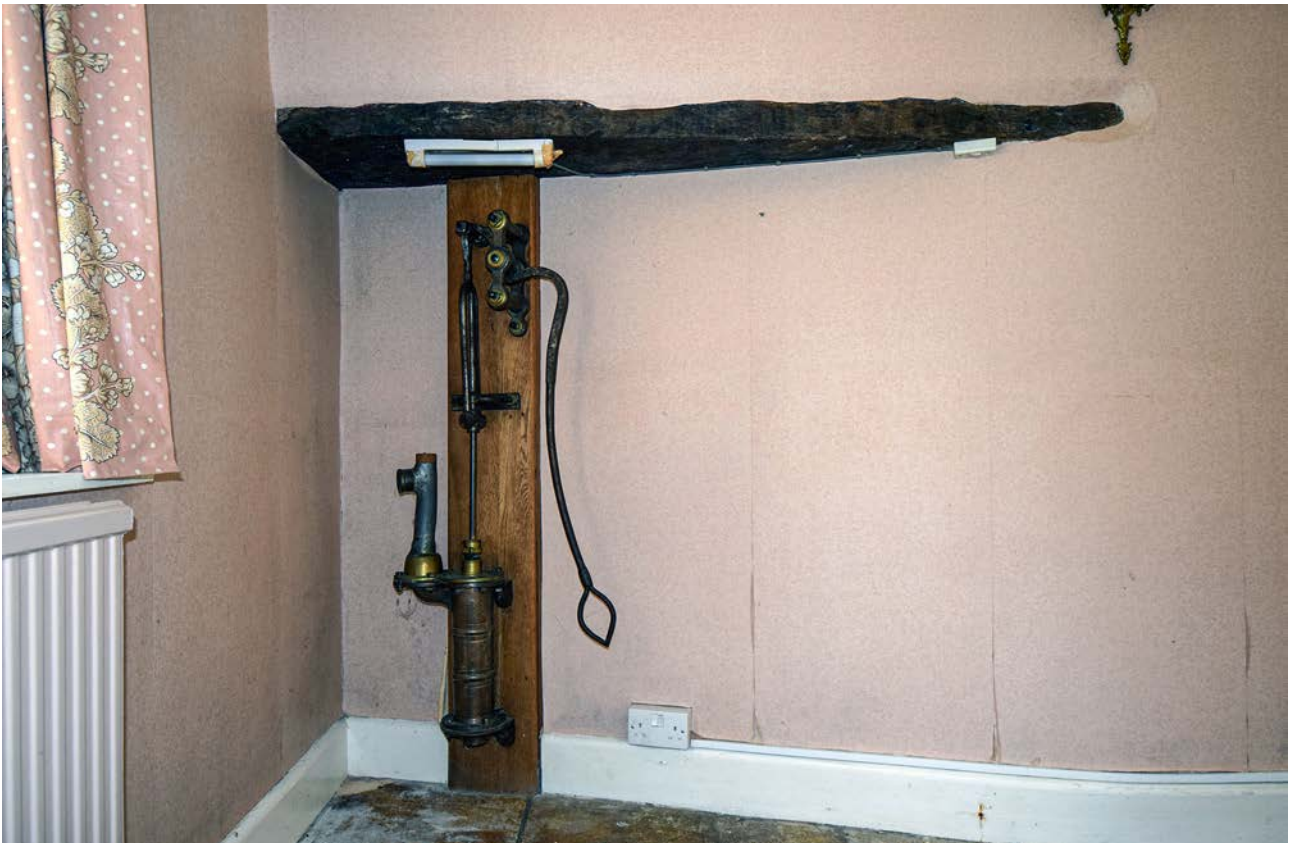
Plate 19: The water pump in the north-east corner of the dining room, looking north-east

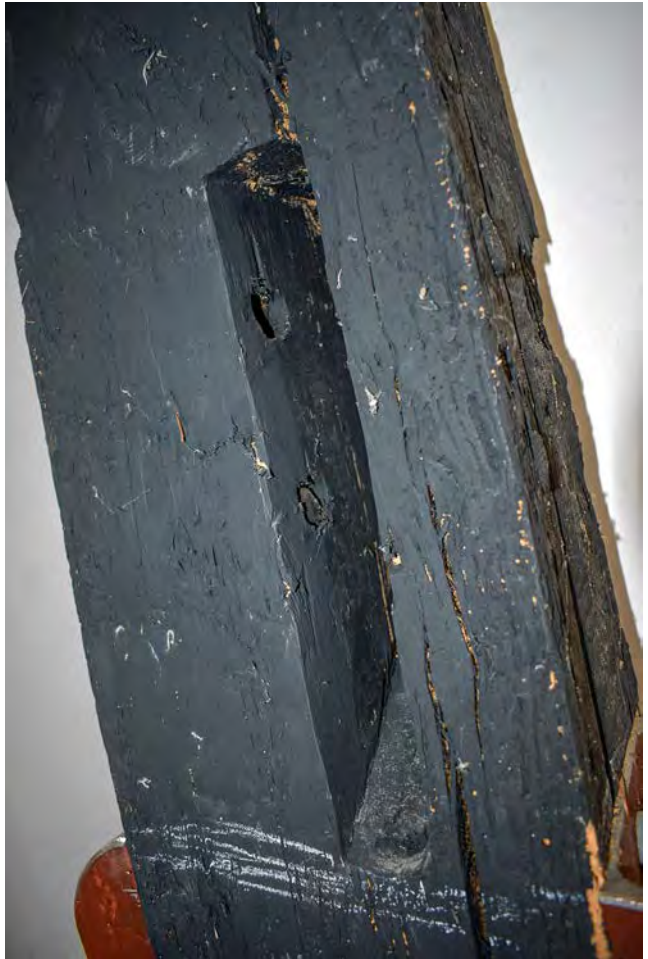
Plate 39: Empty mortise in the truss in the attic corridor, looking south-west

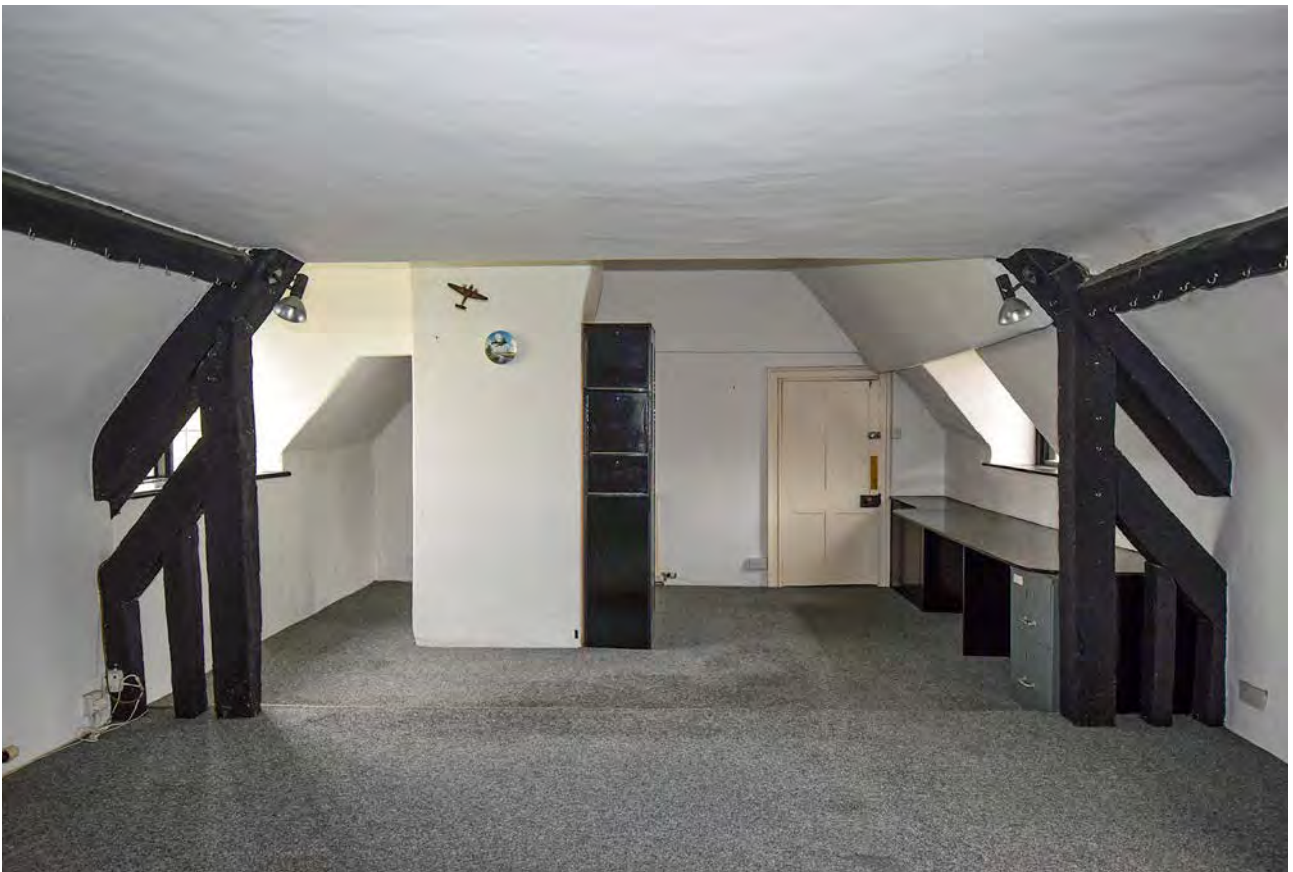
Plate 44: Bedroom 8, looking south

3.3.33 **Bedroom 8** is entered through a doorway in the north end of the corridor with a 19th-century, four-panel door, an iron lock box and a narrow, moulded architrave. It is a large room that takes up the north bay and partially takes up the next bay to the south. The chimney breast that separates these bays stands in isolation towards the south end of bedroom 8 (Plate 44). It has no fireplace and has modern shelving units against its south and west sides. Two dormer openings featuring timber-framed, two-light casement windows with leaded panes extend from the west side of the pitched ceiling. The windows are 20th-century in date. A further dormer opening extends from the west side and the casement window here has three lights with leaded panes, also dating to the 20th century. These windows are likely to be contemporary with the 19th-century joinery in the attic. Against the west gable is 20th-century shelving and along the west wall, under the windows, is a 20th-century sideboard.

3.3.34 Various elements of the roof structure of the manor house are visible in this room. The principal rafters of two trusses can be seen as well as the intermediary butt purlins. Supporting the truss on the south side are large struts, which presumably rest on a beam concealed by the step. Tenoned into the struts, and running parallel underneath the principal rafters, are diagonal braces, themselves supported by two shorter struts. In the north-east corner of the room is the doorway into a small storage space and the lower purlin of the east side of the roof can be seen here, resting in the stonework of the north gable (Plate 45). Above it are the historic common rafters and at least one modern common rafter. Here, unlike other rooms where the purlins were cut, it is likely to be concealed underneath the windows.

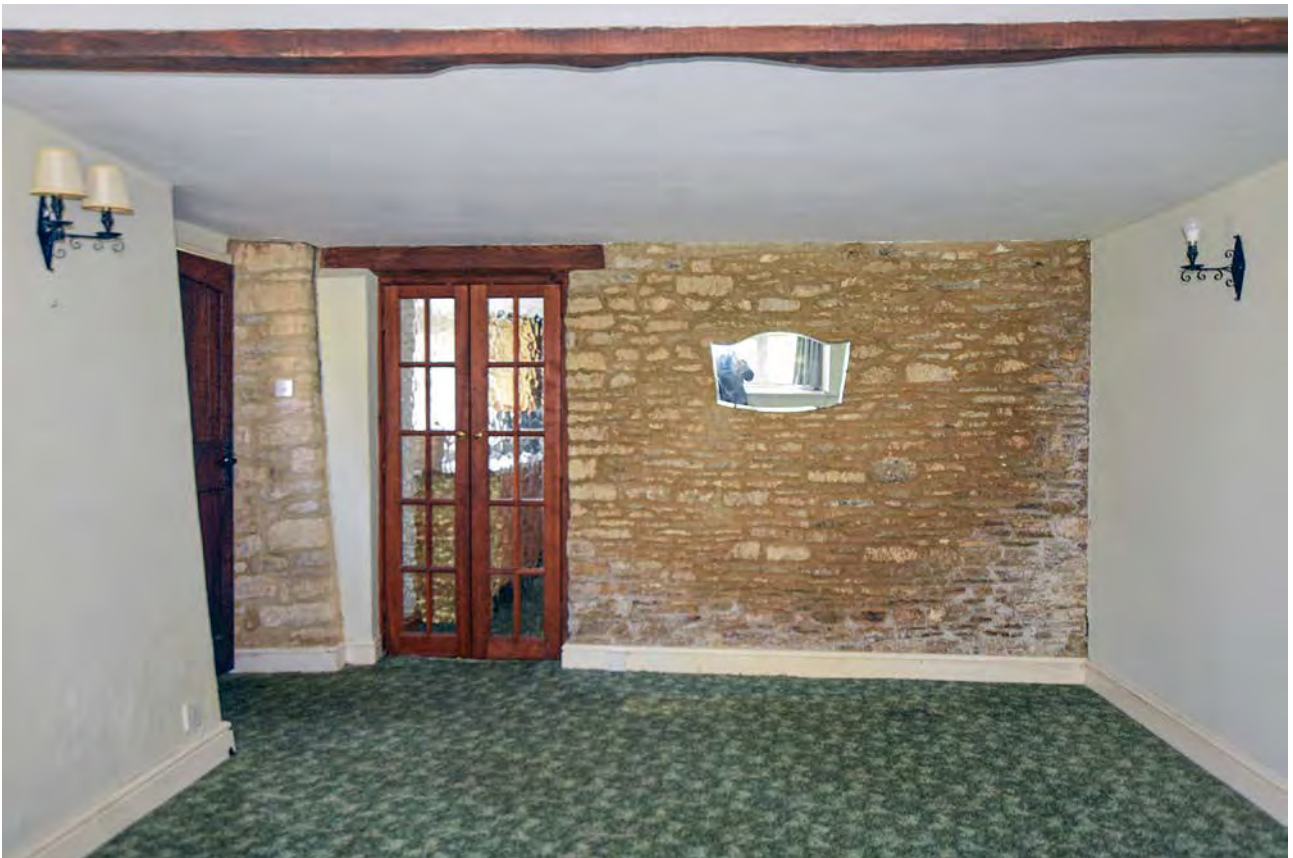
Plate 48: The sitting room of the cottage, looking south

- 3.4.4 The cottage is divided into two bays, north and south (Figure 8). It is entered through the doorway in its east elevation and it opens into the north bay, a small sitting room with a bare, stone wall on its south side (Plate 48). In the north and east walls are the window openings, over which are historic, timber lintels. A timber beam that crosses the ceiling, east to west, has signs of being machine cut, indicating that it is later and likely to have been inserted when the building was converted. The room has modern carpeting, skirting boards and light fittings to the walls. Modern, glazed double doors have been inserted into a gap in the stonework on the south side. These doors open into the south bay.

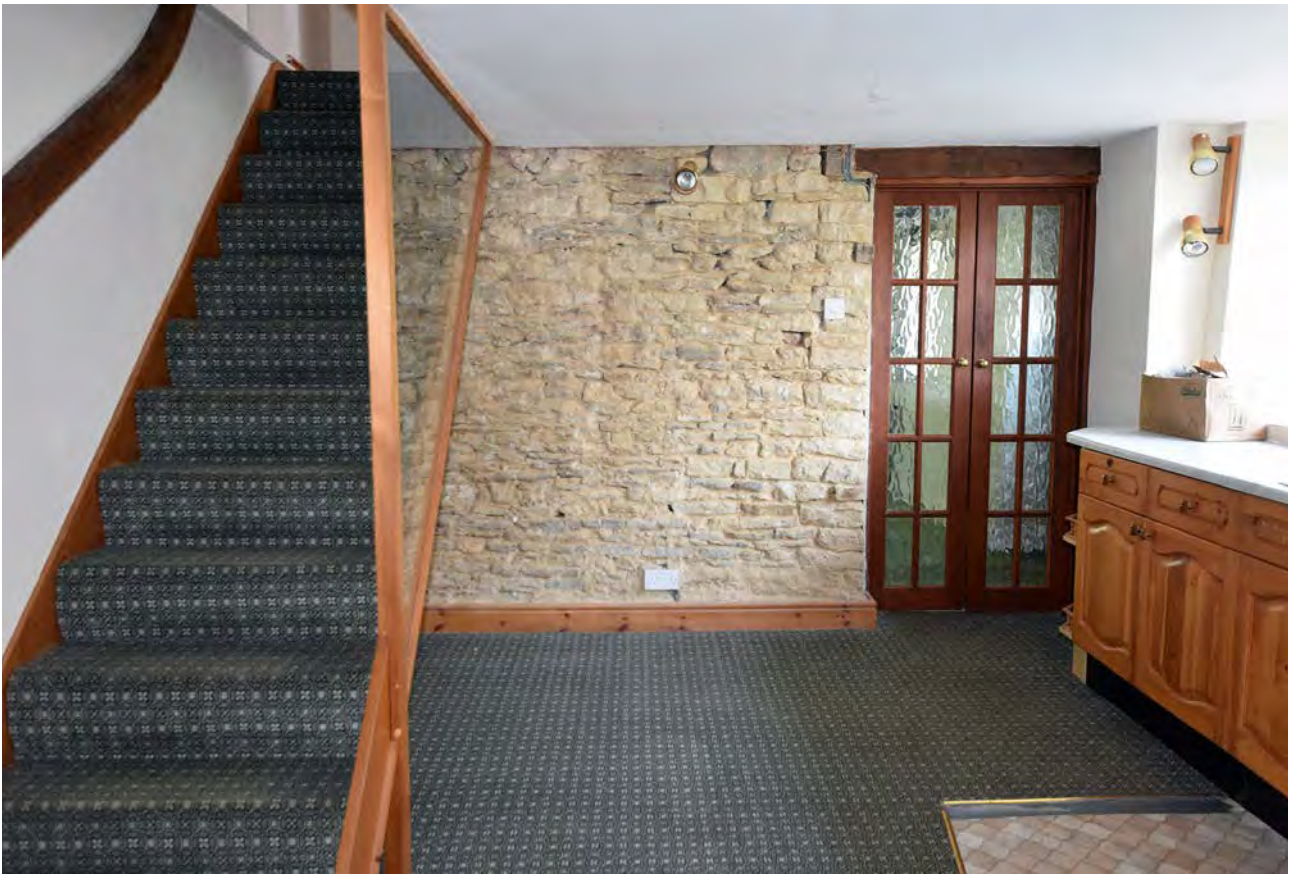
Plate 49: The kitchen of the cottage, looking north

- 3.4.5 The south bay of the cottage is a small kitchen-dining room with modern kitchen units along the east and south sides. Against the west wall is a modern staircase that ascends south to north (Plate 49). It has closed treads and is enclosed with a glass panel on its east side. The wall that divides the bays has bare stonework on this side also. The beam that crosses the ceiling east to west has signs of being machine cut, indicating it was probably put in when the cottage was converted from outhouses. In the south wall is a doorway with a modern, glazed door that leads to the lean-to. The room otherwise has modern carpeting, skirting boards and light fittings to the walls. There is modern linoleum around the kitchen units that is the same as that in the kitchen of the manor house, suggesting changes were made to both buildings at the same time.

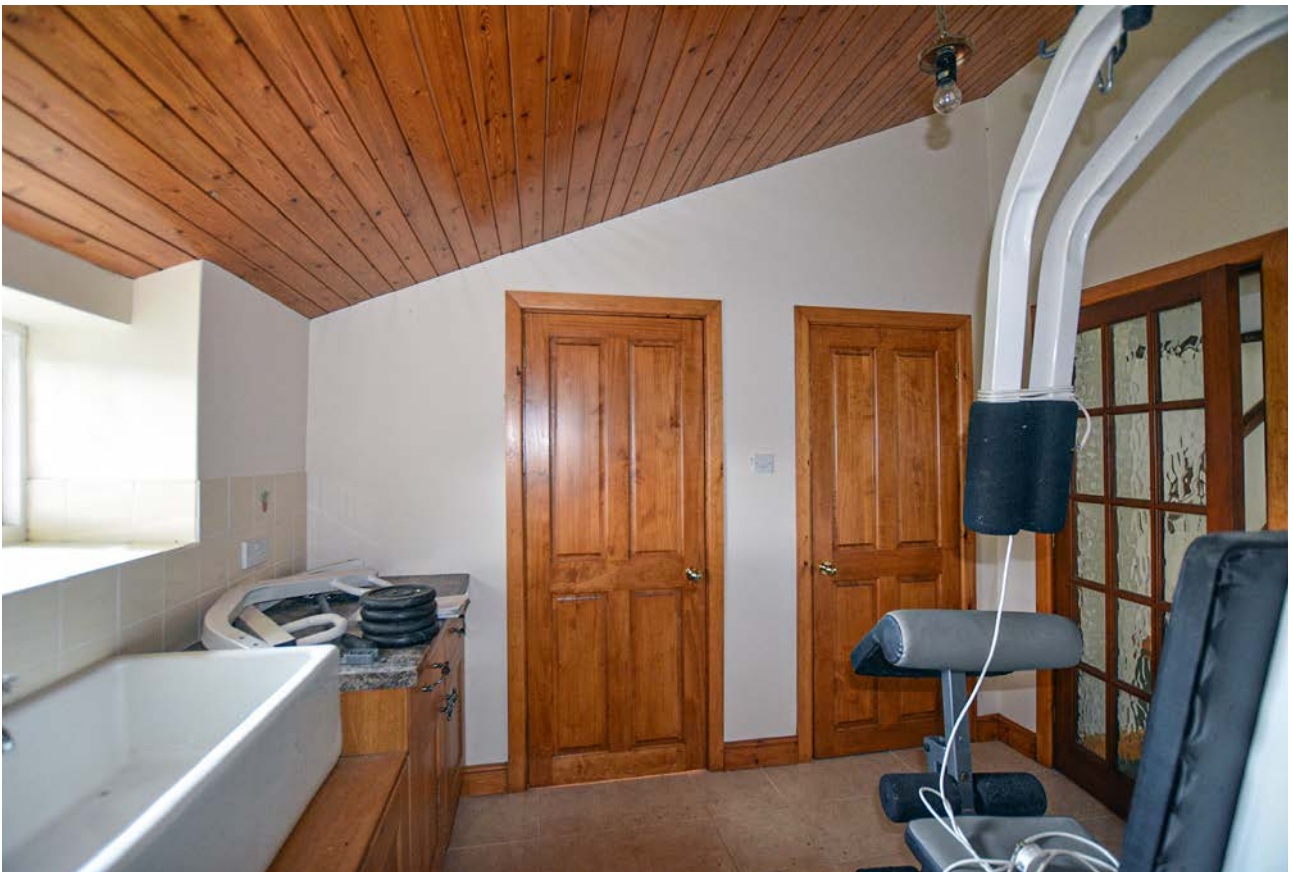
Plate 50: The utility room of the cottage, looking west

- 3.4.6 The interior of the lean-to is modern in appearance with kitchen units and a Belfast sink against the south wall under the window (Plate 50). The ceiling has modern,

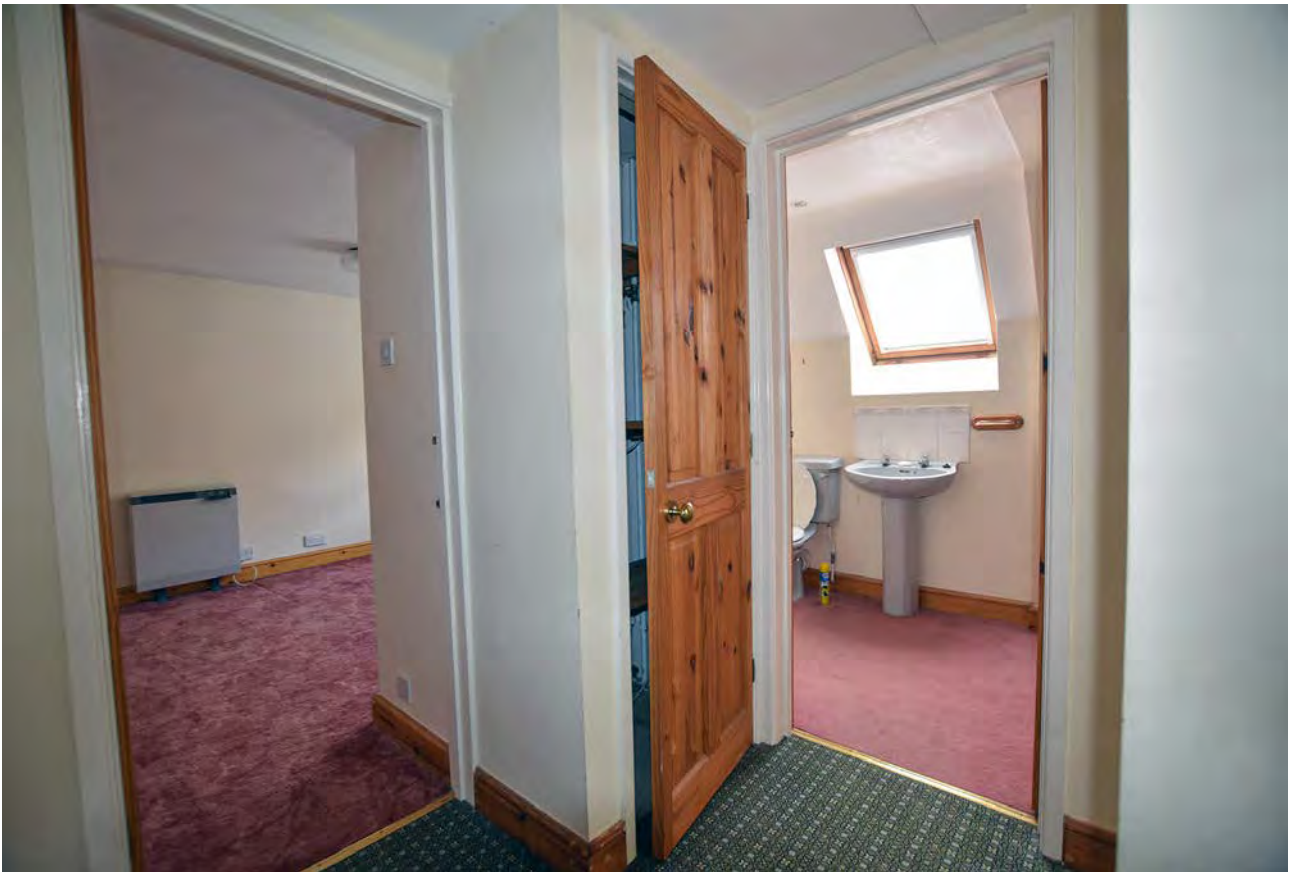
Plate 51: The attic landing of the cottage, looking north-east

- 3.4.7 The stairs to the attic level of the cottage open onto a small landing on the west side (Plate 51). On the east side is a doorway into a modern bathroom and on the north and south sides are doorways into two small bedrooms (Figure 9). Another doorway between that of the bathroom and the north bedroom leads to a small space with a boiler. This upper floor is clearly a modern insertion with modern subdivisions of space. The joinery, skirting boards, doorways and windows are all modern and appear to be contemporary with each other.

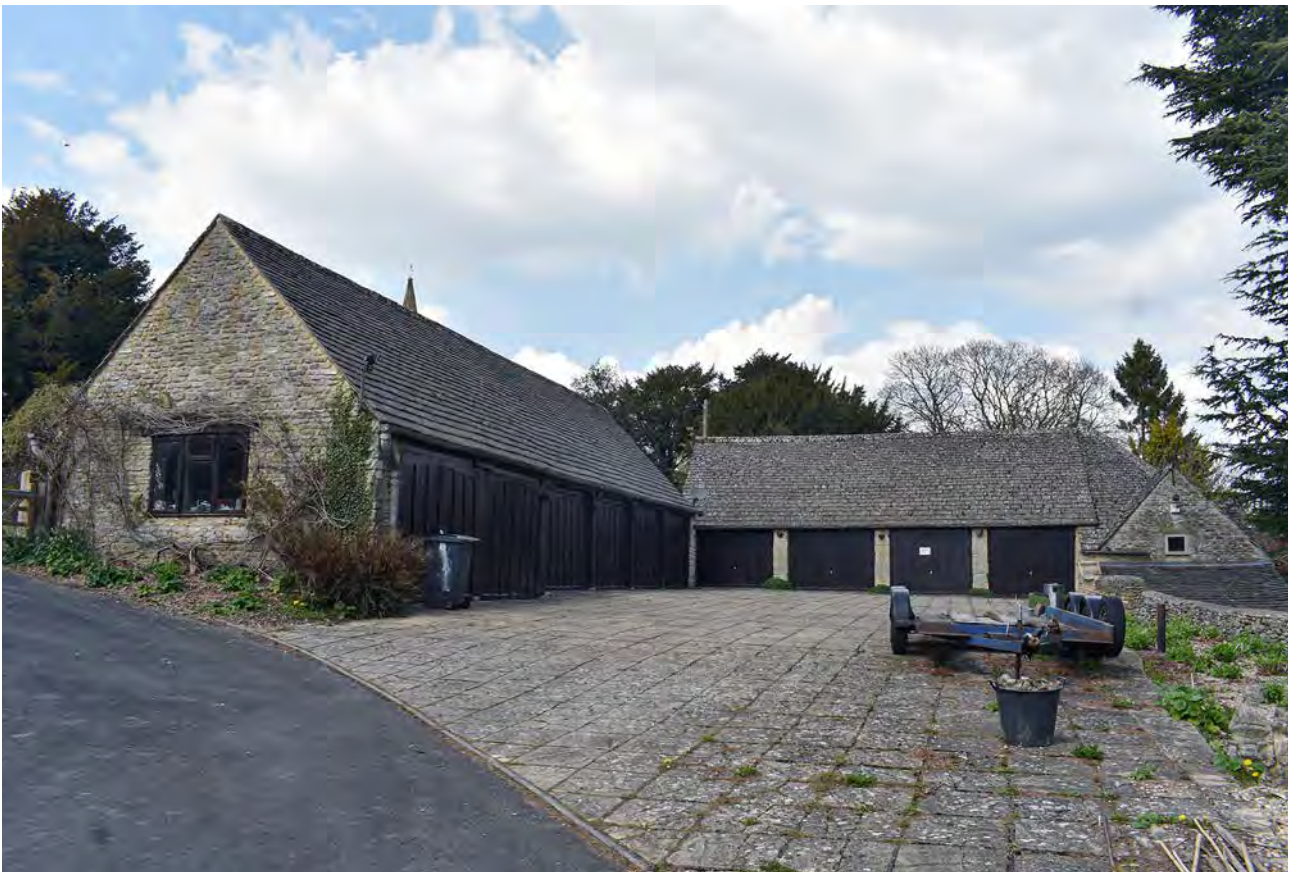
Plate 52: The garages, looking north

- 3.5.1 The garages are situated on a wide terrace elevated over the manor house on the west (Plate 52). These were altered substantially by the previous owners in the 1980s. The flagstone paved terrace is reached by means of a small road that turns from the road that runs southwards from the east front of the manor house, and runs northwards and up the hill. The garages comprise two linear buildings. That on the north side of the terrace is orientated east to west and extends eastwards from the cottage. That on the west side of the terrace is orientated north to south, running perpendicular to the north garage (Figures 8 & 9). The west garage, which faces east over the terrace, has six bays, denoted by six large garage doors along its east side (Figure 10). These are modern timber doors but the gable end walls on the north and south sides are stone and likely to be earlier. The pitched roof is covered with stone tiles. On the interior, the shell of the building is lined with concrete breezeblocks on the north, west and south sides (Plate 53). The space is divided into two large rooms with a smaller vestibule room between them, behind which is a narrow, closed staircase that ascends west to east to the roof space over the larger, northern room. The partitions are built with plywood boards (Plate 54). The roof space has a floor made from plywood boards over a series of east to west running, softwood joists. Along the west side of the roof are four Velux windows, two of which illuminate the room on the south side and two of which illuminate the roof space. There is also a modern, four-light picture window in the south gable of the garage.
