# Witley Court Service Wing Great Witley Worcestershire

## Buildings Analysis

**Witley Court Service Wing**  
**Great Witley, Worcestershire**

*Historic Building Analysis*

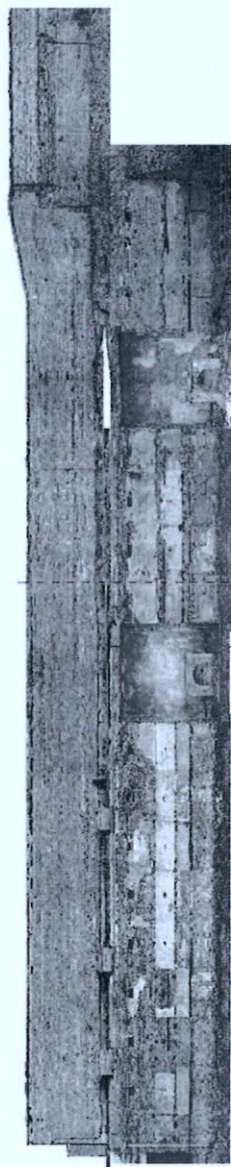
Drawing  
No. Figure 9

Title  
Overall view of the  
north stables, elevation  
and plan.

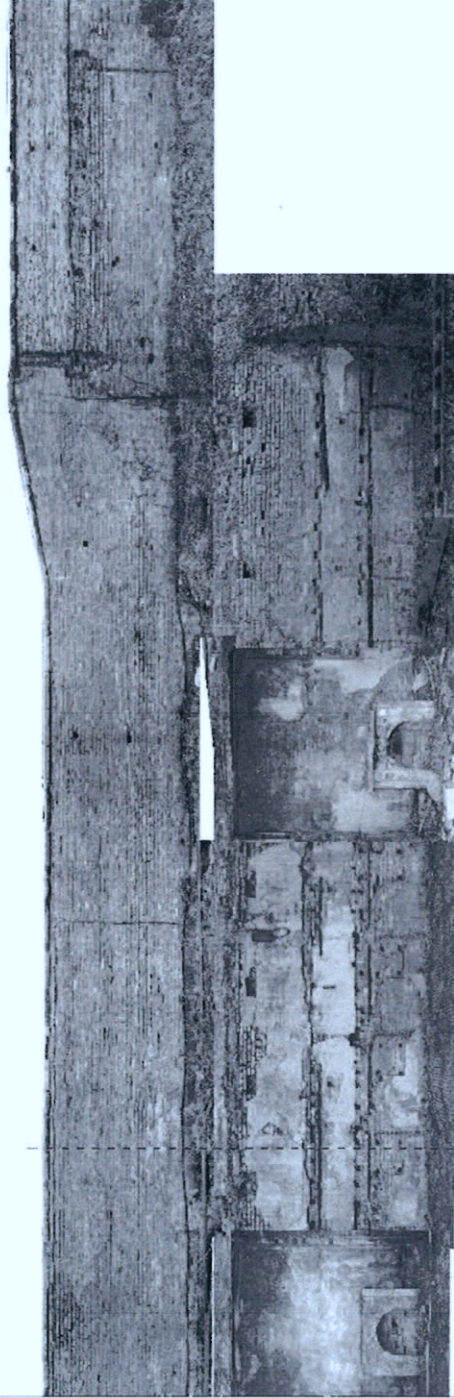
Title  
East end of the north  
stables.

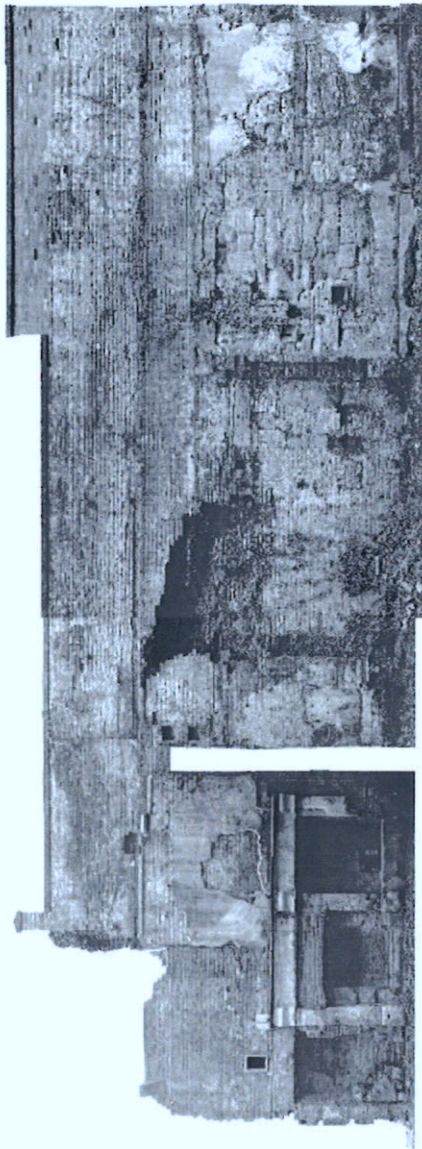
Drawing  
No.  
Figure 20

- Key
- Flue
  - Wood
  - Iron box
  - Render
  - Perpendicular walls

Title  
East facing internal  
elevation of the  
kitchen and east  
churchyard wall.

Figure 19	Reconstruction of Kitchen and Scullery
Figure 20	Kitchen and scullery: elevation
Figure 21	Kitchen and Scullery: elevation showing flues and voids
